' PRESERVATION BRIEFS

The Maintenance and Repair of Architectural Cast Iron

John G. Waite, AIA

U.S. Department of the Interior
National Park Service
Cultural Resources

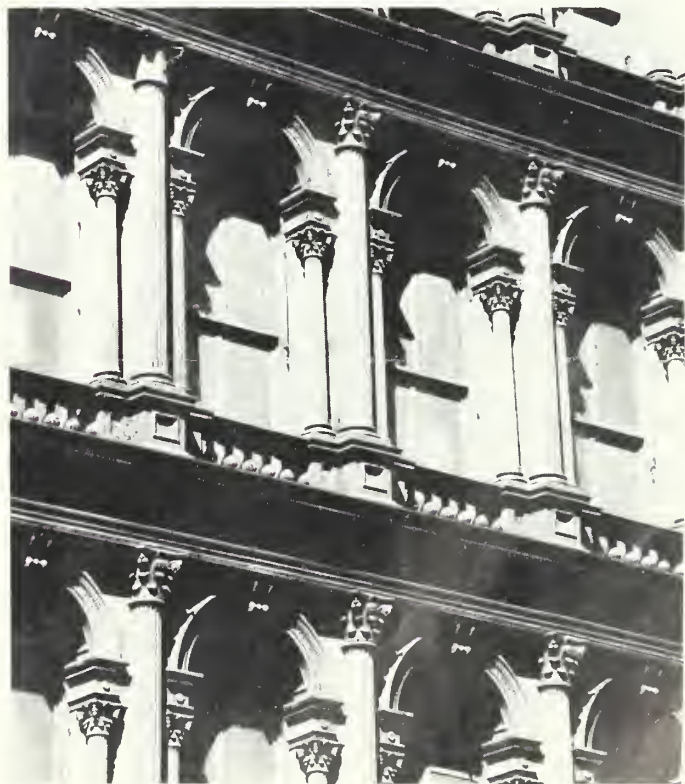
Fig. 1. The Haughwout Building in New York City is an excellent example of the quality and character of mass-produced cast-iron architecture. Once wood patterns were made, any number of elements could be cast, as was done with each of these repetitive bays. Photo: New York City Landmarks Preservation Commission.

Cast iron played a preeminent role in the industrial development of our country during the 19th century. Cast-iron machinery filled America's factories and made possible the growth of railroad transportation. Cast iron was used extensively in our cities for water systems and street lighting. As an architectural metal, it made possible bold new advances in architectural designs and building technology, while providing a richness in ornamentation (Fig. 1).

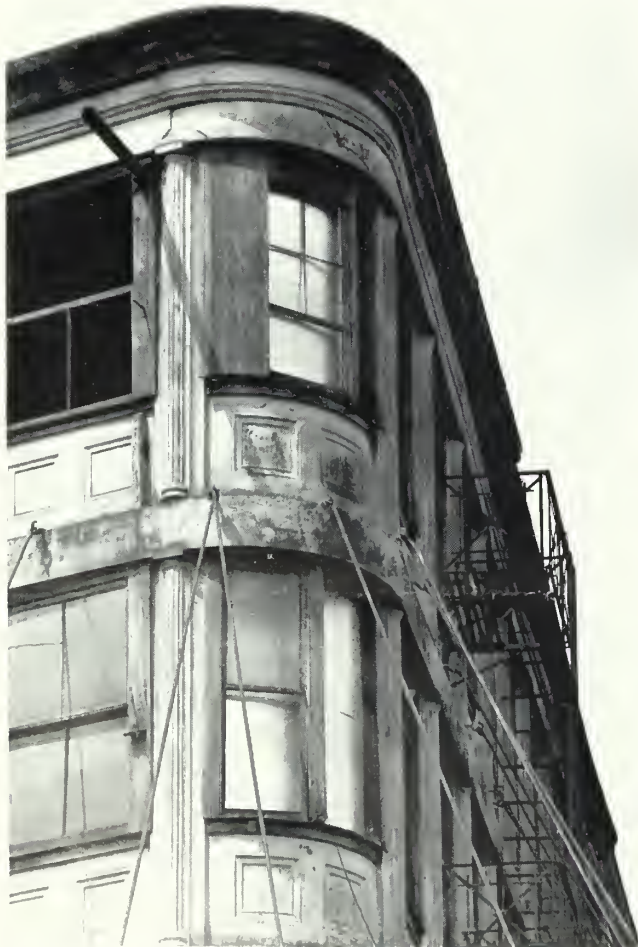
Fig. 2. The Edgar Laing Stores Block in New York City was designed by James Bogardus. It was the first building constructed with facades of self-supporting cast iron. This corner view shows the Doric-style engaged columns, panels, and spandrel beams; the loss of most of the original ornamental castings give it an austere look. As part of an urban renewal project, the facades were carefully disassembled in 1971 for later re-creation in another location—only to have its iron parts stolen for scrap. Photo: Jack E. Boucher, HABS Collection.

In 1849 Bogardus created something uniquely American when he erected the first structure with self-supporting, multi-storied exterior walls of iron. Known as the Edgar Laing Stores, this corner row of small four-story warehouses that looked like one building was constructed in lower Manhattan in only two months. Its rear, side, and interior bearing walls were of brick; the floor framing consisted of timber joists and girders. One of the cast-iron walls was load-bearing, supporting the wood floor joists. The innovation was its two street facades of self-supporting cast iron, consisting of multiples of only a few pieces—Doric-style engaged columns, panels, sills, and plates, along with some applied ornaments (cover photo and Fig. 2). Each component of the facades had been cast individually in a sand mold in a foundry, machined smooth, tested for fit, and finally trundled on horse-drawn drays to the building site. There they were hoisted into position, then bolted together and fastened to the conventional structure of timber and brick with iron spikes and straps (Fig. 3).

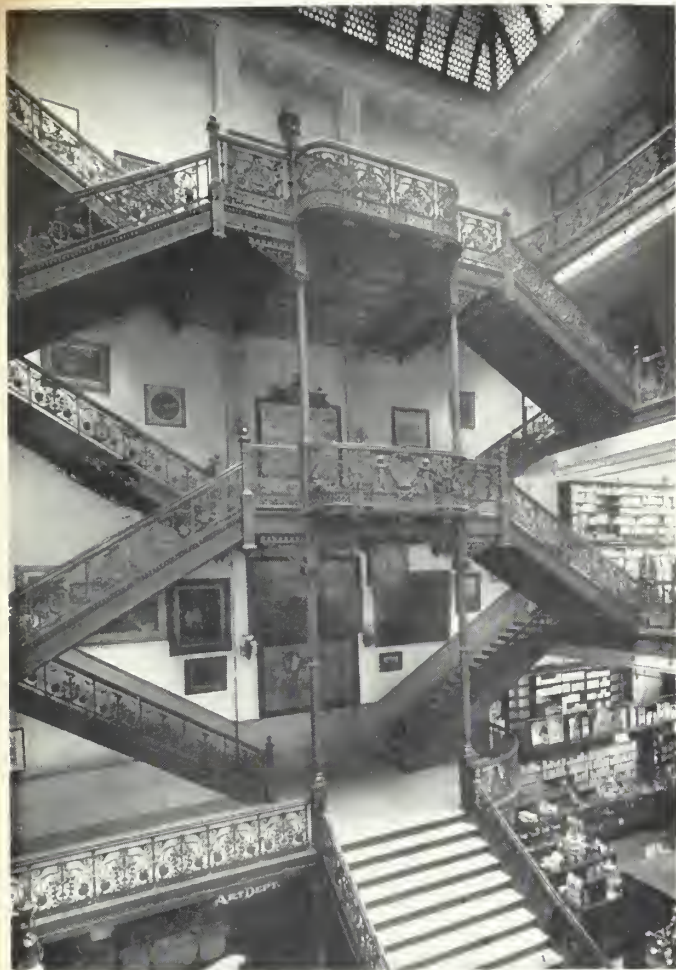
Fig. 4. The 1904 grand stairway of the former Frear's department store in Troy, N.Y. was constructed of cast iron, as was the frame of the skylight above. Some ornamental wrought iron was also employed. This use of iron was typical in major commercial buildings constructed throughout the United States. Courtesy: Rensselaer County Historical Society.

In addition to these exterior uses, many public buildings display magnificent exposed interior ironwork, at once ornamental and structural (Fig. 4). Remarkable examples have survived across the country, including the Peabody Library in Baltimore; the Old Executive Office Building in Washington, D.C.; the Bradbury Building in Los Angeles; the former Louisiana State Capitol; the former City Hall in Richmond; Tweed Courthouse in New York; and the state capitols of California, Georgia, Michigan, Tennessee, and Texas. And it is iron, of course, that forms the great dome of the United States Capitol, completed during the Civil War. Ornamental cast iron was a popular material in the landscape as well, appearing as fences, fountains with statuary, lampposts, furniture, urns, gazebos, gates, and enclosures for cemetery plots (Fig. 5). With such widespread demand, many American foundries that had been casting machine parts, bank safes, iron pipe, or cookstoves added architectural iron departments (Fig. 6). These called for patternmakers with sophisticated design capabilities, as well as knowledge of metal shrinkage and other technical aspects of casting. Major companies included the Hayward Bartlett Co. in Baltimore; James L. Jackson, Cornell Brothers, J. L. Mott, and Daniel D. Badger's Architectural Iron Works in Manhattan; Hecla Ironworks in Brooklyn; Wood & Perot of Philadelphia; Leeds & Co., the

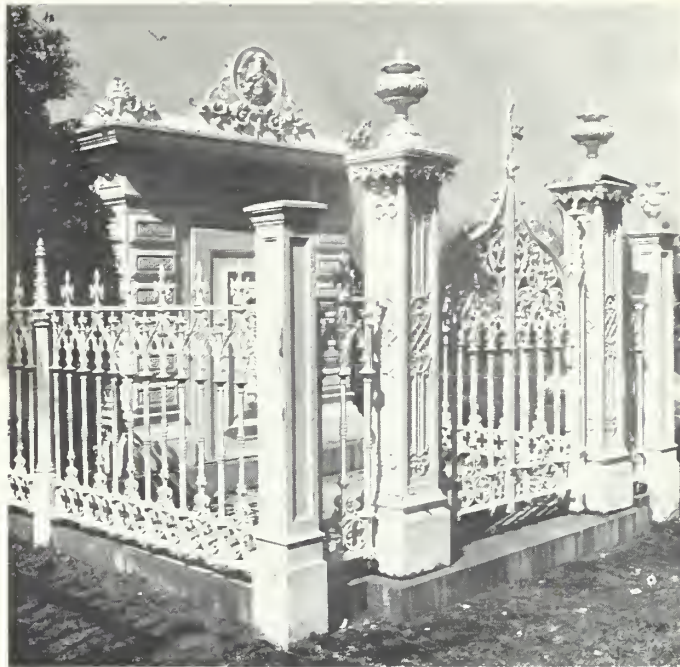
Fig. 5. The Slatter Family Tomb in Mobile, Alabama, consisting of a cast-iron manseloni and fence, exhibits the wide range of uses of the material in the 19th century. Photo: Jack E. Boncher. HABS Collection.

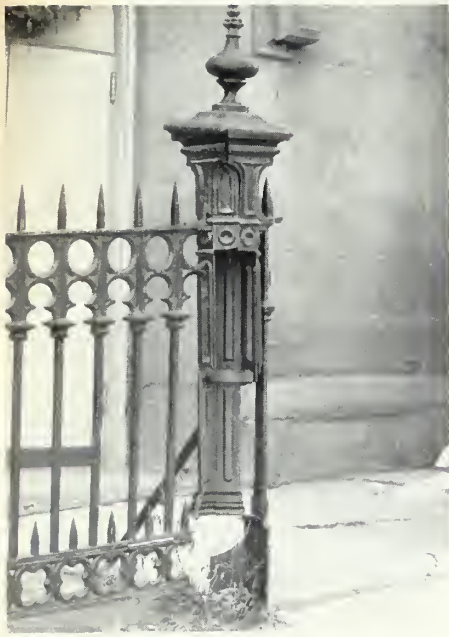
Fig. 7. Despite an impact that shattered the main castings, this fence post remains upright, demonstrating the great strength of cast iron. Originally, the post was held together by a long bolt that extended from the finial to the base. Photo: John G. Waite.

Common problems encountered today with cast-iron construction include badly rusted or missing elements, impact damage, structural failures, broken joints, damage to connections, and loss of anchorage in masonry (Figs. 7, 8).

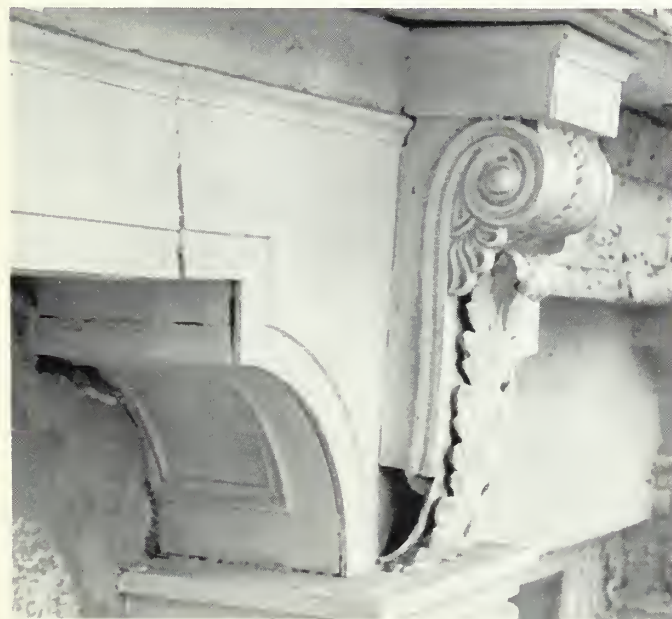
Fig. 8. Structural cracks, gaps at joints between components, and a large opening where part of the console bracket is missing are the problems evident in this cast-iron assembly. Photo: Ford, Powell & Carson.

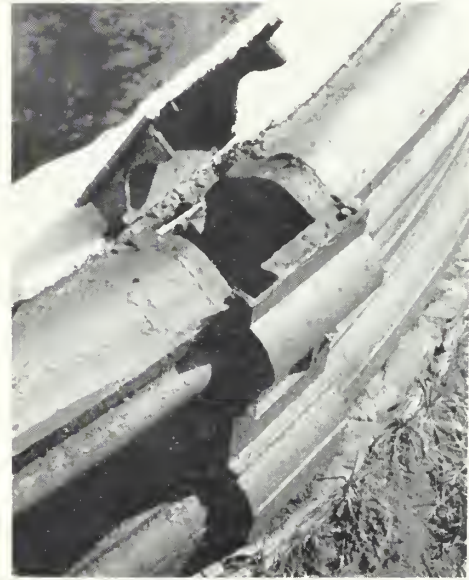
Fig. 9. Galvanic corrosion occurred where a patch of copper was installed alongside the cast-iron cap at the base of a fountain. The use of terne-coated stainless flashings with appropriate caulking would have been a more suitable repair. Photo: John G. Waite.

Galvanic corrosion is an electrochemical action that results when two dissimilar metals react together in the presence of an electrolyte, such as water containing salts or hydrogen ions (Fig. 9). The severity of the galvanic corrosion is based

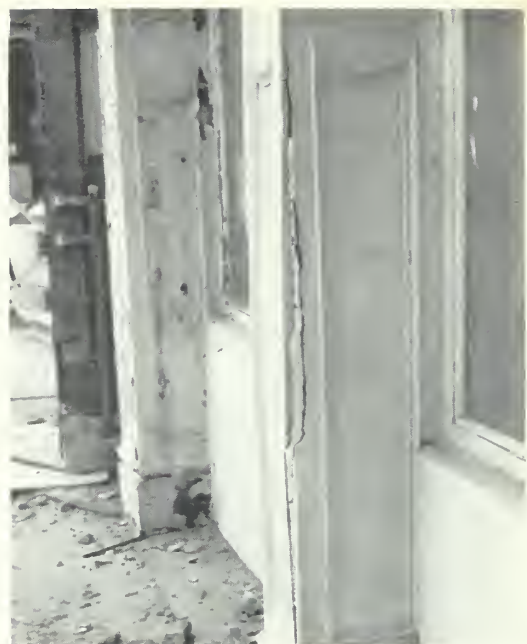
Fig. 11. Major cracks in the piers of this cast-iron storefront in Galveston, Texas resulted from the transfer of load onto the iron from internal brick piers eroded by rising damp. This crack was inappropriately filled with concrete, which trapped moisture and accelerated internal corrosion, pushing the iron further apart. Photo: Ford, Powell & Carson.

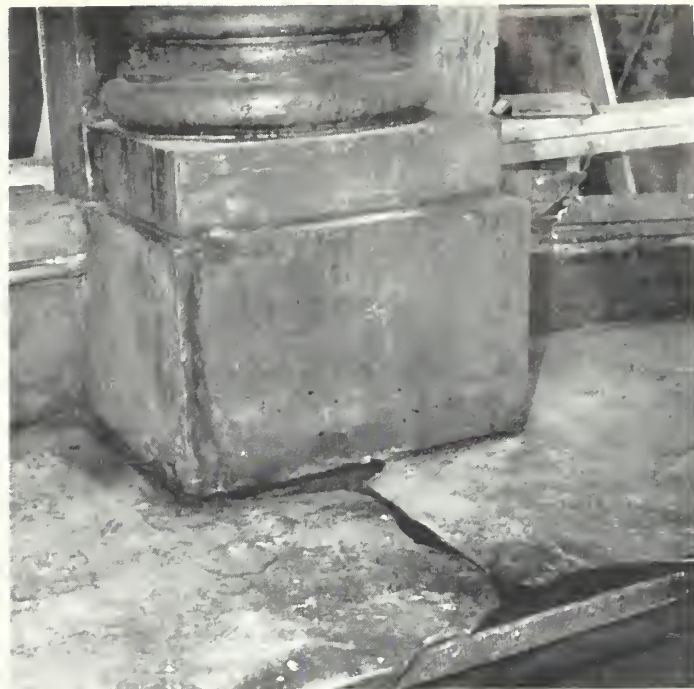
Fig. 12. Paint stripping exposed a large defect under a faulty patch at a joint of this wide cast-iron water table. The damage can be repaired mechanically by splicing in a cast-iron replacement piece. Photo: Peter Jensen, Kapell and Kostow Architects.

Many of these techniques are *potentially dangerous* and should be carried out only by experienced and qualified workers using proper eye protection, protective clothing, and other workplace safety conditions. Before selecting a process, test panels should be prepared on the iron to be cleaned to determine the relative effectiveness of various techniques. The cleaning process will most likely expose additional coating defects, cracks, and corrosion that have not been obvious before (Fig. 12).

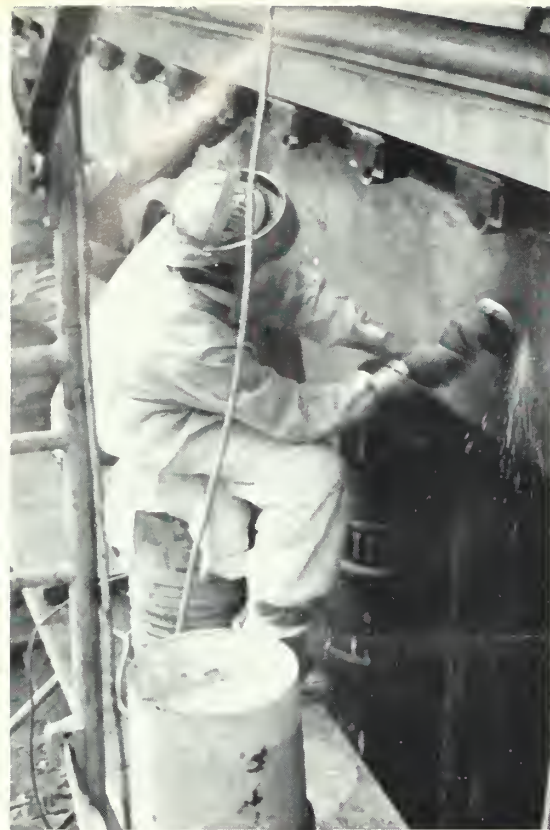
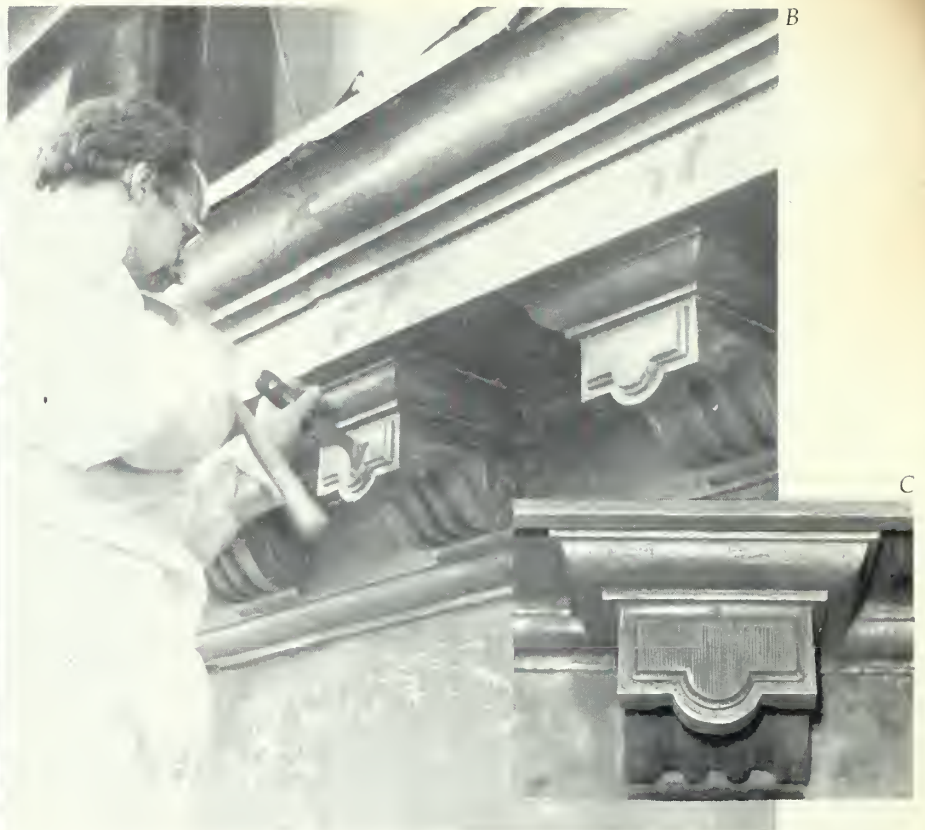
Fig. 13. Surface preparation may involve several different techniques. Where chemical paint stripping is involved, careful planning of the sequence of work and inspection by an architect or conservator to ensure strict compliance with the contract documents is important to minimize the risk of problems. After the chemical paste and paint was scraped off, the remaining paint and chemical residue were removed with a wire brush (a) and scrapers selected or cut to fit the shape of the iron surfaces (b). The surface was then wiped with solvent to create a completely clean surface prior to repainting (c). Photos: Raymond M. Pepi, Building Conservation Associates.

Hand scraping, clipping, and wire brushing are the most common and least expensive methods of removing paint and light rust from cast iron (Fig. 13a, b). However, they do not remove all corrosion or paint as effectively as other methods. Experienced craftsmen should carry out the work to reduce the likelihood that surfaces may be scored or fragile detail damaged.

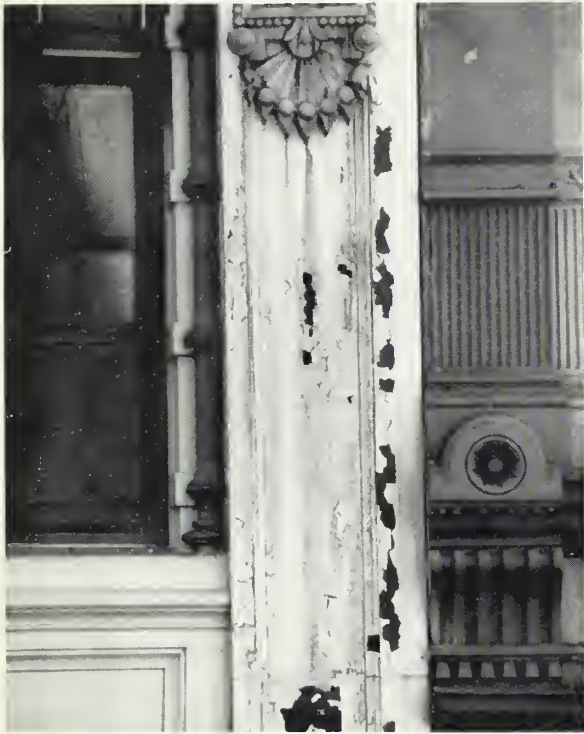
Fig. 14. Major problems can result if work is undertaken without proper sequencing and precautions. On this building, a strong alkaline paint remover was used, and apparently was not adequately rinsed or neutralized. Over a period of months, the newly applied paint began to peel and streaks of rust appeared on the iron. Photo: Kim Lovejoy.

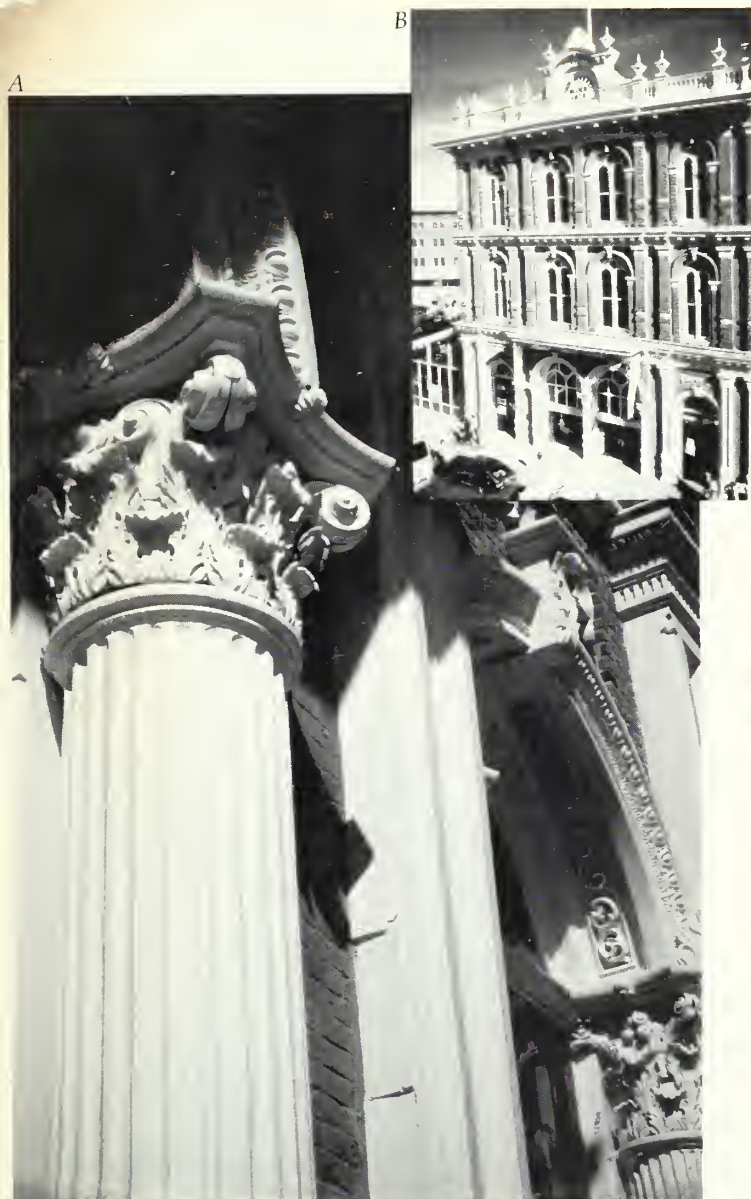
Fig. 19. (a) Fiberglass columns and aluminum capitals were installed to replicate the ornamental features on the east facade of the New Market Theater in Portland, Oregon, that had been destroyed by previous occupants. Like cast iron, crisp ornamental details can be achieved with cast aluminum. Although aluminum may be in contact with fiberglass, galvanic corrosion may result when aluminum is in direct contact with cast iron. Photo: William J. Hawkins, III. (b) The west facade of the theatre retains its original cast iron features. Photo: George McMath.

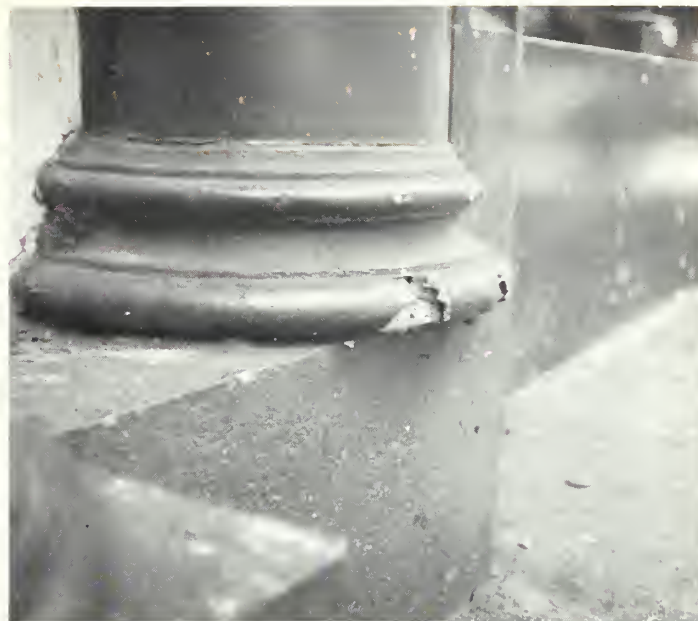
Fig. 20. The location of the feature must be taken into account if a substitute replacement material is being considered. This lightweight fiberglass column at street level sustained damage from impact within a few years of installation. The great strength of cast iron makes it ideal for storefronts and elements that must withstand heavy use. Photo: Building Conservation Associates.

corrosive, but is susceptible to ultraviolet degradation. Because of its rather flimsy nature, it cannot be used as a substitute for structural elements, cannot be assembled like cast iron and usually requires a separate anchorage system. It is unsuitable for locations where it is susceptible to damage by impact (Fig. 20), and is also flammable.

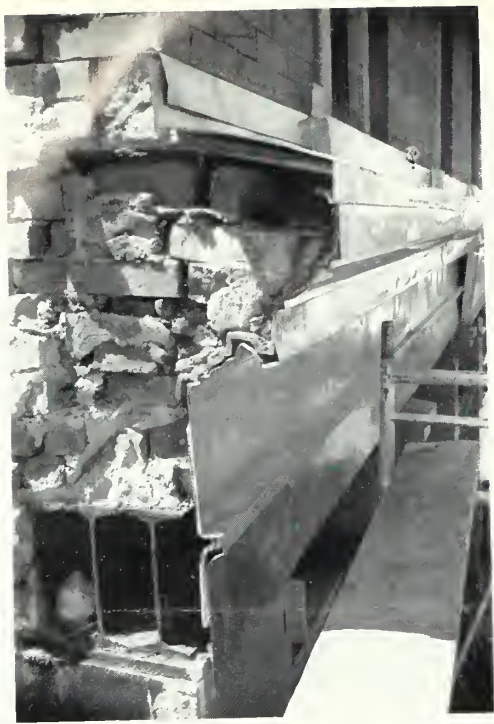
Fig. 18. This cast-iron storefront cornice was corroded beyond the point of repair, and could not be removed easily for replacement. Terne-coated stainless steel, the most durable metal for flashing cast iron, was applied to the cornice and fitted as closely as possible to the historic profile. Although painting is not necessary to protect terne-coated stainless steel, the cornice should be painted to be consistent with the historic character of the building. A primer which is compatible with the terne coating should be used. Photo: Dean Koga, Robert E. Meadows, P.C., Architects.

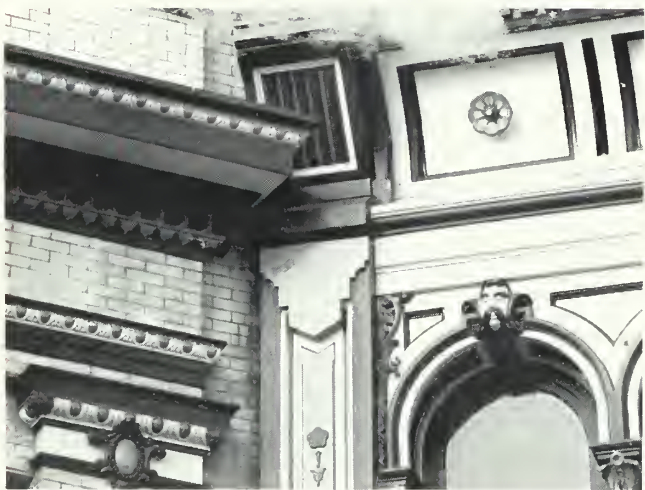
Detail of polychromed cast-iron facade at 23 Petaluma Boulevard, Petaluma, Calif. (1886; O'Connell and Lewis, *Architectural Iron Work*, San Francisco). Photo: Don Meacham.
