Rehabilitating Historic Office Buildings: Two Projects Using Federal Tax Incentives

THE PHYSICIANS BUILDING
FRESNO, CALIFORNIA

THE WYANDOTTE BUILDING
COLUMBUS, OHIO

By William G. MacRostie
National Park Service
Technical Preservation Services

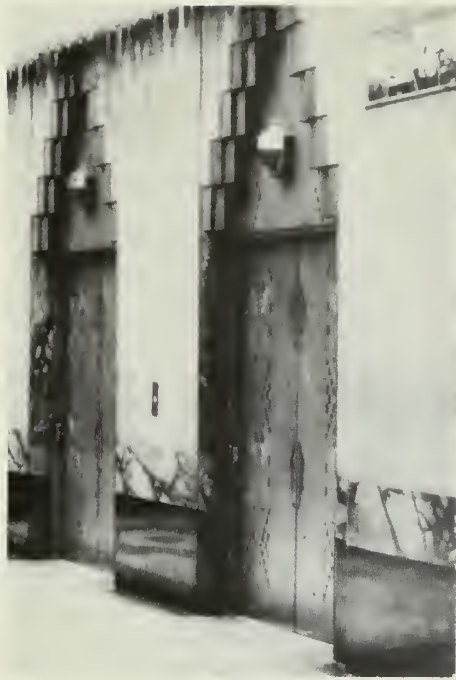
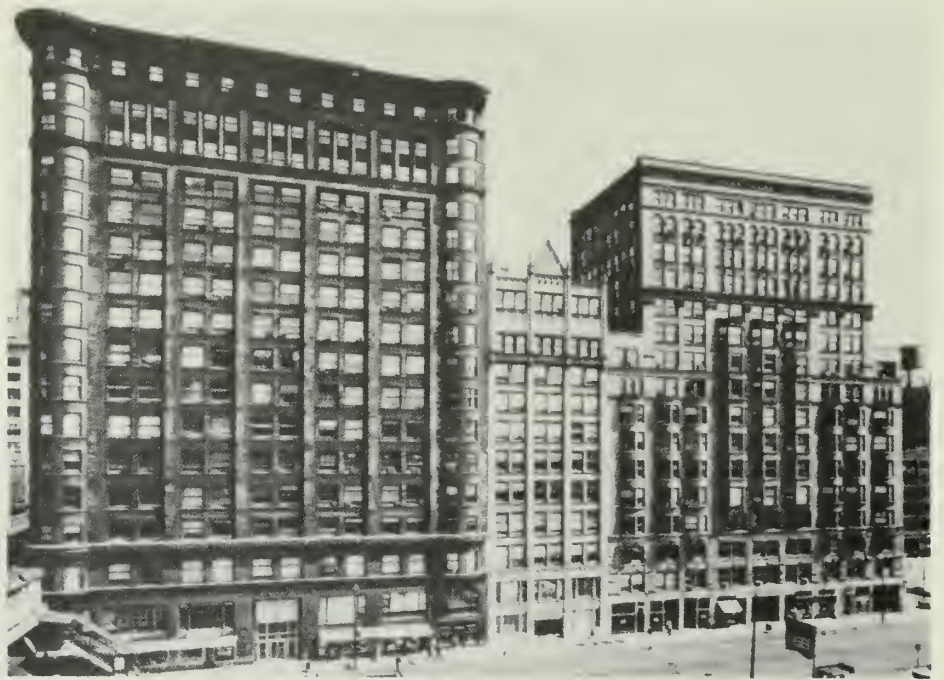
Fig. 2. The elevator doors in the Michigan National Bank, Guardian Building in Detroit (left) and the facades of the Old Colony Building and the Manhattan Building in Chicago (right) possess unique architectural features which are desirable in today's real estate market. (Left courtesy of Smith, Hinchman and Grylls, Architects, right courtesy of Commission on Chicago Historical and Architectural Landmarks)

Quality Construction. In addition to offering prime locations, historic office buildings often possess distinctive interior and exterior architectural features difficult to duplicate in modern office buildings--features increasingly sought after in today's real estate market (see fig. 2).

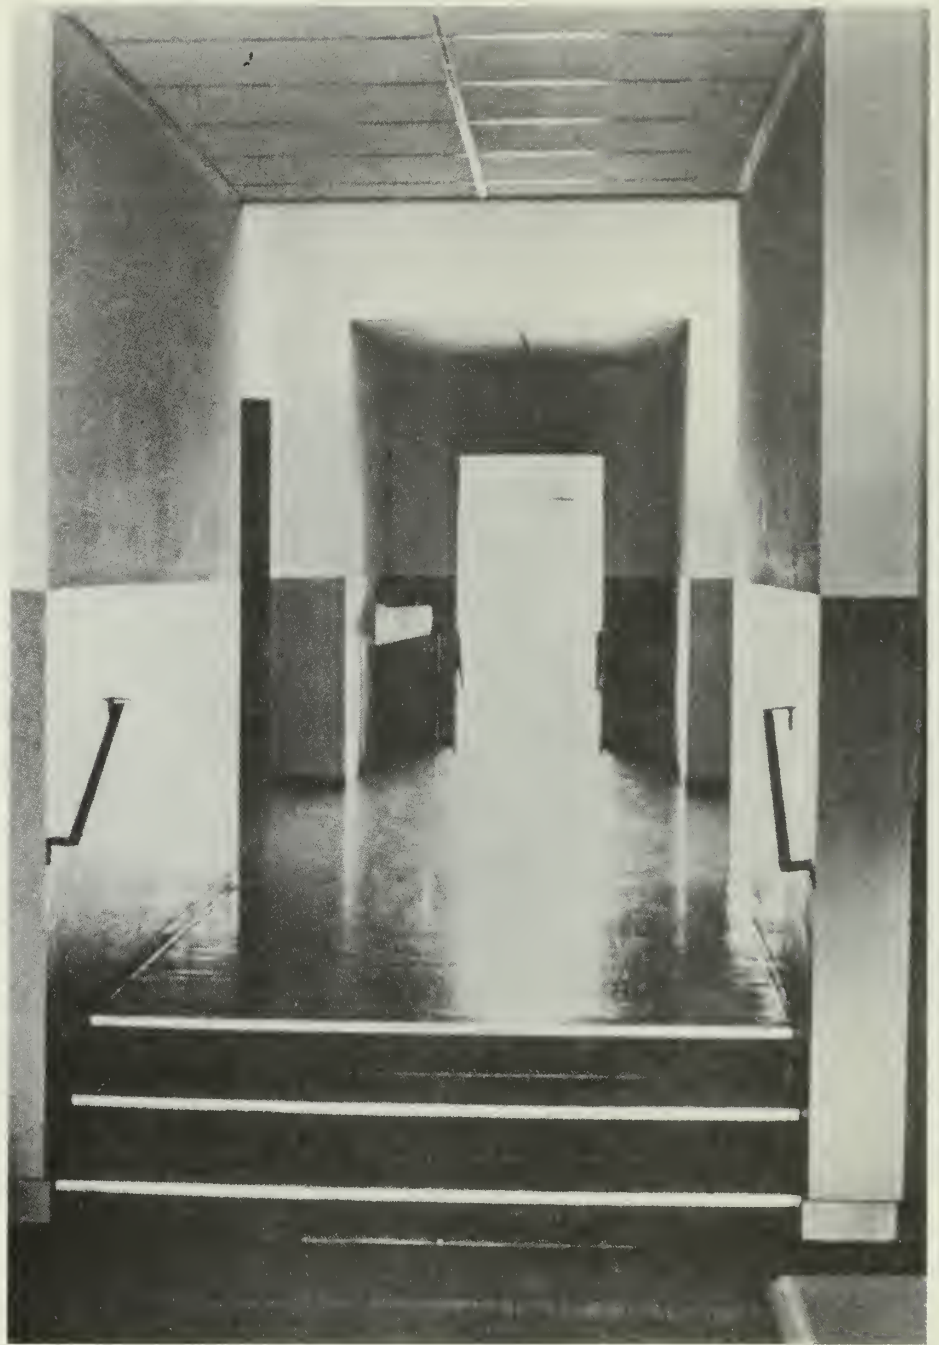
Fig. 5. The courtyard space with 1968 partitions and lowered ceilings. These non-original features were removed in the rehabilitation. (Courtesy of The Klein Group)

The 1968 courtyard partition walls and lowered ceilings were removed, revealing the original pilasters and skylight. Although both were basically sound, newly milled wooden molding needed to be installed to replace deteriorated sections of the skylight. Renovation of the office space surrounding the courtyard, including restoring the ceilings to their original heights (see figure 9), completed the interior work on the building.

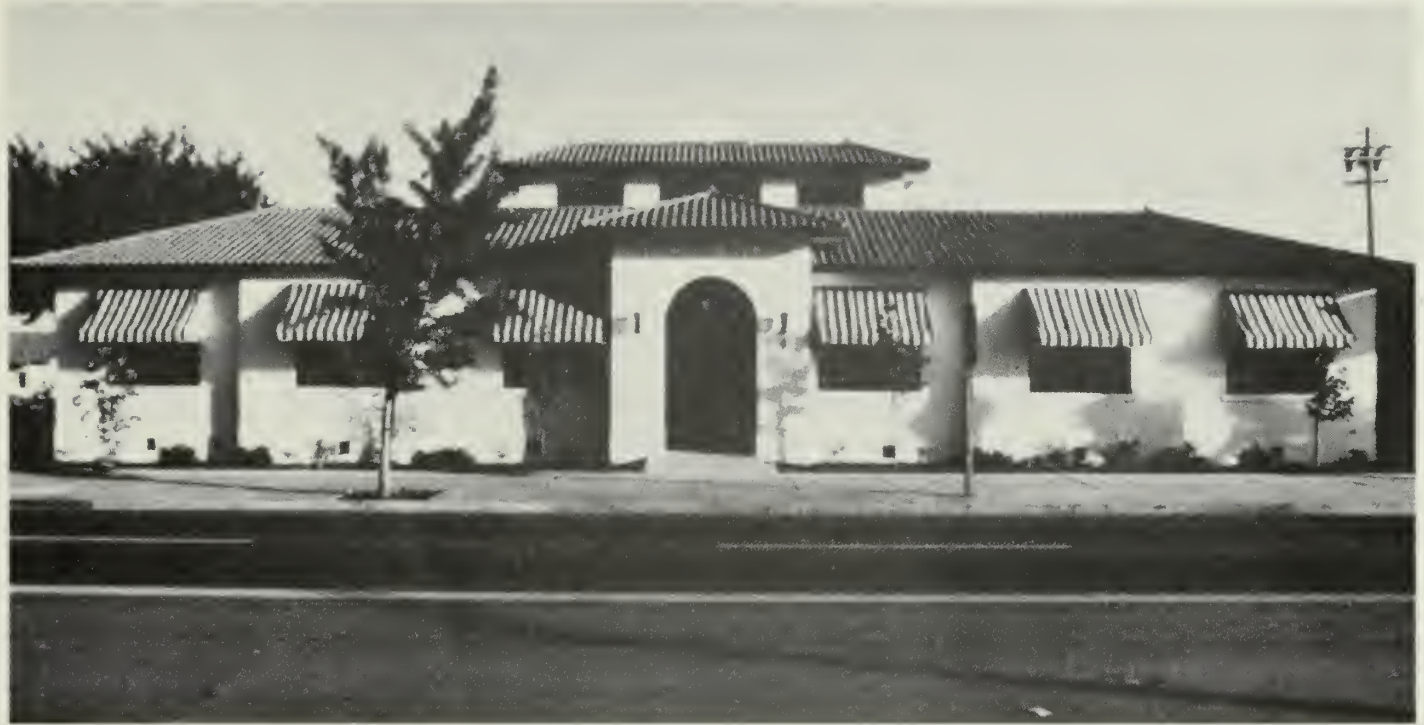
Fig. 6. The Physicians Building after rehabilitation with new awnings in place replicating the originals. (Courtesy of John Powell, The Klein Group)

Before Powell's research proved otherwise, it was thought that both the courtyard and exterior walls originally had been exposed brick surfaces; that the stucco as well as the slump stone had been later additions to the building. When it was established that the building had been stuccoed from the beginning, plans to remove this surface were scrapped. The slump stone alone was removed from the exterior, and the stucco patched and repainted. A fan-shaped transom window above the main entrance had been left intact but painted an inappropriate and nonhistoric color during the 1968 renovation. It was stripped and refinished. The 1968 aluminum-framed entrance doors were replaced with custom-manufactured French-style doors replicating the originals. Window screens with muntin bars mirroring those in the windows they covered (a characteristic of several Butner-designed buildings in Fresno) were installed to match the originals. Five of the original six main elevation awning frames were

found in the attic in good condition, leaving only one to be custom-manufactured. When the newly manufactured canvas awnings, (color coordinated to match the historically accurate trim color), were finally installed on the frames, the exterior work was considered complete (see figure 6).

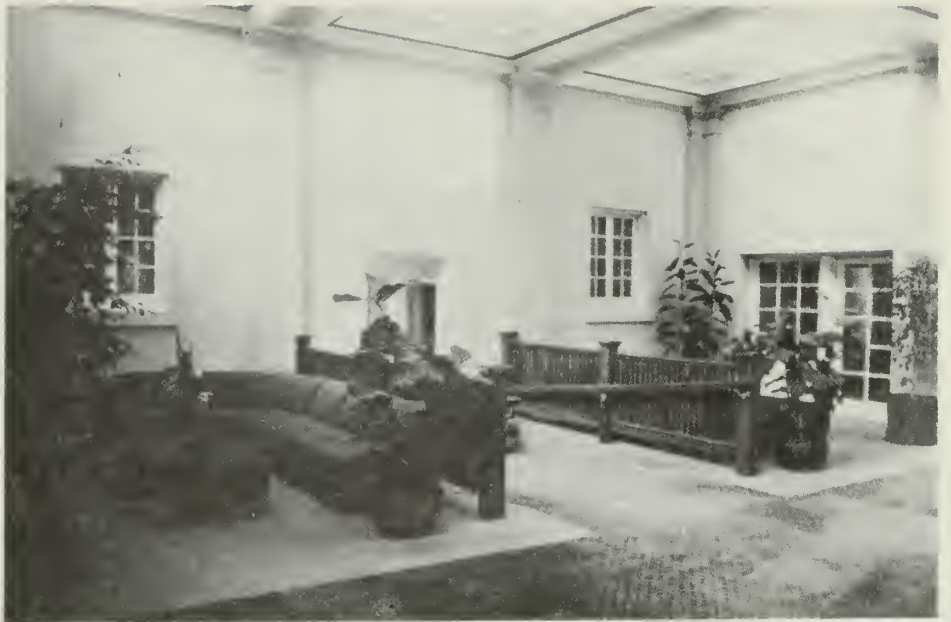
Fig. 8. *The courtyard after rehabilitation. The original pilasters and skylight have been revealed after removal of the suspended acoustical ceiling. The wheelchair access ramp was installed as part of the rehabilitation. (Courtesy of John Powell, The Klein Group)*

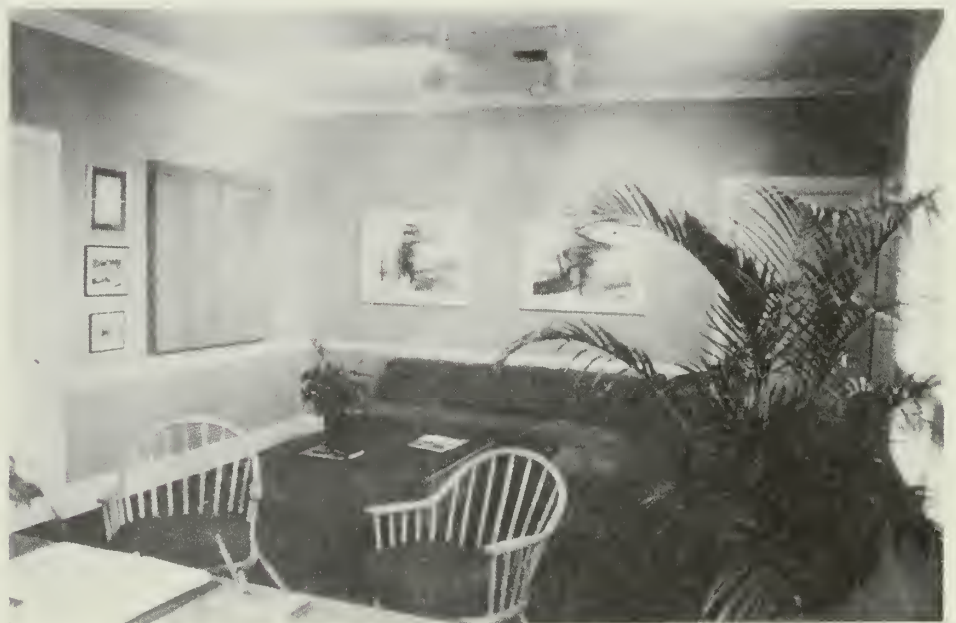
Fig. 9. *Lowered ceilings in the perimeter offices were removed in the rehabilitation, restoring the ceilings to their original height. (Courtesy of John Powell, The Klein Group)*

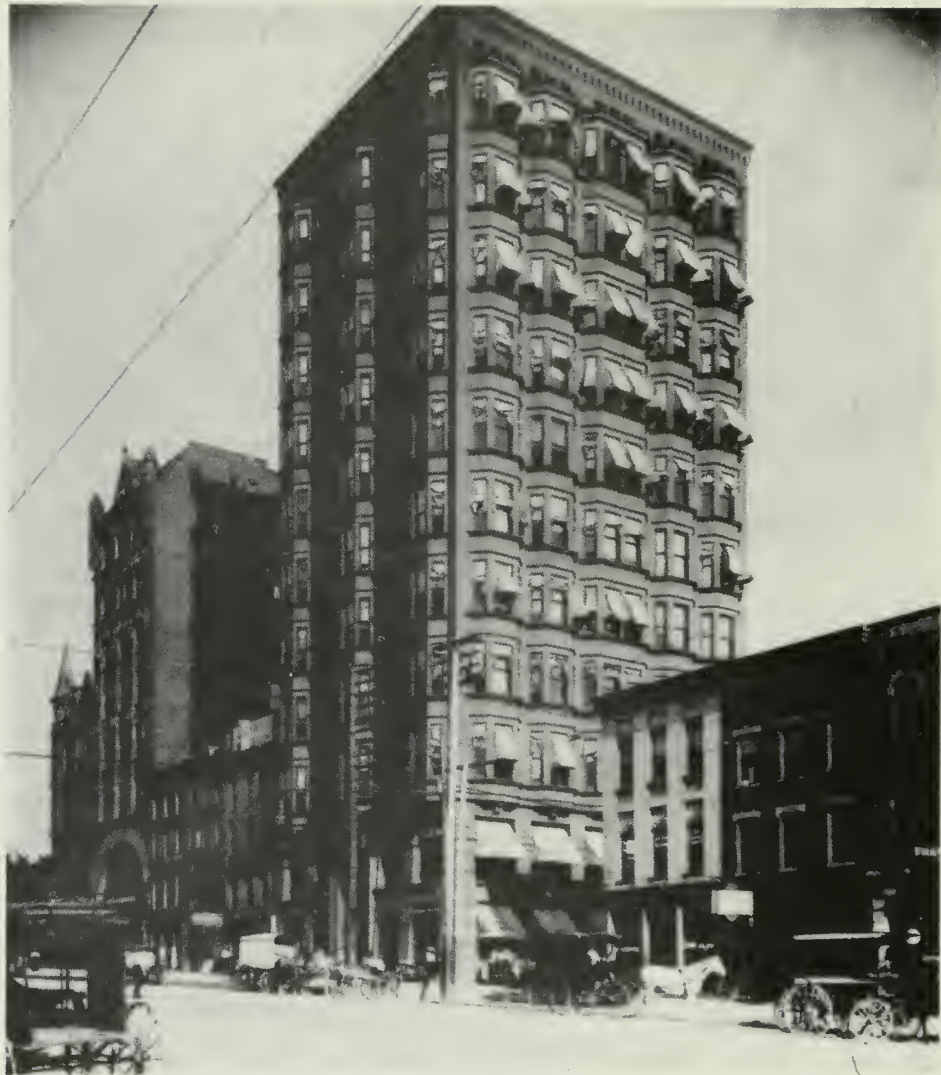
Fig. 10. *The Wyandotte Building about the turn of the century. It was the first steel skelton-frame structure built in Columbus. Note the awnings, an early energy saving device. (Courtesy of the Ohio Historical Society)*

The Wyandotte Building was designed by the nationally renowned architect Daniel Burnham, and was constructed in 1897-1898 for developer John G. Deshler (see figure 10). Located in downtown Columbus at the corner of Broad and High streets and just a half block from the Ohio Statehouse, the Wyandotte originally served as a bank and office building. Because it was the first steel skeleton frame skyscraper built in Columbus, and has such a distinctive appearance, the Wyandotte remains a premier landmark in downtown Columbus.

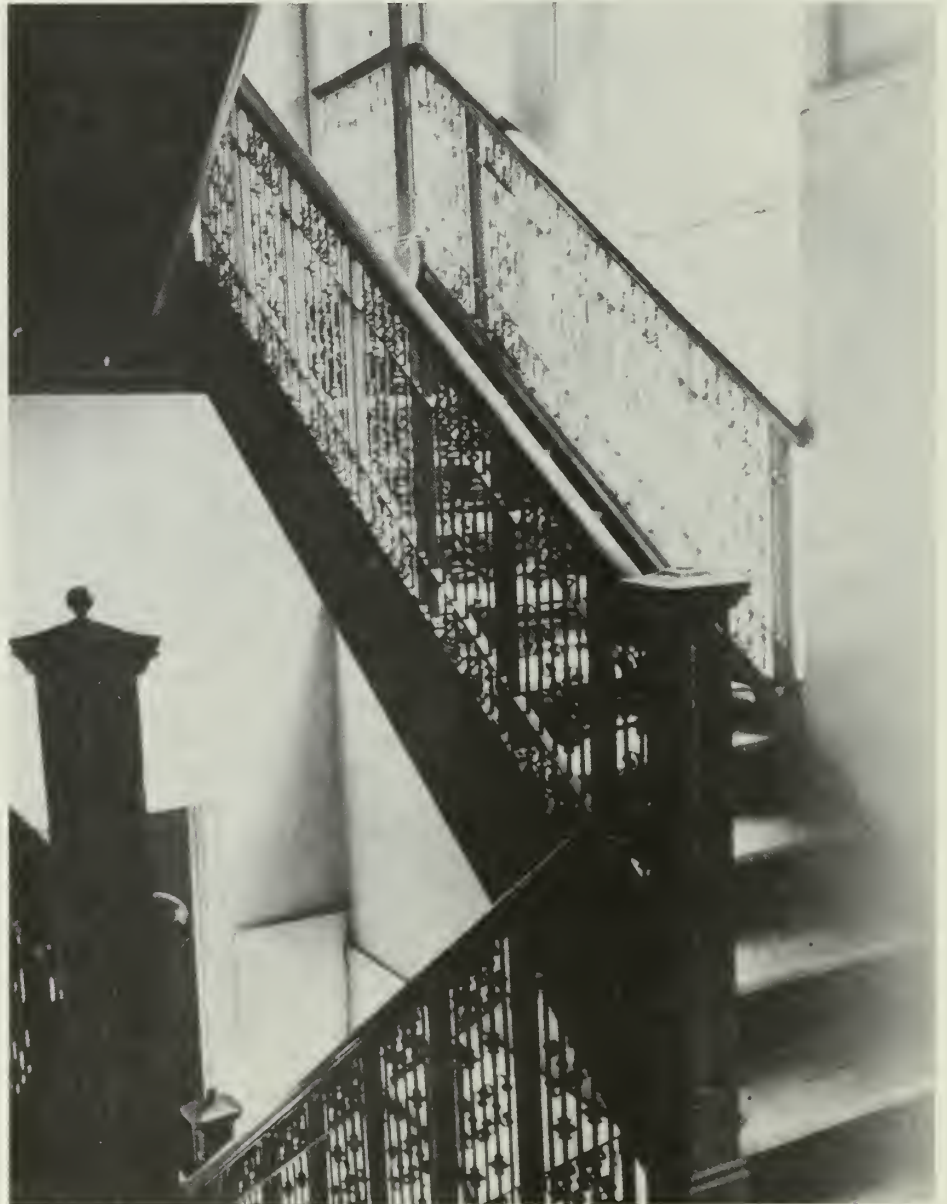
Fig. 11. The Wyandotte's original stairway is one of the building's primary architectural features. (Courtesy of the Ohio Historical Society)

architectural distinction. Through-window air conditioning units had been installed in most offices; the interior wrought-iron and marble stairway, one of the building's architectural focuses (see figure 11), was painted; and the original front doors were replaced with single-pane aluminum doors. With few exceptions the building's architectural features remained intact, although a number of details had been insensitively treated.

not meeting local fire code requirements, the original stairway was highly ornamented and was considered one of the building's primary architectural features. In order to retain this significant element, the decision was made to leave the stairway intact and to construct a new adjacent stairtower. This addition solved the code problem and also provided space for restrooms on each floor. The stairtower was determined by the Department of the Interior to meet the Secretary's "Standards for Rehabilitation" because it was built on a secondary elevation and was compatible in materials (brick), color, scale, and character with the original structure.

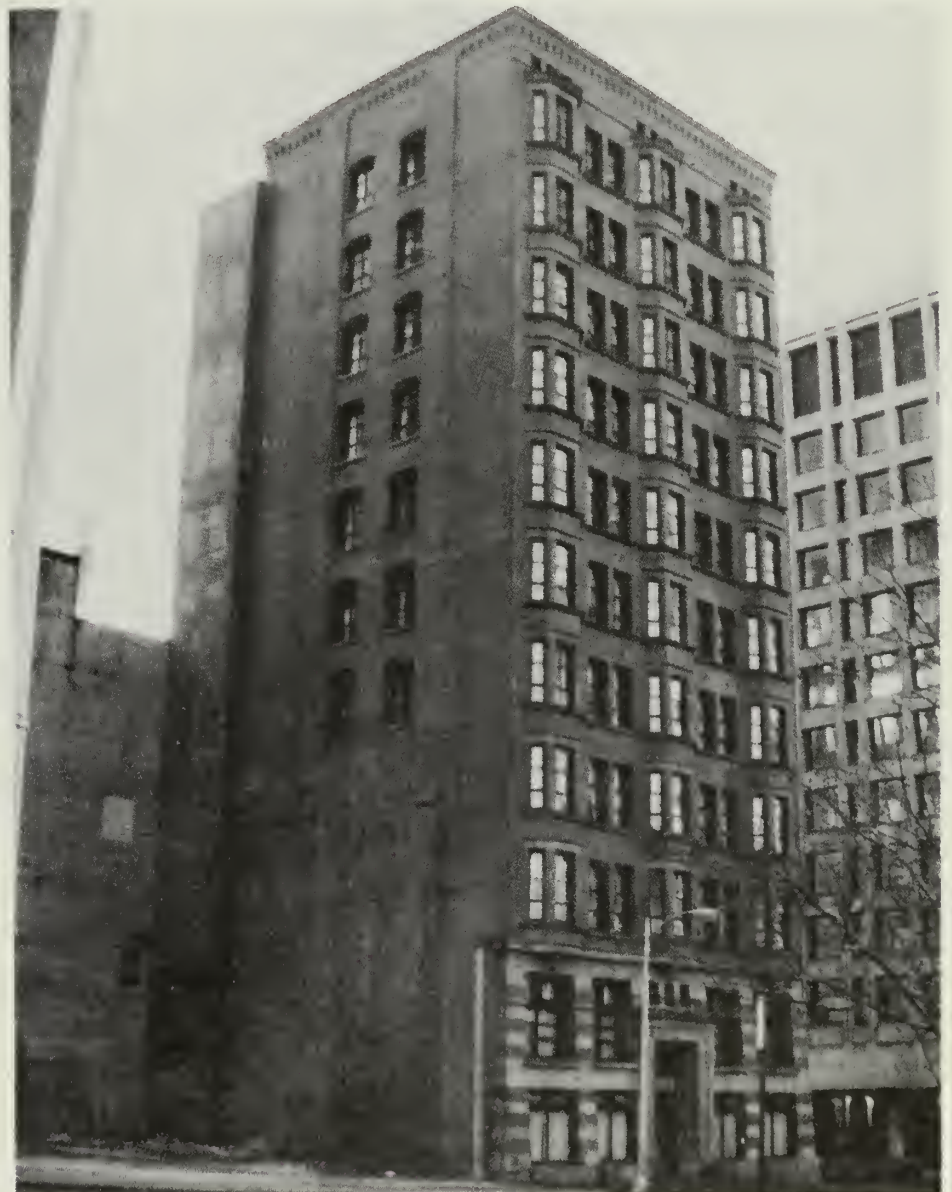
Fig. 12. *The Wyandotte after rehabilitation. The new stair tower addition is at the left. (Courtesy of Judith Kitchen, Ohio Historic Preservation Office)*

The most significant change in the exterior appearance of the Wyandotte was the addition of a stairtower at the rear of the building (see figure 12). Although

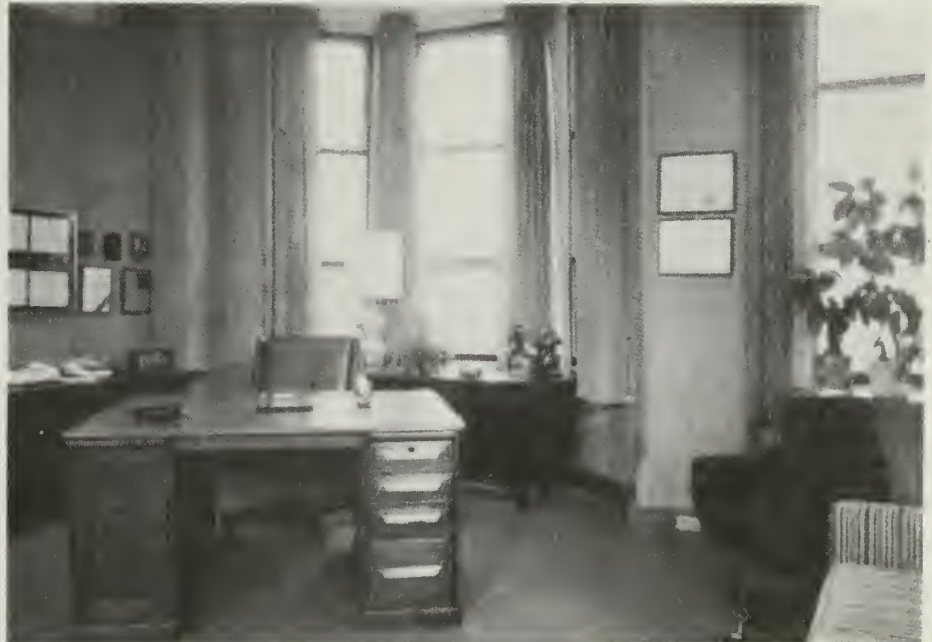
Fig. 14. A bay-windowed office after rehabilitation.
(Courtesy of the Klingbeil Management Group Co.)

By rearranging partitions to provide more open and flexible office space, the appearance of the upper floors was changed somewhat. Individually partitioned offices along the west side of the building, which had traditionally taken advantage of the bay windows on that wall, were retained (see figures 13 and 14).

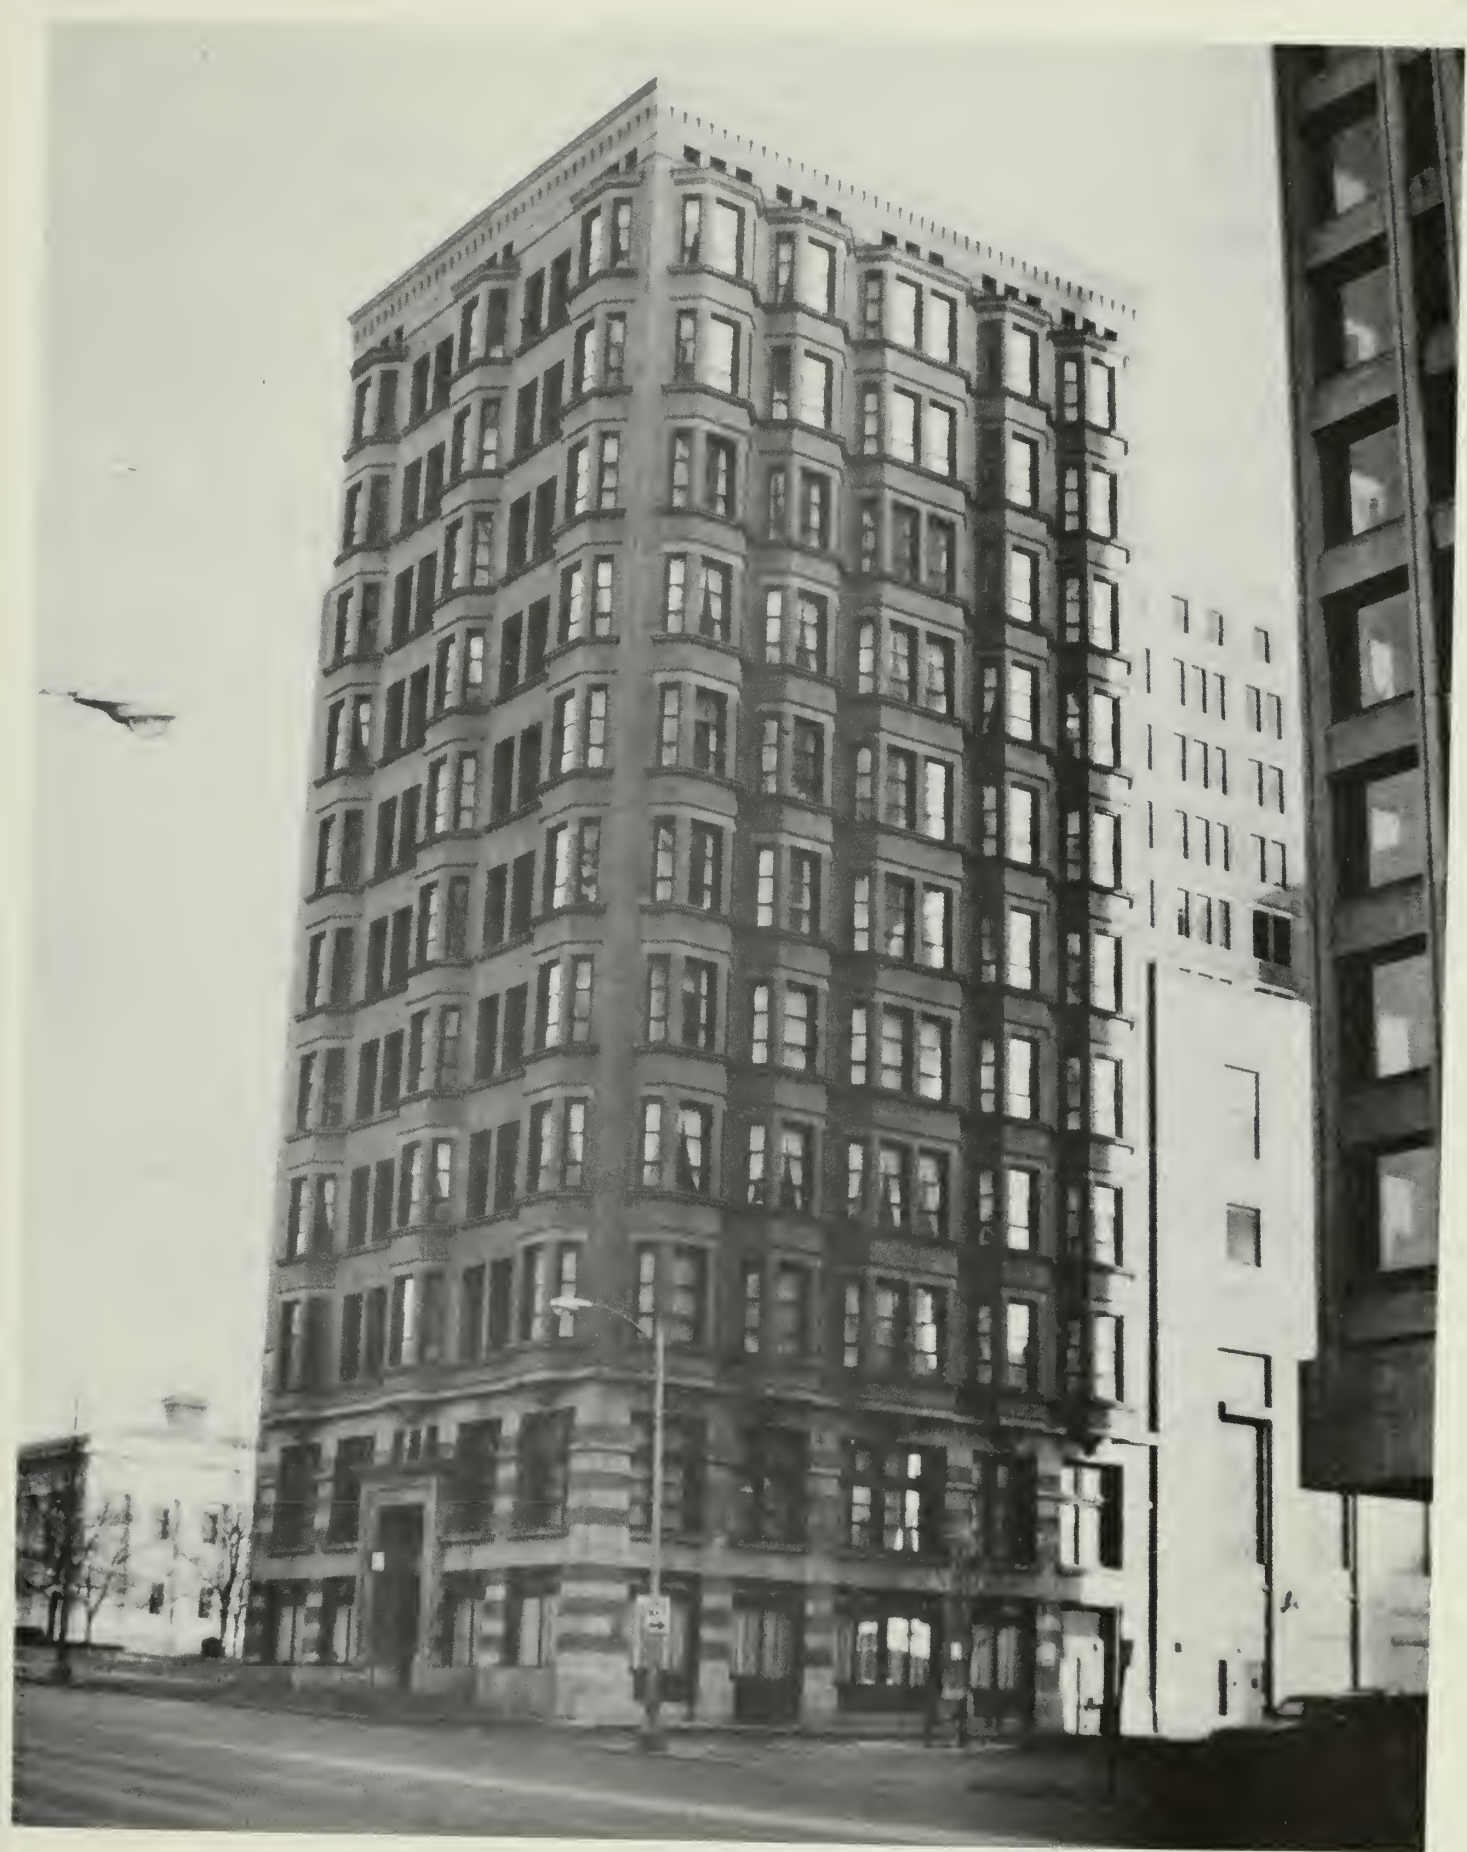
Fig. 15. *The Wyandotte after rehabilitation.* (Courtesy of Judith Kitchen, Ohio Historic Preservation Office)

The rehabilitation of the Wyandotte Building was intended to enhance those features that gave the building its unique character, while providing contemporary and efficient modern office space. Thus, exterior work was primarily directed toward cosmetic and minor maintenance work; interior work, on the other hand, involved the installation and/or repair of major mechanical systems as well as the renovation of all 11 floors of office space.
