CHANNEL CHANGES AT CROSS SECTIONS IN
REDWOOD CREEK, CALIFORNIA

REDWOOD NATIONAL PARK
RESEARCH AND DEVELOPMENT

TECHNICAL REPORT
OCTOBER 1984

By
Nick Varnum

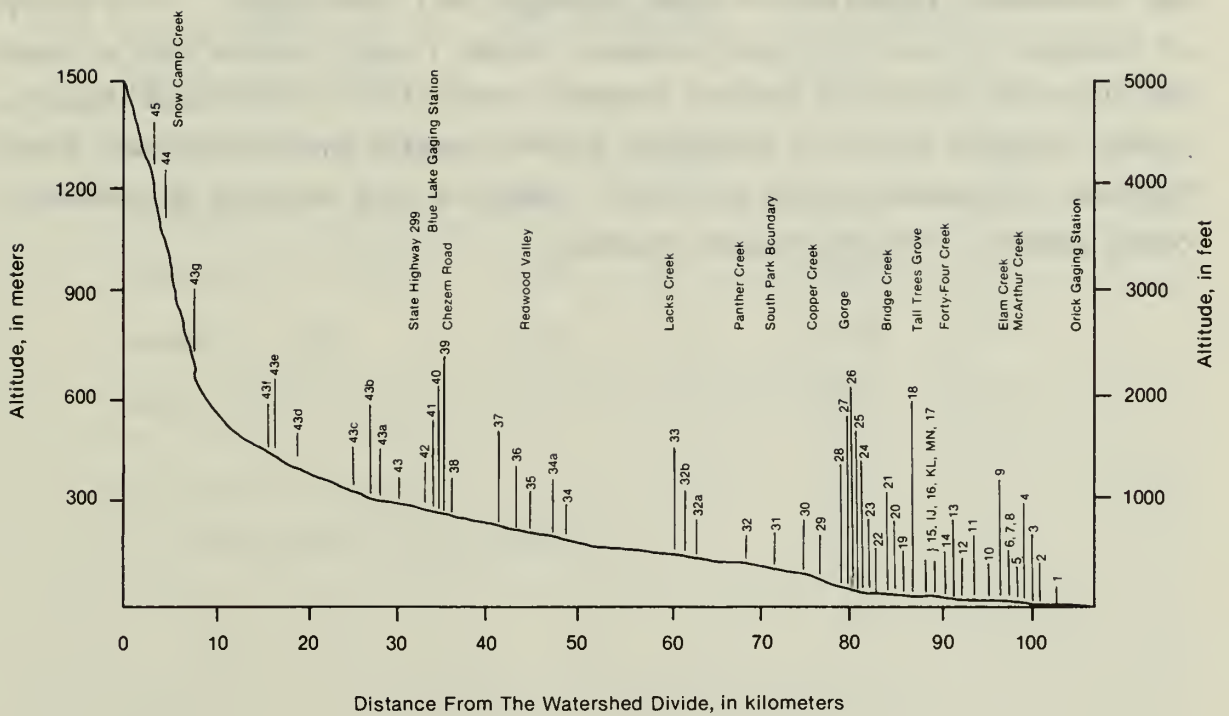
Figure 3: Longitudinal Profile of Redwood Creek showing location of monumented stream channel cross section, major tributaries and roads, and stream gaging stations.

The main channel of Redwood Creek drains a 720 km² area in north-western California (Figure 1). Basin-wide average rainfall is approximately 2,000 mm, 80 percent of which falls between the months of October and March (Janda, 1975). Total basin relief is 1,615 m. Figure 3 is a longitudinal profile of Redwood Creek.

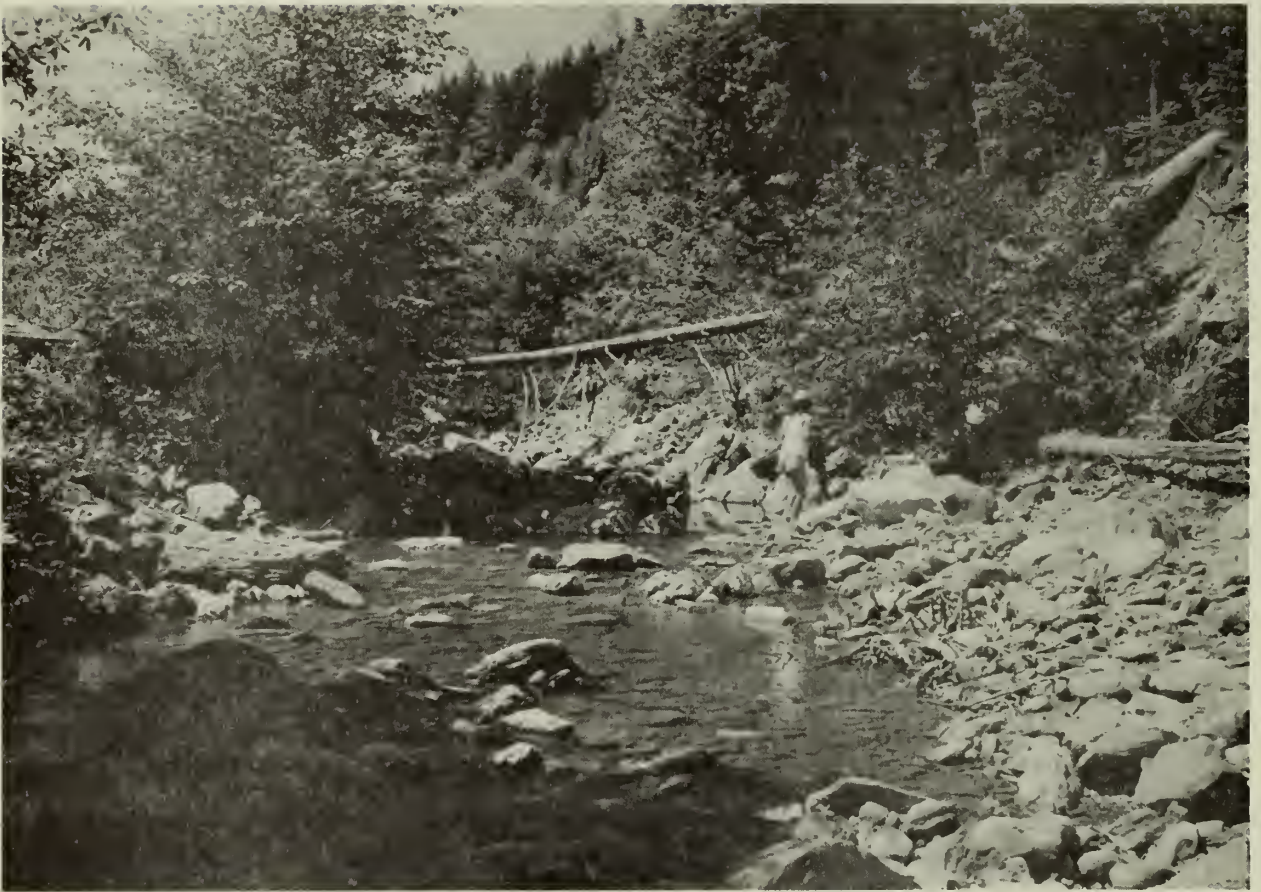
Figure 7: Channel configurations in the long reach above State Highway 299 are highly variable. Configurations range from small valleys with low gradients to steep and narrow channels clogged with boulders up to 4 m in diameter. In general, bed material sizes tend to be large and channel widths narrow, as in this photograph near Cross Section 43g.

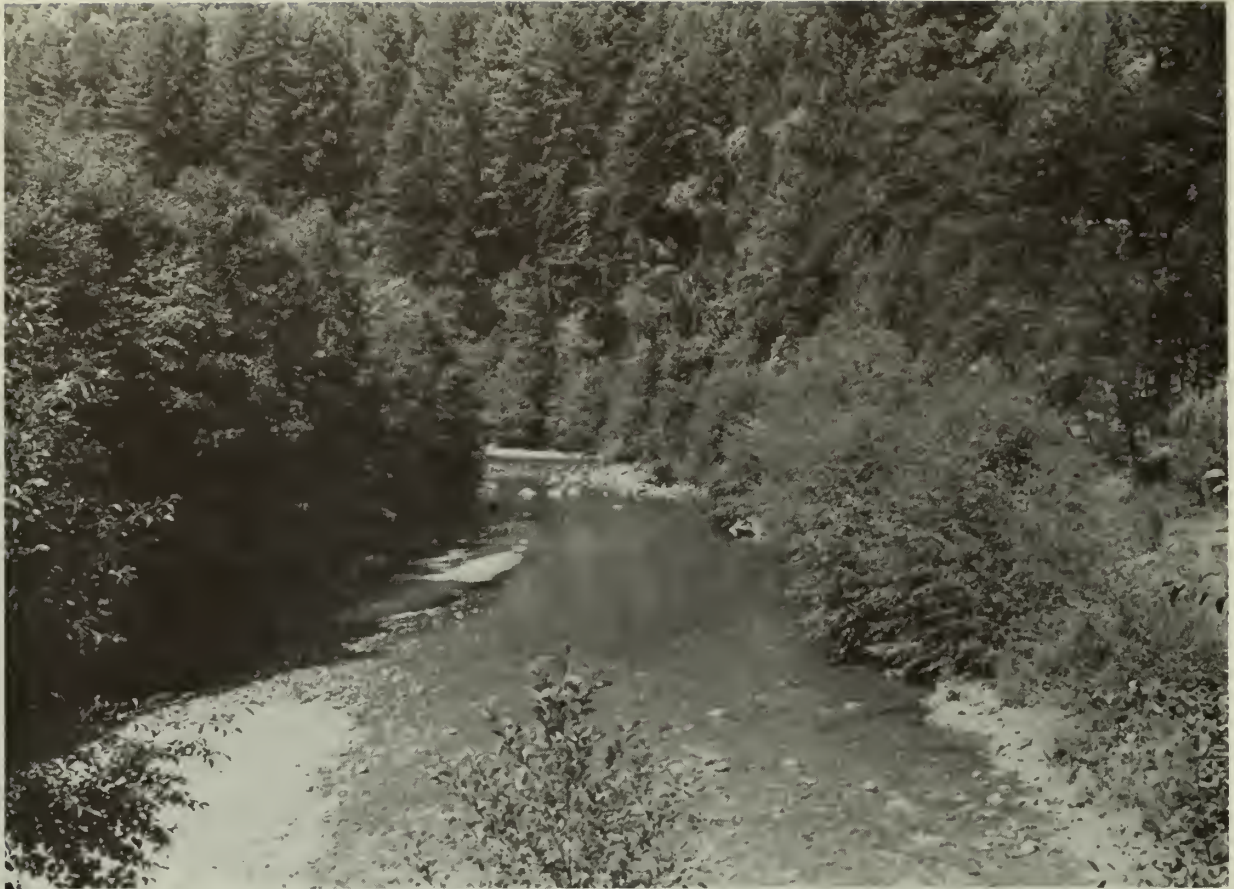
Figure 8: Much of the Channel between Highway 299 and Chezem Road has a consistent width of 30 to 40 m. Records from the U.S.G.S. gaging station near Blue Lake (located at Cross Section 40) together with cross section data indicate stream degradation since 1973 in both this reach and the reach above Highway 299.

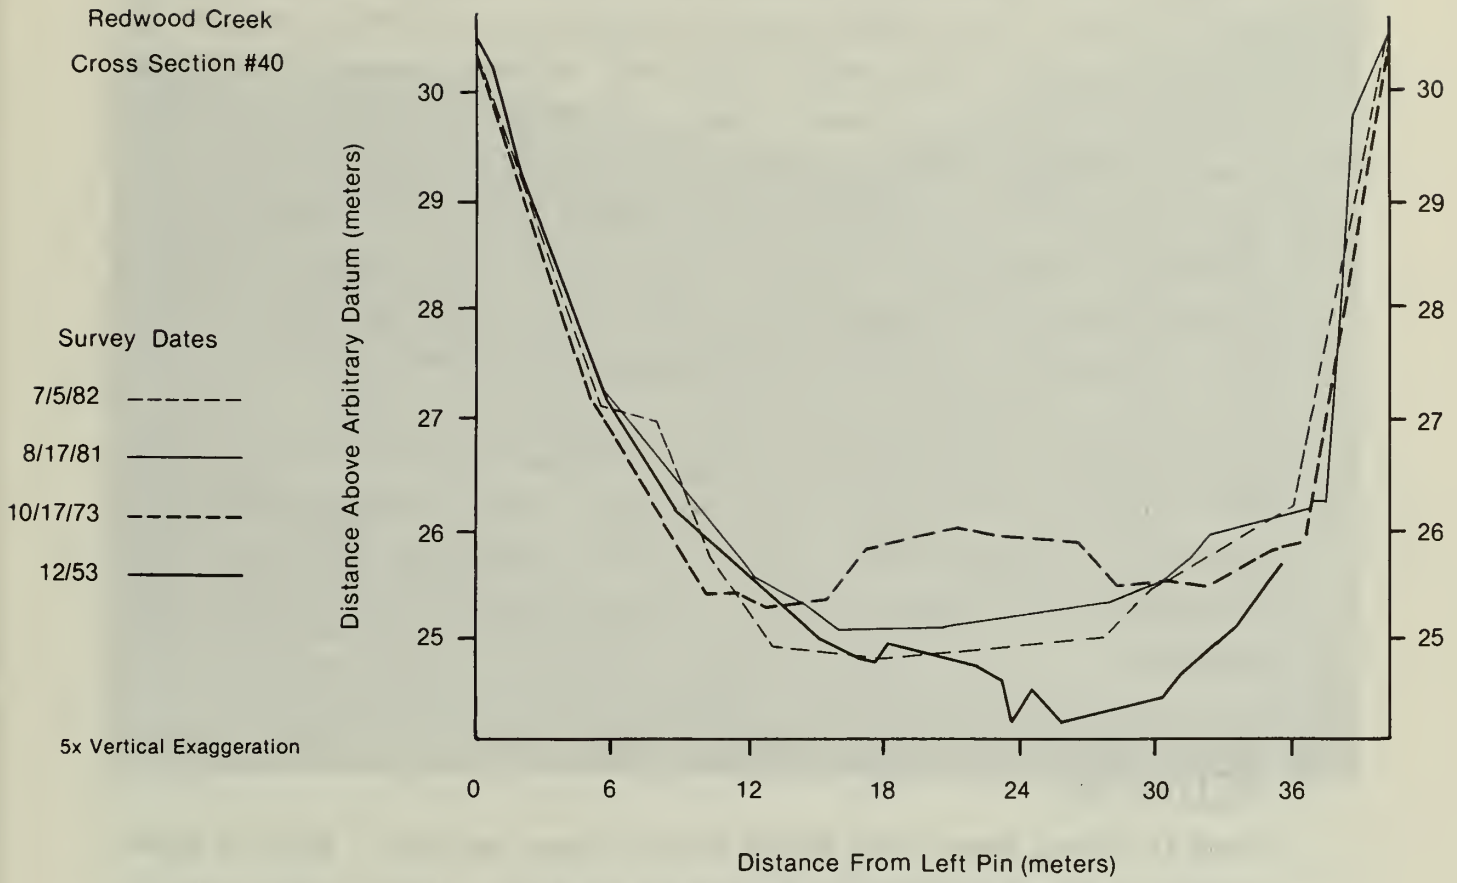
Figure 9: Cross Section at the U.S.G.S. gaging station on Redwood Creek near Blue Lake. Cross sections at or above this location have shown persistent scour for nine years.

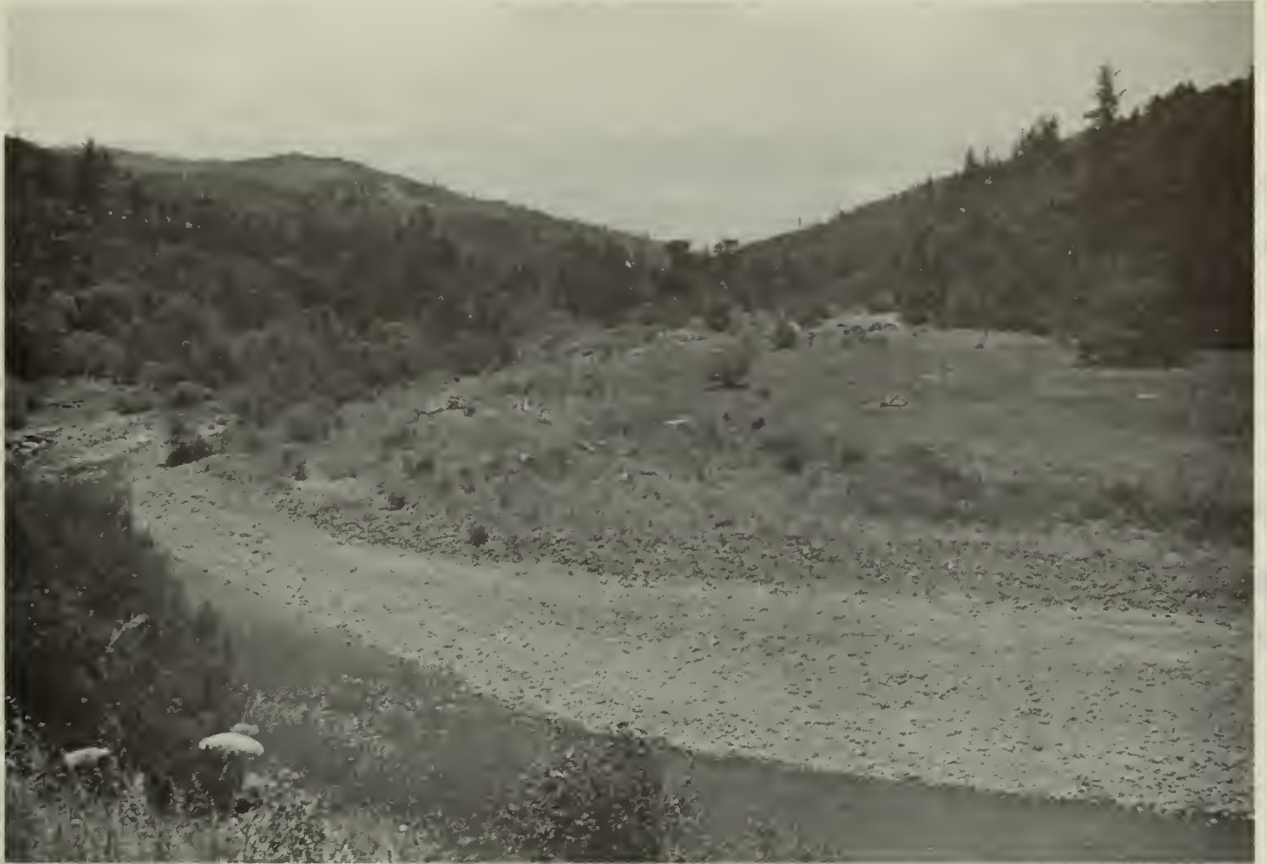
Figure 10: In Redwood Valley, channel widths up to 180 m are common and the streambed gradient is gentle. The lack of older vegetation on the storage bar indicates recent inundation by high flows.

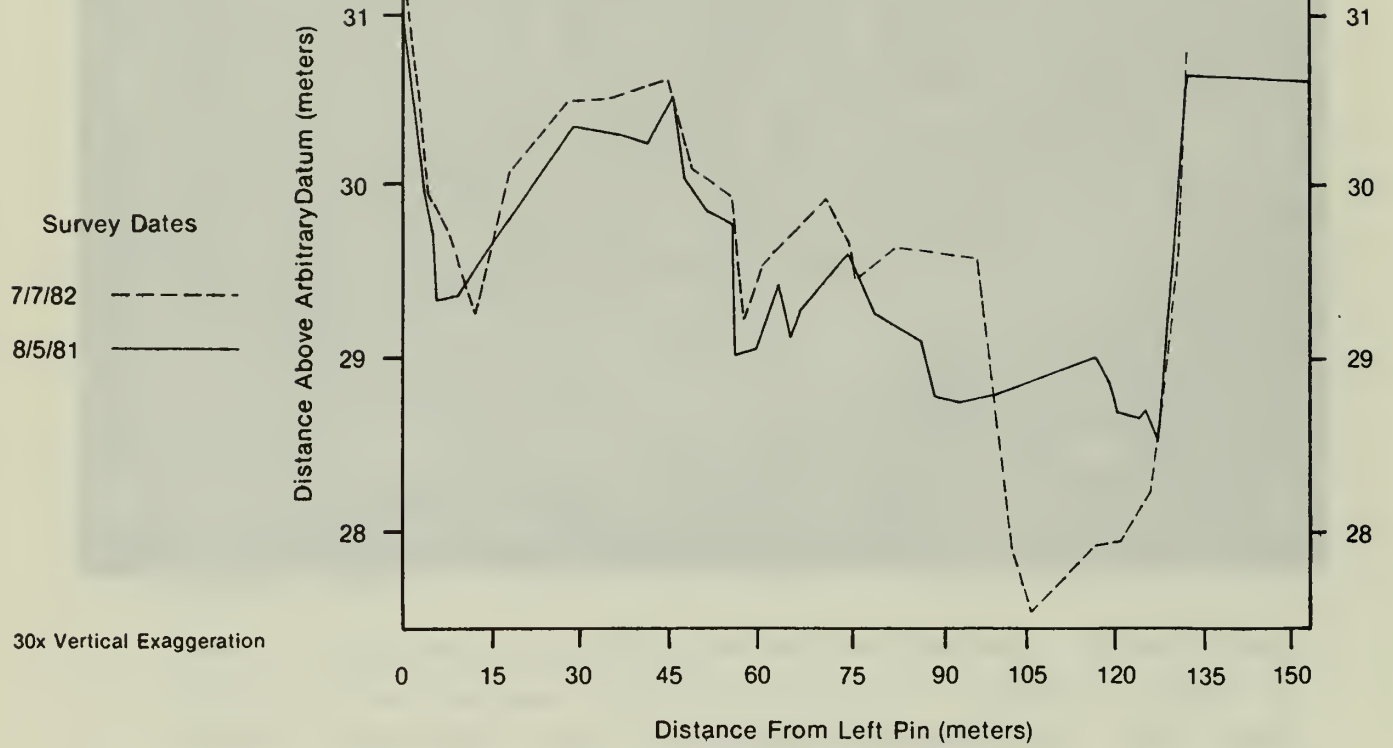
Redwood Creek
Cross Section #34a

Figure 11: Although this cross section showed a small net area change, there were major changes in thalweg shifting and thalweg elevation.

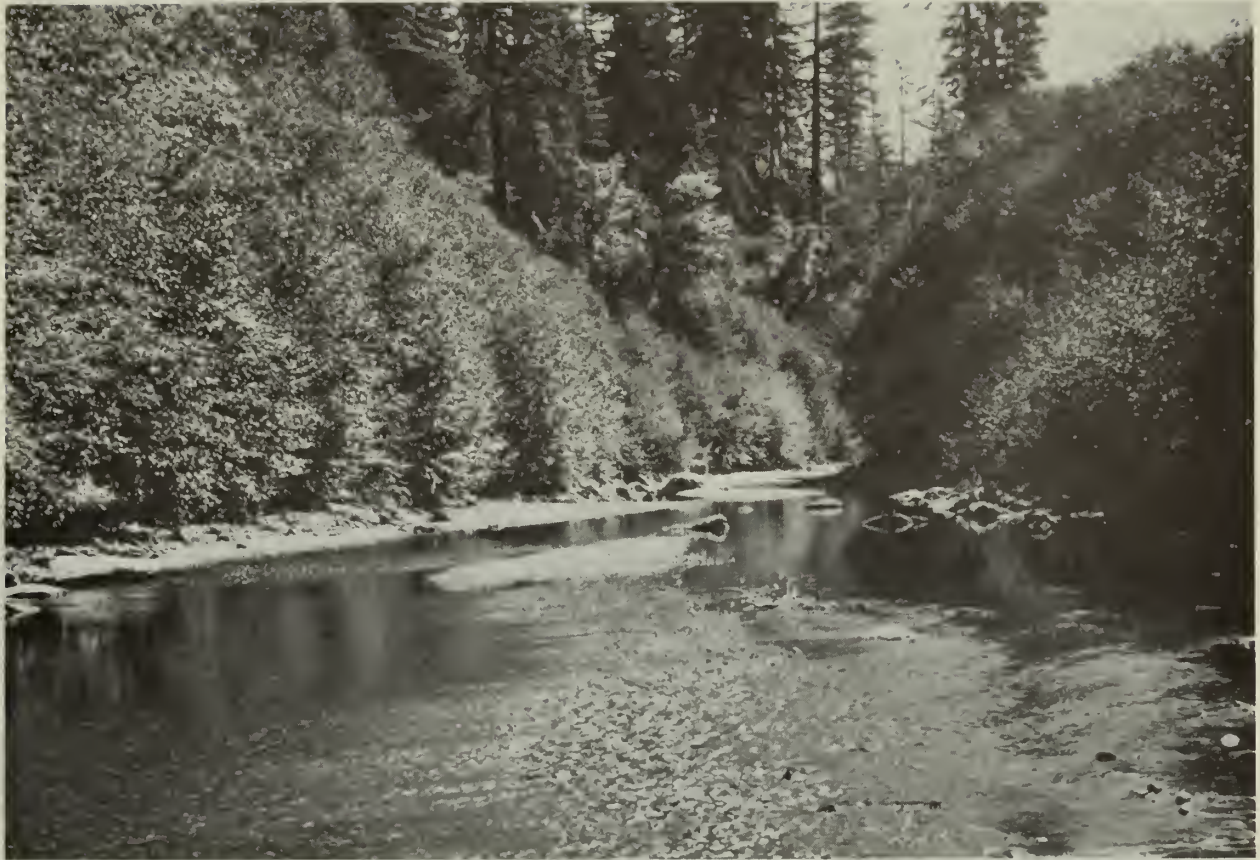
Figure 12: In the reach between Stover and Copper Creeks, the channel again becomes narrow. This photograph is looking upstream from Cross Section 32.

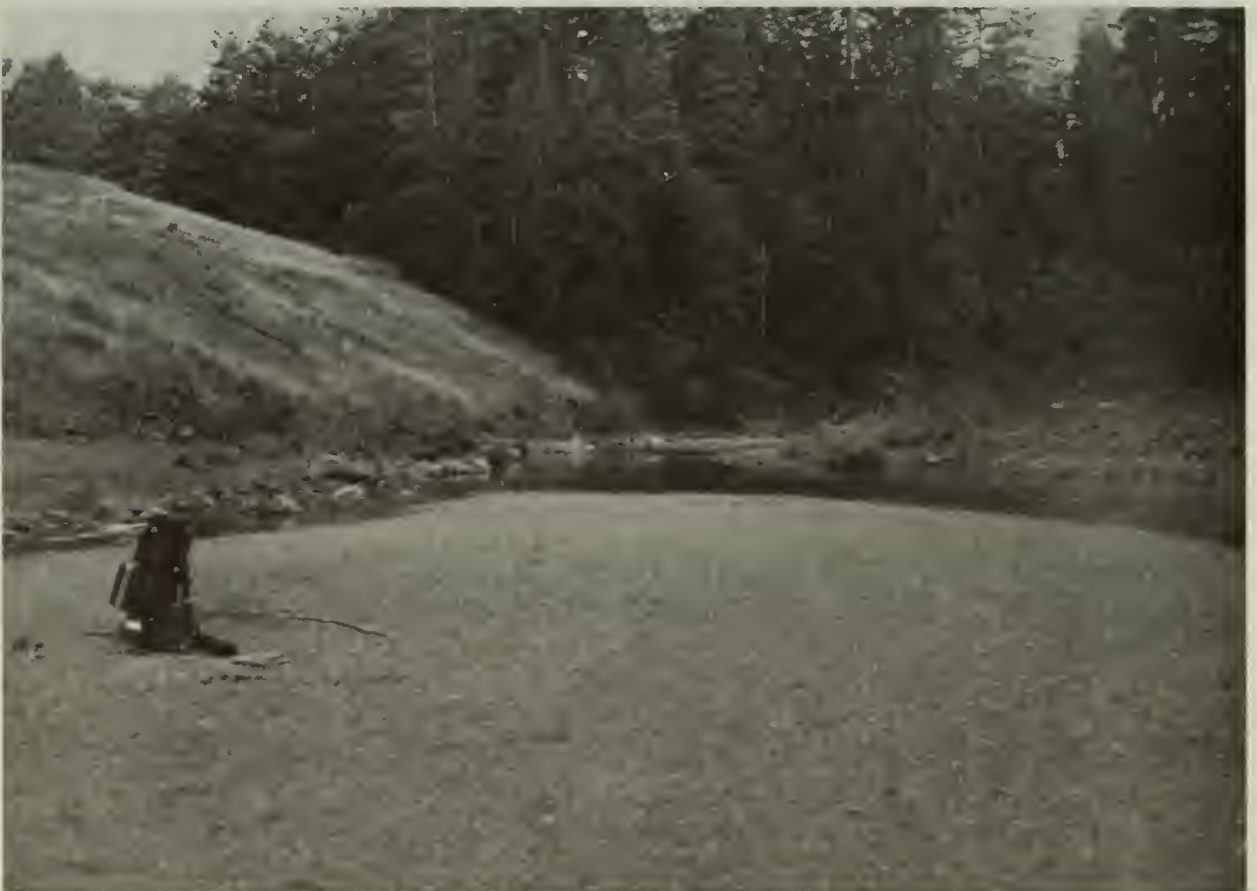
Figure 13: This reach provides space for temporary sediment storage. Earthflows (left) entering from the east side of the channel are major sediment contributors. This photograph is looking upstream from Cross Section 28.

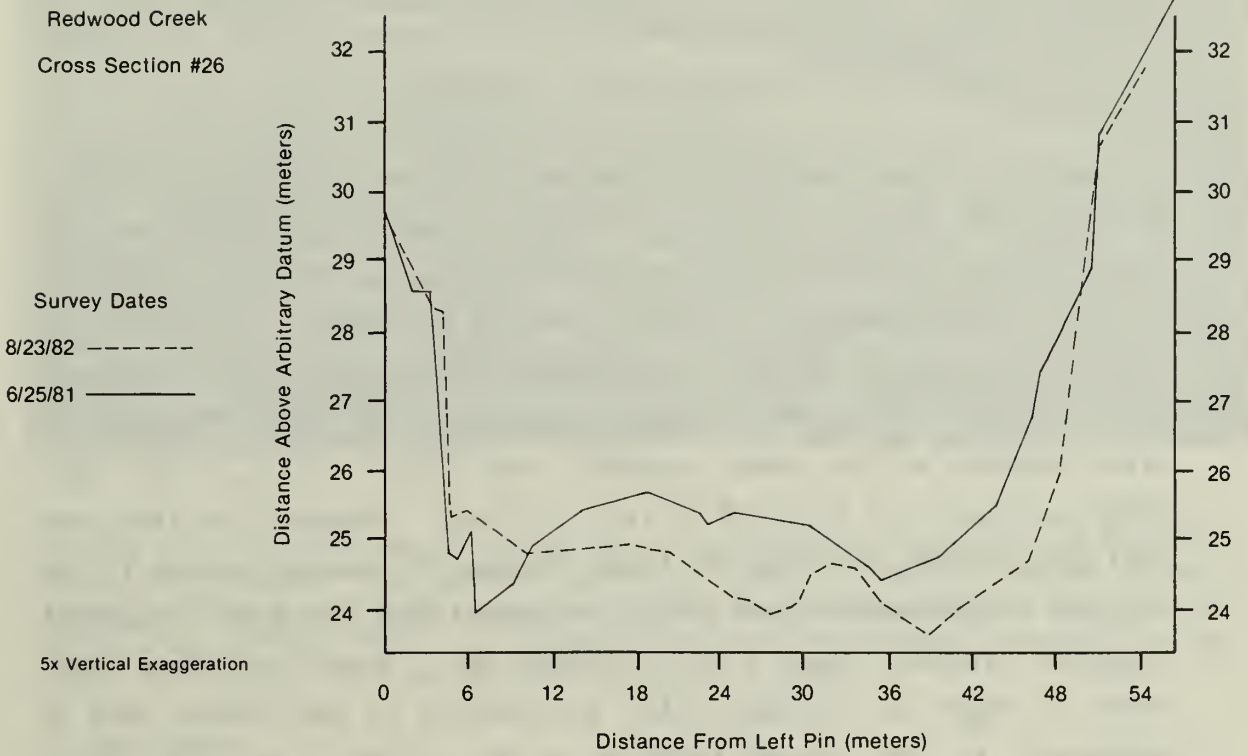
Figure 14: Major changes in mean channel depth in the area immediately above the gorge are common.

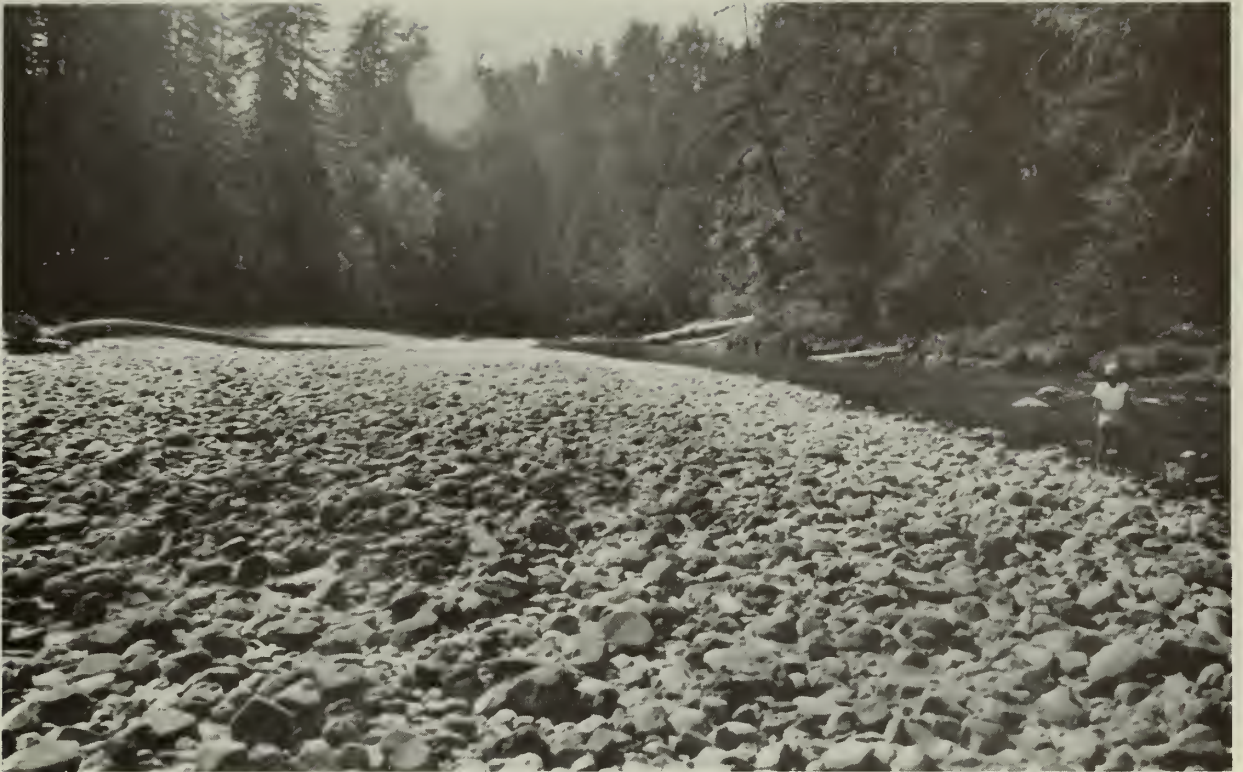
Figure 15: Downstream of the gorge, the riparian vegetation of Redwood Creek is typically old growth redwood forest. The streambed is also characterized by a wide alluviated channel. Between the base of the gorge and Bridge Creek, E_C values have been the highest recorded in the basin. Presently, the streambed is scouring here.

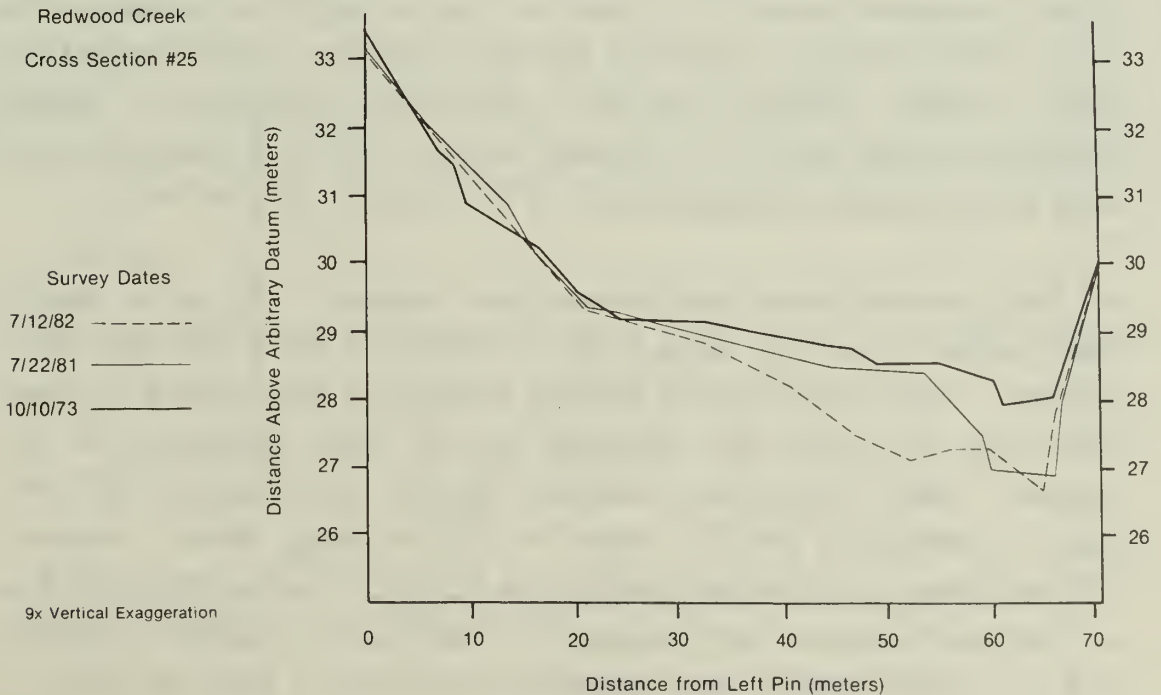
Figure 16: Cross sections immediately below the gorge have been degrading since 1975, following a period of major aggradation.

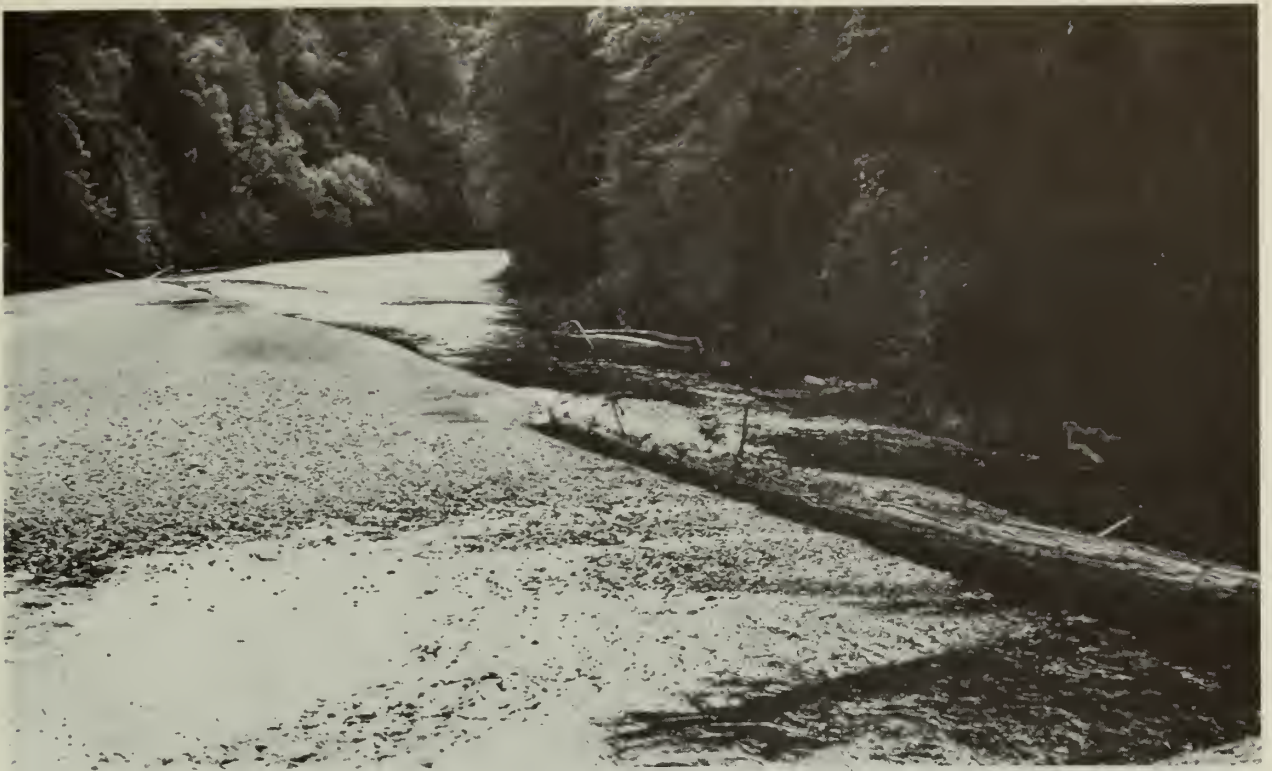
Figure 17: View downstream from Cross Section 20, located between Bridge Creek and the Tall Trees Grove. The fallen redwood tree on the right fell in WY 1981 as the result of effects related to streambed aggradation (see Figure 1).

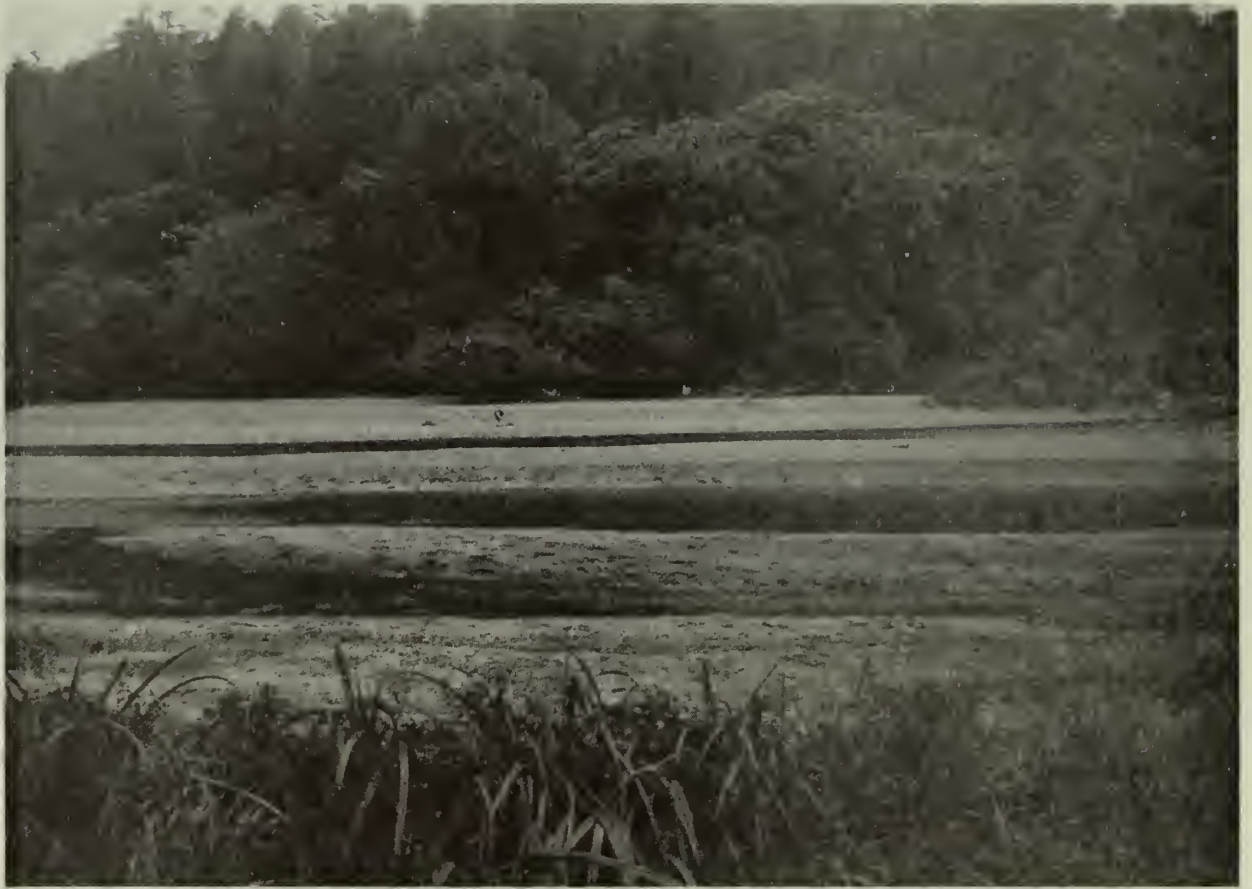
Figure 20. The channel between Forty-Four and Elam Creeks is heavily alluviated, as in most of Redwood Creek, and the presence of multiple channels may reflect abnormally high sediment loads.

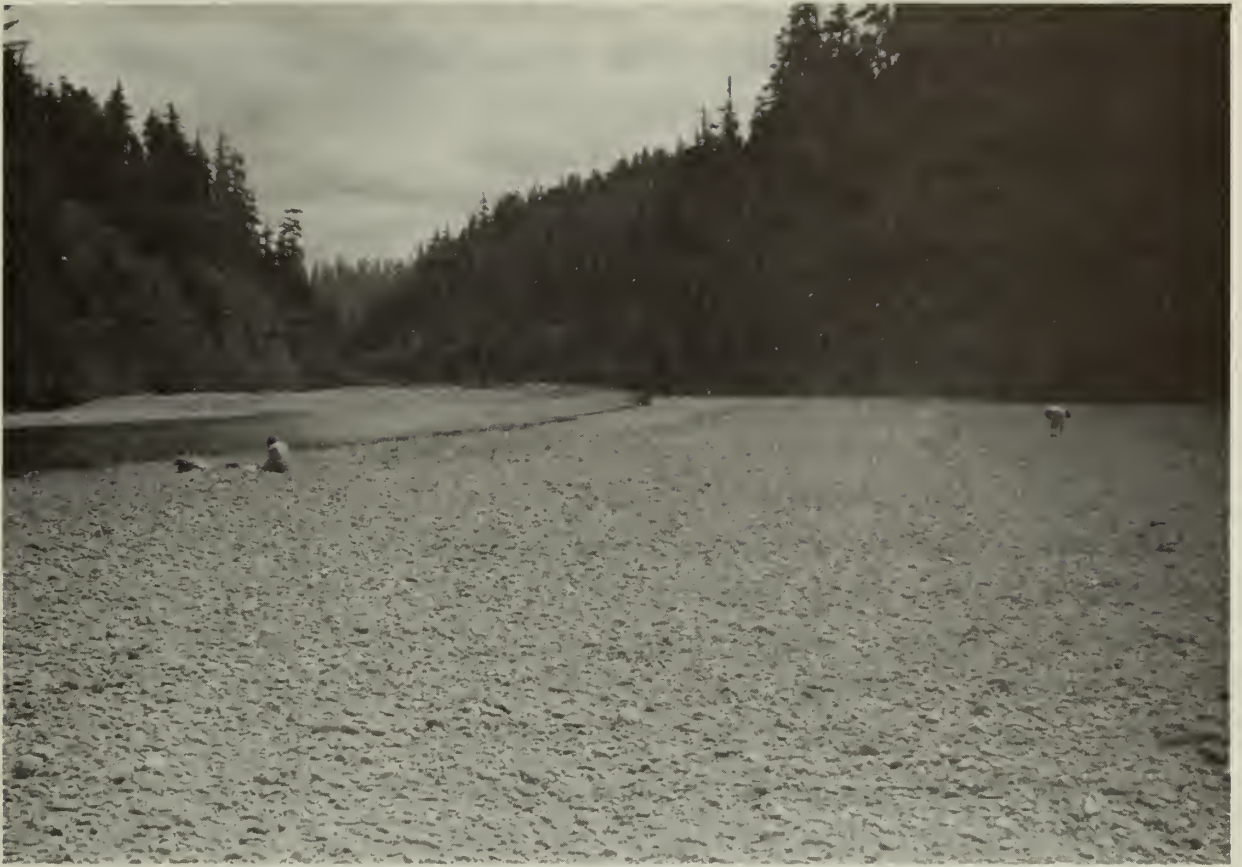
Figure 21: Channel shifting is common in the broad, alluviated reach between Elam and Prairie Creeks.

This reach is very wide, with most bank-to-bank widths near 140 m (Figure 21). Thalweg shifting has been very common here, sometimes eroding the bases of terraces and inactive gravel bars. Changes in net area (ΔA_n) in WY 1982 varied from 22.1 m² scour to 4.7 m² fill, and changes in the thalweg elevation were fairly large, ranging from 0.4 m fill to -0.6 m scour. Since WY 1974, distinctive trends in scour and fill were not apparent.

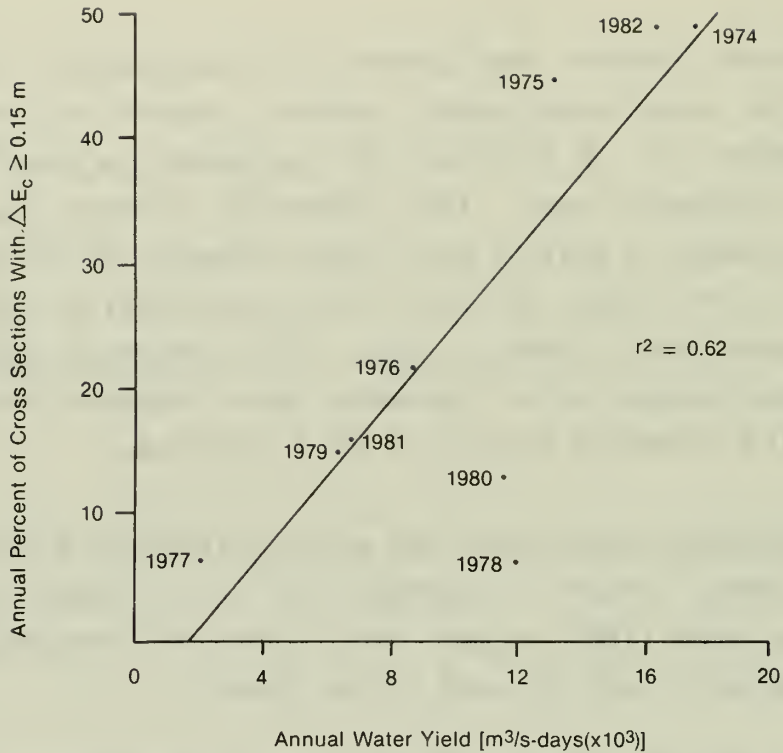
Figure 24: Relationship of annual percent of cross sections with a magnitude of change ≥ 0.15 m to annual water yield at the Orick, CA gaging station.

The relationship between the percent of cross sections with ΔE_C of ≥ 0.15 m to the annual water yield is shown in Figure 24. The coefficient of determination (r^2) is 0.62 and the correlation is significant at the 95 percent confidence level. The relationship between high magnitude change and number of days in which flows exceeded 235 m³/s is somewhat better ($r^2 = 0.74$, Figure 25) and is also significant at the 95 percent confidence level with 9 years of data. The number of moderately high runoff events appears to be somewhat more important than the total annual runoff in effecting changes of large magnitude.

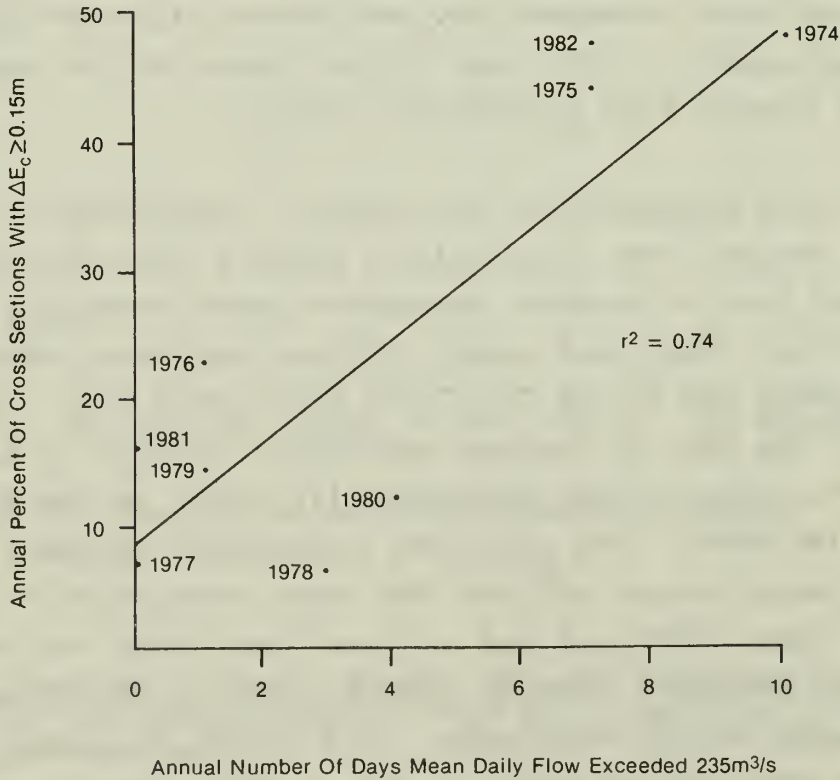
Figure 25: Relationship of annual percent of cross sections with a magnitude of change ≥ 0.15 m to annual number of days mean daily flow exceeded 235 m³/s (8300 ft³/s) at Orick, CA.
