**Historic Structures Report  
July 2002**

# **The Slave Quarters Historic Structures Report**

**Redcliffe Plantation  
State Historic Site**

**Beech Island, South Carolina**

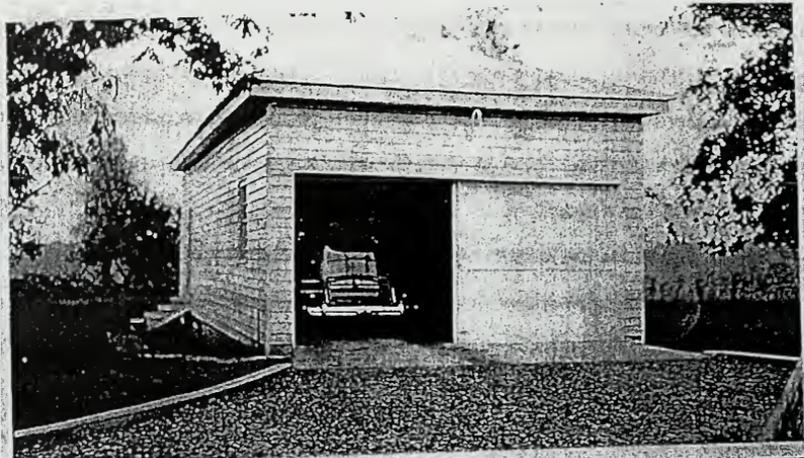
Slave Quarters/Garage, southwest oblique, October 1936. *Old Carriage House remodeled into garage—Concrete floor, Electric lights, Space for two cars, Gravel driveway, Chauffeur's quarters at rear. Our new Packard "in residence".* Source: J. S. Billings Scrapbook #1, 1887-1939. Courtesy, South Caroliniana Library.

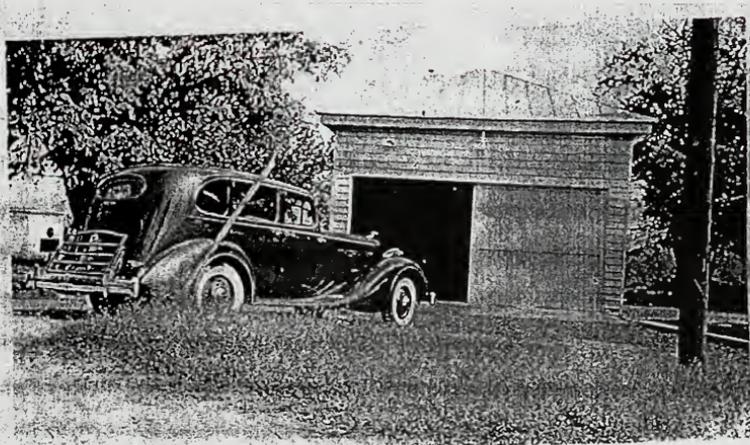
Slave Quarters/Garage, south elevation, October 1936. *Under the Packard's rear wheels is an ancient well, bricked over years ago.* Source: J. S. Billings Scrapbook #1, 1887-1939. Courtesy, South Caroliniana Library.

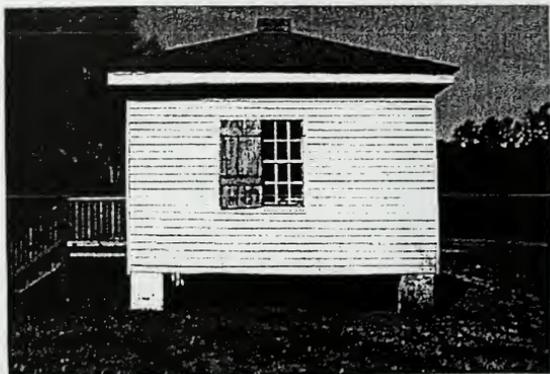
Slave Quarters, east elevation

The chimney base and the two other center piers also appear to be part of the 1936 renovation as indicated by their concrete mortar. Note that on the east elevation, a visible difference exists between the older and newer brick piers; their deterioration is evident.

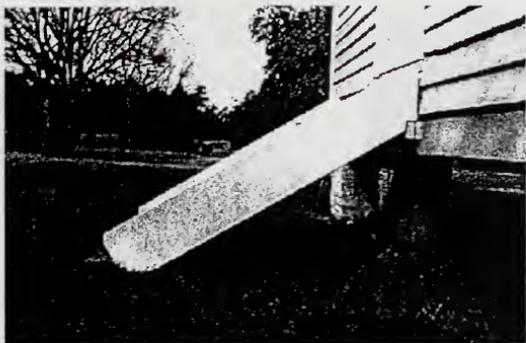
Slave Quarters, west cabin steps, south elevation

Two sets of steps on the south elevation lead up to the two doors. The west steps are replicas of stairs seen in a 1930s photograph and are not accessible by the public. The east steps were replaced in 2001 and are more substantial, with handrails for ease of entrance into the

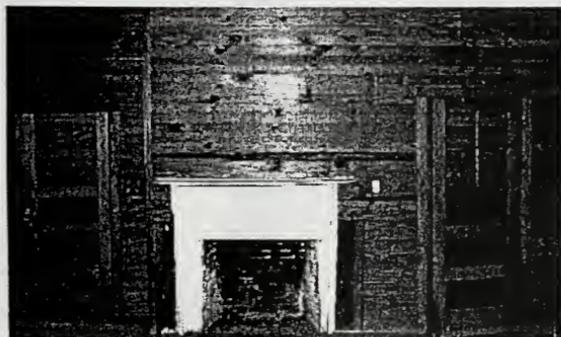
In the east room, to the north of the door dividing the rooms is a fireplace that has a cement hearth and brick firebox with an open flue. It is surrounded by a white, wooden mantelpiece with a shelf. In the west room, the fireplace is the same as in the east room, but does not have a mantel. There is a flue opening to the chimney with a metal surround above the fireplace, which is evidence of a wood-burning cookstove.

Slave Quarters, east room, west wall/partition with fireplace in center, closet on right, and door to west room on left

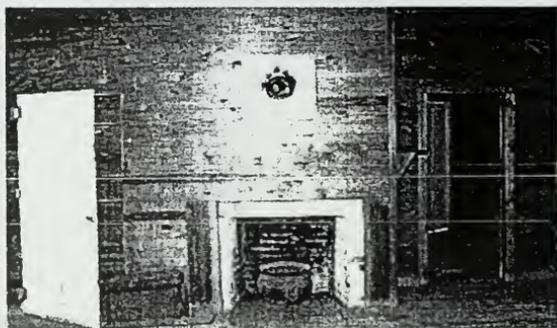
Slave Quarters, west room, east wall/partition; door to east room  
on the right; closet on the left

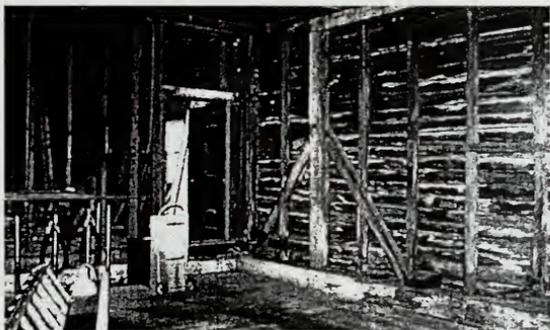
Slave Quarters/Garage, south room, northeast corner. Note doorframe leading to south room.
