CULTURAL LANDSCAPE REPORT FOR JOHN MUIR NATIONAL HISTORIC SITE

VOLUME 2: TREATMENT

By Jeffrey Killion
Historical Landscape Architect

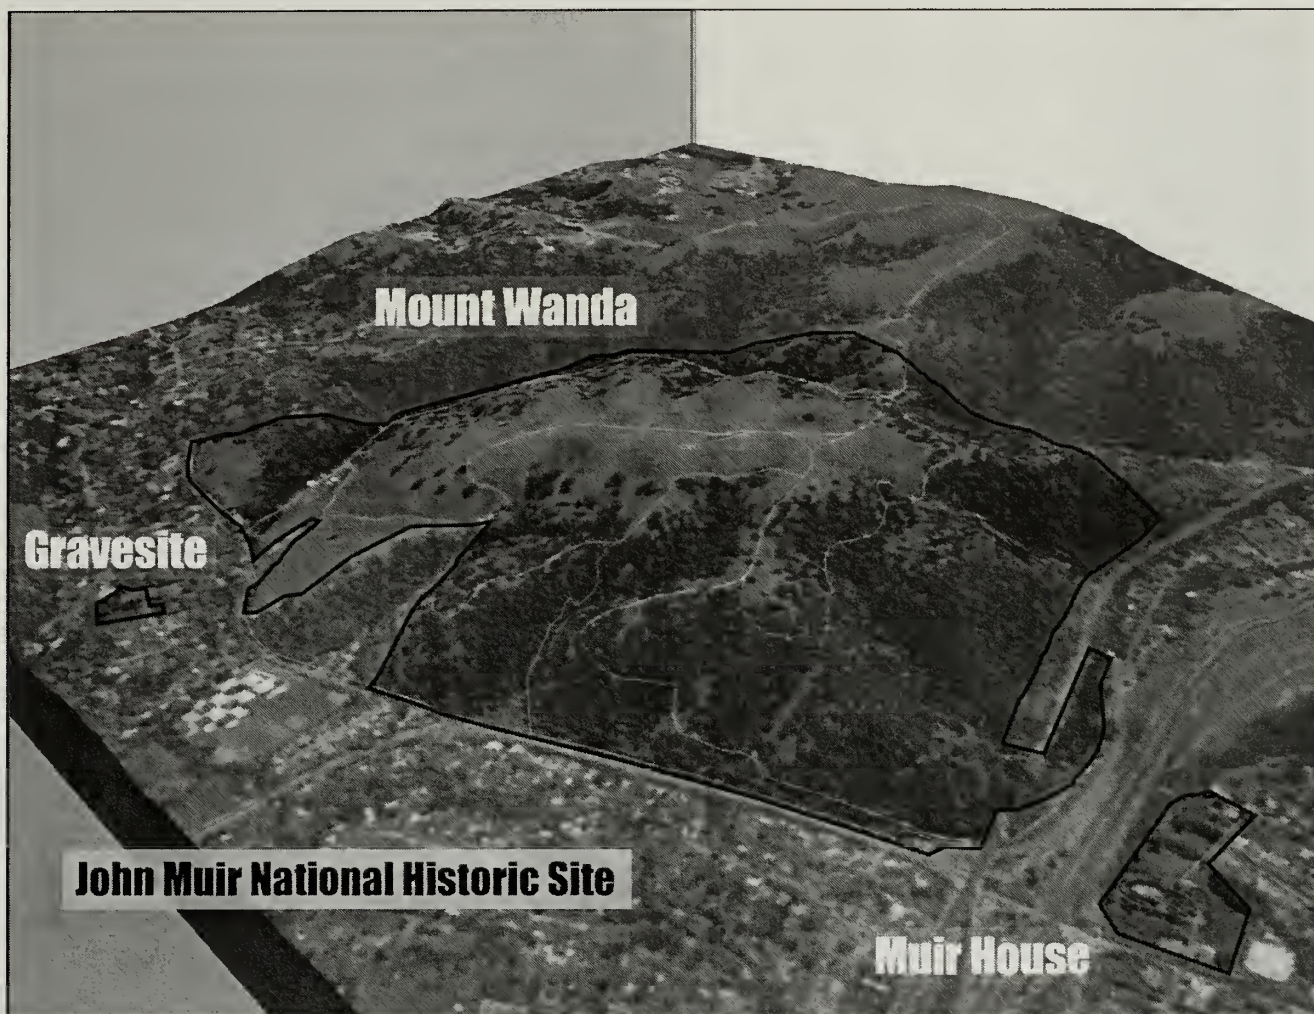
Figure 0.1: Three-dimensional topographic map showing the three units of the park. (John Muir National Historic Site - hereafter JOMU - geographic information system. Adapted by Olmsted Center for Landscape Preservation - hereafter OCLP - 2003).

The park is composed of three separate land units – the 8.9-acre House Unit, the 326-acre Mt. Wanda Unit, and the 1.3-acre Gravesite Unit – that together represent a small portion of the Strentzel-Muir Ranch that at its peak encompassed over 2300 acres (Figure 0.1). In August 1964, in advance of suburban development, the National Park Service (NPS) acquired the House Unit, which includes the Muir House, Martinez Adobe, and historic orchard and vineyard spaces. In 1988, the park's boundaries grew considerably with the acquisition of much of Mt. Wanda and the Strentzel-Muir gravesite area. The Mt. Wanda Unit (acquisition completed in 1991/92) was desired primarily because its steep wooded hillsides and remote grasslands – which were a favorite

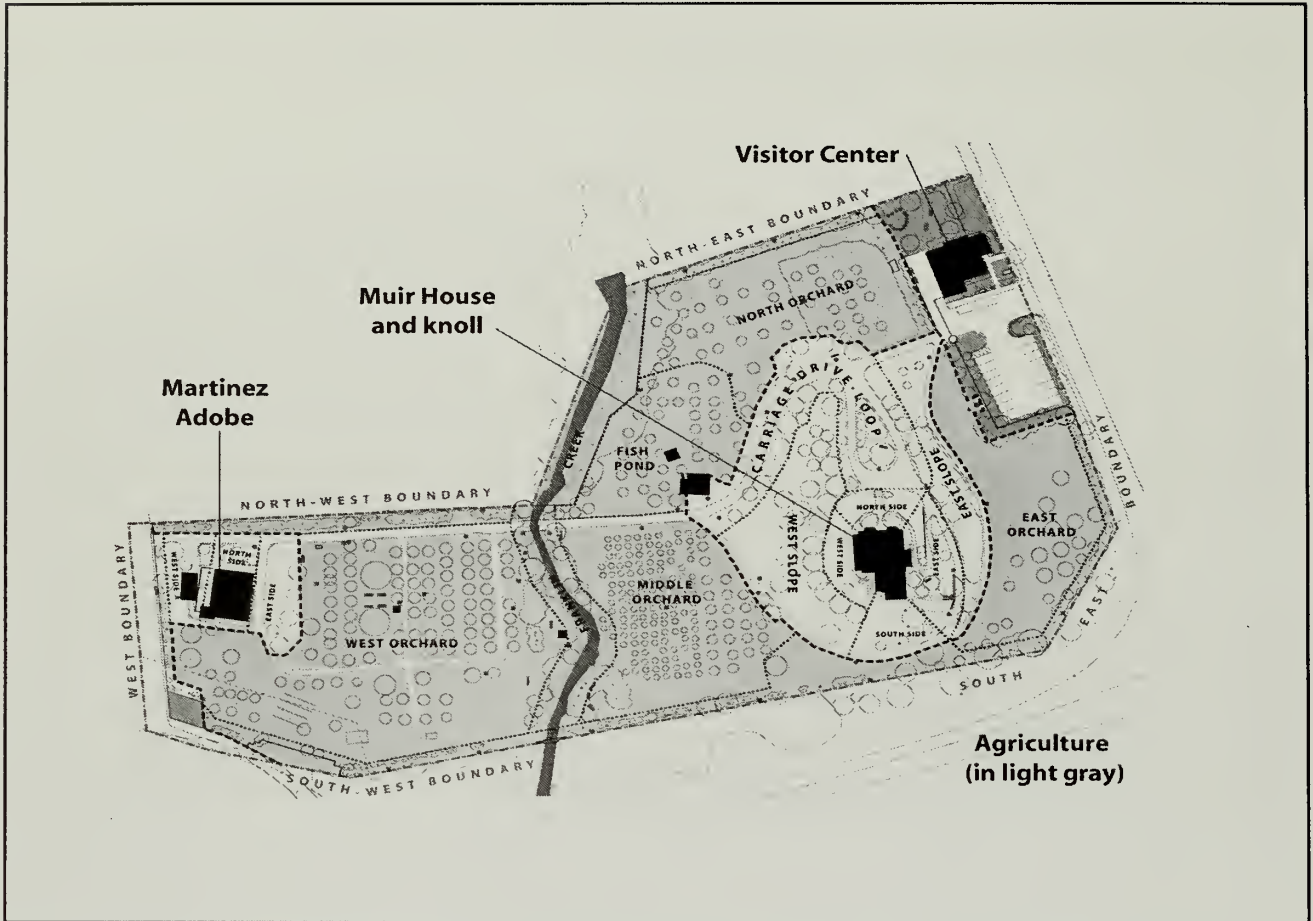
Figure 0.2: Character areas and feature zones at the House Unit. White areas represent the Muir House and knoll and Martinez Adobe areas, light gray indicates agricultural areas, and dark gray represents the Visitor Center area and utility easement. (OCLP, 2003).

As discussed in Volume 1, Chapter 8: Analysis of Landscape Characteristics and Features, this CLR is organized with a hierarchy of landscape character areas, characteristics, and features that together define the landscape at John Muir NHS. The landscape character areas have been determined by current park boundaries and landscape characteristics such as topography, types of vegetation, and concentration of buildings. The feature level treatment recommendations are organized according to the four character areas in the House Unit – Muir House and knoll, Agriculture, Martinez Adobe, and Visitor Center – as well as the Gravesite Unit and Mt. Wanda Unit character areas. They are as follows (Figure 0.2):

into seven smaller feature zones that generally radiate outward from the house: *north side, east side, south side, west side, and foundation*. Adjacent to these are the *west slope, east slope, and carriage drive-loop*.

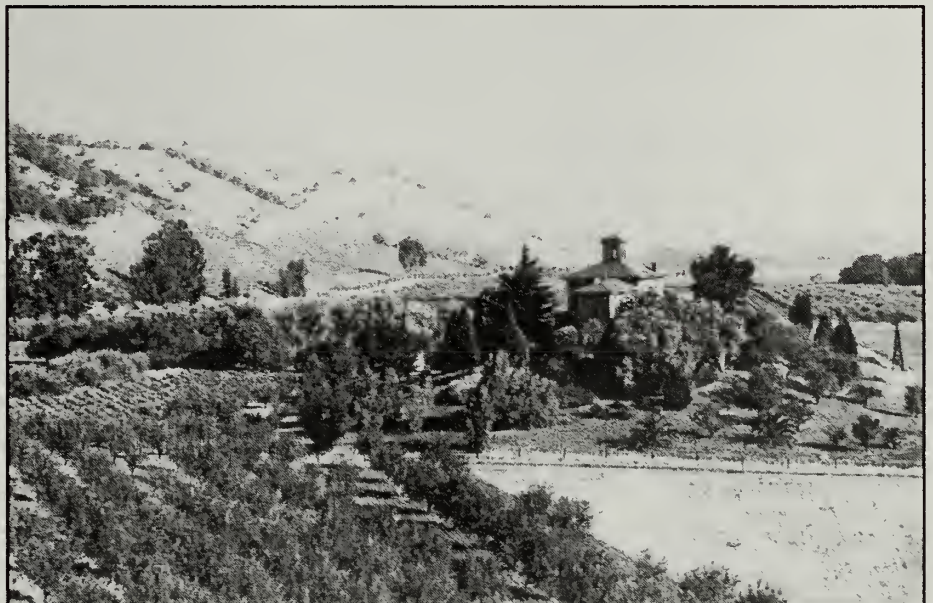
Figure 2.14: This view from c.1910 provides good views of the Mt. Wanda pear orchard and the plums and grapes southwest of the Muir House. (A1-30, JOMU, Ref: 1910-14c P29. Same as Figure 3.14 in Volume 1 of the CLR).

The eucalyptus grove contributes to the significance of the park as a character-defining vegetation feature of the historic period (1849- 1914). The trees appear in a photograph from c.1910 as two groups that are perhaps fifteen feet tall (Figure 2.14). Most of these trees were included within the fence of the Muir Homestead when the boundaries were set out in 1908. However, when the park’s boundaries were set out in 1964, many were not included in the property because of the right-of-way and fill slopes associated with upgrades to State Route 4. Today, there are seven large trees, four of which are within the park’s boundaries. The trees should be retained and maintained through a cyclical maintenance program and propagated for future replacement. The park should continue to monitor the trees on CALTRANS property and work with them to address preservation and maintenance issues and to ensure the dense mass of vegetation beyond the fence near the creek is maintained and kept low so as not to block views of Mt. Wanda.

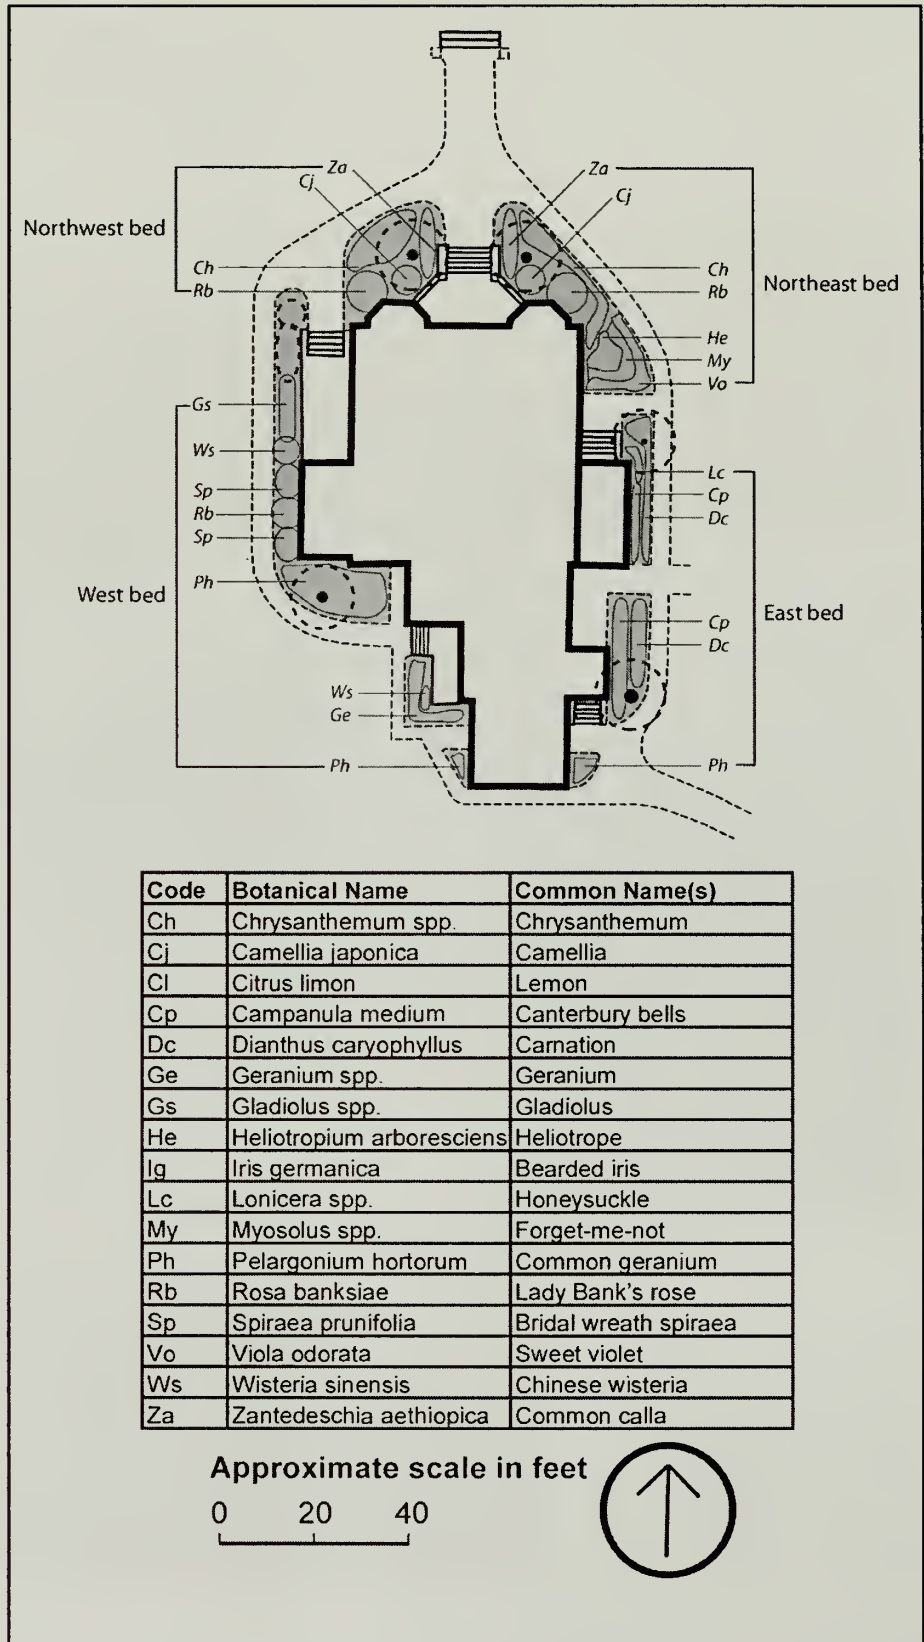
Figure 2.15: Reestablish historic character of the foundation beds - Proposed plantings around the foundation of the Muir House. (OCLP, 2003).

- 2.15 Reestablish historic character of the foundation beds at the Muir House. (OCLP, 2003).
- 2.16 Improve pedestrian and maintenance access into the west side of the House Unit. (OCLP, 2003).

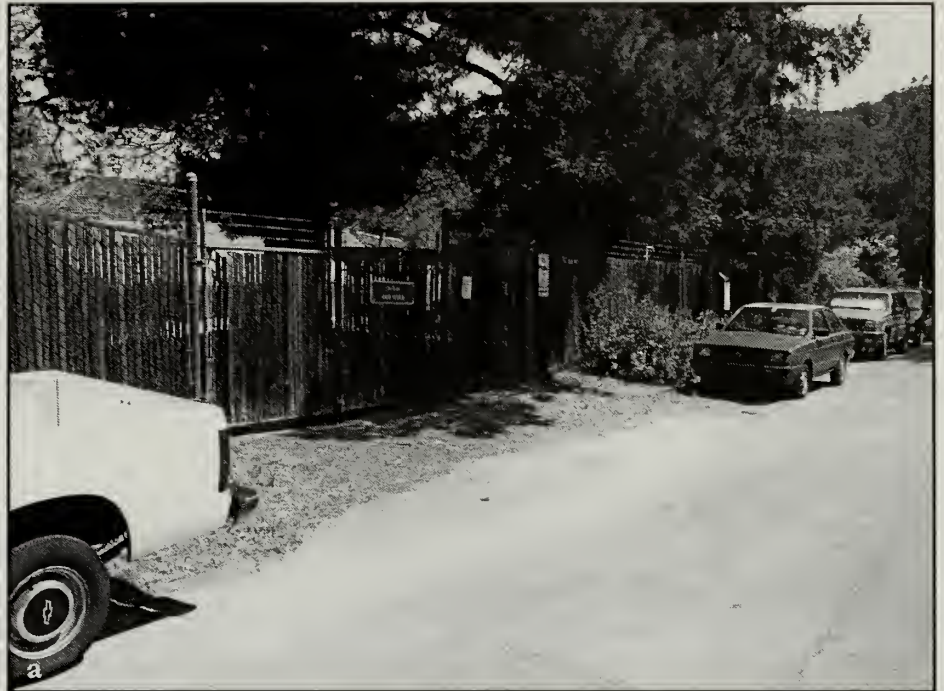
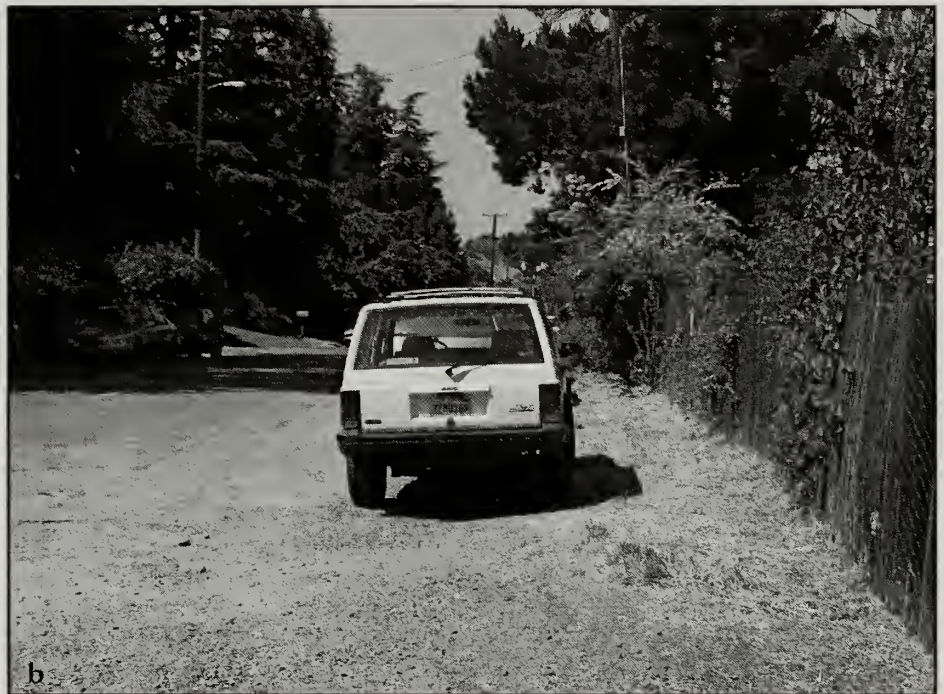
Figure 2.16: Improve pedestrian and maintenance access into the west side of the House Unit - (a) View looking southeast at the vehicular gate on Canyon Way. The pedestrian gate is between the second and third cars from the right, and (b) View looking north on Canyon Way and the path pedestrians and maintenance vehicles currently use. (OCLP, 2003).

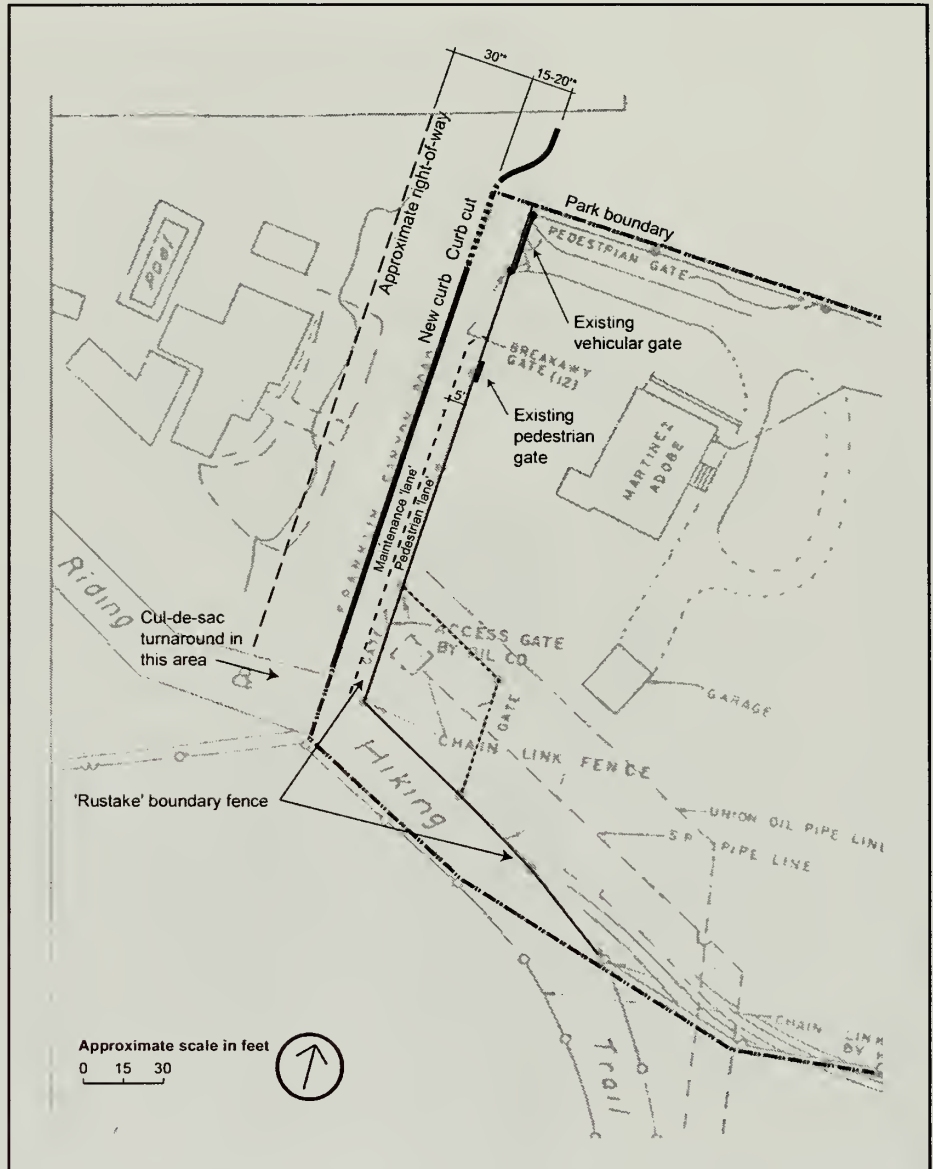
Figure 2.17: Improve pedestrian and maintenance access into the west side of the House Unit - Schematic drawing for a multi-purpose concrete path along Canyon Way. (Drawing adapted by OCLP. "Utilities," John Muir National Historic Site, National Park Service, Washington Regional Office, August 24, 1968, Drawing No. 426/80001).

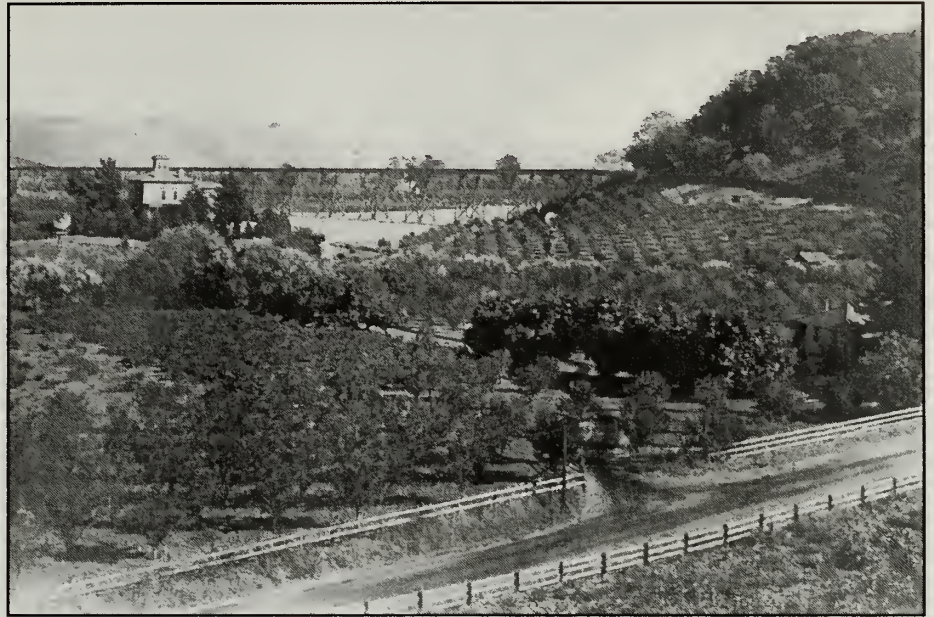
Figure 2.18: View looking southeast in c.1905 at the Muir House, railroad trestle, and the Martinez Adobe. (F13, Fr.#645. Holt-Atherton. Same as Figure 3.9 in Volume 1 of the CLR).

A line of fig trees was planted west of Franklin Creek along the north side of the main farm road by c.1885 (Figure 2.1). They did not form a continuous line, however, with a distinct gap roughly midway between the creek and the Martinez Adobe (Figure 2.18). Another opening may have been located opposite the Martinez Adobe for a farm lane that ran from the main farm road to Franklin Canyon Road, but this exact location has not been determined. After the historic period, all but one of the figs died; it still remains as do nine of thirteen clones which are about as tall as the north-west boundary fence. The other plants were added in between the figs to screen the residences on the other side of the fence. The location of the butterfly-bush approximately corresponds to the location of the historic gap mentioned above.

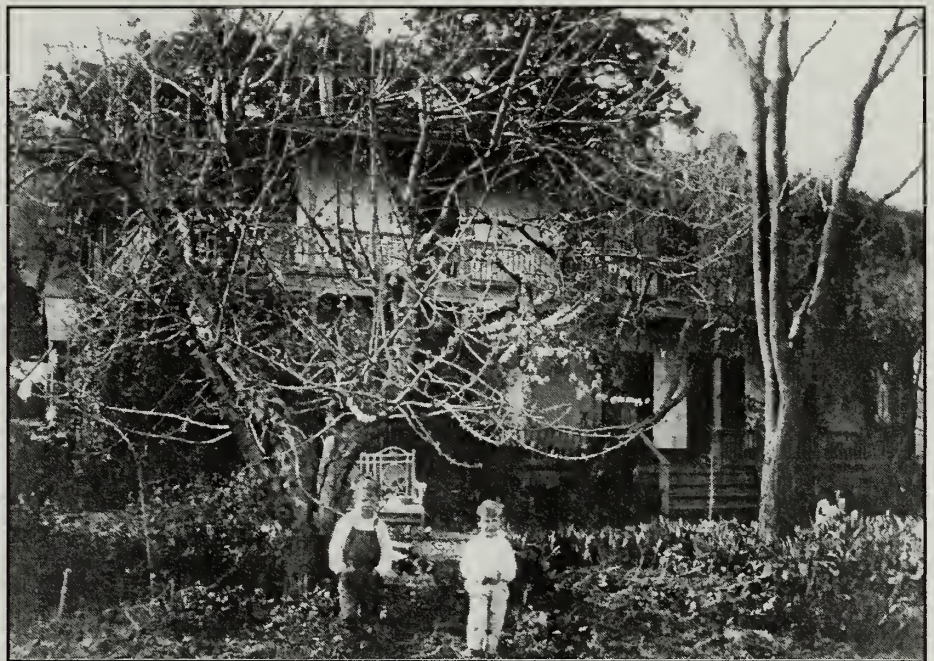
Figure 2.19: View from c.1912-1913 looking west at the front of the Martinez Adobe. (B1-39, JOMU. Same as Figure 3.18 in Volume 1 of the CLR).

The plantings on the east side of the Martinez Adobe do not contribute to the significance of the park as characteristic vegetation features of the historic period (1849- 1914) and are incompatible with the historic setting. During the Strentzel- Muir Ranch period, the Martinez Adobe was initially used as a storehouse and ranch headquarters and then as a residence. A c.1885 photograph suggests this area was probably a workyard and showed some type of fruit tree in front (Figure 2.1). The only detailed photograph of the front of the building dates from c.1912- 1913 and shows one of the three black locust trees remembered by Mr. Figuerado and others surrounded by a mass of low shrubs and flowers (Figure 2.19). Mr. Figuerado also remembered a redwood tree to the southeast and a pine to the northeast.

This area was likely well- shaded because of the tall locust trees. To restore this character, three black locust trees should be planted in front of the building. The location of the southernmost specimen can generally be estimated from Figure 2.19. The other trees should be planted parallel to the east driveway about twenty feet apart to encourage their canopies to eventually merge as they mature. As the trees mature, their lower limbs should be managed to preserve the view to the east of the Muir House. Replacement of the flowers and shrubs around the black locust is not recommended because the size of this bed is not known. Similarly, the historic location of a pine recalled by Mr. Figuerado as “northeast of the house” is too vague to recommend a replacement.

The two memorial Colorado blue spruces and one white spruce, as well as a Sitka spruce, should be removed, but the coast redwood should be retained and maintained as it may be the tree remembered by Mr. Figuerado or a later stem. The quince should be removed, as its form does not appear to be consistent with the fruit tree shown in Figure 2.19. The park should consult

The wisteria on the east foundation of the Martinez Adobe contributes to the significance of the park as a characteristic vegetation feature of the historic period (1849- 1914). There is no reliable historic documentation regarding other plants on the east side or the foundation plants around the south, west, and north sides. The wisteria was present in c.1912- 1913 and replanted by the NPS in the same location. In a photograph from that time, the wisteria is tangled around each end of the veranda. Other relatively low vegetation is visible and appears to be mostly perennials, but they cannot be accurately identified (Figure 2.19).

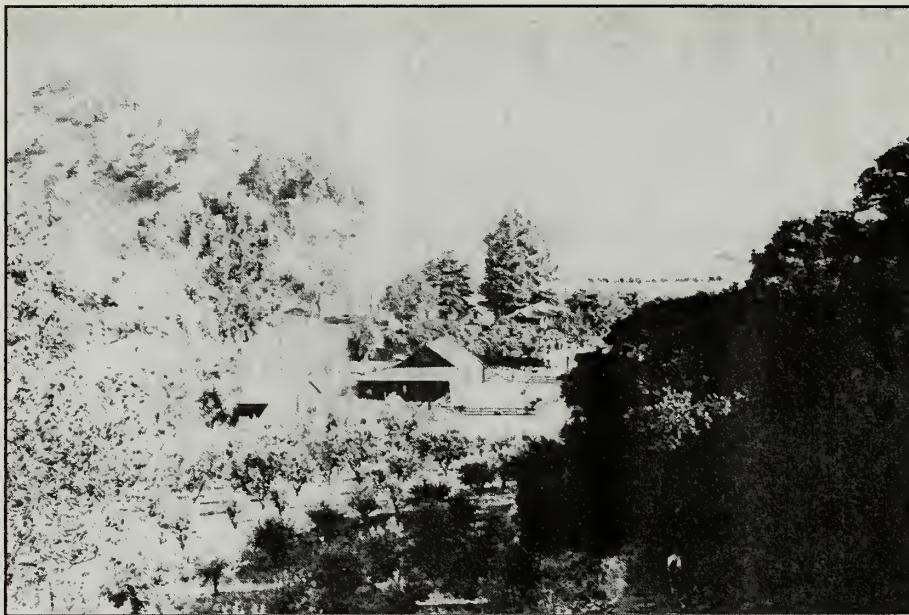
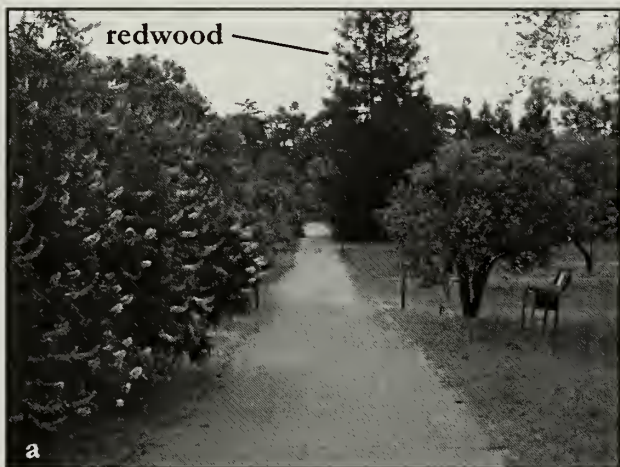
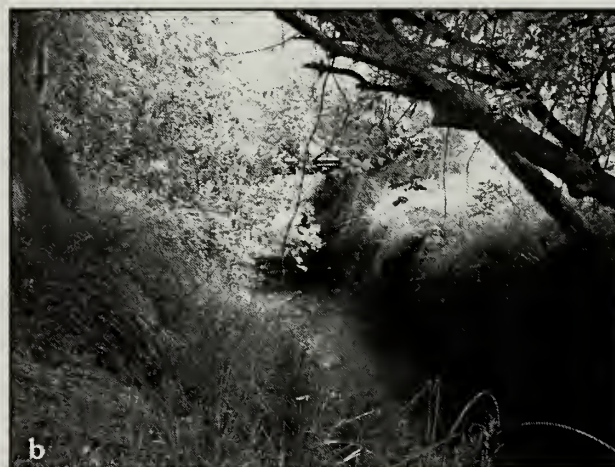
Figure 2.21: Retain and reestablish historic character of Franklin Creek - (a) The tall coast redwood next to the Franklin Creek Bridge should be removed to restore a view from the main farm road to the Muir House; (b) Removal of many of the tall trees will open up the views across the creek. (OCLP, 2003).

- 2.21 Retain and reestablish historic character of Franklin Creek. (OCLP, 2003).
- 2.22 Replace the Alhambra windmill. ("Windmill Platform, Tower, and Well," John Muir National Historic Site, NPS, Office of History and Historic Architecture, Division of Historic Architecture, March 1971, Drawing No. 426/41002).

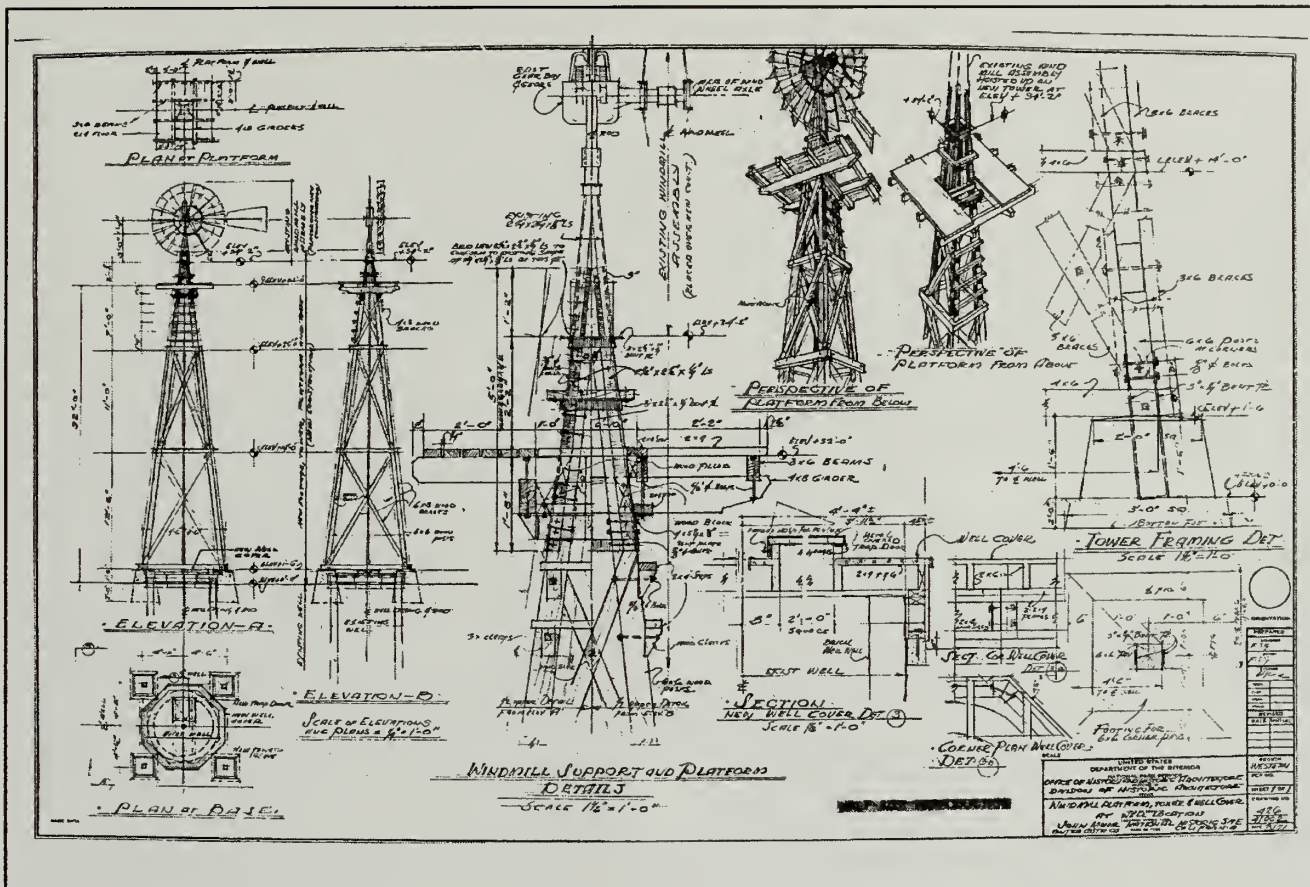
Figure 2.22: Replace the Alhambra windmill - Details for the reconstructed Franklin Creek Windmill. ("Windmill Platform, Tower, and Well," John Muir National Historic Site, NPS, Office of History and Historic Architecture, Division of Historic Architecture, March 1971, Drawing No. 426/41002).

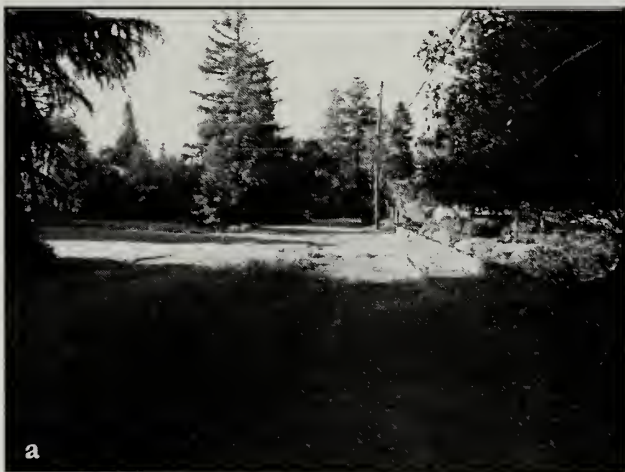
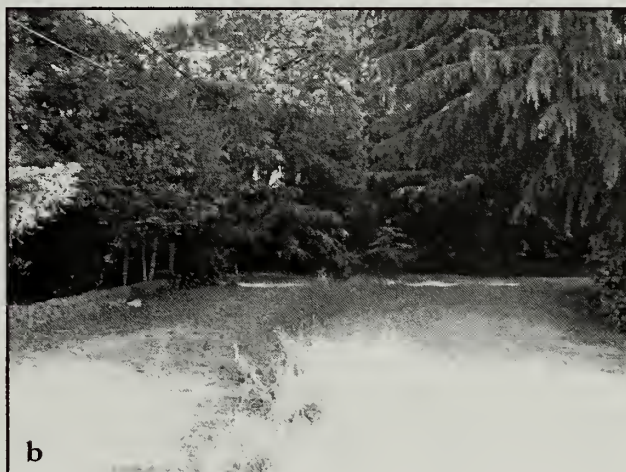
Figure 2.23: Survey Gravesite Unit; develop program for visitor and maintenance access - (a) View looking north at the paper street from the entrance clearing at the Gravesite Unit. Parallel or angled parking spaces could be developed next to the stone wall on the right, and b) View looking south at the same street. The parking spaces would be on the left next to the wall, just before the entrance into the site. Since these photographs were taken, plantings of olives have been installed in these areas. (OCLP, 2003).

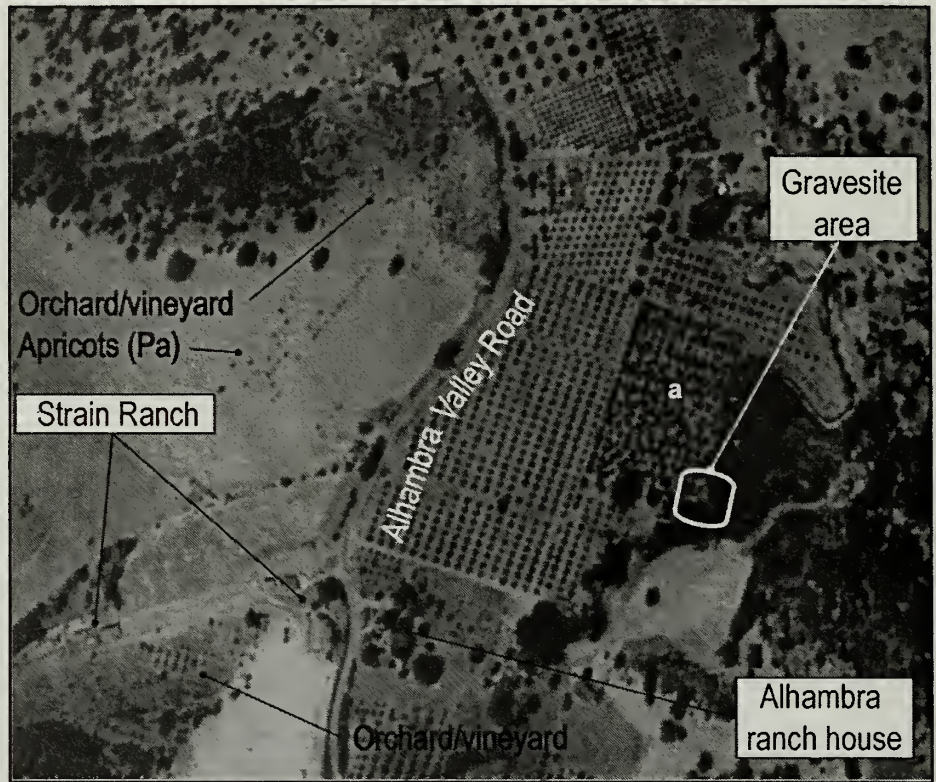
Figure 2.24: This portion of the 1939 aerial photograph shows the gravesite area, Strain Ranch, and the Alhambra ranch house. In addition to the apricots and olives on Mt. Wanda, the pear orchard (a) next to the gravesite can also be seen. (JOMU, no #. Same as Figure 4.6 in Volume 1 of the CLR).

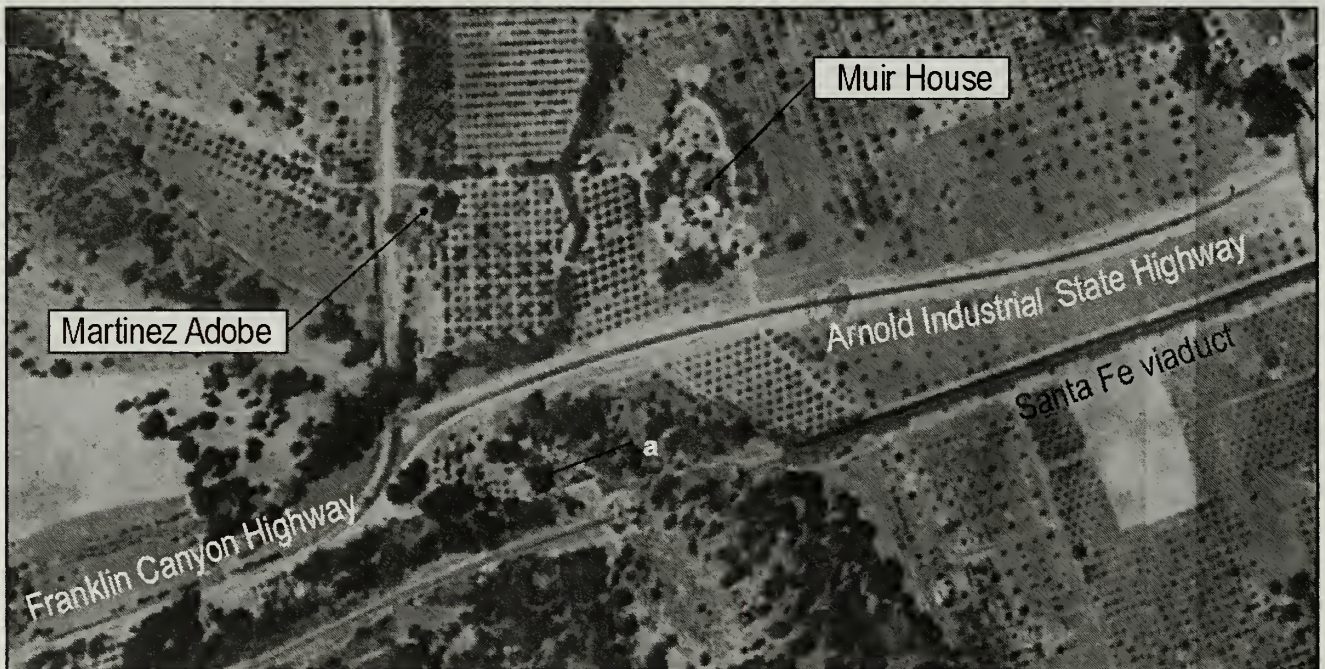
Figure 2.25: This portion of the 1939 aerial photograph shows what may be part of the walnut orchard (a) on the lower north slope of Mt. Wanda. (JOMU, no #. Portion of Figure 4.2 in Volume 1 of the CLR).

The significance of the California black walnut and English walnut trees on the lower north slopes of Mt. Wanda has not been determined due to the lack of historical documentation (Figure 2.25). Recommended short- and long- term actions are as follows:

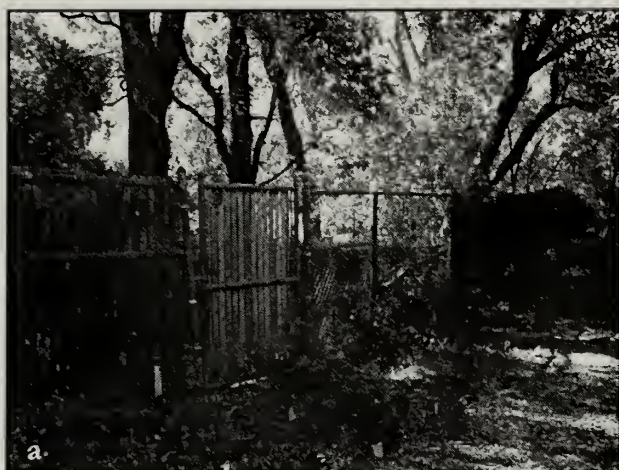
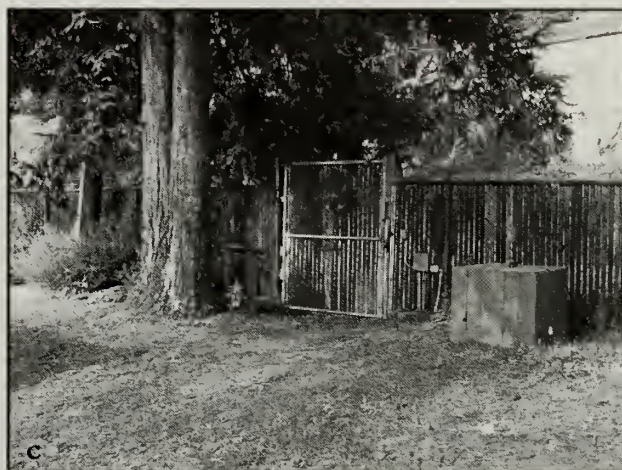
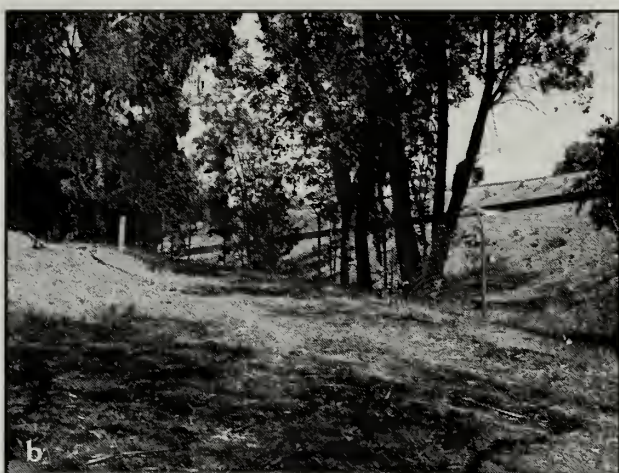
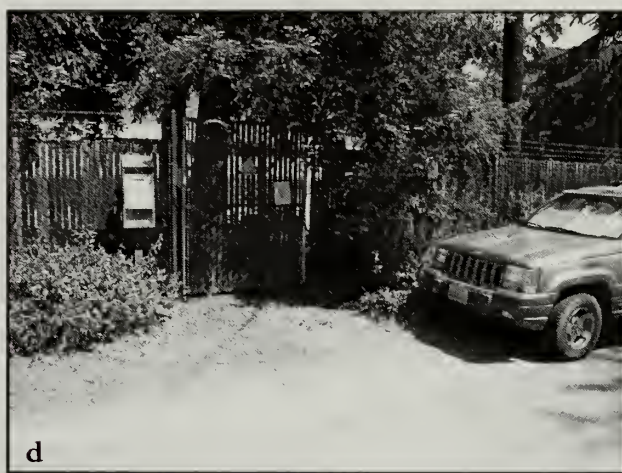
Figure 2.26: Alter the existing boundary fences and gates, and oil valves fence at the House Unit - (a) Replacement pickets should be installed along the fence at Franklin Creek ; (b) new pickets should be installed along the south-east boundary fence paralleling State Route 4 from the apple orchard to Franklin Creek; c-d) Removal of the pickets would reestablish a historic view to and from Canyon Way. (OCLP, 2003).

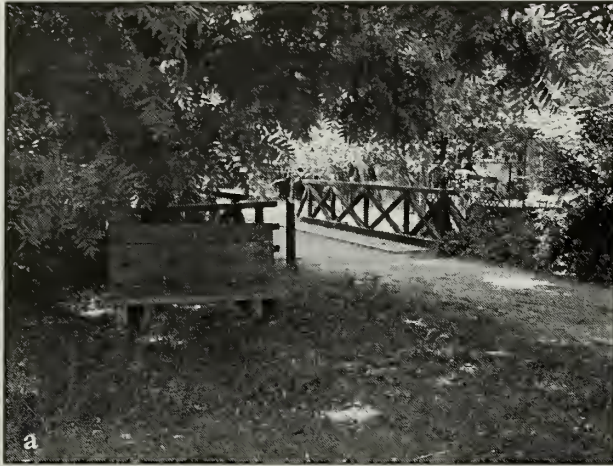
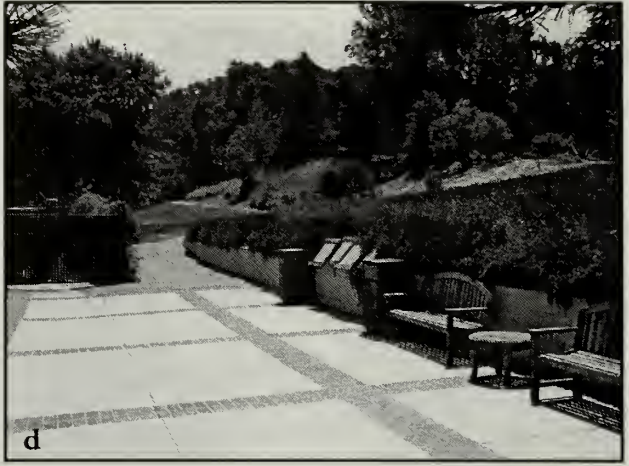
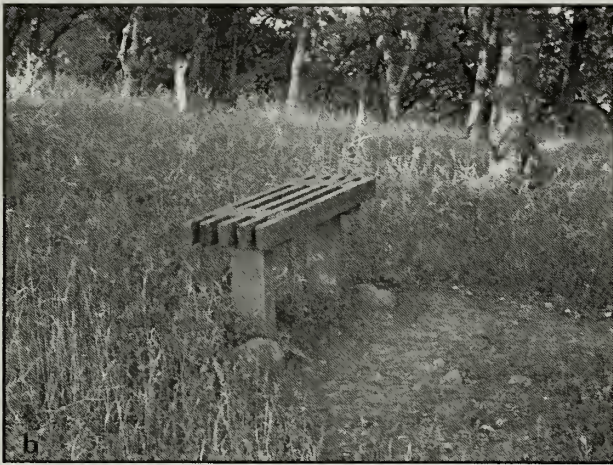
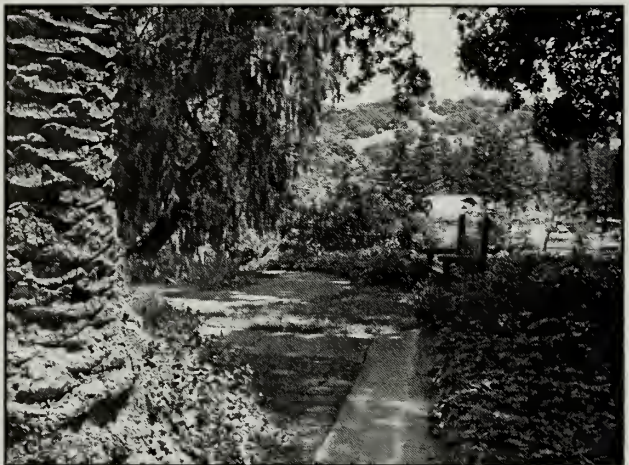
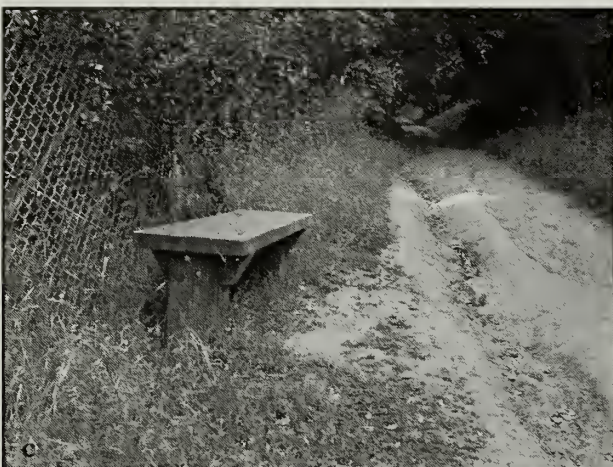
Figure 2.27: Select consistent bench design throughout the park -
(a) Bench at Franklin Creek Bridge; b) bench at Mt. Wanda;
c) bench at kiosk near park and ride lot; d) prefabricated benches at Visitor Center; and e) prefabricated bench on east side of the Muir House. (OCLP, 2003).

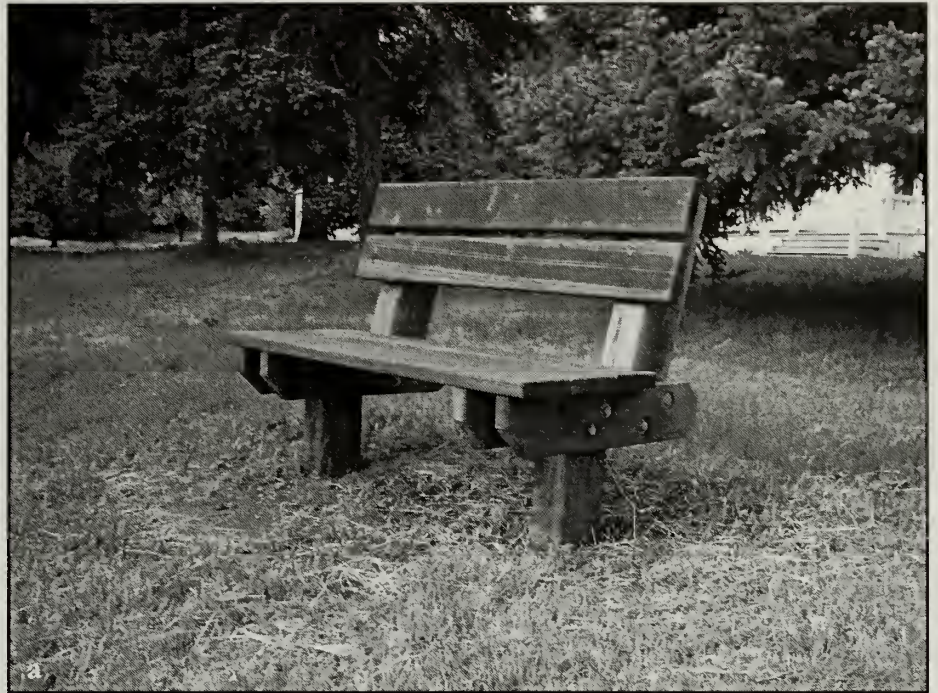
Figure 2.28: Select consistent bench design throughout the park -

(a) The preferred design for a seating bench with back is located in the west orchard northeast of the Martinez Adobe, near the main farm road; and b) the preferred design for a backless bench is located at the bottom of the carriage drive-loop near the bent California fan palm. Both of these types of benches are also located under the grove of redwoods next to Franklin Creek. (OCLP, 2003).

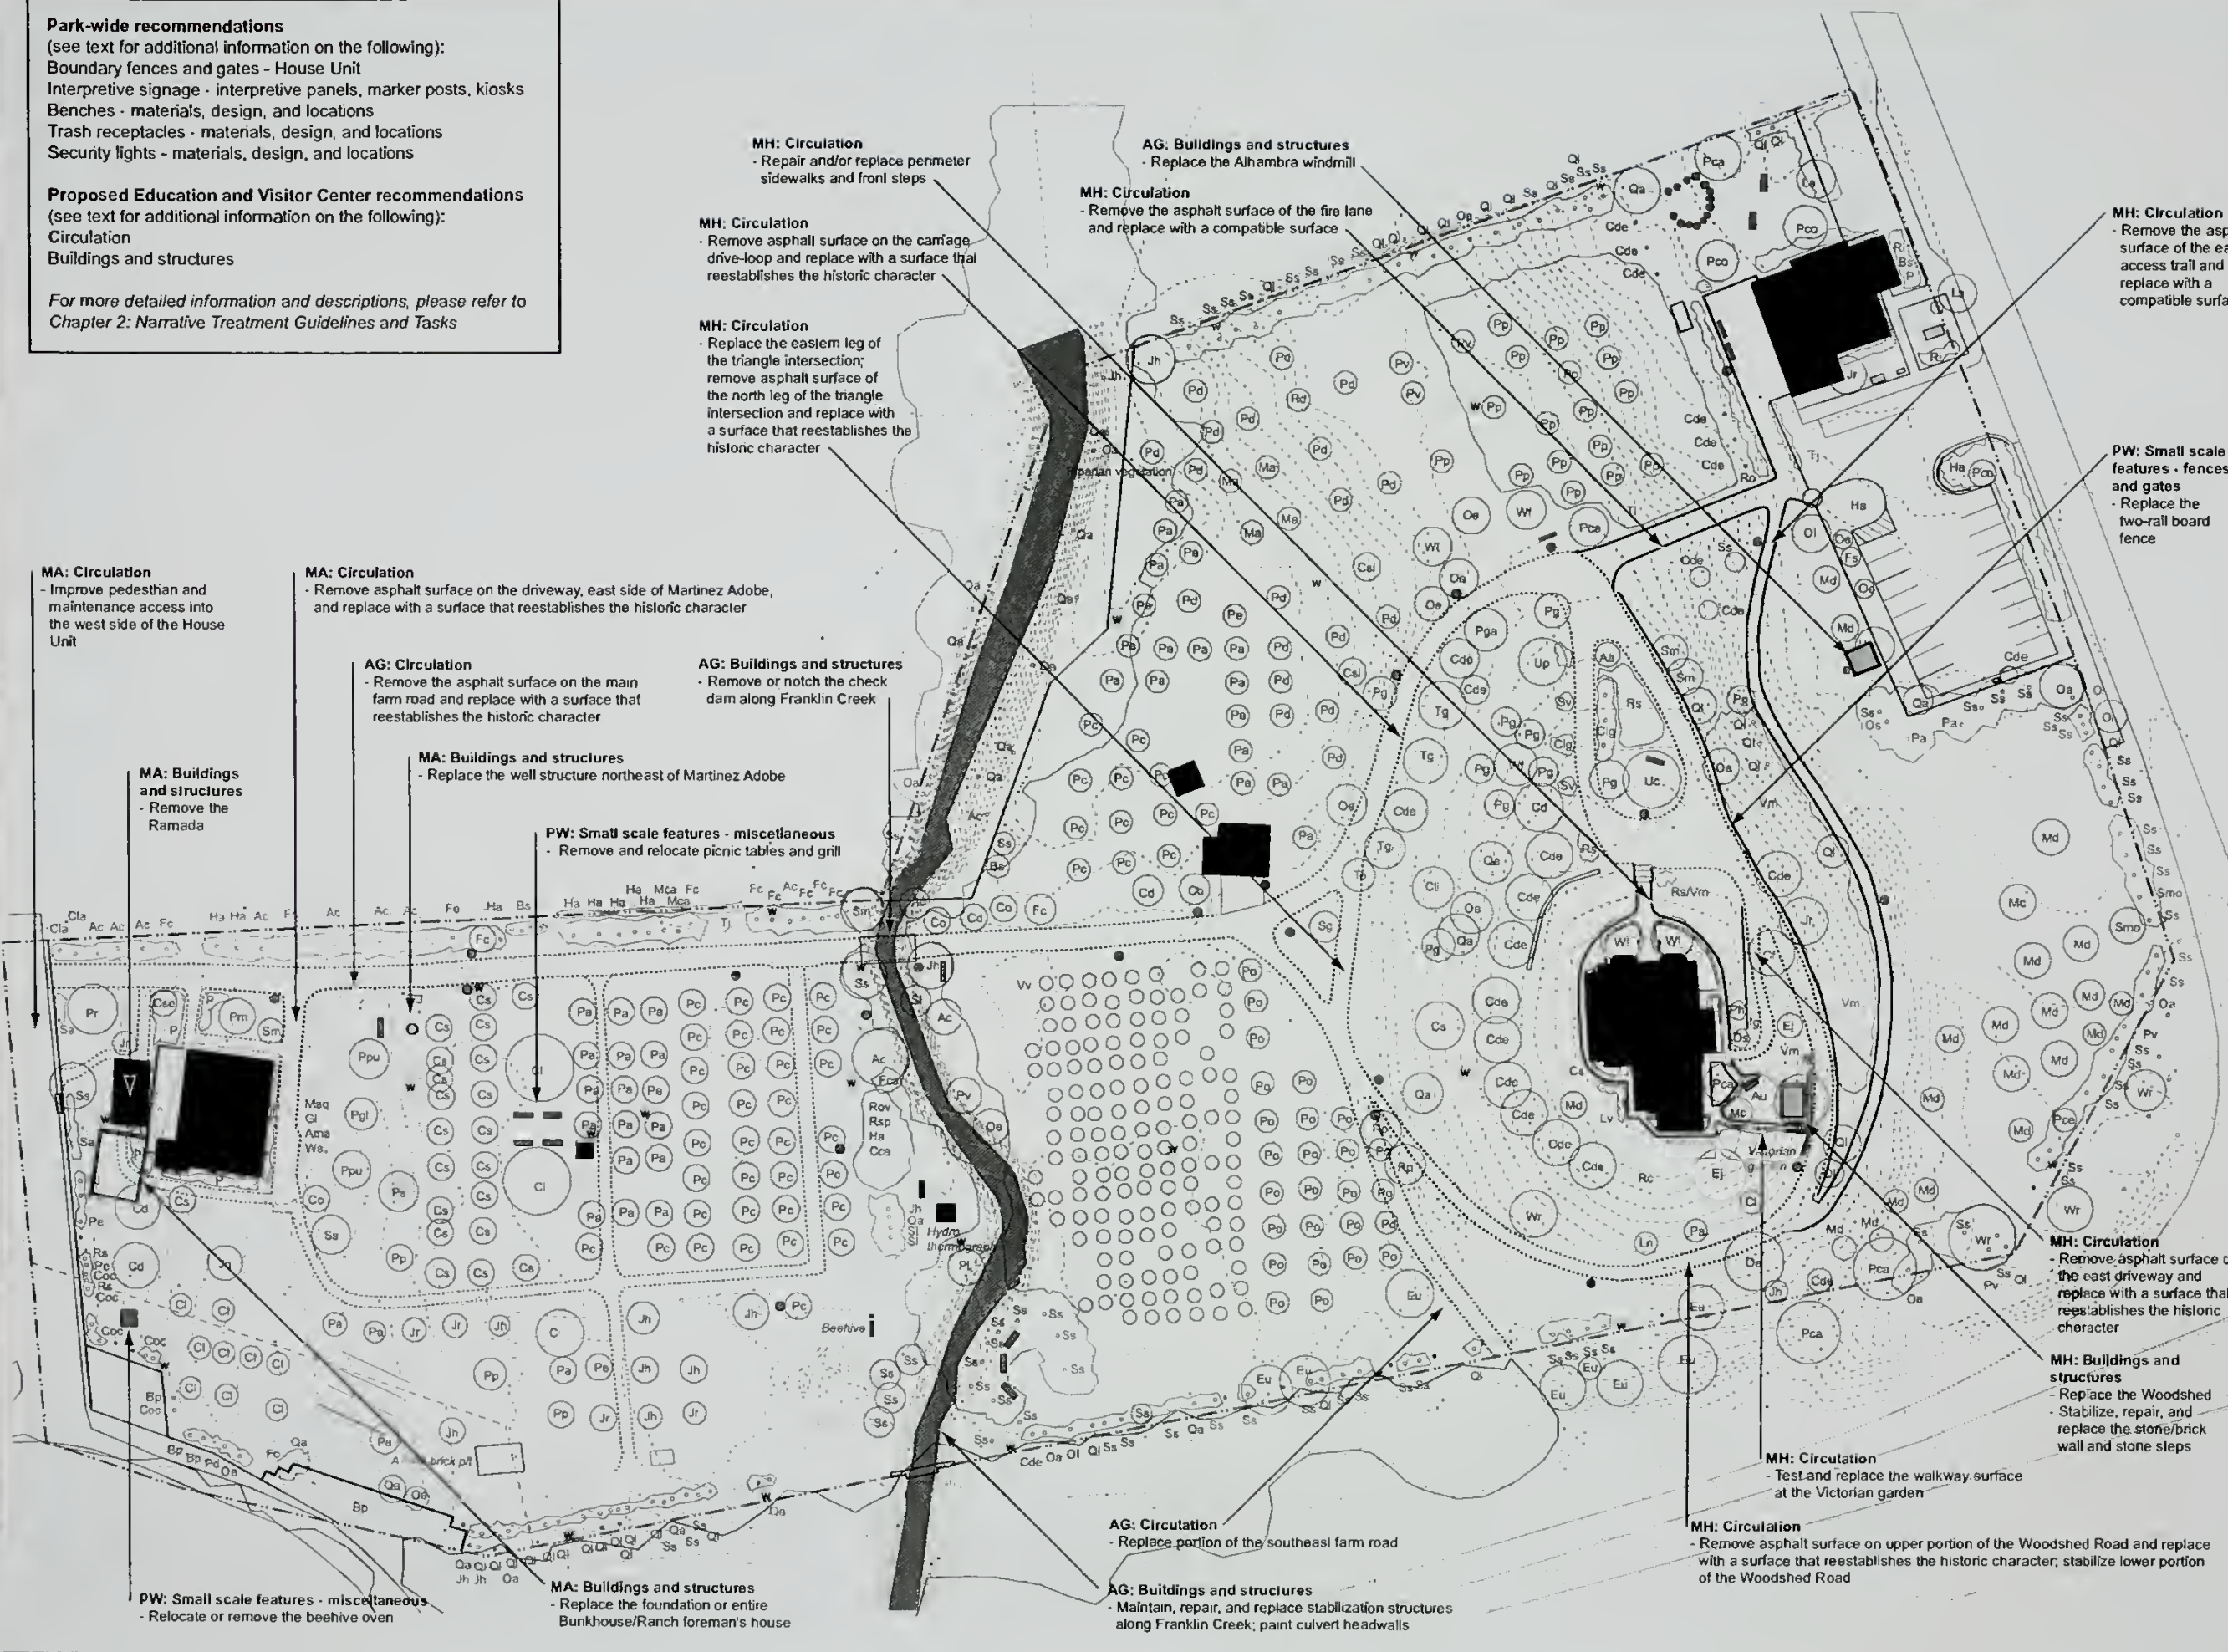
MH: Circulation
- Repair and/or replace perimeter sidewalks and front steps

AG: Buildings and structures
- Replace the Alhambra windmill
