CULTURAL LANDSCAPE REPORT FOR JOHN MUIR NATIONAL HISTORIC SITE

VOLUME 2: TREATMENT

By Jeffrey Killion
Historical Landscape Architect

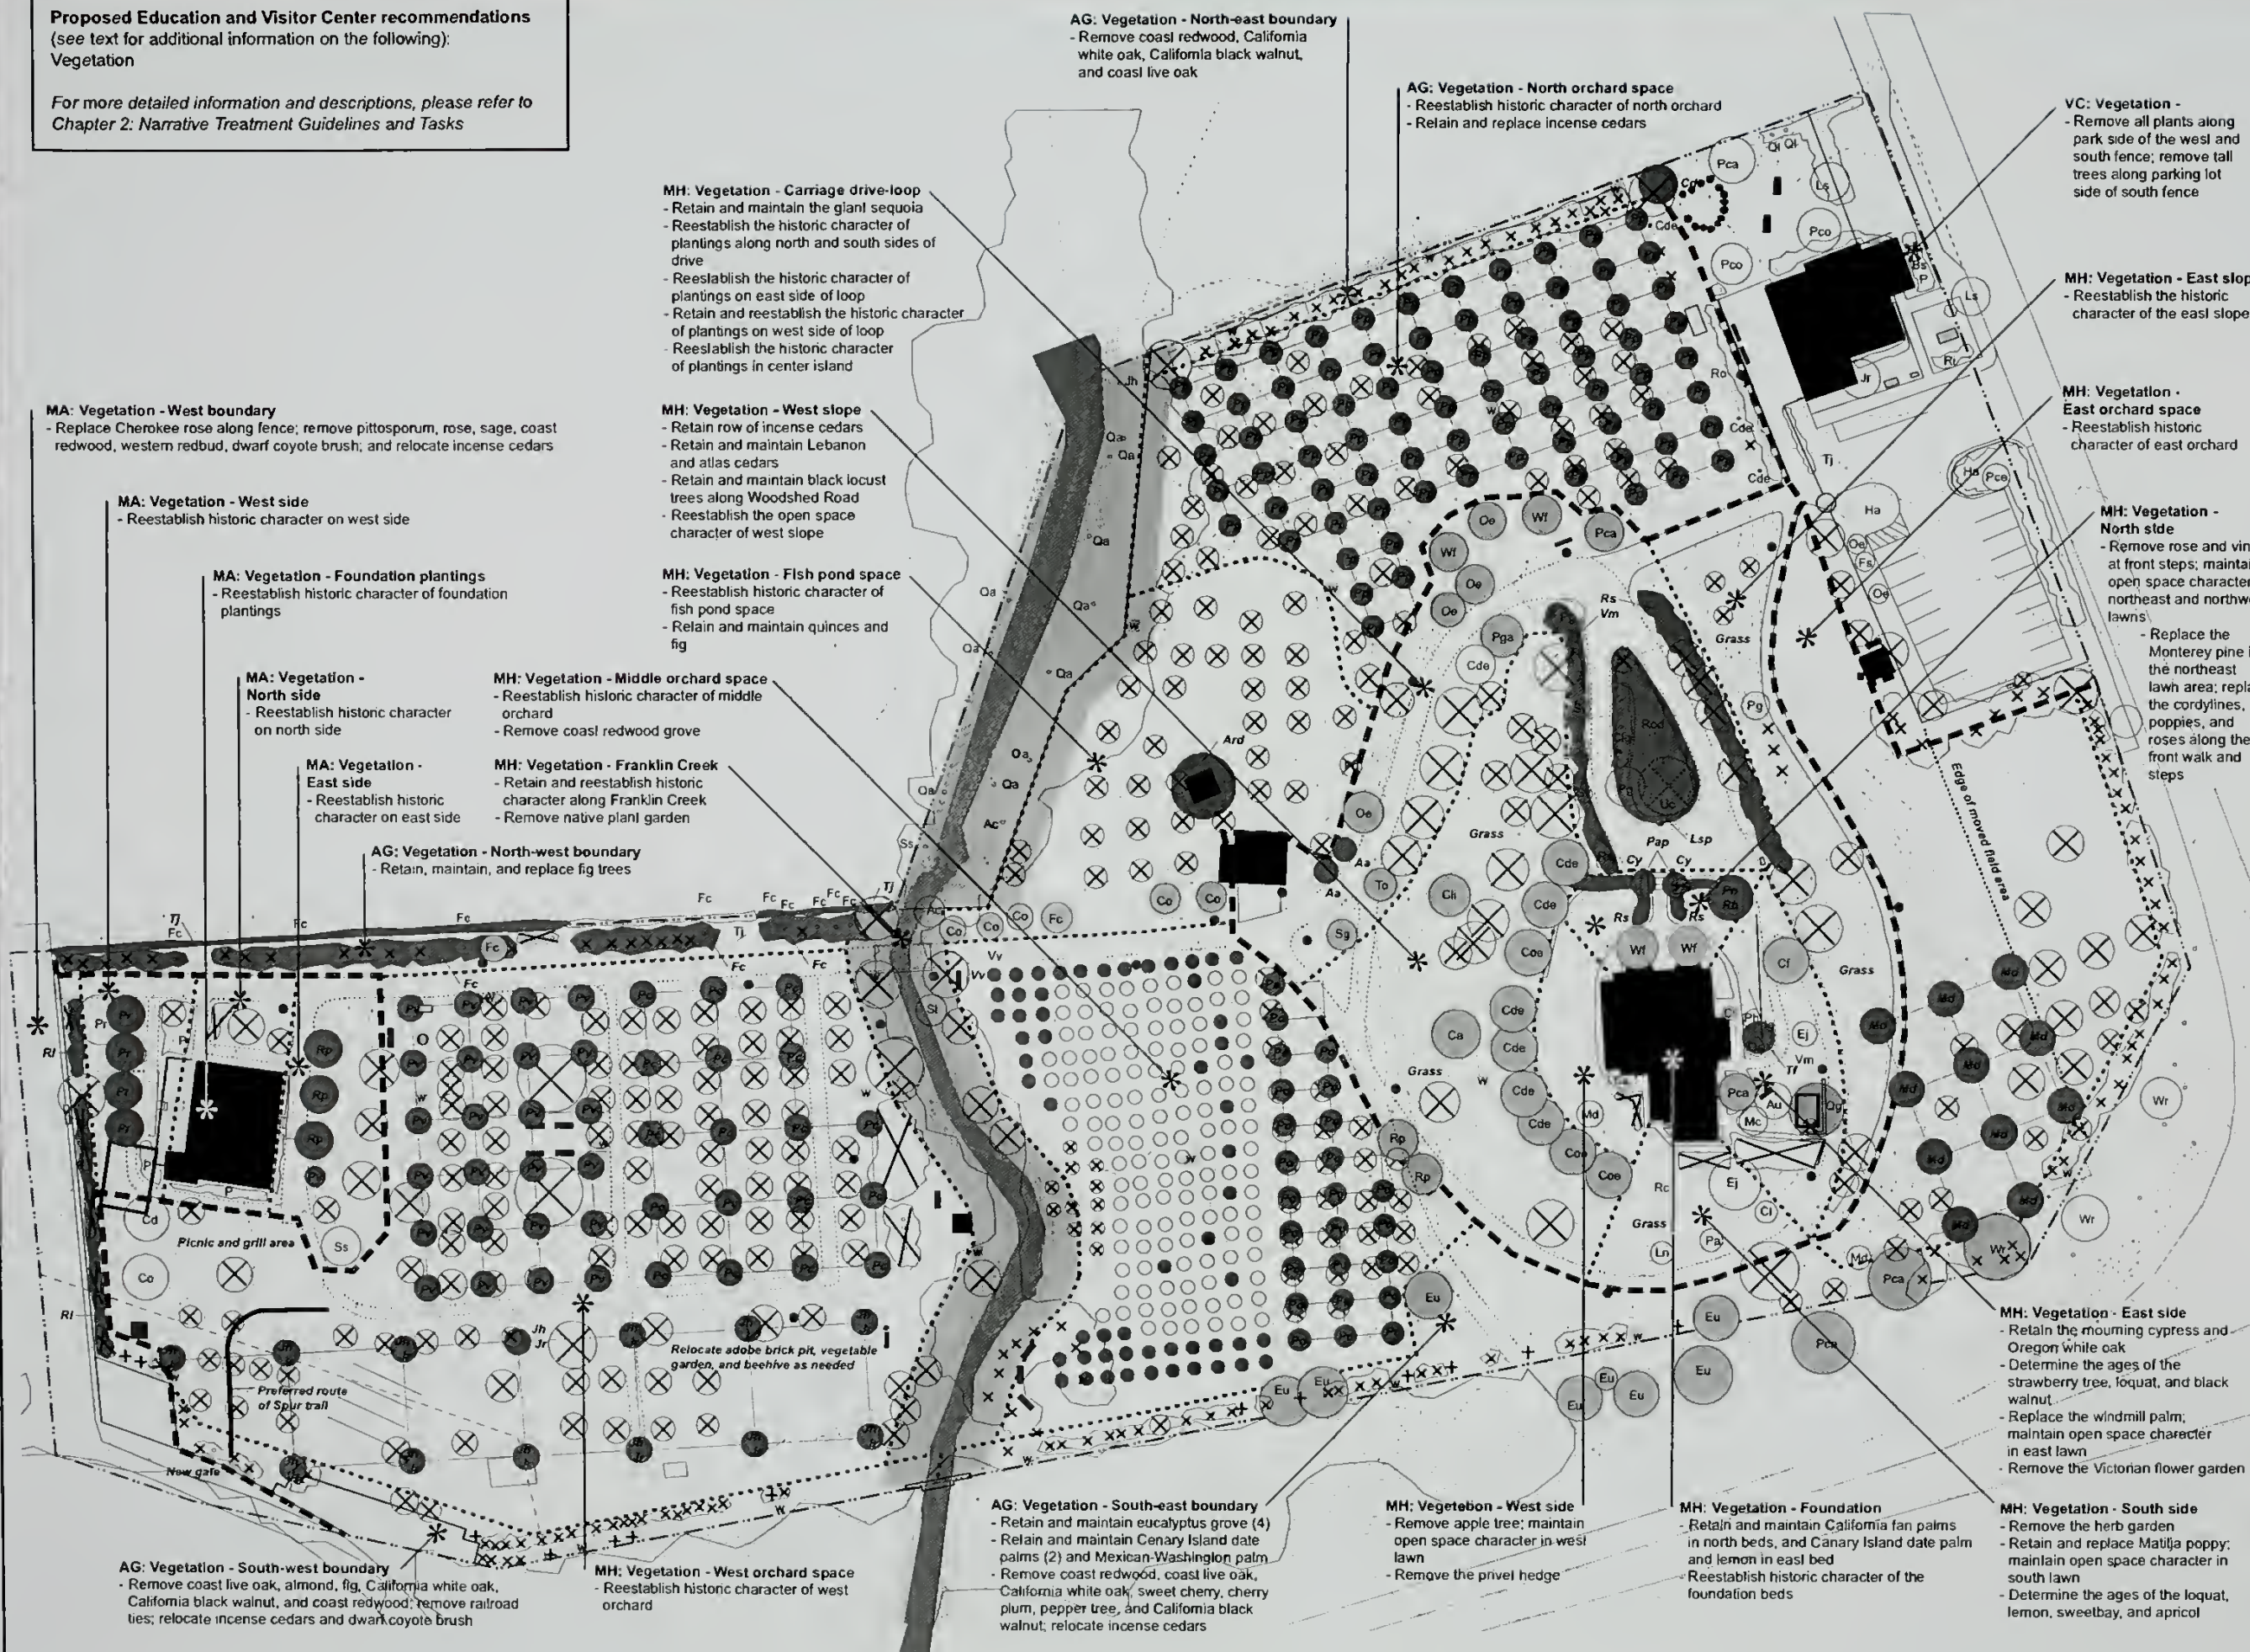
MH: Vegetation - Carriage drive-loop
- Retain and maintain the giant sequoia
- Reestablish the historic character of plantings along north and south sides of drive
- Reestablish the historic character of plantings on east side of loop
- Retain and reestablish the historic character of plantings on west side of loop
- Reestablish the historic character of plantings in center island

MH: Vegetation - West slope
- Retain row of incense cedars
- Retain and maintain Lebanon and atlas cedars
- Retain and maintain black locust trees along Woodshed Road
- Reestablish the open space character of west slope

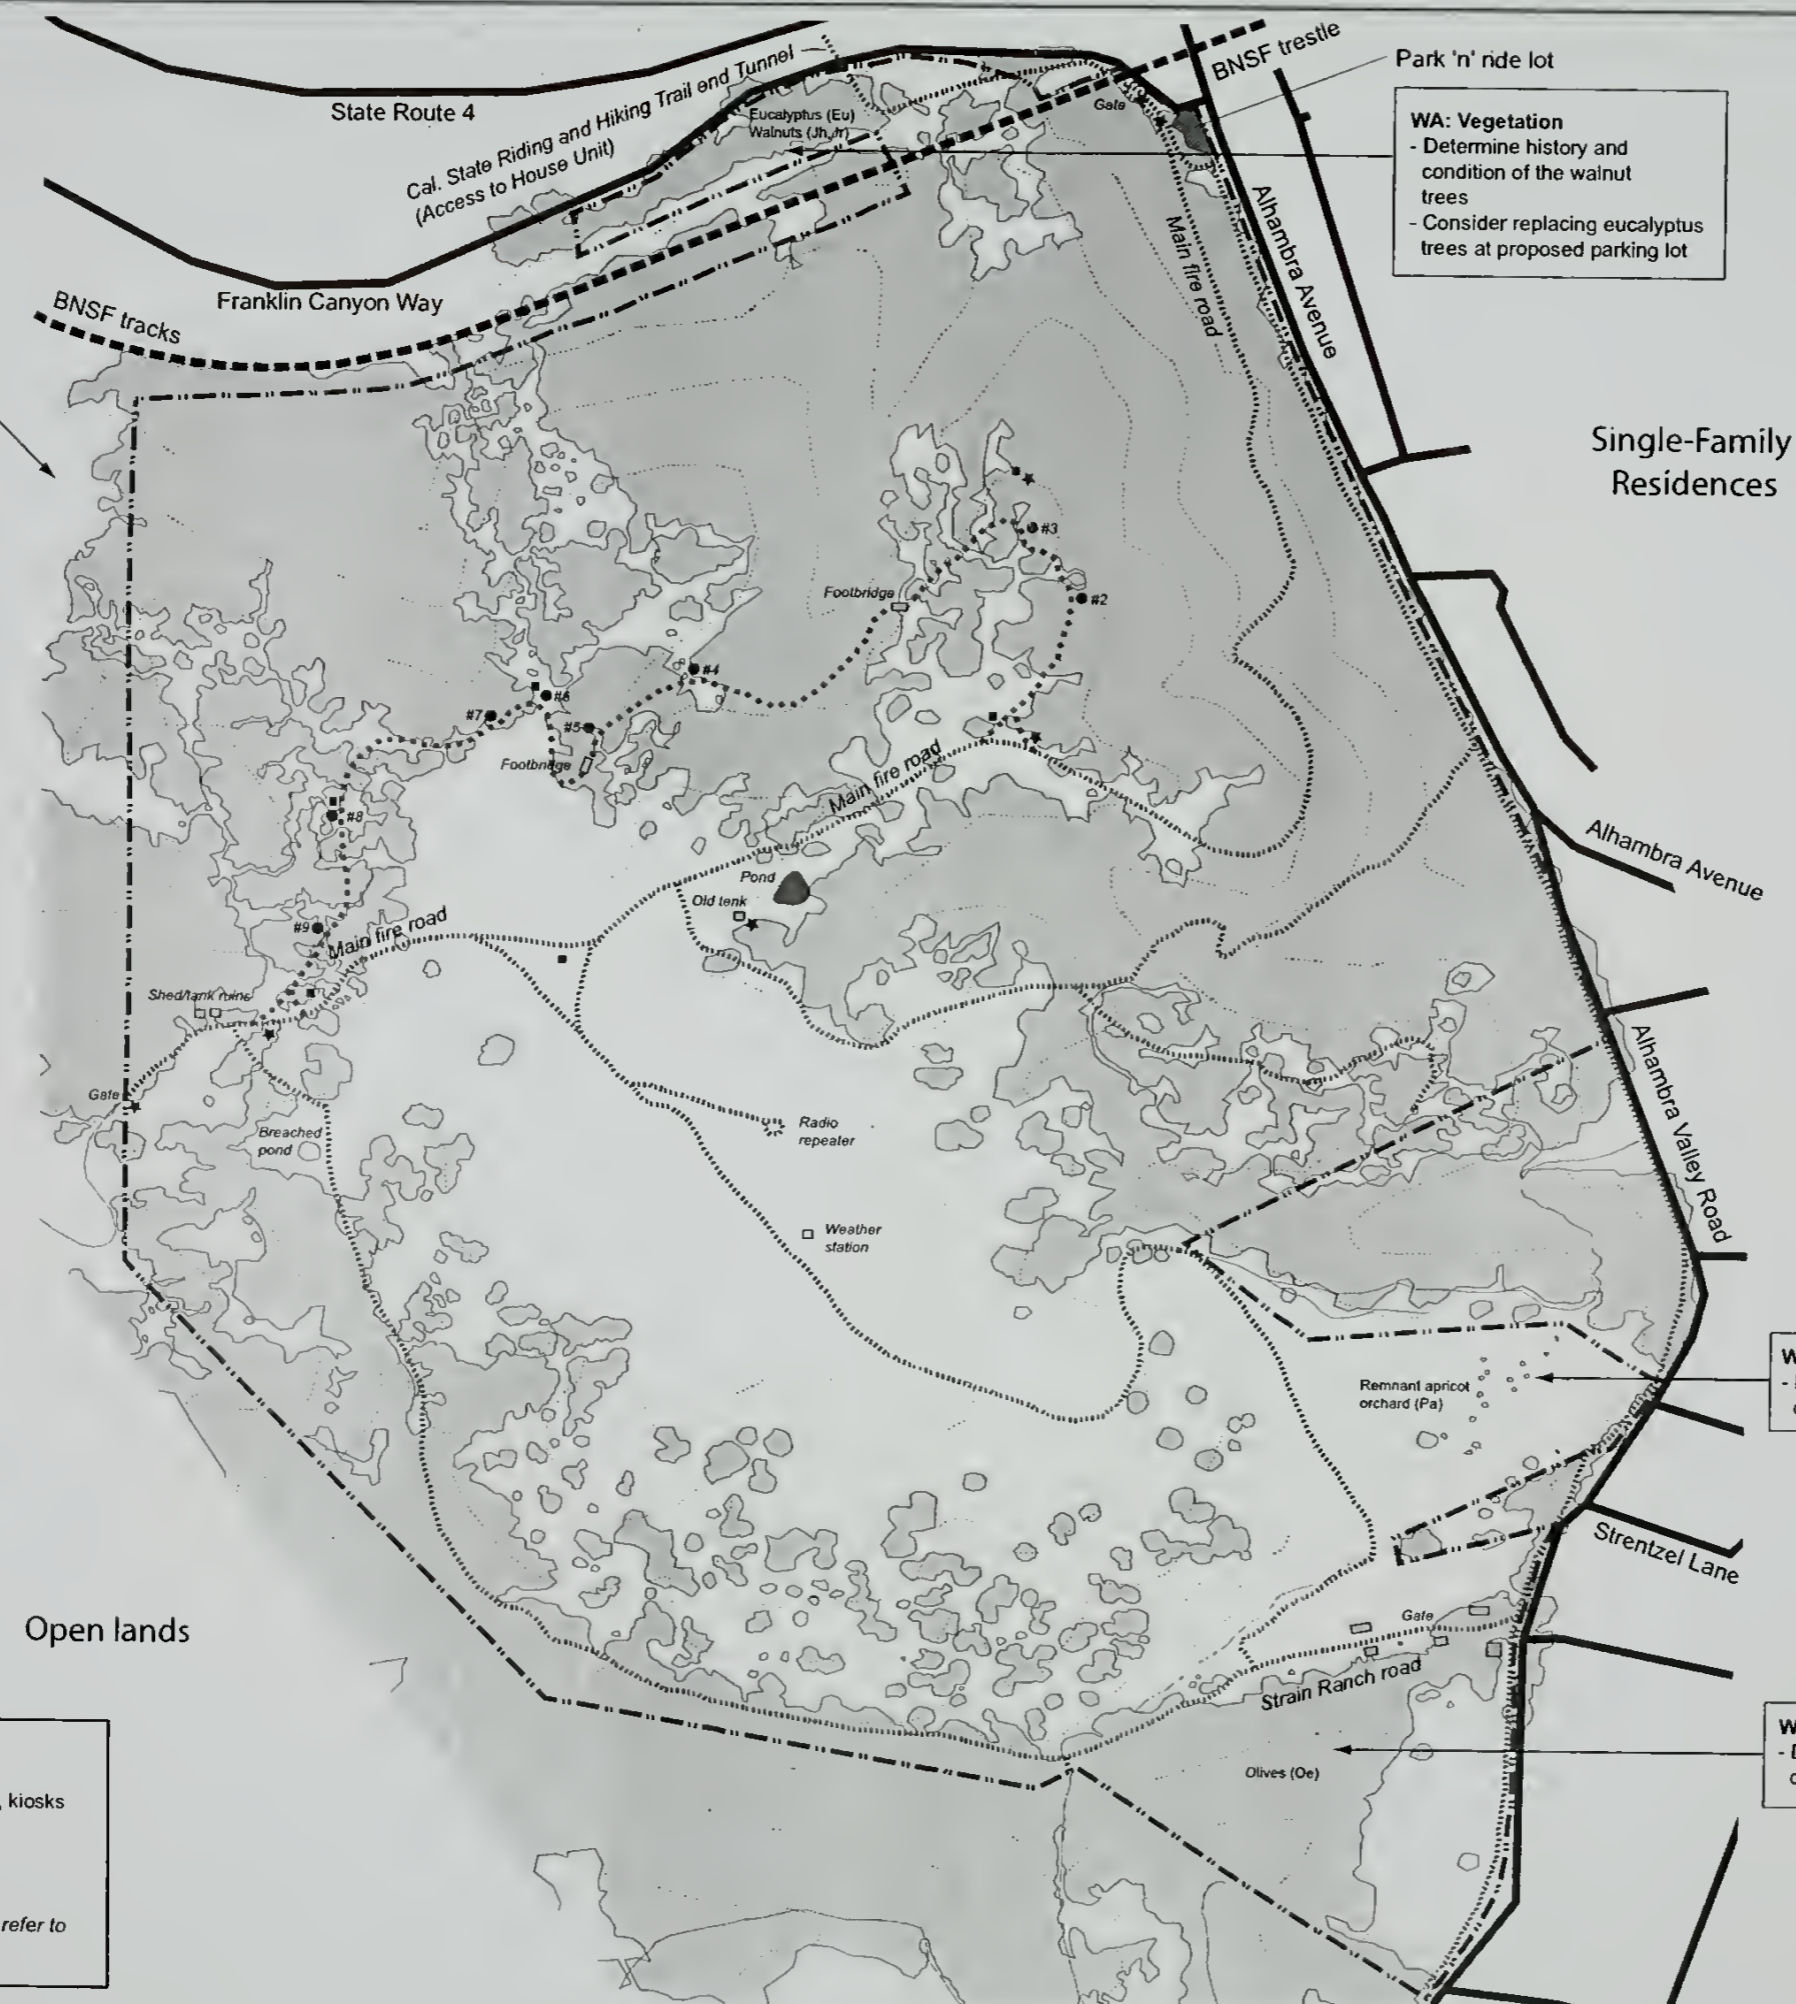
WA: Vegetation
- Retain and maintain pattern of woodlands and grasslands

WA: Vegetation
- Determine history and condition of the walnut trees
- Consider replacing eucalyptus trees at proposed parking lot
