HISTORIC STRUCTURE REPORT ♦ THUNDERBIRD LOOGE

CANYON DE CHELLY

HISTORIC STRUCTURE REPORT  
CHINLE TRADING POST, THUNDERBIRD RANCH,  
AND CUSTODIAN'S RESIDENCE  
CANYON DE CHELLY NATIONAL MONUMENT  
ARIZONA

NATIONAL PARK SERVICE  
SOUTHWEST REGIONAL OFFICE  
SANTA FE, NEW MEXICO  
OCTOBER 1989

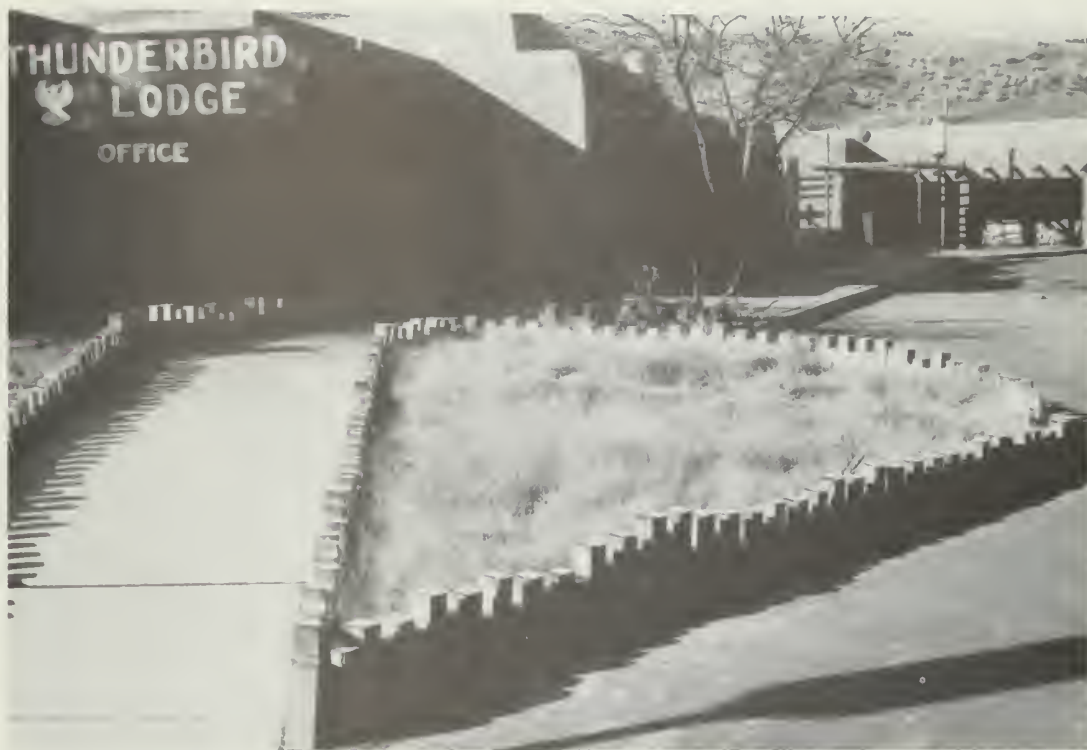
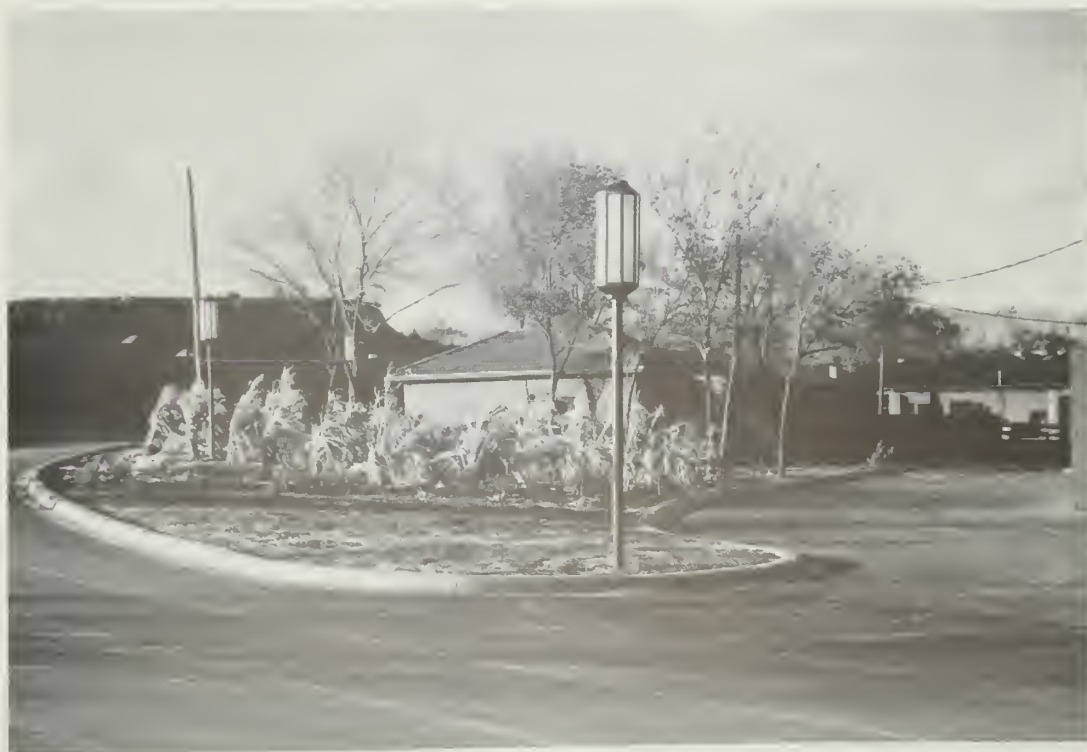
Planting beds contain materials native to the Southwest. Some of the beds have timber edges. In the future only native grasses should grow in these islands, and timber edges should be avoided. National Park Service photos by Beverley Spears.

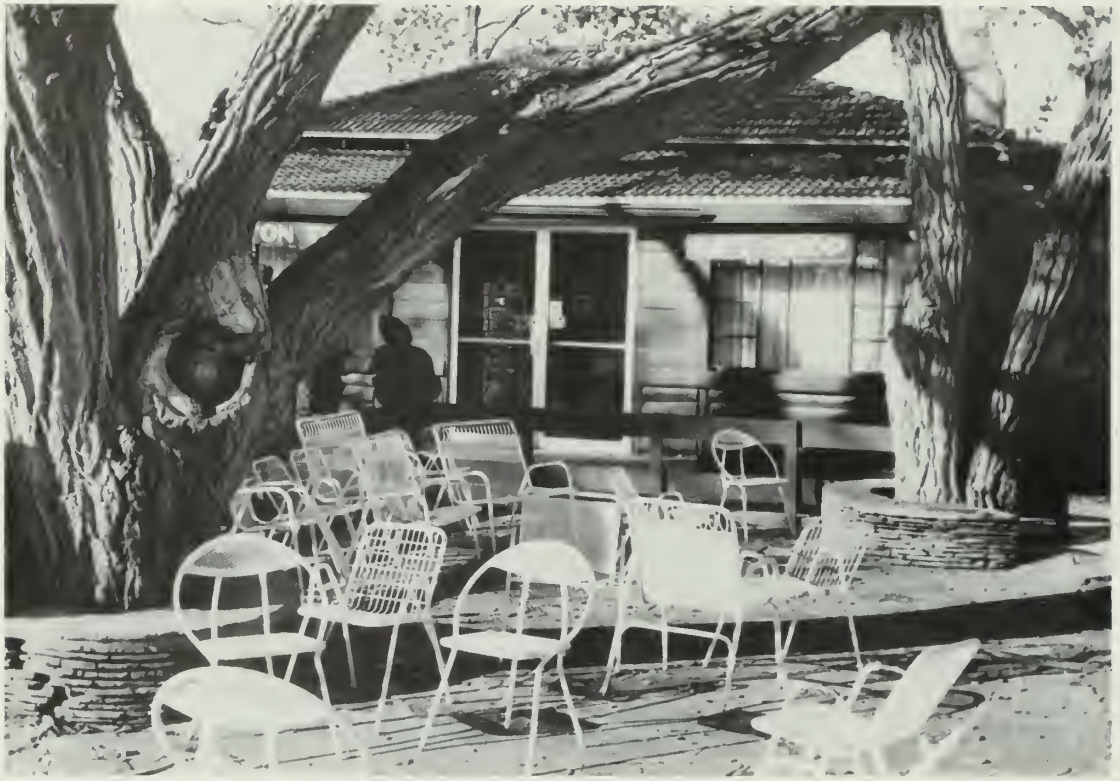
The cottonwoods in front of the gift shop outgrow the stone benches surrounding them. These were among the first trees planted at Thunderbird Ranch.

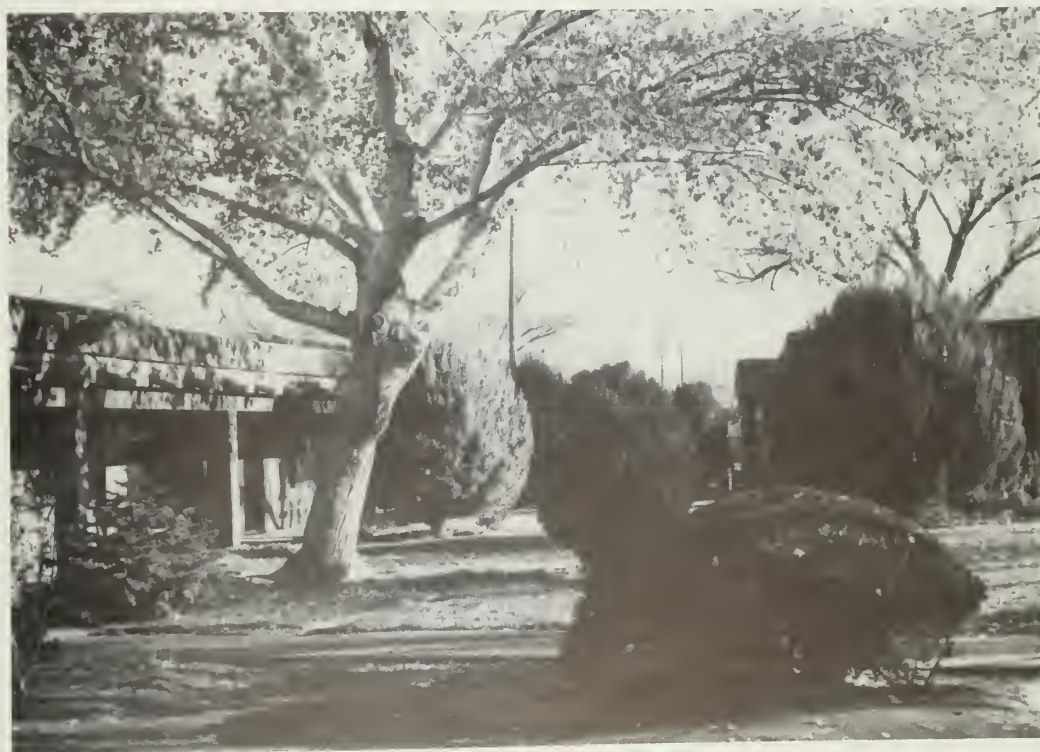
Grassy areas, such as this one, adjacent to the modern structures date from the La Fonts' time, and should be maintained.

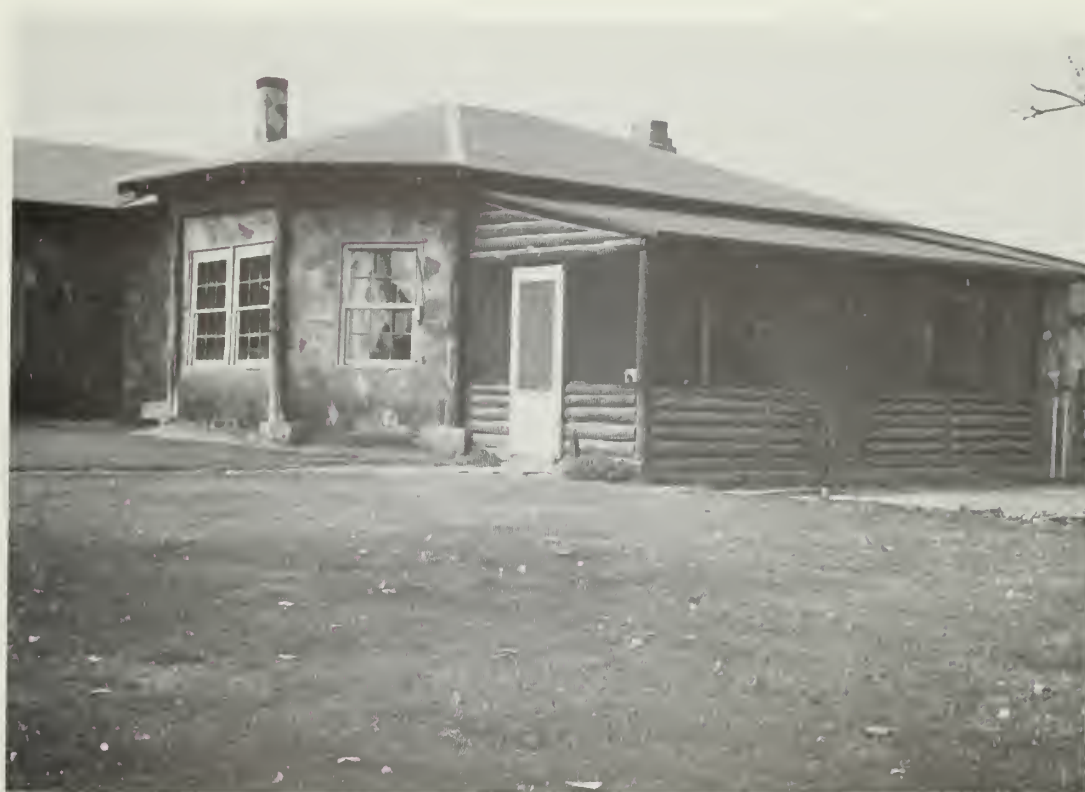
The front entrance to the main building of Thunderbird Ranch (circa 1955) had a screened-in front porch. Log-slab siding made up the lower portions of the porch walls. Flagstone covered the paths between the buildings and the small patio (right). The grassy lawn filled the spaces between the pathways on the south and east sides of the ranch house. Dark stains at the base of the building indicated moisture seeping into the base of the building.

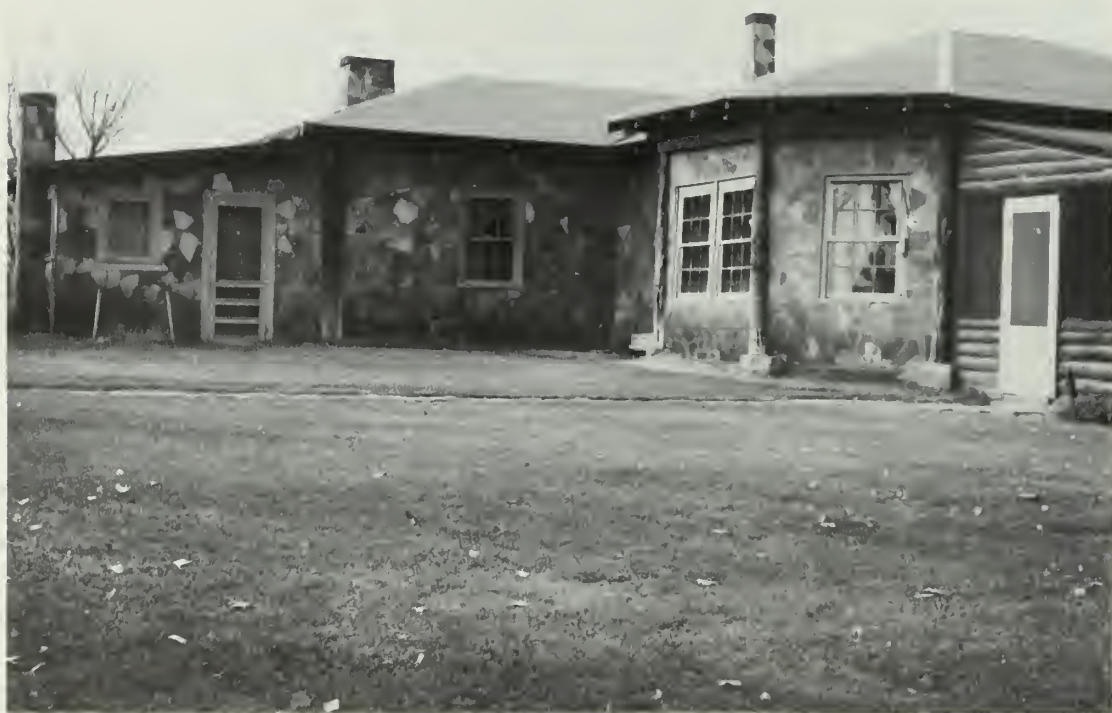
Three chimneys served the south end of the building. Most of the windows were six-over-six, and the window on the right had an alarm system. Watering this grassy expanse of lawn undoubtedly had some effect on the moisture seeping into the building.

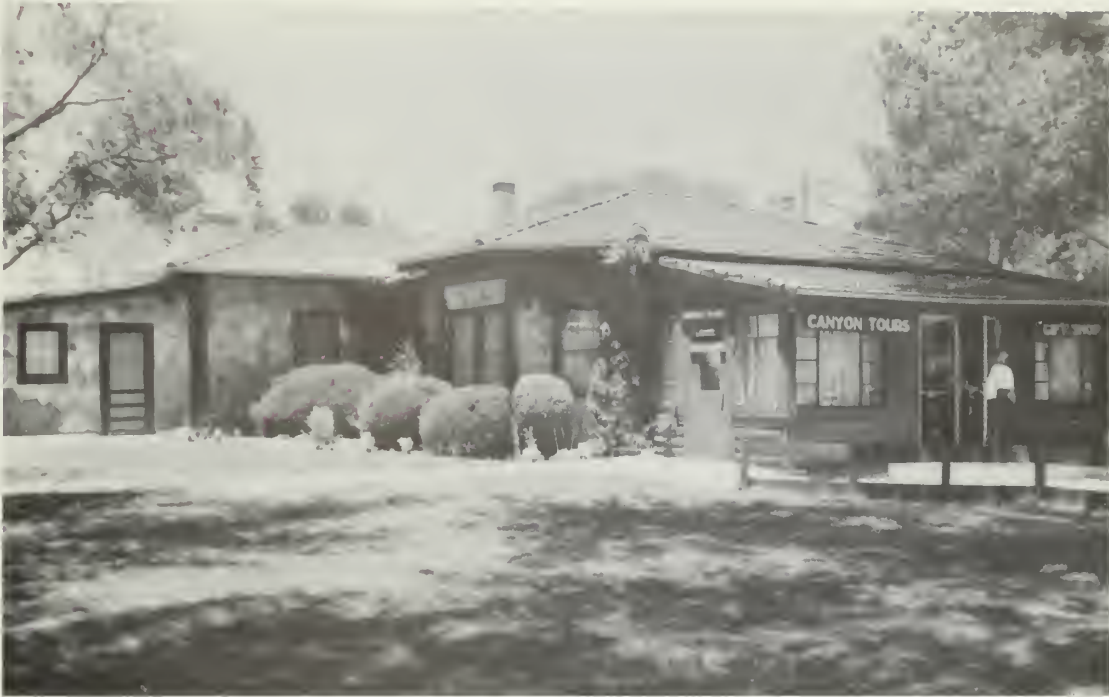
In 1986, shrubs and vines visually softened the lines of the old ranch house. Although the red tile roof improved its appearance, it detracted from the historic structure's integrity.

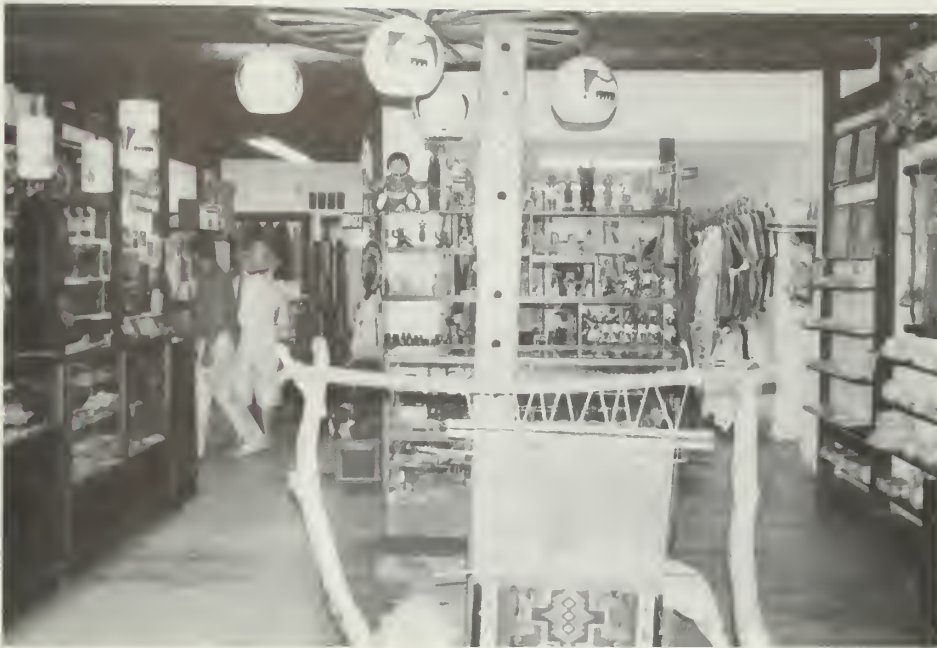
In 1986, the wagon-wheel chandelier still illuminated the former living room of the ranch house, however it had undergone some alteration. The wood floors, dark-stained vigas, and original fireplace mantle remained in tact.

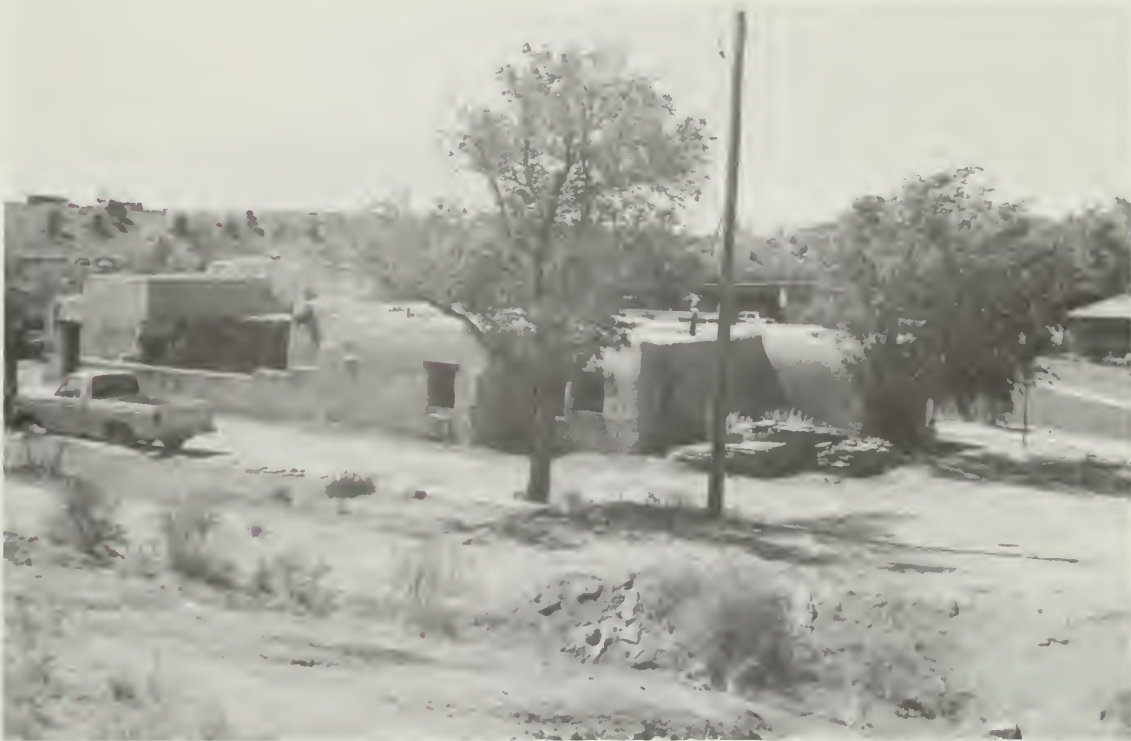
From the rear (south) the building's original massing remains. The stucco finish is too highly textured for this building.

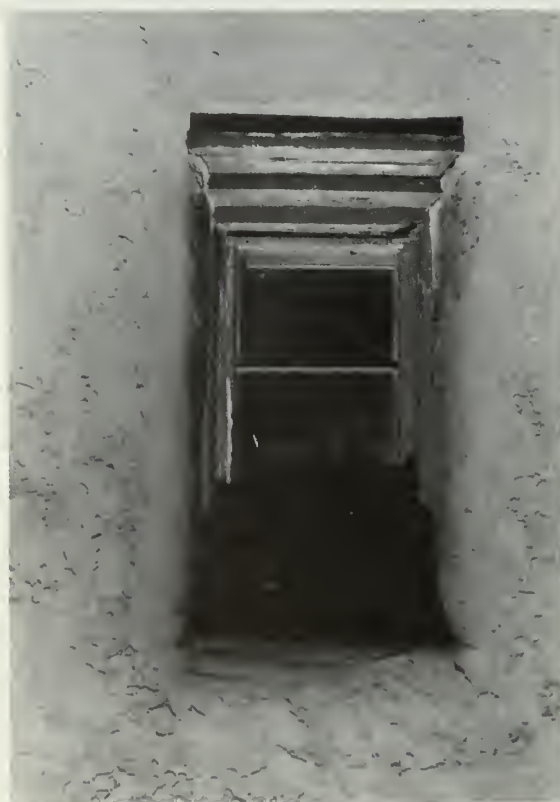
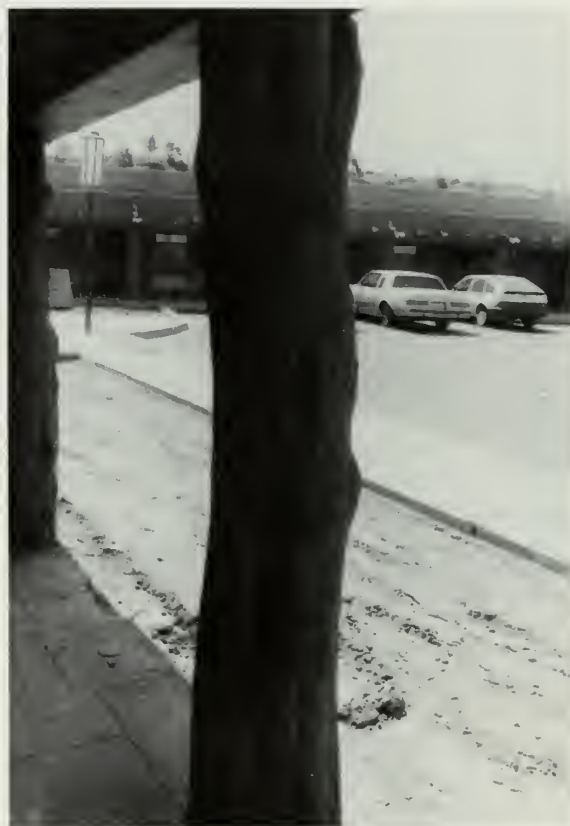
The brocade stucco finish is not appropriate for a structure of this type.

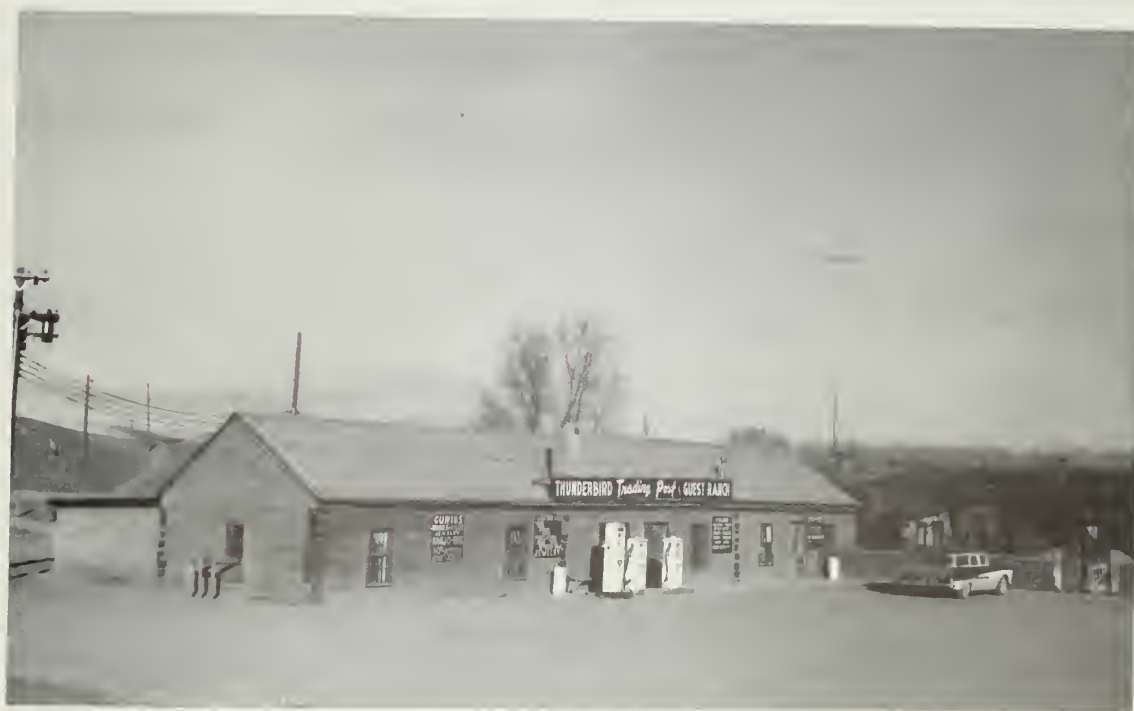
When the concessioners stuccoed the old trading post building in 1954, they left the log ends poking out of the stucco. The 1957 concrete block addition (left) made the rear wall of trading post even with the end of the vault.

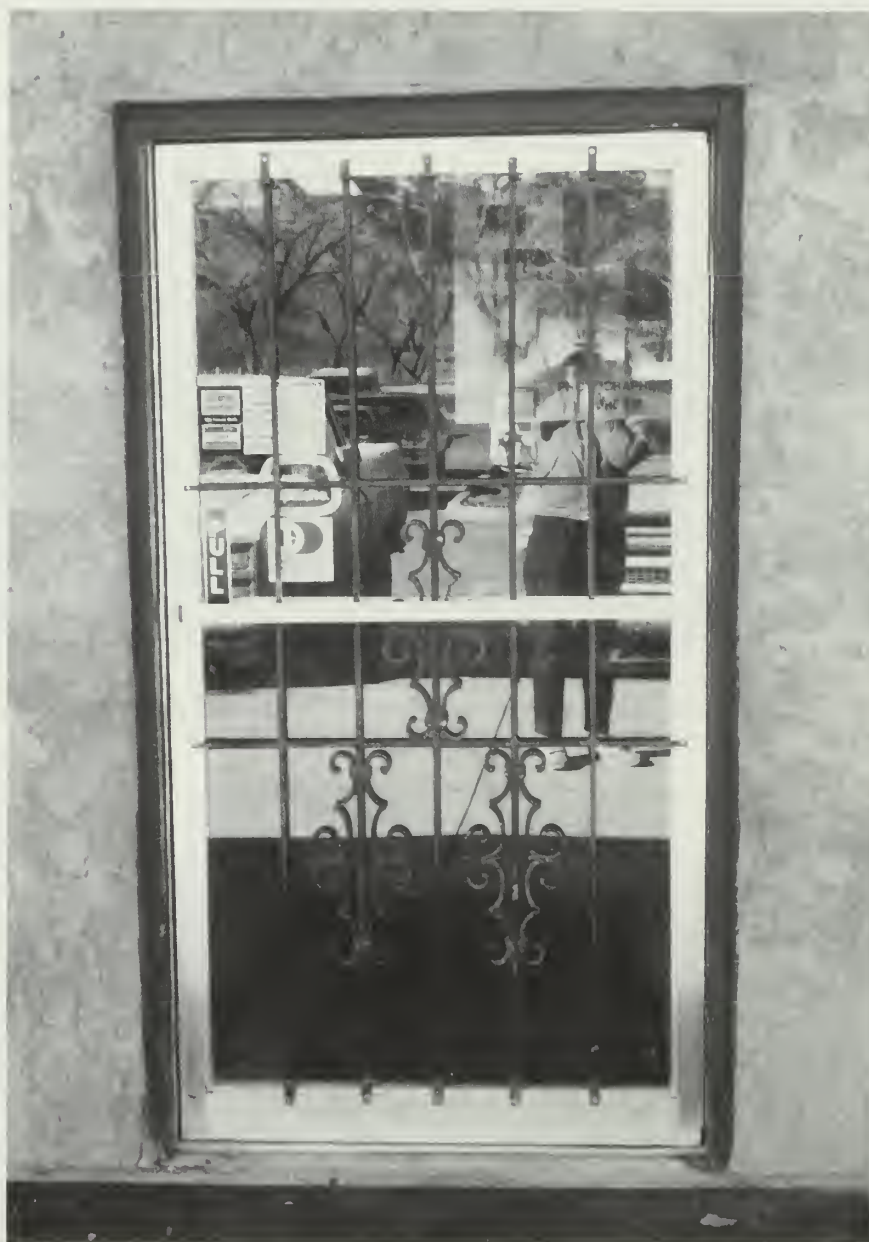
The aluminum door at the main entrance is so modern it tends to obscure the building's historic origins.

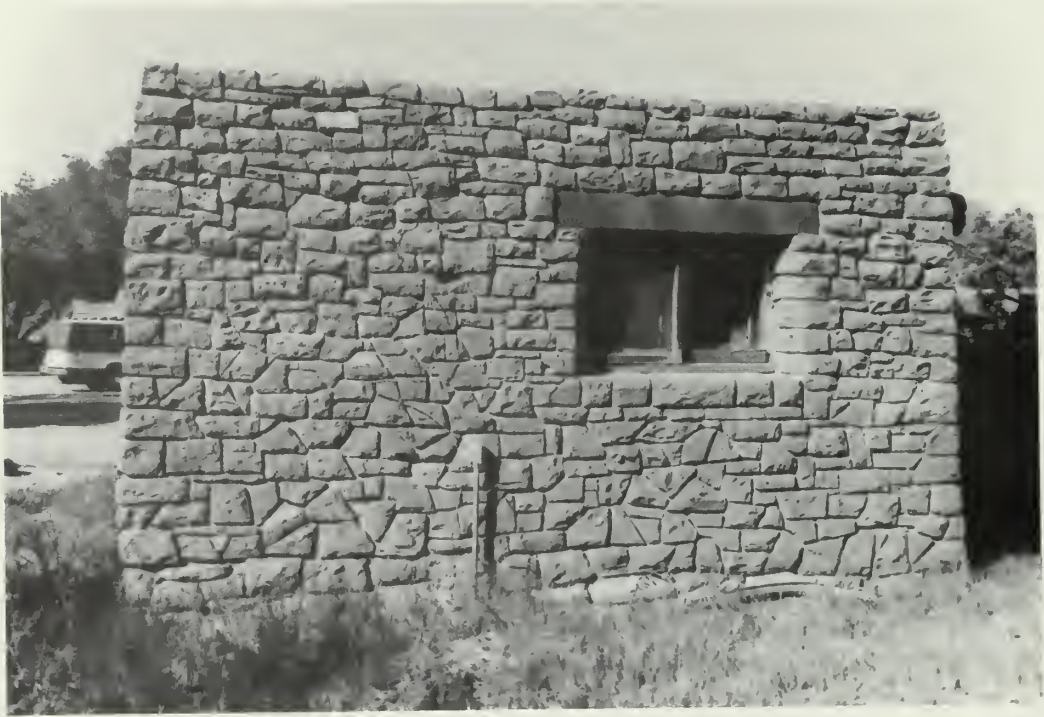
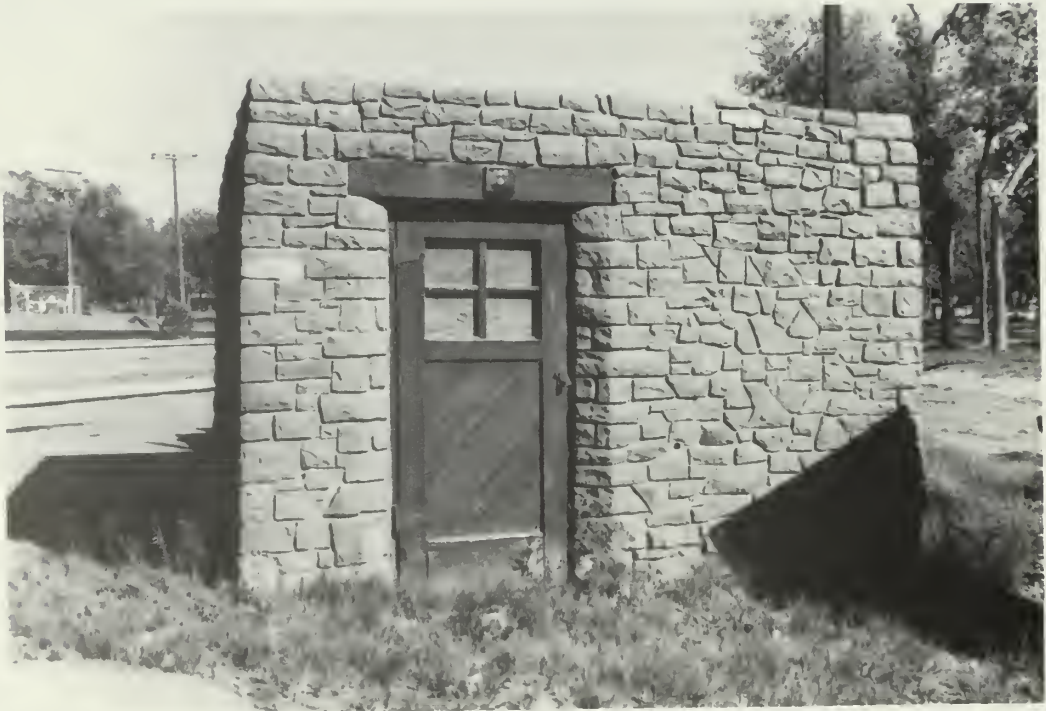
Navajo stone masons built the monument's pumphouse in 1936. The building is in excellent condition, but it is vacant.

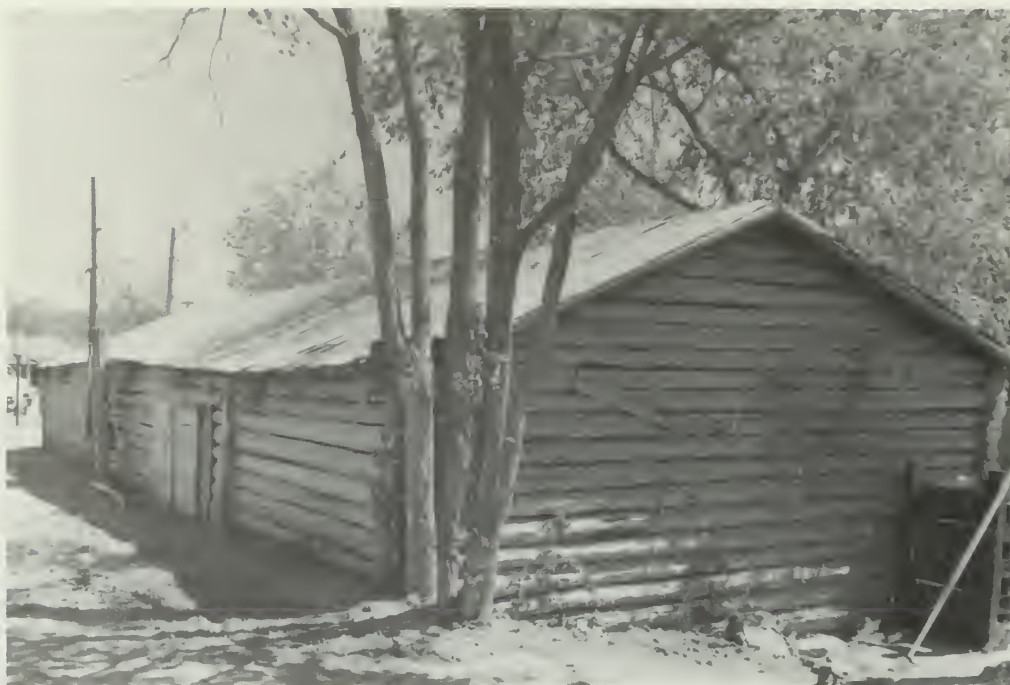
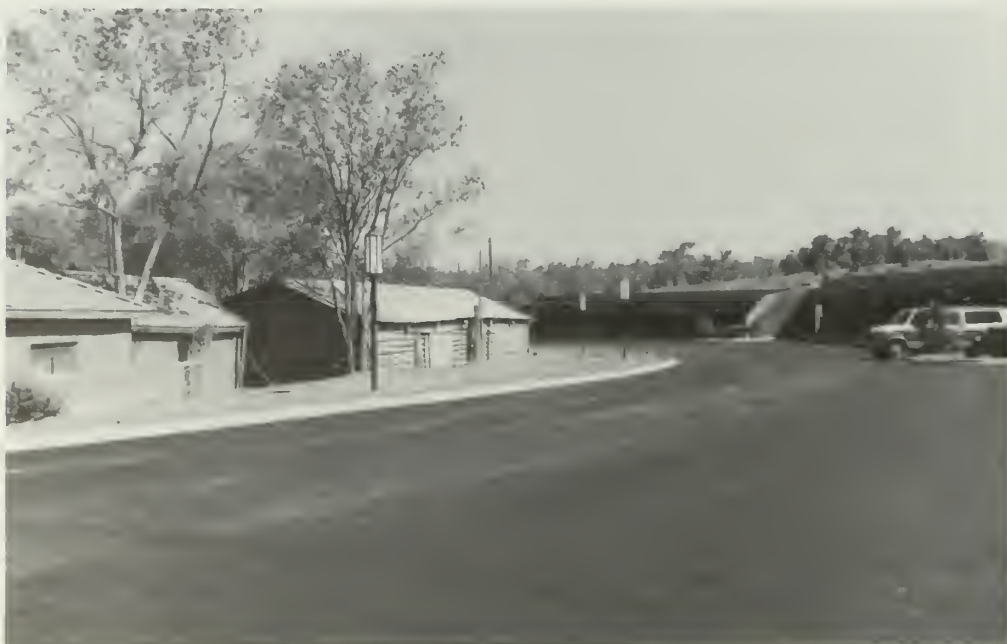
The barn's architectural context (above) was altered dramatically when in 1986 grading for the new parking lots covered up at least five of the lower logs on the barn's west elevation (below). Fill also covered the stone foundation on the south wall (below/right). The jaunty-angled board on that south wall appeared in a 1953 photograph.

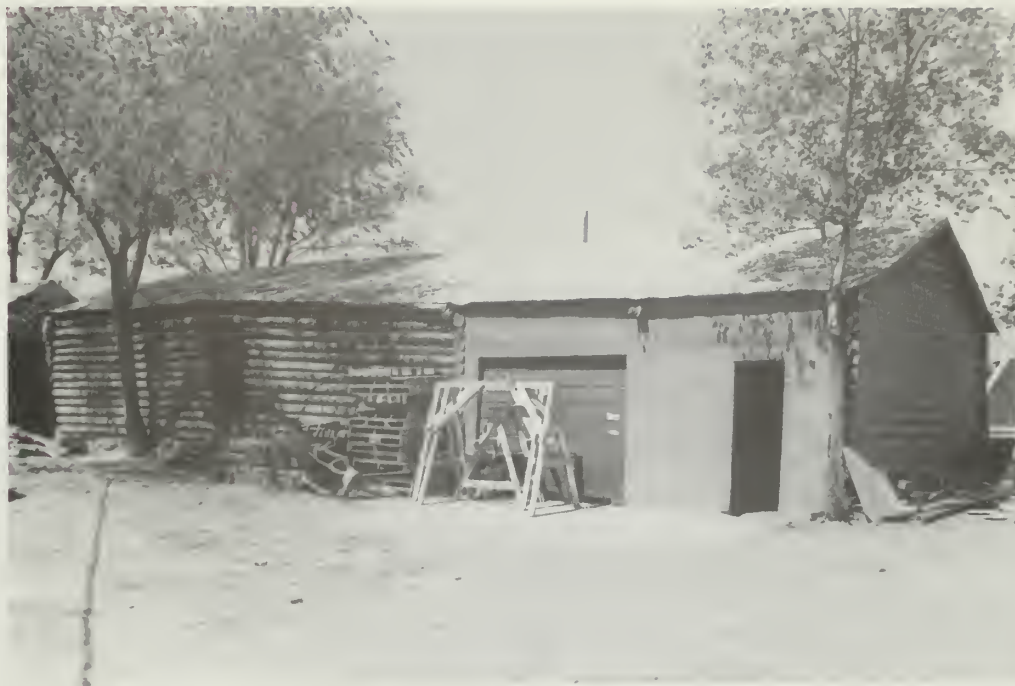
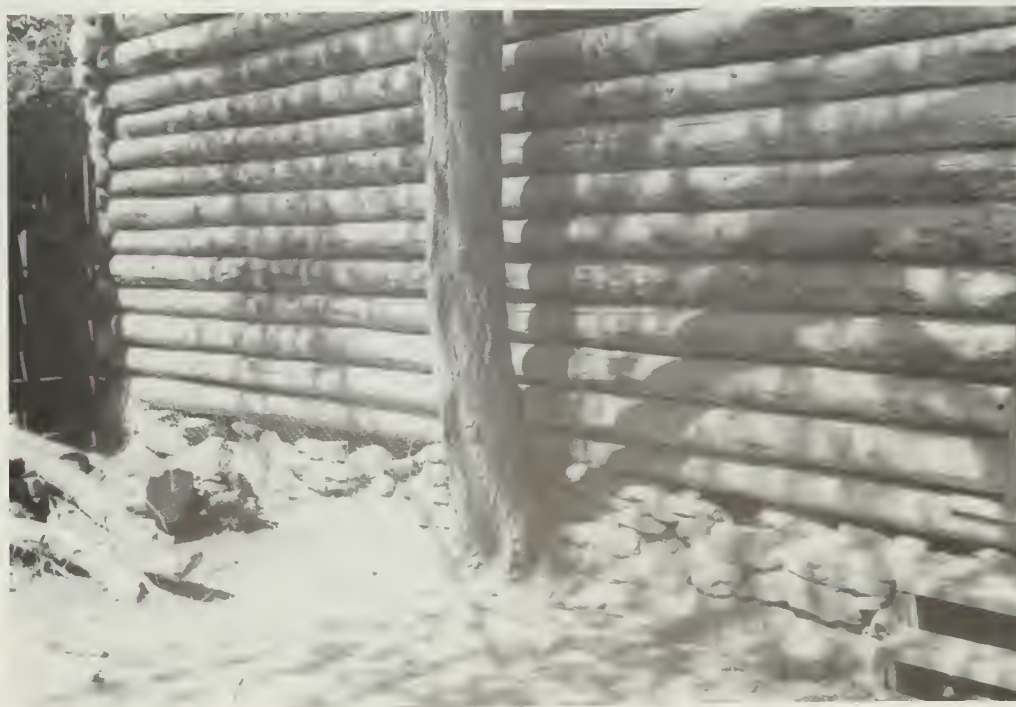
In 1986 stucco covered the east wall of the garage. A tree grew out from the stone foundation at the south end of the east wall.

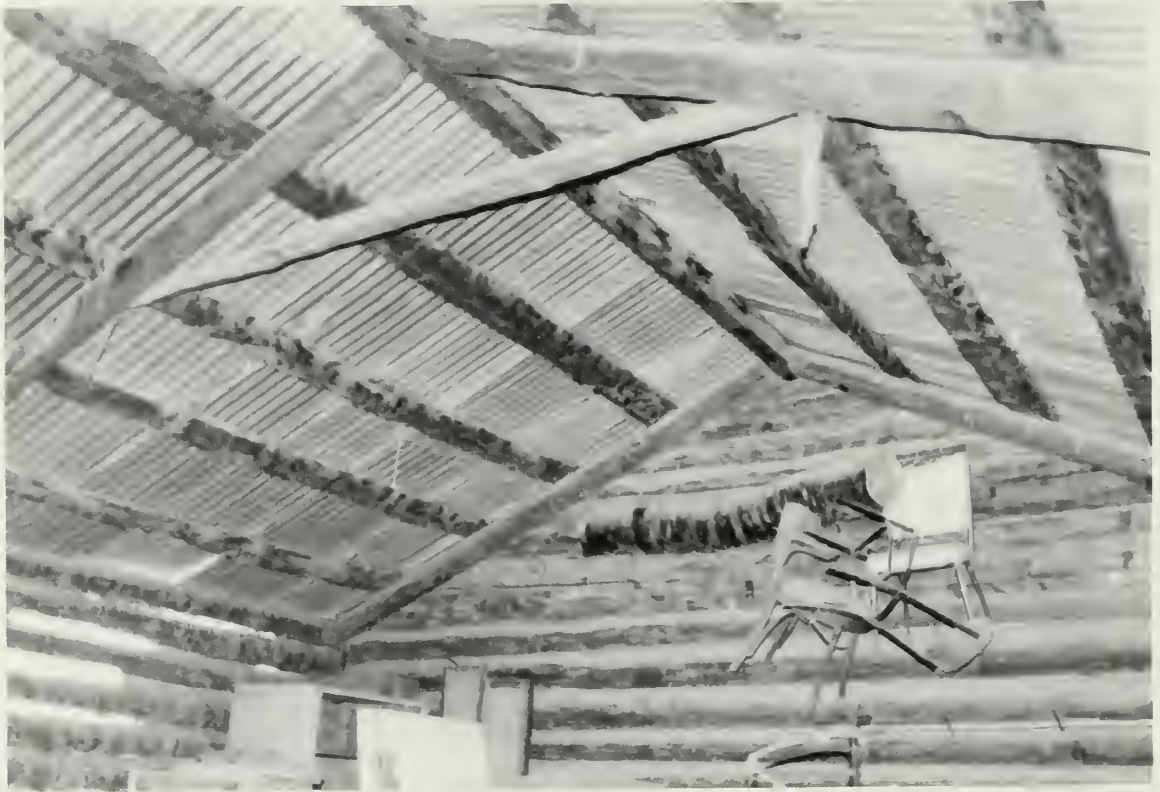
The log barn's roof structure of peeled poles is visible on the interior. In 1986 the building was used for storage.

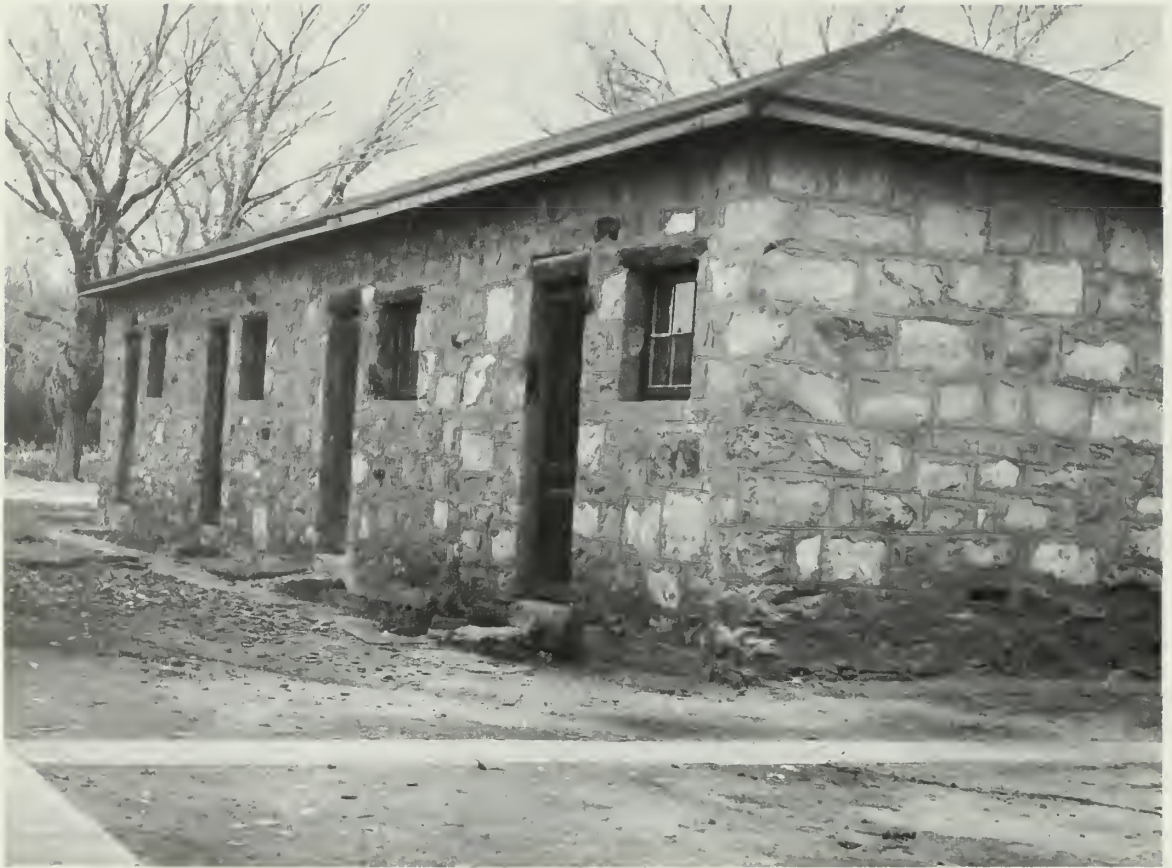
During the 1950s four doors on the west wall of building 14 (guest units 3,4,5, and 7) provided access. The concrete walkway did not extend as far as the building. Flagstone pavers led up to the steps. Moisture was evident around the bases of the walls.

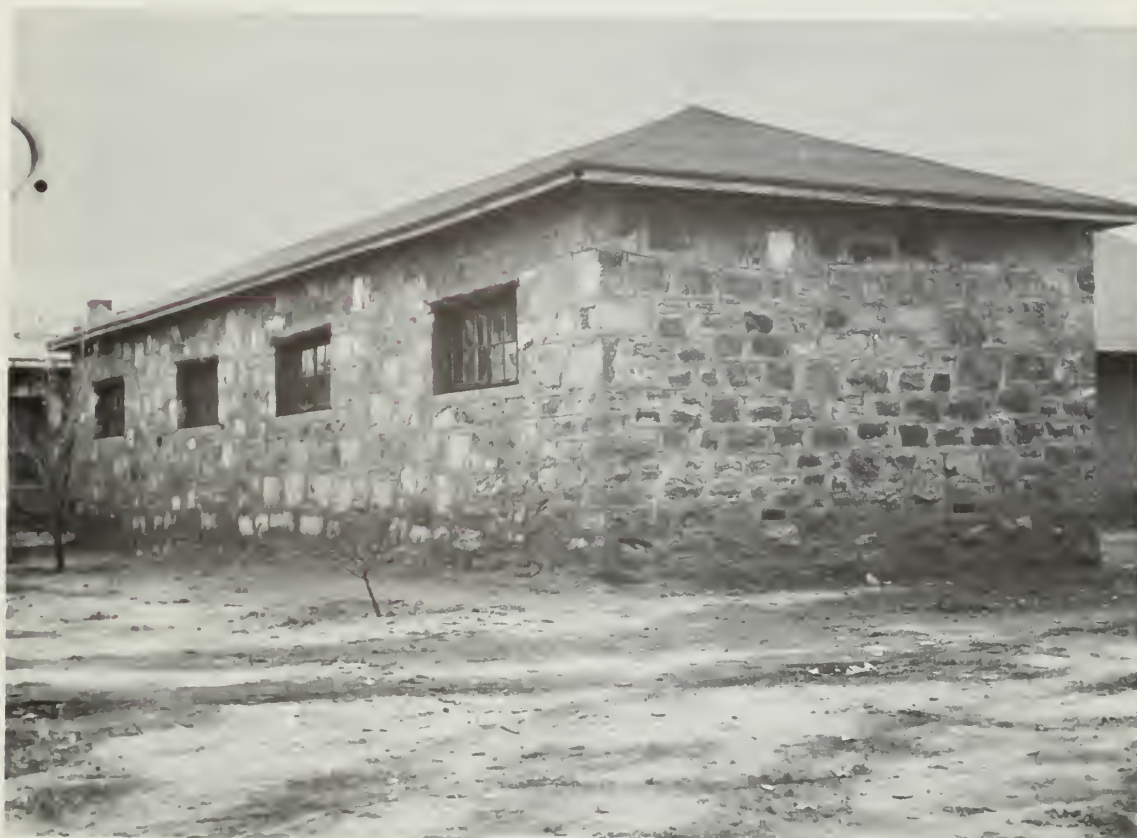
During the early 1950s the east elevation had four multi-light windows for fenestration. The north wall was solid. Small trees (left) had been planted to the east of the building, and the ground had no groundcover. Moisture was evident around the bases of the walls.

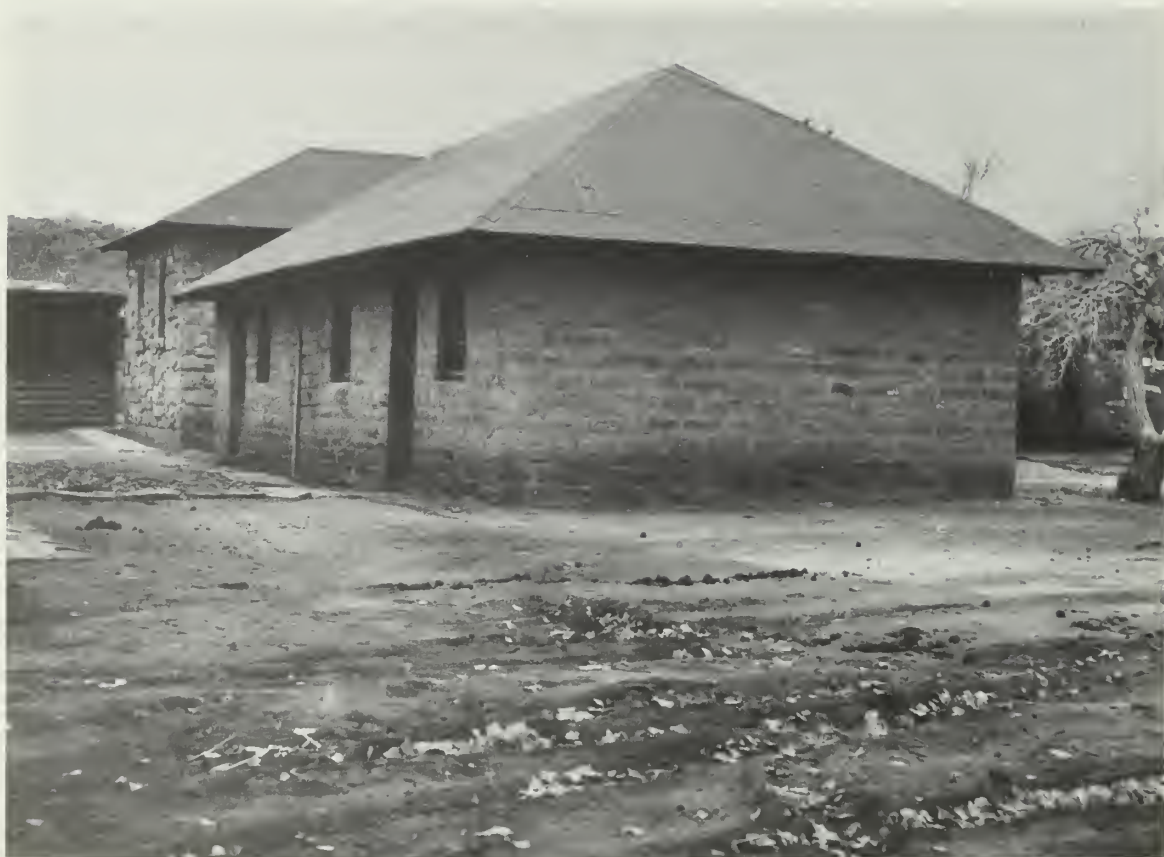
In the 1950s flagstone walkways and pavers led up to Building 15. Horses roamed the barren ground of the dude ranch. Moisture darkened the lower courses of stone.

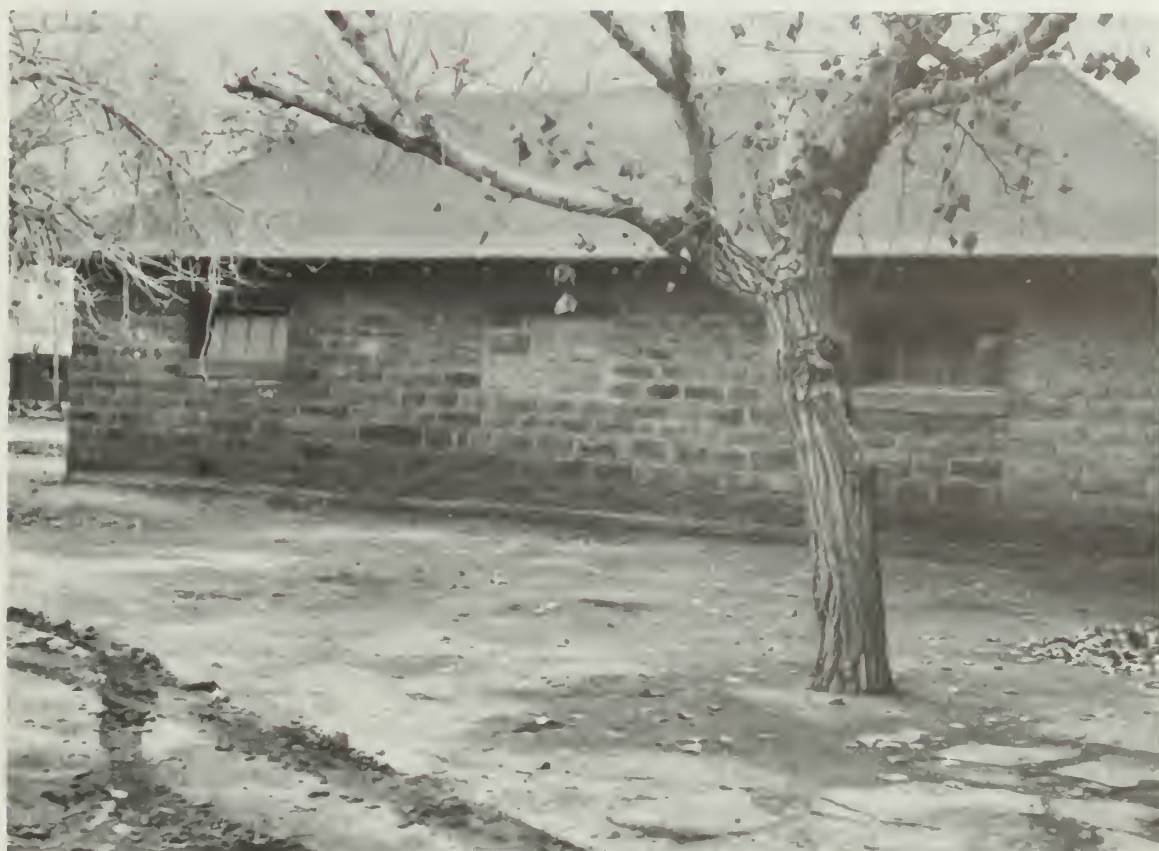
Even as early as the 1950s the concessioners had walled in one of the original windows on the west wall of Building 15. During this time huge quantities of earth sat under the hip roof and insulated the guest rooms.

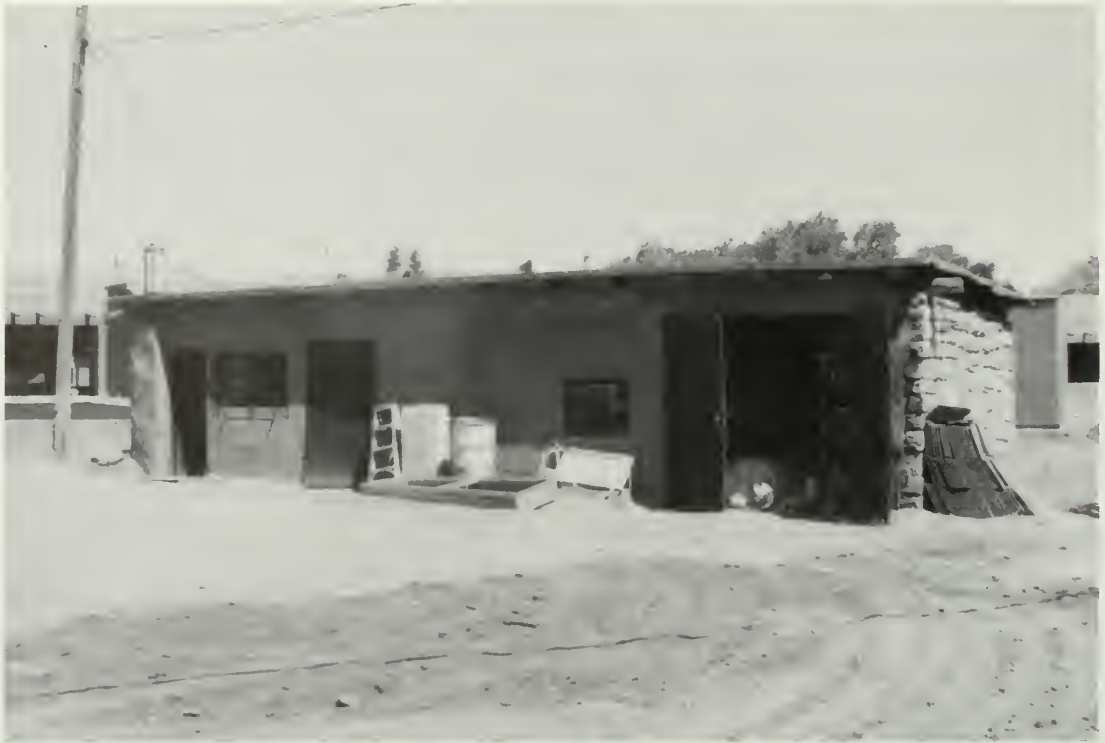
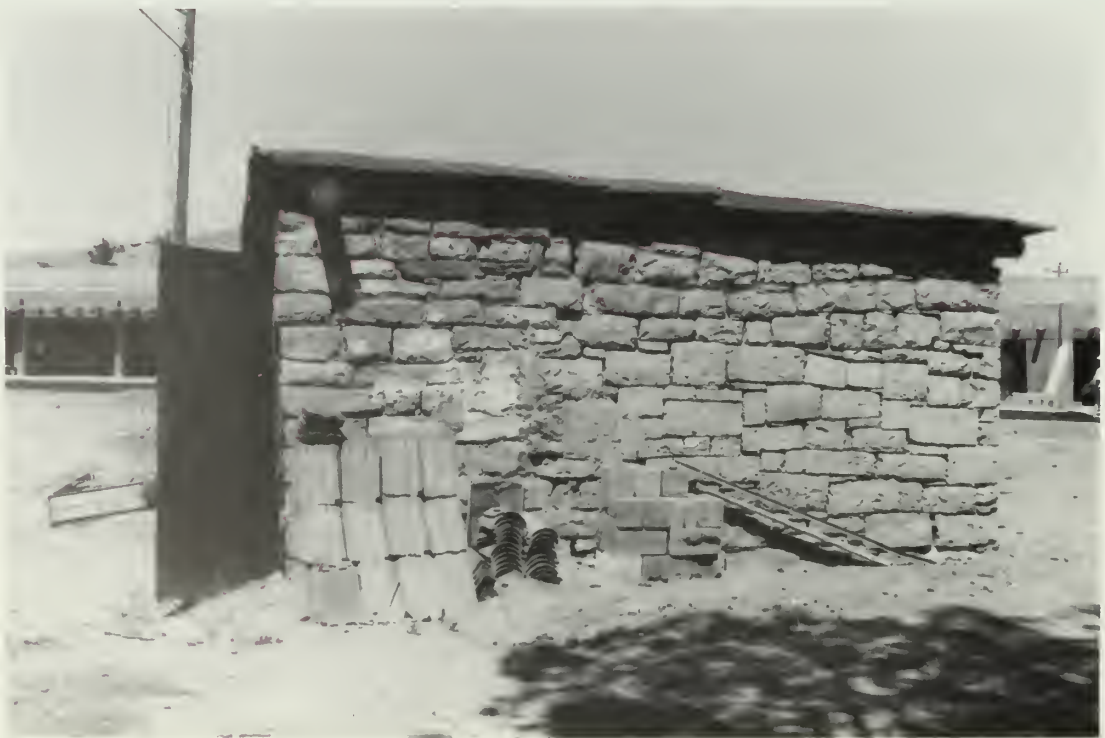
In 1986 the stone shed housed miscellaneous building materials. The front elevation had a stucco finish. The door opening in the east wall no longer existed (below).
