FINAL PHASE 1 REPORT WITH EMPHASIS ON FITTON CAVE AREA

INVENTORY AND DELINEATION OF KARST HYDROLOGY FEATURES, BUFFALO NATIONAL RIVER, ARKANSAS.

March, 1999

Thomas Aley and Catherine Aley
Ozark Underground Laboratory, Inc.

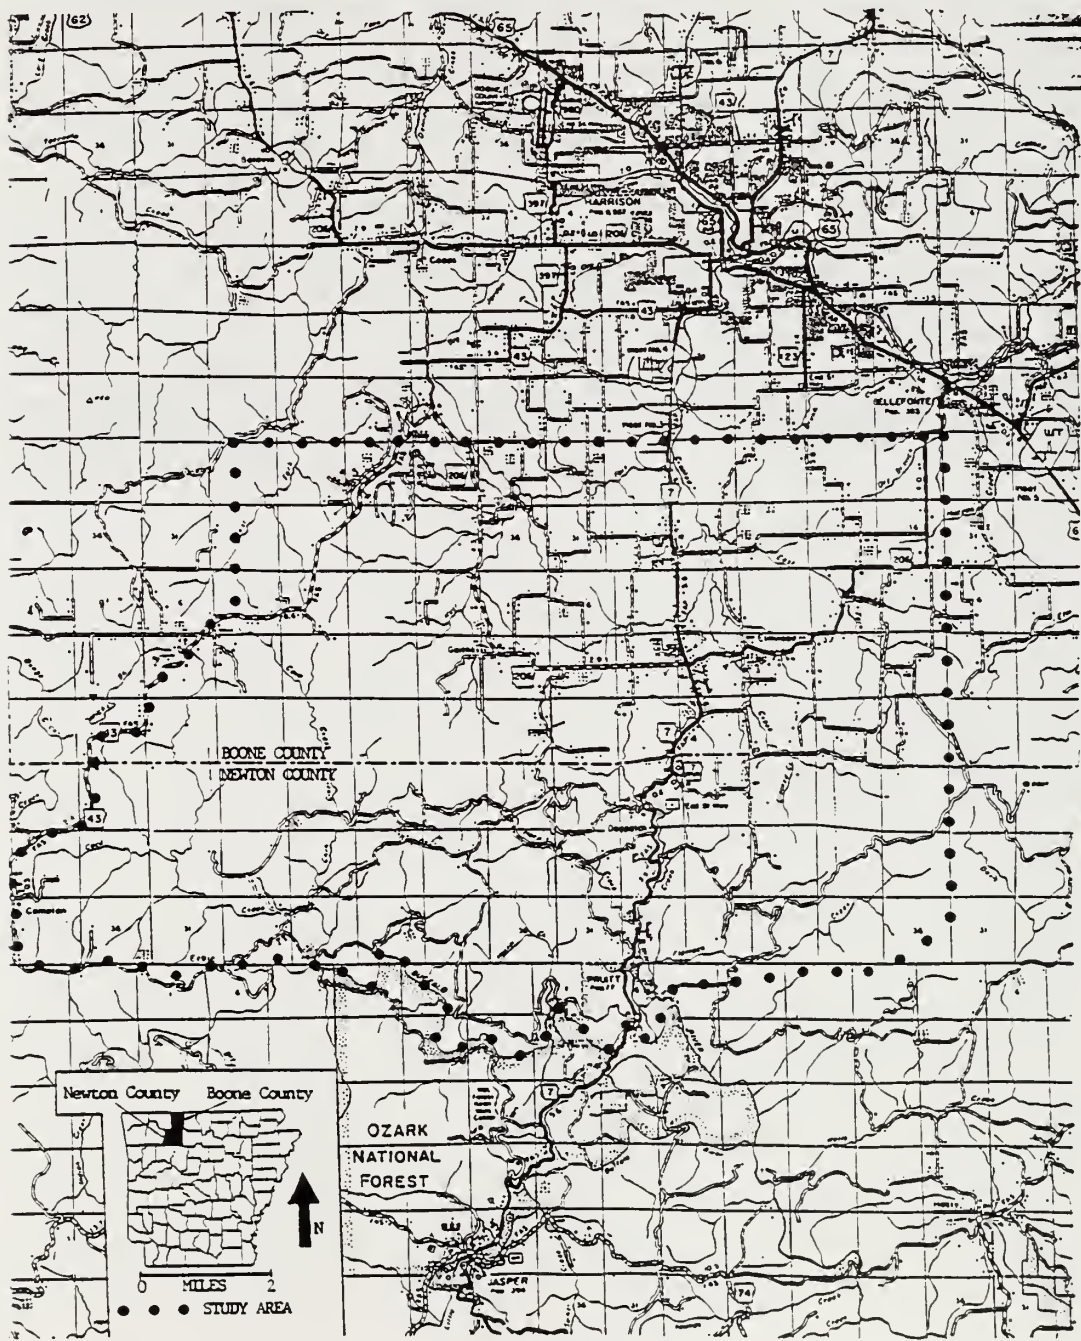
Figure 1. Regional Study Area. Map source: National Park Service request for proposal.

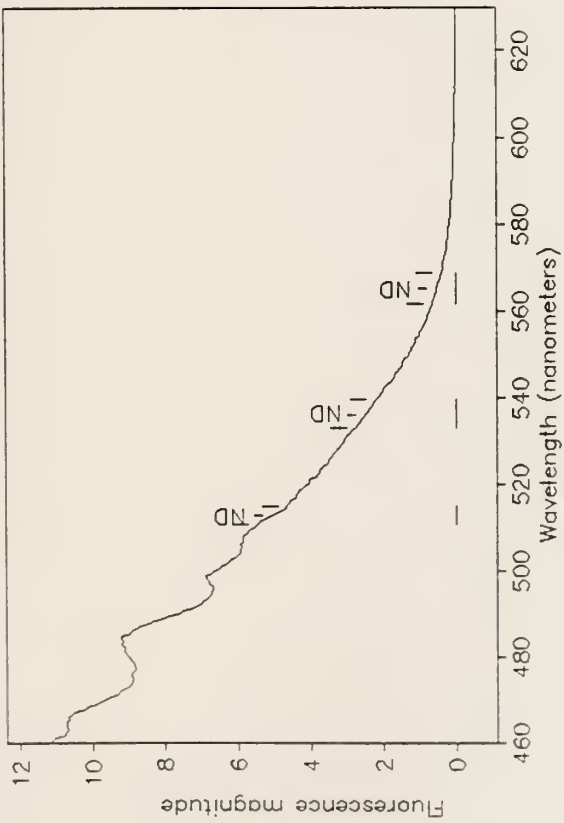
Station 101: Chestnut Spring near Caver Cabin
OUL number: F6838 Type: Charcoal Analyzed: 19960920
Date placed: 08/30/96 Date recovered: 09/11/96
Time placed: 1315 Time recovered: 1225

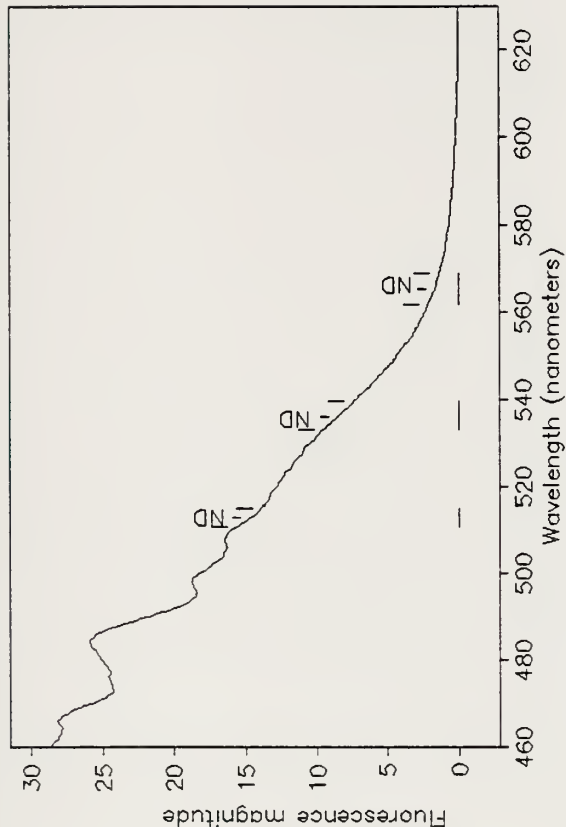
Station 102: Fitton Spring
 OUL number: F7584 Type: Charcoal Analyzed: 19961111
 Date placed: 09/11/96 Date recovered: 11/08/96
 Time placed: 1200 Time recovered: 1350

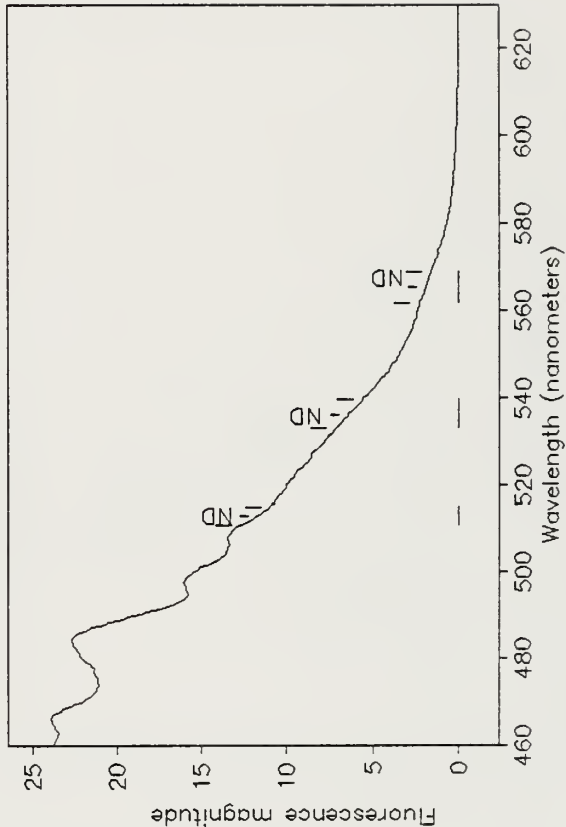
Station 102: Fitton Spring
 OUL number: F7831 Type: Charcoal Analyzed: 19961211
 Date placed: 11/14/96 Date recovered: 12/06/96
 Time placed: 1030 Time recovered: 0920

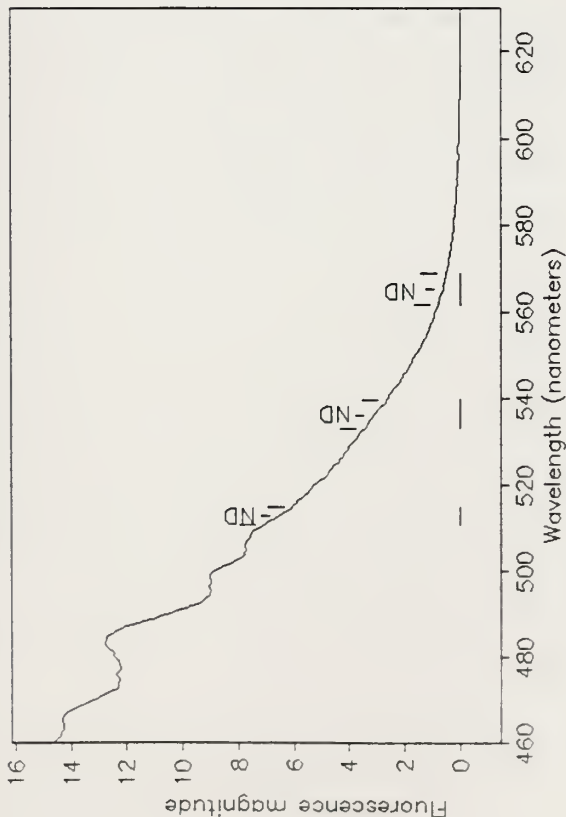
Station 102: Fitton Spring
 OUL number: F6839 Type: Charcoal Analyzed: 19960920
 Date placed: 08/30/96 Date recovered: 09/11/96
 Time placed: 1345 Time recovered: 1200

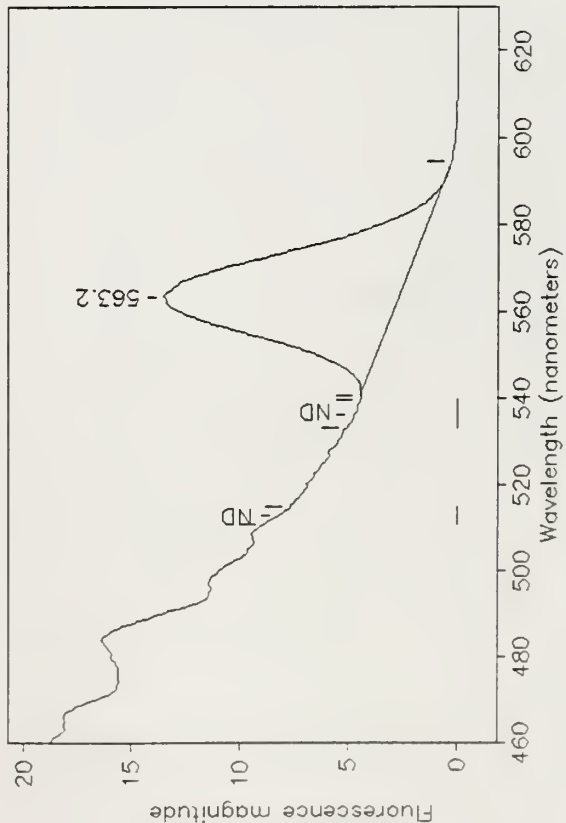
Station 102: Fitton Spring
 OUL number: F7624 Type: Charcoal Analyzed: 19961115
 Date placed: 11/08/96 Date recovered: 11/14/96
 Time placed: 1350 Time recovered: 1030

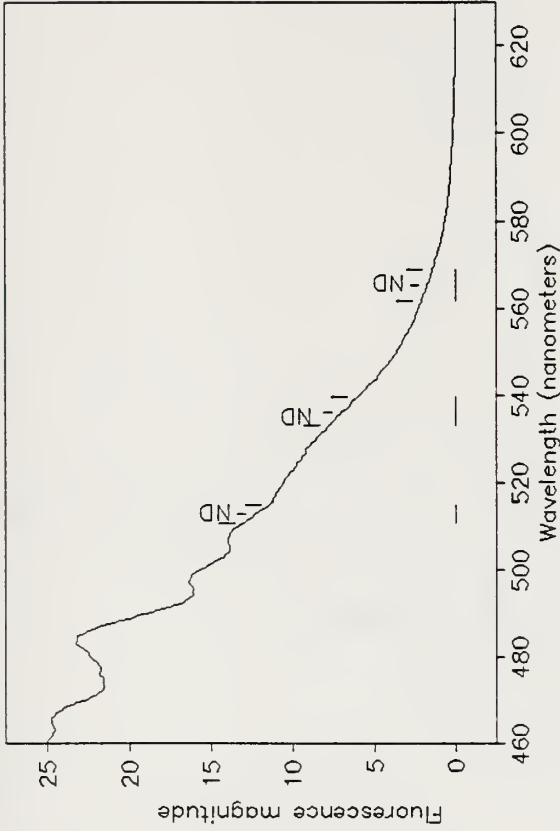
Station 102: Fitton Spring
 OUL number: F9716 Type: Charcoal Analyzed: 19970321
 Date placed: 12/16/96 Date recovered: 03/20/97
 Time placed: 1225 Time recovered: 1230

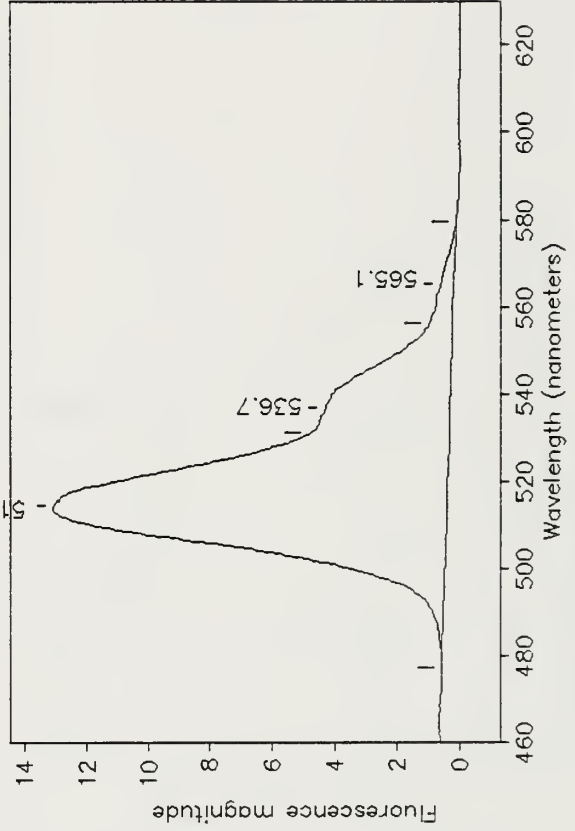
Station 102: Fitton Spring Diluted 1: 100
 OUL number: G0513 Type: Charcoal Analyzed: 19970414
 Date placed: 03/26/97 Date recovered: 04/03/97
 Time placed: 1120 Time recovered: 1105

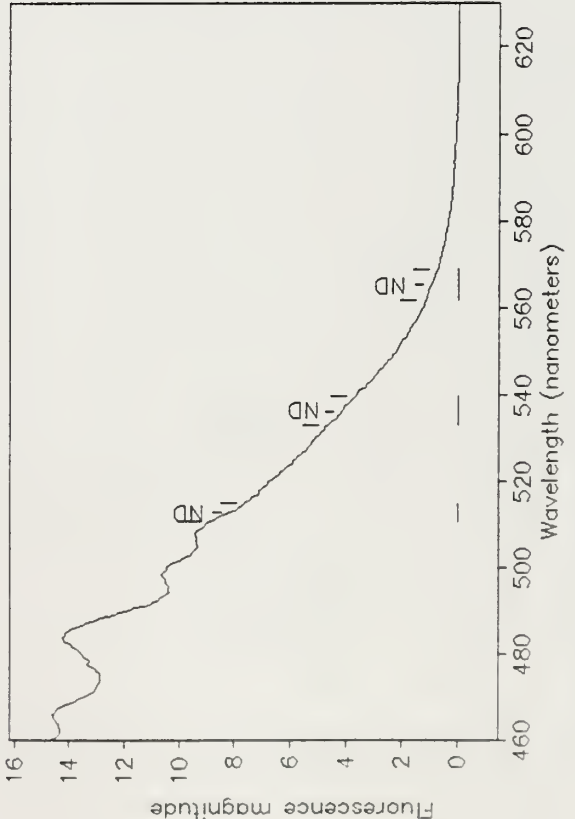
Station 102: Fitton Spring
 OUL number: F9990 Type: Charcoal Analyzed: 19970331
 Date placed: 03/20/97 Date recovered: 03/26/97
 Time placed: 1230 Time recovered: 1120

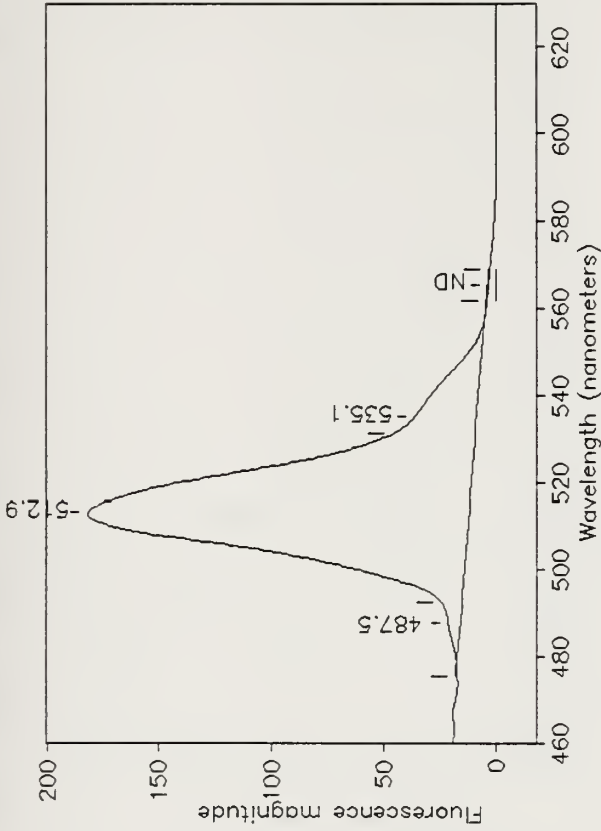
Station 102: Fitton Spring
 OUL number: G1755 Type: Charcoal Analyzed: 19970430
 Date placed: 04/11/97 Date recovered: 04/17/97
 Time placed: 1250 Time recovered: 1710

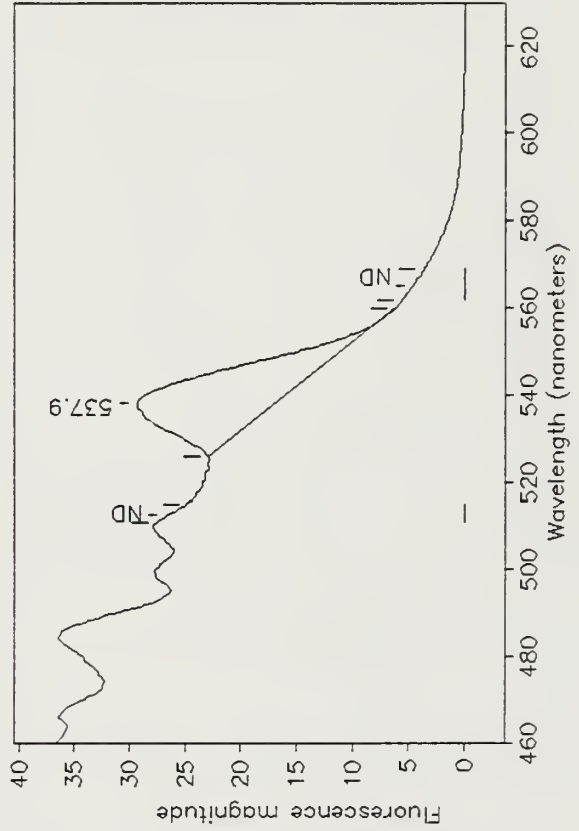
Station 102: Fitton Spring
 OUL number: G8894 Type: Charcoal Analyzed: 19970929
 Date placed: 06/03/97 Date recovered: 09/13/97
 Time placed: 1325 Time recovered: 1110

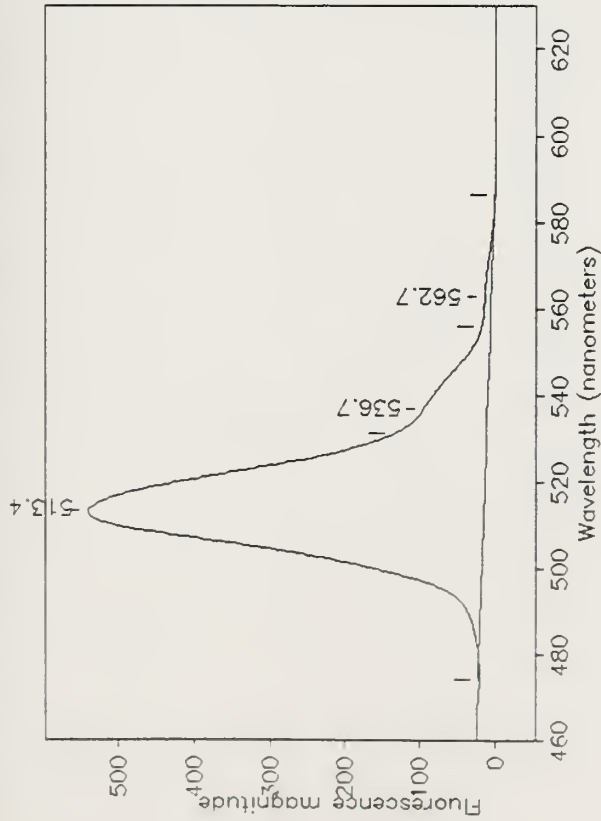
Station 102: Fitton Spring
 OUL number: G0588 Type: Charcoal Analyzed: 19970414
 Date placed: 04/03/97 Date recovered: 04/11/97
 Time placed: 1105 Time recovered: 1250

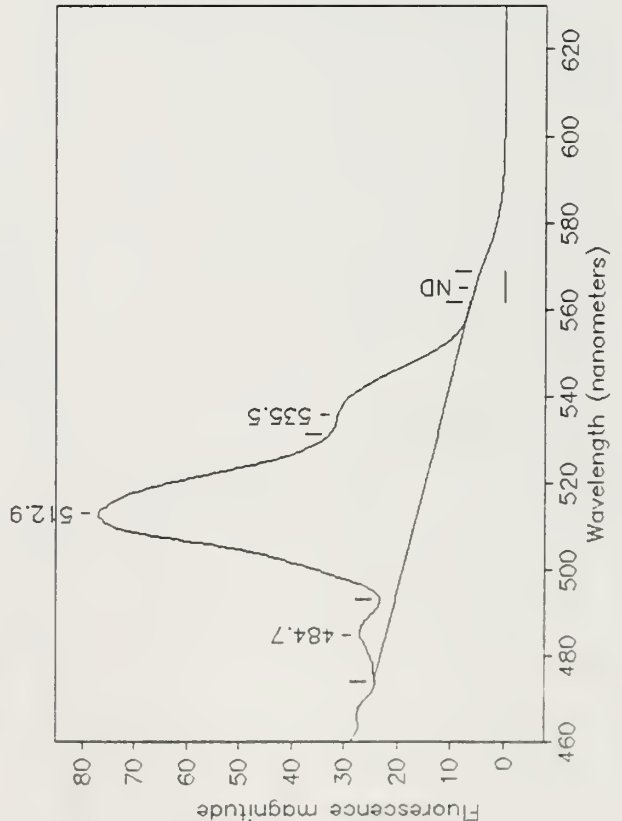
Station 102: Fitton Spring
 OUL number: G4047 Type: Charcoal Analyzed: 19970607
 Date placed: 04/17/97 Date recovered: 06/03/97
 Time placed: 1710 Time recovered: 1325

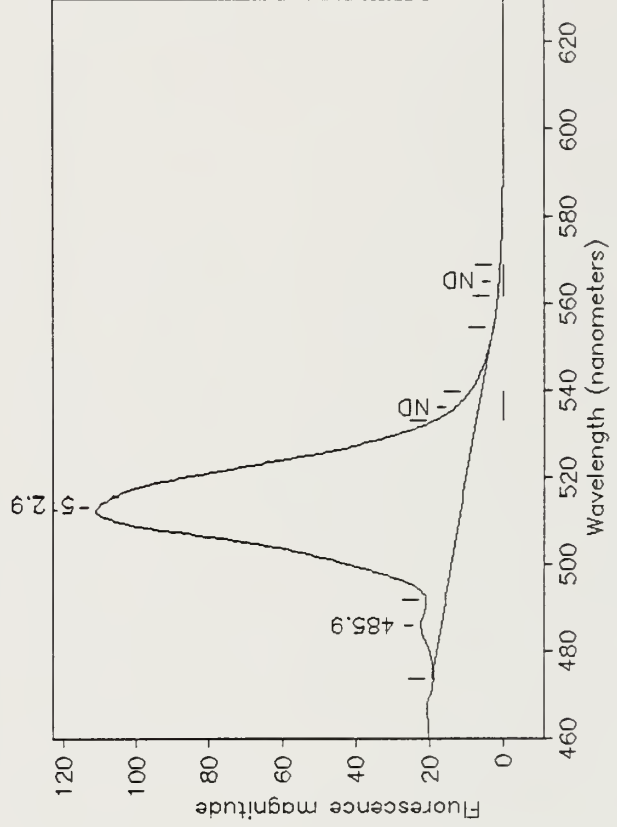
Station 102: Fitton Spring
 OUL number: H1656 Type: Charcoal Analyzed: 19980325
 Date placed: 03/03/98 Date recovered: 03/23/98
 Time placed: 1300 Time recovered: 1200

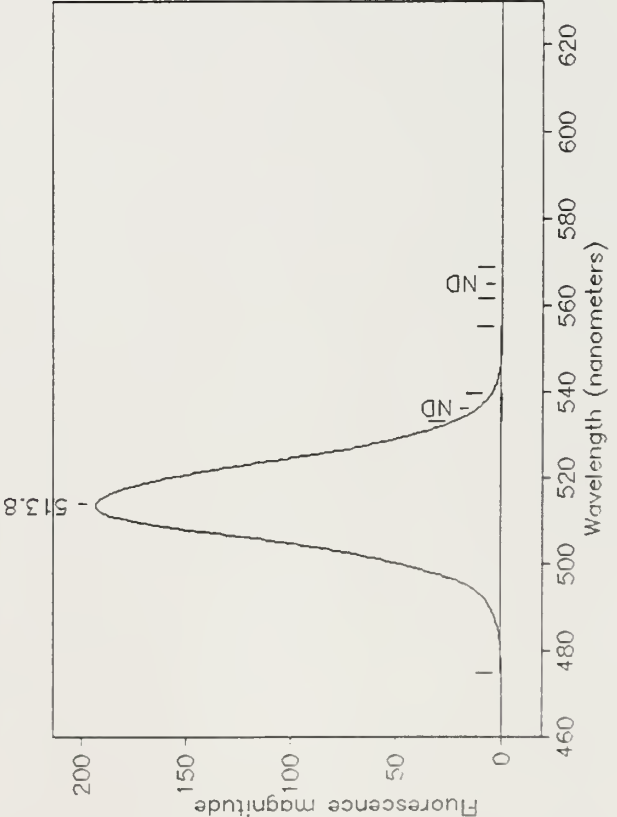
Station 102: Fitton Spring
 OUL number: H1309 Type: Charcoal Analyzed: 19980306
 Date placed: 02/25/98 Date recovered: 03/03/98
 Time placed: 0940 Time recovered: 1300

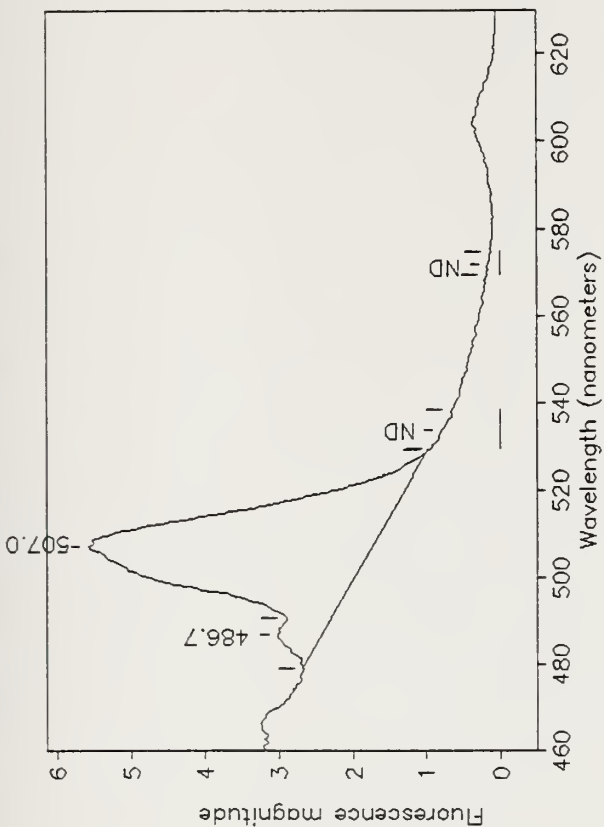
Station 102: Fitton Spring
OUL number: H1396 Type: Water Analyzed: 19980310
Date collected: 03/03/98 Time collected: 1300

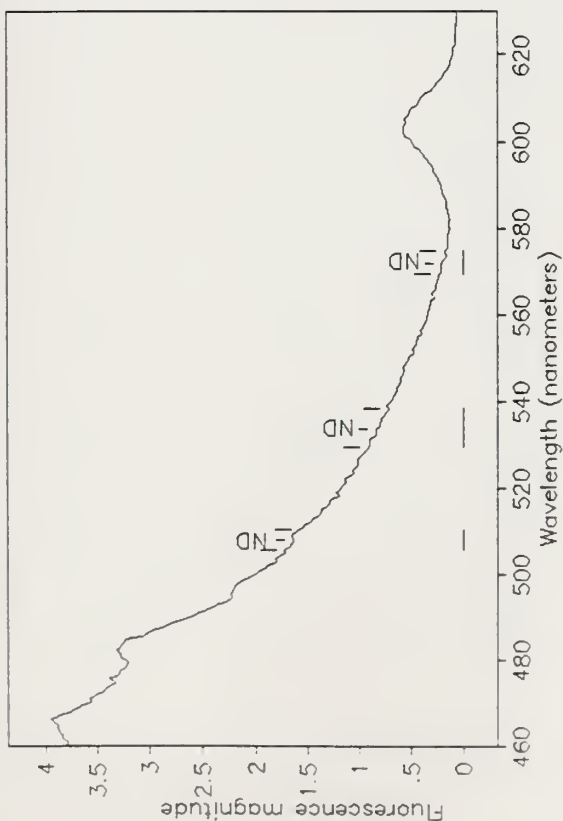
Station 102: Fitton Spring
OUL number: F9719 Type: Water Analyzed: 19970321
Date collected: 03/20/97 Time collected: 1230

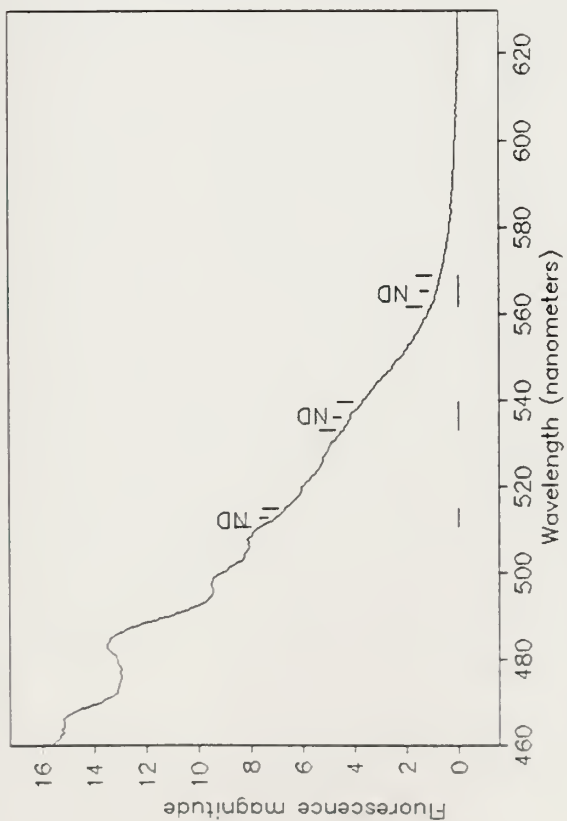
Station 103: Cecil Creek upstream Fitton Spring
OUL number: F6841 Type: Charcoal Analyzed: 19960920
Date placed: 08/30/96 Date recovered: 09/11/96
Time placed: 1520 Time recovered: 1150

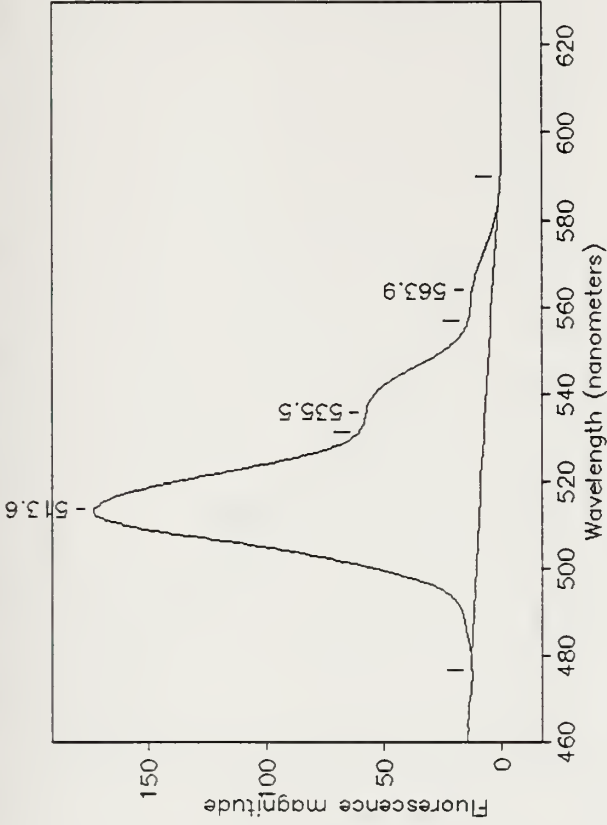
Station 105: Cecil Creek upstream Cove Creek
 OUL number: G0516 Type: Charcoal Analyzed: 19970414
 Date placed: 03/26/97 Date recovered: 04/03/97
 Time placed: 1430 Time recovered: 1045

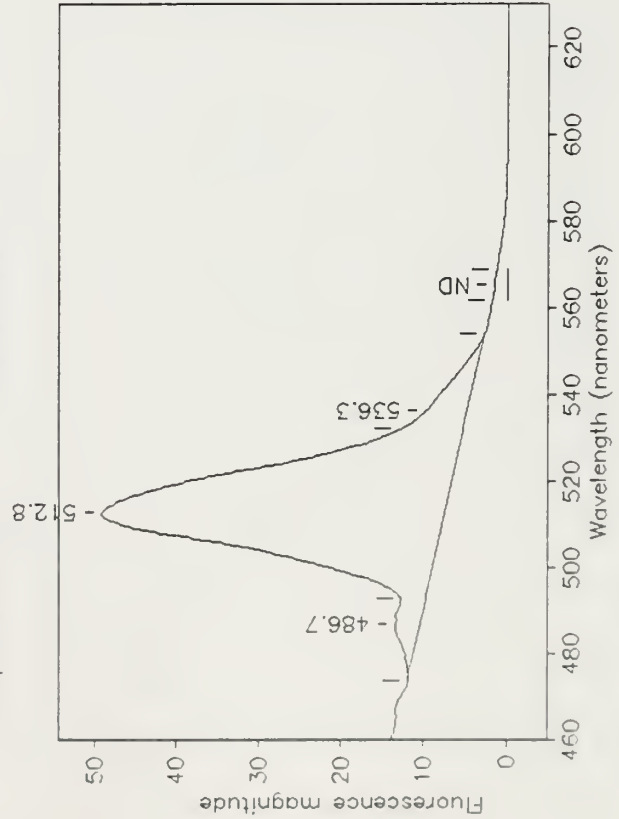
Station 105: Cecil Creek upstream Cove Creek
 OUL number: G0587 Type: Charcoal Analyzed: 19970414
 Date placed: 04/03/97 Date recovered: 04/11/97
 Time placed: 1045 Time recovered: 1225

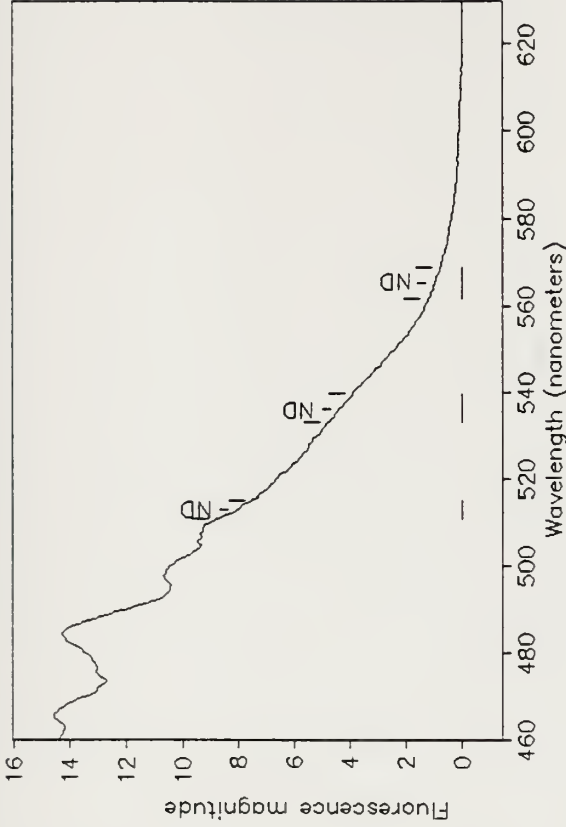
Station 106: Cove Creek at Mouth
OUL number: F9989 Type: Charcoal Analyzed: 19970331
Date placed: 03/20/97 Date recovered: 03/26/97
Time placed: 1211 Time recovered: 1105

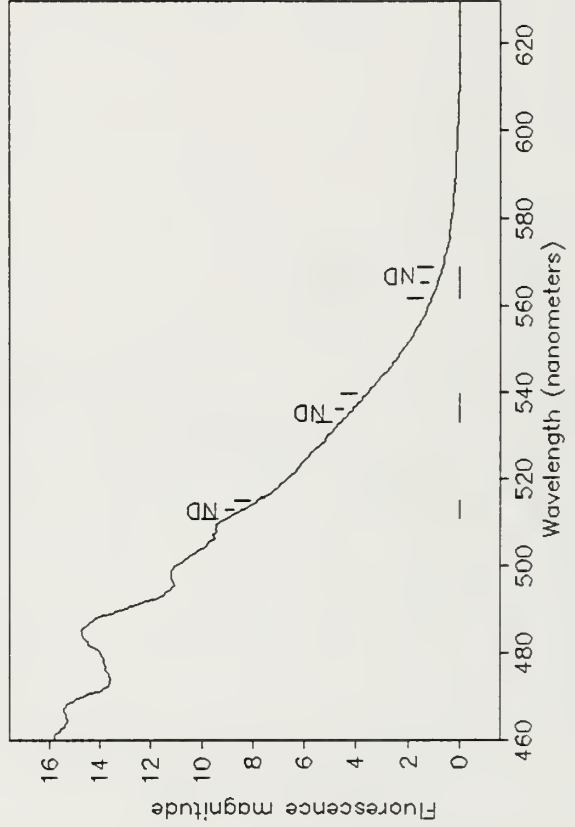
Station 106: Cove Creek at Mouth
OUL number: G0586 Type: Charcoal Analyzed: 19970414
Date placed: 04/03/97 Date recovered: 04/11/97
Time placed: 1050 Time recovered: 1230

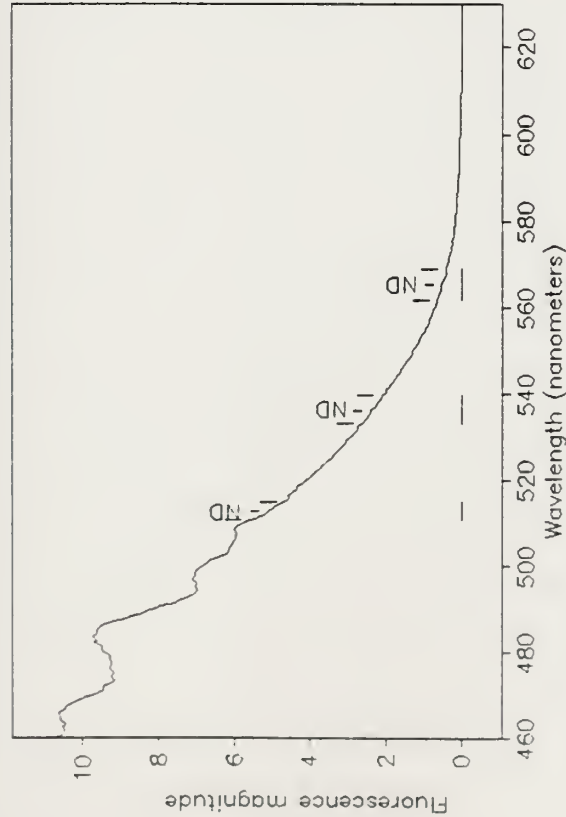
Station 106: Cove Creek at Mouth
OUL number: F6843 Type: Charcoal Analyzed: 19960920
Date placed: 08/30/96 Date recovered: 09/11/96
Time placed: 1440 Time recovered: 1110

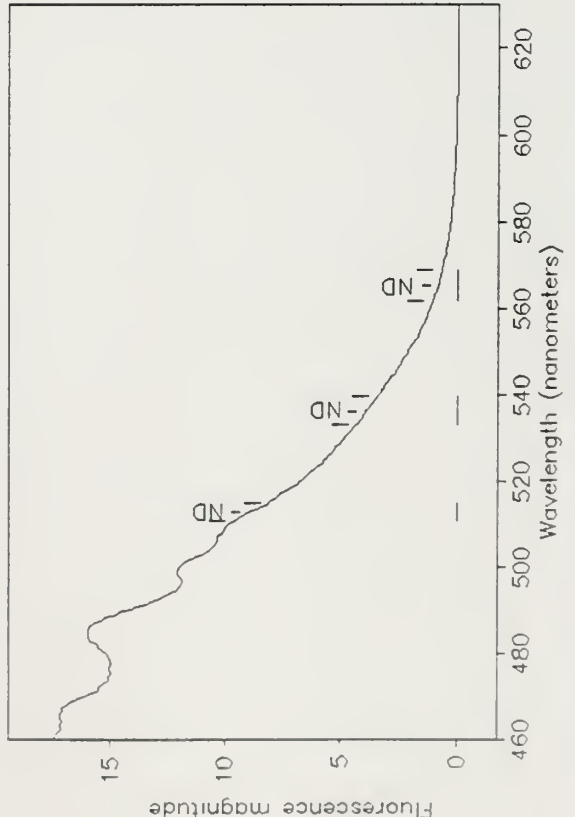
Station 106: Cove Creek at Mouth
OUL number: G0512 Type: Charcoal Analyzed: 19970414
Date placed: 03/26/97 Date recovered: 04/03/97
Time placed: 1105 Time recovered: 1050

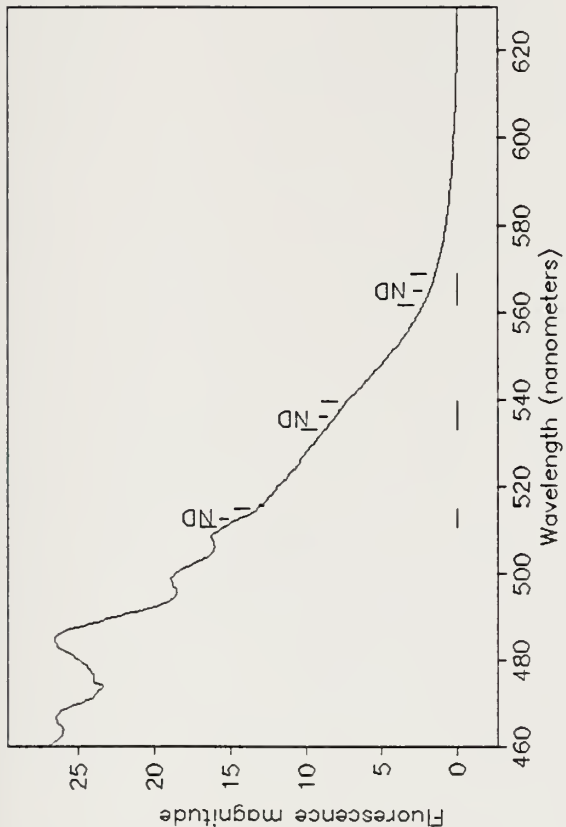
Station 106: Cove Creek at Mouth
 OUL number: G8895 Type: Charcoal Analyzed: 19970929
 Date placed: 06/03/97 Date recovered: 09/13/97
 Time placed: 1310 Time recovered: 1205

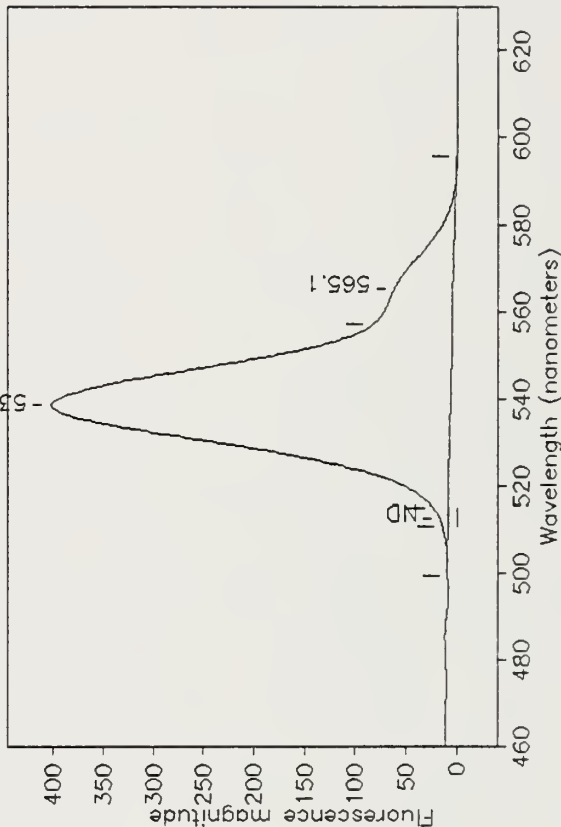
Station 106: Cove Creek at Mouth
 OUL number: H1310 Type: Charcoal Analyzed: 19980306
 Date placed: 02/27/98 Date recovered: 03/03/98
 Time placed: 1355 Time recovered: 1225

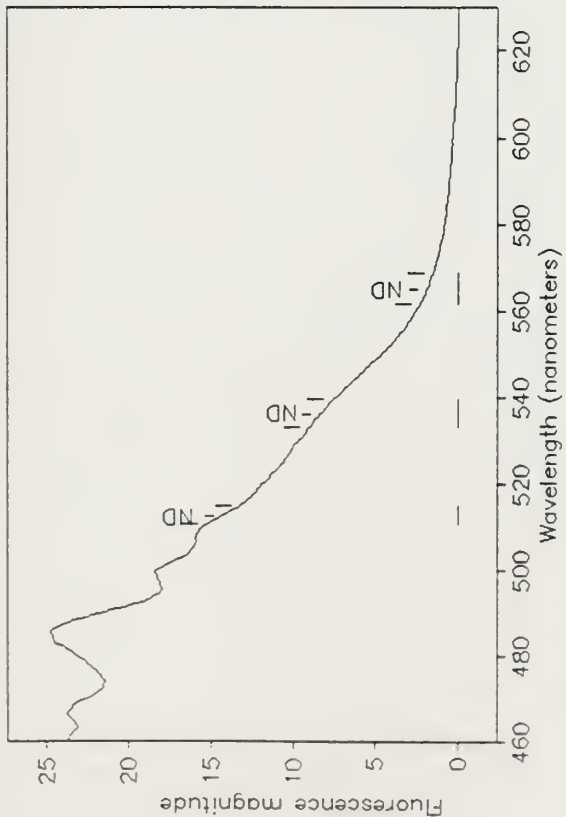
Station 106: Cove Creek at Mouth
 OUL number: G4051 Type: Charcoal Analyzed: 19970607
 Date placed: 04/11/97 Date recovered: 06/03/97
 Time placed: 1230 Time recovered: 1310

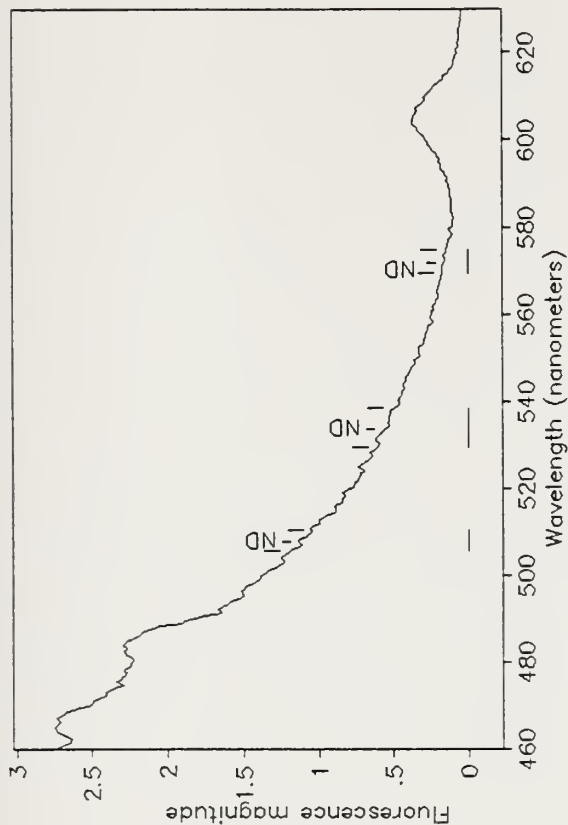
Station 106: Cove Creek at Mouth
OUL number: H1397 Type: Water Analyzed: 19980310
Date collected: 03/03/98 Time collected: 1225

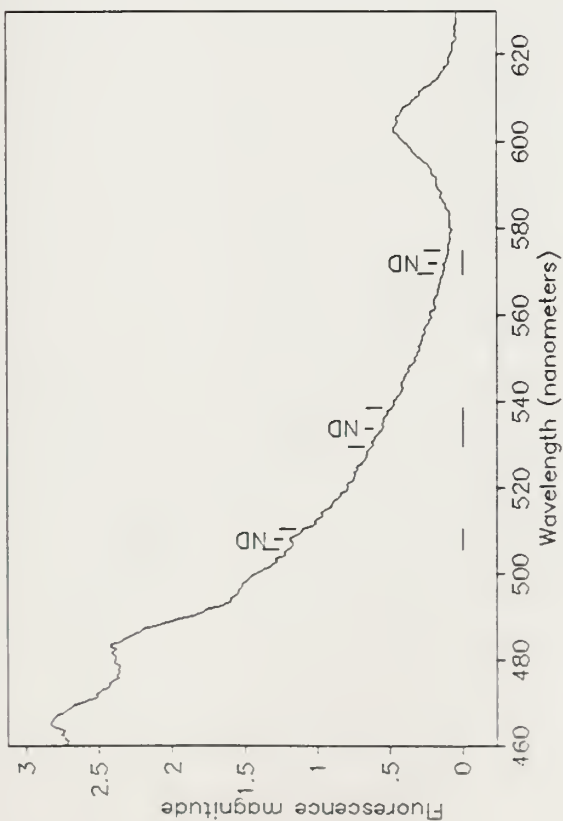
Station 106: Cove Creek at Mouth
OUL number: F9715 Type: Water Analyzed: 19970321
Date collected: 03/20/97 Time collected: 1211

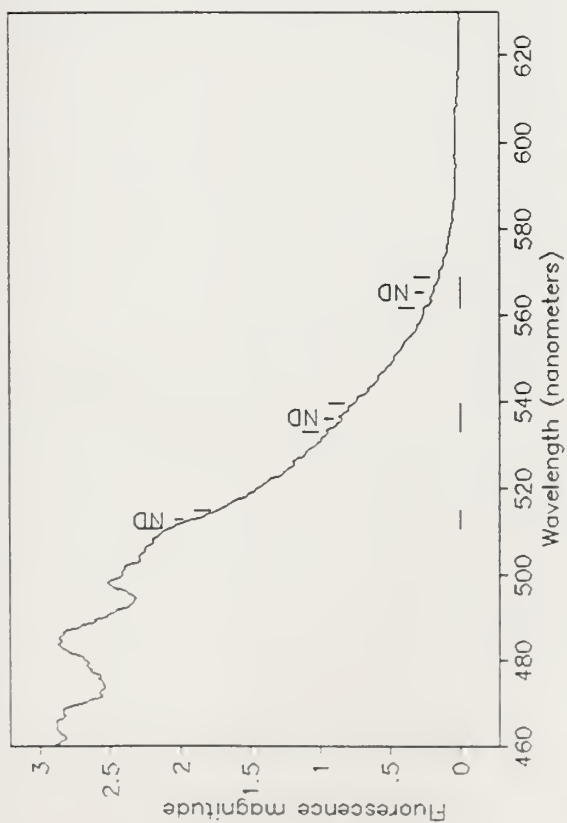
Station 107: Rippled Slab
OUL number: F6844 Type: Charcoal Analyzed: 19960920
Date placed: 08/30/96 Date recovered: 09/11/96
Time placed: 1500 Time recovered: 1120

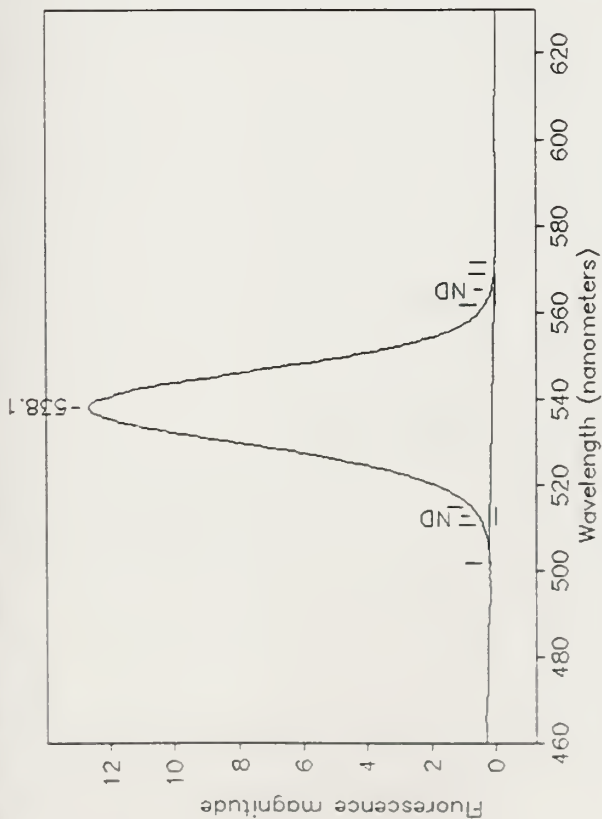
Station 108: First Tributary d/s of Van Diluted 1: 100
OUL number: F7622 Type: Charcoal Analyzed: 19961115
Date placed: 11/08/96 Date recovered: 11/14/96
Time placed: 1700 Time recovered: 1140

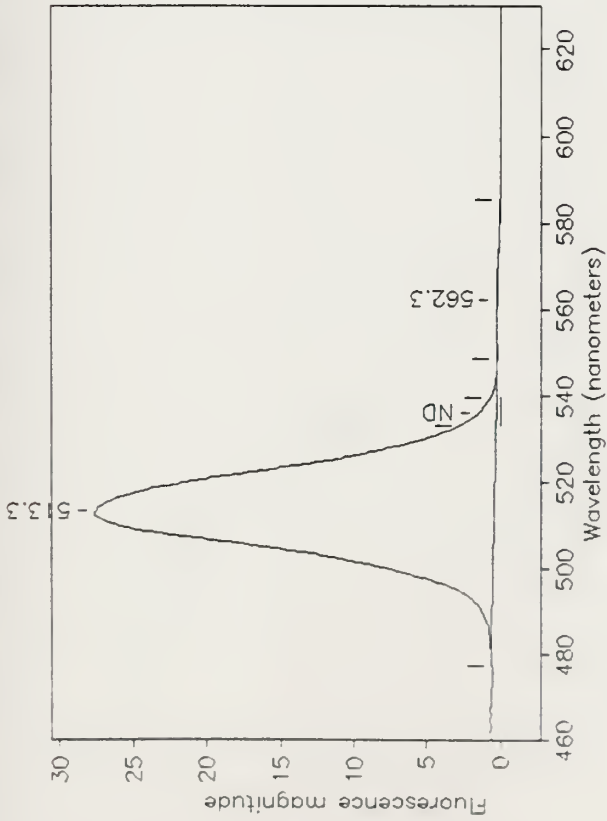
Station 109: Cecil Creek Overflow near Van Dyke Spring
 OUL number: F7623 Type: Charcoal Analyzed: 19961115
 Date placed: 11/08/96 Date recovered: 11/14/96
 Time placed: 1640 Time recovered: 1120

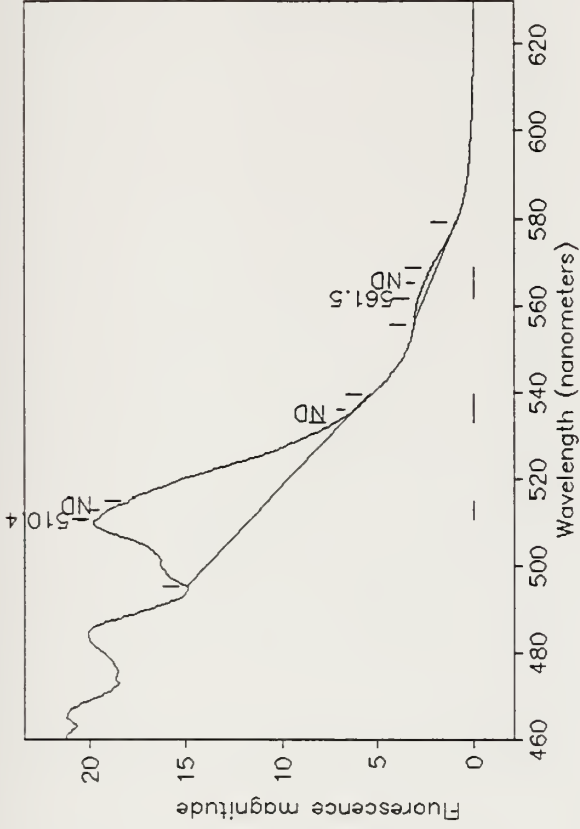
Station 109: Cecil Creek Overflow near Van Dyke Spring
 OUL number: F7832 Type: Charcoal Analyzed: 19961211
 Date placed: 11/14/96 Date recovered: 12/06/96
 Time placed: 1120 Time recovered: 1005

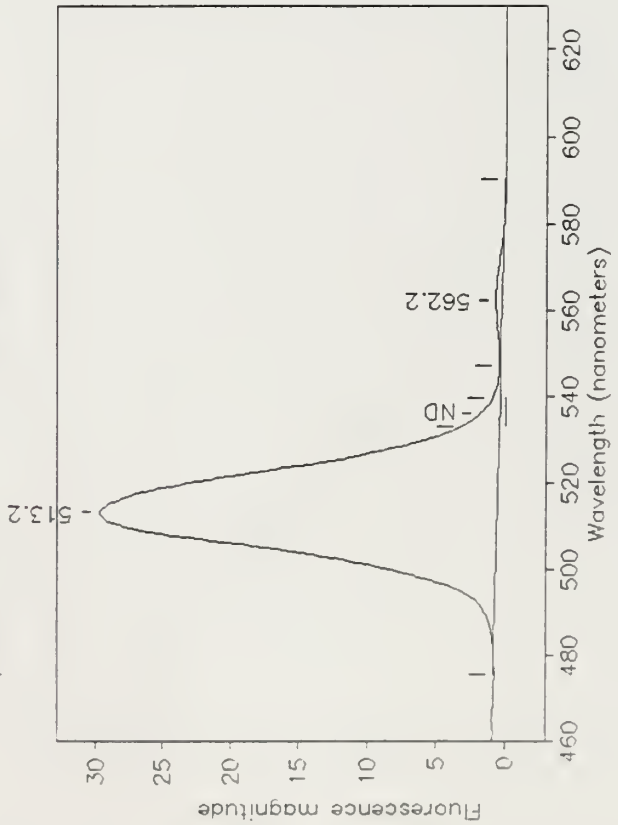
Station 109: Cecil Creek Overflow near Van Dyke Spring
 OUL number: F7884 Type: Charcoal Analyzed: 19961217
 Date placed: 12/06/96 Date recovered: 12/16/96
 Time placed: 1005 Time recovered: 1250

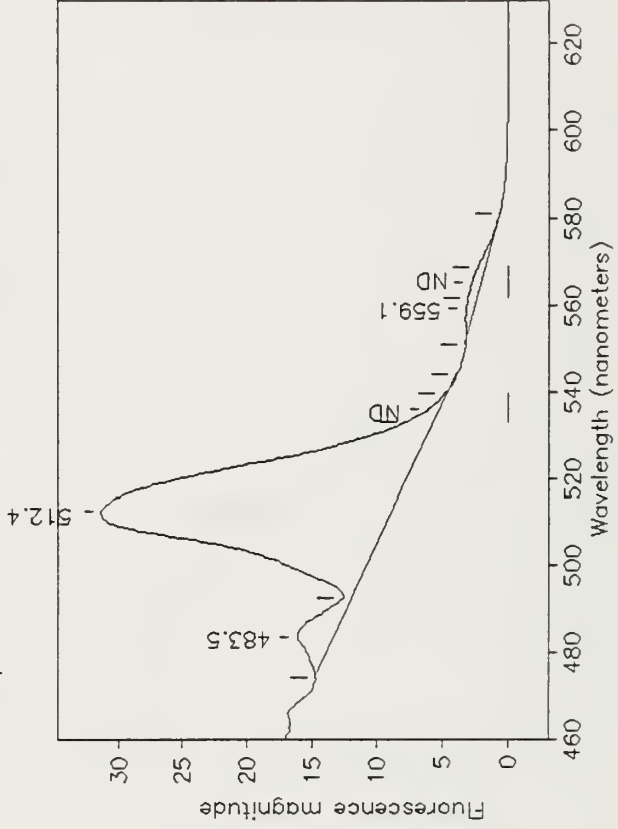
Station 109: Cecil Creek Overflow near Van Dyke Spring
 OUL number: F9718 Type: Charcoal Analyzed: 19970321
 Date placed: 12/16/96 Date recovered: 03/20/97
 Time placed: 1250 Time recovered: 1316

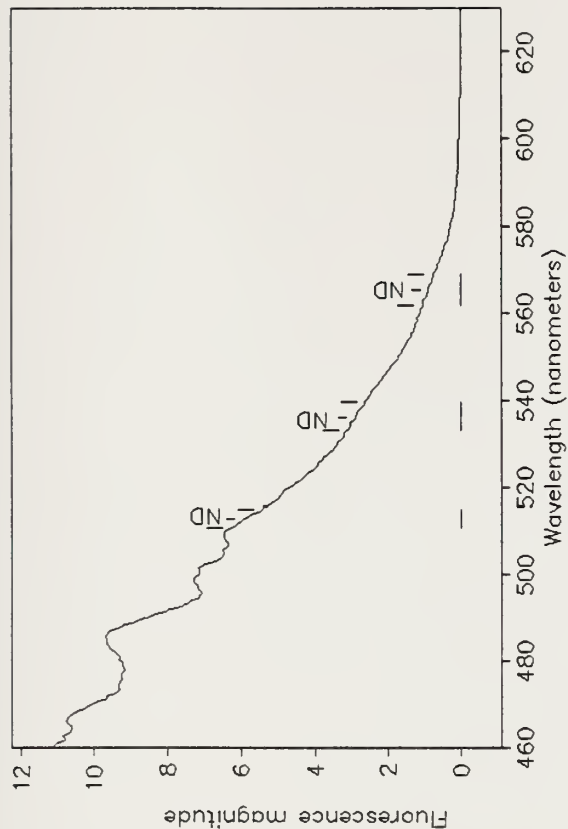
Station 109: Cecil Creek Overflow near Van Dyke Spring
 OUL number: G0510 Type: Charcoal Analyzed: 19970414
 Date placed: 03/26/97 Date recovered: 04/03/97
 Time placed: 1035 Time recovered: 1230

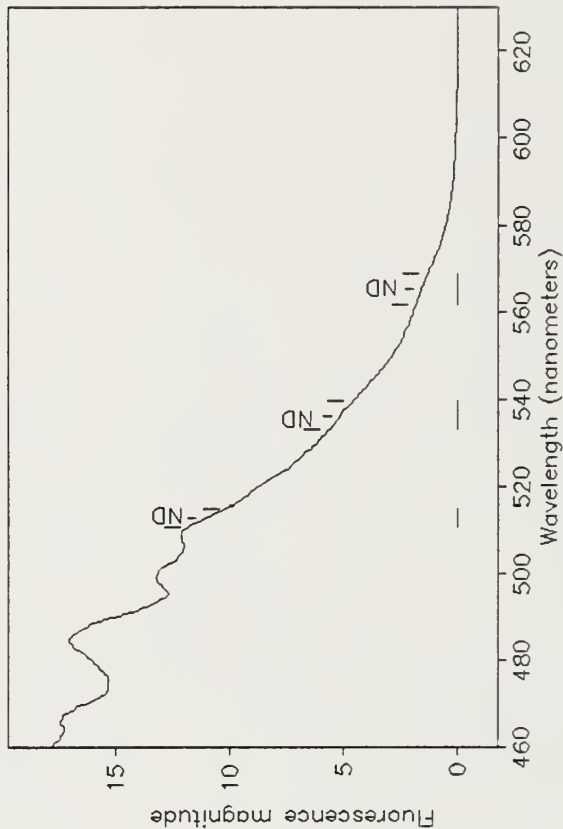
Station 109: Cecil Creek Overflow near Van Dyke Spring
 OUL number: G4050 Type: Charcoal Analyzed: 19970607
 Date placed: 04/11/97 Date recovered: 06/03/97
 Time placed: 1321 Time recovered: 1355

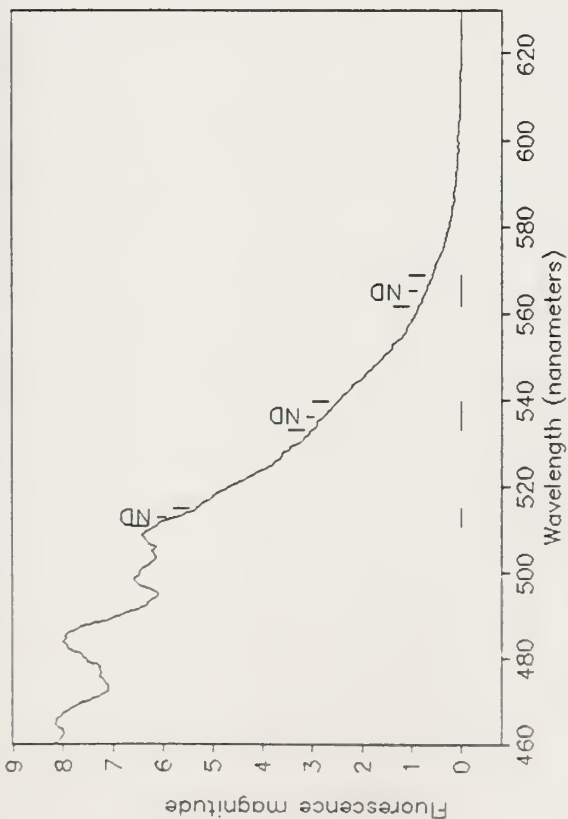
Station 109: Cecil Creek Overflow near Van Dyke Spring
 OUL number: F9987 Type: Charcoal Analyzed: 19970331
 Date placed: 03/20/97 Date recovered: 03/26/97
 Time placed: 1316 Time recovered: 1035

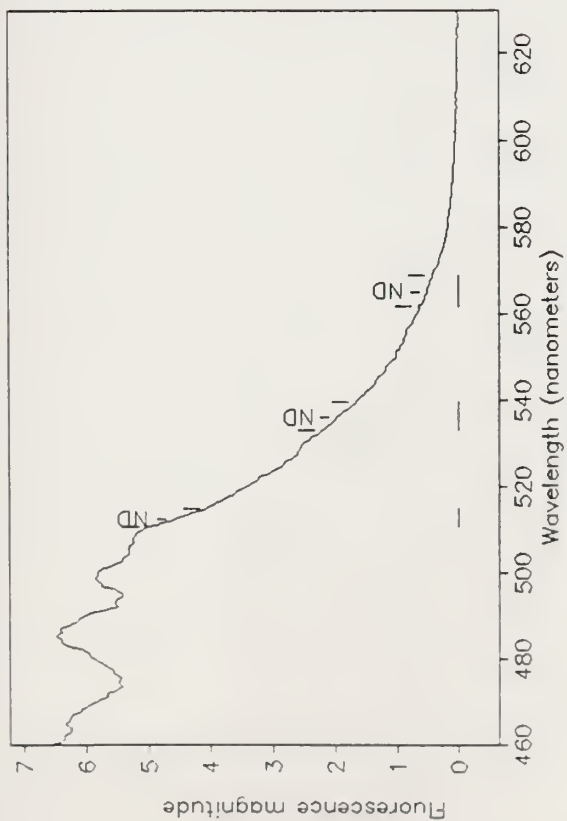
Station 109: Cecil Creek Overflow near Van Dyke Spring
OUL number: G8896 Type: Charcoal Analyzed: 19970929
Date placed: 06/03/97 Date recovered: 09/13/97
Time placed: 1355 Time recovered: 1030

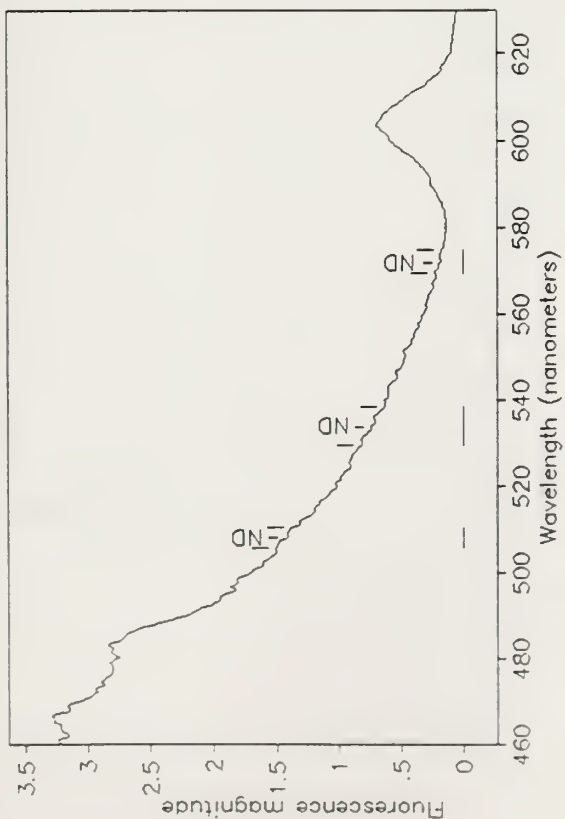
Station 109: Cecil Creek Overflow near Van Dyke Spring
OUL number: F9722 Type: Water Analyzed: 19970321
Date collected: 03/20/97 Time collected: 1316

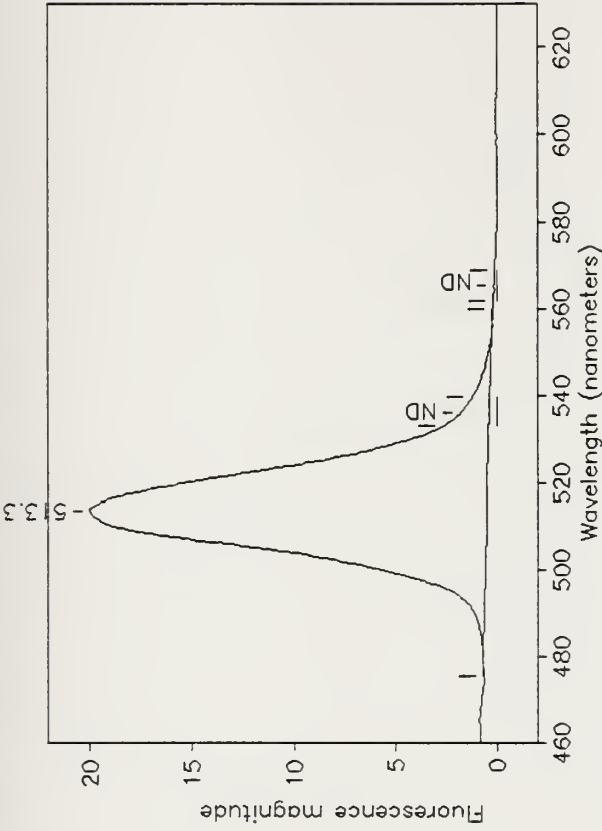
Station 110: Van Dyke Spring Diluted 1: 100
 OUL number: F76250 Type: Charcoal Analyzed: 19961211
 Date placed: 11/08/96 Date recovered: 11/14/96
 Time placed: 1630 Time recovered: 1130

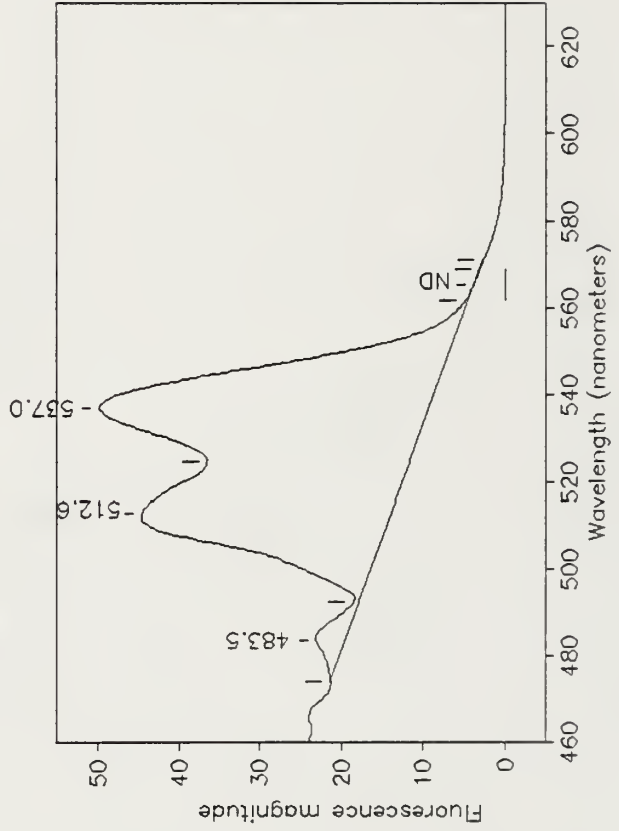
Station 110: Van Dyke Spring Diluted 1: 100
 OUL number: F78300 Type: Charcoal Analyzed: 19961211
 Date placed: 11/14/96 Date recovered: 12/06/96
 Time placed: 1130 Time recovered: 1010
