FINAL PHASE 1 REPORT WITH EMPHASIS ON FITTON CAVE AREA

INVENTORY AND DELINEATION OF KARST HYDROLOGY FEATURES, BUFFALO NATIONAL RIVER, ARKANSAS.

March, 1999

Thomas Aley and Catherine Aley
Ozark Underground Laboratory, Inc.

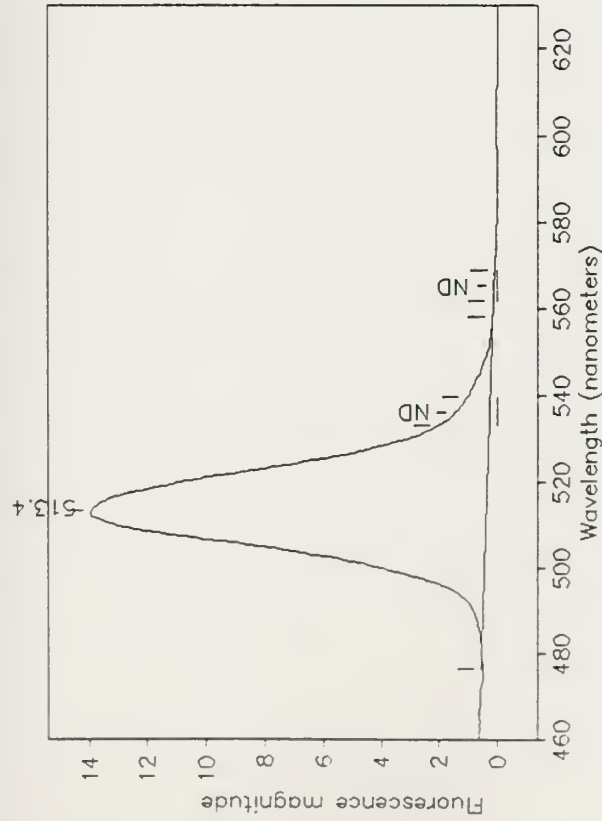
Station 110: Van Dyke Spring Diluted 1: 100
 OUL number: F7625 Type: Charcoal Analyzed: 19961115
 Date placed: 11/08/96 Date recovered: 11/14/96
 Time placed: 1630 Time recovered: 1130

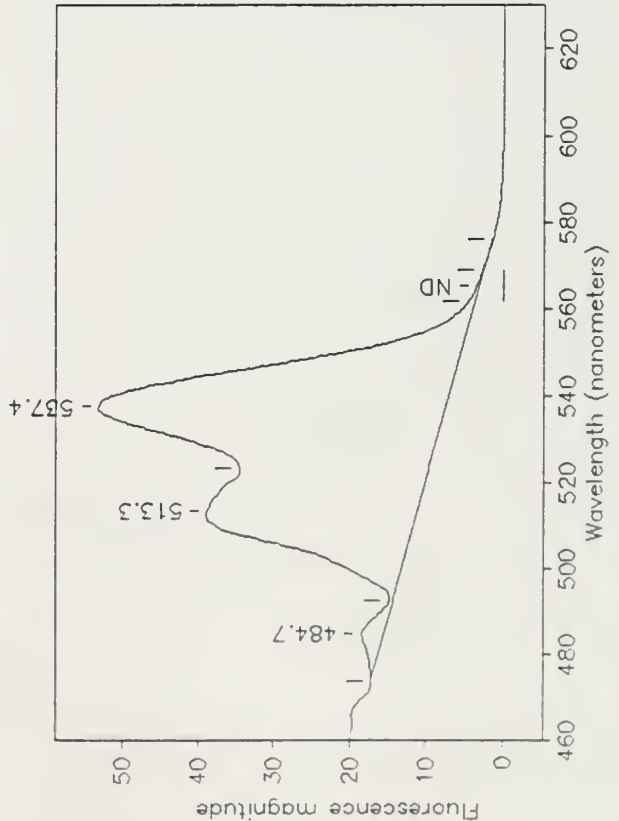
Station 110: Van Dyke Spring Diluted 1: 100
 OUL number: F7830 Type: Charcoal Analyzed: 19961211
 Date placed: 11/14/96 Date recovered: 12/06/96
 Time placed: 1130 Time recovered: 1010

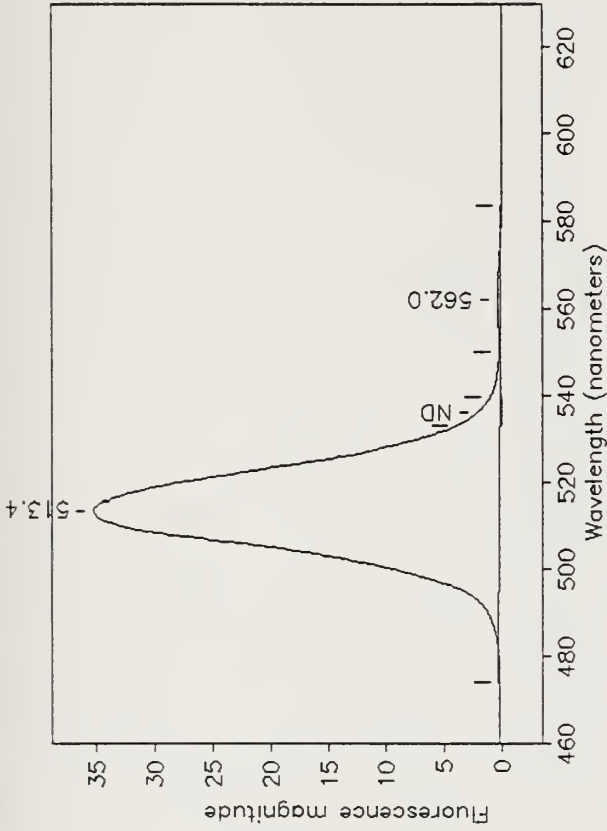
Station 110: Van Dyke Spring Diluted 1: 100
 OUL number: F7882D Type: Charcoal Analyzed: 19961220
 Date placed: 12/06/96 Date recovered: 12/16/96
 Time placed: 1010 Time recovered: 1255

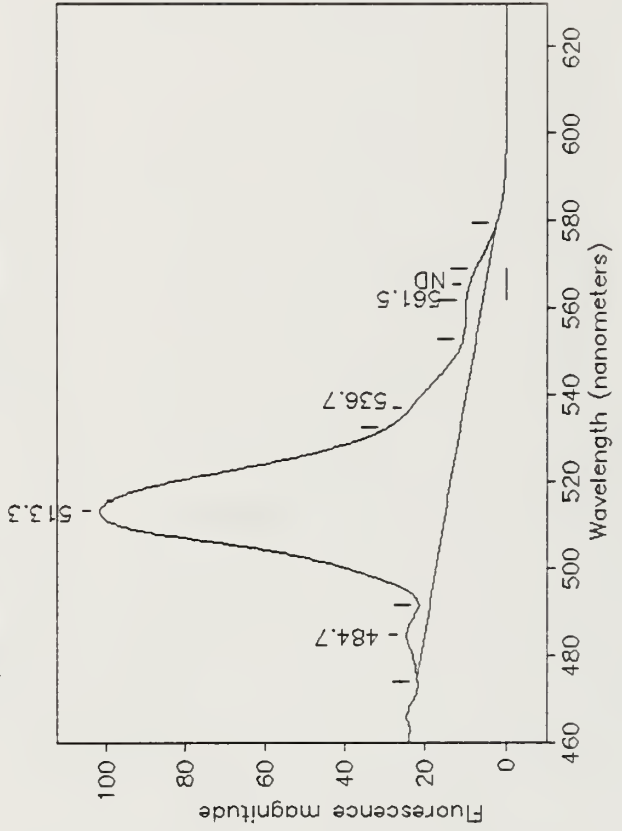
Station 110: Van Dyke Spring
 OUL number: F9717D Type: Charcoal Analyzed: 19970321
 Date placed: 12/16/96 Date recovered: 03/20/97
 Time placed: 1255 Time recovered: 1325

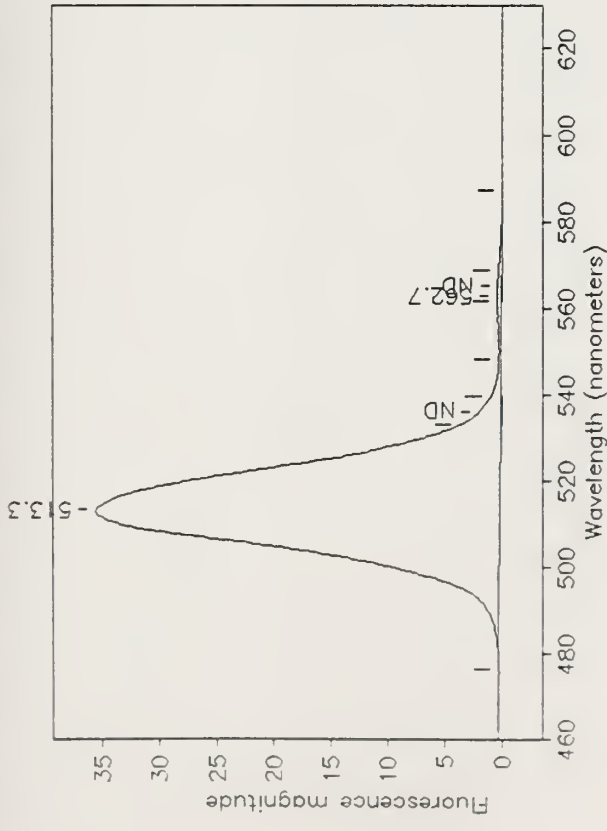
Station 110: Van Dyke Spring Diluted 1: 100
 OUL number: F7882 Type: Charcoal Analyzed: 19961217
 Date placed: 12/06/96 Date recovered: 12/16/96
 Time placed: 1010 Time recovered: 1255

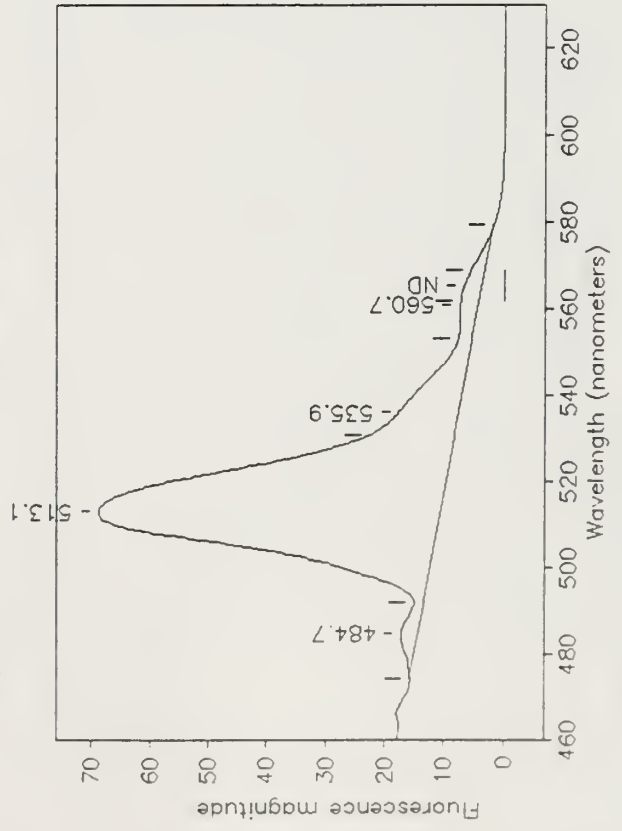
Station 110: Van Dyke Spring
 OUL number: F9717 Type: Charcoal Analyzed: 19970321
 Date placed: 12/16/96 Date recovered: 03/20/97
 Time placed: 1255 Time recovered: 1325

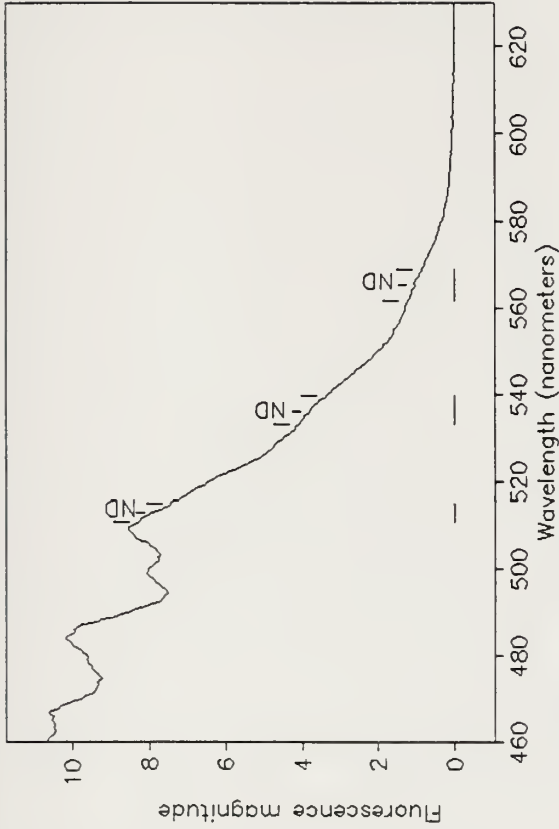
Station 110: Van Dyke Spring
OUL number: F9988D Type: Charcoal Analyzed: 19970331
Date placed: 03/20/97 Date recovered: 03/26/97
Time placed: 1325 Time recovered: 1040

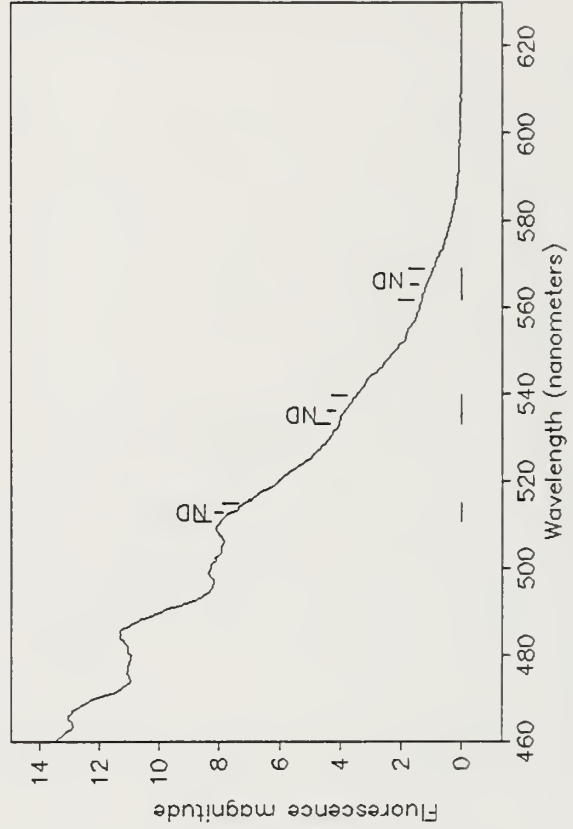
Station 110: Van Dyke Spring
OUL number: G0511D Type: Charcoal Analyzed: 19970414
Date placed: 03/26/97 Date recovered: 04/03/97
Time placed: 1040 Time recovered: 1235

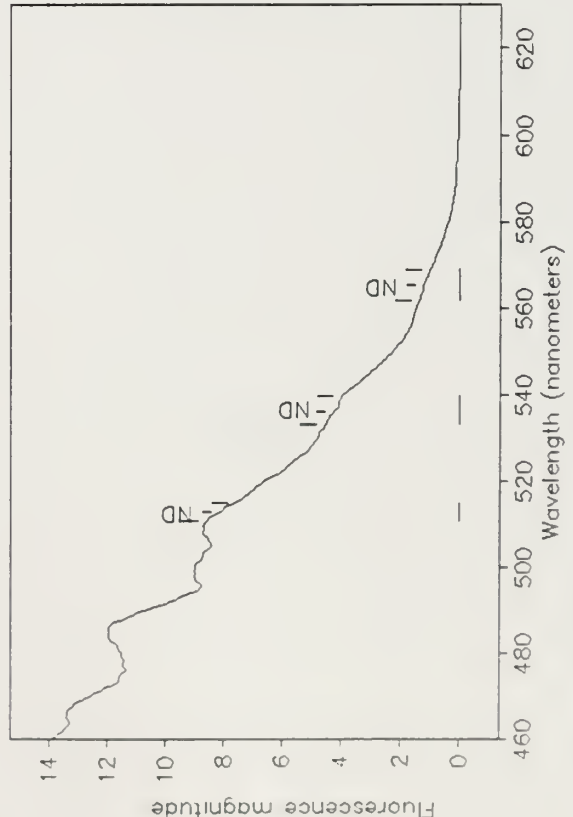
Station 110: Van Dyke Spring
OUL number: G0511 Type: Charcoal Analyzed: 19970414
Date placed: 03/26/97 Date recovered: 04/03/97
Time placed: 1040 Time recovered: 1235

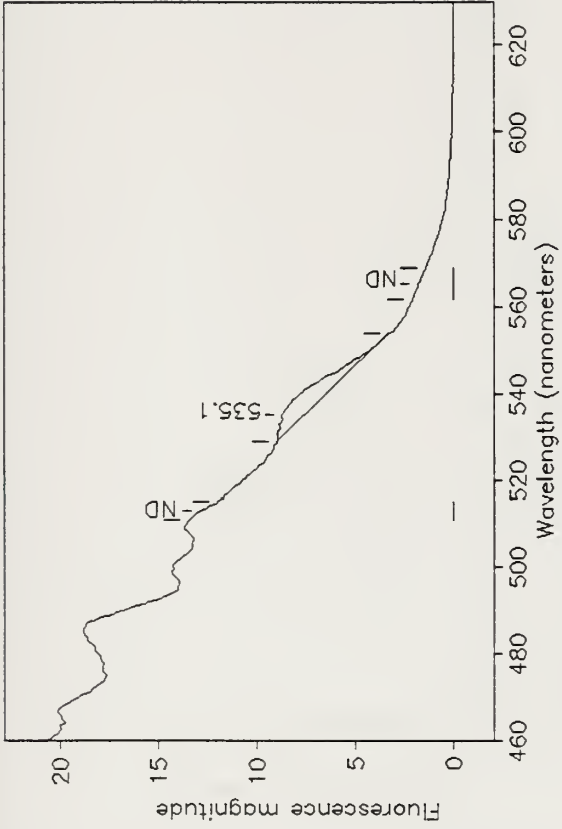
Station 110: Van Dyke Spring
OUL number: G05890 Type: Charcoal Analyzed: 19970414
Date placed: 04/03/97 Date recovered: 04/11/97
Time placed: 1235 Time recovered: 1325

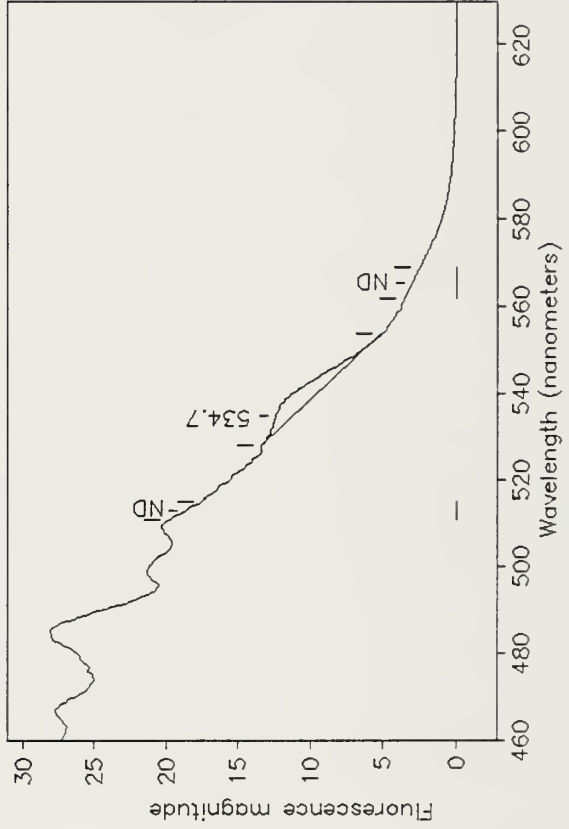
Station 110: Van Dyke Spring
OUL number: G40490 Type: Charcoal Analyzed: 19970607
Date placed: 04/11/97 Date recovered: 06/03/97
Time placed: 1325 Time recovered: 1400

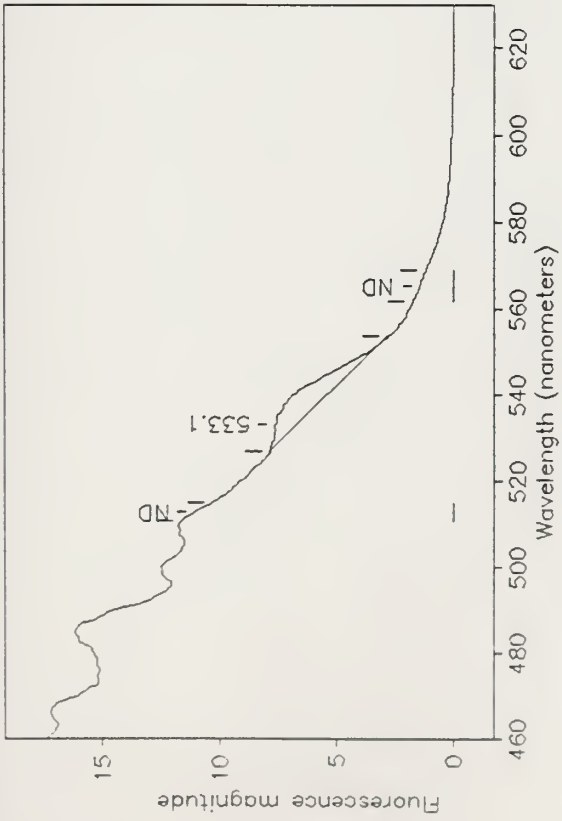
Station 110: Van Dyke Spring
OUL number: G0589 Type: Charcoal Analyzed: 19970414
Date placed: 04/03/97 Date recovered: 04/11/97
Time placed: 1235 Time recovered: 1325

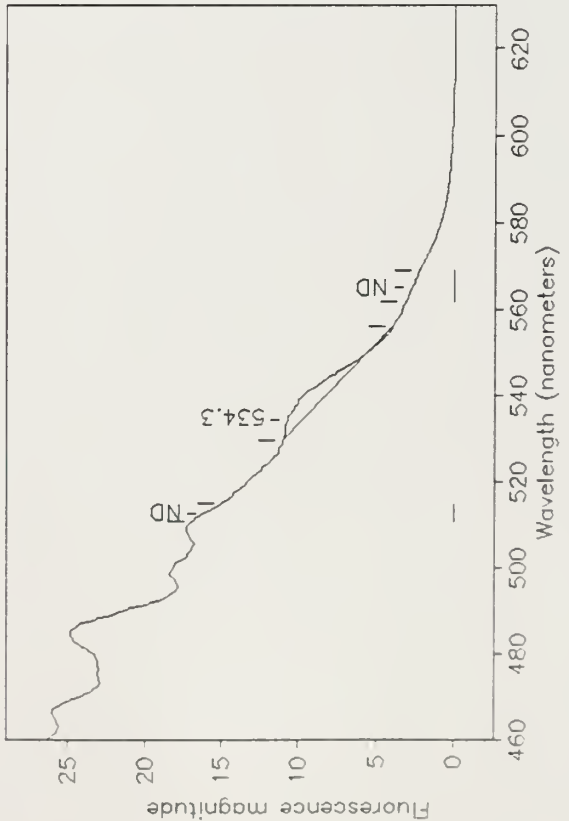
Station 110: Van Dyke Spring
OUL number: G4049 Type: Charcoal Analyzed: 19970607
Date placed: 04/11/97 Date recovered: 06/03/97
Time placed: 1325 Time recovered: 1400

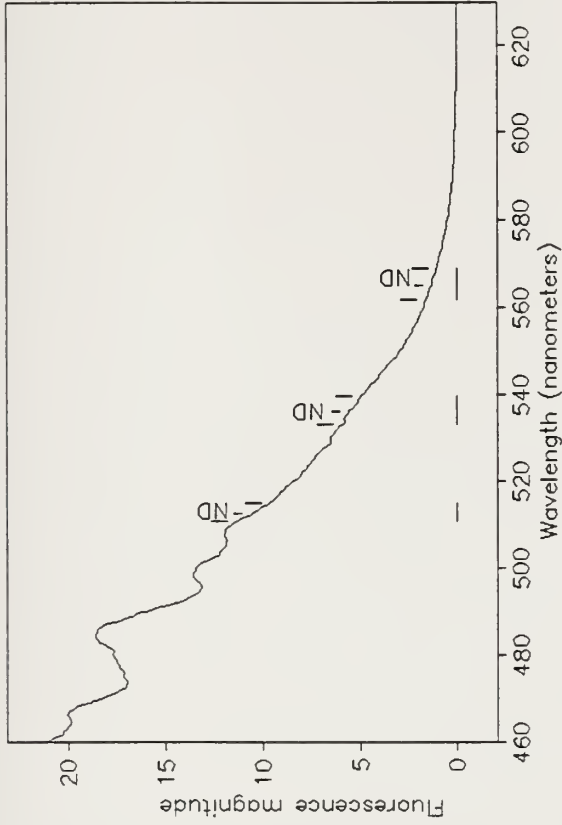
Station 110: Van Dyke Spring
OUL number: G8897D Type: Charcoal Analyzed: 19970929
Date placed: 06/03/97 Date recovered: 09/13/97
Time placed: 1400 Time recovered: 1035

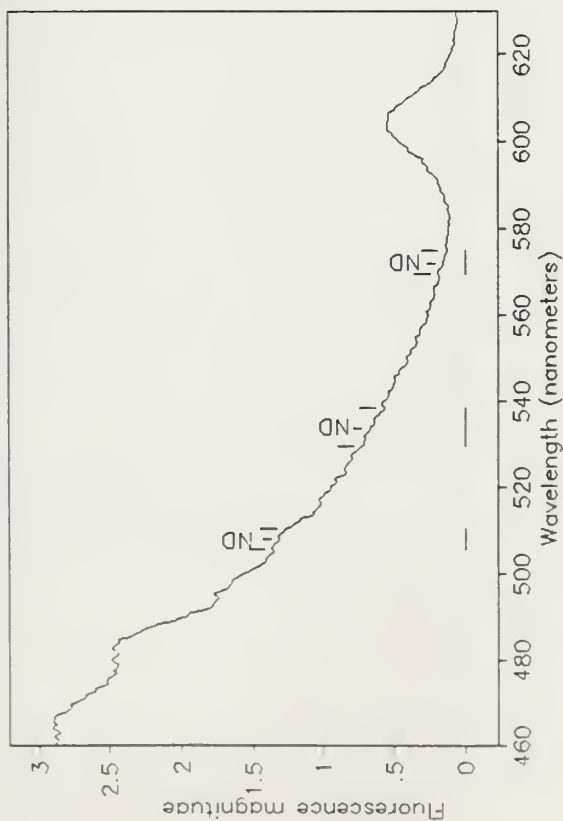
Station 110: Van Dyke Spring
OUL number: F9721 Type: Water Analyzed: 19970321
Date collected: 03/20/97 Time collected: 1325

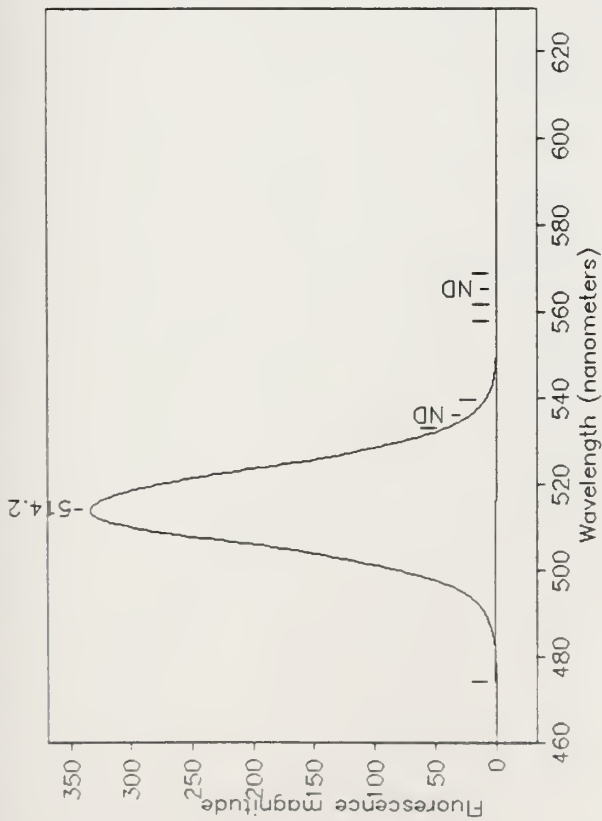
Station 111: Trib to Cecil Crk @ Rd XingDiluted 1: 100
OUL number: G0514 Type: Charcoal Analyzed: 19970414
Date placed: 03/26/97 Date recovered: 04/03/97
Time placed: 1400 Time recovered: 1120

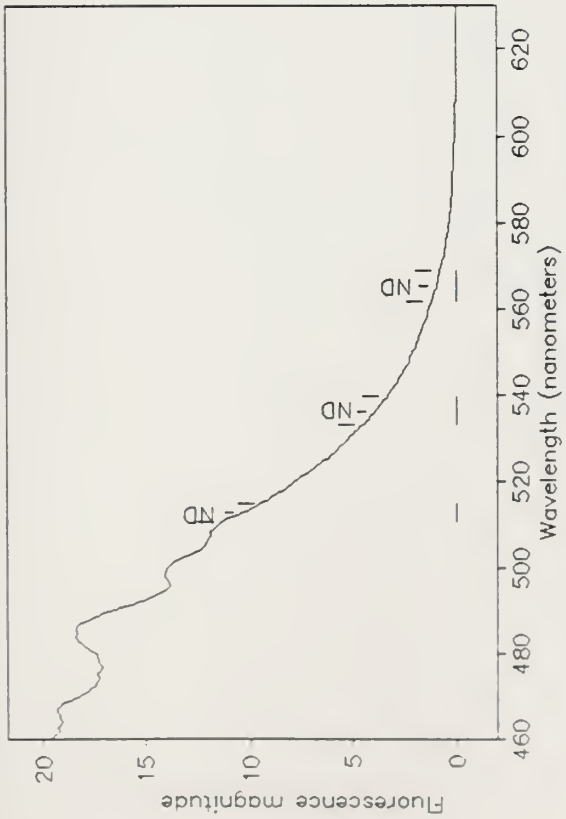
Station 112: Little Spring Branch
OUL number: G0515 Type: Charcoal Analyzed: 19970414
Date placed: 03/26/97 Date recovered: 04/03/97
Time placed: 1413 Time recovered: 1125
