Oakland Plantation Big House Historic Structure Report

HISTORIC
STRUCTURE
REPORT

Cultural Resources, Southeast Region
National Park Service

2004
Historic Structure Report
Big House at Oakland Plantation
Cane River Creole National Historical Park
Natchez, Louisiana
LCS#: 91620

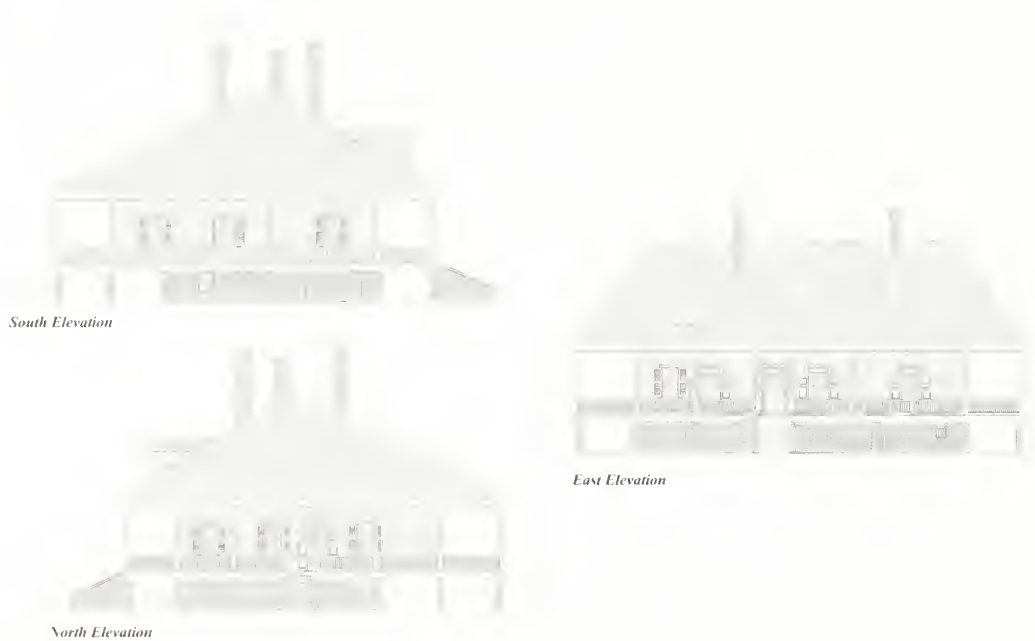
Figure 16 Conjectured appearance of the Big House, c. 1835. (T. Jones, NPS-SERO-CRS, 2001)

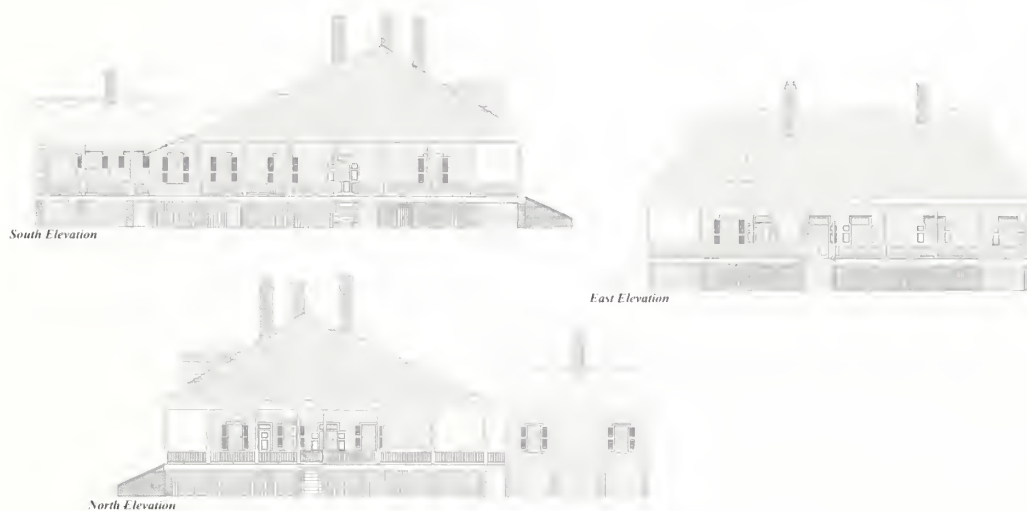
Figure 18 Conjectured appearance of the Big House, c. 1875. (T. Jones, NPS-SERO-CRS, 2001)

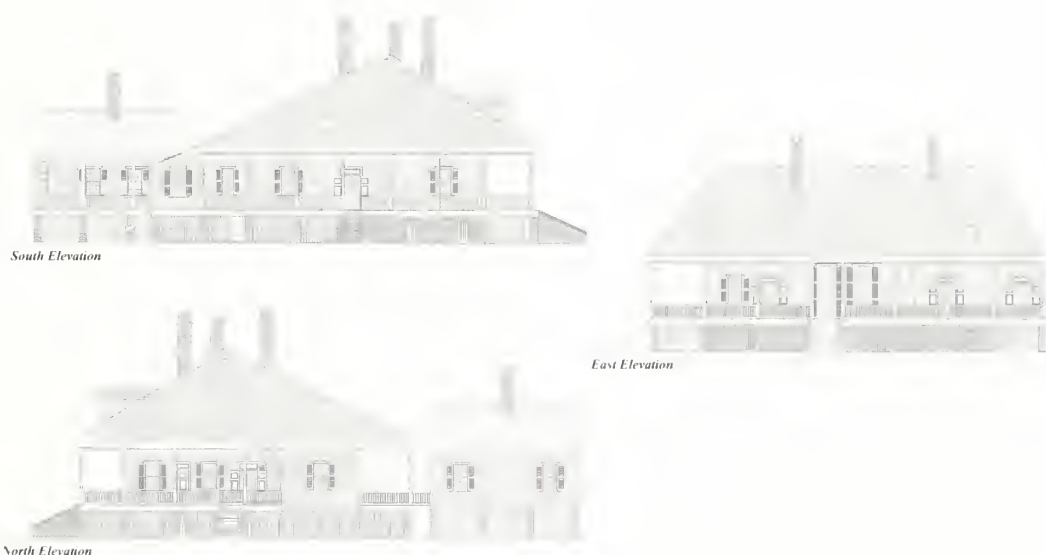
Figure 20 Conjectured appearance of the Big House, c. 1885. (T. Jones, NPS-SERO-CRS, 2001)

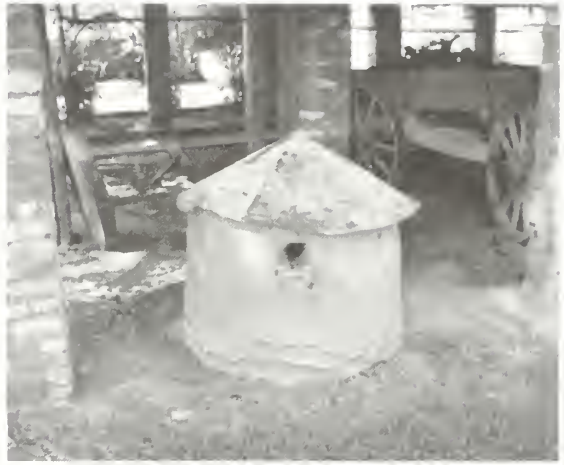
Figure 30 View of cistern beneath kitchen gallery. (NPS-SERO-CRS, 2001)

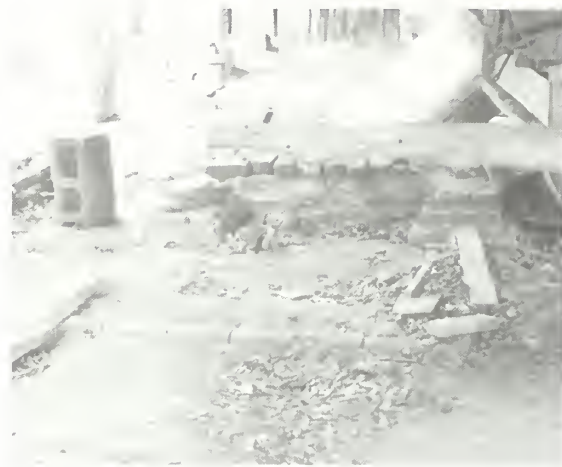
Figure 32 Demolished foundation for fireplaces under kitchen wing. (NPS-SERO-CRS, 2001)

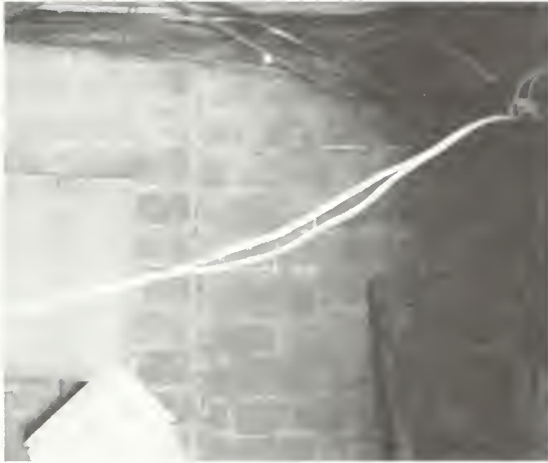
Figure 33 Detail of north wall of gas room (106), showing two earliest generations of brick work, both with mortar joints pencilled in white over red. (NPS-SERO-CRS, 2001)

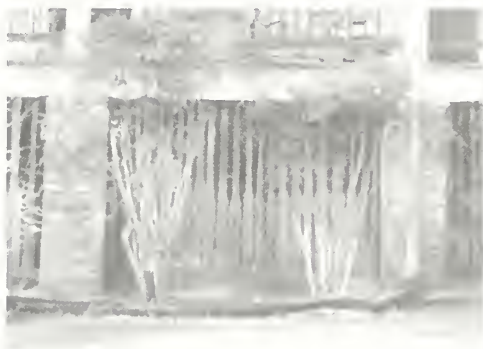
Figure 39 Views of earliest type of foundation enclosures, (c. 1870). (NPS-SERO-CRS, 2001)

Foundation Enclosures: Before the Civil War, there was apparently no enclosure of the foundation piers around the perimeter of the house. The brick walls of the basement rooms remained clearly visible and were painted red with "pencilled" mortar joints. Fragments of that treatment can still be found in Room 106 (see description below) with red paint still visible on the brick at several other locations. The

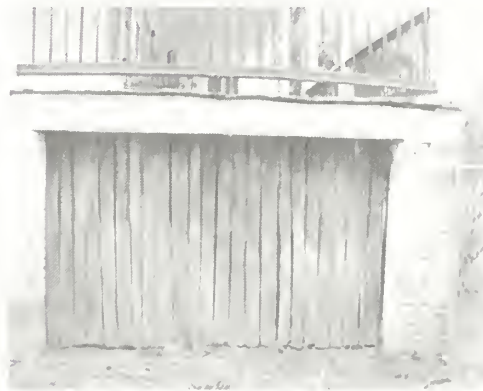
Figure 41 View of the third type of foundation enclosure. (NPS-SERO-CRS, 2001)

remain from the enclosure of that area. Horizontal boards (now covered with corrugated metal) above a grade-level course of brick are present beneath the west side of Room 214B. Wood-framed walls with horizontal planking were once present between the piers of the kitchen wing, but only fragments of the framing remain in place beneath the east end of the south side of the wing. These walls were reportedly removed in the 1940s.

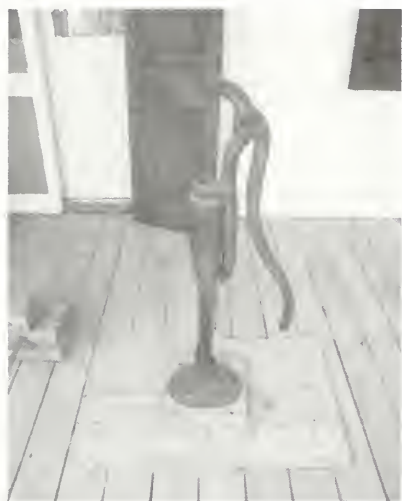
Figure 48 Myers pump on rear gallery, still connected to cistern located below. (NPS-SERO-CRS, 2001)

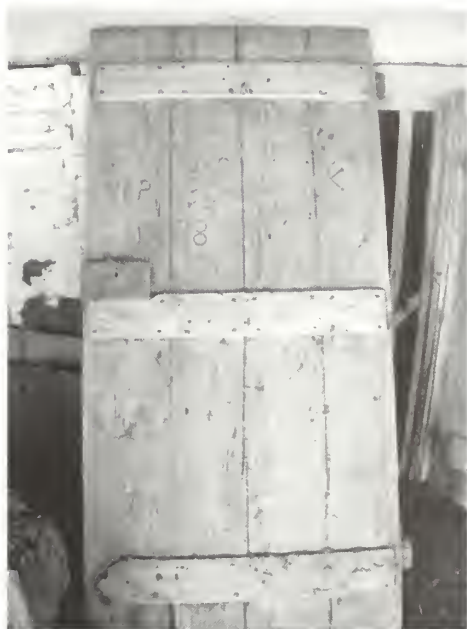
Figure 51 View of board door at basement level, typical of the oldest doors in the house. (NPS-SERO-CRS, 2001)

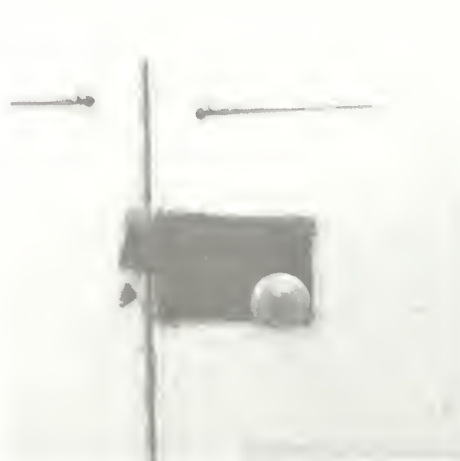
Figure 53 Early spring lock on French doors in dining room. (NPS-SERO-CRS, 2001)

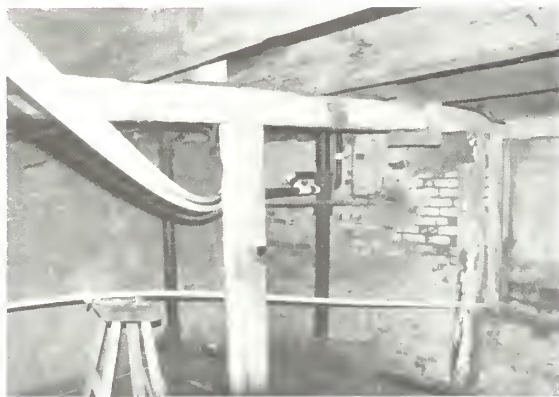
Figure 54 View southeast in Room 101, showing plumbing lines from bathroom 203. (NPS-SERO-CRS, 2001)

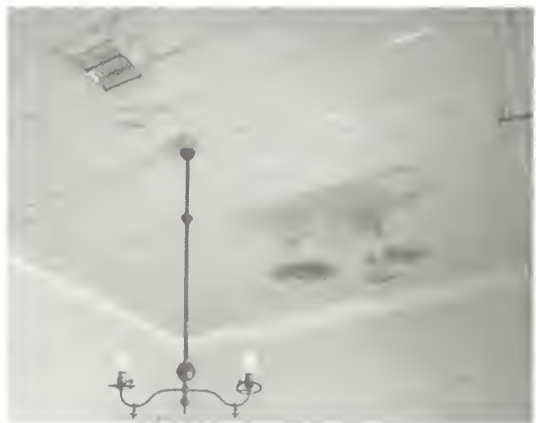
Figure 95 View of water-damaged ceiling in stranger's room. (NPS-SERO-CRS, 2001)

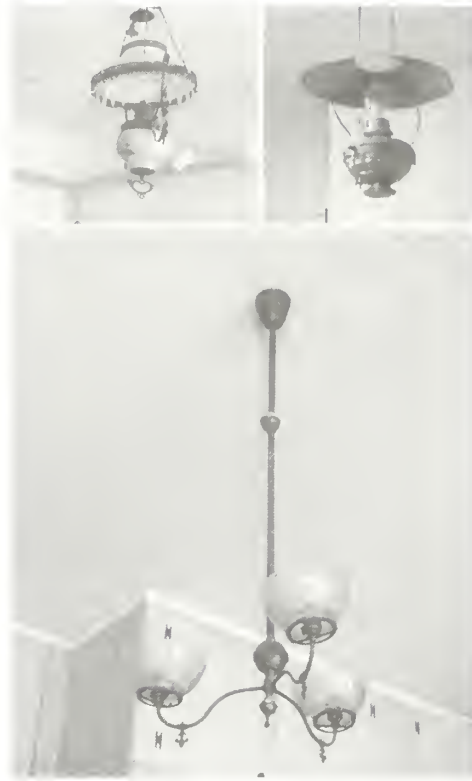
Figure 112 Top, view of nineteenth- century kerosene light fixtures and, below early twentieth- century gas light fixtures, all of which were converted to electricity in the late 1930s.

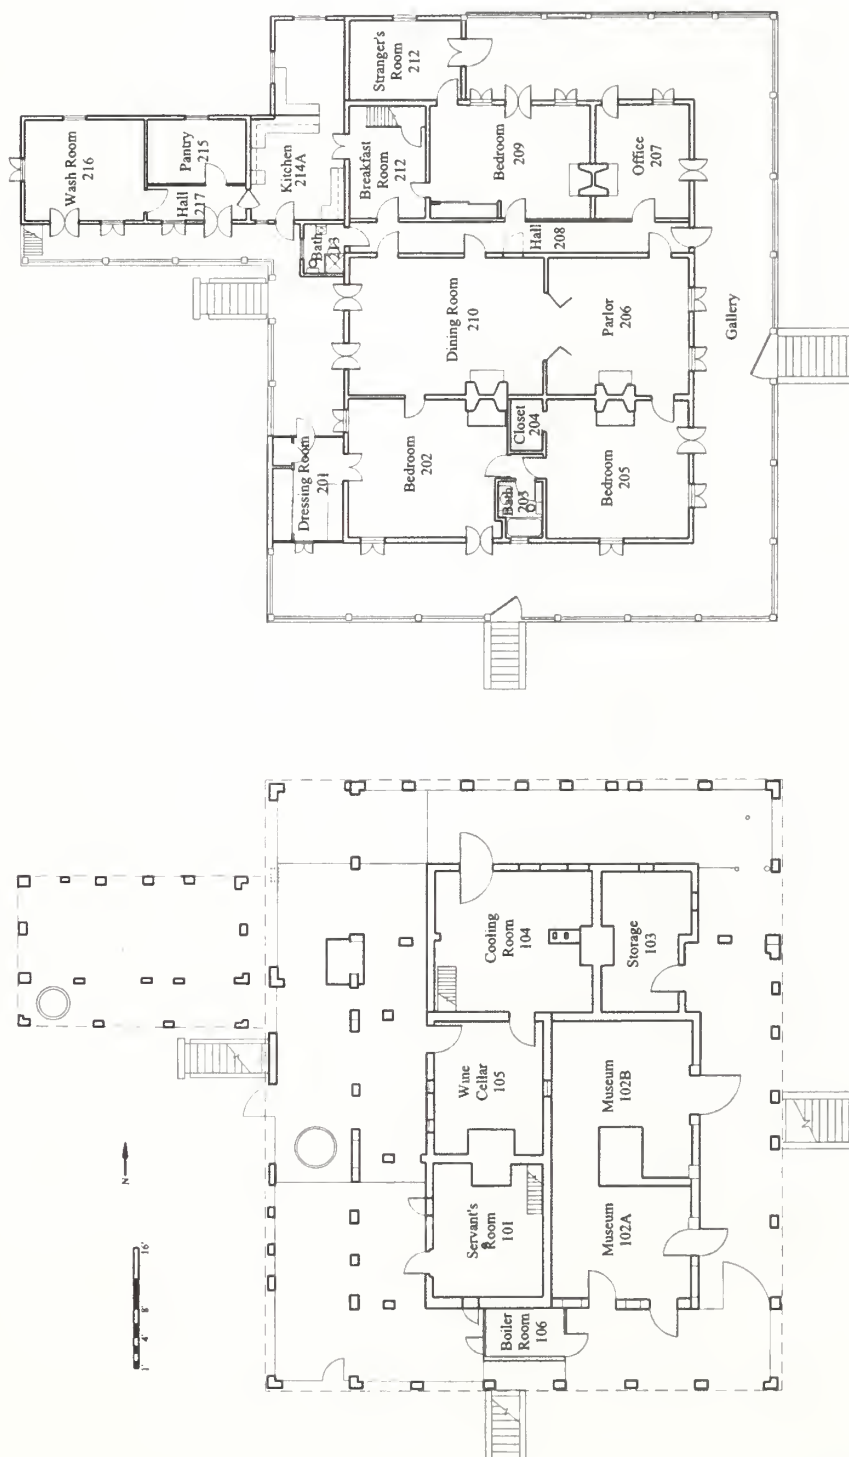
Figure 113 Plans of existing basement and main story of house.
(NPS-SERO-CRS, 2001)
