HWR No. 01-010

*An Evaluation of Hydrologic and Riparian
Resources in Saguaro National Park,
Tucson, Arizona*

Kathryn J. Baird
Robert Mac Nish
D. Phillip Guertin

Department of Hydrology and Water Resources, and
University of Arizona Research Laboratory for Riparian Studies
University of Arizona
Tucson, Arizona 85721

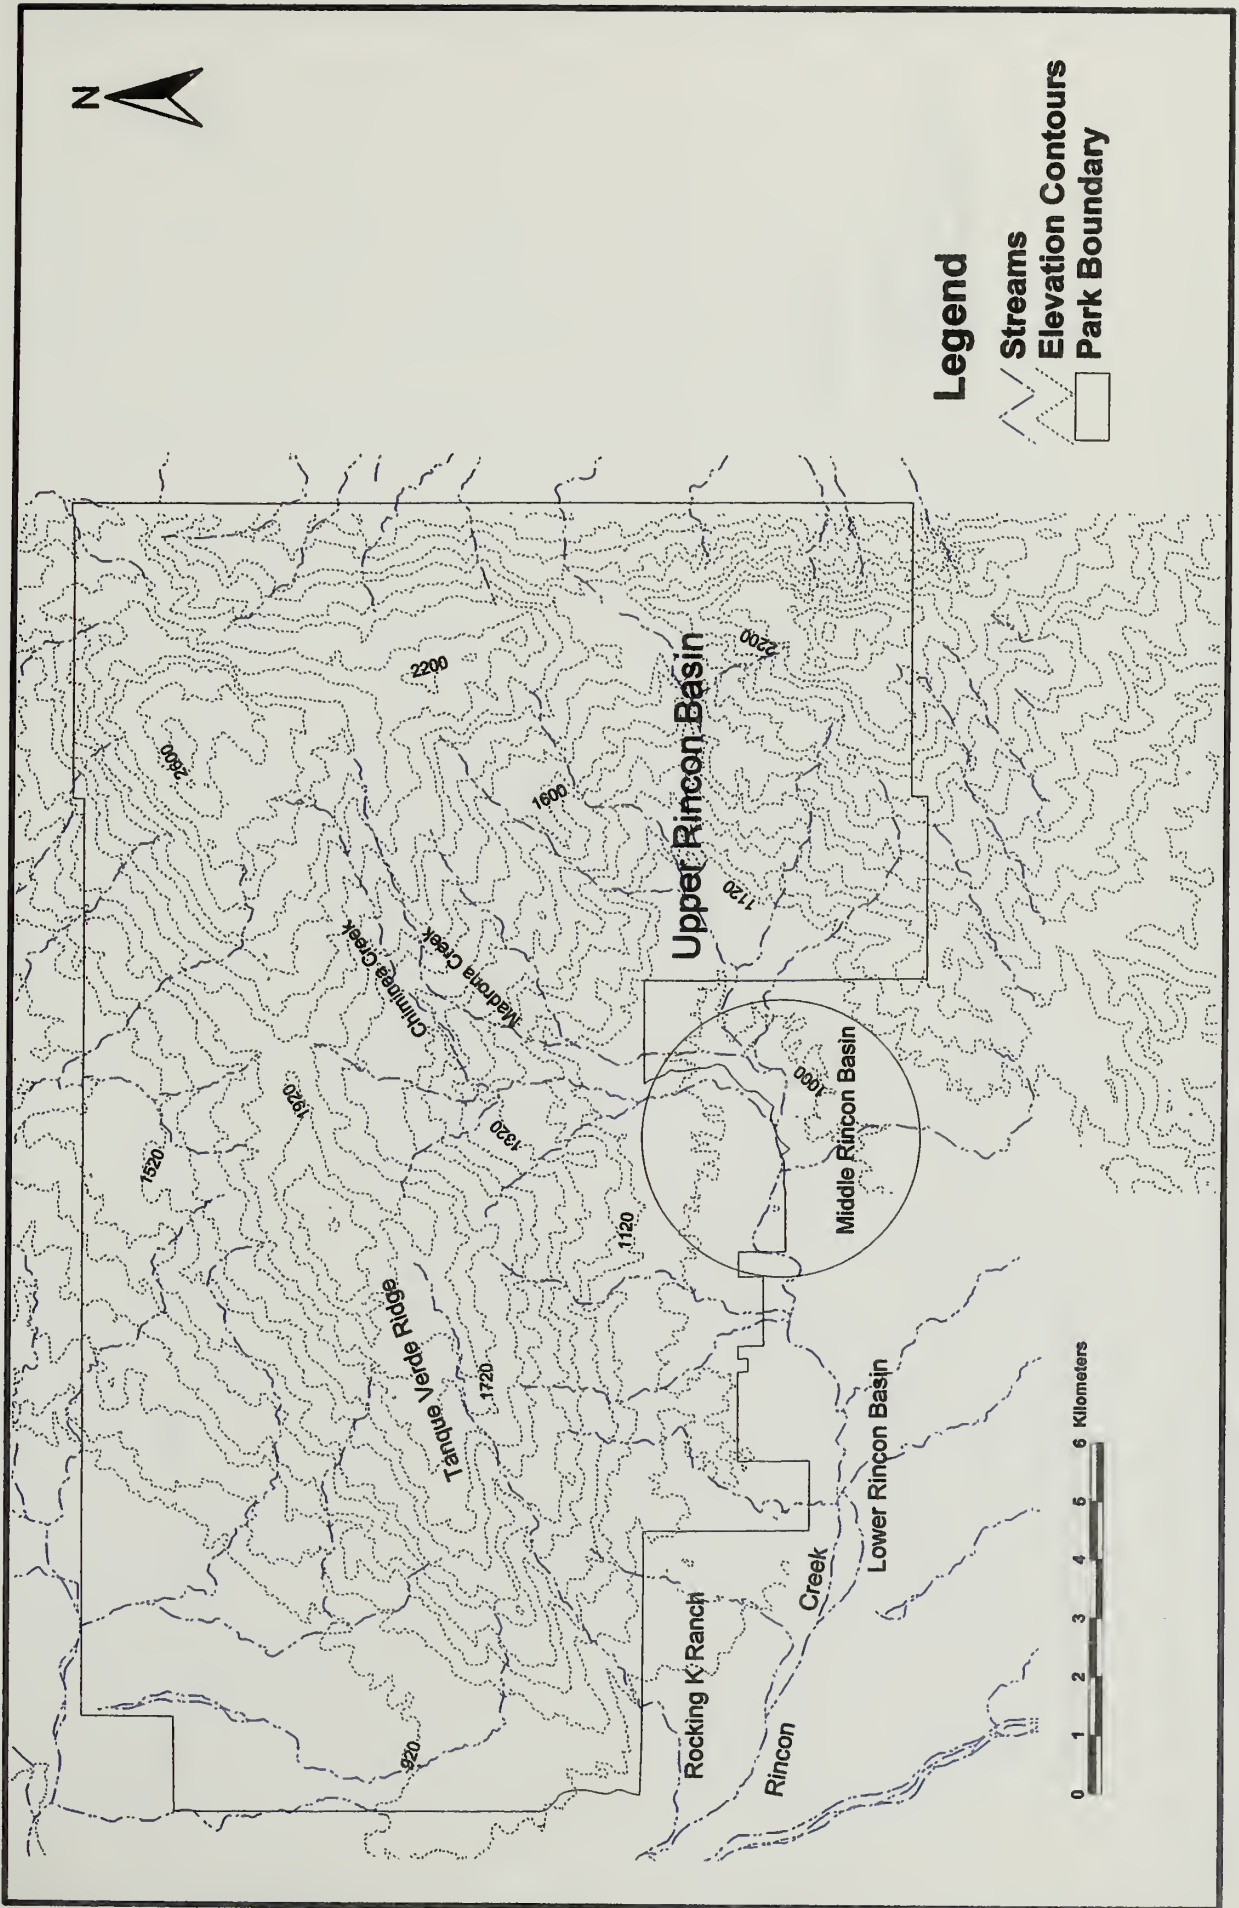
Figure 1. Saguaro National Park, East and associated portions of Rincon Creek.

Rincon Creek drains a large portion of the southwestern side of the Rincon Mountains and borders Saguaro National Park along its southern edge (Figure 1). It flows almost due west through the Rincon Valley to its confluence with Pantano Wash. Short reaches of Rincon, Madrona, and Chimenea Creeks flow from park land, across private land and enter the Park's expansion area (Briggs et al., 1996). Within the expansion area, Rincon Creek is intermittent or ephemeral. However, the high groundwater table in portions of the expansion area supports good quality riparian habitat along its banks.

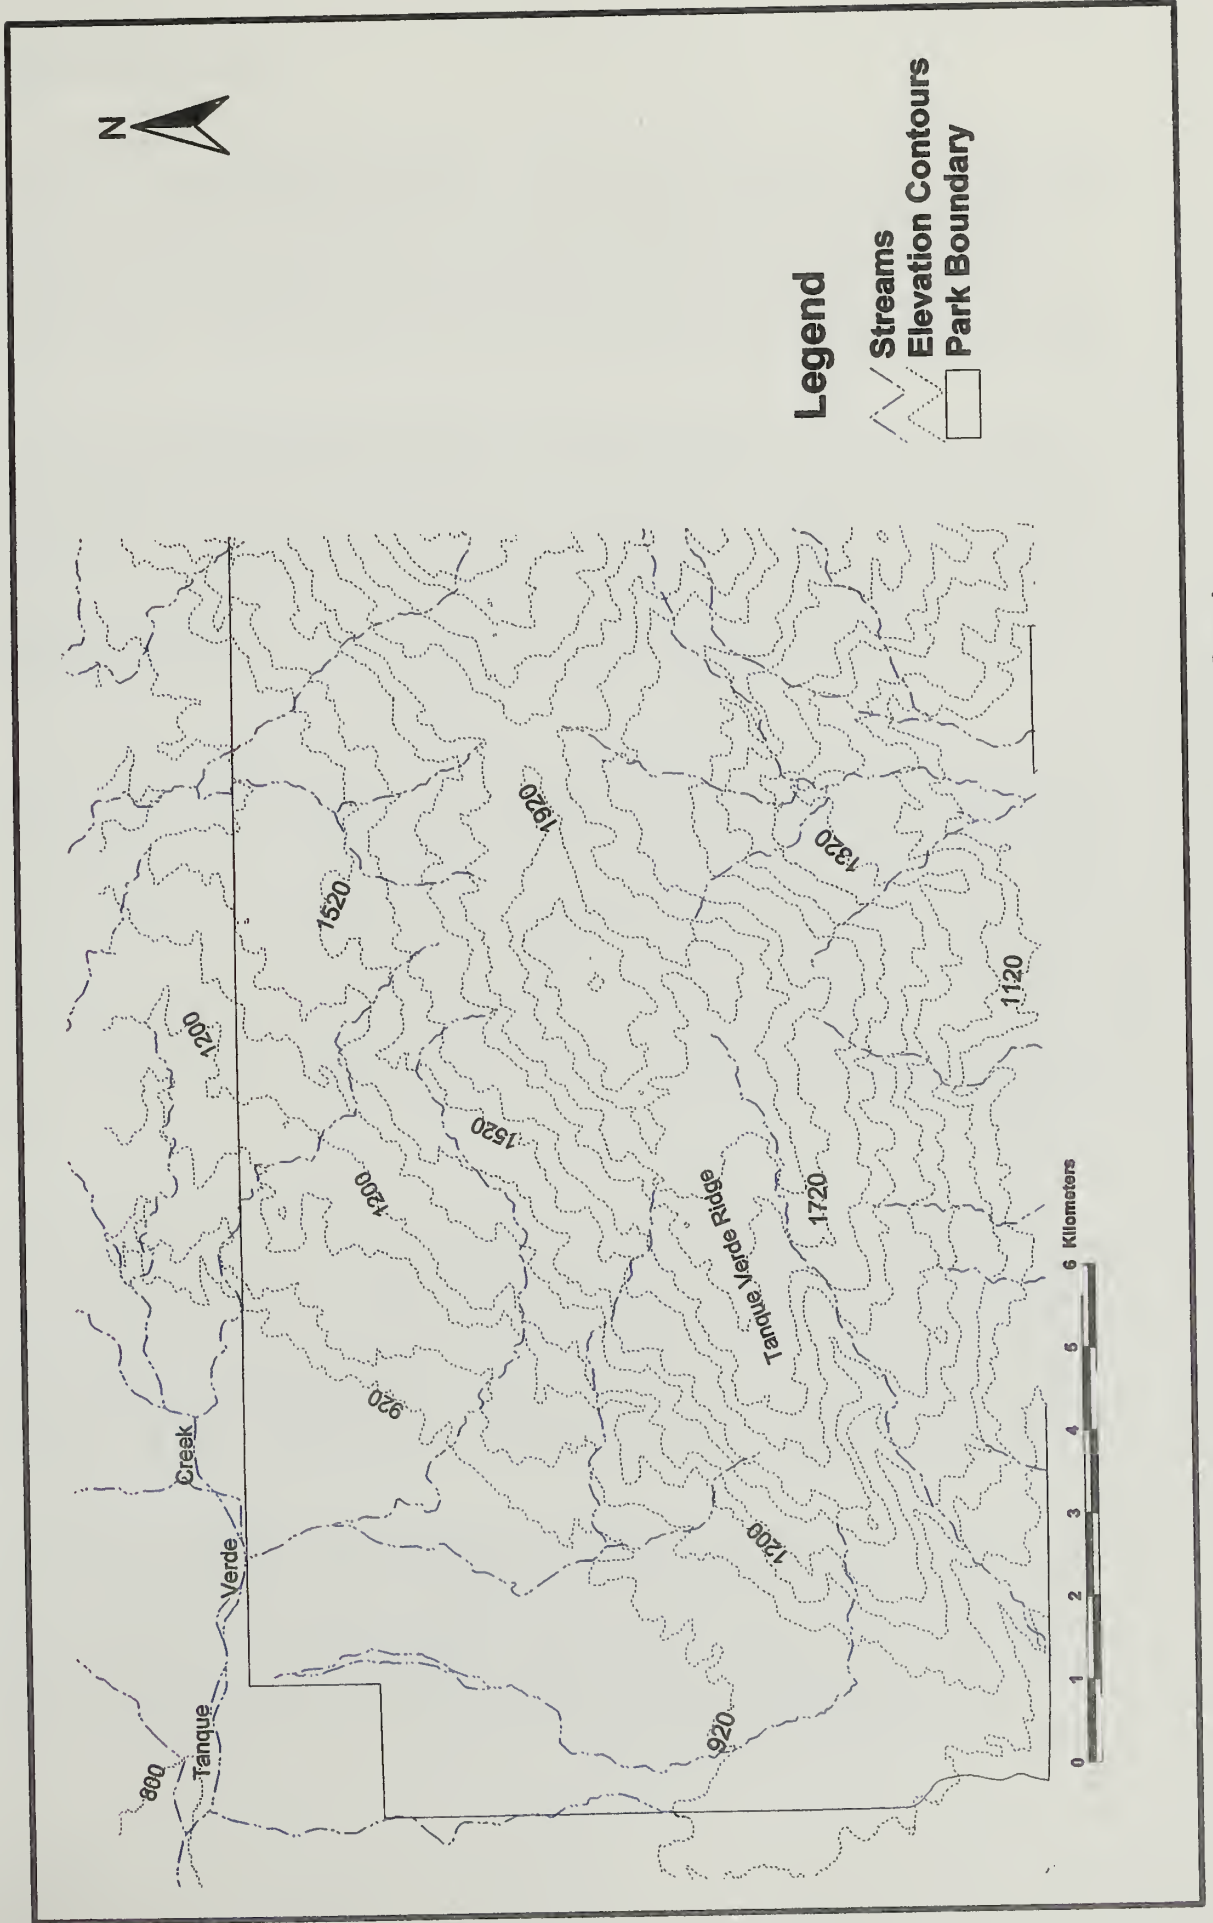
Figure 2. Saguaro National Park, East and associated portions of Tanque Verde Creek.

Tanque Verde Creek flows for 25 km from its headwaters in the Rincon Mountains to its confluence with Pantano Wash. The lower ten-kilometer stretch of Tanque Verde Creek is a relatively low gradient ephemeral creek. Remnant mesquite bosques line the wide sandy channel (Stromberg et al., 1992). With a mean elevation of 1,323 meters, Tanque Verde basin receives a mean annual precipitation of 424.2 mm. While Tanque Verde Creek proper lies outside of Saguaro National Park, numerous tributaries lie within the Park. Several of these tributaries support important riparian/mesquite bosque communities (Figure 2).

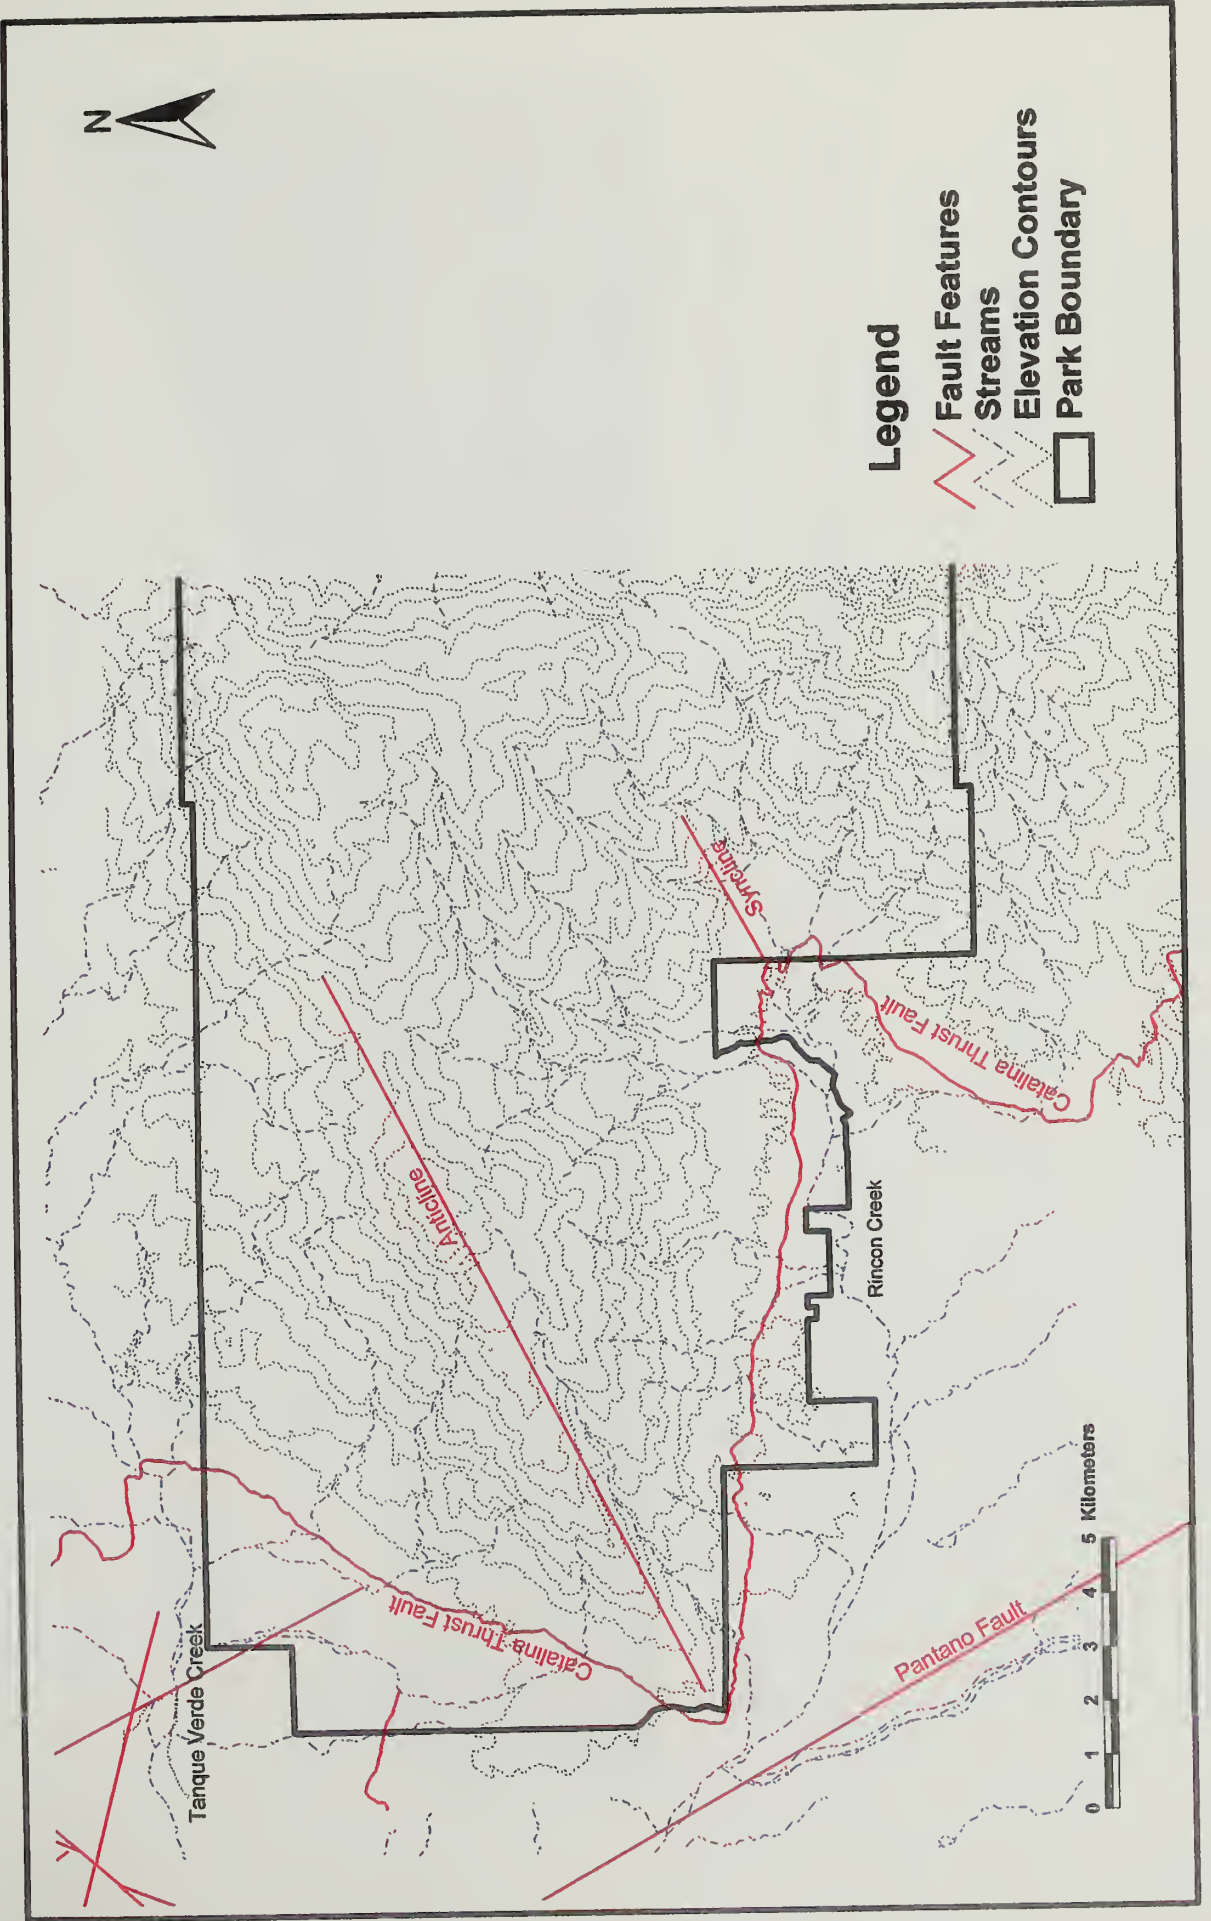
Figure 3. Major Faults in the vicinity of Rincón Creek.

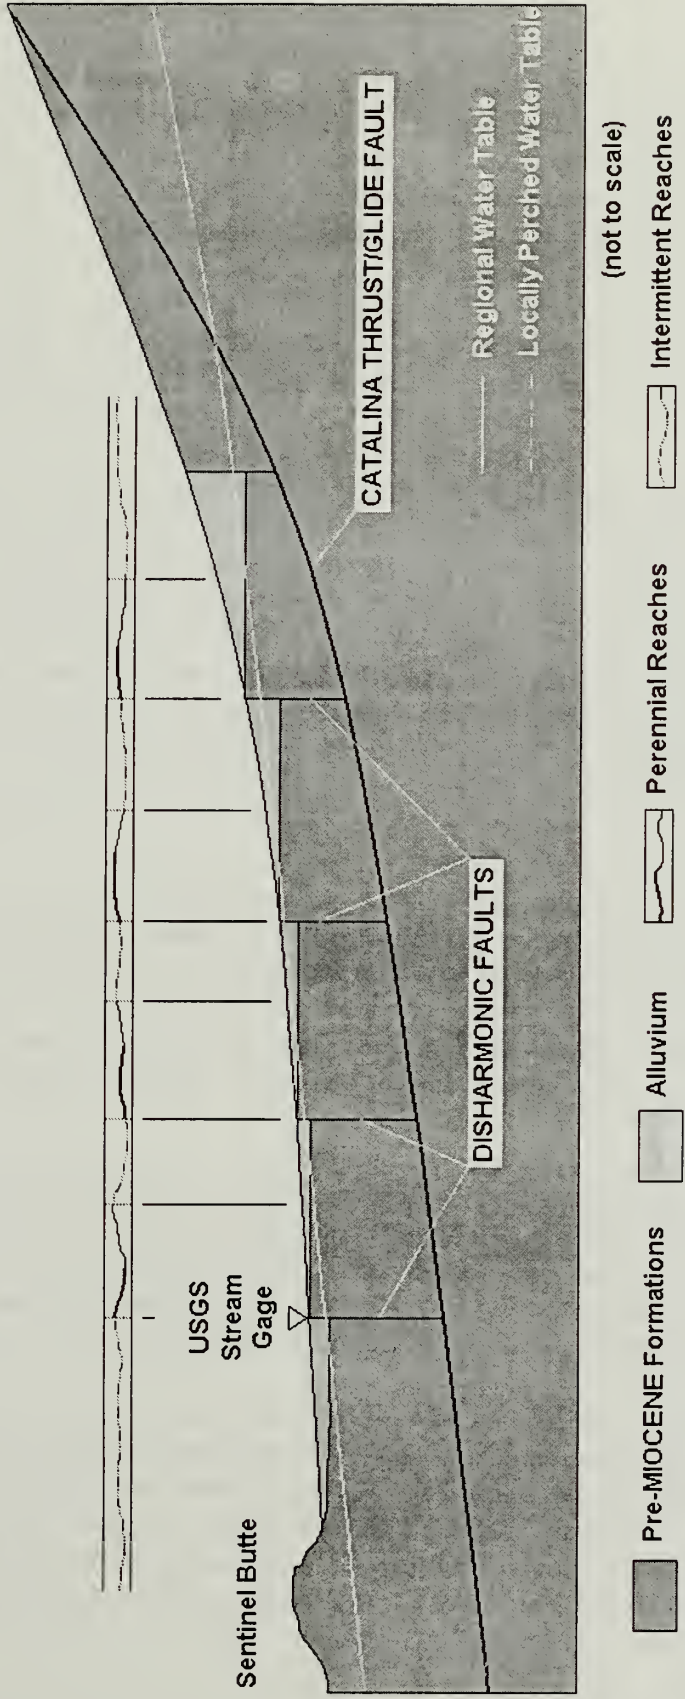
Figure 4. Schematic Cross-section along the axis of the Rincon Valley syncline from Sentinel Butte to the outcrop of the Catalina Fault.

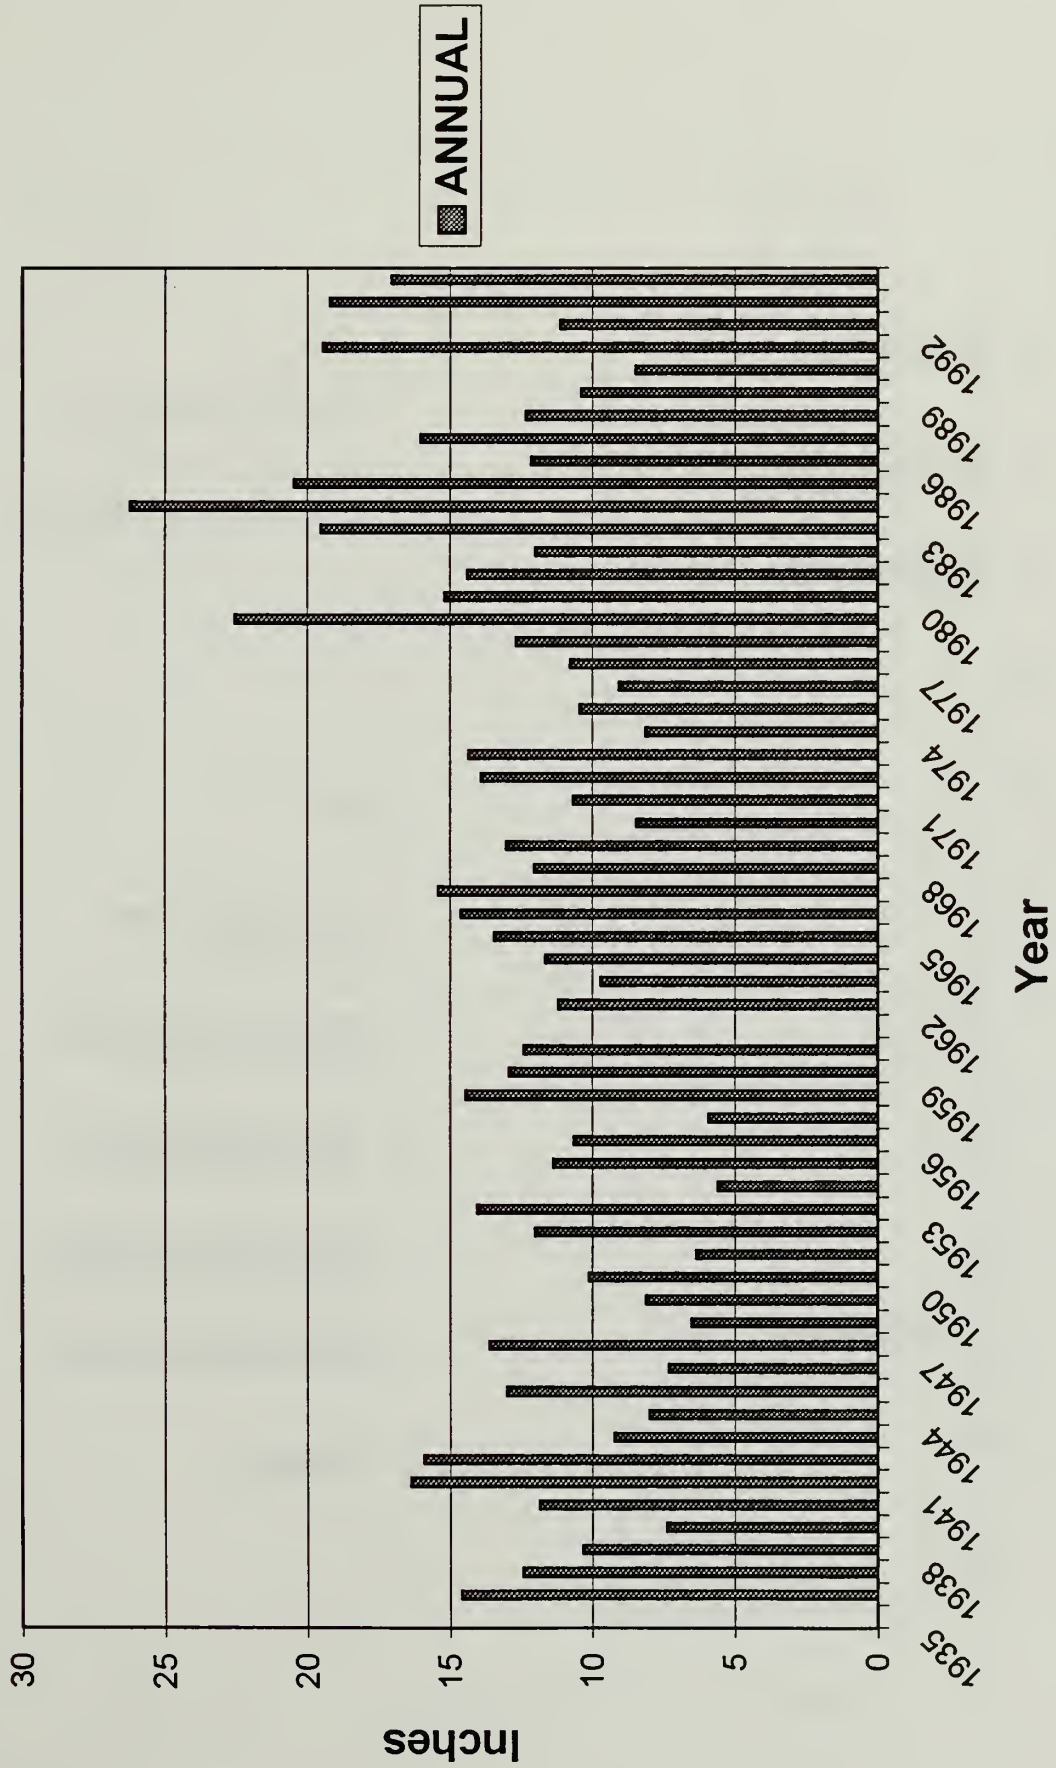
Figure 5. Total annual precipitation in inches, Tucson Magnetic Observatory (1935-1993)

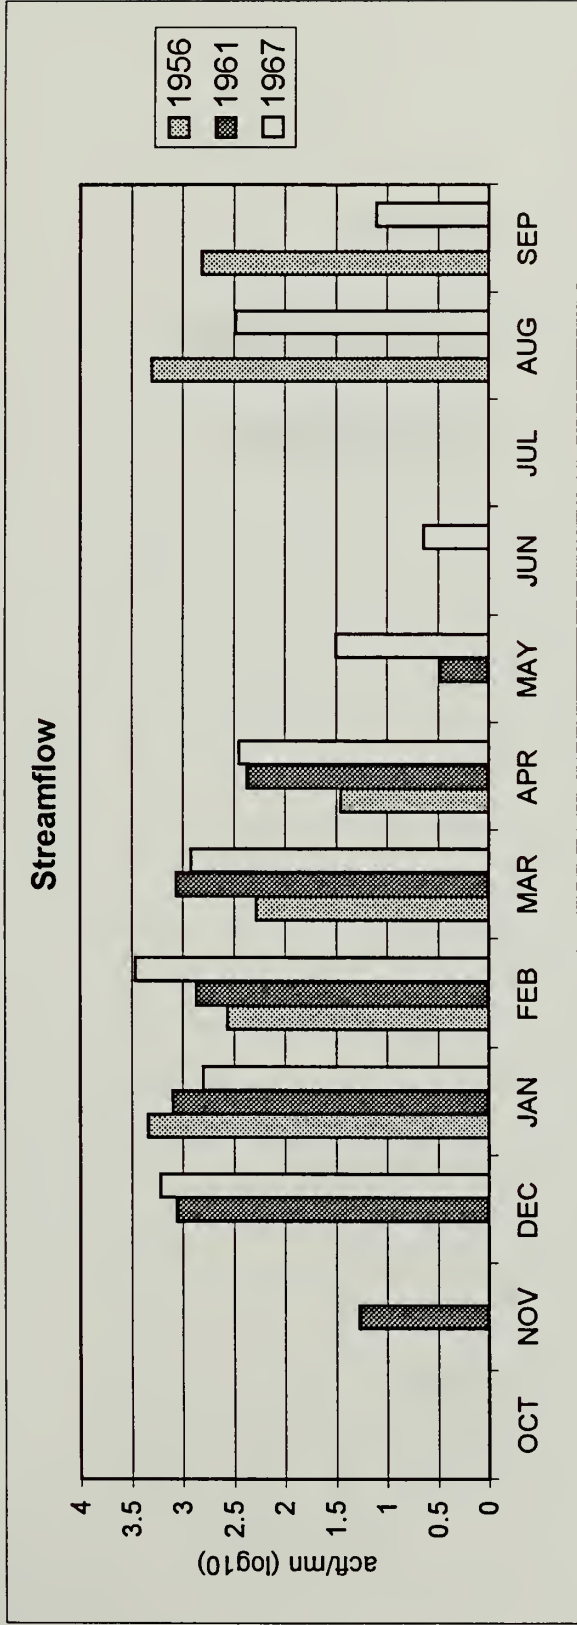
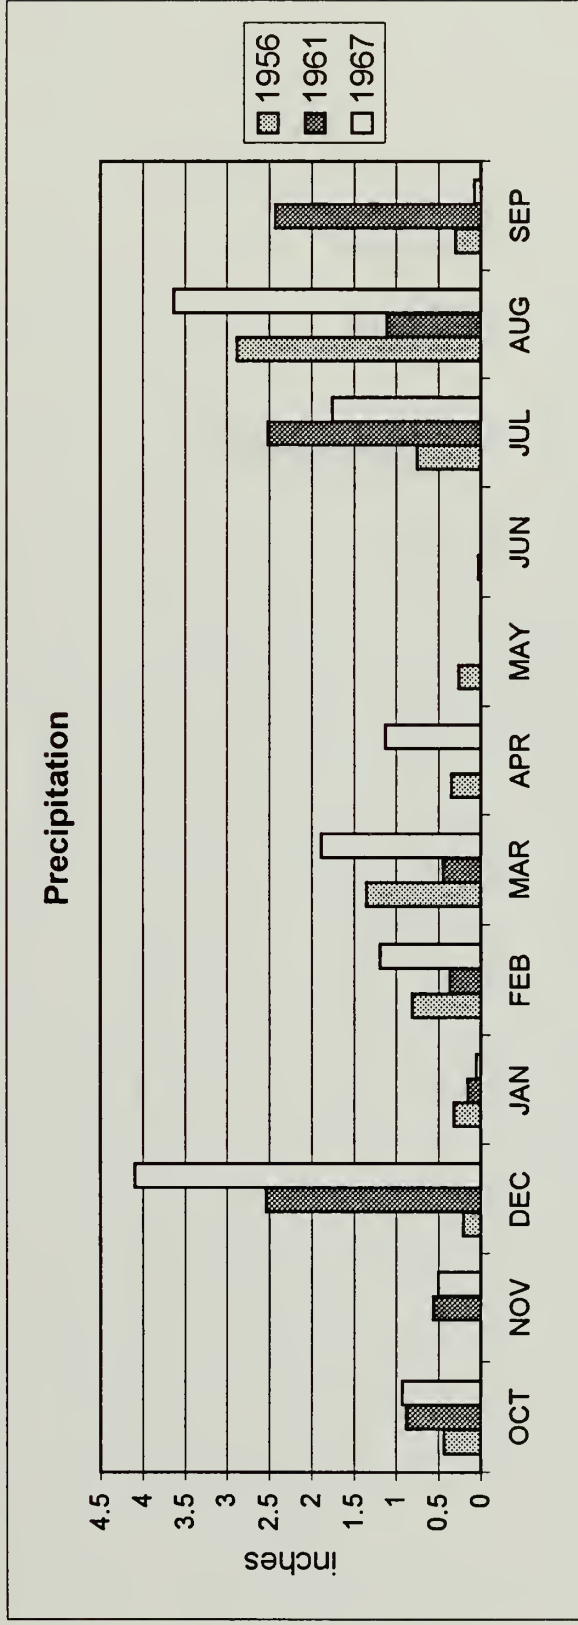
Figure 6. Total monthly precipitation at TMO (top) and total monthly streamflows (acre feet month) Rincon Creek. Data from three relatively wet years.

To get a rough idea of how Rincon Creek responds to precipitation events, monthly precipitation measured at the observatory was graphed against monthly stream flow on Rincon Creek. Several assumptions are inherent in this comparison. The first is that rainfall at TMO reflects conditions on the Rincon Creek watershed. In the winter with the large, slower moving frontal storms common to the Tucson area this isn't a bad assumption. However, summer precipitation falls as a result of very localized convective thunderstorms and conditions can vary greatly from one location to the next. Figure 6 shows three relatively wet years while Figure 7 reflects three drier years. None of these years represent extreme years. In both cases, there is a general pattern of increasing stream flow in response to increased precipitation. Note that on both figures streamflow is calculated on a log-scale that accentuates low flows.

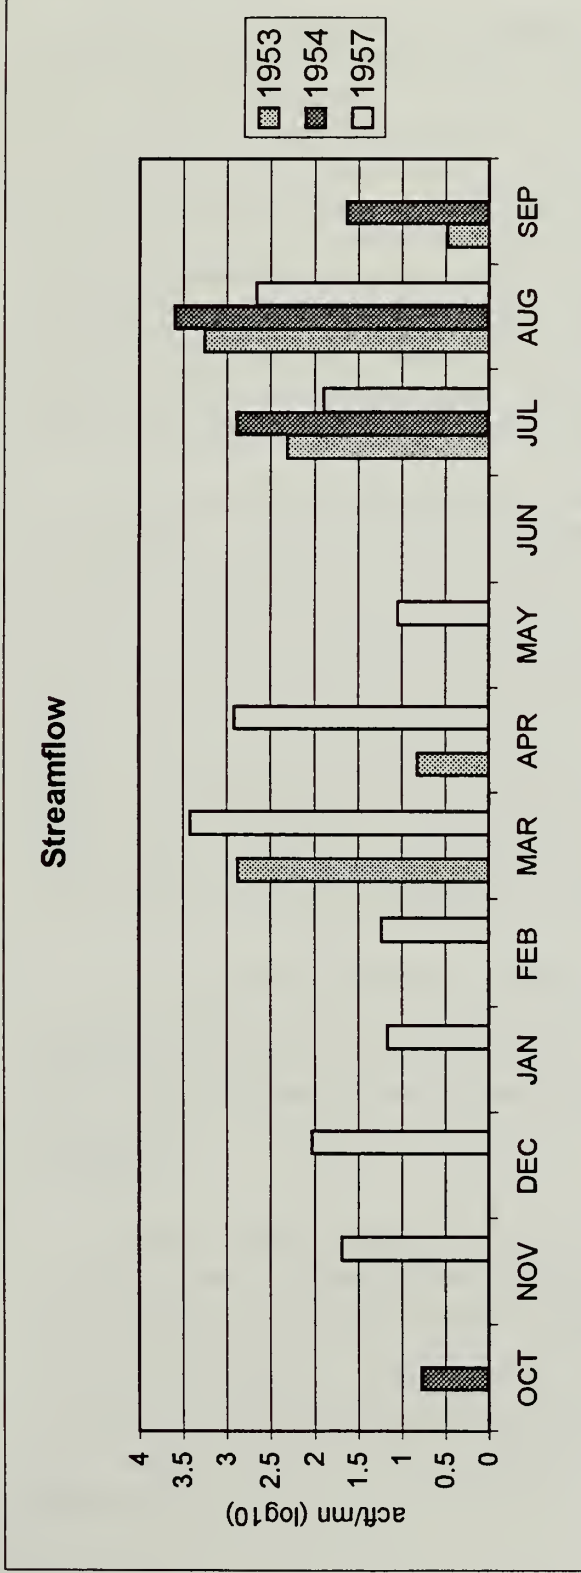
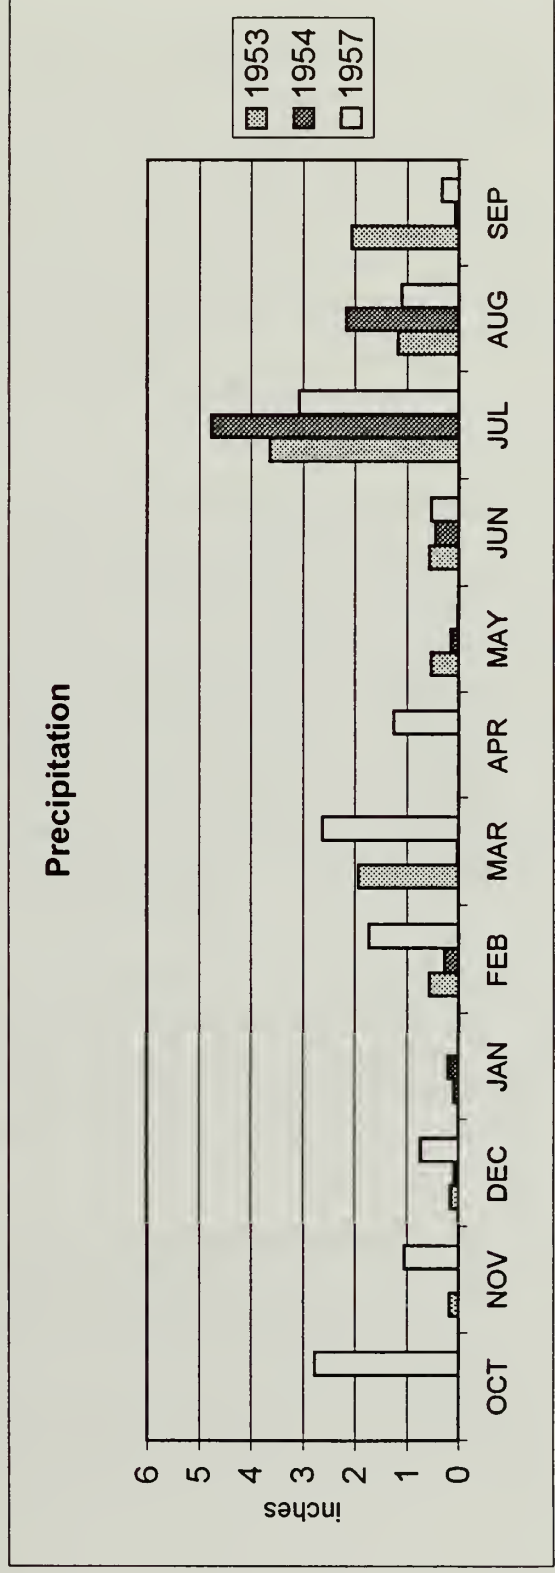
Figure 7. Total monthly precipitation at TMO (top) and total monthly streamflows (acre feet month) Rincon Creek. Data from three relatively dry years.

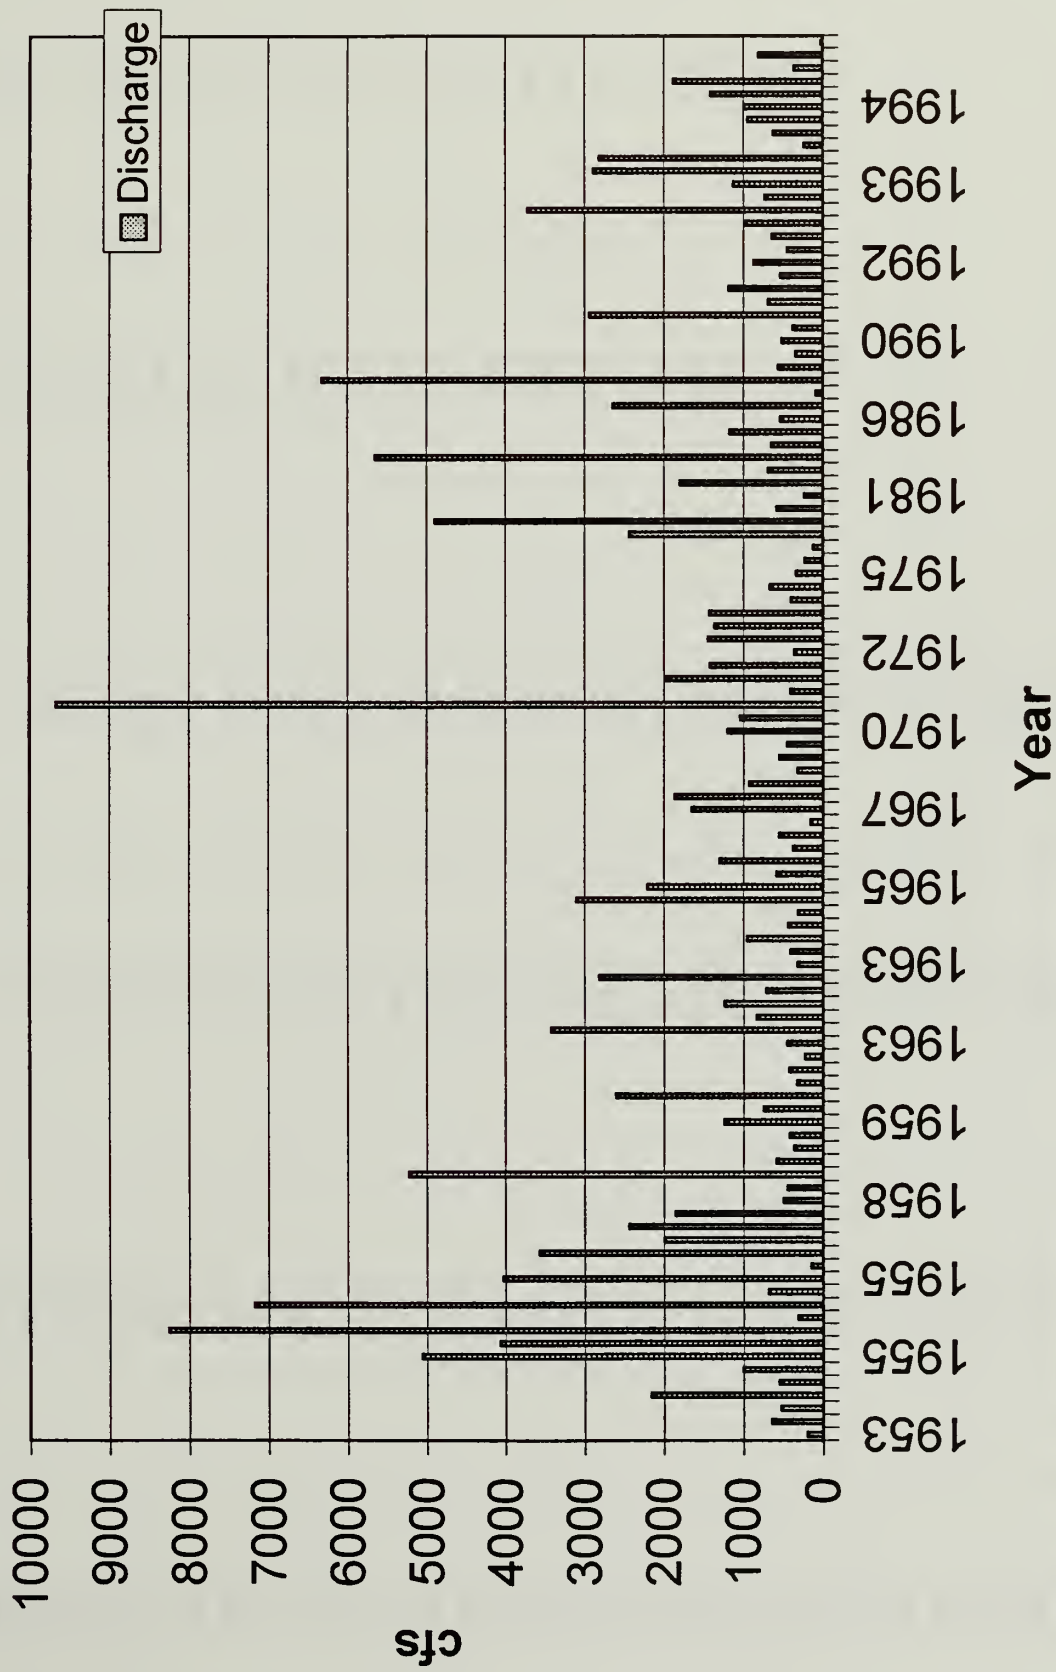
Figure 8. Historic peak streamflows (cubic ft./sec), Rincon Creek.

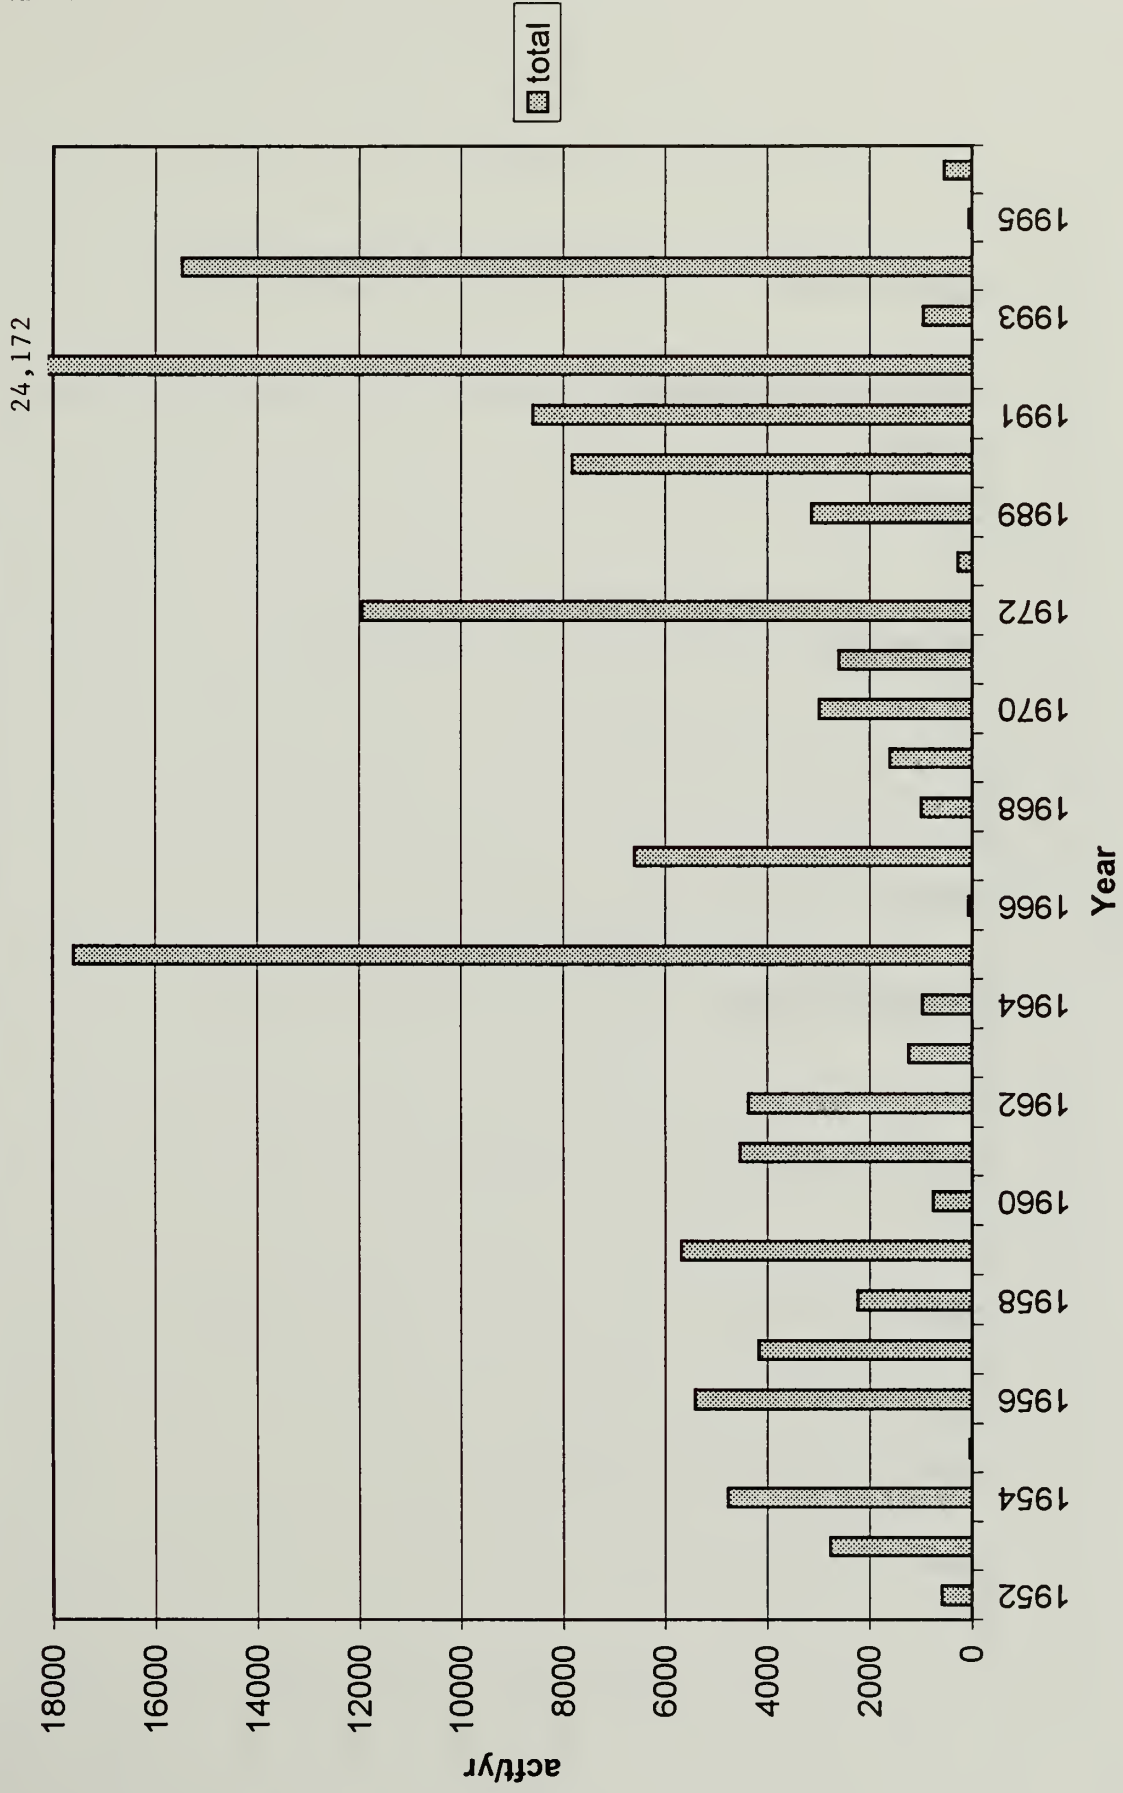
Figure 9. Total annual streamflow (acre-feet/year) for years 1952-1973 and 1989-1996, Rincon Creek.

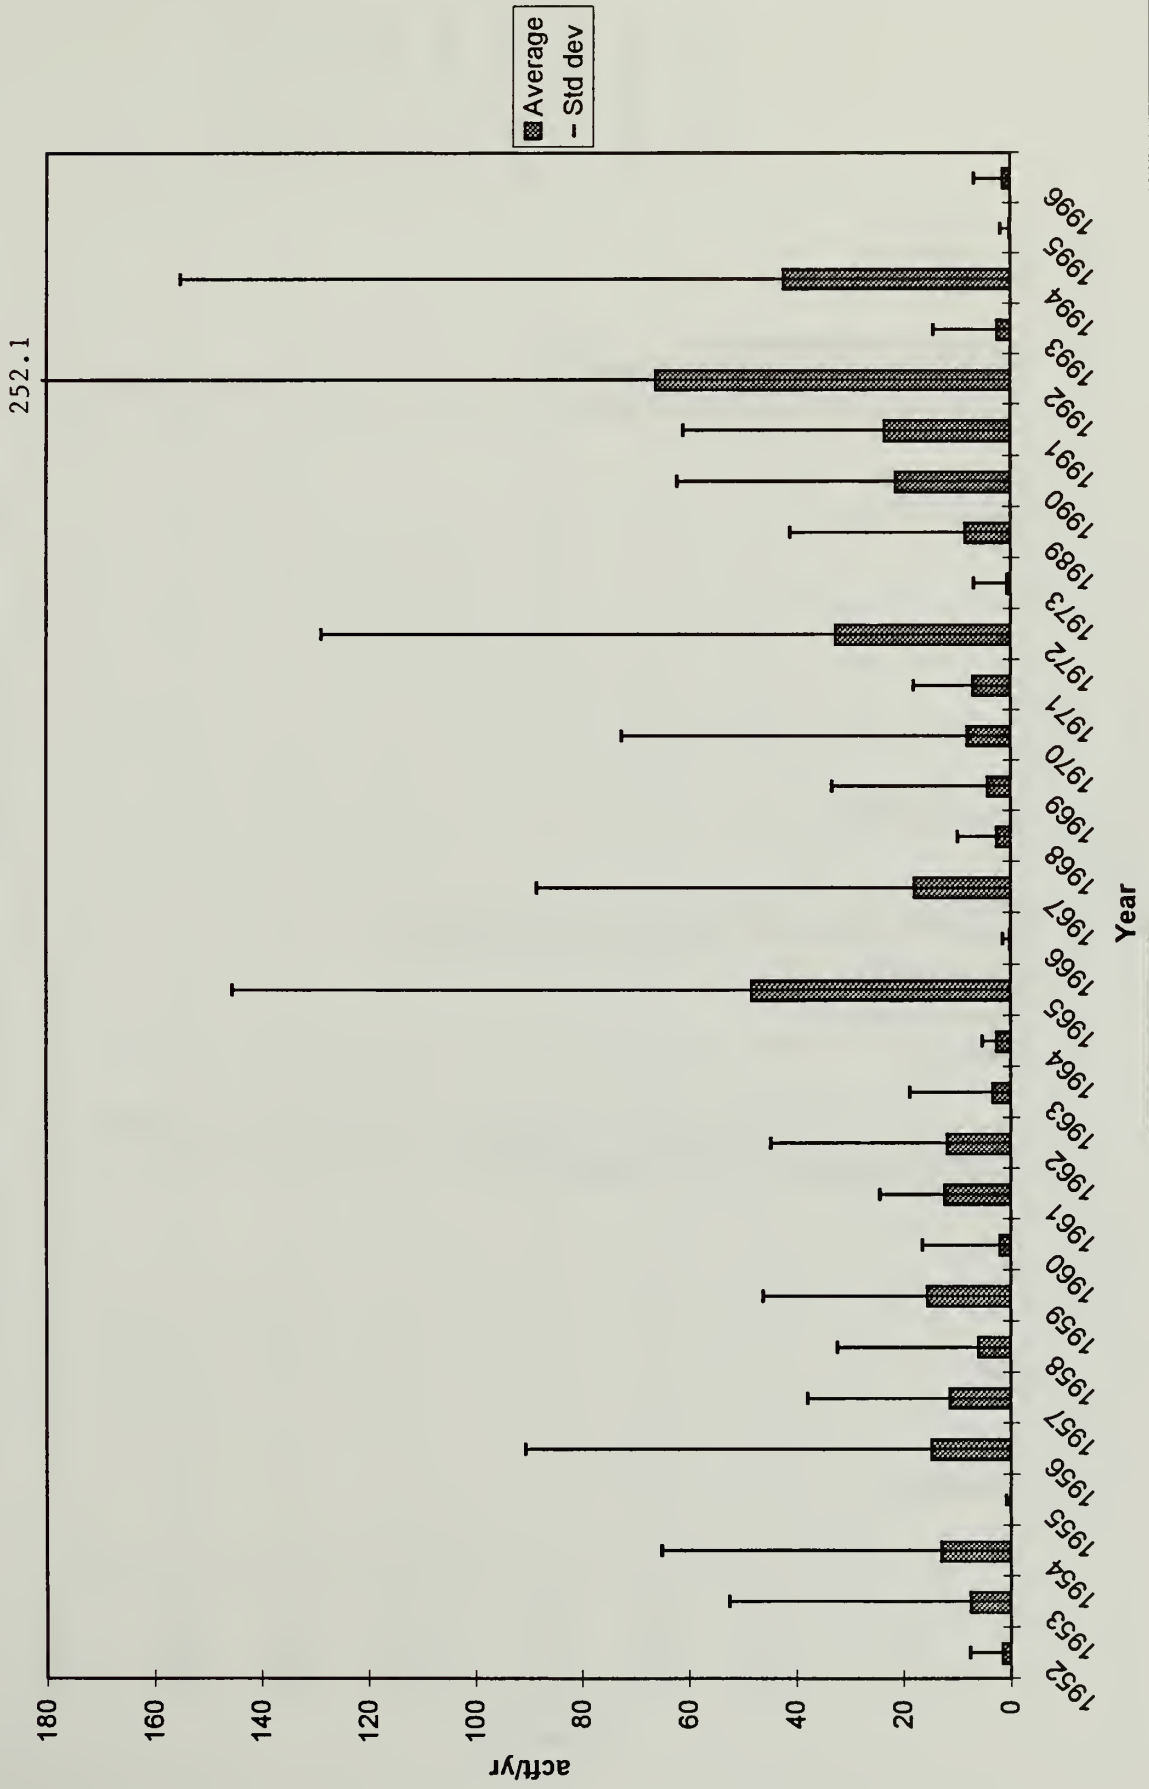
Figure 10. Average annual streamflow plus one standard deviation (acre ft/year), Rincon Creek.

Due to the skewed distribution of flows and the high number of no-flow days, it is often more telling to look at the standard deviation around the mean flow. Figure 10 graphically illustrates the wide fluctuations calculated for each mean. The fact that Rincon Creek has years where the calculated average daily flow equaled or exceeded the total annual flow of other years speaks to the extreme variability in hydrologic conditions.

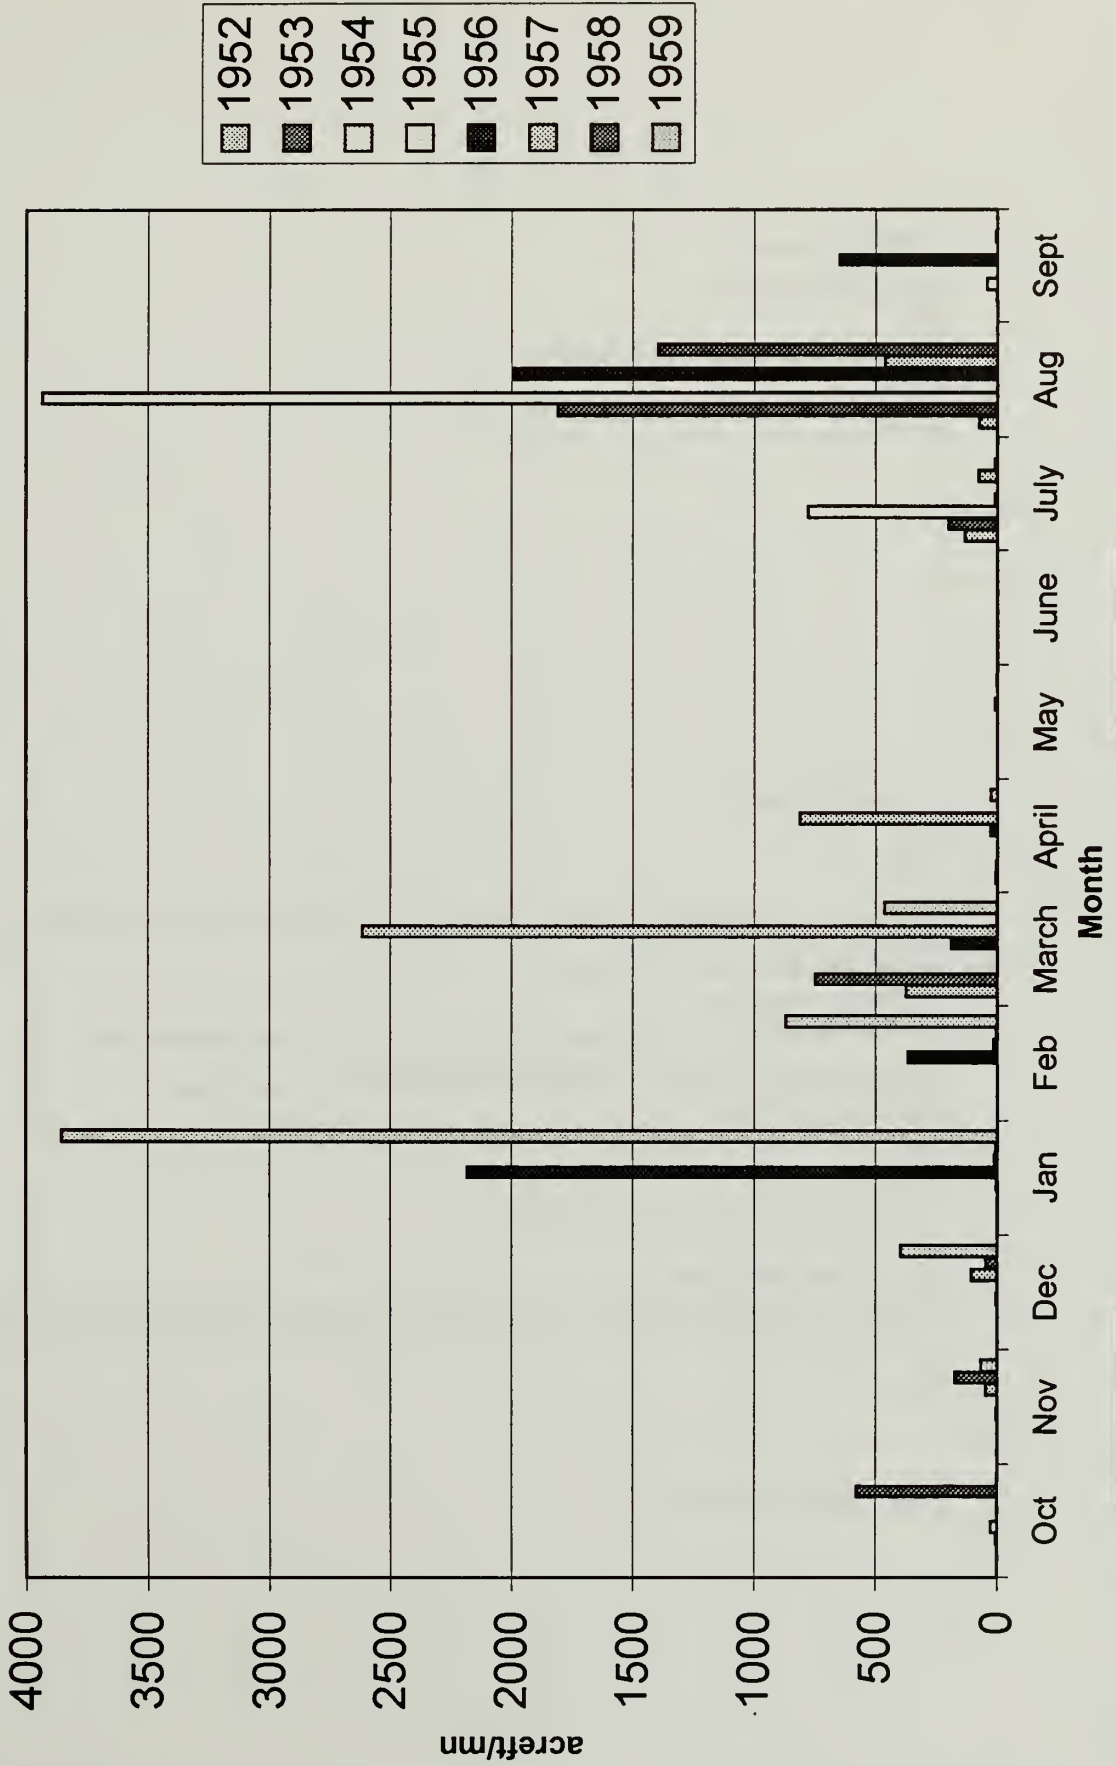
Figure 11. Total monthly streamflow (acre ft/mn) calculated from average daily cfs, Rincon Creek (1950s).
