HWR No. 01-010

*An Evaluation of Hydrologic and Riparian
Resources in Saguaro National Park,
Tucson, Arizona*

Kathryn J. Baird
Robert Mac Nish
D. Phillip Guertin

Department of Hydrology and Water Resources, and
University of Arizona Research Laboratory for Riparian Studies
University of Arizona
Tucson, Arizona 85721

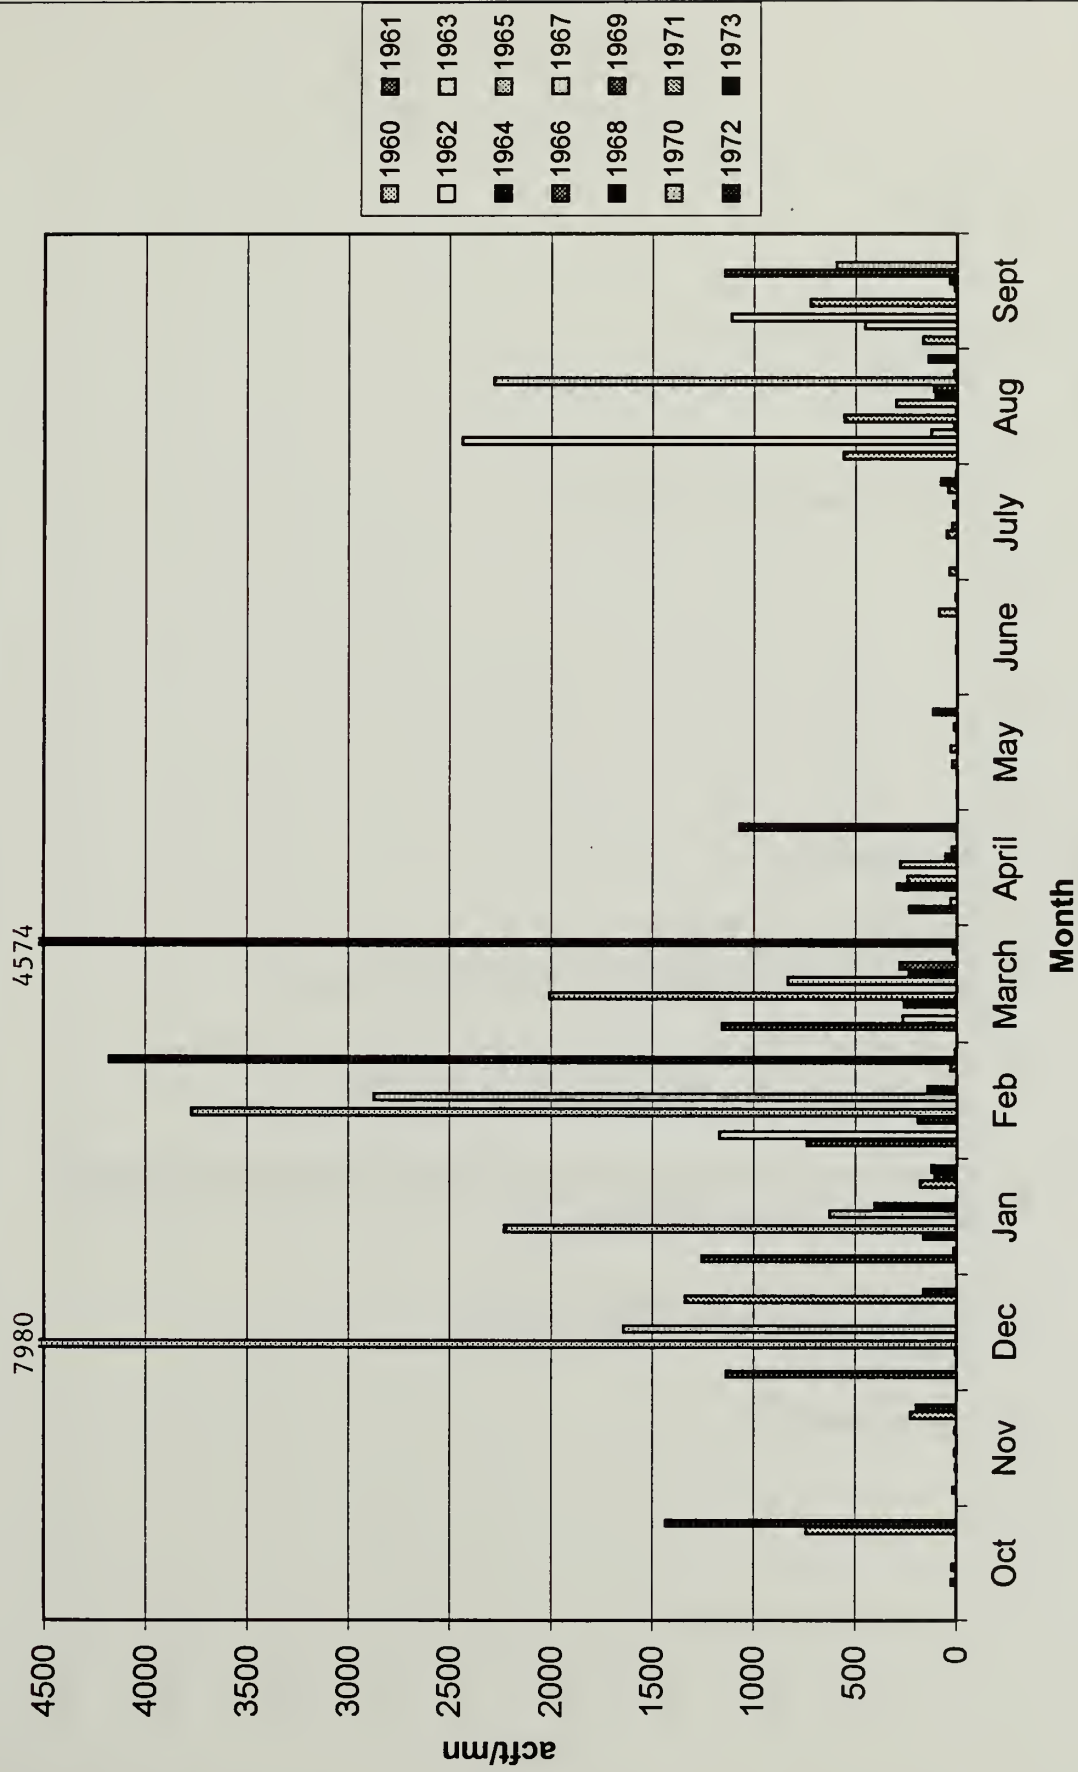
Figure 12. Total monthly streamflow (acft/mn) calculated from average daily cfs, Rincon Creek (1960-1973).

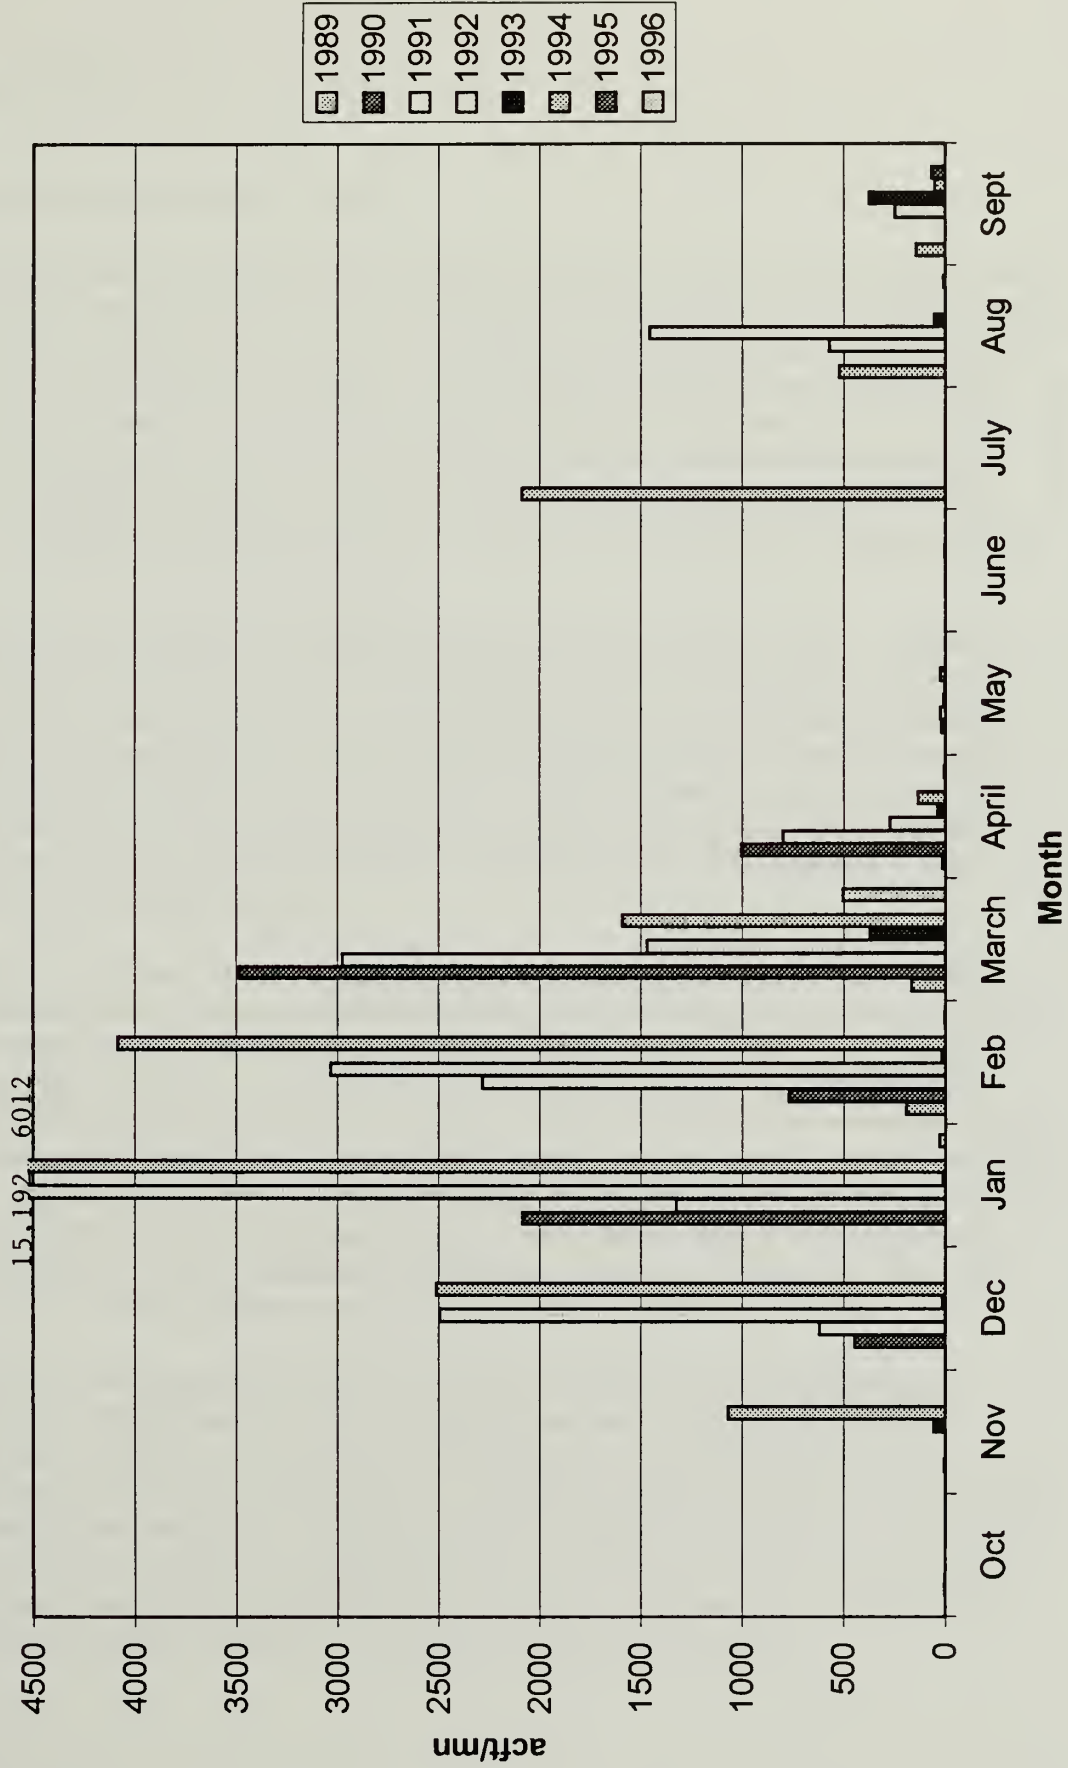
Figure 13. Total monthly streamflow (acre feet/month) calculated from average daily cfs, Rincon Creek (1989-1996).

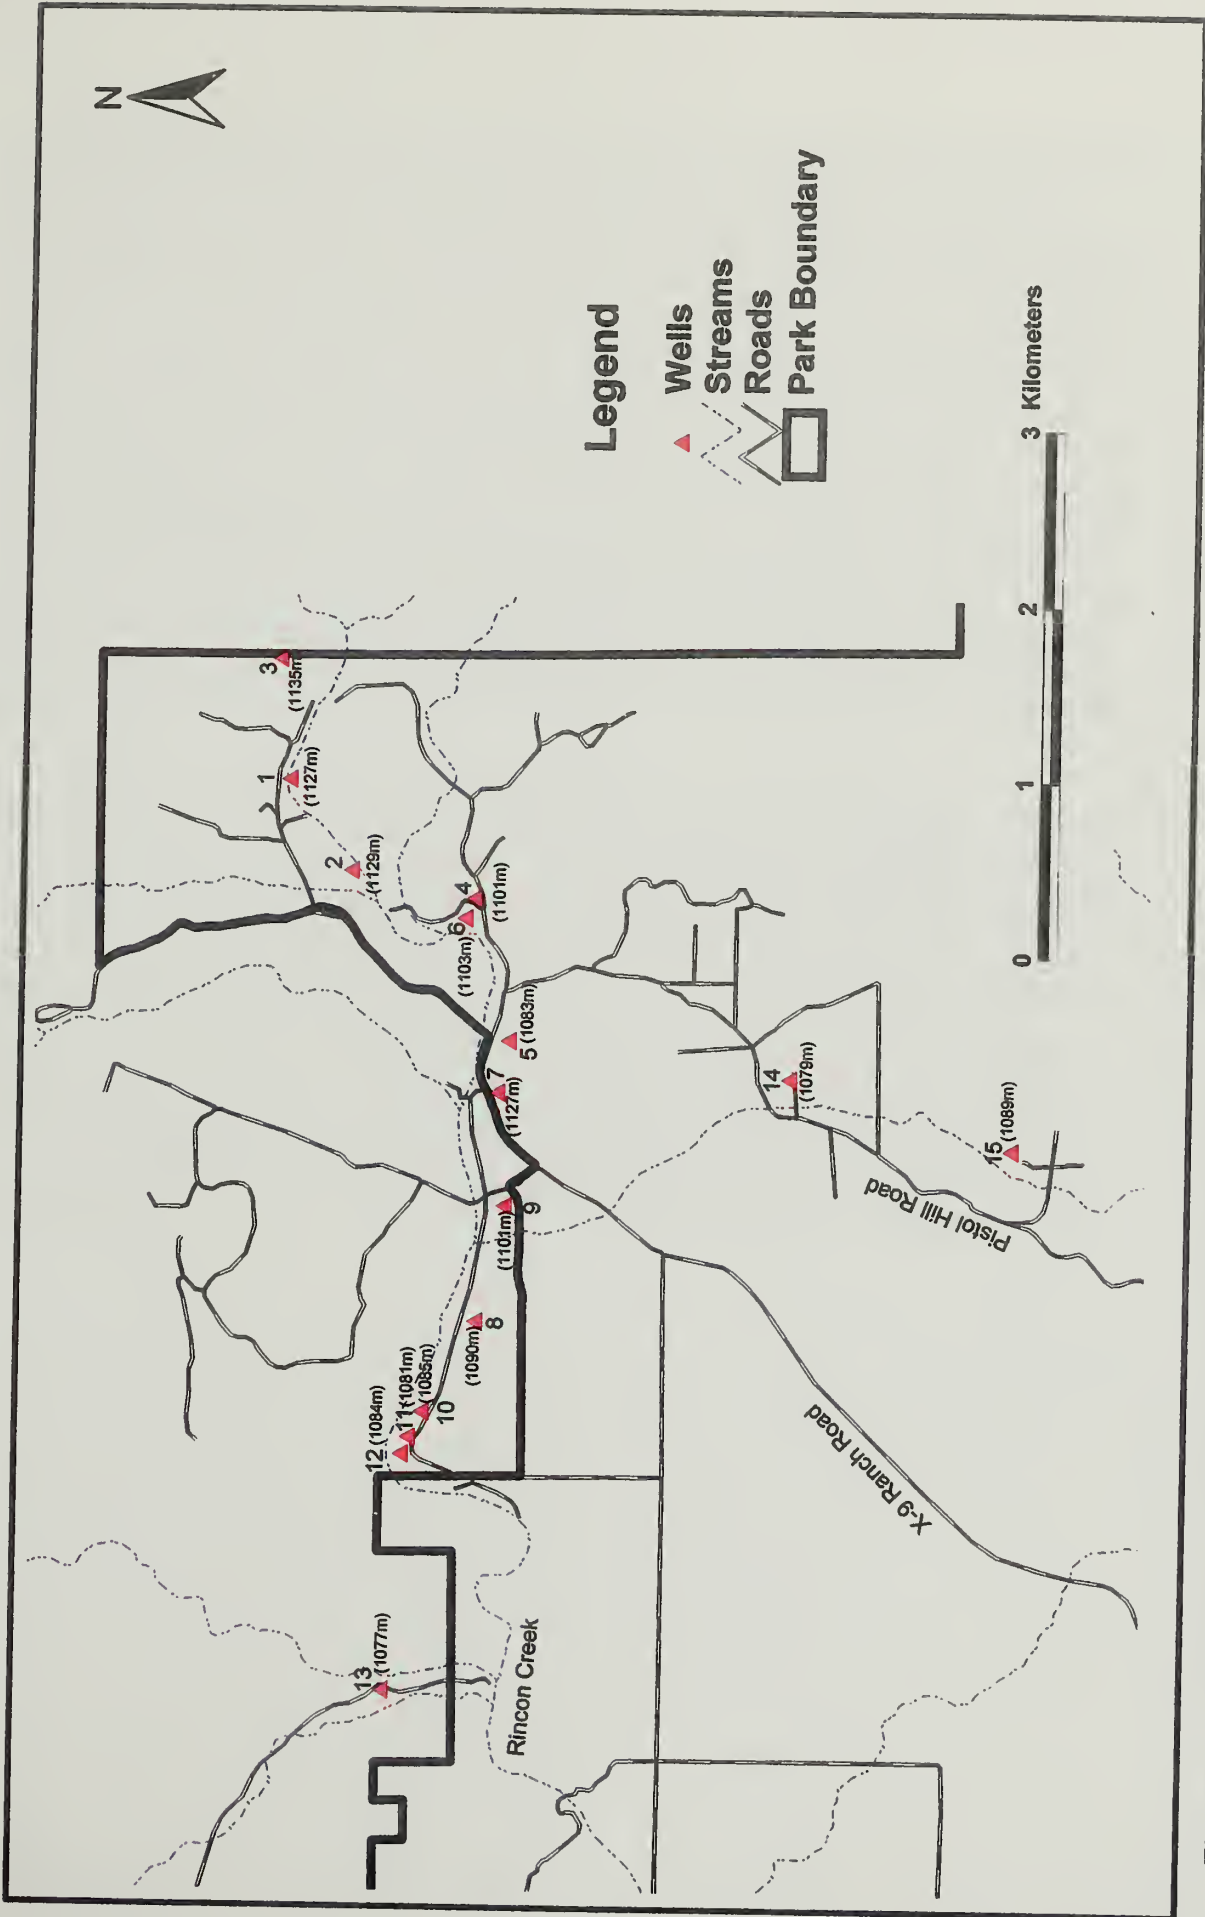
Figure 14. Existing well locations with reported water table elevations (meters above NGD).

Well data was collected for the entire Saguaro National Park area including the following six USGS township (T) and range (R) parcels: T14SR16E, T14SR17E, T14SR18E, T15SR16E, T15SR17E, and T15SR18E. This information has been forwarded to the Parks. Table 3 lists the wells that lie within or adjacent to the expansion area, the northern section of T15SR17E, and the primary focus of this study. If only one measurement date is given it coincides with the well drilling process. In only five cases were repeat water level measurements taken. Figure 14 illustrates water table elevation and the approximate location of the wells with sufficient location data.

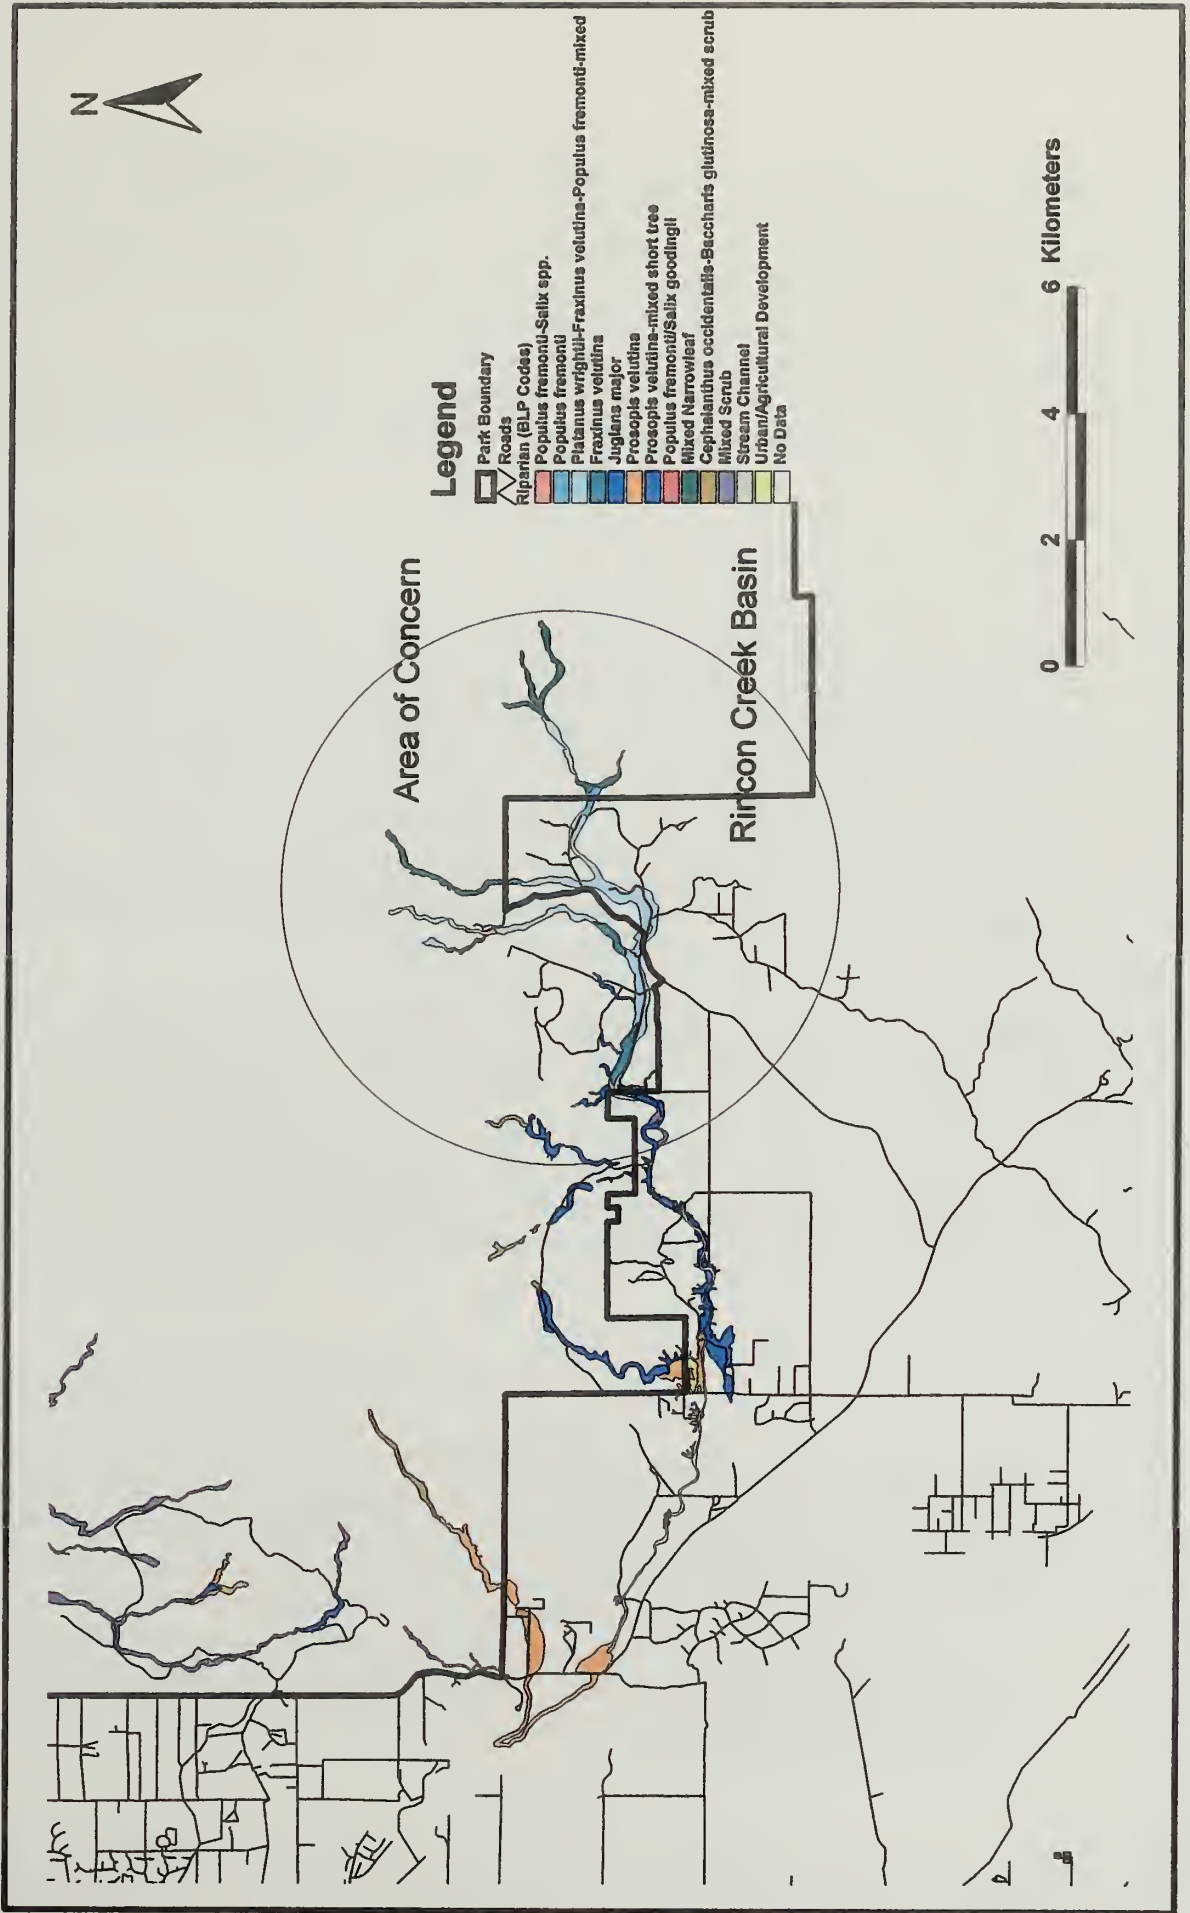
Figure 15. Riparian areas: Rincon Creek and tributaries.

Chimenea, Madrona and upper Rincon Creeks all support valuable habitats (Figure 15). At the higher elevations, 1000-1220 meters, mixed narrow leaf community dominates. This habitat type is characterized by *Prosopis velutina*, *Acacia greggii*, *Parkinsonia* spp., *Chilopsis linearis*, *Celtis* spp., *Baccharis salicifolia*, and *Cephalanthus occidentalis*. Based on previous mapping efforts *Gossypium thurberi*, *Jatropha cardiophylla*, *Muhlenbergia* spp., *Celtis pallida*, and *Lysiloma microphylla* also contribute to this vegetation type. Considered a xeroriparian community, this habitat type is an important resource to the Park. Below 1000 meters, these reaches are dominated by a more typical riparian community of *Platanus wrightii*, *Fraxinus velutina* and *Populus fremontii* with pockets of just *Fraxinus velutina* interspersed.

The riparian dataset is an Arc/Info polygon coverage representing the riparian habitats found below 1219 m (4000 ft) of elevation in Saguaro National Park East. Eighty-four separate riparian vegetation patches (polygons) were identified and mapped using the DOQQs and videography. The map projection is North American Datum (NAD) 1927 with a Universal Transverse Mercator (UTM) coordinate system. Table 3 is a summary of the Brown, Lowe and Pace classes, the number of polygons coded with that class type, and the amount of area associated with each class. Portions of the Arc/Info coverages for the Tanque Verde Creek tributaries and Rincon Creek tributaries are shown in Figures 16 and 15 (main report), respectively.

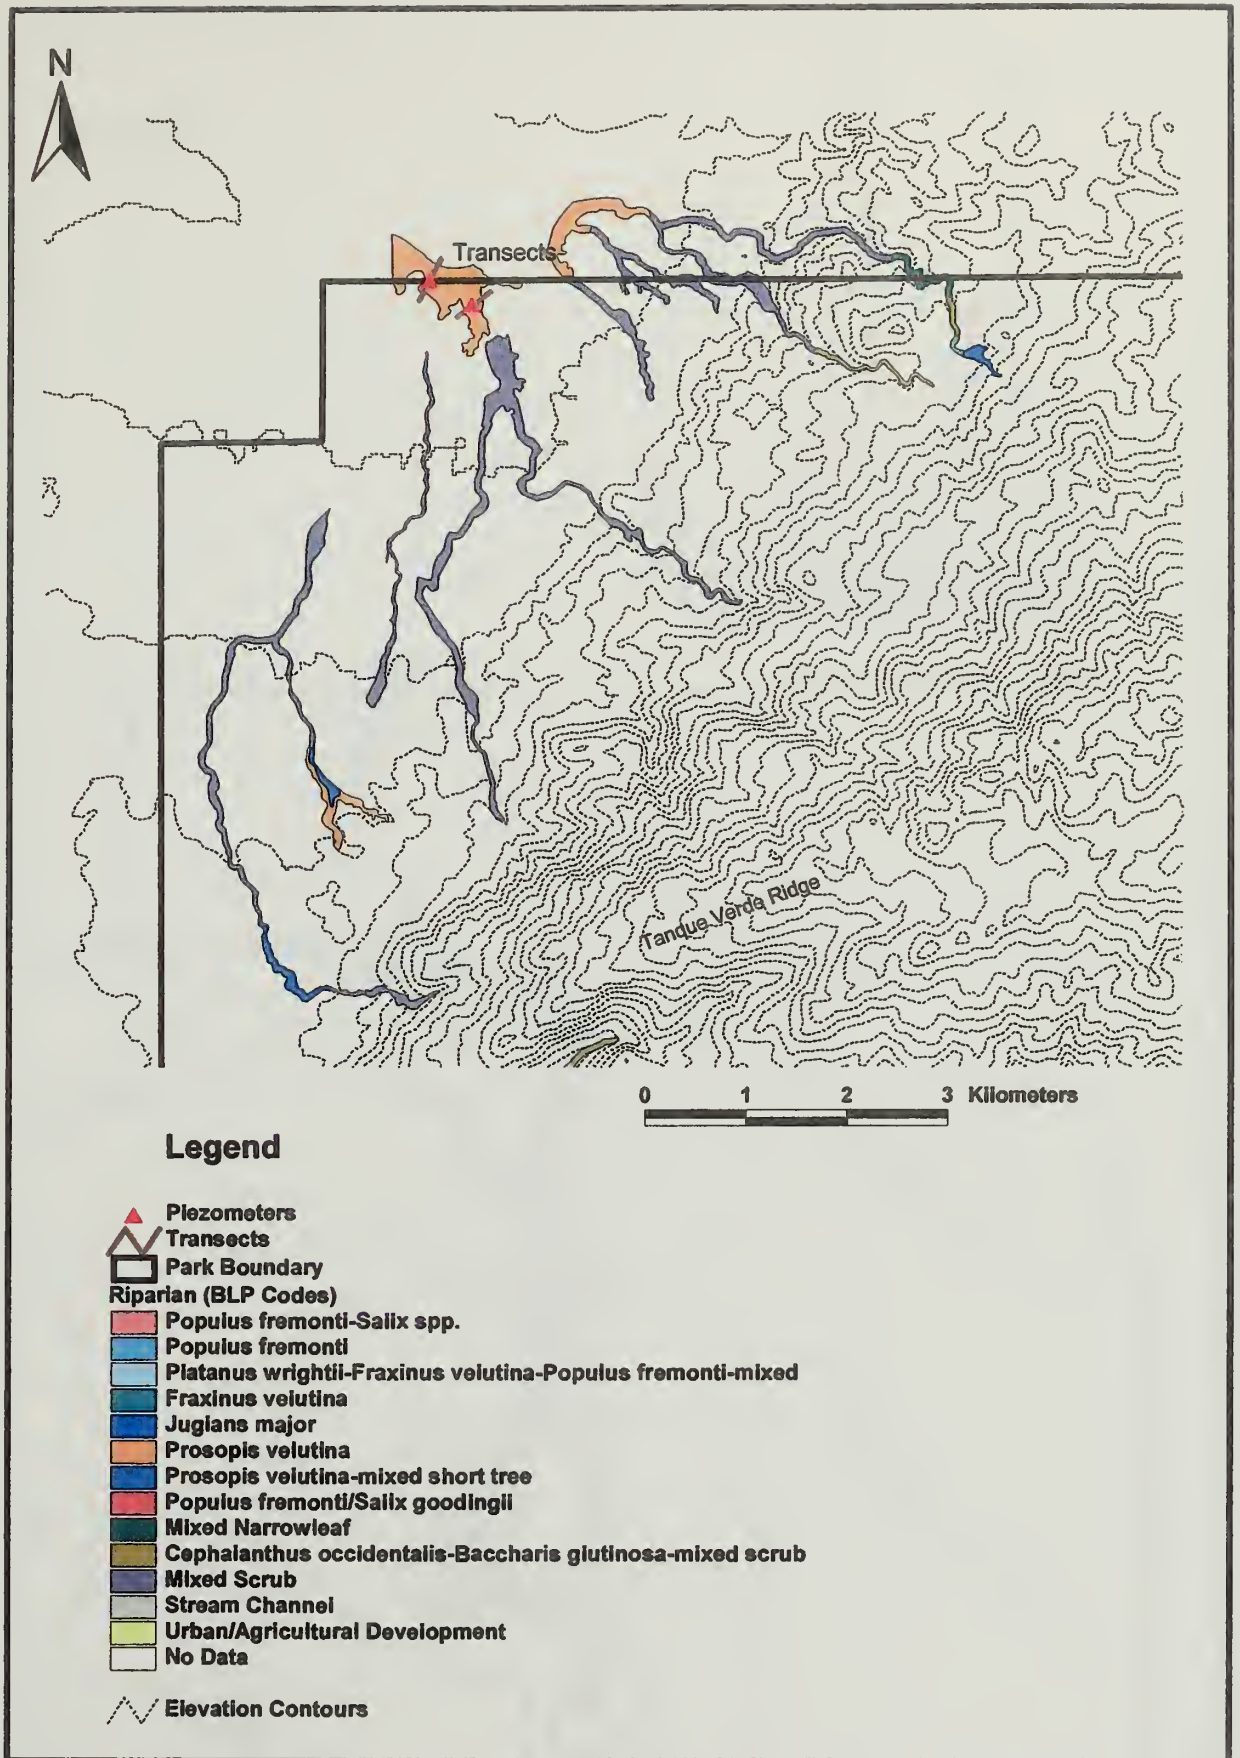
Figure 16. Riparian areas: Tanque Verde Creek tributaries.

Task 2. Streambed: Annual cross-sectional survey of the four transects on Rincon Creek (locations noted on Figure 17), on selected upper watershed tributaries of Rincon (locations to be field determined) and the two Tanque Verde bosque transects (Figure 16).

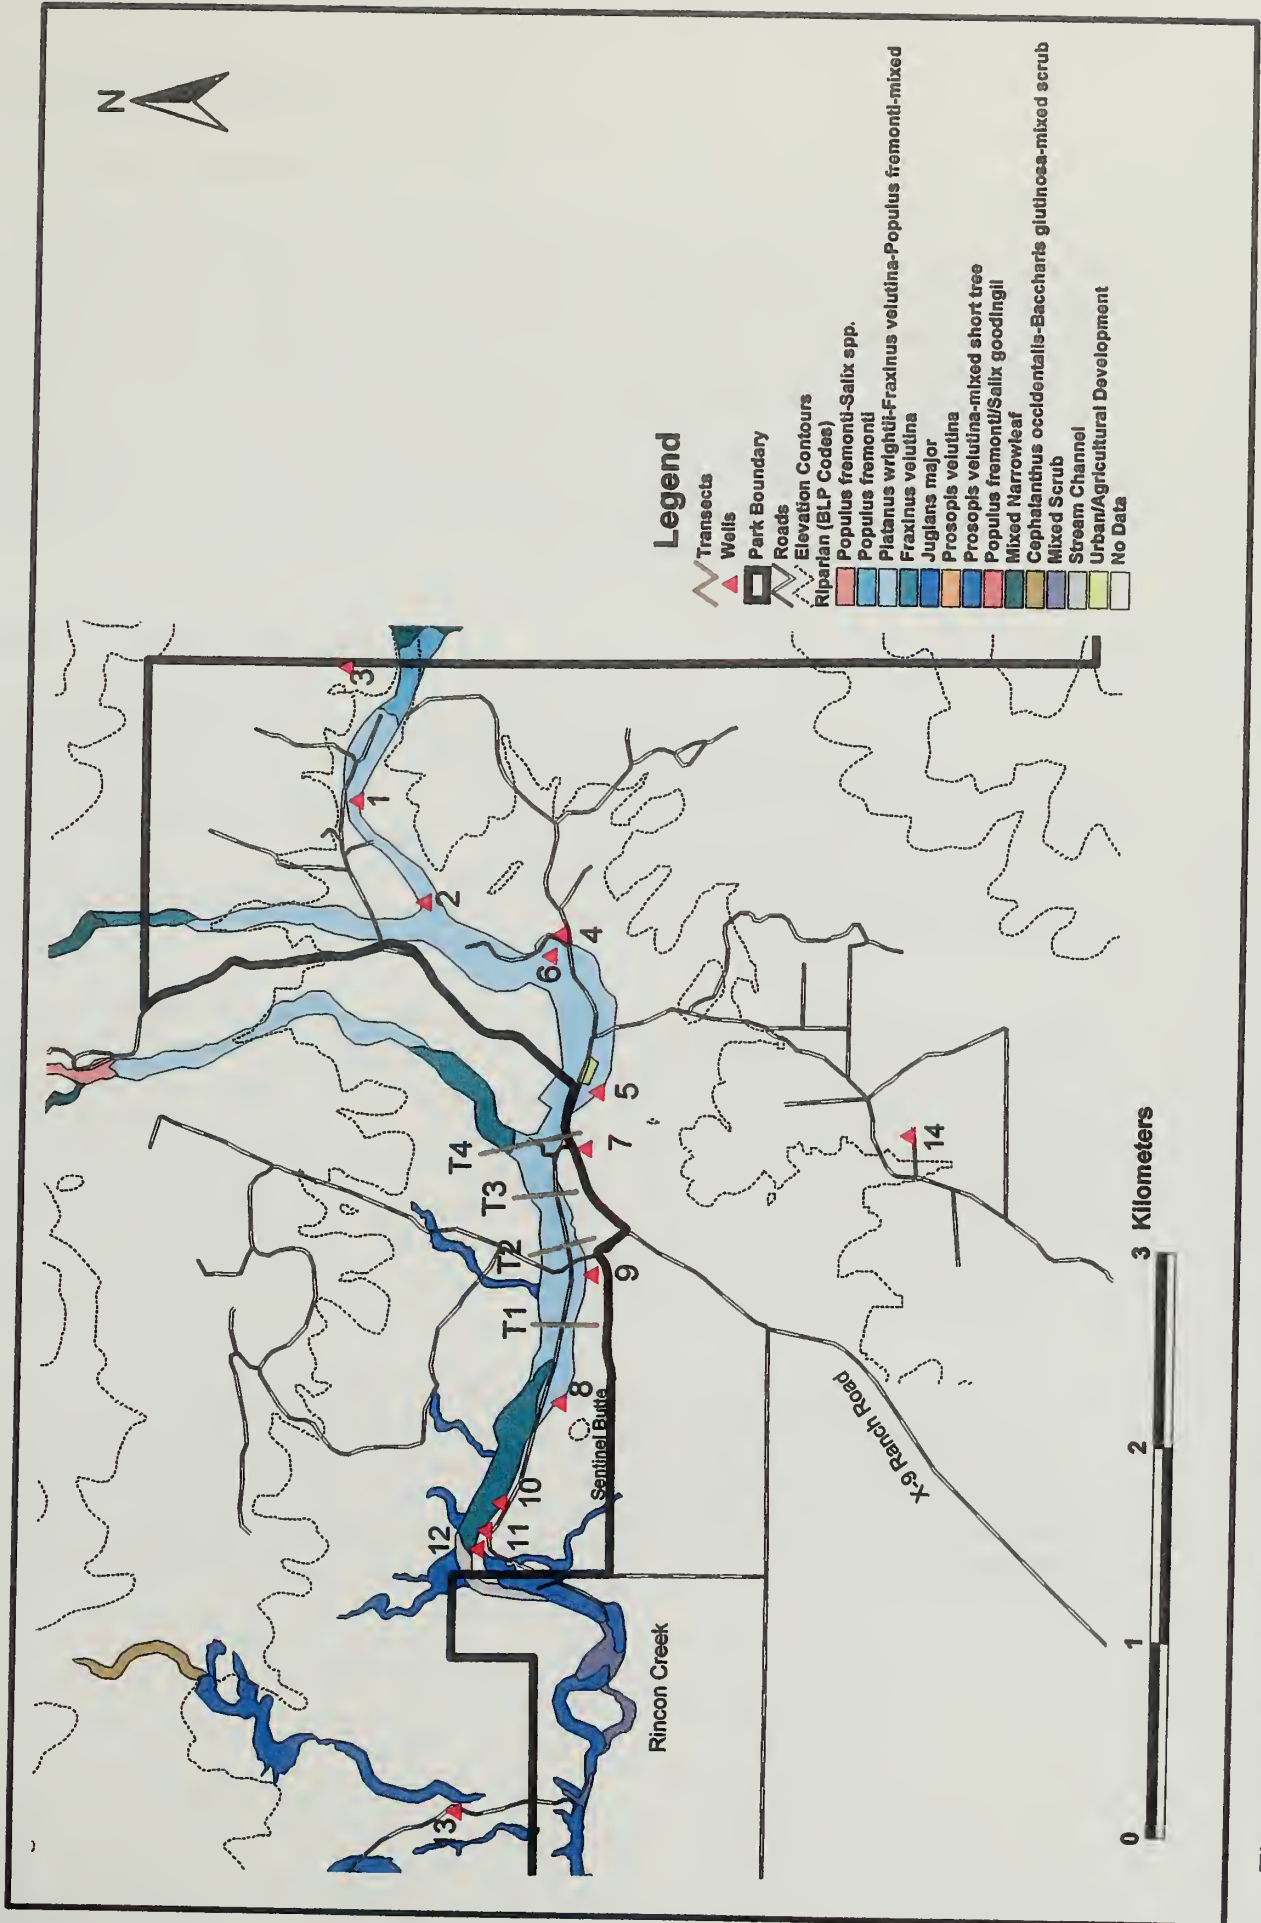
Figure 17. Middle basin riparian areas: Rincón Creek.
