Excavations at Harmony Borax Works

Historical Archeology at Death Valley National Monument

By
George A. Teague
and
Lynette O. Shenk

Western Archeological Center
Publications in Anthropology No. 6

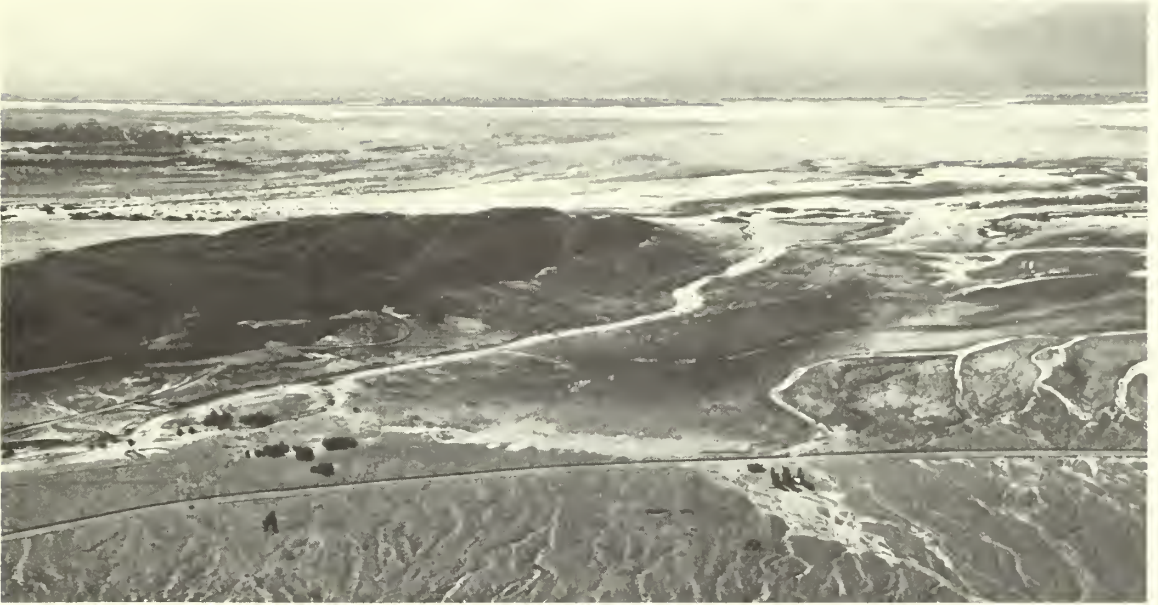
Figure 2. Aerial view of plant (against hill)
and townsite forming Harmony Borax Works.

Coleman, or his field representatives, set up the manufacturing facility on a hillside near Furnace Creek. This positioning allowed for gravity flow, whenever possible, of water and solutions during processing. Overland piping connected water storage tanks on the top of the hill to Texas Spring, some three or more miles away. A graded service road climbed up the hill from the salt marsh on the west and down to the wash on the east, thus allowing for a continuous flow of wagons carrying the unprocessed borax ore to the plant.

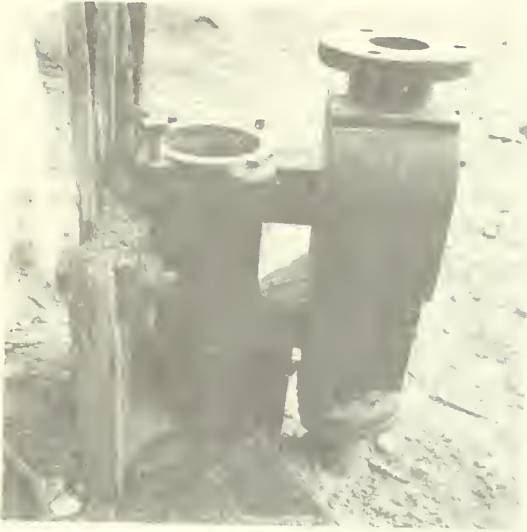
Figure 12. Reciprocal, steam-driven pump on tier 3.

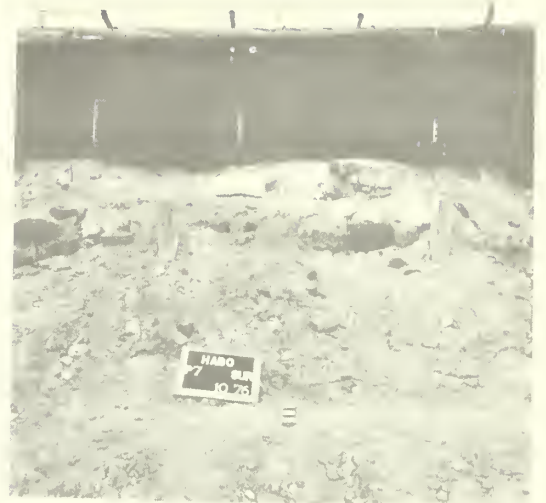
Figure 13. Platform support posts in front of east dissolving tank.

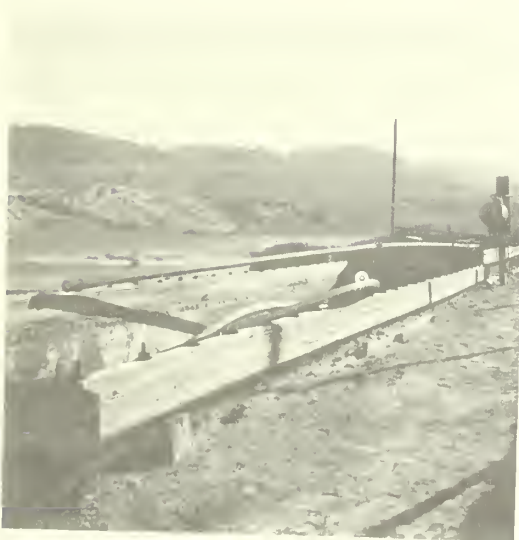
Figure 14. Dissolving tanks with lumber bolted around rim.

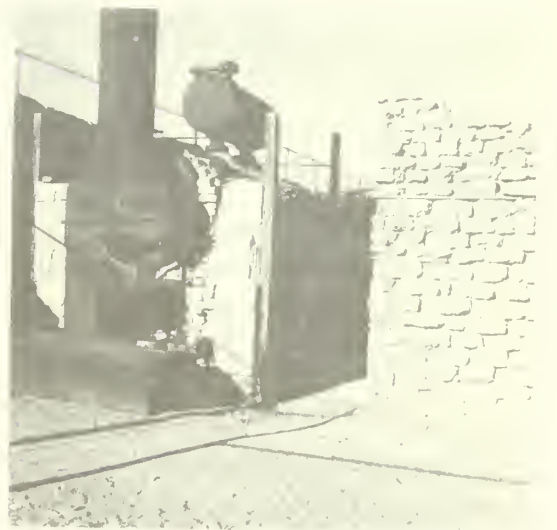
Figure 15. Boiler and machine room.

In the room center is a platform of massive lumber, bolted together. This served to raise a large engine off the floor. A photo, taken in 1947, shows such an engine in place, but it has since disappeared. Building measurements can be scaled off Figures 11 and 16.

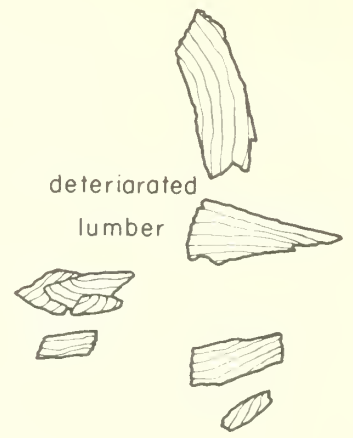
PLAN VIEW AT SURFACE OF UNITS P25 ,P26
HARMONY VICINITY

In mapping-unit P25 was an assembly of badly deteriorated lumber held together with square cut nails. One fairly intact piece of lumber measured 4 in. by 4 in. in section. Unit P26 included long sections of 4x4s to which were fastened 1-1/2 in. by 1/2 in. strap iron. The iron was nailed on with square cut nails. The feature may represent the remains of heavy sled runners.

The wooden features shown in Figure 18 may be remains of abandoned carts or sleds once used for hauling ulexite ore from salt marsh to plant. Both are about 1000 ft from the plant on headings as indicated in Figure 4.

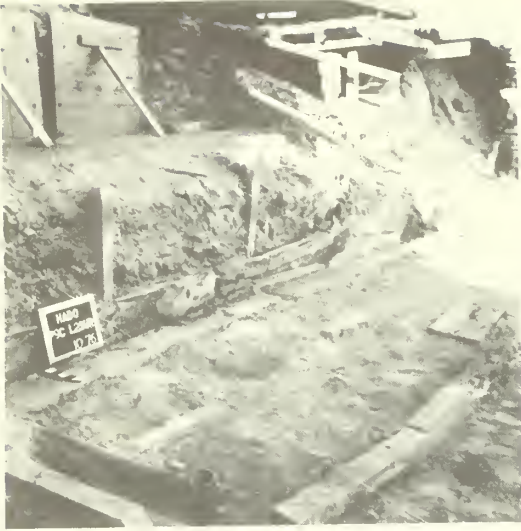
Figure 20. P7 and P9 units.

A low post-and-board wall divided Tier 2 into upper and lower levels (Fig. 20). On the upper, P7 level were found three boards, one of them burnt, and a length of half-inch rope.

On the lower, P9 level was found a quantity of scrap lumber, pipe, and burlap, as well as four 2x12s and 4x4s arranged as if for a footing. Another possible footing is formed by half-a-dozen sandstone blocks set into the artificial grade surface. Surfaces are covered with traces of hardened borax spill.

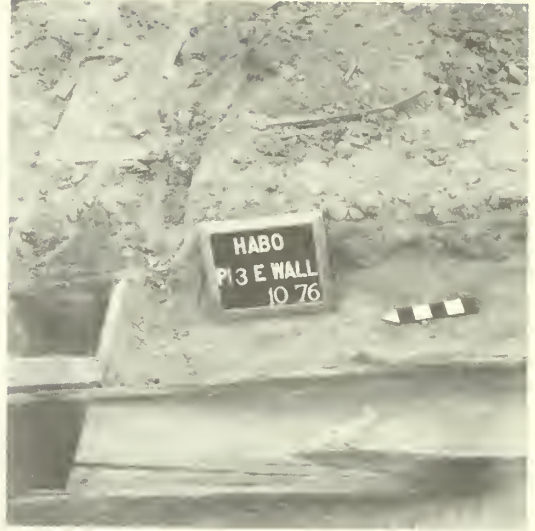
Figure 21. Wooden troughs in P13.

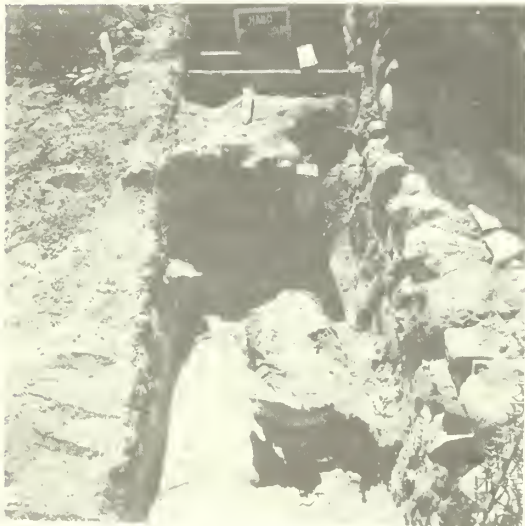
Figure 22. P14 with wooden drain, tier 3 retaining wall, and iron vat bottom.

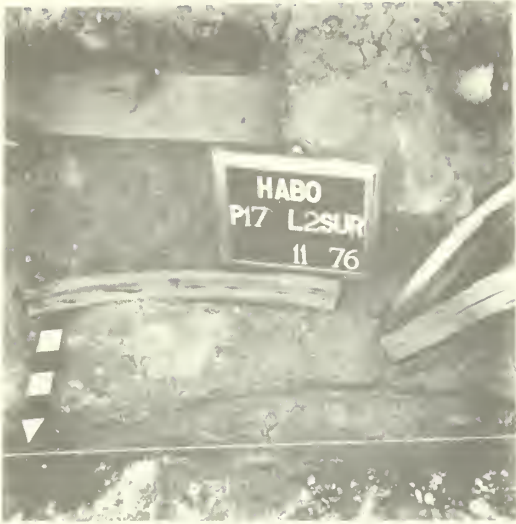
Figure 24. Lip of vat bottom and wooden cover rims of P17.

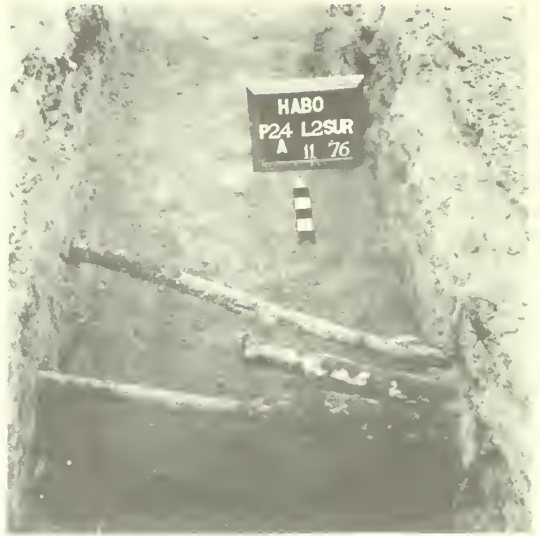
Figure 25. Iron vat hanger rods in P24A.

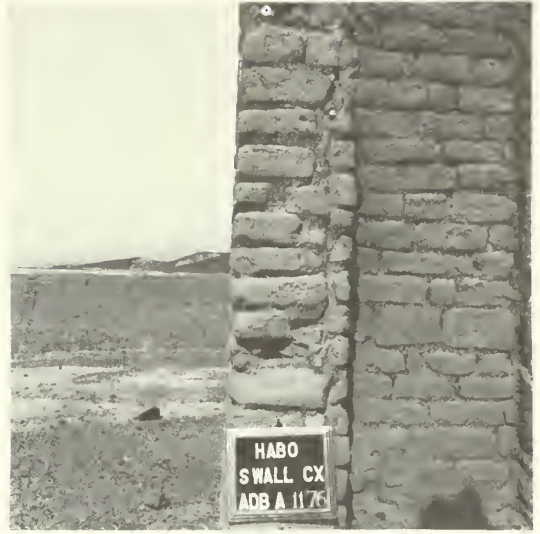
Figure 31. Brick pattern and interior veneer of adobe A.

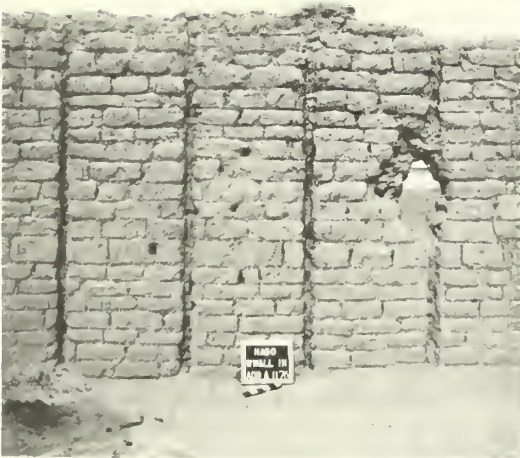
Figure 32. Interior vertical notches in adobe A.
