# CULTURAL LANDSCAPE REPORT: Dumbarton Oaks Park, Rock Creek Park

National Park Service

Part I: Site History, Existing Conditions, and  
Analysis and Evaluation

August 2000

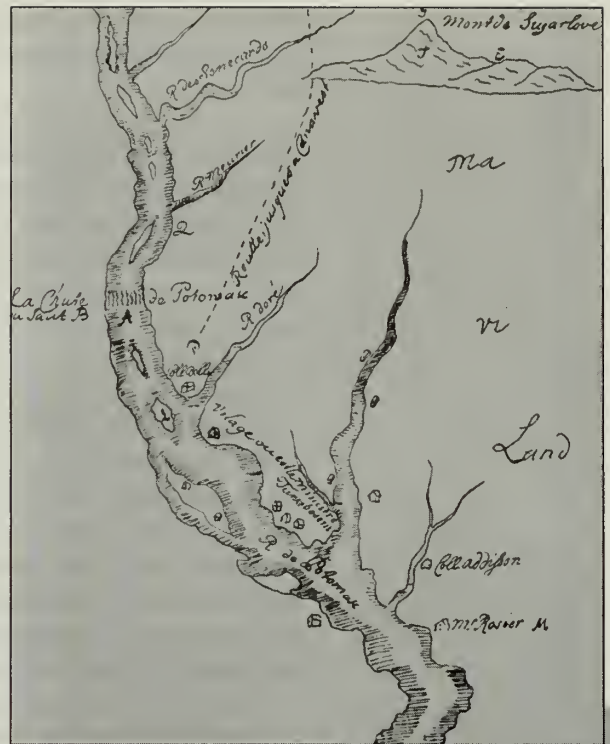
Map 2 Land Tract Survey for Rock of Dumbarton. From Baron Christopher de Graffenreid's map of 1712, in *Dunbarton Oaks* by Walter Muir Whitehill.

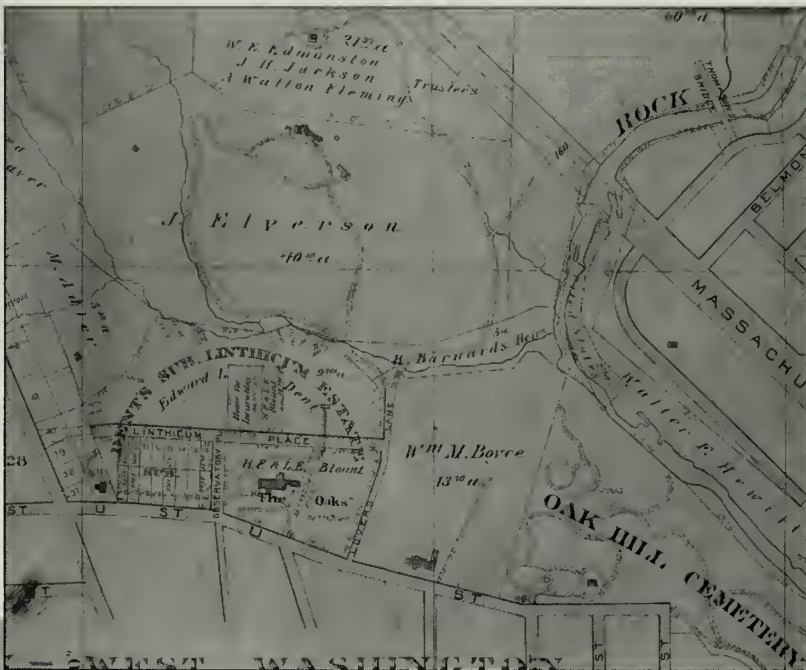
Map 4 Land parcel changes made by Edward Linthicum Dent at the end of the nineteenth-century. From Hopkins Real Estate Plat Book, vol. 3 (1894), Library of Congress.

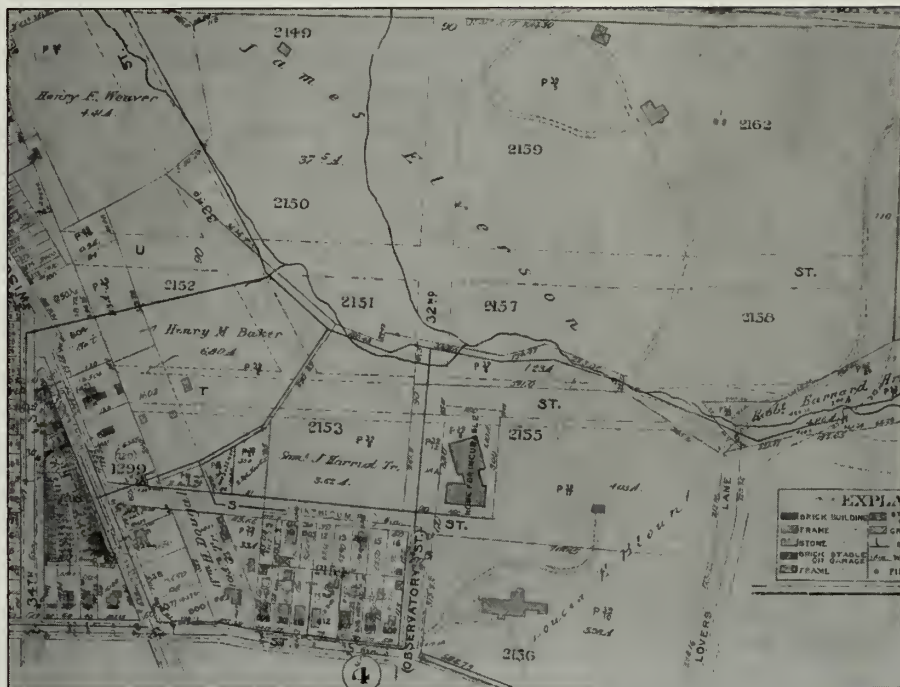
Map 5 Development changes to Blount and Elverson properties as shown by George William Baisted, Real Estate Atlas, vol. 3 (1919), Library of Congress.

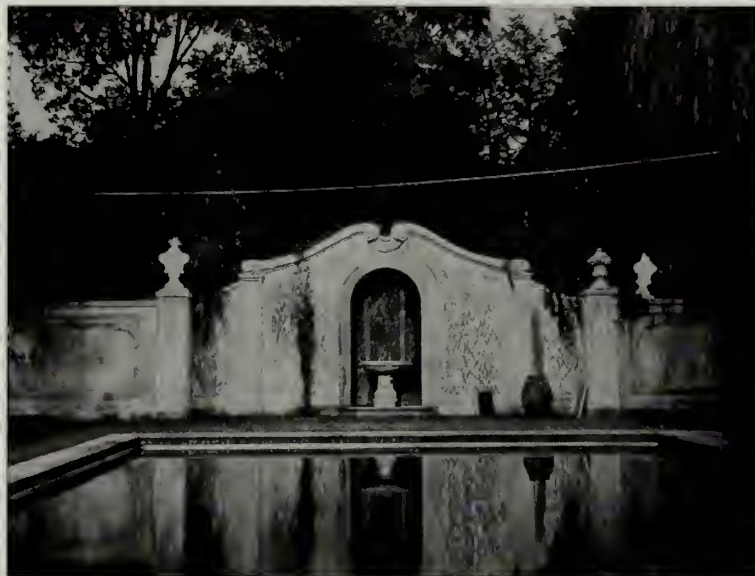
*Figure 2 Upper gardens, swimming pool with mock-ups of two urns, September 1932. Dumbarton Oaks, Studies in Landscape Architecture (DOSLA), Photo Archive, #42.46.*

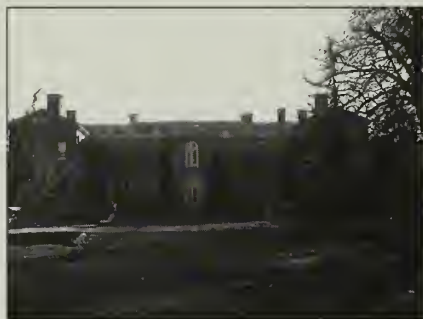
Figure 3 Contemporary view of rear (north) elevation of Dumbarton Oaks, showing changes made by the Blisses, December 1998. National Capital Region (NCR), Cultural Landscape Program Photo Archive, DOP 45-11.

Reconstruction of the house, for which the Blisses first employed local architect Frederick H. Brooke, began in August 1921. In 1929, they added a music room at the west rear, designed by architect Lawrence White of McKim, Mead & White.<sup>50</sup> White was responsible for other additions and structures as well. Farrand and White worked together closely, and Farrand had a great degree of control over the architecture. The new portions of the house were, in fact, designed to fit her gardens, rather than the opposite.<sup>51</sup> Robert Woods Bliss retired from the Foreign Service in 1933, at which time the Blisses returned to the U.S. to take up permanent residence in Washington.

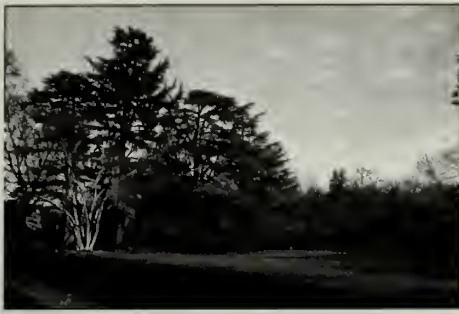
Figure 6 The sloping ground of the east lawn, December 1998. NCR, Photo Archive, DOP 45-1

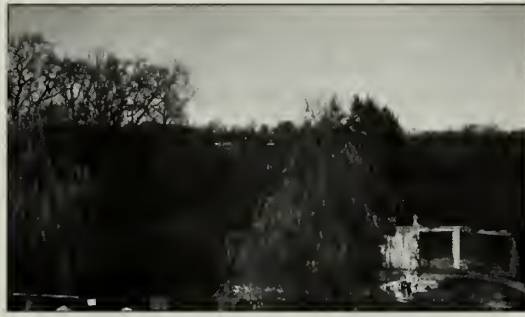
Figure 7 View from the Green Terrace to the stream valley, December 1998. NCR, Photo Archive, DOP 45-5

Farrand organized the upper gardens around several dominant axes. The main axis is a series of terraced gardens extending east from the house, beginning at the large Green Terrace along the Orangery. This was the Blisses' primary outdoor space for entertaining. It offers extensive views over the whole of the property.<sup>57</sup> The Green Terrace leads to the Beech Terrace, which, in turn, gives onto the small Box Terrace, originally a simple green anteroom to the Rose Terrace, the largest and most important of the terraced gardens.<sup>58</sup> Below the Rose Terrace is the Fountain Terrace, the major flower garden at Dumbarton Oaks. North of the Fountain Terrace is the Pot Garden or Arbor Terrace. A large purple beech tree (*Fagus sylvatica* 'Purpurea Riversii') growing on the hillside below the Fountain Terrace and above the Lovers' Lane Pool visually anchors this axis.

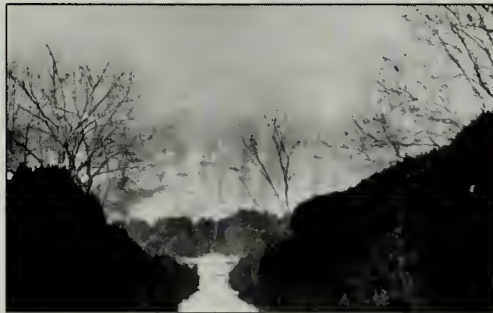
Figure 8 A view from the Box Walk looking north to the Box Ellipse and Clifton Hill, ca. 1930. DOSLA, Photo Archive, #15.7.

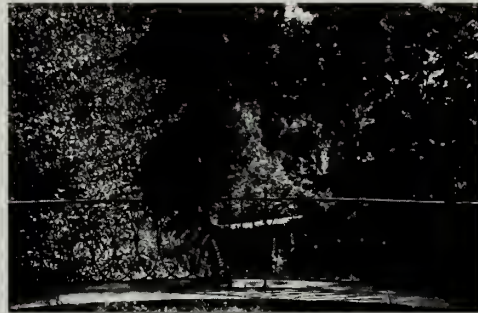
Figure 9 A view from the main house to the North Vista, July 9, 1997. NCR, Photo Archive, DOP 3-9.

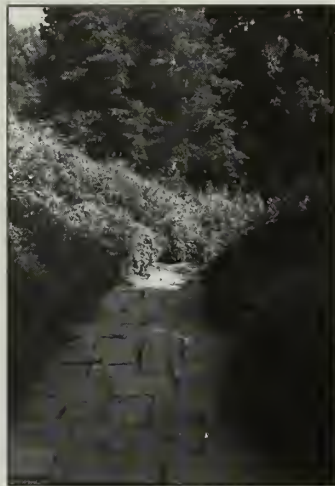
Figure 12 A view down Forsythia Dell within the upper gardens, July 9, 1997. NCR, Photo Archive, DOP 3-24a

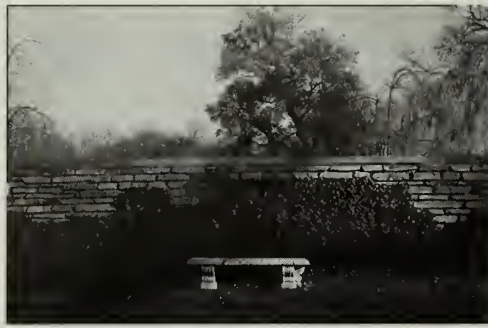
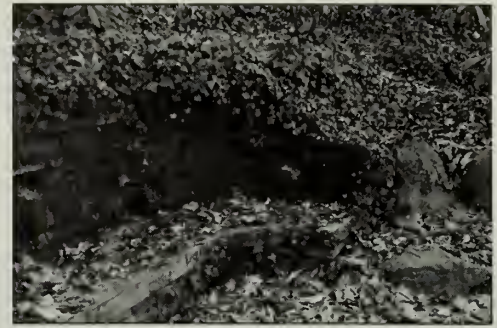
Figure 14a & b Comparison of stone walls from the upper gardens (December 1998. NCR, Photo Archive, DOP 45-10) and stream valley (December 1998. NCR, Photo Archive, DOP 48-5).

The treatment of materials becomes increasingly less formal as one moves through the garden. Near the house, walls and walks are primarily brick. Moving further from the house, such features are made of both brick and stone; then stone is used alone in the naturalistic garden. Stonework becomes increasingly rough, and the type of stone changes from flagstone to local fieldstone. The actual design of such features also becomes progressively more informal throughout the gardens: the wall along R Street is a pilastered brick wall topped with an openwork brick balustrade, while the high retaining wall in the Rose Garden is made of stone with brick pilasters. The informal hillside gardens have stone retaining walls planted with herbaceous vegetation; similar constructions in the park, such as the Stream Arbor, have ferns growing from the interstices of the stones.

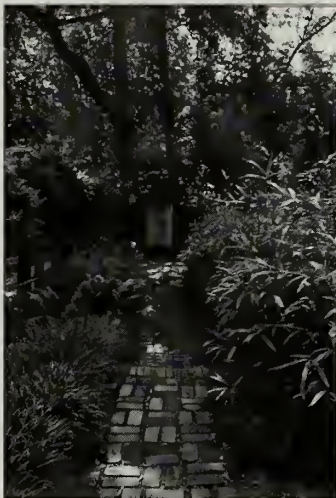
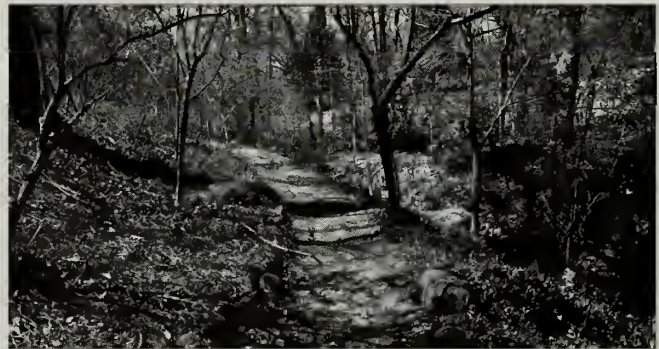
Figure 15a & b Comparison of two paths showing the progressive nature of the design from formal (July 9, 1997. NCR, Photo Archive, DOP 4-20) to naturalistic (April 1, 1997. NCR, Photo Archive, DOP 1-25).

Farrand used stones, either singly, in pairs, or in series, to mark the beginning of a path, line its route, or call attention to a view or feature. River stones line certain sections of paths running through the informal gardens. In the naturalistic garden, river stones lined the southern edge of the stream path in the lower section, while the northern edge was marked with larger stones placed at irregular intervals; the more defined edge, therefore, was on the side of the path nearer to the upper gardens, and the less formal edge was next to the stream. On the stream path, east of the Forsythia Steps, periwinkle (*Vinca minor*) or a similar groundcover grew over the border of river stones, underscoring the change in character as the path progressed. Individual

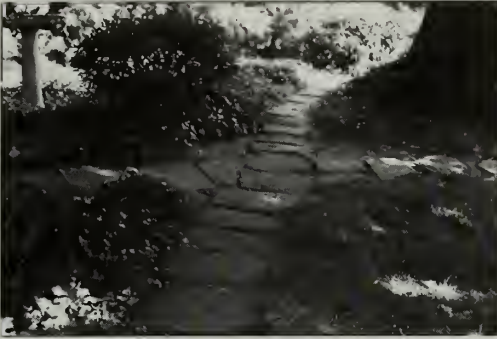
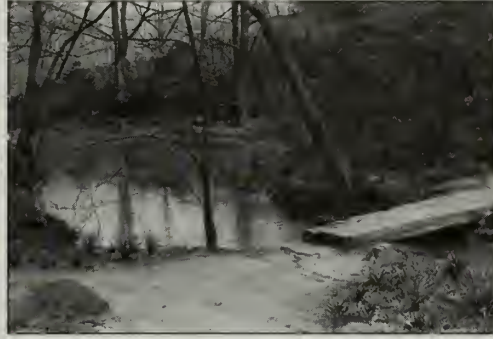
*Figure 16a & b Similar treatment of marker stones at path intersections. Fair view hill stepping-stone path (July 9, 1997. NCR, Photo Archive, DOP 3-6) & West Laurel Falls crossing at the north stream path (March 13, 1941. NCR, Museum Resource Center (MRC), Photo Archive, #108).*

large stones first appear in the upper gardens: for example, on Fair View Hill, they occur both along the steps which descend along the western boundary, and on the grassy slope of the hill further to the east. Large stones were used in a similar manner in the naturalistic garden to mark the end of a path or path intersection, or to indicate a view of a falls, meadow, or other feature.

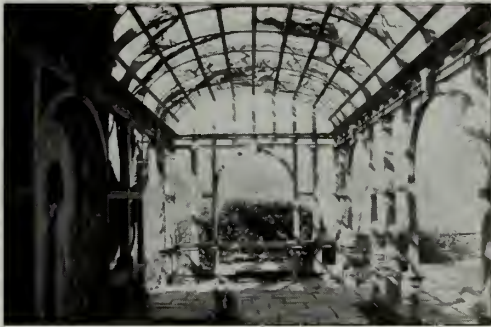
*Figure 17a & b Farrand's design progression is evident in the treatment two arbors: Arbor Terrace in the upper gardens, (March 1998. NCR, Photo Archive, DOP 37-7) and the Stream Arbor in the naturalistic garden, 1932 (DOSLA, Photo Archive, #13.2).*

Wooden arbors are treated in a similar fashion. Farrand adapted the arcaded arbor at the western end of the Arbor Terrace from a plate in a book by the 18th-century French architect Du Cerceaux. Wisteria grows in profusion over its vaulted roof. The Stream Arbor in the naturalistic garden was a rustic structure built of hewn timbers, most likely covered with wild grape (*Vitis* sp.) and wisteria (see *Chapter 4 - Analysis and Evaluation: Landscape Characteristics, Structures*).

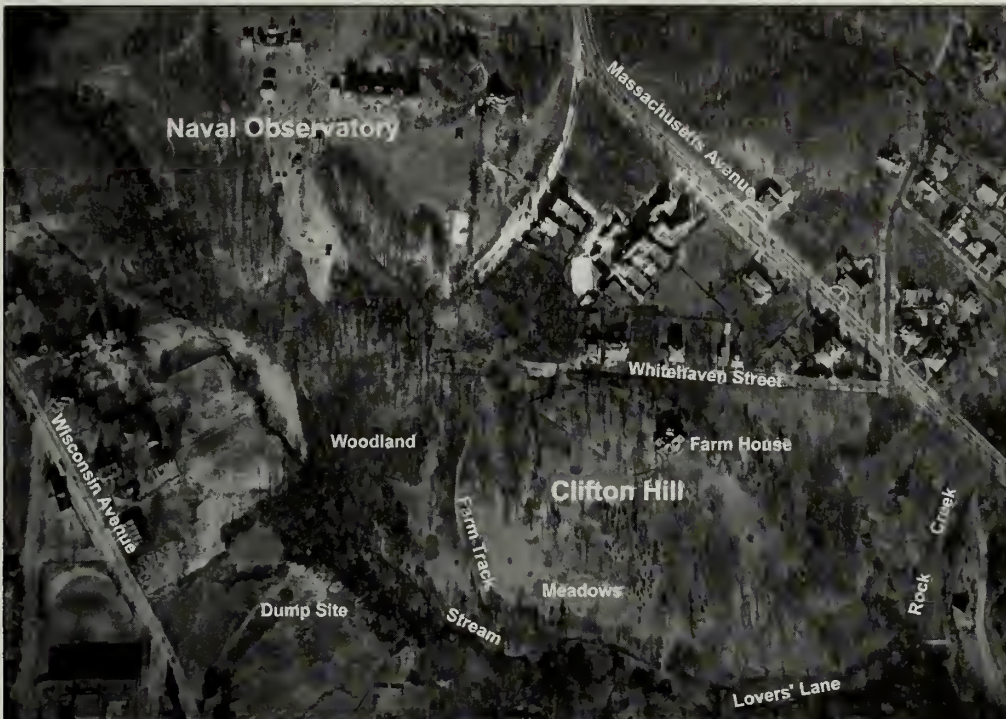
Figure 19 Aerial view of valley garden showing early development of the park-- layout of farm track, open meadows and woodland areas, 1930-1945. NCR, Photo Archive, DOP 54-1.

For her design Farrand took cues from the existing topography and vegetation. She included the old farm track in her circulation system, and incorporated the farm structures: the Old Stone Pump House, the Old Pump House, and possibly a structure of unknown purpose on the north side of the stream (which she may have used in the late 1930s for the foundations of the William Gray memorial arbor). She apparently rebuilt the bridge and constructed a brick enclosure for a natural spring. She augmented the thin fringe of trees on the crest of Clifton Hill, and let it fill out by natural succession into a dense, wooded backdrop. Judging from the historic aerial photographs, it seems that Farrand divided the large field by planting lines of trees to supplement natural lines of plantings, generally following existing ravines or swales. Some may have had Scotch broom (*Cytisus scoparius*) added to

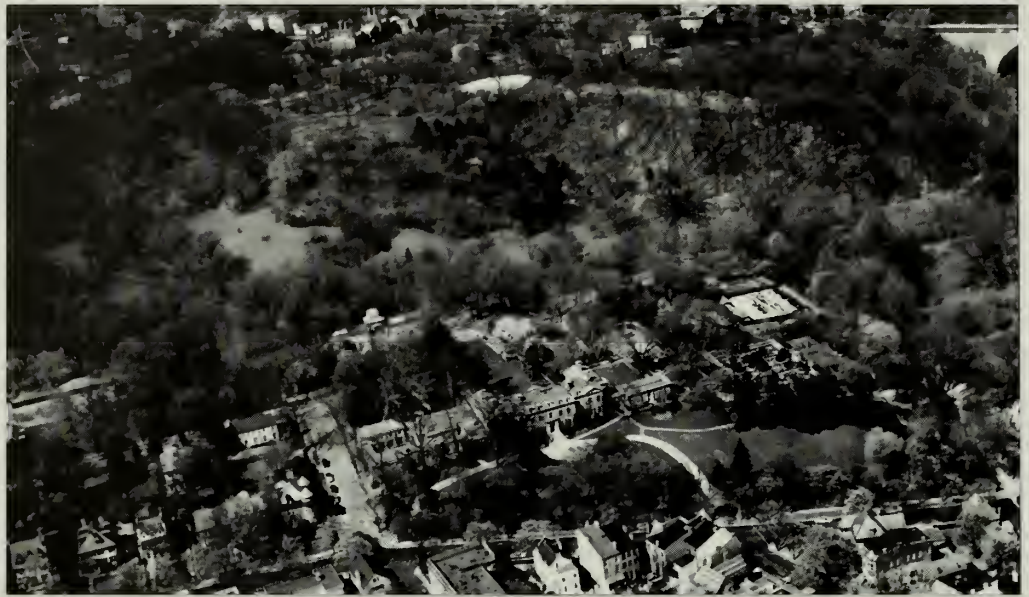
Figure 20 Bird's eye view showing maturing Dumbarton Oaks designed landscape, 1945-1955. DOSLA, Photo Archive, #3.12.

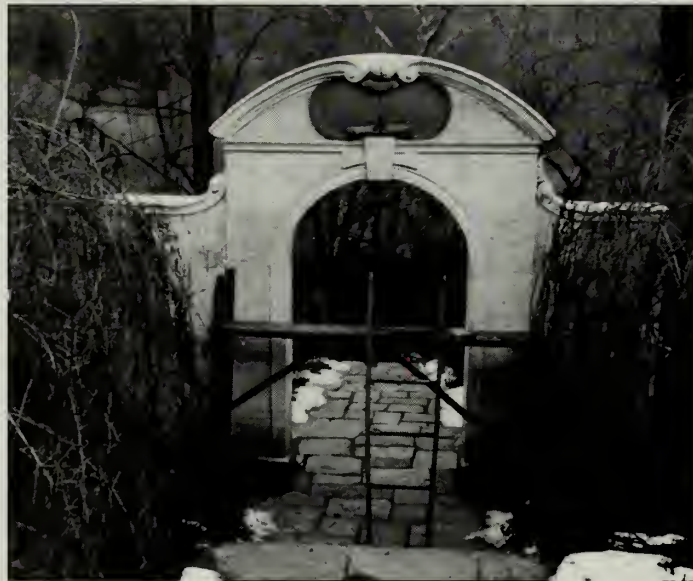
Figure 21 Construction of Forsythia Arch, ca. 1938. DOSLA, Photo Archive, #17.13.

The paved path, which wound down Forsythia Hill through the dense plantation of forsythia, led to a formal entryway dating from the late 1930s. An iron gate, known as the Forsythia Gate, was set within a masonry archway, the Forsythia Arch, constructed of limestone veneer over rubble brick. The arch had a scrolled, broken segmental pediment, ornamented with carved foliage; its tympanum (the wall surface within the pediment) was inscribed with “Dumbarton Oaks Park” on its south face and “Dumbarton Oaks” on the north. In late 1938 Mildred Bliss wrote to Farrand: “...the arch-way as the entrance to the park from Dumbarton Oaks and vice versa should carry some weight, both actual and metaphorical.”<sup>79</sup> The design of the arch and its relation to the adjoining fence caused some concern, with Mildred Bliss telling Farrand to “please push through the Forsythia Arch so its wings minimize the unfortunate fence”<sup>80</sup> Though whether a wooden stockade fence was still present at this time is unknown.<sup>81</sup> The path passed through the arch and descended in a series of limestone stairs, the Forsythia Steps, through the remainder of the forsythia plantation, terminating at the stream path, which wound along the foot of the slope.

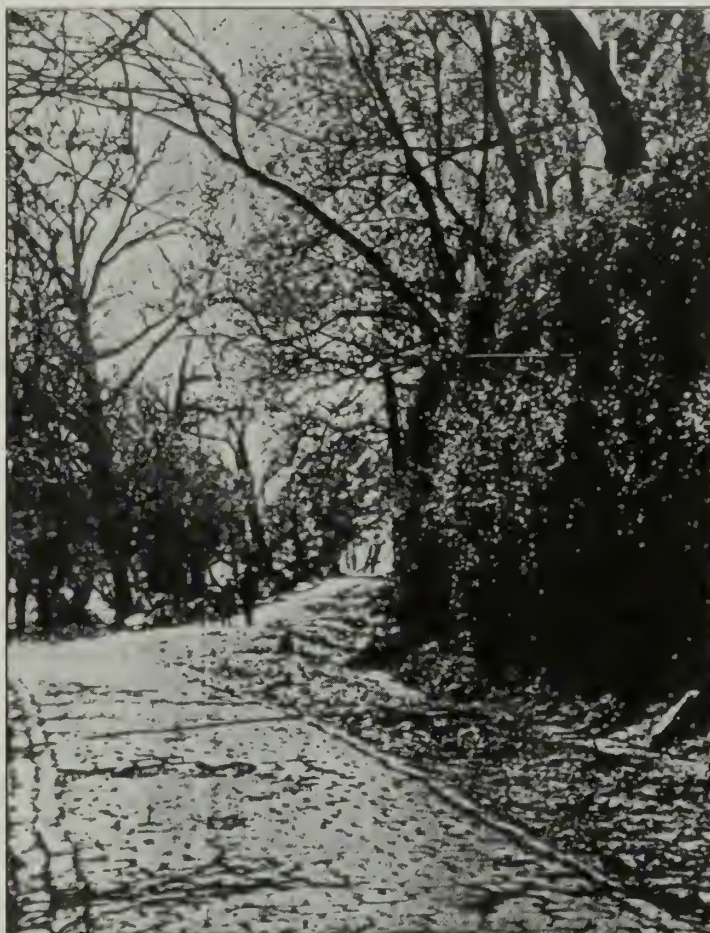
*Figure 22 The cobbled road and decorative drainage channel of Lovers’ Lane as it appeared on Dec. 29, 1940 in the Washington Star, Sunday edition.*

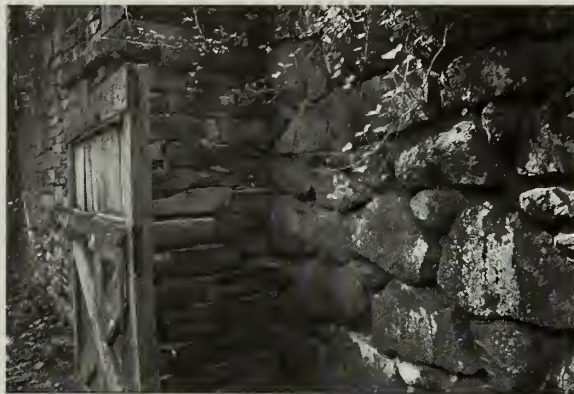
Figure 23 Comparison of Lovers' Lane Wall and Beech Grove Wall, August 1997. NCR, Photo Archive, DOP 40-4.

pre-dated Farrand and the Blisses (two foundation stones are inscribed with the date 1909). Sometime before 1926, a fence made of wood palings was erected on top of the wall along Lovers’ Lane.<sup>82</sup> Below the wall was a channel or gutter, possibly designed by Farrand, composed of slabs of stone that were interrupted at points with stone rills. Its sides were lined with river stones. On the opposite side of Lovers’ Lane, along its border with Montrose Park, was a low fieldstone wall that also pre-dated Farrand.

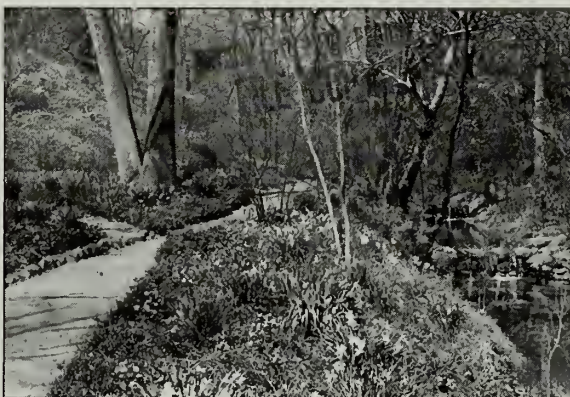
Figure 25 Stream path and waterfalls, April 18, 1963. Photo by Abbie Rowe. NCR, MRC, Photo Archive, #97.

The main feature of the naturalistic garden was the stream, bordered on its south side by a gently winding path which linked a series of discrete spaces or garden rooms. Judging from its appearance in historic photographs and its current condition, the path was composed of a soil and gravel mix. Along the course of the stream, Farrand developed a series of eighteen dams, composed of rounded river stones laid over concrete cores. The stream cascaded over the dams as falls. There

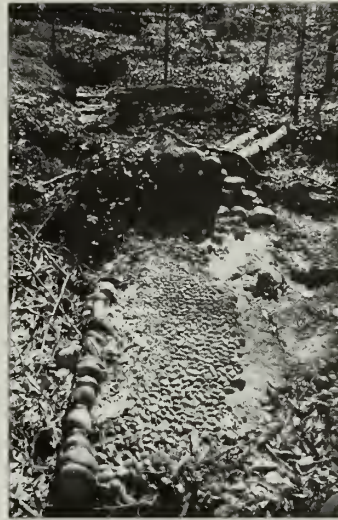
*Figure 28 Innovative system of drainage channels that separates storm water and fresh water. April 1, 1997. NCR, Photo Archive, DOP 2-5a.*

In addition to the off-site storm sewer system, an internal stormwater system from the upper portion of the garden was laid down the hill, and the runoff was dumped directly into the stream. One of the storm drains, a rubble-stone outlet resembling a grotto, drained onto the pebble stream. Storm water cascaded down the pebble channel to the stream. Several water lines also ran down the hill from the upper gardens to the stream valley, presumably to irrigate the new plantings. One of the water lines is clearly visible in a 1931 aerial photograph of the valley, running up Clifton Hill and along the edge of the northern woodland.<sup>92</sup> At some point before 1932, a gas line and an overhead telephone line were laid, running along the Lovers' Lane corridor and then northeast up to Massachusetts Avenue.<sup>93</sup>

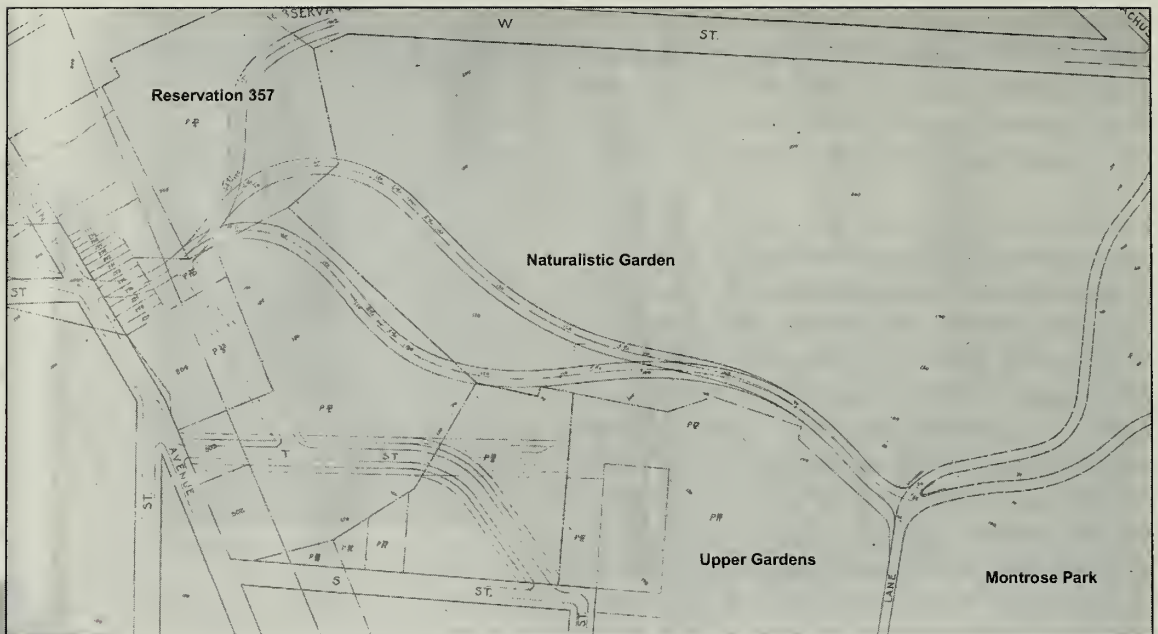
*Map 9 National Capital Park Commission's alternative parkway alignments through the stream valley, May 1925. (NCR, Plans and Drawings Collection, #863/80002).*

Three different routes were proposed for the completion of Whitehaven Parkway between Tunlaw Road and Rock Creek and Potomac Parkway. Two would have run through what is now Dumbarton Oaks Park, with the first located south of the stream and the second running to its north through the meadow. Both alternatives then followed the same alignment through the eastern half of the Dumbarton Oaks Park property, intersecting with Lovers' Lane and continuing east to join Rock Creek and Potomac Parkway. The third alternative route curved north from Wisconsin Avenue to Observatory Circle, cutting through what is now Federal Reservation 357. A 1920 map shows Whitehaven Street running from Observatory Circle on the west to Massachusetts Avenue on the east, cutting across the north-west corner of the site. This map shows no other streets through this section of Dumbarton Oaks. A 1941 map shows Whitehaven Street running across the north-west corner of Dumbarton Oaks Park, but moved slightly further to the north.<sup>97</sup>

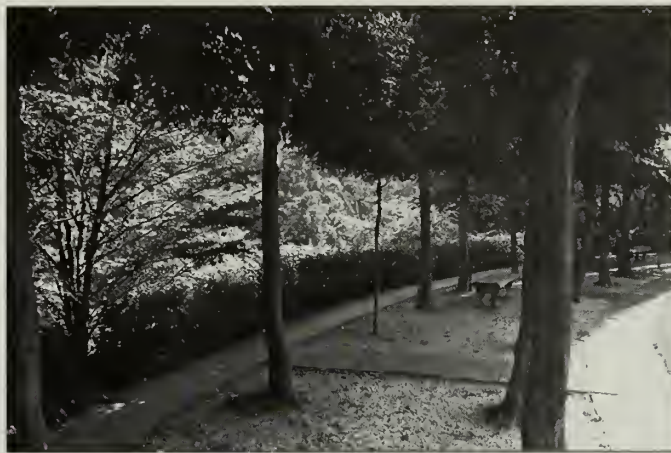
Figure 30 Aerial hornbeam hedge at the redesigned Ellipse, July 9, 1997. NCR, Photo Archive, DOP 3-24.

boxwood hedges of the North Vista were replaced with low stone walls.<sup>109</sup> The vista now terminated in a wrought-iron balcony, opening up a view into the stream valley below.<sup>110</sup> The hedge of small trees and shrubs on the Catalogue Hill below was thinned to open a view into the stream valley. In 1958, landscape architect Alden Hopkins replaced the boxwood of the Box Ellipse with an aerial hedge of pleached hornbeam (*Carpinus caroliniana*). Soon after in 1960, the firm Griswold, Winters,

and Swain refined the design with the addition of a balcony that provided a view to the stream valley. The balcony was subsequently removed in 1966. The simple fountain Farrand had placed in the center was removed, and a more elaborate French Provençal fountain, which had been located in the

Copse, took its place. The redesigned Hornbeam Ellipse possessed a far more formal, 18th-century French character.<sup>111</sup>

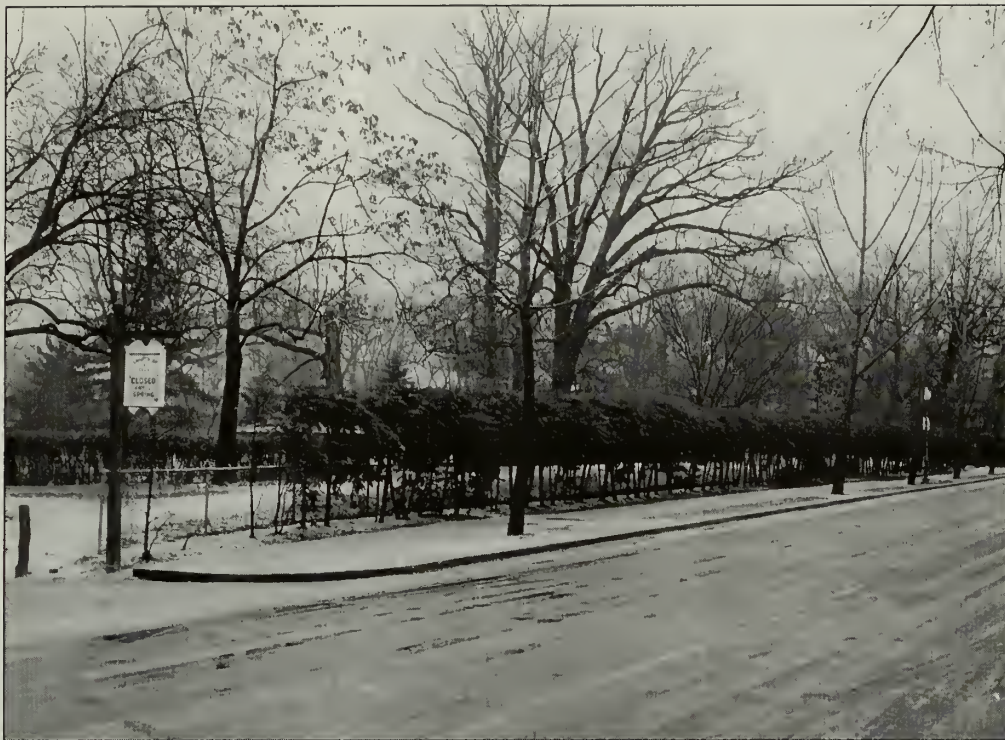
Figure 32 Lovers' Lane entrance sign at R Street entrance, January 15, 1944. Rock Creek Park Cultural Resource, Photographic Collection (ROCR), #217a.

In December, Farrand provided suggestions for signs at the different falls.<sup>116</sup> Their size and appearance depended on their location in relation to the stream path. She suggested four types of designs: three would identify water features, such as dams and pools; the fourth was a “caution sign type.” She suggested setting larger signs directly into the existing walls or stream banks. These were to be made of blue-stone or what she termed “natural” stone, with letters either carved or sand-blasted.<sup>117</sup> It does not appear that any of these were made. By 1945, wooden entrance signs had been placed at the top of Lovers' Lane at R Street, and at the Lovers' Lane entrance gate, and there were signs also at the stone bridge and the Laurel Pool. By 1951, two additional entrance signs had been placed along the Forsythia Steps, at their base in the valley and in Dumbarton Oaks Gardens just north of the gate. The NPS revised the entrance signs in 1967 (see *Chapter 4 - Analysis and Evaluation: Landscape Characteristics, Small-Scale Features, Signs*).

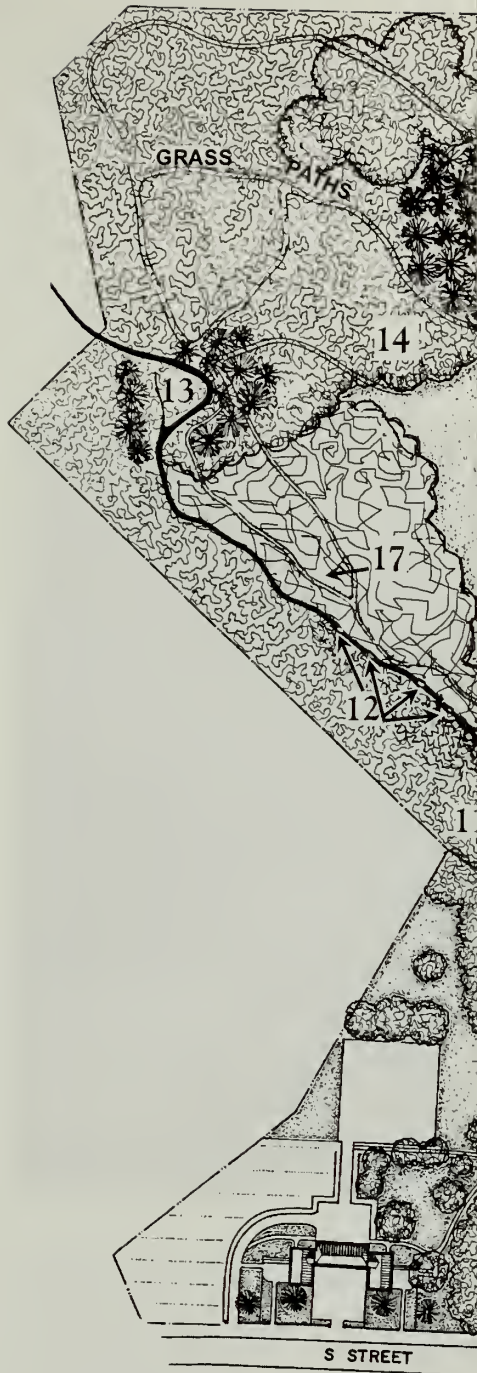
- 1 OLD STONE PUMP HOUSE AND EAST FALLS
- 2 THREE BRIDGE FALLS
- 3 GRAY ARBOR MEMORIAL
- 4 THREE SISTERS FALLS
- 5 LAUREL POOL
- 6 WEST LAUREL FALLS
- 7 OLD PUMP HOUSE
- 8 OLD WATER WHEEL FALLS
- 9 ARBOR FALLS
- 10 CLAPPER BRIDGE FALLS
- 11 THREE MEADOWS FALLS
- 12 JUNGLE FALLS
- 13 ISLET
- 14 ANIMAL GRAVEYARD
- 15 STREAM ARBOR
- 16 SPRING GROTTO
- 17 UNICORN LADY STATUE
- 18 HAZEL WALK
- 19 FORSYTHIA STEPS
- 20 IRIS PATH
- 21 BEECH GROVE

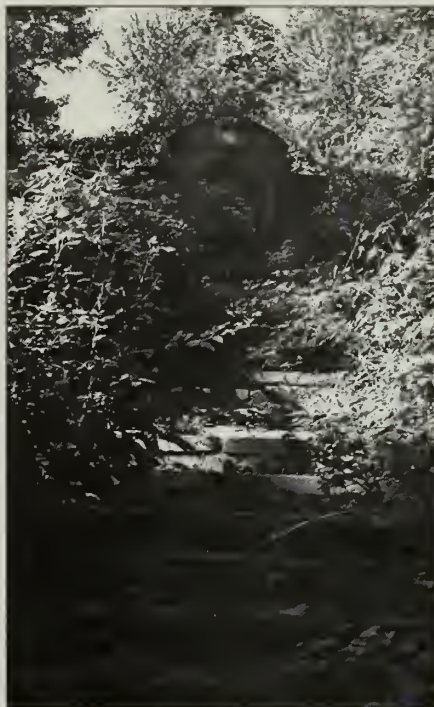
Figure 38 Forsythia Steps and sealed archway, July 11, 1997. NCR, Photo Archive, DOP 6-14.

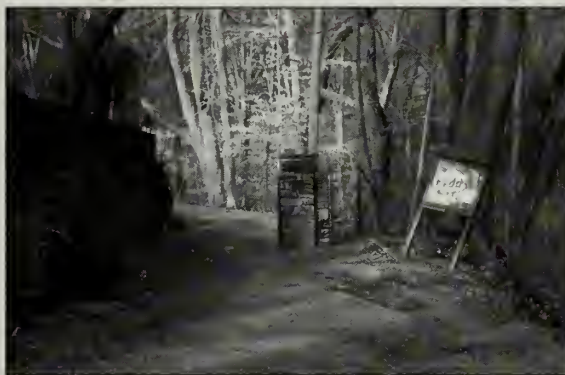
Figure 39 Lovers' Lane entrance gate and signs vandalized in the 1980s. NCR, Photo Archive, DOP 19-13.

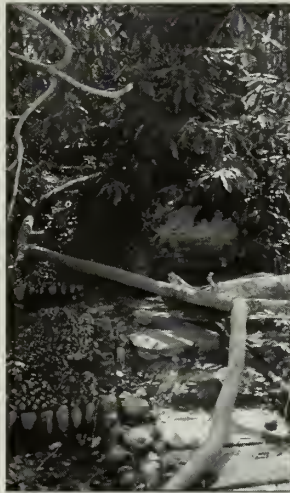
Figure 40 Historic American Building Survey existing conditions photos of spring grotto, 1988. Photo by Jack Boucher. HABS No. DC-571-19. (Library of Congress)

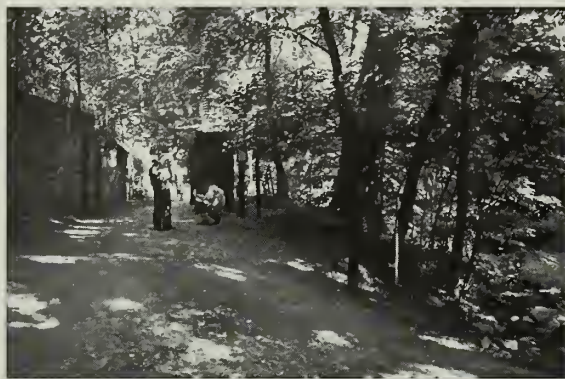
Figure 44 Main entrance to Dumbarton Oaks Park from Lovers' Lane, July 9, 1997. NCR, Photo Archive, DOP 5-24a.

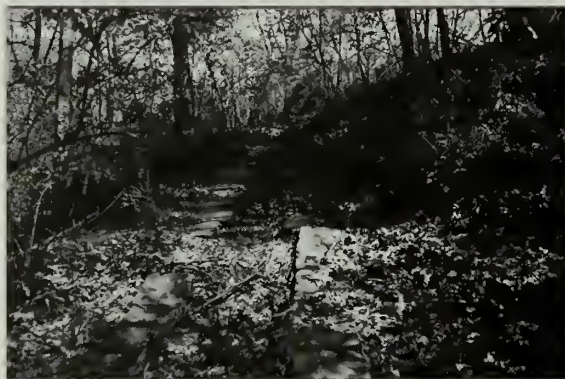
Figure 46 The stones for Hazel Walk are obscured by thick vegetative growth, April 1, 1997. NCR, Photo Archive, DOP 1-34.

All the stones which paved the Hazel Walk remain, but its upper portion is impassable due to thick vegetation. The last connecting path, the Forsythia Steps, is intact, but its arched gate opening leading to the upper gardens is sealed with stone and mortar. The continuation of the path within the upper gardens has been altered.

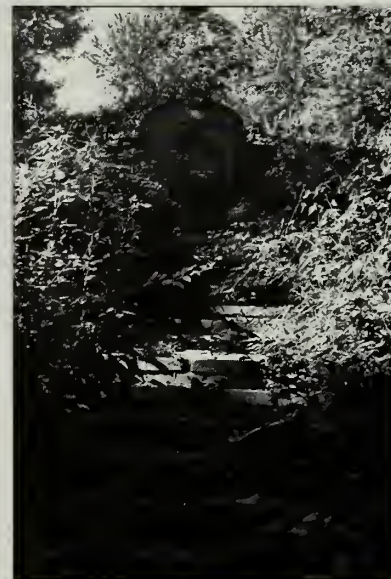
Figure 47 Even though the Forsythia Steps are still somewhat useable, visitors rarely go up the steps because of the blocked archway, July 11, 1997. NCR, Photo Archive DOP 6-13.

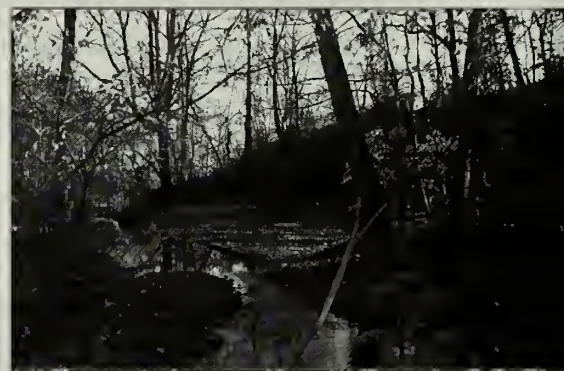
Figure 53 The area around the Laurel Pool has been affected by excessive siltation filling up the pool, December 1998. NCR, Photo Archive, DOP 47-19a.

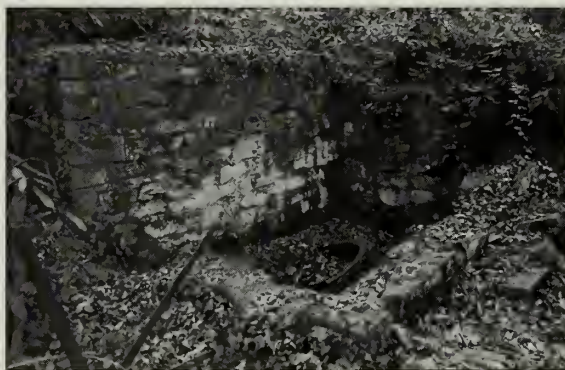
Figure 54 Rusted broken parts from the old water wheel are laying beside the Old Pump House, December 1998. NCR, Photo Archive, DOP 48-22.

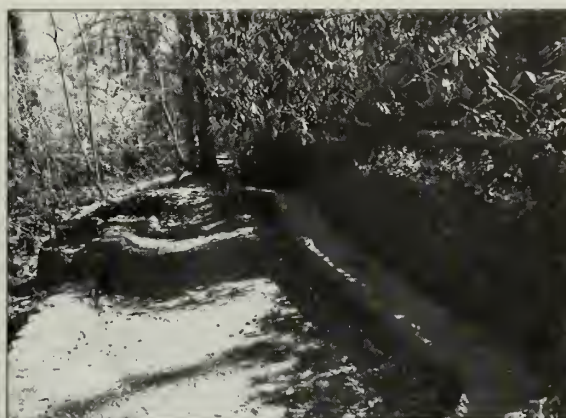
*Figure 55 Many of the original flagstones that were laid beside the cedar channel, have been displaced or lost, April 1, 1997. NCR, Photo Archive, DOP 2-3a.*

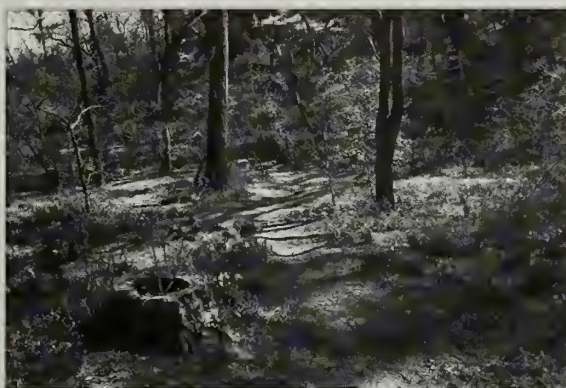
*Figure 57 There are many worn paths that visitors use along the north bank, April 1, 1997. NCR, Photo Archive, DOP 2-29a.*

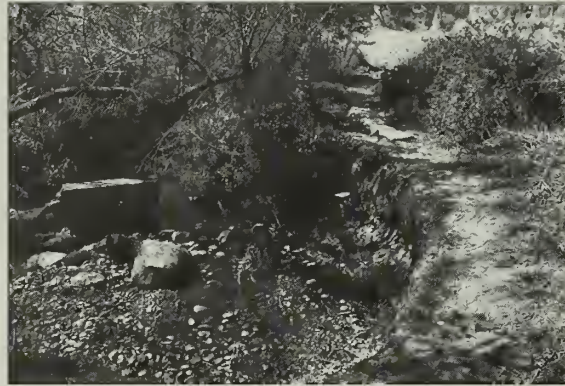
*Figure 58 Upper stream path eroded away by meandering stream channel, April 1, 1997. NCR Photo Archive, DOP 2-12a.*

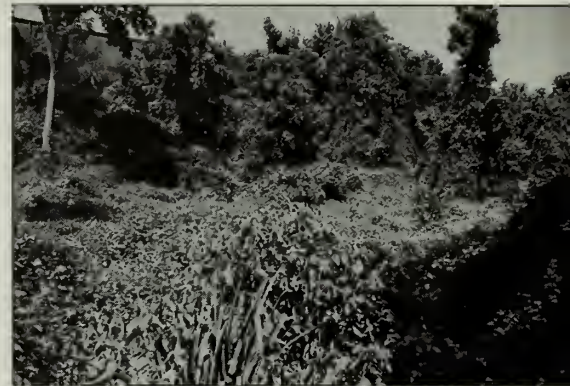
*Figure 59 Multiflora rose covered by vines, blanket most of the upper stream valley, July 11, 1997. NCR, Photo Archive, DOP 7-16.*

From Clapper Bridge Falls, the stream path (the “upper stream path”) continues upstream along the foot of the fifth meadow before entering an area heavily overgrown with invasive vegetation. The path runs through dense shrub and vine growth along the northern bank of the stream. This section of trail was severely eroded and washed out in one area near dam #16, one of the Jungle Falls. Once past the last Jungle Falls, the vegetation changes drastically. Invasive shrubs and vines run rampant, blanketing the stream valley and the opposite side of the stream, including the steep slope behind the retail development (the Safeway grocery store) which fronts on Wisconsin Avenue.

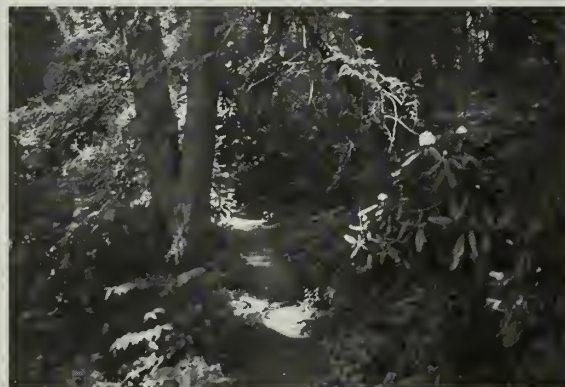
The path then leads to a fairly dense woodland, identified in this report as “the designed woodland.” The first section of the path through the woods is still lined by overgrown rhododendrons and passes by the small island, or “Islet,” which Farrand seems to have formed in the course of the stream. Beyond this first section of the designed woodland path, a secondary path breaks off to the west, following the stream and ending abruptly when the stream course curves to the south.

*Figure 60 A path cuts through a plantation of overgrown rhododendrons into the designed woodland, July 11, 1997. NCR, Photo Archive, DOP 7-18.*

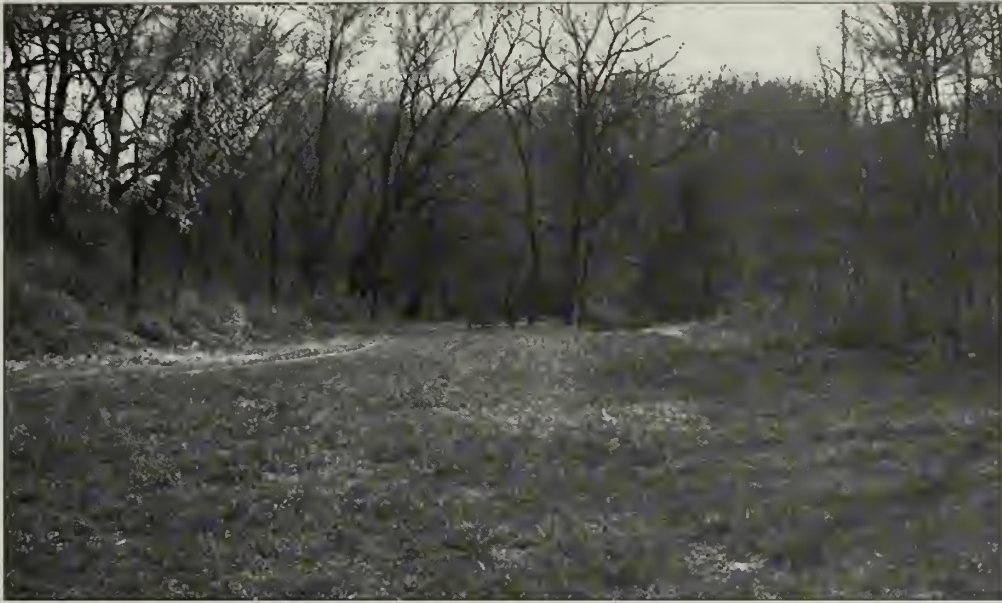
Figure 61 A view of the westernmost meadow looking back toward the Stream Arbor, April 1, 1997. NCR, Photo Archive, DOP 2-20a.

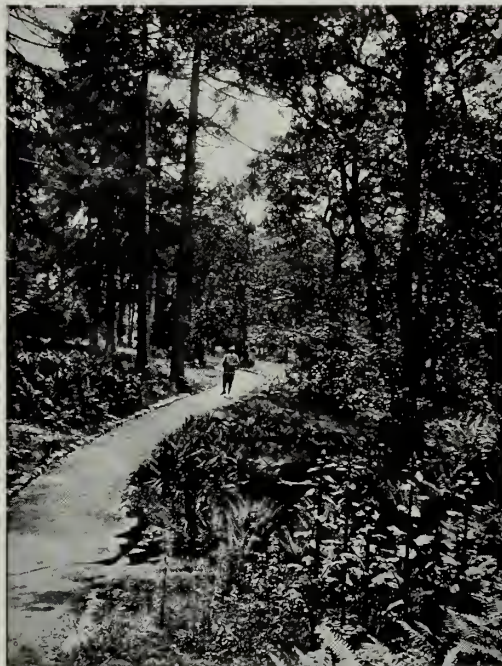
Mawson suggested various means of developing views and of facilitating circulation around a property. He recommended treating woodland walks with a border of rough stones, and planting larger trees on the brow of a hill, with smaller shrub plantations in the hollows, making use of the natural bays and swells of a landscape.<sup>221</sup> At Dumbarton Oaks Park, Farrand placed shrub masses in natural ravines. She chose a site for the statue, the “Unicorn Lady,” that was immediately south of a hill, the top of which she planted with gray birch trees (*Betula populifolia*), thus augmenting this natural feature with plantings that drew attention to the sculpture.

Figure 63 Farrand may have been inspired by Thomas Mawson's treatment of vegetation along a woodland walk at Mount Stuart on the Isle of Bute. Illustration No. 62 from Mawson's *The Art and Craft of Garden Making* (New York: Chas. Scribner's Sons, 1901 rev. edition).

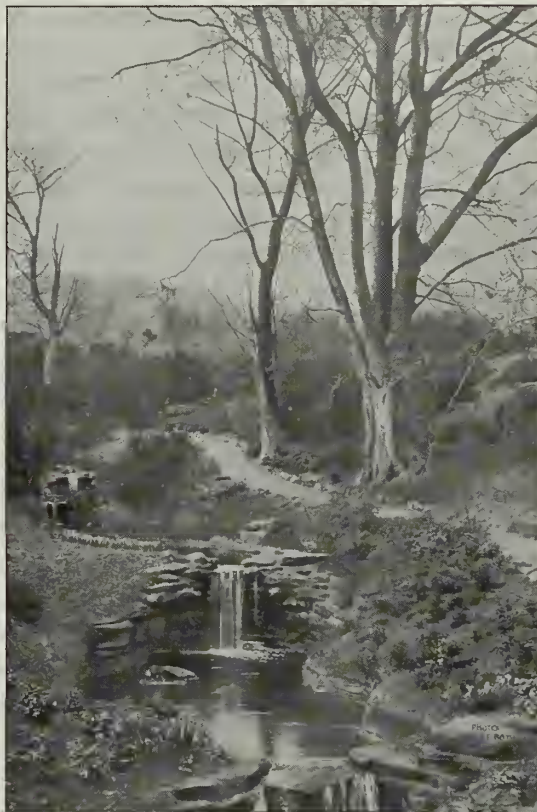
Figure 64 Waterfalls and path at Mount Stuart Estate designed by Thomas Mawson on Isle of Bute. From Thomas H. Mawson, *The Art and Craft of Garden Making* (New York: Chas. Scribner’s Sons, 1901 rev. edition): Illustration No. 32.

Farrand constructed a series of 18 waterfalls and three pools along the stream, making it the primary design feature of the naturalistic garden. In addition, she incorporated a natural falls between the Three Bridge Falls and the Three Sisters Falls. Farrand wrote: “While, of course, the stream is in no way a really natural brook, it should have a certain eighteenth century quality of the naturalistic, which can be preserved by intelligent management and without much cost of plant material.”<sup>313</sup> Some of her modifications may have been influenced by the work of Thomas Mawson or others.<sup>314</sup> (See *Figure 64*.)

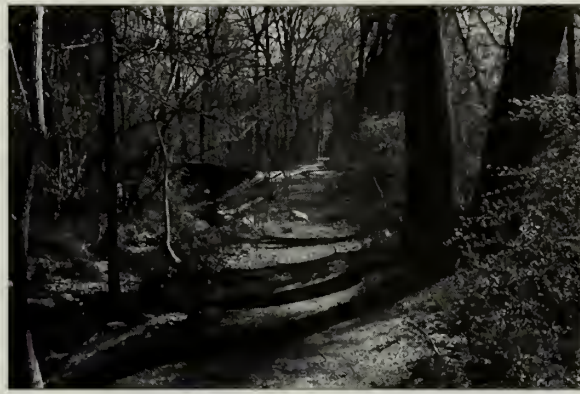
Figure 65 A distinctive double sycamore tree marks where the Forsythia Dell path meets the south stream path, April 1, 1997. NCR, Photo Archive, DOP 1-22.

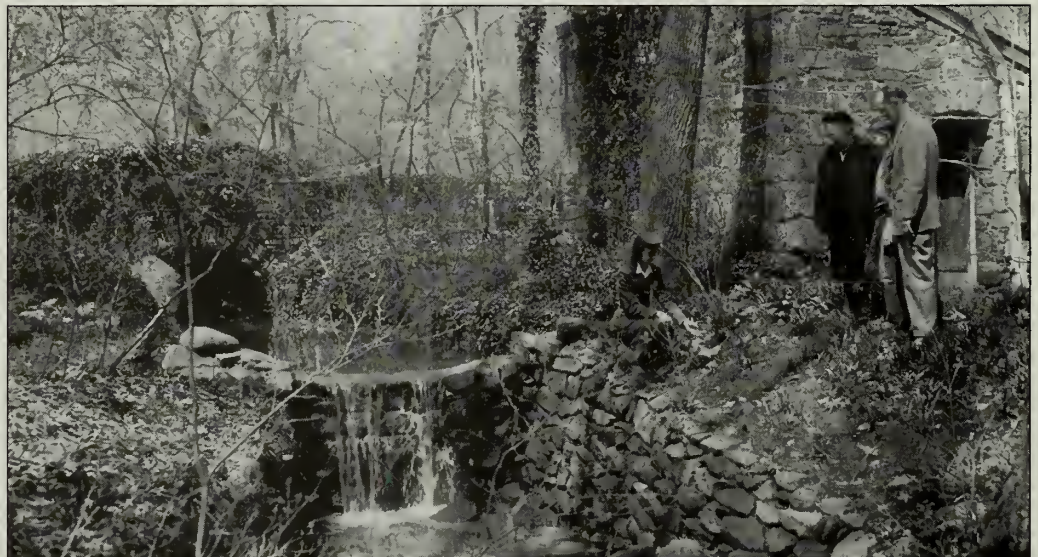
Farrand’s use of existing structures in the design of Dumbarton Oaks Park reflects her knowledge of Arts and Crafts garden design, in which new or existing structures are made to appear part of the historic fabric of the landscape. Arts and Crafts garden theory recommended growing plants on structures to soften their contours and help them blend in with their surroundings. Farrand grew English ivy (*Hedera helix*) on both the stone bridge and the Old Stone Pump House, and used various vines to cover the Gray memorial arbor and the Stream Arbor.

Figure 67 View of the Old Stone Pump House and stone bridge covered in English ivy, April 16, 1961. Photo by Abbie Rowe. ROCR, #6516-A.

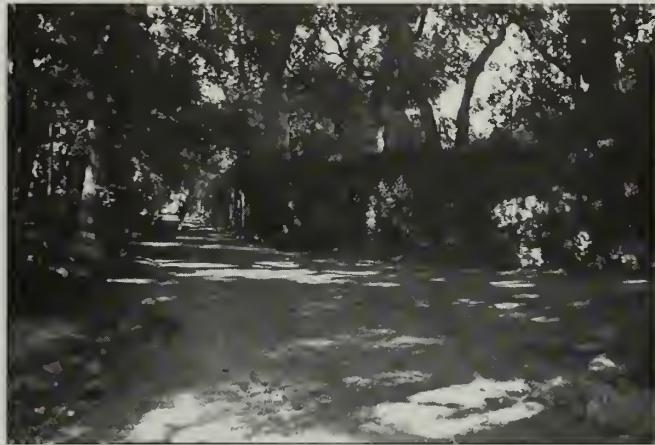
Figure 68 Looking up the corridor from the base of Lovers' Lane, July 11, 1997. NCR Photo Archive, DOP 5-23a.

upper gardens. Defined on the west by the high stone retaining wall of Dumbarton Oaks Gardens, and on the east by the low fieldstone wall of Montrose Park, Lovers' Lane had a relatively formal appearance. Trees in the bordering garden and park lined the route and arched above the road, creating a tunnel-like enclosure. Along the base of the retaining wall was the innovative gutter system that was probably designed by Farrand (see *Small Scale Features - Drainage* for complete description).

Many layers of asphalt have been added to the road. Both walls and the gutter suffer from various degrees of damage. The gutter is also choked with invasive vegetation.

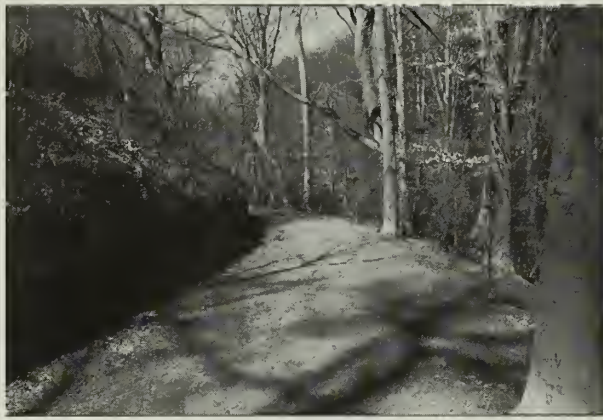
Beginning at the Lovers' Lane Entrance, Farrand adapted an old farm road that led through a grove of American beech trees. To create a sense of enclosure, she supplemented the existing tree canopy with understory shrubs on the north, and added the retaining wall on the south. The experience of arrival at the park

Figure 69 The Beech Grove lacks an understory to enclose the corridor, April 1, 1997. NCR, Photo Archive, DOP 1-10.

entrance has changed because of the loss of horizontal and vertical elements and of defined path edges.

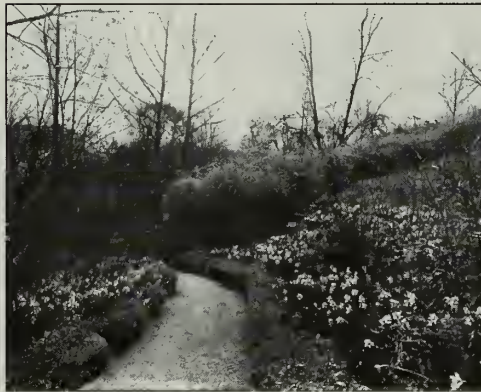
Figure 70 Looking east where the south stream path follows along the base of the southern slope and the forsythia plantation, c. 1932. DOSLA, Photo Archive, #13.39.

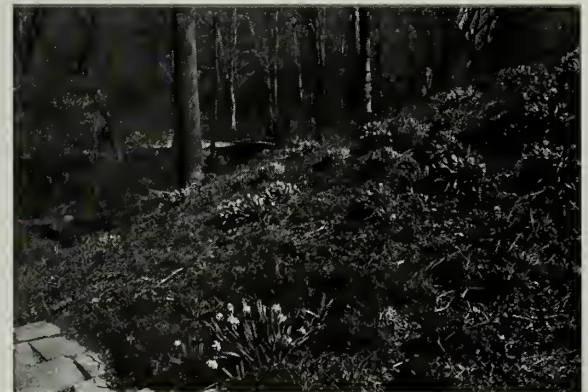
Figure 71 Clumps of daffodils were uncovered when the hillside along the Forsythia Steps was cleared in the spring of 1997, April 1, 1997. NCR Photo Archive, DOP 1-23.

This area was one of the most intricate and diverse sections of the park, but uncontrolled vegetative growth has compromised its integrity. The planting layout in relation to three of the paths has been lost (the exception being the Forsythia Steps), and the major portion of the southern slope is now covered by an impenetrable vegetative barrier. Physical connections with the upper gardens no longer exist, and it is difficult to visualize that the two areas were originally one. In 1996, 1997, and 1998, volunteer work groups from the Friends of Montrose and Dumbarton Oaks Parks, college students performing court-ordered community service, and NPS staff removed non-contributing vegetation from Forsythia Hill. Plans are currently underway to restore the forsythia massing.
