# CULTURAL LANDSCAPE REPORT: Dumbarton Oaks Park, Rock Creek Park

National Park Service

Part I: Site History, Existing Conditions, and  
Analysis and Evaluation

August 2000

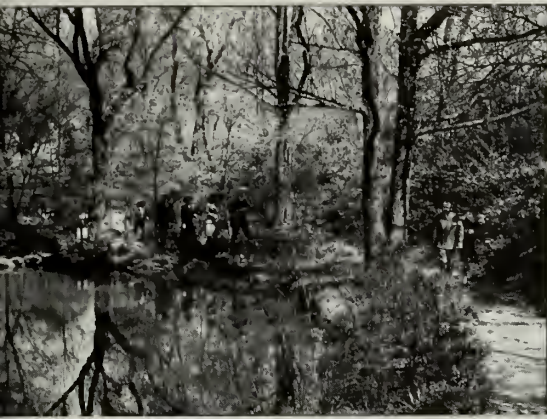
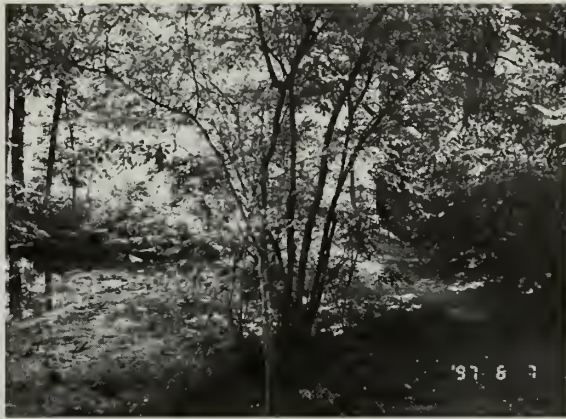
Figure 72 View of Laurel Pool and visitors enjoying the springtime appearance at Dumbarton Oaks Park, 1945. ROCR, Photo Archive, #137-AF.

Figure 73 View from same vantage point as 1945 image, showing the siltation of the pool, June 7, 1997. NCR, Photo Archive, DOP 9-3.

Since its initial development, much of the vegetation in this area has been lost or overgrown, and badly damaged by erosion of the stream banks. The majority of the garden rooms are now overgrown and fragmented, destroying the sense of progression and the intimate scale of the spaces. Areas that were once more open, forming a contrast to the garden rooms, no longer exist. As a result, it is difficult to perceive the rooms and passages as separate spatial entities, and intended views and vistas from one area to the next have been lost.

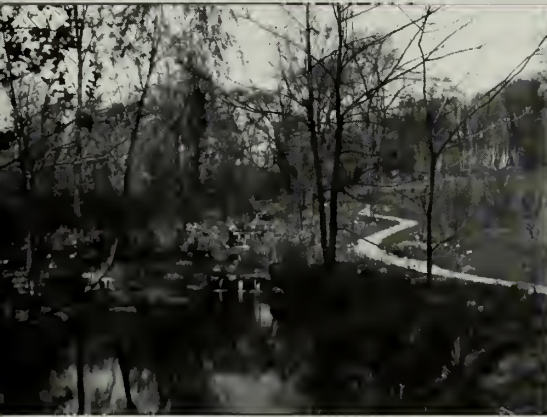
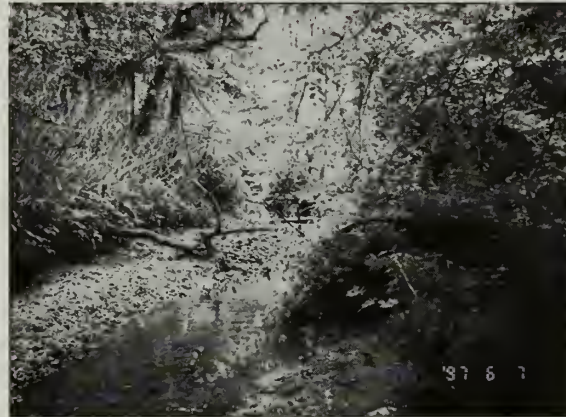
Figure 74 There is a change in character in the stream path after crossing over the Clapper Bridge crossing, c. 1935. DOSLA, Photo Archive, #13.13.

Figure 75 Invasive vegetation now blocks this same view from the Clapper Bridge Falls to the upper stream valley, June 7, 1997. NCR, Photo Archive, DOP 9-13.

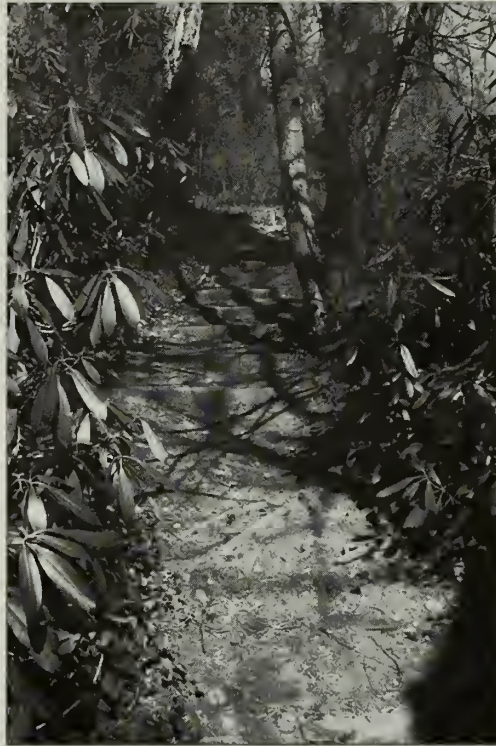
Figure 76 Last original path still in use in the designed woodland, April 1, 1997. NCR, Photo Archive, DOP 2-17a.

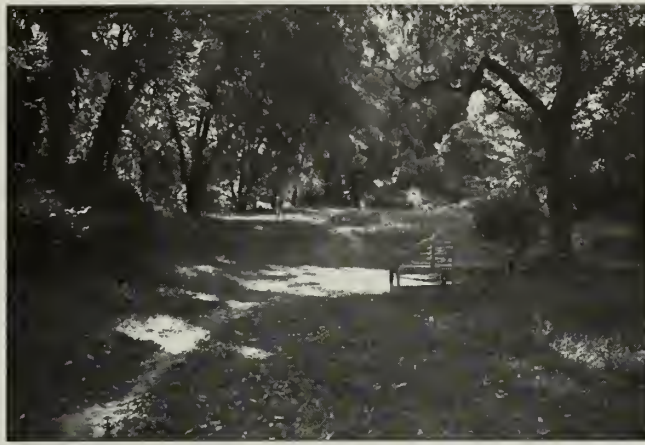
The meadows' integrity has been compromised by the encroachment of woody vegetation, which has altered their scale and disrupted the sense of enclosure. For example, in the largest meadow, a grouping of three black walnut trees (*Juglans nigra*), a euonymous shrub (*Euonymus* sp.; planted by the NPS) and a wooden bench (placed there by the Friends group in 1992) separate the meadow into two discrete spaces, destroying its expansiveness. Woodland has invaded all five meadows, diminishing their size.

*Figure 77 A bench placed in the middle of the largest meadow, destroys the expansiveness that Farrand envisioned, August 1997. NCR, Photo Archive, DOP 42-32a.*

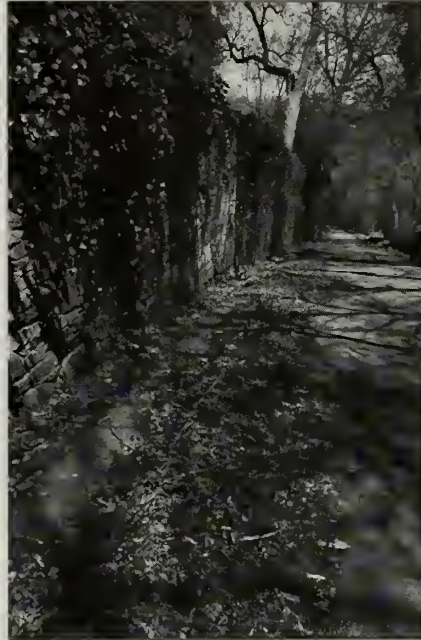
Figure 82 Dumbarton Oaks Garden retaining wall and gutter along Lovers' Lane, April 1, 1997. NCR Photo Archive, DOP 1-2.

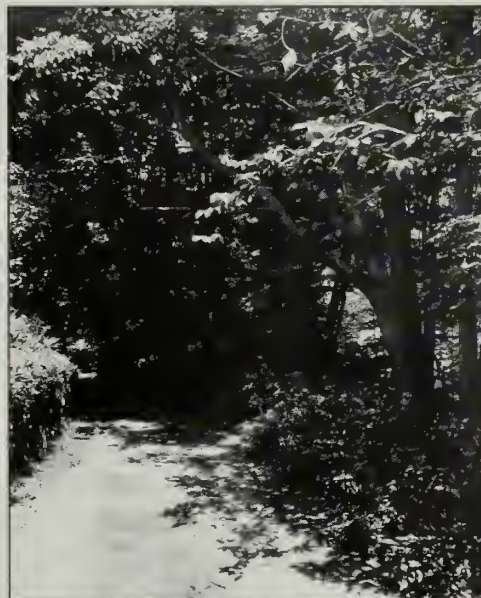
Figure 83 Beech Grove corridor as it appeared in the summer of 1932. DOSLA, Photo Archive, #13.27.

The present condition of the Beech Grove path is poor. Vehicular and pedestrian use have caused the path corridor to become ill-defined. The path has been widened to ten feet and has lost its original sweeping curves. The small flight of steps, constructed of railroad ties with rounded stones at the sides, still leads down the south bank to the stone platform at the East Falls.

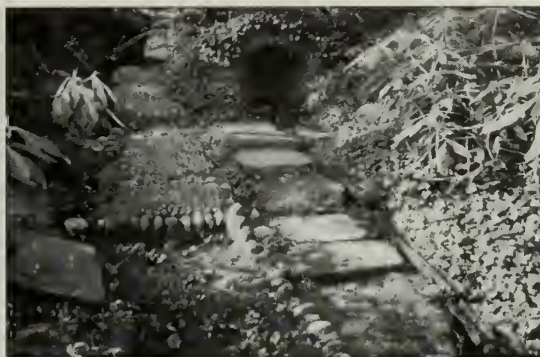
No evidence of this path remains on NPS property, but a portion is visible in the upper gardens. Visitors now walk up the pebble stream to see the upper culvert, a small half-dome structure made out of rounded river stones, a practice that is unsafe because stormwater has undermined the concrete slab of the pebble stream. This has caused a section of the structure to collapse (see *Structures, Spring Grotto and Pebble Stream* for further description).

Figure 88 Eroded pebble stream now used by some visitors as a path, April 1998. NCR, Photo Archive, DOP 34-22.

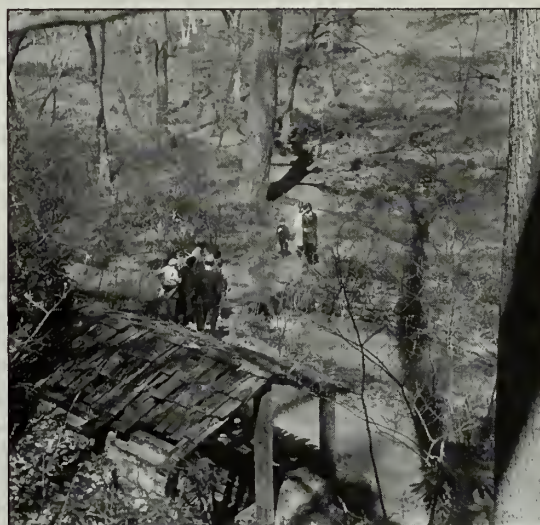
Figure 89 Looking down hill to the Old Pump House and Old Water Wheel Falls ford crossing where it joins the north stream path, April 16, 1961. ROCR, Photo Archive, #6516-C.

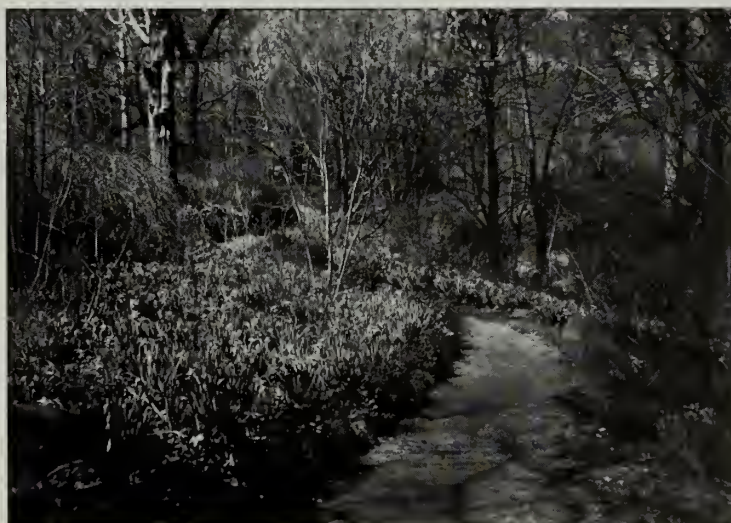
Figure 90 Serpentine character of lower stream path, c. 1935. DOSLA, Photo Archive #13.29.

stones were used in two separate sections of the south stream path: from the stone bridge to the Laurel Pool and from the spring grotto to the Clapper Bridge Falls (see *Small-Scale Features, Edging and Marker Stones* for further information on the river stones). Farrand laid out the stream path in a gently winding two- to three-foot wide course. The flowing form encouraged movement. Occasionally a short, sharp rise or threshold occurred at the entrance to an outdoor room, an effect Farrand used several times. The first such grade change occurred at the south end of the stone bridge, where three steps constructed of railroad ties and stones led down to the beginning of the path. In two other locations, the Laurel Pool and the spring grotto, the path sloped up to the next room. In the latter case, to the west of the Old Pump House, the path led up three rough-cut fieldstone steps and around a tulip poplar; on the far side of the tree, the path joined the pebble stream of the spring grotto. A stone was set into the pebble stream at the point where the stream path met the channel to provide a crossing for visitors.

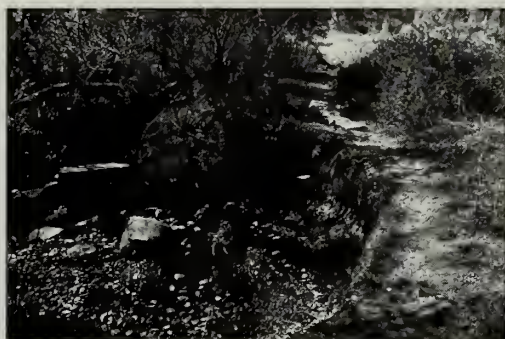
The present condition of the stream path is poor. In most sections, though the path still exists, its integrity has been compromised by four factors: visitor use, water damage, improper maintenance, and neglect. These have damaged or destroyed its character. Unregulated use, from mountain bike riding to dogs running unleashed, has created many social trails and worn areas throughout DOP, especially along the stream corridor. This is particularly evident along the south side of the Laurel Pool, where the area has been denuded of vegetation. Stormwater flooding and excess surface water runoff have also had a detrimental impact on the stream path. Portions of the lower and upper stream paths have been washed out. The most visible damage has occurred in an area along the upper stream path where the bank was almost entirely eroded away, leaving a dangerous five-foot drop-off by the path; in the summer of 1997, this area was stabilized with sandbags by a Student Conservation Association crew.

*Figure 93 Eroded stream path by the first Jungle Falls, April 1, 1997. NCR Photo Archive, DOP 2-12a.*

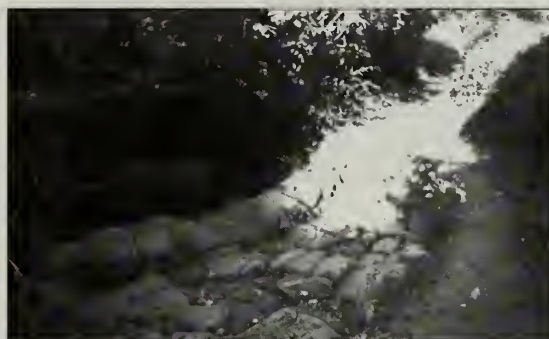
*Figure 94 In the summer of 1997, eroded path and the stream bank were stabilized by the Student Conservation Association, August 1997. NCR, Photo Archive, DOP 42-14a.*

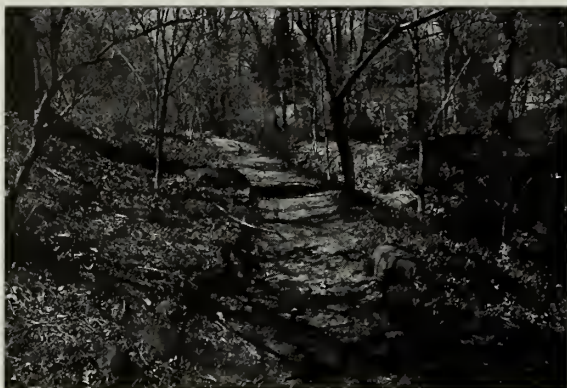
Figure 95 The stream path has retained its character between the Forsythia Steps and the Gray arbor memorial, April 1, 1997. NCR Photo Archive, DOP 1-25.

There are three sections of the stream path where the historic character has remained intact: from the base of the Forsythia Steps to the Laurel Pool, from the West Laurel Falls to the Old Water Wheel Falls, and from the spring grotto to the Clapper Bridge Falls. The path in these areas still retains its five-foot width. The edging of river stones remains in its historic location from the Forsythia Steps to the entrance of the Laurel Pool area, and then from the spring grotto to Clapper Bridge Falls.

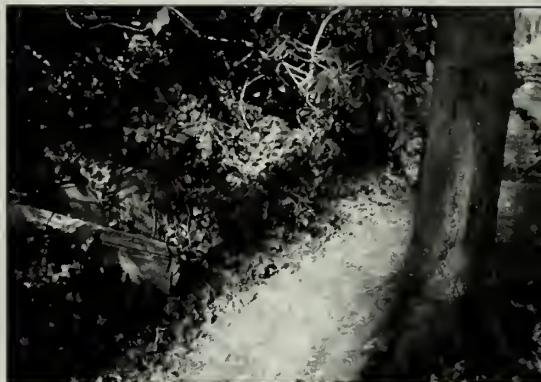
Figure 96 The original character of the stream path is also evident between the spring grotto and the Stream Arbor, April 1998. NCR, Photo Archive DOP 34-24.

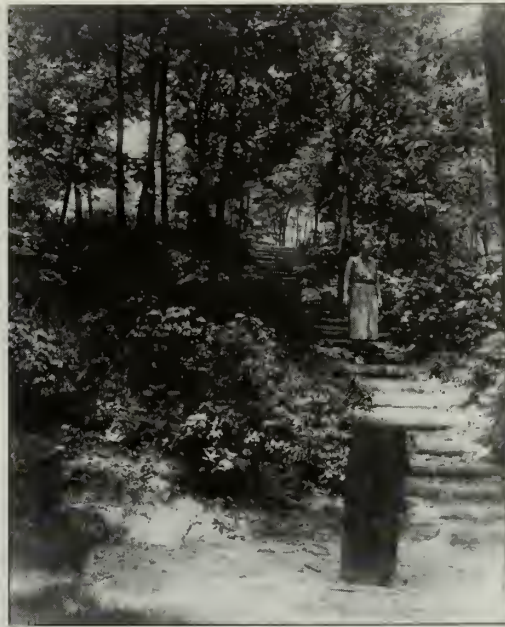
*Figure 97 Character of railroad tie and stone steps going through the uppermost portion of the designed woodland, 1961. ROCR, Photo Archive, #6516-B.*

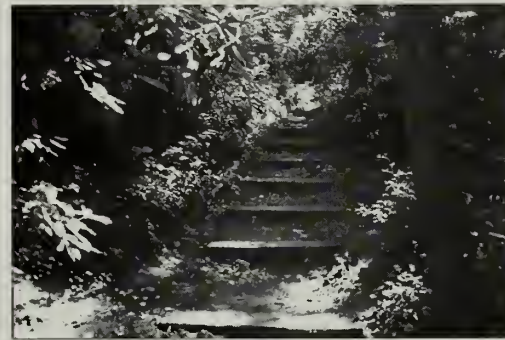
Only one section of the original woodland path is used currently, leading from the Islet through the designed woodland and exiting near the Animal Graveyard. There are remnants of the northernmost woodland path, such as stepping stones and railroad ties, but it is no longer used. Numerous social trails have replaced the original grass tracks. Two new trails enter DOP: one begins on the western boundary from Whitehaven Street and connects with the path by the Islet, and the other leads from the northern boundary on Whitehaven Street to the top of the old farm track. The former connects trails in Glover Archbold Park and Rock Creek Park and is maintained by the Potomac Appalachian Trail Club. The access point on the western boundary is used frequently by visitors and has altered Farrand’s original intent for the circular walk. Two other worn trails lead up the slope to a temporary structure built by a homeless man, situated 50 yards from the property line of the Naval Observatory.

*Figure 98 Only remaining path in designed woodland showing railroad tie steps up the hill, July 11, 1997. NCR, Photo Archive, DOP 7-14.*

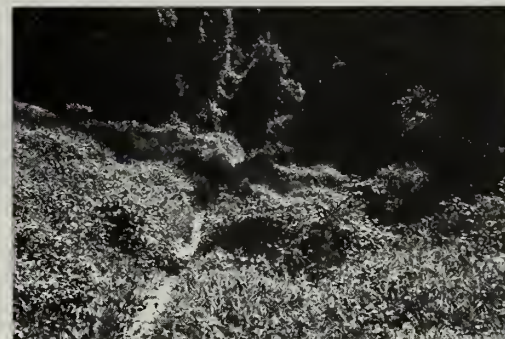
*Figure 99 Worn path from Whitehaven Street entering Dumbarton Oaks Park through the western boundary fence, July 11, 1997. NCR, Photo Archive, DOP 7-20.*

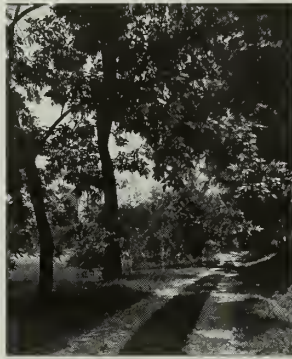
Figure 101 Well worn farm track as it appeared in April 1997. NCR, Photo Archive, DOP 2-26a.

Though it still follows its original alignment, the character of the road has changed. In the early years of the naturalistic garden, the farm track had a grass strip down the middle with worn tracks on either side, retaining its rural character. Today, only the mid-section of the route retains this character. The surface of the upper and lower portions of the road is now a mixture of compacted gravel, dirt, and sand.

Though the NPS has repaired road damage over the years, it has failed to recognize the importance of keeping the original character. The short track to the north of the Old Stone Pump House is still evident, though it is narrower than it was.

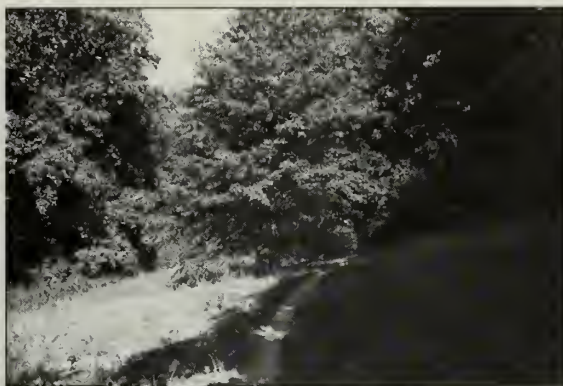
A sign plan from 1966 suggests that the NPS tried to limit the wearing of paths through the meadows by placing signs instructing visitors to stay on the designated paths. In many respects, the social trails that now cross the fifth meadow reflect the current usage of the park. The wooden bench placed in the middle of this meadow in 1992 interrupted the vista and obscured Farrand's design intent. Because of its location, worn trails were cut through the meadow to the bench. A wooden platform still spans an intermittent stream to provide a dry crossing from the fifth meadow to the old farm track. (See *Small-Scale Features, Pedestrian Bridges*) Because of encroaching woodland, the eastern portions of the Clifton Hill Walk no longer follow what is presumed to have been their intended alignment; instead, the walk now cuts through two of the meadows down to the farm track, rather than following the upper portion of the hill in a more aesthetically pleasing manner and linking the northern woodland path with the stone bridge.

*Figure 102 Clifton Hill Walk as it crosses through the fourth meadow, August 1997. NCR, Photo Archive, DOP 41-22.*

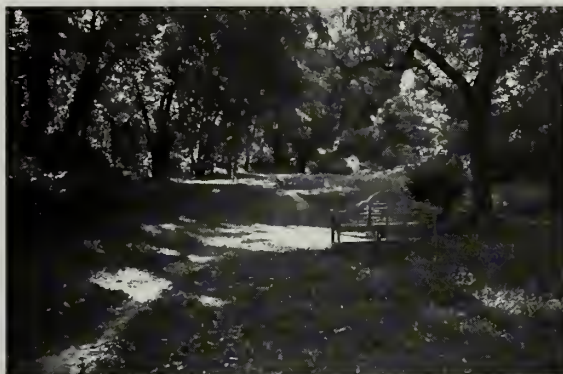
*Figure 103 Worn path going to bench in the middle of the fifth meadow, August 1997. NCR Photo Archive, DOP 42-32a.*

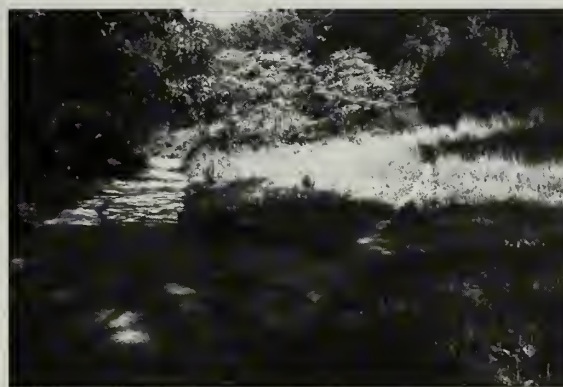
*Figure 104 New segment of the Clifton Hill Walk cutting down through second meadow to the farm track, July 11, 1997. NCR, Photo Archive, DOP 6-10.*

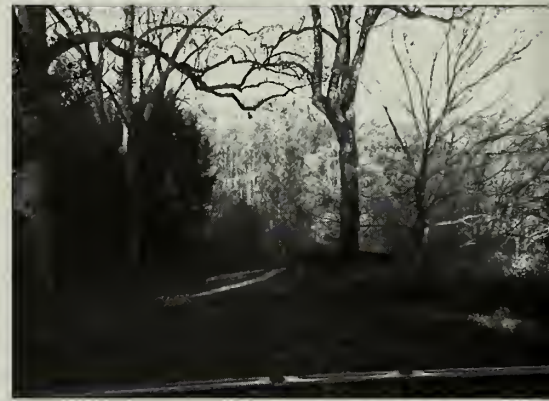
Figure 105 Panoramic view #1 from the Green Garden of the gardens, July 9, 1997. NCR Photo Archive, DOP 4-25.

Figure 106 View #2 from the balcony at the end of the North Vista to the stream valley, December 1998. NCR, Photo Archive, DOP 45-13.

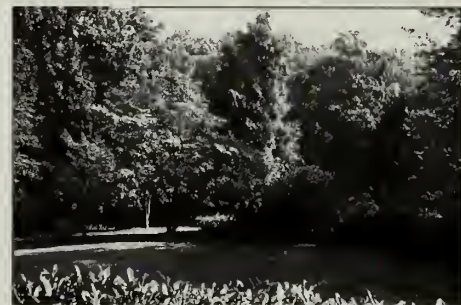
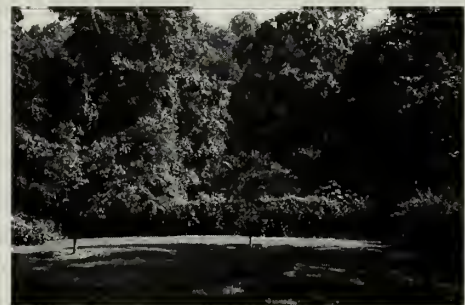
Figure 108a&b Views from benches below North Vista to a canopy of trees and Clifton Hill in the background, July 9, 1997. NCR, Photo Archive, DOP 3-2 (view #4a) and 3-14 (view #4b).

Though some panoramic views between the garden and park are impeded by vegetation growth on the boundary fence, most are still evident. In some areas, sapling trees from the Farrand period which were once understory planting are now mature specimen trees that either filter or obscure views into the stream valley. Modifications in the plant palette of the upper gardens have also led to certain

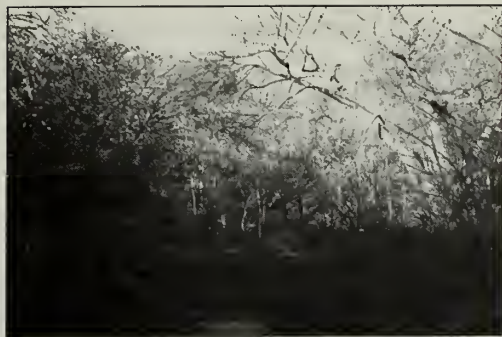
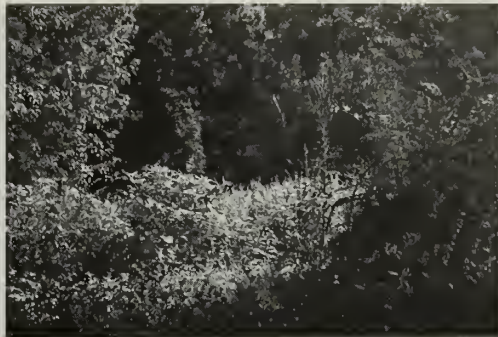
Figure 109 Vista #5 from bottom of Plum Walk to the valley above the stone bridge, December 1998. NCR, Photo Archive, DOP 46-14a.

Figure 110 View #6 from the Ellipse down to the stream valley. Large pyracantha shrub on right hand side of photograph starting to block view to valley, July 9, 1997. NCR photofile DOP 3-20.

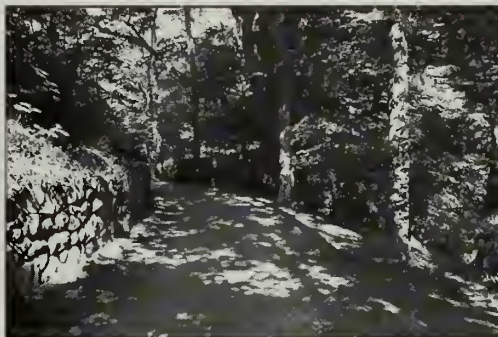
Figure 111 First glimpse of stream valley from Lovers' Lane Entrance gate (view #7), August 1997. NCR, Photo Archive, DOP 40-2a.

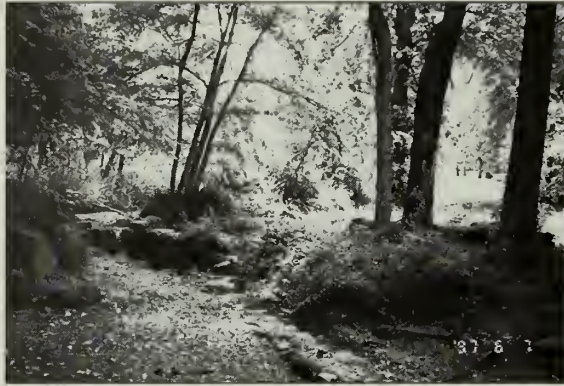
Figure 112 View # 8 from Stream Arbor up the fifth meadow, June 7, 1997. NCR, Photo Archive, DOP 9-16.

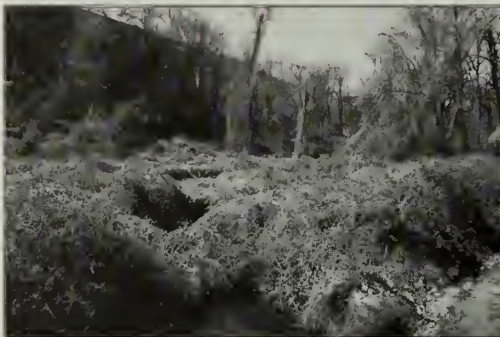
Figure 113 Non-contributing view #1 from the upper stream path to the rear of buildings along Wisconsin Avenue, April 1, 1997. NCR, Photo Archive, DOP 2-14a.

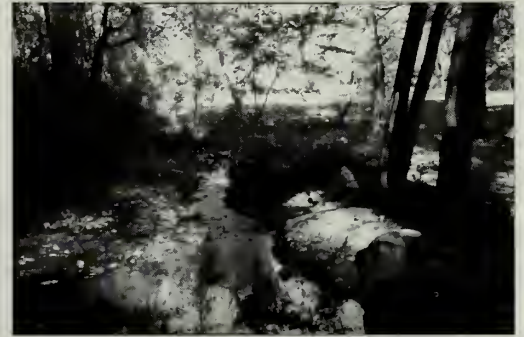
Figure 114 Existing view #9 from Clapper Bridge Falls blocked by woody vegetation that encloses the view up the stream, October 1998. NCR, Photo Archive, DOP 53-7.

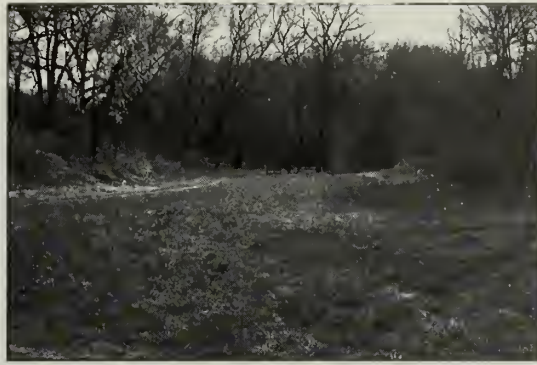
Figure 115 Trees and bench blocks view #10 from the top of the fifth meadow to the Stream Arbor, April 1, 1997. NCR, Photo Archive, DOP 2-20a.

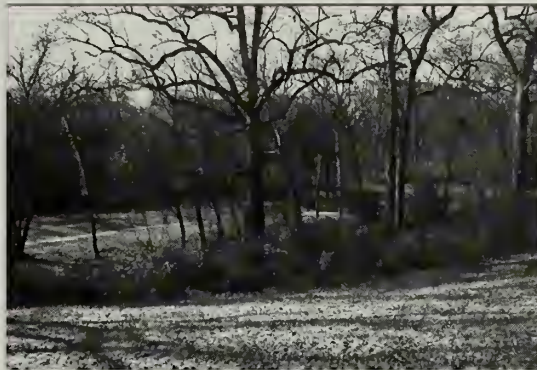
Figure 116 View #11 from fourth meadow into the fifth meadow, December 1998. NCR photofile DOP 49-23

The old farm track is now lined by scrubby woody and herbaceous vegetation, which limits the views to the meadows and stream. Views from the benches along the farm track are no longer evident, since scrubby growth has invaded the edges of the meadows. The Clifton Hill Walk still permits views back down to the stream valley, but invasive growth along the lines of trees separating the meadows has restricted the view zone.

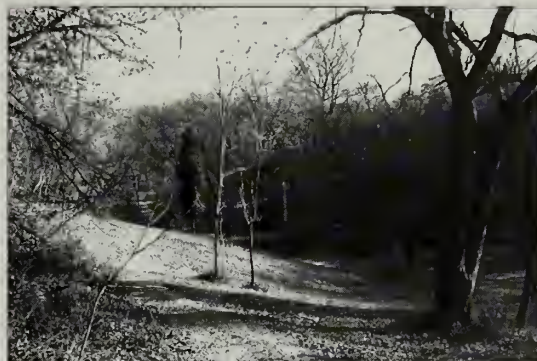
Figure 117 View #12 from the Clifton Hill Walk down to the stream valley, December 1998. NCR, Photo Archive, DOP 49-19.

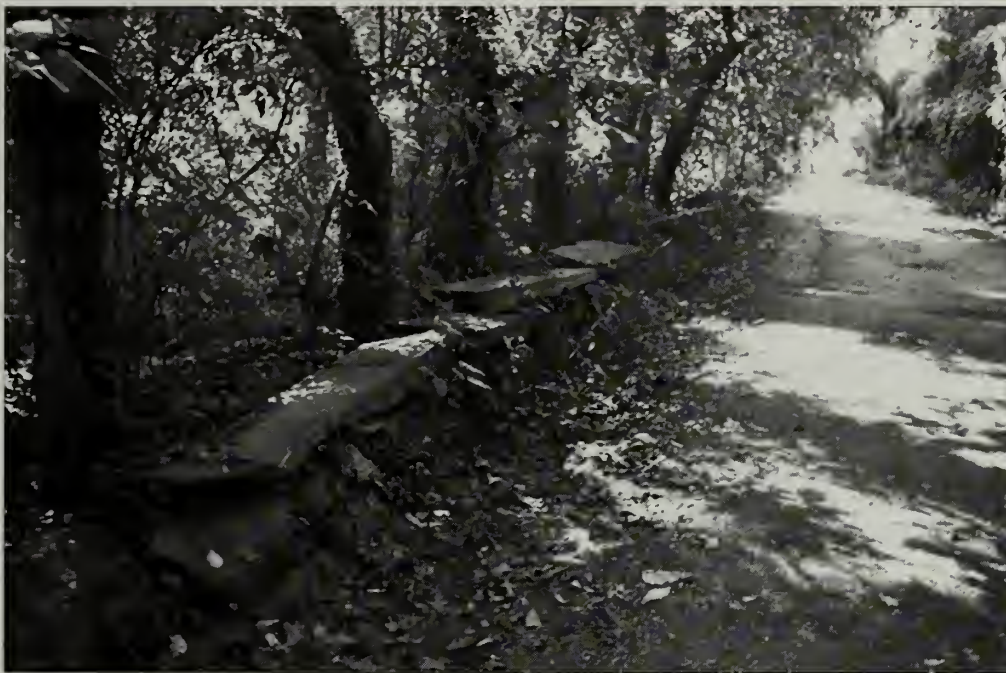
*Figure 118 Mature Osage-orange trees line the eastern side of Lovers' Lane, August 1997. NCR, Photo Archive, DOP 40-11*

Because the corridor is owned by three different jurisdictions—eastern boundary, the National Park Service; road surface, the District of Columbia; and western boundary, Harvard University—the entire corridor has not been maintained in a consistent manner. English ivy and Japanese honeysuckle vines drape over the stone walls along with invasive herbaceous vegetation, softening the appearance of the wall as Farrand had intended. But this same vegetation also clogs the drainage channel. The row of Osage-orange trees along the Montrose Park wall are now overgrown, no longer forming a hedge as they did when they were originally planted in the early 1900s.

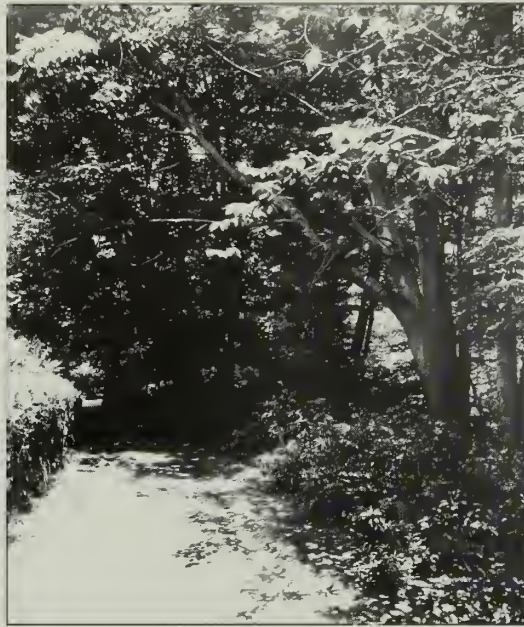
Figure 119 Dense mountain laurel understory and canopy of American beech trees define character of corridor, summer 1932. DOSLA, Photo Archive, #13.27.

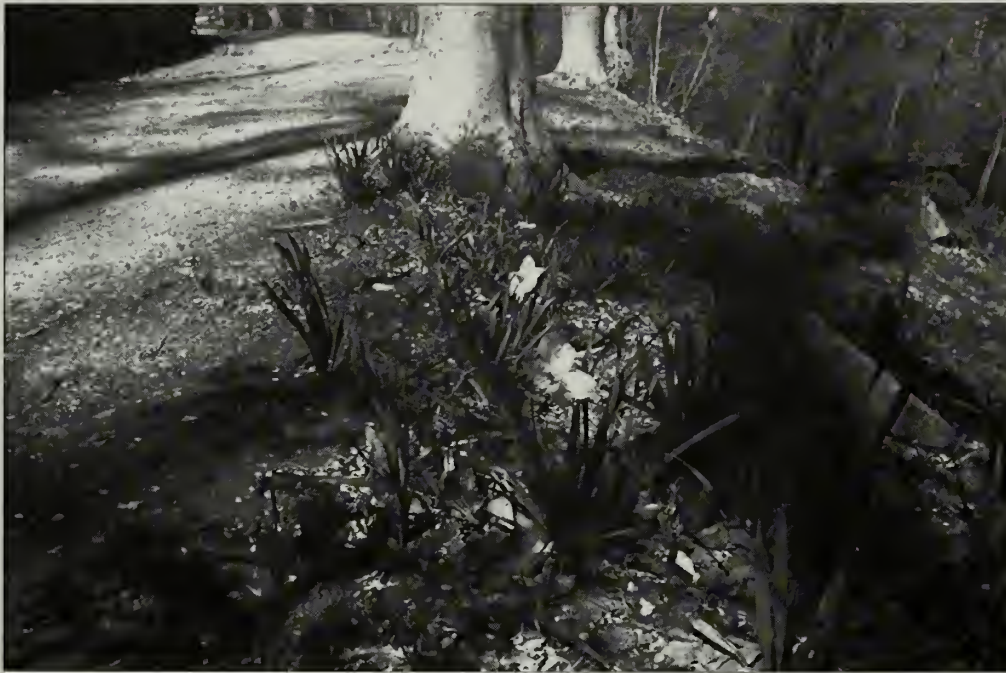
Figure 120 Daffodils bloom beneath the open understory of American beech trees, April 1, 1997. NCR, Photo Archive, DOP 1-11.

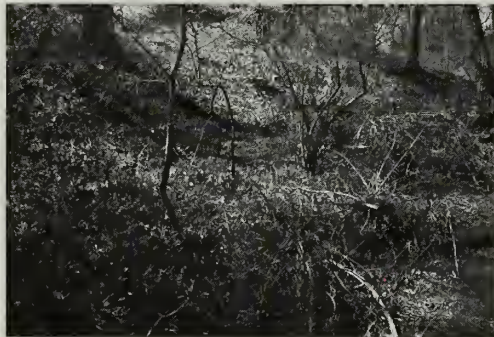
Figure 121 Spring bulbs blooming to the south of the stone bridge, April 1, 1997. NCR, Photo Archive, DOP 1-18

Today, boxelder, black cherry, and Norway maple form a dense overhead canopy, altering Farrand's design. A scrubby invasive growth now dominates the shaded understory, resulting in the loss of filtered views and disturbing the careful balance Farrand sought to achieve between the different types of vegetation. Garlic mustard (*Alliaria petiolata*), porcelain berry (*Ampelopsis brevipedunculata*), jewelweed

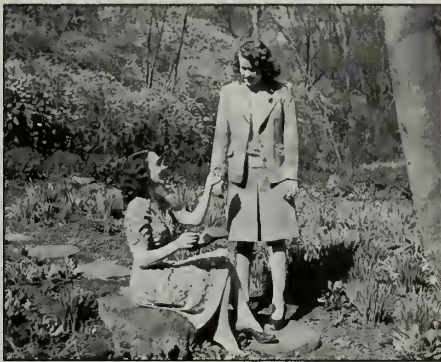
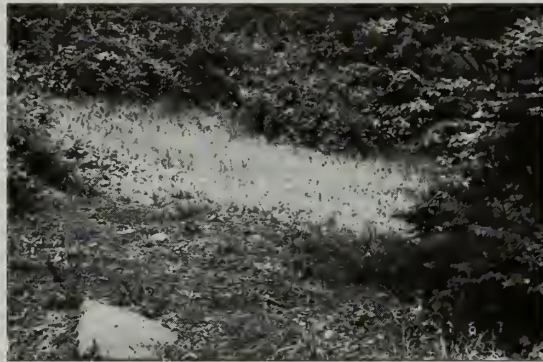
Figure 122 Bottom of Forsythia Hill at the base of the sentinel sycamore tree, March 23, 1945. ROCR, Photo Archive, #431-F.

Figure 123 Same vantage point as Figure 121 showing condition of vegetation on June 7, 1997 (the same stone is in the foreground). NCR, Photo Archive, DOP 8-12.

This area is currently being restored. Its historic open character still remains, though the lack of an overhead canopy has allowed sun-loving invasive vines to replace the forsythia. A large mass of the original shrubs remains on the west side of the flight of steps and there are a few plants on the east side. An extensive layer of invasive groundcovers, including garlic mustard, Oriental bittersweet, English ivy, Japanese honeysuckle, poison ivy, wild grape, jewelweed, multiflora rose, and porcelain berry, prevents this area from reverting to woodland. Virginia bluebells and seven different types of daffodils still flower in spring, along with crocuses, glory-of-the-snow, squills, snowdrops, spring snowflakes, jack-in-the-pulpit, mayapples, violets, Spanish and English bluebells, and star-of-Bethlehem (*Ornithogalum umbellatum*). It is not known whether the flowering bulbs growing on the slopes

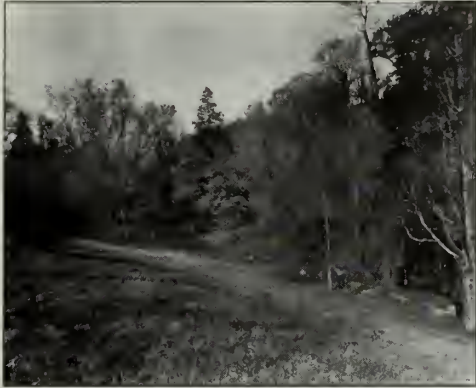
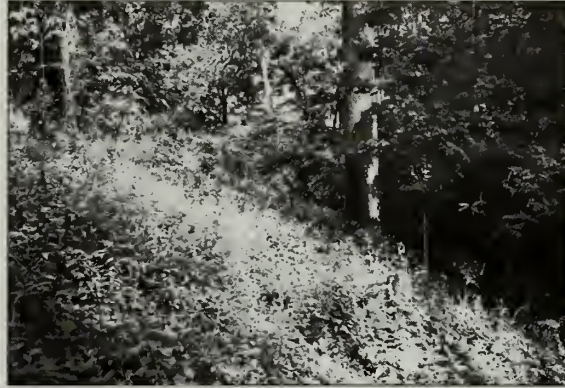
Figure 124 View of southern slope meadow to the west of Forsythia I, c. 1935. DOSLA, Photo Archive, #13.26.

Figure 125 Same vantage point as previous photo. The meadow is now covered by invasive vines and woody vegetation, June 7, 1997. NCR photofile DOP 8-18.

The open meadow from the Farrand period has been lost. Instead, a scrubby invasive growth of tatarian honeysuckle, Oriental bittersweet, porcelain berry, multiflora rose, Japanese honeysuckle, Japanese knotweed (*Polygonum cuspidatum*), pokeweed (*Phytolacca americana*), poison ivy, and garlic mustard has replaced the grassy meadow. In addition, the edges of the meadow are being invaded on the upper and western portions by black cherry, choke cherry, wild crabapple, box elder, and Norway maple. Poison ivy and Japanese honeysuckle vines covering the boundary fence also block reciprocal views between the upper and lower gardens. The Norway maple currently marking the top section of the meadow was “deplored” by Farrand. She recommended using a silver or sugar maple to replace it.<sup>289</sup>

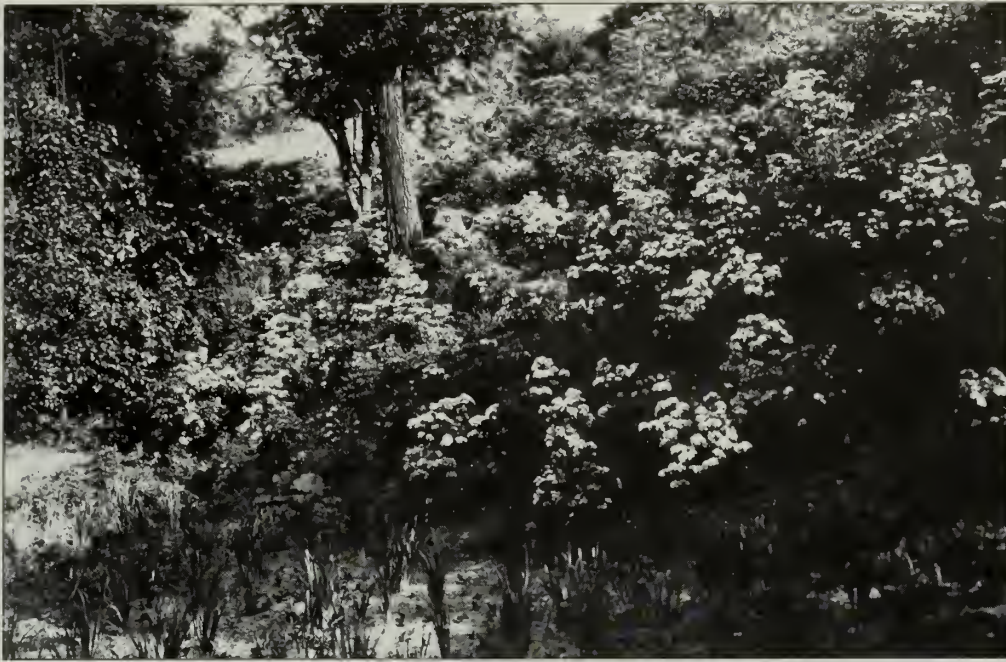
Figure 126 Mountain laurels in full bloom, soon after they were planted below the Hazel Walk, c. 1935. DOSLA, Photo Archive, #13.37.

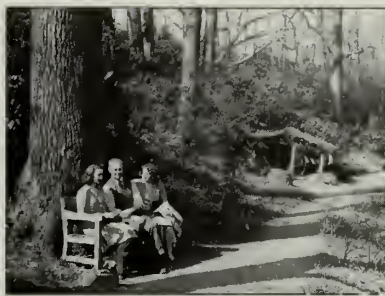
The rhododendrons now range in height from eight to eleven feet. In some cases they have spread beyond their original boundaries, narrowing the access for the stream path and blocking views of the spring grotto area. Even though the rhododendrons are larger and have spread to adjacent areas, this area still remains essentially intact, composed of deciduous and coniferous canopy trees, an understory of rhododendrons, and a groundcover of English ivy.

Figure 127 Rhododendron plantation on southern slope by Old Pump House, March 23, 1945. ROCR, Photo Archive, #431-E.

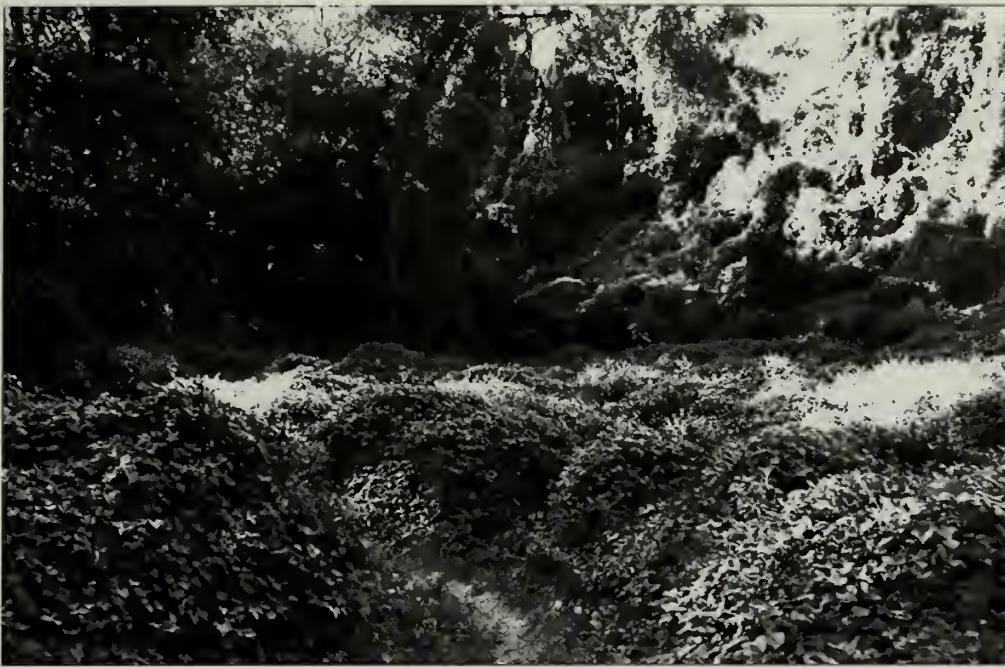
Figure 128 Invasive vegetation has strangled and killed the tree canopy in the upper stream valley. August 1997. NCR, Photo Archive, DOP 42-22a

This area is in very poor condition. Continued disturbance from adjacent properties has contributed to the demise of the woodland.<sup>294</sup> Because of its invasive growth habit, the bamboo has spread and naturalized beyond its original boundaries. Other robust exotics, such as multiflora rose, porcelain berry, wild grape, Oriental bittersweet, Japanese honeysuckle, English ivy, and tatarian honeysuckle, have decimated the woodland habitat and now cover the majority of this area. Vines threaten the very existence of the remaining trees, which include hemlock, beech, and tulip poplar. Instead of screening the intrusive development, the invasive plants now blanket the understory and allow clear views to the adjacent commercial buildings which front Wisconsin Avenue.

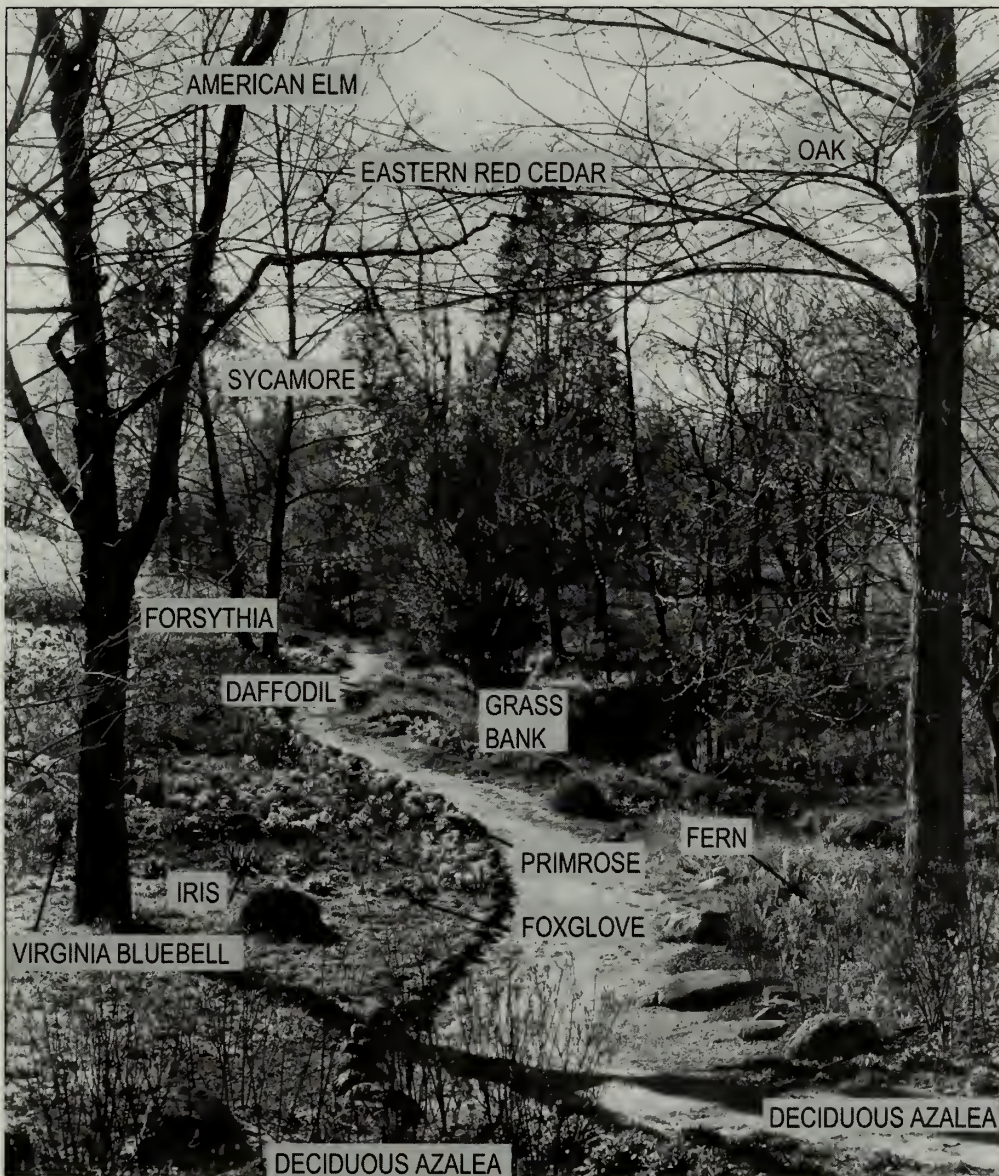
From the stone bridge to the Laurel Pool, the herbaceous planting extended four feet beyond either side of the stream path.<sup>297</sup> Farrand's possible thinning of the tree layer created an open appearance. Hemlocks grew among Eastern red cedars (*Juniperus virginiana*) for winter color. The understory included flowering dogwood and sweetbay magnolia. A swath of deciduous azaleas (*Rhododendron* sp.) planted at the beginning of the stream path next to the bridge created, in conjunction with the steps, a threshold entrance. On the south side of the path grew a mixture of ferns, English ivy, perennials, and bulbs, including foxgloves (*Digitalis* sp.), iris, primroses, bluebells, and daffodils. This drift continued west from the

Figure 129 Annotated photograph highlighting vegetation arrangement along the lower stream path, c. 1935. DOSLA, Photo Archive, #13.30.

stone bridge and was intermixed with clumps of grass. At the base of the Forsythia Steps, a sentinel sycamore tree marked the intersection with the south stream path. In this area, periwinkle trailed over the stone edging, softening the appearance of the path. Numerous drifts of primroses accentuated the location of log bridges and highlighted the stepping-stone path leading to the Forsythia Steps. In 1942, Farrand suggested to the NPS that they order up to 1250 primroses of the Munstead strain, but there is no information regarding where these might have been planted.<sup>298</sup>

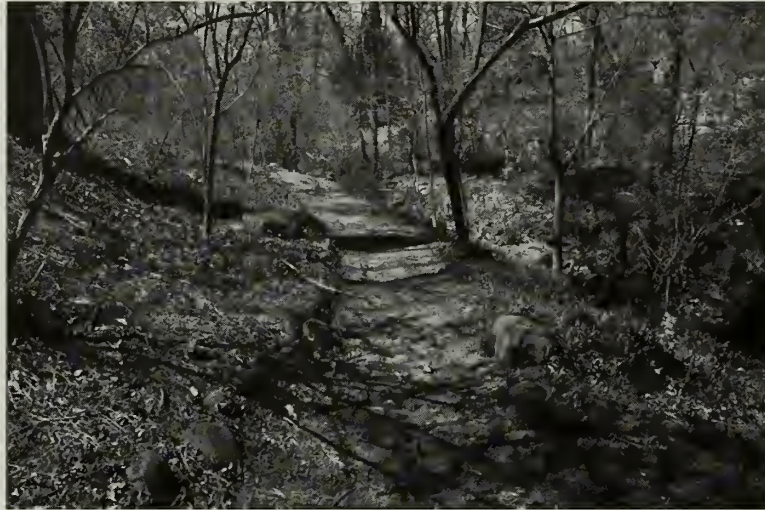
Figure 130 Many of the spring-flowering bulbs and herbaceous plantings remain in this area along the south stream path near the Gray arbor memorial, April 1, 1997. NCR, Photo Archive, DOP 1-25.

There is some design integrity left in this area. Even though many mature trees remain from the Farrand era, invading pioneer species of sugar maple, black walnut, and black cherry diminish the open woodland

character. The understory contains woody exotic invasive growth dominated by tatarian honeysuckle, spicebush, and various types of viburnum. Other possible remnant vegetation includes several dogwoods and magnolias (*Magnolia* sp.), and a Carolina silverbell (*Halesia carolina*). Major sections of the stream's south bank, from the stone bridge to the base of the Forsythia Steps, have been washed out, exposing the 1903 combined storm sewer. The small amount of remaining English ivy protects the stream bank from further erosion. In contrast to the tree and understory layers, quite a few perennials and bulbs survive from the original planting, including Virginia bluebells, jack-in-the-pulpit, Spanish and English bluebells, and daffodils. (However, the original locations of such plants are not precisely known.) Other invasive plants, including tatarian honeysuckle, garlic mustard, multiflora rose, Virginia creeper, wild grape, porcelain berry, and jewelweed, dominate the groundcover after the spring flowering. Japanese knotweed (*Polygonum cuspidatum*) and Japanese barberry (*Berberis thunbergii*) are now establishing a foothold in the area opposite the Gray arbor memorial, due to the lack of regular maintenance.

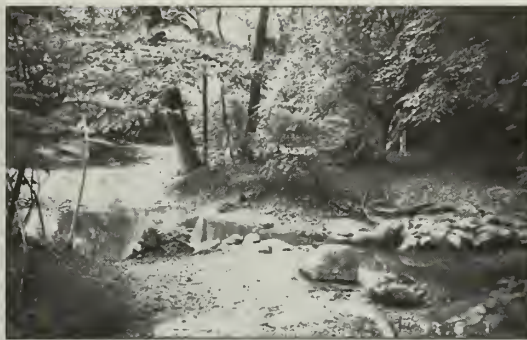
the south bank across the pool to the open meadows are blocked by spicebush and tatarian honeysuckle. The tree canopy now forms a dense covering. Only vegetation that does not require full sun has survived. Farrand's original herbaceous planting for the south bank, which included trillium, mayapples, ferns, and daffodil species, still remain in the dappled shade.

Figure 132 The ground is bare on the south side of the Laurel Pool. June 7, 1997. NCR. Photo Archive, DOP 9-7.

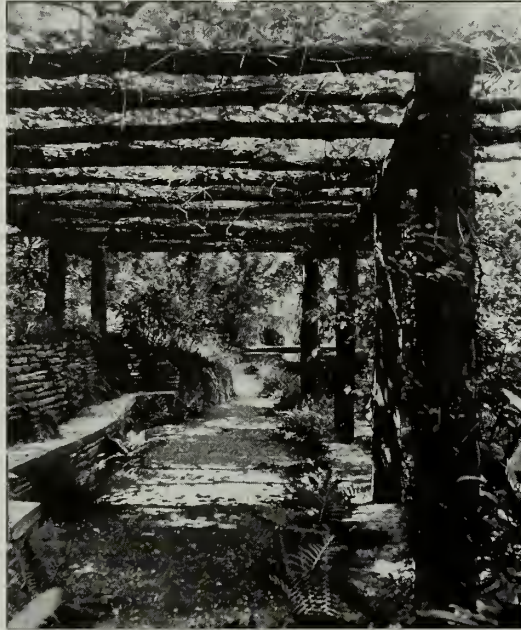
Figure 133 Clumps of ferns grow in pockets along the back of the Stream Arbor wall and a tangle vines grows on the arbor, c. 1935. DOSLA, Photo Archive, #13.4.

A tangle of vines covered the rustic arbor structure, making the Stream Arbor into a quiet retreat.<sup>302</sup> One newspaper account from 1940 stated that grapevines grew over the arbor.<sup>303</sup> Farrand relied on an abundance of ferns to soften the rough stone walls in this area. Wall pockets in the back of the Stream Arbor bench were filled with ferns and small groupings grew along the path.

In November 1942, Farrand recommended to Harry Thompson of the NPS that additional Christmas ferns (*Polystichum acrostichoides*) and ostrich ferns (*Matteuccia struthiopteris pennsylvanica*) should be ordered for this area “to

replace some that were lost in the floods near the Arbor and in occasional spots west of the Laurel Pool.”

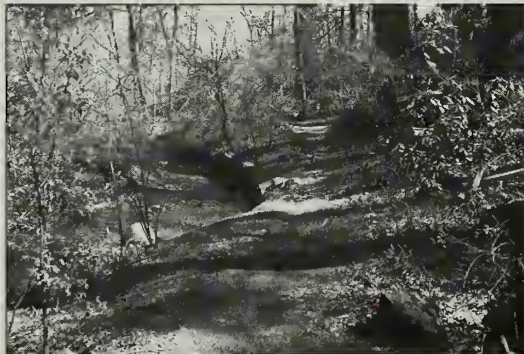
Figure 134 Mature tulip poplars, dominate the canopy in the Tulip Glen, April 1, 1997. NCR, Photo Archive, DOP 1-37

Today, a thick matting of English ivy, periwinkle, and Japanese honeysuckle protects the stream bank from the scouring effect of periodic floods. Where there is no ground-cover, soil and vegetation are more susceptible to erosion. In other places, pioneer trees including red maple (*Acer rubrum*), boxelder (*Acer negundo*), and black cherry have started to take hold in the understory. Little remains of the

deciduous shrub massing and the large drifts of ferns. A remnant group of Christmas and ostrich ferns can still be found on the north bank beyond the West Laurel Falls. Since the arbor structure is no longer standing, the vines that perhaps originally grew on the arbor have spread throughout the area.

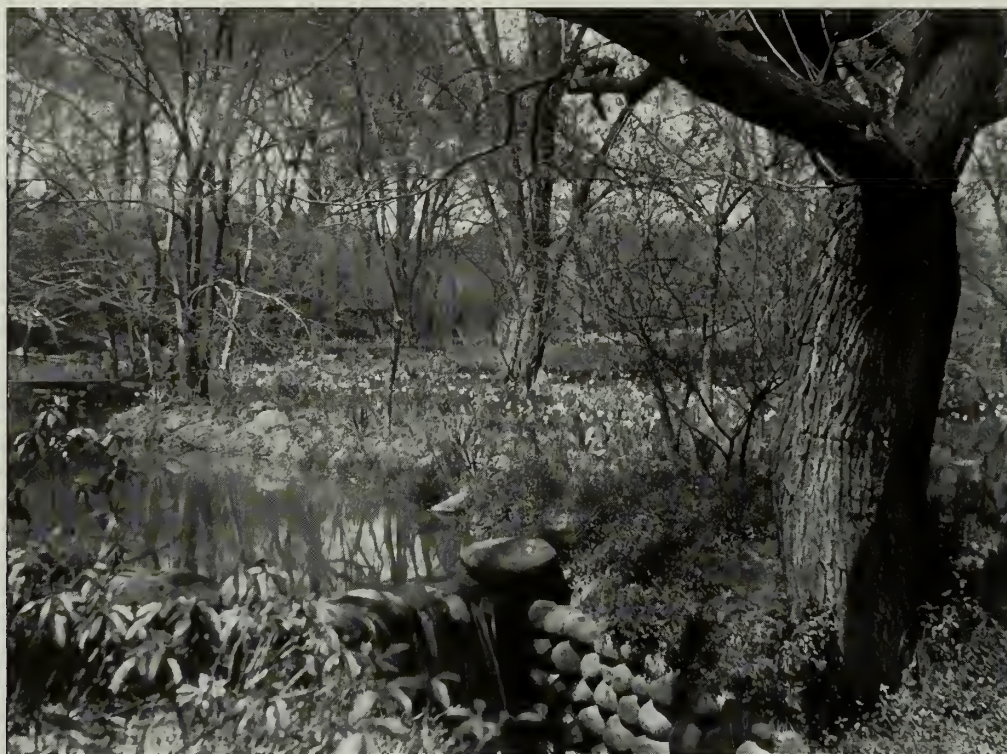
Figure 135 Drifts of bulbs and perennials on north bank by the Laurel Pool, c. 1935. DOSLA, Photo Archive, #13.17.

White pheasant's eye narcissus were massed north of the Laurel Pool, between groups of Virginia bluebells.<sup>305</sup> Present-day conditions indicate that the herbaceous material was laid out in crescent-shaped drifts, extending from the Tulip Glen over to the farm track and up into the meadows. Throughout the spring, a parade of blue-flowering plants, including Siberian squills, two-leafed squills, and Spanish and English bluebells mixed with drifts of pheasant's eye narcissus and mayapple, formed a blue carpet with splashes of white. Farrand appears to have made use of the shrub and tree layer to create contrasts between shade and light. Different species are grouped together, rather than being massed individually, as they were in herbaceous plantings elsewhere in the valley. Seasonal interest was extended into the winter months with cedars and hemlocks, clustered near the farm track and Laurel Pool.

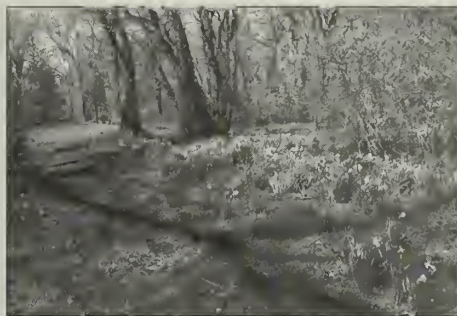
Since this area has not been adequately managed for at least 20 years, the once-open understory is now pioneer woodland. This woodland of sugar maple, tatarian honeysuckle, box elder, spicebush, and black cherry now provides dense shade. The intact spring-flowering bulb display now gives way to the perennial and invasive weeds of summer, including porcelain berry, jewelweed, pokeweed, multiflora

rose, nettles, Virginia creeper, and poison ivy. The invasive vines threaten the few remaining trees by continuing to creep up into the canopies. The historic vegetation is also affected by unrestricted visitor use and uncontrolled runoff which has formed channels in the soil. This has created a patchwork of bare earth throughout the north bank area.

Figure 136 Current display of spring bulbs is not as abundant as in the 1930s, April 1, 1997. NCR, Photo Archive, DOP 2-11a.

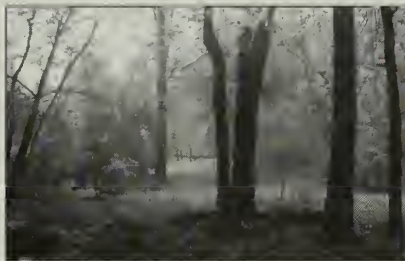
Figure 138 View from Clapper Bridge Falls looking upstream to an overgrown meadow path area, November 3, 1997. NCR, Photo Archive, DOP 24-37.

In the area beyond the Clapper Bridge Falls, the vegetation has lost its design integrity. Portions of the woodland have expanded far into the meadow on the north side of the path and merged with the woodland on the south side of the stream. There is no longer a defined transition from the meadow path to the largest meadow on the north, where loosely-grouped understory trees once stood (redbuds, willows, and dogwoods). Only one clump of iris, one witch hazel, and a few ferns have survived along the stream. Invasive vegetation blocks most views of the stream and conceals the original meadow-path alignment.

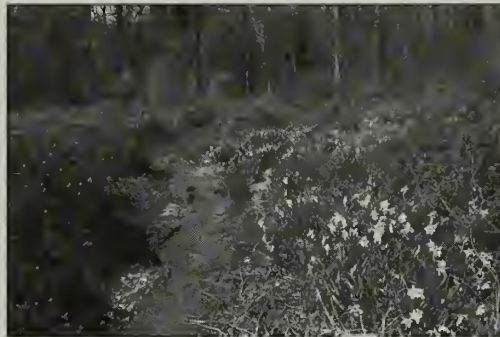
While rhododendrons, one mountain laurel, and a single redbud can still be found, they have lost their form and no longer contribute to the original design intent.<sup>308</sup> The original plantings have been replaced by a thick matting of invasive vegetation, including Japanese honeysuckle, multiflora rose, poison ivy, garlic mustard, porcelain berry, Oriental bittersweet, English ivy, tatarian honeysuckle, Japanese knotweed, and Japanese stilt grass. Surprisingly, large drifts of spring-flowering bulbs still thrive in this area. The Unicorn Lady area has the largest variety of spring-flowering bulbs of any of the management zones, the next closest being the Forsythia Hill area. This may be an indication of Farrand’s intention to use the floral display to focus the view to the statue. Due to minimal maintenance and the aggressive nature of the invasive plants, this very important designed area retains little integrity.

Figure 140 Large drifts of bulbs emerge every spring through the thick mat of invasive vegetation, April 1, 1997. NCR, Photo Archive, DOP 2-15a.
