# CULTURAL LANDSCAPE REPORT: Dumbarton Oaks Park, Rock Creek Park

National Park Service

Part I: Site History, Existing Conditions, and  
Analysis and Evaluation

August 2000

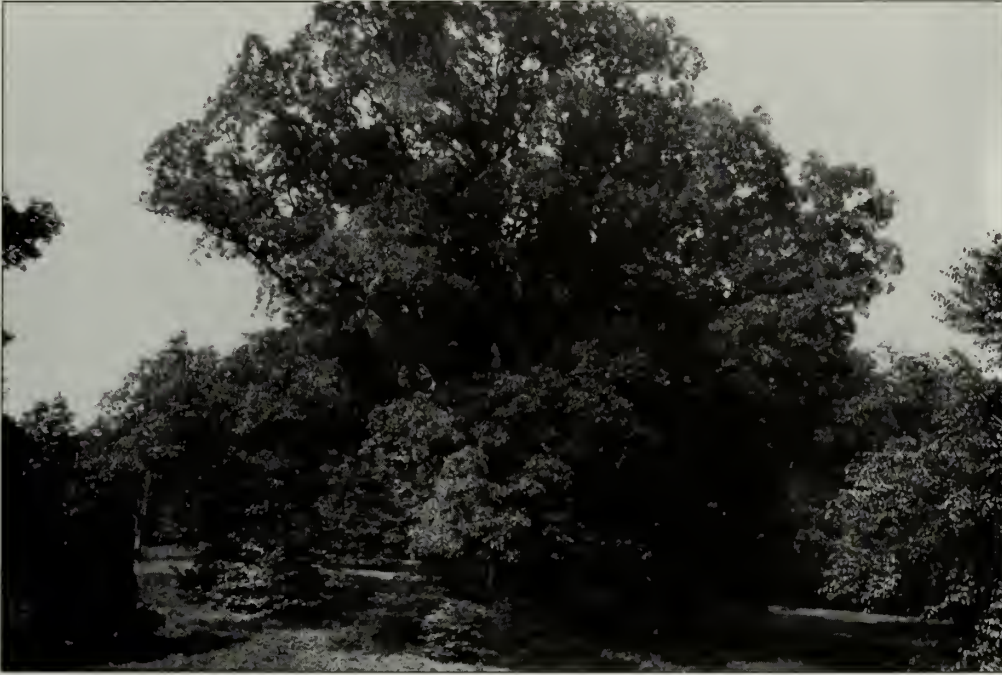
Figure 141 A mature Southern red oak was the central feature of the first meadow, June 1941. DOSLA, Photo Archive, #13.34

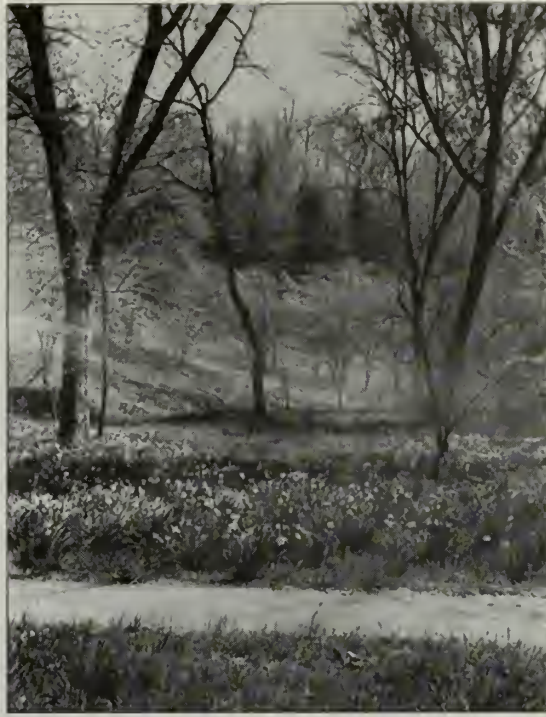
*Figure 143 Blooming dogwoods in background define the border between the second and third meadows, c. 1961. Photo by Abbie Rowe, MRC, Photo Archive, #100.*

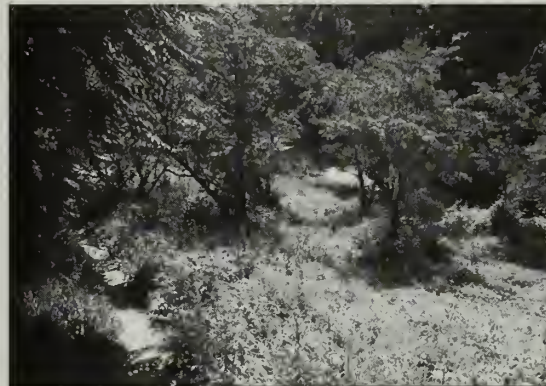
A large portion of the meadow is being overrun with invasive plant material. Because of the steep incline, it is more difficult to maintain and control aggressive vegetation in the third meadow than in others. Woody vegetation continues to creep into the upper portion of the meadow, covering a third of it.

*Figure 144 Dogwood border is now being encroached by invasive vegetation growing underneath, August 1997. NCR, Photo Archive, DOP 41-4*

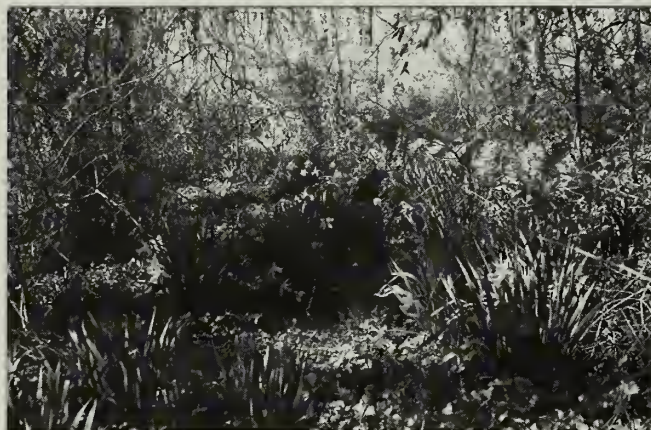
Figure 146 A wide variety of bulbs have naturalized in the fifth meadow, even though invasive vegetation has become established in the upper part of the area, April 1, 1997. NCR, Photo Archive, DOP 2-21a.

The succession of blooms starts early during the waning days of winter with the lavender crocus, common snowdrop, two-leaved squill, and Siberian squill. A long, narrow drift of snowdrops follows the swale on the eastern edge of the meadow's upper reaches. Just east of the animal cemetery, squill spreads under a

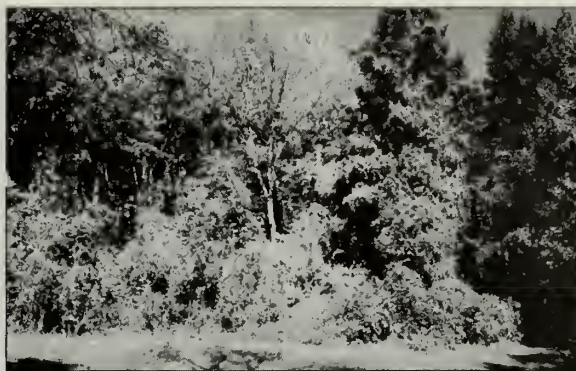
The integrity of the fifth meadow is threatened by aggressive vines and trees, herbaceous weeds, and woody shrubs, which are competing with the original Farrand era vegetation. Exotic vines such as porcelain berry, Oriental bittersweet, English ivy, Japanese honeysuckle, roundleaf greenbriar, wild grape vine, and morning glory are encroaching into the meadow and adjacent woodlands, covering the existing plants and changing the character of the designed spaces by killing the trees.

Figure 147 Invasive vegetation has started to creep into the fifth meadow, October 1998. NCR, Photo Archive, DOP 50-26

Herbaceous weeds such as garlic mustard, Japanese stilt grass, Japanese knotweed, and yellow nutsedge displace native and herbaceous plant materials. Woody shrubs and aggressive trees such as multiflora rose, tatarian honeysuckle, wild raspberry, Norway maple, red maple, tree-of-heaven, and mimosa now obscure the northernmost third of the fifth meadow.

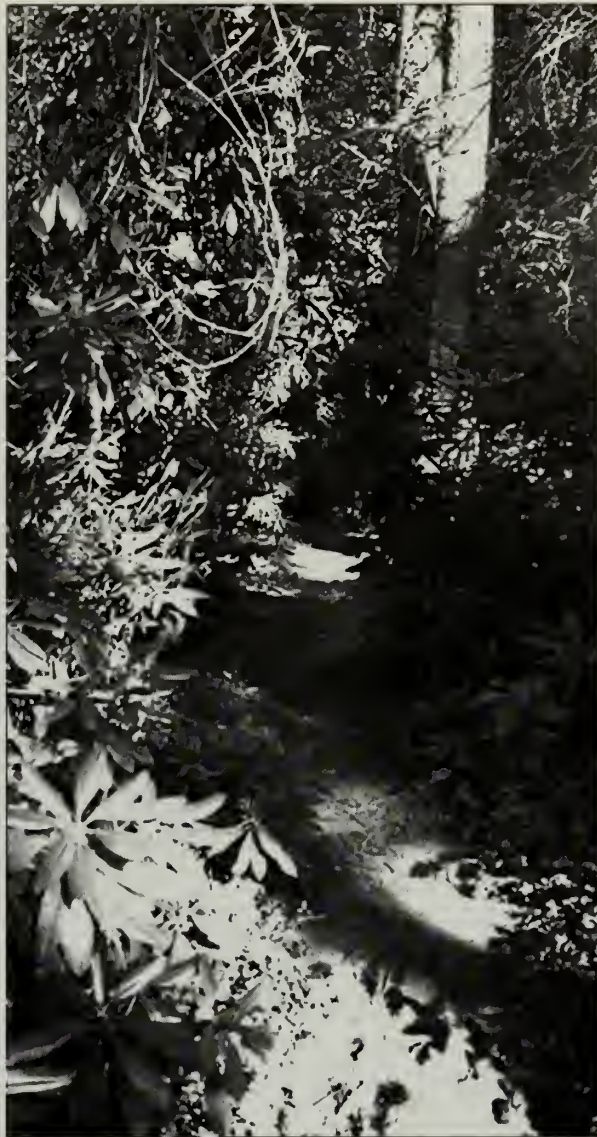
Today, the only physical remnants of the northernmost path are small groupings of English and Spanish bluebells and daffodils, and a series of wood-and-stone steps. Spring is the best time to follow the northern trace, when the bluebells are in full bloom. At the highest point in the designed woodland, a climax beech, maple, and mixed oak forest remains free of the invasive plant material, such as tree-of-heaven, multiflora rose, and tatarian honeysuckle, that is starting to encroach along the edges and southernmost portion of the area. Most of the mountain laurels and azaleas have died, leaving an overgrown grouping of rosebay rhododendron. Though remnant massings of perennials and bulbs still flower in the spring, invasive vegetation, such as Japanese honeysuckle, garlic mustard, and English ivy, is starting to encroach on them.

*Figure 148 Rhododendron massing surrounding woodland path, August 1997. NCR, Photo Archive, DOP 42-24a.*

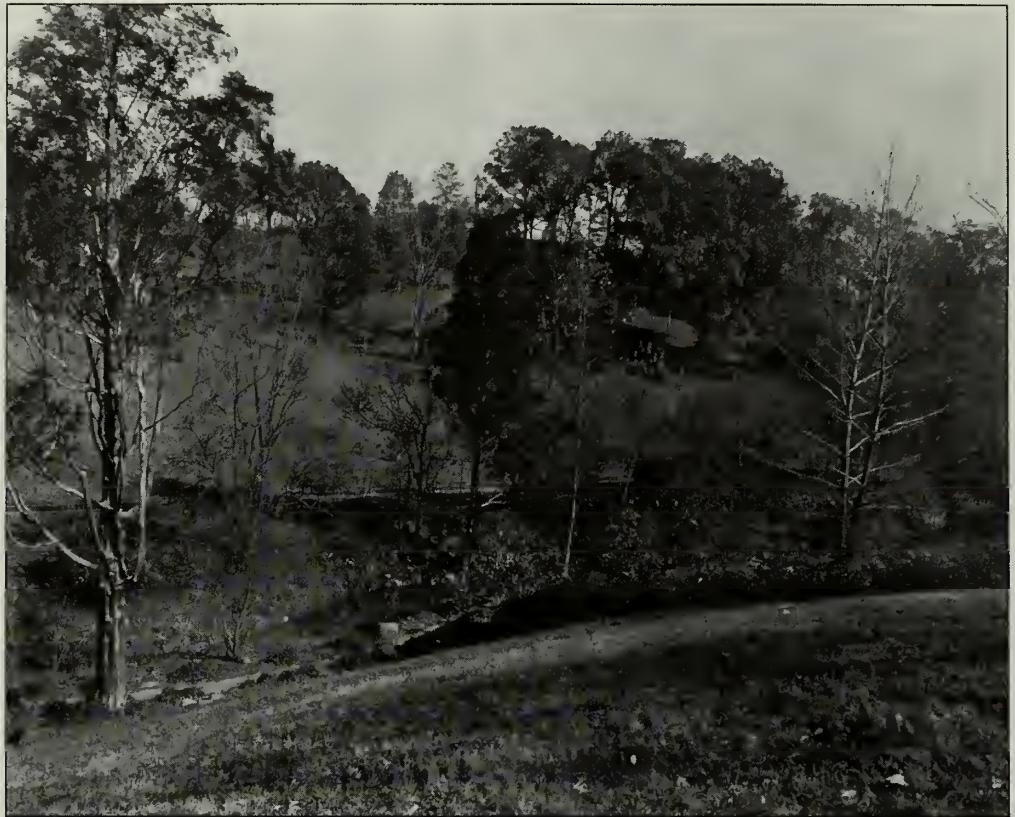
Figure 149 View from the southern slope meadow to the open northern woodland on Clifton Hill, before an understory was allowed to fill in, c. 1935. DOSLA, Photo Archive, #13.25

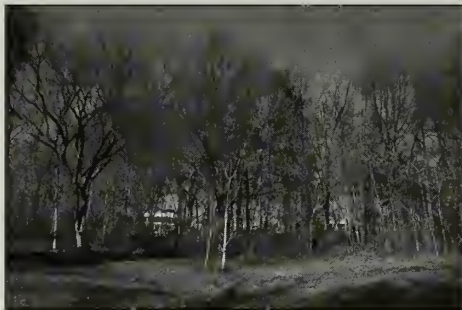
Figure 150 Northern woodland also serves as a buffer, screening adjacent development, such as the Danish Embassy, December 1998. NCR, Photo Archive, DOP 47-17a

This mainly deciduous woodland is still in relatively good condition. It consists of a canopy of tulip poplar, elm, beech, hickory, and various species of maples and oaks. The understory contains all of the latter, as well as hemlock, white ash, black walnut, white mulberry, sassafras, hornbeam, Eastern red cedar, and American holly. The edge of the forest is dominated by tree-of-heaven, with a dense invasive undergrowth consisting of porcelain berry, wild grape, Oriental bittersweet, and Japanese honeysuckle. Over the past ten years, exotic invasive plant material has continued to move deeper into the woodland as well as continuing to spread into the adjoining meadows. Spring-flowering bulbs and wildflowers such as squill, glory-of-the-snow, bluebells, and jack-in-the-pulpit are growing in the ravine which extends up from the first meadow into the northern woodland.

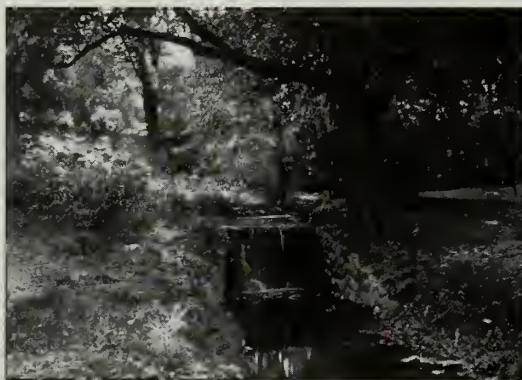
The dam structures were constructed of concrete and faced with round river stones; at the base of each dam was a clean-out device, or “plug,” which could be removed to enable siltation to be washed through from behind. Wing walls projected upstream from the dams to funnel the water over the spillway, and retaining walls were built in front of the dams on either side of the spillway to protect the banks and channel water towards the next feature.

*Figure 152 Third falls of Three Sisters Falls, downstream from the Laurel Pool, c. 1935. DOSLA, Photo Archive, #13.15.*

In 1995, a group of neighborhood volunteers attempted to restore four of the dam structures and the Laurel Pool using HABS photos and drawings. Though stones used in the “restoration” work were apparently taken from the streambed, they were not properly replaced on the dams and walls and thus channeled water incorrectly, creating additional problems.

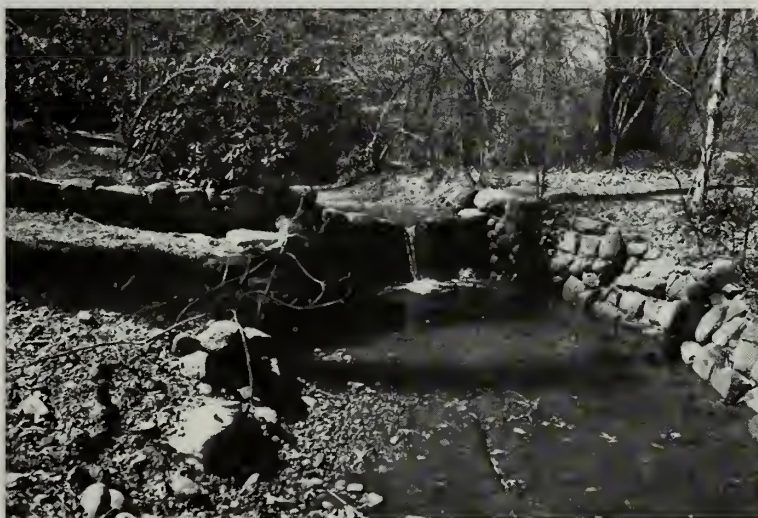
The Old Water Wheel Falls was the only one designed so that visitors could cross the stream using the spillway like a ford where it connected the south stream path and north stream path.

*Figure 154 Old Water Wheel Falls as seen after the south bank wingwall was rebuilt, April 1, 1997. NCR, Photo Archive, DOP 2-1a.*

Water flows around the south and north retaining walls during storms. In 1995 the spillway and south bank wingwall were partially rebuilt by neighbors, but they do not represent the historic configuration of the waterfall. A stone wall, which extended approximately 80 feet downstream from the Old Water Wheel Falls, protects the south bank and stream path.

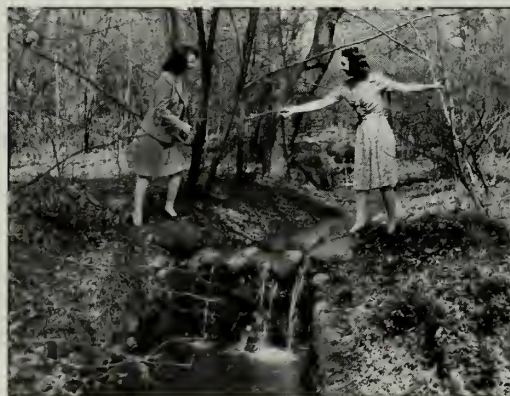
*Jungle Falls (2 of 4)* - The second dam of the Jungle Falls was of similar construction to the rest. The dam is in good condition. There is minimal upstream and downstream siltation; however, the stream has

rerouted to the north of the dam, with only a small amount of water now flowing over the spillway.

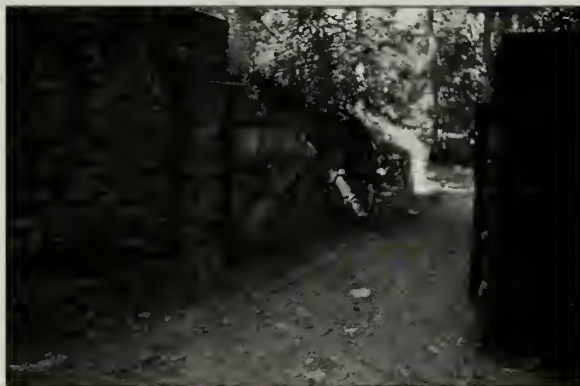
Figure 157 Lovers' Lane gate is now left permanently open for visitors to enter into Dumbarton Oaks Park, NCR, Photo Archive, DOP 40-6.

The gates consist of two heavy wood panels, with cross-members on their lower halves and three large steel strapwork hinges each. The north gate has a pull ring, probably wrought iron, with a star-shaped escutcheon on the front. The south gate has a long gate pin on the inside face. A round stone with a

drilled hole is set into the ground in the center of the threshold to hold or anchor the gate pin. The piers and gates are in good condition overall, though the gates do not fully close, overlapping by a couple of inches, and the metalwork is rusty.

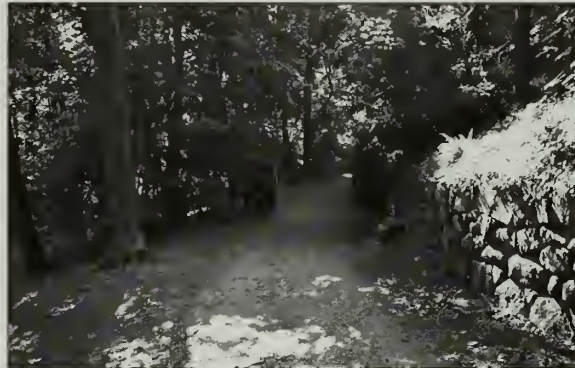
The retaining wall along the south side of the Beech Grove corridor, built in the 1920s or 1930s, is a continuation of the Lovers' Lane retaining wall, though it differs in the type, shape, size, and the coursing of its stones. The stones in the Beech Grove retaining wall are larger, rounded, and uncoursed. The wall gradually decreases in height from east to west along the length of the corridor, until it tapers into the ground. It incorporates a niche, built to accommodate the trunk of a tree (now dead). As noted in the *HABS Report* (p. 22), the change in character of the retaining wall indicates the change in landscape character as one enters the park. The wall remains in good condition.

Figure 158 View of the Beech Grove retaining wall and Lovers' Lane gate, August 1997. NCR, Photo Archive, DOP 40-2.

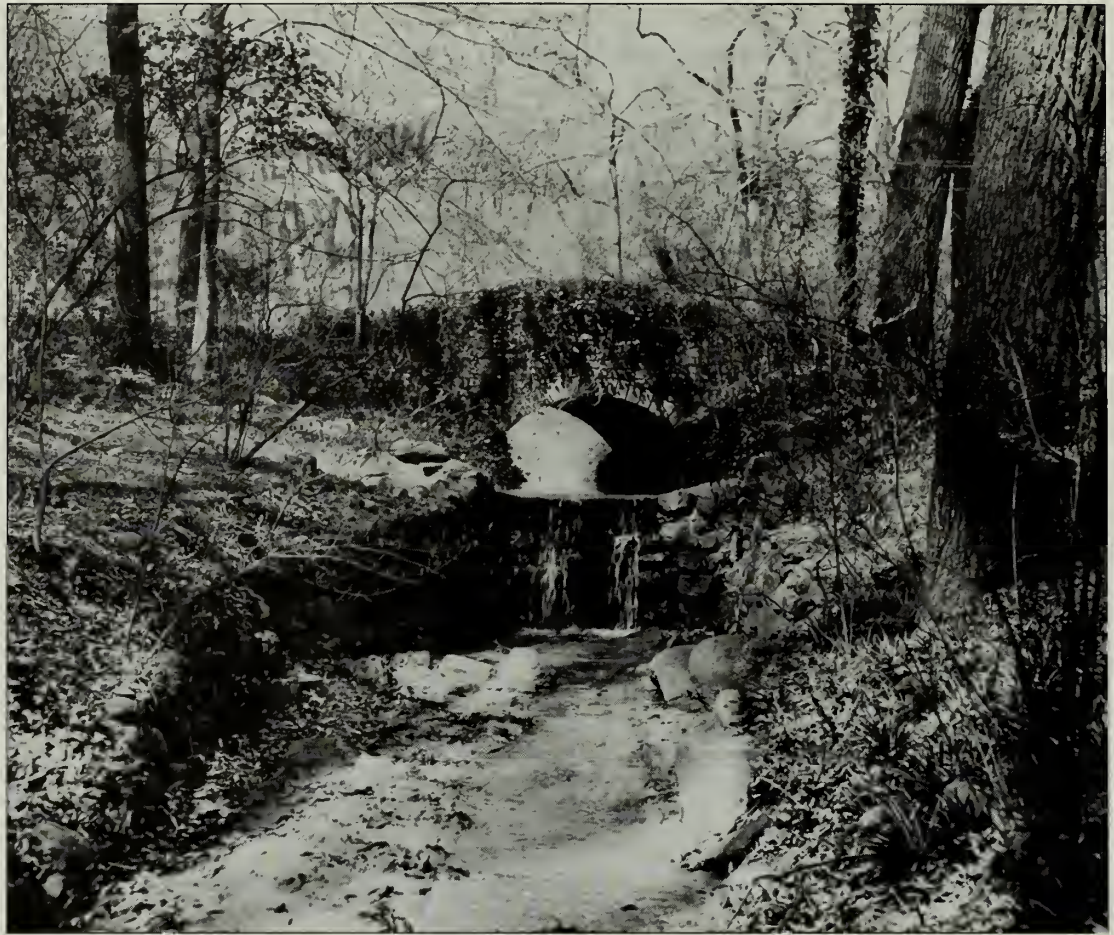
Figure 160 English ivy was allowed to grow on the stone bridge, April 12, 1963. MRC, Photo Archive, #96

cap stones on the parapet walls, and rises in a low arch on the side elevations. It measures approximately 31 feet long by 15 feet wide, and the parapet walls measures 32 inches at their highest point.

Farrand allowed English ivy to partially grow over the structure, softening its appearance and tying it into the landscape. The bridge appears structurally sound, though some deterioration is evident on the south side where some of the cap stones have come loose with age. There is graffiti on the underside of the arch.

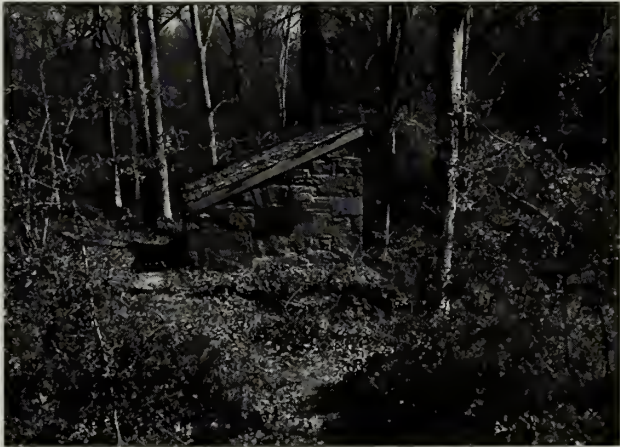
door, though a photograph from the 1940s indicates that the original door was constructed of wood. A path formerly circled the building, providing access to the door and the East Falls, but this is no longer evident. Graffiti has recently been scrawled on some of the stones and a stubby pipe protrudes from the ground in front of the entrance.

Figure 162 View of west side of Old Stone Pump House, April 1, 1997. NCR, Photo Archive, DOP 2-35a.

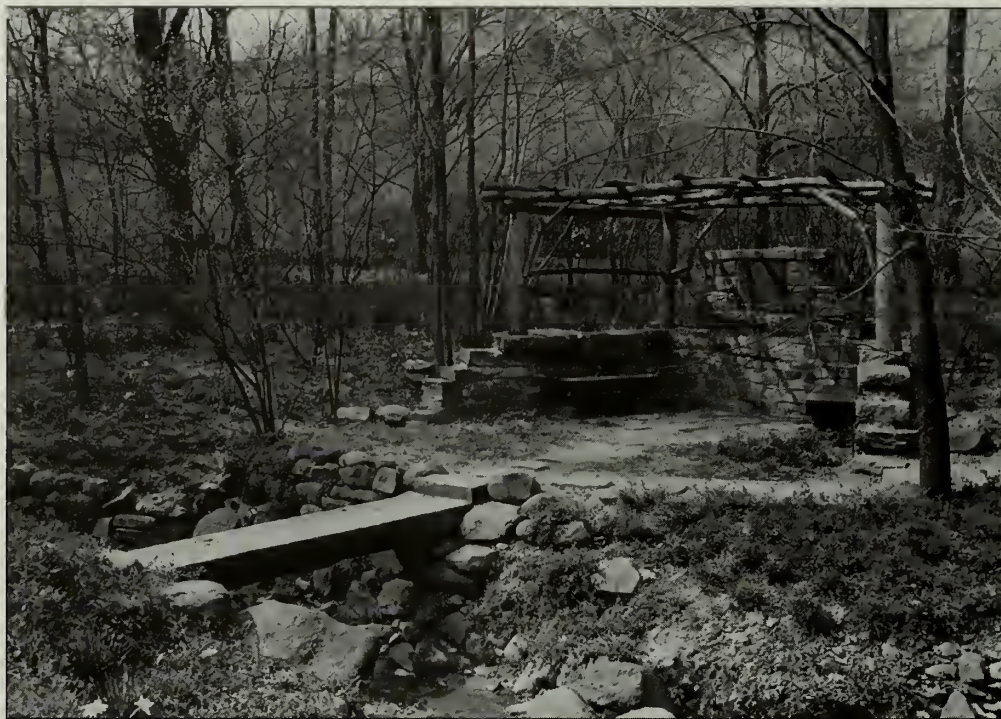
Figure 163 Gray arbor memorial as it appeared in 1963. Photo by Abbie Rowe. MRC, Photo Archive, #95.

The Gray arbor memorial, located on the north bank of the stream opposite the first of the Three Sisters Falls, first appears on the 1942 NPS topographic map. It was built sometime between 1937 and 1942 as a memorial to William James Gray, Superintendent of Grounds for Dumbarton Oaks from 1922 until 1937. The National Gardeners' Association donated a memorial plaque, apparently made of slate, which probably bore the legend, "Woods and Groves Have Felt Thy Blessing."<sup>322</sup> The walls were made of coursed rubble stone set in mortar, and the rear wall was raised in the middle to accommodate the plaque. In front of either side wall was a wooden bench. Historic photographs show that the memorial was originally covered by a simple, rustic timber arbor. (There is some indication that the memorial may have been built on the location and possibly, at least in part, on the foundations of some pre-existing structure.)<sup>323</sup>

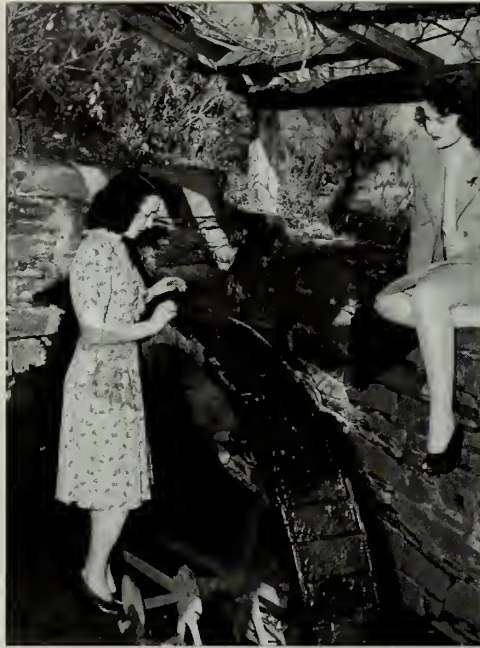
Figure 166 Deteriorated Old Pump House with water wheel broken into pieces as documented by the NPS, 1976. NCR, List of Classified Structures (LCS), Photo Archive, Rock Creek Park.

suggest that the roof was rebuilt between 1945 and 1951, at which time the support column at the entrance was moved from an offset position to the center ridge pole. The water wheel was added inside the pump house as a purely decorative element. A pipe connecting with the spring grotto fed water to the Old Pump House, where it ran along a small rill (probably made of cedar) before falling onto the wheel. A millstone was situated near the entrance to the structure on the east side (see *Small-Scale Features, Site Furniture*).

Currently, the replacement roof structure lies a short distance down the path, rotting and covered with understory vegetation. The axle for the wheel lies near the Old Pump House. The wheel itself is broken into sections, which are submerged on the flooded floor of the building. Exposure to the elements has left this steel wheel rusted and covered with moss. The Pump House is in very poor condition because of exposure, flooding, and invasive growth.

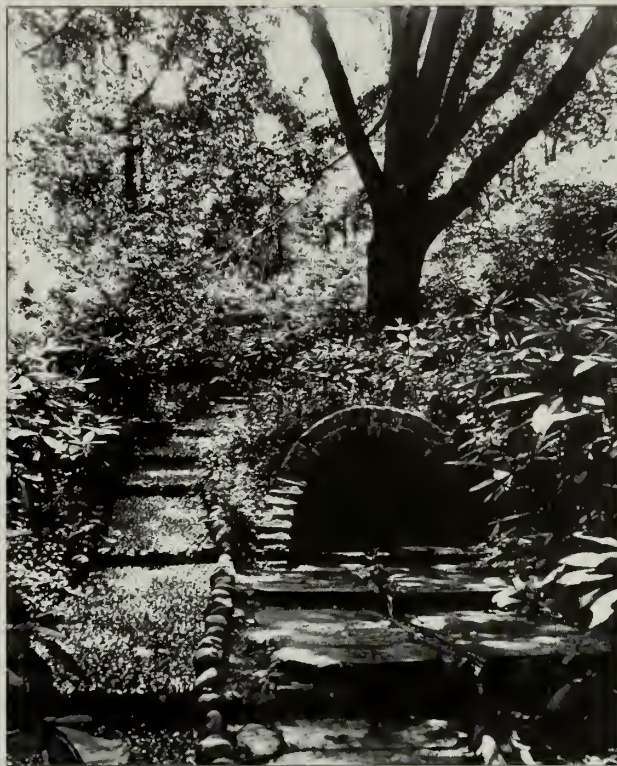
*Figure 168 Spring Grotto and pebble stream with water flowing over the pebbles and through the cedar rills, c. 1935. DOSLA, #13.21.*

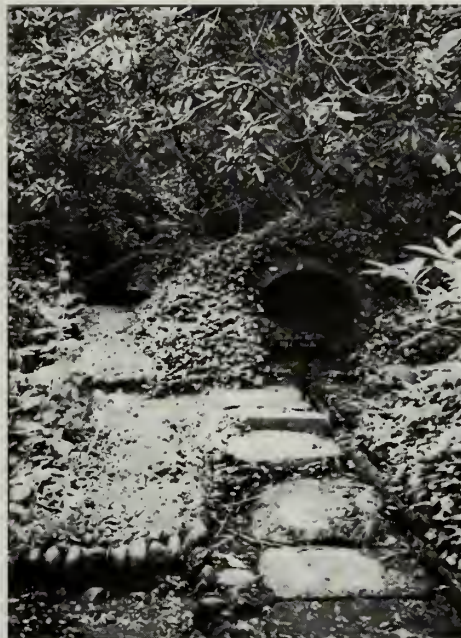
*Figure 169 Condition of spring grotto and pebble stream as they appeared on June 9, 1997. NCR, Photo Archive, DOP 9-17.*

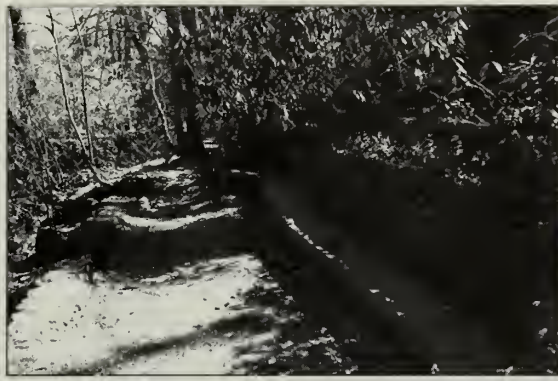
Figure 171 Stream Arbor is still a pleasant place to sit on a spring day, April 1, 1997. NCR, Photo Archive, DOP 2-9a

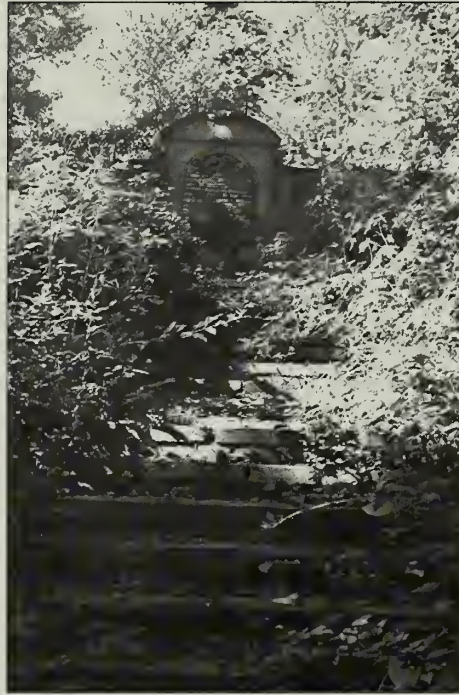
Figure 173 Forsythia Arch sealed with stone, July 11, 1997. NCR, Photo Archive, DOP 6-14.

The arch remains in relatively good condition, though the gate was removed in the late 1960s or early 1970s because vandals found it easy to scale and thus enter Dumbarton Oaks Gardens from the park when the gardens were closed (see endnote 176, *Chapter 2 - Site History: 1951-1997: The Garden as a Public Park*). The opening was filled with rubble stone crudely laid in rough mortar; the stones were probably sections of sandstone paving removed from the landing in the upper gardens, which was adjacent to the gate. The gate is currently stored in the Dumbarton Oaks Gardens maintenance area.

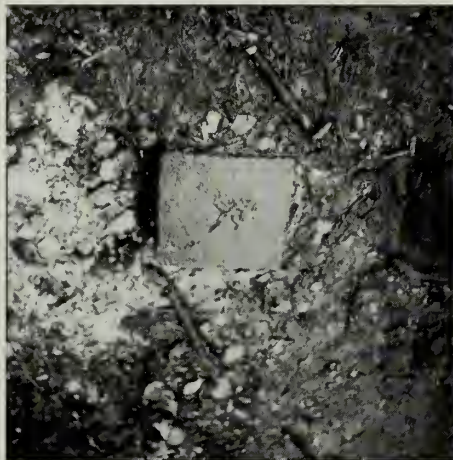
Figure 175 Stone boundary marker in middle of stream path on the north side of the stream, June 13, 1997. NCR, Photo Archive, DOP 14-13

During the 1997 field investigations, three stone markers which predate the Bliss ownership were located on the north side of the stream. They are approximately four inches square and have an "X" carved on the top.

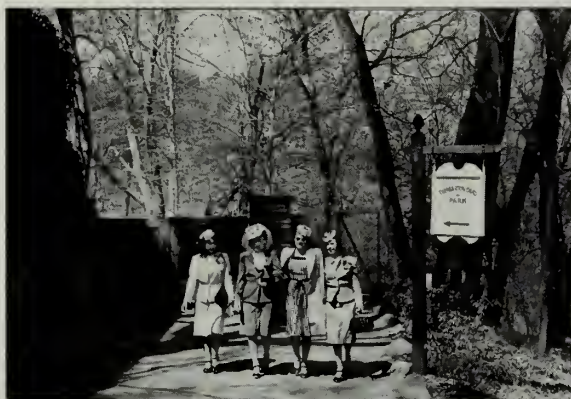
Figure 177 Dumbarton Oaks Park entrance sign at Lovers' Lane entrance, April 1, 1945. ROCR, Photo Archive, #437-A6.

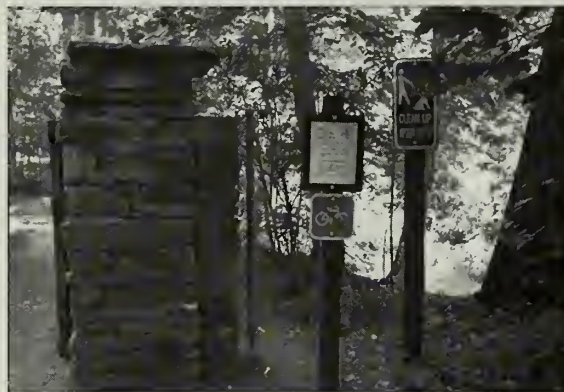
Figure 179 National Park Service regulatory signs placed at the Lovers' Lane entrance to Dumbarton Oaks Park, August 1997. NCR, Photo Archive, DOP 40-7.

At present, there are no formal entrance signs for Dumbarton Oaks Park. Two posts, a wooden post at the Lovers' Lane entrance gate and a metal post at the base of Forsythia Steps, are all that remain of the NPS entrance signs. Two regulatory signs at the Lovers' Lane entrance are the only signs currently in place.<sup>329</sup>

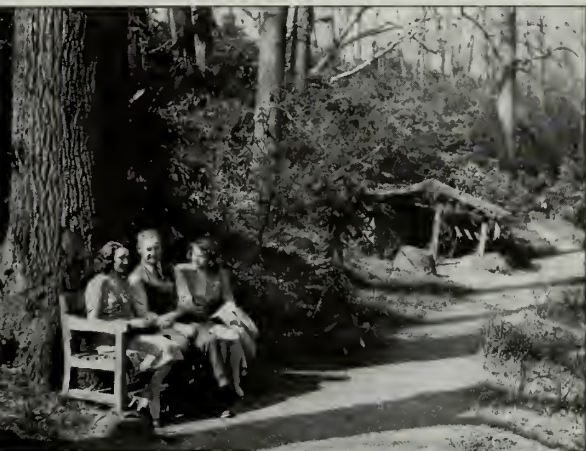
*Figure 180 Teak bench placed near Old Pump House, March 23, 1945. ROCR, Photo Archive, #431-E*

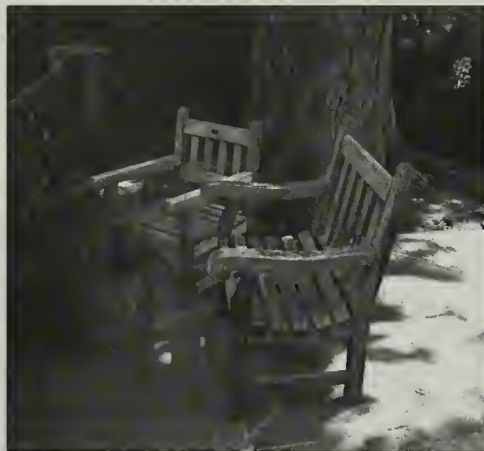
*Figure 181 Teak benches at Dumbarton Oaks Garden, similar to the type that were in the naturalistic garden, July 9, 1997. NCR, Photo Archive, DOP 5-1A.*

Bench situated beside the Laurel Pool is the only other wooden bench currently located in DOP. The remnants of an NPS bench which has rotted and decayed into a pile of scrap wood lie near the Old Pump House. All the original teak benches have either been removed or have rotted.

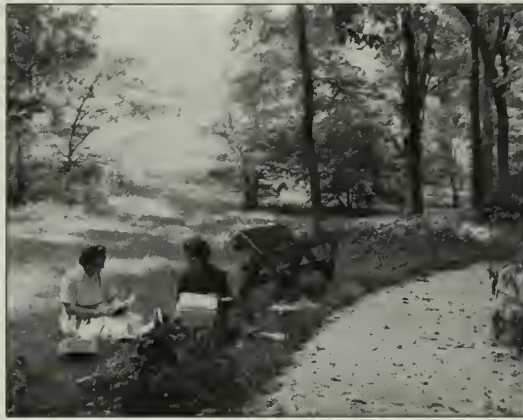
The second type of wooden bench is the NPS “Washington Bench,” a rustic bench made of cedar timber.<sup>331</sup> By 1963, a Washington Bench stood along the path north of the Clapper Bridge Falls and along the north stream path. The last type of wooden bench, the Lutyens-style bench, is a reproduction of one which the architect Edwin Lutyens created for Gertrude Jekyll’s house, Munstead Wood. Though no bench of this sort had ever been used in the park, in 1992 a donated Lutyens bench was placed in the middle of the westernmost meadow.<sup>332</sup> A Washington

Figure 182 A Washington bench was placed along the north stream path, July 17, 1963. Photo by Abbie Rowe. MRC, Photo Archive, #103.

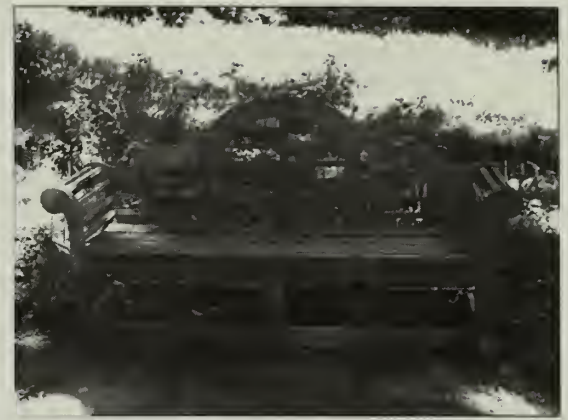
Figure 183 Lutyens style bench in middle of fifth meadow, July 11, 1997. NCR DOP 7-12.

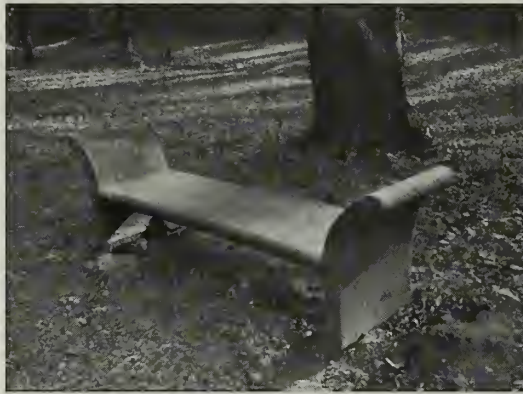
Figure 184 Cast stone chaise bench placed along farm track, December 1998. NCR, Photo Archive, DOP 49-24.

There are three identical concrete or cast-stone benches located along the old farm track, probably the benches referred to in a 1941 memo indicating that the Blisses planned to donate three stone benches to the park. They have a simple, elegant, backless chaise lounge form, with curved seats and curved arms ending in scrolls. It is not known if they were designed by Farrand. Two are placed to take advantage of views up into the

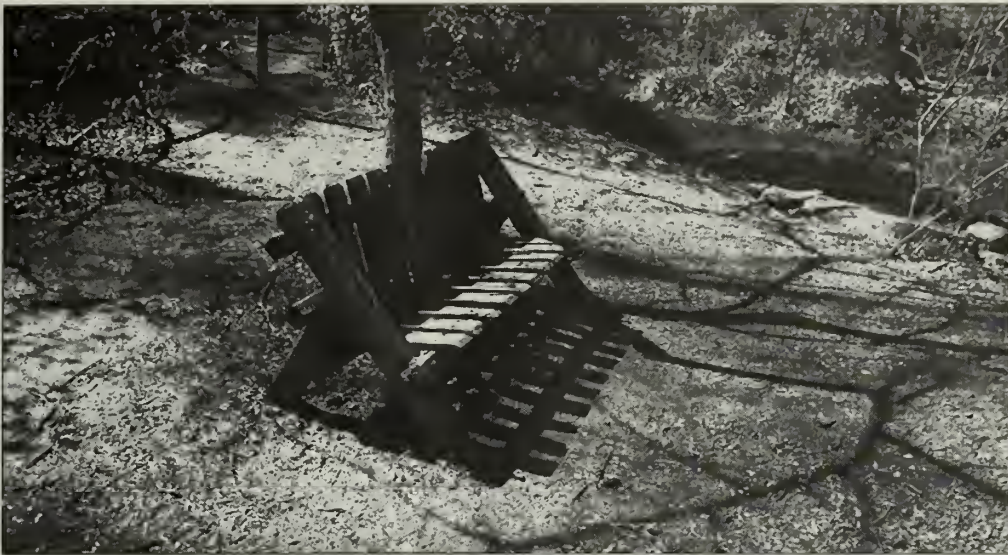
Figure 185 Existing Washington Bench located by the Laurel Pool, April 1, 1997. NCR, Photo Archive, DOP 1-33.

old farm track, as they did historically. The two existing wooden benches in the meadow and at the Laurel Pool do not occupy historic locations.

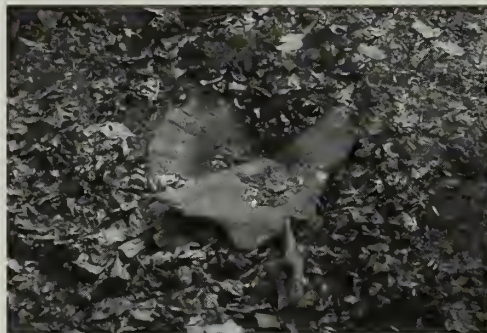
Figure 186 Scallop-shaped concrete birdbath broken into pieces, January 14, 1998. NCR, Photo Archive, DOP 29-24.

This basin is still extant, though it is badly deteriorated and broken into several pieces. It is not known whether other birdbaths were used or where they might have been placed.

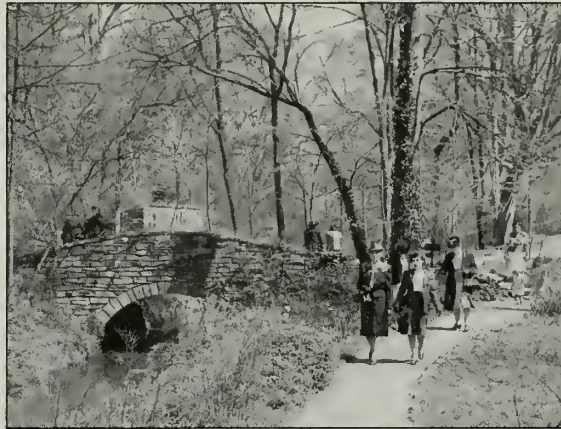
Figure 187 Round edging stones line the south stream path, April 1, 1945. ROCR, Photo Archive, #437AE.

Farrand used round river stones to mark the edges of paths, and larger marker stones to indicate an intersection or feature. The smaller round stones were generally placed along both sides of the lower south stream path, with the stones on the uphill side tightly spaced and the stones on the stream side placed more sporadically.

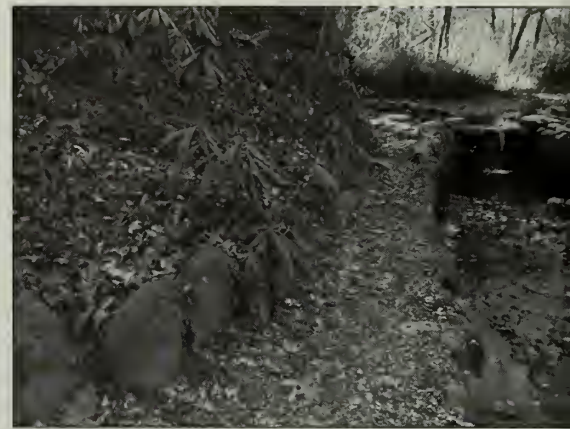
Figure 188 More elongated type edging stone near the Stream Arbor, December 1998. NCR, Photo Archive, DOP 48-9.

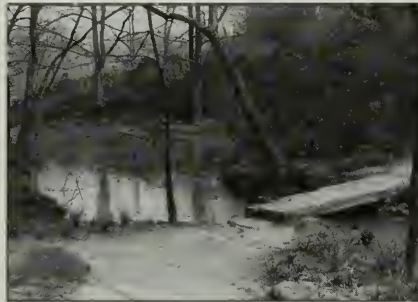
Figure 189 Large stone on the left, marks the intersection of the north stream path with the West Laurel Falls crossing, March 18, 1941. MRC, Photo Archive, #108

The larger marker stones indicated the beginning of side trails (i.e., at the base of Forsythia Steps) and sometimes the location of a waterfall (i.e., Three Meadow Falls, #2 of 3). Many of these stones no longer

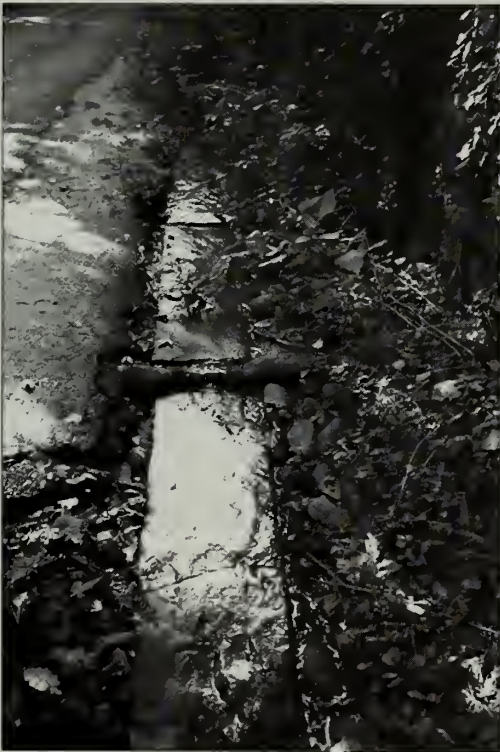
This channel runs along the western edge of Lovers' Lane, from R Street down to the entrance to Dumbarton Oaks Park. It is not part of the DOP property; it may be owned by Dumbarton Oaks Gardens or the District of Columbia. Probably designed by Farrand, it is composed of long, narrow stone slabs laid end to end, interrupted at points by stone rills. Its sides are lined with river stones set in mortar.<sup>336</sup> Water from a natural spring and stormwater flow down this channel and cascade over the rills.<sup>337</sup> If this feature was, in fact, designed by Farrand, it may have been meant to foreshadow the designed water features within the park, in particular the pebble stream. The channel resembles certain drainage features in Dumbarton Oaks gardens—for example, the gutter along the Kitchen Garden, which also has a bottom formed of stone slabs and sides lined by rounded river stones.

*Figure 191 Slate slab gutter with stone rill along Lovers' Lane, August 1997. NCR, Photo Archive, DOP 40-13.*

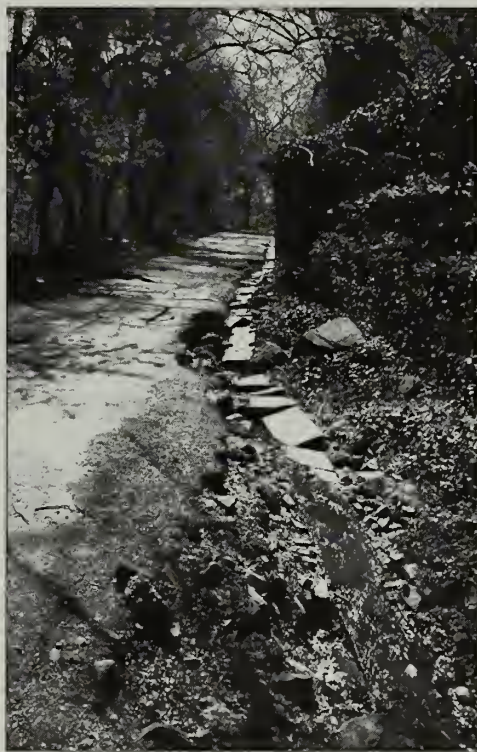
*Figure 192 Eroded gutter at the base of Lovers' Lane, April 1, 1997. NCR, Photo Archive, DOP 1-7.*

Over time, excessive runoff from R Street and a storm sewer has undermined the gutter feature, damaging its slabs, rills, and river stones. Because of the location of a natural spring emerging midway down the slope, water constantly flows over the lower section of the channel. Though most of the slabs remain, many have been dislodged, and the channel is choked by weeds. The structural damage and invasive vegetation partially obstruct the flow of water. The problem has been exacerbated by the fact that the originally cobbled surface of Lovers' Lane has been raised by the addition of many layers of asphalt, so that water from both Montrose Park and the road runs into this gutter rather than a gutter on the east side of the lane, which has been filled in. The original character of the channel is still evident for a short section near the top of Lovers' Lane near R Street.

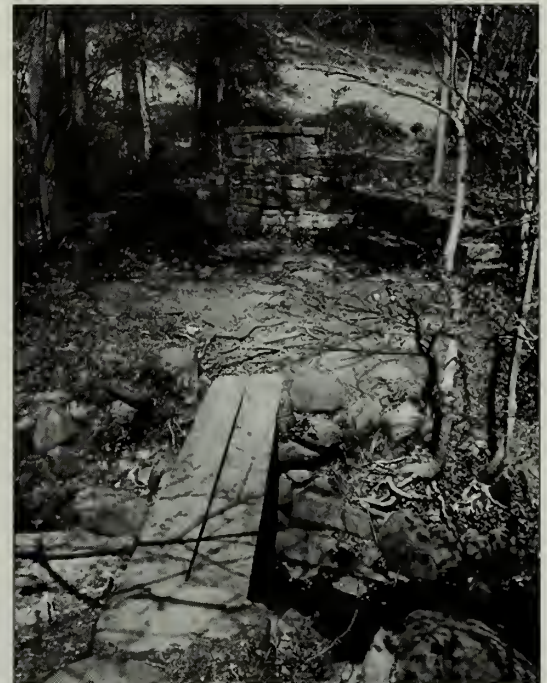
Figure 194 Plank foot-bridge crossing stream at the Gray arbor memorial, April 1, 1997. NCR, Photo Archive, DOP 1-26.

three locations which still has a bridge is the Gray arbor memorial, though the current bridge is made of standard boards rather than the original rustic half-logs. (A log structure that may possibly be an original or a replacement bridge is lying on the ground north of the Gray arbor memorial.) At West Laurel Falls and Clapper Bridge Falls, visitors now ford the stream by walking across the dams.<sup>338</sup> In addition, there was a ford at the Old Water Wheel Falls.

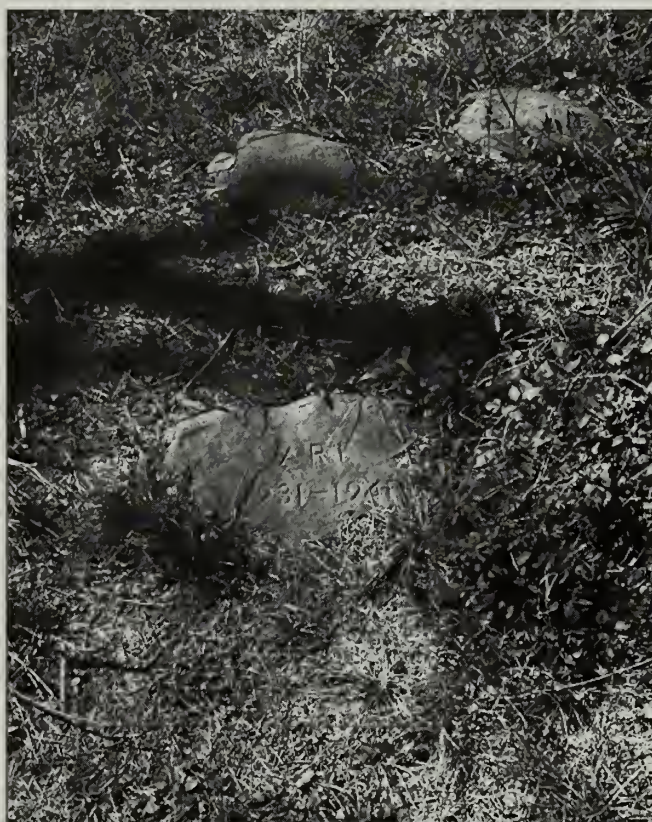
The Animal Graveyard is situated in the northwest corner of the westernmost meadow. It was the burial ground for six of the Blisses's dogs and two of their horses. This feature was also referred to by Farrand as the "Quadrangle," the name of one of the horses buried there. The animals' names and their birth and death dates were carved onto large river stones. In the summer months, vegetation obscures the headstones. An NPS weekly report from 1967 indicates that originally there were eight gravestones instead of the present six. The six stones visible during the 1997 field investigations bear the names of only the dogs; these are placed side by side in two lines of three. The missing stones bore the names of the horses.<sup>340</sup>

*Figure 195 Remnant gravestone at Animal Graveyard, April 1, 1997. NCR, Photo Archive, DOP 2-19a.*

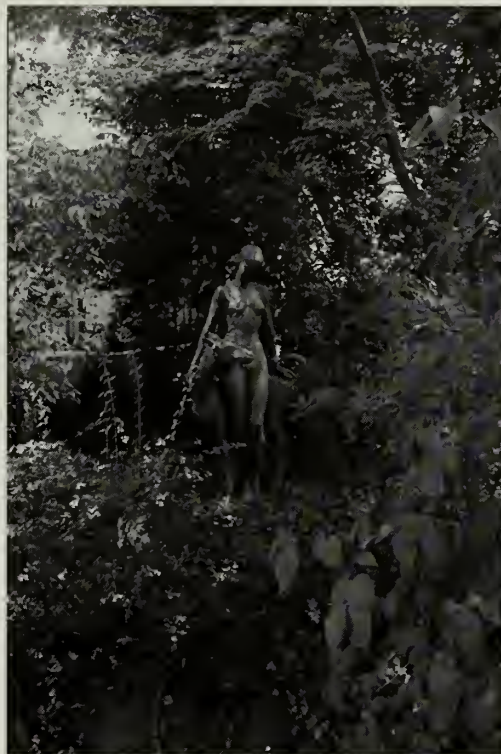
Figure 196 Unicorn Lady statue in Directors Garden at Dumbarton Oaks Garden, July 9, 1997. NCR, Photo Archive, DOP 5-22A

In 1938, the six-foot tall Unicorn Lady statue, made of lead and bronze, was placed in the garden at the point where the upper stream path forked, after the last Jungle Falls and just before the designed woodland.<sup>341</sup> The statue was a focal point for the upper stream path. A historic photograph shows the statue surrounded by a stand of eastern redbud near a plantation of azaleas. In a 1942 memo, Farrand recommended that the statue be moved to the upper gardens to prevent vandalism.<sup>342</sup> The statue was moved soon after, and it now stands in the Director's Garden at Dumbarton Oaks Gardens. The 1997 field survey of DOP found a stone base near the last Jungle Falls which may have been the original base of the statue.
