Historic Furnishings Report Painted Desert Inn

PAINTED DESERT INN PETRIFIED FOREST NATIONAL PARK

**Part 1: Historical Data
Part 2: Implementation Plan**

**Northeast Museum Services Center
National Park Service
May 2004**

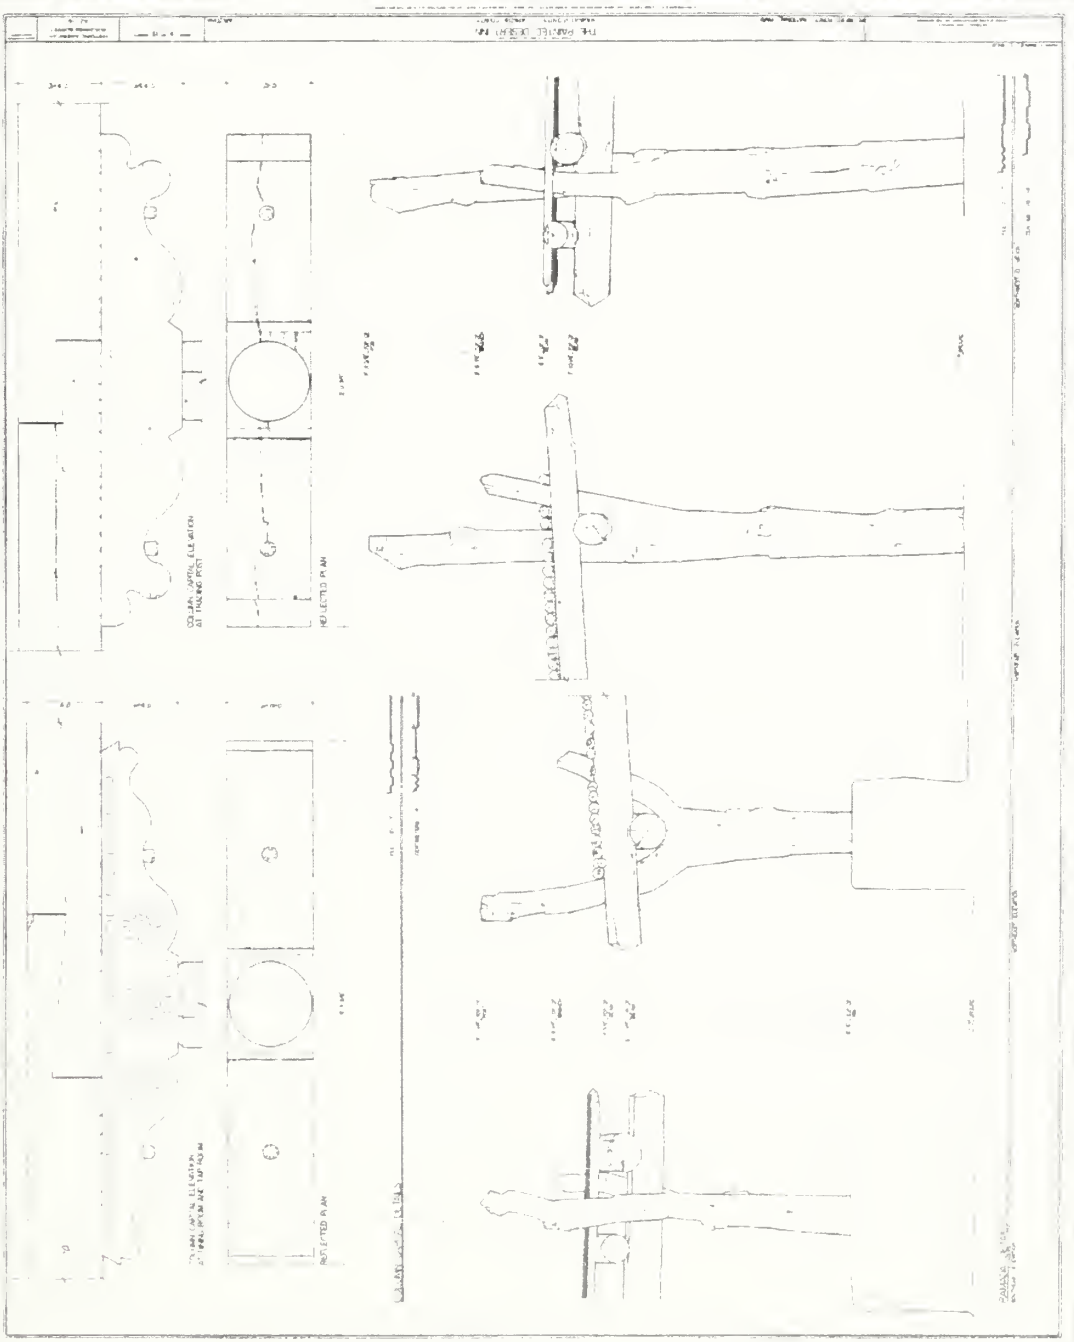
8. "Stamped Tin Lamp Details." 1992, Drawing by Historic American Buildings Survey, Museum Collection, Archives, Petrified Forest National Park, Petrified Forest, Arizona, HABS: AZ-161, sheet 9 of 12.

One tin lighting fixture in the lunchroom has been conserved. Others that currently hang in the Painted Desert Inn dining room, lunchroom, trading post room, ranger room, and guest room are intact but need to be assessed in terms of condition. Other tin fixtures in storage all need to be conserved and vary in terms of condition. Once conserved, *in situ* extant shelving and furnishings (such as the tap room bar, and fagon fireplaces in the guest rooms) can be used as installation objects.

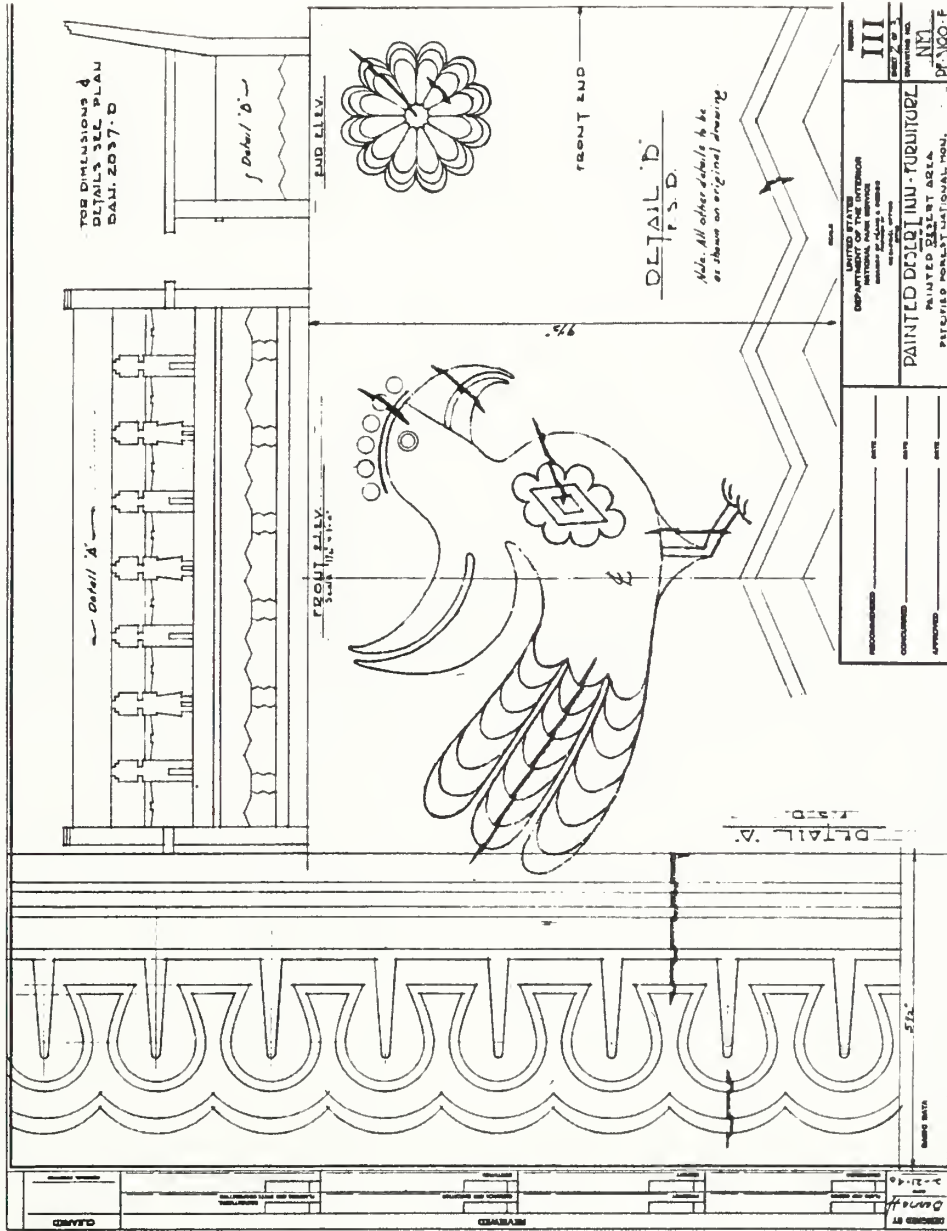
30. "Furniture--Details of Wood Bench with Carved Decorative Patterns."
February 1940, Plan by Lyle Bennett, Museum Collection, Archives,
Petrified Forest National Park, Petrified Forest, Arizona, PF 3100-F,
Sheet 3.

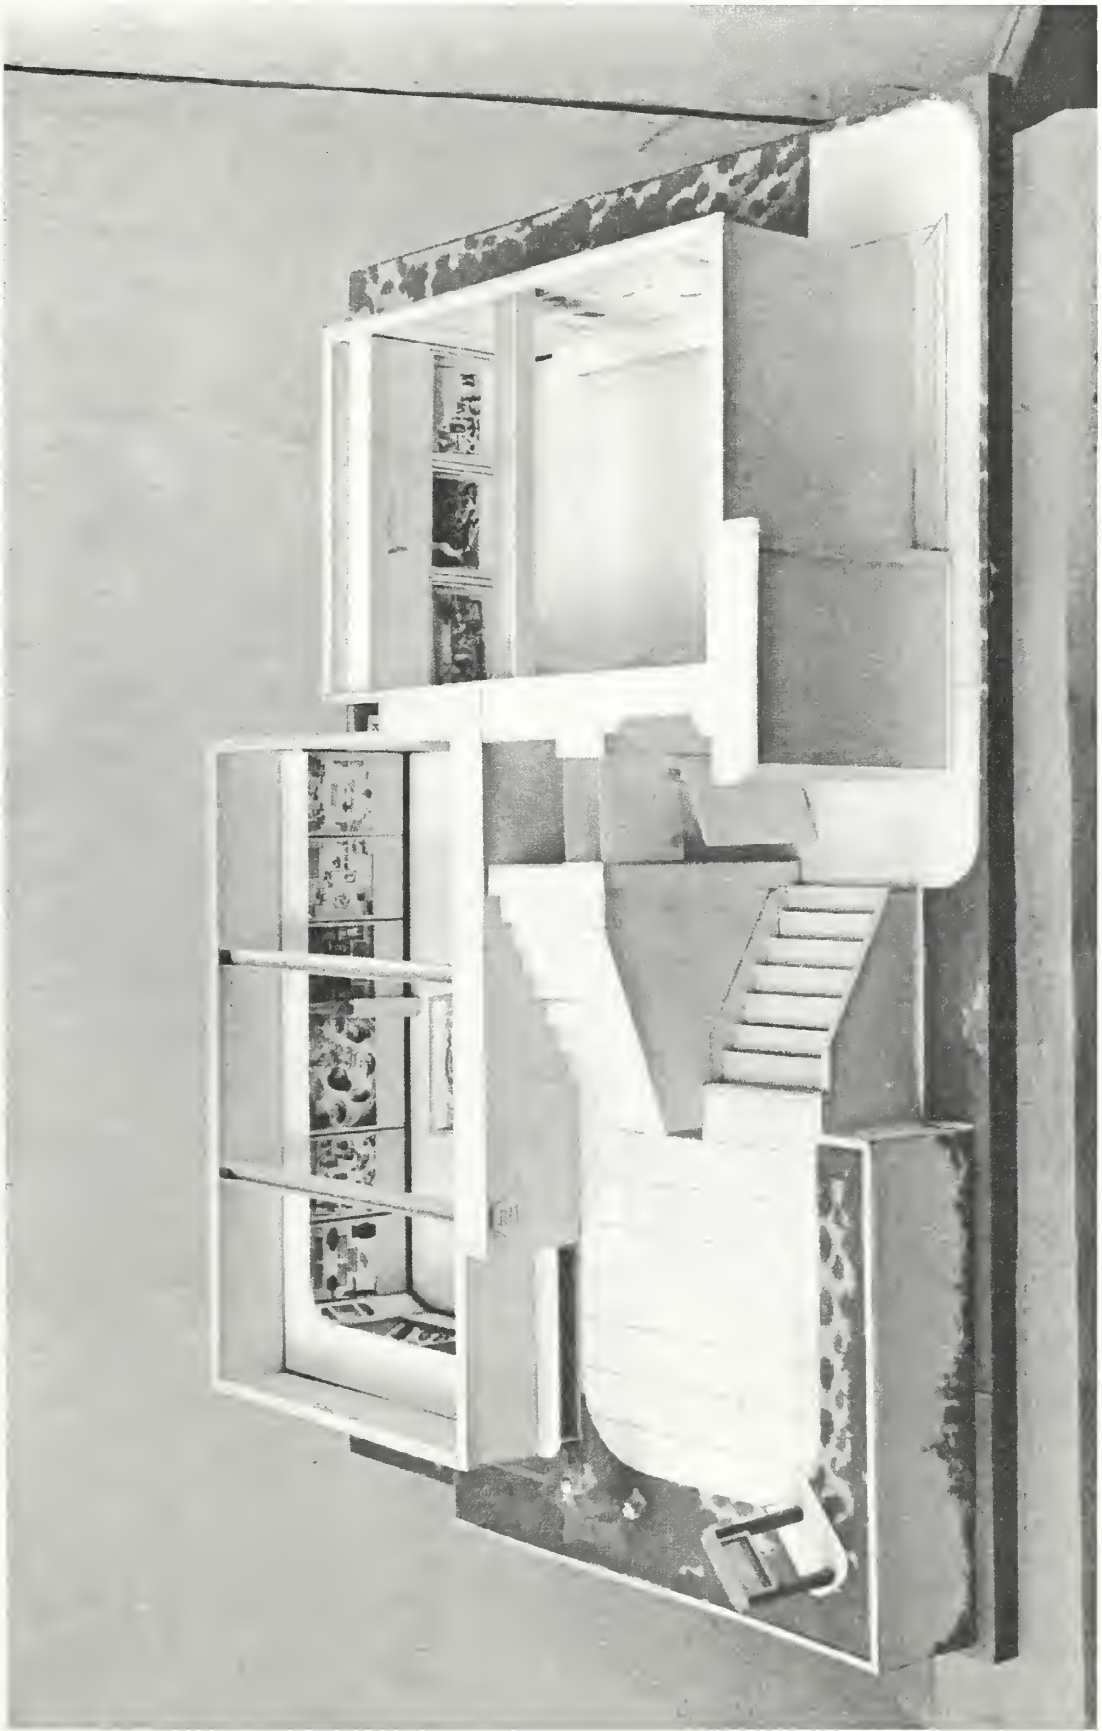
37. "Museum Case Details for Room 19." November, 1938, Plan by Lyle Bennett, Museum Collection, Archives, Petrified Forest National Park, Petrified Forest, Arizona, PF 3100-D, Sheet 13A.

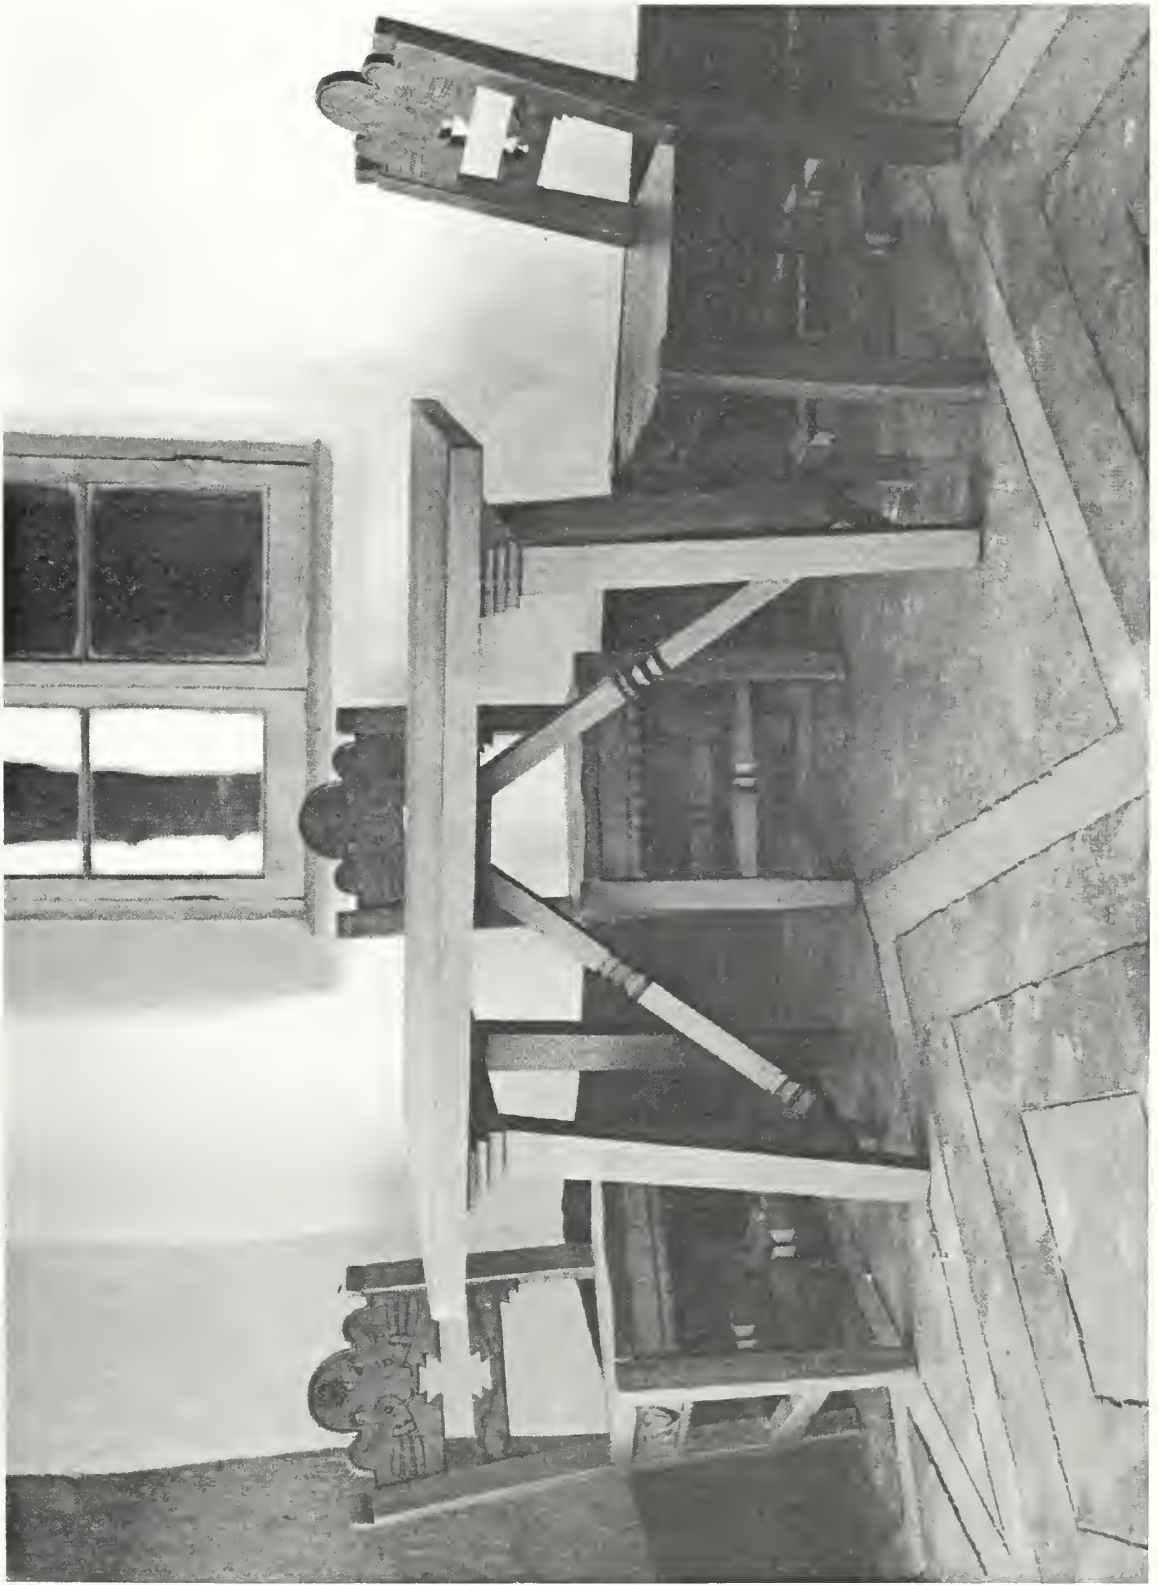
45. "Ornament for Dining Room Chairs." February 1940. Plan by Lyle Bennett, Museum Collection, Archives, Petrified Forest National Park, Petrified Forest, Arizona, PF3100-F, Sheet 1.

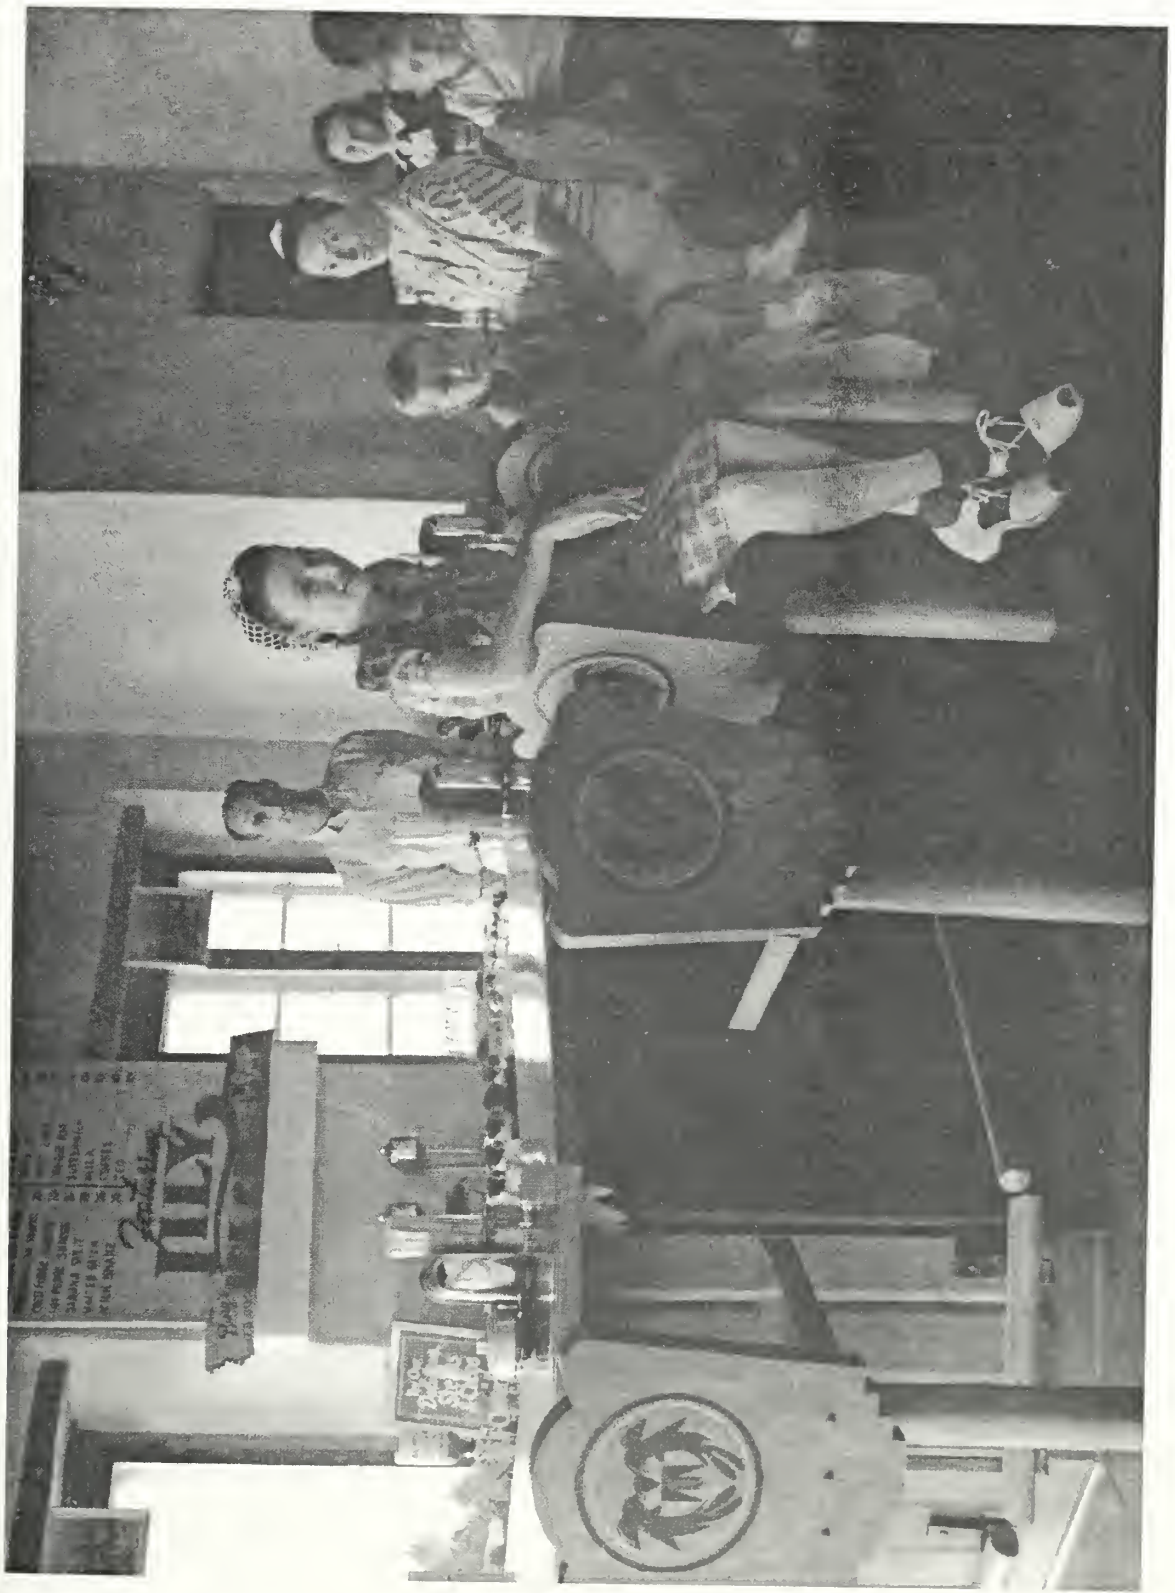
54. "Lunchroom Layout." March 3, 1939, Plan by Lyle Bennett, Museum Collection, Archives, Petrified Forest National Park, Petrified Forest, Arizona, PF 3100-E, Sheet 1.

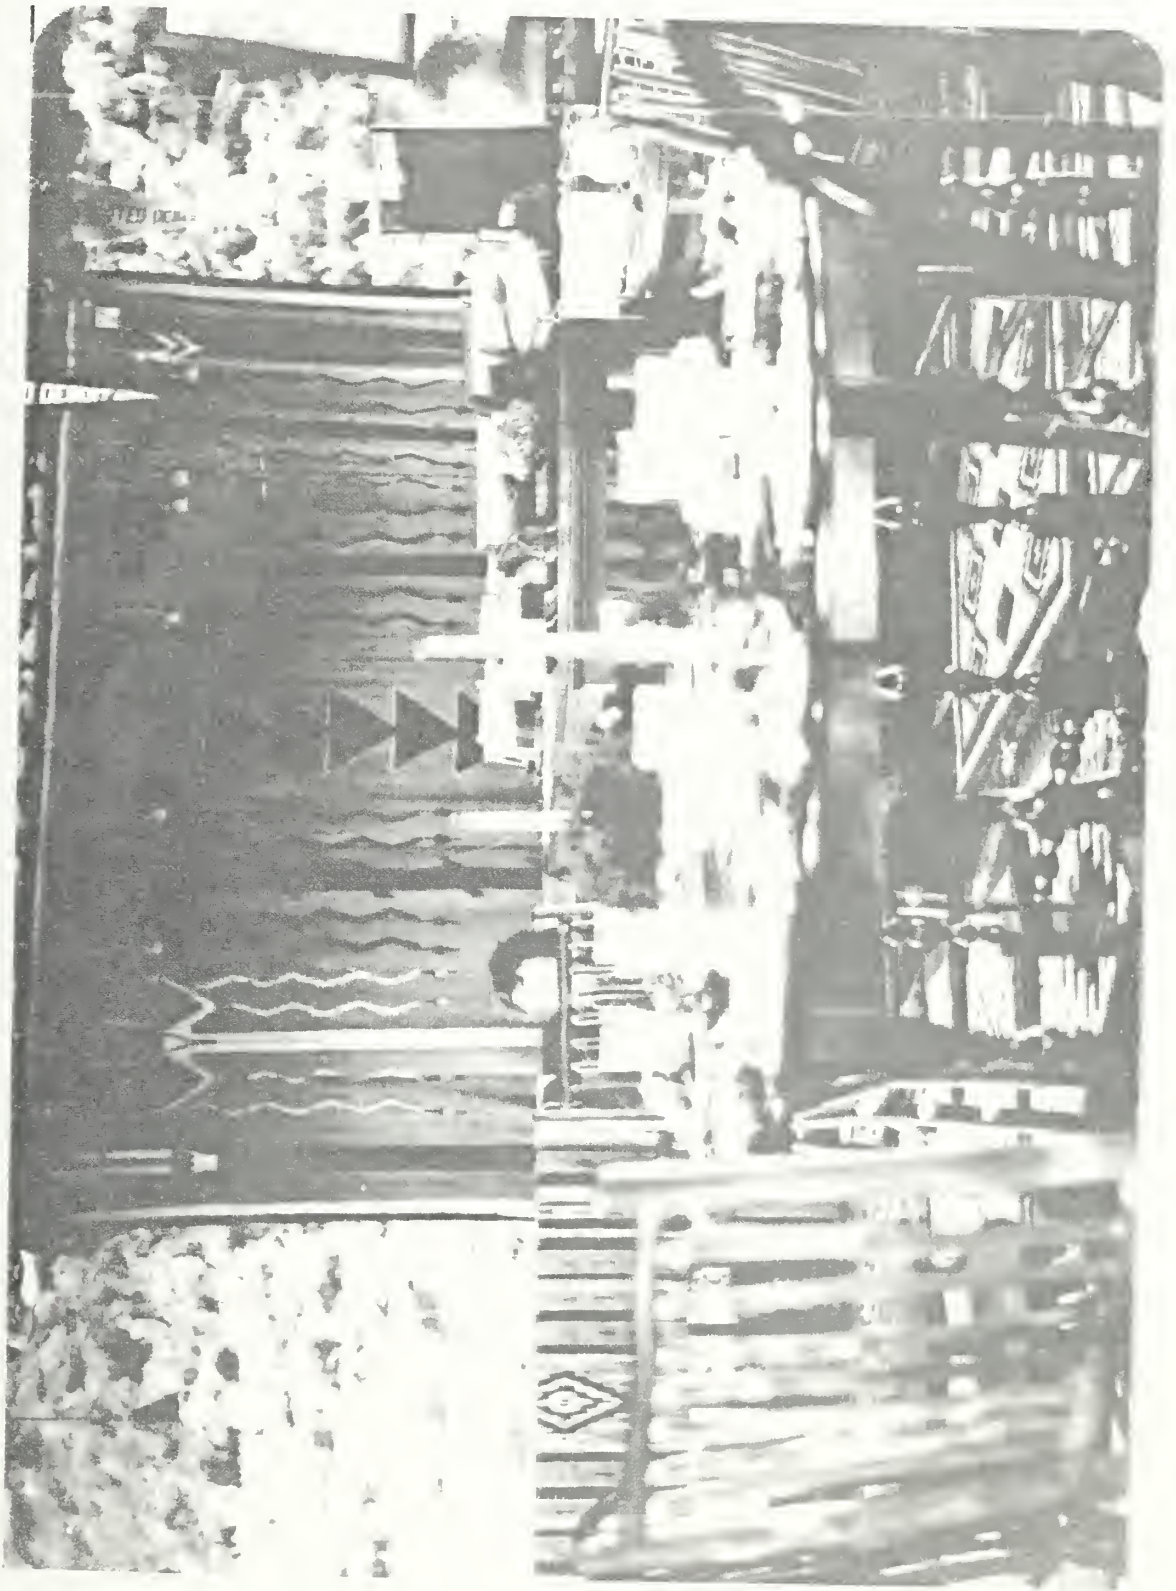
62. "Fixtures--Shelving and Rug Platforms for Room 104." March 16, 1940, Plan by Lyle Bennett, Museum Collection, Archives, Petrified Forest National Park, Petrified Forest, Arizona, PF 3100-H.

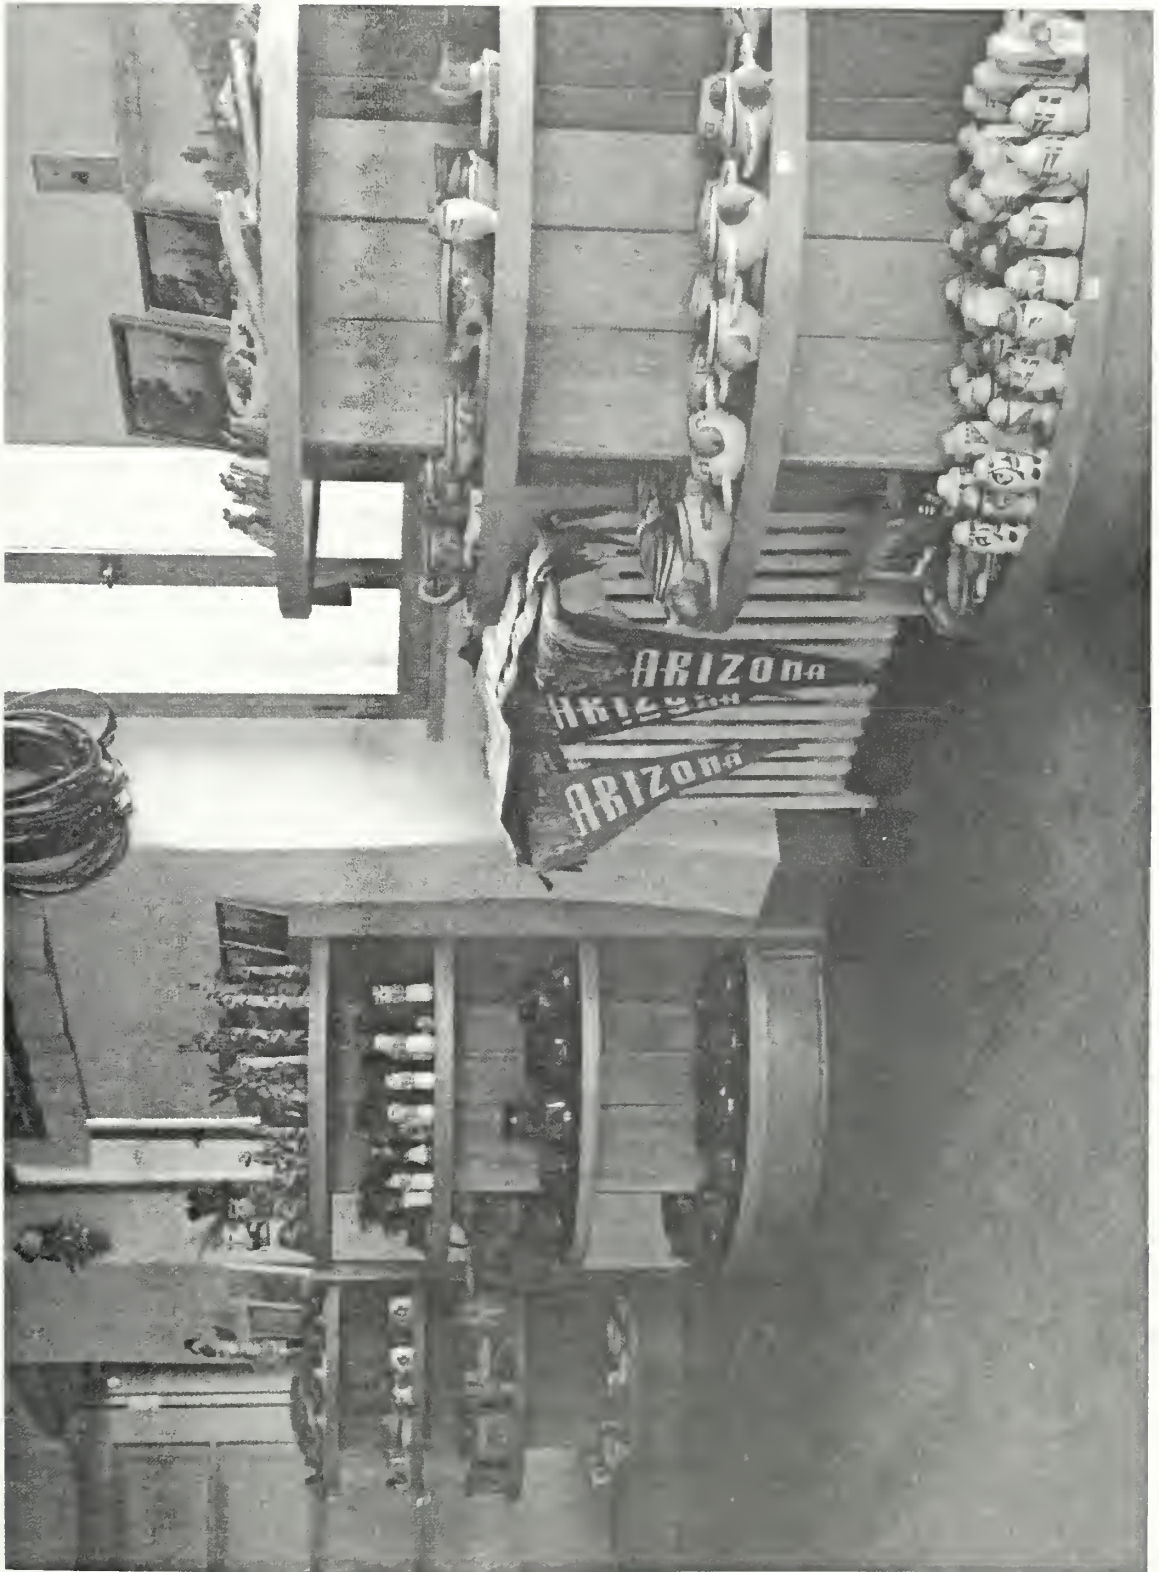
65. "Skylight Details, Multiple Glass Panels, Trading Post Room, (Room 104)." 1975, Unknown Photographer, Museum Collection, Archives, Petrified Forest National Park, Petrified Forest, Arizona, PEFO CAT. # 20756.

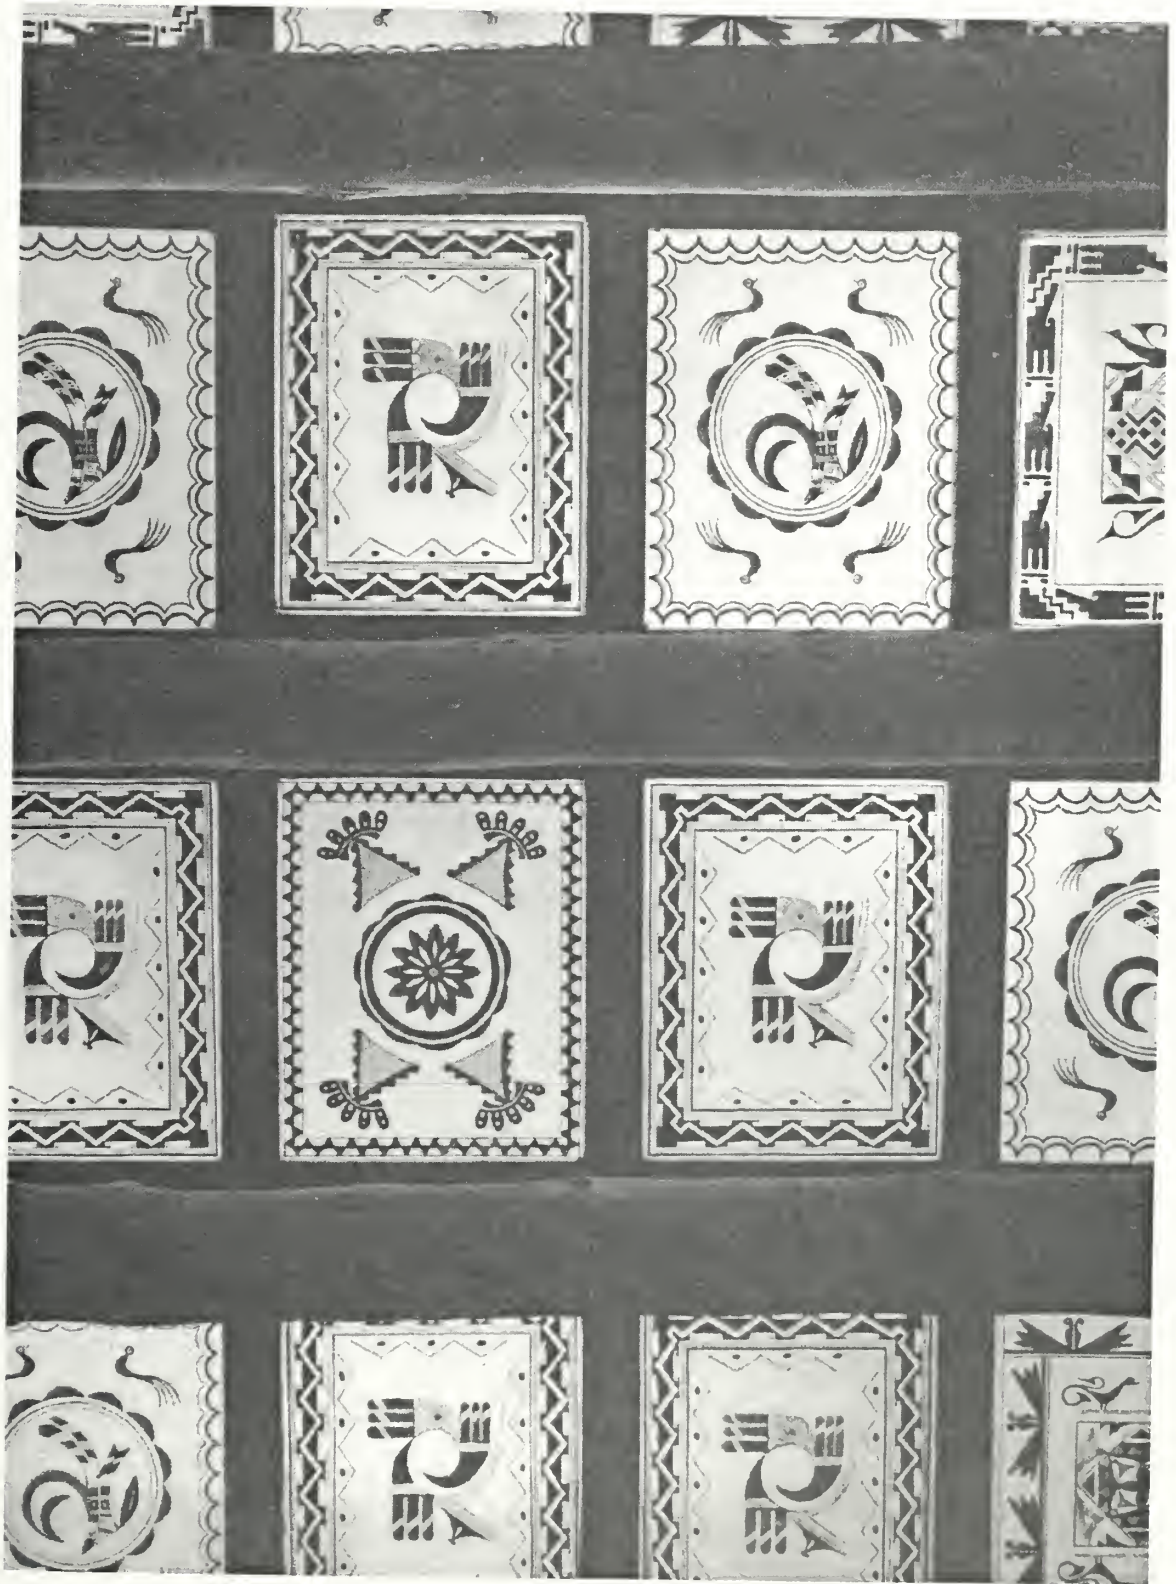
66. "Skylight Details, Trading Post Room, (Room 104)." 1992, Drawing by Historic American Buildings Survey, Museum Collection, Archives, Petrified Forest National Park, Petrified Forest, Arizona, HABS: AZ-161, sheet 10 of 12.

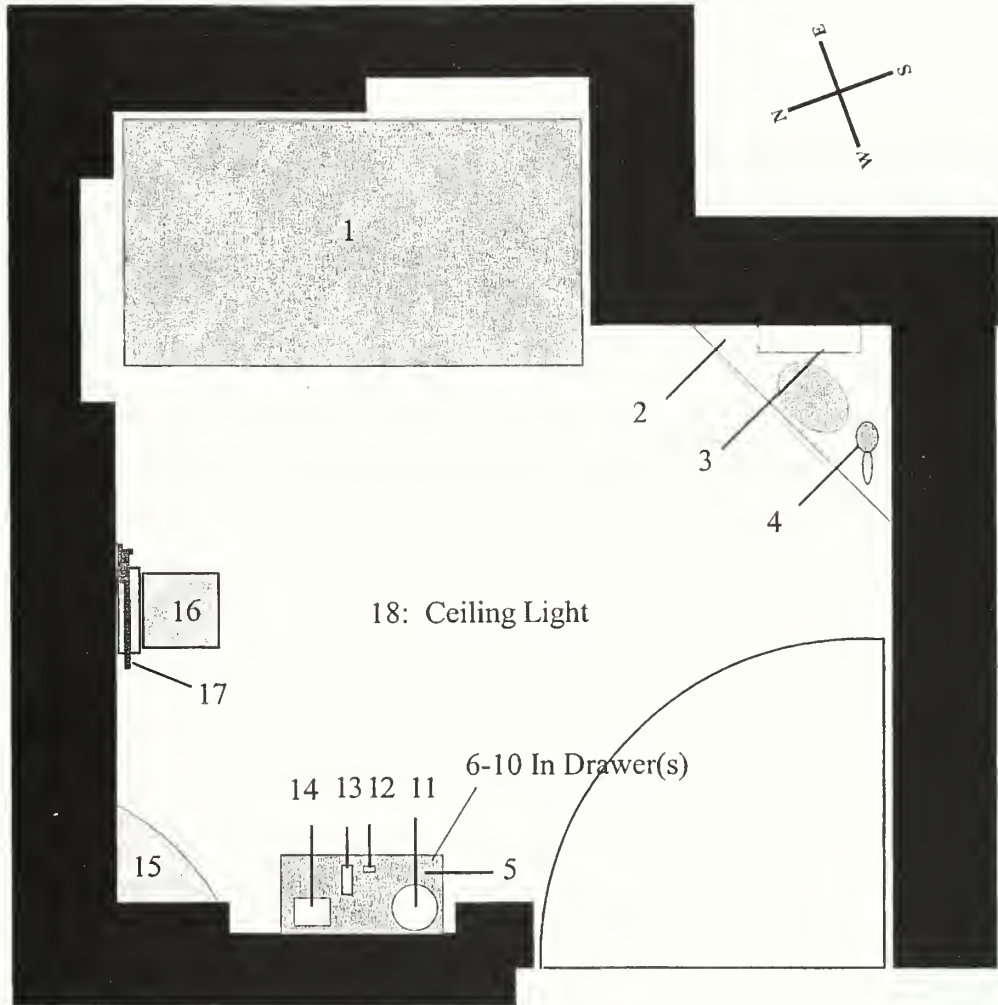
2. Painted Desert Inn, Room 101--Kitchen, Recommended Objects for “Salad Table Vignette” Installation, Plan by Laura DeNormandie.

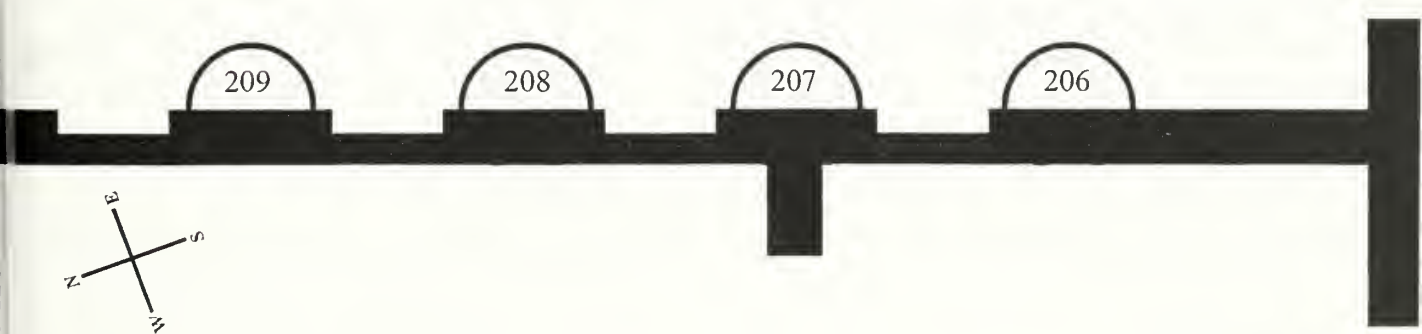
6. Painted Desert Inn, Room 104--Trading Post Room, Recommended Objects for Top Counter of Display Units, Plan by Laura DeNormandie.

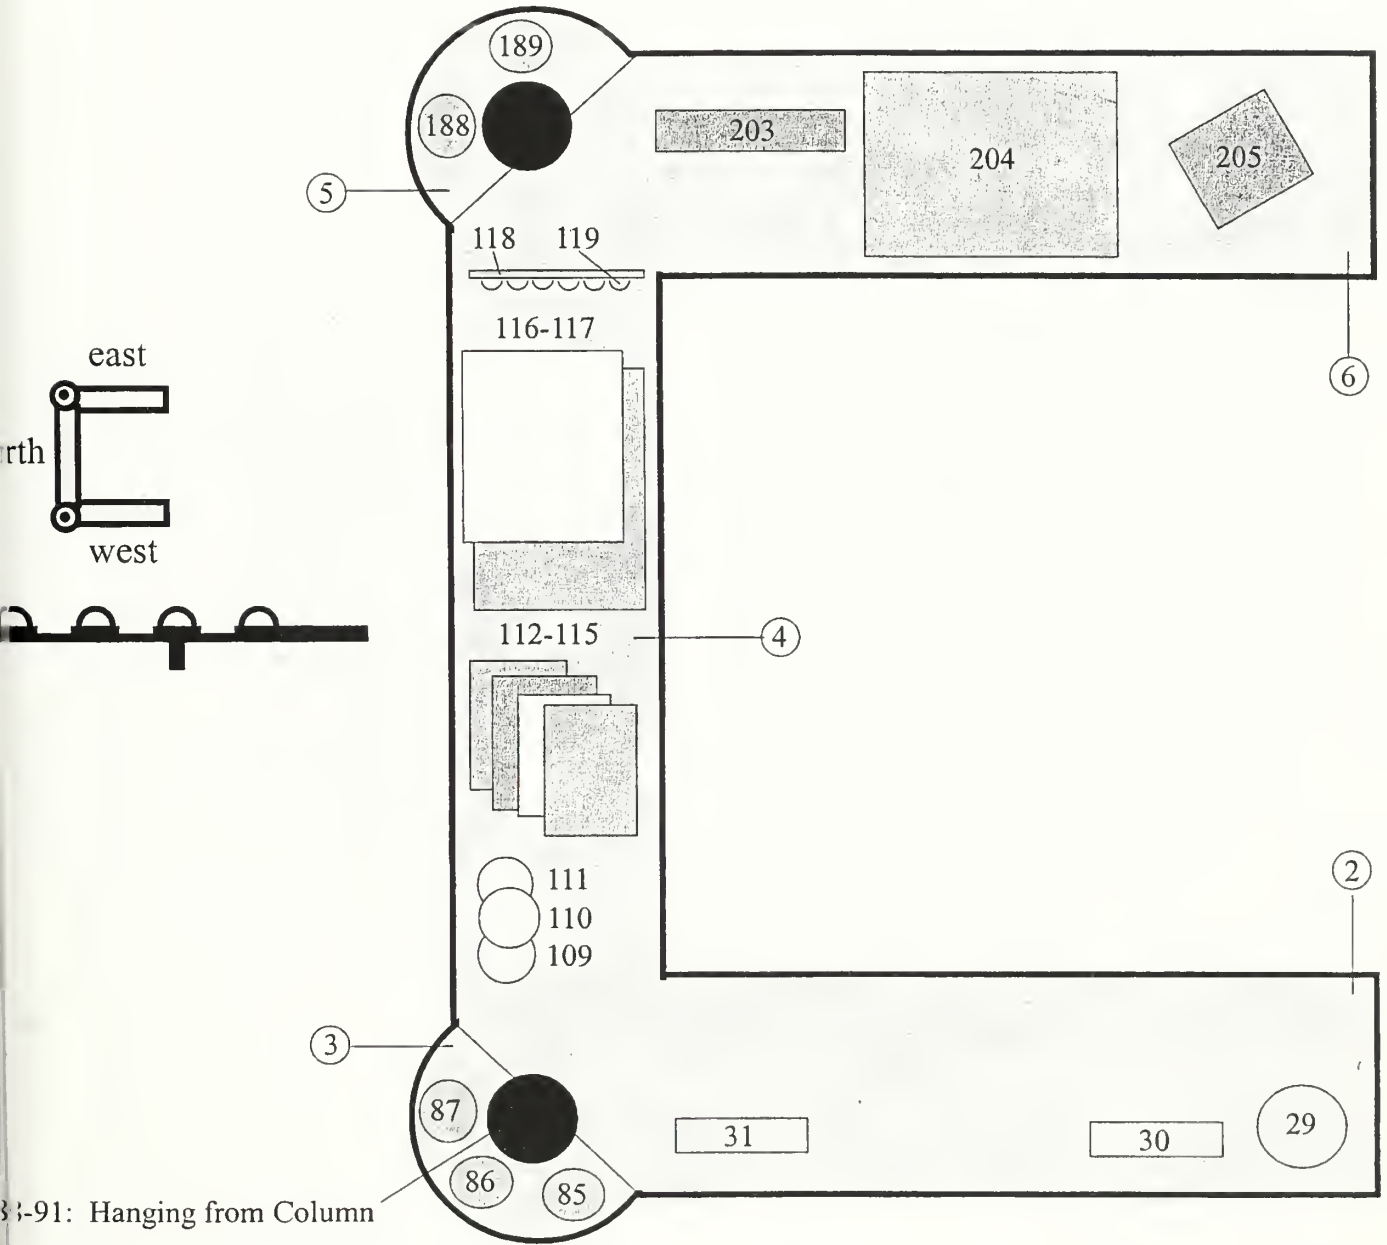
7. Painted Desert Inn, Room 104--Trading Post Room, Recommended Objects for Upper Shelves of Display Units, Plan by Laura DeNormandie.
