# ANTRAM - GRAY HOUSE

## Roger Williams National Memorial

Historic Structure Report

1981

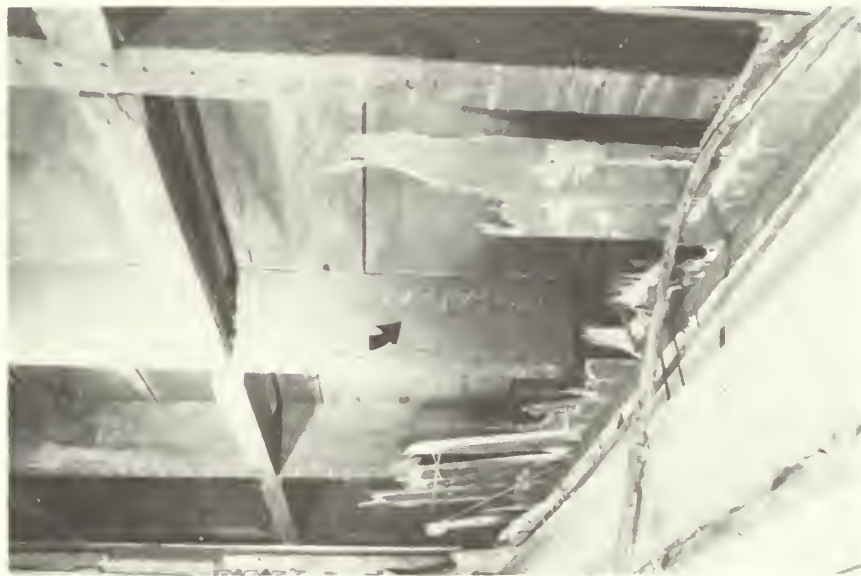
**Illustration 14.** Antram-Gray House: Second-Floor Joist  
Inscribed with Signature and Date.

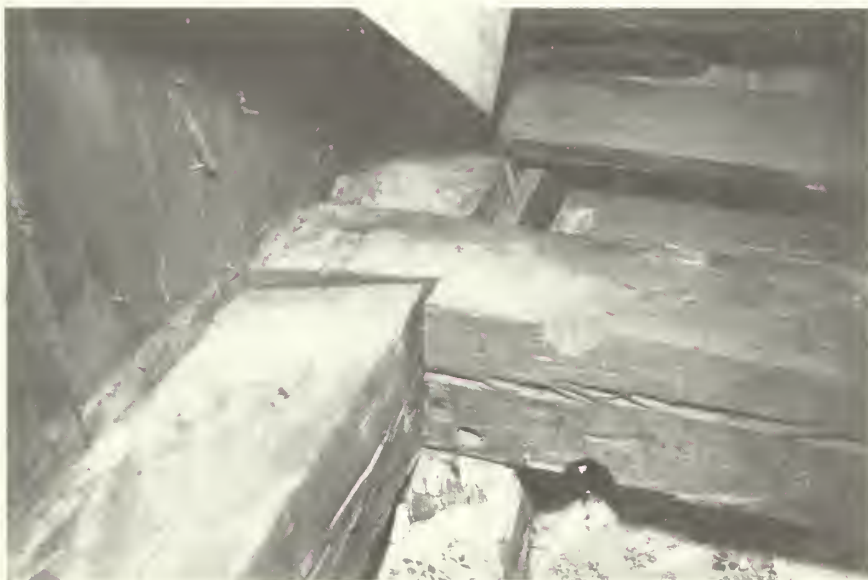
**Illustration 19.** Antram-Gray House: Dovetail Joints of Wall Plates in Northeast Corner of Attic.

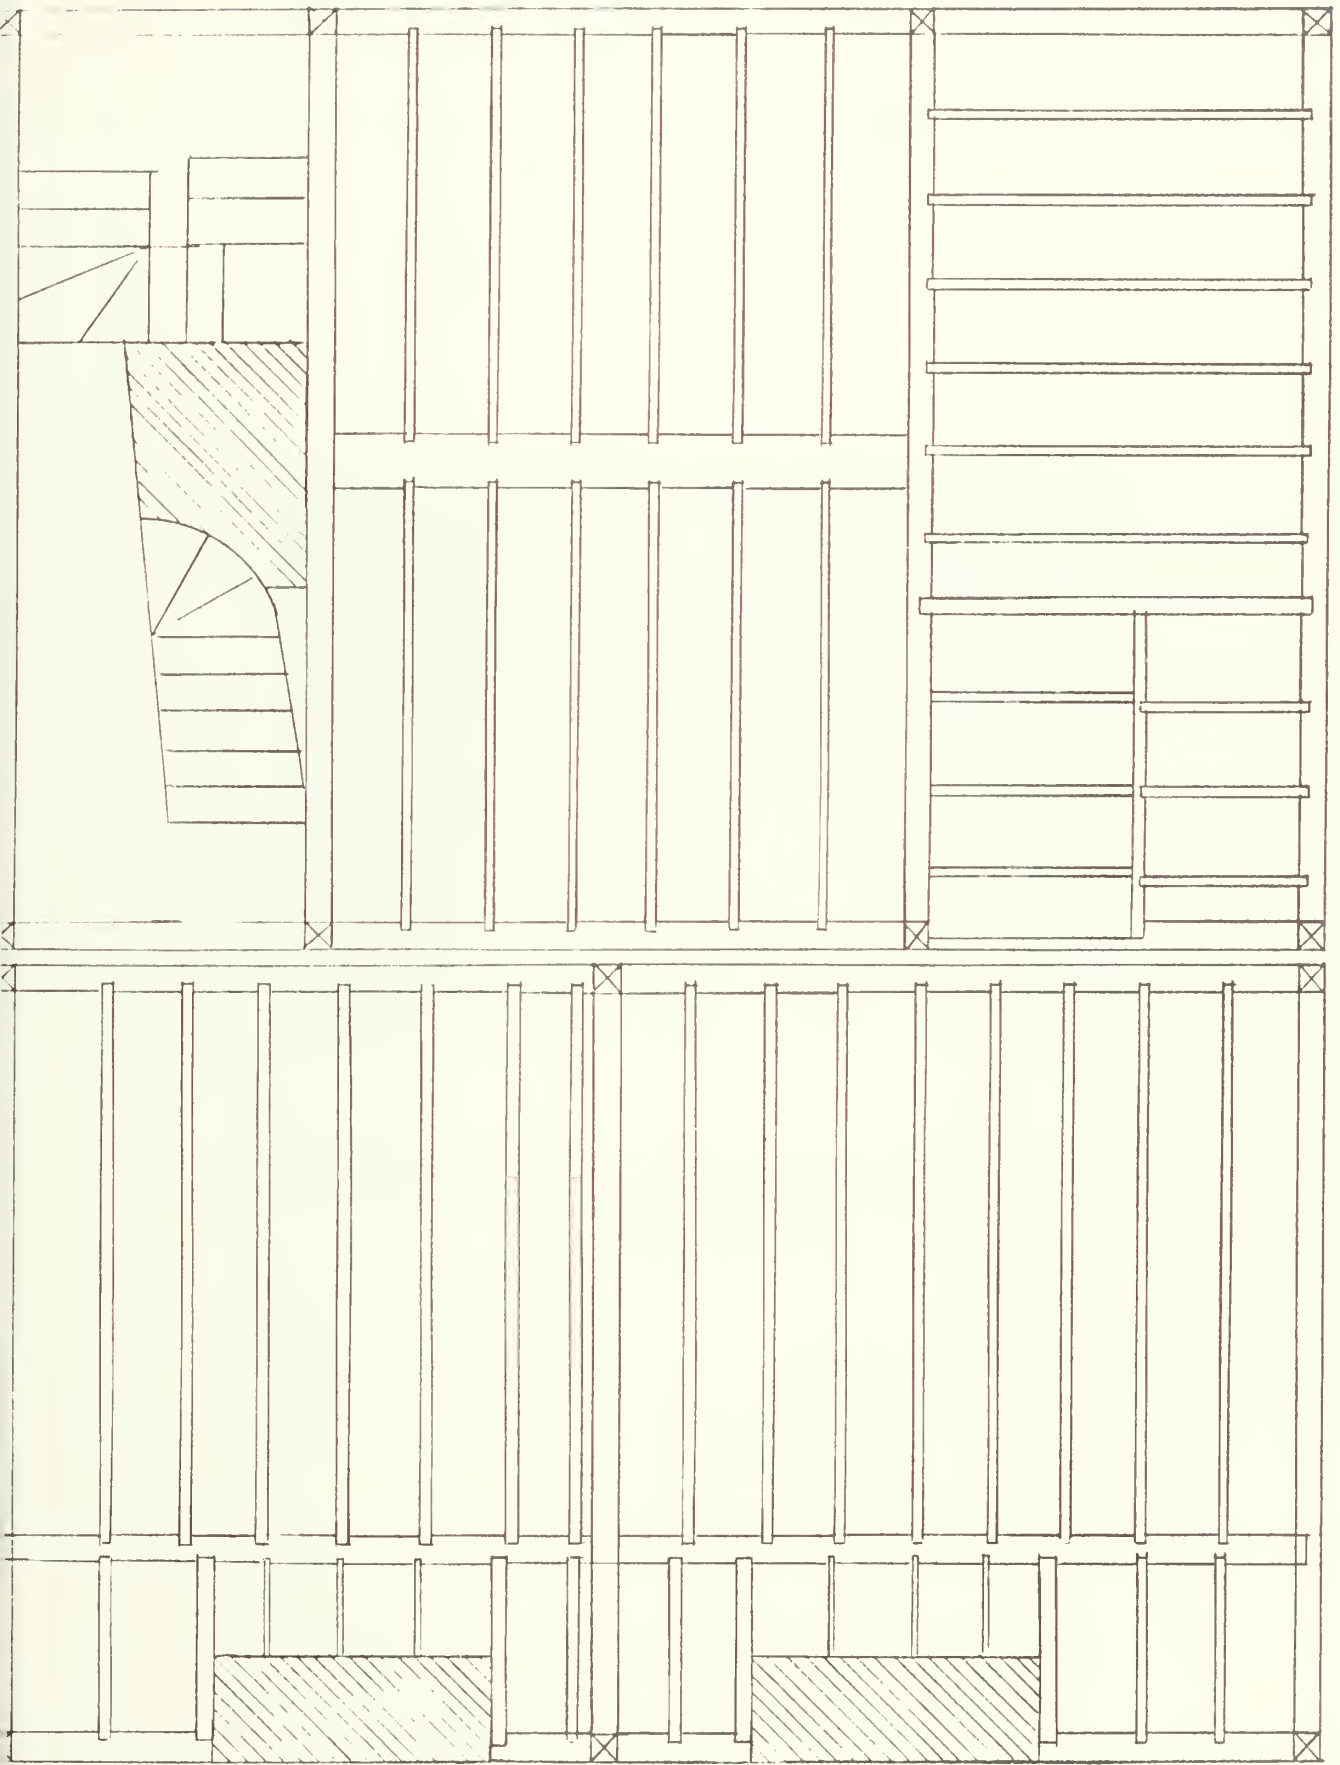
**Illustration 21.** Antram-Gray House: Second-Floor Framing Plan.

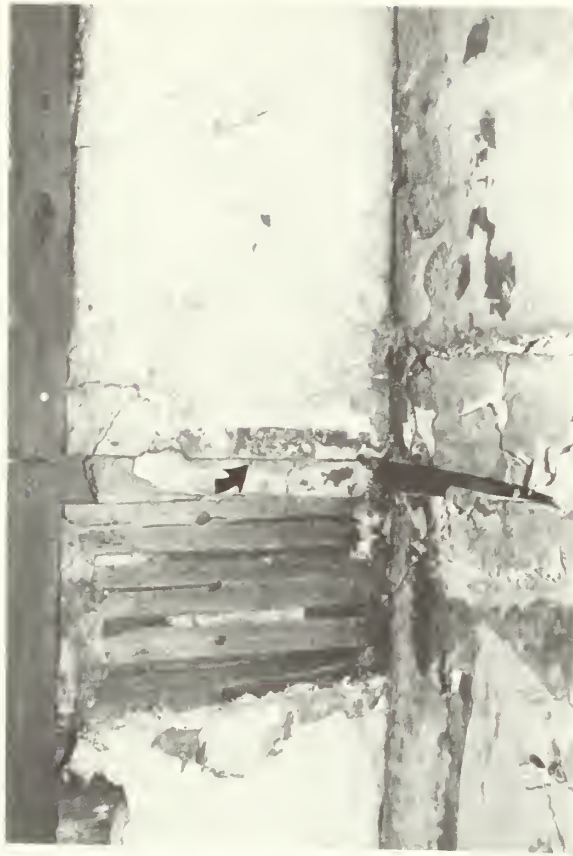
**Illustration 30.** Antram-Gray House: Painted Border Above Chair Rail, Room 204.

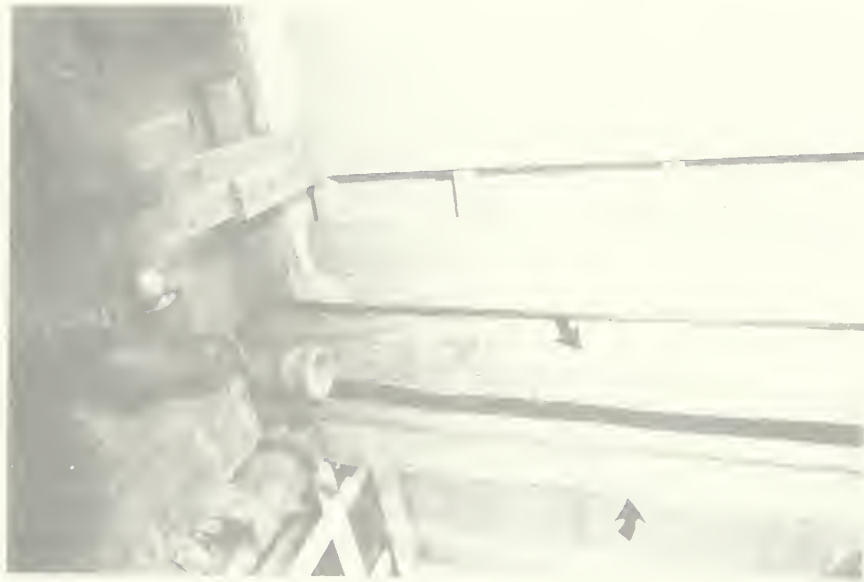
**Illustration 35.** Antram-Gray House: West-Wall Framing of First Story, Showing Adjacent Circa-1730 and Circa-1798 Corner Posts and End Girts.

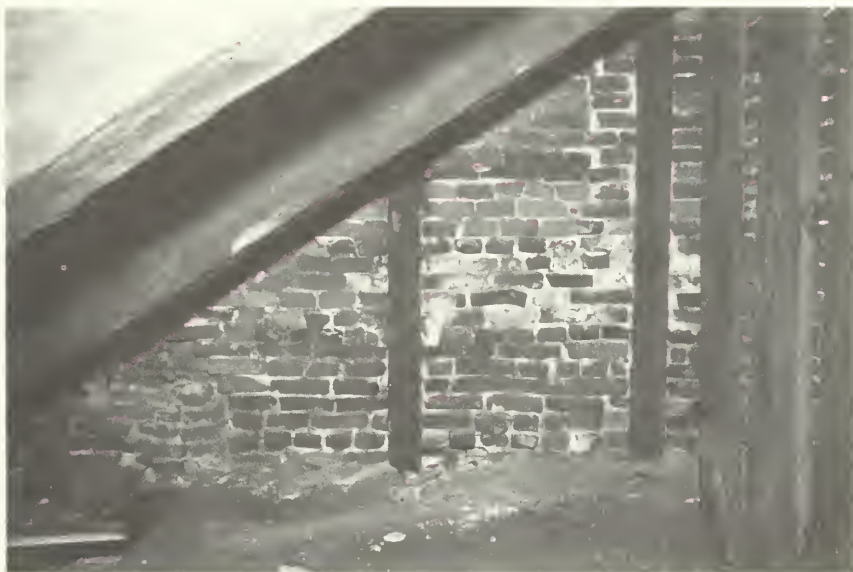
**Illustration 37.** Antram-Gray House: South Wall of Attic, East End, Showing Studs Embedded in Brickwork.

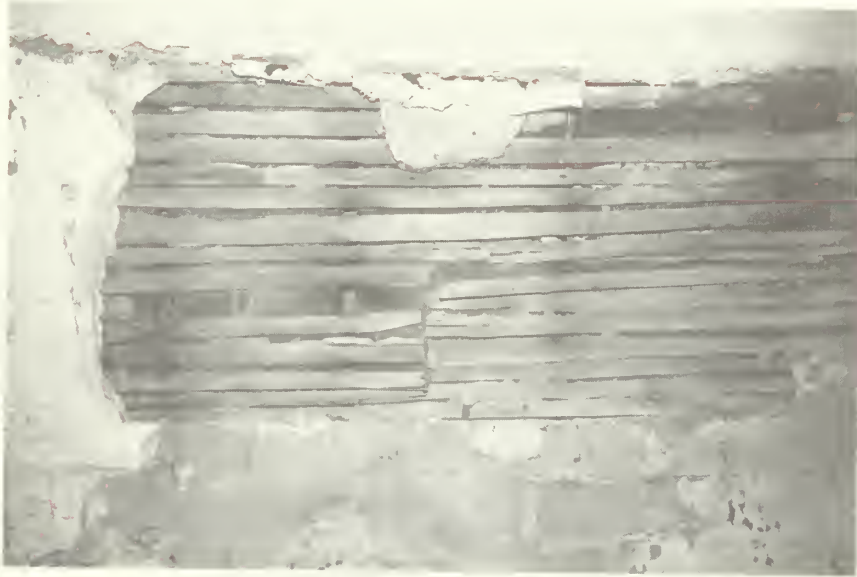
**Illustration 40.** Antram-Gray House: Type-III Lath and Plaster, Circa 1798, on West Wall of Room 202.

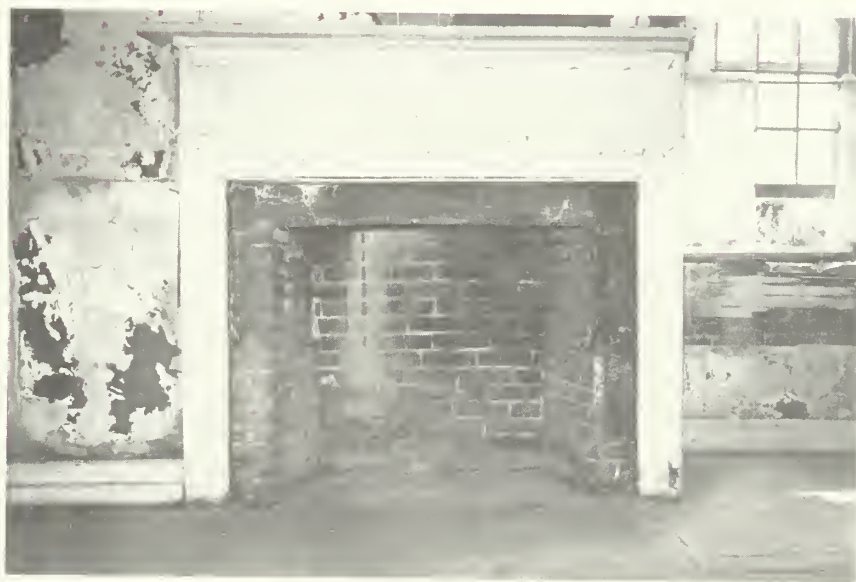
**Illustration 43.** Antram-Gray House: Fireplace in  
Room 202.

The firebox opening in Room 202 measures 3 feet, 10 inches wide, 3 feet high, and 1 foot, 3 inches deep. The sides are splayed (Ill. 44). The surfaces of the firebox are covered with natural cement. Embedded in the east side, at heights of 1 foot, 4 inches and 2 feet, 7 inches, are two wrought-iron bolts. The hearth measures 2 feet by 1 foot, 10 inches, and is made of 4-inch square bricks, similar to those used for the fireplace hearth in Room 204. The hearth in Room 204 also has been dated to ca. 1820, as will be discussed shortly.

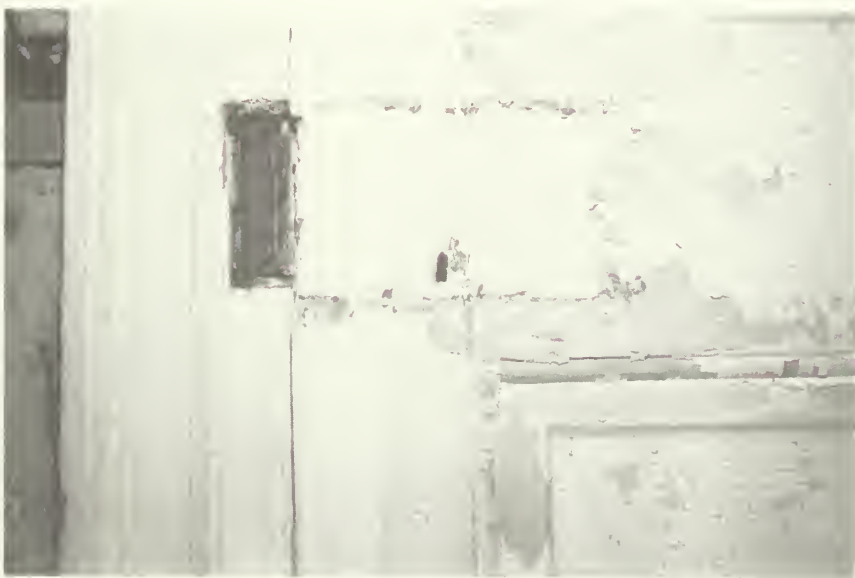
**Illustration 45.** Antram-Gray House: Door 204, South Side, Showing Paint Evidence of Missing Rim Lock.

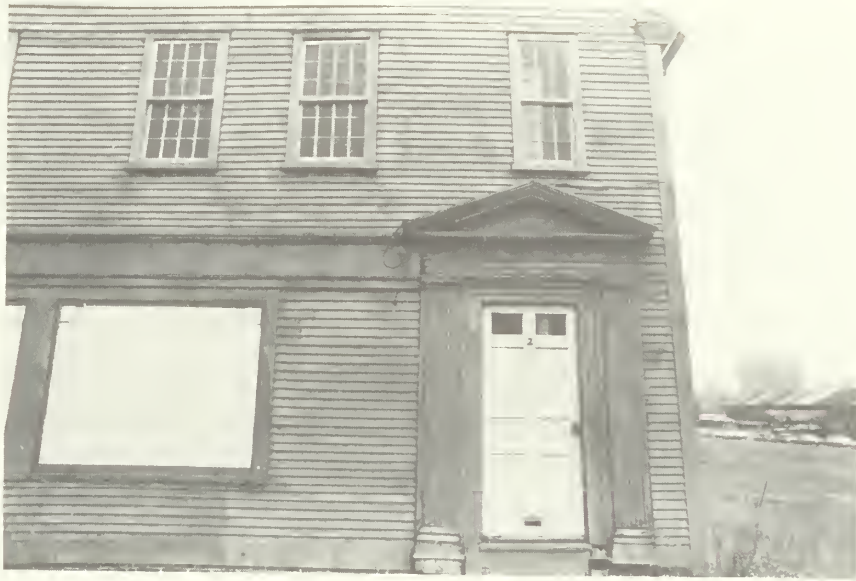
**Illustration 46.** Antram-Gray House: North Facade,  
Showing Circa-1798 Doorway Frontispiece.

Paint samples taken from this frontispiece contain a full sequence of paint colors dating from ca. 1798 (see samples P226, 271). These samples are the best evidence that remains for the early exterior paint colors of the Antram-Gray House. They indicate that ca. 1798, the wooden trim on the house was painted white.

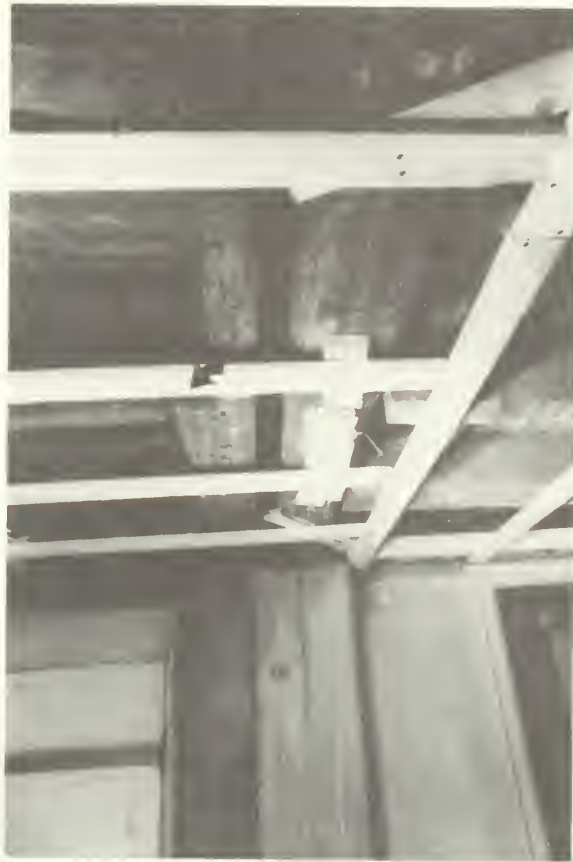
**Illustration 48.** Antram-Gray House: First-Floor Framing, Showing Circa-1730 South Girt Cut Out for Southeast Stair.

Another ca.-1798 addition to the first-floor story was a stair built in the southeast corner of the original house, in Rooms 105 and 205. This seems to have been required for access to the second-story rooms of the addition, which had no

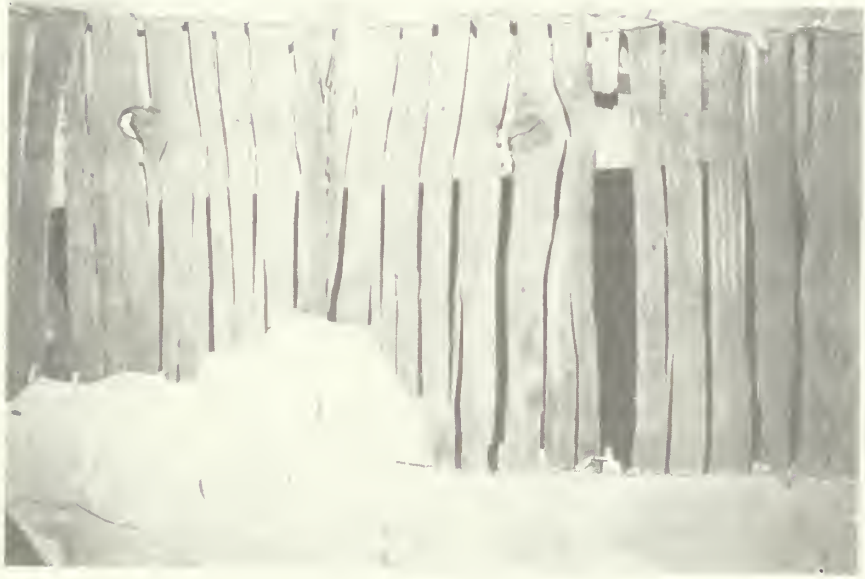
**Illustration 50.** Antram-Gray House: Accordion Lath and Plaster, Circa 1830, on South Wall of Northeast Attic Room.

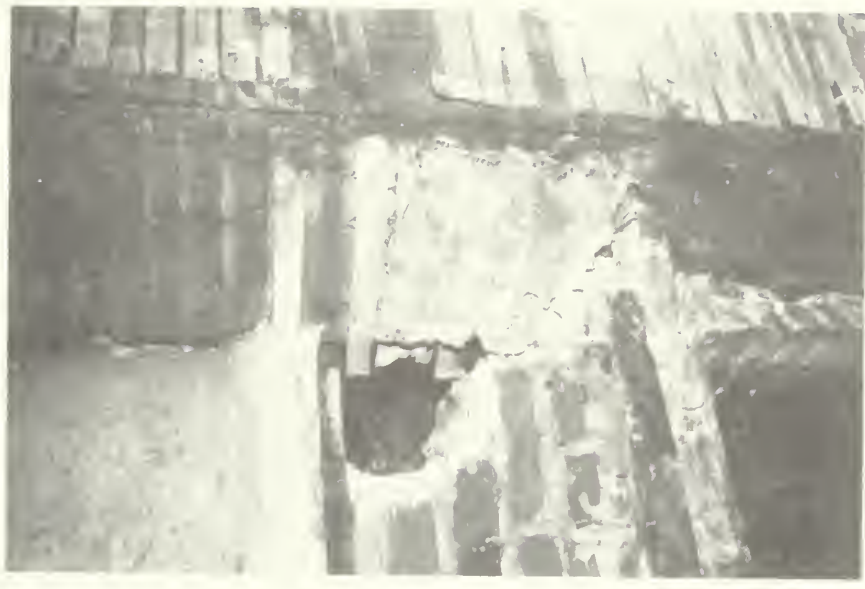
**Illustration 51.** Antram-Gray House: Plaster and Wallpaper, Circa 1798, Uncovered on North Reveal of Fireplace in Room 204.

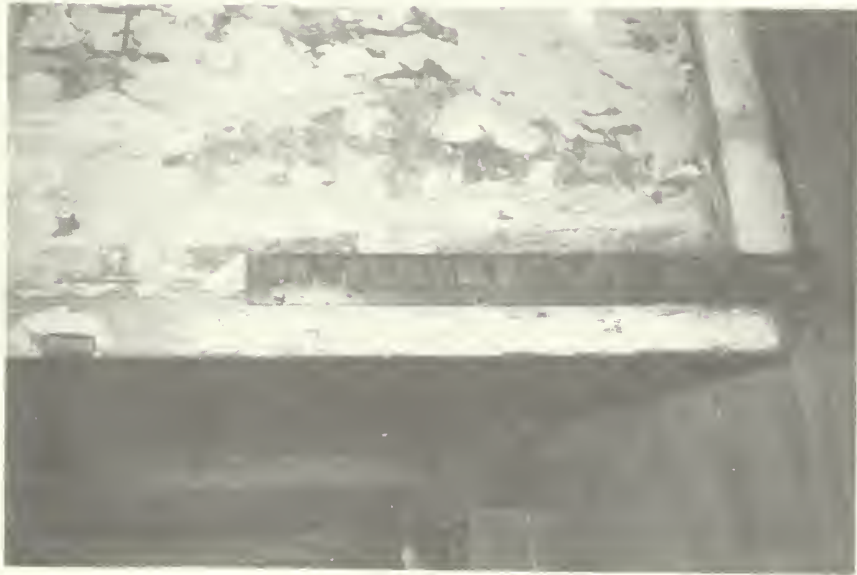
**Illustration 54.** Antram-Gray House: Fireplace in Room 204, Showing Circa-1820 Overmantel, Mantel, and Firebox.

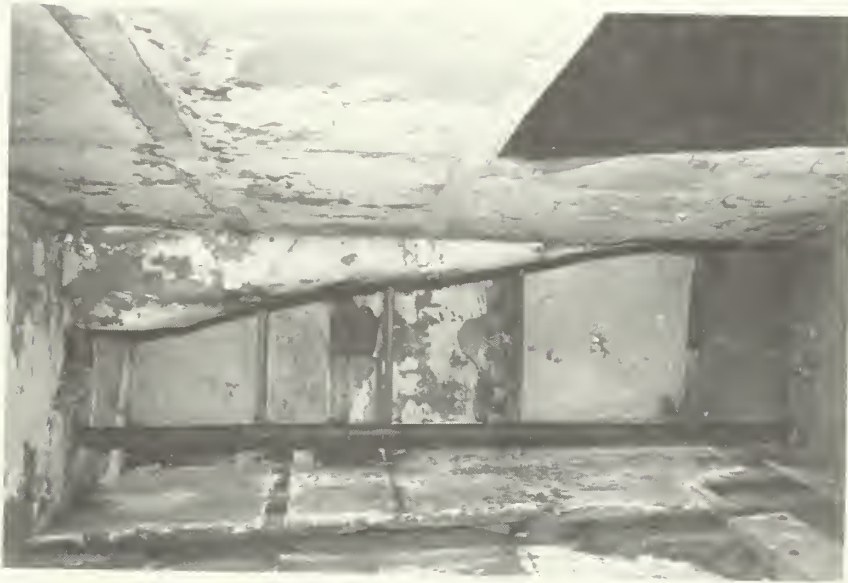
**Illustration 58.** Antram-Gray House: North End of Room 203, Showing Wooden Shelves.

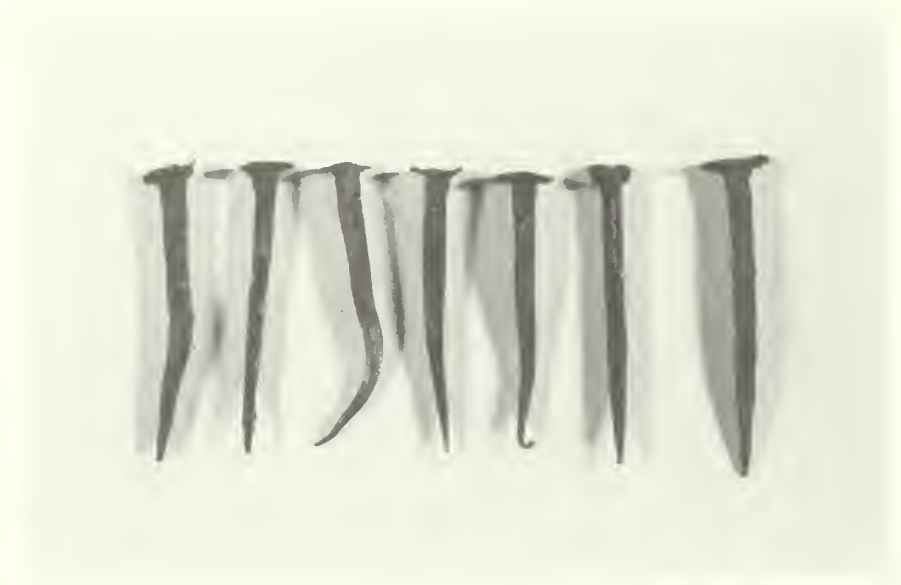
Photograph No. 6: 8d (2-1/2 inch) early machine-cut nails with handmade, T-shaped heads, ca. 1798
