### Three Farewells to Manzanar

The Archeology of Manzanar National Historic Site, California

Part 1: Chapters 1 – 9

Publications in Anthropology 67 1996

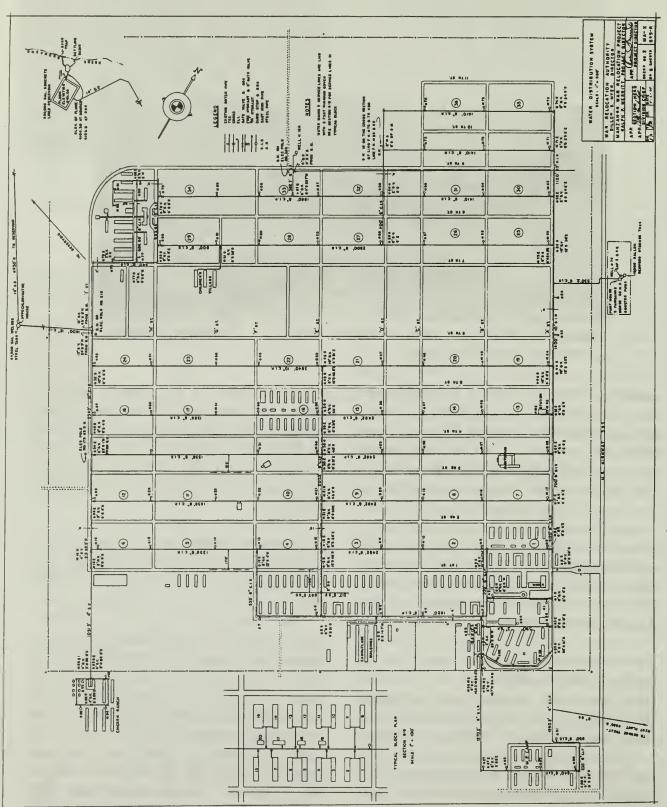
Figure 4.20. Water distribution system (National Archives, Cartographic Division).

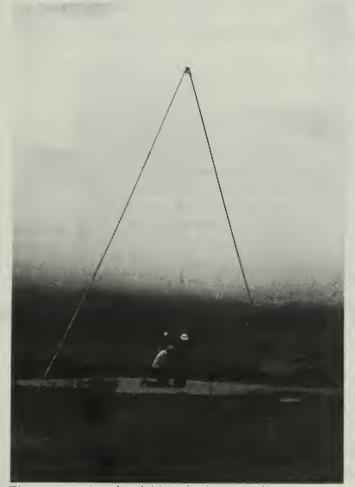
Figure 8.4. Overhead bi-pod photography at garbage can washing rack foundation.

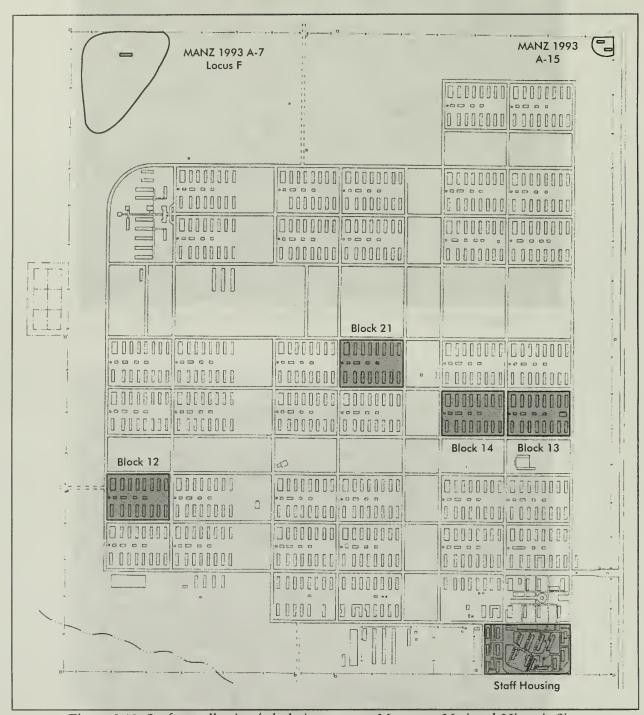
Figure 8.10. Surface collection/tabulation areas at Manzanar National Historic Site.

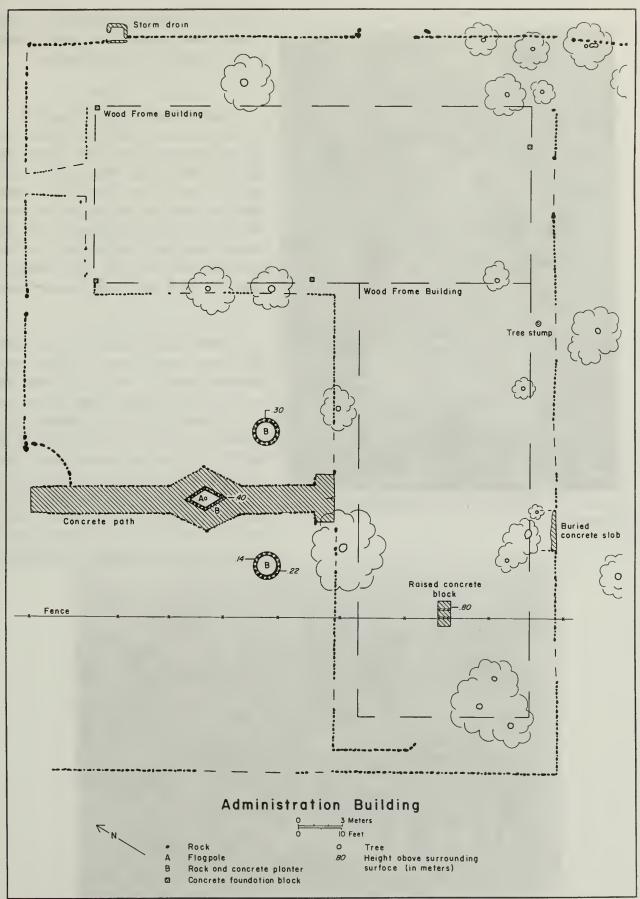
Figure 9.7. Administration Building (Features A-1, A-13, and A-14).

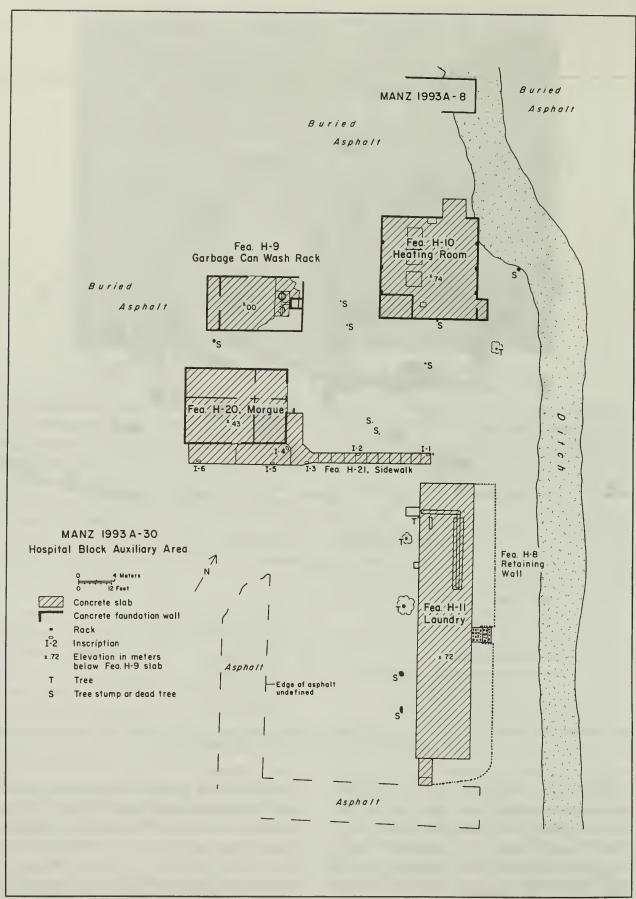
Figure 9.28. Hospital Block auxiliary area (Features H-8 to H-11, H-20, and H-21).

The concrete slab foundations of the hospital laundry room, hospital heating plant, morgue, and garbage can washing rack were cleared of sand and debris and mapped in detail (Figure 9.28). In addition to these, a concrete side-

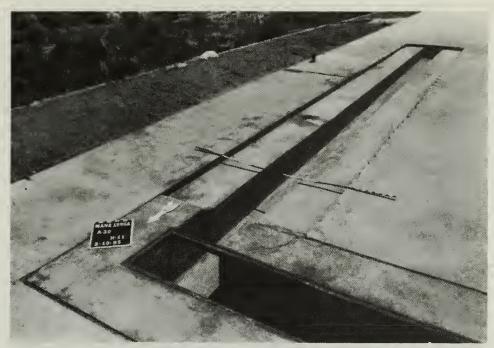
Figure 9.31. Detail of Hospital Block Laundry foundation (Feature H-11) after removal of debris.

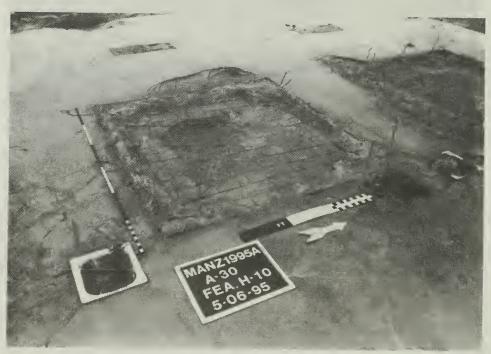
Figure 9.36. Detail of Hospital Heating Room (Feature H-10) showing boiler foundation after removal of debris.

Remains at the hospital heating plant (Feature H-10) consist of a 36 ft by 38 ft concrete slab that incorporates two rooms divided by low concrete walls, and an attached 4 ft by

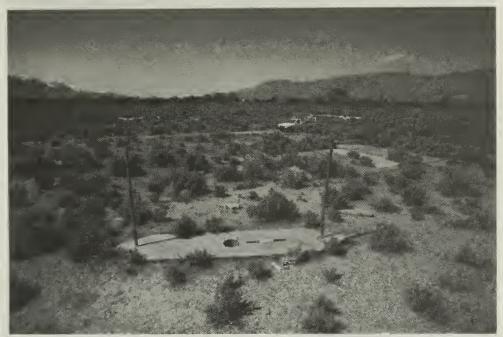
Figure 9.47. Foundation of Service Station gasoline pump (Feature Se-1).

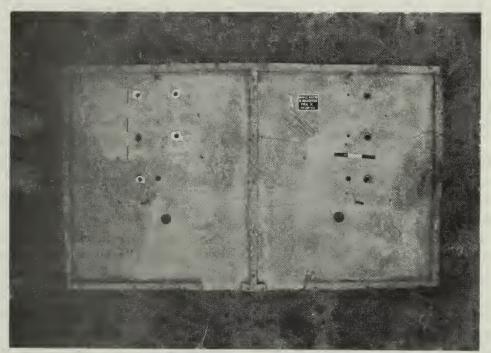
Figure 9.56. Overhead bi-pod view of latrine in Warehouse Block after removal of debris (Feature W-3).

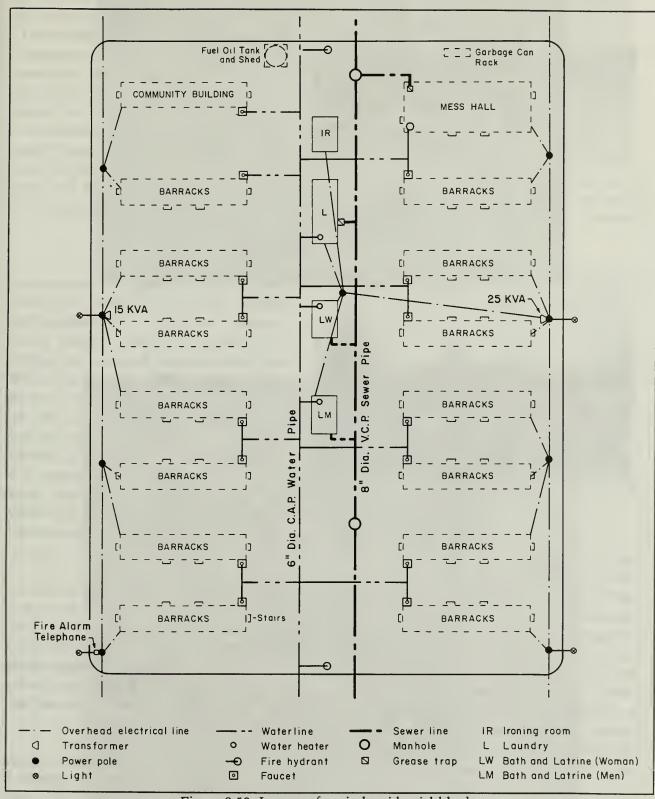
Figure 9.58. Layout of typical residential block.

The latrines consisted of two separate (men's and women's) 20 ft by 30 ft buildings. Each had a

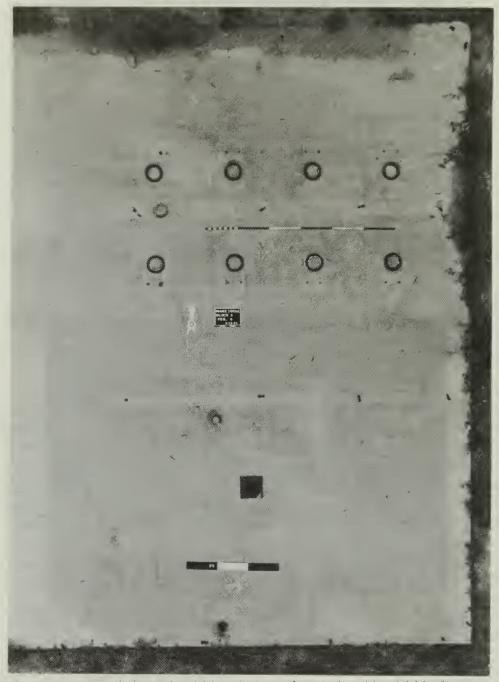
Figure 9.66. Detailed overhead bi-pod view of typical residential block men's latrine.

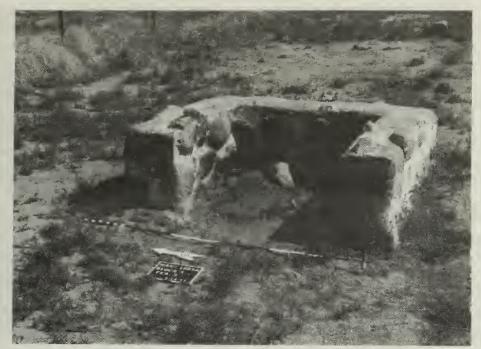
Figure 9.67. Block 1 storm drain (Feature 1-2).

There are storm drains constructed of concrete and rock along the road east of Barracks 1 (Features 1-1 and 1-2, Figure 9.67) and a rock alignment between them along the road (Feature 1-4). Other evacuee-constructed features are

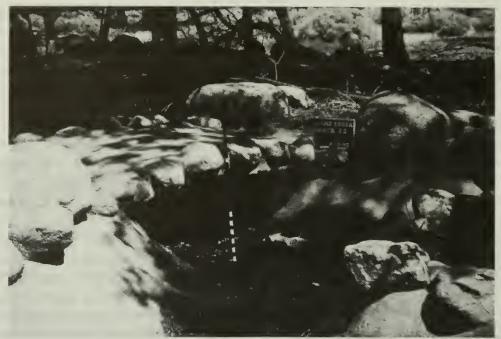
Figure 9.87. Concrete bridge at Block 22 Pond (Feature 22-3).

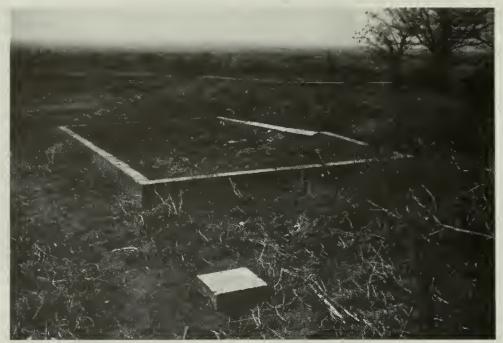
Figure 9.116. Concrete perimeter foundation (Feature P-7).

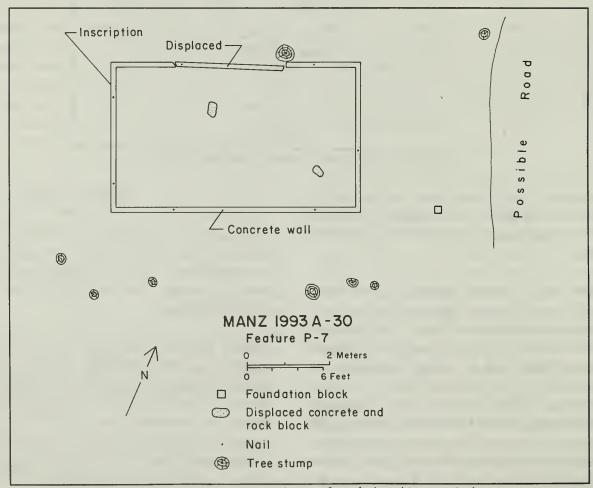
Figure 9.117. Concrete perimeter foundation (Feature P-7).

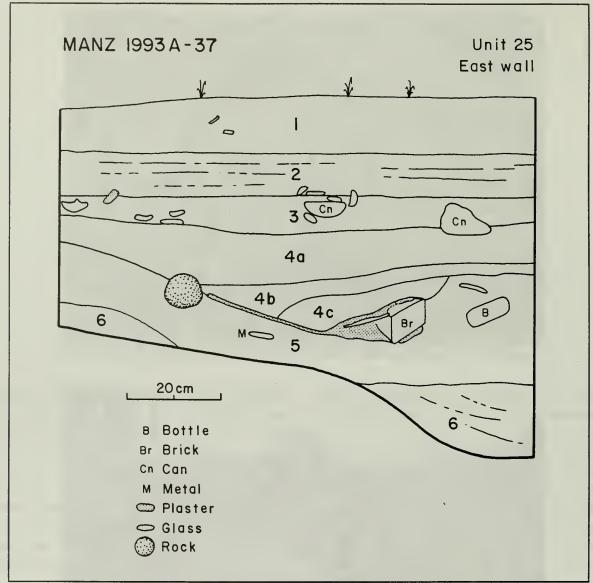
Figure 9.124. Excavation Unit 25 east sidewall profile (MANZ 1993 A-37, Locus A).

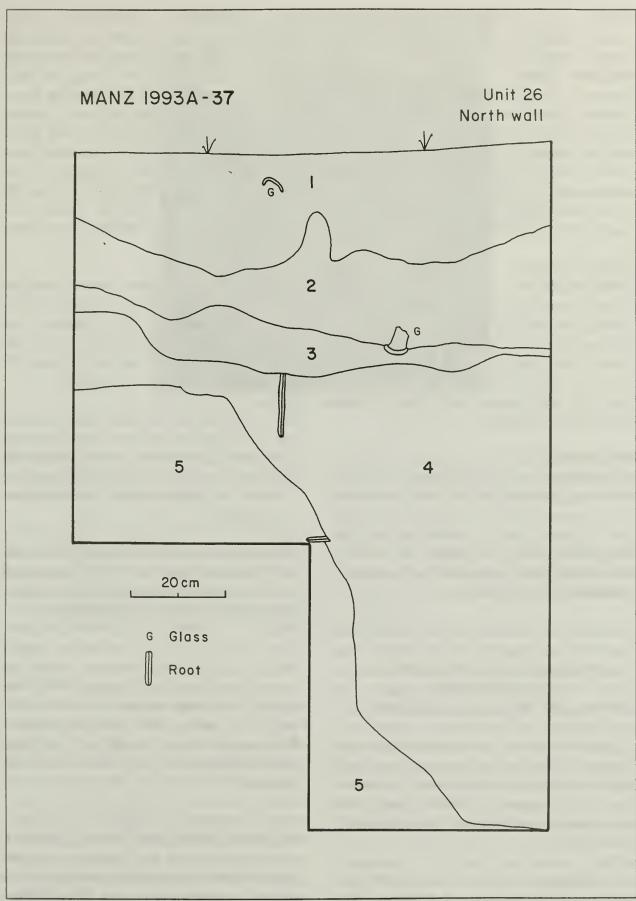
Figure 9.126. Excavation Unit 26 north sidewall profile (MANZ 1993 A-37, Locus C).
