CULTURAL LANDSCAPE REPORT

FOR SAGAMORE HILL

NATIONAL HISTORIC SITE

Site History, Existing Conditions, and Analysis

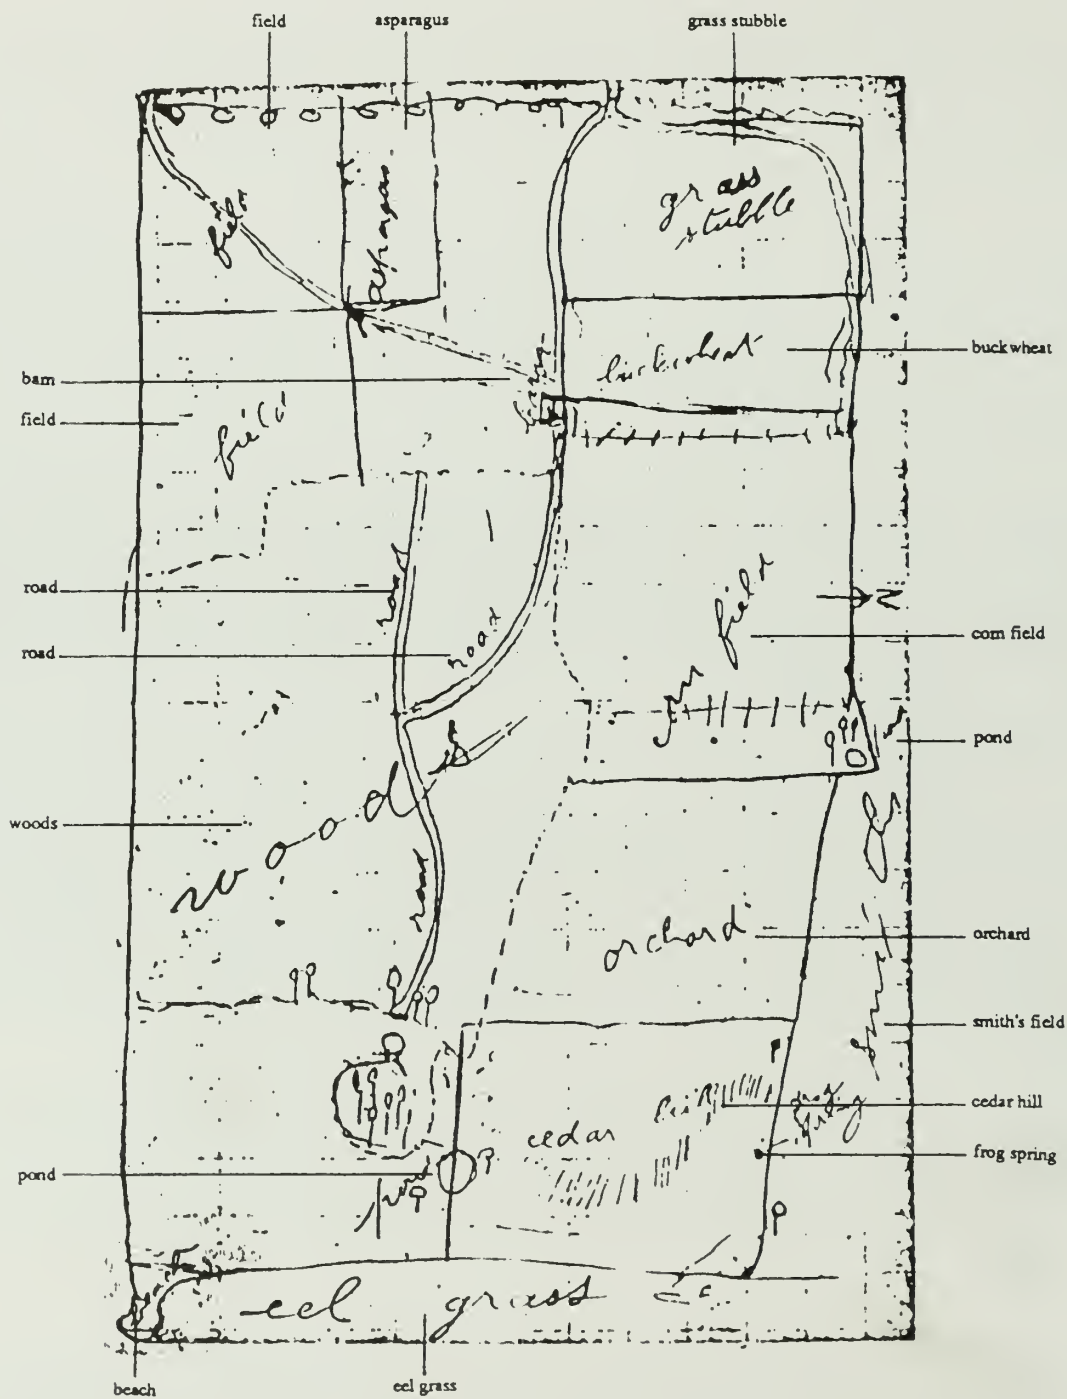
FIGURE 1.3: Theodore Roosevelt's sketch of his property, c. 1880. (SAHINHS Archives).

Roosevelt also noted a spring on the property in the woods west of Cold Spring Harbor (see figure 1.3). According to the sketch, the spring was very close to the north property limit.⁴⁴

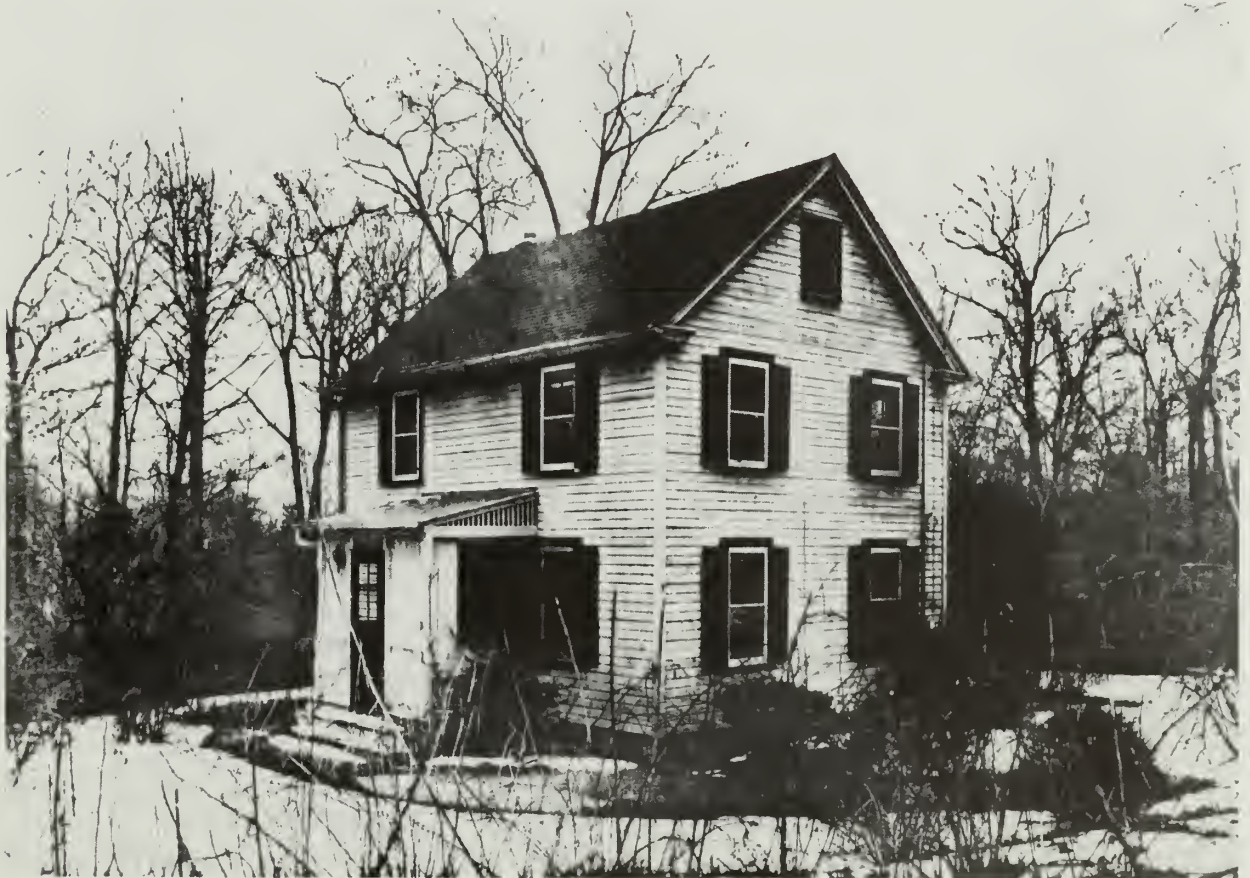
FIGURE 1.8: The Gray Cottage, 1964. (Courtesy of the Library of Congress).

The Gray Cottage – The Gray Cottage was constructed in 1910 for Theodore Roosevelt's valet and coachman (James Amos and Charlie Lee) and their families. The Gray Cottage was located on the edge of the woodlands east of the ravine (see figure 1.8, Overall Site: Theodore Roosevelt Stewardship). This rectangular 26' x 20', two and one-half story wood frame clapboard building was divided into two apartments and had a small enclosed one-story front porch. "While the porch may not have been enclosed originally, there is evidence that it was done at a very early stage in the history of the house."⁵³ There was also a one-story, enclosed porch in the back, on the south side of the house. The cottage had an attic and a full basement. The building was symmetrical and had four windows with shutters on the north and south facades, and four windows and one attic window on the east and west facades. The roof was wood shingles. The building was gray.

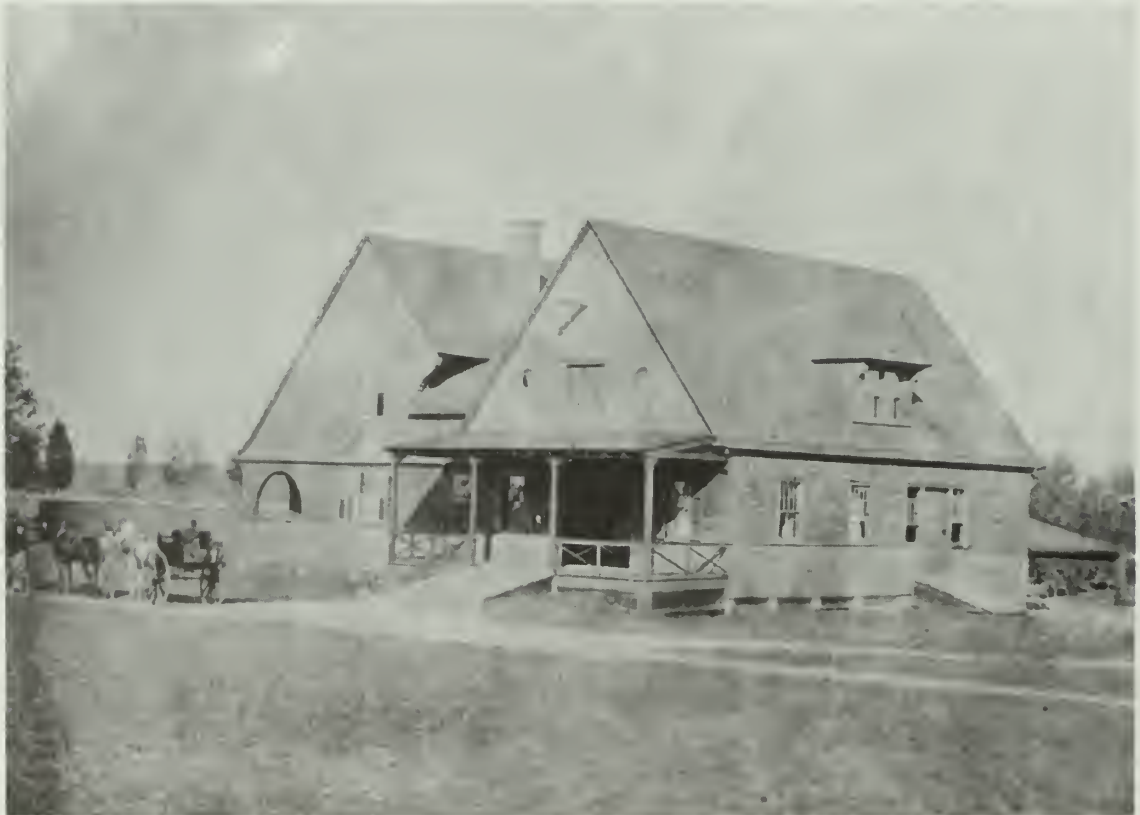
FIGURE 1.16: The west facade of the stable and lodge at Sagamore Hill, 1905. (SAHINHS, no. 1112, Box 6).

The front of the building faced west. There were two ramps into the stable, one on the west facade and the other on the south.⁶⁷ The entire building had a stone foundation and was approximately 65' by 75', somewhat of an L-shape structure (see Inner Core: Theodore Roosevelt Stewardship).⁶⁸ The exterior cladding consisted of shake shingles on the upper wall (from approximately 6' above ground to the roof). The building's three dormers were clad in shake shingles. The bottom portion (from the ground to approximately 6') was clapboard. There was a small covered porch on the front with a simple railing of a sill and plate with an x-pattern in between (see figure 1.16).

The ground floor consisted of a carriage room, stalls for five horses, a storage closet, and a harness room. The east facade of the stable had a shed roofed addition, presumably used for storage. The building had a basement, except under the carriage room. The stable basement was used to store grain and hay, and also had room to house four to six cows, and two horses. The lodge was separated from the stable by a brick firewall; the interior layout of the lodge is unknown.⁶⁹ The color of the stable and lodge is unknown.

Stable and Lodge – The stable and lodge, the first building Theodore Roosevelt had constructed on the site in 1883, burned in 1947 (see figure 1.16). The building had been used as a residence by the caretaker of the site at the time, Valenty Mazur. After the fire, he moved into the new barn. The foundation of the stable and lodge remained intact and was covered with soil.¹⁹⁴

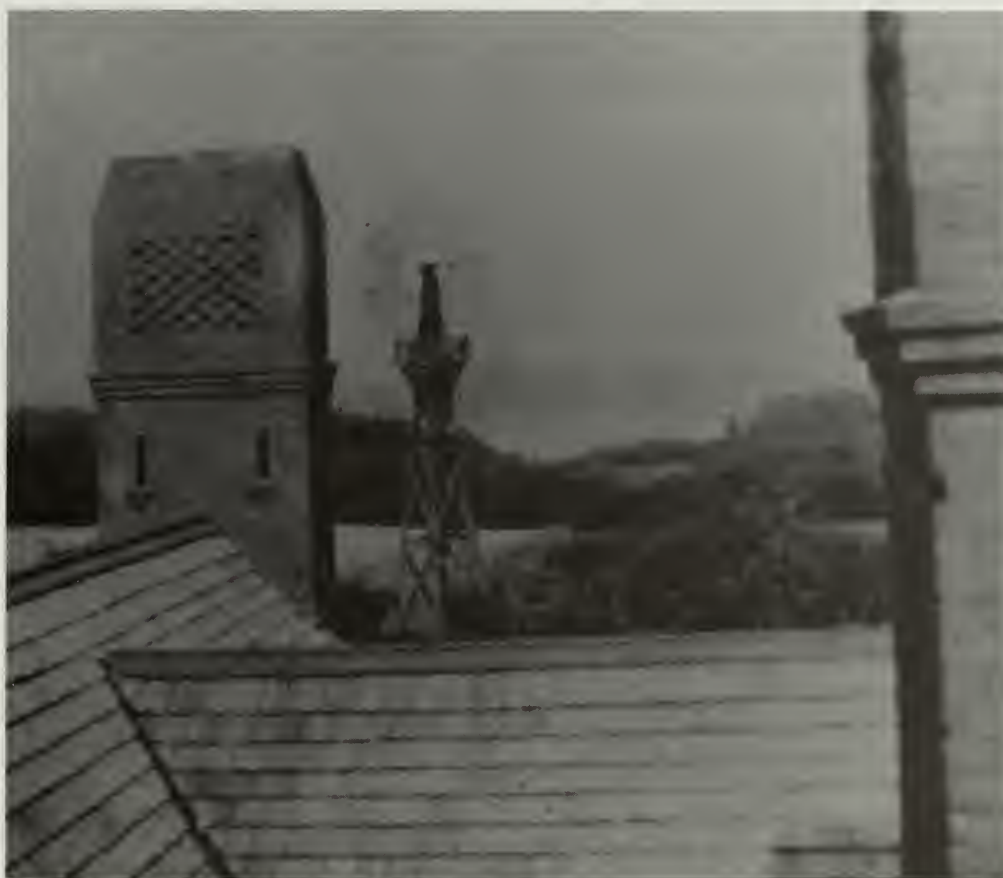
FIGURE 1.24: Windmill at Sagamore Hill, pre-1907. (SAHINHS, no. 1125, Box 6).

The Windmill – Between 1884 and 1886 a windmill was constructed on the site in association with the estate's water system (see figures 1.24 and 1.25). It was located approximately 100' northeast of the ice house (see Inner Core: Theodore Roosevelt Stewardship). This windmill was replaced in 1905 with a new, improved wheel, measuring 22'6", and a new tower. Corcoran, the contractor, proposed a new tower 42' high from the ground to the tank platform and made of Georgia yellow pine.⁸²

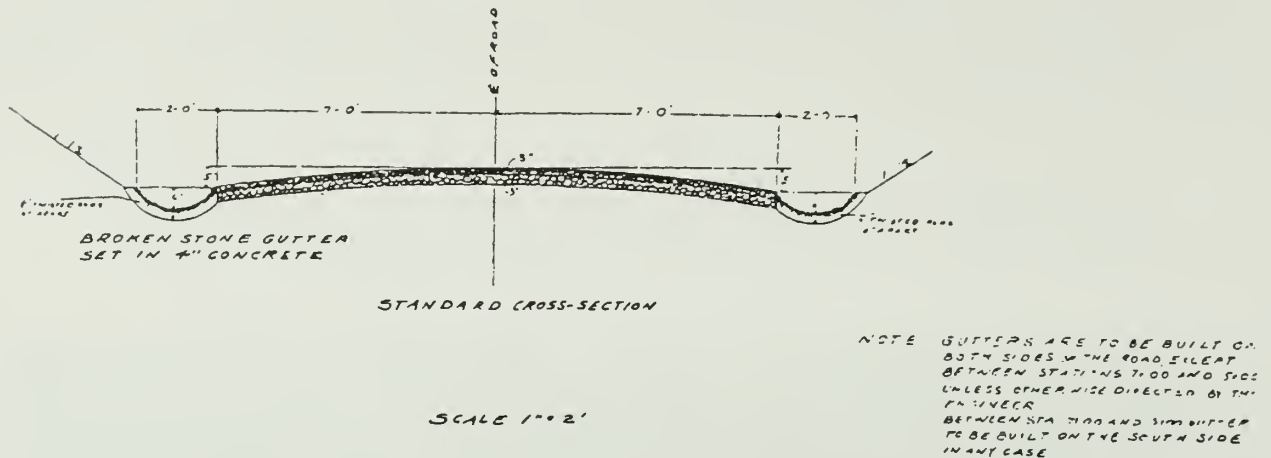
FIGURE 1.32: Gutter detail. Redrawn from Hans Rude Jacobsen, *Improvements on the Estate of Theodore Roosevelt, Esquire, Town of Oyster Bay, August, 1911*. (Bellavia, 1993. SUNY CESF).

Drainage gutters were installed in 1911 on both sides of the new entrance road constructed by Hans Rude Jacobsen (see figure 1.32). The gutters were made of broken stone set in 4" of concrete with 1/4" twisted rods 4" on center.

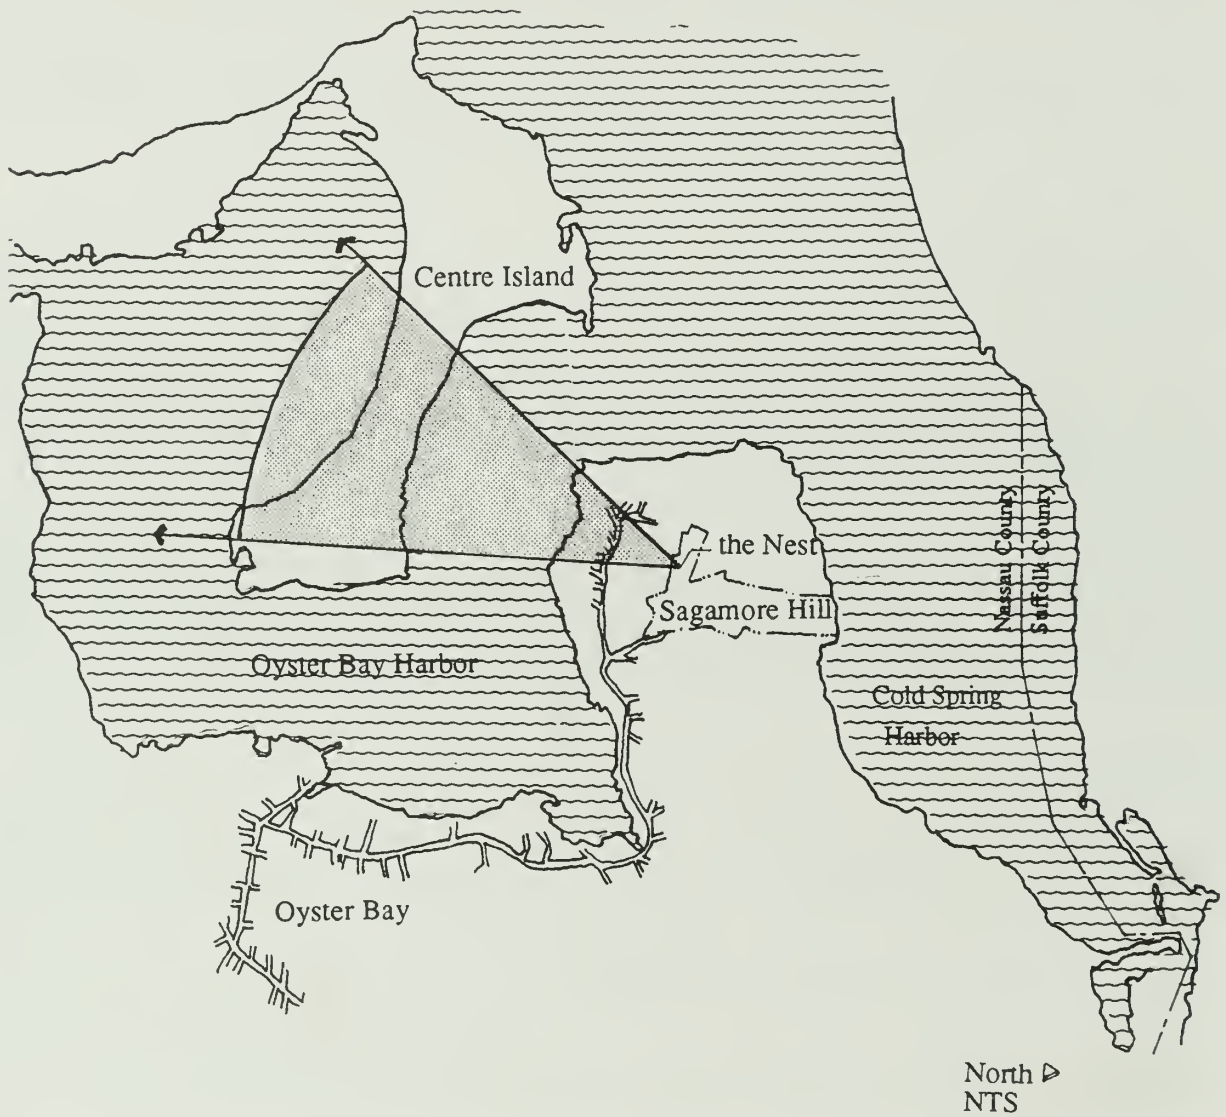
FIGURE 1.54: Diagram showing viewshed from the "Nest" to Oyster Bay Harbor and Long Island Sound. (Bellavia, 1993. SUNY CESF).

The views from the top of the hill at Sagamore were quite extravagant, and very important to Theodore Roosevelt. In 1900, a writer for the *New York Tribune* wrote, "...the visitor has a beautiful view in every direction, especially to the north and east where the waters of the Sound and Cold Spring Harbor are seen."¹⁵⁸ Theodore Roosevelt mentioned the same view in his autobiography. He wrote, "The house stands right on top of the hill,....We see the sun go down beyond long reaches of land and water...." and, "On the evening of the first day I sat in my rocking-chair on the broad verandah, looking across the Sound towards the glory of the sunset...."¹⁵⁹ The views were of such interest to Roosevelt that he cleared trees to maintain them. In 1906, he wrote to his son Kermit informing him that he chopped trees to clear the view.¹⁶⁰ He also wrote to his sister Anna Roosevelt Cowles (Bamie) that year about his fortune in acquiring Smith's Field because it enabled him to cut a view to the Long Island Sound.¹⁶¹

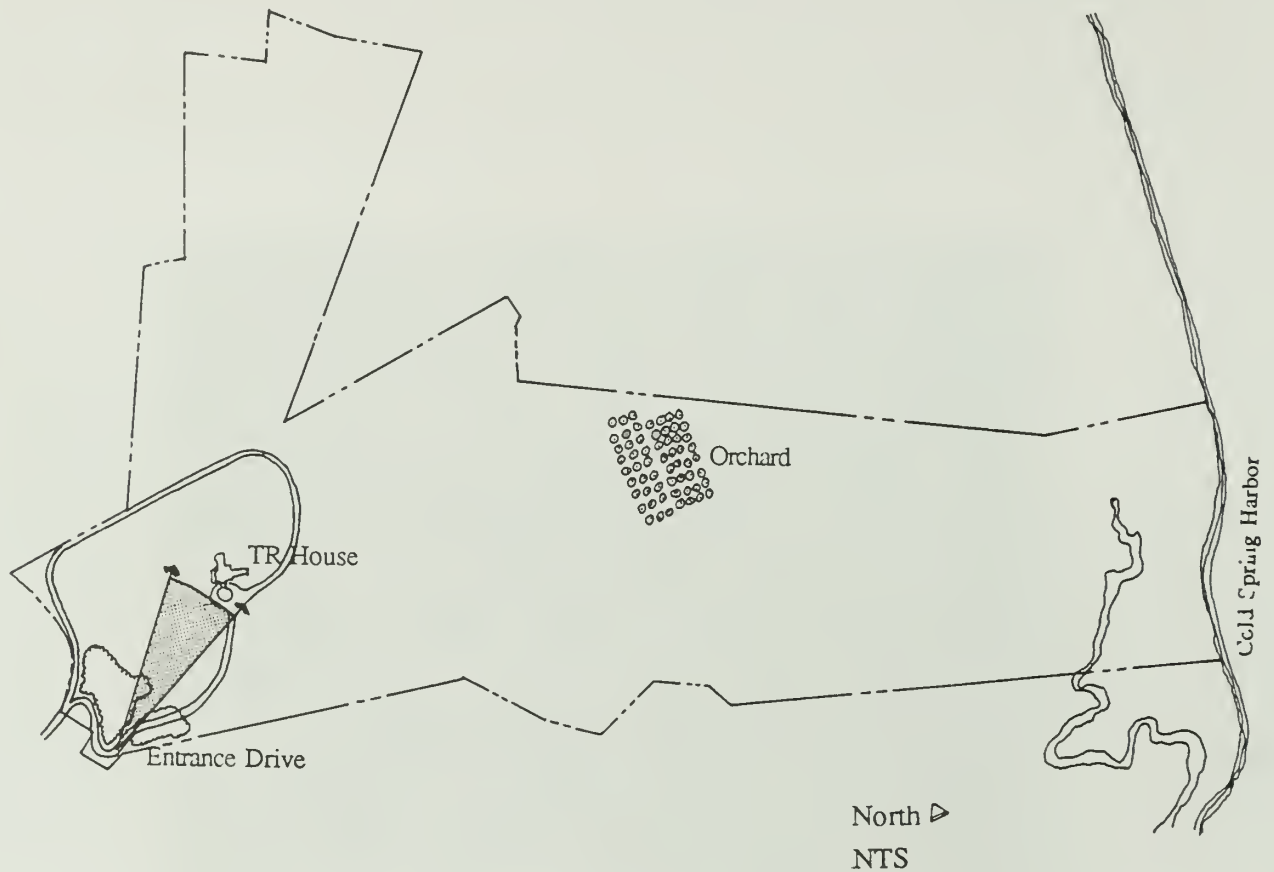
FIGURE 1.56: Diagram showing viewshed from entrance drive to Sagamore Hill. (Bellavia, 1993. SUNY CESF).

There also was a significant view to the house from the approach on the main entrance drive from the southwest (see figures 1.55, 1.56). "It [the house] is approached by a steep, winding roadway, which takes the visitor through a dense wood before revealing to him the house itself...."¹⁶² In 1905, a reporter wrote, "...now it [the road] reaches back at a higher elevation; until finally there comes into view a house on a hilltop, swept by salt breezes."¹⁶³ This view was changed in 1911 when a new entrance road was built. No information regarding the new view of the house was found during the research for this report.
