historic structure report

design and installation of a fire detection and suppression system
september 1983

YOSEMITE
WAWONA HOTEL

WAWONA HOTEL
YOSEMITE NATIONAL PARK
California

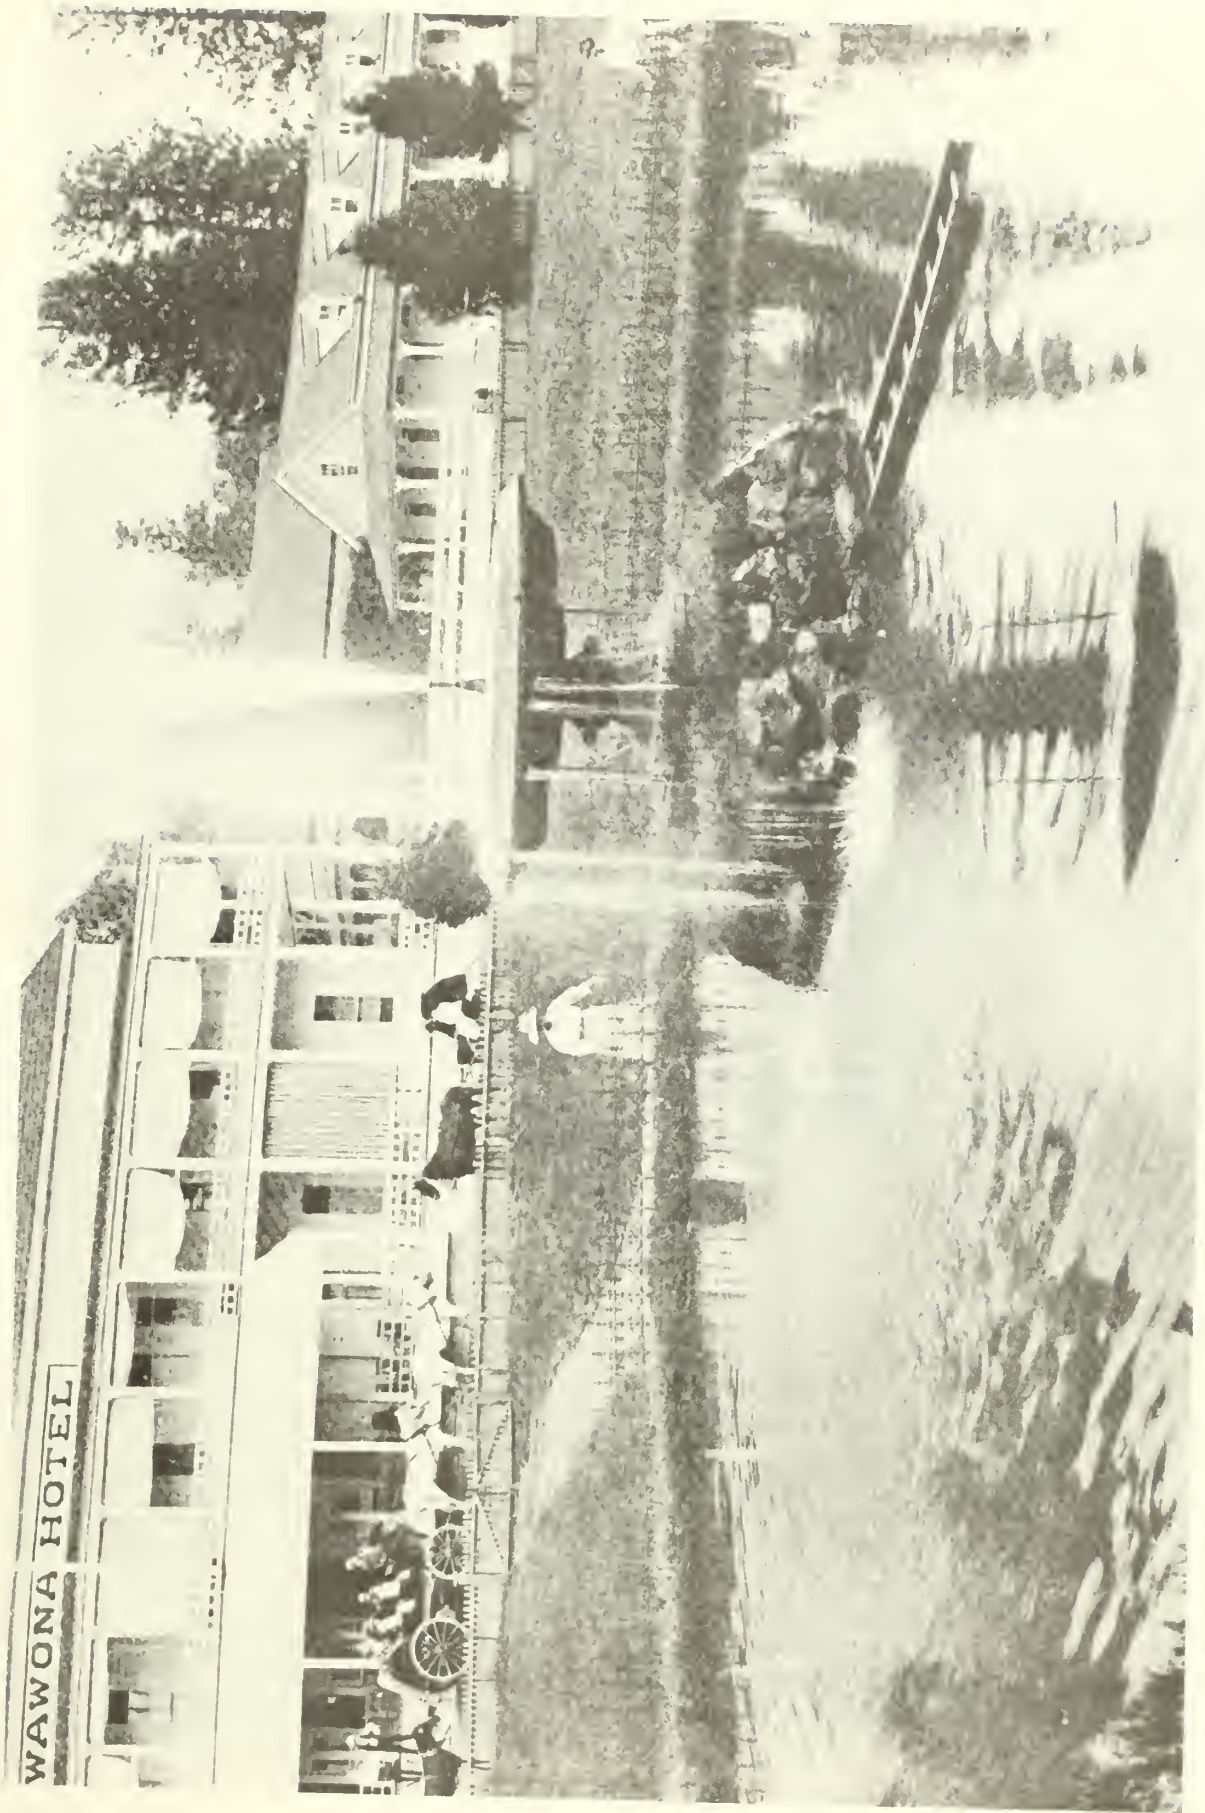
The Wawona Hotel, looking southeast, from the first generation fountain. Photograph undated but taken before September 1914.

Illustration 15 is a fine view of Long White looking southeast. This photograph could not have been taken after September 1914 for at least two reasons. First, it is well documented that the stage line ceased to operate in 1914. Second, Long Brown had not yet received its second story, which the hotel company added in August/September 1914. With respect to Long White, the photograph is of interest because it shows that the walkway siding and the siding on the west side of Long White's porch was painted white. It may also be inferred from Illustration 19 that Long White's porch decking was painted a darker color. Al Gordon affirms that as long as he can remember, the hotel company painted all porch decks in the group a battleship gray.²

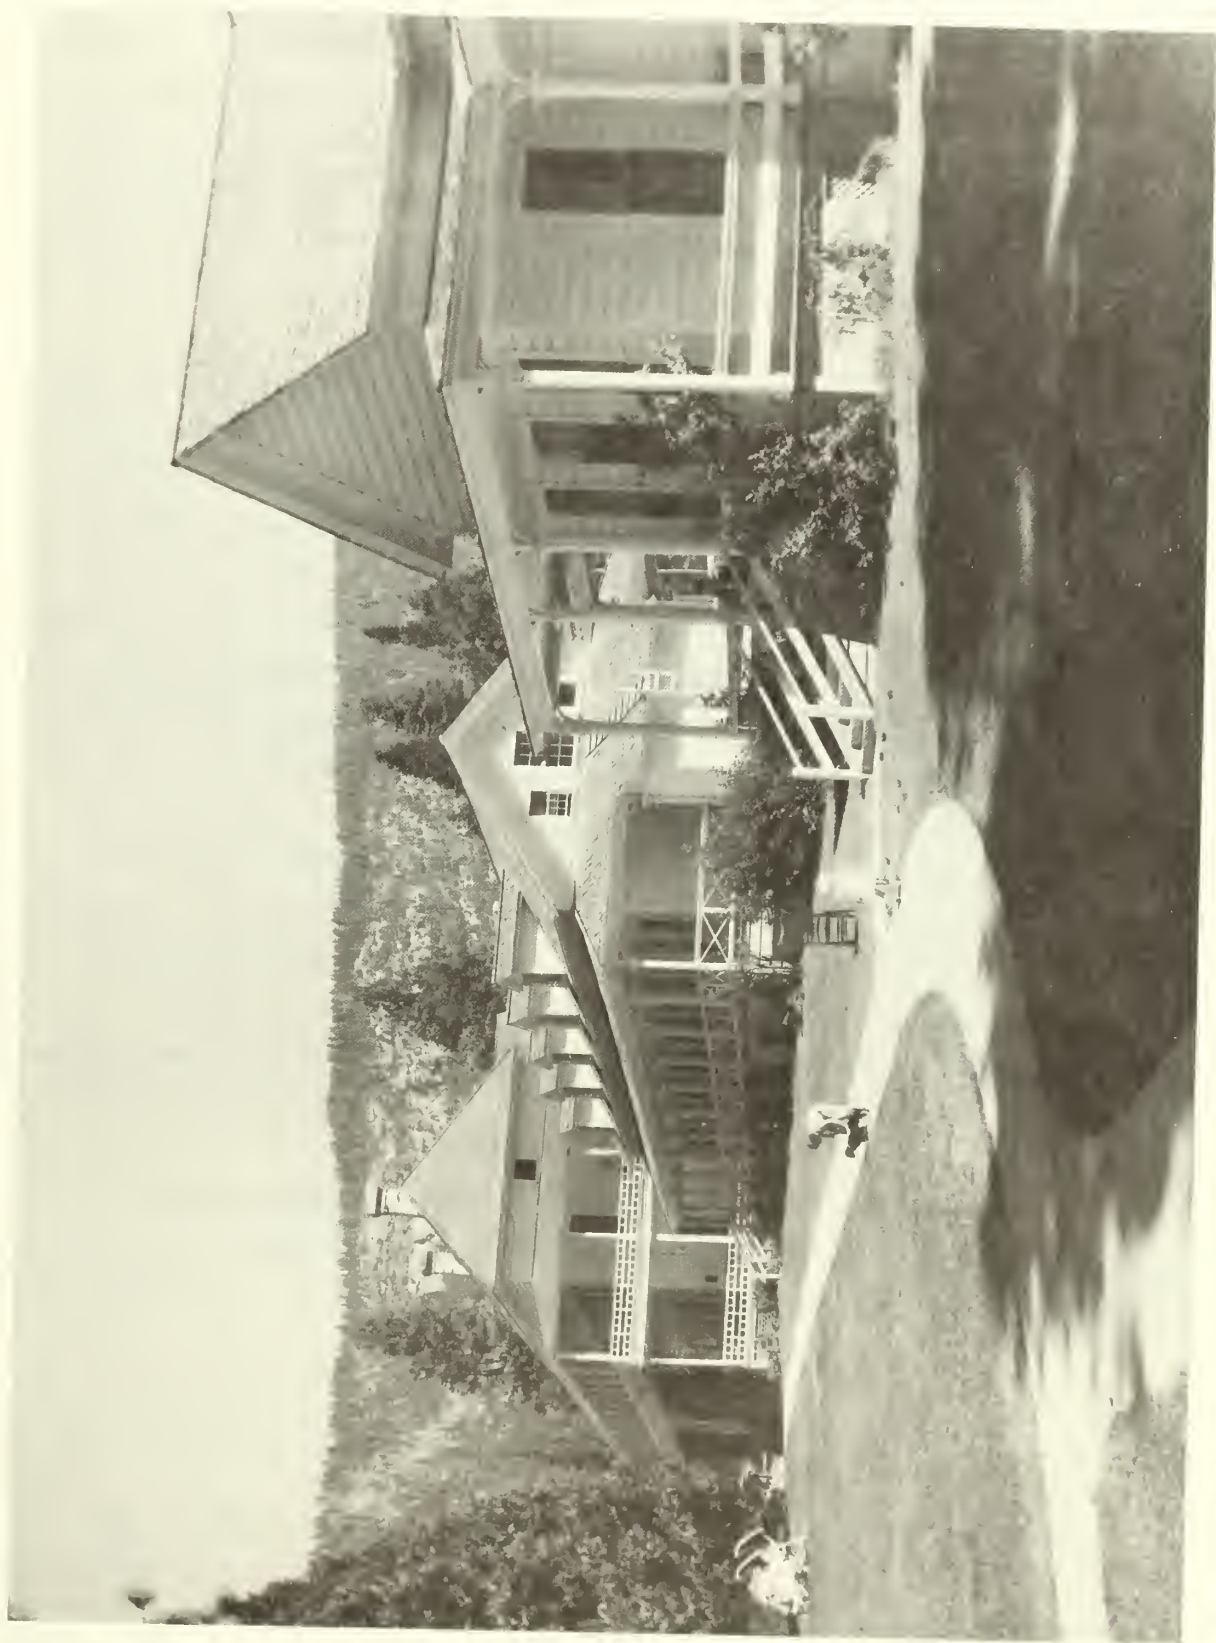
ILLUSTRATION 17

The Wawona Hotel, looking north, ca. 1940.

The photograph shows a spruced-up Long White, whose west porch had been freed of climbing vines.

Illustration 17, dated 1940, shows the effect of the porch repairs in fiscal year 1937. Apparently the YP & CC rebuilt the west stairs, and a railing for this structure was constructed to match the rest of the porch.

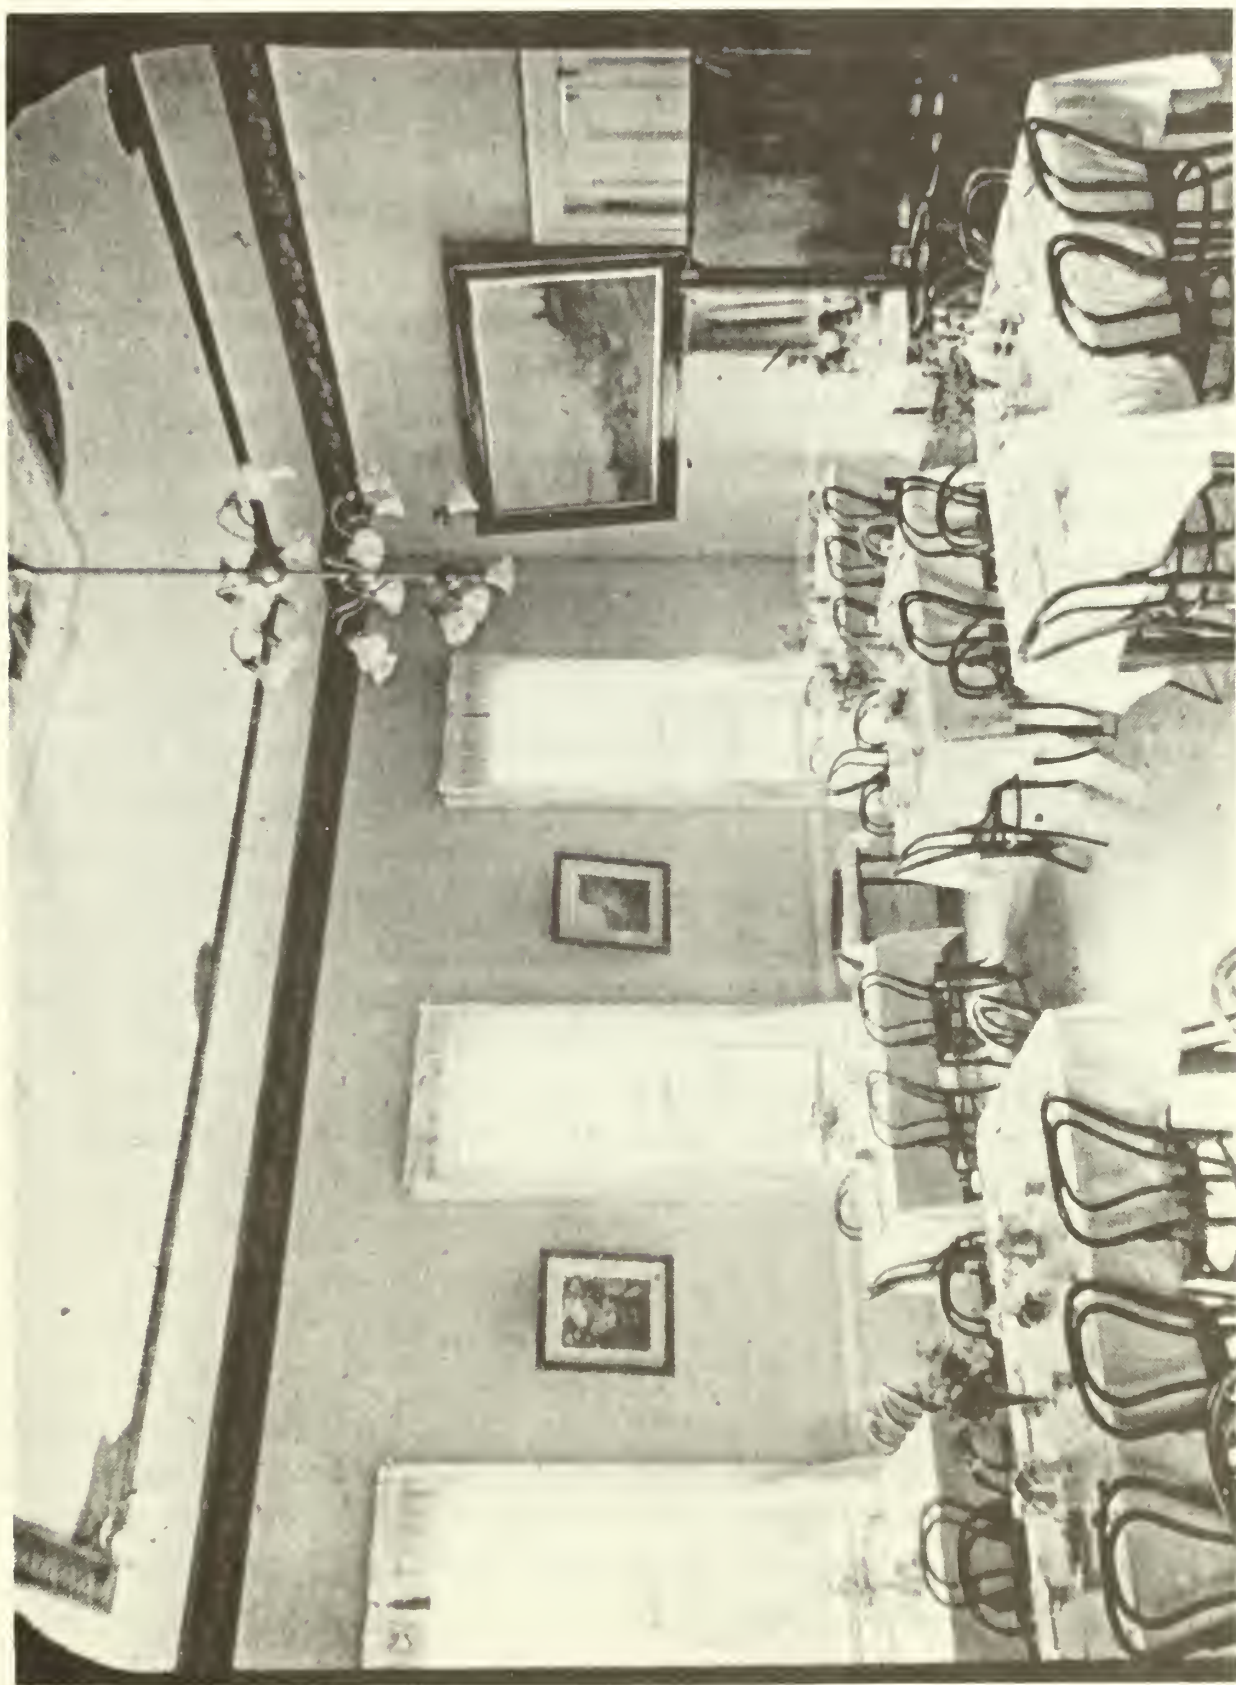
ILLUSTRATION 23

"Dining Room-Wawona," looking northeast. Issued by the
Passenger Department, Southern Pacific Co., San
Francisco, California.

at the photograph's right edge would have led into the hotel's kitchen. The only potential problem with this interpretation is the presence of what presumably is the same furniture purchased in February 1915 by the Washburns for the expanded dining room several months after the addition was added. However, the physical evidence completely supports the interpretation that the photograph is of the pre 1914 dining room.

The arrangement of three consecutive windows did not occur on the original building except on the north side (Illustration 19). This arrangement did not occur on the west side of the 1914 addition but could possibly have existed prior to 1917 on the north side. There is no photographic evidence to indicate the window arrangement during the 1914-1917 time period. However, even if this were the case, the door location for the 1914 room would not be appropriate.

By establishing vanishing lines on the photograph and geometrically proportioning the door and the wall to the left of the door, the distance from the corner to the door trim was found to be approximately eight feet, plus or minus one foot. The distance from the corner of this room to the existing north wall of the kitchen is approximately thirteen feet, hence the door in the photograph could not have led into the kitchen wing. The only other possibility is that it led to the exterior from the 1914 addition, however, no evidence of a previous doorway was found when the existing door was cut through this wall in the winter of 1980-81. In addition the decorative treatment of the painted ceiling is more representative of the third quarter of the nineteenth century than of 1914.

Because of the overwhelming evidence, the interpretation has to be that the furniture in the photograph is not that purchased in February of 1915. Similar, certainly, but apparently the existing furniture remained and was added to in 1915. It should be noted that while all of the tables visible in Illustration 23 accommodate either six or eight places, some smaller ones in illustrations 29 and 30 accommodate only four places.

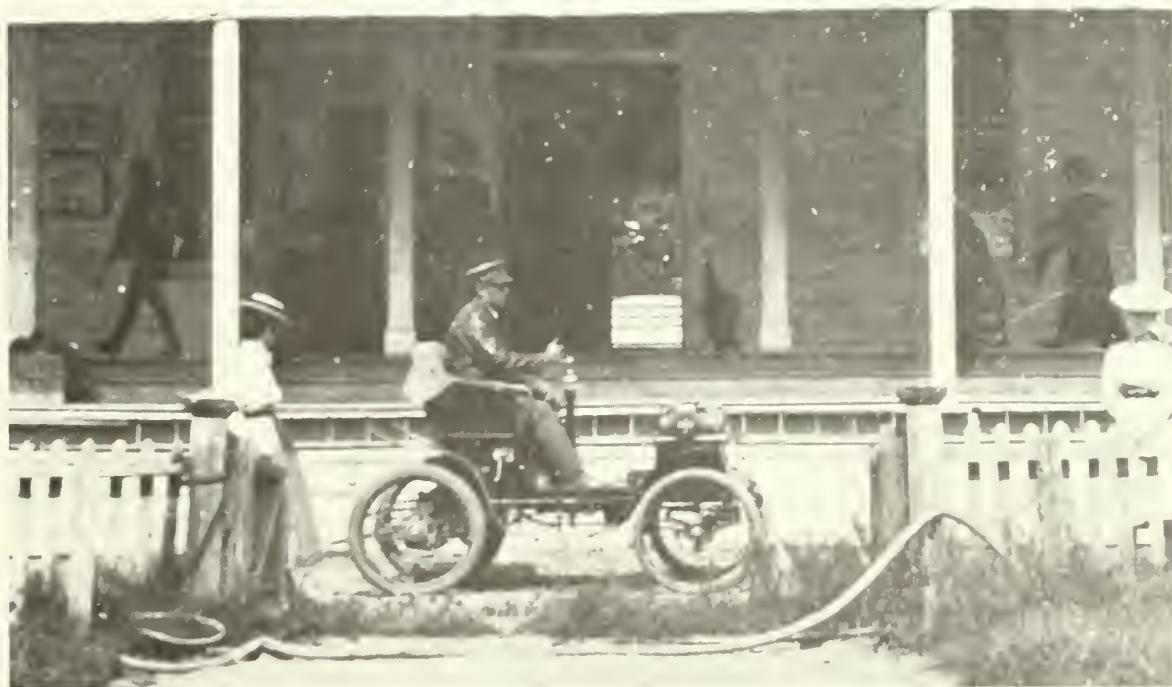
Illustration 28, a full view of the hotel looking east, shows the effects of the 1917-18 renovation. Three sets of changes deserve special attention: First, beams perpendicular to the vertical columns supported the additional width on the first-story porch. The porch underwent the extension where its ceiling line breaks on the second story in the photograph. Second, the canvas-covered porch on the west side with stairs on its north and south ends was removed. Whalin replaced the porch with frontal stairs leading directly up to the main entrance. Flanking stair abutments of cobblestones were each surmounted with an electric globe. Clarence Washburn noted that a plasterer finished these abutments on April 8, 1918. Third, the new dining room's exterior, facing west, showed four sets of quadripartite twenty-one lite windows. A sense of how much Whalin widened the dining room to the west can be obtained from Illustration 24 by studying the area just behind the fountain.

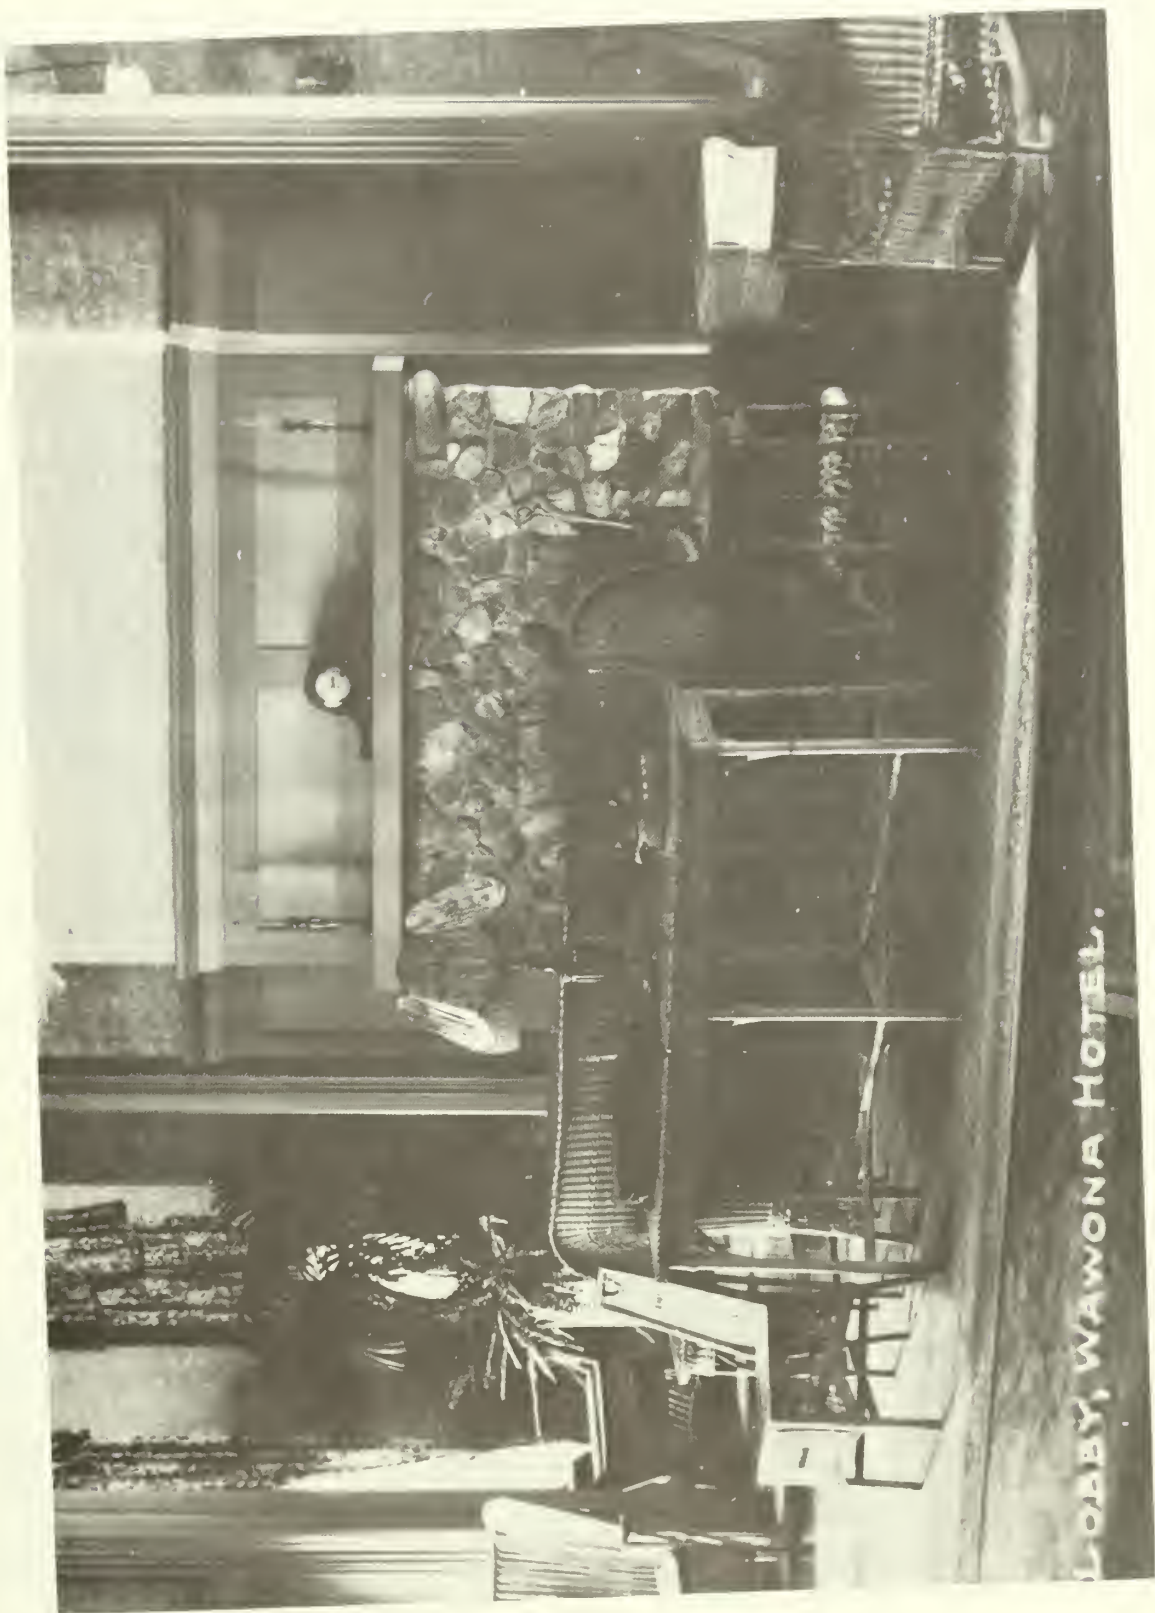
ILLUSTRATION 34

The Wawona Hotel lobby, looking south. Close-up of south fireplace. Photograph contemporary to Illustration 33.

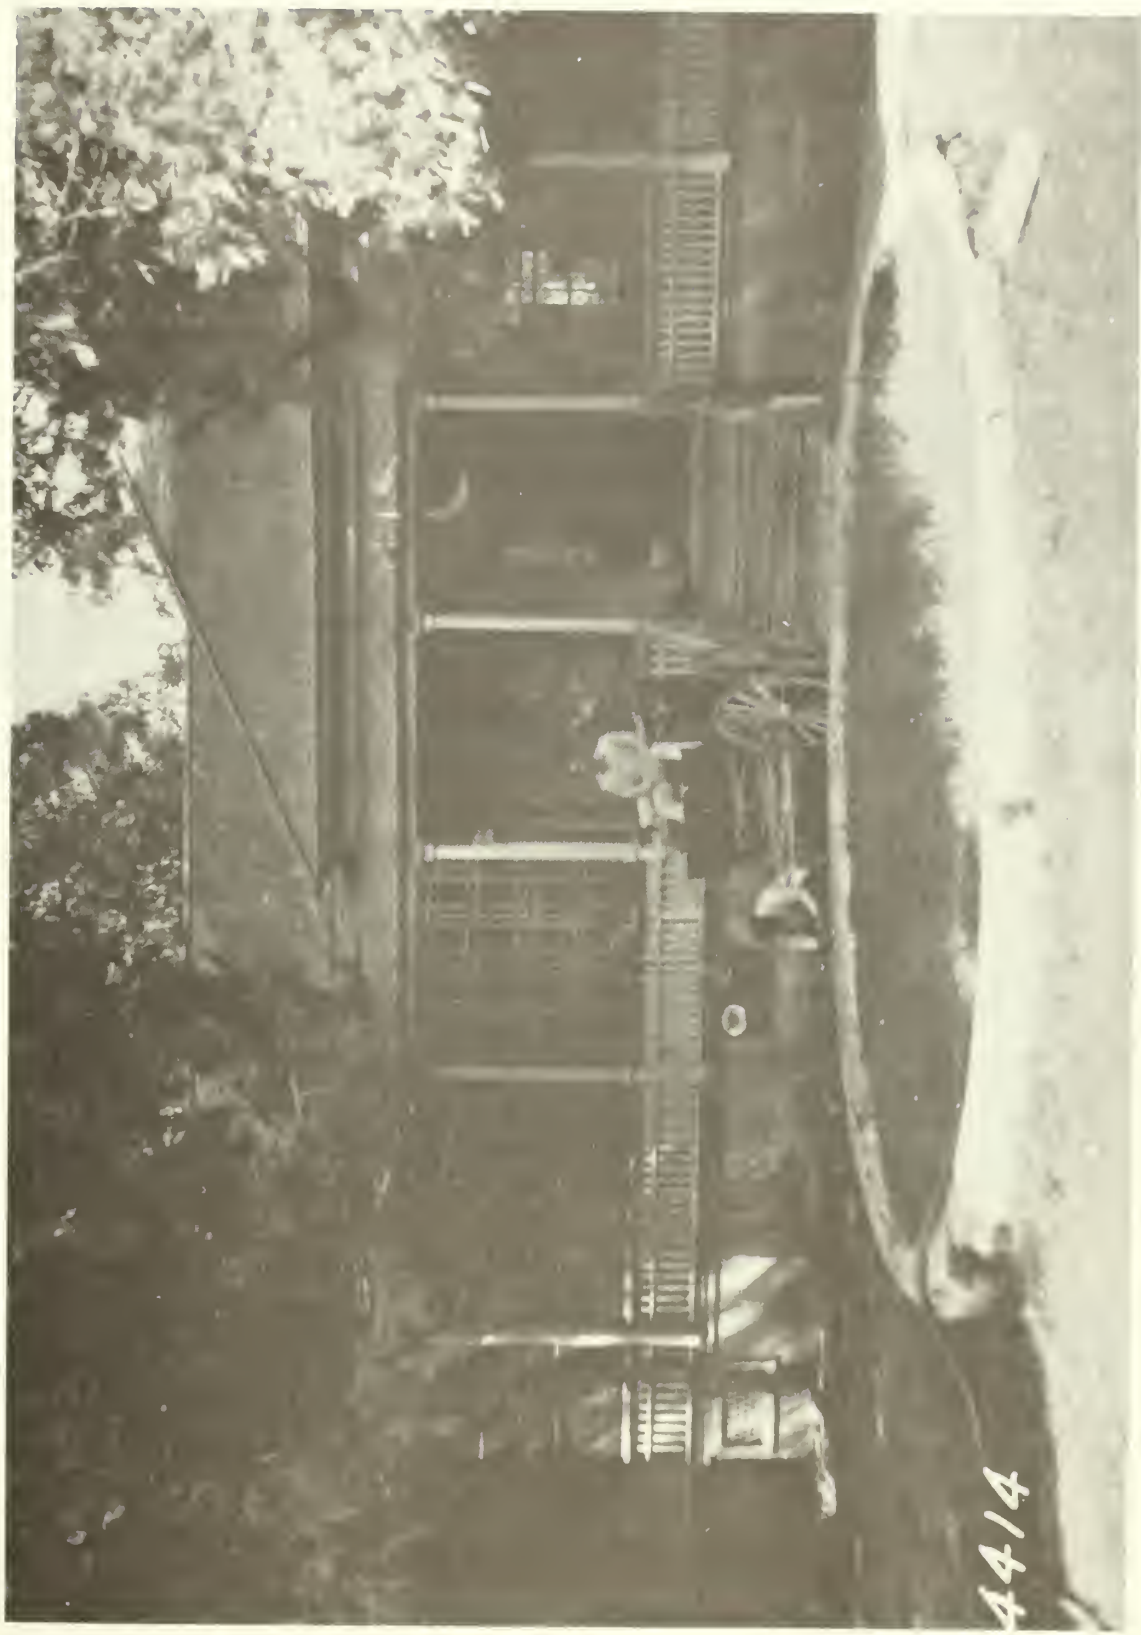
ILLUSTRATION 43

The Thomas Hill studio after the 1916 changes.

installed two four-over-four, double-hung windows to flank the main entrance and another pair of windows where the original four-over-four, double-hung windows had been. All four windows were embellished with decorative architraves; carpenters changed the main entrance to a pair of wood doors, each with twenty-eight lights; the skylight was removed.

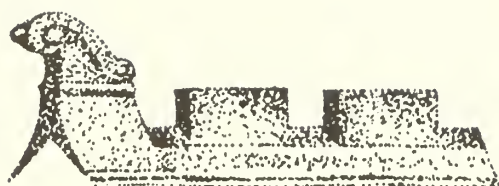
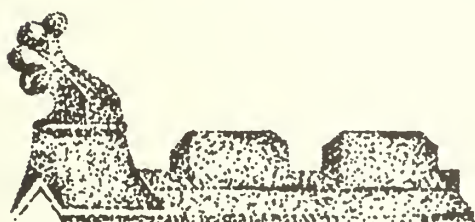
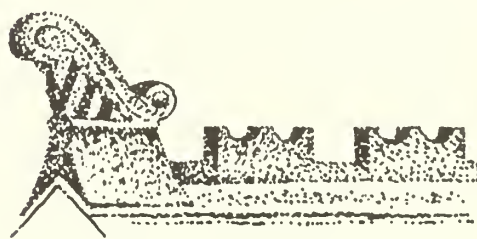
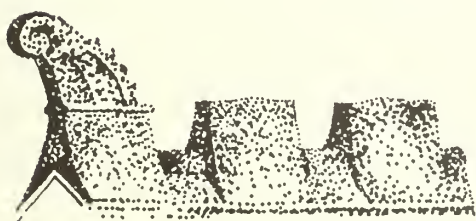
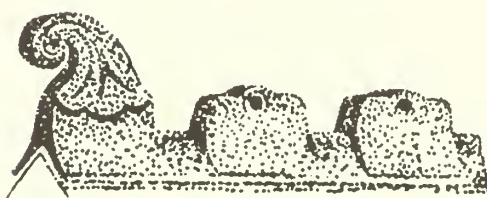
Four examples of galvanized iron crestings from an 1896 catalog of the Illinois Roofing and Supply Company of Chicago, Illinois.

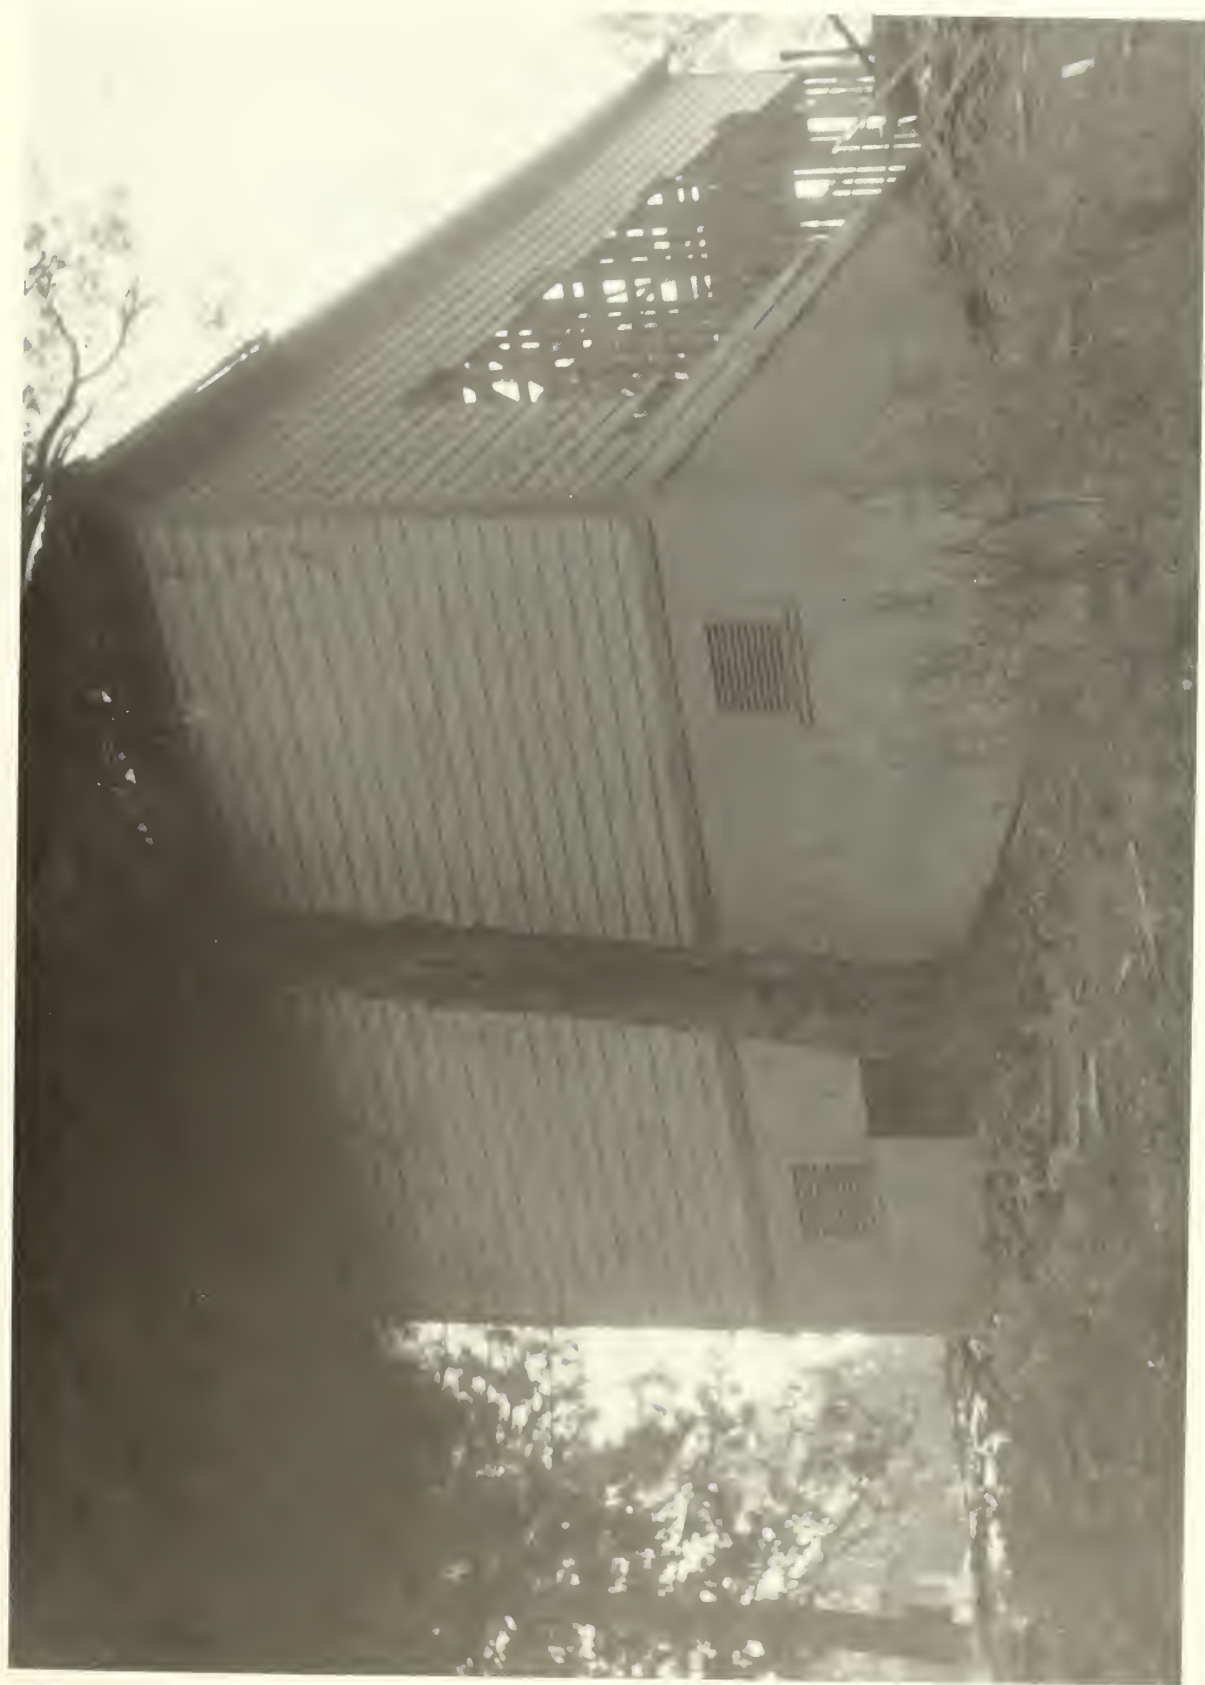
ILLUSTRATION 53

The partially dismantled Dance Hall at Wawòna, looking south/southeast, in October 1933.

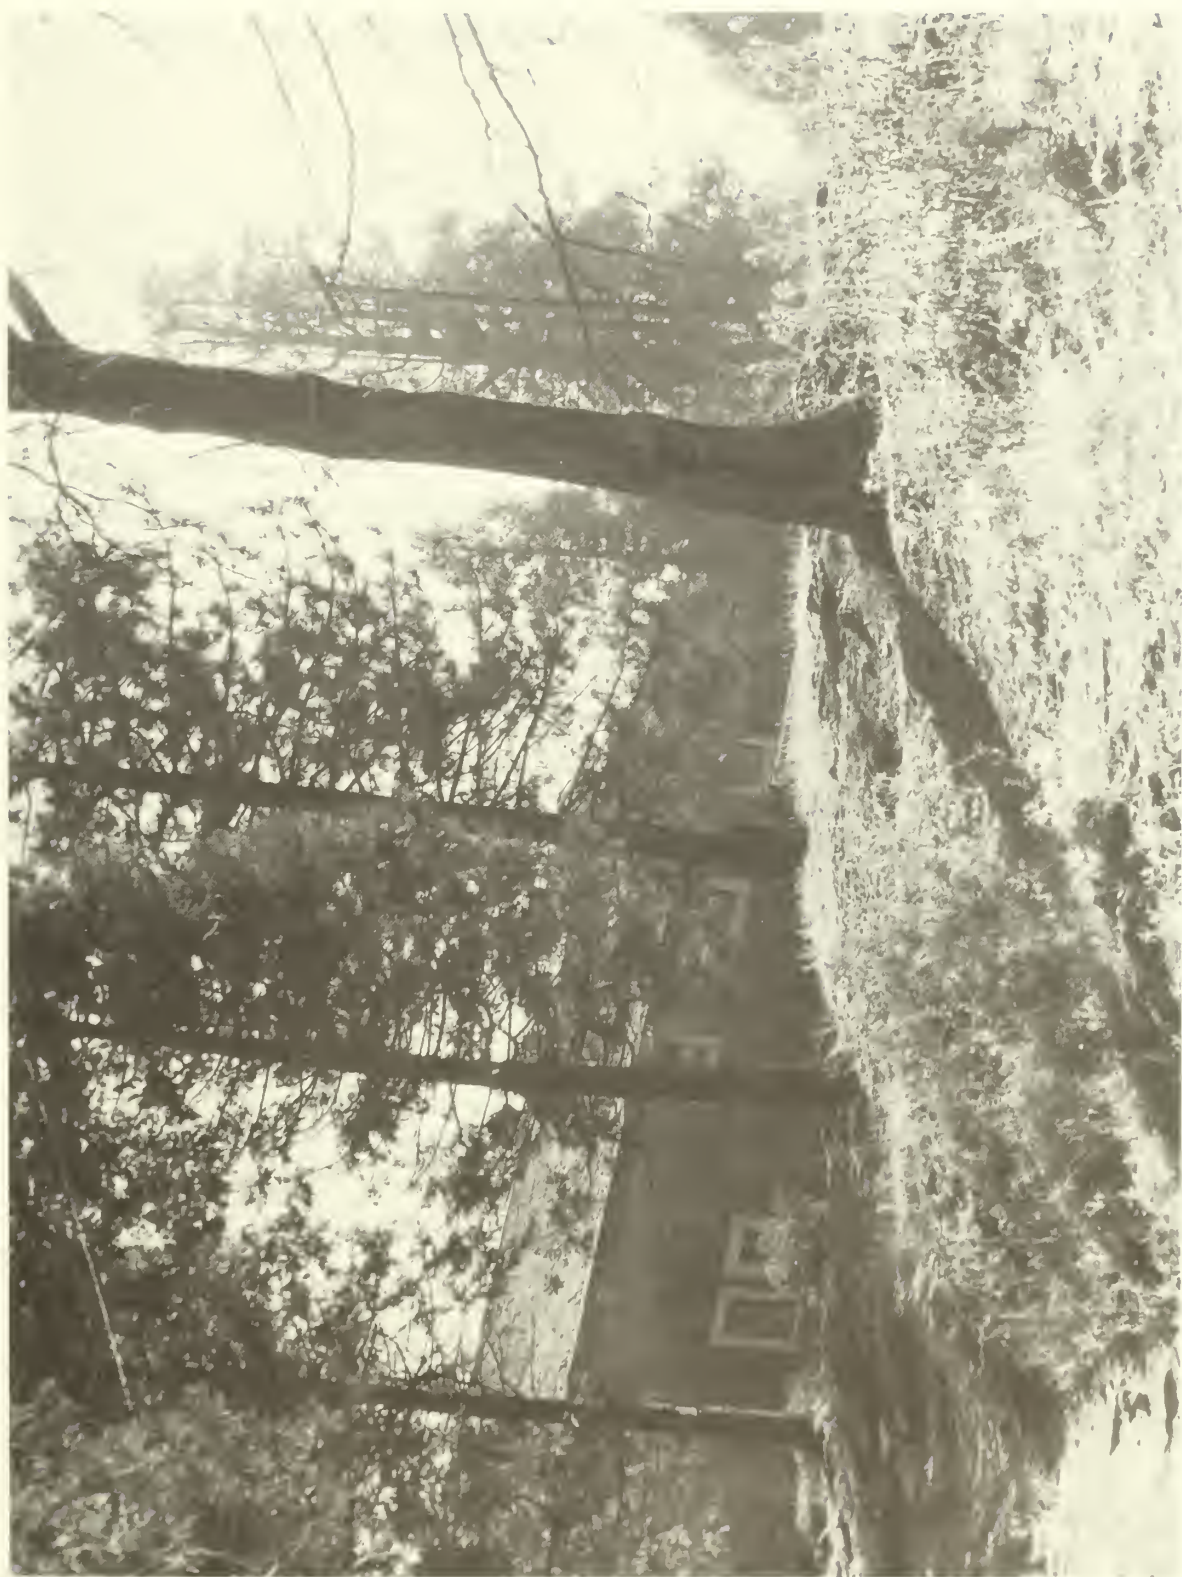
West exterior wall of the second Wawona Hotel store, ca.
September 1933.

The concessioner's November 1932 inventory¹⁰ noted that the store's interior featured a butcher shop in the rear with two built-in ice boxes. There was also a smokehouse in this part of the building with a wood burning stove. The smokehouse contained a lard kettle and combination smoke bin and corned beef press. There were two bedrooms upstairs at the building's rear. The store's half-cellar contained a refrigeration machine and dairy supplies.

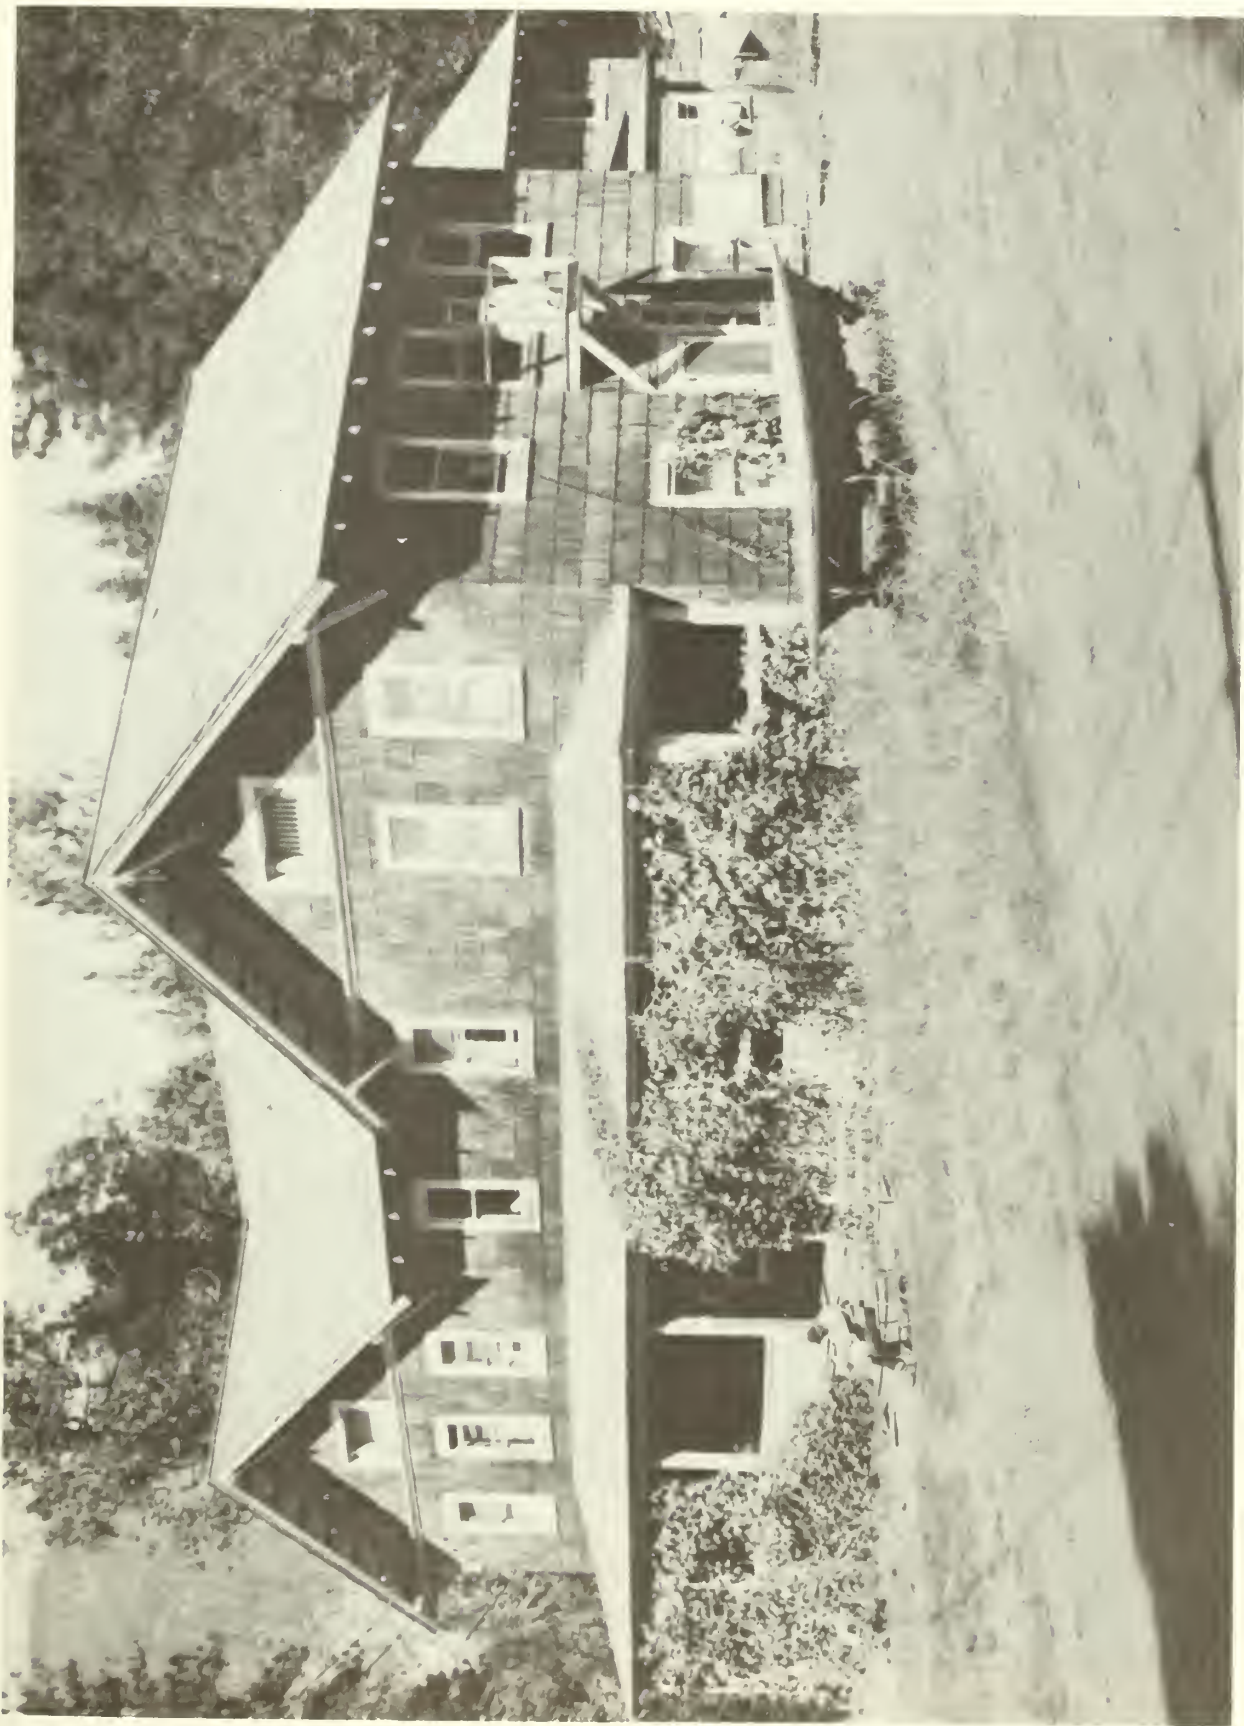
The Sequoia Dormitory, looking northeast. Undated.

During fiscal year 1938, the YP & CC spent \$776.44 to reroof the "Sequoia Dormitory." In fiscal year 1941, the concessioner spent \$203.22 to replace the building's sewer line and some toilet connections.¹⁴

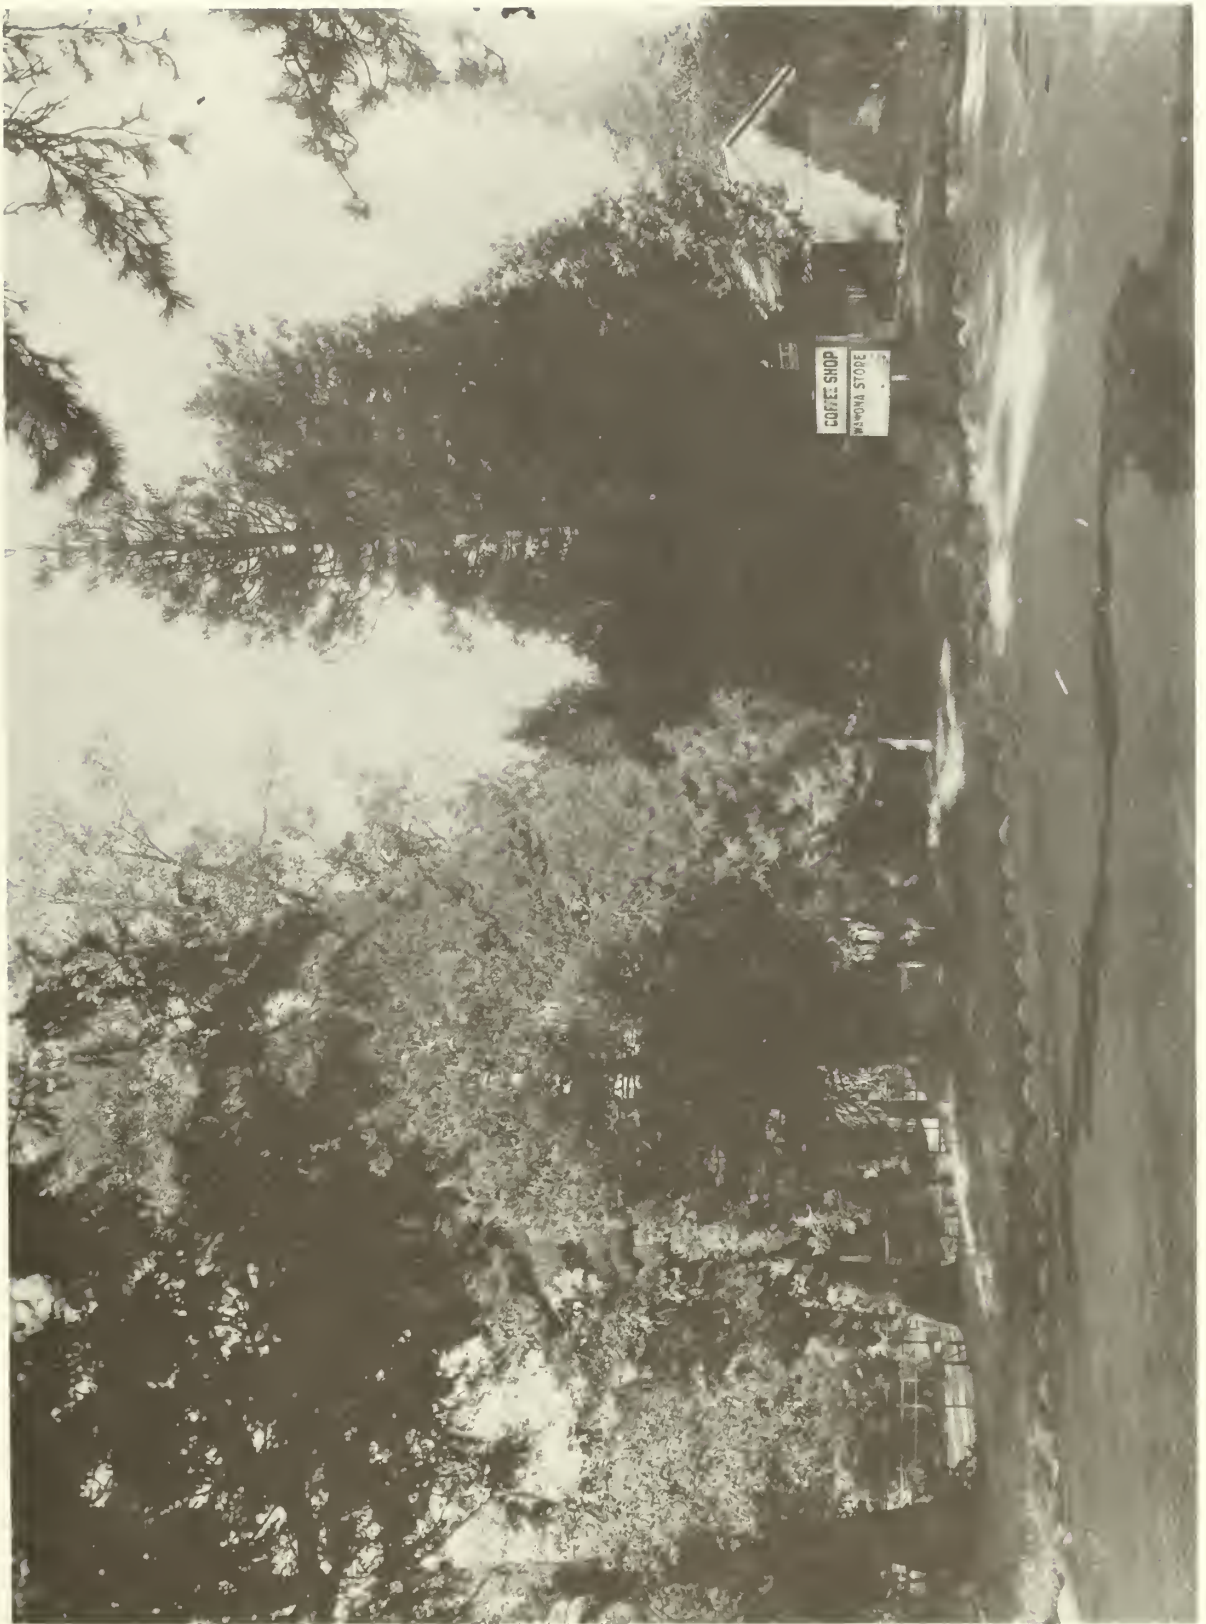
A view, looking north, of the 1922 tennis court.

A number of entries in the Washburn Diary suggest there were two tennis courts prior to construction of the present court in 1937. The earliest entries regarding a tennis court date from 1917. On July 30 of that year, Washburn remarked that he had "Cut down one of the trees at the tennis court." A few days later, on August 5, he noted that the hotel company "Blew the big stump out at [the] tennis court."
