BEACH EROSION AND BEACH NOURISHMENT

CAPE HATTERAS
NORTH CAROLINA

U. S. DEPARTMENT OF INTERIOR
NATIONAL PARK SERVICE
OFFICE OF NATURAL SCIENCE
WASHINGTON, D. C.

DUNE STABILIZATION STUDY
NATURAL RESOURCE REPORT NO. 4
1972

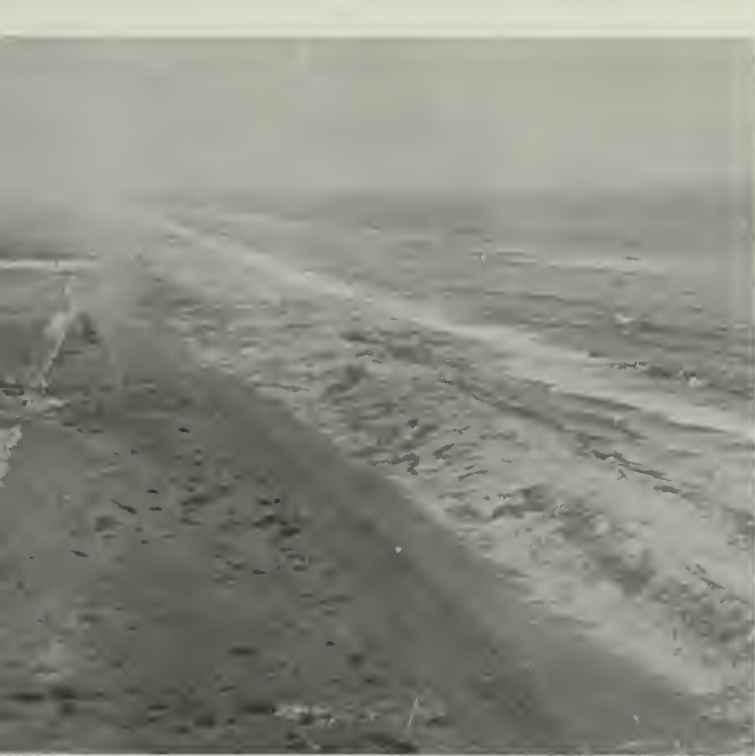
1940

Buxton, N.C. – The Problem

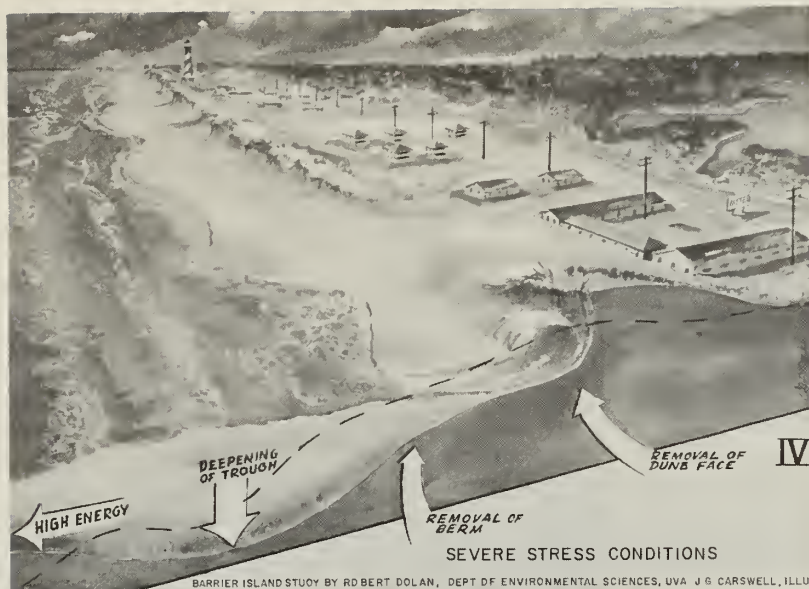
NATURAL

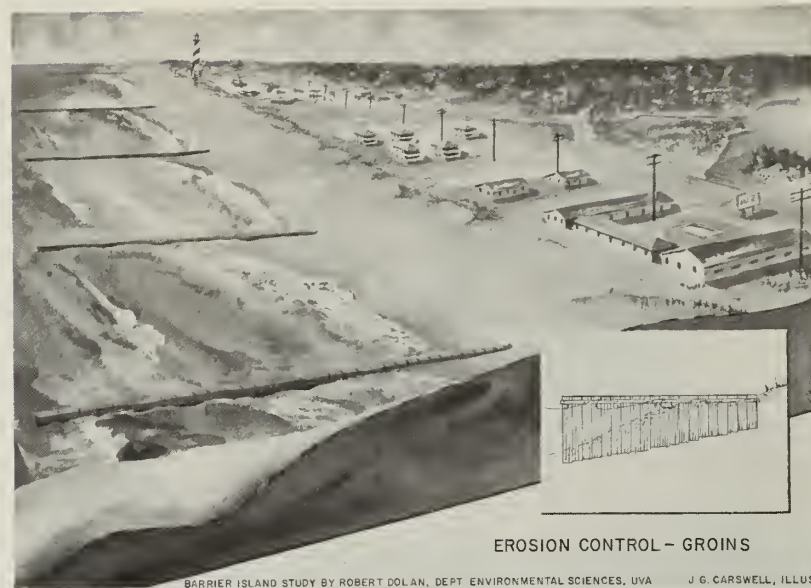
GROIN FIELDS

Groins are obstructions placed in the path of the longshore currents for the purpose of trapping littoral drift. These structures work only when [1] littoral drift sediment is significant in volume,[2] the material is at least sand size, and [3] only when the land down the beach from the groin is considered expendable. The best method of beach restoration is any method that is similar to the natural process. Structures are designed to alter the energy flow, interfering with the natural equilibrium of the beach. Rebuilding beaches artificially, by placing sand in the system, permits the natural process to continue essentially unhampered.

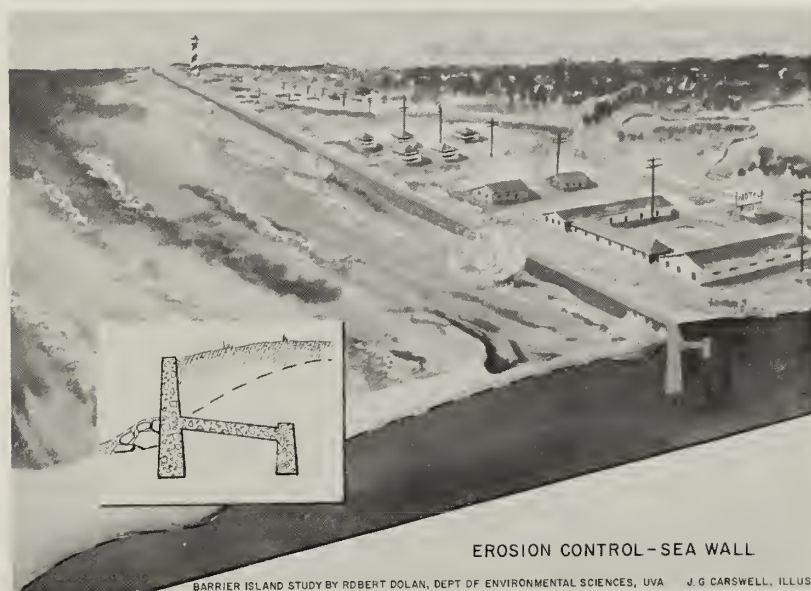
SEA WALL

Sea walls are designed to absorb and reflect wave energy, but they do not prevent the loss of sand in front of the structures. They may, in fact, accelerate the loss of sand as the wall deflects the wave forces downward into the beach deposit.

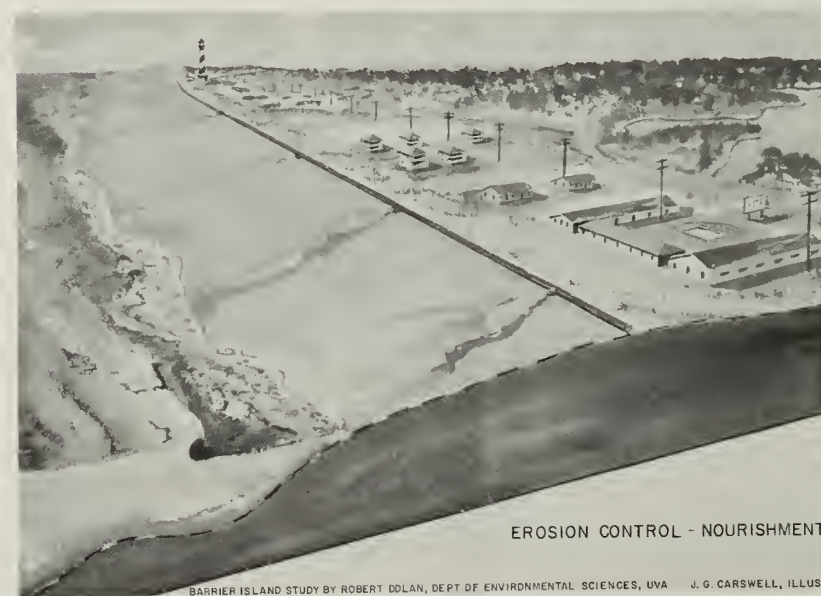
NOURISHMENT

Artificial beach nourishment is considered the most desirable method of protection because:

- [1] The placement of sand in the beach-energy system results in a beach suitable for recreational purposes.
- [2] Beach nourishment not only checks the effect of erosion in the problem area, but also supplies sand to adjacent beaches.
- [3] It is the most economical method if large quantities of sand are available.
- [4] It does not require a major long-term management commitment. If the beach nourishment does not produce the desired result, it is not as permanent as sea walls or groins.

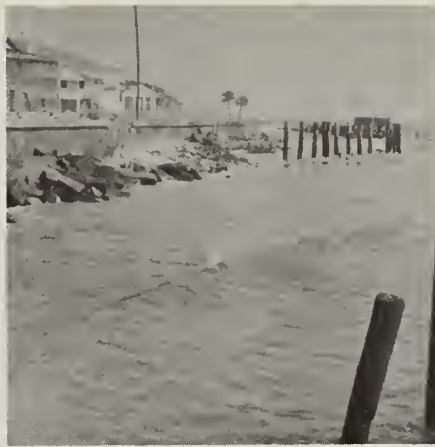
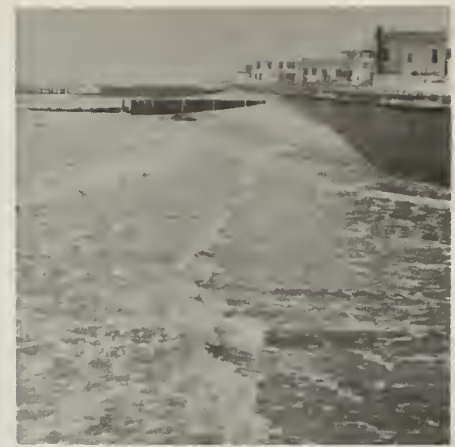
GROIN FIELD — HATTERAS

Although the design of the groins was modified, they do provide protection for the U.S. Navy Facility and the Lighthouse. However, areas adjacent to the groin field, both to the north and to the south, continue to erode at rates equal to, or in excess of, rates recorded before 1969. Therefore, the National Park Service was forced into a "hold-the-line" strategy, using sand bags and spot dune construction, for these newly created problem areas.

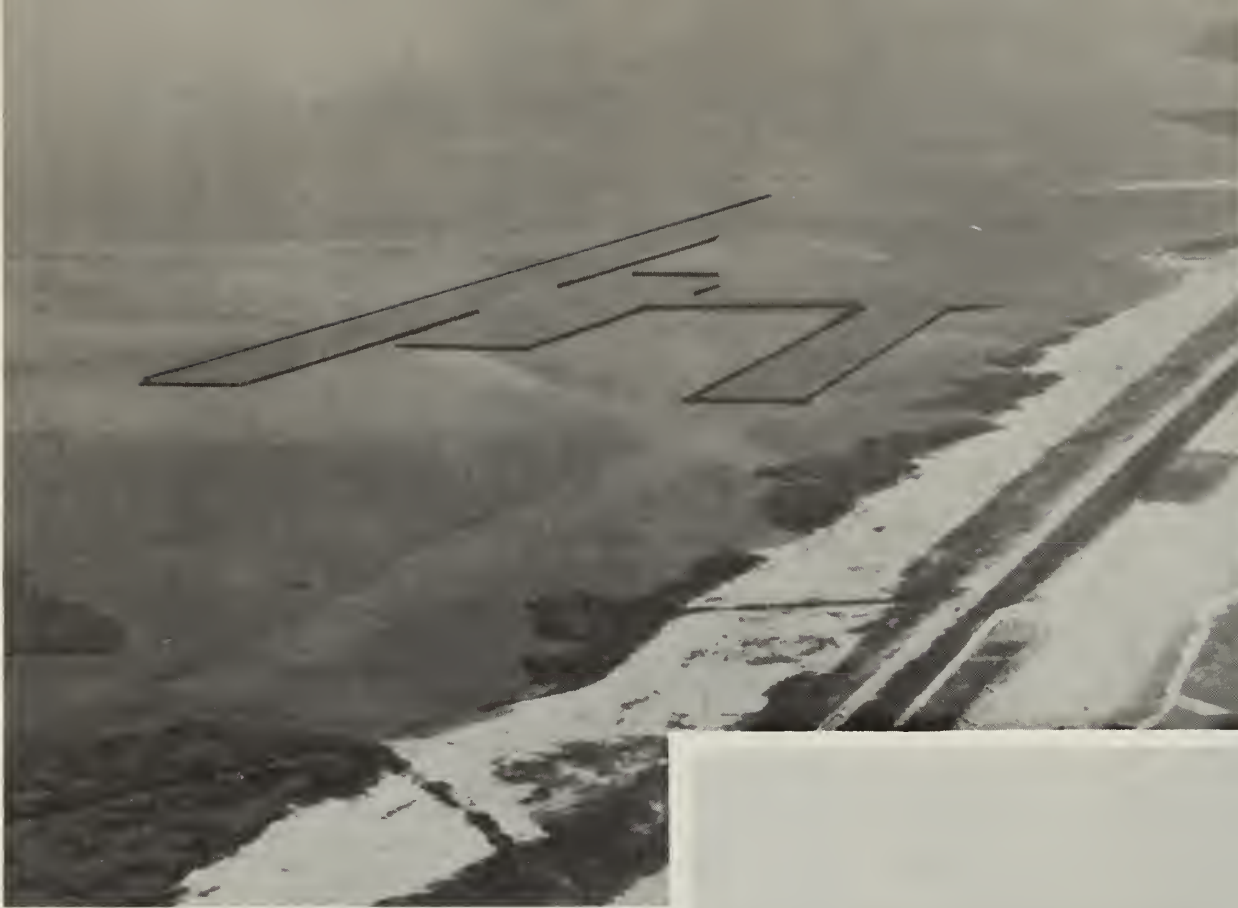
SOUND EXCAVATION

The major disadvantage in artificial nourishment is that great quantities of sand of suitable quality (type and size) may not be available near the problem beach. In the past, sands were dredged from sounds and bays immediately inland from the beach, or transported from inland sources. With the recent concern about estuarine ecology, and the fact that sound materials are usually much too fine to be effective as beach nourishment, estuarine and bay sources are less desirable and no longer as available. The future prospect for large enough quantities of sand to be effective for large beach restoration projects will probably be offshore sources, and materials dredged from the coastal inlets. For example, along the Outer Banks alone, great quantities of high grade beach sediment are dredged from Oregon and Hatteras Inlets and dumped into deep water offshore. Diamond Shoals also represents a major source for beach nourishment--perhaps in excess of ten billion cubic yards.

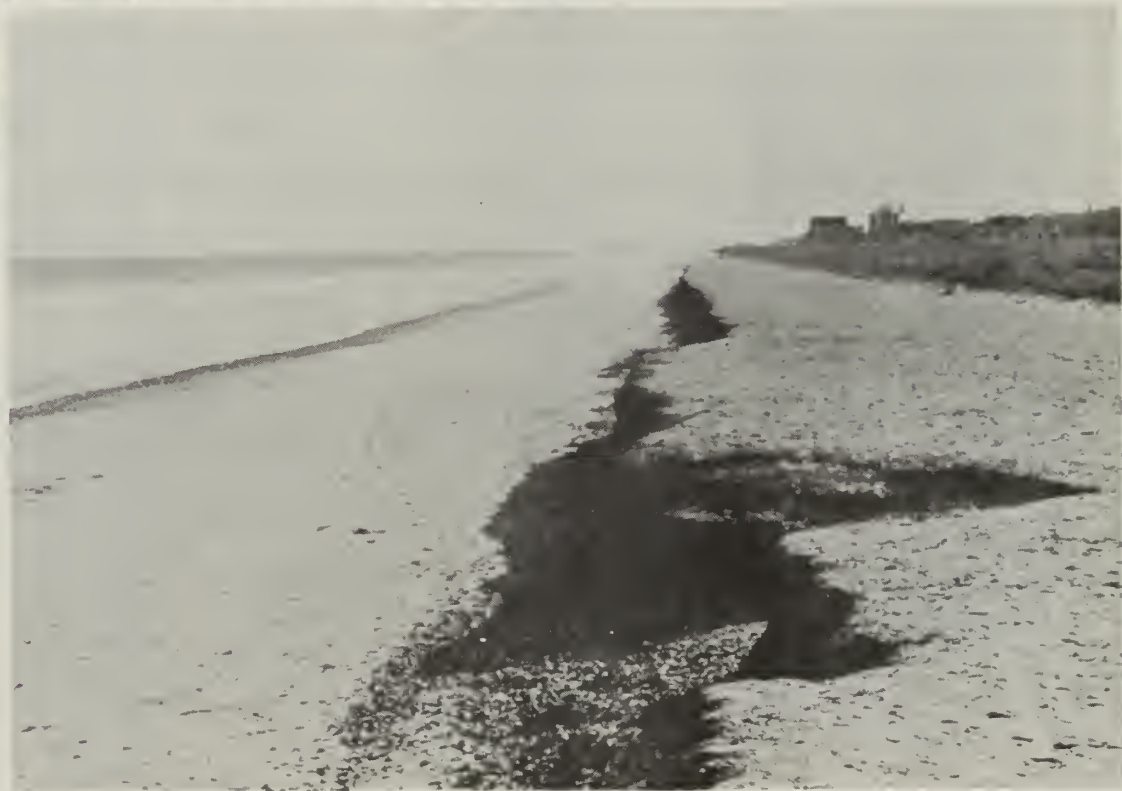
IMPROPER
MATERIAL

The borrow material was taken from Pamlico Sound. It was too fine to remain as part of the subaerial beach system and the quantity, 312,000 cubic yards, was too little to have significant impact on the inshore bar-trough system to provide even temporary protection.

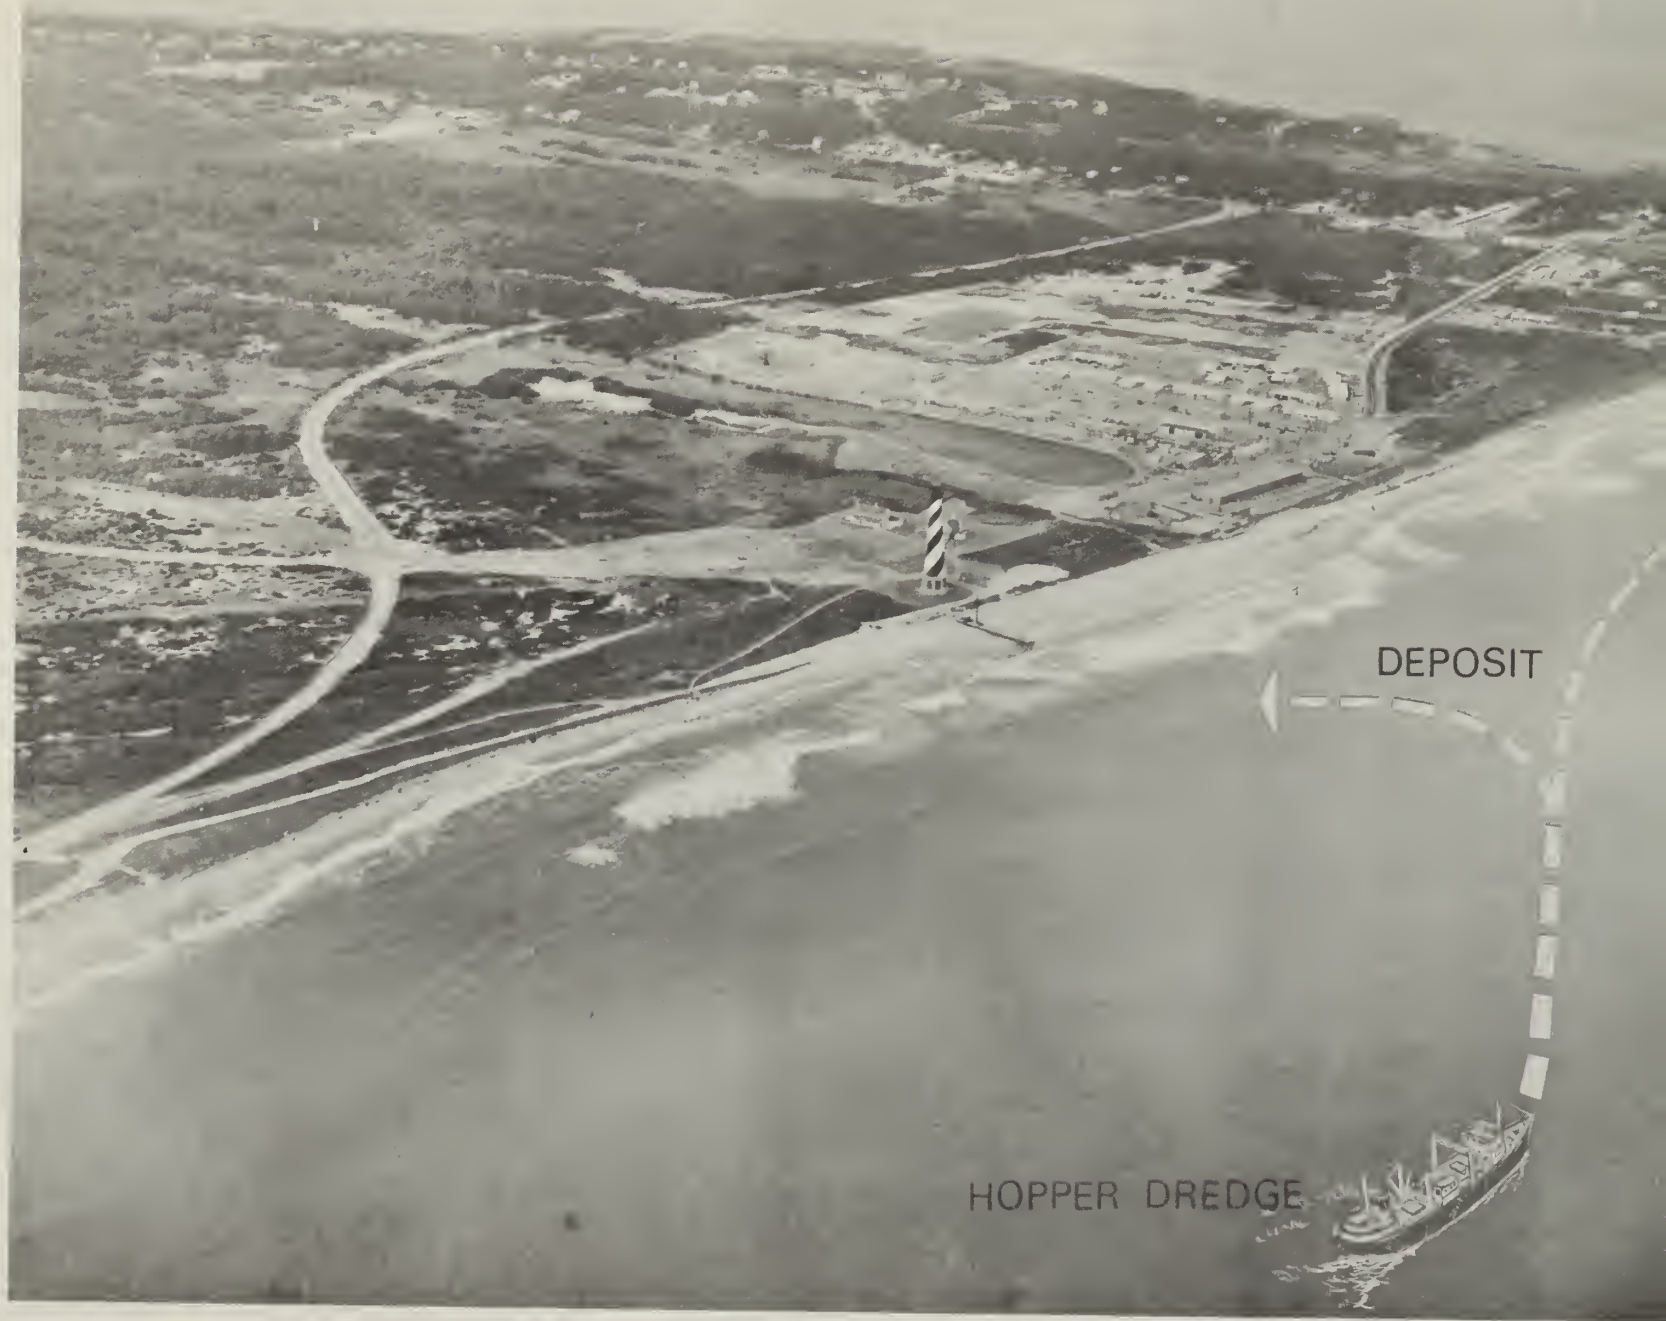
DEPOSIT

HOPPER DREDGE

The nourishment system of the future will involve the inexpensive transfer of large quantities of sand from offshore sources directly into the inshore bar-trough system. This would eliminate the costly step of placing the material directly upon the subaerial beach--sand added to the subaerial beach ends up deposited within the bar-trough system within a short period of time. This system of sand transfer requires a new concept in hopper dredge design--equipment capable of working in shallow water, perhaps 12 to 18 feet or less.

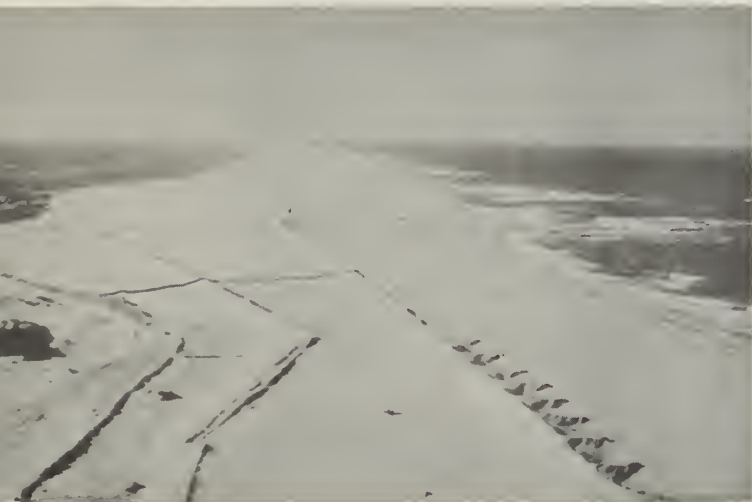
1933 DUNE CONSTRUCTION PICTURED
FROM HATTERAS LIGHTHOUSE -
LOOKING NORTH

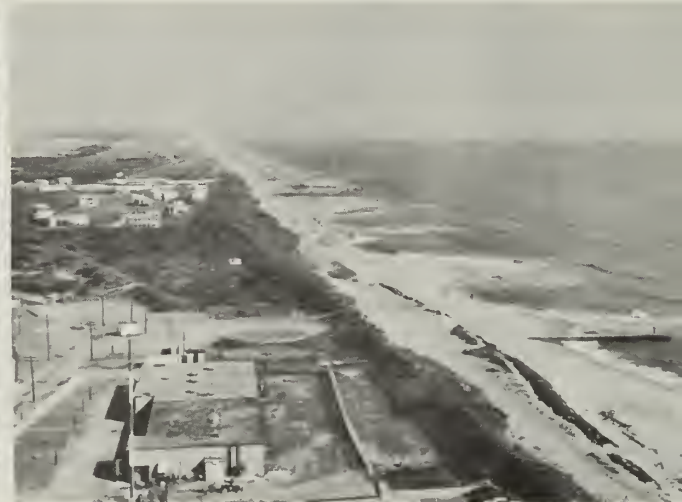
IDENTICAL LOCATION - 1972

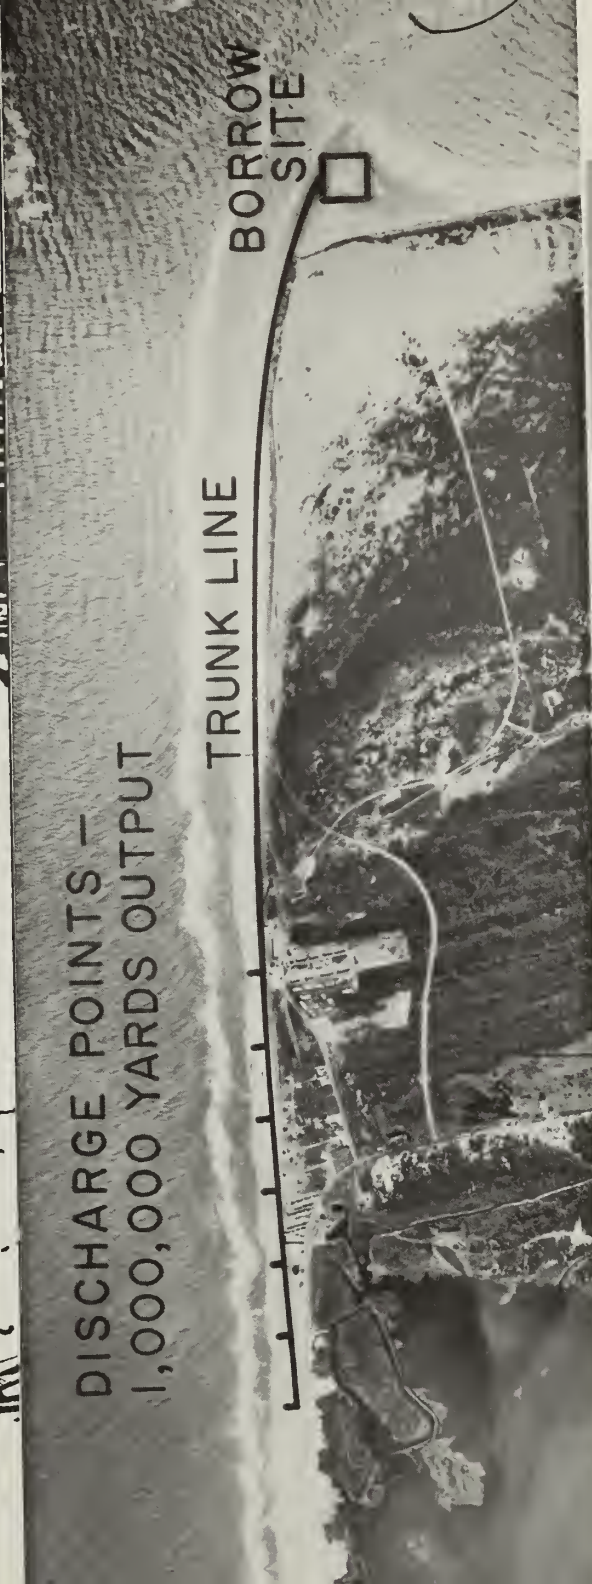
DISCHARGE POINTS —
1,000,000 YARDS OUTPUT

TRUNK LINE

BORROW
SITE

The 1972-73 Buxton beach nourishment project will consist of a hydraulic transfer of about one million cubic yards of native beach sands from the Cape Point spit three miles to the north, where it will be deposited on the beach. The borrow site is the best available in terms of material characteristics, technology, and environmental impact. Cape Point is, in effect, the terminal point of sand transfer for the northeast facing reach of the Outer Banks. Therefore, the project is actually recycling sands that were originally part of the beach system to the north. At the close of the project, normal overwash processes will fill the borrow pit with beach materials. A detailed investigation will be conducted to determine the [1] effectiveness of the project as an erosion control measure, and [2] environmental impact of one million yards of sand on the beach-energy system.
