Cultural Landscape Report: Cant Ranch Historic District

JOHN DAY FOSSIL BEDS NATIONAL MONUMENT, OREGON

September 1996

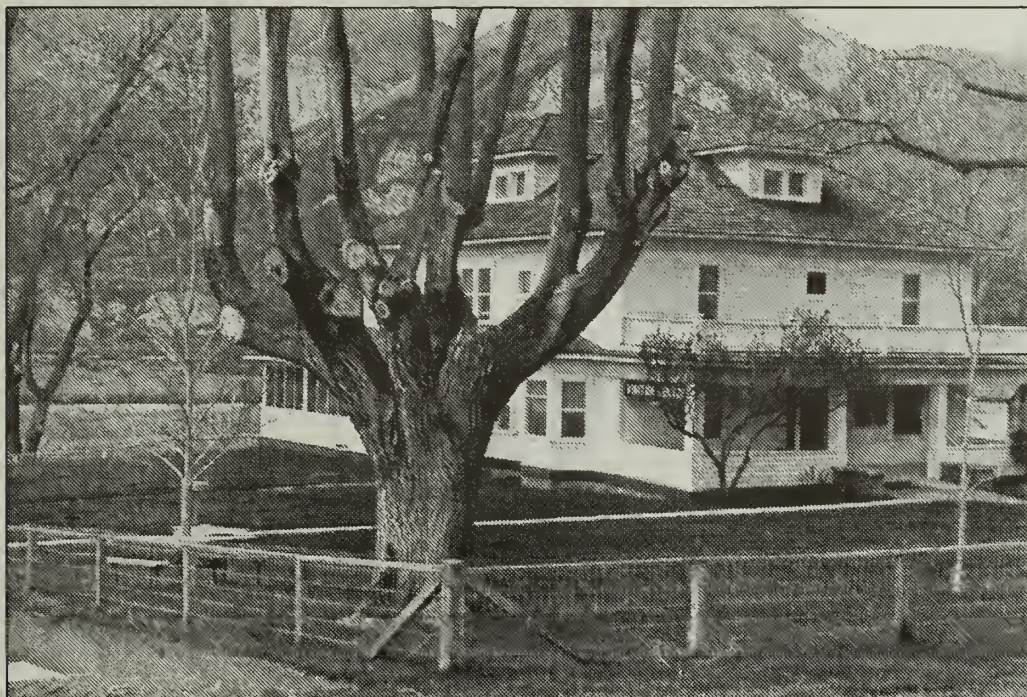
Cant House. View looking southeast, 1993.

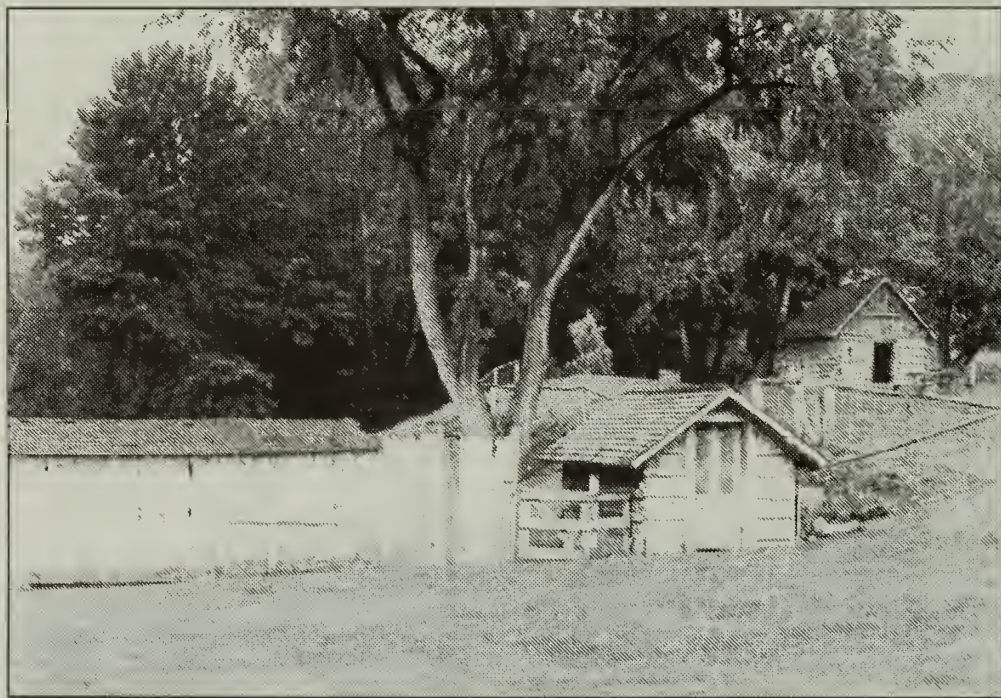
Outbuildings east of the main house. View looking south, 1993.

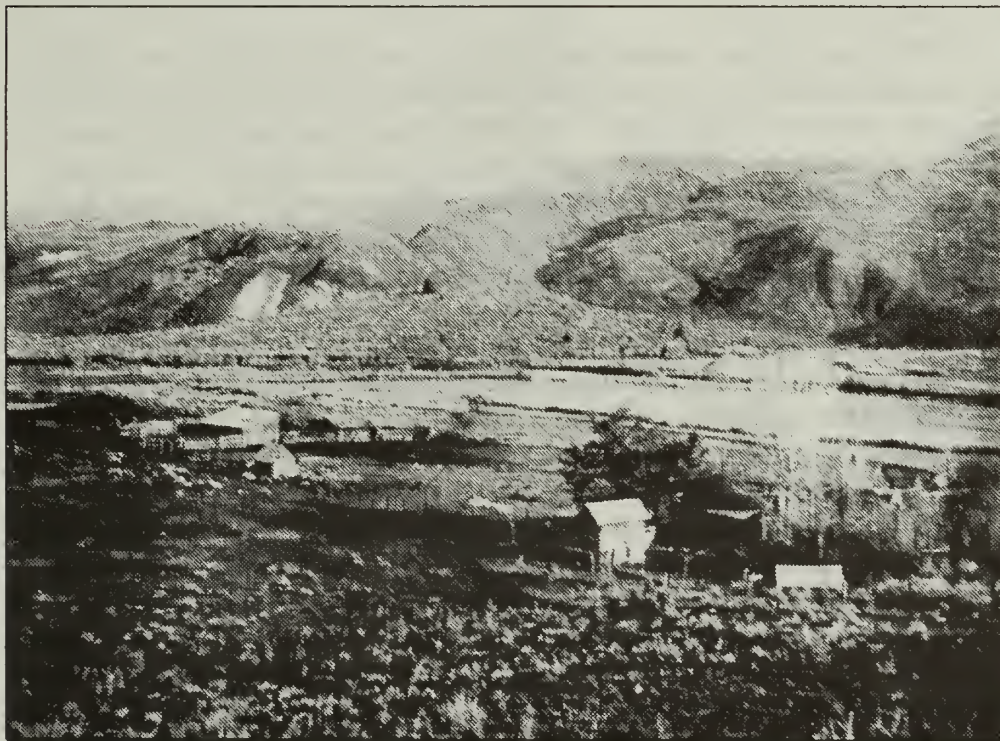
Early view of Officer Homestead, with irrigation ditches east of the structural complex. View looking east, ca. 1900.

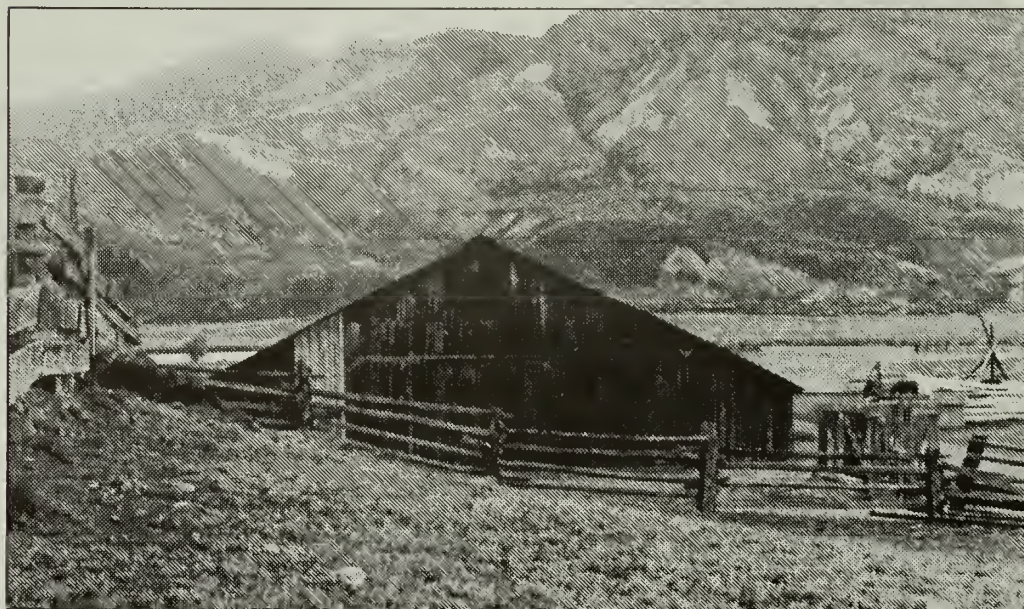
Barn and corrals. View looking east, 1993.

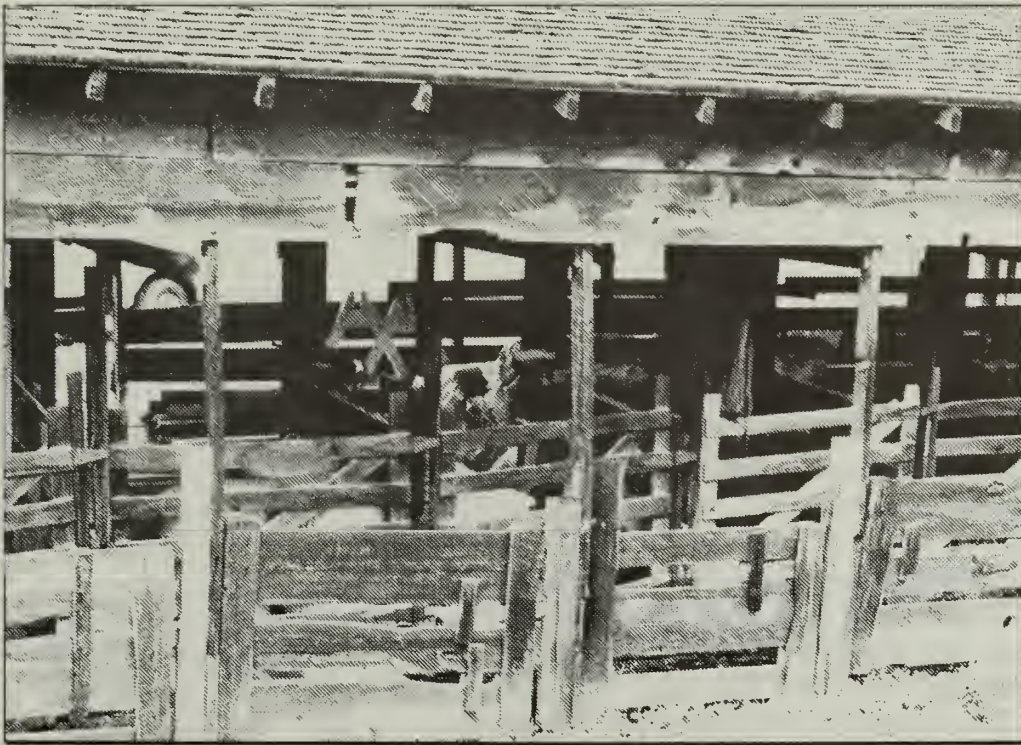
Sheep shearing pens next to barn, 1993.

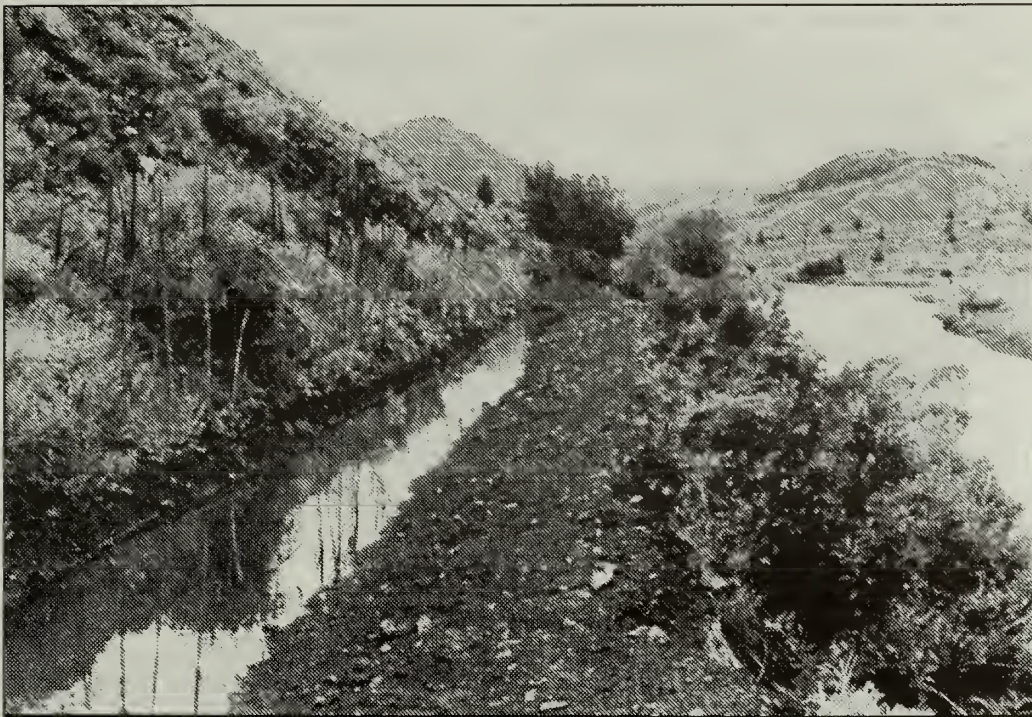
Rock Creek irrigation ditch. View looking north, 1993.

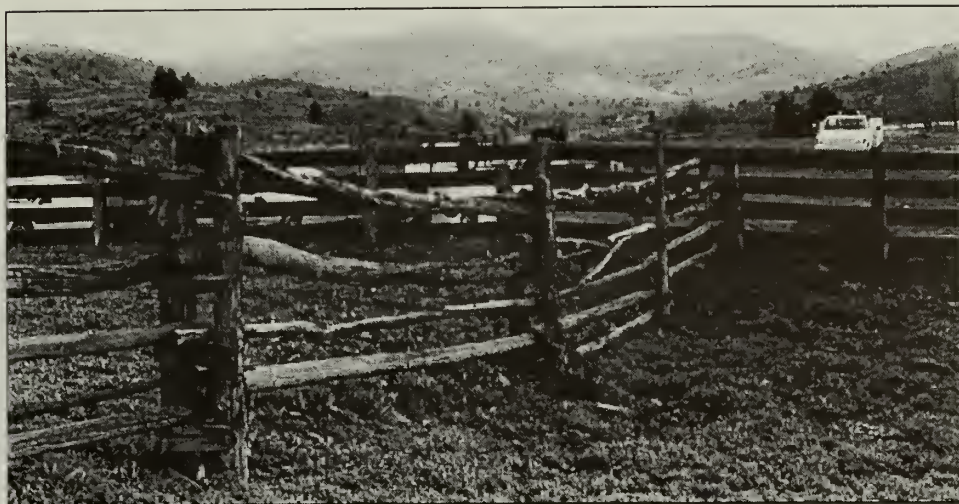
Post and rail fence in corral, 1993.

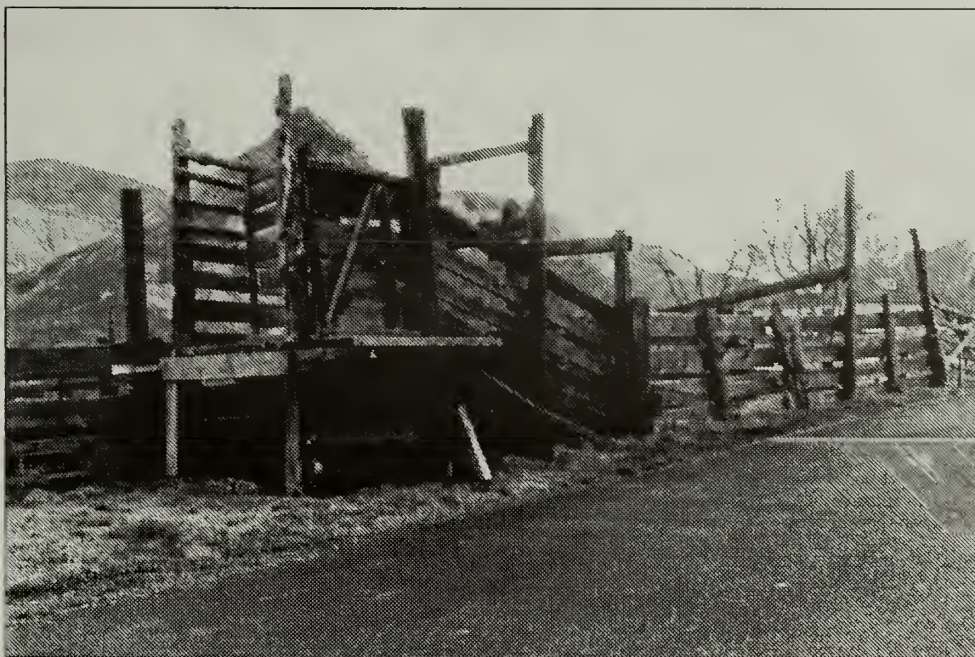
Cattle chute next to Highway 19. Photo, 1993.
