ELISHA JONES HOUSE AND SHED

Minute Man National Historical Park
Concord, Massachusetts

HISTORIC STRUCTURE REPORT

James J. Lee III
Architectural Conservator

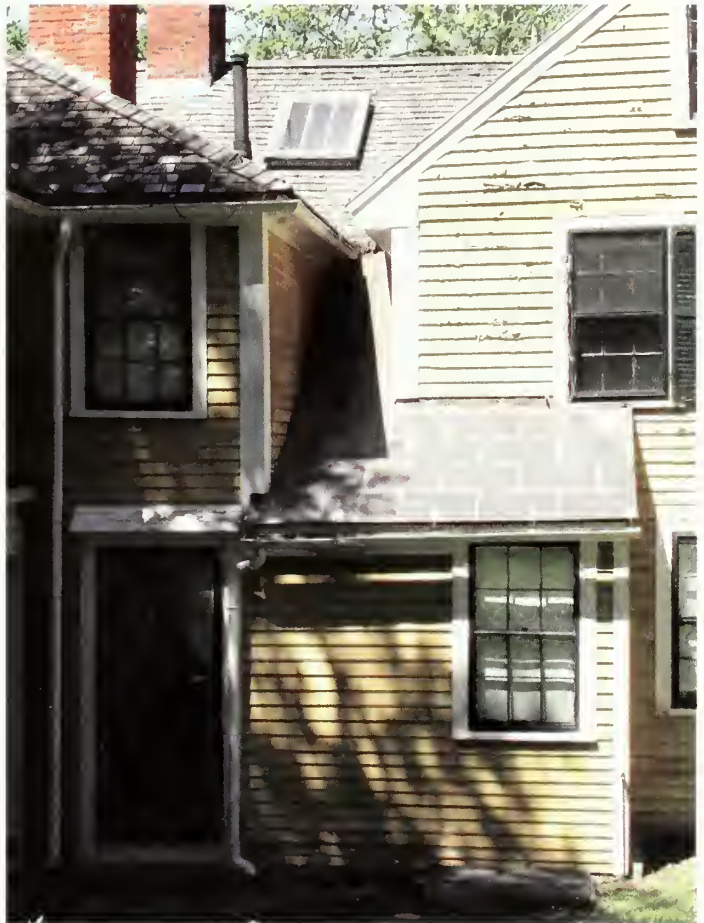
Figure 22. Elisha Jones House:
East elevation, showing southeast
hip roof (left) and north gable roof
(right), with remnant of former
lean- to roof kept as a valley
between the two roofs (2006).

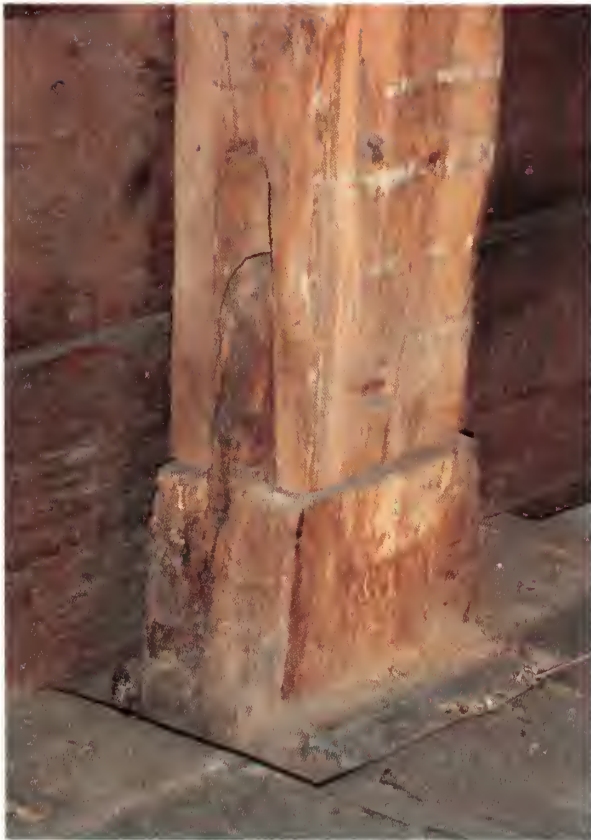
Figure 23. Elisha Jones Shed:
Spliced timber on east elevation
of second story (2006).

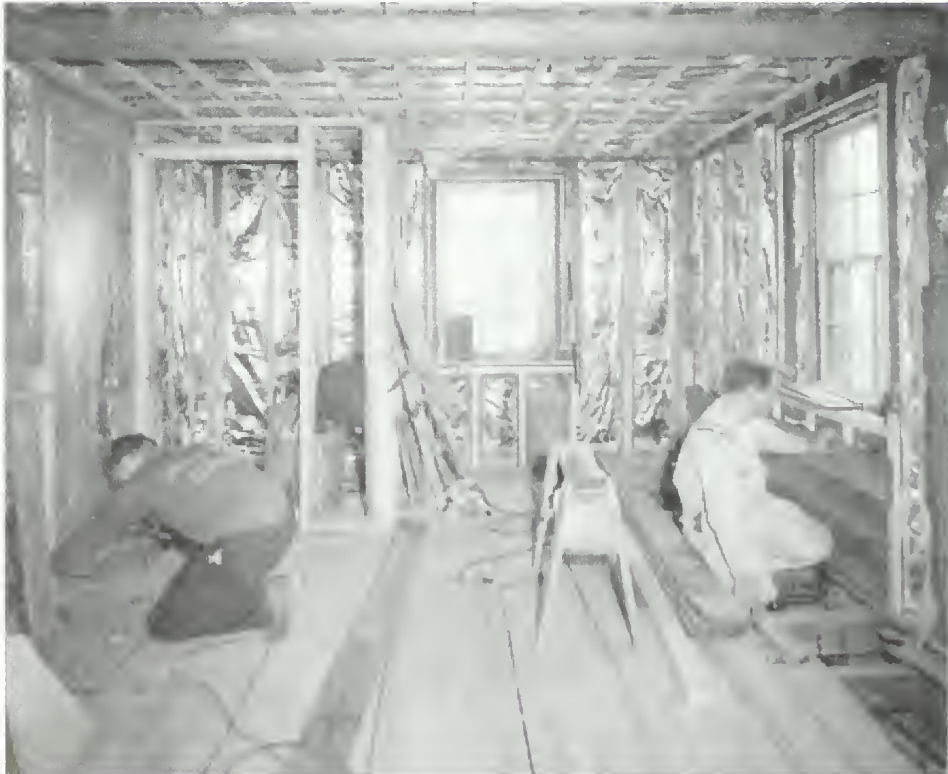
Figure 33. Elisha Jones House: East extension of north lean-to, installation of chestnut wainscoting in kitchen ell during 1966 rehabilitation work.

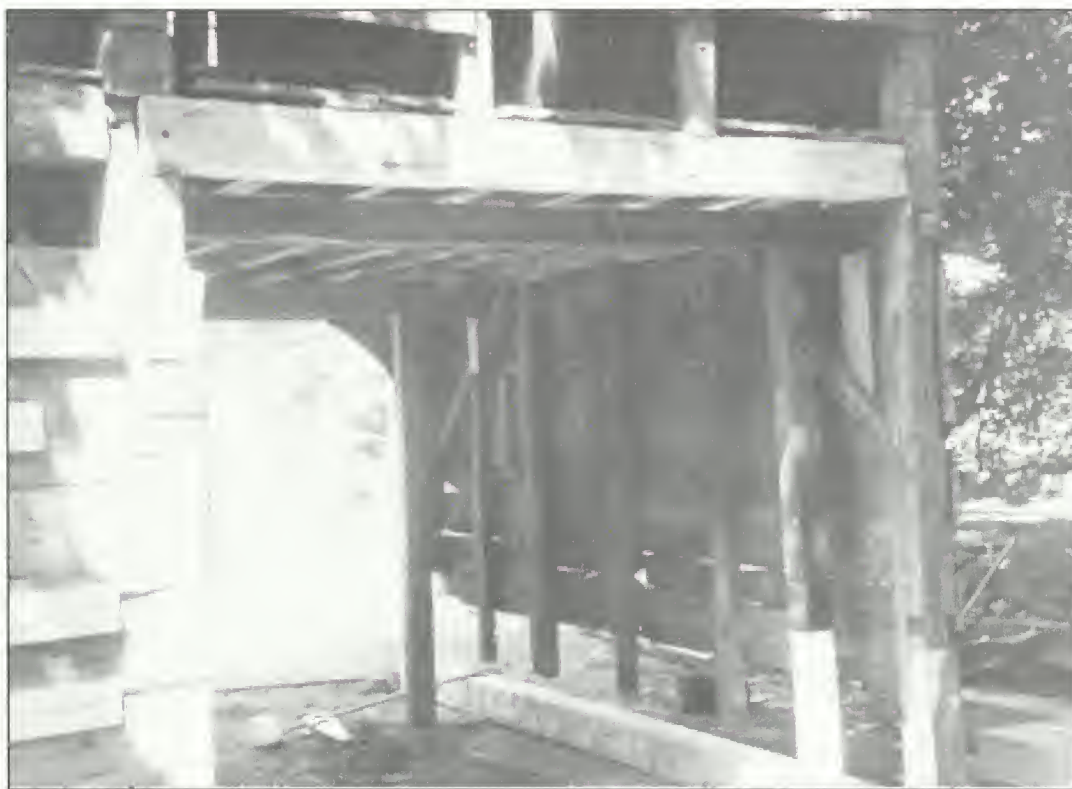
Figure 35. Elisha Jones Shed: East and north wall repairs, including replacement of east- wall girt and north- wall sill, and splicing of posts and studs, 1974.

35. Elisha Jones Shed: East and north wall repairs, including replacement of east- wall girt and north- wall sill, and splicing of posts and studs. Photograph by Orville Carroll, 1974. Minute Man NHP Museum Collection, Architectural Conservator Research Records, Box 5, Folder 1, Envelope for Illustration No. 3.....	89

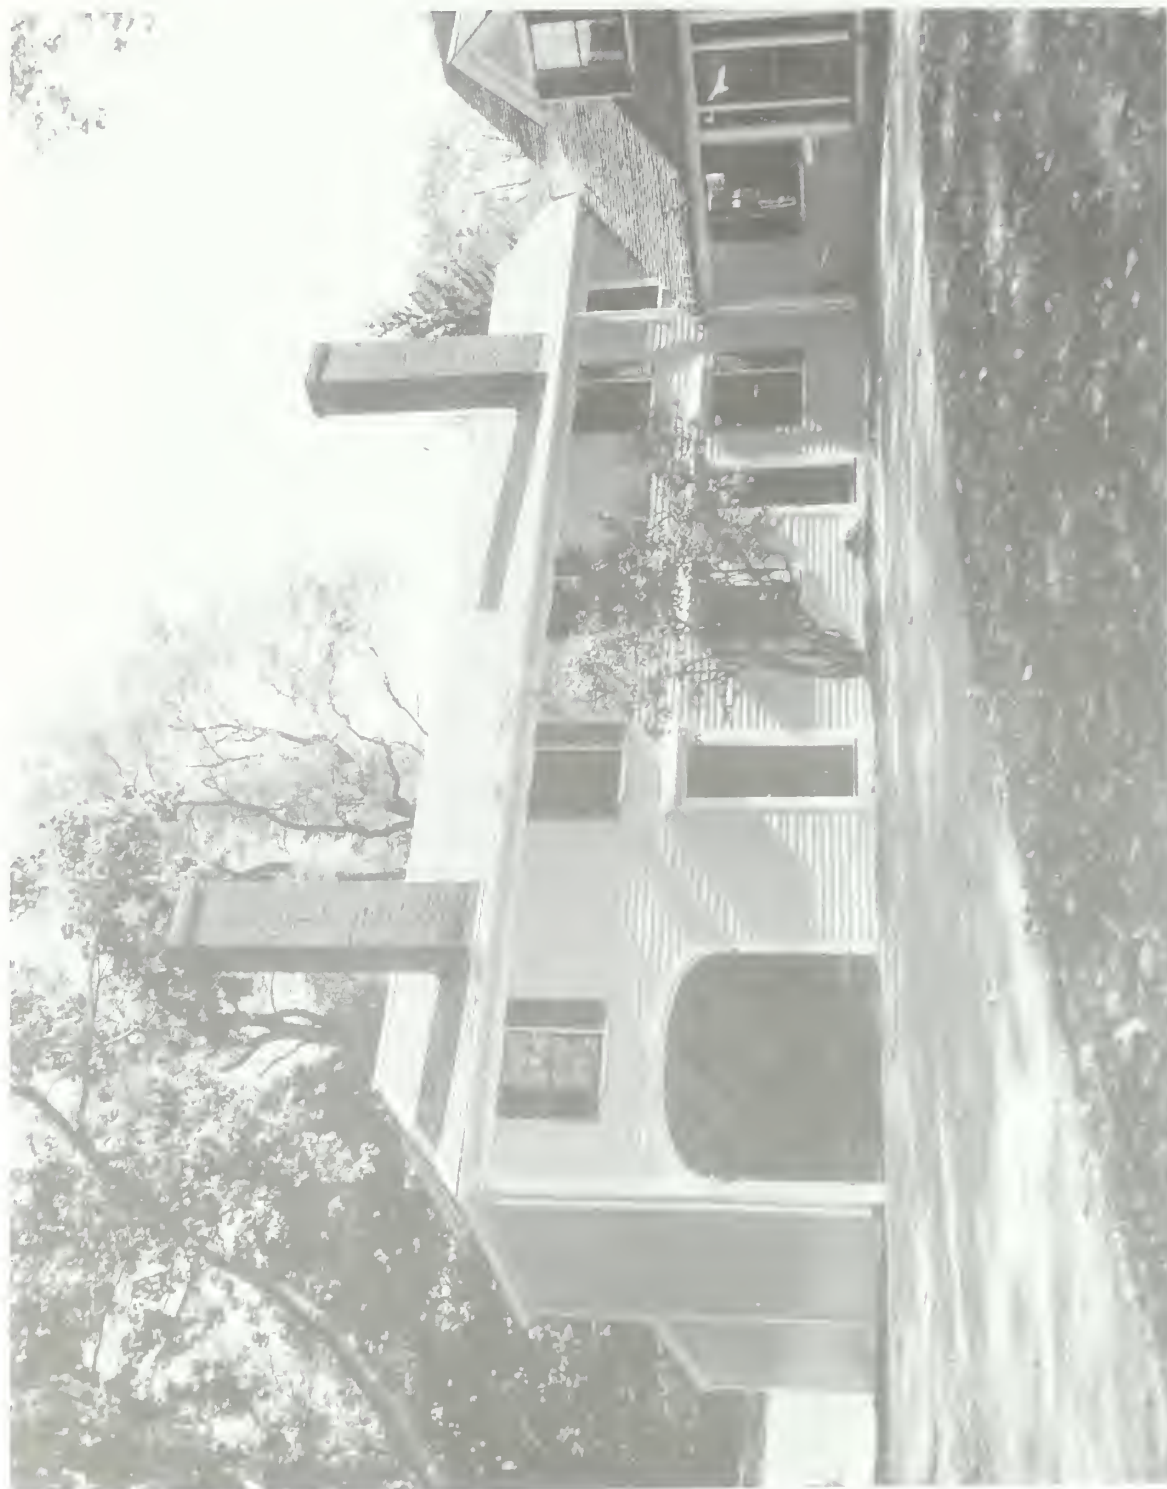
Figure 36. Elisha Jones Shed: North and west elevations after 1974-75 restoration (October 1975).
