**WATER RESOURCES MANAGEMENT PLAN**

**Vanderbilt Mansion National Historic Site  
Eleanor Roosevelt National Historic Site  
Home of Franklin D. Roosevelt  
National Historic Site • New York**

SEPTEMBER 1997

UNITED STATES DEPARTMENT OF THE INTERIOR  
NATIONAL PARK SERVICE

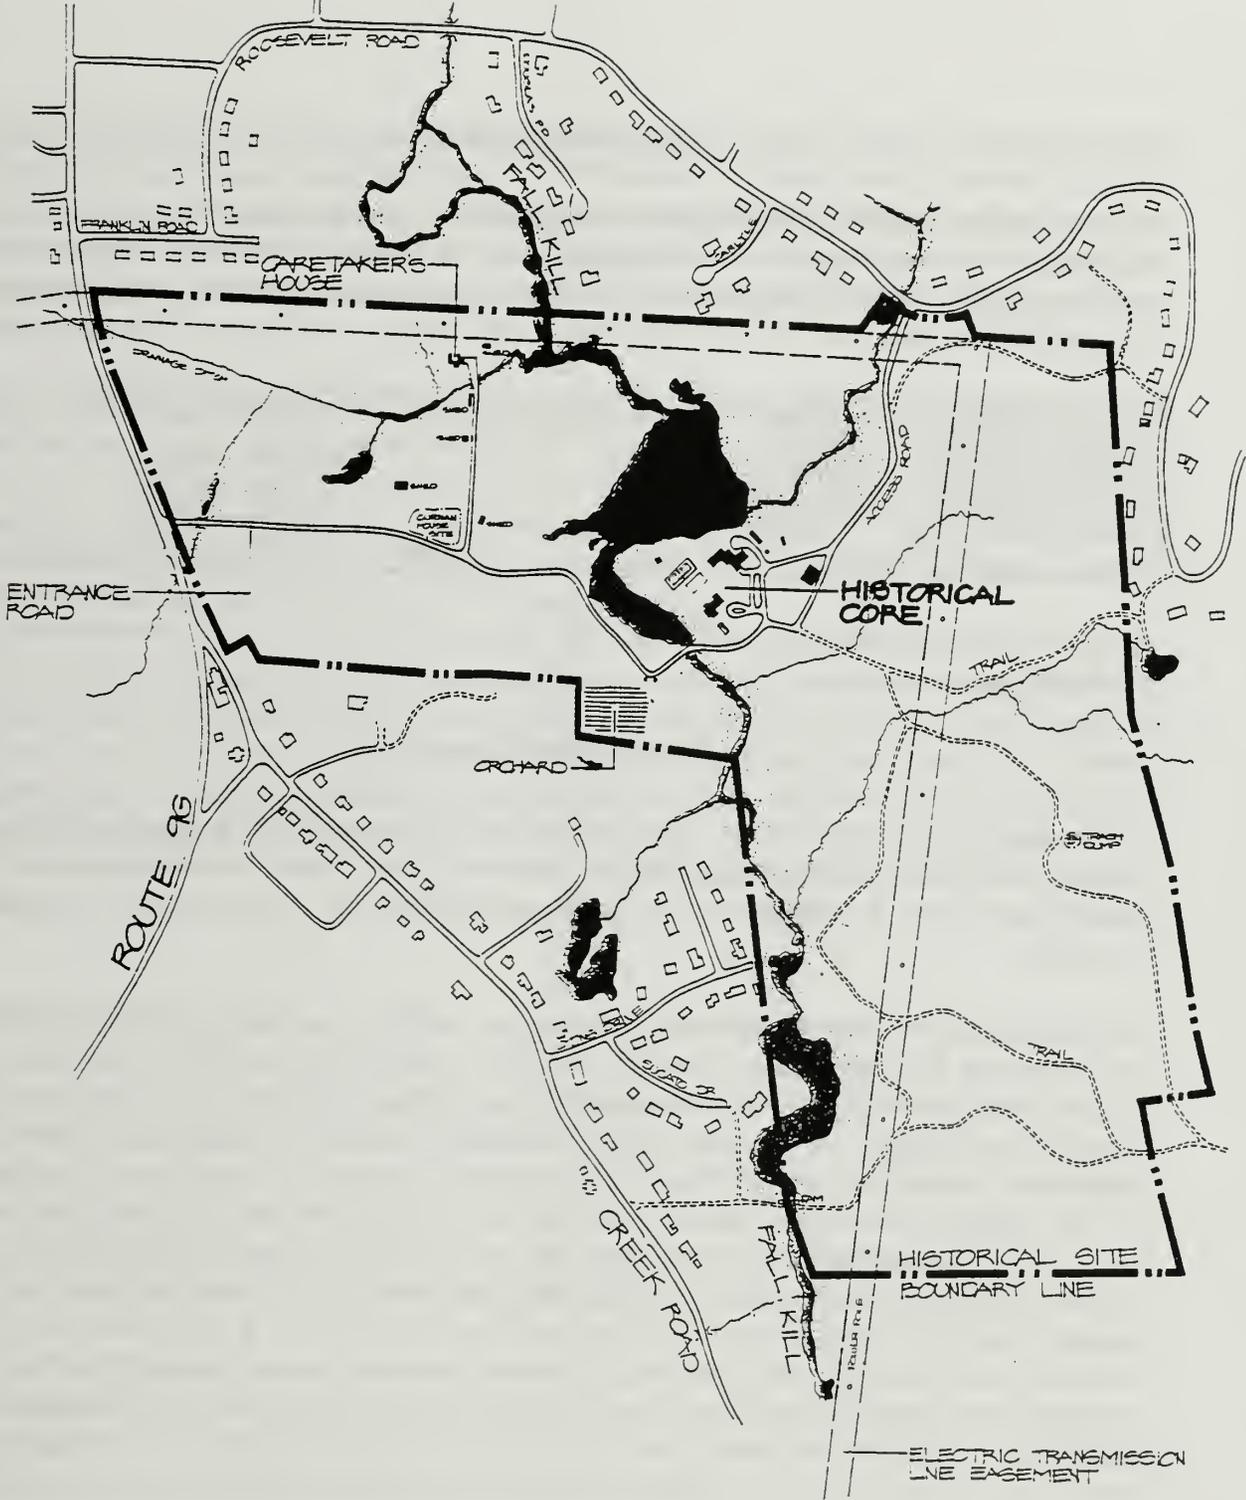
Figure 4. Map of Eleanor Roosevelt National Historic Site.

Eleanor Roosevelt National Historic Site (Figure 4) was established on May 26, 1977 (Public Law 95-32). "Val-Kill", as the site was called by the Roosevelt family, was the place that Eleanor Roosevelt considered her only real home. The operation of the site is a joint effort between the National Park Service and Eleanor Roosevelt's Val-Kill Inc., a private, nonprofit group instrumental in the effort to designate Val-Kill as a national historic site. The site consists of approximately 181 acres east of U.S. Route 9G, and encompasses all the buildings, gardens, orchards, ponds, fields, and woods important to Eleanor Roosevelt.

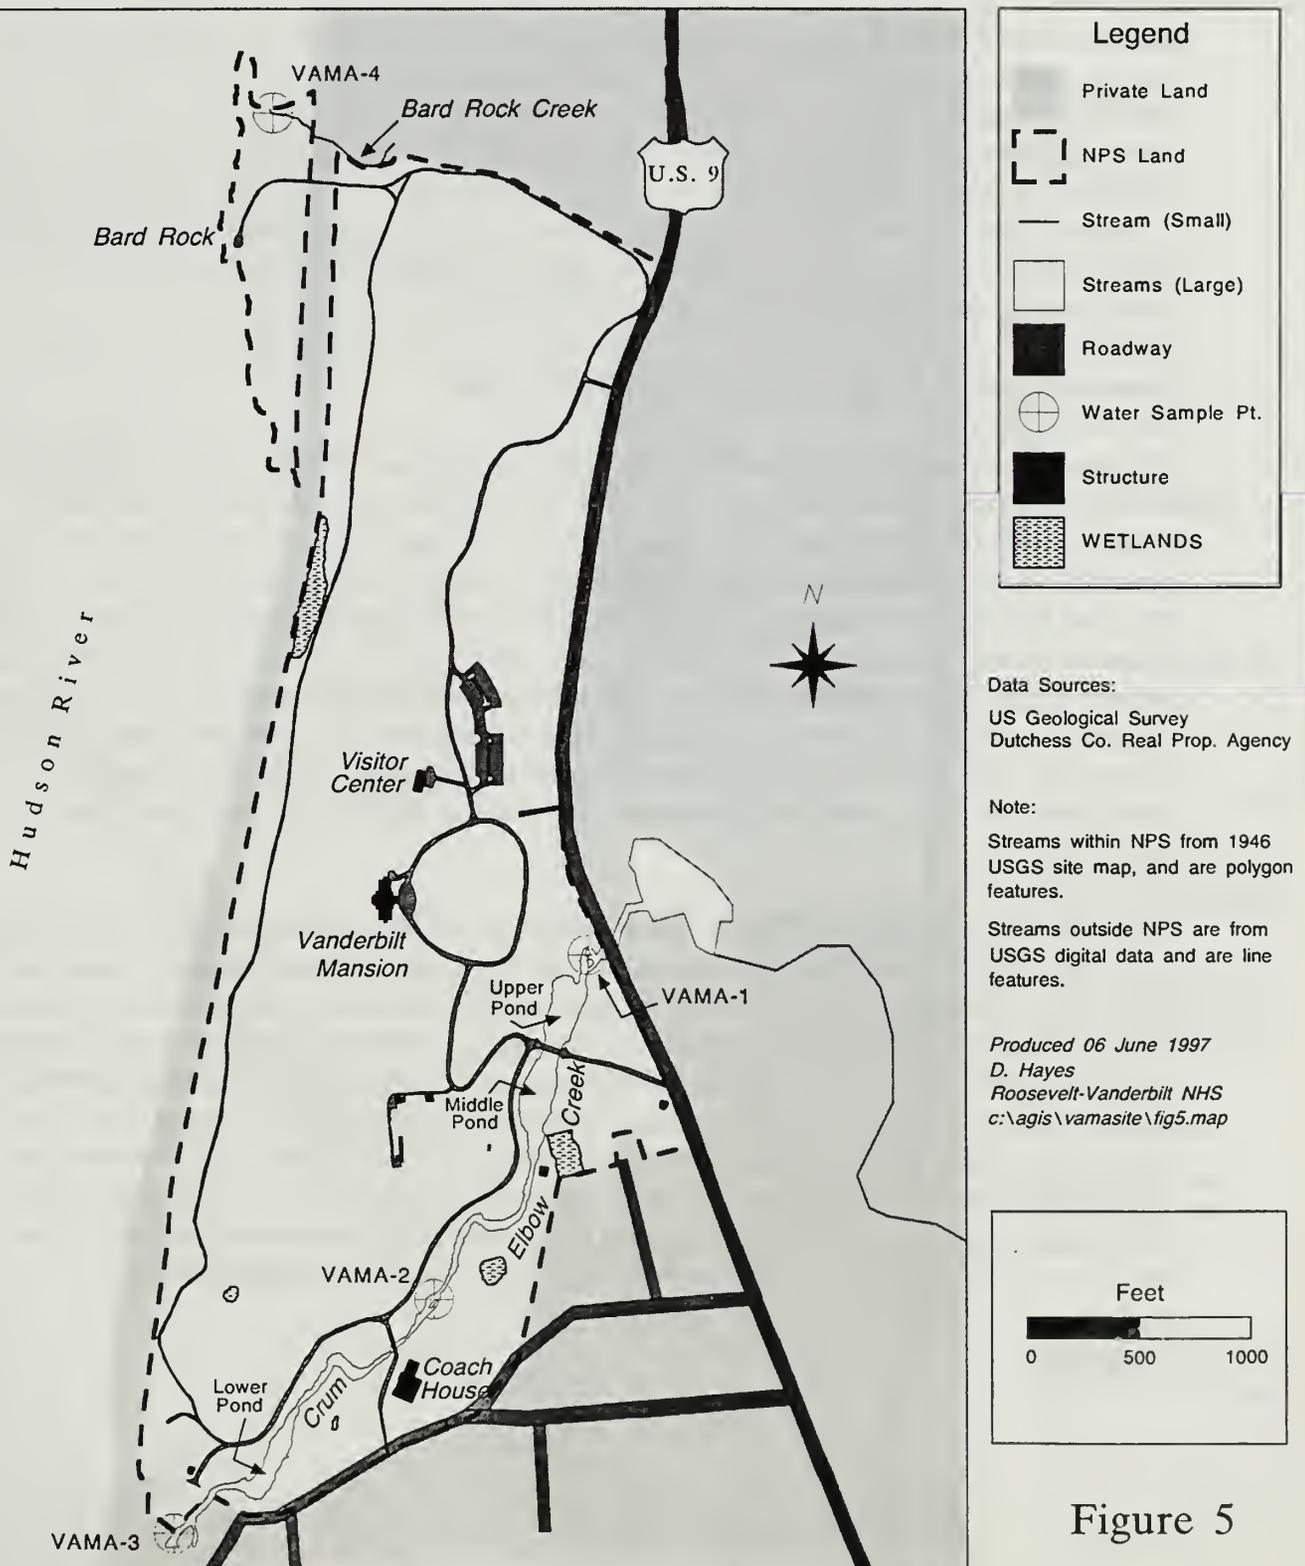
Figure 5

The only permanent ponds were constructed during the ownership of Frederick W. Vanderbilt around 1900. These three ponds (approximately 3 acres in total), Upper (White Bridge) Pond, Middle (Powerhouse) Pond and Lower (Lower Dam) Pond are impoundments on Crum Elbow Creek (Figure 5). They have significant sediment deposits in their basins and are shallow with depths ranging from 1 to 3 feet.

An obvious parameter missing from the monitoring program is stream discharge. A stage-discharge relation should be established at the following sites: VAMA-1, HOFR-1, and ELRO-1 (Figures 5, 6, and 7). Staff gages will need to be installed and a rating curve developed for each gaging site. This may require purchase or long-term loan of a flow meter. Purchase price of a quality flow meter ranges from about \$1000 to \$1500.

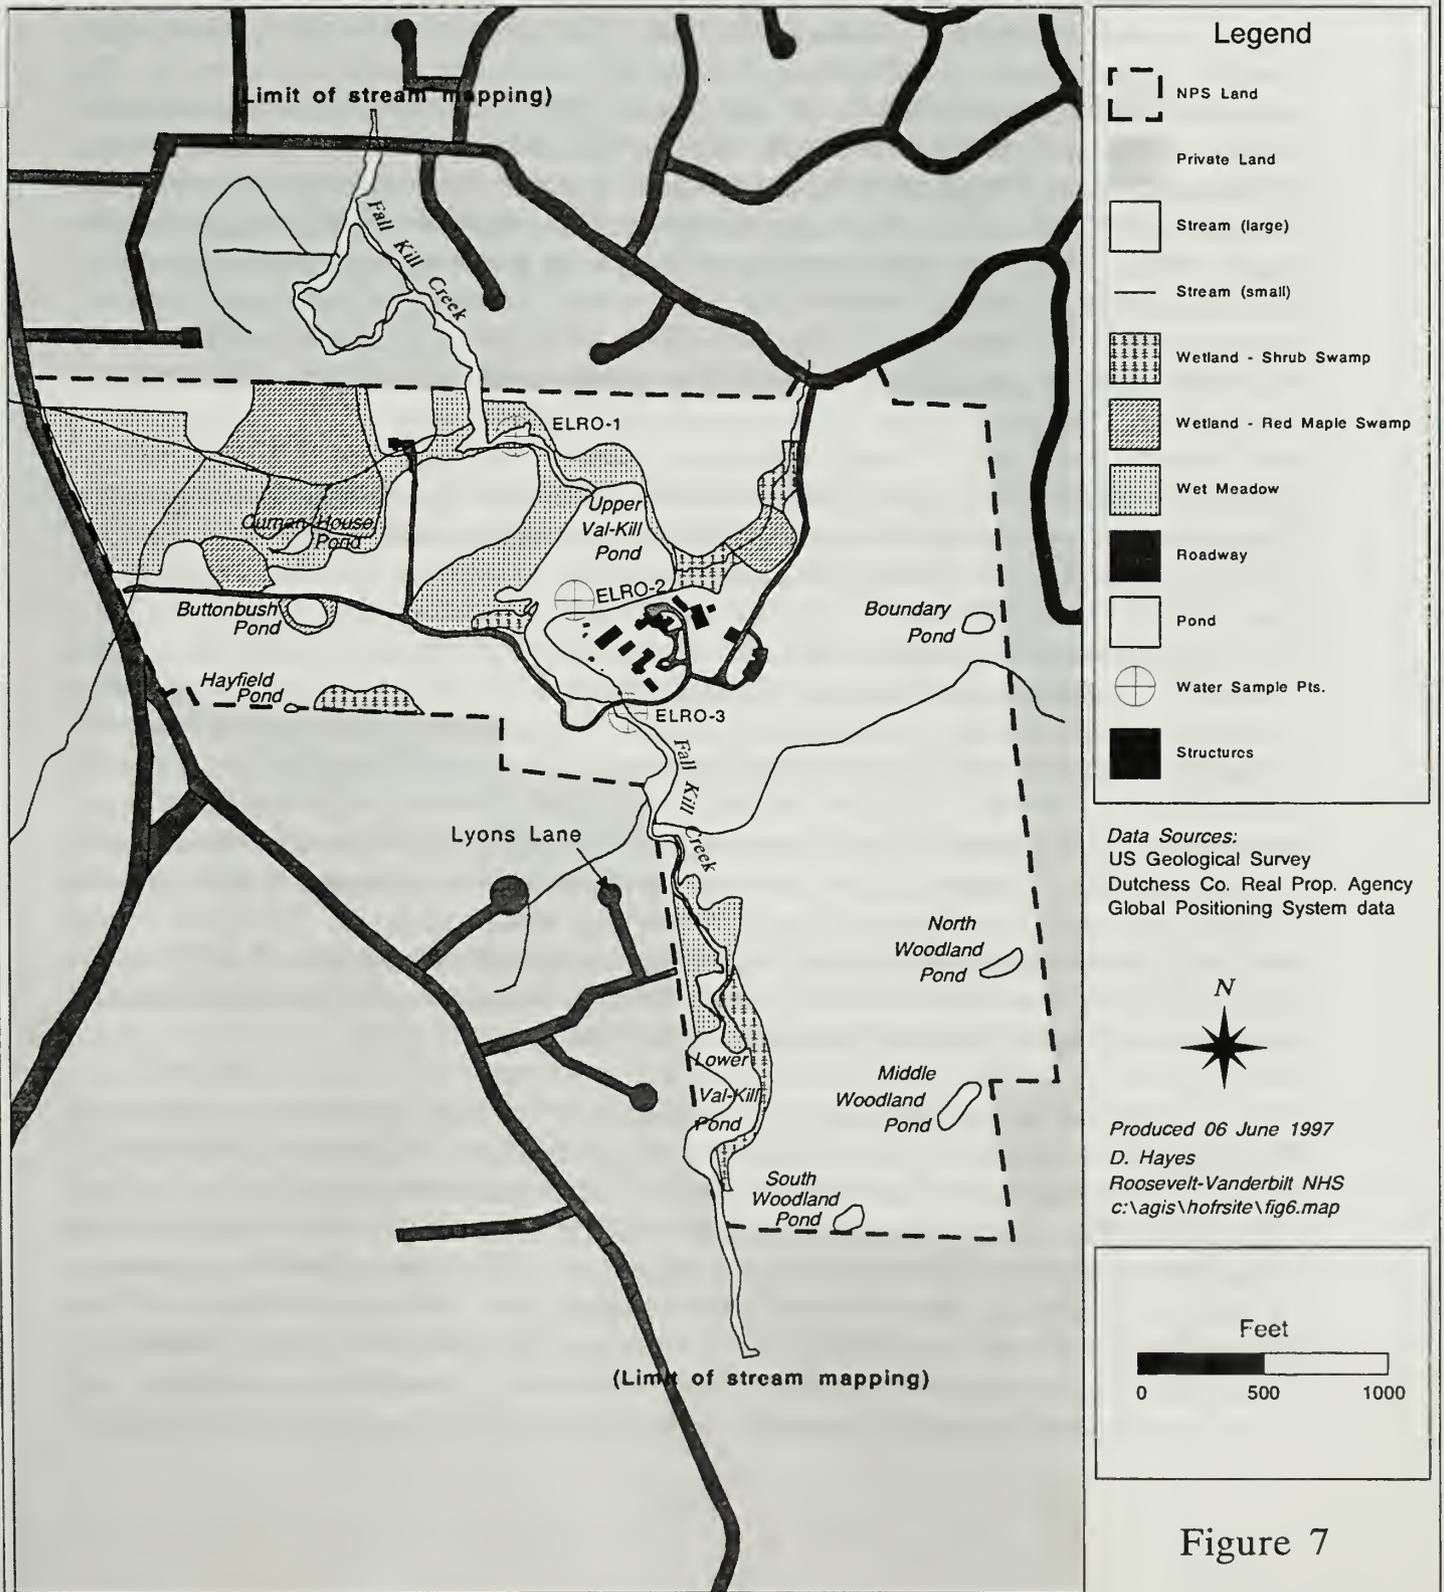
Figure 7

Two vernal or non-permanent ponds occur in the park (Figure 7). The North Woodland Pond is a small pond that is ephemeral. There is no aquatic vegetation present because of the fluctuation in water level, and it has a substrate of leaves and organic debris over gravel. This pond is noted as a significant amphibian breeding site during wet periods (Klemens et al. 1992). The Buttonbush Pond contains water except during the most severe droughts. It is approximately 1 foot deep, with significant stands of buttonbush (*C. occidentalis*).

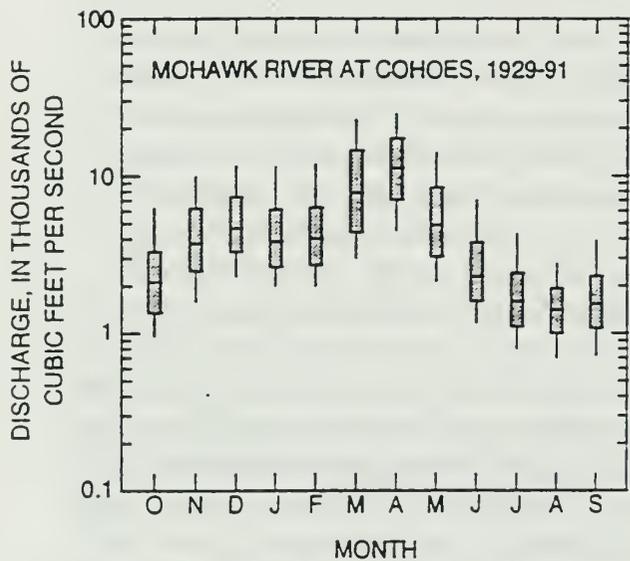
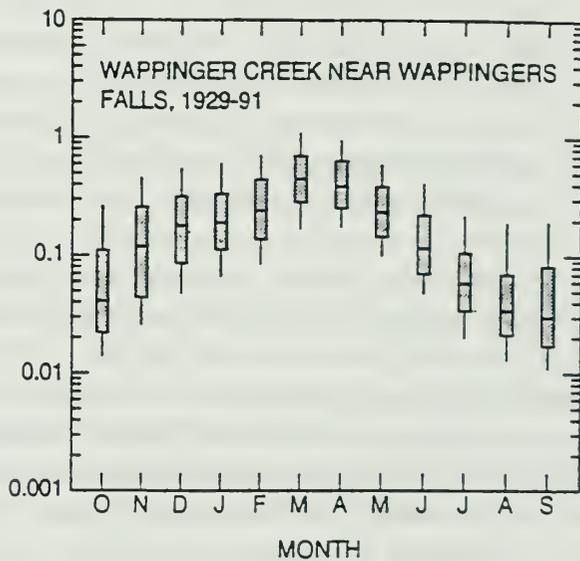
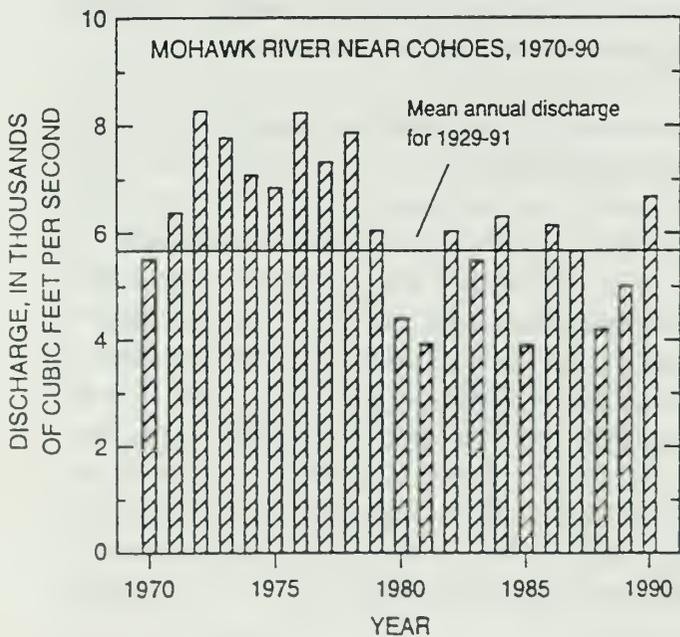
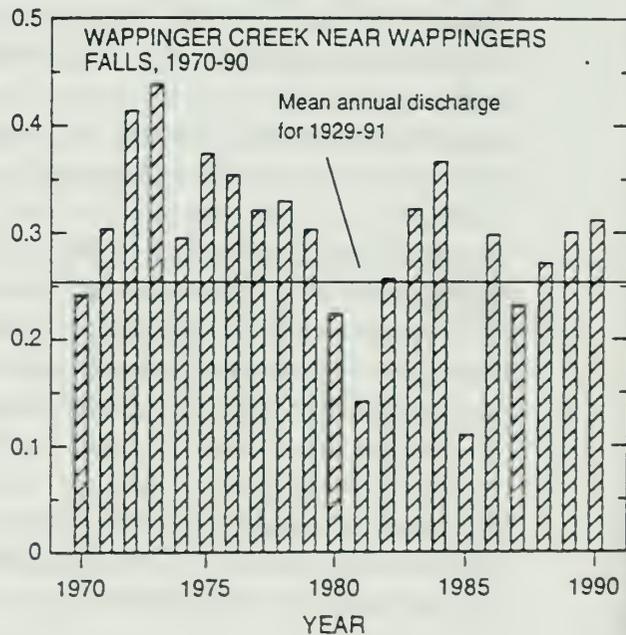
Figure 8. Monthly and annual mean discharge for the Mohawk River at Cohoes, NY and Wappinger Creek near Wappingers Falls, NY (from Phillips and Hanchar 1996).

Seasonal and annual patterns of runoff in the Hudson River basin were calculated using daily discharge data from the Mohawk River at Cohoes (Phillips and Hanchar 1996). The median monthly discharge of the Mohawk River at Cohoes for 1929-1991 ranges from less than 2,000 cfs in August to over 10,000 cfs in April (Figure 8). Discharge typically increases from October through December as temperatures decrease, rainfall increases, and the growing season ends. Discharges for January and February, when temperatures decline and much of the precipitation falls as snow, are typically lower than those for December; and median daily discharge typically peaks in March and April, during spring snowmelt. Discharges generally decline from May through August as snowmelt decreases and temperatures and infiltration increase.

Other than the Hudson River, no fluvial system within or adjacent to Roosevelt-Vanderbilt national historic sites is or has ever been monitored for discharge on a consistent basis. In an attempt to conduct a seasonal analysis of water quality data collected in and around Roosevelt-Vanderbilt national historic sites, the National Park Service (1995) found the nearest U.S. Geological Survey Hydro-Climatic Data Network (HCDN) station that is most representative of streamflow conditions at the park. The HCDN is basically a subset of U.S. Geological Survey streamflow stations and includes only those stations that are unaffected by artificial diversions, storage, or other disruptions of the natural channel. All HCDN stations generally have at least a 20-year period of record. Consequently, discharge patterns at these stations should reflect only hydrologic and climatic influences. The station most representative of streamflow conditions at Roosevelt-Vanderbilt national historic sites is Wappinger Creek near Wappingers Falls, NY, which is approximately 15 miles south of Hyde Park (National Park Service 1995). Figure 8 displays the mean annual hydrograph and distribution of daily flows by month for the Wappinger Creek station.

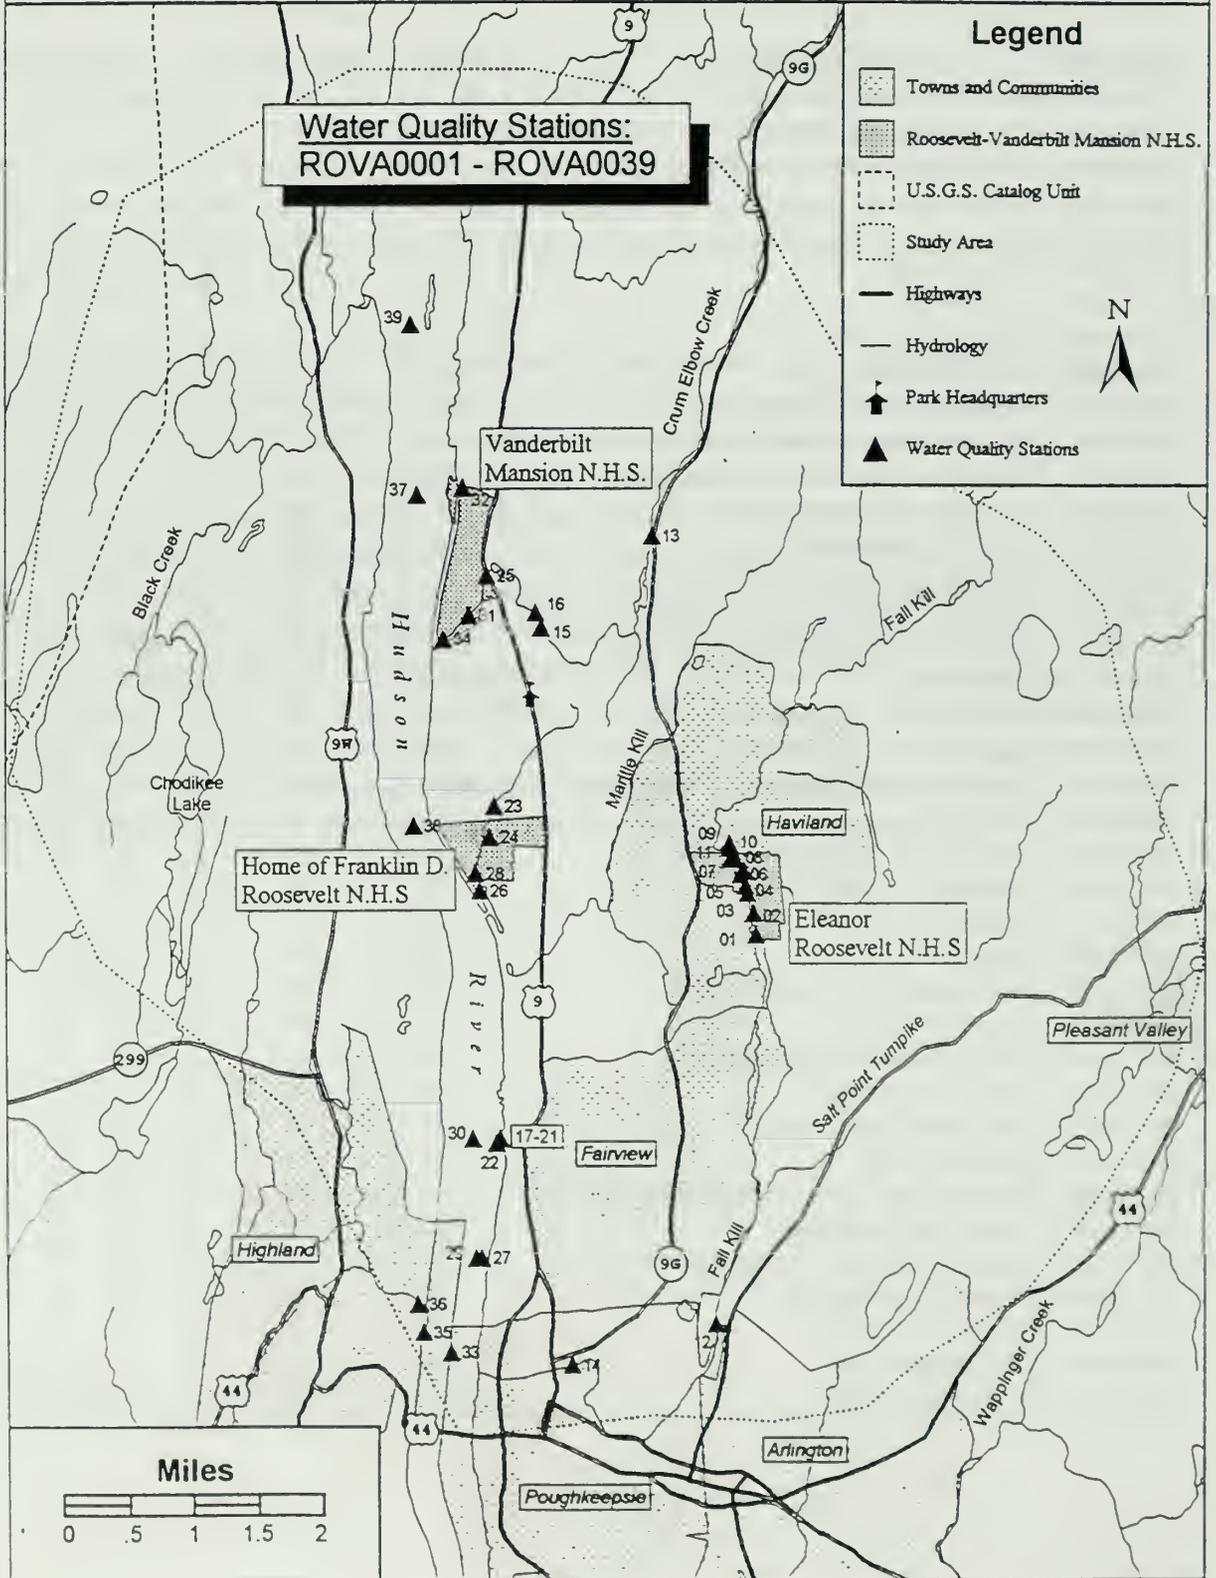
Figure 9. Locations of water quality monitoring stations at Roosevelt-Vanderbilt national historic sites (after National Park Service 1995). See Table 1 for further explanation of station codes.

Nineteen of 39 water quality monitoring stations in Table 1, represent stations located within or immediately adjacent to park boundaries (Figure 9). However, data from eight stations (ROVA0001 to ROVA0003; ROVA0005; and, ROVA0008 to ROVA0011) are from a 1978-1979 intensive study of Fall Kill on Eleanor Roosevelt National Historic Site by Pandullo Quirk Associates (1979). The remaining 11 monitoring stations (ROVA004; ROVA0006; ROVA0007; ROVA0023 to ROVA0026; ROVA0028; ROVA0031, ROVA0032; and, ROVA0034) represent recent and continuous monitoring efforts that allow an interpretation of water quality conditions for Roosevelt-Vanderbilt national historic sites. These stations represent the current water quality monitoring program initiated by Roosevelt-Vanderbilt national historic sites in 1994.

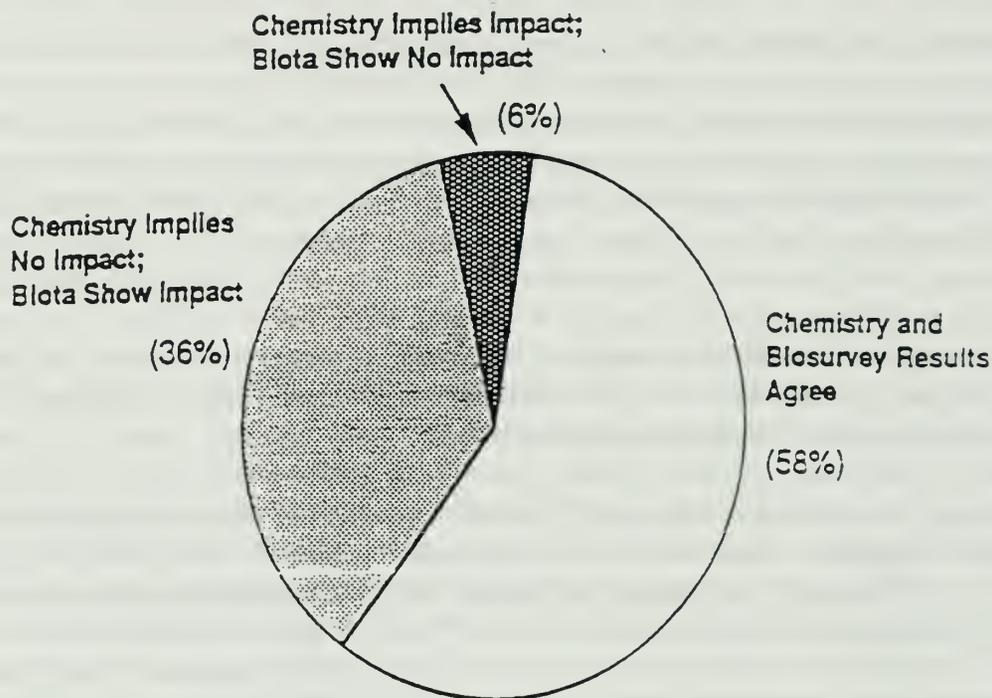
Figure 10. Comparison of impact assessment for instream chemistry and biological surveys when conducted at the same locations (modified from Ohio Environmental Protection Agency 1988).
