Metals in America's Historic Buildings

Uses and Preservation Treatments

U.S. Department of the Interior
National Park Service
Cultural Resources
Preservation Assistance
Washington, D.C.
1992

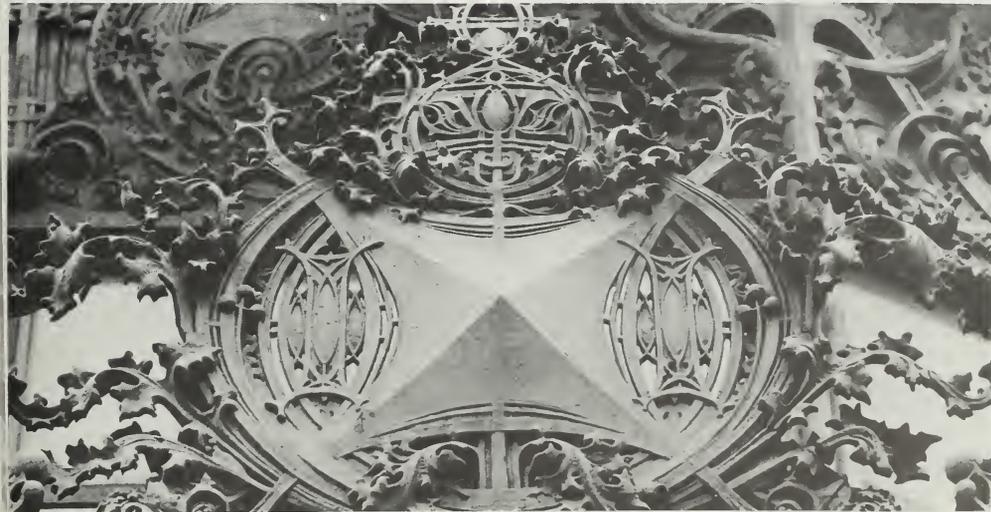
Figure 1. Cast-iron Ornamentation, Carson Pirie Scott and Company Store, Madison and State streets, Chicago, Illinois, 1899-1906; Louis H. Sullivan, architect; Winslow Brothers, foundry. The two lower floors of this building are embellished by Sullivan's extraordinarily complex designs executed in cast iron which enframe the windows and curved corner entrance. Cast iron was used in every conceivable form in the 19th century; it was the utilitarian metal. Cast-iron columns, storefronts, whole building facades, and stairs appeared, as did cast-iron doors, windows, clocks, fountains, and furniture. What could not be made of cast iron was made of wrought iron or steel. Beams were made of wrought iron or steel, and metal ceilings and roofs were made of sheet iron or steel. Often ironworkers combined cast iron and wrought iron in a design, using each metal for the elements for which it was best suited. (Becket Logan)

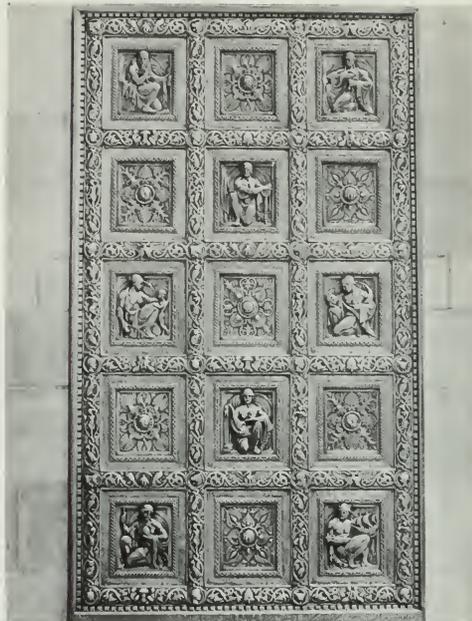
Figure 2. Bronze Entrance Door, Bowery Savings Bank, 110 East 42nd Street, New York City, 1923; York and Sawyer, architects; William H. Jackson, foundry. Cast in the boom era after World War I, this main entrance door reflects the aura of success and stability bank officials sought. The color of polished bronze probably accounts for its use as much as its permanence and molding qualities. This is a good example of a building in which art, architecture, and sculpture were combined in an overall concept down to the smallest detail. (Courtesy of the Bowery Savings Bank)

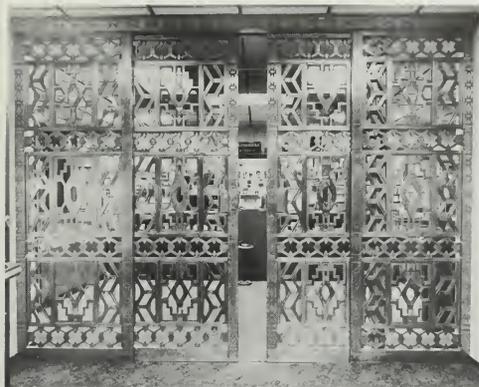
Figure 3. Monel Metal Gates, National Bank of Commerce (Guardian Building), 500 Griswald Street, Detroit, Michigan, 1929; Smith, Hinchman, and Grylls, architects; Gorham Co., foundry. These geometric Art Deco style gates are fabricated from a nickel-copper alloy developed in the 20th century. Monel metal combined hardness and durability and was used for roofs and plumbing as well as decorative details in the 1920s and 1930s. It was one of the so called "white metals" popular during that period. The scarcity of nickel during World War II accounts for its decline. In the 1950s, stainless steel, which is less expensive, supplanted Monel metal. (Alan Stross)

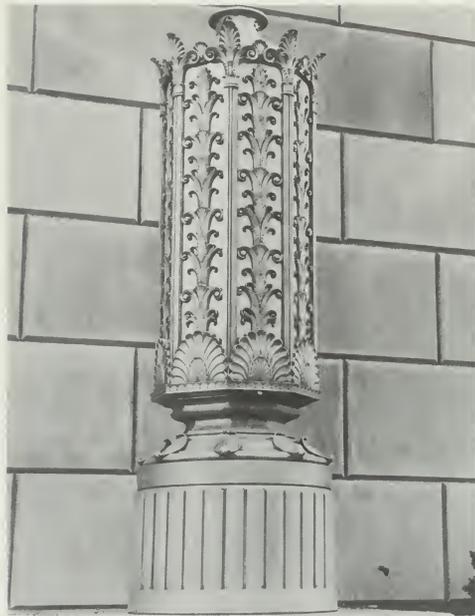
Figure 4. Aluminum Lamp, U.S. Custom House, Chestnut, Second, and Third streets, Philadelphia, Pennsylvania, 1933; Ritter and Shay, architects; Edward Ardolino, sculptor. Aluminum was first refined from bauxite in the 19th century and was considered a rare metal. Its light weight and corrosion resistance were recognized as qualities appropriate for a variety of uses, but many years passed before sufficient quantities were produced at a reasonable cost. By the 1930s aluminum was in wide use for exterior, weather-resistant architectural elements as well as interior decorative details. (Esther Mipaas)

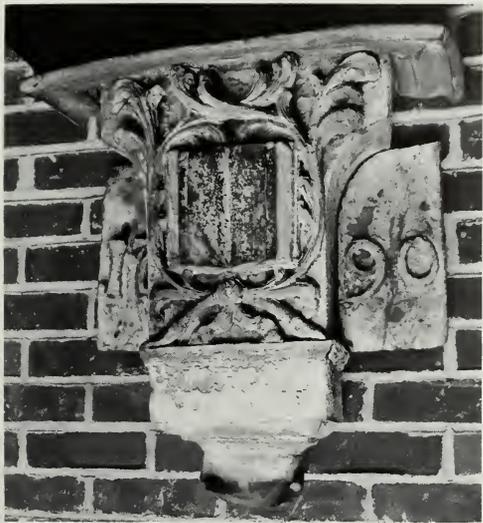
Figure 5. Lead Rain Conductor Head, Library Hall, Philadelphia, Pennsylvania, 1789–1790; from designs of Dr. William Thornton. When the library was razed in 1884, this conductor head was saved and became part of the collection of the Library Company of Philadelphia. Many early rain conductor heads were constructed of lead, and frequently included date flanges, as seen here. However, this is the only known example of a lead conductor head with an “open book” motif. (Jack E. Boucher)

By the time of the American Revolution, large quantities of imported lead were used for flashings, gutters, conductor heads, and downspouts on public buildings and the homes of wealthy people. During the Revolution, many of these leaden architectural elements were removed and melted to make shot for the war effort. In Philadelphia, preserved inventories of these donations give documentary evidence to the extent of the use of lead, especially for rain conductor heads and downspouts (figure 5).

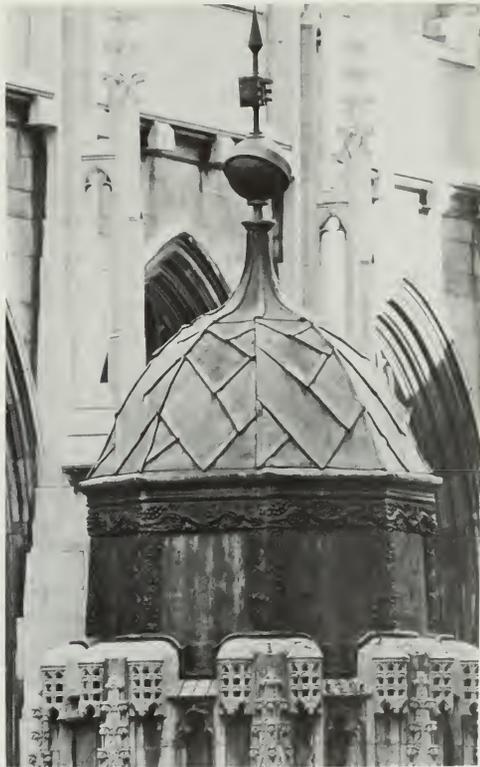
Figure 6. Lead Roofing, Saint Thomas Church, Fifth Avenue and 53rd Street, New York City, 1909–1914; Cram, Goodhue, and Ferguson, architects; Henry Hope and Sons, lead craftsman. Ralph Adams Cram designed St. Thomas Church using the spirit and many of the techniques of medieval builders, including the use of small overlapping sheets of lead for roofing curved surfaces. The decorative grapevine frieze and panel borders, also of lead, show the versatility of this material, which can be cast with sharp detail. (Becket Logan)

American architects sometimes specified lead finials, crockets, cresting, spires, or turrets for 19th- or early-20th-century Romanesque or Gothic Revival churches, municipal buildings, or university buildings. A fine example is the small, rounded turret with its ball finial on the 53rd Street side of St. Thomas Church in New York City (figure 6).

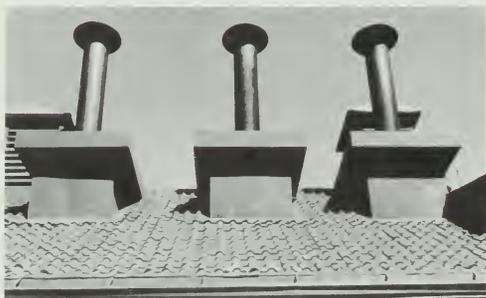
Figure 7. Terneplate Pantiles, Union Depot, foot of NW Sixth Avenue, Portland, Oregon, 1892-1894; Van Brunt and Howe, architects. The pantiles are identical to the 1895 "Spanish Tile" advertised by Merchant and Company of Philadelphia and painted a terra-cotta color to imitate a real clay tile roof. (John G. Waite)

Figure 12. Sheet Metal Pantiles. These pantiles, to look like terra-cotta tiles, could be installed one at a time or in clusters of six. A roof with these pantiles needed a pitch of at least 3 inches per foot. The special eaves course plates shown here had decorated edges. The pantiles were available in 1905 in painted or galvanized steel or copper. These are similar to the pantiles on Union Depot, Portland, Oregon (see figure 7). (Library of Congress)

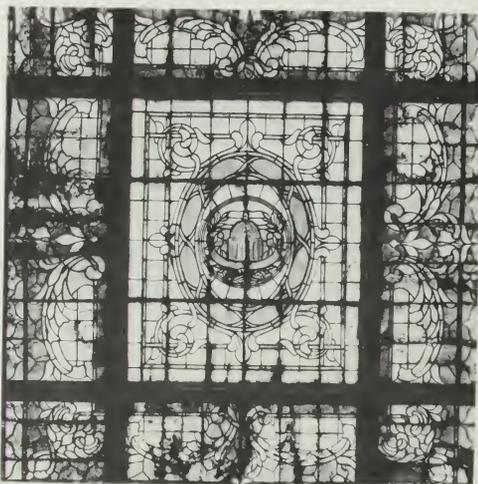
Figure 8. Leaded Glass Skylight, Capital Hotel, 117 West Markham Street, Little Rock, Arkansas, 1873. Lead has long been used to join pieces of glass into windows utilizing lead "cames", which are H-shaped sections grooved to fit glass into the top and bottom channels with soldered joints. (Earl Saunder)

The skillful application of lead and glass in doorway fanlights and sidelights appeared in some late Georgian and many Federal houses. Later, during the Victorian era, stained-glass windows, doors, and decorative skylights became fashionable for public buildings and residences as well as for churches. The stained-glass skylight in the Capital Hotel in Little Rock, Arkansas, is a good example of this (figure 8).

Figure 125. Lead Came Damage. *One of the most common uses of lead is the comes in stained glass windows, transoms, and skylights (see figure 8). Although lead comes are sometimes damaged by corrosion, especially where rain or condensation might collect at the bottom border came (a very slow process), they usually are damaged by creep and fatigue. The weight of the lead and glass in the entrance transom pictured above has caused the comes to creep, resulting in a noticeable sag and outward bulge. This transom did not have iron support bars found on many stained glass windows. The bars (sometimes called saddle bars) were usually set into the frame and attached to the lead comes with copper wires. Transoms are adversely affected by the vibrations of slammed doors and the outward force of compressed air in a vestibule. To complicate things further, the difference in the expansion and contraction coefficients of the lead comes and lead-tin solder has resulted in fatigue cracking, usually at joints.* (H. Weber Wilson)

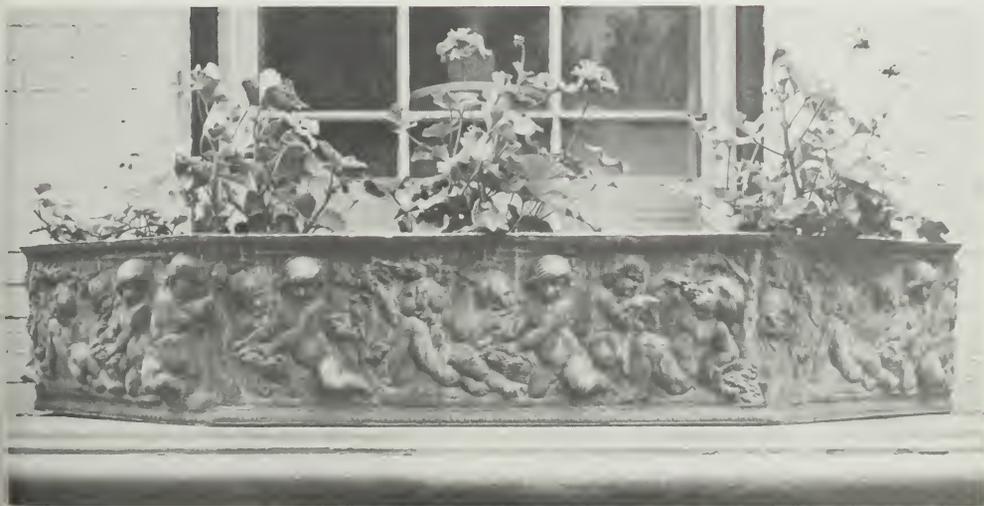
Figure 9. Lead Flowerbox, Adrian van Sinderen House, 70 Willow Street, Brooklyn, New York, ca. 1839. This is one of three large lead flowerboxes, supported by huge cast-iron brackets, which were added later in the 19th century to the facade of this Greek Revival house. The brackets were painted with sanded paint to look like brownstone. (David W. Look)

Unfortunately, lead is so soft that statuary, fonts, and fountains cannot be very large, because without support the cantilevered parts may sag and become distorted. Lead sculptures and landscape accessories were popular in the 19th and early 20th centuries (figure 9), and are still produced in traditional and contemporary designs.

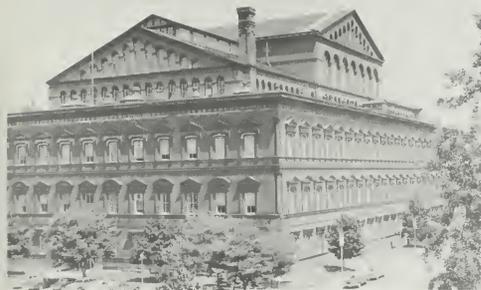
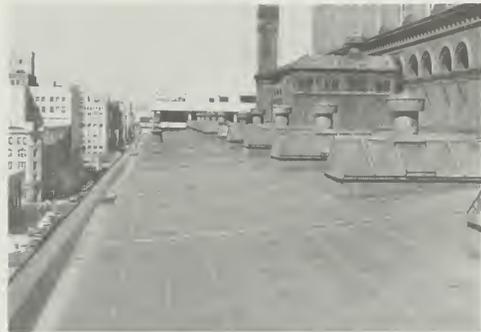
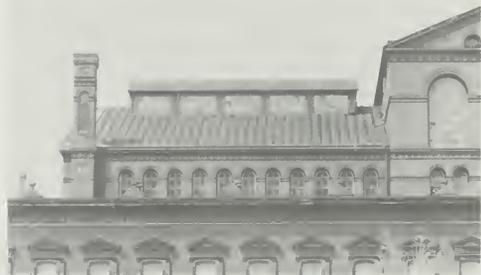
Figure 10. "Tinplate" Roofing, Old Pension Building, Fifth and G Streets, NW, Washington, DC, 1883; Montgomery C. Meigs, engineer. (a) The building consists of offices around the perimeter of a large court. The roof over the offices has a very low pitch and is covered with flat-seam tinplate, while the steep-pitched roofs over the court have batten tinplate roofs. (b) Flat seam tinplate roofing was used on low-pitched roofs because the edges of the plates could be interlocked and soldered together to provide a continuous waterproof covering. Stamped on each plate of the Pension Building roof is "Holkingshee Forge Best Roofing, 40 lbs., Manion Process License." The metal is actually terneplate. Surviving examples of true tinplate iron or steel are rare. (c) The batten tinplate roofs over the central court were typical of steep-pitched roofing of tin and other materials. They can be seen at a distance and provide a strong design element to the building. (David W. Look)

For the first third of the 19th century, tinned iron roofs were constructed from plates measuring a standard 10 inches by approximately 14 inches. In the 1830s, plates 20 inches by 14 inches became available. Most early tinplate roofs had flat seams and were soldered together to produce a continuous waterproof covering. These were used on both low-pitched roofs and steeper roofs. (figure 10a and b). Standing seam tinplate roofs did not come into common use until the Civil War era. Tinplates were soldered together with flat seams to form long strips, which were joined to other strips by standing seams. The pattern of the dominant standing seams gave the typical vertical pattern to these roofs. Standing seam roofs were not used on flat or on very low-pitched roofs where water might collect, since standing seam roofs are not watertight (figure 10c).

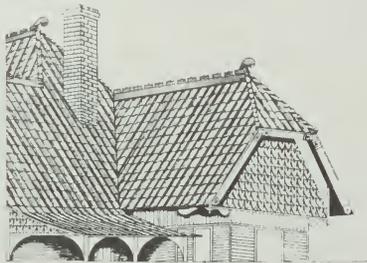
Showing Complete Roof.

"Saint Paul" Metal tiles are suitable for any building—stone, brick or frame, where the pitch is more than 3 inches to a foot. For a roof to be satisfactory, it must at all times be absolutely weather-proof. "Saint Paul" tiles affords perfect protection against rain, snow, hail or sleet.

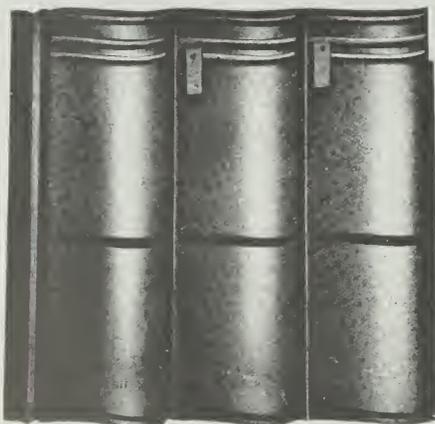
CLUSTER.

No. 6 Cluster—Covering size $17\frac{1}{2} \times 19$ inches; 44 pieces to the square.

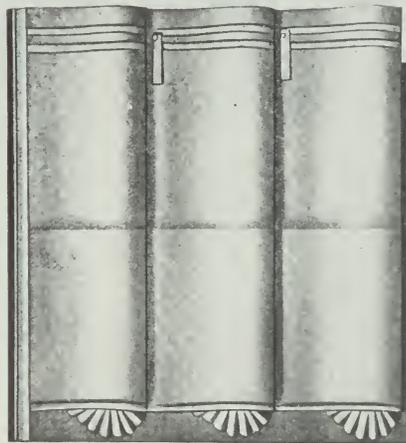
EAVES COURSE PLATE.

No. 7—This shows our "Saint Paul" eaves course plate or starter, used along the eaves for the first course of No. 6 metal tile. When ordering style No. 6, specify how many lineal feet of No. 7 you require. Covering size 19 inches wide by 20 inches long.

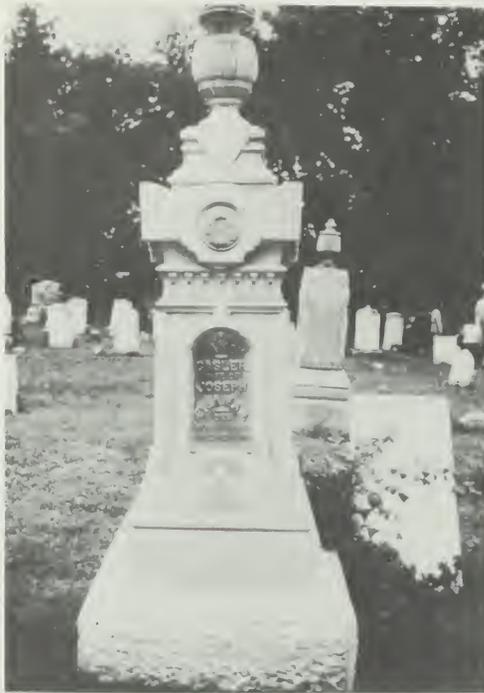
Figure 14. Zinc Grave Marker, Herkimer, New York, ca.1874; Monumental Bronze Co., Bridgeport, Connecticut. The manufacturer's name is discreetly recorded in small letters along the edge of the plinth. This company's 1882 catalog used the phrase "pure cast zinc" while insisting that "unlike commercial zinc ours is a pure metal, like gold or silver." The embossed epitaph is still crisp and new looking. In some respects the zinc monuments have survived in better condition than their stone counterparts. These light gray markers were cast in many sections, sandblasted to produce a rough stone-like surface, then bolted together with the connections disguised. (Margot Gayle)

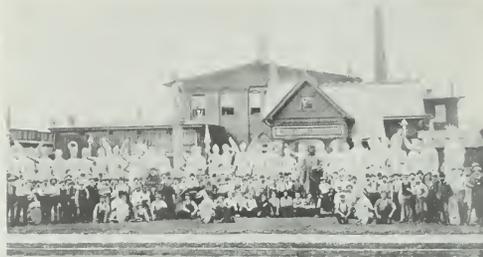
Figure 15. Zinc Statues, Art and Architectural Metal Work Catalogue, W. H. Mullins, Salem, Ohio, 1896. Many of the statues of Freedom, Liberty, Justice, and the Muses that grace the tops of domes and cupolas were pressed in zinc and painted to match the stone of the courthouses, city halls, libraries, or other public or private monumental buildings on which they stood. A prime producer of these statues was W. H. Mullins whose employees posed for this group photograph with some 52 figures ready for shipment to the Cotton States and International Exposition in Atlanta, Georgia. In the foreground, note the four griffins, which are identical to those on the Waterworks in Peoria, Illinois. (Library of Congress)

Zinc statues adorn many city halls, county courthouses, and post offices. Some may have been custom designed, but many were purchased from zincworks catalogues such as that of W. H. Mullins of Salem, Ohio. During the last quarter of the 19th century, foundries hired artisans and sculptors to model figures in clay and make the molds. Zinc statues were then fabricated from pressed and cast sections, some of enormous size (figure 15). A zinc statue of a fireman holding a rescued child stands on a cast-iron base in both Owego and Middletown, New York.

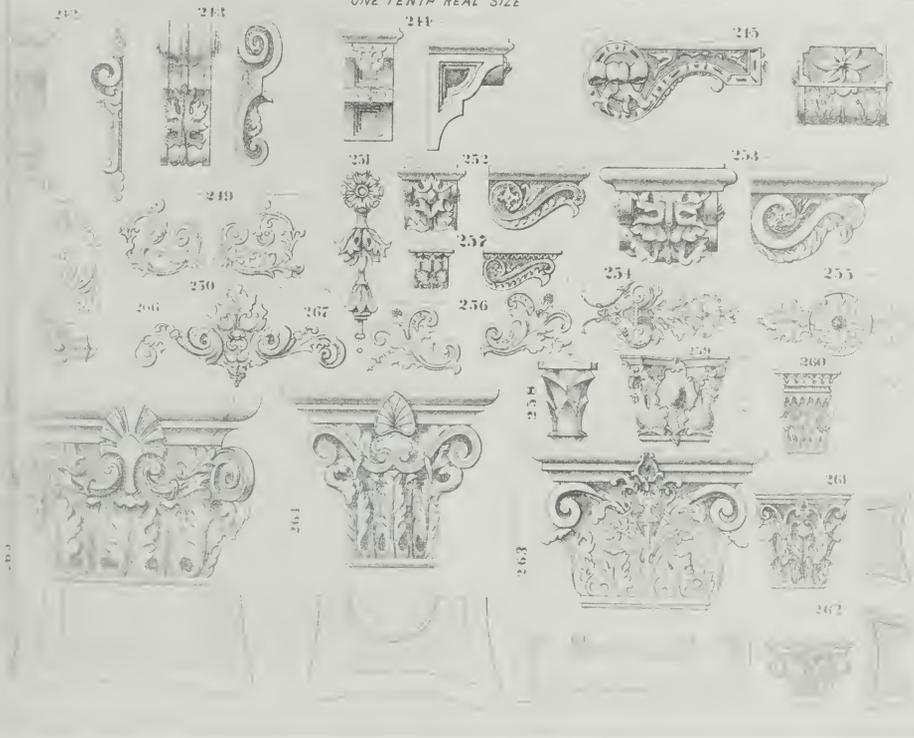
Figure 16. Zinc Brackets, Scrolls, and Column Capitals, Catalogue of Ornamental Designs in Zinc, Zinc Roofing and Ornamenting Co., Chicago, Illinois, 1871. Although some of these pieces could have been stamped in one piece, most were cast or stamped in sections and applied to a pressed metal support. (Library of Congress)

more expensive metals. Urns, balusters, and letters (for signs) were often cast in zinc. Architectural brackets for cornices and capitals for columns and pilasters were cast in zinc (figure 16).

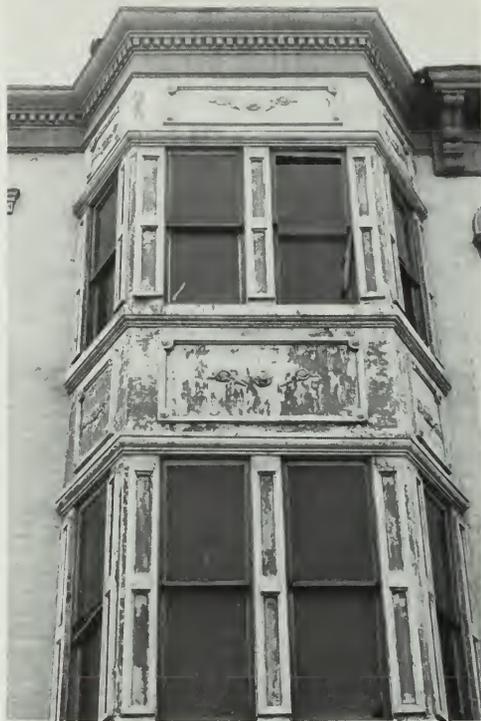
Figure 18. Galvanized Sheet Iron Bay with Applied Zinc Ornament, 608 Indiana Avenue, NW, Washington D.C. When sheet metal work is kept well painted, it is very difficult to identify it as sheet iron or steel, galvanized or tinplated. However, if the metal is not maintained, its composition becomes more obvious. Paint does not adhere well to pure zinc, or to galvanized iron or steel. When the paint peels, it usually comes off completely, including the primer, to reveal a clean metal surface. If the metal is galvanized, it will have a spangled appearance and may show some rust or rust stains from the iron base metal. If it is cast or pressed zinc, it will have a grayish-white appearance. This bay is covered with galvanized sheet iron with pure zinc ornaments on the surface. Even if well painted, a magnet test will reveal what is galvanized iron or steel (which is magnetic) and what is pure zinc (which is non-magnetic). (David W. Look)

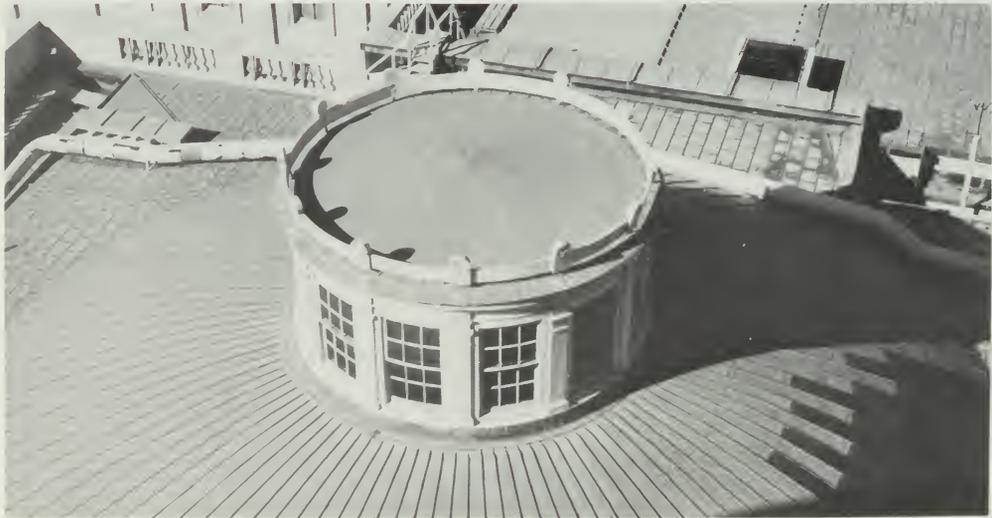
Figure 19. Copper Roof, Old Senate Chamber, United States Capitol, 1819; Benjamin H. Labrobe, architect. After the British burned the Capitol in 1814, the entire structure was rebuilt, including a new copper roof. Little is known about the roofing installed in 1819 since it was removed in 1900. It was probably all flat seams because the machine for forming standing seam roofing was not invented until about the time of the Civil War. When the surfaces were reroofed in 1975, every effort was made to duplicate the 1900 roofing patterns, configuration, and size of sheets. Sheet copper can be shaped to cover many types of curved surfaces. The dome has standing seams while the cupola and the area around the dome, which is flatter, have flat seams. (Charles Parrott)

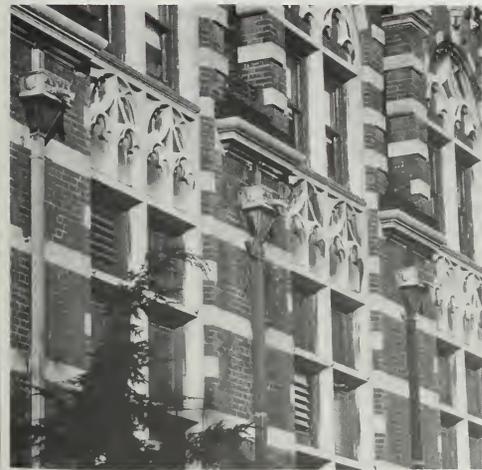
Figure 20. Copper Conductor Heads and Downspouts, former U.S. Post Office, Bounded by Hamilton, Clark, Ward streets and Lee Place, Paterson, New Jersey, 1899; William Martin Aiken, Architect of the Treasury. Rain conductor heads and downspouts are almost always made of metal, in some cases copper. The former post office, now an annex to the Paterson County Court House, includes copper conductor heads and downspouts as part of the rich Flemish architectural design. Twenty of these decorative devices are spaced on all four sides of the banded red brick and stone building. (Jack Stokvis)

Copper was hammered or stamped into decorative details to ornament the cornice lines of many buildings (figure 23), and to sheath oriel and bay windows as well (figure 24). Copper was also fabricated into running moldings, masks, lion heads, rain conductor heads (figure 20), and Greek-inspired anthemions at roof edges.

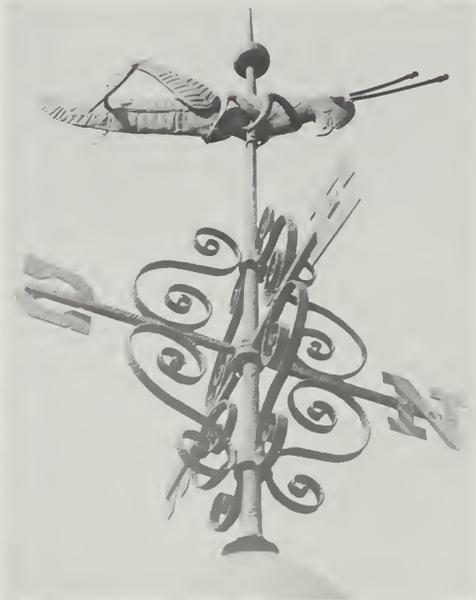
Figure 21. Copper Grasshopper Weather Vane by Shem Drowne, 1742, Faneuil Hall, Dock Square, Boston, Massachusetts. The weather vane is wrought iron except for the grasshopper and the four points of the compass which are copper. The grasshopper, which is gilded and has glass eyes, measures 53 inches long, 6 1/4 inches wide, and weighs 38 pounds. The history of the weather vane is well documented. In 1755 it was damaged by an earthquake; it was later repaired by Thomas Drowne in 1768. On January 11, 1974, the weather vane disappeared only to be found a few days later wrapped in a blanket and hidden in the cupola. The weather vane had been damaged during the attempted theft, but it was repaired and reinstalled on February 15, 1974. (Index of American Design, Mass-Me-230, National Gallery of Art)

The initial cost of copper was traditionally high, but its length of service more than compensated for the price. Because of these high costs, copper in quantity was used only on major structures, mostly public buildings. However, copper in small quantities was widely used on more modest buildings for roof flashings, gutters, and downspouts (figure 20), and decorative elements. Copper was also commonly used for weather vanes and finials (figures 21 and 22). The resistance of

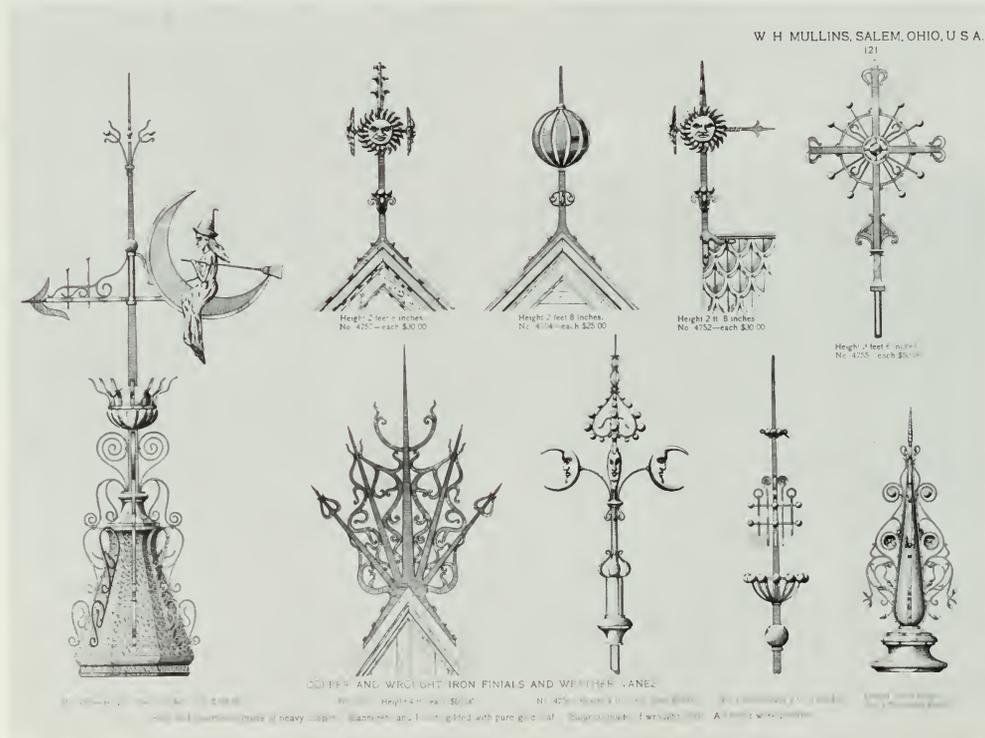
Figure 22. Copper and Wrought-iron Finials and Weather Vanes. The bases and bannerets of the weather vanes were made of heavy copper, with the bannerets and points of the compass sometimes gilded with gold leaf. The rest of the material in these decorative objects was usually wrought iron. In 1896, these unusual designs, as well as the traditional rooster and eagle, were offered in the catalog of W. H. Mullins of Salem, Ohio. (Library of Congress)

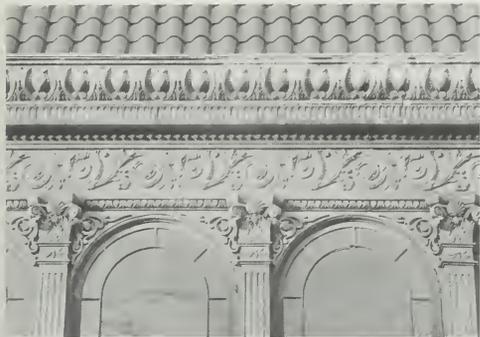
Figure 23. Pressed Copper Sheet Metal Cornice, Frieze, and Pilasters; Conservatory of the Christian Heurich Mansion, 1307 New Hampshire Avenue, NW, Washington, D.C., 1902; Appleton Clark, architect. The copper work was assembled from many pieces of sheet copper pressed with low relief designs. (Jack E. Boucher, NAER)

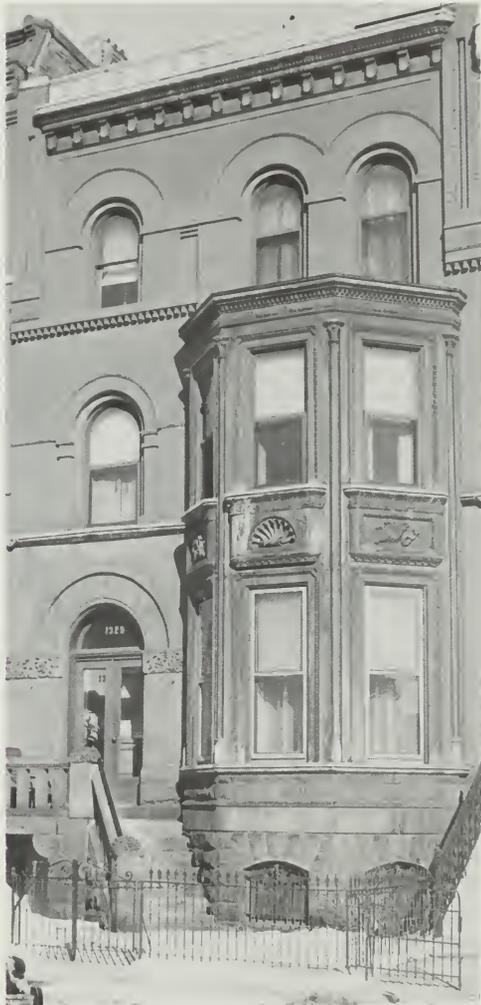
Figure 24. Copper-Clad Bay Window and Cornice, Thomas C. Whyte House, 1329 R Street, NW, Washington, D.C., 1892; George C. Johnson, architect. From the first-floor window sills to the cornice above the second floor, the bay window is sheathed entirely with pressed sheets of copper, and there are slender two-story copper pilasters flanking the windows. The spandrel between the first- and second-floor center windows has a shell design and the side spandrels have winged sea creatures. Both the cornice of the house and the cornice of the bay window have copper classical dentils and modillions. (David W. Look)

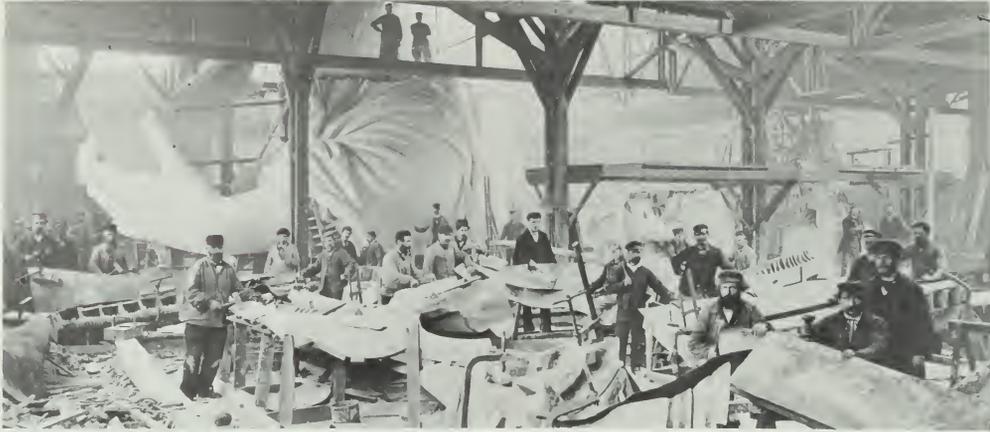
Figure 25. Copper Statue of Liberty, New York City Harbor, 1883–1886; Frederic Auguste Bartholdi, sculptor; Alexandre Gustave Eiffel, engineer. *This photograph was taken in the metal shop in France where the sheet copper was fabricated. In the foreground, sheet metal workers are hammering the copper over wooden forms. The temporarily assembled arm and shoulder in the background, were later disassembled and shipped to the United States. Eiffel, who later designed the 984-foot Eiffel Tower of the Paris Exhibition of 1889, engineered the steel armature to support the statue built to the design of Bartholdi. (Rare Book Division, New York Public Library; Astor, Lenox and Tilden foundations)*

Occasionally, statues used as architectural ornaments were made of copper. Sections of sheet copper can be hammered over wooden or other forms to create statues. Once the copper sheets have taken the shape of the form, they are removed and soldered together over a wooden or metal framework. The most famous example of this type of statue is the Statue of Liberty, which consists of copper sheathing over a steel framework. The 152-foot-tall statue, erected in New York Harbor, was a centennial gift from France (figure 25).

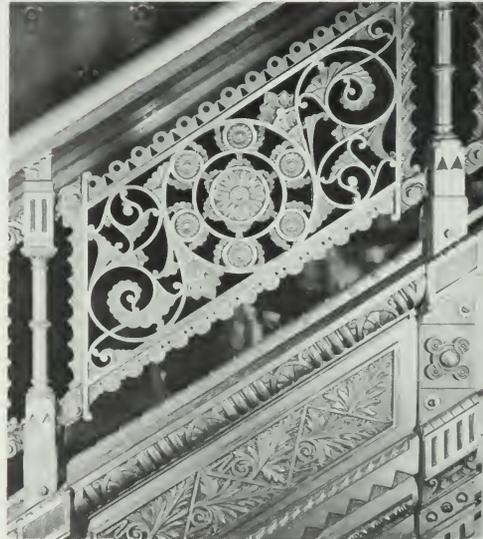
Figure 26. Copper-Plated Cast-iron Stair Railing, Christian Heurich Mansion, 1307 New Hampshire Avenue, NW, Washington, D.C., 1892–1894; John Granville Meyers, architect. *This iron railing was sand cast in many pieces, and the flat areas of the design were ground smooth before the pieces were copper plated. Most of the parts were bolted together, but a few pieces of the newell post were brazed. The railing has a brass hand rail. (Jack E. Boucher, NAER)*

The color of antique copper, which is a little more orange than new bronze, was much admired in the late 19th century. Victorian cast-iron hardware was sometimes copper-plated, although brass-plated hardware was more common. Cast-iron stair railings and newel posts (figure 26) were sometimes copper plated. An excellent example is the copper-plated cast-iron staircase, designed by Louis Sullivan in 1894, that was saved from the demolished Chicago Stock Exchange and has been re-erected in the American Wing of New York's Metropolitan Museum.

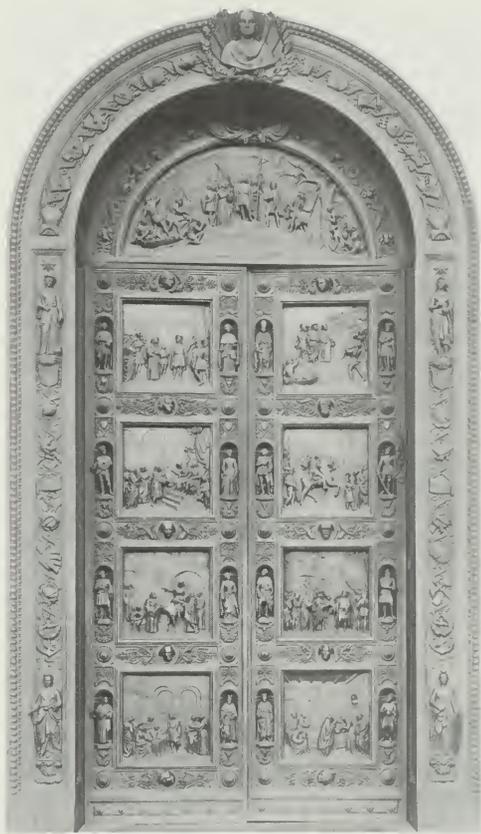
Figure 27. Bronze "Columbus Doors," Rotunda of the U.S. Capitol, Designed by Randolph Rogers, 1858, installed 1863; Royal Bavarian Foundry, Munich, Germany. Shortly after Thomas Crawford received his commission for the Senate doors in 1855, Randolph Rogers was commissioned to design the doors of the Rotunda. He proposed scenes based on the life of Columbus. Although Rogers was an American, he modeled the doors in his studio in Rome, sent photographs to America for approval, and had the doors cast in Munich in 1861. These doors were shipped to America and installed on the House side of the Rotunda in 1863, before Crawford's doors for the Senate were finished. Rogers' doors were later moved in 1871 to the main entrance of the Rotunda. (Courtesy of the Architect of the Capitol)

The first bronze doors installed in America were the "Columbus Doors" by Randolph Rogers at the U.S. Capitol, (figure 27), which were cast in Germany. The doors of the new Senate wing of the Capitol were the first bronze doors both commissioned and cast in America. Thomas Crawford received the commission for these in 1855. He had completed the plaster cast of one

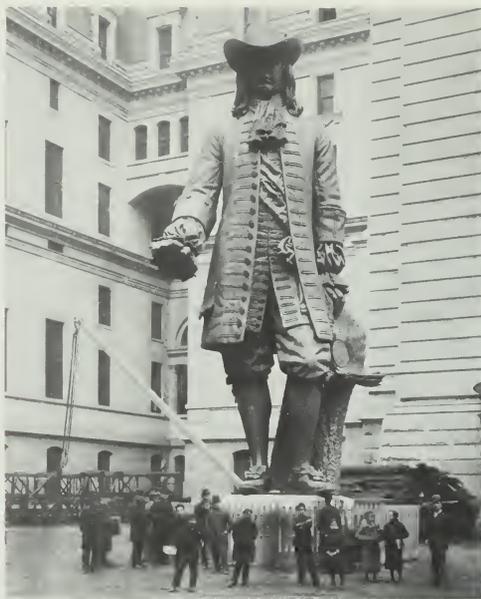
Figure 28. Bronze Statue of William Penn, City Hall, Philadelphia, Pennsylvania, 1886-1894; Tacony Iron and Metal Works, Philadelphia. Bronze was chosen by sculptor Alexander Milne Calder, the grandfather of the 20th-century sculptor, for his monumental statue of William Penn, founder of Philadelphia and the colony of Pennsylvania. When Calder had completed the clay sections, his assistants executed a huge plaster model. However, the model stood idly in City Hall for a year and a half because there was no foundry in the United States capable of casting the statue, which would be the largest cast bronze statue in the world at that time. By 1889, the newly founded Tacony Iron and Metal Works was able to handle the project. On November 6, 1892, the completed statue, measuring 36 feet 4 inches tall and weighing 27 tons, was erected in the courtyard of the City Hall for public viewing while the iron clock tower was completed. Two years later, the statue was hoisted in sections to the top of the tower. (Historic photograph courtesy of George Eisenman)

From 1870 to 1940, many public buildings included the integrated expressions of sculptors and architects working together, often using bronze as well as other costly materials. The City Hall of Philadelphia, designed by architect John McArthur in the Second Empire style, is a good example. Alexander Milne Calder and his staff modeled hundreds of pieces of sculpture for the building, ranging from architectural details such as carved pilaster capitals, to the gigantic bronze statue of William Penn (figure 28).

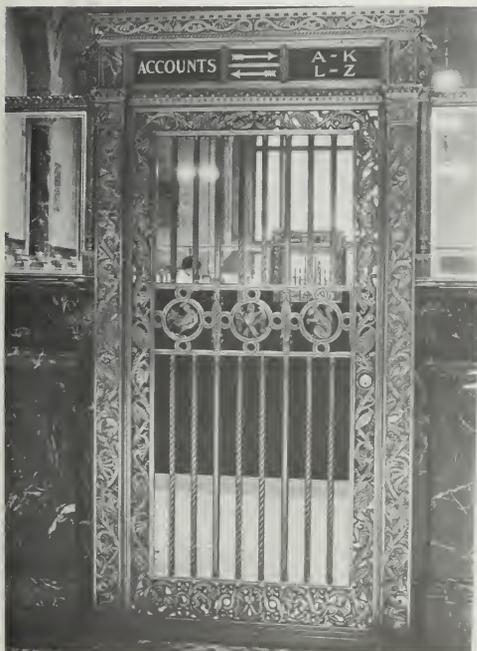
Figure 30. Bronze Teller Cage and Mailbox, Bowery Savings Bank, 110 East 42nd Street, New York City; 1923, York and Sawyer, architects; William H. Jackson Co., foundry. *The Bowery Savings Bank has been relatively unscathed by "modernizing" and is literally filled with bronzework: doors, elevators, check writing desks, window trim, tellers' cages, gates, and even mailboxes. (a) Although the function of tellers' cages was to provide security, they were transformed into decorative features. (b) During the late 19th and early 20th centuries, functional items such as letter boxes were custom designed for each building and integrated into the total design. (Bowery Savings Bank)*

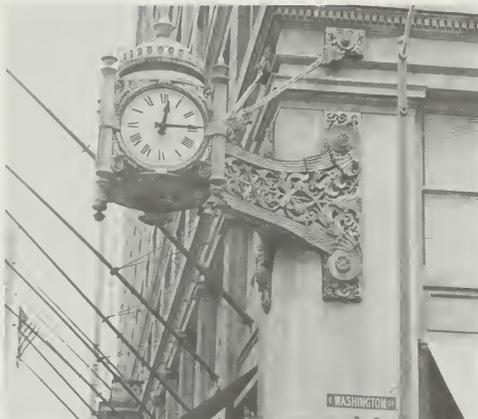
Figure 29. Bronze Clock, Marshall Field and Company Department Store Addition, corner of State and East Washington Streets, Chicago, Illinois, 1907; Graham, Anderson, Probst & White, architects. *This huge bronze clock, weighing 7 3/4 tons and hanging 17 feet above the sidewalk, was designed by Pierce Anderson for the addition to Marshall Field's store. With a 46-inch face and a minute hand measuring 27 inches, the clock and its twin on another corner of the building can be seen for blocks. These magnificent works of art have become part of the city's landscape as a fourth generation of Chicagoans meet "under the clock."* (Margot Gayle)

In the late 19th century, American architects used a great deal of bronze in the detailing and decoration of large neoclassical public buildings and commercial buildings such as Marshall Field and Company Department Store (figure 29). Sculptor Daniel Chester French created the large bronze doors of the Boston Public Library to complement the building's Renaissance Revival design by Charles Follen McKim. Bronze appeared in museums, libraries, university buildings, banks (figure 70), stores, and railroad stations, and other post-Columbian Exposition structures made possible by American affluence.

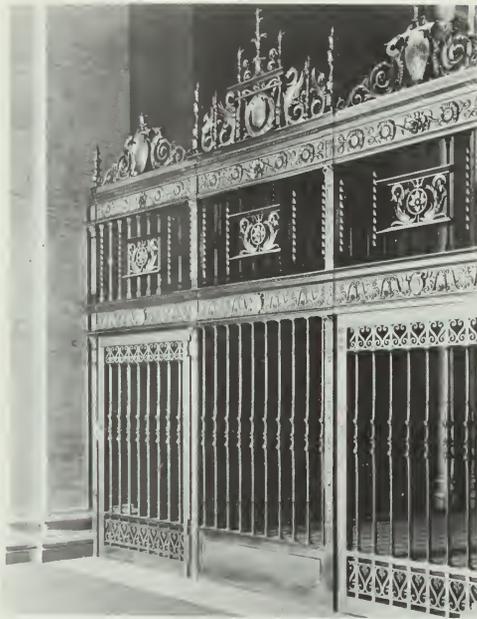
Figure 31. Bronze Screen and Gates, New York Life Insurance Company Building, 51 Madison Avenue, New York City, 1928; Cass Gilbert, architect, William H. Jackson Co., foundry. The bronze gates in the foyer guard the broad stairway to the first basement and subway entrance. (New York Life Archives)

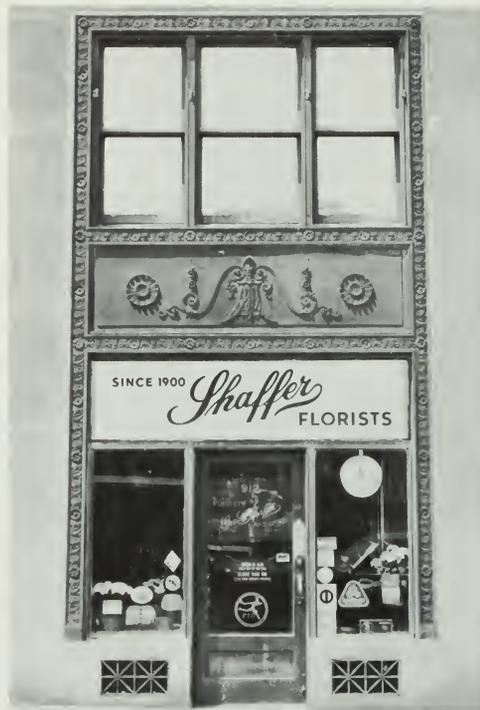
Figure 32. Bronze Storefront, Grilles, Spandrel Panel, and Window, Southern Railway Building, 912 Fifteenth Street, NW, Washington, D.C., 1928; Waddy Butler Wood, architect. This building is typical of many large commercial buildings with extensive use of bronze. Everything from the grilles to the windows and spandrels to the storefronts were fabricated of bronze. Although many storefronts have been remodelled beyond recognition, this one still has its original design and materials. (David W. Look)

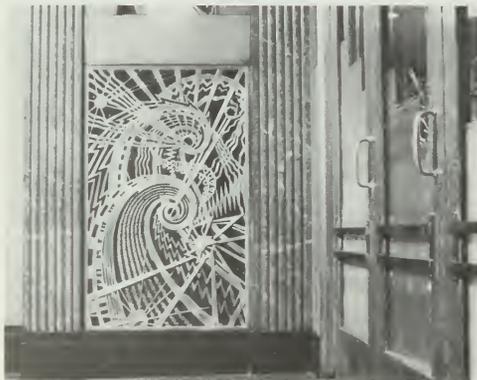
Figure 33. Bronze Ventilation Grille, Chanin Building, 405 Lexington Avenue, New York City, 1929; Sloan and Robertson, architects; lobby design by Jacques Delamarre. The foyer of this Art Deco style building contains four highly modeled ventilation grilles in an abstract design, in what some designers called the "Futuristic" style. (David W. Look)

& White of Chicago, contains a wealth of Art Deco bronzenwork complemented by polished marble, as do many Art Deco buildings in New York City, including the Chanin Building (figure 33).

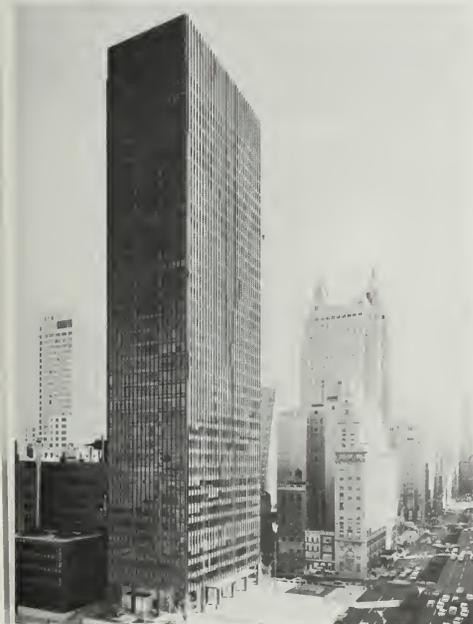
Figure 34. “Bronze” Curtain Wall, Seagram Building, 375 Park Avenue, New York City, 1958; Ludwig Mies Van der Rohe, architect. The curtain wall consists of 4 1/2- by 6-inch extruded architectural “bronze” (really brass: 57% copper, 3% lead, and 40% zinc) I-beam mullions (2 1/2 inches larger than the largest bronze sections extruded to that time), Muntz metal spandrels (brass also: 60% copper and 40% zinc), and pink-gray, heat- and glare-resistant glass in story-high architectural bronze frames. The 26-foot-long architectural bronze I-beams were extruded rather than built up with welded plates to avoid waviness in the sections. The architectural bronze, which only resembles real bronze with a statuary brown patina in color, is regularly rubbed with oil to prevent the bronze from forming a natural green patina. (Ezra Stoller)

Bronze is still used for doors and windows, frames, railings, elevators, escalators, lamps, and hardware. Today, commercial “bronze” and architectural “bronze” contain zinc rather than tin; these materials are actually brasses but are marketed as bronze because bronze is generally considered a more prestigious metal. One example of this is the “bronze” clad Seagram Building (figure 34) in New York City by Mies Van der Rohe.

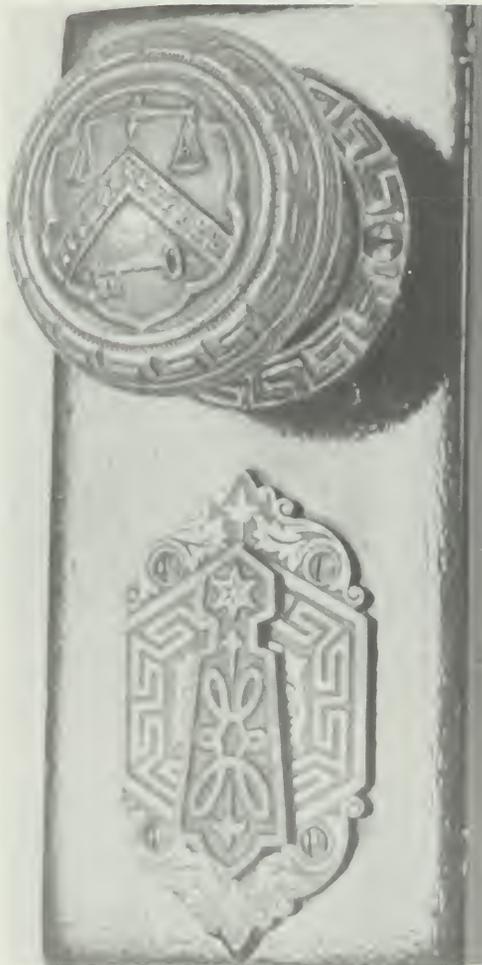
Figure 35. Brass Doorknob and Escutcheon Plate, Old United States Mint, San Francisco, California, 1869-1874; Alfred B. Mullet, architect of the Treasury. Throughout most of the 19th and into the early 20th centuries, hardware was often specially designed for significant public and some private buildings. This doorknob displays the seal of the U.S. Treasury and reflects the tastes and styles of the time by combining classical and Victorian motifs on the escutcheon plate and keyhole cover. (General Services Administration)

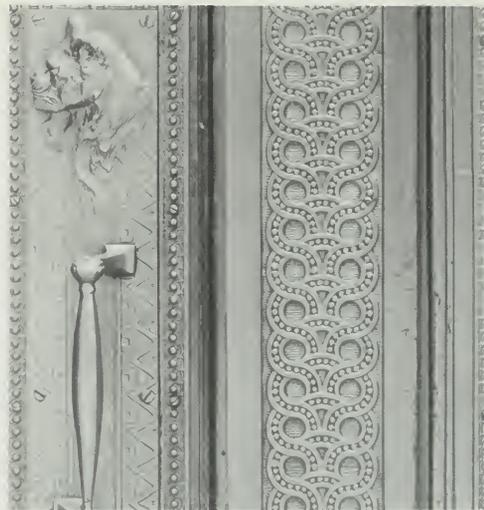
Figure 36. Brass Puma Pushplate, Door and Surround, Marquette Building, 140 Dearborn Street, Chicago, Illinois, 1893-1894; Holabird and Roche, architects; Edward Kemeys, sculptor. The entrances and lobbies of early skyscrapers were not only finished in high-quality materials, but also were sometimes decorated by well-known artists and sculptors who were commissioned to design individual elements and details. Kemeys, who created animal sculptures for the 1893 Columbian Exposition in Chicago including the lions in front of the Art Institute on Michigan Avenue, sculpted the puma heads for the pushplates on the doors leading into the Dearborn Street lobby. (Barbara Crane, Courtesy of the Commission on Chicago Historical and Architectural Landmarks)

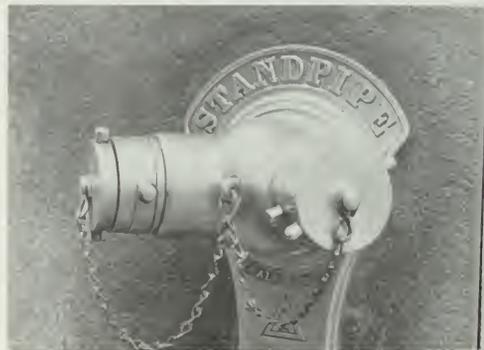
Figure 37. Brass Siamese Standpipe Connection, Rookery Building, 209 South LaSalle Street, Chicago, Illinois, 1886; Burrham and Root, architects; W. D. Allen, manufacturers. Brass fittings can be functional and very attractive when kept well polished. Even though the natural weathered dark patina on brass is protective, it is generally considered to be unsightly and great effort is expended to recapture the metallic gleam. (Margot Gayle)

In colonial America, public buildings and fine homes often had brass hinges, door knobs, door knockers, chandeliers, and fireplace andirons; however, almost all of the brass hardware was imported from England until after the Civil War. In the Victorian era in England and America, brass was used for light fixtures, plumbing fixtures, and every type of builder’s hardware. Although much of the hardware (figures 35 and 36) was solid brass, some was cast iron plated with brass. Even such mundane fixtures as siamese connections were crafted from brass (figure 37).

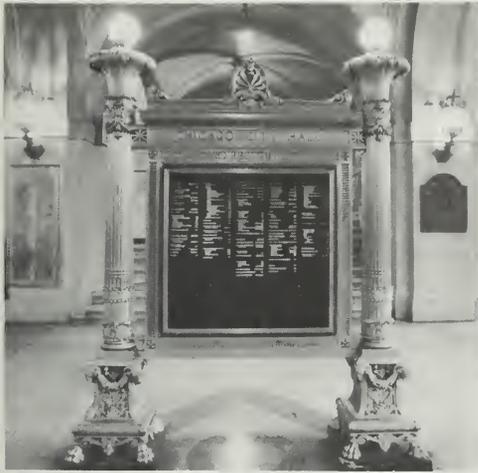
Figure 38. Brass Lobby Directory, City Hall and County Building, Chicago, Illinois, 1911; Holabird and Roche, architects. A dual purpose lobby directory and light standard, this piece of brass lobby "furniture" displays the capacity of brass to take the most opulent and ornamental cast shapes. This design is in keeping with the elaborate style of many neoclassical buildings erected in the early years of this century. (Office of the Mayor, City of Chicago)

The Commercial Style buildings that appeared with the increase of commerce and manufacturing in the late 19th century brought new uses of brass and other metals. The great architects of office buildings and early skyscrapers, such as Burnham and Root and Adler and Sullivan, used large quantities of brass to enhance the appearances of theaters, company headquarters, banks, and stores. Corporations and municipalities commissioned craftsmen and architects to beautify their structures; polished brass was a favorite for handrails on stair railings and in elevators, lobby furniture, bulletin boards, lobby mailboxes, name plaques, and building directories (figure 38).

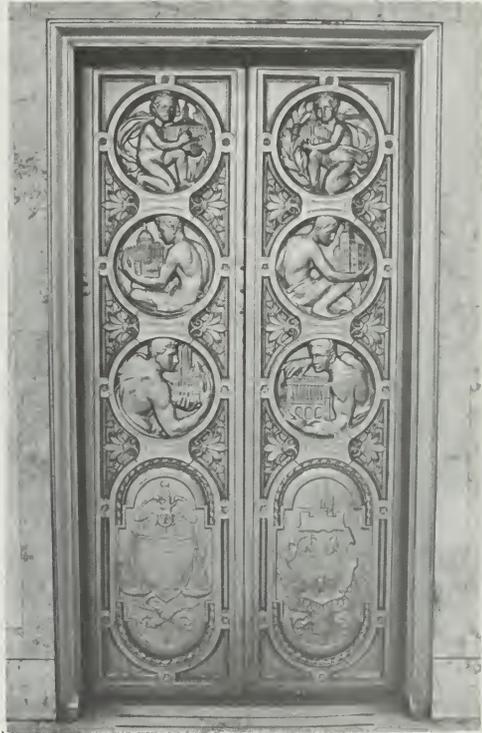
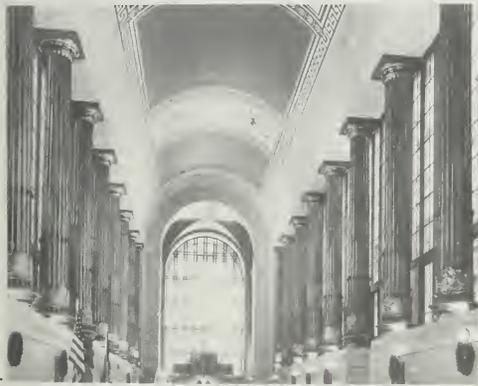
Figure 39. Brass Elevator Doors and Brass-Sheathed Columns, City-County Building, Pittsburgh, Pennsylvania, 1915–1917; Palmer, Hornbostel and Jones, architects; Edward B. Lee, associate architect; Tiffany and Co., designers (for columns only). (a) Brass was used extensively for interior decorative features in 19th- and 20th-century buildings, and was especially popular for statuary, large-scale furniture, and elevator doors in government and office buildings. This set of highly modelled brass doors tells the story of Pittsburgh's development as reflected in its important buildings. (b) The large structural steel columns that support the barrel vault of the lobby are sheathed in brass—an unusual choice of material for columns. Over the years the fluted shafts and stylized capitals had acquired a dull, dark patina, but when the lobby was restored in 1972, the columns were polished and lacquered to return them to their original appearance. (Pittsburgh History and Landmarks Foundation)

As the Beaux Arts and Neoclassical styles became popular in the early 20th century, apartment buildings, hotels, and government offices were often decorated with brass in the private as well as the public spaces. It was the beauty of brass, its gleam and color, that influenced the choice rather than its more practical quality of resistance to corrosion. The Beaux Arts City-County Building in Pittsburgh (1915-1917) displays a traditional use of brass in its elevator doors, and an innovative and visually powerful use of brass-sheathed columns (figure 39). The Utah State Capitol of the same period (1913-1916) has exterior brass doors (figure 40).

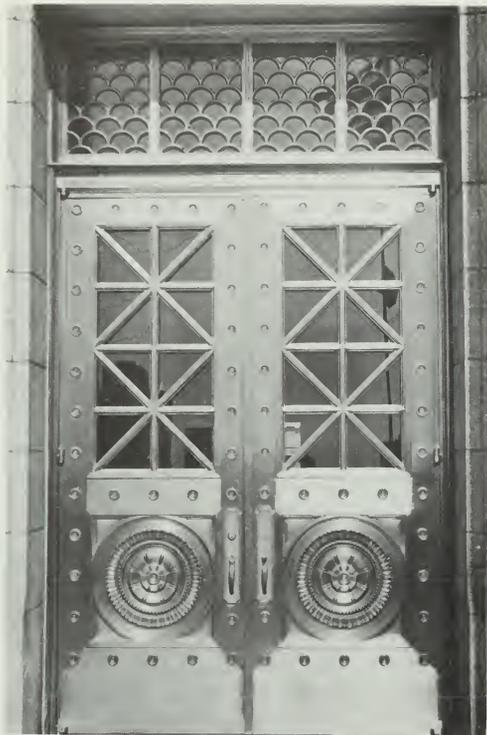
Figure 40. Brass Doors, Utah State Capitol, Salt Lake City, 1913–1916; Richard Kletting, architect. Brass was not used for exterior doors as often as bronze, although many doors that are reportedly bronze may actually be brass. These highly polished exterior brass doors, make a strong architectural statement reinforcing the overall design of the building. Classical motifs include Roman grate windows, circular shields in the lower panels, and a scallop design in the transom. (Margot Gayle)

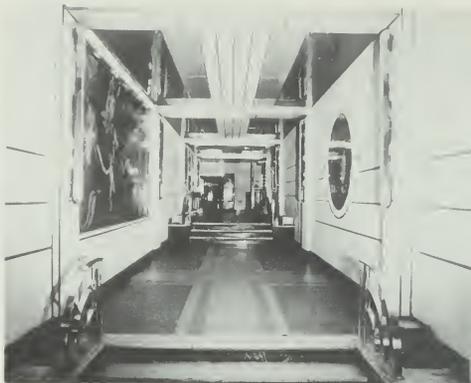
Figure 41. Brass Wall Trim, Edison Hotel, 228 West 47th Street, New York City; 1929–1930, Herbert J. Krapp, architect. Here is a very unconventional use of brass. Thin strips of brass on the walls and ceiling along with mirrors, murals, and chrome-plated railings, all contrast and contribute to the precise composition of this Art Deco interior. (Stan Shaffer)

In the 1920s and 1930s, some architects preferred using white metals (see nickel silver, Monel metal, stainless steel, and aluminum) to accent their designs, but other architects used brass in nontraditional ways to achieve special design effects such as the brass strips on the interior of the Hotel Edison in New York City (figure 41).
