Metals in America's Historic Buildings

Uses and Preservation Treatments

U.S. Department of the Interior
National Park Service
Cultural Resources
Preservation Assistance
Washington, D.C.
1992

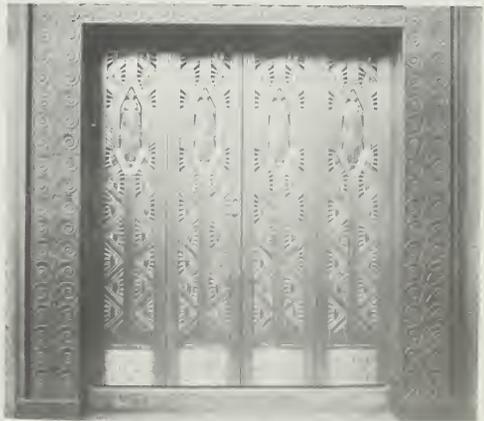
Figure 42. Nickel Silver Doors, Manufacturers Hanover Trust, 481 Seventh Avenue, New York City, 1930; Sugarman and Berger, architects. Cast in yellow nickel silver, the Art Deco style doors on this bank look like brass and are in striking contrast to the bronze door surround and red granite walls. (David W. Look)

properties. The metal was popular for sculpture, decorative panels, plaques, chandeliers, doors, grilles, and railings (figures 42, 43, and 44). The terms *white bronze* and *nickel bronze* were used for cast nickel silver hardware, not necessarily because of the low tin content (2½% to 4%), but because of a cultural preference for the more prestigious bronze.

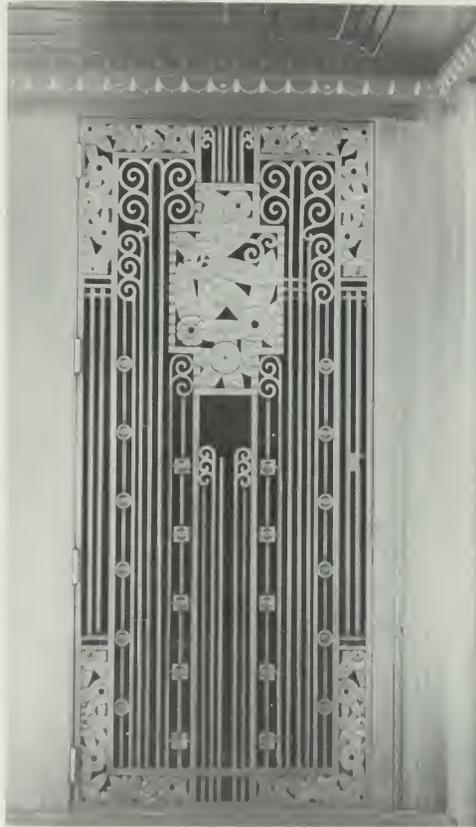
Figure 43. Nickel Silver Art Deco Grille, Chicago Daily News Building (now Riverside Plaza Building), 2 North Riverside Plaza, Chicago, Illinois, 1929; Holabird and Root, architects. Nickel silver, one of the polished "white metals" popular in the Art Moderne movement, now called Art Deco, was used in this building for radiator grilles, elevator doors, directory cases, and stair railings. (Margot Gayle)

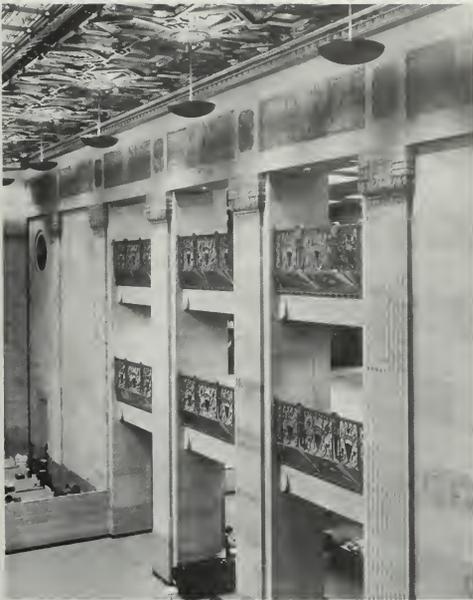
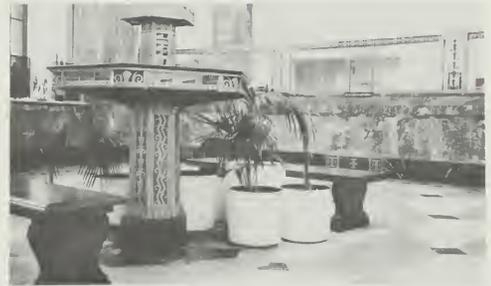
Figure 45. Nickel Silver Check Writing Desk and Teller Cages, City Bank Farmers Trust Company (now First National City Bank), 6 Hanover Street, New York City, 1931; Cross and Cross, architects. To achieve subtle definition and emphasis, architects frequently contrasted materials and colors in Art Deco designs. The nickel silver entrance doors and transom (not shown) of this building are accented with red bronze plaques. The grille of the teller windows (background) also has details in bronze, while the desk (foreground) is monochromatic, using only nickel silver. (David W. Look)

Figure 44. Nickel Silver Railings, Texas Commerce Bank, Gulf Building, Houston, Texas, 1929; Alfred C. Finn, Kenneth Franzenheim, J. E. R. Carpenter, associated architects; Gorham Co., foundry, Providence, Rhode Island. The doors to the banking rooms, elevators, and shops and all radiator grilles were cast by the Gorham foundry, well-known for its fine art metal work. The nickel silver railings in the lobby galleries reflect the enthusiasm for Egyptian designs in Europe and America following the discovery of Tutankhamen's tomb. (Ed Stewart Photography and Associates, Inc., courtesy of Texas Commerce Bank)

In the first National City Bank in New York City, pale yellow nickel silver is contrasted with red bronze (figure 45). Probably the most elaborate set of nickel silver doors were those of the Goelet Building. The tympanum above these doors used the contrasting colors of nickel silver, copper, bronze, and brass (figure 46).

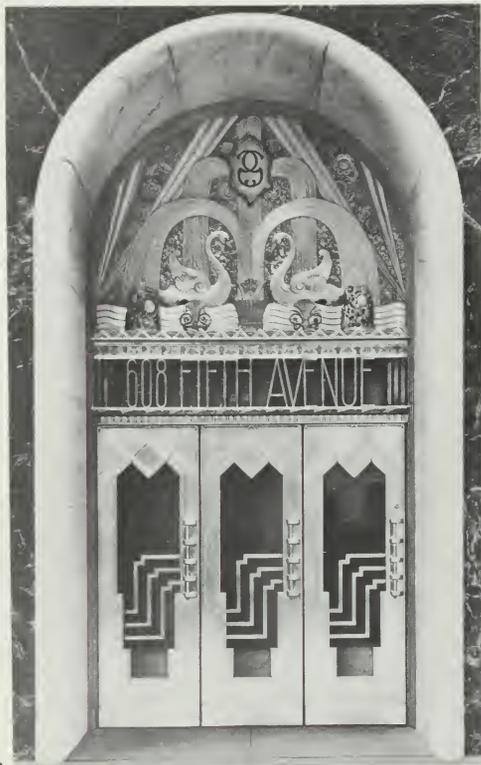
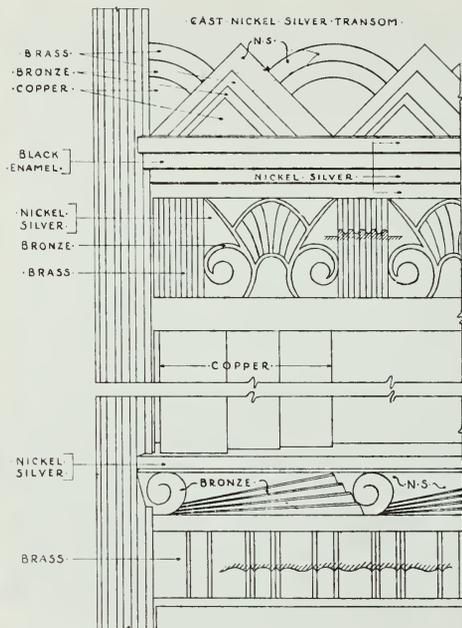
PART ELEVATION OF UPPER AND LOWER TRANSOM BARS.

Figure 46. Nickel Silver Doors and Tympanum, Goelet Building, New York City, 1932; E. H. Faile, architect; General Bronze Corp., foundry, Long Island, New York. (a) This Art Deco-style entrance features silvery-yellow geometric doors which are almost overshadowed by the exuberant swan and fountain design in the tympanum with its array of colorful shapes. (b) The effect was achieved with a combination of copper, bronze, brass, nickel silver, and black enamel as indicated on the original drawing. When the first-floor facade was remodeled in 1966, the doors were removed and stored; the tympanum was taken to Newport, Rhode Island, to be reinstalled in a private club. (International Nickel Company)

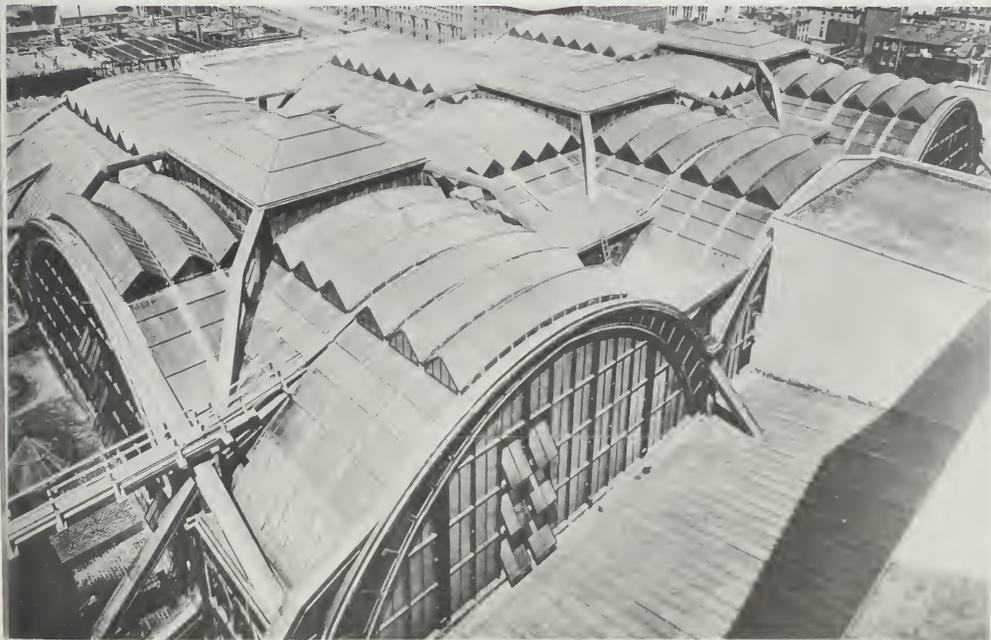
Figure 47. Monel Roof, Pennsylvania Railroad Terminal, New York City, 1907-1910; McKim, Mead and White, architects; International Nickel Company. The first architectural use of Monel metal was the sheet roofing of the Pennsylvania Station, which was completed in 1909. When the station was demolished in 1965, the Monel roof was in excellent condition, having needed no major repairs since its installation. (International Nickel Company)

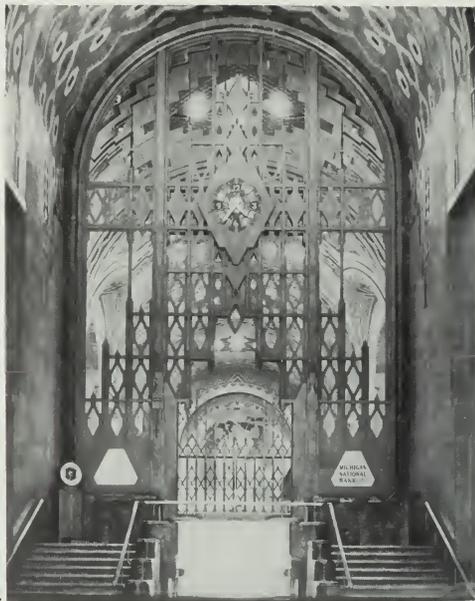
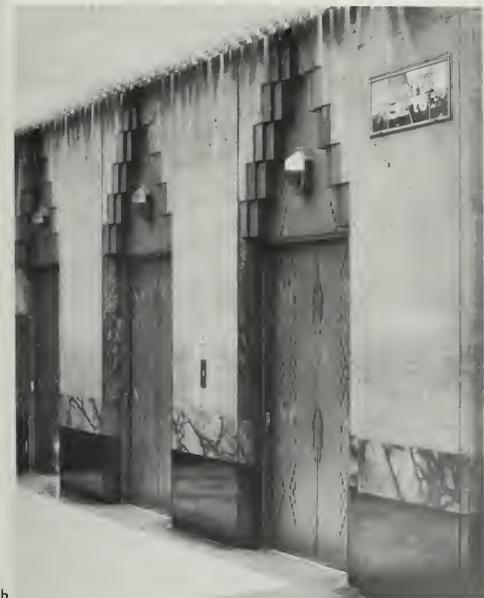
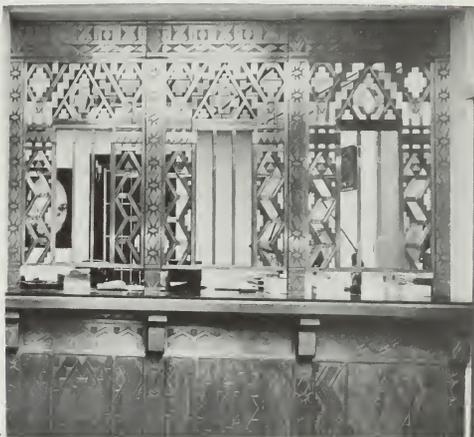
Figure 48. Monel Entrance Screen, Elevator Door, and Tellers' Cages, National Bank of Commerce (now Michigan National Bank), Union Trust Building (now Guardian Building), 500 Griswold, Detroit, Michigan, 1928; Smith, Hinchman and Grylls, architects; Gorham Co., Providence, Rhode Island. (a) Over 40,000 pounds of Monel metal were used in this Art Deco bank and office building for such features as the Monel clock, two-story grille, gates, railings, and signs of this monumental entrance screen. (b) The design of the elevators was executed in Monel metal and colorful favrile glass from Tiffany. (c) In the banking area, Monel was used for tellers' cages, grilles, gates, check writing desks, screens, and even switch plates. The commercial areas were similarly enriched with Monel. (a and b) Smith, Hinchman and Grylls, architects; (c) Allen Stross, NAER

Designers in the Art Deco and Depression Modern periods strongly favored the white metals, especially when contrasted with yellow metals such as bronze. Monel metal, like nickel silver, was very popular for decorative exterior and interior metalwork. The Union Trust Building in Detroit is an extravagant example of Monel metalwork (figure 48). A monumental screen of Monel metal separates the bank from the lobby entrance, and all the other metalwork—elevator doors, grilles, gates, teller cages, and check-writing desks—are of Monel.

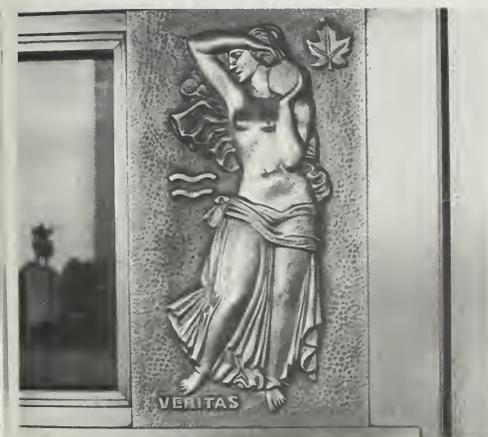
Figure 49. Monel and Nickel Silver Doors, United Nations General Assembly Building, First Avenue between East 42nd and 48th Streets, New York City, 1953; Ernest Cormier, designer, Montreal. The contrasting pale yellow nickel silver and platinum-colored Monel metal doors were a gift from Canada to the United Nations. The seven nickel silver doors were fabricated from extruded sections by the Anaconda American Brass, Ltd.; and the Monel metal sculptural panels representing Truth, Peace, Justice, and Fraternity were cast by Robert Mitchell Company, Ltd. (David W. Look)

Artistic effects could be achieved with Monel metal. The sculptural panels on the nickel silver doors of the United Nations Building in New York City were cast of Monel (figure 49). Like bronze, Monel can be etched, as the elevator doors were in the Walker Building in Washington, D.C. (figure 50).

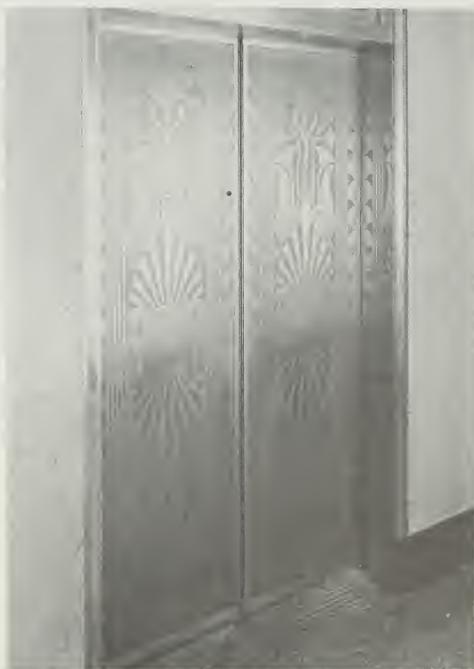
Figure 50. Etched Monel Metal Elevator Doors, Walker Building, 734 15th Street, NW, Washington, D. C., 1937; Porter and Lockie, architects, Baltimore. The Egyptian Revival design was etched into the highly polished Monel metal doors, providing a subtle decorative effect. (Walter Smallog, Jr.)

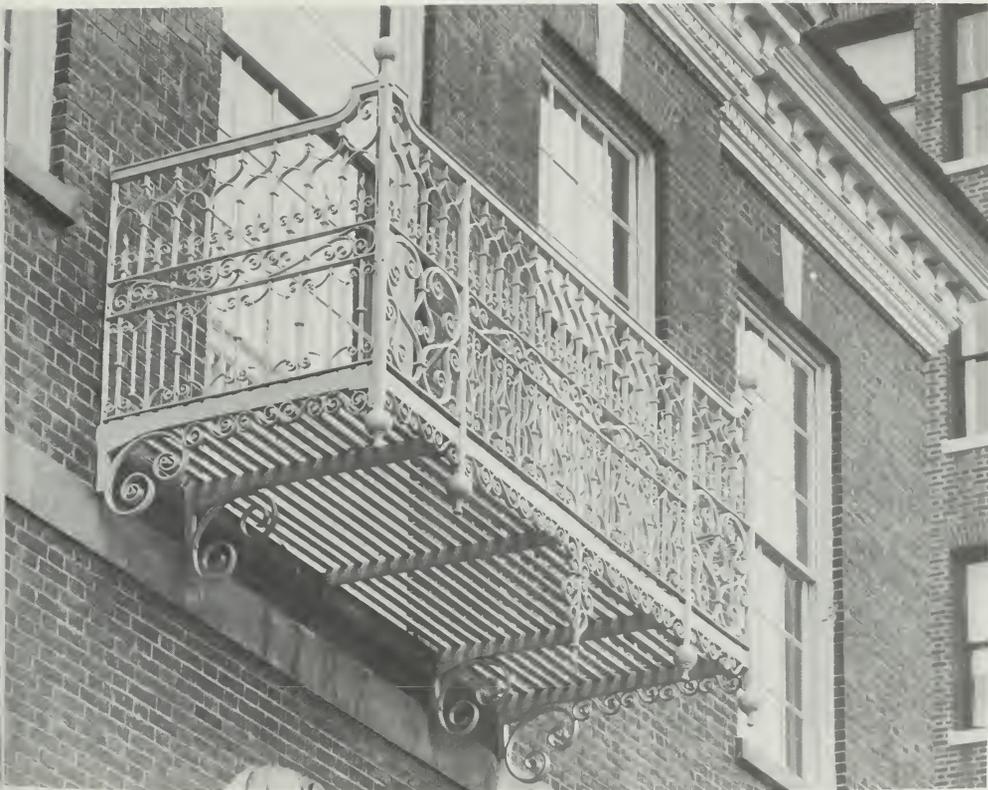
Figure 51. Wrought-iron Balcony, Samuel Wheeler, blacksmith; Congress Hall, 1787-1789, Chestnut Street at 6th Street, Independence National Historical Park, Philadelphia, Pennsylvania. Built as the Philadelphia County Court House, this building was used by the Federal Congress from 1790 to 1800. In 1961, the National Park Service removed many layers of paint from the balcony over the front door prior to its restoration. During the process, the name and date "S. Wheeler 1788" was discovered. The inscription was located on the inside of the balcony facing the window. Just a few layers of new paint have already obscured the marking. (Jack E. Boucher, NAER)

Fences, gates, railings, and balconies have been traditional architectural uses of wrought iron. The iron combines the strength and ornamentation desired in each of these items. The wrought iron balcony at Congress Hall in Philadelphia (figure 51) was signed and dated by the craftsman, S. Wheeler, in 1788. Wheeler also made and signed the ornate gates of Christ Church in Philadelphia (figure 52). Although such identification became common for cast iron, it was rare for wrought iron.

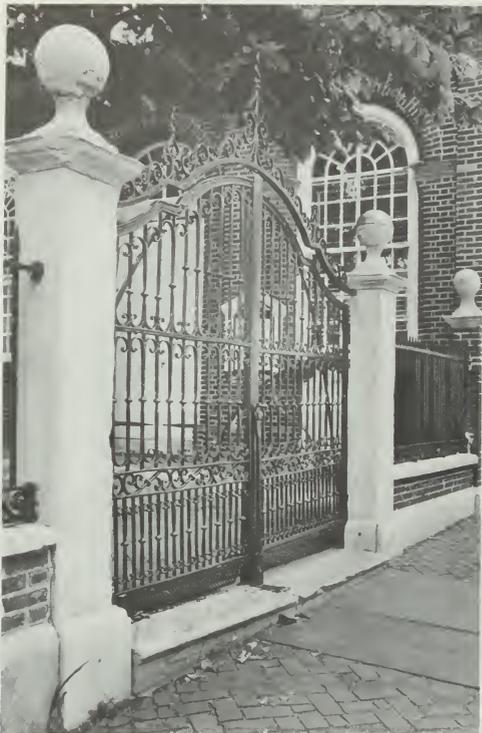
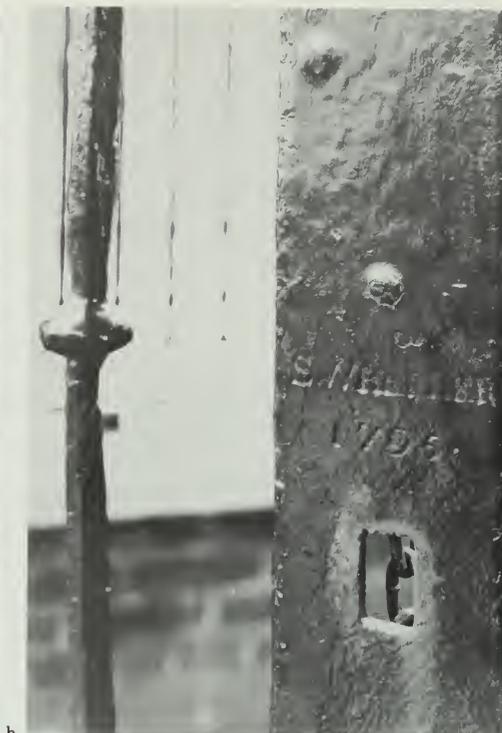
Figure 52. Wrought-iron Gates, Samuel Wheeler, blacksmith; Christ Church, 22-26 North Second Street, Philadelphia, Pennsylvania, 1727-1744; attributed to Dr. John Kearsley, builder-architect. (a) *The wrought iron was heated, hammered, bent, and twisted to achieve the various parts of the design. The verticals were split and then bent to form the scrolls, rather than bent and attached to the verticals.* (b) *Like the balcony on Congress Hall (see figure 51), these gates are signed and dated: "S. Wheeler 1795" appears on the edge of the gate, seen only when the gates are open. (Jack E. Boucher, NAER)*

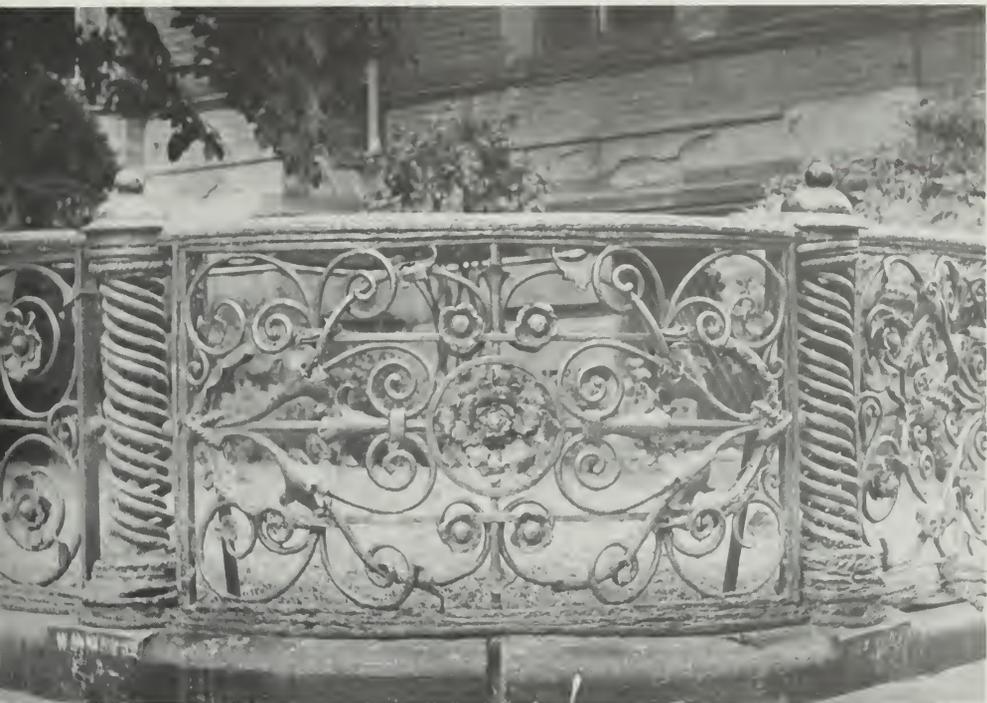
Figure 53. Wrought-iron Fence, Frederick Ames Mansion, 306 Dartmouth, Boston, Massachusetts, 1872; John Sturgis, architect. This fence was fabricated by hand from iron bars; square and round sections were hot-worked into spirals, circles, and scrolls. Even the fence posts are compact spirals of strong rods shaped about a central support to make them rigid. (Esther Mipaas)

The visual effect achievable with wrought iron ranged from simple, straight, geometric designs to curvilinear, organic designs (figure 53). Since each part is individually hand made, no two are identical. The subtle variation in shape and tool marks adds to the unique artistic expression of each piece of ironwork. In general, wrought iron is light in appearance and uses only enough material to achieve the desired design. In contrast, cast iron usually appears more massive (larger designs were usually hollow but appear solid) with highly repetitive design elements.

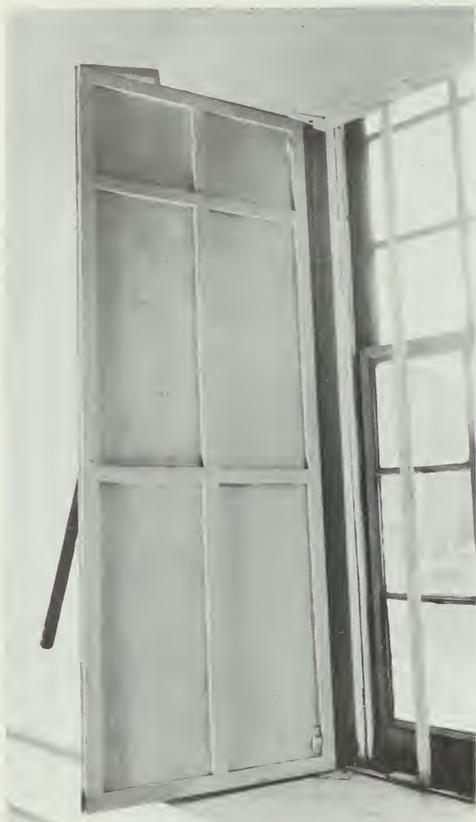
Figure 54. Wrought-iron Shutters, Arch Street Meeting House, 302-338 Arch Street, Philadelphia, Pennsylvania, 1803-1804; Owen Biddle, architect and master builder. The shutter is on the window of the "fireproof" vault used to store records. The iron shutter has a frame of hand-forged rectangular bars to which a series of rolled sheets was riveted. (George Eisenman)

Many nonstructural uses of wrought iron were only minimally decorative. Some utilitarian objects such as wrought iron shutters were made of rolled sheets of iron and were quite plain (figure 54).

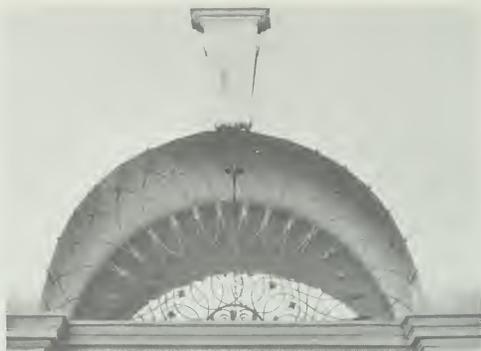
Figure 55. Wrought-iron Guard, Old City Hall and Market, 111 South Royal Street, Mobile, Alabama, 1853; ironwork by J. B. Wickersham, New York City. Wickersham produced some of the earliest iron foundry catalogues, with his first published in 1855. It was probably through his catalogue advertising that he generated so much later business in the South. Although his catalogues carried everything from iron beds to verandas, his fences were most popular and can be found almost everywhere. Most of these designs were based on his patent for bending bars and then fixing them in place by casting rosettes onto the intersection of the bars. (NAER, Library of Congress)

Decorative work in wrought iron was popular throughout the United States. Beautiful grilles, galleries and stair railings, both interior and exterior, remain from the late 18th and early 19th centuries in many eastern seaboard cities and in towns throughout the South. An early surviving design, the grille on the Old City Hall and Market in Mobile, Alabama, combines wrought-iron woven wire with cast-iron fasteners (figure 55), a technique widely used for grilles and fences.

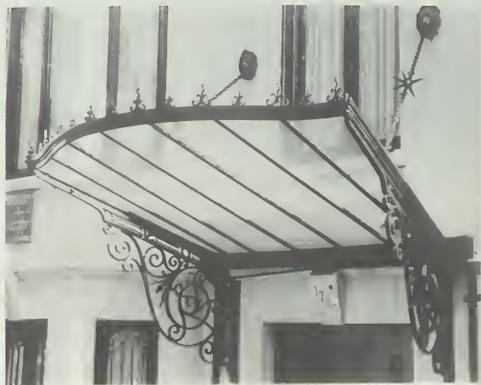
Figure 56. Wrought-iron and Glass Canopy, 1734 N Street, NW, Washington, D.C., ca. 1885. Iron is found in a variety of forms from strap hinges to fragile glass and iron combinations—such as the canopy protecting the entrance of this elegant townhouse. Glass panels were set in an iron frame with fleurs de lis on the front edge and flourishes as supporting brackets. (David W. Look)

Later 19th-century buildings display decorative wrought-iron and cast-iron stair railings, porches, balconies, verandas, roof cresting, lamps, grilles, fences, and canopies (figure 56).

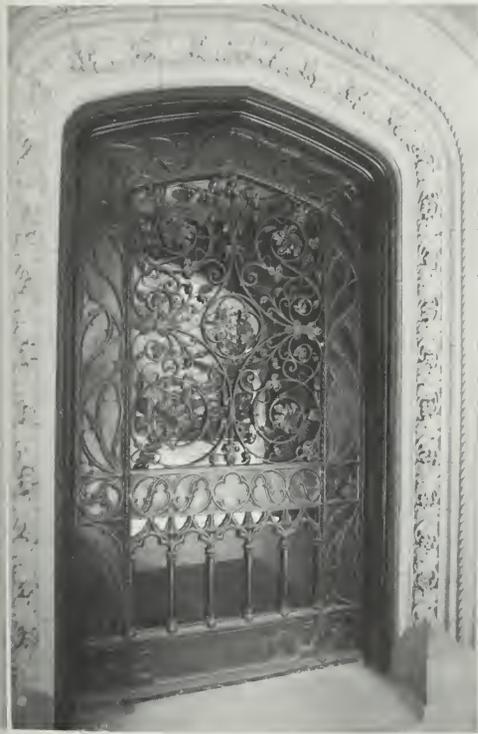
Figure 57. Wrought-iron Door, Joslyn Castle, 3902 Davenport Street, Omaha, Nebraska, 1902-1904; Winslow Bros., foundry, Omaha. The one-ton iron door to the entrance hall of this Scottish baronial-style mansion is precision balanced and swings easily. A hand-forged wrought-iron grille consisting of scroll and vine motifs is set in Gothic cast-iron framing. (Robert Peters)

At the end of the 19th and beginning of the 20th centuries, there was a rebirth of the crafts in America, of which ironworking was a part (figure 57). Fine artistic expressions were achieved in wrought iron by blacksmiths such as Samuel Yellin in and around the Philadelphia and Washington, D.C., areas (figure 58). Wrought iron was used on every type of building from residences, to Art Deco office buildings and stores. Although most blacksmiths used traditional methods, commercial ironworking firms began to use welding instead of rivets and collars and to use machines to bend and twist bars.

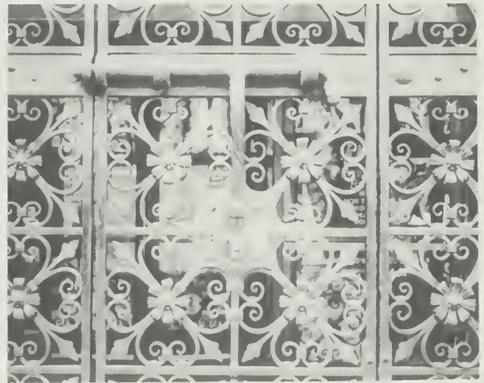
Figure 58. Wrought-iron Entrance Gates, Packard Building, southeast corner of Chestnut and 15th streets, Philadelphia, Pennsylvania; 1924, Ritter and Shay, architects; Samuel Yellin, artist and blacksmith. In the 20th century, the name Yellin stands for excellence in ironwork in America. Although he called himself a blacksmith, he was much more—an artist with iron for his medium. An immigrant from Poland, Yellin executed most of his major commissions between 1920 and 1940. He used every method of metalworking—cutting, splitting, twisting, scrolling, punching, incising, repoussé, and banding—to achieve unique designs. (David W. Look)

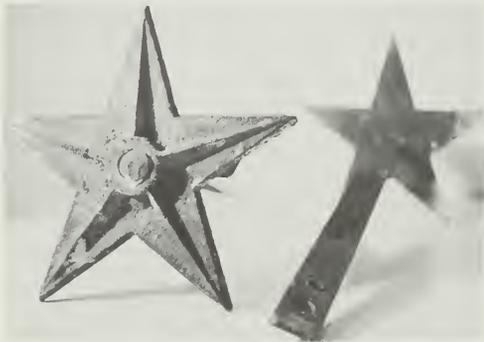
Figure 59. Wrought-iron Tie Rods with Cast-iron Star Anchors. Wrought-iron tie rods were added to buildings to prevent the walls from buckling or separating from interior walls. The rods were bolted to cross beams or to a parallel masonry wall. They were always made of wrought iron to take tension. To prevent horizontal forces from pulling the tie rods through the wall, they were connected to cast-iron stars, rosettes, or "S" anchors on the outside of the wall. The anchors, which spread the force over a greater area, were the only visual evidence of the presence of the tie rods. As a precaution, tie rods and anchors were sometimes included in original construction; but the more usual use was their addition when an outer brick wall began to lean or buckle. The addition of a tie rod could not bring the wall back to its original vertical alignment, but it prevented the wall from moving further. (David W. Look)

Often the hidden iron bars, straps, pins, U-shaped bridle-irons, and tie rods are revealed only at times of alteration or demolition. Star-shaped anchors on the exterior brick walls of old buildings mark the location of wrought-iron tie rods, sometimes called straps, which may be tied to wooden joists inside or may run through the structure to hold the wall in plumb. Often the anchors, which are of cast iron, take the form of stars, but they may be S-scrolls or fancier devices (figure 59). Occasionally tie rods are visible and are even ornamented, as in the Trolley Station in Seattle's Pioneer Square (figure 60).

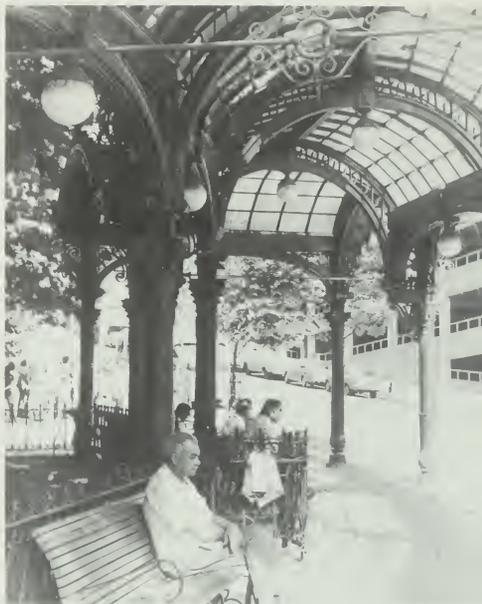
Figure 60. Iron and Glass Pergola, Trolley Station, Pioneer Square, Seattle, Washington, 1909. *This station, which has become a symbol of the revival of the city's old commercial area, consists of glass panes held between ribs of wrought iron supported by cast-iron arches and columns, both of which are in compression. The wrought-iron tie rods (top of photo) take the outward thrust of the arches; thus, the rods are in tension. Iron members in tension had to be made of wrought iron because cast iron is suitable only for compressive loads. However, iron members in compression could be of either cast iron or wrought iron, whichever was more economical and convenient for the iron shop to fabricate. By the late 1960s, most of the glass in the pergola was broken and the iron was rusting. Preservationists, planners, and city officials worked together to rehabilitate Pioneer Square with the pergola as its centerpiece. Wooden patterns were carved from which sand molds were made to recast the lost and broken iron parts. With new lamps and fresh paint, the pergola was rededicated in 1973. (John Iochman, Seattle Office of Historic Preservation)*

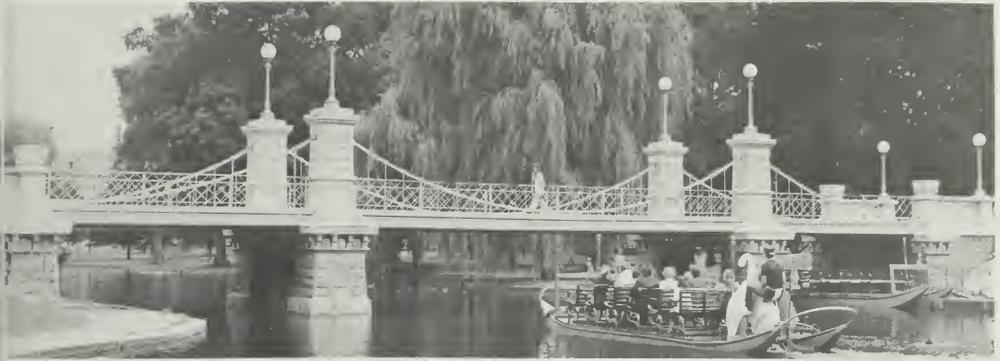
Figure 61. Suspension Bridge, Public Garden, Boston, Massachusetts, 1867; Elemens Herschel and William Preston, engineers. Popular among Bostonians, this small suspension bridge originally consisted of plank flooring hung from chains made of flat wrought-iron links. In 1921 the bridge's deteriorated wood was replaced with steel beams; the bridge was reinforced in 1975 with more steel and concrete. Although the deck has been replaced, the masonry piers and the chains hung between them are still largely original. (Carleton Knight, III)

Wrought-iron rods were universally used in mid-19th-century wooden and iron trusses for buildings and bridges where the structural member was put in tension. Also, flat link chain and cables of early suspension bridges were made of wrought iron (figure 61).

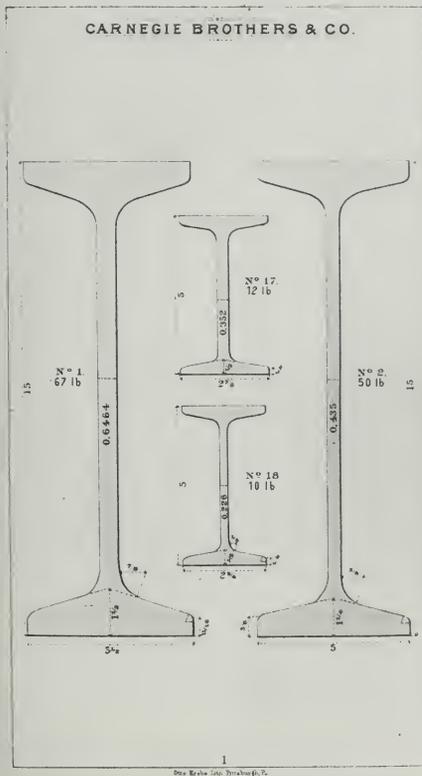
Figure 62. Wrought-iron Beams, Carnegie Brothers and Company's Pocket Companion . . . , 1876. The earliest known wrought-iron handbook of wrought iron structural shapes was published by Carnegie Kroman and Co. in 1873, some 18 years after the first wrought-iron I-beams were rolled in the United States by the Trenton Iron Works, founded by Peter Cooper. Copies of the 1873 handbook are quite rare; however, the Library of Congress has a copy of the 1876 handbook of Carnegie Brothers and Co. The Iron and Steel Beams: 1873 to 1952, published by the American Institute of Steel Construction, Inc., is a valuable resource book because it documents the handbook dates, the sizes, weights, and properties of all rolled beams during this period. The largest beam in the 1873 handbook was 15 inches deep and 67 pounds per lineal foot, the same as the beam shown in this illustration at the far left. (Library of Congress)

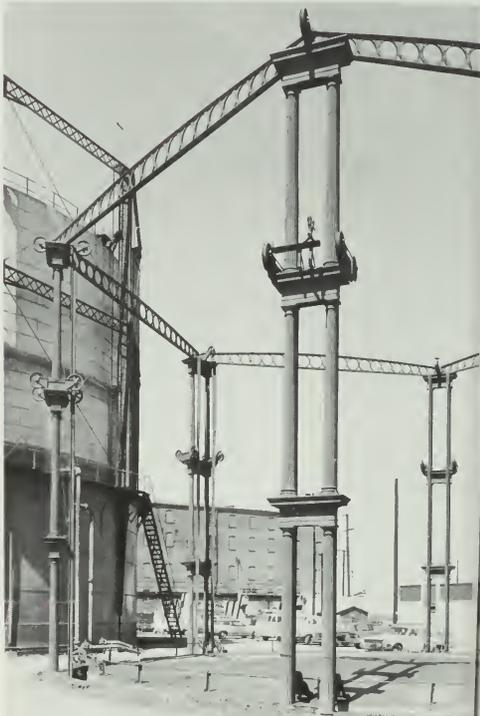
Figure 63. Cast-iron Gasholder, Petersburg Gaslight Company, Petersburg, Virginia, 1851–1852. The Greek Revival style gasholder has six pairs of slender Doric columns three tiers high which served as “guides” for the expandable tanks. Cast-iron horizontal members, which provided stability and carried only their own weight, are widest at the centers to resist bending. In this case the top of the beam is in compression and the bottom is in tension. To reduce weight, the beams were perforated with circles graduated in size toward the ends. (Jack E. Boucher, NAER)

Cast-iron columns (figure 63) were often secured from small local foundries. Later, if they could not be procured locally, they were ordered from catalogues published by a number of large firms, such as James L. Jackson Ironworks and Architectural Iron Works, New York (figure 64), Buffalo Eagle Works, and Tasker and Co., Philadelphia.

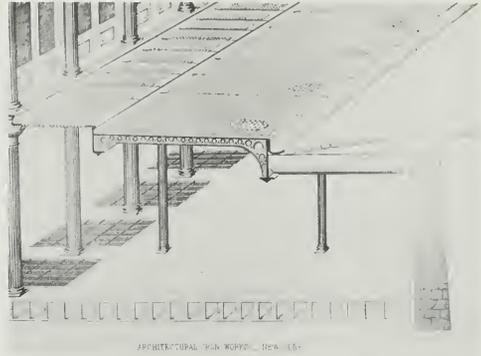
Figure 64. "Elevation and Section of Sidewalk Showing Vault Under Street," Plate LXXXIII, no. 45, from Daniel D. Badger's 1865 Catalogue, *The Architectural Iron Works of New York City*. The basement areas of 19th-century commercial buildings often expanded into the space beneath their sidewalks and occasionally out under the street. To make this possible, heavy cast-iron columns carried the facade of the building, while additional cast-iron columns supported the sidewalk and vault roof. Getting daylight into the cellars or vaults required imaginative engineering, since lighting with gas or kerosene presented hazards in these enclosed spaces where ventilation was limited and the possibility of fire was ever present. The ingenious invention of the "vault light" Theodore Hyatt patented in 1845—a sturdy type of iron grating plugged with chunky glass blocks—allowed natural light to filter through the sidewalk into the basements yet provided a surface rigid enough to support pedestrian traffic. Such glazed grilles eliminated the need for basement window areways and allowed passersby to step close to shop windows to examine merchandise. Vertical panels of vault lights were often set into foundations. Library floors and whole staircases were fabricated with this system. (Avery Library, Columbia University)

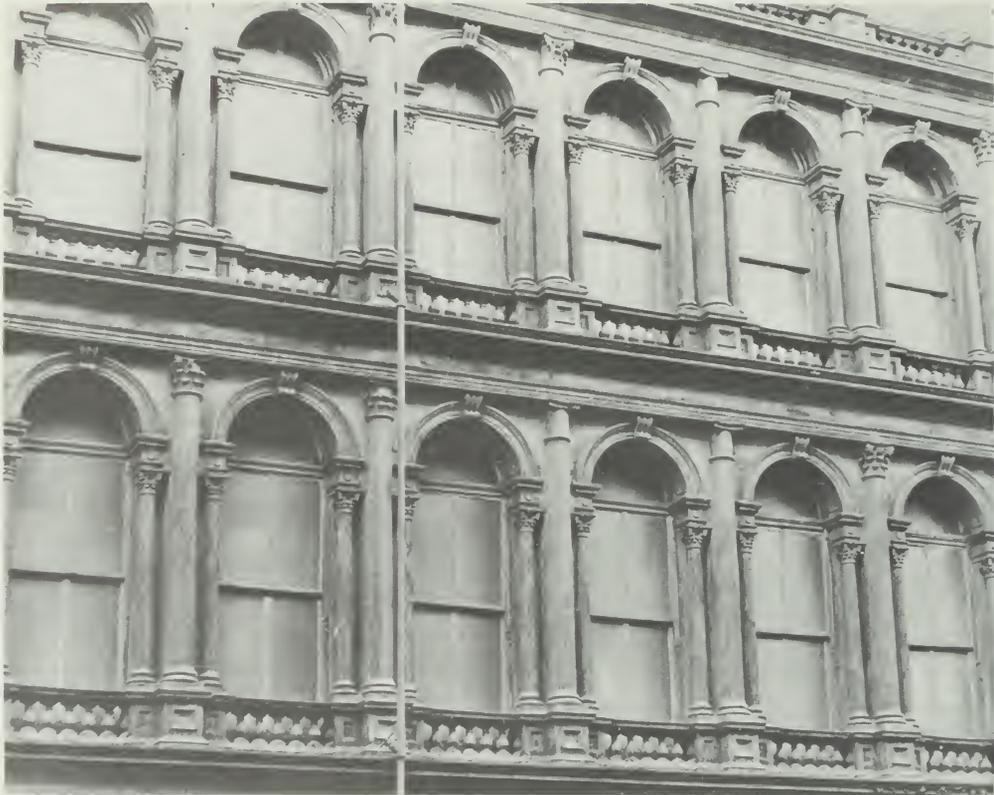
Figure 65. Cast-iron Haughwout Building, 490 Broadway, New York City, 1856; John P. Gaynor, architect; Daniel D. Badger's Architectural Iron Works of New York City. Some of the best iron front buildings stand in the SoHo area of the city. There are excellent examples of the quality and character of mass-produced 19th-century ironwork. Once foundry patterns were prepared, any number of like building fronts could be cast. The facade of the Haughwout Building consists of a single module, Palladian in character, repeated again and again. The result was an impressive design at a moderate cost. (Clover Vail)

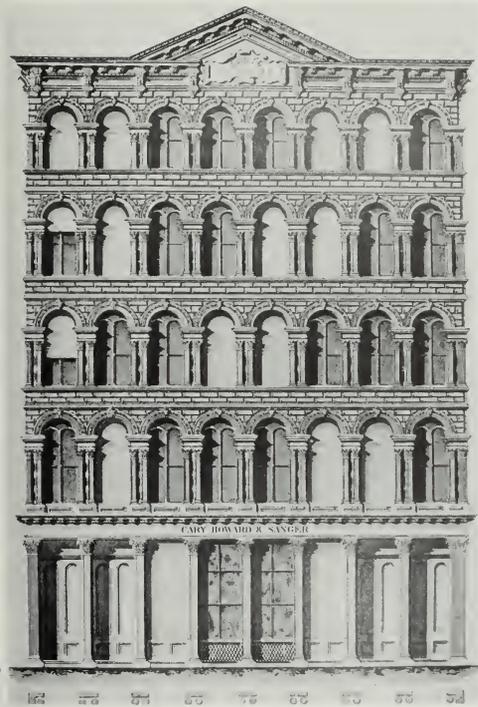
Figure 66. Catalog Illustration, Cary Building, New York City, 1856; John Kellum, architect; Daniel D. Badger's Architectural Iron Works of New York City. This iron front design depicted in the 1865 catalog of Badger's foundry is still standing in downtown Manhattan. Although the iron is scored to look like ashlar, the slender freestanding colonettes between the windows reveal that the facade is metal, not stone. Many of the rolling metal shutters at the windows have been pulled shut. Badger sold rolled iron shutters before he started promoting cast-iron storefronts. (Avery Library, Columbia University)

In the last century, cast iron was used for building fronts (figures 65 and 66). Its function was both decorative and structural. The ironwork could comprise the entire facade or only the first-floor level (figure 67). It could support its own weight and part of the floor system when used in a building on a corner lot.

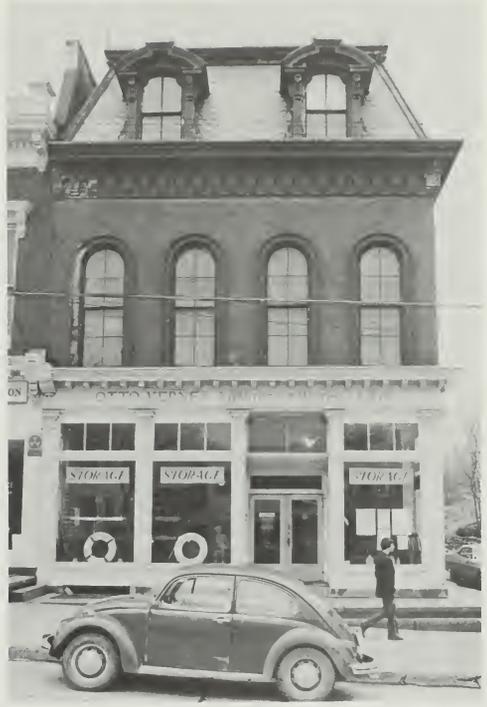
Figure 67. One-story Cast-iron Storefront, 75 Main Street, Cold Spring, New York. This modest facade is typical of cast-iron storefronts popular for decades after their introduction about 1825. Fabricated by both small local foundries and large nationally known companies, storefronts were available in a variety of styles and sizes, and could be ordered from catalogs. The slender piers and columns could support the weight of several stories, usually masonry, while providing the framework for broad expanses of glass. The open front was perfect for the display of merchandise. (Otto Verne)

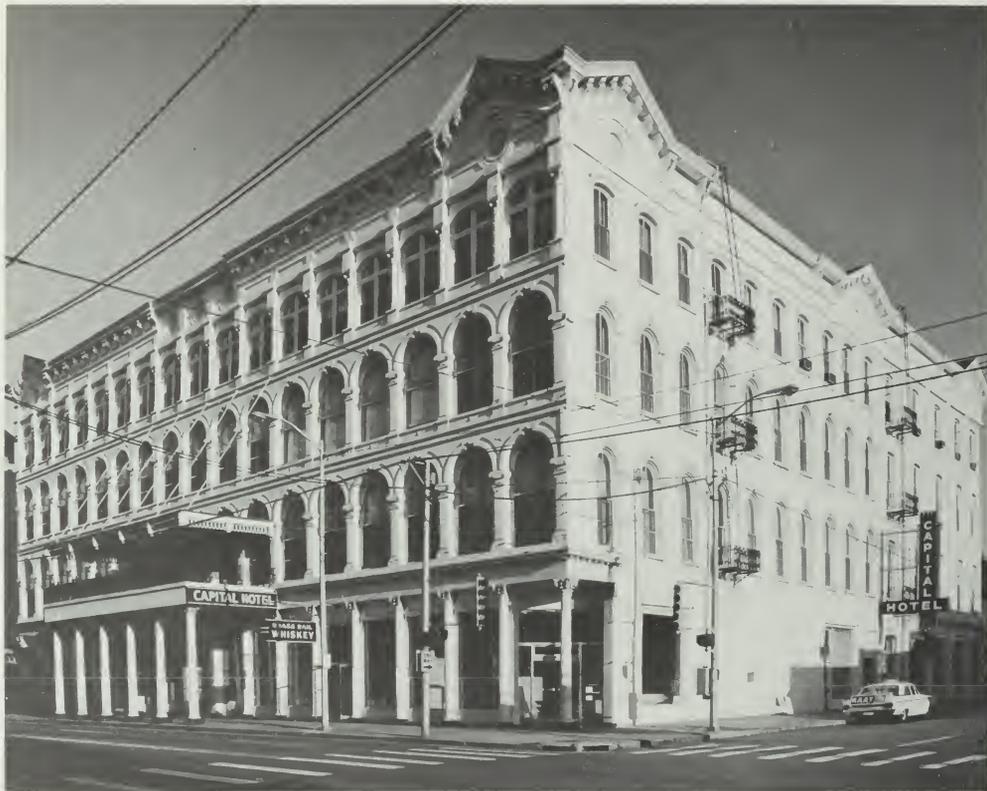
Figure 68. Cast-iron Facade, Capital Hotel (originally the Denkla Office Building), 117 West Markham Street, Little Rock, Arkansas, 1873. The Italianate office building was converted in 1877 into a hotel. Being located near the state capitol, it became popular with politicians and was often used as campaign headquarters. Note the difference in window size in the facade and the masonry sidewall. The larger windows of the cast-iron front provided a great deal of natural light, which the building's original use (offices) required. Although not apparent from a distance, the top story of the front facade and the cornice are pressed sheet metal, probably galvanized iron. (Earl Saunders)

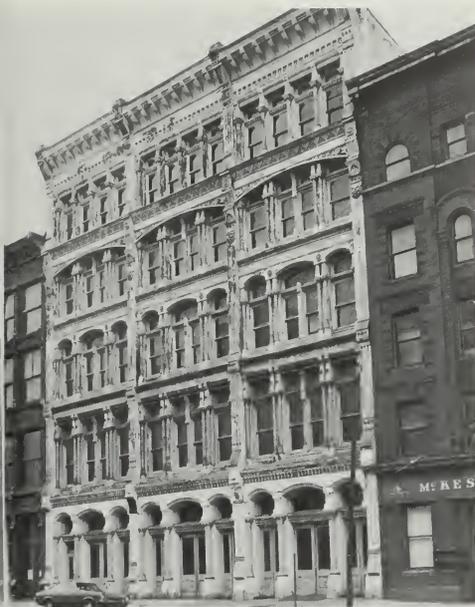
Figure 69. Iron Front Hildebrand Building, 730 Main West Street, Louisville, Kentucky, 1884; Charles D. Meyer, architect. The elaborate iron front of this five-story commercial building in the old downtown section exemplifies the advantages of cast-iron construction. The tall iron columns and colonettes between windows, slender as they are, take the weight of the materials, allowing large openings and light rooms. Iron manufacturers linked the technical requirements of their material with aesthetically appealing design, a fact which is evident even in this unrestored building. (John Albers and Preservation Alliance)

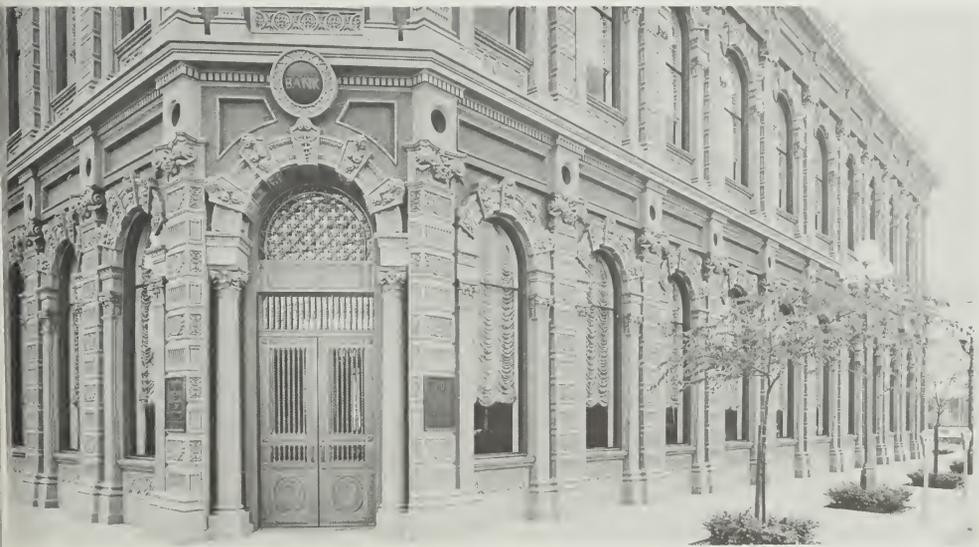
Figure 70. Ladd & Bush Bank (Branch of the U.S. National Bank of Oregon), 302 State Street, Salem, Oregon, 1869, Willamette Iron Works; addition by Skidmore, Owings and Merrill, 1967. The elaborate iron elements of this bank in Salem were a near twin to the Ladd and Tilton Bank in Portland, also cast by the Willamette Iron Works in 1868. When the latter was demolished, its iron facade was saved and later used for expansion of the Salem bank. Additional parts were cast as needed by the original foundry. Note the bronze doors which were added in 1912. (Donald Sipe)

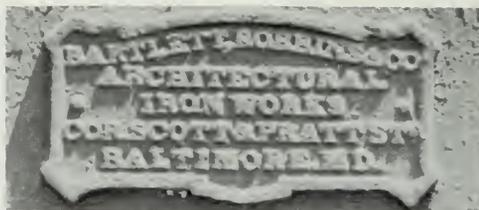
Figure 71. Foundry Label: “BARTLETT, ROBBINS & CO., ARCHITECTURAL IRON WORKS, COR. SCOTT & PRATT ST., BALTIMORE, MD.” Foundries often attached labels to their work, a tradition started by bronze founders. A combination of pride and promotion, foundry labels can be found on architectural ironwork all over the country. This label appears on a building in downtown Baltimore. For some years the firm's name was Hayward, Bartlett and Co., under which it cast iron fronts for an attractive row of stores in Richmond, Virginia, recently restored as an office building. (David W. Look)

cast, polished, checked for fit and given a protective coat of paint in the iron foundry. Then they were shipped as separate pieces to the construction site and bolted together to form an entire facade of iron. Assembly of the prefabricated pieces was much faster than traditional construction methods allowed. Often the foundry cast its name on a facade element, usually on the base of a column, pilaster, or pier (figure 71).

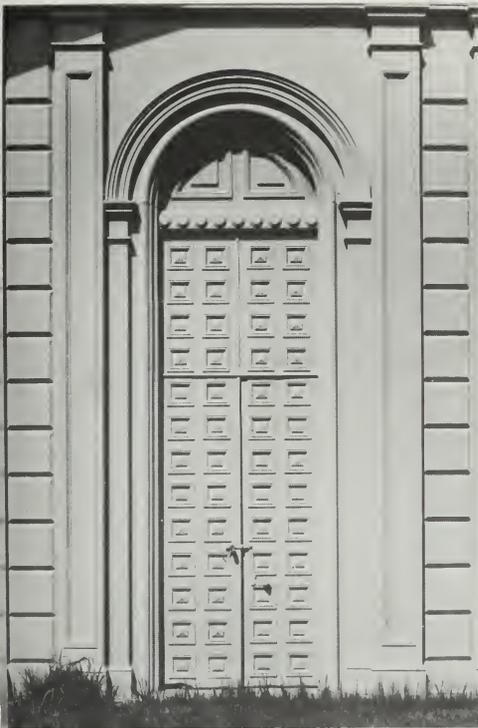
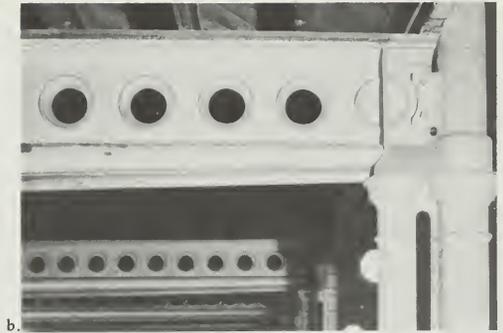
b.

Figure 72. Cast-iron Personnel Door (south elevation) and Girder-Column Detail (interior), Watervliet Arsenal, New York, 1859; Daniel D. Badger's Architectural Iron Works of New York City. (a) This military storehouse is the most nearly all-iron building in the United States: the walls, window frames, doors, and columns are all cast iron, and the roof trusses are wrought iron. Built as a "fireproof" warehouse for ammunition storage, this classical Greek and Roman building was cast in sections at Badger's foundry and shipped by barge up the Hudson River to be assembled on the foundation in less than three months. (b) The detail shows a cast- and wrought-iron girder connected to a cast-iron column. The cast-iron part of the girder, the top three-quarters, is perforated to reduce the weight of the load and slightly arched to take compressive stresses. The wrought-iron part is at the bottom of the girder to take tensile stresses. (Jack E. Boucher, NAER)

The U.S. Army owns one of the most remarkable iron buildings in existence, it is nearly *all* iron. The structure was erected just before the Civil War to serve as a gun carriage storehouse. Measuring some 100 by 200 feet in size, it is located at Watervliet Arsenal, an Army installation on the Hudson River opposite Troy, New York (figure 72).

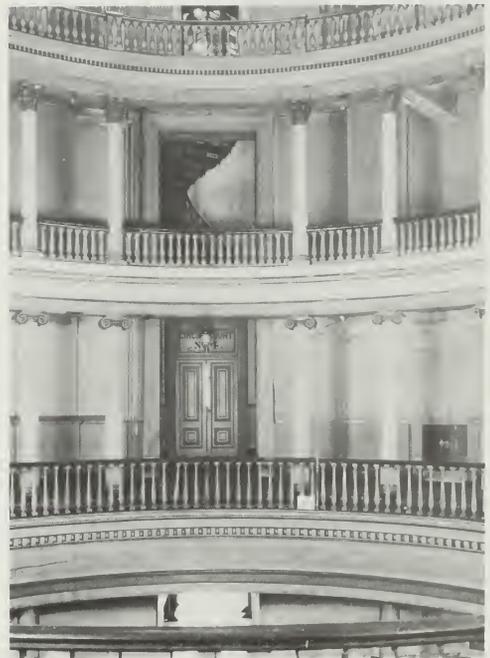
Figure 73. Rotunda Galleries, Old St. Louis Courthouse, Fourth and Market Streets, St. Louis, Missouri, 1859 expansion; William Rumbold, architect. The courthouse has many iron elements, including the intricate elliptical cast-iron staircases in the wings and half of the Ionic and Corinthian columns which support the rotunda galleries. Every other column is wood. The cast-iron columns were added to take the increased load of the dome, a major feat of engineering and architectural design. William Rumbold accomplished the detailed engineering of the dome between 1859 and 1862, one and one-half years before the dome of the U.S. Capitol was completed. (Piaget, NAER)

Even the most cursory look at the significant mid-19th-century public structures is enough to see how widely iron was used. The Old St. Louis Courthouse has an iron dome which predates that of the U.S. Capitol (1859-1862). It has iron elements from top to bottom. Although the building suffered two fires and underwent several alterations, the iron has survived intact. Architect William Rumbold's plan for the Italianate style iron dome, submitted in December 1859, called for strengthening the existing structure to receive it. He replaced stone columns with cast-iron replicas to support the first gallery in the rotunda. The second and third galleries have 20 slender cast-iron columns alternating with wooden columns painted to look alike (figure 73). This columnar system ran up through the building to the drum of the iron dome, which it supported. The drum itself consisted of a ring of iron columns with Italianate windows between them.

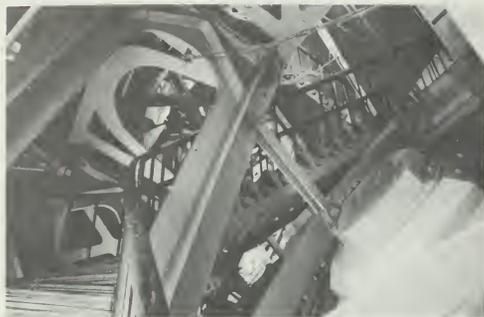
Figure 74. Stairs between the Inner and Outer Domes, U.S. Capitol, 1856-1865; Thomas U. Walter, Architect of the Capitol; Montgomery C. Meigs, engineer. The double shell dome construction is supported by 36 radiating, arched trusses. In this view of the stairs to the lantern, every element is cast iron except the wrought-iron tie rods and bolts. To the right is the back side of one of the cast-iron coffers of the inner dome. The center of the coffer can be unbolted for inspection and maintenance of the inner dome. (David W. Look)

The great dome of the U.S. Capitol, completed in 1865, is the most monumental example of cast-iron architecture in America. Thomas U. Walter, Architect of the Capitol, designed the Renaissance style dome and engineer Montgomery C. Meigs made erection of the dome technologically feasible and supervised its construction. Several iron foundries handled the casting work; innumerable iron pieces were bolted together—smaller assemblies at the foundry, larger ones at the site—to create the pie-shaped sections, curving from base to tip, that form the exterior “skin” of the big dome.

The highly decorated skin was laid over a daringly conceived armature of 36 main radial ribs, each an open-web truss made up of 10 iron sections. These massive trusses can withstand the driving force of winds and the expansion and contraction resulting from temperature changes. The dome of the Capitol stands on an iron drum which is ringed by a peristyle of iron columns cast in Baltimore. Except for the bronze statue of Freedom at its apex, all of the dome structure above the roof of the center pavilion, in both framing system and covering, is iron (figure 74). The influence of the U.S. Capitol's design can be seen in the many state capitols which display Renaissance style domes. Some are totally of iron, while others are sheathed with copper.

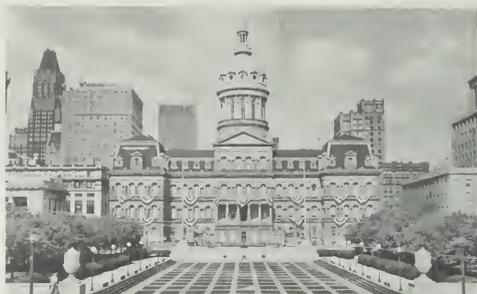
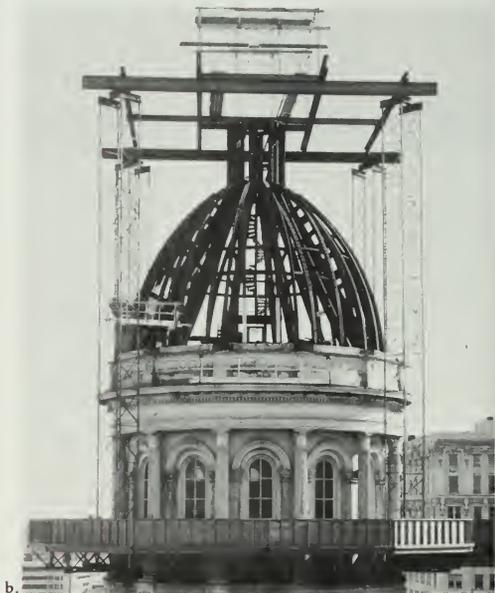
a. Figure 75. City Hall and the Restoration of the Dome, 100 North Holliday Street, Baltimore, Maryland; 1867-1875; George A. Frederick, architect; Wendel Bollman, engineer; restoration, 1975. (a) This Second Empire building was designed by Frederick, but the dome and lantern were designed by Bollman, inventor of the Bollman truss and sole proprietor of the Patapsco Bridge and Ironworks of Baltimore, Maryland. By 1970 the dome was in a seriously weakened condition. The sentiment of the townspeople and the mayor to keep the dome and rehabilitate the building was so strong that an \$8 million bond issue was approved for the project. (b) All parts of the dome pictured are cast iron. The outer plates were removed for strengthening the ribs. (Filip Sibley, Office of the Mayor, Baltimore; Robert M. Vogel)

Many city halls and county courthouses throughout America have cast-iron domes and cupolas. Built shortly after the U.S. Capitol dome and probably influenced by it, the Baltimore City Hall's cast-iron dome was recently restored (figure 75). The cupola of Brooklyn's Borough Hall burned in 1895; when it was rebuilt, the original wooden cupola was reconstructed in cast iron and sheet metal (figure 76).
