Metals in America's Historic Buildings

Uses and Preservation Treatments

U.S. Department of the Interior
National Park Service
Cultural Resources
Preservation Assistance
Washington, D.C.
1992

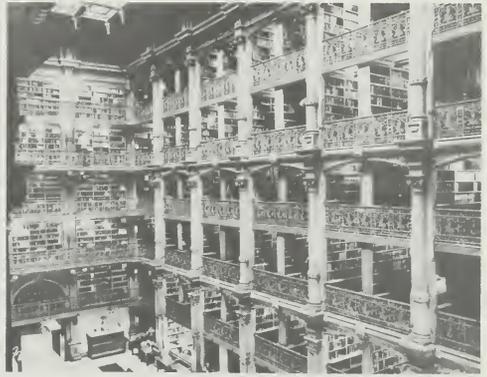
Figure 77. Cast-iron Interior, Peabody Institute Library, Mount Vernon Place, Baltimore, Maryland, 1857-1878; Edmund George Lind, architect; Bartlett, Robbins and Co., Architectural Iron Works, Baltimore. A gift from the philanthropist, George Peabody, who started his career in Baltimore, the Peabody Institute included a library which is virtually all cast iron and glass. Although the building's exterior is a traditional Renaissance design in stone, the most innovative materials of the time were used on the interior to safeguard the collection of books and manuscripts from fire. The central area of the library is surrounded by five floors of cast-iron galleries and is covered by one great skylight of glass set in an iron frame. The floors of the five decks are of iron inset with blocks of translucent glass. The decks are supported by cast-iron piers with applied two-story fluted pilasters rising in three tiers from floor to roof. (Peabody Library)

Before the introduction of electric lighting, it was difficult to illuminate adequately the interior spaces of large public buildings. Many 19th-century capitols, city halls, and other large structures, such as the Library of the Peabody Institute in Baltimore (figure 77), were designed to include ornamental light courts to bring natural light into the core of buildings. These three- or four-story-high spaces were covered by iron and glass skylights. Cast-iron columns typically supported these gallery-like openings in the floors.

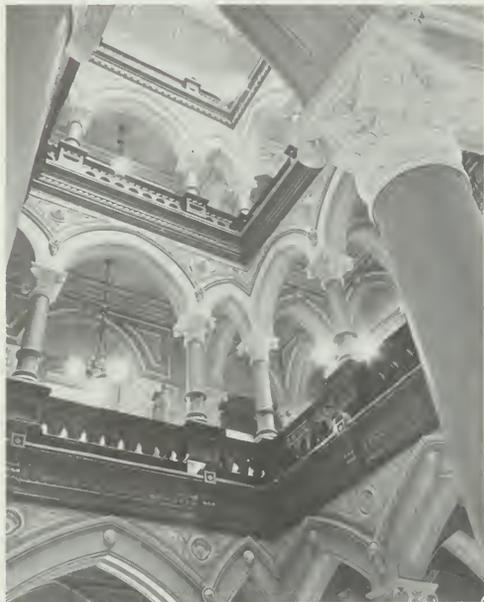
Figure 78. Cast-iron Light Court, Old City Hall, bounded by 10th, Broad, 11th, and Capitol Streets, Richmond, Virginia, 1886–1894; Elijah E. Myers, architect. The great central light court with its tiers of enriched cast-iron columns, spandrels, railings, and brass fixtures ranks as one of the most impressive municipal interiors in America. In imitation of stone, the cast iron has a massive, solid quality consistent with the character of the exterior masonry. (William Edwin Booth)

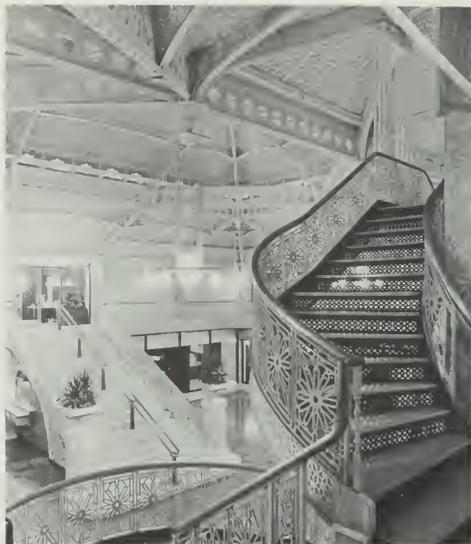
Figure 79. The Rookery, 209 South LaSalle Street, Chicago, Illinois, 1886; Burnham and Root, architects; Hecla Iron Works, Brooklyn, New York. The central foyer of this early 11-story skyscraper is a fine example of the integration of structural and decorative cast iron. The vaulting beams are perforated to reduce the dead load of the structural members without reducing the strength—the same principle as the truss. The chandeliers were designed by Frank Lloyd Wright in 1905. Unfortunately, the glass roof has been painted over. (Becket Logan)

In Burnham and Root's Rookery Building in Chicago, offices were wrapped around a large light court with an iron and glass skylight just above the foyer (figure 79). The upper floors surrounding the light court look onto an unroofed light well. Los Angeles' Bradbury Building is another instance of filigree cast-iron balustraded galleries (which serve as open corridors) and iron and marble stairs rising five stories. The entire light court is covered with an iron and glass roof (figure 80).

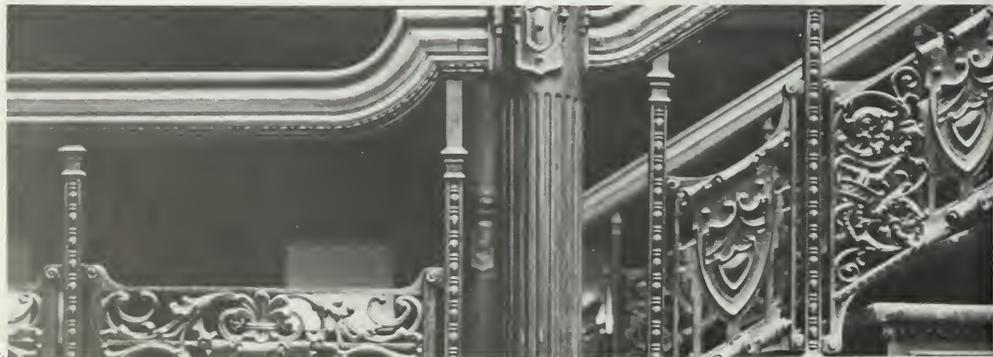
Figure 80. Light Court and Detail of Cast Iron Stairs, Bradbury Building, 304 Broadway, Los Angeles, California, 1893; George Wyman, architect; Winslow Brothers, foundry, Chicago, Illinois. (a) Built for the successful miner Louis Bradbury, this conventional masonry building gives no hint from the outside of its remarkable interior light court with its iron and glass skylight. The five-story open space has bird-cage-like elevators moving in open shafts with the machinery and counterweights exposed. (b) The elaborate openwork design of the galleries was cast in bold relief on both sides of the panels. The railings were cast in many parts and then assembled. Slender beaded balusters take the form of clawed feet where they attach to the staircase. All parts of the railing and galleries are outstanding examples of the art of sandcasting. (Becket Logan)

The first passenger elevator was installed by Elisha Graves Otis in 1857 in the still standing iron front Haughwout Store in New York. Open-cage elevators soon developed an architectural style of their own. Because of changing tastes and modern fire and safety laws, however, only a few survive. Vestiges of the metal shaftway grillage can still be found in some older office buildings and public structures. Once out of style, cast-iron elevators are now admired and occasionally a way is found to preserve them in the rehabilitation or adaptive reuse of a building. One such example is the 1905 elevator in the Pioneer Courthouse in Portland, Oregon, where the architects of the 1973 renovation put fire-resistant panels behind the iron grillework of both shaft and elevator cab (figure 83). On the other hand, an original system still survives in the 1893 Bradbury Building in Los Angeles where cage elevators move up and down in open shafts (figure 80).

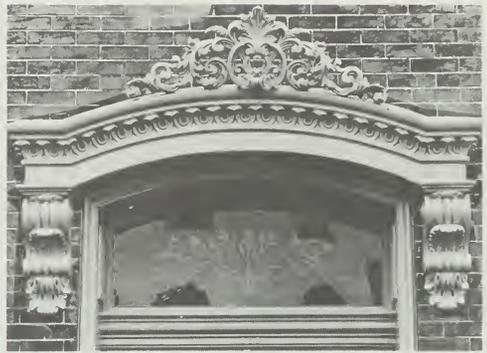
Figure 85. Cast-iron Cellar Window Grille, Matthew Quay House, northeast corner of Spruce and 11th streets, Philadelphia, Pennsylvania. Although little noticed, there is a seemingly endless variety of decorative cellar window grilles in Philadelphia. With the first-floor level several feet above grade and the sidewalks often extending right up to the facade, these articulated iron grilles were installed to protect exposed cellar windows while still allowing ventilation. The grille photographed here displays a motif of cast-iron vines set in a pair of arched panels. (Harley J. McKee, FAIA)

the day. Cast-iron window grilles were widely used on houses or public buildings for street-level or below-grade windows that had to be secured, yet where ventilation was desired. Philadelphia abounds in varied cellar window grilles of both cast and wrought iron (figure 85). The glass lights in exterior doors were often covered with custom-fitted ornamental cast-iron security grilles that were both effective and attractive. Many buildings built after 1840 used lacy ventilating grilles set under the eaves. These grilles could be ordered from catalogs, as could cast-iron hot-air registers (figure 86), grating, and panels for use under shop windows.

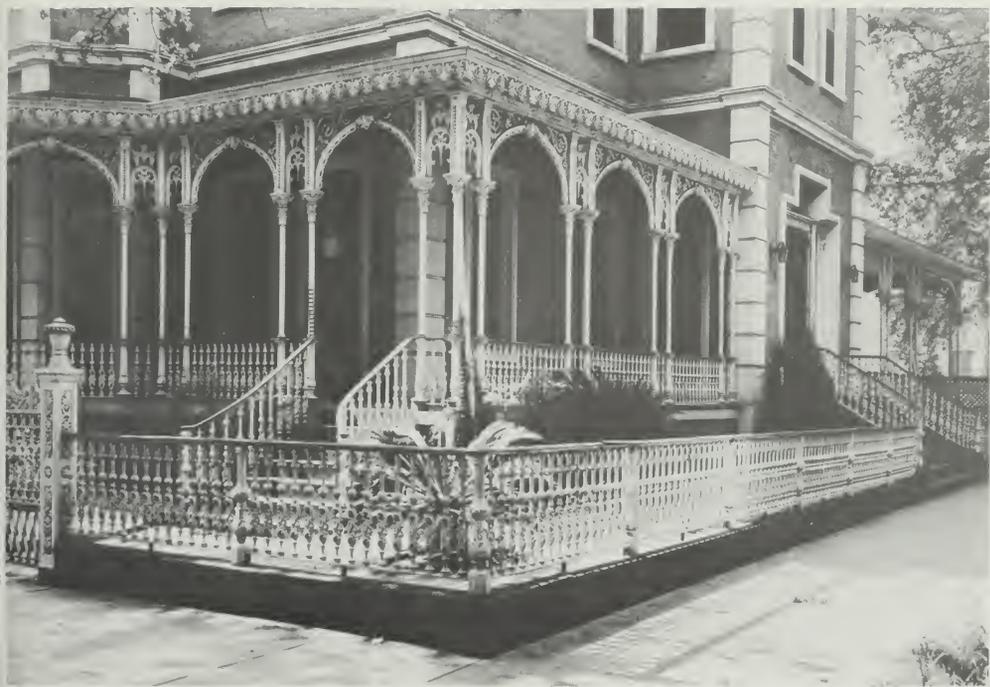
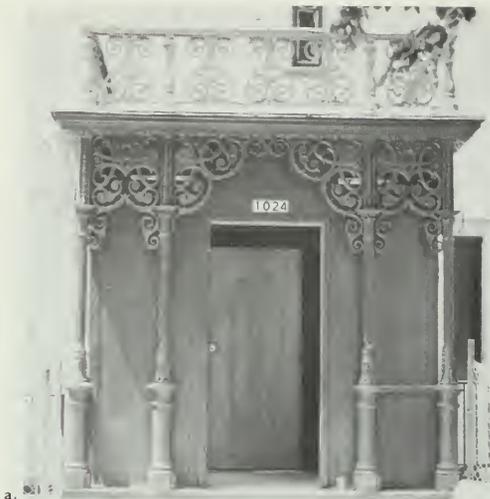
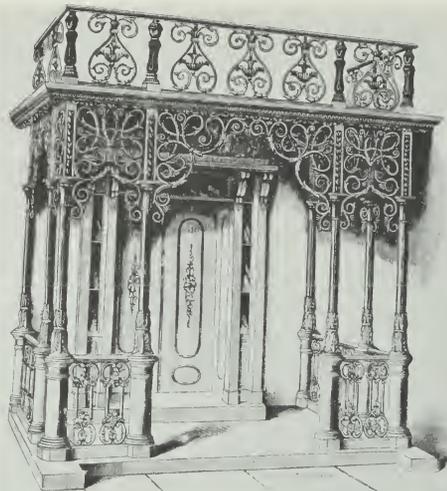
Figure 88. Cast-iron Veranda, Zephaniah Jones House, 1024 10th Street, NW, Washington, D.C.; Jones, Kirtland and Co., foundry. (a) It is a rewarding experience to see an advertisement for an architectural feature in a foundry catalog, then to discover the original model is still extant. (b) This veranda appears in Jones, Kirtland and Company's 1870 catalog of ornamental ironwork. The caption reads, "Verandah made to order for Z. Jones, Esq. of Washington, D.C." The veranda, in need of repair, remains on the Jones House over 100 years after its installation. (David W. Look)

Cast-iron verandas and balconies are almost universally identified with the streets and courtyards of New Orleans and with other Southern cities such as Savannah and Mobile (figure 87); but they are also found in many other localities (figure 88). If kept painted, these balconies and verandas can be preserved indefinitely. Sections may deteriorate or get broken, but they can be recast and inserted.

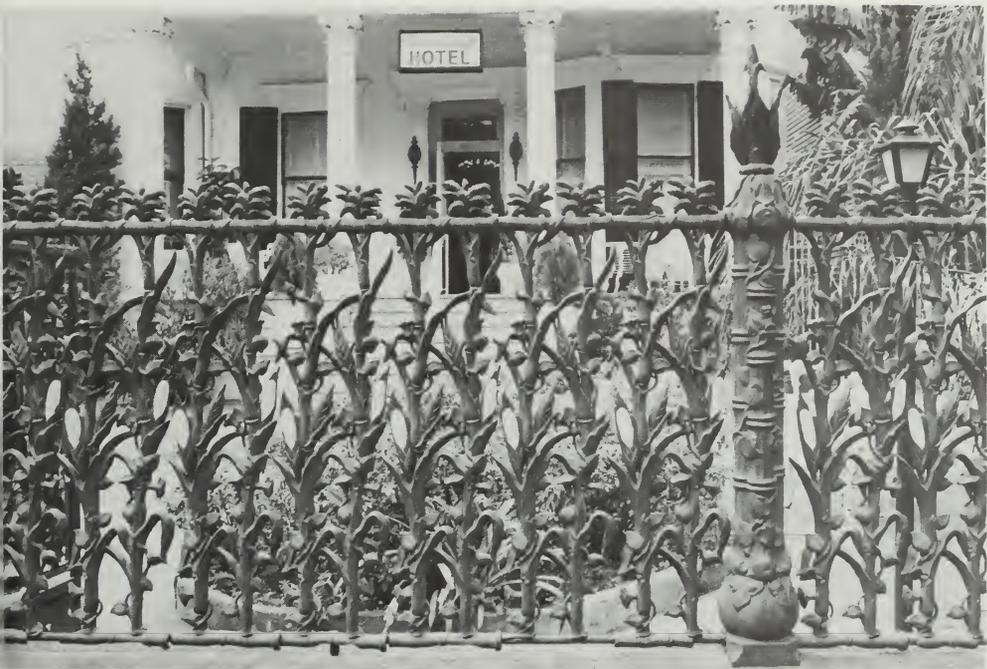
Figure 89. Cast-iron Fence, Cornstalk Hotel, 915 Rue Royale, New Orleans, Louisiana, ca. 1855; Wood and Perot, foundry, Philadelphia. In the 1850s, Dr. Joseph Biamenti brought his bride to this New Orleans house, later converted to a hotel. In an effort to keep her from feeling homesick for her native Iowa, the doctor commissioned this cornstalk fence from the well-known Philadelphia foundry. Representing a field ready for harvest, the green and yellow fence sports ripe cast-iron ears of corn on their stalks. Pumpkin vines entwine the stalks and climb up the ironposts to the bundle of corn ears which make up the finials. Once a foundry made patterns, it would usually advertise the new design in its catalog and reuse the molds as orders were received; a rendering of this fence appeared in the 1858 Wood and Perot catalog. In 1859 another cornstalk fence was erected by Wood and Altenger, the New Orleans branch of Wood and Perot, at the Short-Favrot House in New Orleans Garden District. (Becket organ)

Closely related to railings in style and composition were the cast-iron fences and cresting. Molten iron could be cast in so many different shapes from simple to elaborate that designers and patternmakers had free rein. They made grapevine fences and fences resembling rows of swords thrust into the ground; there were also fences with Greek key designs for Greek Revival style houses. Railings, fences, and gates done in Gothic tracery were favored for churches, and a favorite cemetery gate motif shows lambs lying beneath a weeping willow tree. Other fences were made to look like a row of corn stalks (figure 89). Many custom designed fences carried symbols related to the structures with which they were associated.

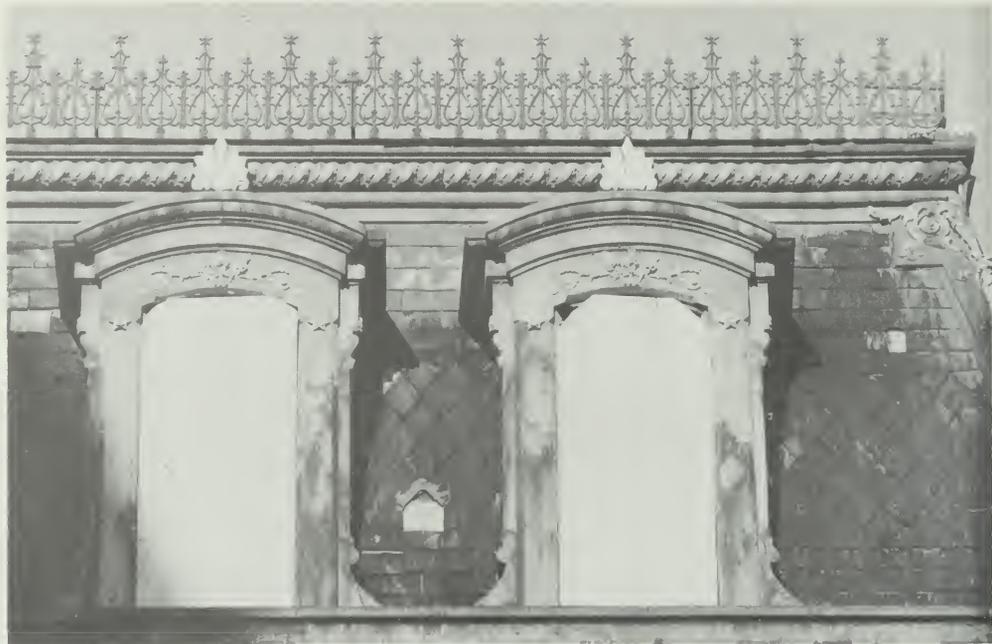
Figure 90. Cast-iron Cresting, Moran-Bogus Building, 501-509 G Street, NW, Washington, D.C., 1889-1890. This slate Mansard roof was added in 1890 by George Bogus, the second owner, to a brick commercial building built the year before by J. E. Moran. Cast-iron cresting was a popular ornamental feature on Gothic Revival and Second Empire style buildings, but can be found on other styles of structures during the Victorian era. Note also the galvanized sheet-iron rope molding and dormers with cast zinc ornament. (David W. Look)

Cast-iron cresting decorated the ridges of roofs and the edges of bay and porch roofs (figure 90). These decorative additions were mass produced and could be purchased in a variety of designs.

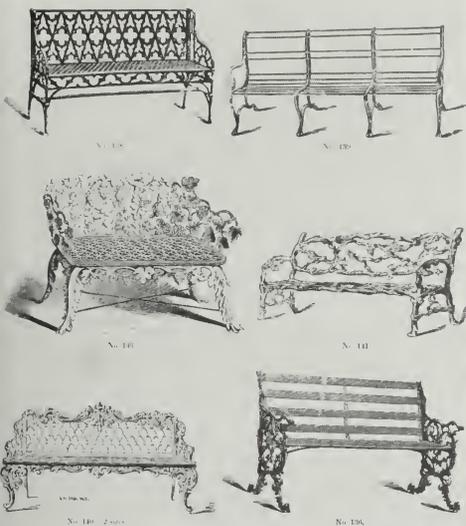
Figure 91. Cast-iron Benches, Illustrated Catalogue of Ornamental Iron Works, Janes, Kirtland & Co., 1870. Cast-iron furniture for both indoor and outdoor use enjoyed great popularity with the Victorians, especially for furnishing conservatories, porches, lawns, gardens, parks, public squares, and cemeteries. Benches such as these were cast in 10 or 12 sections, which were assembled and bolted together. After the rough edges were filed away to protect the user's clothing, the benches were painted several times to prevent rust from forming. This page of the catalog illustrates designs in the Gothic, rapévine, Rococo, and rustic styles. (Library of Congress)

"Street furniture" is very much a part of the urban landscape. It applies to various objects on our streets that facilitate public activities, including metal mailboxes and fire alarm boxes, fire hydrants, street lamps, trash containers, and also such amenities as benches (figure 91), drinking fountains, flower planters, and occasionally tall sidewalk clocks. Until recent years, most of these amenities were fabricated of cast iron. A few manufacturers still cast street furniture in Victorian designs or popular later designs.

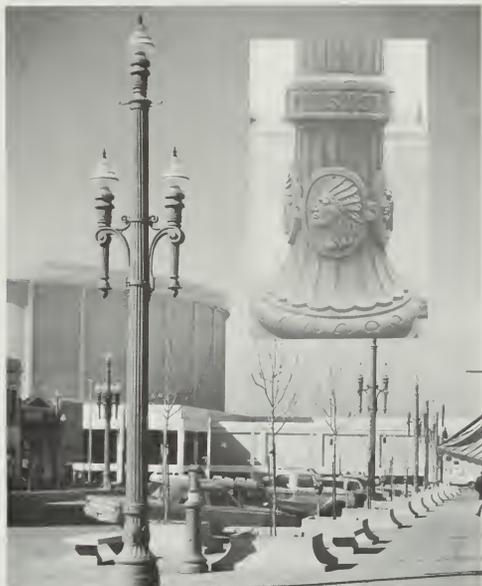
Figure 92. Cast-iron "Indian Head" Lamps, Salt Palace Complex, Salt Lake City, Utah. (a) Electric street fixtures began to replace gas fixtures in the 1880s; many of the ornate electric street lamps were erected about the time of World War I. (b) Salt Lake City put up cast-iron street lamps with Indian head medallions on the bases. With the recent revival of interest in the downtown area, the Utah Power and Light Company refurbished the surviving lamps and had others made. (Hal Rumel Studio; Utah Power and Light Co.)

Salt Lake City, one of the first American cities to have systematic electric street lighting, developed an elegant type of lamp standard with three lights on a tall fluted shaft. The cast-iron bases of these lamps bear four medallions displaying profiles of Indians in feathered war bonnets (figure 92). The city keeps old lamps and globes in good condition, replicates where necessary, and lines at least one central thoroughfare with them.

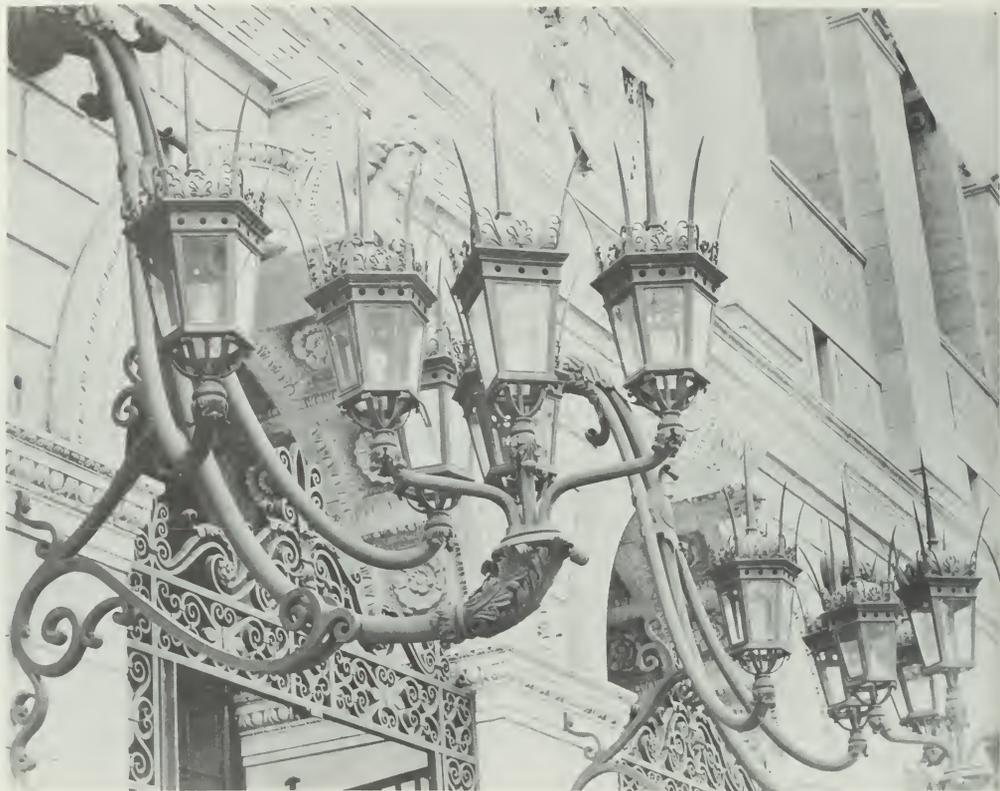
Figure 93. Iron Lamps, Boston Public Library, Copley Square, Boston, Massachusetts, 1895; Charles Follen McKim, architect. *The Boston Public Library contains many forms of metal ornamentation: bronze doors by Daniel Chester French, wrought-iron gates and grilles, and Strozzi-type wrought- and cast-iron lamps which flank the three entryways. Repeated casting from the same molds made ornamentation worthy of a Renaissance palace affordable in the 19th century.* (Esther Mipaas)

Sometimes lamps were added to a building many years after construction, but occasionally exterior lighting fixtures were designed as part of the building's facade. This is the case of the lamps on the Boston Public Library, which are an integral part of the building's composition (figure 93).

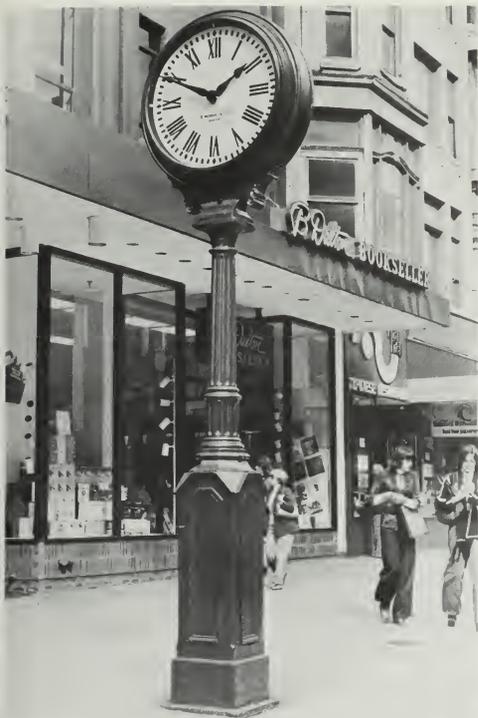
Figure 94. Cast-iron Post Clock, Boylston Street, near the corner of Berkley, Boston, Massachusetts, ca. 1900; E. Howard Clock Co. The iron post clock was a familiar item of street furniture for over a century, and was used nationwide as a form of advertising for merchants, especially jewelers, and for banks. This clock in the Boylston Street shopping area was manufactured by the noted New England clockmaker Edward Howard, whose company also made street clocks, steeple clocks, and watches long after his death in 1904. Other examples of such clocks can be found in Milwaukee, St. Louis, Salt Lake City, and Portland, Oregon. However, the post clock is a vanishing amenity, its useful life shortened by street widenings, abandonment of inner cities, and the ravages of the automobile. (Esther Mipaas)

Tall cast-iron street clocks were popular at the turn of the century, especially as picturesque advertisements for banks and jewelry shops. But they also rendered a public service (figure 94). Many still exist, and several cities, including Milwaukee, San Francisco, and Portland, Oregon, have designated them official landmarks.

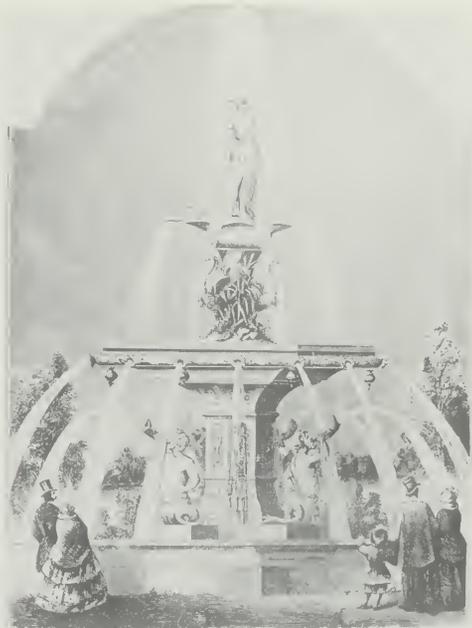
Figure 95. Cast-iron Fountain, Plate Number 5, Illustrated Catalogue of Ornamental Iron Works; Janes, Kirtland and Co., 1870. Large cast-iron fountains became part of America's urban landscape after the 1851 London Crystal Palace Exhibition, where several iron fountains attracted attention. A French example was said to have inspired this design, which was first made for the city of Savannah, Georgia. In 1856, the fountain was installed in Forsyth Park where, with the benefit of a recent restoration, it exists today. Janes, Beebe and Co., maker of the fountain and forerunner of Janes, Kirtland and Co., offered it in the 1858 catalog for \$2,500 plus the cost of the basin. Poughkeepsie, New York, and Madison, Indiana, have similar fountains. The tri-level fountain was made of hundreds of pieces of cast iron, which were shipped to the site, bolted together, then caulked and painted. The lowest level displays large trumpeting Tritons, the second waterfowl, and the top a figure holding a water-spouting torch. (Library of Congress)

opulent, tiered structures decorated with waterbirds, porpoises, tritons, cherubs, and even life-size human figures. Although they were often expensive items and represented a considerable civic investment (figure 95), they were less expensive and more common than bronze. Smaller iron fountains were produced for the lawns of institutions and for private gardens.

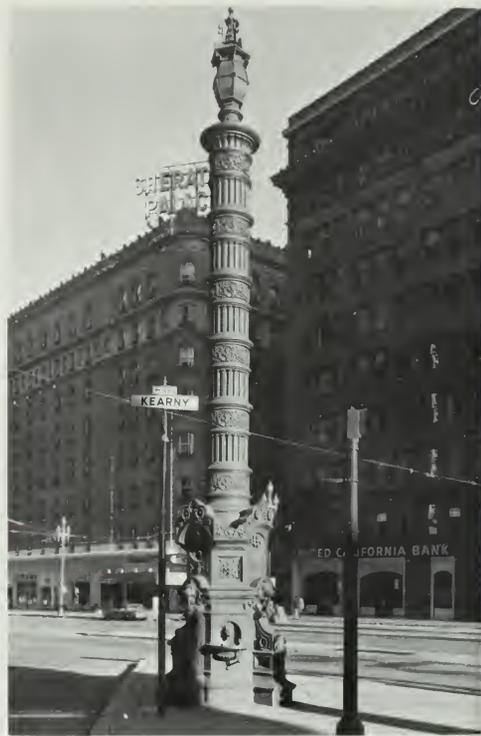
Figure 96. Cast-iron Drinking Fountain, intersection of Market, Kearny, and Geary streets, San Francisco, California, 1875. Cast iron took many shapes in the 19th-century urban landscape. One of the more interesting is this public drinking fountain given to the city by Lotta Crabtree, a grateful citizen who had acquired fame and fortune there as an actress. The fountain was restored and rededicated on its 100th birthday in 1975. (Becket Logan)

Some Victorian cast-iron fountains were both utilitarian and ornamental. Such is the case with Lotta's Fountain in San Francisco (figure 96). This sentimental 1876 gift to the city from the famous actress Lotta Crabtree incorporates four spigots for drinking water along with a tall decorated column with a light on top. Its base is heavily ornamented with cast-iron medallions depicting gold miners and sailing ships.

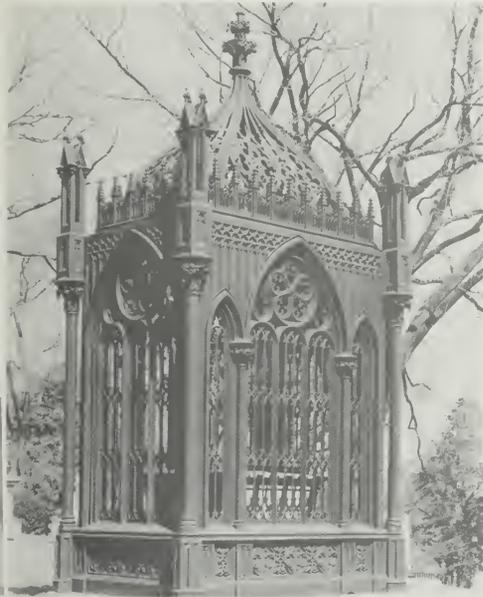
Figure 97. Cast-iron Tomb Enclosure, Grave of President James Monroe, Hollywood Cemetery, Richmond, Virginia, 1859; Albert Lybrock, architect; Wood and Perot, foundry, Philadelphia. The ceremonial enclosure of the tomb of James Monroe is a particularly fine example of cast-iron design and craftsmanship. In the 1850s the state of Virginia took steps to move Monroe's resting place from New York to his native state. The Gothic Revival design chosen for the tomb was that of German-born Richmond architect Albert Lybrock. Perhaps more important was the selection of Wood and Perot, manufacturers of ornamental iron, to prepare the patterns, make the molds, and cast the separate parts that would compose this work of art. The words "Robert Wood, Maker" can be found at the edge of the enclosure. In later years, Wood and Perot presented sketches of the tomb cover in its sales catalog. It measures 7 feet wide by 10 feet long, with a perforated canopy rising 20 feet to a finial of crockets. Four miniature corner towers enclose side panels filled with Gothic arches and refoil patterns. (F. Heite, Library of Congress)

One of the finest examples of the founder's sculptural art is the 1859 iron tomb marking the grave of President James Monroe. In Richmond, Virginia's, Hollywood Cemetery on a prominence overlooking the James River, this Gothic style cast-iron masterpiece was designed by German-born Richmond architect Albert Lybrock and cast in the foundry of Wood and Perot in Philadelphia (figure 97). "Cast iron Mausoleums of beautiful design and finish" were advertised by Wood, Miltenberger and Co., the New Orleans branch of Wood and Perot. Several splendid iron tombs exist in New Orleans' historic cemeteries, while others, apparently stock designs, can be seen in Mobile, Alabama. Examples of modest-scale cast-iron architecture, these elegant little buildings were made of parts separately cast and bolted together by the same methods employed for iron front warehouses, hotels, and stores. Like their commercial counterparts, some tombs were individually designed and others could be ordered from catalogs.

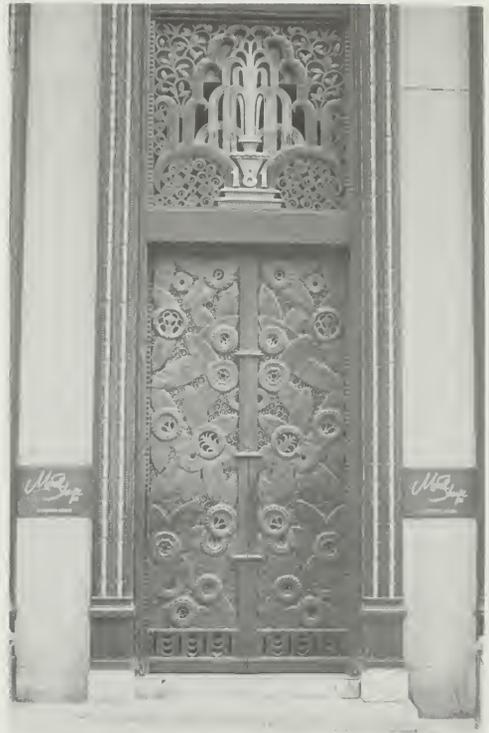
Figure 98. Cheney Brothers Silk Store (now Merrill Sharpe, Inc.), 181 Madison Avenue, New York City, 1925; Howard Greenley, designer; Ferrobrant, foundry. Originally fabricated under the direction of Jules Bouy for Cheney Brothers Silk Store. These doors were later moved in 1928 to their present location, the Madison Belmont Building. Edgar Brant of Ferrobrant fabricated the additional metalwork for the new building. Note that the parts of the frame and transom painted gold (the lighter color in the photo) are actually cast bronze, recently restored and polished. (David W. Look)

Other uses of cast iron continued uninterrupted until new styles eliminated their use or they could be more economically made of new materials. Two late examples are the Charles Scribner's Sons Bookstore on Fifth Avenue in New York City, which has an iron and glass storefront built in 1913, and the doors of the Cheney Brothers Silk Store, which were cast in iron in 1925 (figure 98). Cast iron was even used in the Art Deco period, when many new metals were becoming available.

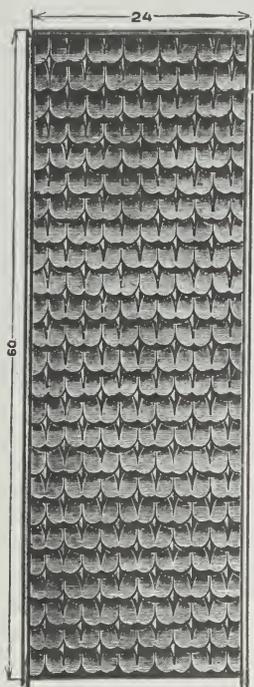
Fig. 139.

Fig. 139 shows Cluster Shingle, with pressed standing seam edges, applied with cleats.

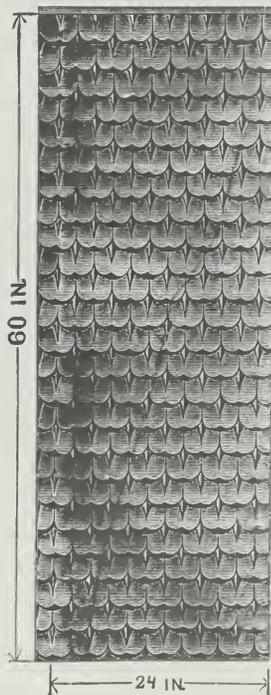
Fig. 140.

Fig. 140 shows Cluster Shingle in sheets. This is particularly adapted for gables, mansards and siding. The side lap is made by lapping one-half of a shingle and is perfectly water-tight when properly nailed.

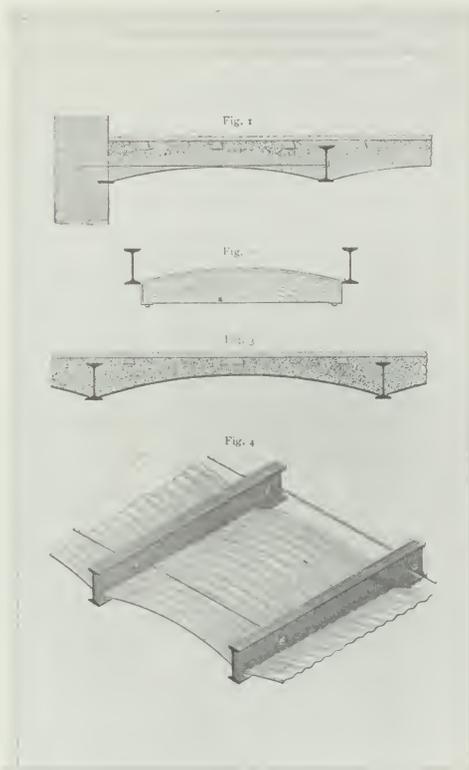
Figure 100. Corrugated Iron Arched Floor Construction Pocket Companion . . . , Carnegie, Phipps and Co., Ltd., Pittsburgh, 1890, p. 43. In an effort to reduce the time needed for arch construction (figures 1 and 2), the corrugated iron arch was introduced (figures 3 and 4) with a concrete fill. The sheets of corrugated iron, bent to a radius, were sprung between the bottom flanges of the I-beams. Note the tie rods between the beams to keep correct spacing and beam alignment. Even though iron is noncombustible, these floors were not "fireproof" because the iron arches and beams lost their strength and collapsed when exposed to the high temperatures of a fire. (Library of Congress)

Corrugated iron and later steel had other uses besides roofing; the most important was in floor construction. Arched sheets of corrugated metal were placed on the bottom flanges of beams spaced 4–5 feet apart (figure 100). Concrete was then poured over the beams and sheets to provide a flat floor. Previously, brick arches had been used between the beams, but the corrugated sheet iron or steel was faster to install. Both types were usually plastered to provide a finished ceiling for the room below.

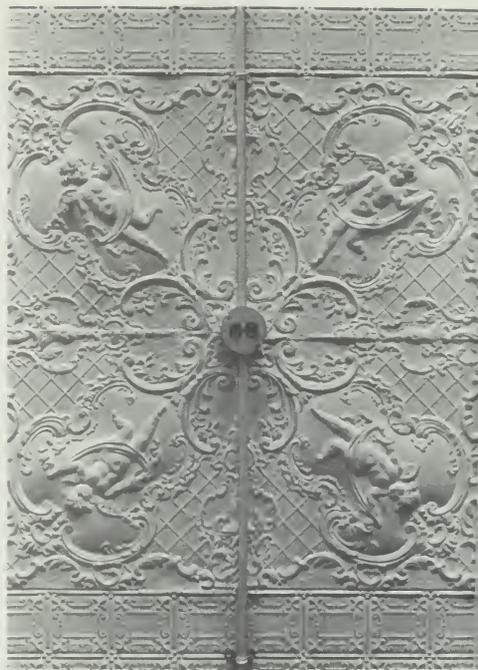
Figure 101. Pressed Metal Ceiling, 212 West Main Street, Johnstown, New York. Mistakenly called "tin ceilings," pressed metal ceilings were stamped sheet iron and later sheet steel; only one or two isolated companies coated them with tin. Pressed metal was sometimes galvanized with zinc, especially when used outdoors or as porch ceilings. It was sold by the sheet with the patterns fitting neatly together for covering ceilings and sometimes walls or wainscoting. Accessory pieces, such as ceiling medallions, were available. Cornices provided the transition from ceiling to walls. (Becket Logan)

As early as 1868, sheet iron was used for ceilings, probably to provide some fire protection. The early ceilings were corrugated, and sheet iron and steel was also sometimes stamped with designs (figure 101). Although commonly called "tin ceiling," these pressed sheets were not usually tin plated for indoor use, but were always painted to protect them from deterioration. Some galvanized sheet iron or steel ceilings were produced. Pressed metal ceilings were popular through the first two decades of the 20th century. They are still available today. At least one company now makes pressed metal ceilings that are tin-plated.

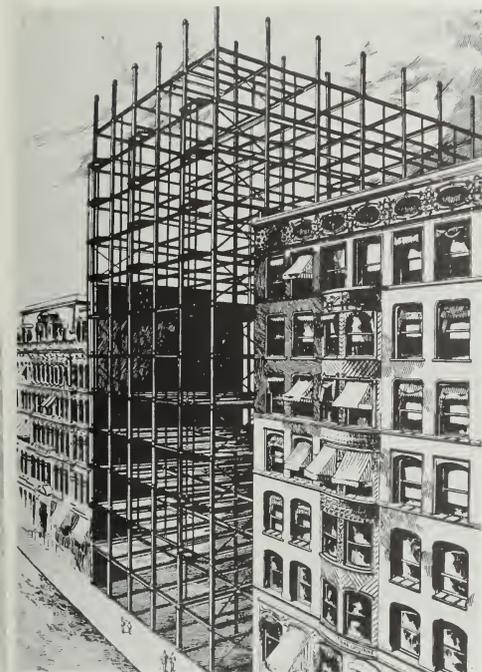
Figure 102. Iron and Steel Skeleton Frame, Unity Building, Chicago, Illinois, 1891-1892; Clinton J. Warren, architect. One of the best-known contributions of Americans to the development of architecture is the skeleton frame, pioneered by architects of the "Chicago School" in the late 19th century. Before the steel skeleton, construction of buildings of even moderate height required thicker and thicker walls to bear the increased load. With the new method, the weight of the building is carried on the frame, not the walls. The skeleton frame allowed buildings to rise to tremendous heights without using increasing amounts of floor space for wall thickness, thus increasing rental income. Construction documents of this period reveal other records. Construction of the Montauk Building was continued through the winter of 1881 by covering the frame with canvas and heating the space with steam. Electric lights allowed crews to work around the clock. Construction records were set when steel for the top ten stories of the Reliance Building were erected in 15 days, from July 16 to August 1, 1894. Once the frames are fireproofed, they are not seen again until a building is rehabilitated or demolished. (*Industrial Chicago*, volume 2, 1891, facing page 234, Library of Congress)

102). The exterior walls were "hung like curtains" on a lighter but stronger frame. A whole new vocabulary of building connections was developed for anchorage of the curtainwalls to the skeleton and for the complex connections between columns, beams, and girders (figure 103).

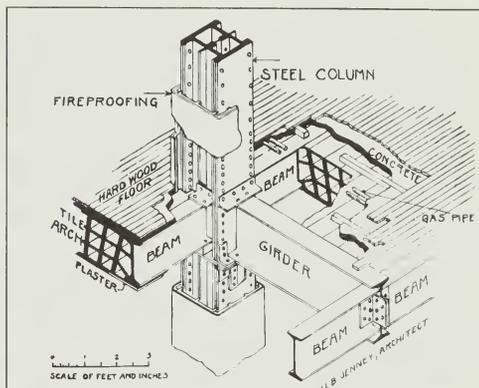
Figure 103. Detail of a Column-and-Girder Connection and Floor Construction, The Fair Store, South State, West Adams, and South Dearborn Streets, Chicago, Illinois, 1892; Jenney and Mundie, architects. This is a connection of the type used in many iron and steel connections. Note the "fireproofing" of the columns, which consisted of terra-cotta tile and plaster. The floors were constructed of lightweight, flat tile arches covered with a concrete topping slab with wooden sleepers to receive the hardwood floor. The bottom of the flat tile arches was plastered to provide the finished ceiling of the room below. (*Industrial Chicago*, volume 2, 1891, facing page 842; Library of Congress)

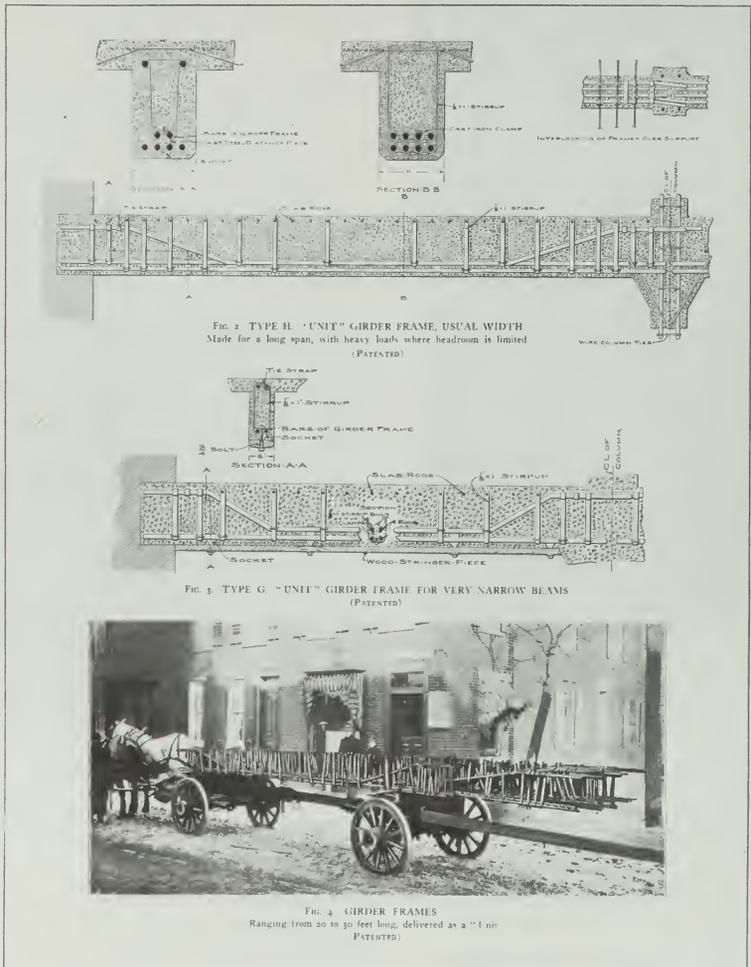
Figure 104. Reinforced Concrete, Advertisement of the Unit Concrete Steel Frame Company, Philadelphia, Pennsylvania, from "Sweet's" Indexed Catalogue of Building Construction, 1906, p. 128. This company specialized in the prefabrication of reinforcing for concrete girders ranging from 20 to 30 feet long, delivering them as a "Unit" to the construction site by horse-drawn wagon. Reinforced concrete girders and beams, consist of concrete (which is good only in compression) reinforced with bars of steel (which is good in both compression and tension). Most of the steel bars are placed at the bottom of the girder at the center of the span where the top part of the girder is in compression (to be taken by the concrete) and the bottom part of the beam is in tension (to be taken by the steel rods). Slab rods are only for controlling shrinkage of the slab. The opposite situation appears at the ends of the girder where it passes over a support. There the bottom part of the girder is in compression and the top part is in tension, explaining why some of the bars are bent up at an angle toward the ends of the girder. Note the cast-iron clamp and cast-steel distance piece which hold the reinforcing bars in correct vertical and horizontal alignment when the wet concrete is poured around the bars in the temporary wooden formwork (not shown). The 1/8- by 1-inch stirrups take shear loads.

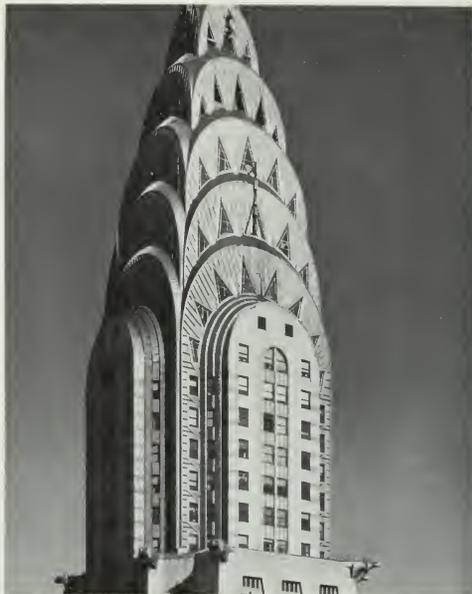
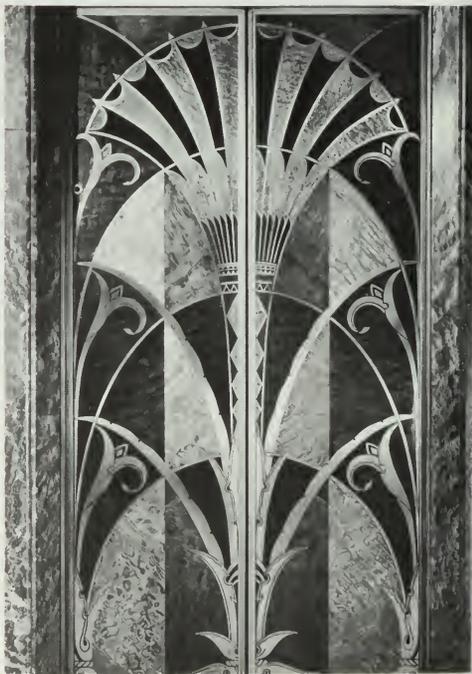
Figure 105. Stainless Steel Dome, Gargoyles, and Elevator Doors, Chrysler Building, 405 Lexington Avenue, New York City, 1928-1929; William Van Alen, architect. (a) *The Chrysler Building was the first extensive use in America of chromium-nickel steel, now commonly called stainless steel, as an exterior finish on a large commercial structure. There are many types of stainless steel with different properties: the type used here was Nirosta, K.A.2 (Krupp's formula), installed by the sheet metal contractor, Benjamin Riesner, Inc. According to the architect, "The sheet metal covering for the needle or upper third of the spire (not shown) was attached directly to the structural steel frame. A base of "nailing" concrete was provided for the sheet metal work, completely covering that portion of the dome and spire below the needle, and extended down on both sides of the circular-head dormers to the 59th floor level. The sheet metal ribs were fastened to fireproofed wood nailing strips placed on top of the concrete and fastened to the structural steel frame. Standing or lock seams, made without solder, were used throughout, except where they were impossible or undesirable, where soldered seams were used. The radial ribs on the fronts of the metal-covered dormers of the dome and similar ribbed construction are formed by sheet metal-covered wooden battens. Contact between dissimilar metals was avoided by using Nirosta steel nails, screws, bolts, nuts, and rivets for fastening the sheet steel in position."* (b) *Influenced by the discovery of the King Tut's tomb, these stainless steel elevator doors are inlaid with rare woods in a stylized Egyptian design featuring a lotus blossom at the top.* (Cervin Robinson)

Stainless steel sheets have been used for roofing, flashing, gutters, leader heads, downspouts, and cladding. One of the most extensive early uses of stainless steel was in the Chrysler Building in New York City. Architect William Van Alen originally intended to use aluminum to clad the building's Art Deco pinnacle (figure 105a), but finally decided in favor of stainless steel. The gargoyles were cast of stainless steel; the main entrance and storefronts are fabricated of rolled sheets and extruded sections of the same material. The elevator doors are stainless steel inlaid with wood (see figure

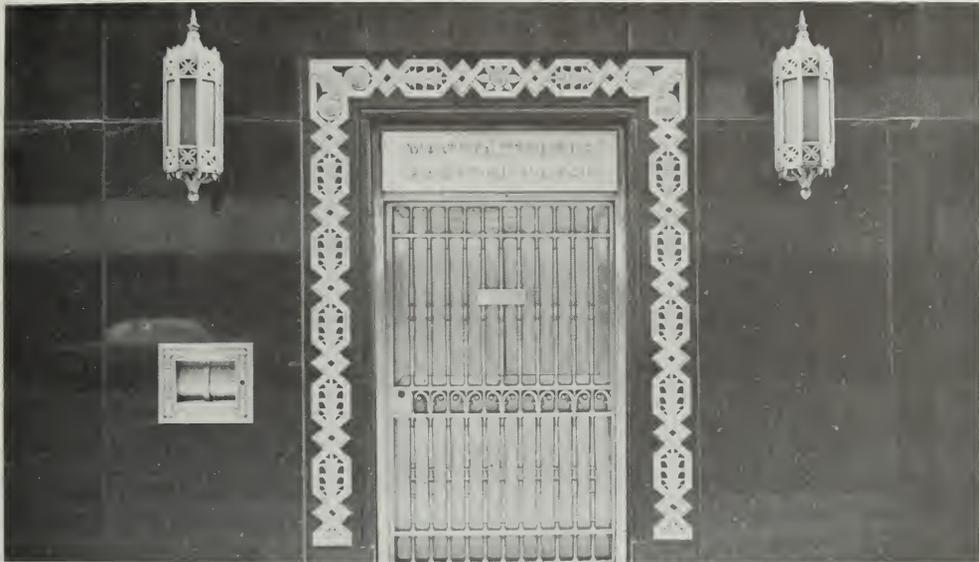
Figure 106. Cast Stainless Steel Entrance, Manufacturers Hanover Trust, Chrysler Building, New York City, 1931; Cooper Alloy Foundry, Elizabeth, New Jersey. The gate, door, frame, lamps, night deposit, and lettering were cast in Nirossta stainless steel. (David W. Look)

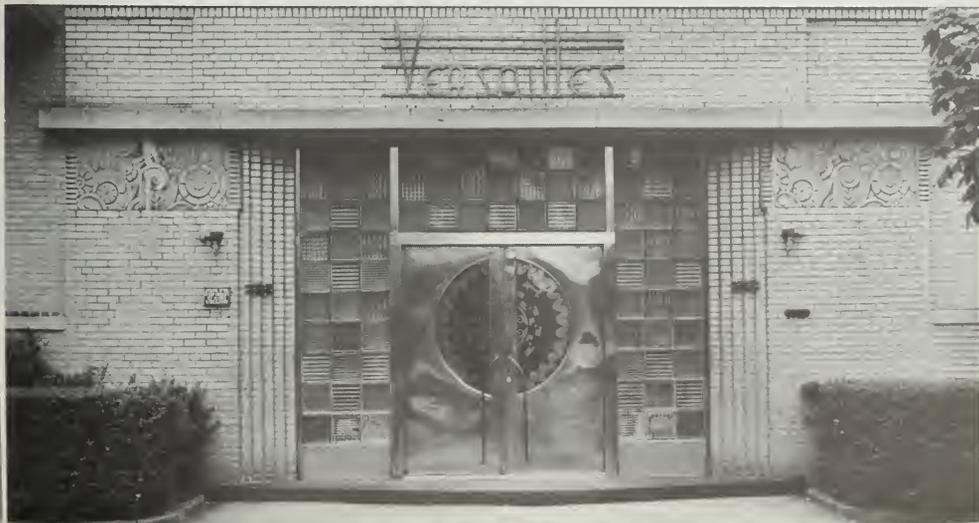
Figure 107. Typical Stainless Steel Doors, Versailles Apartment Building, 1717 Avenue N, Brooklyn, New York, 1936; Kavy and Kavovitt, Inc., architects. The doors were fabricated from sheets of stainless steel with etched and frosted glass in the window. The stainless steel frame was produced from rolled sections and inset with glass blocks. Identical doors with clear glass can be found on the Majestic and Gynwood apartment buildings in Washington, D.C. (David W. Look)

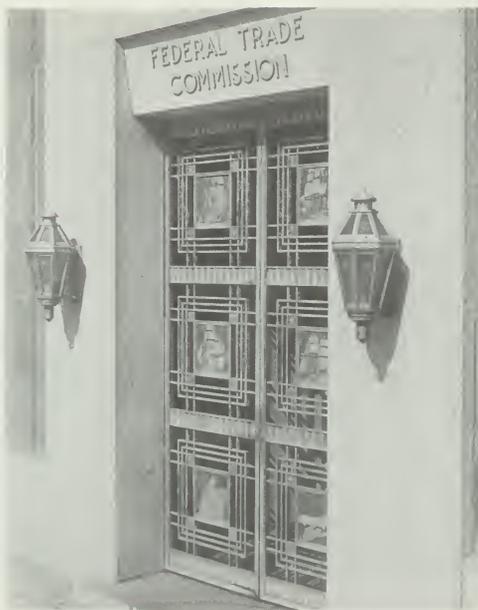
Figure 108. Stainless Steel Gates, Lamps, and Lettering, Federal Trade Commission, Sixth and Constitution Avenue, NW, Washington, D.C., 1937; Bennett, Parsons, Frost, architects; William McVey, sculptor. During the 1930s stainless steel was frequently used for monumental doors and ornamental gates on government buildings. Noted sculptors were employed to design custom ornamental metalwork. The lamps, lettering, and window grilles (not shown) are all stainless steel. (David W. Look)

In the late 1920s and 1930s, the use of white metals increased with the rise of Art Deco, Depression Modern, Streamline Modern, and the International styles. Mirror finish chromium-plated metalwork was frequently used, but the plating often wore through to the base metal in high traffic areas such as entrances and lobbies. Since stainless steel is very hard, can be highly polished, and requires little maintenance other than periodic washings, it was a good choice for doors and storefronts. Some designs for stainless steel doors that became standard stock models can be found on several buildings, including the Versailles Apartment Building in Brooklyn (figure 107). Others were custom designed such as the stainless steel gates on the Federal Trade Commission Building in Washington, D.C., modeled by sculptor William McVey (figure 108).

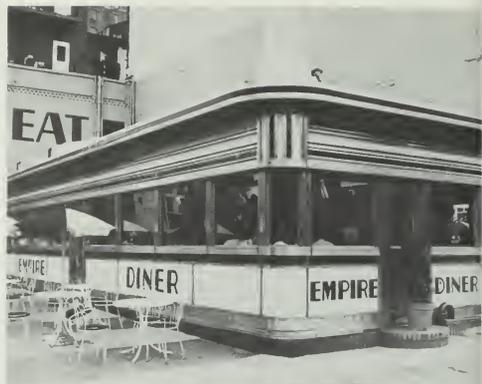
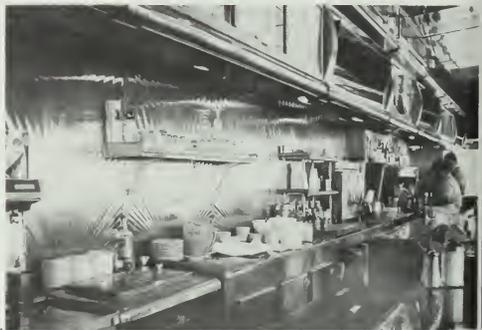
Figure 109. Stainless Steel Empire Diner, 210 Tenth Avenue, Chelsea, New York City, 1943, altered, 1976; Carl Laanes. (a) Early diners were horse-drawn wooden wagons, but after the advent of the automobile they soon became stationary. Although companies built diners in a range of sizes and styles, and of various materials, the stainless steel diner became the ultimate expression in diners. The exterior of the Empire Diner has panels and strips of white and black enameled steel which contrast with the polished stainless steel. (b) Although some early diners had wooden interiors and Monel metal equipment, most diners were paneled with pressed stainless steel and had stainless steel equipment by the 1940s. (David W. Look)

Although there has been a long search for a noncorrosive material for bridge construction, stainless steel has not been used extensively, probably because of cost. As early as 1909, some nickel steel was used in construction of the Queensboro and Manhattan bridges crossing the East River in New York City. In 1937, 3,680 tons of 3.5% nickel steel were used for structural members of the San Francisco-Oakland Bay Bridge and 370 tons of stainless steel were used for pins in the cantilevered portion of the bridge. However, a total stainless steel bridge has never been built. After World War II, stainless steel replaced Monel metal for dairy, hospital, kitchen, restaurant, and laboratory equipment for economy. During the 1940s and 1950s, the stainless steel diner became a familiar part of American cities (figure 109).

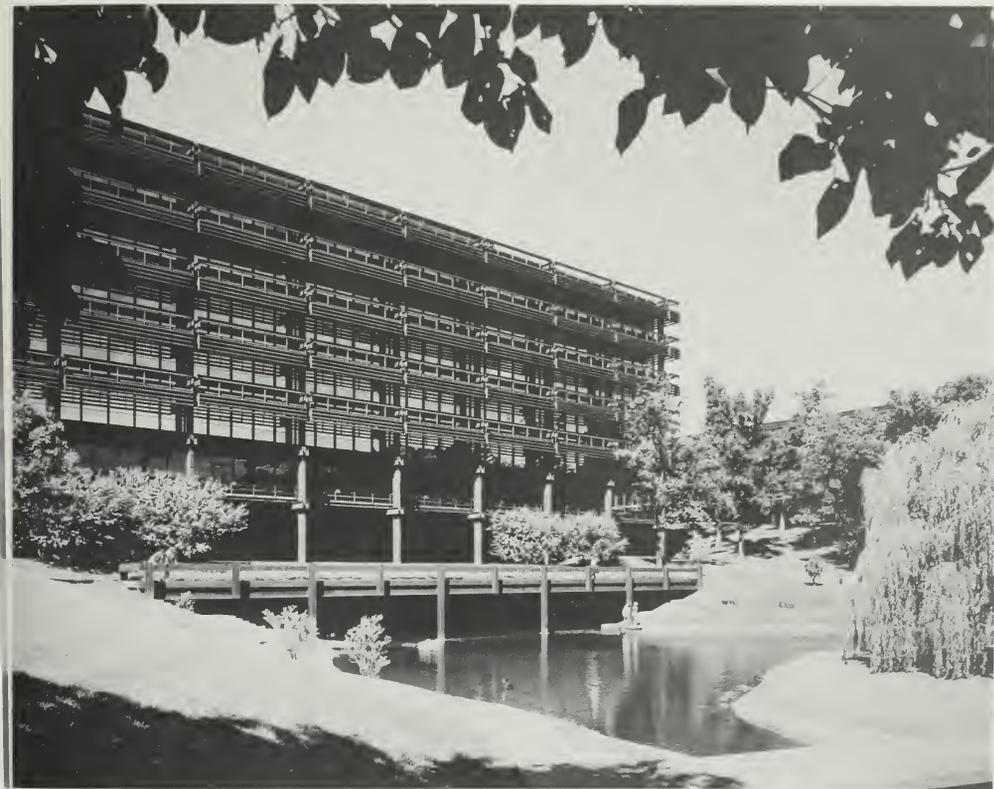
Figure 110. "Corten" Steel, Deere and Company Administrative Center, Moline, Illinois, 1964; Eero Saarinen, architect. *The Deere and Company building, which received many architectural awards, was among the first to make extensive architectural use of this unpainted, corrosion-resistant material for exterior steel members. (Deere and Company)*

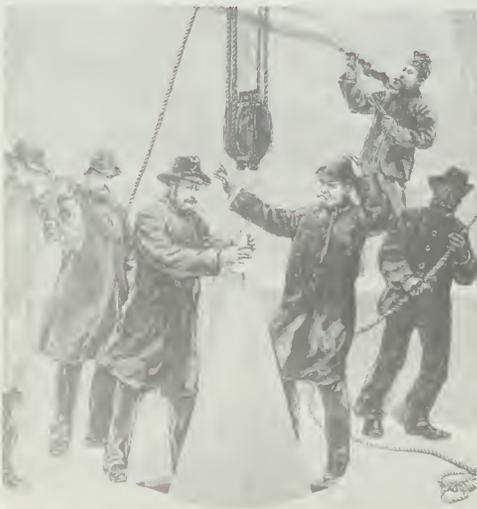
Figure 111. The Setting of the Aluminum Tip on the Washington Monument, Washington, D.C. The first architectural use of aluminum was the small pyramidal cap of the Washington Monument, which was set in place on December 6, 1884. At that time, aluminum was still considered a precious metal. (Engraving in Harper's Weekly, December 20, 1884; Martin Luther King Library)

In 1855 at the Paris Exposition aluminum was introduced to the public. Napoleon III had pocket watches and a table service designed of it, and during the American Civil War, General Ulysses S. Grant received an aluminum medal from the U.S. Congress. One hundred ounces of the rare metal were cast to form the small pyramidal cap of the Washington Monument in Washington, D.C. Before ceremonial positioning of the cap atop the monument on December 6, 1884 (figure 111), it was displayed in Tiffany's window in New York City. The monument cap was the first American architectural use of aluminum.

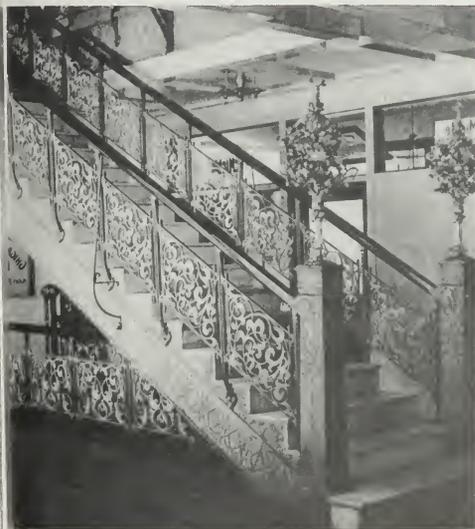
Figure 112. Cast Aluminum Staircase, Monadnock Building, 13 West Jackson Boulevard, Chicago, Illinois; Burham and Root, architects; Winslow, Brothers, Co., foundry. Although the Monadnock Building is widely known as the last skyscraper with load bearing walls, few people know that it contains the second known architectural use of cast aluminum in America. The first story staircase, including the newell posts, electroliers, alustrade railing, facias, and stringers, are all cast of aluminum. The lamps have been removed. Aluminum ventilation grilles near the exterior doors are also illustrated, but have also been removed. (plate 4, Collection of Photographs of Ornamental Iron Executed by Winslow Bros., 1893, Library of Congress)
