Metals in America's Historic Buildings

Uses and Preservation Treatments

U.S. Department of the Interior
National Park Service
Cultural Resources
Preservation Assistance
Washington, D.C.
1992

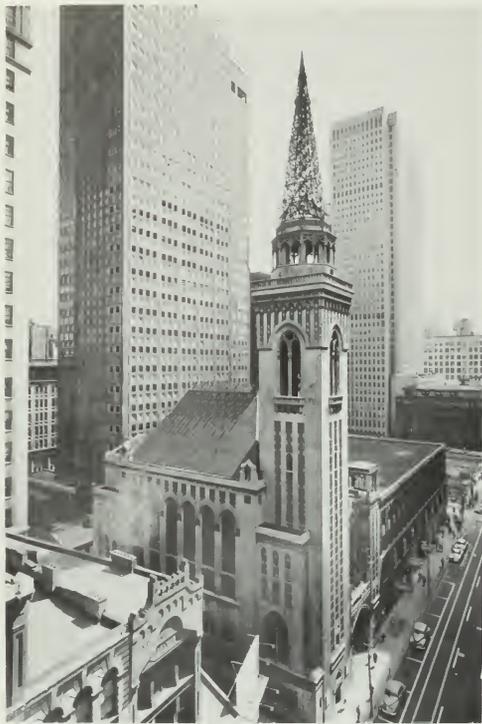
Figure 113. Cast Aluminum Spire, German Evangelical Protestant Church, Pittsburgh, Pennsylvania, 1926; Henry Hornbostel, architect. Also Alcoa Building (background, left), Golden Triangle, 1952; Harrison and Abramovitz, architects. *The perforated spire of the German Evangelical Protestant Church, now the Smithfield Street Congregational Church, consists of 22 filigree aluminum castings. The Alcoa Building is the first multistory structure with an aluminum curtain wall. The other tall building (right) is the United States Steel-Mellon Building. (Carnegie Library of Pittsburgh)*

The perforated Gothic spire of the Smithfield Street Congregational Church was cast in Pittsburgh and affixed to the church in 1926 (figure 112). Another exterior use of aluminum was in the 1929 Springfield, Illinois, Post Office where decorative aluminum panels are set into the walls, and bold stylized anthems stand along the roofline.

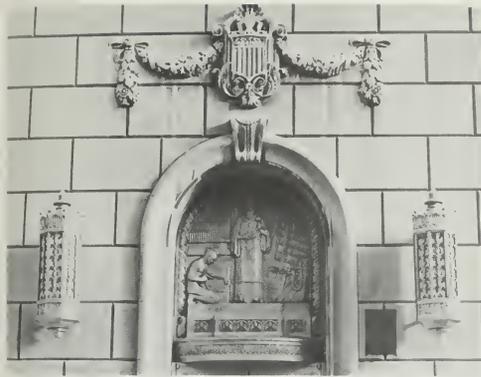
Figure 114. Aluminum Bas-Relief Sculpture in Tympanum and Lamps, U.S. Customhouse, bounded by Chestnut, Second, and Third streets, Philadelphia, Pennsylvania, 1933; Ritter and Shay, architects; Edward Ardolino, sculptor. In the 1920s and 1930s, architects frequently chose one of the white or silvery metals for their buildings; those designing in the Art Moderne, now called Art Deco style, especially considered gold or bronze colored metals "old-fashioned." The highly stylized bas-relief mural in the tympanum is flanked by cast aluminum and glass lamps. (Esther Mipaas)

In 1933 almost 65,000 pounds of aluminum sheets were used to roof the Union Terminal in Cincinnati. That same year the architectural firm of Ritter & Shay, designed the U.S. Custom House on Chestnut at Second Street in Philadelphia, which had aluminum light standards and sculptural bas-relief figures in tympanum panels over the doors (figure 113). In Washington, D.C., sculptor Carl Paul Jennewein modeled the aluminum work for the Department of Justice Building (figure 114).

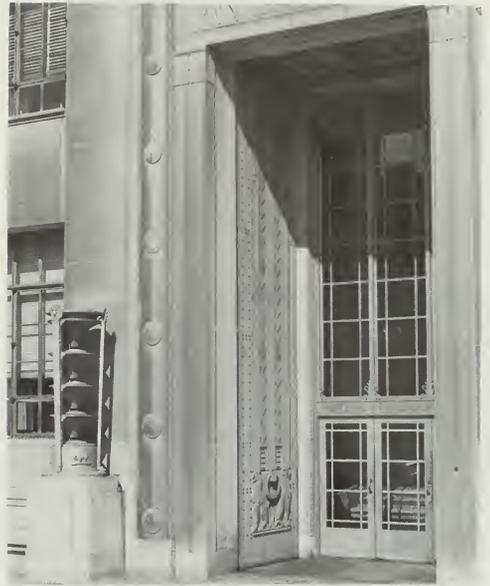
Figure 115. Aluminum Doors and Lamps, U.S. Department of Justice, Ninth and Constitution Avenue, NW, Washington, D.C., 1934; Zantzing, Boris, Medary, architects; Carl Paul Jennewein, sculptor. The monumental doors, fabricated of cast lions and rolled sections of aluminum riveted together, are opened back into pockets of the walls of the entrance showing the inner set of aluminum and glass doors and transom. Flanking the entrance are cast aluminum lamps with stylized eagles, buffaloes, and dolphins. The work was executed by Anthony D. Lorenzo. (David W. Look)

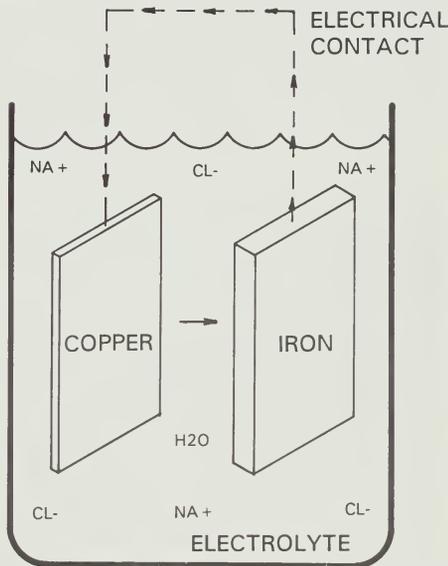
MECHANISM OF COPPER / IRON GALVANIC CORROSION

ARROWS INDICATE ELECTRON FLOW PATH

Figure 116. Galvanic Corrosion. A galvanic action occurs between the copper and iron with the water serving as the electrolyte. (Texas Instruments)

Galvanic Corrosion is an electrochemical action that occurs between two different metals in electrical contact in the presence of a common electrolyte forming an electrical couple (where there is a flow of electrons). Positive ions can travel through an electrolyte such as ionized water (which must be present). A galvanic action will occur only (1) when there are two dissimilar metals having a difference in a potential, (greater and lesser degree of nobility), (2) when the two dissimilar metals are in electrical contact so there can be a flow of electrons, and (3) when there is an electrolyte so that ions can move from one metal to the other (figure 116). In some cases, the electrolyte may be moisture or condensation on the surfaces of the metals. If any of the three conditions are not present, then galvanic action will not take place.⁷

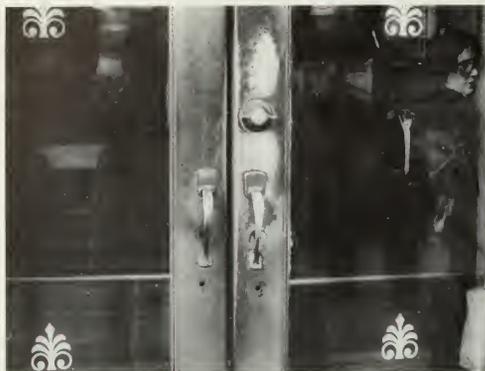
Figure 117. Human Abrasion At the Old Post Office in Baltimore, Maryland, the bronze and glass doors show the abrasive effect of human hands on the natural patina combined with a residue of dirt and oil (from skin, which contains a minute amount of acid). This wear with accompanying superficial discoloration is only a minor problem. Over the years, these doors have received inadequate maintenance and inappropriate changes (to the hardware) and repairs. Such doors should be thoroughly cleaned to the bare metal; the holes plugged, ground down, and polished; and new chemical artificial bronze patina applied and protected by a lacquer with a corrosion inhibitor and/or with periodic applications of wax or oil (see section on bronze Chapter 15). (David W. Look)

ing the protective corrosion deposits from the metal surface. Abrasion is an especially critical problem with metal flashings and valleys used on slate roofs. As the slate deteriorates, particles break off and are washed down the valleys, causing erosion. Other examples of abrasion are when the patina, push plates and rail on bronze and brass doors (figure 117), chrome plating on railings, and brass thresholds are worn by pedestrians.

In the case of human wear and tear, lacquer, wax, and oil have been applied to brass and bronze to resist corrosion and provide a renewable surface. Replaceable plastic guards may be installed over the metal to prevent wear in high pedestrian traffic areas.

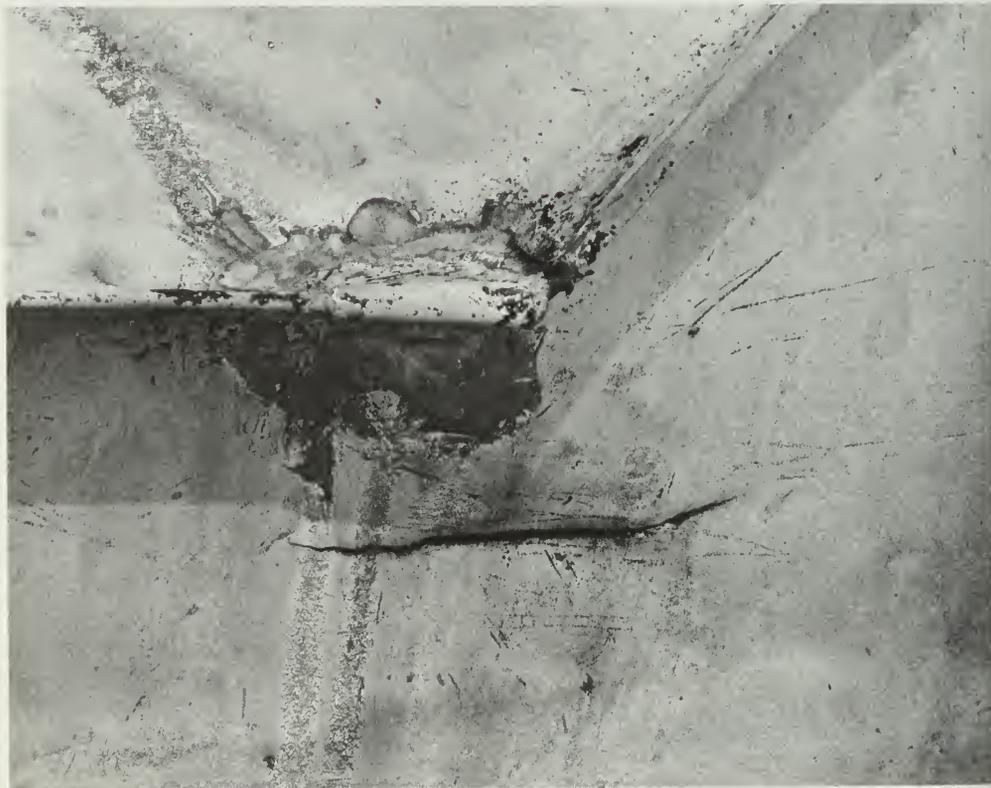
Figure 118. Fatigue Failure. This is an example of fatigue cracking of the copper roof of the Senate House, Kingston, New York. Repeated expansion and contraction due to daily and seasonal temperature changes has caused this sheet-copper roof to crack. Note cracking both at the joint and on the planar surface. (John G. Waite)

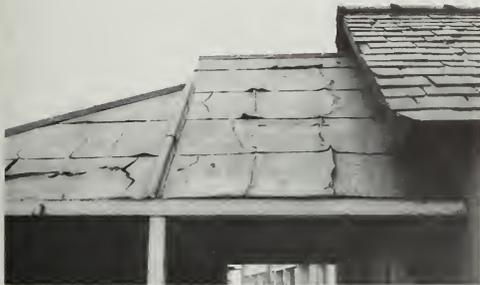
Figure 119. Creep. Deterioration of milled sheet lead roof on a 19th century canal warehouse and office at Nantwich Basin of the Shropshire Union Canal at Nantwich, Cheshire, England. The failure has been caused by creep and the expansion and contraction of the lead. (John G. Waite)

metal. The problem of creep is often associated with sheet lead roofing (figure 119), lead statuary, and pure zinc.

Because lead has a relatively high coefficient of thermal expansion (three times that of steel), it is subject to buckling and fatigue cracking caused by daily and seasonal temperature changes. Creep (figure 119) is damaging to lead roofs, especially where the sheets are of an excessive size, improperly attached, and/or the pitch of the roof is steep.

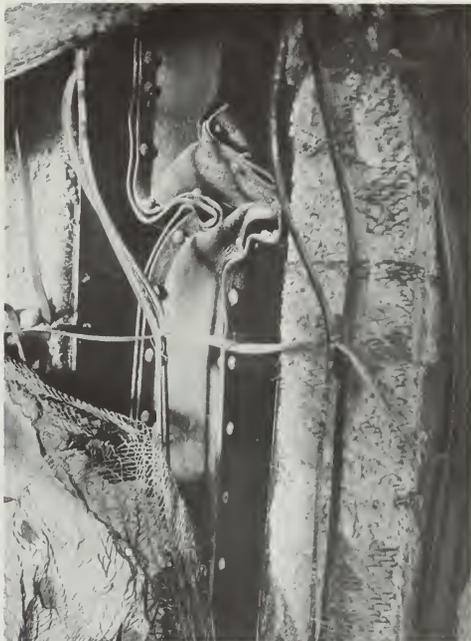
Figure 120. Column Buckling from Fire. In 1906 San Francisco was shaken by a severe earthquake, followed by fires that raged out of control for hours. In the Fairmont Hotel, the metal lath and plaster that covered the columns was probably damaged by the earthquake and was not sufficient to protect the steel from the intense heat. Portions of this building settled down approximately 7 feet from their original position because 37 columns buckled from the heat in this manner. (From *Trial by the Fire at San Francisco: The Evidence of the Camera, 1906*, Library of Congress.)

Fire can cause unprotected metal (iron and steel) framing members to become plastic and fail rapidly (figure 120). Lead roofs have melted during fires, and sheet metal decoration can buckle from heat and fall off buildings when its anchorage is lost. Structural iron or steel that has survived a fire without deformation is usually safe to reuse, but any questionable member should be load tested.

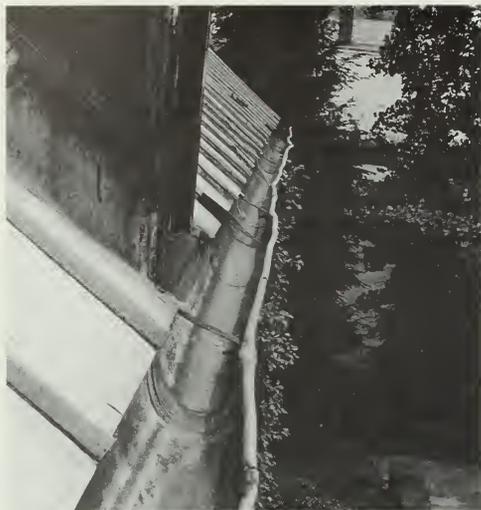
Figure 121. Overloading. The copper gutter on the Senate House, Kingston, New York, installed in the 1920s, has been distorted by ice and snow; the seams between gutter sections have opened. The problems were compounded by the lack of stiffness of the gutter and the absence of adequate provisions for expansion and contraction. The steel restraining straps are deteriorating because of an electrolytic reaction (galvanic corrosion) with the copper (the more noble metal). (John G. Waite)

Overloading is the stressing of a metal member beyond its yield point so that permanent deformation, fracturing, or failure occurs. The member can fail through the application of static loads, dynamic loads, thermal stresses (figure 121), and settlement stresses either singly or in combination. "Buckling" is a form of permanent deformation from overloading which is usually caused by excessive weight but can also be caused by thermal stresses. Members can also be overloaded if their support is removed and loads are redistributed to other members which can become overstressed and deformed (figure 122).

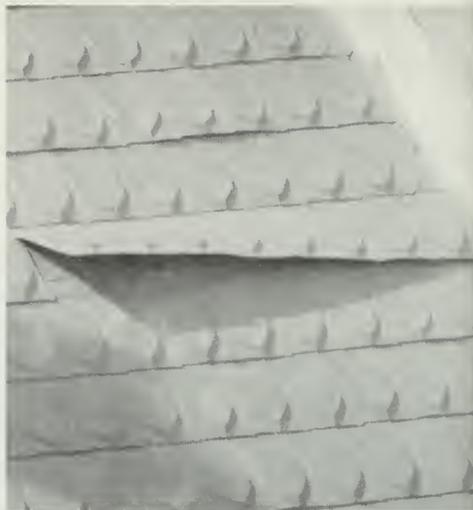
Figure 123. Anchorage Failure. The nails holding down this section of embossed galvanized sheet-iron roofing have deteriorated and the wind has lifted up the corner of the sheet, allowing water to leak through the roof sheathing. Other sections (not shown in the photo) had flapped in the wind until the sheet metal cracked with fatigue failure and tore loose. In 1977 this roof at St. Edward's University in Austin, Texas, was cleaned and supplemented with reproduction "shingles" where needed. (St. Edward's University)

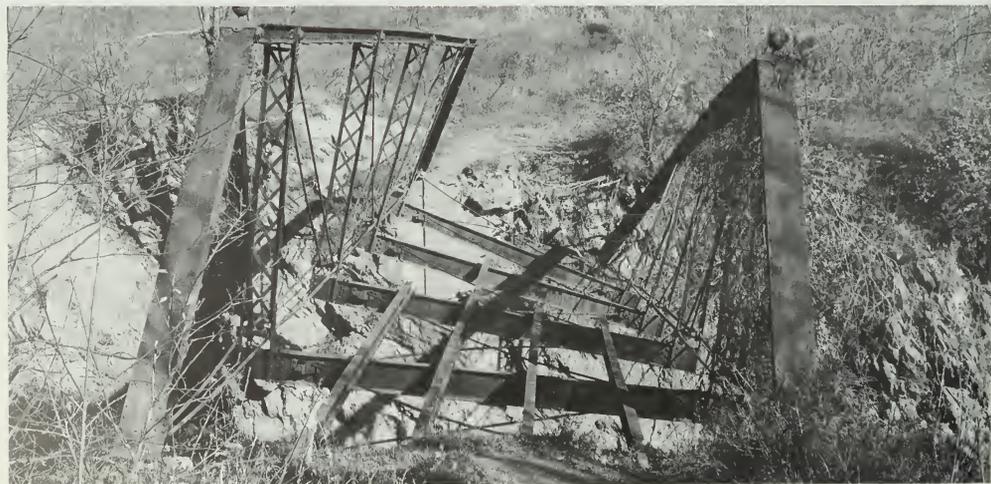
Figure 122. Structural Failure. This 19th-century wrought-iron truss bridge at Brunswick, New York, partially collapsed because the cut-stone abutment supporting it washed away. Once the support was removed, the bridge twisted. (John G. Waite)

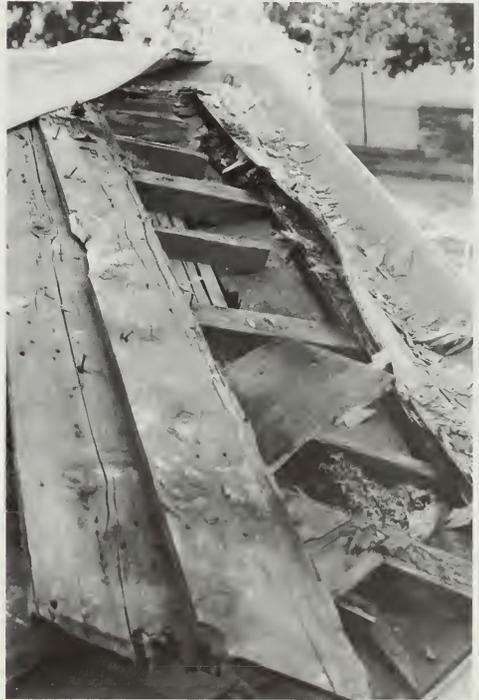
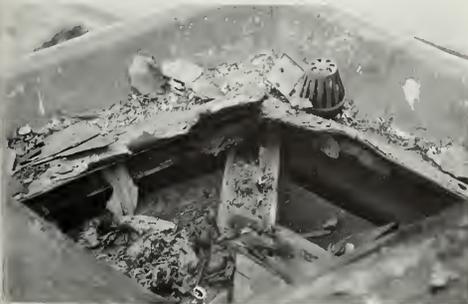
Figure 124. Successive Failure. If a metal architectural element such as a tinplate roof fails, more than just the tinplate may be destroyed. (a) Deterioration is evident in the original framing and roof sheathing of the Schuyler Mansion entrance wing in Albany, New York. The entrance wing was added to the building about 1817 and reroofed with tinplate sheets during the 19th century. The tinplate gutter liners eventually deteriorated and were replaced with copper during the 1930s. However, the tinplate roof remained and electrolysis occurred along the roof perimeter where the copper and tinplate were in contact. (b) Consequently, the tinplate was completely corroded away (as seen here) when the deteriorated roofing was removed. This resulted in major damage to the sheathing, framing, and masonry walls of the entrance. (John G. Waite)

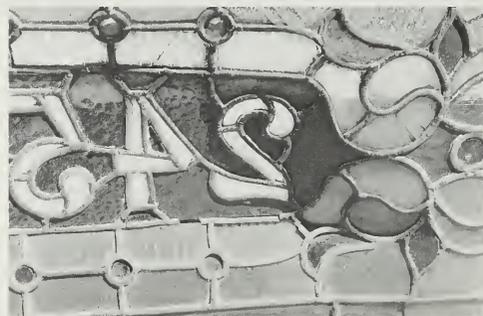
Figure 125. Lead Came Damage. *One of the most common uses of lead is the comes in stained glass windows, transoms, and skylights (see figure 8). Although lead comes are sometimes damaged by corrosion, especially where rain or condensation might collect at the bottom border came (a very slow process), they usually are damaged by creep and fatigue. The weight of the lead and glass in the entrance transom pictured above has caused the comes to creep, resulting in a noticeable sag and outward bulge. This transom did not have iron support bars found on many stained glass windows. The bars (sometimes called saddle bars) were usually set into the frame and attached to the lead comes with copper wires. Transoms are adversely affected by the vibrations of slammed doors and the outward force of compressed air in a vestibule. To complicate things further, the difference in the expansion and contraction coefficients of the lead comes and lead-tin solder has resulted in fatigue cracking, usually at joints.* (H. Weber Wilson)

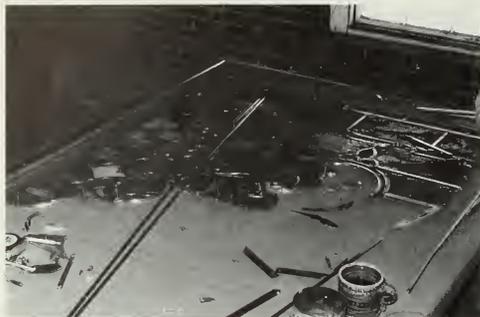
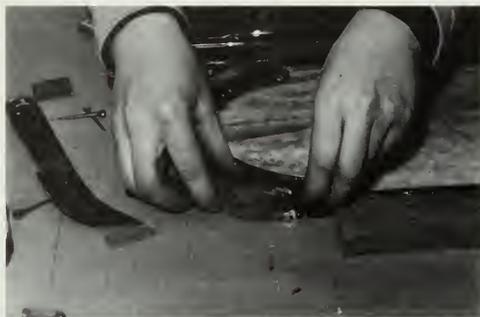
Figure 126. Lead Came Replacement. (a) On the table is a tracing of the original pattern of the lead comes of a late 19th-century stained glass window from the Pilgrim Congregation Church, Cambridge, Massachusetts. Because of the severe deterioration of the original lead comes, it was necessary to replace them with new comes that matched the original configuration. (b) This is a detail of the fitting of the new comes around the original glass. (Cummings Studios)

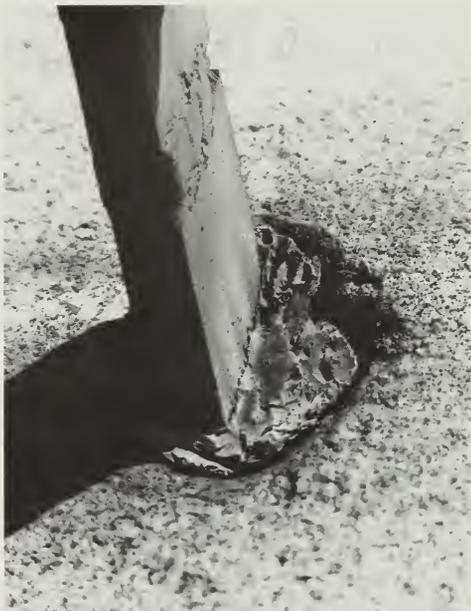
Figure 127. Lead Packing. *At the U.S. Treasury Building in Washington, D.C., the iron fence is supported by stone posts. The iron rails are fitted into pockets in the stone. Water seeped into the pockets and the iron rusted, causing it to expand. Rust, plus freezing and thawing action, caused the stone to spall. To remedy the situation, the iron fences were removed; the ends of the rails were cleaned of rust and repainted; and the fence was re-erected with lead packing. This lead is soft enough to accommodate thermal expansion and contraction of the iron. It also waterproofs the ends of the bars. (John Myers)*

Electrolysis is not often a problem with lead because the protective patina acts as an electrolyte insulator. Normally copper, zinc, and iron (if painted) can be used in contact with lead. For example, copper nails are traditionally used with lead sheets without galvanic corrosion and lead is frequently used to waterproof ironwork where it is fitted into stone²⁶ (figure 127).

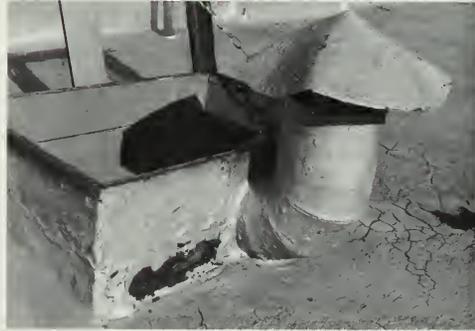
Figure 128. Deterioration of Tinplate by Asphalt Coating. *The tinplate flashing of the roof hatch has been corroded away (between the corner and the vent) by the action of the asphalt coating and water. (John G. Waite)*

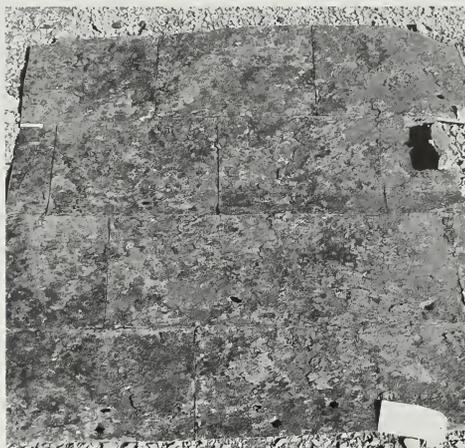
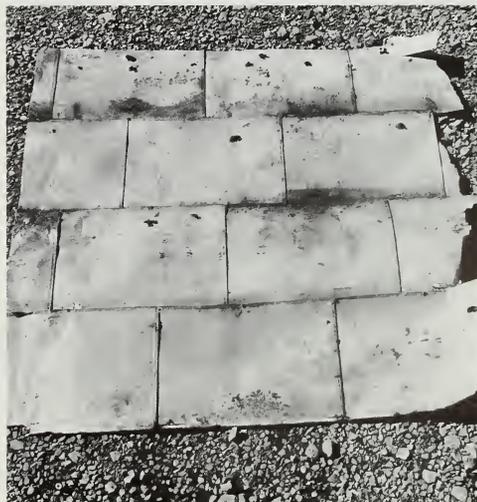
Figure 129. Corrosion Failure of Terneplate Roofing. *Hyde Hall, built between 1817 and 1833, near Cooperstown, New York, was roofed with flat-seam terneplate. (a) The plates have deteriorated because of a lack of proper maintenance. Unfortunately, the exposed (top) surface of the terneplate was painted with asphalt coating, which accelerated the corrosion of the roofing. (b) The terneplate also corroded from the underside. When installed, the terneplate was not painted on the underside as it should have been. Condensation formed on the unprotected bottom side of the metal roof and could not evaporate, an ideal situation for corrosion. (John G. Waite)*

When exposed to the atmosphere, tin readily develops a thin film of stannic oxide, which helps resist corrosion. Although pure tin is mildly corroded by exposure to acids, marine atmospheres, and certain alkalis, tinplate roofing is generally very durable as long as the tin or terne coating maintains its integrity. Once the plating has been broken and the iron or steel is exposed to oxygen, the deterioration begins and is accelerated by the galvanic action between the tin and iron. The more active tin acts as a cathode to the iron. This protects the iron from corrosion but accelerates the deterioration of the tin, exposing more of the iron to be corroded. Tin and terneplate roofing and flashing will deteriorate when in contact with copper, for instance, in gutters. Also they can be corroded by asphaltic and bituminous roofing compounds and building paper (figures 128 and 129a), as well as by paints containing acids, bitumen, asphalt, or aluminum. Tinplate roofing can corrode on the underside from water vapor condensation if the tin is not protected by a coating of paint and/or a nonacidic vapor barrier (figure 129b).

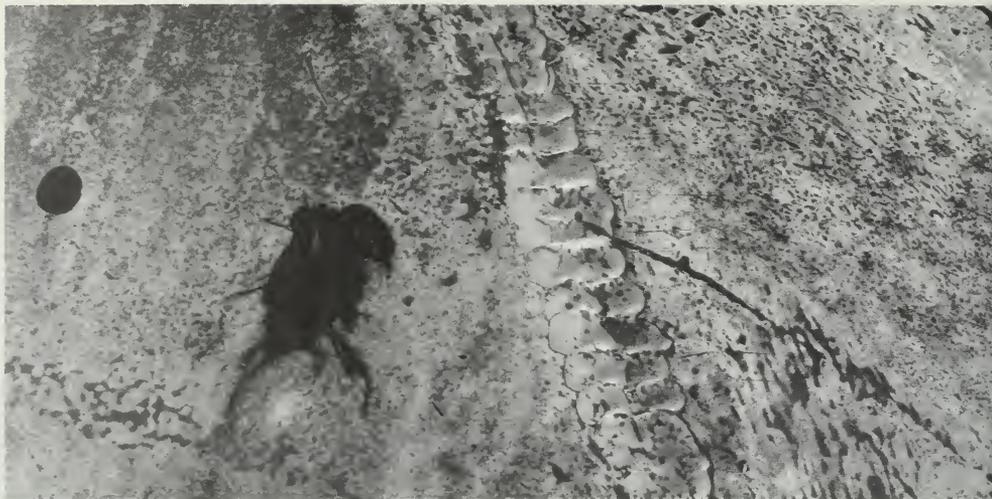
Figure 130. Modern Solder Joint on a Terneplate Roof. Solder was used to make watertight joints at the edges of terneplates on flat-seam roofs. Nineteenth-century soldered joints were almost invisible, that is, the solder was confined to the seam. These wide-soldered joints are on the Old Pension Building in Washington, D.C. The problems with wide-soldered joints are: (1) they facilitate galvanic corrosion because they provide a wider surface area with which the plates can react, and (2) they tend to fail because of the different coefficients of expansion and contraction of the solder and the terneplate. The black spots to the right of the solder are asphalt or a bituminous roof patching compound, which may cause deterioration of the terneplate and should be removed. (David W. Look)

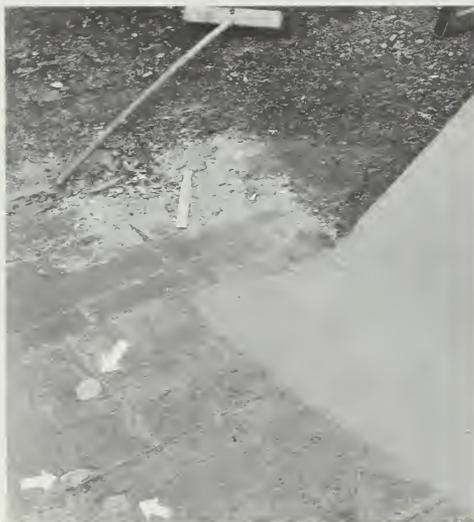
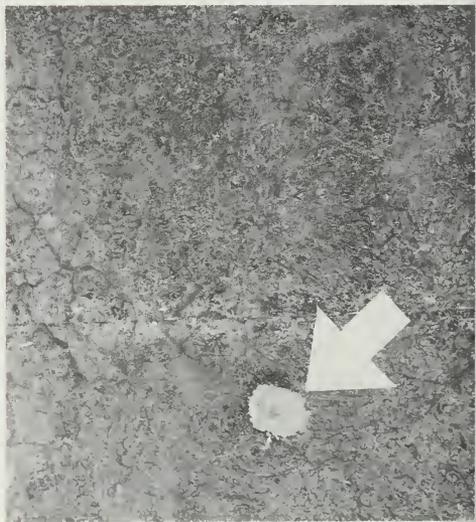
Figure 131. Salvaging a Flat Seam Terneplate Roof. (a) The roof of the Henry E. Bradford House Carriage Barn (c. 1860s) in Bennington, Vermont, had been covered with an asphalt coating (background) which obscured the true cause of the leaking roof. Once the asphalt coating was scraped from the surface (foreground left), it was noticed that the nails in the sheathing had "popped up" (light spots) and had cut through the terneplate. (b) After the asphalt coating had been scraped away and the nail holes repaired with solder (left foreground), the roof was then painted with red-lead primer (right foreground). The primed roofing was given two finish coats of iron oxide paint. (John G. Waite)

Techniques for repair range from small localized patches to wholesale material replacement. If a joint in tinplate roofing opens up, or a nail head pops up and punctures the tinplate, it should be repaired by cleaning and resoldering using a solder of 50% pig lead and 50% block tin applied with a rosin flux (figures 131a and b).

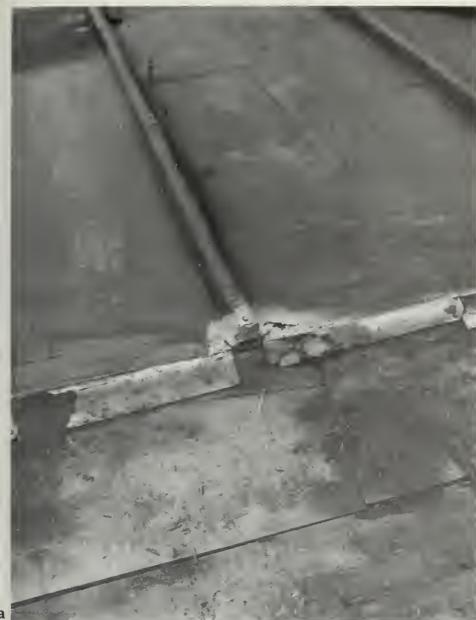
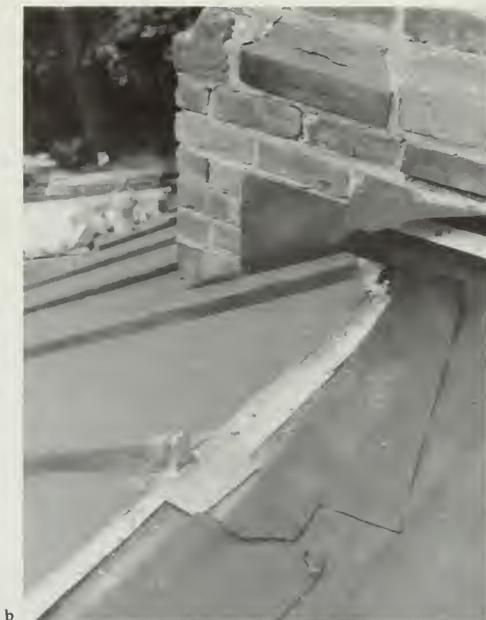
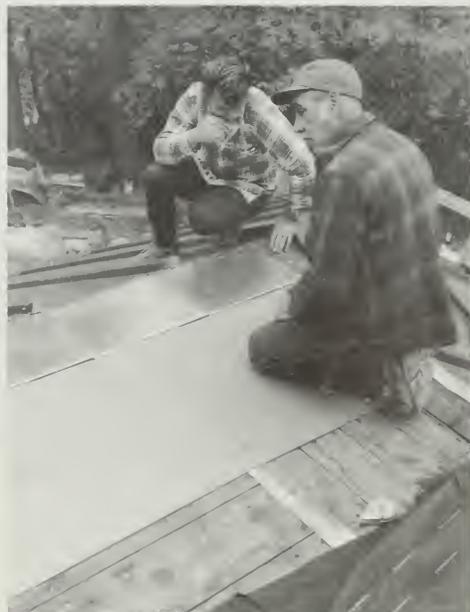
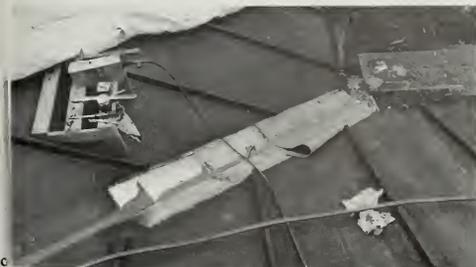
Figure 132. Repair and Replacement of Terneplate Roofing. (a) The ends of the original terneplate batten covers at Lindemoald were badly corroded and could not be replaced. (b) The unsalvageable sections were cut out and replaced with terne-coated stainless steel soldered in place. (c) The deteriorated terneplate valley was replaced with sheets of terne-coated stainless steel; the terne coating allowed the valley to be soldered to the original roofing plates. Although terne-coated stainless steel was a good choice, in theory, it proved to be a difficult material to work with in the field. (Correctly, the availability of thinner gauges and a more malleable stainless steel have improved the workability of this material.) (d) The original terneplate had rusted through completely in some areas, requiring reroofing. New sheets of terne-coated stainless steel, duplicating the pattern of the original terneplate, are being laid over rosin paper. (John G. Waite)

Replacement of tinplate or terneplate sheets which have rusted through may be the only practical preservation solution. Damaged sections should be removed and replaced with new materials of similar composition, configuration, and construction (figures 132a, 132b and 132c). Materials other than tinplate or terneplate should not be used to patch tinplate because galvanic corrosion will occur. However, if all of the tinplate roofing or siding must be replaced, it may be desirable to replace the old tinplate or terneplate with units of terne-coated stainless steel or lead-coated copper (figure 134) because these materials are more durable and easier to maintain than tinplate. Although both are more expensive than terne-coated steel in initial cost, they last longer and cost less to maintain if not painted. Either of these materials, if used in visible areas, should match the size, configuration, and construction details of the original roof, and should be painted to match the original color. Although lead-coated copper has been used successfully as a replacement material for tin and terneplate (figure 135), recently terne-coated stainless steel has proven to be a better replacement for tinplate.

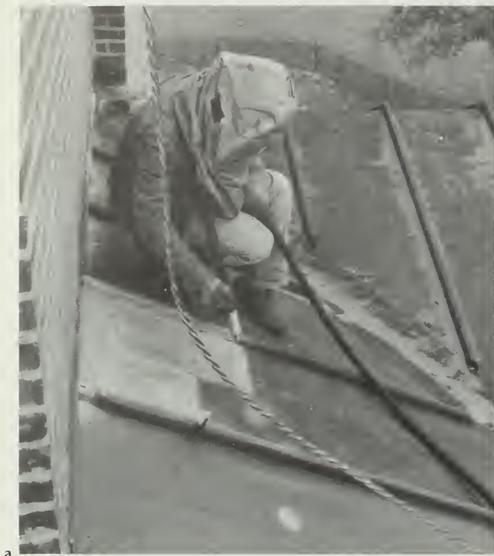
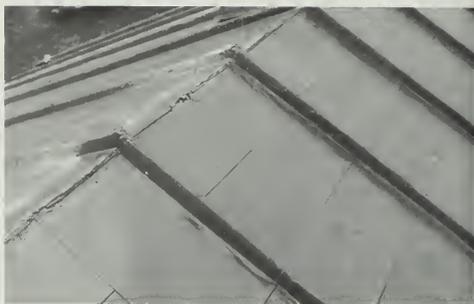
Figure 133. Abrasive Cleaning of Terneplate Roof and Replating. (a) Sections of the original terneplate roof at Lindenwald (Martin Van Buren National Historic Site) in Columbia County, New York, designed by architect Richard Upjohn in 1848, were cleaned with a low-pressure blasting of crushed walnut shells to remove accumulated paint and rust before replating with a lead/tin alloy. (b) The new terneplating was applied in localized areas (only where the original terne had been damaged by falling slates or removed because the sheet iron underneath had corroded). The new terneplating was applied where the bare iron was exposed using a soldering "copper" (a large soldering tool) fabricated for the project. After cleaning and replating, the restored roof was painted. (John G. Waite)

It is not normally practical to replate a deteriorated sheet of tinplate under field conditions. However, at Lindenwald (Martin Van Buren National Historic Site), the terneplate roof installed during the 1848 renovation under the direction of architect Richard Upjohn was cleaned and the coating was repaired *in situ* (figures 133a and 133b). Rust, paint, and asphalt coatings were removed by low-pressure abrasive cleaning using walnut shells. Where the original terne coating had failed, small areas of the iron sheets were recoated with a tin-lead mixture applied with a specially designed soldering "copper." (Historically, a small soldering tool is called a soldering "iron" and a large soldering tool is a soldering "copper.") After this partial recoating, the entire roof was painted.

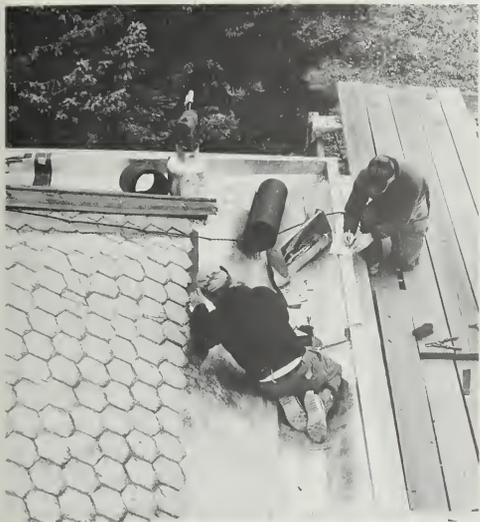
Figure 134. Replacing Flashing and Gutters. Workmen replaced the deteriorated terneplate flashing and gutters at Olana, built between 1870 and 1874 near Hudson, New York, for the noted artist Frederic E. Church. The polychromed slate roof was restored to the original pattern, and lead-coated copper was substituted for the original terneplate flashing and gutters because of ease of maintenance - it does not require painting, unless there is a need to match the terneplate in color. The original terneplate was painted. (John G. Waite)

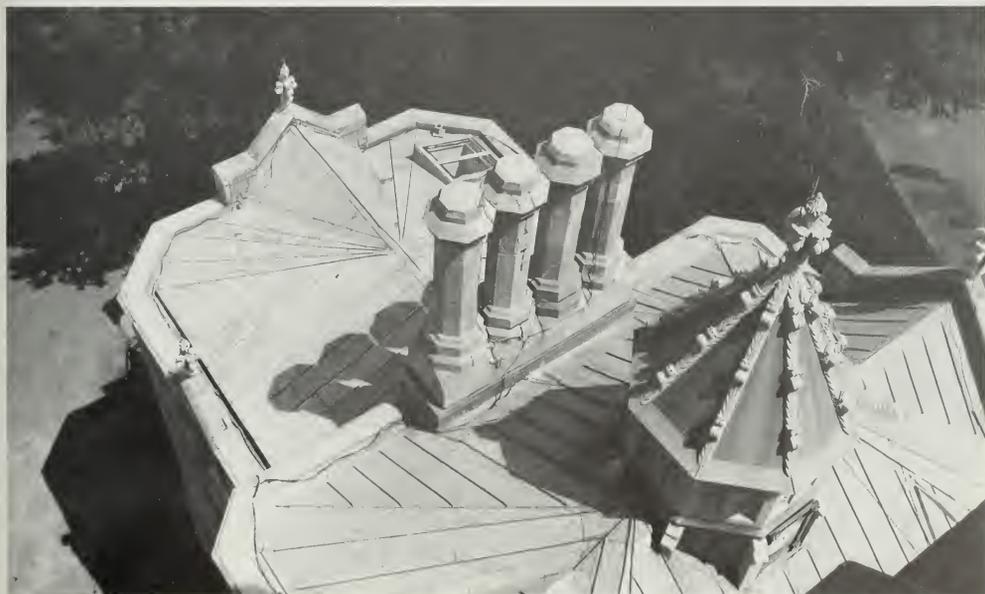
Figure 135. Complete Substitution of Lead-Coated Copper Roofing for Terneplate Roofing. The 1864 wing addition of Lyndhurst, Tarrytown, New York, originally had a terneplate roof. In an attempt to find a more permanent roofing material, a lead-coated copper roof was substituted for the terneplate, duplicating the pattern and sheet sizes of the original roof. In such substitutions, details may have to be redesigned because of differences in expansion and contraction rates and differences in workability of the material. The color of lead-coated copper is not the same as terneplate because terneplate roofing was never left unpainted. Therefore, lead-coated copper roofing substituted for terneplate should also be painted if it seen from normal viewing angles (usually from street level). (John G. Waite)

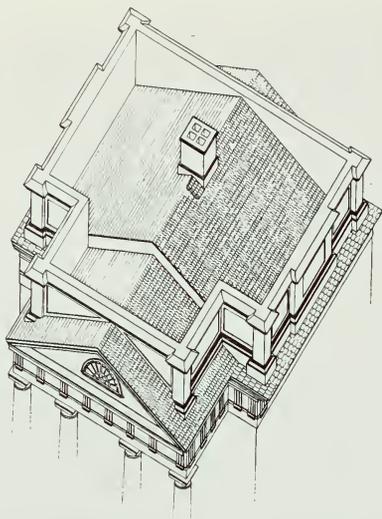
a. Pavilion X roof (Mesick•Cohen•Waite Architects)

Figure 136. Replacement of a Thomas Jefferson Tinplate Roof on Pavilion X. Most of the pavilions constructed between 1817 and 1826 at the University of Virginia originally had tinplate roofs applied with a unique system which did not use soldered seams (a). Consisting of thinly rolled wrought-iron sheets dipped in tin, the edge of each plate was fitted into the fold of the adjacent plate, folded over, and nailed to the wood roof sheathing. It was a very simple system that only required basic carpentry skills to install (b).

Historically, seams of tinplate roofs were often not soldered. Instead they either were installed dry, as was the case with the tin roofs designed by Thomas Jefferson (figure 136), or the seams were filled with white lead

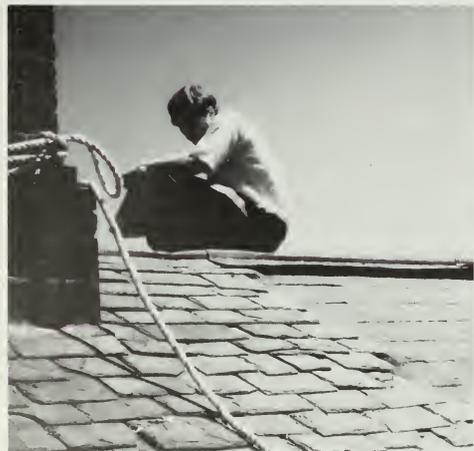
c. Original tinplate roof beneath slate (John G. Waite)

In 1985, during investigations of leaks in the roof of Pavilion X, the entire original Jefferson tinplate roof was found intact beneath a later slate roof (c). The original tinplate roof was preserved in situ and encapsulated by new plywood sheets. A new roof, identical in detailing, was applied over the plywood and a neoprene sheet membrane (d). Using 6 3/4 by 10 inch sheets of stainless steel with a terne coating, the roof exactly duplicates the appearance of the original. Terne coated stainless steel was used because tinned wrought-iron sheets are no longer available.

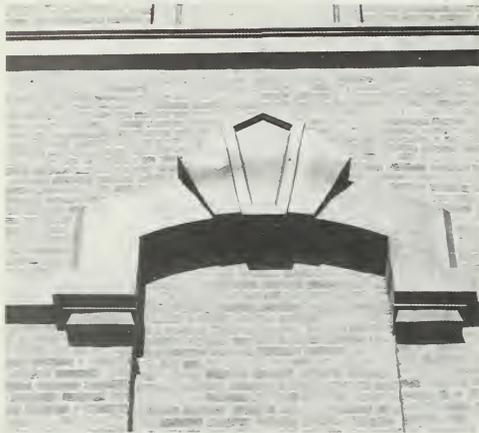
Figure 137. Deterioration of Zinc. At the 1874 Cohoes Music Hall, Cohoes, New York, the original zinc window lintels and belt course were cleaned by sandblasting, resulting in pitting and corrosion of the metallic surface. Note the whitish corrosion products caused by the abrasive cleaning and subsequent exposure to the weather. The lintels had been painted originally but were left bare after the cleaning. Zinc and galvanized sheet iron should always be primed and painted with paints especially formulated for zinc. (John G. Waite)

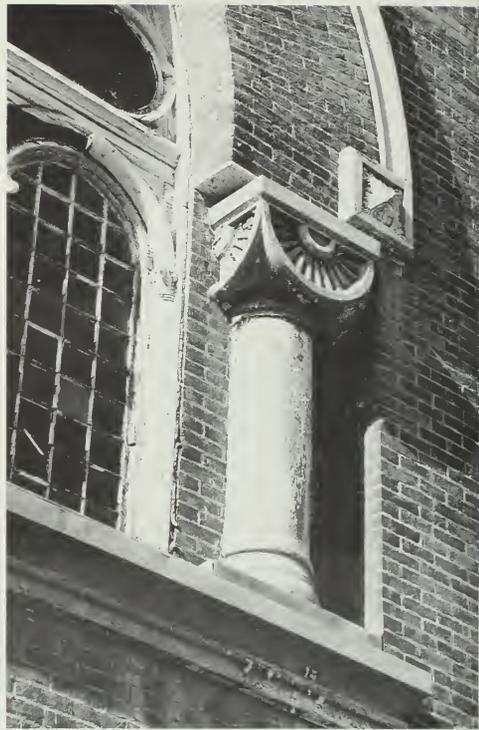
Figure 138. Zinc Deterioration and Staining. On the First Presbyterian Church in Alexandria, Virginia, the engaged columns, arch molding, corner blocks, and the sill molding are fabricated of cast zinc and galvanized sheet iron (the windows and frames are wood). The paint has deteriorated, leaving the surface of the metal bare in some places. The zinc or zinc coating on iron has oxidized. Notice the whitish corrosion stain on the brick from the zinc carbonate coating which continues to wash over the surface of the bare metal and then down over the bricks. The metalwork should be scraped down to remove all loose zinc carbonate. Joints should be caulked and/or resoldered, and repainted with a zinc chromate primer. (Baird M. Smith)

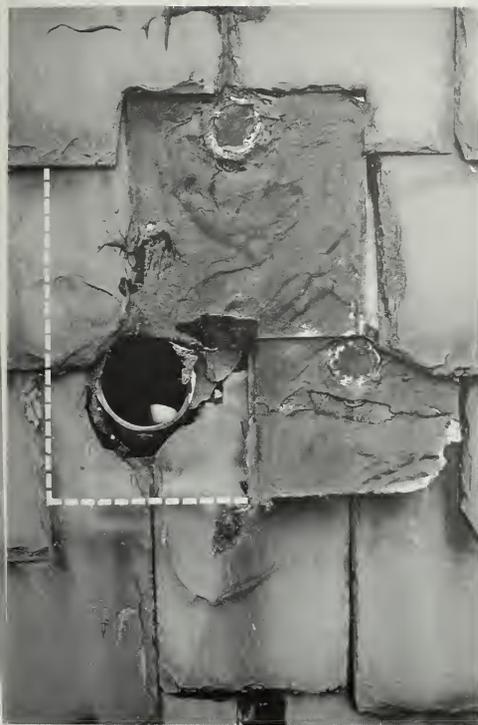
Figure 139. Zinc Corrosion, Erosion, and Inappropriate Repairs. In construction of the Nott Memorial at Union College in Schenectady, New York, during the 1870s, architect Edward Tuckerman Potter used "illuminators" in the ornamental slate roof. These were slate-sized zinc plates with a small colored-glass disc 1 3/4 inches in diameter inserted in the center. Barely discernible from the outside, they transformed the vaulted dome within a "heaven" of red, yellow, purple, orange, and green stars. Shown here is a cluster of three illuminators, each consisting of a zinc plate with a small colored-glass insert and the connecting tube through the metal deck and plaster to the interior. The zinc was inaccessible and not kept painted. Small fragments of slate broke off and tumbled down with gravity. The wind and rain eroded away the layer of corrosion from the zinc surface. The left plate is missing (see dotted line), showing the connecting tube. The corner of the lower right plate is missing because it became brittle and fractured off. Unfortunately, modern roofing cement applied over the zinc plates is accelerating the deterioration. (John I. Mesick, *The Nott Memorial: A Historic Structure Report Schenectady, New York*: Union College, 1973, p. 65)

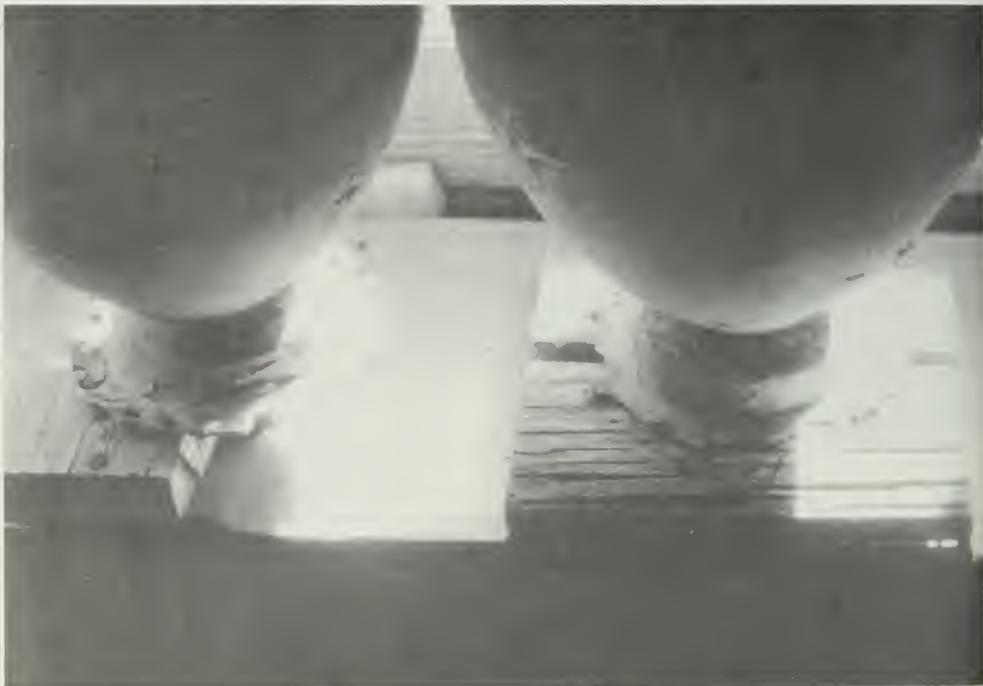
Figure 140. Galvanic Deterioration. Bases of zinc vases from the roof balustrade of Lorenzo, Casenovia, New York, have deteriorated because of the electrolytic action between the zinc and the machine-cut iron nails used to fasten the vases to the balustrade. The zinc was sacrificed in favor of the iron because the iron is more noble than the zinc. (Douglas Clinton)

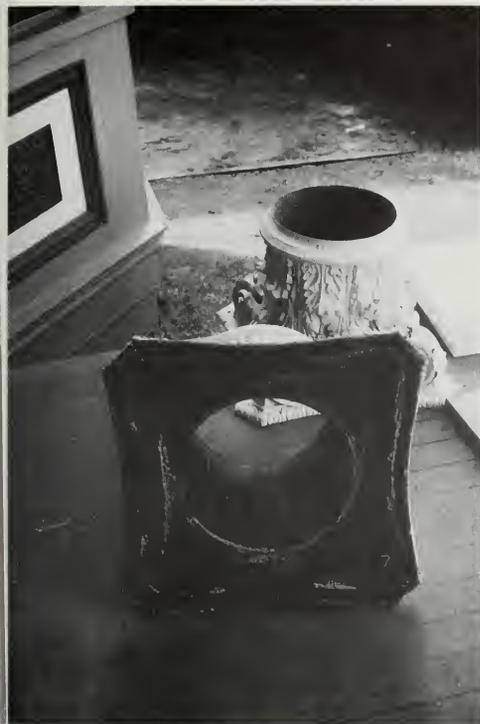
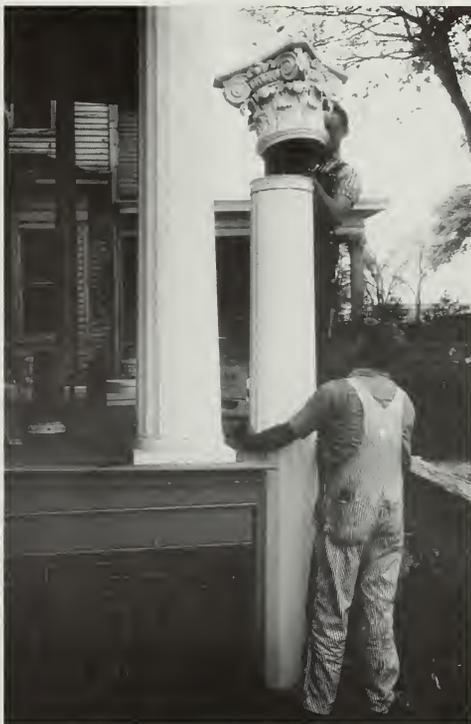
Figure 141. Repair of Galvanized Sheet Metal Capitals. (a) Fabricated for the 1890 Bullard-Hart House, Columbus, Georgia, these Corinthian capitals were originally assembled from many pieces of pressed sheet metal, which were soldered together to form the acanthus leaves. (b) The capitals were in salvageable condition and were taken to a sheet-metal shop where they were cleaned. Loose pieces were resoldered and caulked; missing pieces were replaced with new stamped pieces; and the completed capitals were repainted. The deteriorated wooden column shafts were repaired and repainted. The restored capitals were refitted onto the shafts and the entire columns were then returned to their original positions. (Thomas Taylor)

In some cases, galvanized sheet metal elements can be removed and repaired in the shop, rather than in the field (figure 141 and 142). Preassembly of large cornices may be cost effective (figure 143).

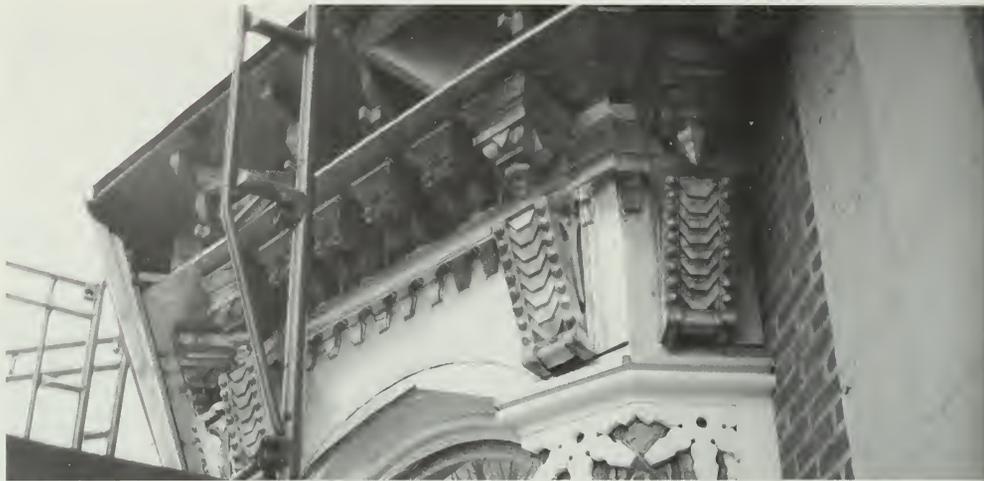
Figure 142. Restoration of Galvanized Sheet Iron and Cast-Zinc Cornice. This is the upper third of a wooden bay window on a Second Empire brick rowhouse in the Logan Circle Historic District of Washington, D.C. (a) From the window down, the bay is wood and glass. The roof of the bay had leaked for years and the wooden roof rafter and projecting supports for the cornice had rotted. The bay window was carefully disassembled and rebuilt replacing all deteriorated lumber. The surviving pieces of galvanized sheet-iron and cast-zinc cornice were taken to a sheet-metal shop. The pieces that were repairable were cleaned; missing portions of brackets on the right were replicated of galvanized sheet iron using the originals as a model. (b) On the opposite side of the bay, all of the brackets and modillions are repaired originals but all of the flat and molded sections are new 26-gauge galvanized steel. The 65-year-old sheet-metal worker on this job said that the only two major advances in metal cornices in his lifetime are the use of pop rivets for fasteners (used also in leatherwork) and the use of autobody putty to patch holes, mold small missing details, and waterproof joints. The putty dries hard and can be sanded. (David W. Look)

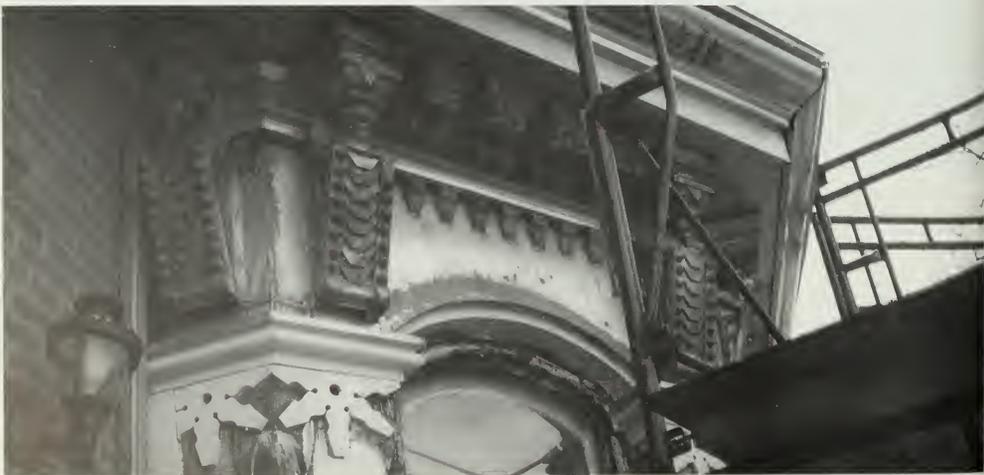
Figure 143. Preassembling Cornice. As illustrated in figure 12, most sheet-metal cornices were supported by wooden support members projecting out from the facade of the building—either as an extension of the roof framing or as a cantilever from a parapet wall. In either case, these wooden support members are often found to be rotten and have to be replaced. For large cornices high above the street level, it may be economically unfeasible to use scaffolding for in situ repairs and reconstruction unless the scaffolding is also needed for other work. The entire galvanized sheet-iron cornice of the ZCMI Store in Salt Lake City, Utah, was preassembled on the ground with repaired original parts and new pieces onto a new support system fabricated on mill steel angles. Fifty-foot sections of the preassembled cornice were then hoisted to the top of the facade and bolted to the building without the need for scaffolding. (Steven T. Ford)

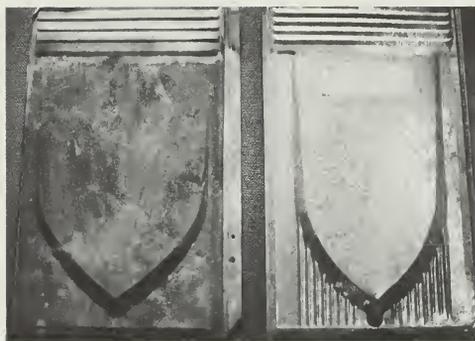
Figure 144. Reproduction of Galvanized Sheet-Iron Shingles. Wind and hail had damaged many of the sheet-iron shingles at St. Edward's University in Austin, Texas (see Figure 122). Mass production of replicas was economically feasible. A die was made with the pattern of the original shingle and new galvanized sheet-steel shingles were stamped. The new, unpainted shingle (right, notice spangled appearance) is a reproduction of the other shingle (left). These shingles are from the private collection of Charles E. Fisher, III. (John Myers)

member. All corrosion, rust, and loose paint must be removed before painting. In other cases it may be necessary to reproduce severely deteriorated or lost elements (figure 144). In some situations, often for economic reasons, reinforced polyester, commonly known as fiberglass, has been used for reproduction of missing cornices and other sheet metal details (figure 179).

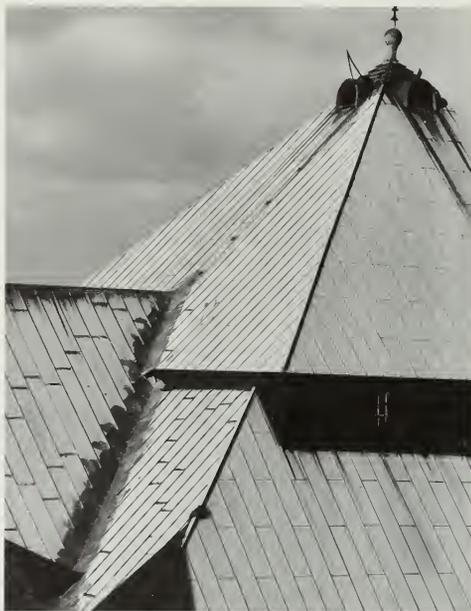
Figure 145. Galvanic Deterioration. An electrolytic reaction between the copper roof and the cast-iron roof finial and monitor window frames on the former Temple Beth Emeth, Albany, New York, built in 1887, is causing extensive deterioration of the iron. The corrosion products are staining and streaking the copper. Another area where deterioration is occurring is the valley, which has been coated with an aluminumized asphalt roofing compound. Electrolysis is occurring between the copper and aluminum (causing the less noble aluminum to corrode) and between the aluminum and cast iron of the monitor window frames (causing the less noble aluminum to corrode). (John G. Waite)

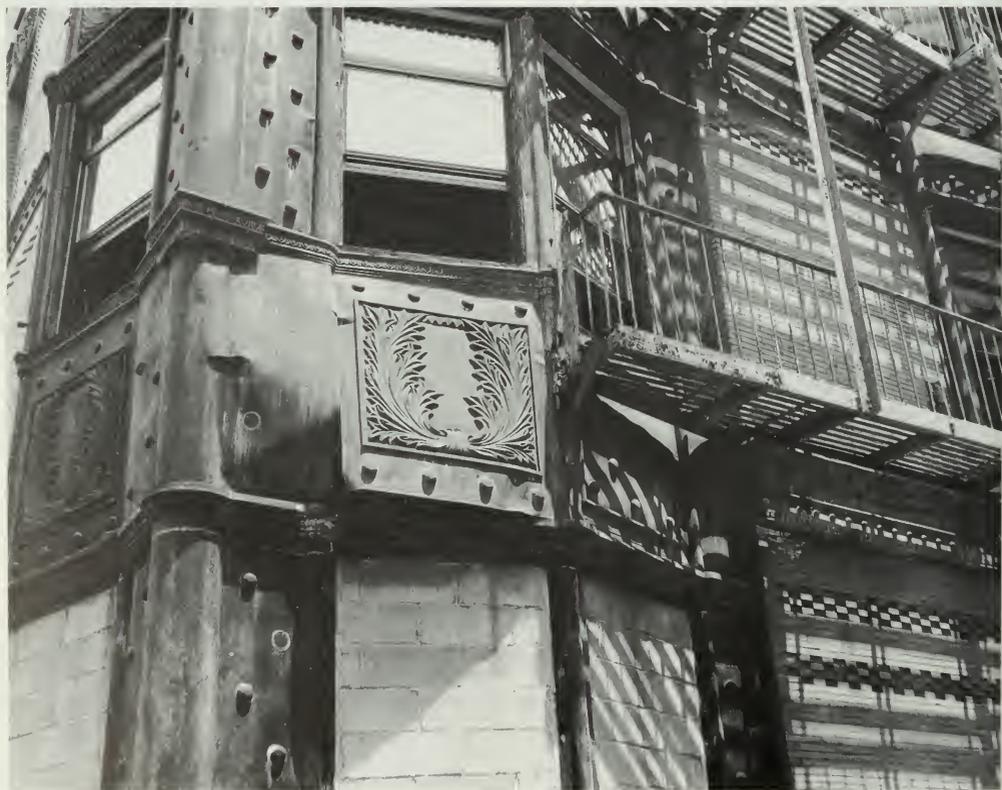
Figure 146. Loose and Damaged Copper Cladding and Deteriorated Steel Fire Escapes. *The corner bay of the Hotel Margaret (1889) in Brooklyn Heights, New York, was clad in ornamental panels of pressed sheet copper. Anchors have deteriorated and the wind has lifted the corners. Galvanic action between the noble copper and the baser steel (in the fire escape) has caused the steel to deteriorate.* (David W. Look)
