Metals in America's Historic Buildings

Uses and Preservation Treatments

U.S. Department of the Interior
National Park Service
Cultural Resources
Preservation Assistance
Washington, D.C.
1992

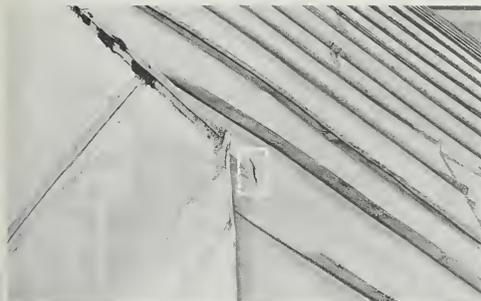
Figure 147. Fatigue Failure. Fatigue failure occurred on the copper roof installed during the 1920s on the Senate House in Kingston, New York. (a) Failure was caused by cyclical expansion and contraction of the copper without adequate provisions for it. Additionally, the copper sheet was too thin and not rigid enough to resist buckling and sagging between the too-widely-spaced roof sheathing. The use of bituminous roofing paper between the copper and sheathing also contributed to the failure; when the paper was heated by the sun, it adhered to the copper, further restricting its movement (see figure 117). (b) The drawing shows the actual roof installation and the correct procedure, which allows for expansion and contraction. (John G. Waite)

Where new sheets of copper are used to repair an existing copper architectural component, the maximum length of the sheets should be 8 feet. Adequate provisions should be made for thermal expansion and contraction within the repaired area and all fastenings should utilize copper cleats held with either copper nails or brass screws. Copper roofing sheet should be separated from the wooden sheathing by rosin building paper to allow free movement of the sheets (figure 147b).

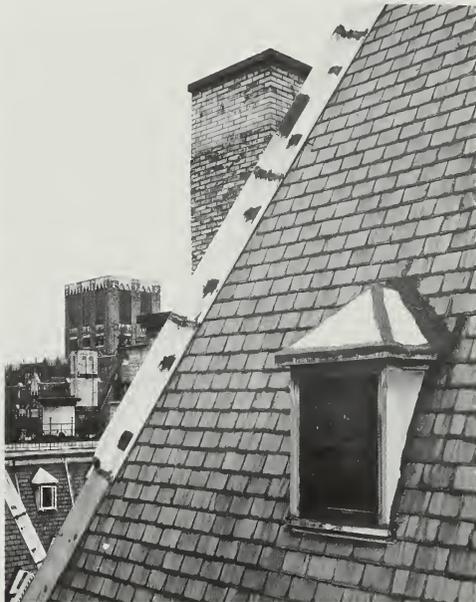
Figure 148. Inappropriate Patching Compounds. Corrosion of a copper roof ridge on the Dakota Apartments (1884), New York City, was caused by the use of an asphalt roofing compound for temporary patches over nailheads and joints between ridge sections. (John G. Waite)

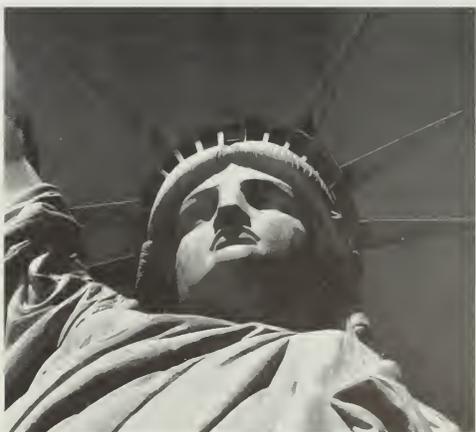
Figure 149. Resistance to Corrosion. Little damage had occurred to the copper at The Statue of Liberty. Galvanic corrosion, however, occurred where saline rainwater provided the electrolyte between the copper and the iron armature, resulting in considerable loss in the cross-section of the armature. (Robert Baboian)

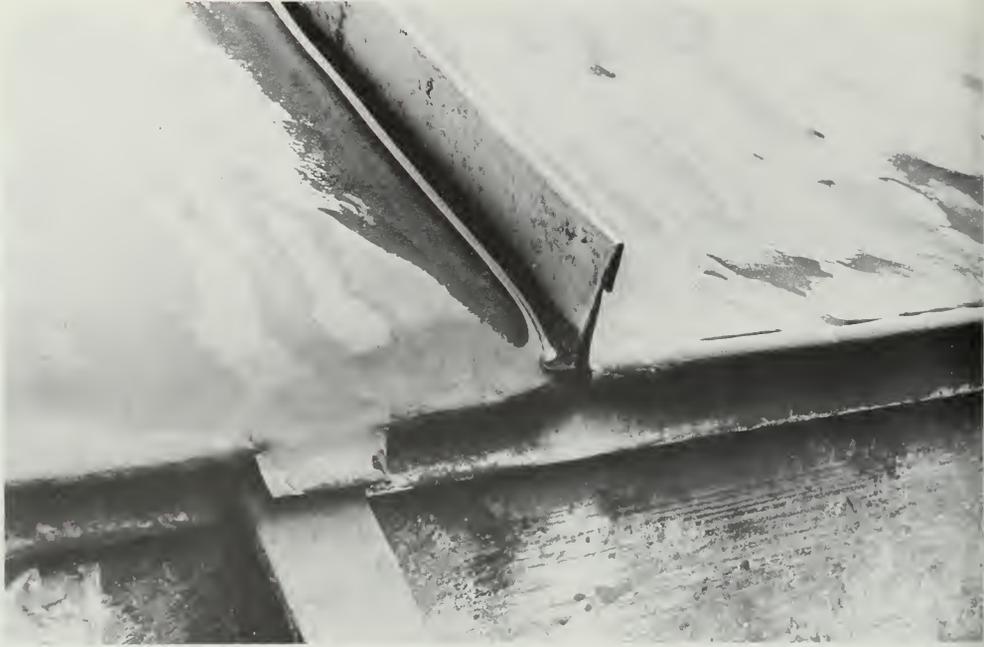
Figure 150. Erosion of Copper. This caves detail of the 1920s copper roof on the Senate House State Historic Site in Kingston, New York, illustrates erosion of the copper at the edge of the roof caused by continued exposure to rain and snow, which scoured the roof as it flowed to the gutter. Fatigue failure has also occurred at the base of the standing seam, resulting in a tearing of the copper. This failure was caused by the lack of provision for expansion and contraction, as well as the use of bituminous roofing felts, which restricted the movement of the copper. (John G. Waite)

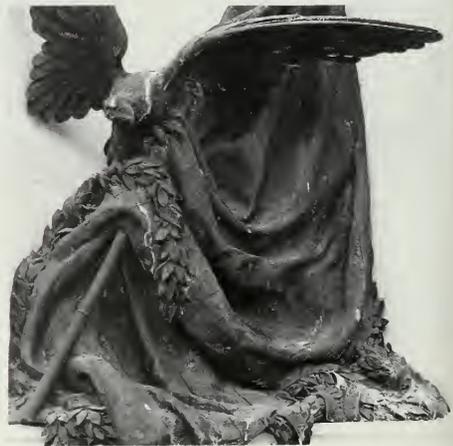
Figure 151. Bird Droppings. The 1914 bronze memorial to the writing of the "Star Spangled Banner," which is located in a niche on the porch of the Baltimore City Hall, is a favorite roost for birds. Bird droppings contain acids which are harmful to bronze and should be removed periodically. (David W. Look)

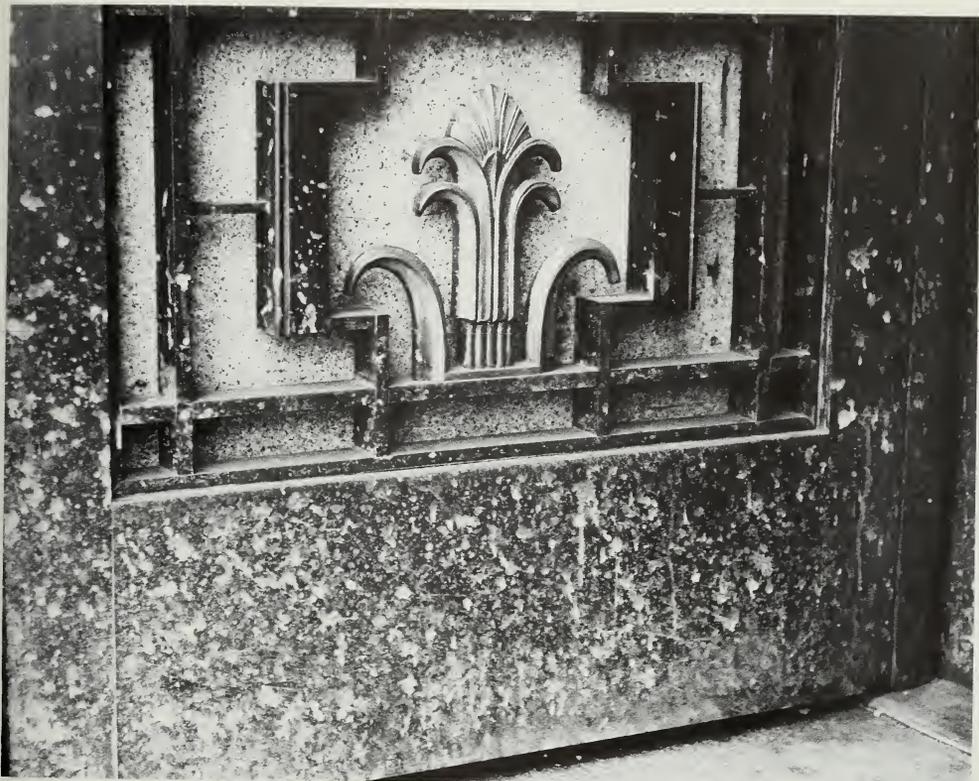
Figure 152. Snow Salt Damage. *On the Circuit Court of Appeals Building in Washington, D.C., the lower extremities of the exterior-bronze gates are discolored and unsightly from repeated splashing of snow-removal salt. As long as the salt remains on the gates, the bronze will continue to deteriorate and its surface may even become pitted. (David W. Look)*

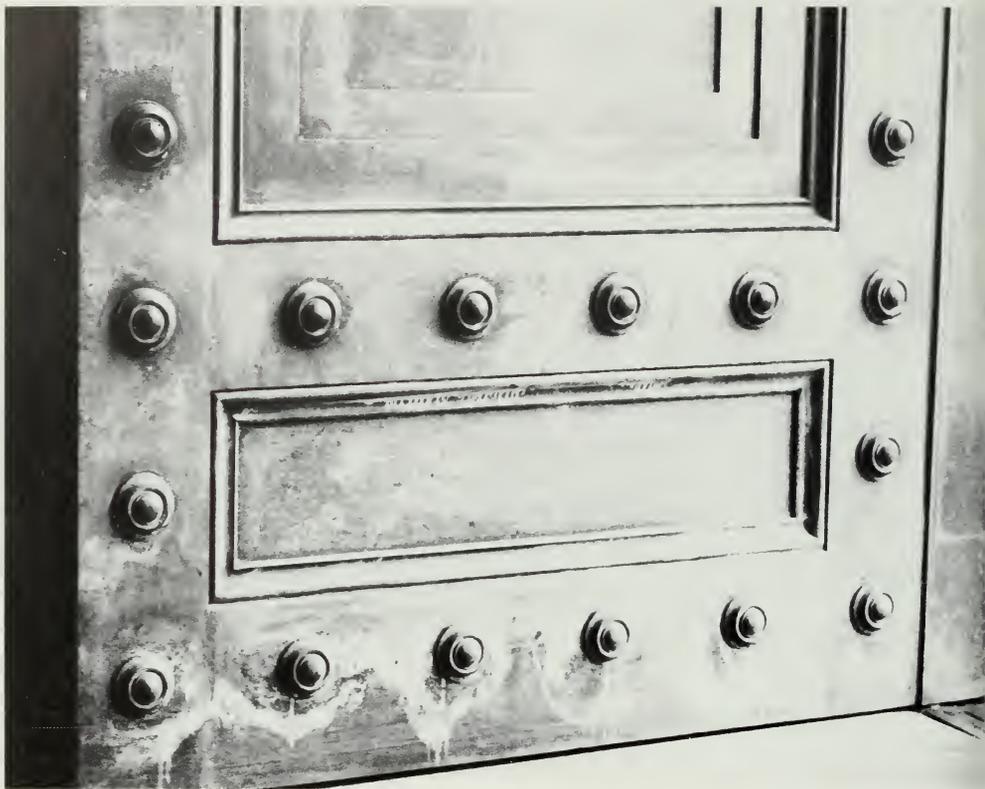
Figure 153. Improper Cleaning of Bronze. The bronze doors on the Pennsylvania Avenue side of the National Archives in Washington, D.C., were cleaned improperly. They now vary in color from a golden bronze to green to copper orange and brassy yellow. Some of the original artificial patina applied at the foundry has been removed, leaving a blotchy appearance. Part of the corrosion from the deicing salt remains, and the doors have a streaked, unattractive appearance. At this point, the only feasible treatment would be to clean the doors thoroughly (down to the bright metal), by mild chemicals or soft abrasive cleaning. A new artificial patina could be applied to return the doors to their original appearance. To protect against future damage, the doors should be given a barrier coating of wax which will need to be renewed periodically. The maintenance staff should be notified not to use salt near the doors and not to clean or polish the doors other than washing them down once a year with a nonionic detergent. When washed, the doors should be thoroughly rinsed with distilled water and wiped dry with a clean cloth to prevent water spots and streaks. (David W. Look)

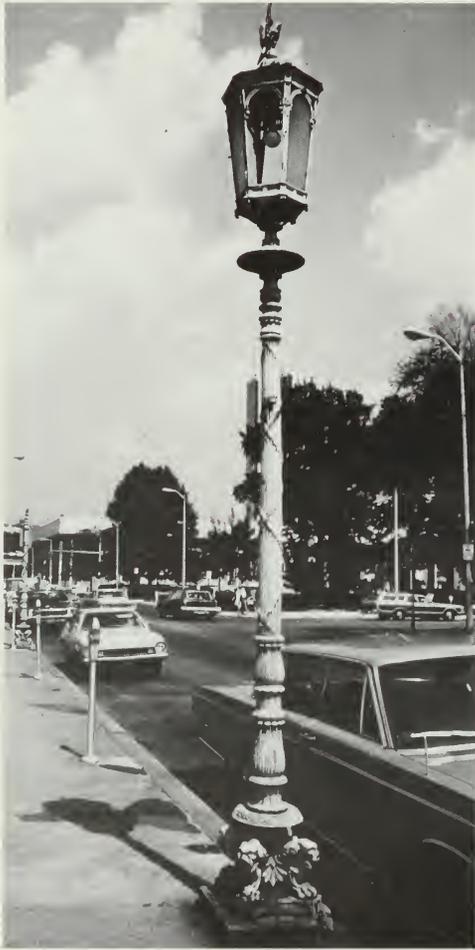
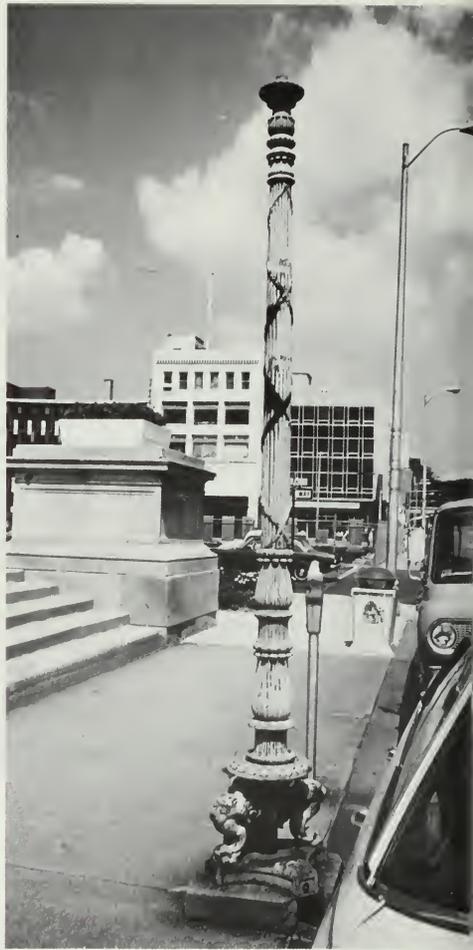
Figure 154. Damage to Bronze. In the Court Square Historic District in Springfield, Massachusetts, five of six bronze street lamps were vandalized or accidentally damaged by automobiles backing into parking spaces. (a) The one lamp that survived intact was used to make new molds. (b) The missing leg and lamp were recast (not shown) and/or repaired with funds from a matching grant from the National Park Service in 1976. The recast pieces were chemically treated to obtain a green patina that matched the weathered appearance of the original sections of the lamps. A plan was drafted to relocate the lamps 12 inches from their previous position at the curb to prevent any further damage from parking automobiles. (Thomas Taylor)

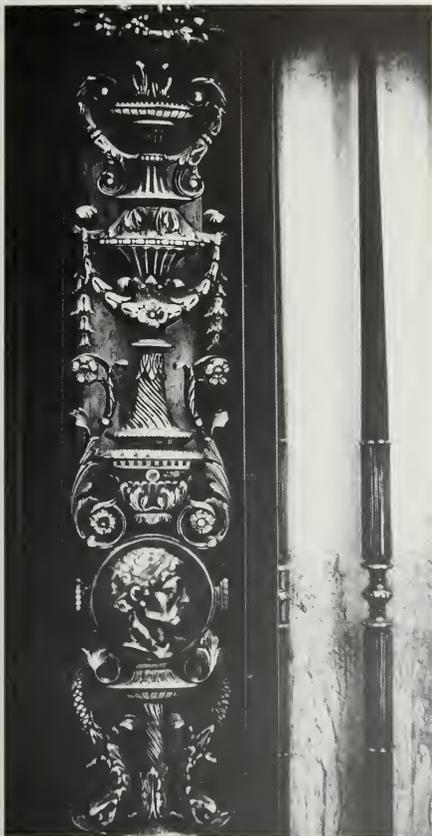
Figure 155. Cleaning Bronze. Recently, the exterior bronze work was cleaned on the Morgan Guaranty Trust Company in the corner of Wall and Board streets in Manhattan. The original finish of the bronze was a statuary brown artificial patina (a chemical process developed in the 19th century) with the bas-relief sculpture highlighted in a lighter pinkish-gold color, probably just the natural color of bronze without artificial or natural patina. The bronzework was cleaned and sealed with a clear coating. Without a coating, a natural patina would form, causing slow color change from pinkish gold to brown to black and eventually to green over an 8-10 year period. The colors are usually uneven and streaked because of the local pattern of wind and rain. The formation of a natural patina would eventually destroy the contrast between the statuary brown and pinkish gold, which was the original intention of the architects, Trowbridge and Livingston, when the bank was built in 1913. (David W. Cook)

Surface deposits and corrosion products can be partially or totally removed from copper, bronze, and brass by various procedures. These range from gentle washing with deionized water, a non-ionic detergent, and natural bristle brushes; to chemical stripping; to air-abrasive blasting, using a variety of abrasive media such as soft organic blasting media like crushed walnut shells or corn cobs, to much harder media like plastic or glass beads. Chemical compounds such as rottenstone and oil, whitening and ammonia, and precipitated chalk and ammonia, can be used along with very mild abrasive techniques such as rubbing with a clean, soft cloth.⁵⁸ Thick crust can be removed by sodium hexametaphosphate and water or dilute sulfuric acid and water prepared and used by persons trained in handling this dangerous acid.⁵⁹ Commercial companies that routinely clean and maintain bronzework use a variety of "secret" formulas which are generally based on their experience and conform to the recommendations of the Copper Development Association. It suggests using a 5% oxalic acid and water mixture together with finely ground India pumice powder.⁶⁰ This slurry mixture is rubbed on with a clean soft cloth. After thorough rinsing with clean water, the surface is wiped dry with a clean soft cloth to prevent water spotting (figure 155).

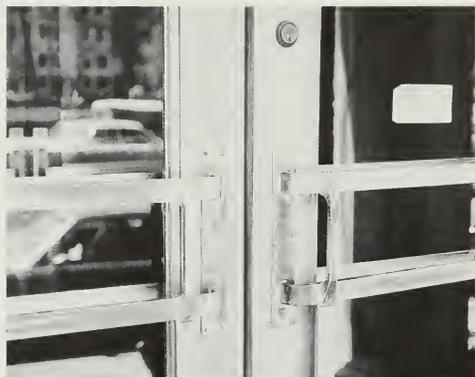
Figure 156. Oxidation of Monel. *These exterior doors on the Headquarters of the United Mine Workers of America in Washington, D.C., have a greenish-brown patina of oxidation and an accumulation of dirt and fingerprints. Although the patina is protective, it is not attractive, and detracts from the overall appearance of the building. The push bars are brass with chrome plating which has worn through. To restore the doors to their original appearance, they should be cleaned and polished; and the push bars should be removed, cleaned, polished, replated, and reinstalled. (David W. Look)*

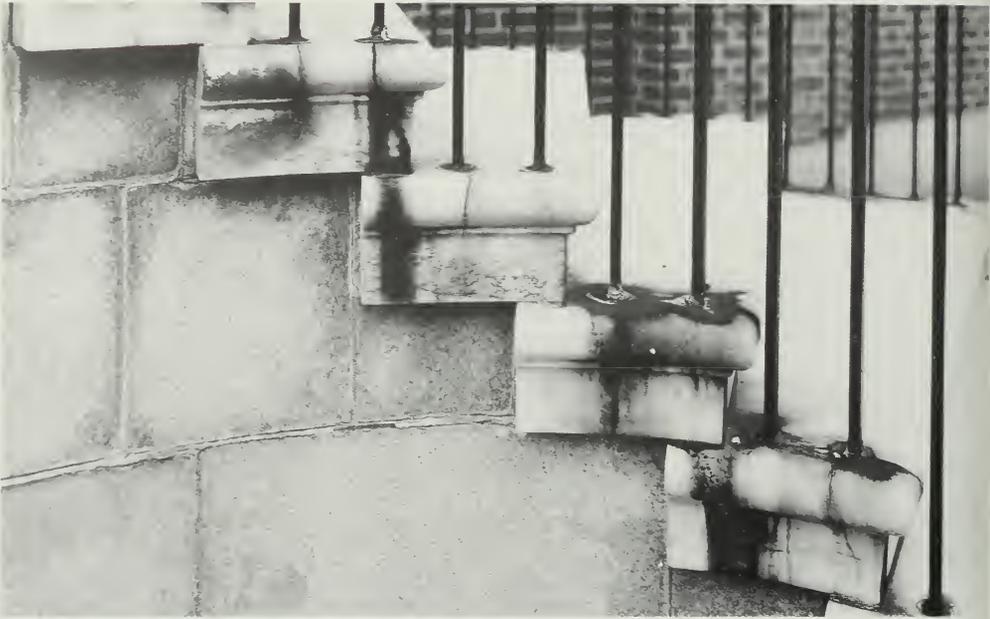
Figure 157. Stone Damage from Rust. In the 1950s the stairs of Library Hall in Philadelphia were reconstructed. Since wrought iron was not available for the railing, steel was substituted. The design of the railing was poorly detailed. The bottoms of the balusters were fitted into stone steps, it cracked the stone because of the expansion in volume of the steel during rusting. (Jack E. Boucher)

the corrosion-resistant alloy steels and stainless steels (figure 157). The oxidation of iron and steel is a highly destructive process (figure 158). The product of this oxidation is rust, which initially consists of a mixture of ferrous and ferric hydroxides (FeO), and later becomes a hydrated ferric oxide (Fe₂(OH)₃) with some traces of a carbonate.⁹¹ The minimum relative humidity necessary to promote rusting is 65%, but this figure can be lower in the presence of pollutants.⁹² When salts are present, they act as electrolytes, accelerating the corrosion of iron and steel and making it more complicated. Once a rust film occurs, its porosity acts as a reservoir for any liquid present,⁹³ which also tends to accelerate corrosion. If simple oxidation is not arrested, its rate will accelerate until the metal is completely destroyed.

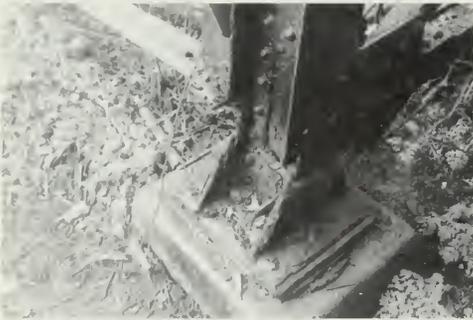
Figure 158. Advanced Corrosion of Rolled Iron. This column base of a New York Central Railroad pedestrian overpass has not been well maintained and has rusted beyond repair. Such exposed ironwork should be painted regularly to keep it from contact with air and moisture. Note the characteristic way that wrought-iron rust exfoliates, or flakes off in layers. (John G. Waite)

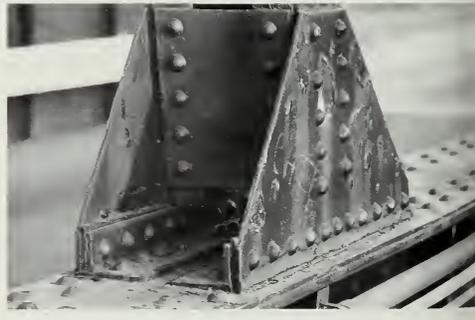
Figure 159. Defective Original Design Detail. Corrosion of the connection between the girder and the built-up truss members has occurred on the former Delaware and Hudson Railroad Bridge, 1884, over the Hudson River between Troy and Green Island, New York, because the connection served as a pocket to trap rain and snow in an area difficult to maintain and protect. This connection is almost impossible to maintain without modification in the design. The connection should be sandblasted, primed immediately, and painted. Since the bottom of the vertical truss member is boxed in, which prevents painting with a brush, the inside of this member could be spray painted. (John G. Waite)

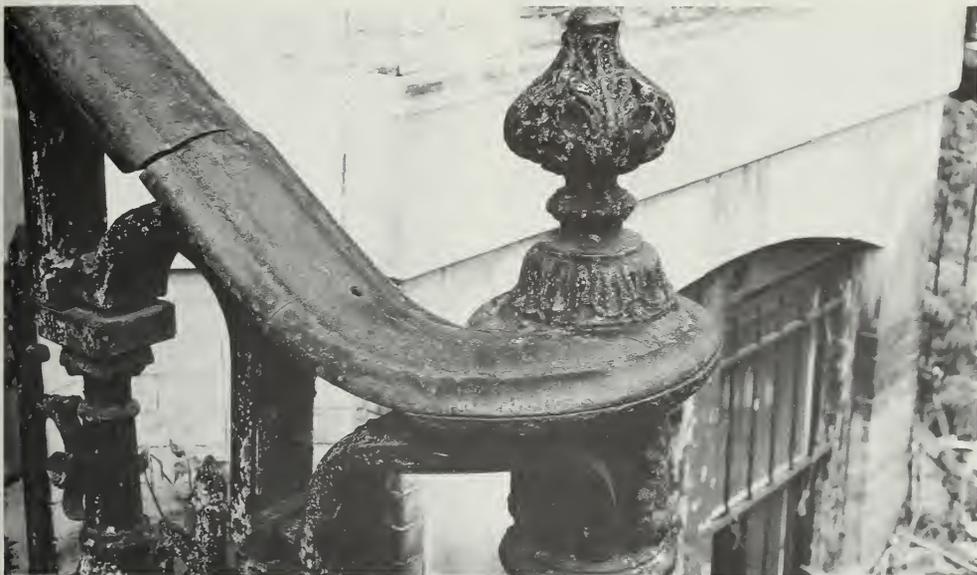
Figure 160. Cast-iron Corrosion, Fracture, and Missing Pieces. (a) The massive newel posts of the stair railings on the entrance of 637 I Street, NW in Washington, D.C., are hollow and are made up of several pieces screwed and bolted together. The newel post to the right side of the stairs is substantially intact. (b) The finial of the left newel post is missing. Note the threaded rod in the center of the newel post used for assembly. Inside the railing, loose rust has collected to a depth of about a half inch. Water seeped into the hollow rail and froze, resulting in the crack. (David W. Look)

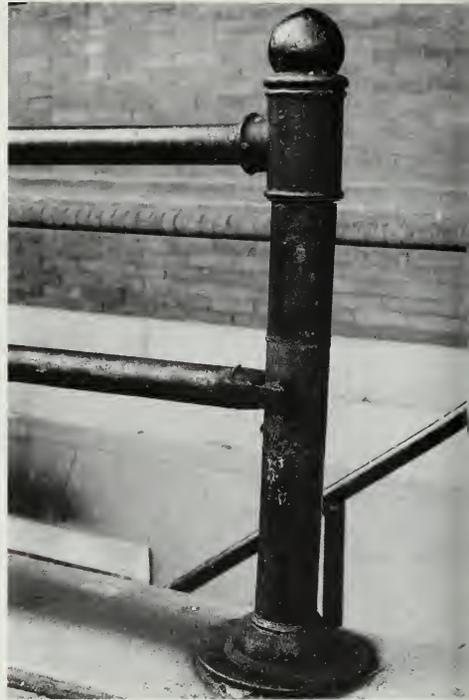
Figure 161. Inappropriate Repairs of Cast Iron. A simple cast-iron pipe railing guards the areaway of the Old Pension Building in Washington, D.C. The collar on the newel post to receive the bottom rail is missing (it probably cracked off from the pressure of expanding rust and/or ice). Unfortunately, a strap was welded to each side instead of repairing or replacing the collar. (David W. Look)

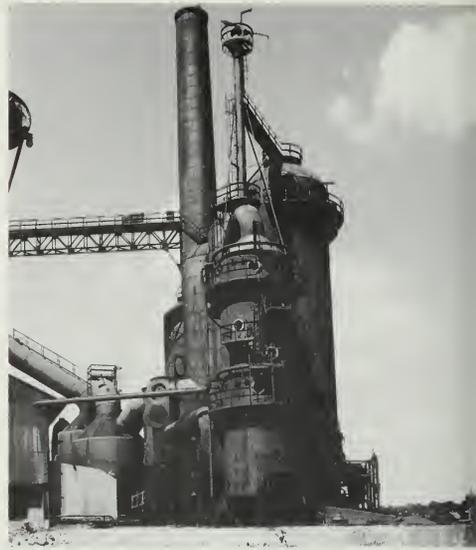
Figure 162. Unpainted Steel. *The Republic Steel Corporation in Troy, New York, could not meet the new environmental quality standards and shut down its 1920s steel blast furnace which was built for the Burden Iron Company. It had never been painted because steel at very high temperatures does not rust. When the heat was turned off, the steel rusted rapidly. (John G. Waite)*

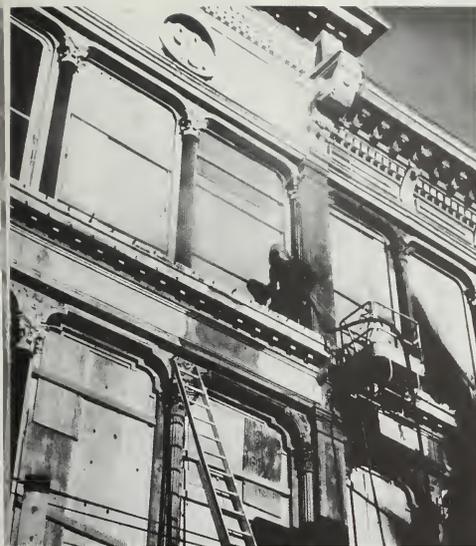
Figure 163. Cleaning Cast Iron. The facade of the Zions Cooperative Mercantile Institute (ZCMI) Store was sandblasted to locate the screws and bolt connections and thereby discover the method of assembly and disassembly. The cast iron should not be heavily sandblasted (down to the bare metal) unless that entire section of the facade is being dismantled. As pieces are being removed, they should be primed immediately to avoid rusting. If the building is not to be dismantled, it is best to remove only the loose paint with a wire brush, being careful not to damage caulked joints and connection holes. Any bare cast iron should be spot primed. (Steven T. Baird, AIA)

tial corrosion (figure 163). Grit blasting is fast, thorough, and economical, and it allows the iron to be cleaned in place. The aggregate can be iron slag or sand; copper slag should not be used on iron because of the potential for electrolytic reactions. Some sharpness in the aggregate is beneficial in that it gives the metal surface a "tooth" that will result in better paint adhesion. The use of a very sharp or hard aggregate and/or excessively high pressure (over 100 pounds per square inch) is unnecessary and should be avoided. Adjacent materials, such as brick, stone, wood, and glass, must be protected to prevent damage. Some local building codes and environmental authorities prohibit or limit dry sandblasting because of the problem of airborne dust.

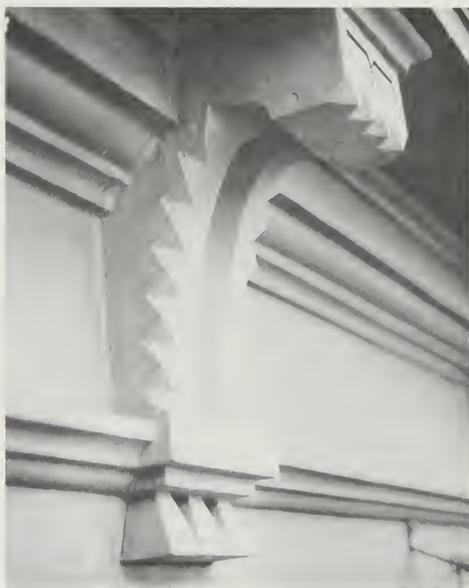
Figure 164. Exposure of Connections and Joints. After the Wilmington Opera House was sandblasted, screw and bolt holes were visible. A cast-iron bracket such as this one may be made of as many as 10 pieces. (Steven T. Baird, AIA)

Many of these techniques are *potentially dangerous* and should be carried out only by experienced and qualified workers using proper eye protection, protective clothing, and other workplace safety conditions. Before selecting a process, test panels should be prepared on the iron to be cleaned to determine the relative effectiveness of various techniques. The cleaning process will most likely expose additional coating defects, cracks, and corrosion that have not been obvious before (figure 164).

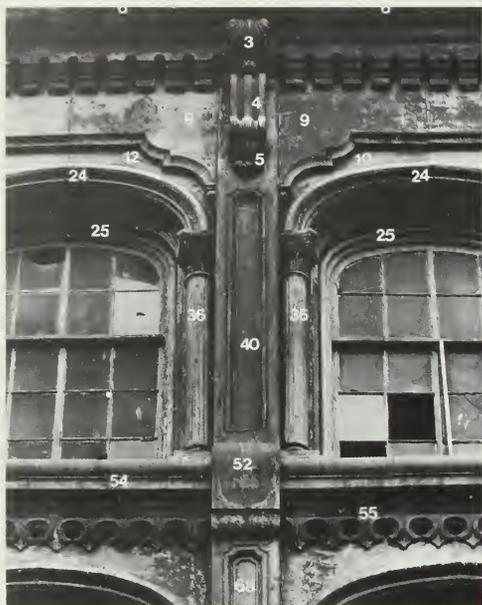
Figure 165. Sequence of Dismantling. Once the bolts and screws have been located, the parts can be numbered. The numbers on the photograph indicate to the contractor the order of disassembling the cast-iron facade, which is the reverse order of its original erection. (Steven T. Baird, AIA)

Most architectural cast iron is made of many small castings assembled by bolts or screws (figure 165). Joints between pieces were caulked to prevent water from seeping in and causing rusting from the inside out. Historically, the seams were often caulked with white lead paste and sometimes backed with cotton or hemp rope; even the bolt and screw heads were caulked to protect them from the elements and to hide them from view. Although old caulking is sometimes found in good condition, it is typically crumbly from weathering, cracked from the structural settlement, or destroyed by mechanical cleaning (figure 164). It is essential to replace deteriorated caulking to prevent water penetration. For good adhesion and performance, an architectural-grade polyurethane sealant is preferred.

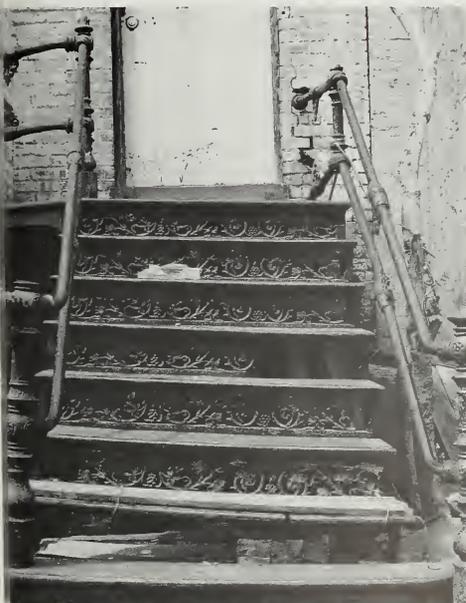
Figure 166. Damaged Cast Iron. This cast-iron perforated stoop in the 700 block of I Street, NW, in Washington, D.C., is fractured in several places because of differential settlement. As the right side of the stairs sank into the ground, the weight of the stoop was redistributed and induced shear, tensile, and torsional forces that were too great for the cast iron to resist. Differential settlement can also be caused by the upward and outward growth of a tree adjacent to a stoop and the downward settlement of a dead tree stump as it decays. Patching or repair work will be effective until the problem is corrected. The stoop should be disassembled and a new concrete foundation poured; the stoop can then be reassembled using welded fractured pieces and recast missing pieces. (David W. Look)

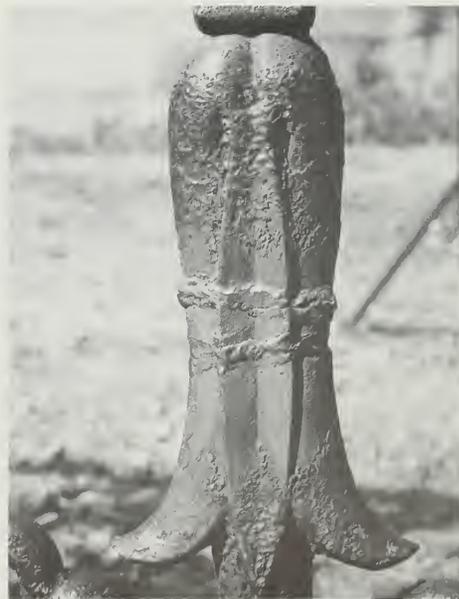
Figure 167. Welding Cast Iron. Although cast iron is very difficult to weld, it can be done by a skilled welder. This is a detail of a weld on the cast-iron fence at the Gardiner-Pingree House in Salem, Massachusetts. "Ni-Rods" welding electrodes, made with a nickel alloy, have been used to weld cast iron since 1947. This weld should have been ground down after completion. (Lee H. Nelson)

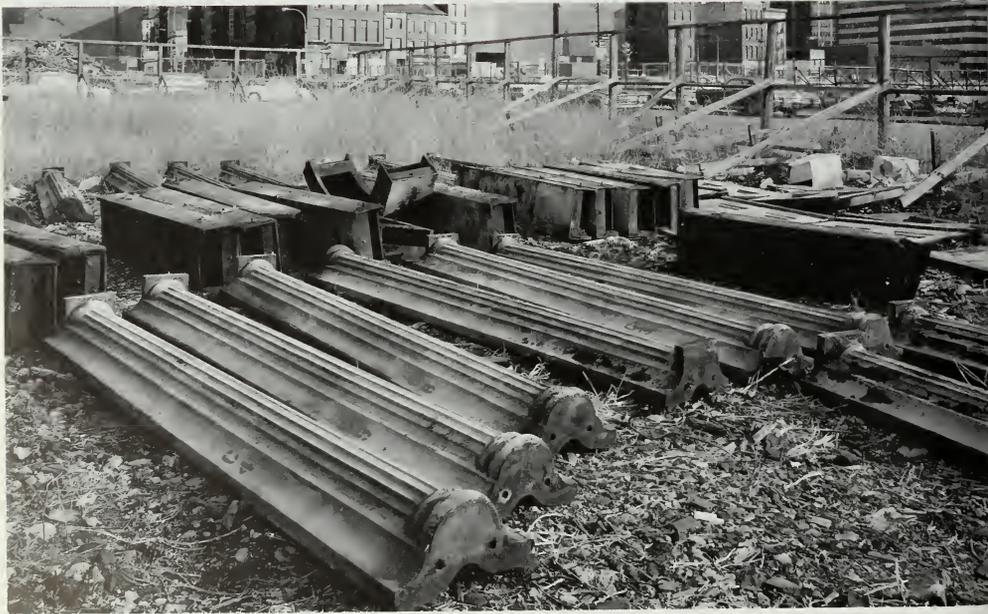
Figure 168. Dismantled Cast-Iron Facade. *The Edgar Laing Stores in New York City were erected by James Bogardus in 1849 and had one of the earliest cast-iron facades. The building was demolished in 1971 for an urban renewal project, but its cast-iron facade was carefully dismantled so it could be reerected on another site at a later date. Unfortunately, while the components were in storage, most of them were stolen and apparently sold for scrap. Dismantling of a building should be considered a measure of last resort, to be attempted after all other efforts to save a building in situ have failed. (Jack E. Boucher)*

The Laing Stores in New York City (figure 168) were dismantled in a last-ditch preservation effort. The connecting nuts and bolts were corroded and had to be burned off with a torch. If this work has to be carried out in the winter, care should be taken to avoid fracturing the cast-iron structural elements by uneven heating

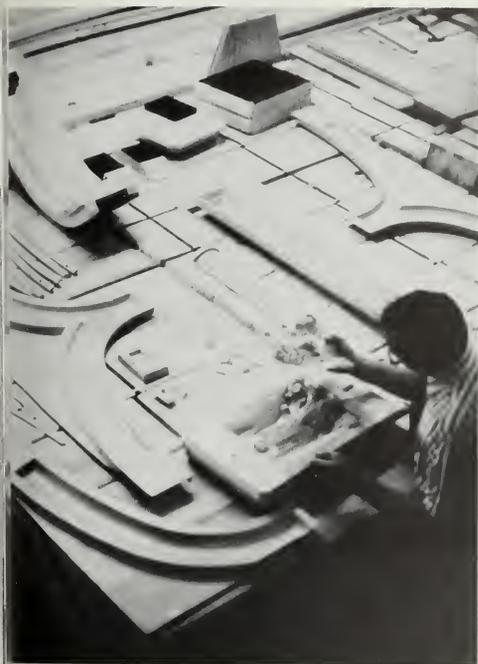
Figure 169. Wooden Patterns. These patterns carved from white pine are inspected, and, if approved, sent to the foundry or making sand molds required for the individual castings. The patterns are made proportionally larger to compensate for the shrinkage of the casting. The percentage of shrinkage is different for cast iron, aluminum, fiberglass, et cetera; therefore, the material of the final casting must be determined before the pattern is carved. (Walter Smalling, Jr.)

The replacement of cast-iron components is often the only practical solution when such features are missing, severely corroded, or damaged beyond repair, or where repairs would be only marginally useful in extending the functional life of an iron element. Sometimes it is possible to replace small, decorative, non-structural elements using intact sections of the original as a casting pattern. For large sections, new patterns of wood or plastic made slightly larger in size than the original will need to be made in order to compensate for the shrinkage of the iron during casting (cast iron shrinks approximately 1/8 inch per foot as it cools from a liquid to a solid)¹²¹ (figure 169).

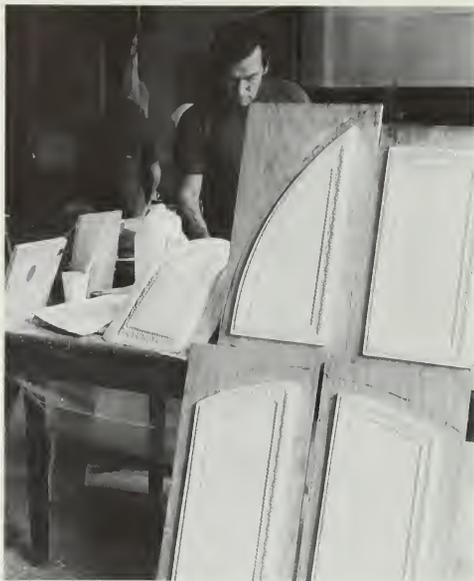
Figure 170. Plastic Patterns. Historically, most patterns for casting iron were carved from wood and pressed into sand to form molds. For the recasting of the iron shutters of the West Virginia Independence Hall, an attempt to use plastic patterns met with only limited success. How the original shutters, with their deeply undercut, beaded molding were cast in one piece is not known. To achieve the same effect in the restoration, the beaded molding of iron had to be cast separately and applied to the replicas. The patterns are mounted on plywood to give them enough rigidity so they may be hammered into the sand to form the molds. (West Virginia Independence Hall Foundation)

In addition to traditional wooden patterns, cast plastic patterns are now being tried. Like ice, which expands as it freezes, some plastics do not shrink when cast, but actually expand while setting (figure 170). This expansion can be used to compensate for later shrinkage of the cast iron or aluminum, but the amount of expansion plastic must be carefully matched to the amount of shrinkage of the cast metal in order for this to be effective.

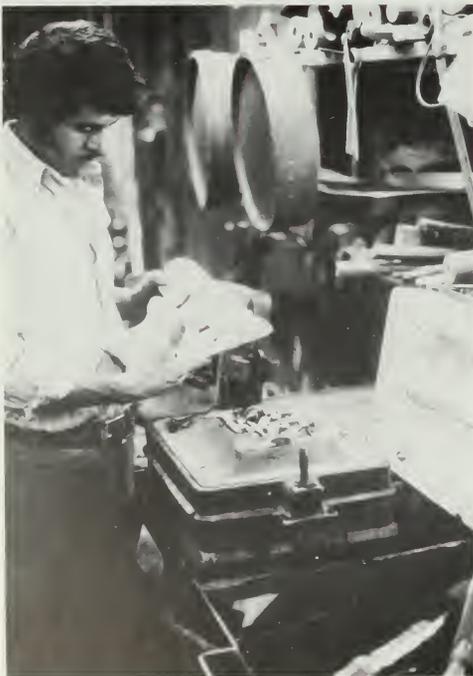
Figure 171. Sand Mold. The pattern has been pressed or hammered into the sand to form an impression or mold. Special casting flasks or boxes are used to hold the sand. Only one flask or box is required for an open mold which produces a casting with a flat top. To cast a piece with relief on both top and bottom requires two flasks stacked and bolted together. (Steven T. Baird)

Architectural elements were traditionally cast in sand molds (figure 171). The quality of the special sands used by foundries is extremely important; unlike most sands, they must be moist. Foundries have their own formulas for sand and its admixtures, such as clay, which makes the sand cohesive even when the mold is turned upside down.

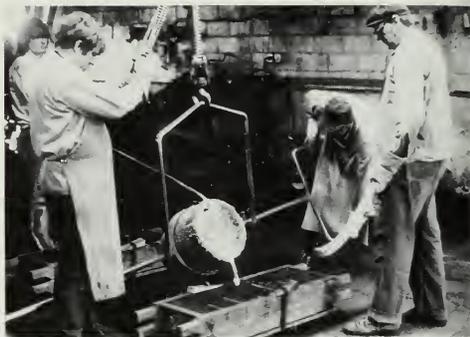
Figure 172. Casting Iron. Molten iron is being poured into the sand molds. For open molds, the molten iron is just poured in from the open top. For closed molds, tunnels (called "sprues") are carved out of the wet sand to allow the molten metal to flow in and "risers" allow the air to escape. Once the casting has cooled to room temperature, the sand is removed from around the casting. The sprues and risers are cut off and any remaining irregularities or ragged edges (called "burrs") are ground smooth. (Walter Smalling, Jr.)

The molding sand is compacted into flasks, or forms, around the pattern. The cope is then lifted off and the pattern is removed, leaving the imprint of the pattern in the small mold. Molten iron, heated to a temperature of approximately 2700 degrees Fahrenheit, is poured into the mold and then allowed to cool (figure 172). The molds are then stripped from the casting; the tunnels to the mold (sprues) and risers that allowed release of air are cut off; and ragged edges (called "burrs") on the casting are ground smooth.

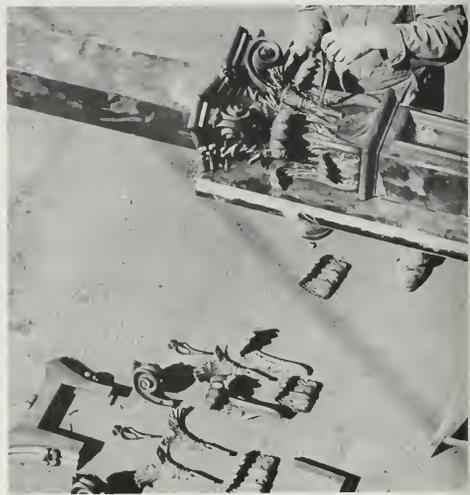
Figure 173. Preassembly of Cast-Iron Components. Before the cast-iron pieces are shipped from the foundry to the job site, the components are laid out and preassembled to insure proper fit. If the parts do not fit because of burrs, the pieces are machined to remove irregularities. If the parts still do not fit, the rejected parts are recast until all of the castings fit together. Some small ornamental parts may be left together, but most of the larger pieces are disassembled before shipping. All of the castings shown were necessary to produce a Corinthian pilaster. (Walter Smalling, Jr.)

The castings are shop-primed to prevent rust, and laid out and preassembled at the foundry to ensure proper alignment and fit (figure 173). When parts do not fit, the pieces are machined to remove irregularities caused by burrs, or are rejected and recast until all of the cast elements fit together properly. Most larger pieces then are taken apart before shipping to the job site, while some small ornamental parts may be left assembled.

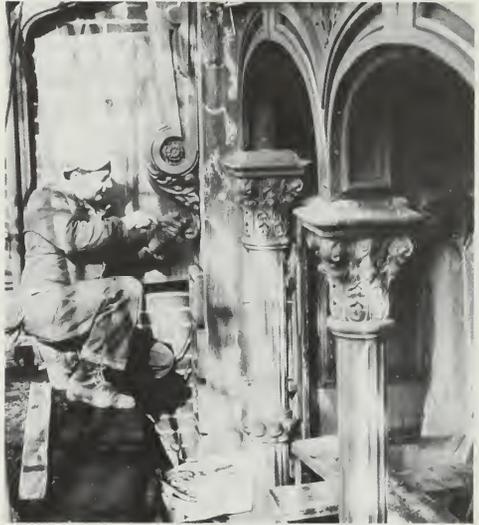
Figure 174. Erection of Cast-Iron Facade. *To assemble the Main Street shop facade of the Wilmington Grand Opera House, many assembled sections and individual pieces were shipped to the job site where they were screwed and bolted together in their final positions. (Steven T. Baird)*

At the job site, the components are erected piece by piece (figure 174) and bolted or screwed together through holes cast in the parts. The new elements should be connected in the same manner as the original components. Bolt holes were originally cast into the pieces to aid trial assembly in the shop and final erection at the job site. With a new building most of the bolt holes will line up; however, with an old building that has settled, the bolt holes may not line up and minor adjustments may be necessary. Thus, in recasting missing or damaged pieces, bolt holes are not always cast into the pieces, but are often drilled on the job site to insure proper alignment (figure 175).

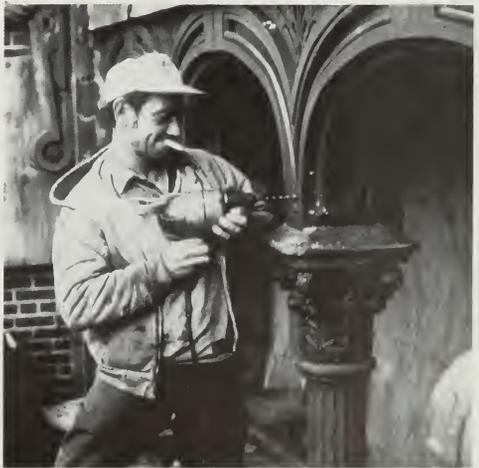
Figure 175. Drilling Holes. *Originally, screw and bolt holes were cast into the pieces of iron for new ironwork; however, for the restoration of existing cast-iron facades which may have settled over the years, the holes are sometimes drilled into the replacement parts at the job site to insure correct alignment. (Walter Smalling, Jr.)*

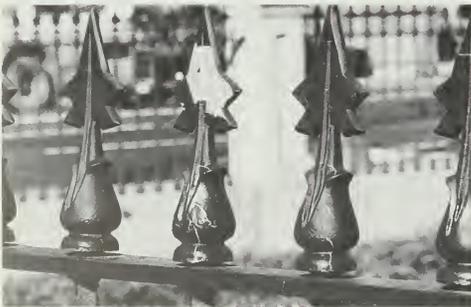
Figure 176. Aluminum Reproduction. Cast aluminum is less brittle than cast iron and more impact resistant; therefore, it is more capable of resisting vandals or souvenir hunters. On the iron fence around the Treasury Building in Washington, D.C., the missing cast-iron spear tips were replaced with cast aluminum. Unfortunately, the paint adhesion has failed and the bare aluminum is visible. (John Myers)

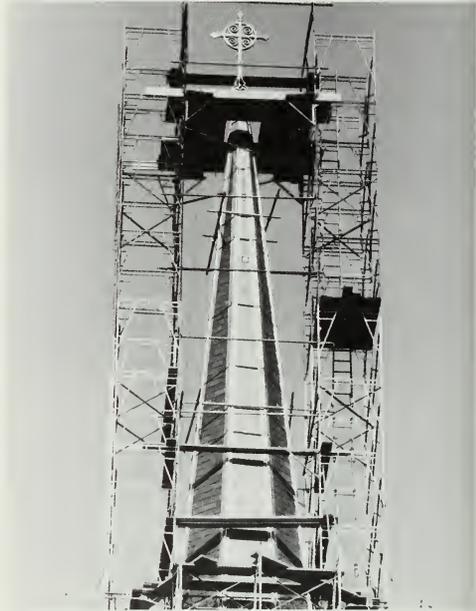
Figure 177. Reinforced Polyester Replica. The original cross of St. Agnes Church, Cohoes, New York, was removed from the steeple in the 1890s to serve as a grave marker. The original wrought-iron steeple cross, still intact, was used as a model to cast a new cross of reinforced (fiberglass) polyester. Fiberglass was chosen as a substitute material because of the inaccessible location (top of the steeple) where maintaining wrought iron (painting) would be difficult and expensive and because from the street level no one would be able to detect the substitute materials. (John G. Waite)

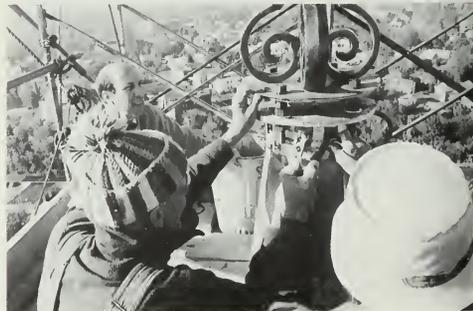
Figure 178. Aluminum Replacement of Minor Structural Elements of a Facade. For minor structural members without great loads, aluminum can be used as a substitute material; however, the capacity of a cast-aluminum column must be designed or checked by a structural engineer and not just assumed to be adequate. When the Grand Opera House in Wilmington, Delaware, was restored, missing cast-iron columns on the first-floor storefronts (flanking center bay entrance, lower center of photograph) were cast in aluminum to match the missing pieces of the original cast iron. (John G. Waite)

Cast aluminum has been used recently as a substitute for cast iron, particularly for ornately detailed decorative elements (figure 178). Aluminum is lighter in

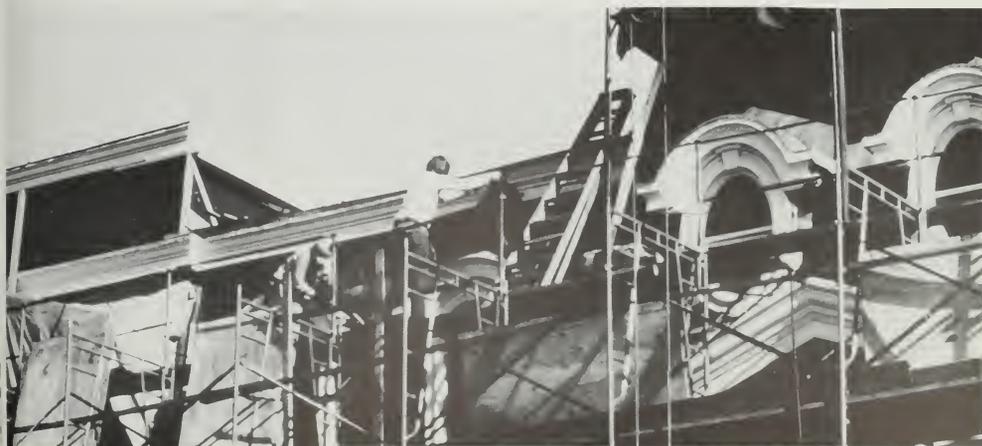
Figure 179. Use of Both Cast Aluminum and Fiberglass as Substitute Materials. After the Mansard roof and dormers of the Wilmington Grand Opera House were destroyed by fire the top floor was rebuilt, but not according to the original design. During restoration of the facade, photographs showing the original Mansard roof and dormers were found, which enabled the re-creation of the missing parts of the facade. The oval windows were cast in aluminum; but the moldings and trim, which may have originally been sheet iron, were made of reinforced polyester. (Walter Smalling, Jr.)

member. All corrosion, rust, and loose paint must be removed before painting. In other cases it may be necessary to reproduce severely deteriorated or lost elements (figure 144). In some situations, often for economic reasons, reinforced polyester, commonly known as fiberglass, has been used for reproduction of missing cornices and other sheet metal details (figure 179).

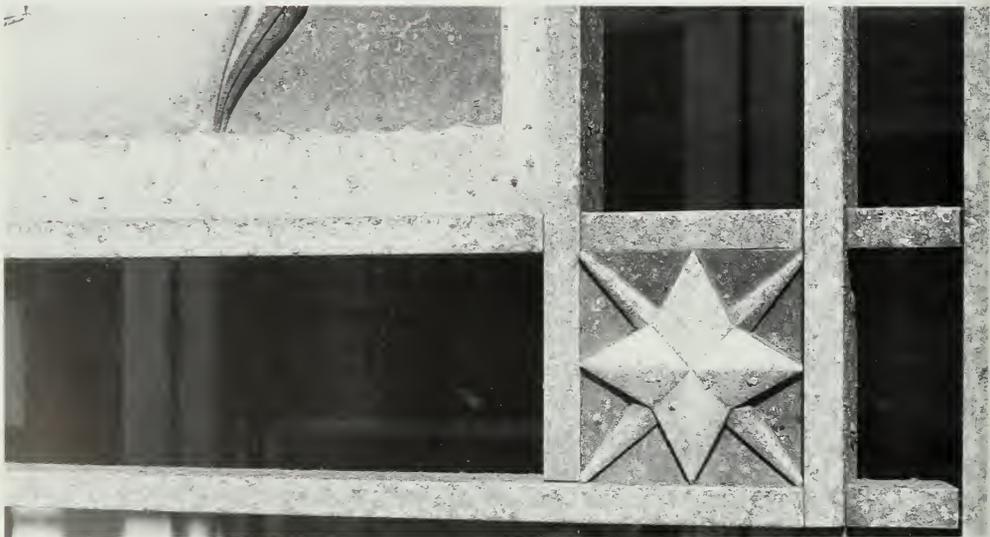
Figure 180. Corrosion and Pitting of Stainless Steel. Although stainless steel was originally believed to be totally corrosion resistant, some types can corrode under certain conditions where the atmosphere is highly polluted. These stainless steel gates at the Federal Trade Commission in Washington, D.C. (see figure 108), have probably never been washed since they were hung and recessed into the facade of the building to protect them from the washing effect of rain. Under each bump of white corrosion, the surface of the metal is pitted. Dirt on the surface of stainless steel encourages corrosion at that particular location because the dirt holds moisture next to it. These doors should be cleaned with water and a non-ionic detergent and polished with a soft clean cloth and pumice powder. The gates should then be washed annually to remove surface dirt and wiped dry to avoid spotting. Corroded stainless steel may look like aluminum; in fact, these gates were recently described as aluminum in photographs in an exhibition on the Federal Triangle at the National Collection of Fine Arts Museum. Chemical tests were necessary to determine if the gates were indeed stainless steel as stated in the original specifications. (David W. Lolk)

Pitting is the localized corrosive attack on the metal (see figure 180 and 181).

To prevent corrosion (figure 180), stainless steel architectural elements should be washed regularly with warm water and a mild detergent to prevent the accumulation of dirt and other pollutants which can cause corrosion through creation of galvanic cells. Any encrustation of grime and dirt or stains can usually be removed with a commercial stainless steel cleaner. Although deterioration of stainless steel is seldom encountered, it may be physically damaged and require repairs, patching or replacement. Care should be taken to match the composition and finish of the original material with the replacement. If cast stainless steel is replaced, patterns must be made larger to allow for shrinkage which is 9/32 inch per foot.

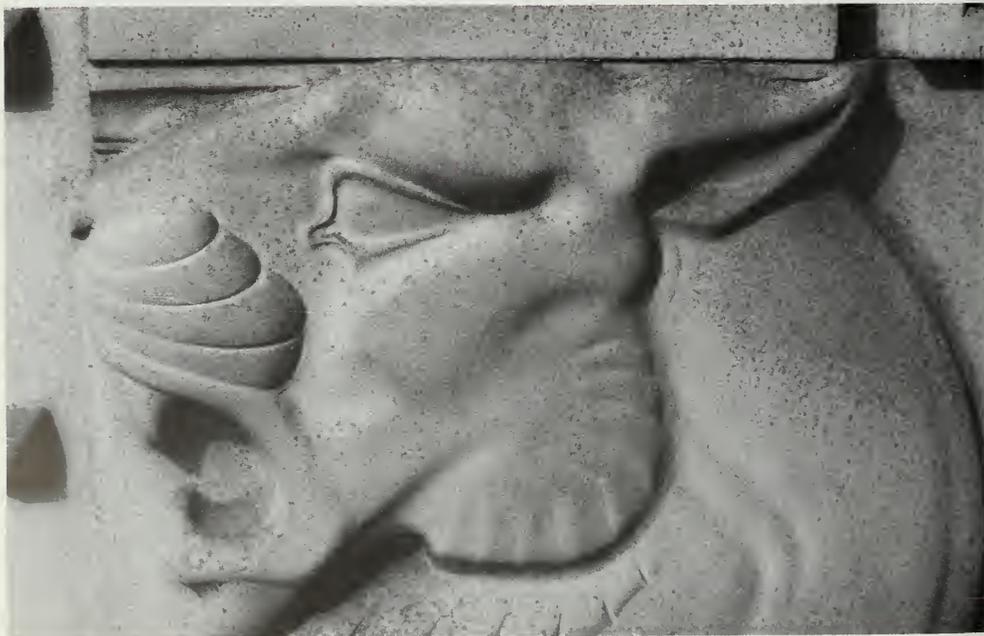
Figure 181. Corrosion and Pitting of Aluminum. Designed by Carl Paul Jennewein, these cast-aluminum doors on the U.S. Justice Building in Washington, D.C., are pitted (see figure 114). Aluminum corrosion is white; however, surface dirt, grime, and pollution have collected on the corrosion products, forming small dark bumps. The pits are actually beneath the bumps and were formed as surface metal oxidized. Pitting is caused by a difference in potential of two or more points on the surface of the same metal and a local breakdown of the protective oxide film. It is encouraged by foreign particles, such as dirt and chlorides which hold moisture next to the surface. (David W. Look)

Aluminum is resistant to most types of corrosion, including attack by sulfur compounds such as hydrogen sulfide and sulfur dioxide. It combines readily and quickly with oxygen to form a transparent, tightly adherent film of oxide which is relatively inert to further chemical action. Aluminum also resists attack by other atmospheric gases (figure 181), moisture, and many kinds of soils.

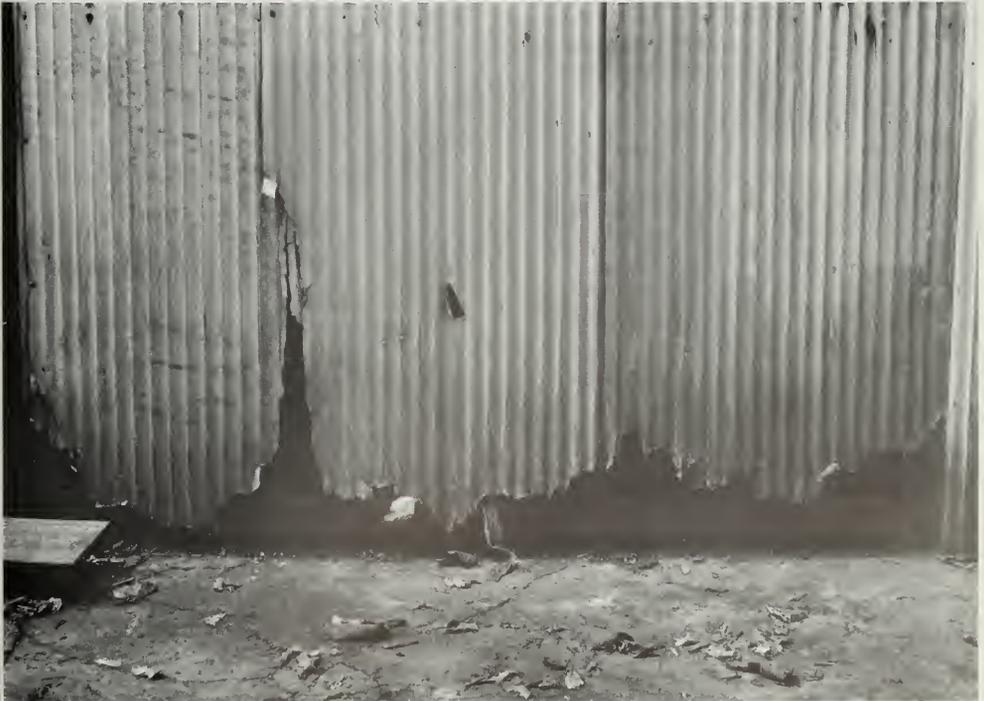
Figure 182. Corrosion and Severe Deterioration of Aluminum. *The corrugated aluminum siding on a commercial building in Green Island, New York, has been severely deteriorated by the splashing of water and snow-melting salts. (John G. Waite)*

Sea water is especially corrosive. Marine atmospheres and sea water contain several corrosive agents including chlorides and other salt particles which can be deposited on the surface of the metal (figure 182). These corrosive agents can affect metals as far as 60 to 70 miles from the sea (depending on weather patterns). Chloride ions are also found in some de-icing salts and in some forms of industrial pollutants. Metals immersed in water are also subject to corrosion by dissolved solids and gases, especially oxygen.

Corrosive agents that actively attack aluminum include alkalis, hydrochloric acid, lead-based paints, certain wood preservatives, and chlorides (figure 182). Wet lime mortar, Portland cement, plaster, and concrete will cause some surface corrosion of aluminum, but once cured, (and no longer alkaline), they have no further corrosive effect. Aluminum is often corroded where it comes into contact with damp, porous brickwork and stonework.¹³² Although dry, seasoned lumber does not affect aluminum, unseasoned, damp oak, cedar, and redwood produce acids which attack the metal. Even water draining off a roof of unweathered wood shingles will corrode aluminum flashing. In addition, any wet wood in direct contact with aluminum will corrode it.
