Metals in America's Historic Buildings

Uses and Preservation Treatments

U.S. Department of the Interior
National Park Service
Cultural Resources
Preservation Assistance
Washington, D.C.
1992

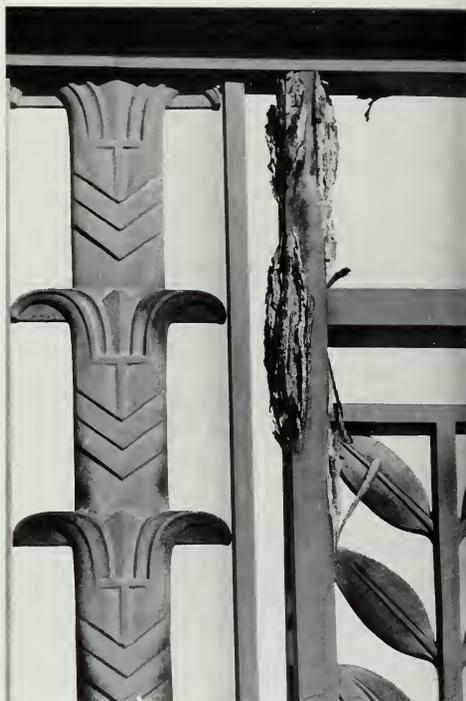
Figure 183. Exfoliation Deterioration. In Washington, D.C., at the Folger Shakespeare Library designed in 1932 by Paul Philippe Cret, the aluminum alloy balcony railing began to exfoliate in layers, similar to rusting wrought iron. The corrosion product was grayish white and lifted up from the surface as if the metal had exploded. All of the cast ornamental sections were in relatively good condition; only the straight, bar stock was affected. The original specifications stated that the railing was to be an aluminum and chromium alloy. However, a recent laboratory report analyzed a four inch section cut from a sound piece of metal next to a corroded area and indicated that it was high-copper alloy (structural aluminum) fitting into the category of alloy 2017, which is not recommended for exposed outdoor use since it is not corrosion resistant. It is amazing that it lasted 47 years outdoors. All of the straight bar stock of the railing should be replaced with alloy 6063. The cast ornament could be cleaned and reused since they are obviously of more corrosion-resistant alloy and show no signs of deterioration. (David W. Look)

Human error is another problem in dealing with aluminum. Sometimes the alloy specified for the job is not the best choice for the function or location, or the material used in fabrication is not the alloy specified (figure 183).
