Part I: A Guide for Management
Part II: Description of the Cultural Resources
and Recommendations

Historic Monument • Stonington Island/Antarctic Peninsula

April 1993

Catherine Holder Spude
Robert L. Spude

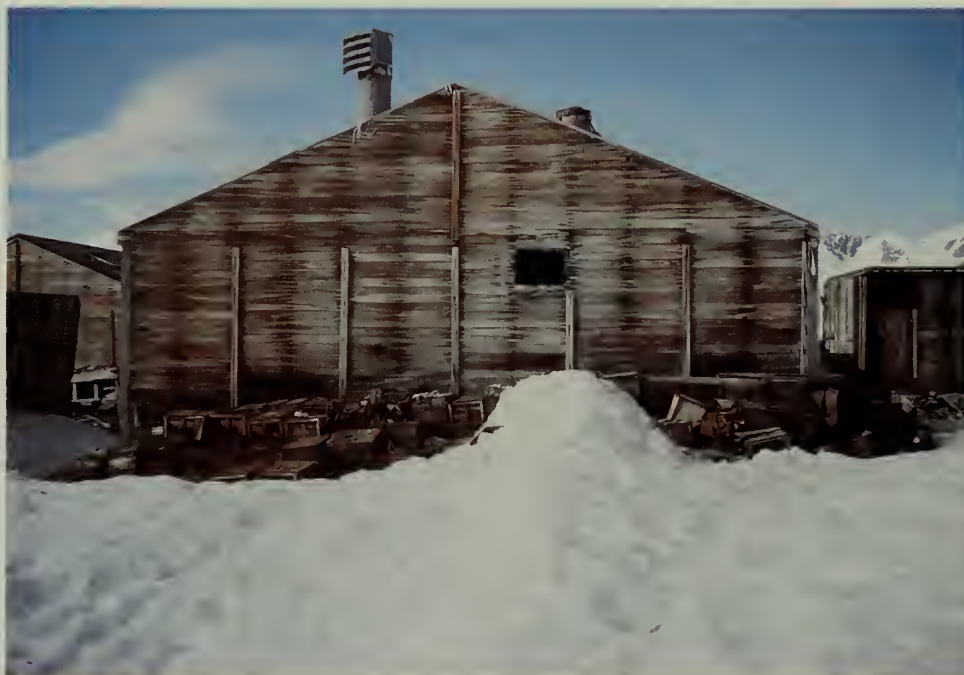
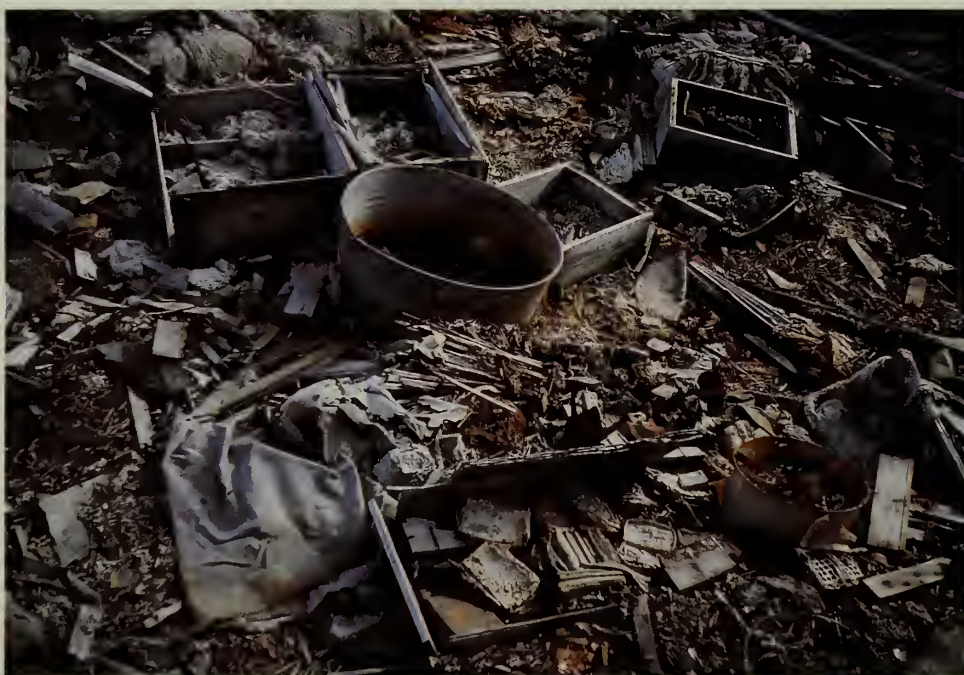
Top: Food cache along the walls of the main building. February 1991.

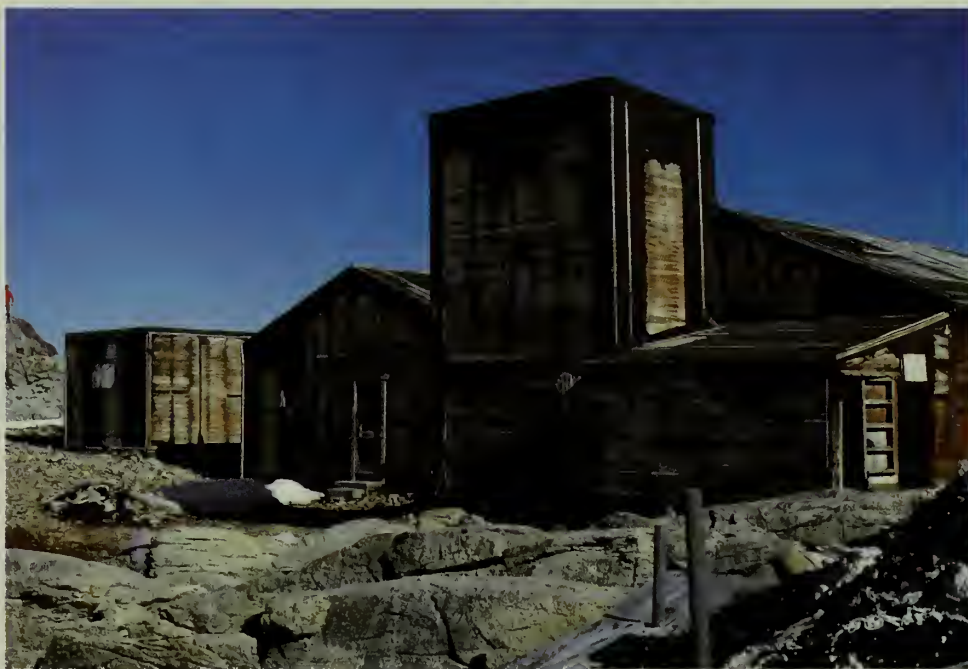
Top: The science building, main building, and outpost building (Ronne hut) comprise the standing structures of East Base Historic Monument.

The East Base camp buildings are in dilapidated condition from years of neglect. Three of the original structures remain — the science building, main building, and outpost building (Ronne hut) — while three have collapsed or burned. The main building contains seal debris and ice that will require extensive efforts to remove. The buildings should be stabilized. Visitors to the island walk through the structures and will continue to do so. Rehabilitation efforts should keep this short-term use in mind. Sections of the buildings may be used for artifact storage and/or display.

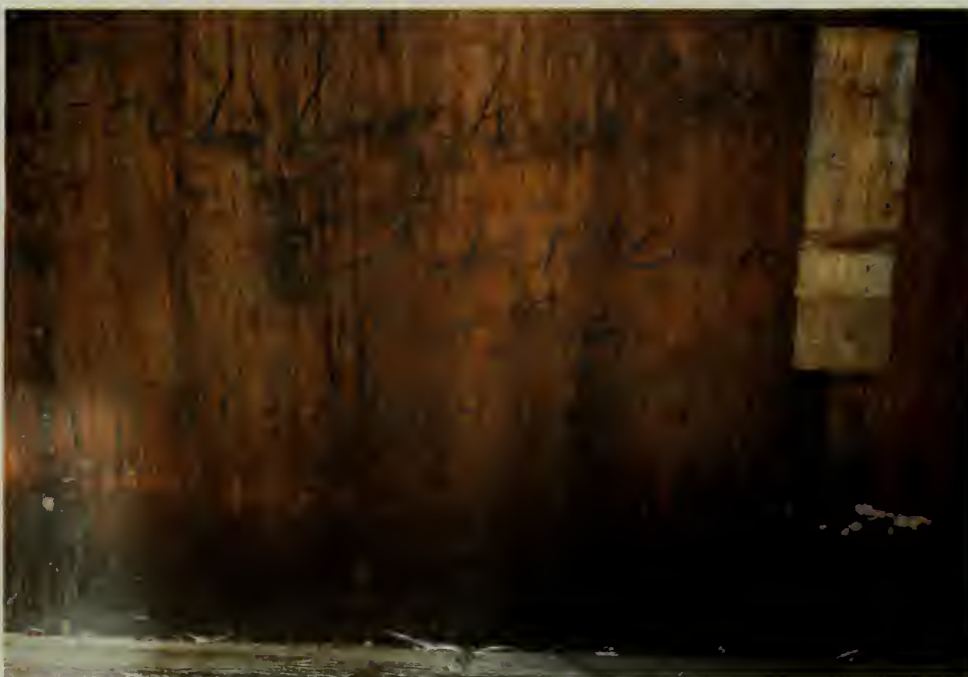
Bottom: Barely visible on the science building wall, is Richard Black's evacuation message.

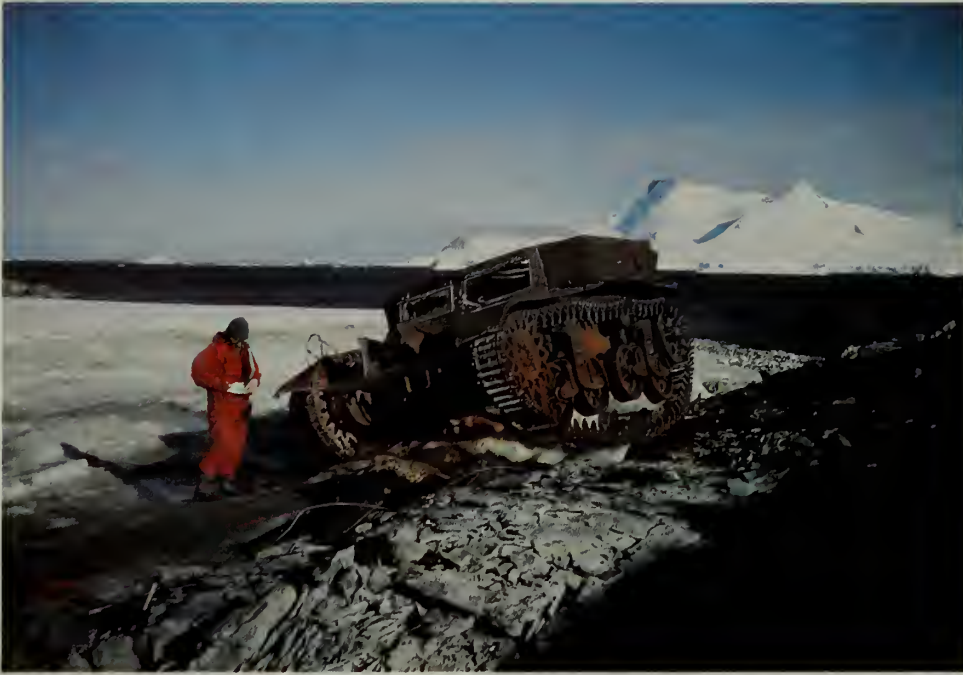
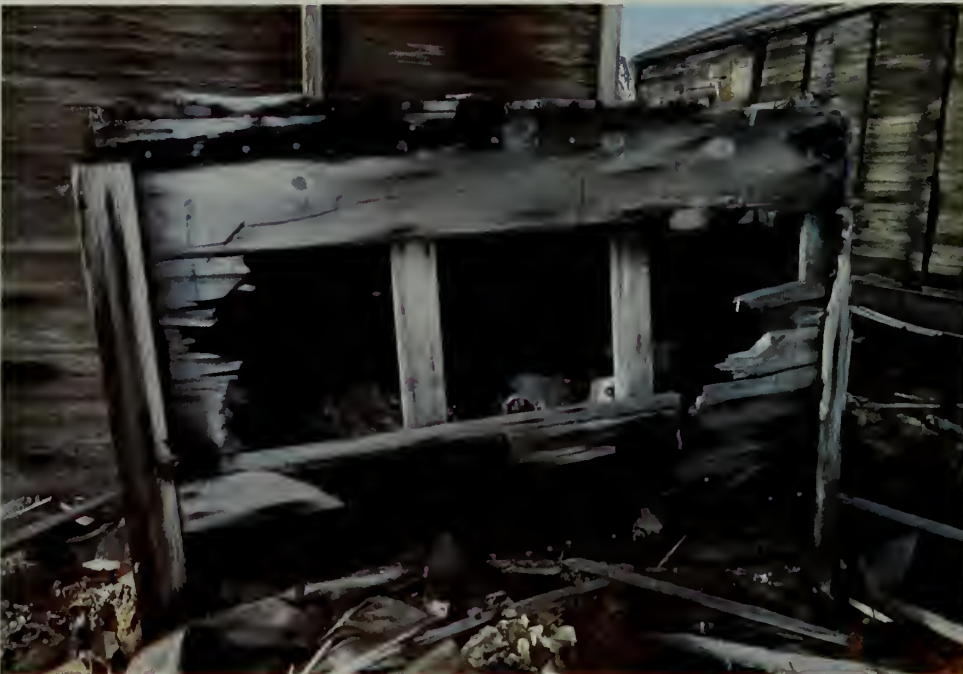
The light tank (above) and the tractor remain on the site as does a Curtiss-Wright airplane engine (below), all brought to the island by the U.S. Antarctic Service in 1940.

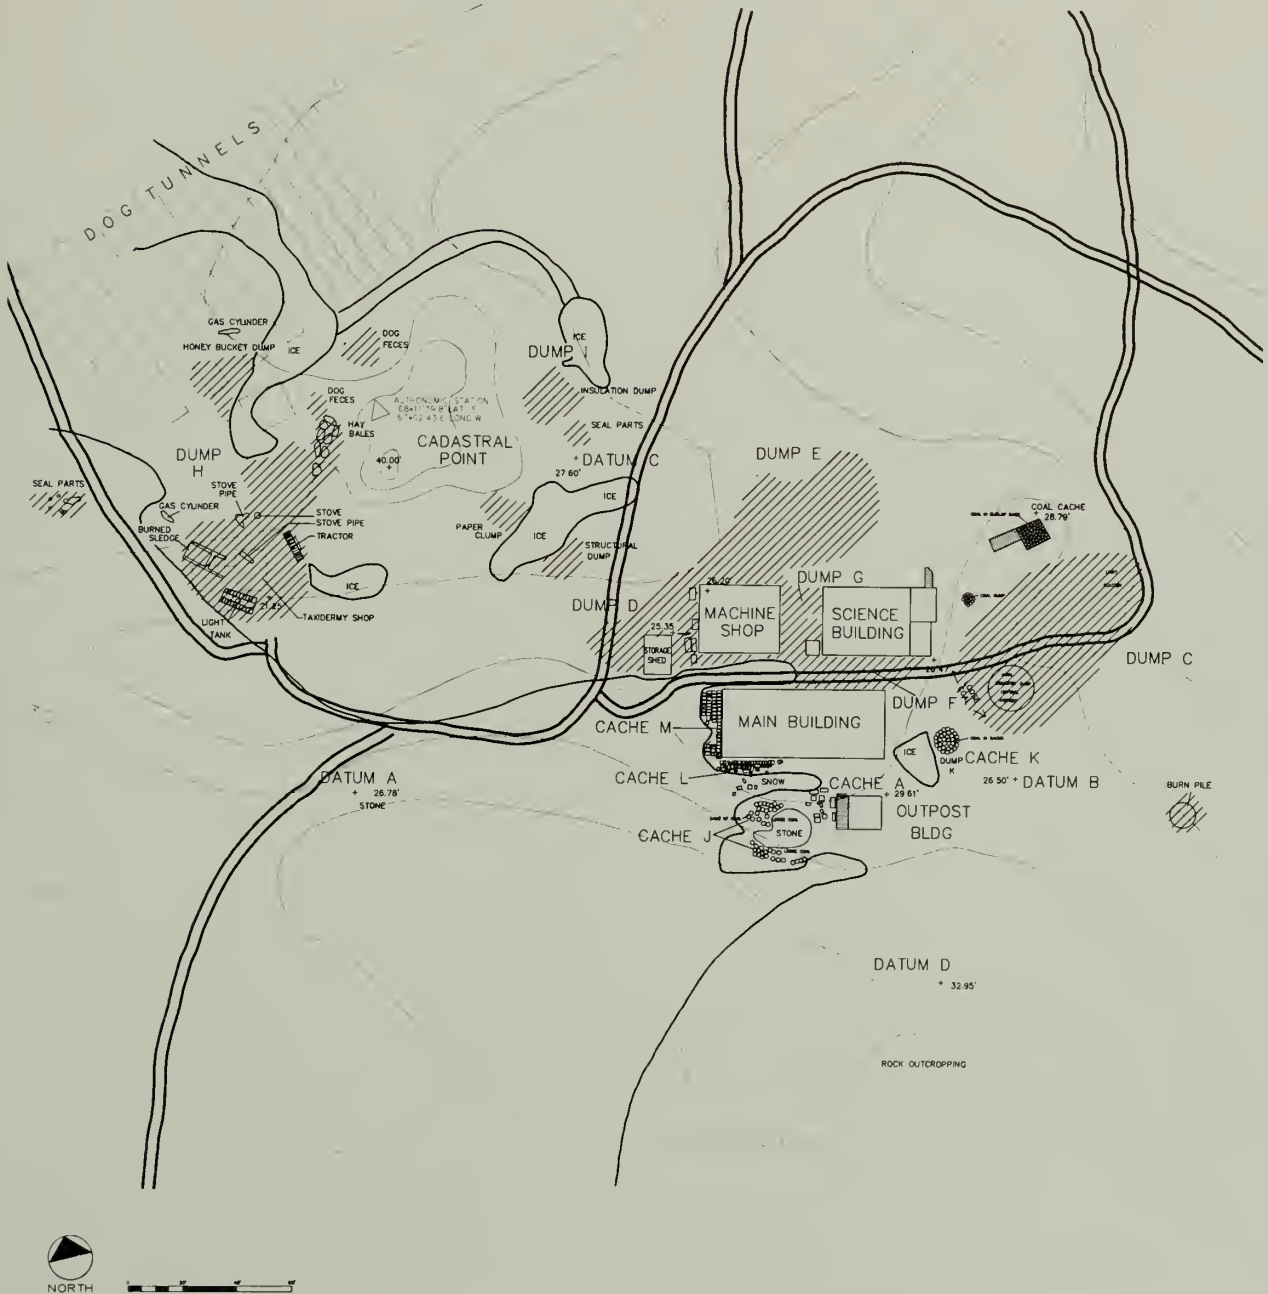
Archeological base map completed by the National Park Service under agreement with the National Science Foundation. It is overlaid on the 1941 map completed by USAS. The earlier map has lighter lines.

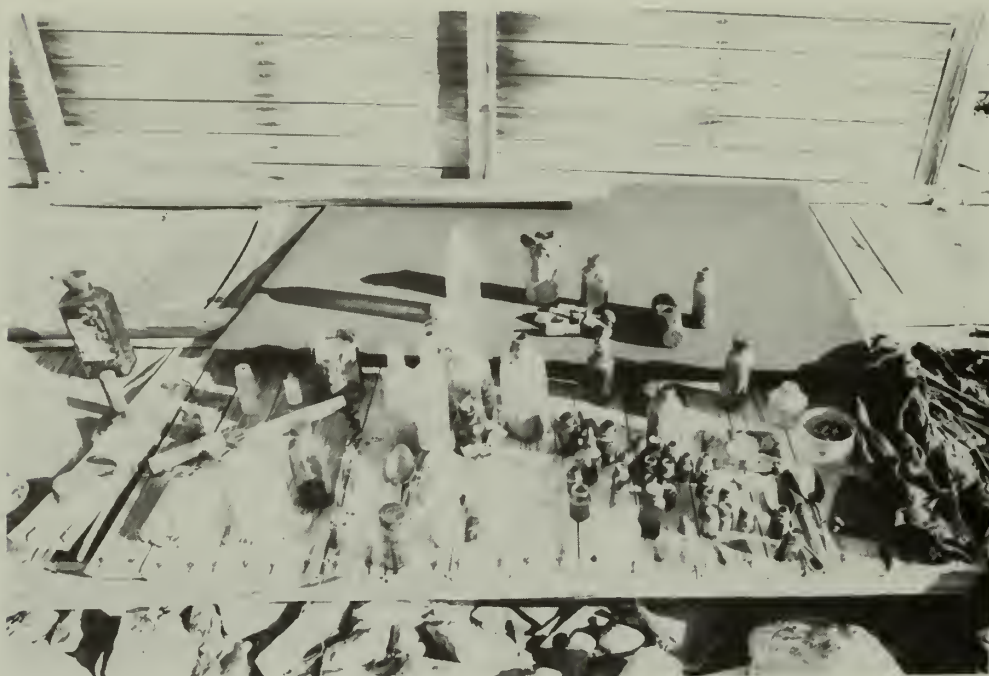
Top: Medicine and chemical bottles sampled from the domestic dump to the north of the science building before being placed in a box in the outpost building.

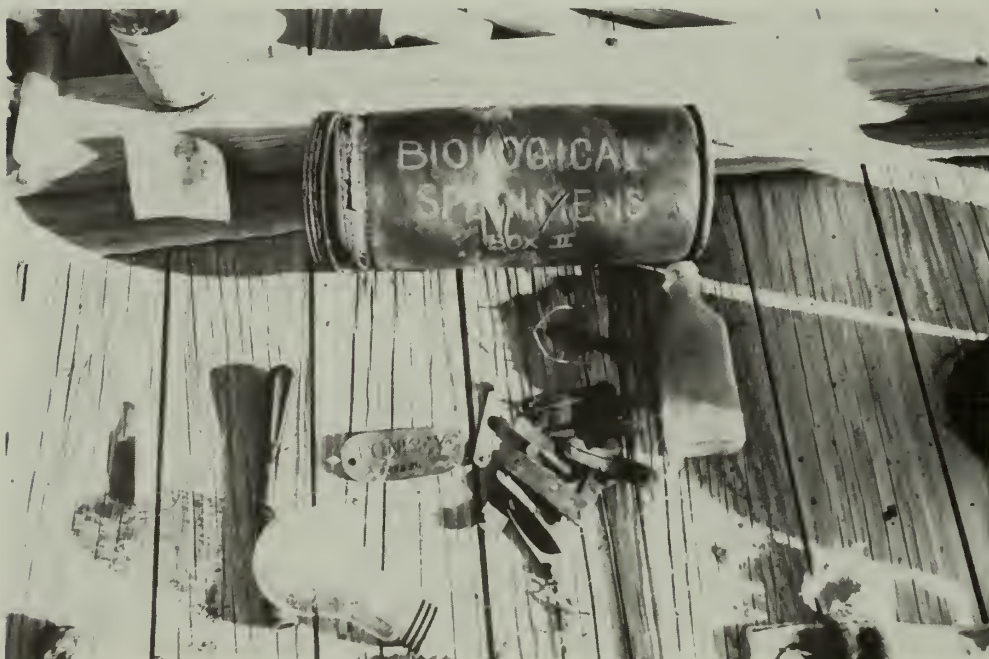
Bottom: Medical supplies and dog tags taken from the dump to the north of the science building before being placed in a box in the outpost building.

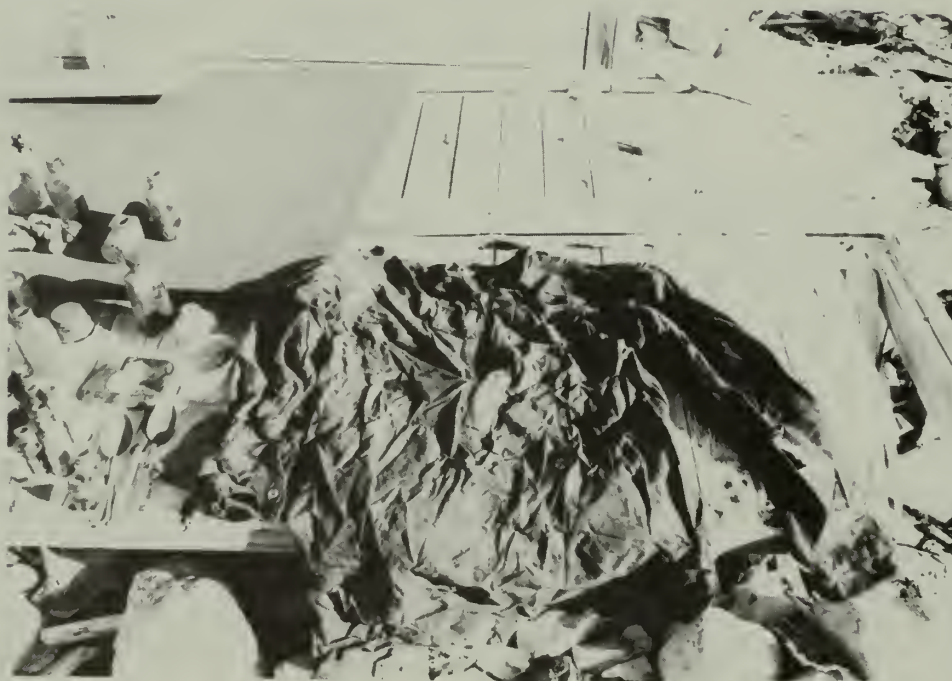
Bottom: Wool shirt recovered from the dump to the north of the science building, still in excellent condition, prior to its placement in a box in the outpost building.

present and need only minor cleaning to be usable. Despite alternately wet and dry conditions, no bacteria or fungi are present, and all organic materials appear to be well preserved. In fact, preservation of these materials is probably better in situ than could be maintained in transit to a repository without refrigeration.

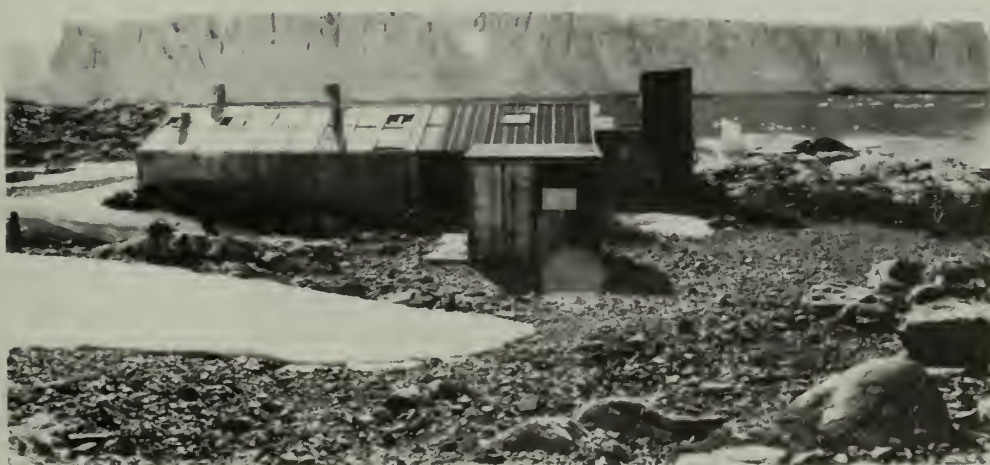
A view of East Base on February 22, 1991, looking north toward the glacier. The outpost building is in the foreground, the main building in the midground, and the science building with the meteorological tower at the rear.

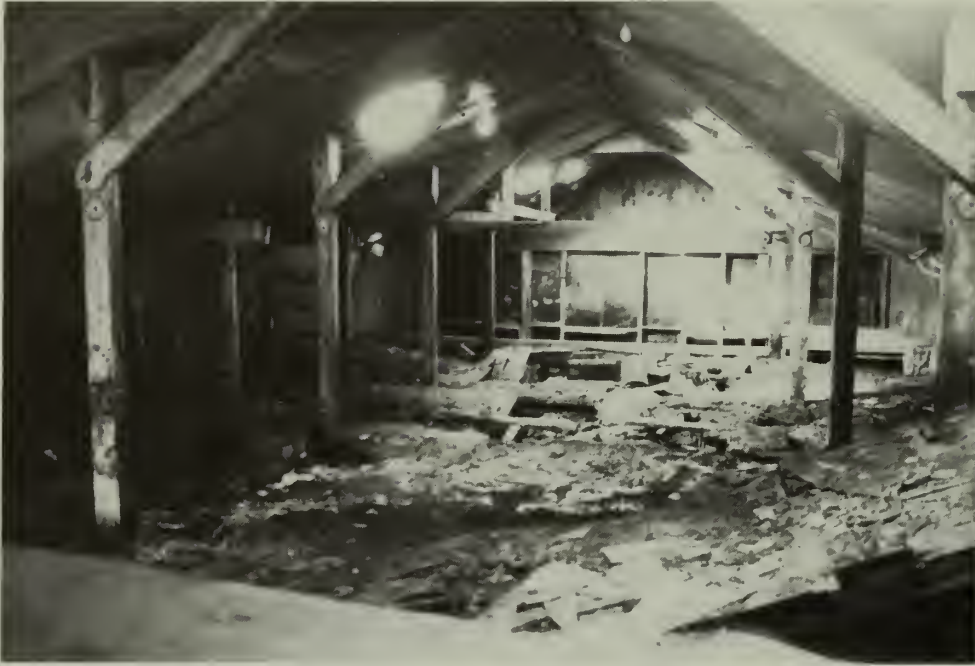
Top: Interior view of the main building with FIDS ramp descending from the right and the middle floor covered with seal debris.

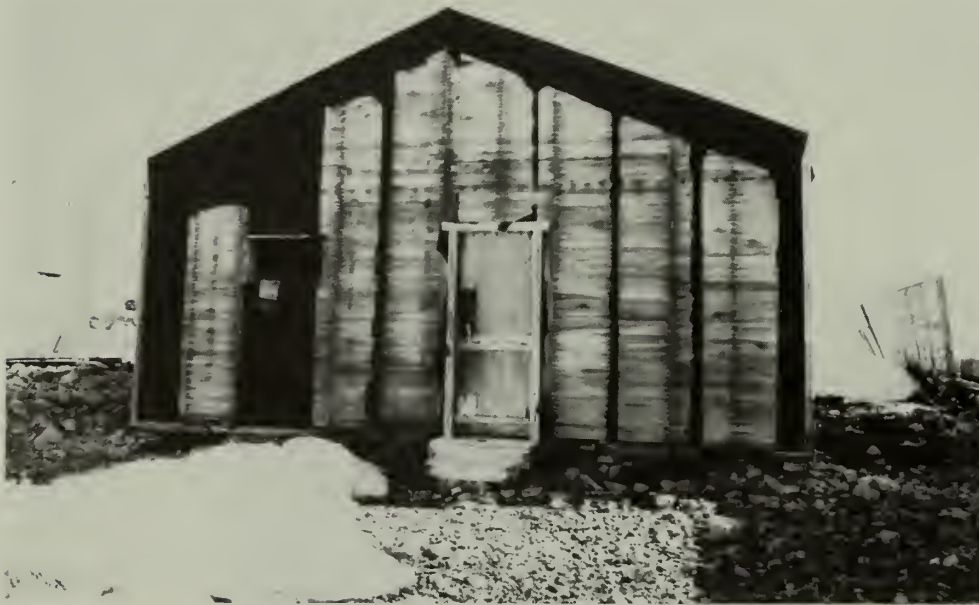
Bottom: The front door of the main building. February 23, 1991.

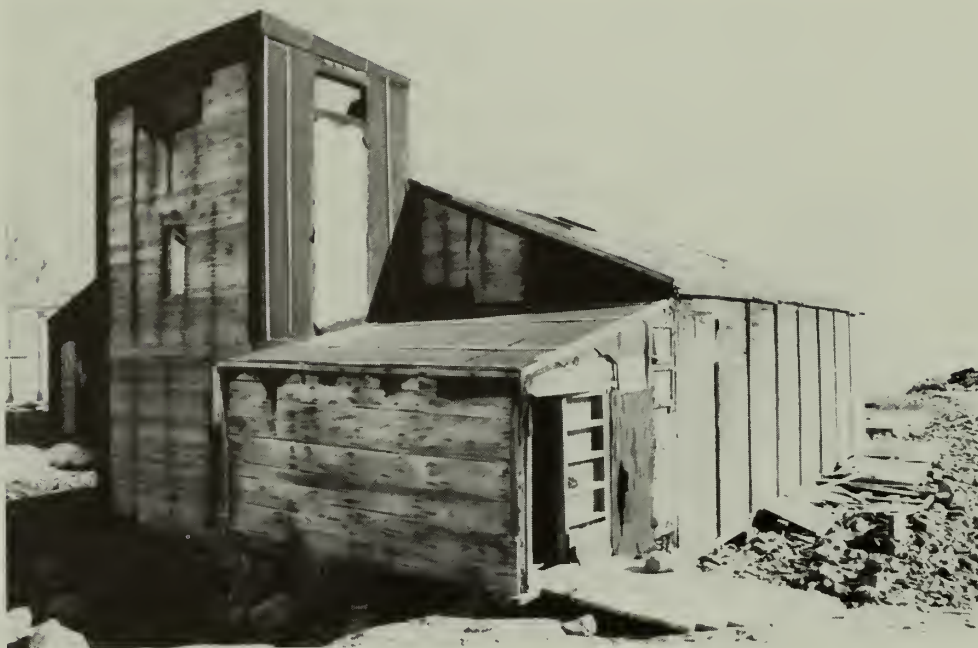
Top: The exterior of the science building on February 23, 1991.

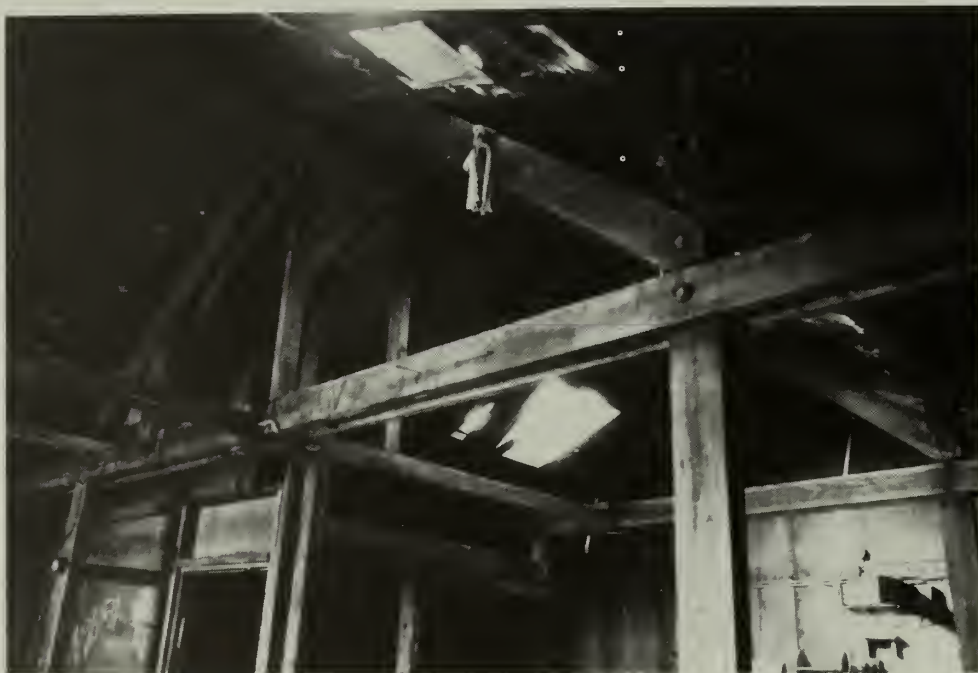
Bottom: The interior of the science building on February 23, 1991, showing trusses.

After RARE left, the British used the building for sled repair and rope storage. Interior walls were removed – only a short section remains – and the windward half of the building was covered with tar paper. The building is currently dry and all exterior openings are covered.

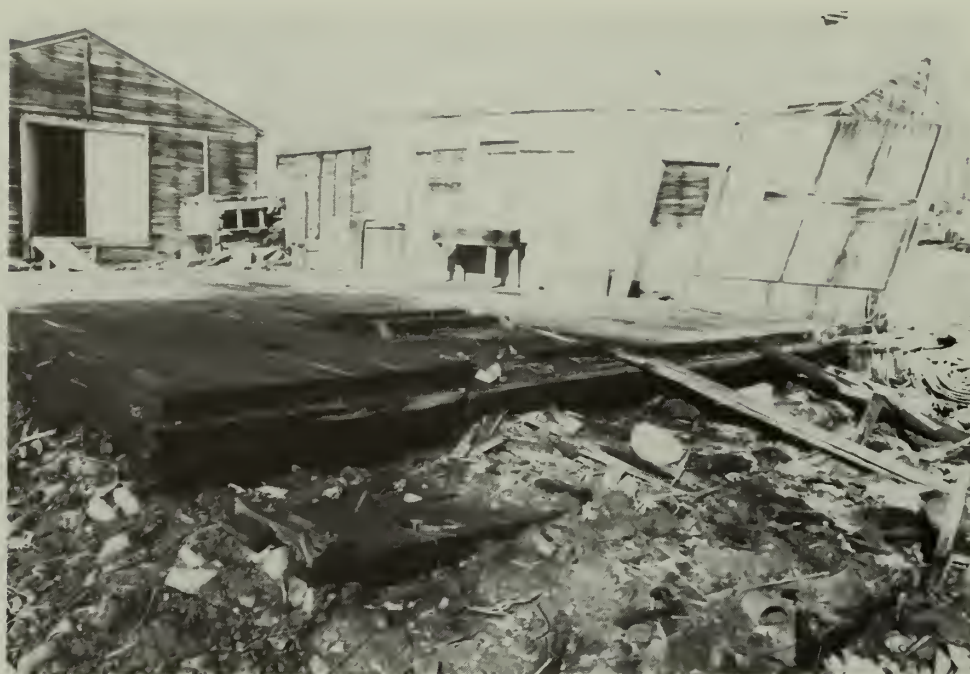
Top: The machine shop as it appeared on February 23, 1991. A fuel tank pad is in the foreground, and the science building is to the left.

The machine shop currently consists of the floor and one wall, which has begun to fall and may not last the winter. The west end of the floor is saturated with diesel fuel. The bolts and foundation for the diesel engine are on the west flooring. The two diesel-powered generators, which once stood on separate foundations adjacent to the floor to the west, have been removed but the foundations remain. When the diesel engine and generators were removed is unknown. The method of construction used at the camp is most evident in the machine shop. The bare structural members, 4-foot panels filled with rock wool insulation, can be easily analyzed at the floor and wall.

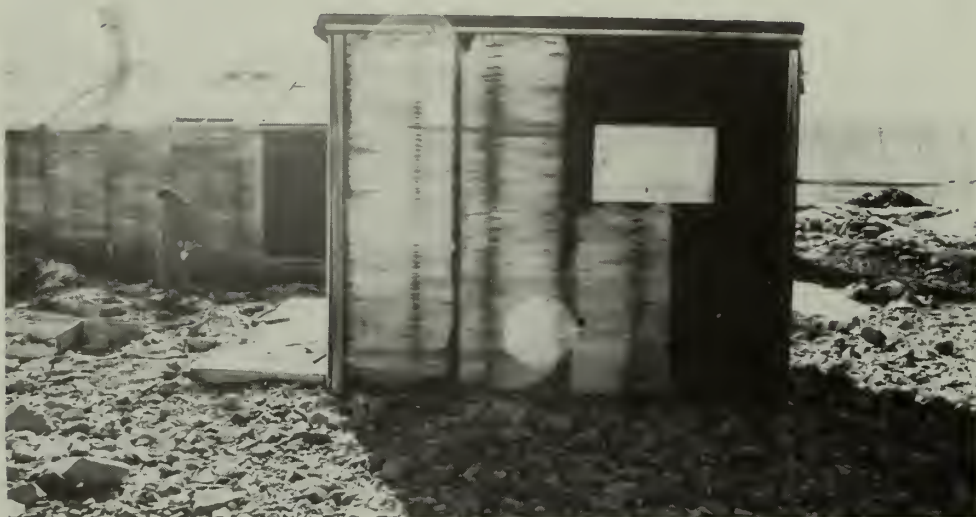
Top: The outpost building (Ronne hut). February 23, 1991.

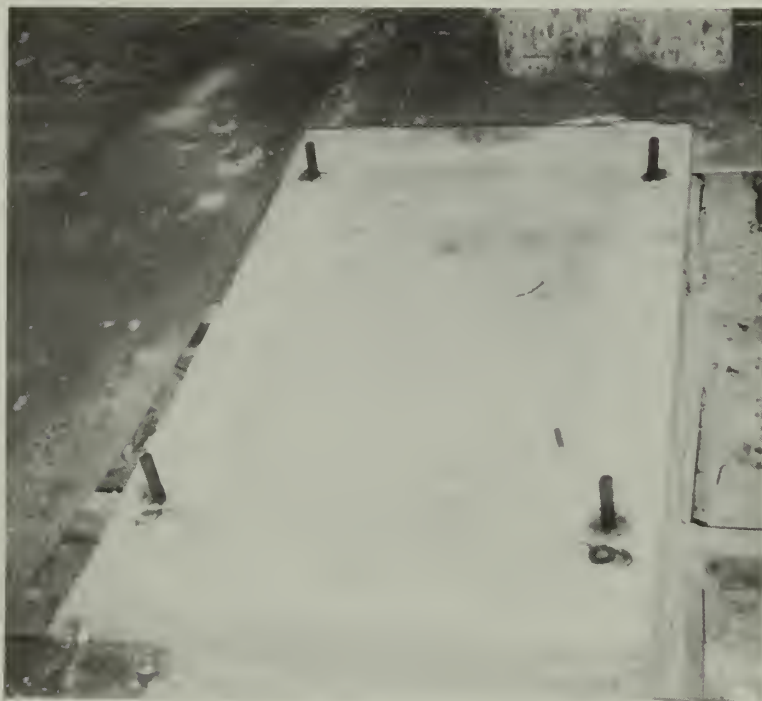
Bottom: The concrete generator pad inside the outpost building (Ronne hut). February 25, 1991. It was placed there by the British after RARE.

After RARE the British reoccupied the base, and Lipps quoted their use of the Ronne hut for an emergency generator.¹⁶ The outpost building now has a concrete foundation in the floor, which was for the generator. The interior has further been altered by the addition of shelves in the northeast corner and the site of the bunk. Otherwise, the general configuration remains the same as it was when it was left in 1948. Tar paper was added to the exterior walls and the roof by the British.

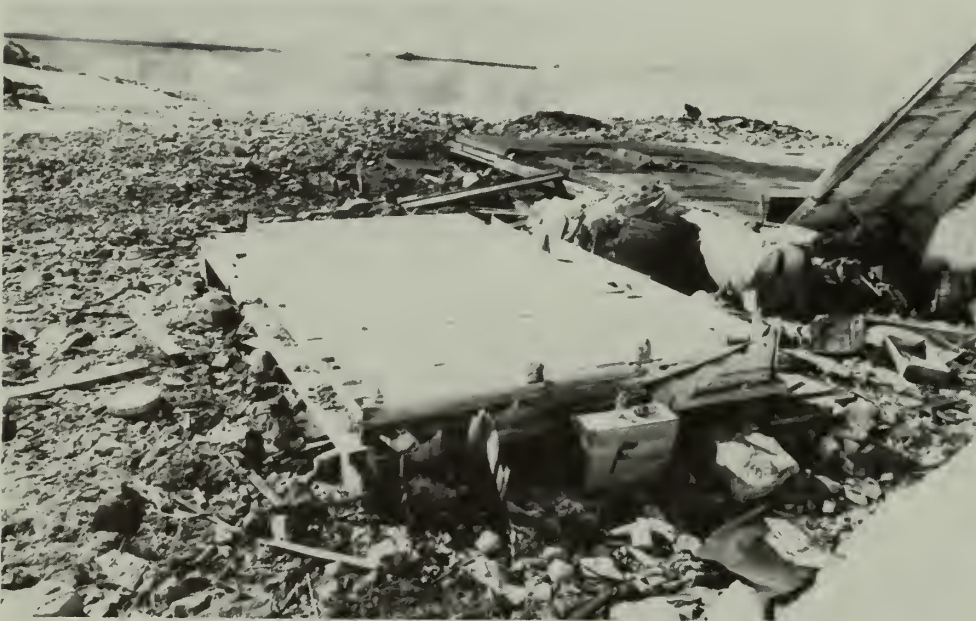
A wooden platform measuring 14 feet, 3 inches by 10 feet lay to the west of the machine shop and appears on the 1941 USAS map as a storage shed. Mrs. Ronne called it the issue shack.¹⁷ It was built in March 1940 from packing crate parts and excess lumber. The walls and roof have since been removed. USAS photographs indicate that a canvas addition connected it to the machine shop, and that it was used to house the light tank.

The storage shed platform, as it appeared on February 23, 1991. The machine shop is to the right.

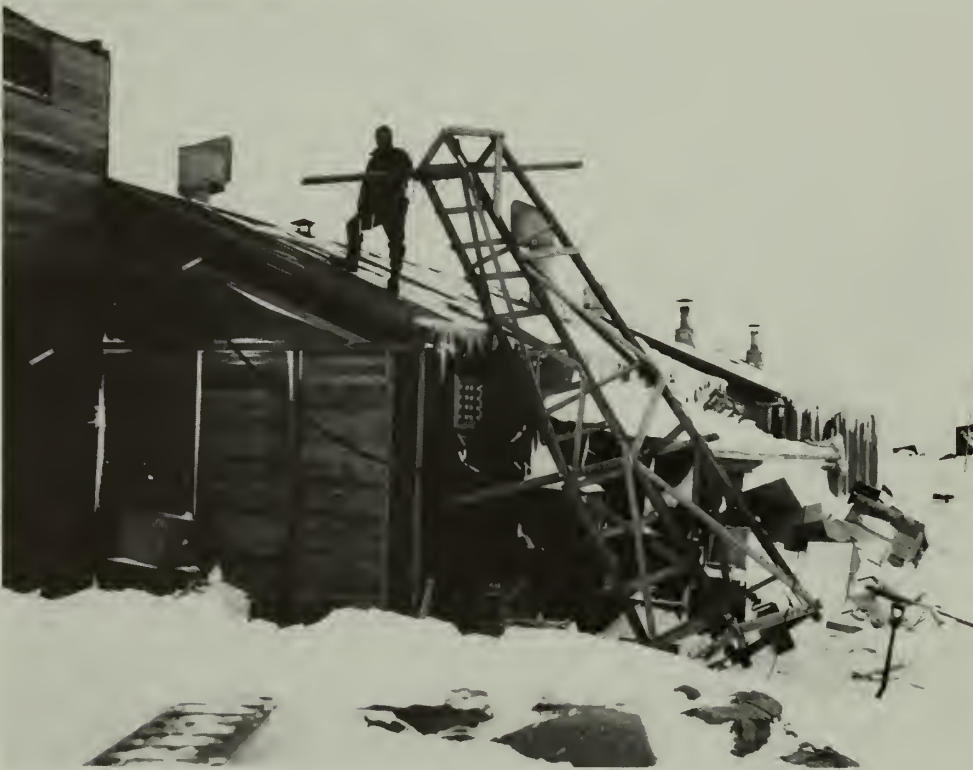
A radio antennae tower that had blown over onto the science building, May 17, 1940 (National Archives, USAS, Photographs, 126-AS-441).

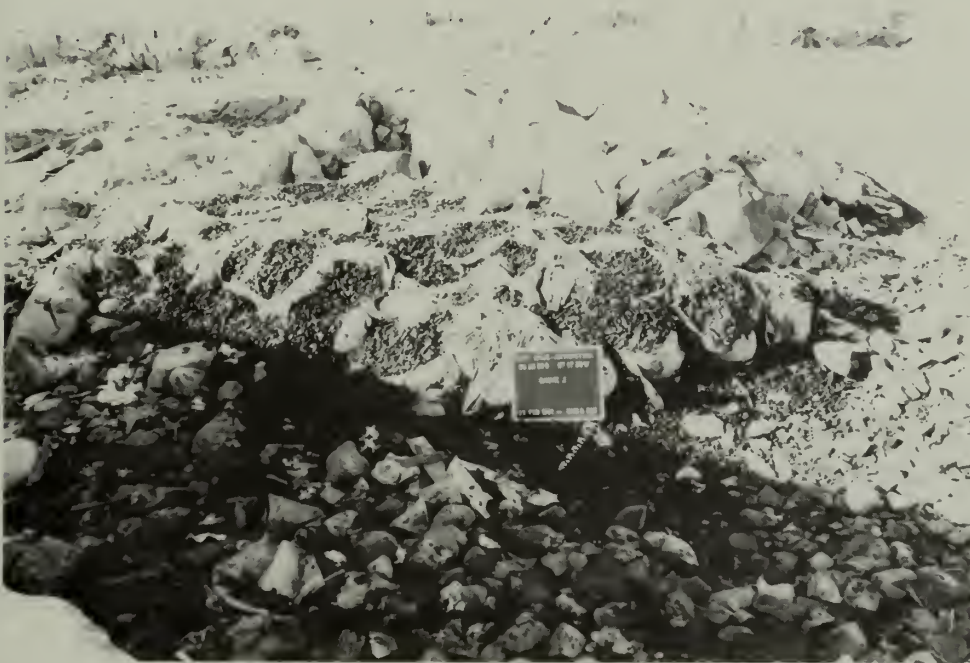
Cache J is located on the south side of the main building, surrounded by an approximately 2-foot-high rock outcrop, and is well protected. This cache is marked on the 1941 map and so may be related to USAS use. Ronne reported that abundant coal supplies had been left by USAS and appeared to be undamaged by the intervening occupants of the site.¹⁹

The cache's position proximate to the outpost building suggests that it was the source of fuel for that building. Finn Ronne lived in the hut during both expeditions and is likely to have chosen the same location for his own fuel cache during both expeditions.

Coal cache J, west of the outpost building facing south. February 23, 1991.

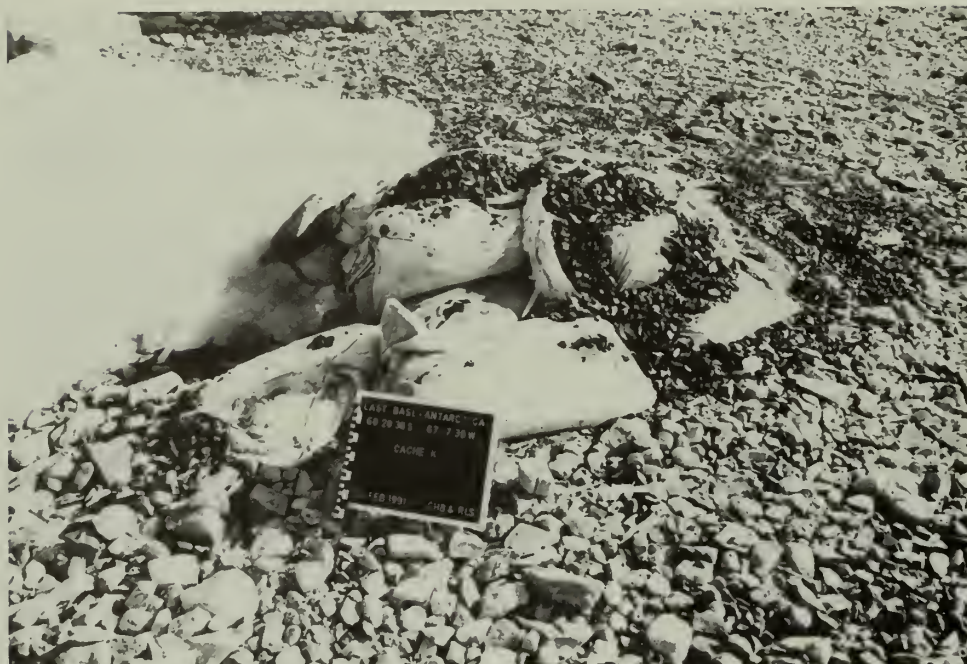
Top: Cache K, in front of the main building. February 23, 1991.

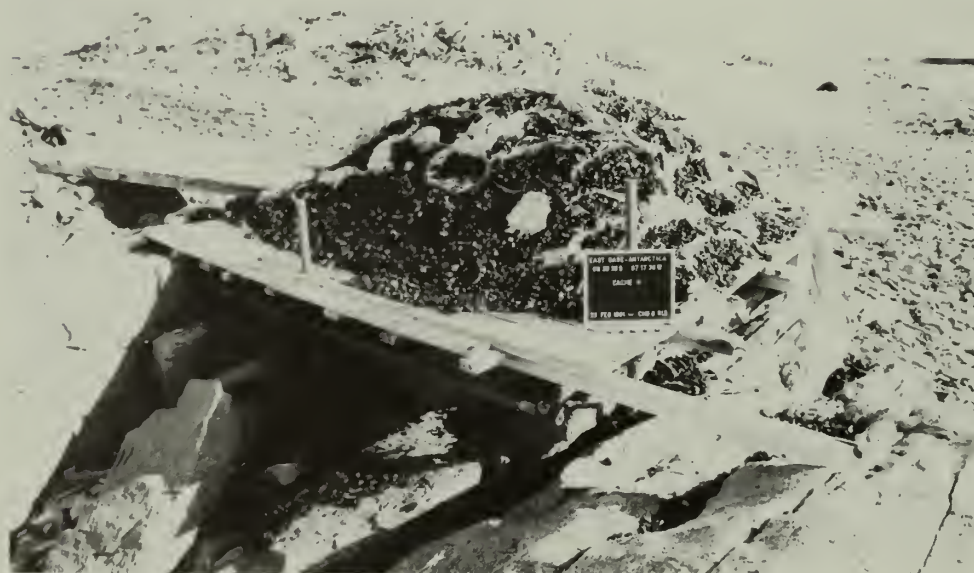
Bottom: Coal cache N, on top of the wood platform to the northeast of the science building looking toward the glacier. February 23, 1991.

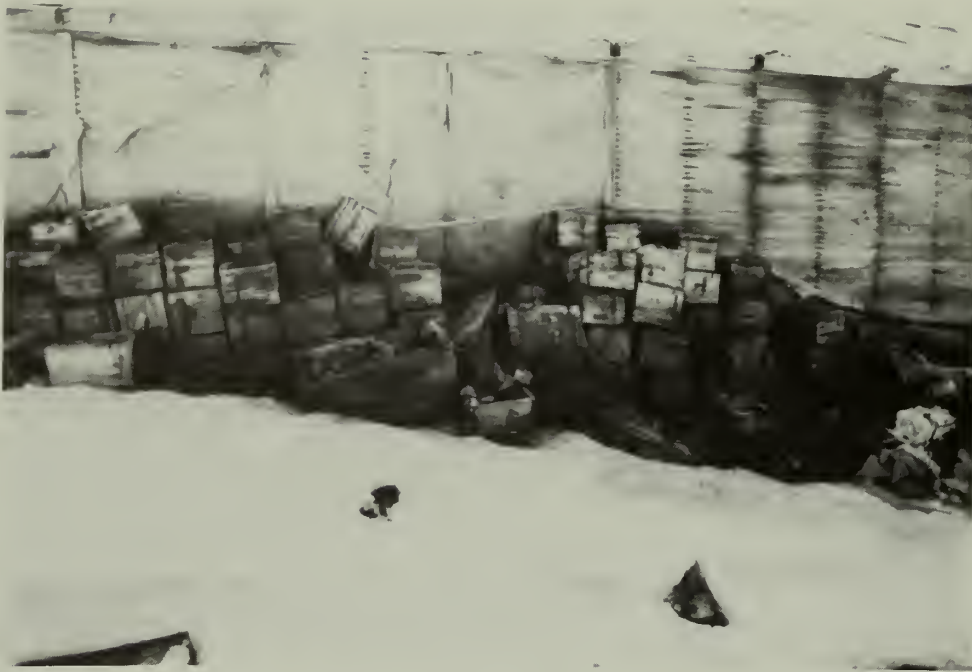
Top: Cache L outside the main building. February 23, 1991.

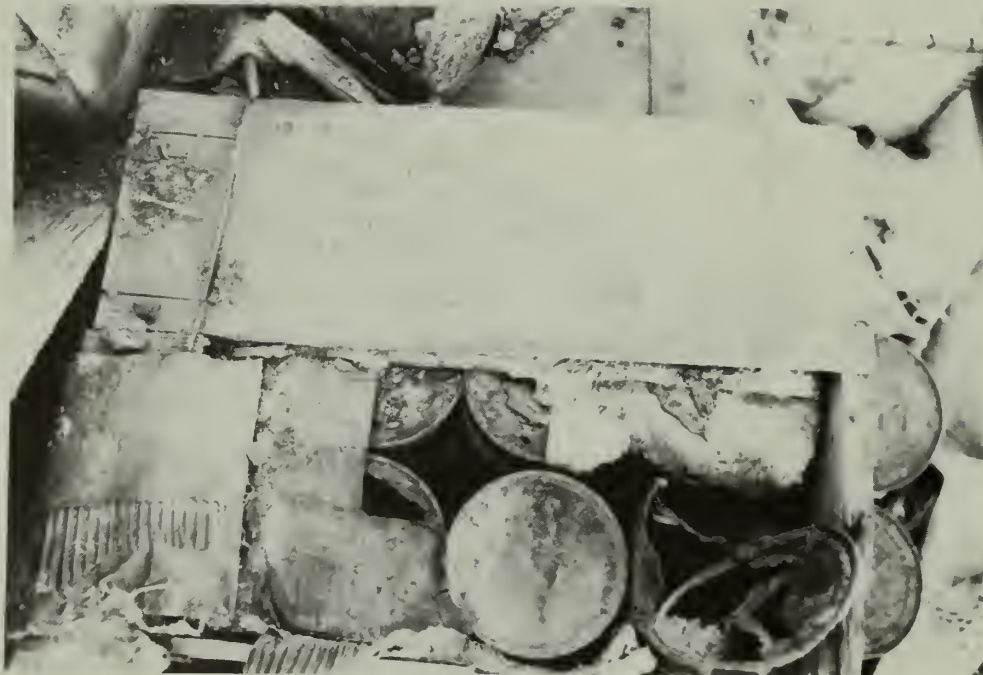
Bottom: One of the crates, with a cardboard lining and containing tin cans. Note address to Paul Siple. February 23, 1991.

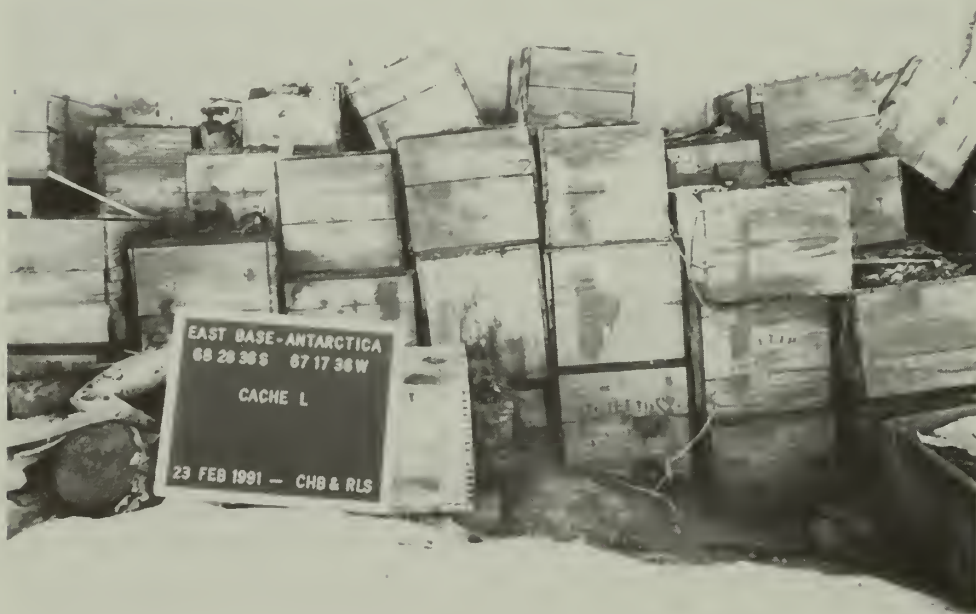
Bottom: A closeup of cache L on the south side of the main building, on February 23, 1991. Note the Phillips Packing Co. and contents labels.

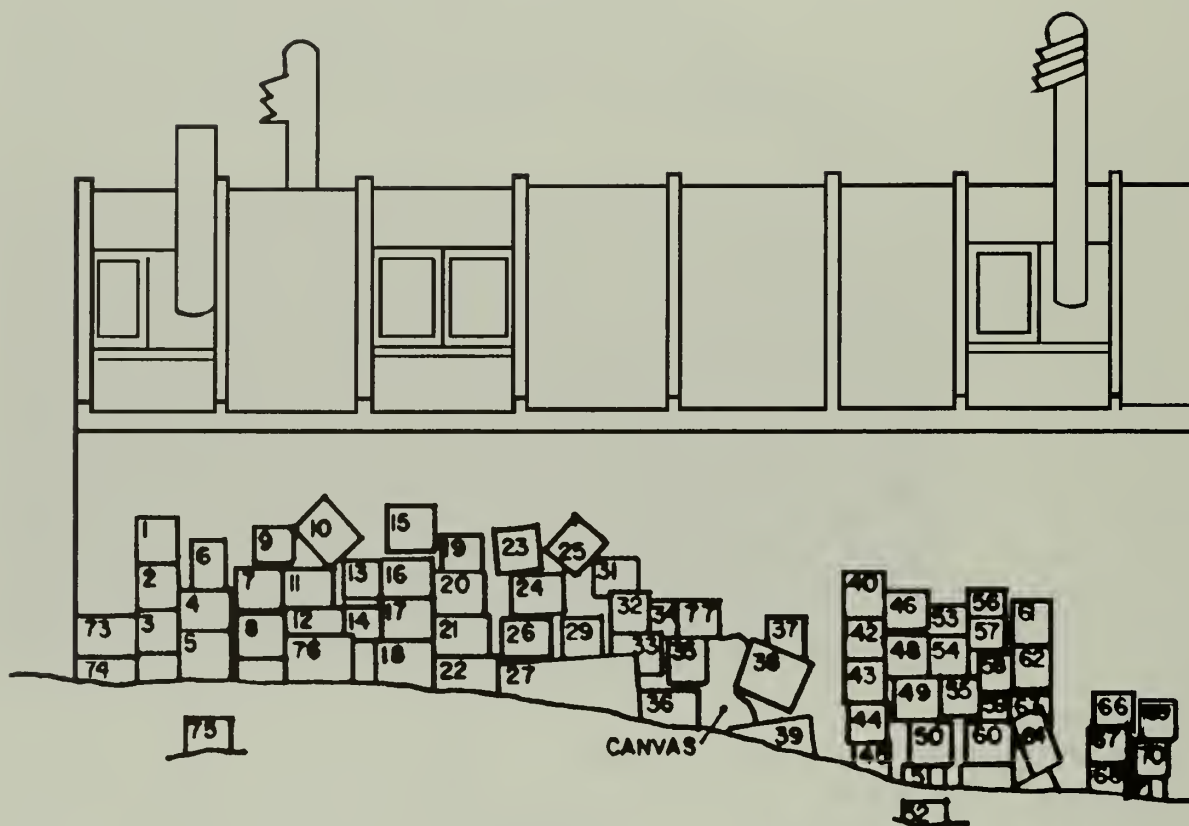
The location of numbered boxes in cache L. The corresponding inventory can be found in appendix D.

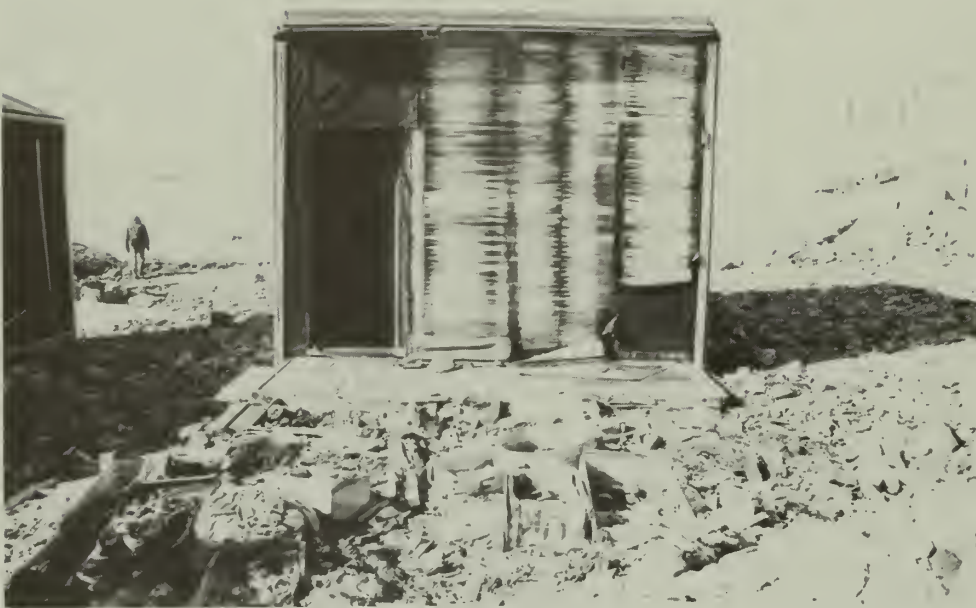
Top: The Ronne cache to the west of the outpost building (Ronne hut). Note the upside-down box marked "UK" and one marked "F" directly to the left and behind.

Interestingly enough, some of the crates appear to have originated with either USAS or FIDS and reused by RARE. One (crate 9) is marked with an "F" (for food) but contained survival gear, and crate 10, marked "UK," was found near Primus stove parts. Ronne remarked that a number of boxes marked for the use of the British had been found at the site when RARE occupied the base in 1947.²⁸

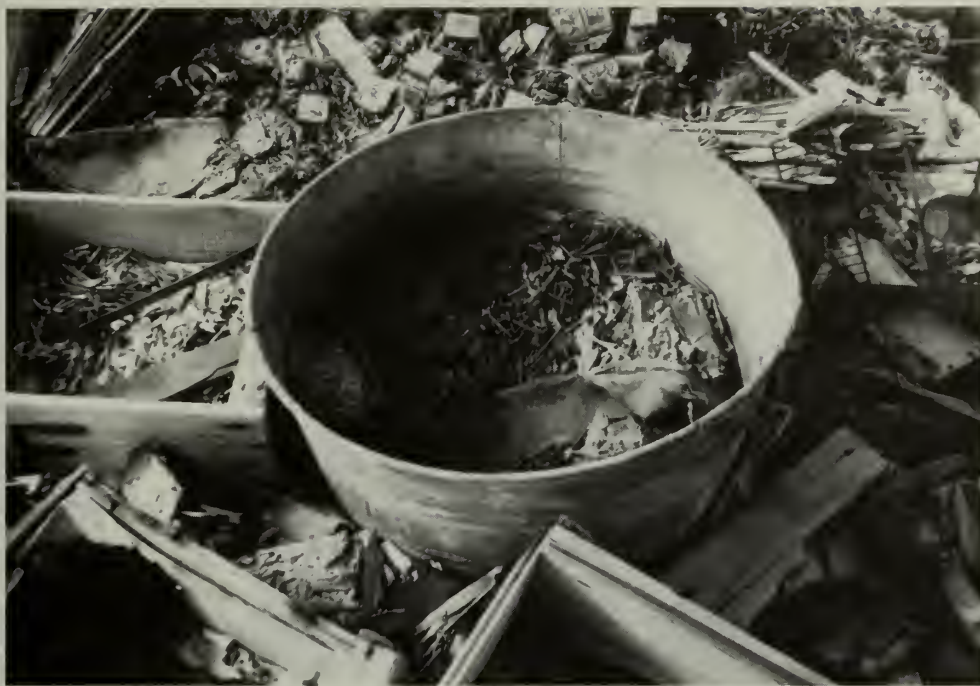
In a 1992 visit to East Base by the National Science Foundation, the Ronne cache area was excavated using archeological techniques. It is notable that a dog skeleton was found under the boxes and washtub in the central portion of the cache. It was probably one of the animals left by the USAS during the 1941 evacuation. The presence of snow and ice on the ground when Ronne reoccupied the site in 1947 no doubt prevented its discovery by that party.

A closeup photograph of the Ronne cache (cache A). Note the matchsticks littering the ground and the prominent washtub.

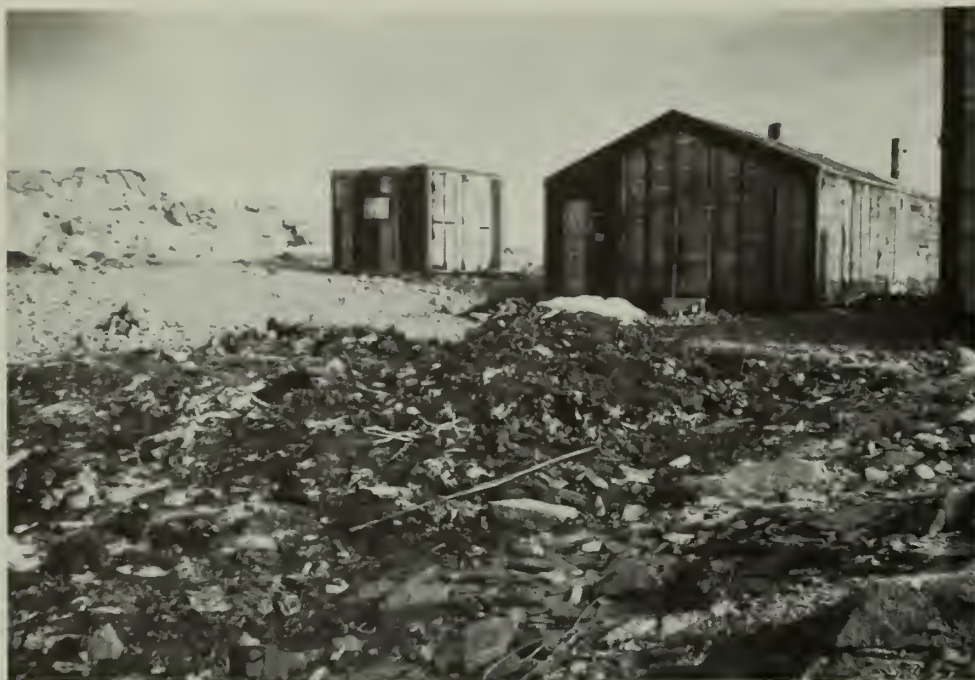
Top: Dump C in front of the main building (center).
