Part I: A Guide for Management
Part II: Description of the Cultural Resources
and Recommendations

Historic Monument • Stonington Island/Antarctic Peninsula

April 1993

Catherine Holder Spude
Robert L. Spude

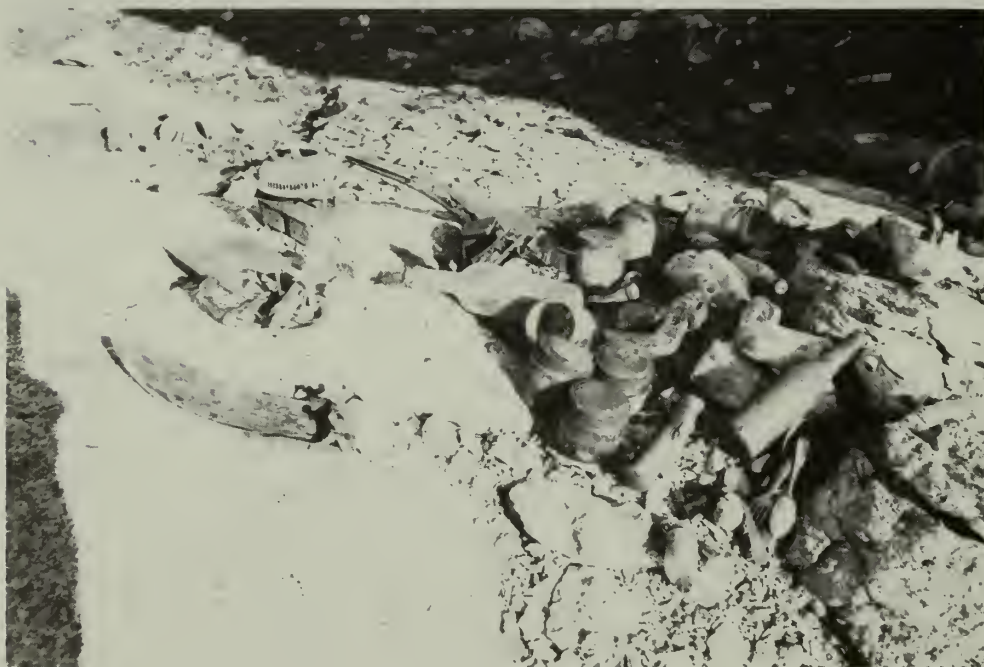
Bottom: Items sampled from dump C. February 25, 1991.

A nonsystematic sample was taken by ASA employees, and so is biased (appendix A). In addition, an inventory of observable surface artifacts was made in order to provide a general idea of the contents of the dump (appendix G). While a good deal of used, no longer useful items were present, it also appears that supplies from the first expedition had been unceremoniously disposed of out the front door. Toothbrushes, eating utensils in perfect condition, film spools loaded with film, clothing items, magazines, bottles, and canisters of liniment still wrapped in newspaper with 1939 dates indicate that the contents of the buildings, items left during the hasty abandonment by the USAS, were summarily deposited in this location. A box of red meteorological balloons indicates that not all of the dump contents came from the main building, as meteorological observations were made daily from the two-story tower at the southeast corner of the science building.²⁹

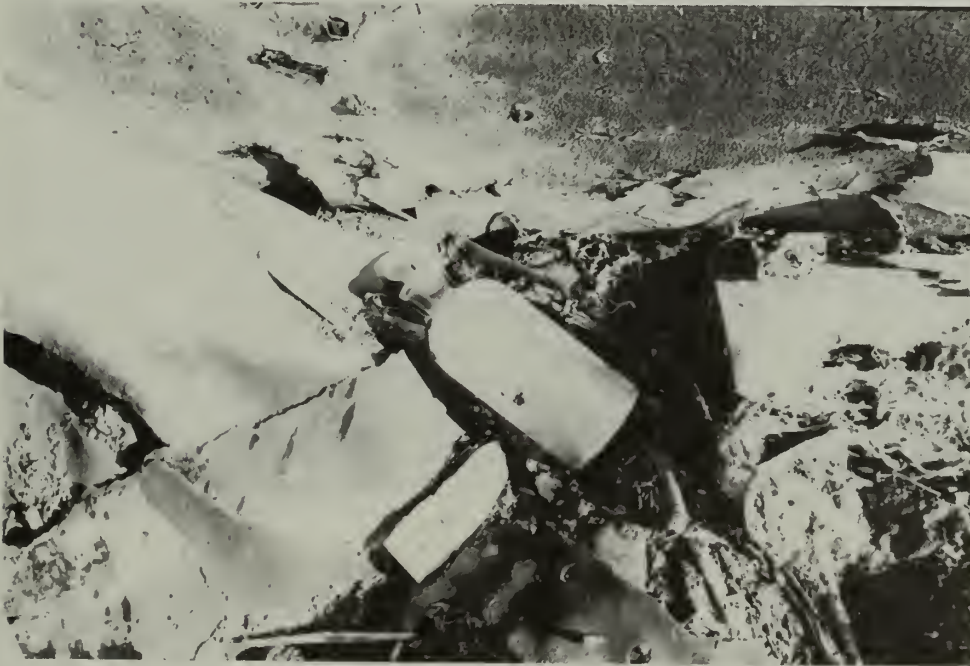
The remainder of the dump area was covered with structural debris of little research value or integrity, such as shattered window glass, insulation material, scraps of torn canvas insulation, tar paper, and broken wooden crates. A quart-capacity glass bottle with a glass stopper may contain nitric acid, a hazardous material. Its presence suggests that caution should be exercised during future cleanup activities.

A glass bottle of nitric acid lying next to the airplane engine. February 23, 1991.

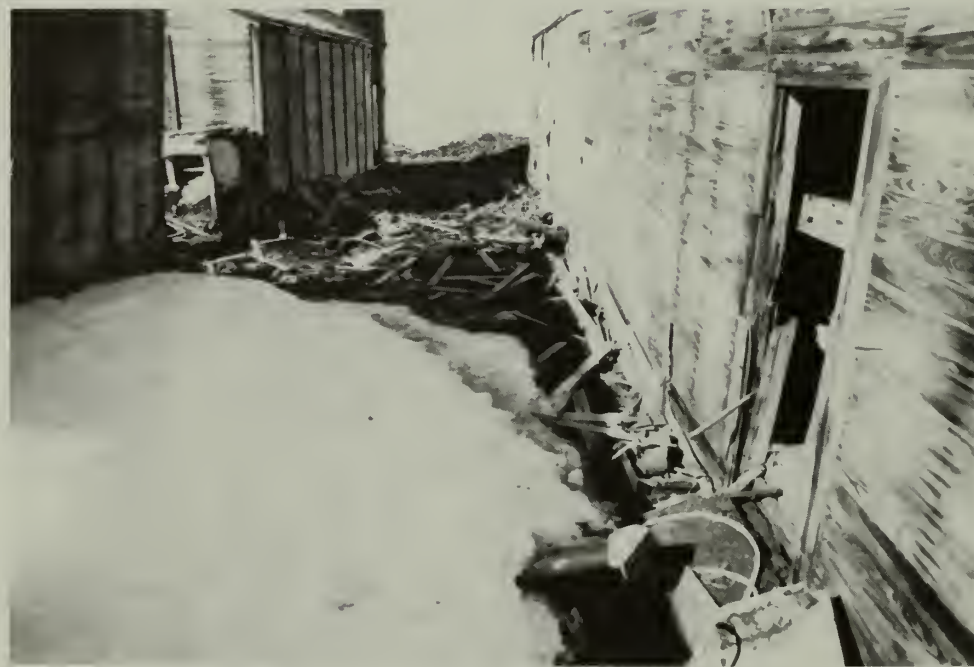
Bottom: The area between the machine shop/science building (left) and the main building (right) with with snow drift and structural debris. February 22, 1991.

Located between the main building and the combined machine shop/science building, the western half of this area was covered by an ice bank. Photographs taken during the 1990 visit suggest that some crates from cache M at the west end of the bunkhouse may be spilling over into this area. The bottom portions of a single row of wooden food crates are located along the north wall of the bunkhouse; coal sacks line the south wall of the science building. Most of the area is covered by a mass of structural debris: fragments of wooden crates, insulation, tar paper, and canvas. Other than the remnants of the caches, the structural debris have little or no research value or integrity.

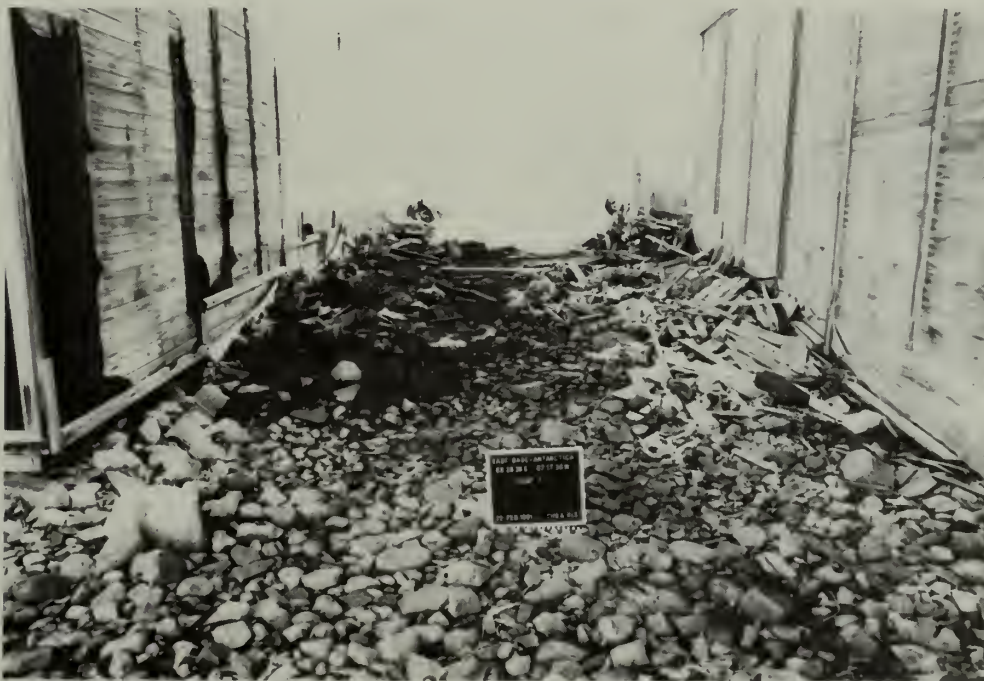
The food crates and coal sacks suggest that this sheltered area was used for the storage of consumables by RARE. Darlington commented that each day's meal had to be chiseled out from the snow banks,⁴² suggesting that the labor involved in merely removing a food crate probably prompted the cook to procure supplies from the most sheltered location he could find. It is unclear whether the crates were labeled for the USAS or for RARE, as only the bottoms remain.

The area between the science building (right) and the main building (left) with structural debris. February 22, 1991.

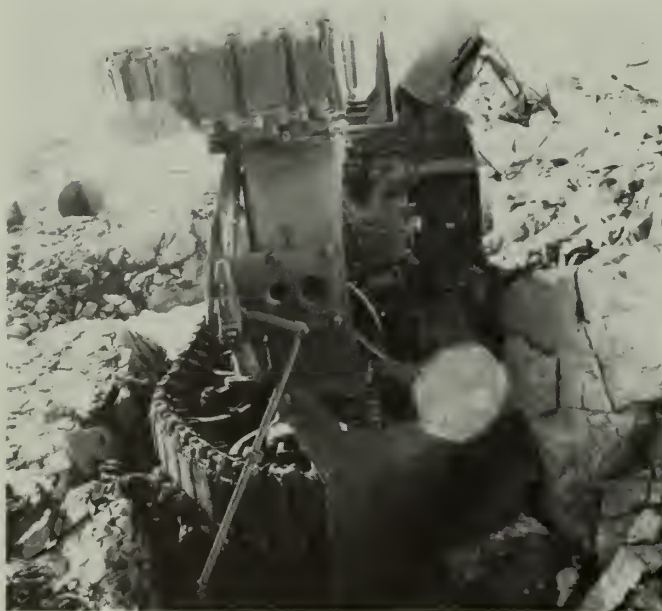
Bottom: The artillery tractor, lying on its side wedged between large rocks. February 22, 1991.

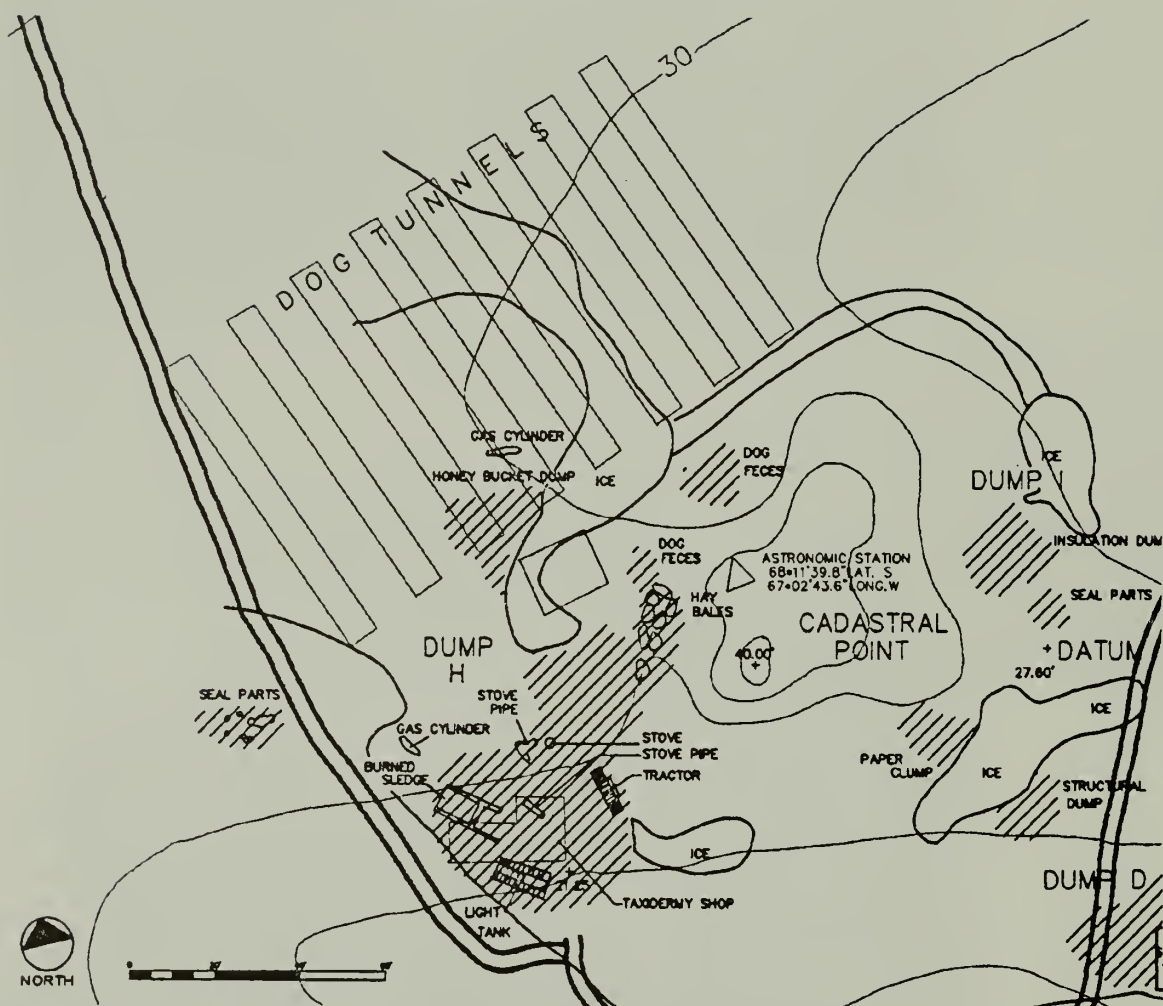
Base map of the dump H area, showing the relative locations of the tank, tractor, burned sledge, stovepipes, and the original location of the taxidermy shop. The 1940-1941 features are shown in lighter lines.

Lipps reported seeing no evidence of the taxidermy shop during his 1975 visit.⁴⁹ The burned sledge and general scorching throughout the area suggest that the building was destroyed by fire. Lipps also noted that the BAS cleaned the grounds around East Base in 1974⁵⁰; it is possible that the building was burned at that time.

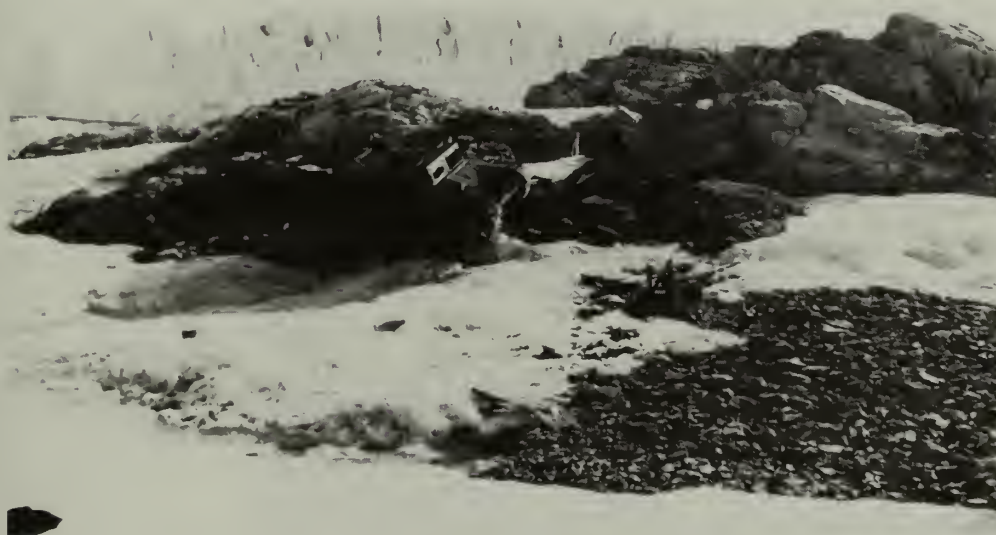
The dump H area, with the tank in the foreground. The cadastral point rock is to the right, and the tractor is under the reflection star. February 25, 1991.

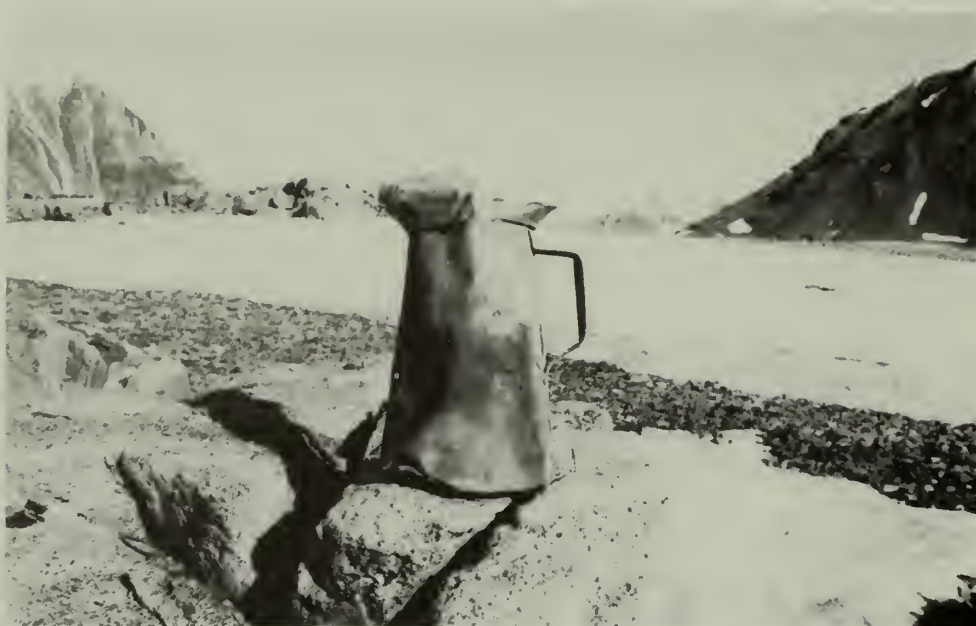
Top: An old fuel can on the rocks above dump H. February 25, 1991.

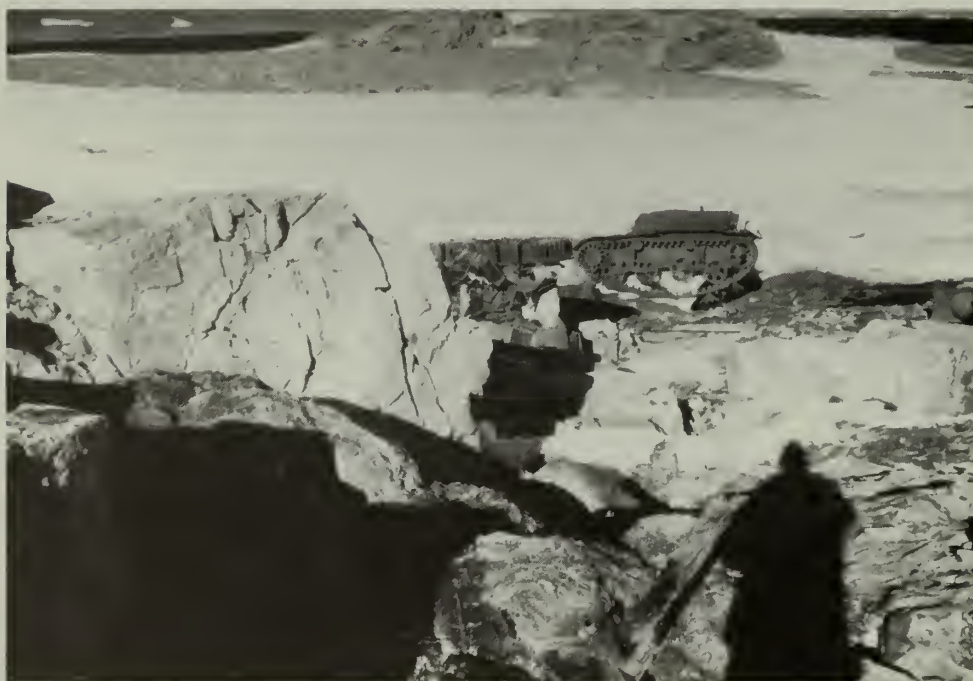
Bottom: The hay cache covering the rocks in the foreground, left of the photographer's shadow. February 25, 1991.

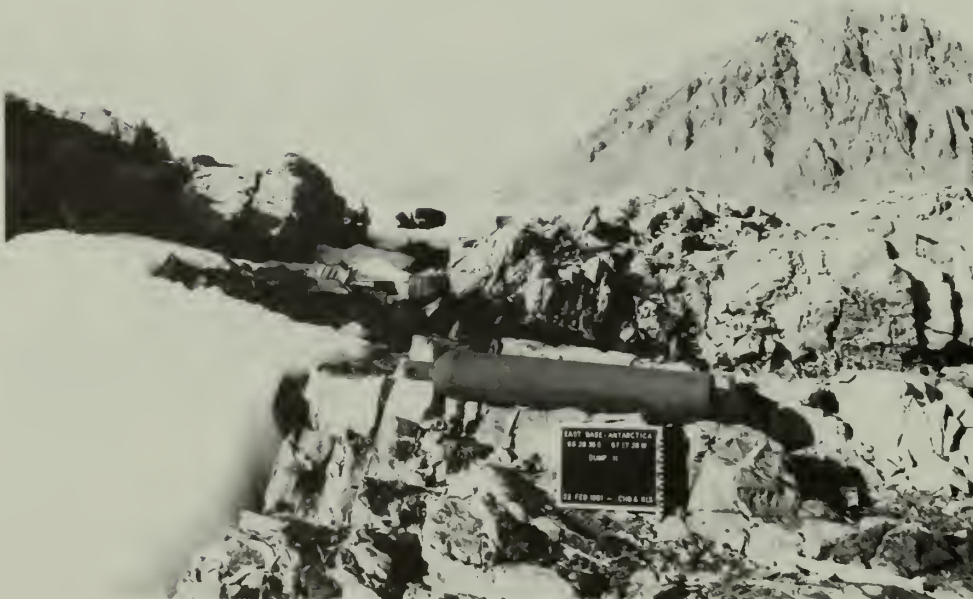
Bottom: The crates in the honey bucket dump can be seen above and to the left of the gas cylinder. February 22, 1991.

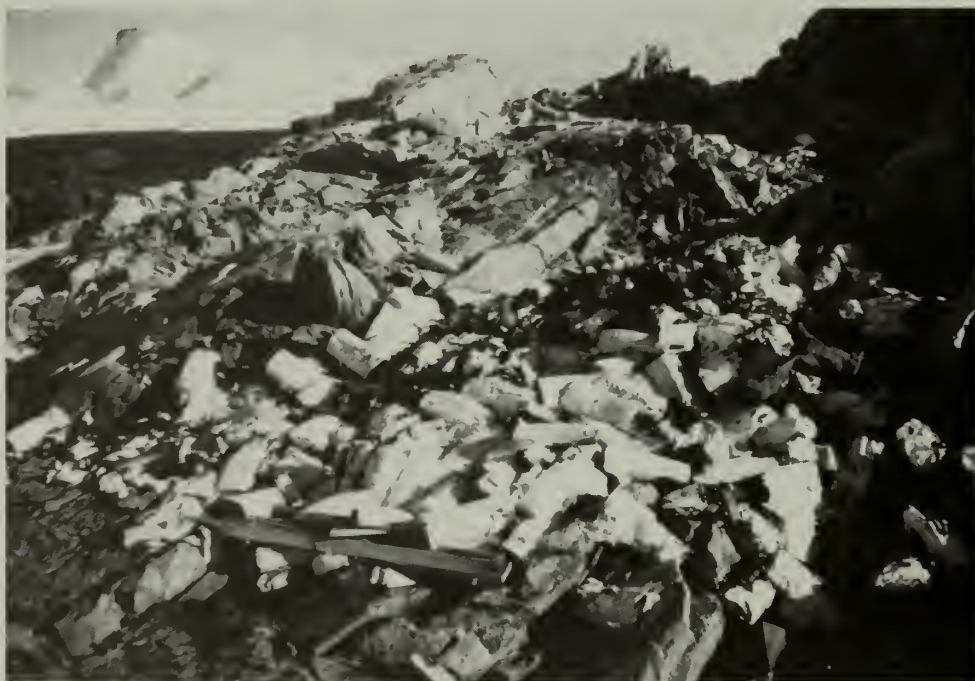
The southern edge of the paper dump is obscured by a 20-foot-wide snowdrift. South of the drift was a very thin surface scatter of a paper-like insulation material and ferrous metal objects, mostly nails, cans, and cables. It may be a part of the same dumping episode that generated the paper cups and towels.

The paper dump as it appeared on February 25, 1991.

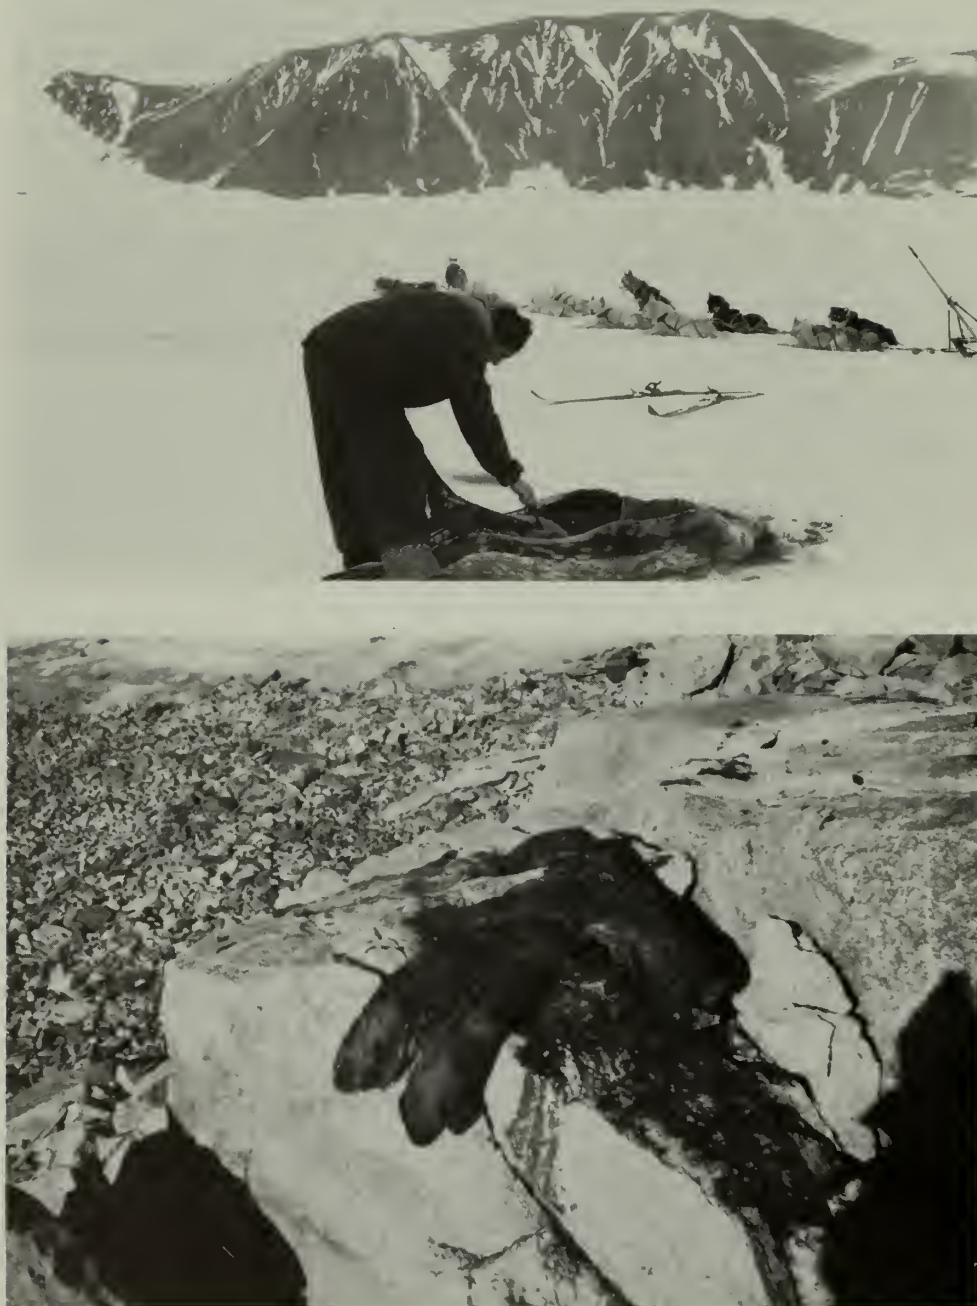
Bottom: Seal tails lying on rocks near the cadastral point. Stains on the surrounding rocks are more common remnants of seals.

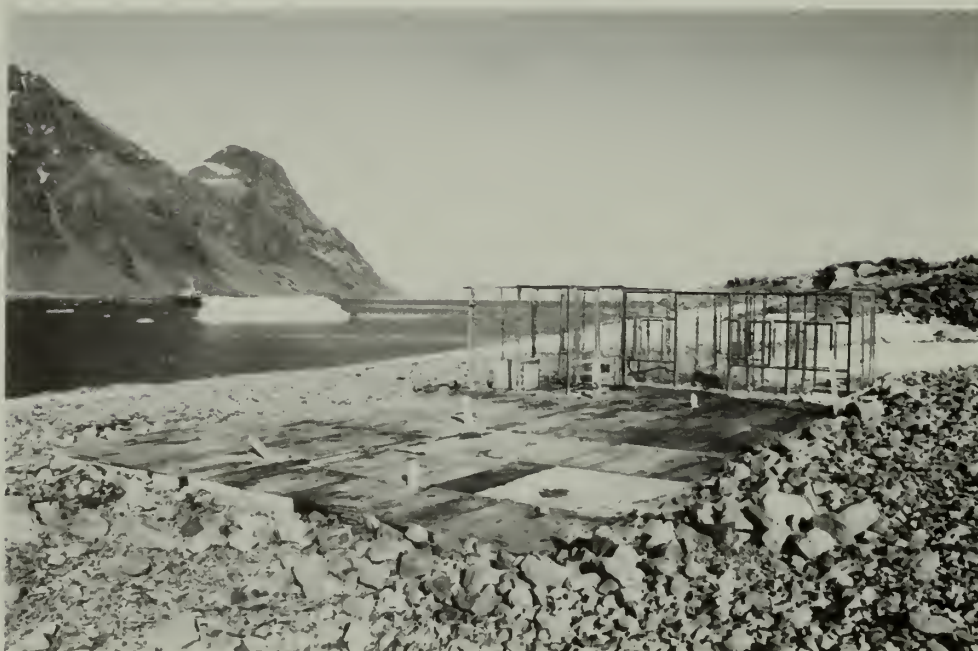
Bottom: Wooden floor and dog kennels in the original location of the British Base E, about 500 feet south of East Base. February 25, 1991.

A number of other features were observed on Stonington Island, all of which were associated with FIDS and BAS activities at Base E. They include Base E itself, located to the south of East Base. In addition some dog kennels made of chain link on galvanized steel frames sitting next to a large wooden platform are in the original location of Base E. Nearby are several piles of burned bone.

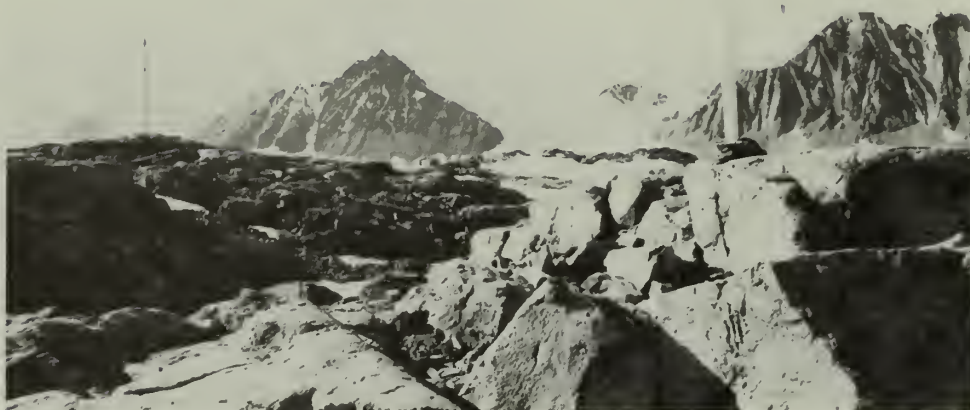
Top: The wooden cross on the monument to British sledgers. Note the flagpole to the left. February 25, 1991.

On a point of land on the western portion of the island is a concrete and stone monument marked by a large wooden cross. The monument contains two plaques to Thomas Allan and John Noel, BAS personnel who disappeared on a sledging journey in 1966. Finally, a small tar-paper-covered shack lies about 200 feet to the south of East Base and appears to be part of the base. However, it is a later British construction.

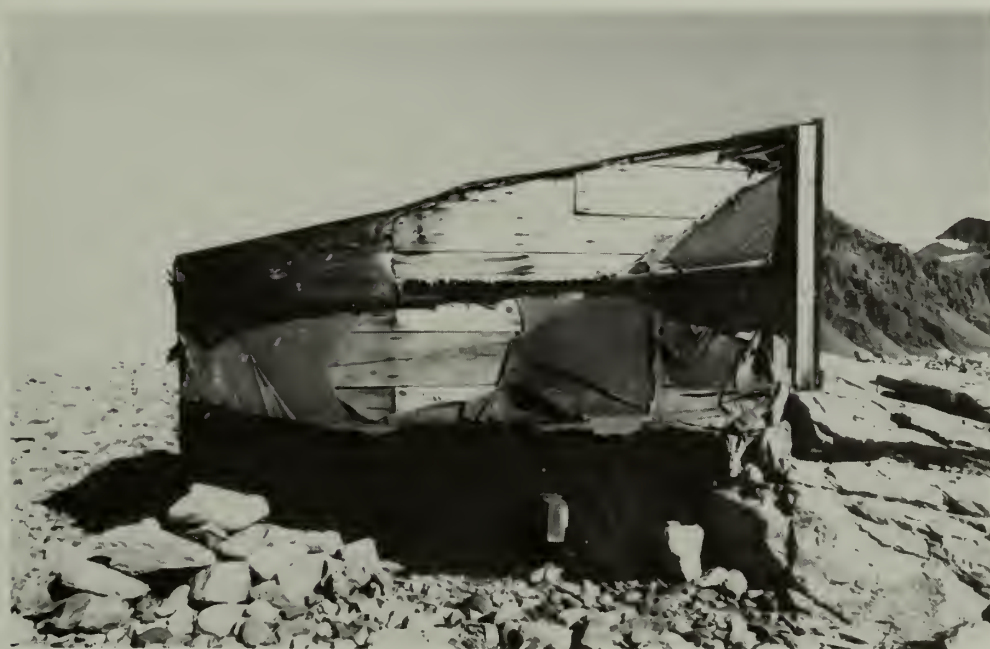
A small hut about 200 feet from East Base, associated with British activities on the island.

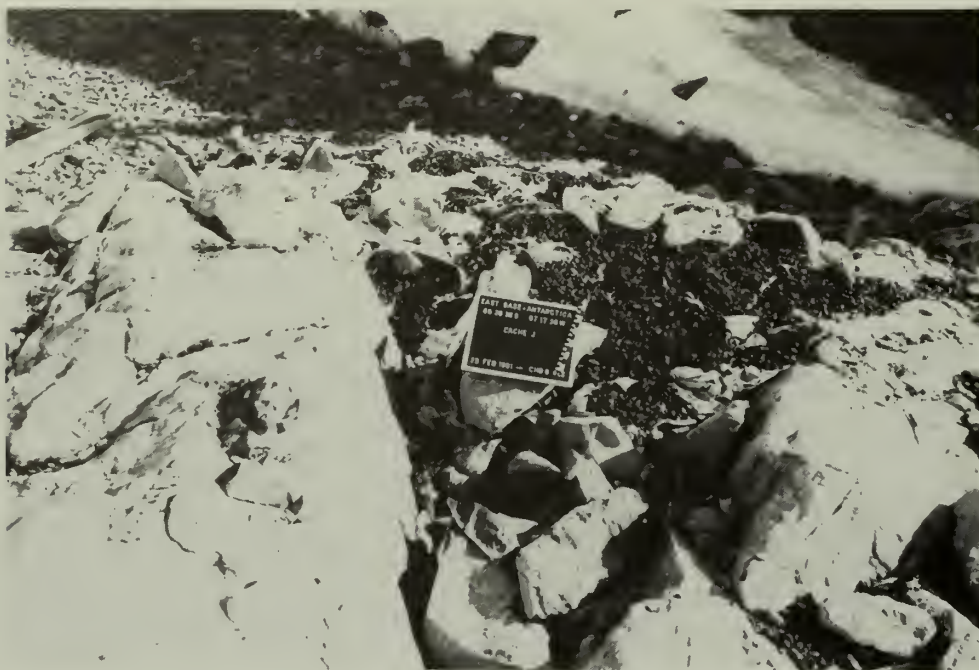
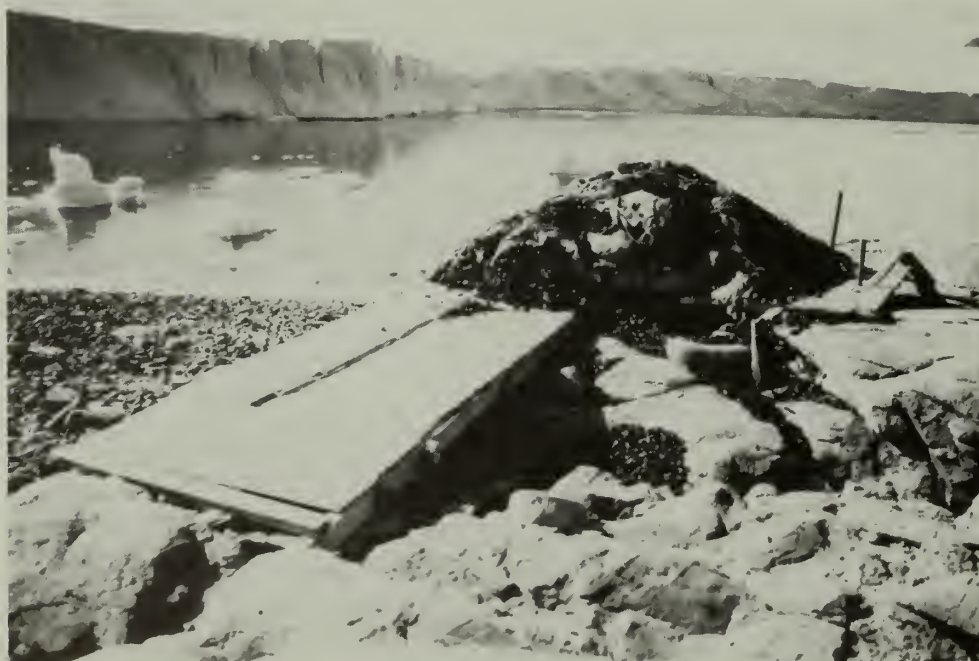
FOOD CACHE

The food cache stored along the south and west sides of the bunkhouse is associated with the USAS, 1940-1941 (caches L and M). The cache appears to be the only material culture related to the early expedition that remains in its original location and that is largely unadulterated. Most of the wooden crates in the food cache are unopened. Contents of the crates should be in good condition, but the food is probably no longer edible and may well be toxic.

1. Post warning regarding toxic contents.
2. Clean up the immediate vicinity (remove loose canvas, broken wood fragments, etc.).
3. Interpret in display and pamphlet.
4. Complete inventory of items covered by snow bank.
5. Arrange for a longer term evaluation by a conservator.

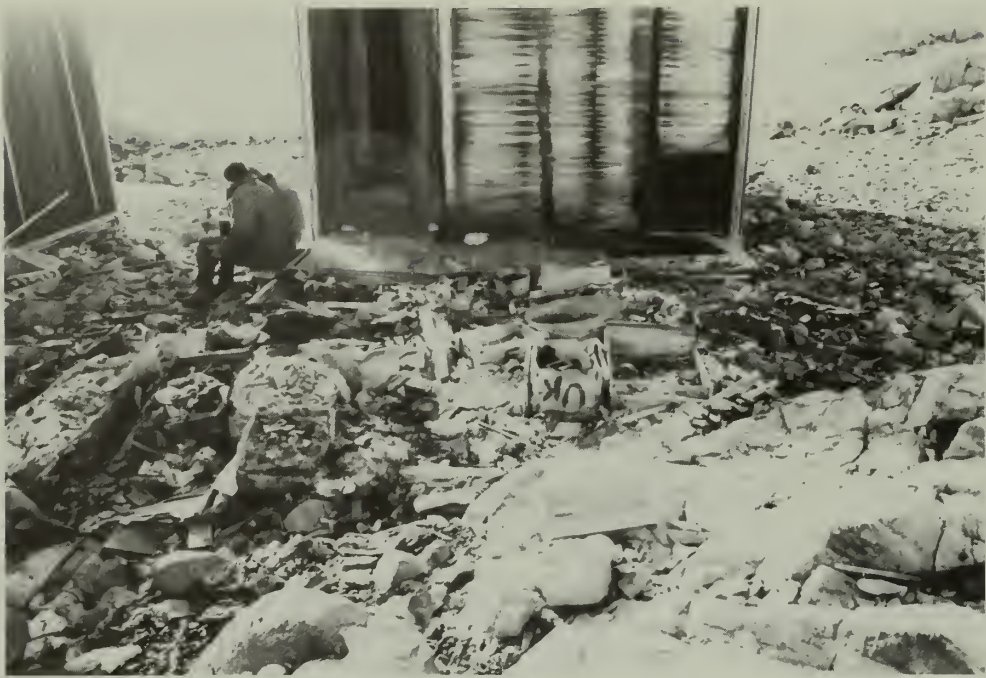
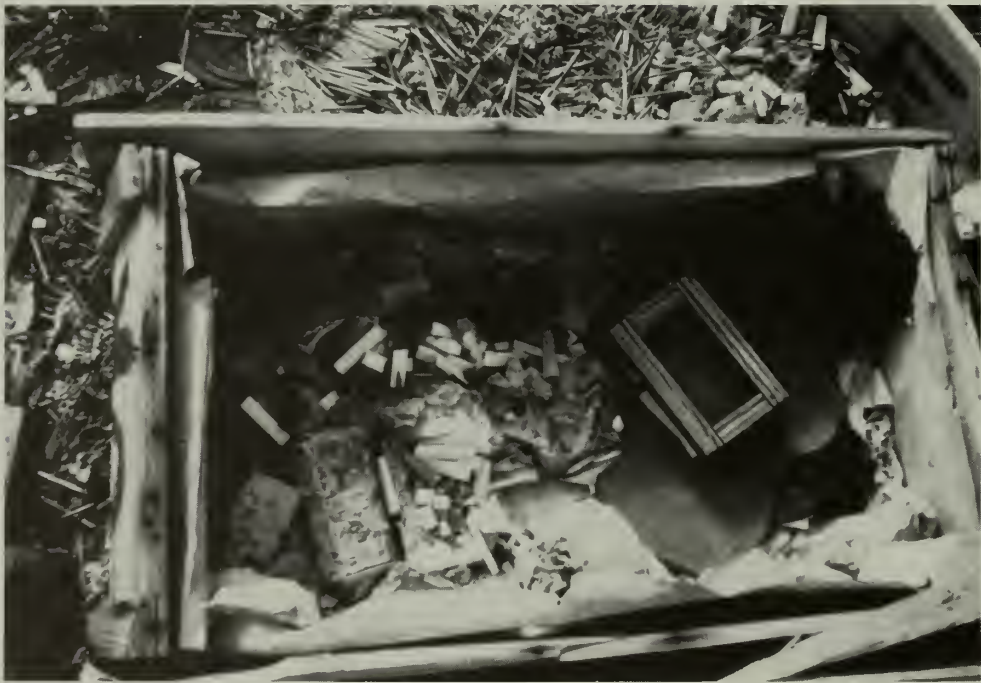
COAL CACHES

Three coal caches remain in the immediate vicinity of the three standing structures. All three are probably associated with RARE, 1947-1948. The coal is stashed in cloth bags, which are deteriorating. The coal itself may have been brought to the site by the United States Antarctic Service in 1940, but appears to have been resacked and placed in its current positions by the later expedition. Cache J is associated with the outpost building and was used by Finn and Edith Ronne; cache K is immediately outside the east door of the main building and was used to warm the living and eating quarters of the rest of the expedition; the cache on the platform to the northeast of the science building and a small one a few feet east of the door in the RARE addition were no doubt used by the expedition members working in that structure.

1. Clean up the immediate vicinity of the caches.
2. Stabilize the platform to the northeast of the science building (e.g., replace deteriorating structural members).
3. Interpret through pamphlet.
4. Take sample of each cache.

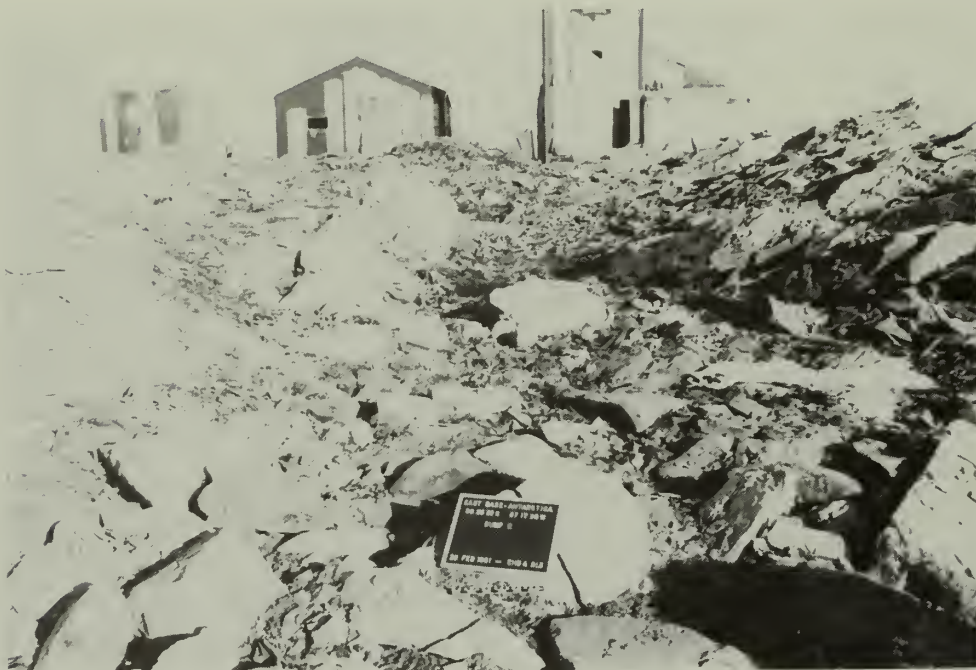
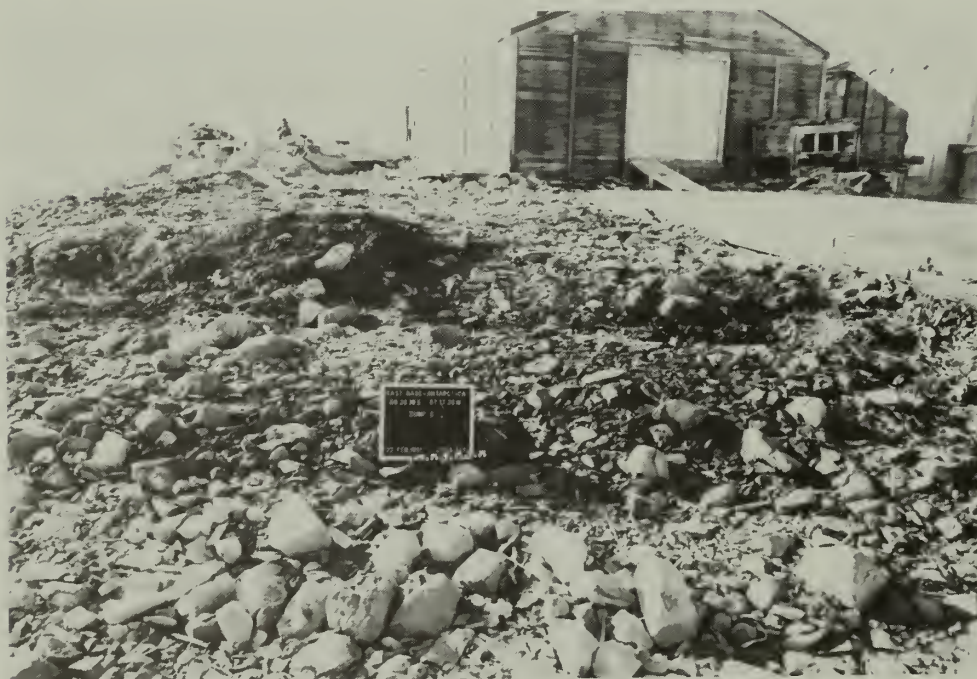
THE RONNE CACHE

The items in the cache do not appear to be in their original crates. The 11 boxes have no lids, and all items are exposed to the elements; therefore, they are suffering a slow deterioration. Matches and other small items scattered haphazardly on the ground create an atmosphere of disorder. A casual examination of the area may lead a visitor to the conclusion that the items are trash and therefore can be mined for curiosities.

1. Record and remove the cache using archeological techniques. Store all items in a secure designated storage area [science building, outpost building, main building?].
2. Seek conservator assistance in the preservation of items outside the cold, abacterial Antarctic environment. Identify a repository for these items for ultimate storage. Transport to that repository only when assured that transportation conditions will be sufficient to meet preservation needs.
3. Interpret in an interpretive panel and pamphlet.

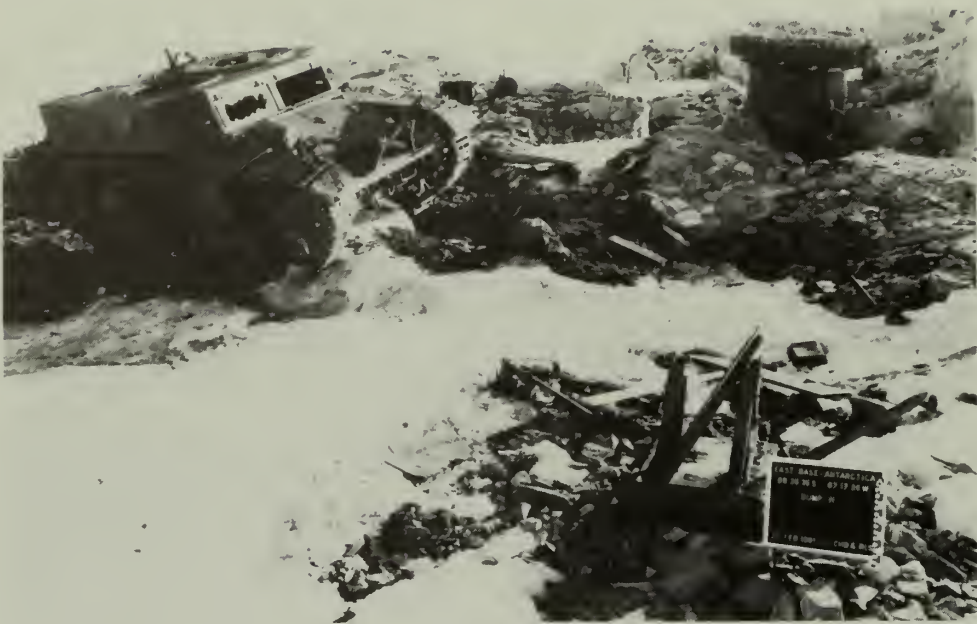
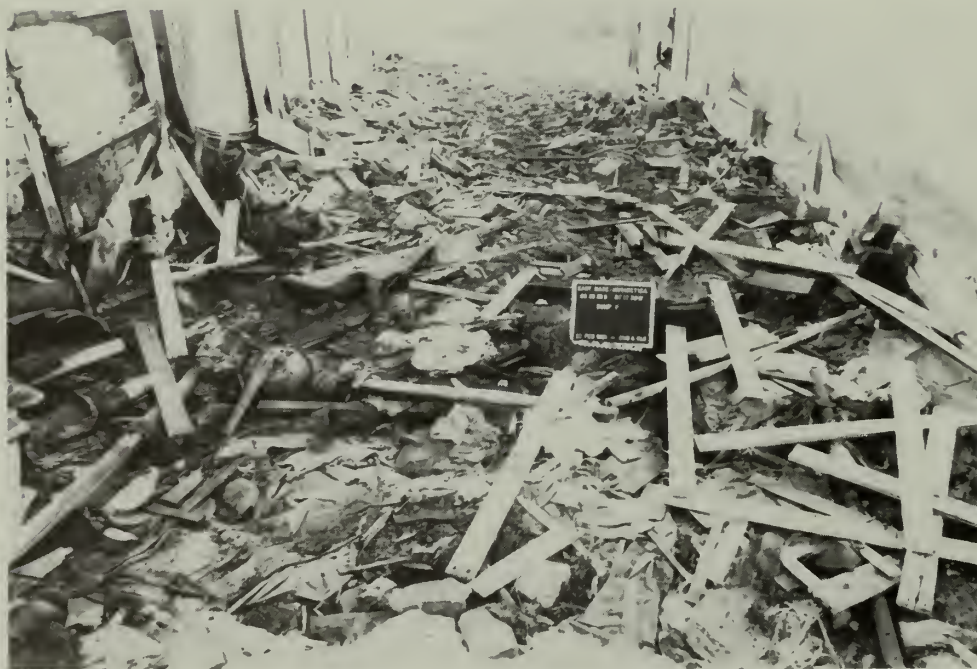
THE DOMESTIC DUMPS

The primary significance of the dumps lies in the scientific information they may contain. Much of the material culture was discarded before it became useless. The dumps therefore have the potential to yield additional information on the types of supplies that were deemed necessary in the mid-20th century for survival in the harsh Antarctic climate and in many cases may provide outstanding examples of items no longer available. Additional information may be available regarding the degradation of medicines over time. Lower levels of dump C may contain kitchen midden, which would reveal the types of items actually consumed by the earlier expedition.

The large extent of each dump makes scientific recovery and subsequent curation almost prohibitively expensive. The presence of medicines and chemicals in the northern dump (dump E) suggests that some hazard may exist to investigators and site visitors if they are careless when rummaging through areas that are inviting “exploration” sites. The dumps are unsightly and contribute to a general atmosphere of neglect at the site.

1. Cover the dumps with a layer of indigenous gravel. This action will remove them from sight, thereby tidying up the site without removing the dumps from their context. It will also hide hazardous materials from curious visitors or animals traversing the surface. Drainage of water through the gravel should not significantly change the abacterial environment.
2. Conduct a systematic sampling of each dump; store material culture on site in a secure area, unless specific repositories are identified in advance of site visit.
3. Allow archeological recovery under permit by legitimate scientists who have identified repositories in advance of site visit.

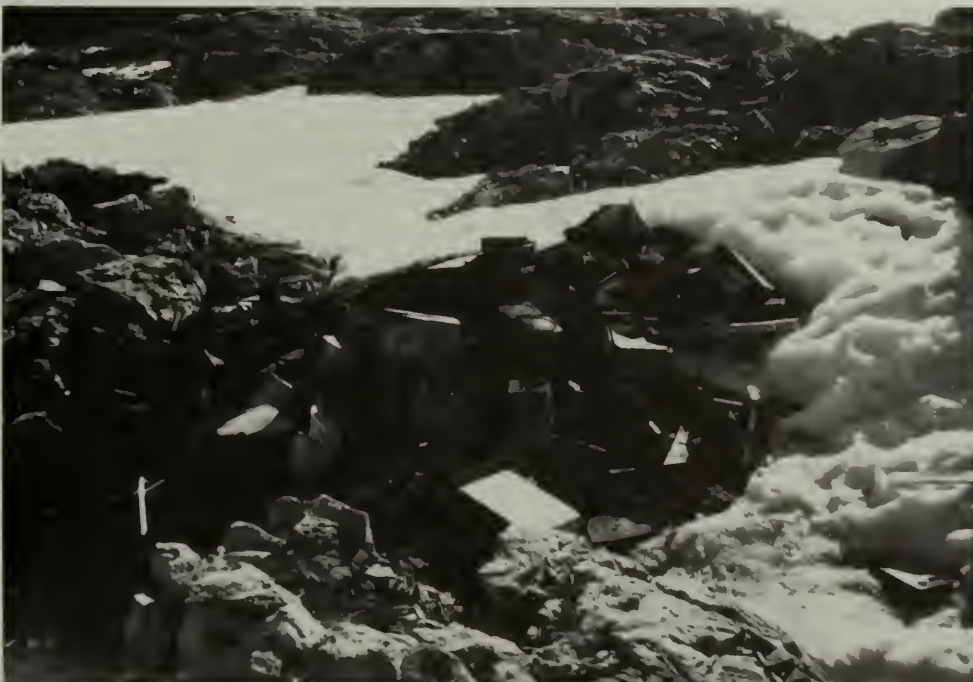
HONEY BUCKET DUMP

The dump is unsightly and possibly hazardous. The fecal material may contain disease organisms that could adversely affect the health of visitors or indigenous fauna. The cool, dry environment creates conditions such that the contents may not be immediately identifiable to visitors exploring the site.

1. Remove surface debris, especially broken wooden crates.
2. Sample for disease organisms.
3. Cover with local gravel, or remove and dispose off site.

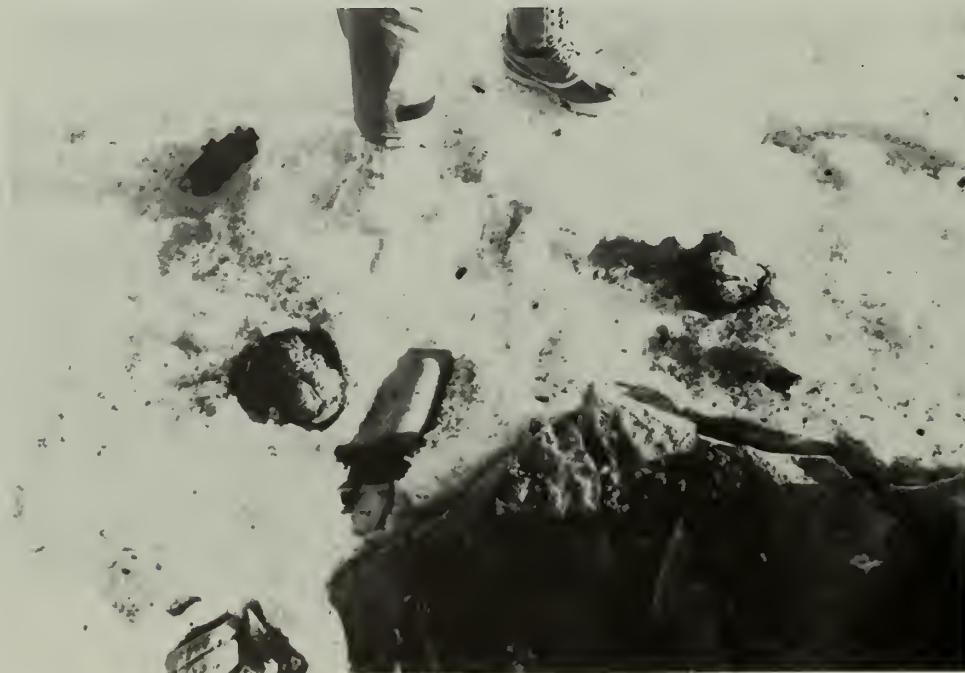
DOG TUNNELS AND SEAL PARTS

In addition, a few seal tails and flippers can be found on the west side of the rock outcrop, and at least three heads and a carcass were observed protruding from the snow bank to the west of dump H. Brown, gelatinous stains on the rocks covering both the cadastral point rock and the outcrop to the south of the building complex are also remains of seals. Seal meat and blubber were processed as dog food by both American expeditions at the taxidermy shop, originally located at the south end of dump H. In addition, the British used the main building for the storage of seal carcasses, also used to feed dogs.

It is unlikely that any of these organic remains pose a hazard to either humans or indigenous fauna. If, under unusual conditions, canine parasites remain viable in the dog feces, they could infect seal populations.

1. Retain in place.
2. Sample dog feces for viable infectious parasites. If present, remove.
3. Interpret seal remains and dog tethers in pamphlet.
