# 33 PRESERVATION BRIEFS

## The Preservation and Repair of Historic Stained and Leaded Glass

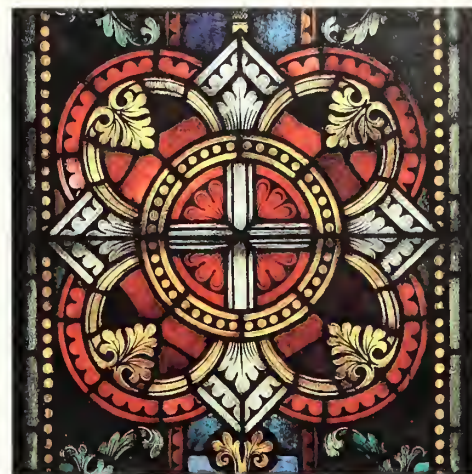
restoration work undertaken on stained and leaded glass must be done by professionals, whether the feature is a magnificent stained glass window or a clear, leaded glass storefront transom. Before undertaking any repair work, building owners or project managers should screen studios carefully, check references, inspect other projects, and require duplicate documentation of any work so that full records can be maintained. Consultants should be employed on major projects.

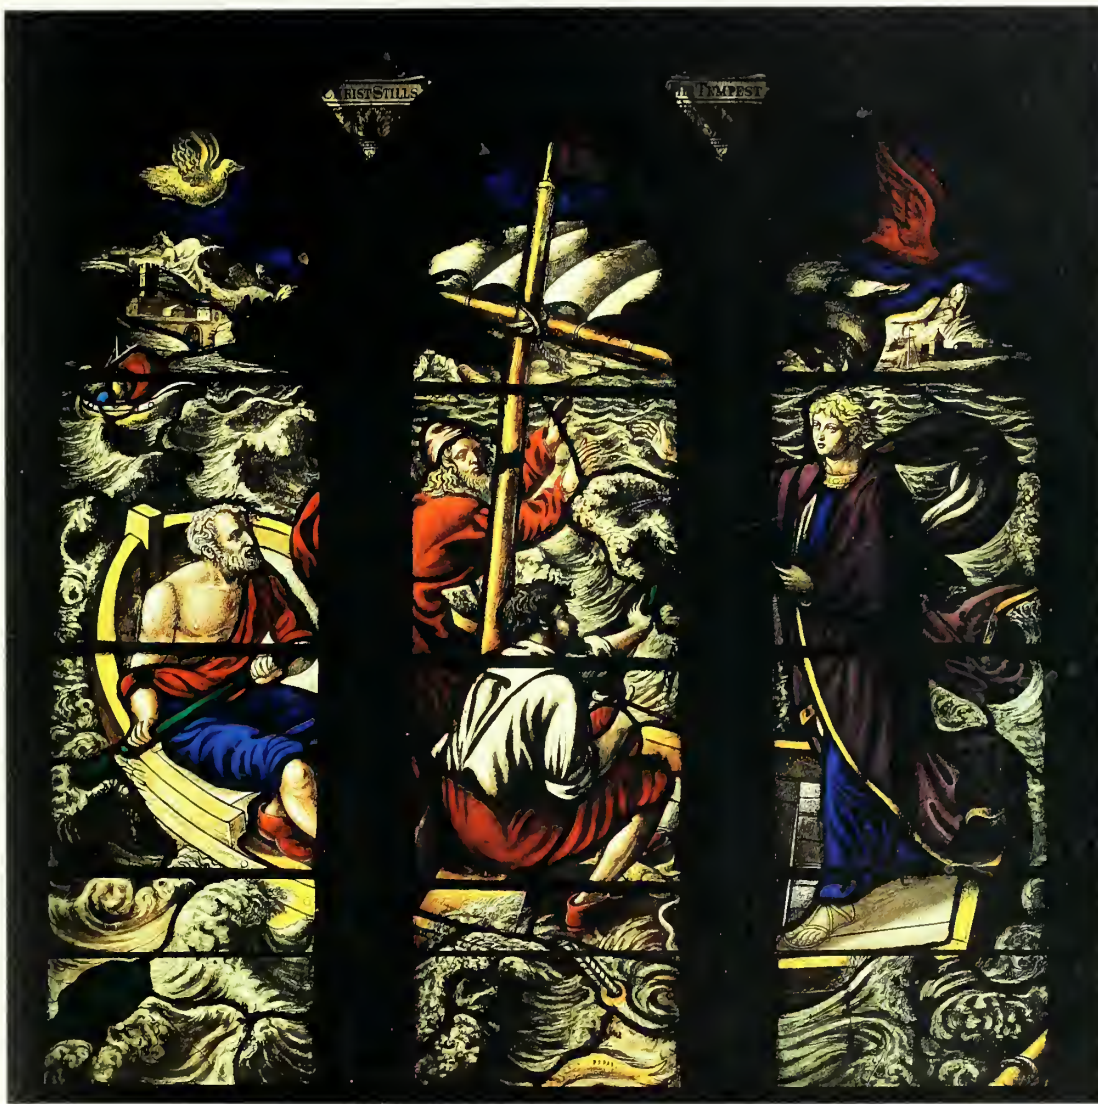
Figure 4. The windows at St. Ann and the Holy Trinity Episcopal Church, Brooklyn, New York, were made between 1843-1849 by John and William Jay Bolton. Photo: Leland A. Cook.

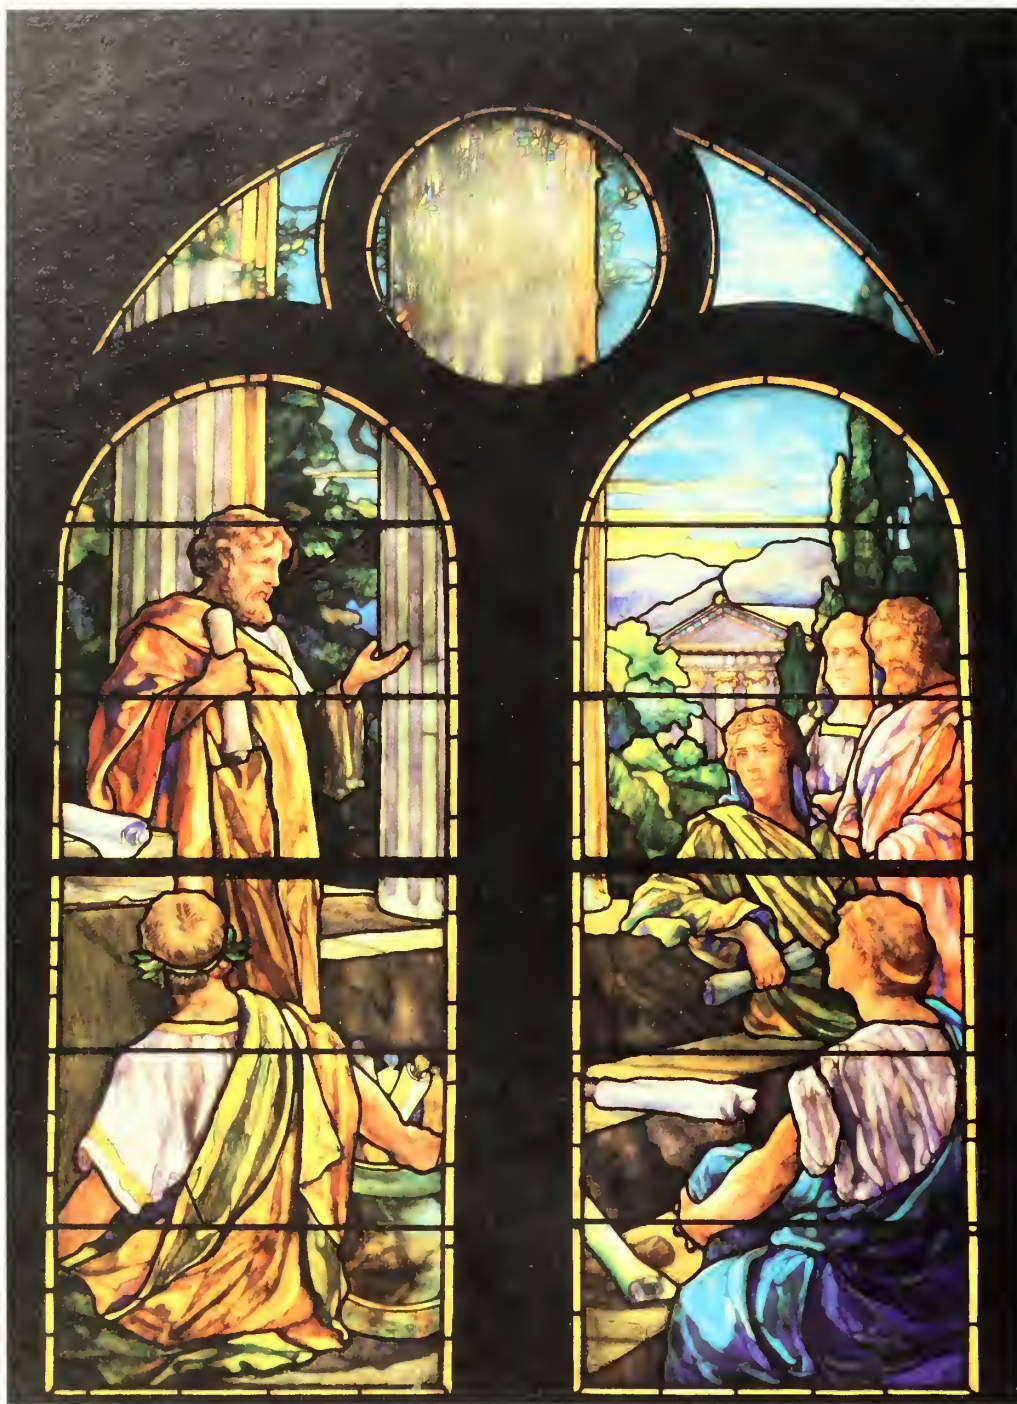
Figure 6. A 1907 window typical of those produced by Tiffany Studios. Characteristics include the use of opalescent glass, intricate leading, copper foil, extensive etching, plating (i.e., several layers of glass), and a scene with perspective that simulates a painting. Hyde Park Union Church, Chicago. Photo: Diana Kincaid.

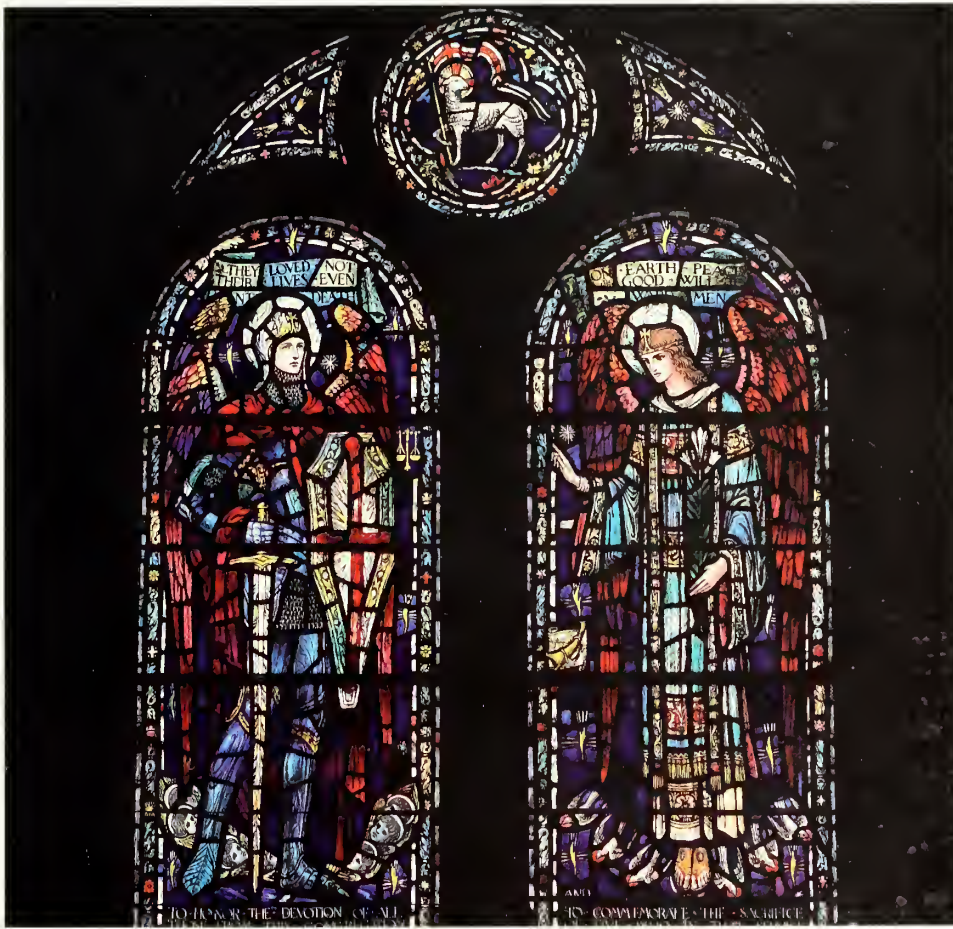
Figure 7. Charles J. Connick was another American master of stained glass. He worked in a modernized Neo-Gothic style. This window is from 1921. Photo: Diana Kincaid.

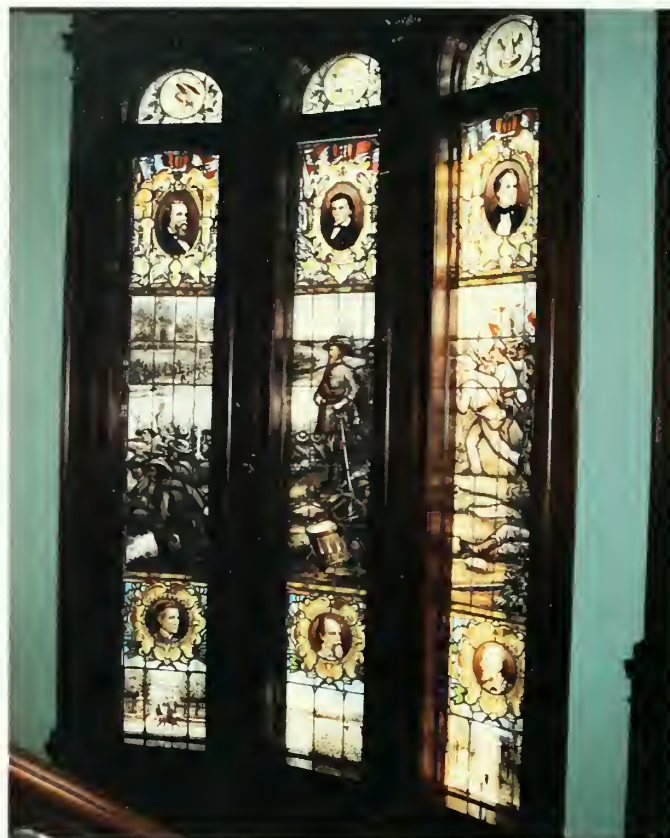
Figure 10. This image illustrates Thomas J. "Stonewall" Jackson and J.E.B. Stuart at the Second Battle of Manassas. The window comprises three of nine panels entitled "The Rise and Fall of the Confederacy" at Rhodes Hall in Atlanta. These windows were executed by Von Gerichten Art Glass Company of Columbus, Ohio, 1905 (installed). A.G. Rhodes reportedly returned one scene to the studio to be redone because the Yankees weren't running fast enough. Photo: Tommy Jones; Courtesy, Georgia Trust for Historic Preservation.

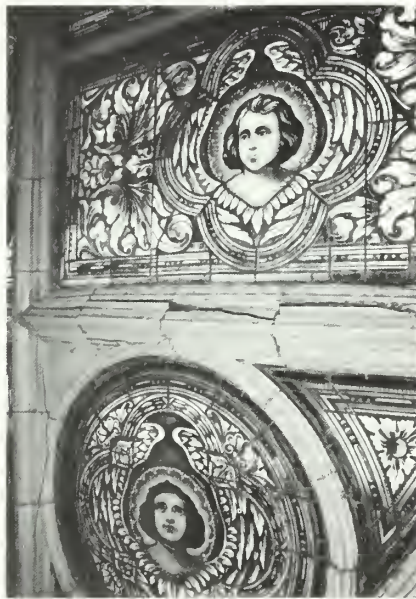
Figure 12. These stained glass angels appear concerned over the cracked terra cotta frames of the rose window they grace. Photo: Neal A. Vogel.

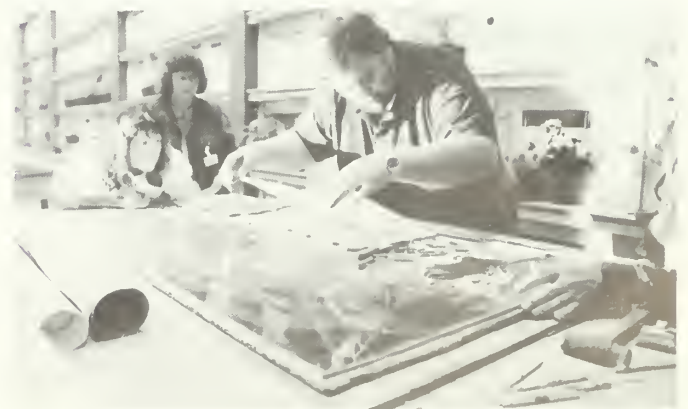
Figure 14. The instructor removes one of six etched plates from a ca. 1905 Tiffany window in order to clean the interspaces and provide a rare educational opportunity at a restoration workshop. Cypress Lawn Memorial Park, Colma, California. Photo: Neal A. Vogel.

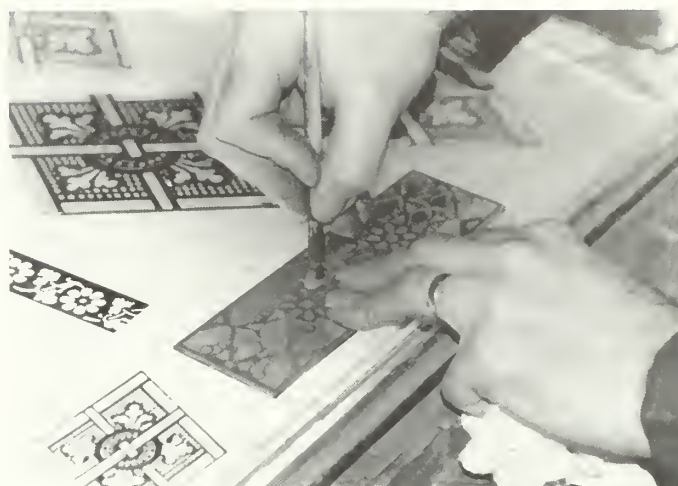
Figure 15. New stencils are used to produce matching replacement glass for repetitive stenciled patterns in a ca. 1870 window. Photo: Neal A. Vogel.

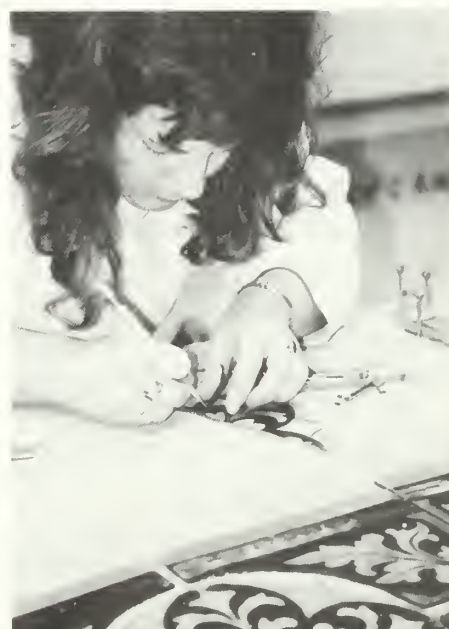
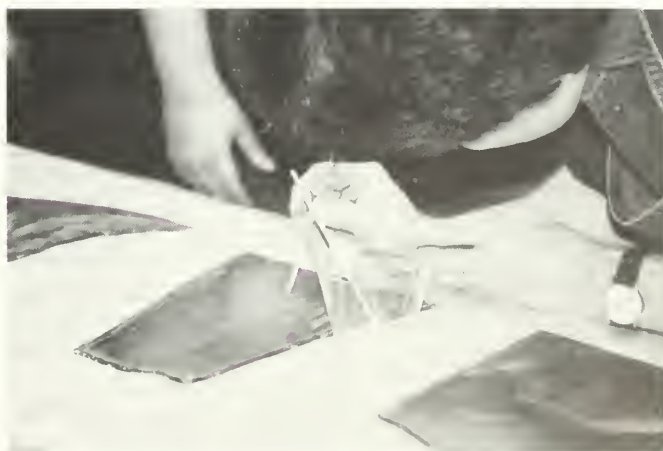
Figure 17. A valuable piece of flashed glass is carefully edge-glued with epoxy and a steady hand. Photo: Neal A. Vogel.

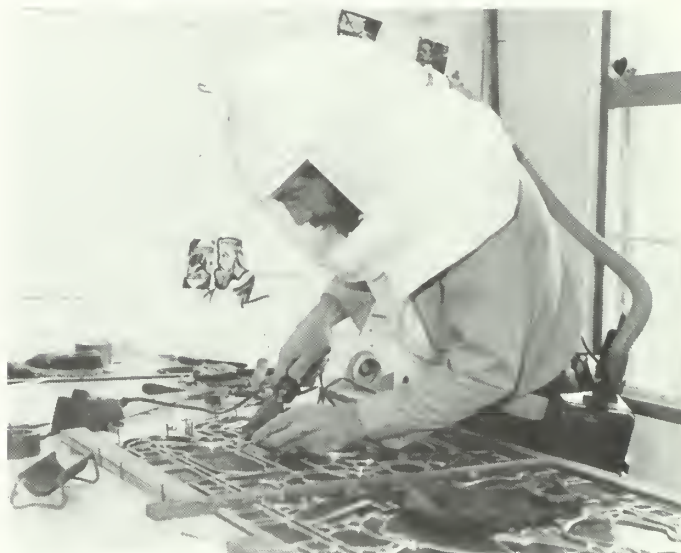
Figure 18. A craftsman releads a window. The full hood offers protection from lead fumes. Photo: Neal A. Vogel.

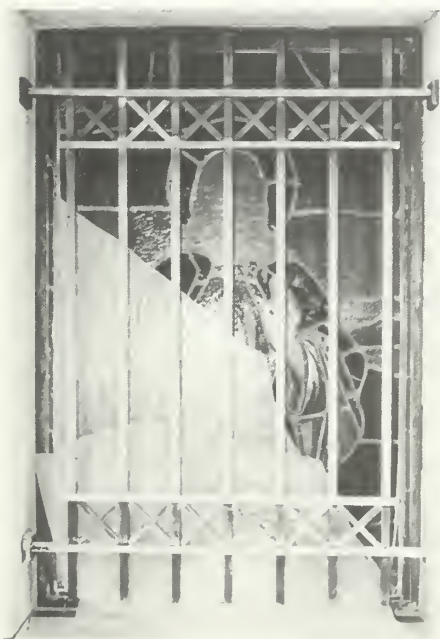
*Figure 19. Stained glass in mausoleums requires protective glazing since vandalism is frequent in cemeteries. This plate glass intentionally softened the light transmitted through the window. This feature should be reproduced in the replacement glazing. It may be possible to repair the plate glass and install another, stronger (clear) layer on the outside. Photo: Neal A. Vogel.*

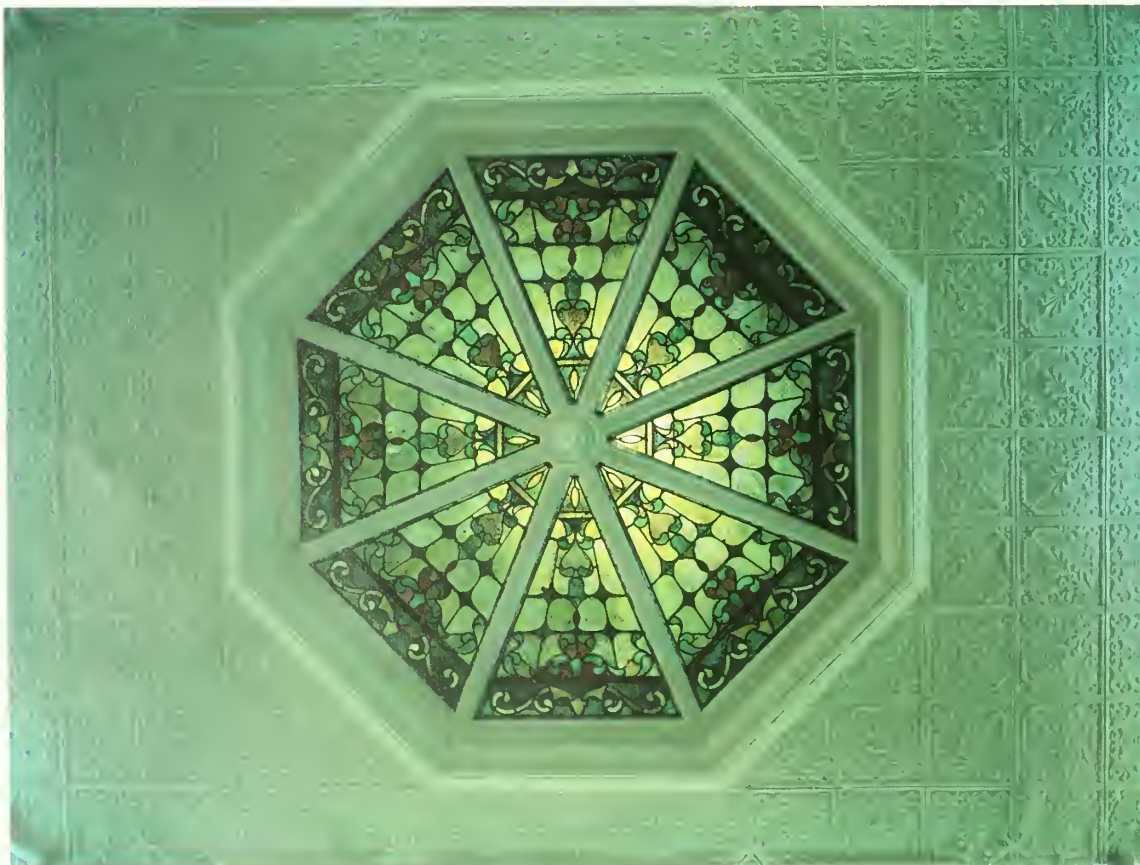
(a). Stained glass ceilings and domes are often principal interior features of churches, hotels, restaurants, railway stations, and civic buildings. This one illuminates the Carnegie Free Library in Union, South Carolina. Photo: Jack E. Boucher, HABS.

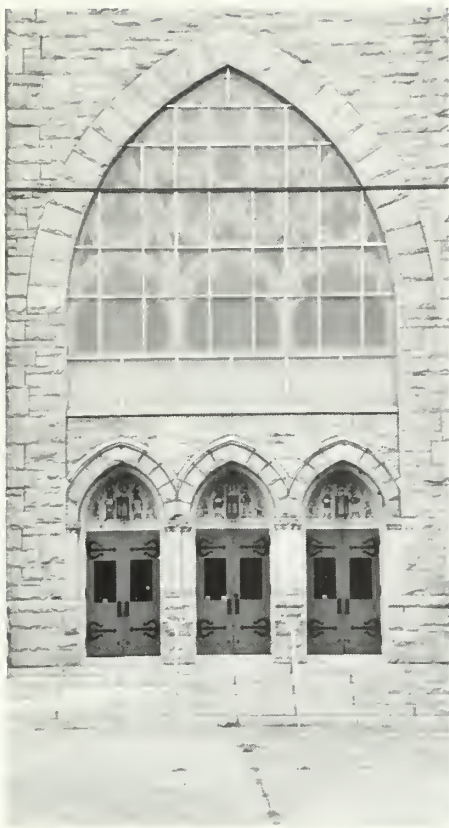
Figure 20. (a) The aluminum frame grid used for protective glazing totally disregards the original tracery of this Neo-Gothic church. The grid mars the appearance of the window inside and out. It also impairs the overall historic character of the building. (b) Protective glazing in this instance preserves both the appearance of the window and its contribution to the building. The latter building is the Cathedral Basilica of the Assumption (St. Mary's Cathedral), Covington, Kentucky (1895-1910). The window, 67' x 24' (20.4m x 7.3m), is among the largest stained glass windows in the United States. Photos: Neal A. Vogel.

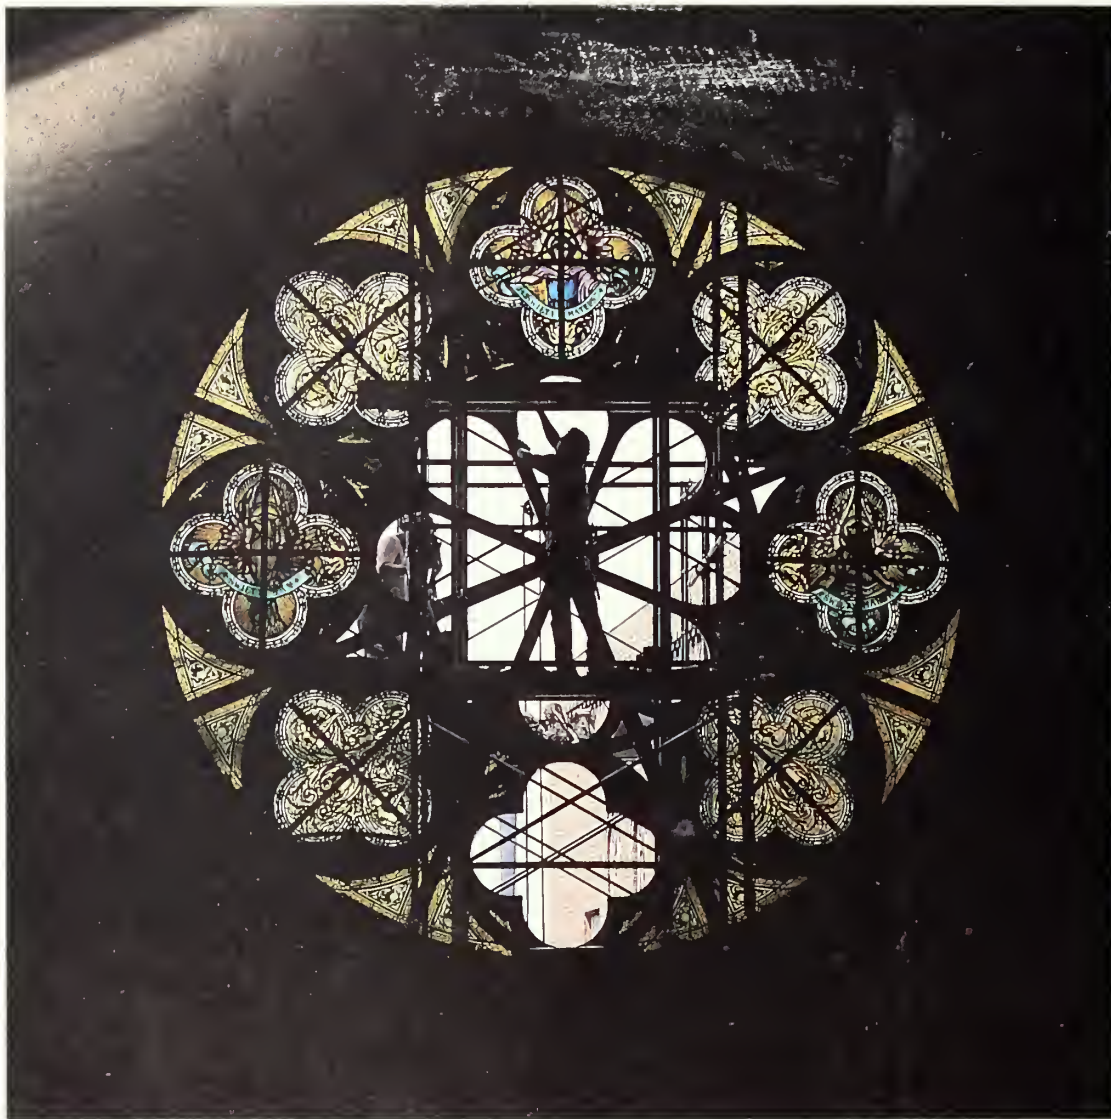
*The rose window at St. John Cantius, Chicago (1906-1908), undergoing restoration (interior view). Photo: Neal A. Vogel.*
