CRM BULLETIN

A National Park Service
Technical Bulletin

Twenty-Eight Coats of White House History

Historic Structures of the National Park Service

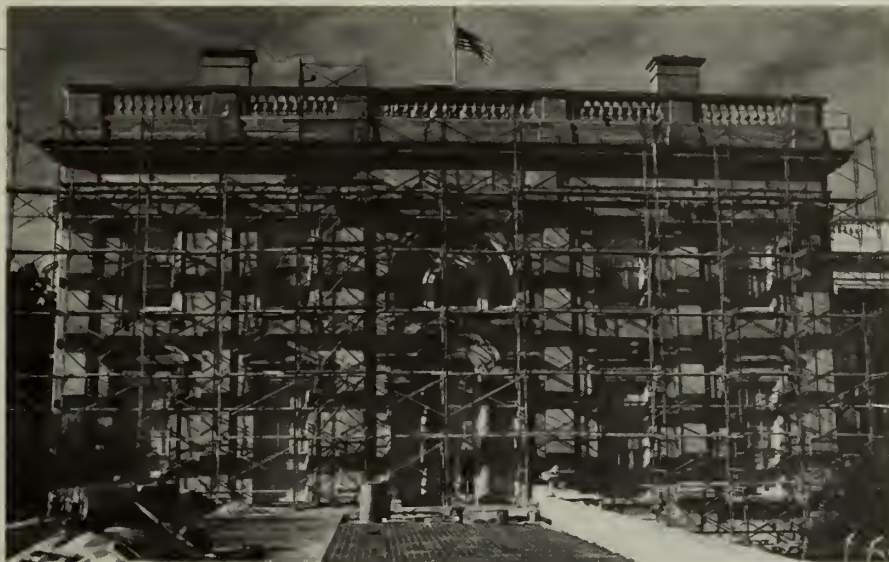
White House, east elevation with scaffolding, after paint removal.

By the end of 1979, NBS scientists were ready to make some firm recommendations to the Chief Usher and the NPS: 1) that all paint on the east elevation be removed down to bare stone, using the chemical/water spray method -- the project was phased starting with the east elevation to create the least visual impact and the least disruption of tours, ceremonies and other official business; 2) that the sandstone be repainted with a linseed oil, tung oil, soya alkyd paint, using 2 coats over bare stone, and one coat over previously painted surfaces; 3) that the results be closely monitored to evaluate the effectiveness of the restoration procedures and to refine the specifications for subsequent restoration of the remainder of the historic structure.

A contract to perform the restoration work was awarded to RUDCO, a building cleaning firm in Hartford, Connecticut. The final specifications called for: 1) complete removal of all paint from the east elevation of the White House; removal of only loose paint and other loose foreign material from the north, west, and south elevations; 2) repair, repointing, and, if needed, replacement of deteriorated masonry; and 3) repainting with a prime coat and finish coat on exposed masonry surfaces, and with only a finish coat on previously painted surfaces. Based on test results, the paint selected for use was a linseed oil, tung oil, soya alkyd coating.

The paint removal process proved to be difficult, because of the multi-layered build-up of different types of coatings. The original base coat was the toughest to remove. RUDCO found it necessary to alter the chemical formulations of the removers at least three times as they worked their way through the 28 layers of paint. Once the paint was removed, the entire elevation was rinsed with a mild solution of acetic acid to balance the alkalinity of the paint removers and

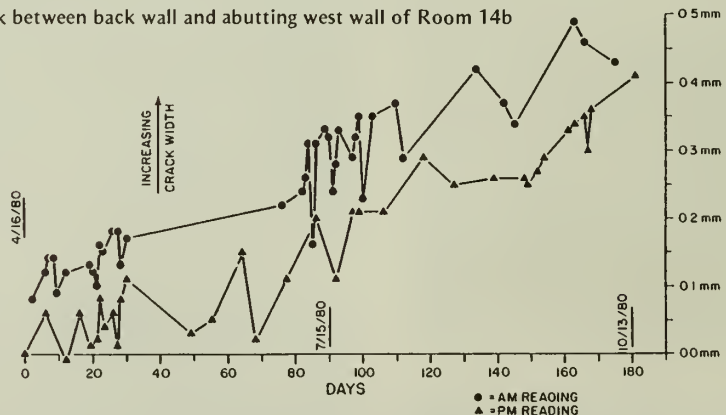
DIAL GAUGE DATA: PUEBLO BONITO

These data show the change in crack width between the wall (shown in profile to the left) and an adjacent wall. In addition to its unstable geometry, the wall is continuing to tilt farther to the north. Plans are underway to install a permanent brace to prevent collapse.

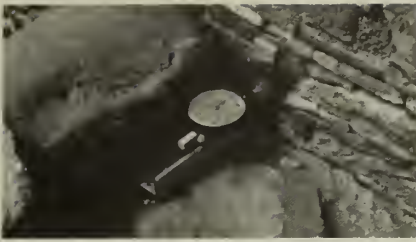
This dial gauge installation produced the data in the line chart. The gauge is mounted on top of a wall on one side of the crack. A metal plate is attached to the taller back wall. The spring-loaded spindle of the gauge rests on the metal plate, but is not attached to it. As crack width changes, the spindle moves and changes the position of the gauge hands.

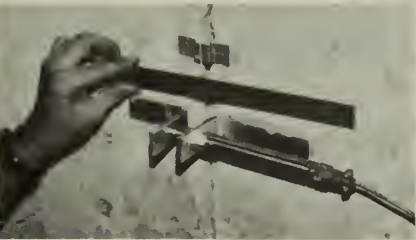
An electronic gauge in place. This gauge is a linear variable differential transformer (LVDT). Its operation is similar to the dial gauge with a spring-loaded spindle resting on a bracket except that it produces a voltage output that can be read at a remote location.

For the ceiling cracks, however, the mechanical gauges may not be appropriate. It is necessary to get to the gauge to read it, and erecting scaffolding every month may be far more expensive than the cost of electronic gauges with a remote readout. The wires from several gauges can go to a central point where the power supply and readout meter are located. All gauges can be read from one meter by plugging in the cables from each gauge, one at a time. In some applications, strip chart recorders are useful in detecting the effects of wind, seismic activity, sonic booms, and other temporary loads. In most cases, however, continuous recording only produces more data than is needed, and the great volume of paper produced is often stored without being analyzed. Periodic readings, recorded manually, and plotted as a function of time, will show long-term trends in structural movement.

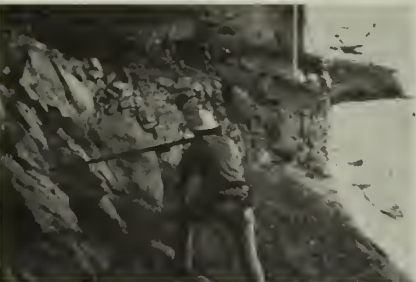
Precise leveling equipment being used to measure settlement of ruins. While similar to conventional surveying in technique, specialized equipment allows direct readings of 1/10 mm with estimates to 1/100 mm.
