RECENT CHANNEL ADJUSTMENTS
IN REDWOOD CREEK, CALIFORNIA

REDWOOD NATIONAL PARK
RESEARCH AND DEVELOPMENT

TECHNICAL REPORT
DECEMBER 1986

Redwood National Park Research and Development
Technical Report Number 18

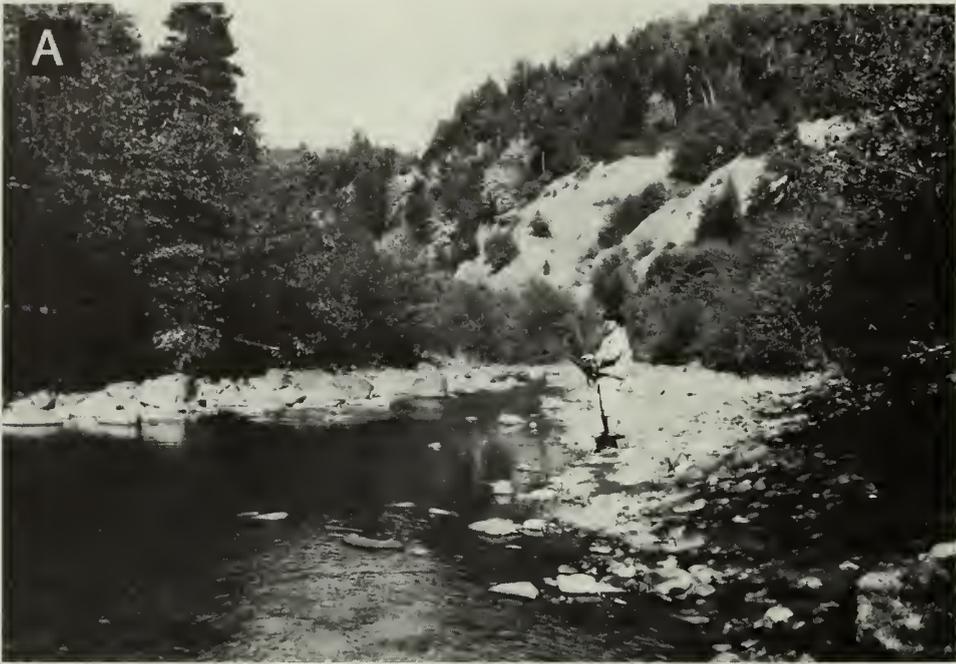
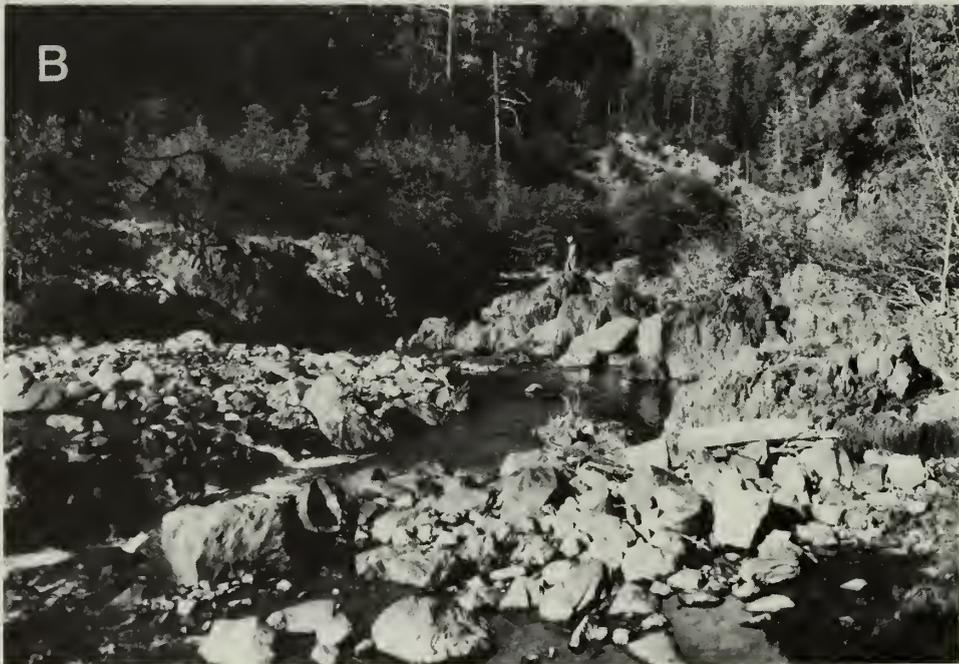
Figure 10. The stream channel in Reach 1 above State Highway 299 varies from small valleys with low gradients (A) to steep, narrow channels with exposed bedrock and boulders (B). In general, bed material is large and channel widths narrow.

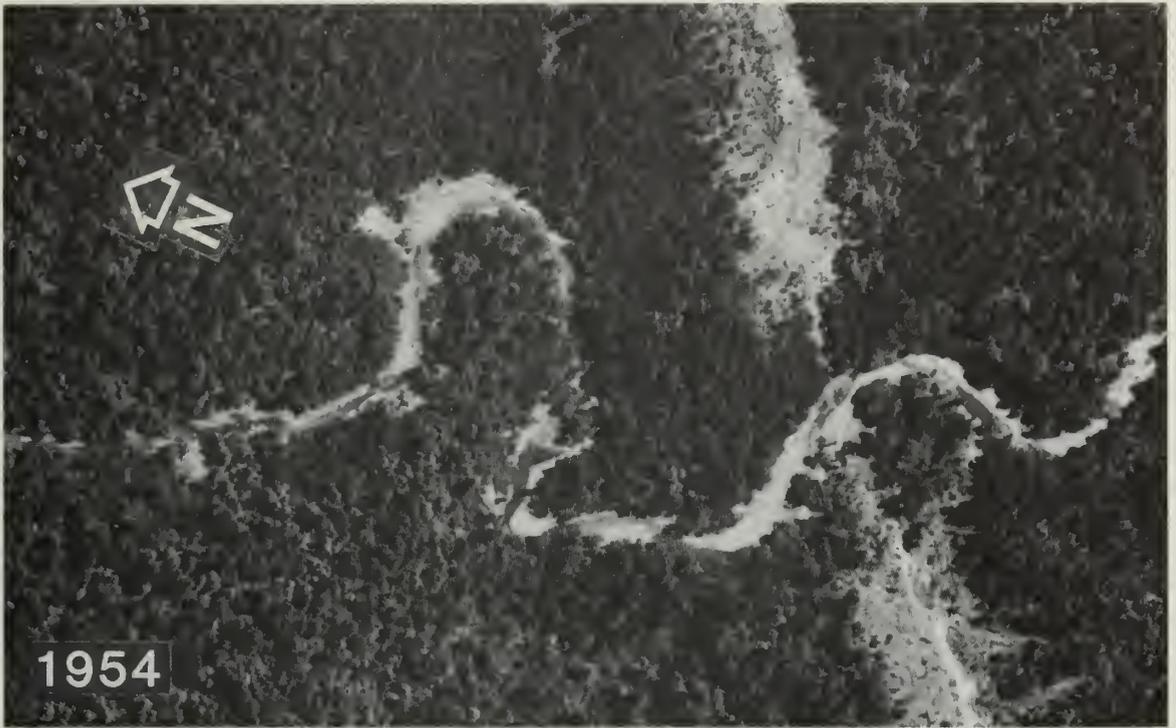
Figure 11. 1954 and 1966 aerial photographs of the main channel about 5 km upstream of State Highway 299. In 1954 photographs, slopes adjacent to this reach were undisturbed with the exception of the powerline right-of-way. Channel widths at cross sections upstream of State Highway 299 increased significantly between 1954 and 1966.

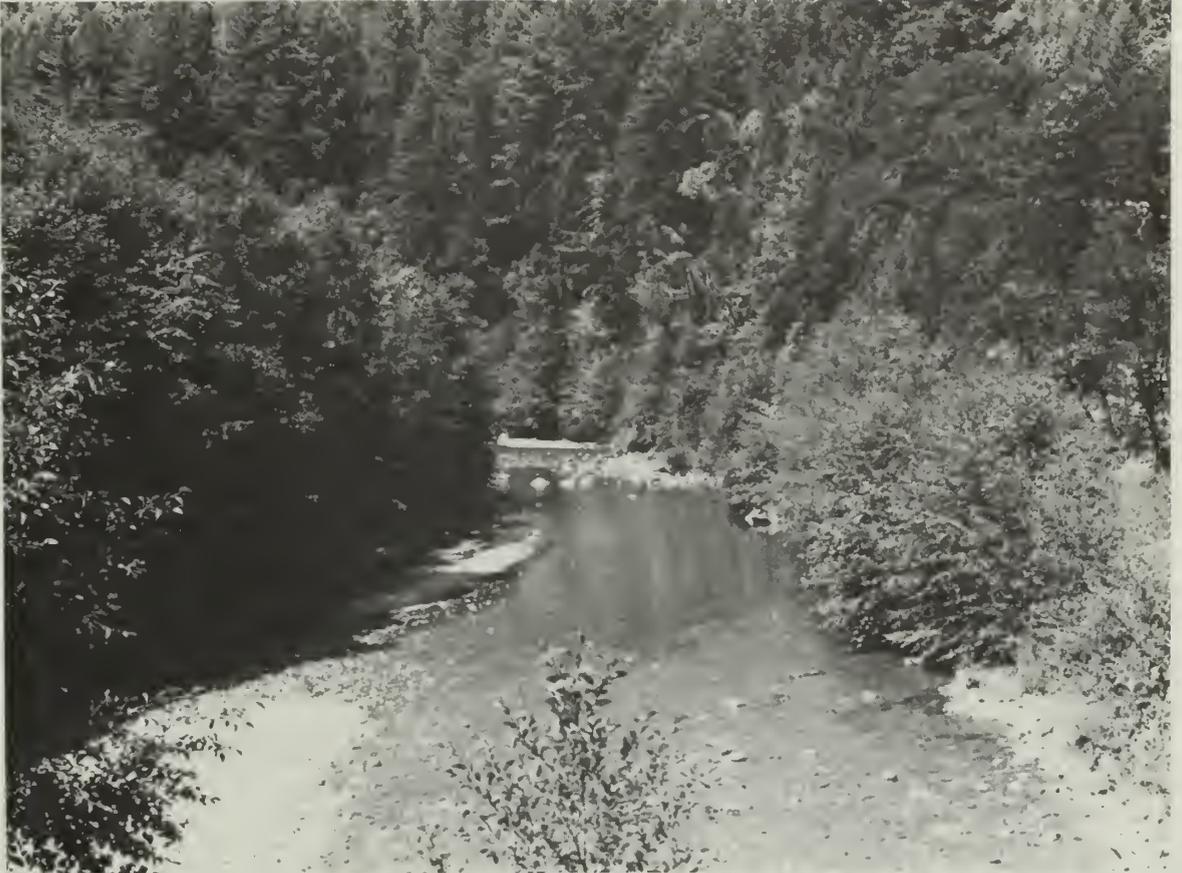
Figure 13. Between State Highway 299 and Chezem Road, the channel is typically narrow with bankfull widths of 30-40 m. Records from the USGS gaging station near Blue Lake (Cross Section 40) and cross section data indicate that degradation has occurred since 1973 in this reach and upstream reaches.

Five cross sections are in this 6.7 km long reach. This reach is typified by a narrow channel and high and steep streambanks. Bankfull widths range from 30 to 40 m (Figure 13) and the channel gradient averages 0.005 m/m.

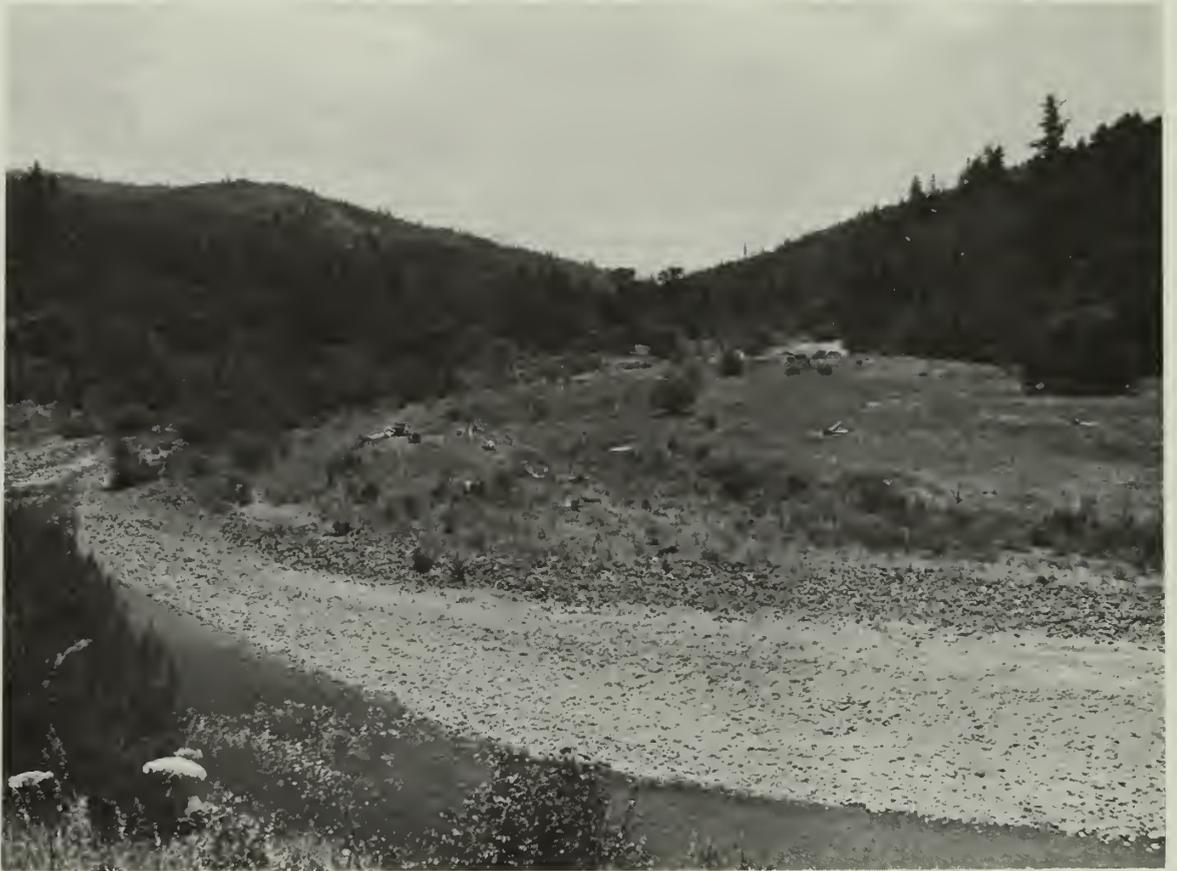
Figure 15. The channel in Redwood Valley is typically wide and alluviated. Bankful widths up to 150 m are common. The stream gradient is gentle in this reach and the lack of older vegetation on the gravel bars indicate recent inundation by high flows.

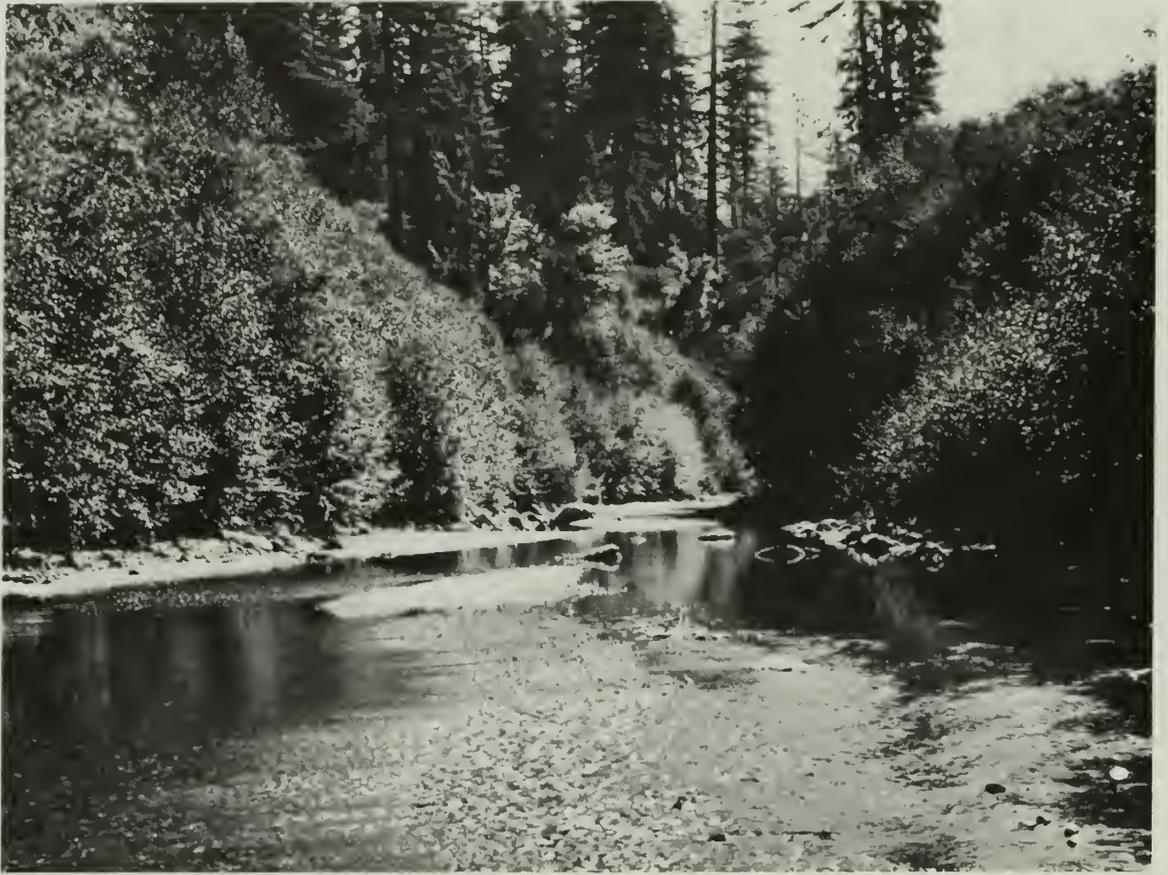
Figure 18. Redwood Creek looking upstream from Cross Section 32. In the reach between Stover and Copper Creek, the channel again becomes narrow. Valley walls are steep with little room for extensive gravel bars.

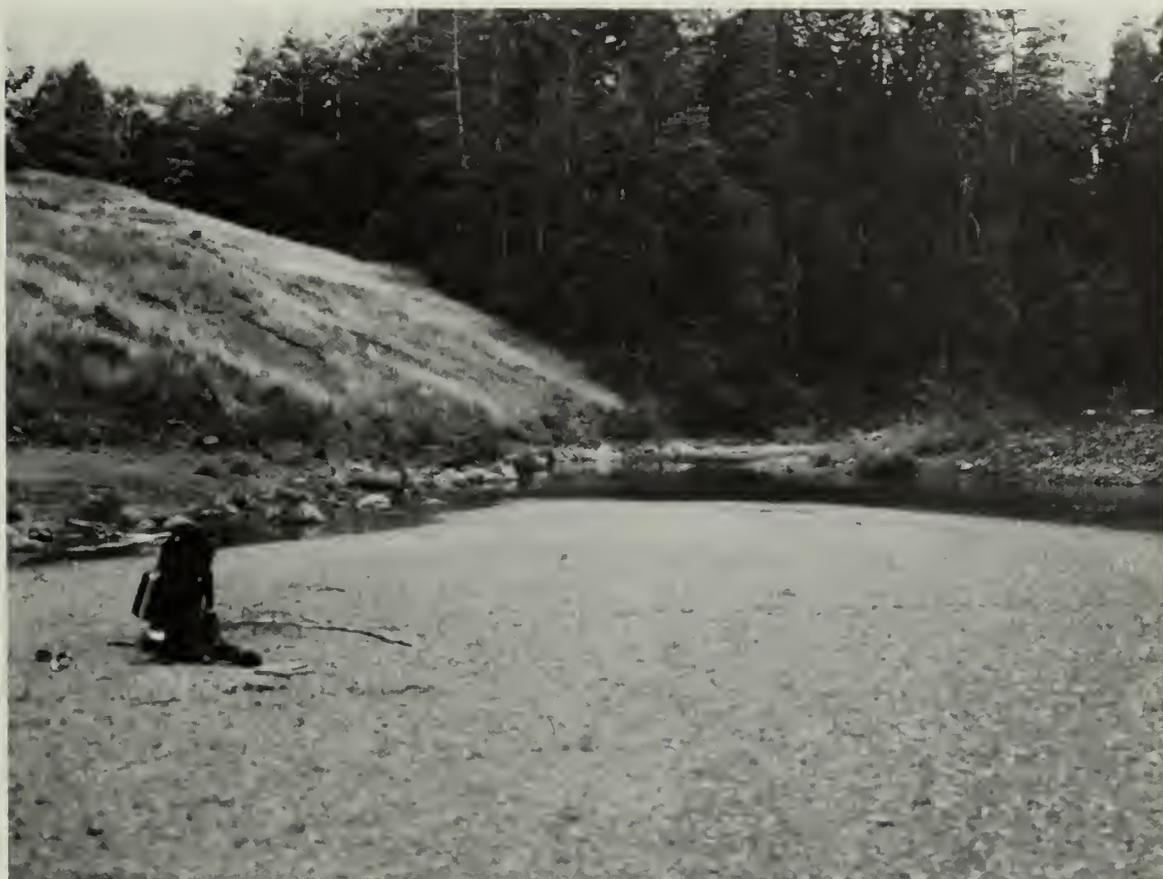
Figure 20. This reach provides a temporary sediment storage site for material from earthflows (left) entering from the east side of the channel. This photograph is looking upstream from Cross Section 28.

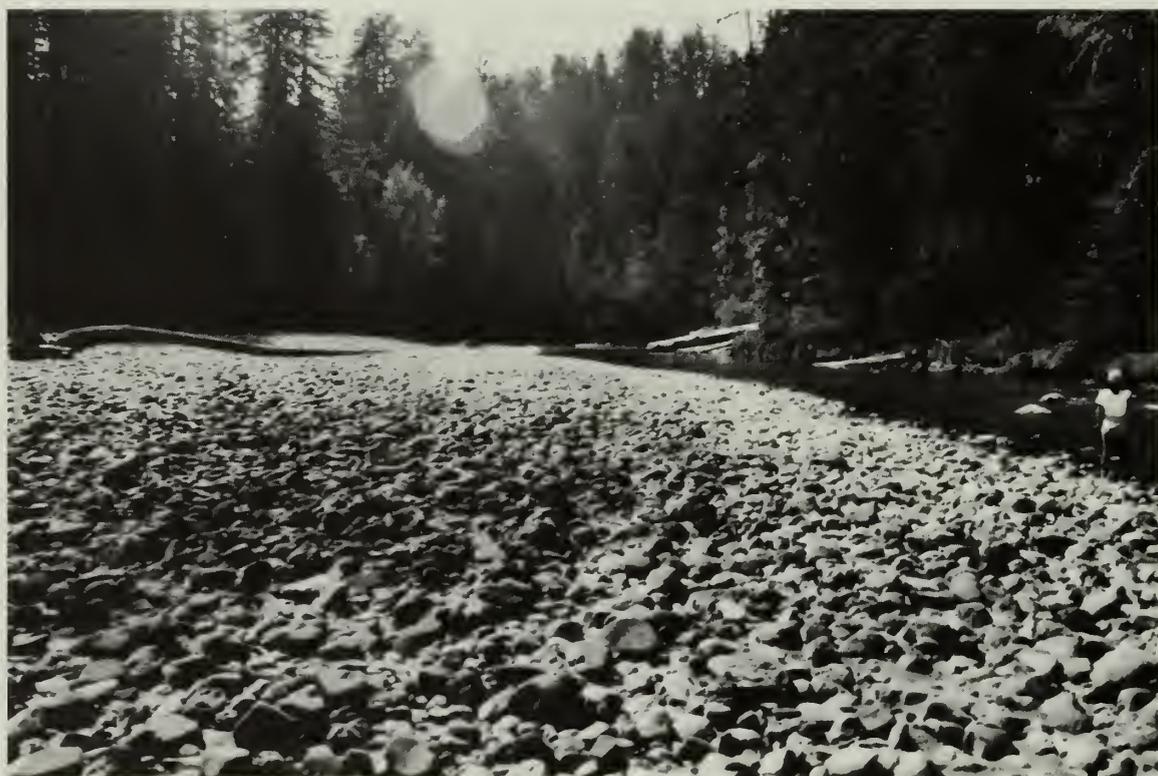
Figure 22. Downstream of the gorge, the riparian vegetation of Redwood Creek is typically old growth redwood forest. The streambed is also characterized by a wide alluviated channel. Between the base of the gorge and Bridge Creek, ΔE_C values have been the highest recorded in the basin. Presently, the streambed is scouring here.

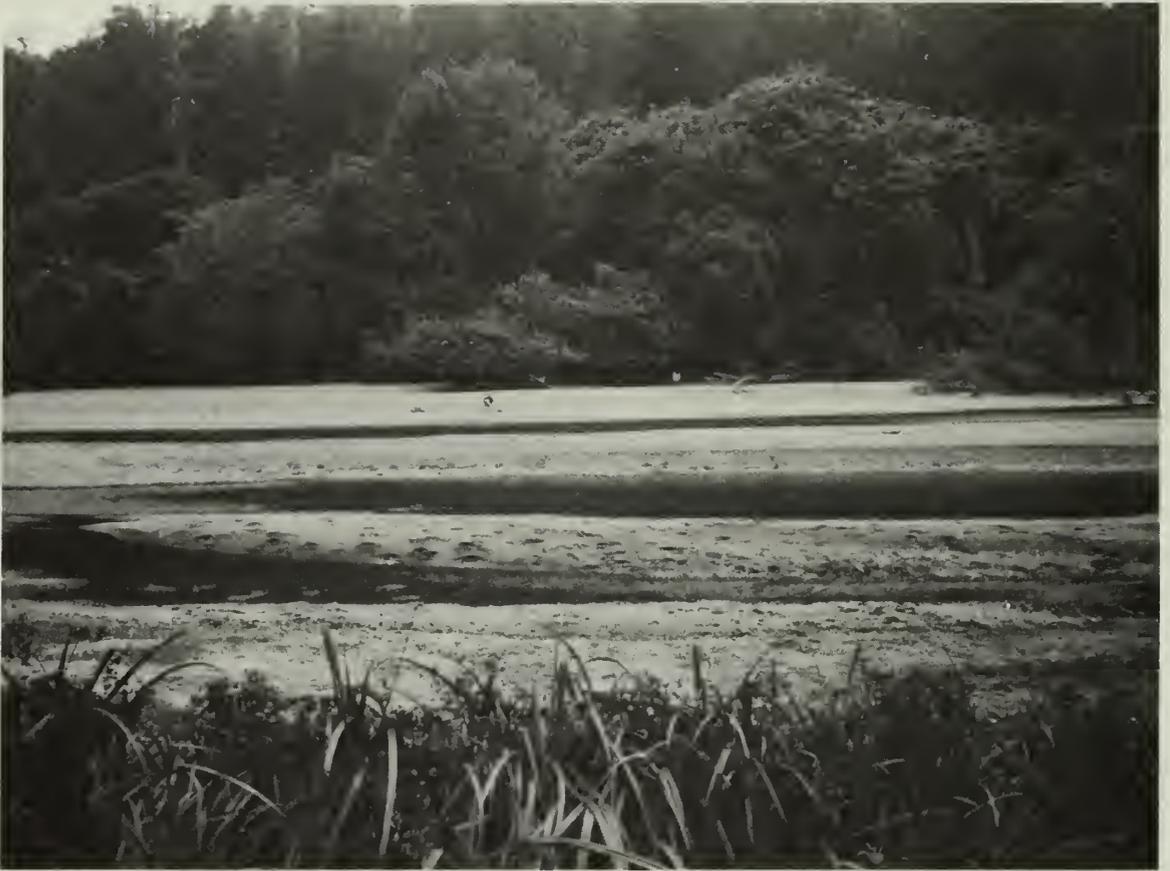
Figure 30. Redwood Creek between Forty-four and Elam Creeks is wide and alluviated. The presence of multiple channels may reflect high sediment loads.

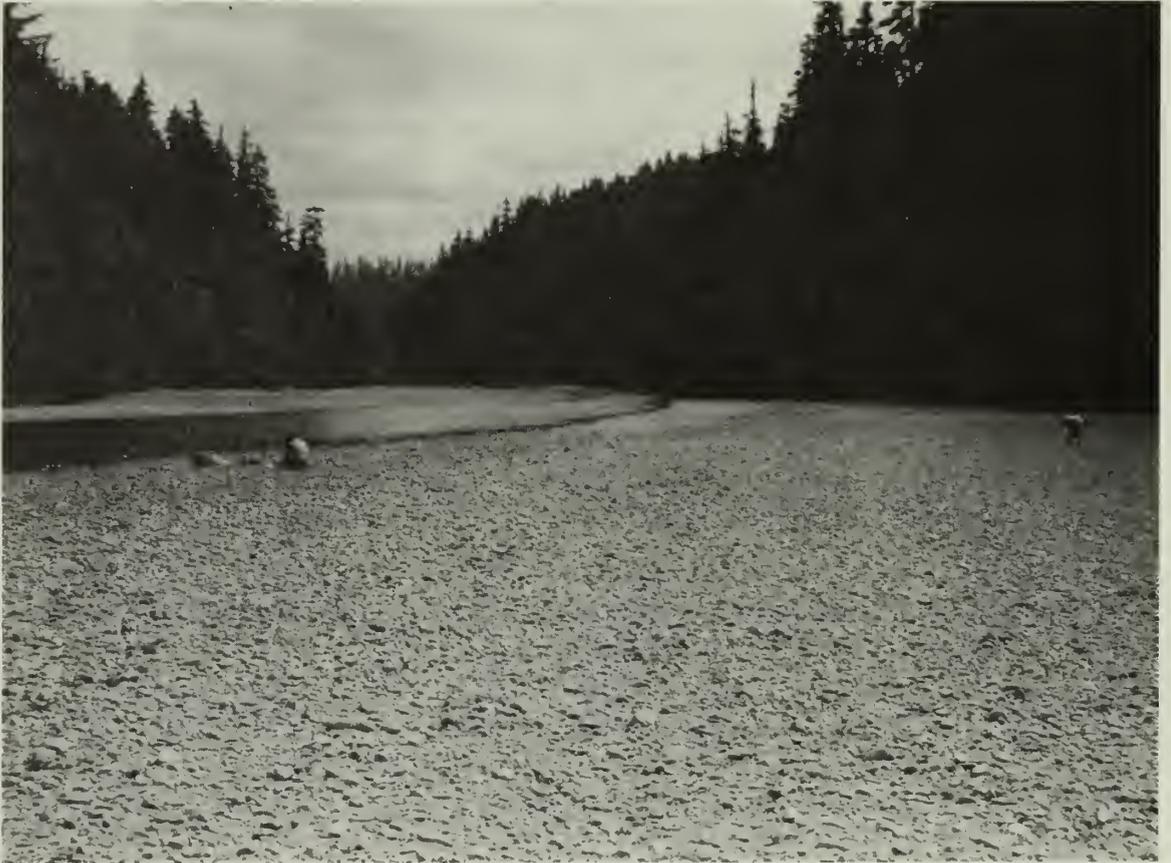
Figure 32. Channel shifting is common in the wide, alluvial reach between Elam and Prairie Creek. This photograph is looking upstream from Cross Section 4.
