29 PRESERVATION BRIEFS

The Repair, Replacement, and Maintenance of Historic Slate Roofs

U.S. Department of the Interior
National Park Service
Cultural Resources
Preservation Assistance

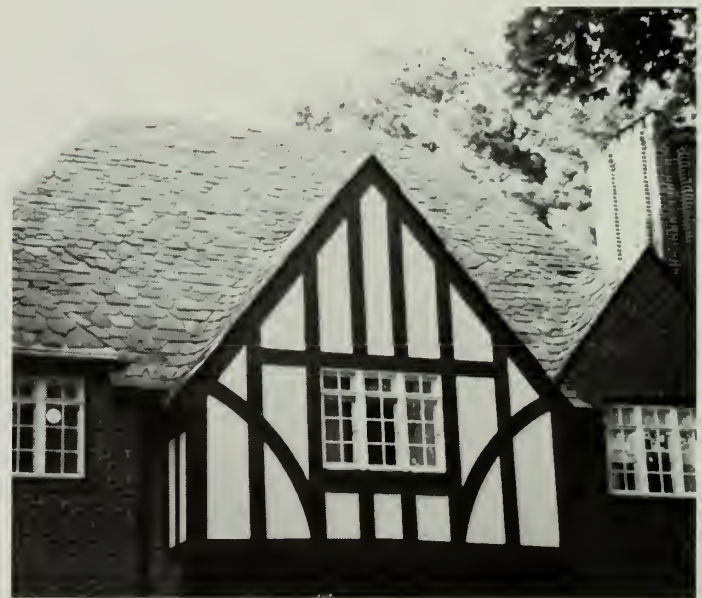
Figure 2. The quaint character of this Tudor style residence is derived, in part, from its textural roof.

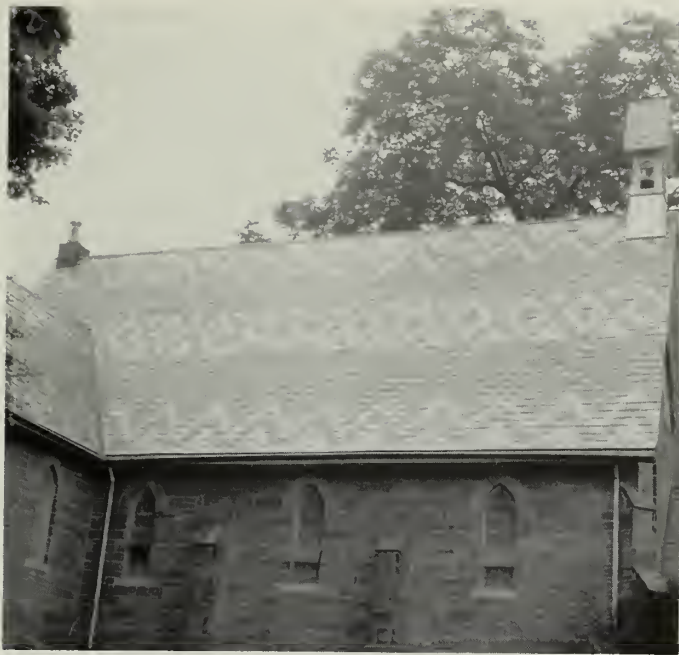
Figure 3. A sawtooth geometric design composed of red, green, and black slates makes this roof the most visually important feature of the building.

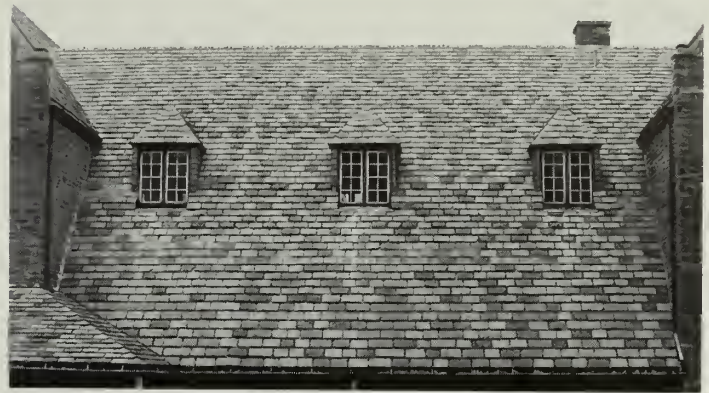
Figure 5. This graduated slate roof is composed of large, thick slates at the eave which are reduced in size and thickness as the slating progresses to the ridge.

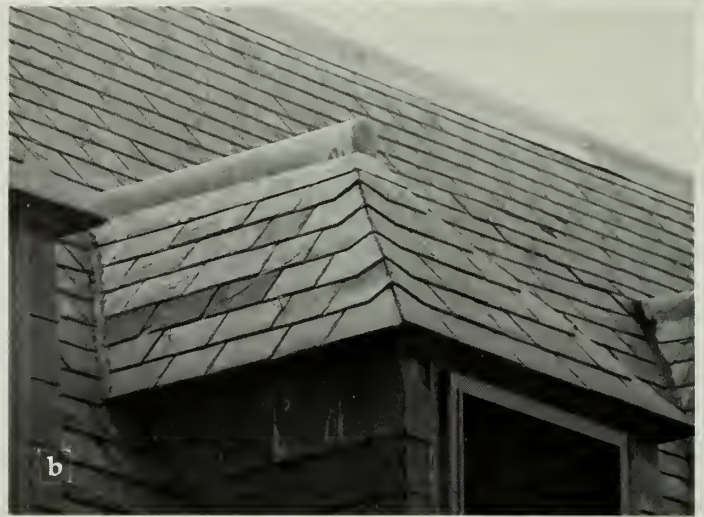
Figure 6. Hips are formed at the external angle of two roofing slopes. In (a), the hips at both the roof and the dormer are covered with metal. Note also the open valley and the built-in gutter. In (b), the dormer hip slates have been laid in a fantail pattern to help shed water. Note also the metal ridge cap.

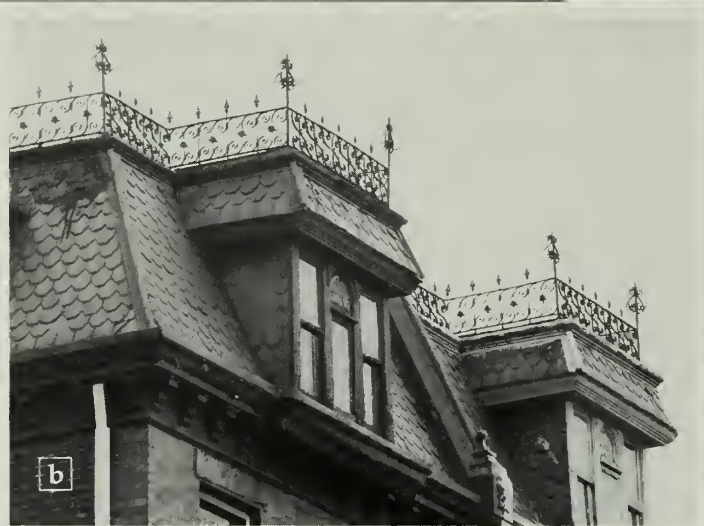
Figure 7. Ridge caps and cresting can be elaborate. Ridges are formed at the long horizontal juncture of two roofing slopes and capping protects this joint from moisture. In (a), a terra cotta capping with a decorative profile complements the finial over the various roof peaks. In (b), the mansard roof has a decorative iron cresting at the break between the lower and the upper roof slopes.

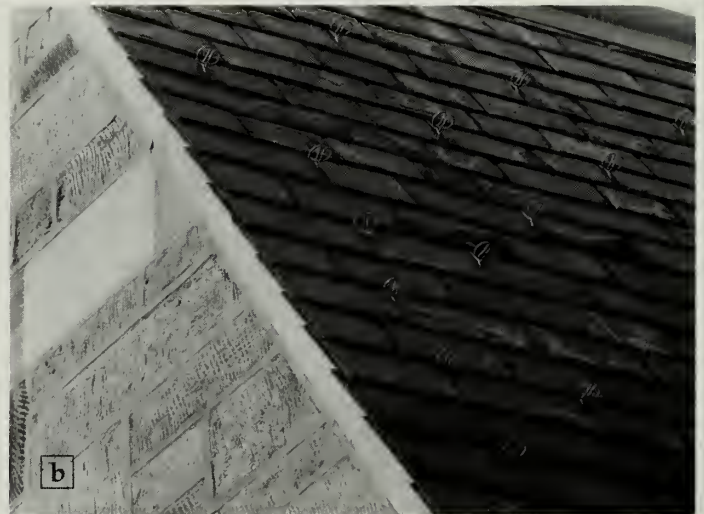
Figure 8. Eave details include snow guards, snow boards, gutter treatments. Snow guards are generally used in areas where ice and snow accumulate to avoid dangerous slides from the roof. In (a) the snow guards are set in two staggered rows above a pole gutter. In (b), the copper wire snow guards are set more frequently up a very steep gable.

Detailing at the hips, ridges and valleys provided added opportunity to ornament a slate roof. Hips and ridges can be fashioned out of slate according to various traditional schemes whereby the slates are cut and overlapped to produce a watertight joint of the desired artistic effect. Traditional slate ridge details are the saddle ridge, strip saddle ridge, and comb ridge, and for hips, the saddle hip, mitered hip, Boston hip, and fantail hip (Figure 6). A more linear effect was achieved by covering the ridges and hips with flashing called "cresting" or "ridge roll" formed out of sheet metal, terra cotta, or even slate (Figure 7). Snow guards, snow boards, and various types of gutter and rake treatments also contributed to the character of historic slate roofs (Figure 8).

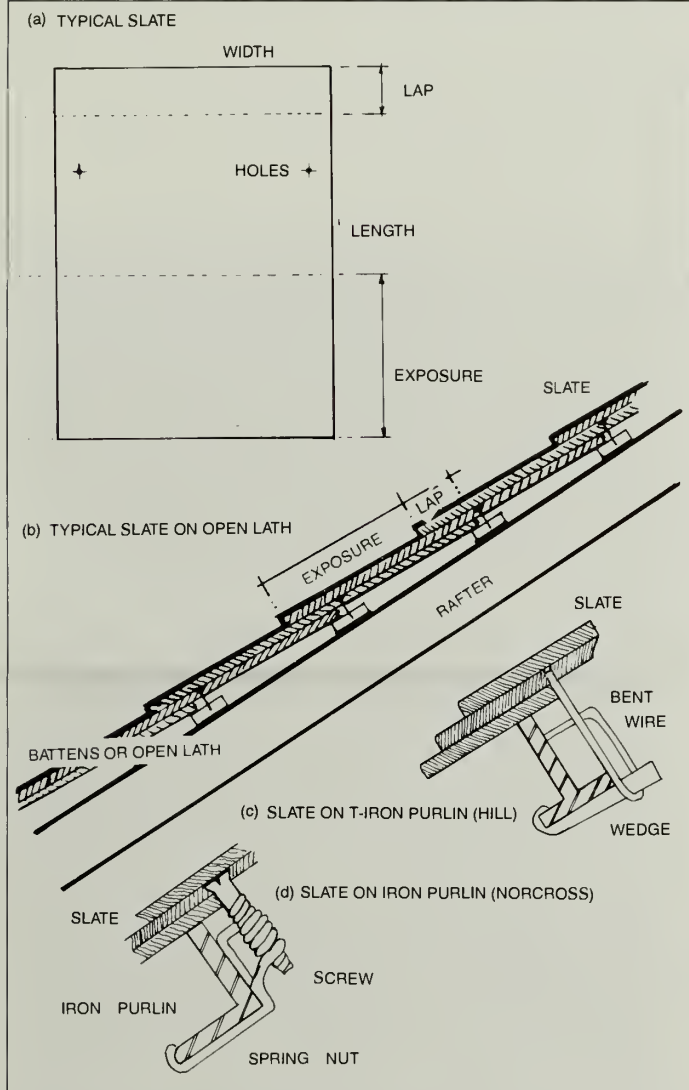
Figure 10. (a) shows a typical slate; exposure may be calculated by subtracting the headlap from the total length of the slate and dividing by two. Slates were typically nailed either to closed wooden decking or to open laths (b). In the late 19th century, with the concern for fireproof construction, special fasteners were developed to secure slate to steel purlins (c) 1881 patent to James G. Hill; (d) 1889 patent to Orlando W. Norcross).

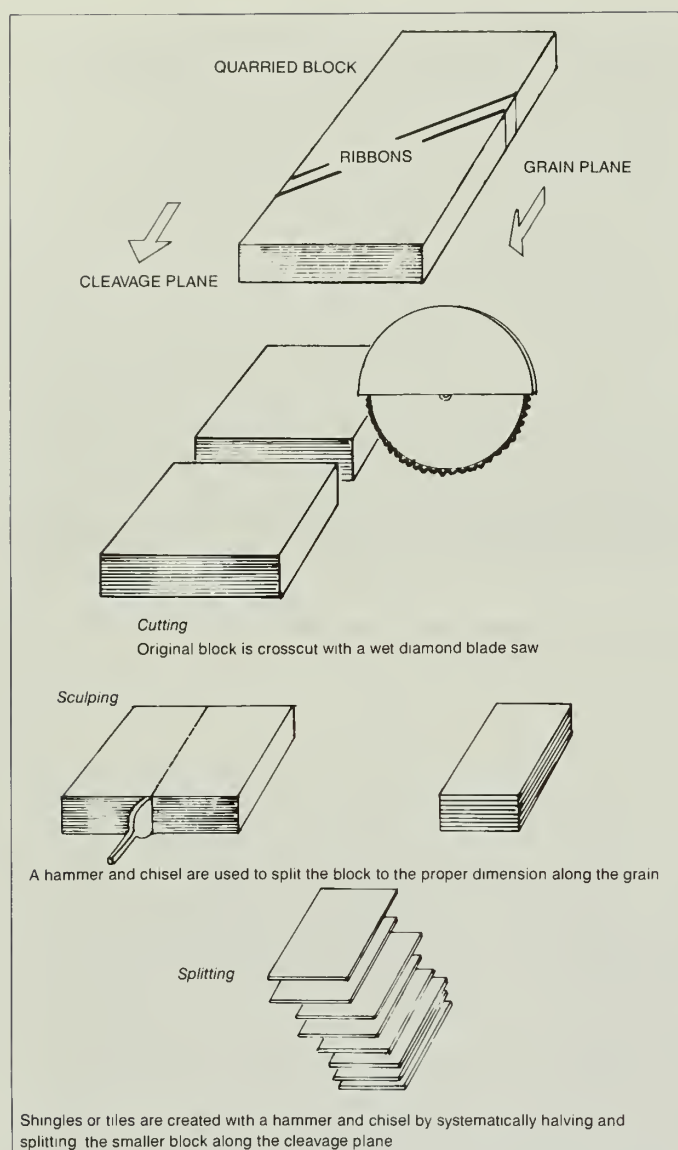
Figure 11. Slate roofing tiles or shingles are still manufactured using traditional methods brought to this country by Welsh immigrants in the nineteenth century. Shown above are the first 3 steps of cutting, sculping and splitting. Once the rough slate tile is made it is trimmed and punched for holes.

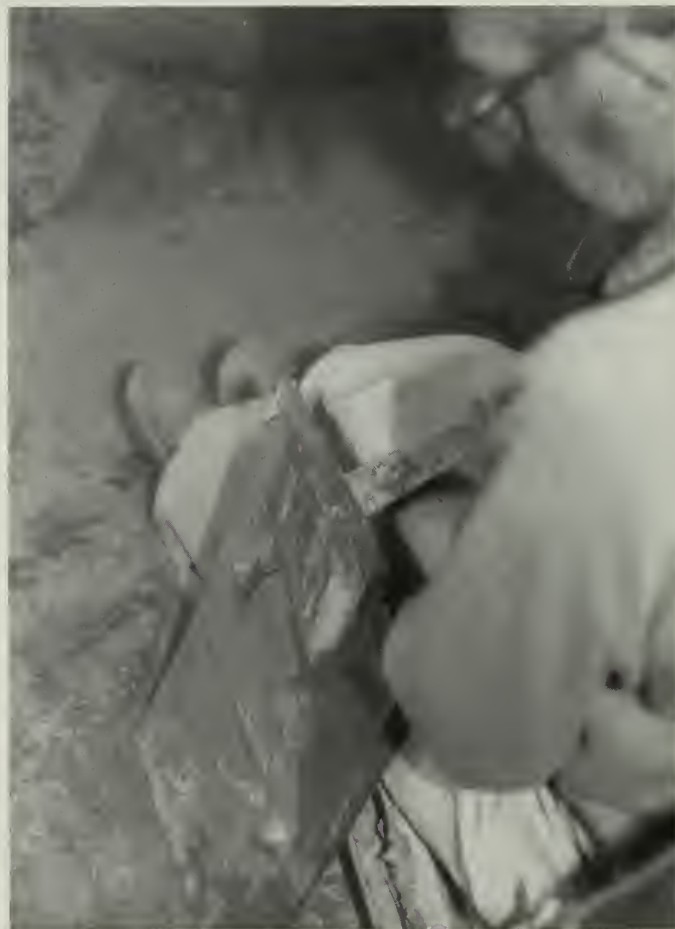
Figure 12. In the splitting area, the slightly oversized blocks are split along their cleavage planes. The splitter's tools consist of a wooden mallet and splitting chisels. The process of halving the split portions is repeated until a tile or shingle of appropriate thinness is obtained.

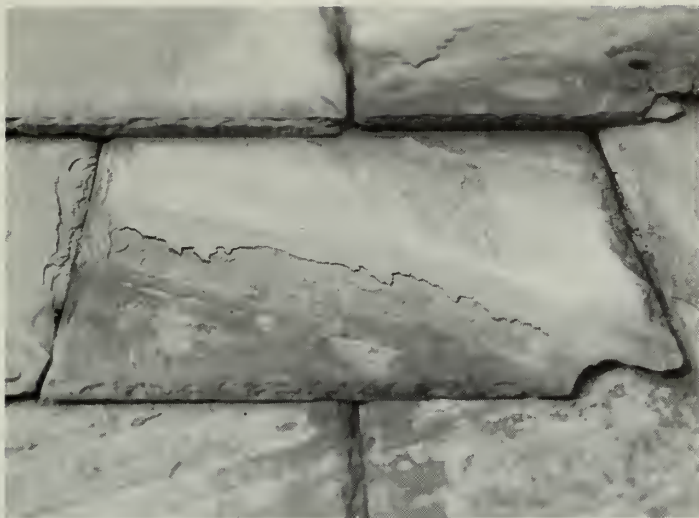
Figure 13. Paper thin lamination can be seen flaking off of this weathered, 120 year piece of Pennsylvania Hard-Vein slate.

The natural weathering of roofing slate manifests itself as a slow process of chipping and scaling along the cleavage planes (Figure 13). Paper thin laminations flake off the surface of the slate and the slate becomes soft and spongy as the inner layers begin to come apart, or delaminate. The nature of the sound given off by a slate when tapped with one's knuckles or slating hammer is a fair indication of its condition. High-grade slate, when poised upon the fingertips and struck, will emit a clear, solid sound. Severely weathered slates are much less sonorous, and give off a dull thud when tapped.

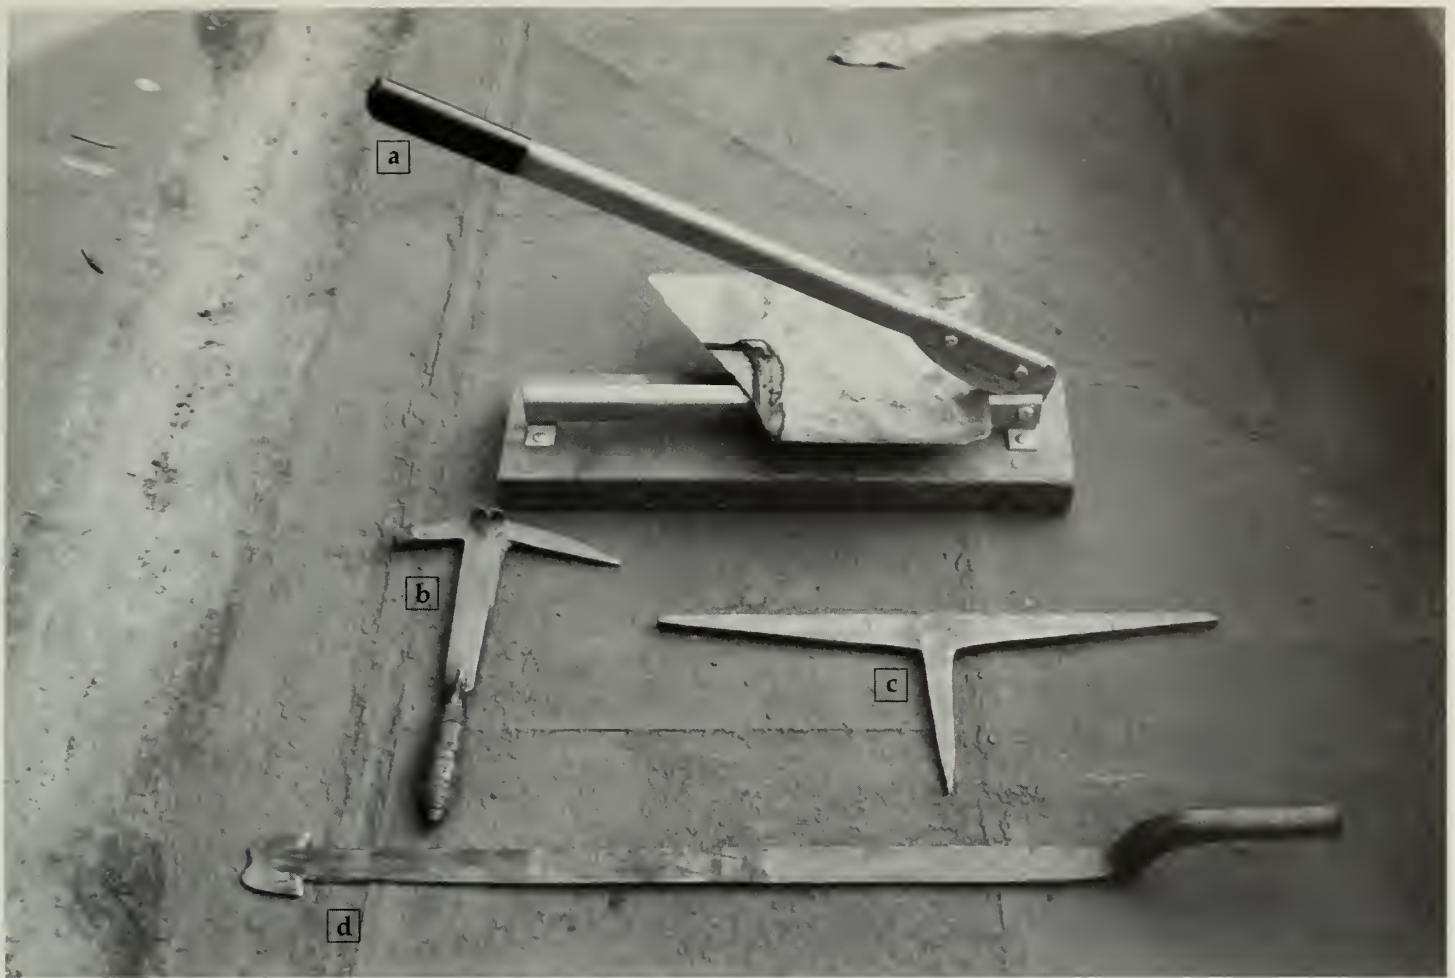
Figure 17. Slater's Tools. The cutter (a) is used to trim slate edges; the slate hammer (b) is used for hammering nails, trimming, cutting and punching holes in slates, and pulling roofing nails; the steak (c) is a T-shaped piece of iron upon which the slater places the edge of a slate to be trimmed; and the ripper (d) is slid under the slates to pull out the nails.

The ability to lay slate properly so as to produce a water-tight and aesthetically pleasing roof requires training, much practice, and the right tools (Figure 17). The

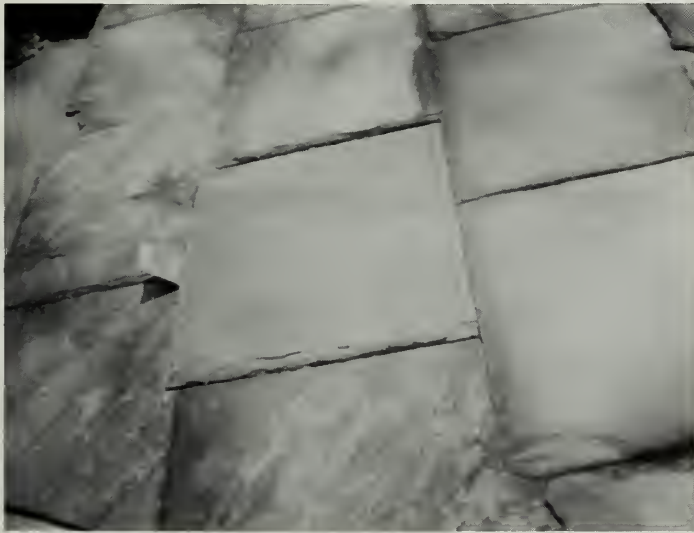
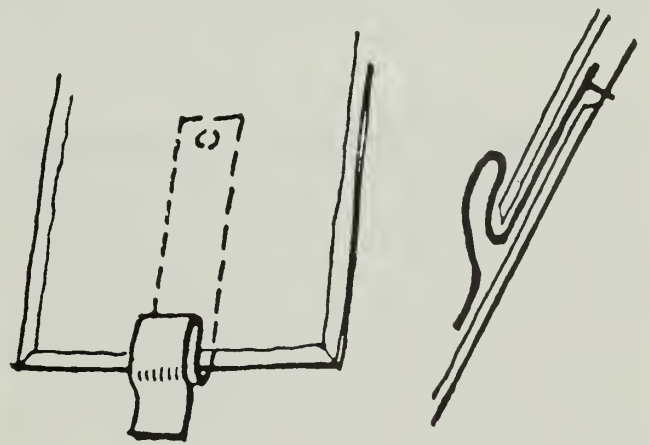
Figure 18. A method of securing replacement slates is shown. The copper strip is nailed to the roof sheathing just above the head of the slate in the course below. The replacement slate is then inserted and the copper tab folded over its tail. This type of repair is not recommended for northern climates where snow and ice can cause the copper tab to fold over, allowing the replacement slate to slide out of position as occurred here on the left.

Broken, cracked, and missing slates should be repaired promptly by an experienced slater in order to prevent water damage to interior finishes, accelerated deterioration of the roof and roof sheathing, and possible structural degradation to framing members (Figures 18 and 19).

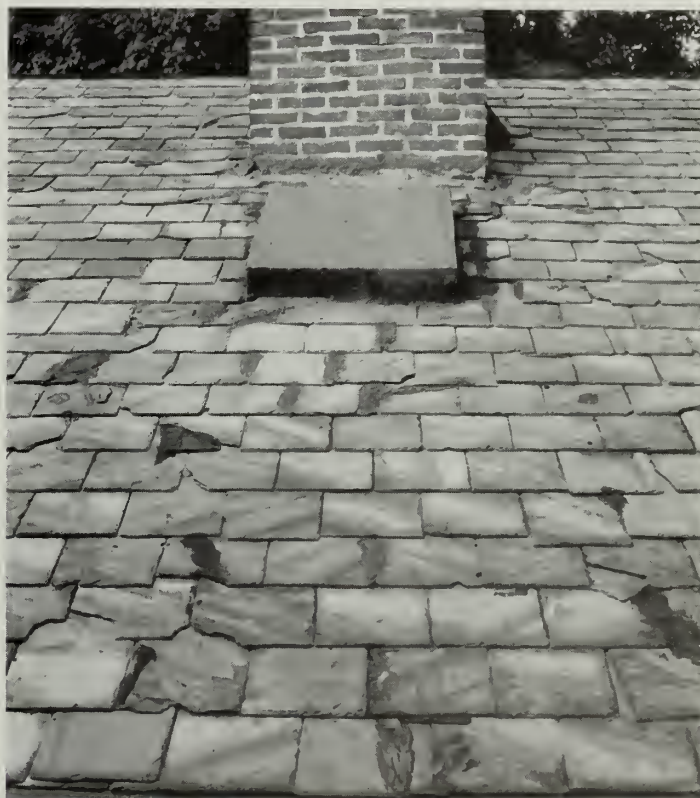
Figure 20. This roof has been poorly repaired numerous times in the past. The installation of mastic to seal out moisture has only exacerbated the problem. A timely repair and good maintenance could have extended the life of this roof.

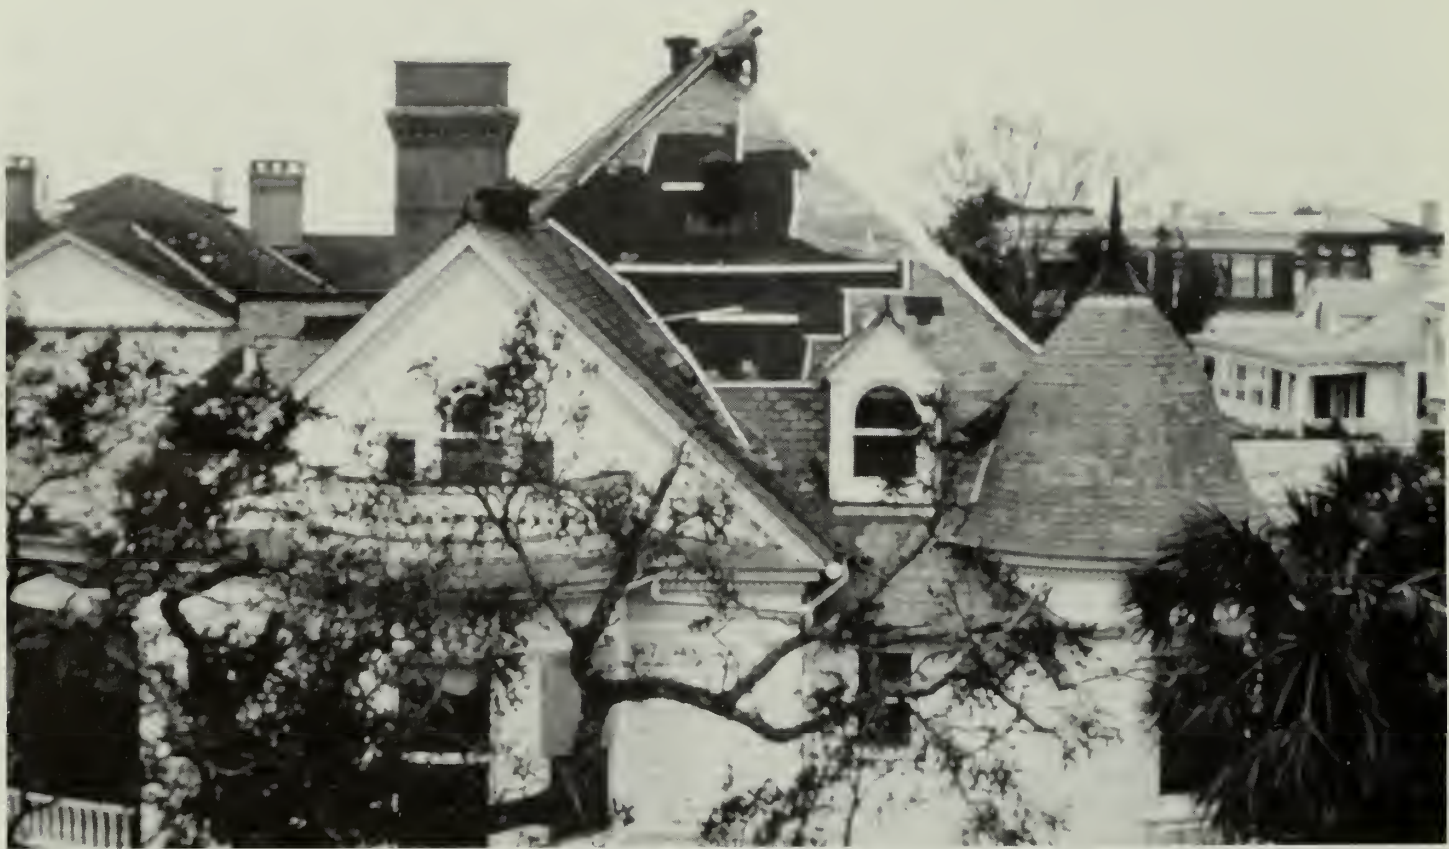
Figure 21. As a result of hurricanes and other disasters, it may be necessary to temporarily stabilize a roof until materials can be obtained and a qualified roofing contractor hired. Heavy roofing felt was stitched into this slate roof to stop moisture penetration until matching slate was obtained for repair. Significant slate roofs should not be stripped off and replaced with asphalt shingles. Photograph courtesy of the National Park Service.

In emergency situations, such as when severe hurricanes or tornadoes blow numerous slates off the roof, a temporary roof covering should be installed immediately after the storm to prevent further water damage to the interior of the building and to permit the drying out process to begin. Heavy gauge plastic and vinyl tarpaulins are often used for this purpose, though they are difficult to secure in place and can be blown off in high winds. Roll roofing, carefully stitched in to areas of the remaining roof, is a somewhat more functional solution that will allow sufficient time to document the existing roof conditions, plan repairs, and order materials (Figure 21).

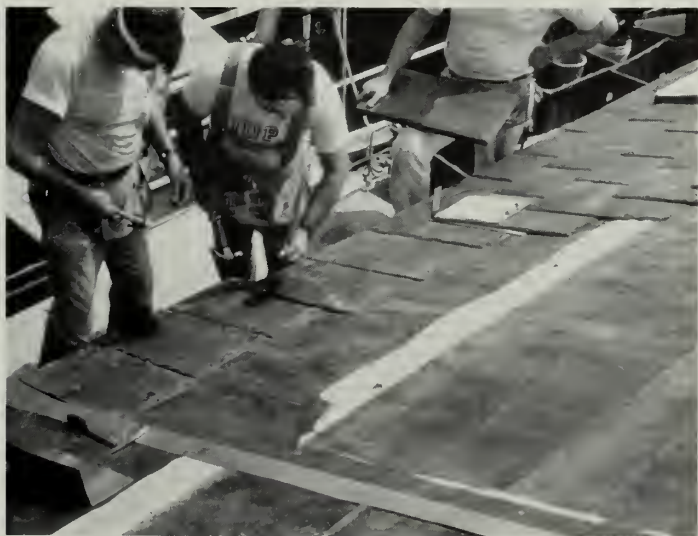
(e) Roofing felt was installed over decking; a rubberized membrane was used selectively at the eaves and under some flashing.

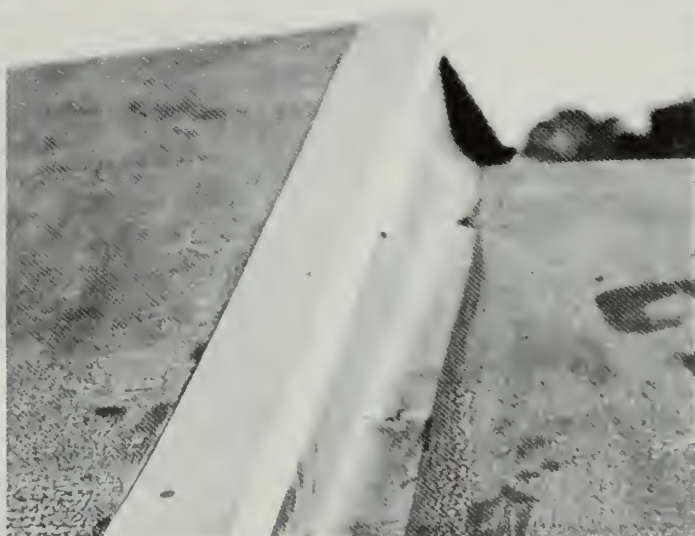
(f) Lead coated copper flashing was installed throughout. Seen is the offset between the portico roof and the main roof in progress.

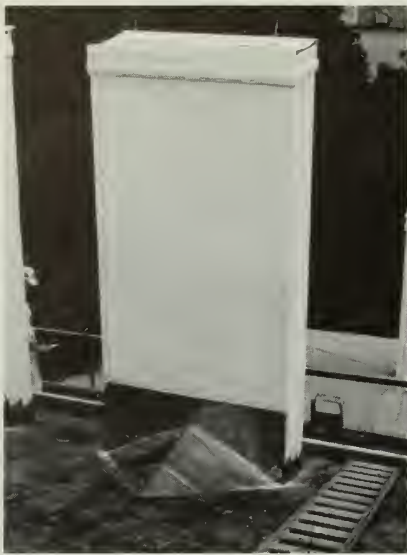
(g) Masonry chimneys were repaired and metal crickets were fabricated at the chimneys.

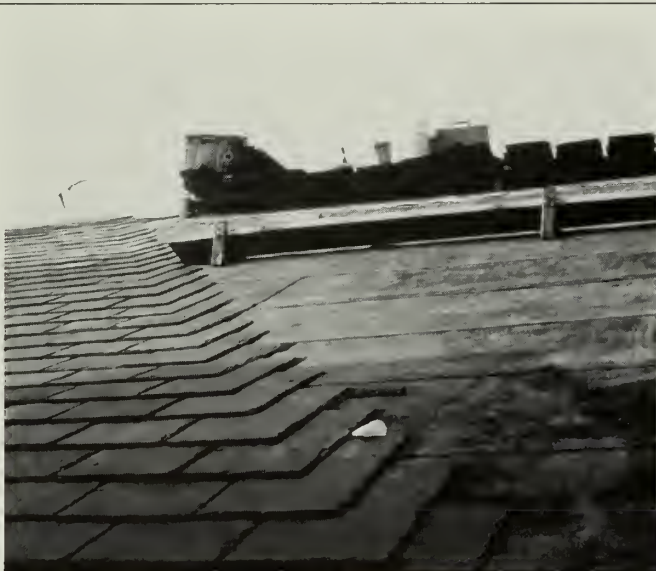
(h) This installation pattern allows the slates to be laid in courses leaving a temporary path of travel to avoid stepping on installed slates.

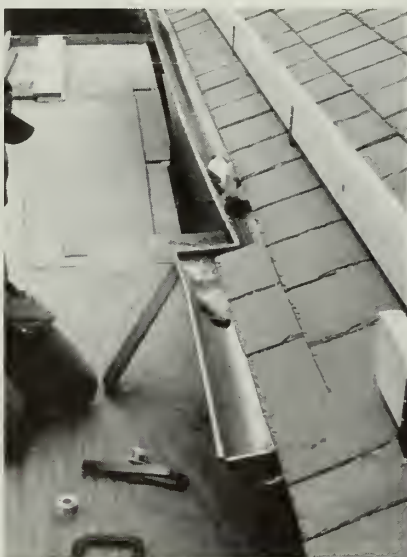
(i) Although the gutters and snow boards were the last elements installed, their support brackets were installed as the slates were laid.

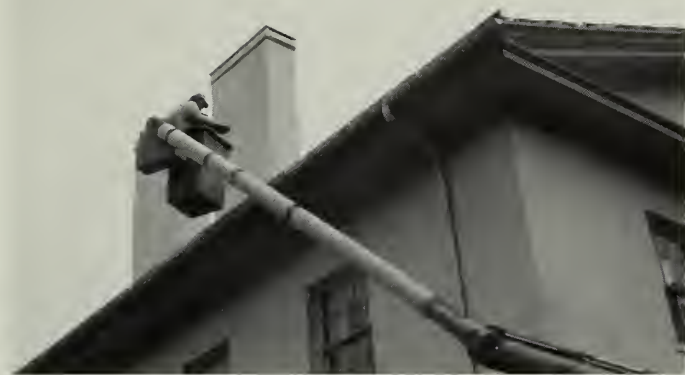
Figure 23. Slate roofs should not be walked on if at all possible. For large projects, lifts can be used to inspect roofs periodically to assess maintenance needs. Photograph courtesy of the National Park Service.

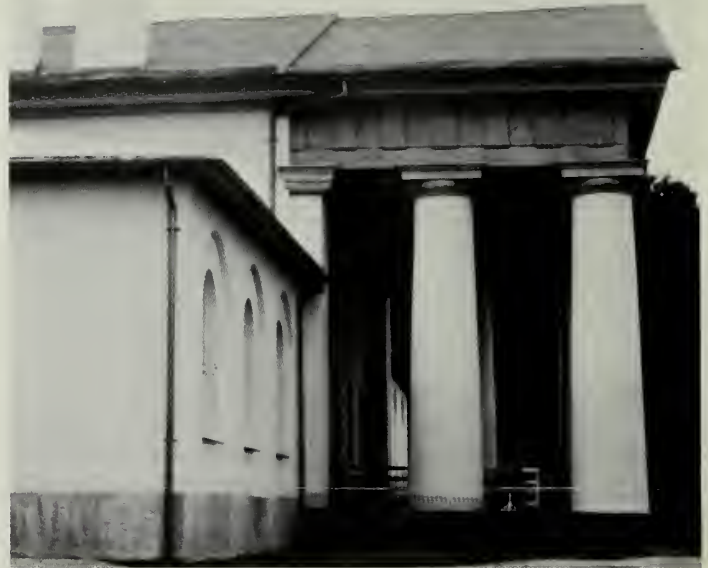
Figure 24. Although slate replacement roofs are expensive, the superiority of materials and craftsmanship will give years of continued service. If amortized over the life of the roof, the replacement cost can be very reasonable. Photograph courtesy of the National Park Service.
