# CULTURAL LANDSCAPE REPORT

### MARTIN VAN BUREN

### NATIONAL HISTORIC SITE

Site History, Existing Conditions, and Analysis

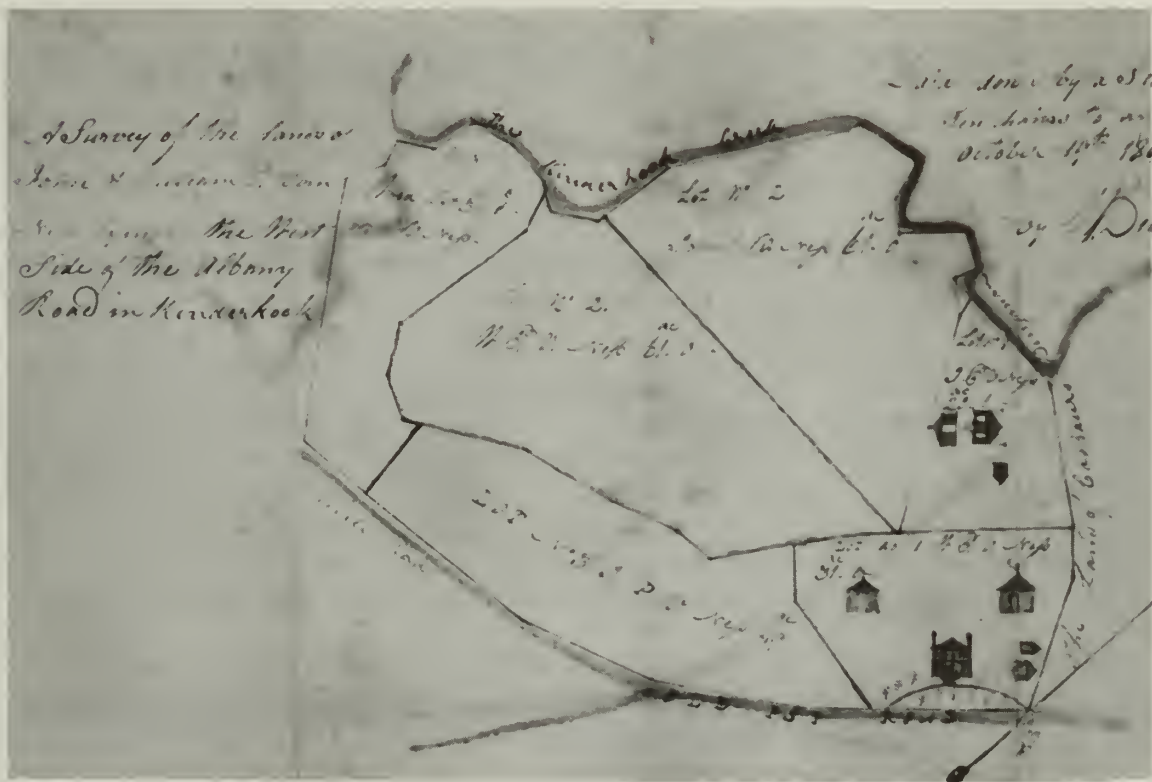
**Figure 1.3:** 1805 Map: Produced as a result of the will of Peter Van Ness in 1805, this demonstrates the division of Kleinrood between John and William Van Ness (Photographic copy on file, MVB NHS).

The Kinderhook Creek was a part of the northwest boundary of the property. This corner of the property was the only portion to abut the Creek during this period. The location of the Creek bed changed many times over the years and may have had a different location than is shown in figure 1.3. The portion of the Creek that formed the northwest boundary of Lindenwald did not change.<sup>57</sup>

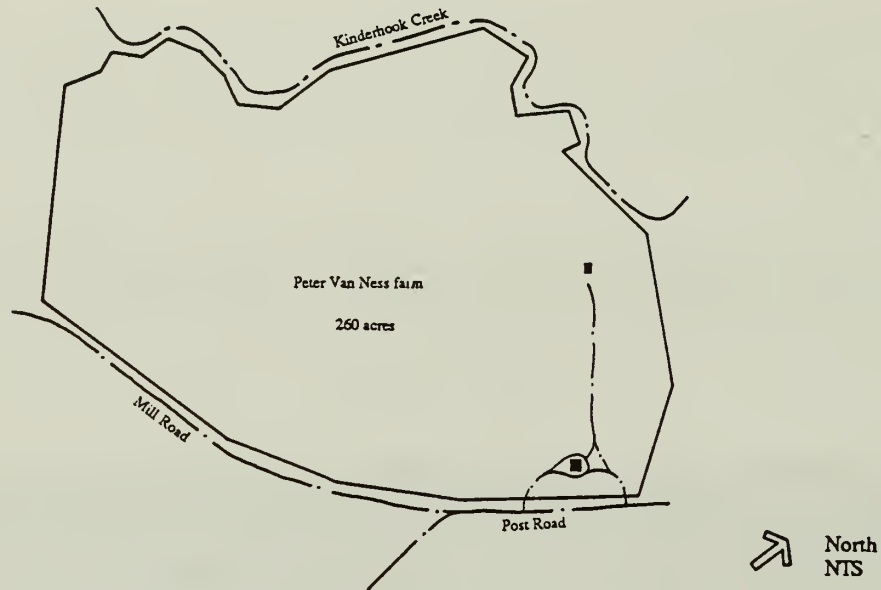
**Figure 1.4: Kleinroad: 1780–1805, Peter Van Ness farm (Uschold, 1993. SUNY CESF).**

The 260-acre property Peter Van Ness purchased consisted of farmland and the Van Alstyne stone house. Peter Van Ness owned other property in addition to this farm, including property on the opposite side of Post Road.<sup>22</sup> Following his purchase of the 260 acres, Peter Van Ness and his family lived in the stone house until 1797 when a new, main house was completed, giving the farm one of the larger and more impressive houses of the Kinderhook area (fig. 1.4).

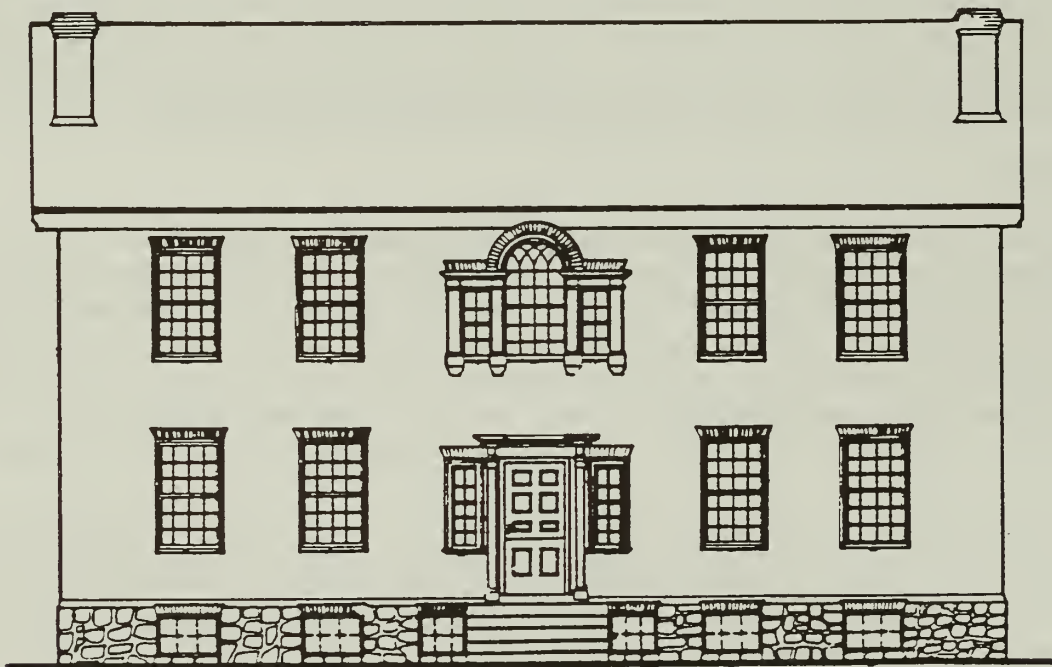
Figure 1.6: 1797 Peter Van Ness house (DSC, National Park Service, n.d.).

Several buildings and structures existed on the property during the Van Ness Period: the stone house, main house, carriage barn, and farm office. Other support buildings and structures existed but cannot be adequately documented.<sup>34</sup> The Van Alstyne had constructed at least two houses on the property: the stone house on the second terrace and another house on the first terrace east of the current house lot.<sup>35</sup> After purchasing the property, Peter Van Ness resided in the Van Alstyne stone house for approximately twenty years; he moved his family into the new house he built in 1797. The new main house was a simple, Late Georgian/Early Federal brick house (fig. 1.6), much larger and more formal in design than the stone house.<sup>36</sup> The new, main house was a rectangular block with two chimneys on each end, four main rooms and a central hall on the first floor, and five rooms around a smaller central hall on the second floor.

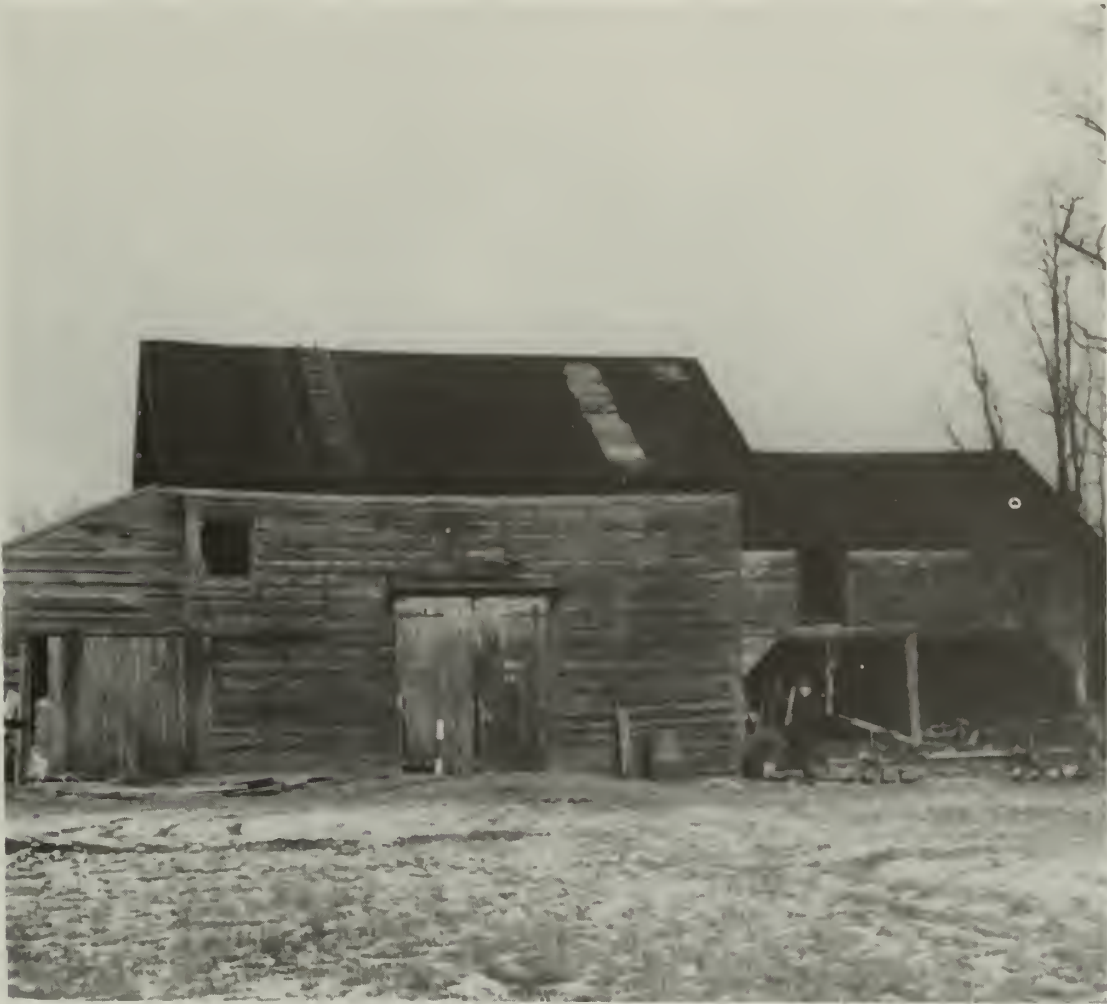
**Figure 1.7:** Carriage barn, 1937 (Photo # CLR-403. On file, MVB NHS).

The carriage barn (fig. 1.7) was located northwest of the house. The size of the carriage barn was approximately thirty feet wide and sixty-five feet long.<sup>37</sup> It was a wood-frame building with clapboard siding and a gable roof.

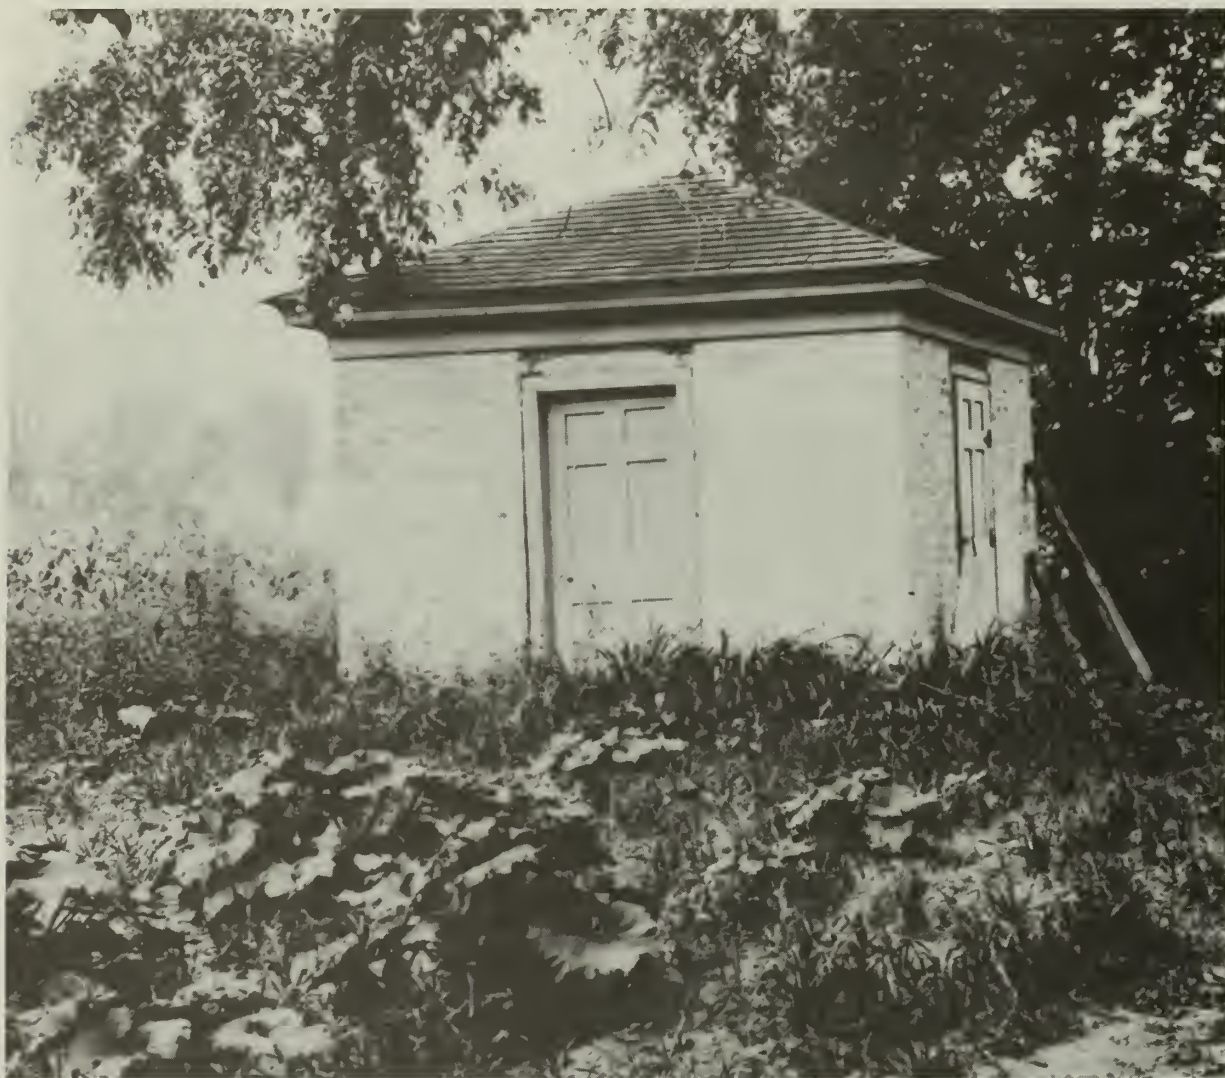
**Figure 1.8:** Farm office, 1936 (Photo # CLR-401. On file, MVB NHS).

The other building existing on the house lot was the farm office, west of the main house. The farm office was a one-story, eleven-foot, square building (fig. 1.8).<sup>38</sup> It was a brick building with a hip roof.

Several buildings and structures were existing on the property when Van Buren purchased it in 1839. The main house, built by Peter Van Ness in 1797, stood at the center of the house lot facing Post Road. Also on the house lot were the carriage barn, northwest of the main house (fig. 1.7), and the farm office, at the northeast corner of the garden (fig. 1.8).<sup>59</sup> The use of the farm office, during this period, is unclear, but during later periods it was used for storage. Its location within the garden suggests it was associated with the garden, but the use is unknown. The condition, or existence, of the stone house cannot be documented after the Van Ness Period. Ruins of the building remained into the deProsse Period (1917–1973), but whether the stone house was intact or in ruins during the Van Buren Period is unknown.<sup>60</sup> The stone house may have been occupied by Van Buren's farm foreman during the first few years of his tenure on the property.

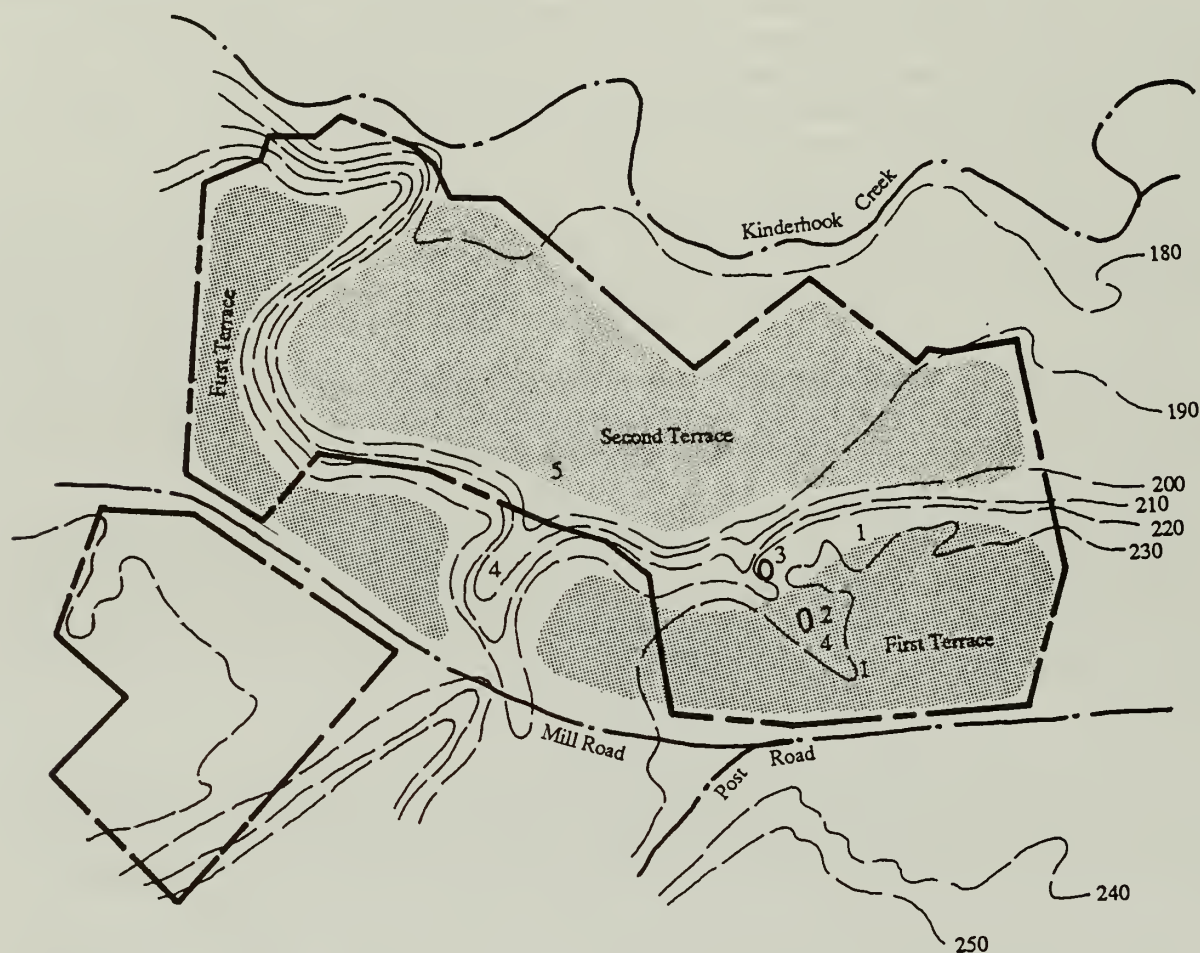
TOPOGRAPHY & HYDROLOGY KEY:

1. Spring
2. Upper Pond
3. Lower Pond
4. Ravine
5. Wetland

The ravine and water flow that fed the wetland on the second terrace remained. In August of 1847 Van Buren drained the wetland by creating ditches. Van Buren stated ". . . a thousand miles of Ditches, . . ." implying the task was quite large.<sup>58</sup> The ditches may have drained into Kinderhook Creek. A spring existed on the south end of the house lot which Van Buren used to feed the two artificial ponds he created on the edge of the house lot. Figure 2.3 illustrates the topography and hydrology for the Van Buren Period.

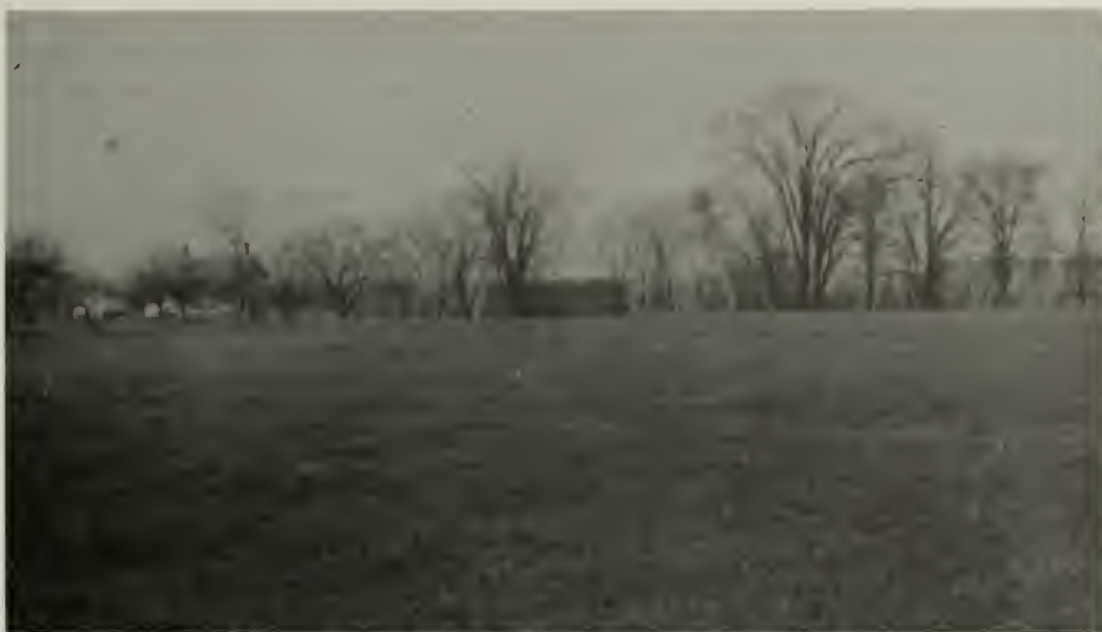
**Figure 2.6:** Farm cottage and red hillside barn, c.1900 (Photo # CLR-002. On file, MVB NHS).

After Van Buren took residence in 1841, he constructed additional buildings on the property. These included a cottage, for his farm foreman, and two large barns. The construction of the cottage and one of the barns was complete by the summer of 1844. Van Buren wrote: ". . . built me what I call a beautiful cottage (for my foreman) on the brow of the hill and a large hay barn in the meadows. . . ." <sup>64</sup> The farm cottage was a small, two-story house reflecting the Federal style. It was built behind the main house, on the edge of the first terrace (fig. 2.6). The barn, referred to as the "black hay barn," was constructed on the second terrace at the bank of the Kinderhook Creek (fig. 2.7). The "red hillside barn" constructed in 1849, was built into the side of the slope between the first and second terraces just behind the farm cottage (fig. 2.6). <sup>65</sup>

hillside barn near the farm cottage. The roof of the barn also was within this view (fig. 2.6). This suggests the view was not as valued by Van Buren as it was by Mr. Gilpin. The addition of these structures were in the immediate view across the farm to the creek but did not obstruct the view to the Catskill Mountains. Van Buren may have considered these elements to be modest intrusions of the immediate view.

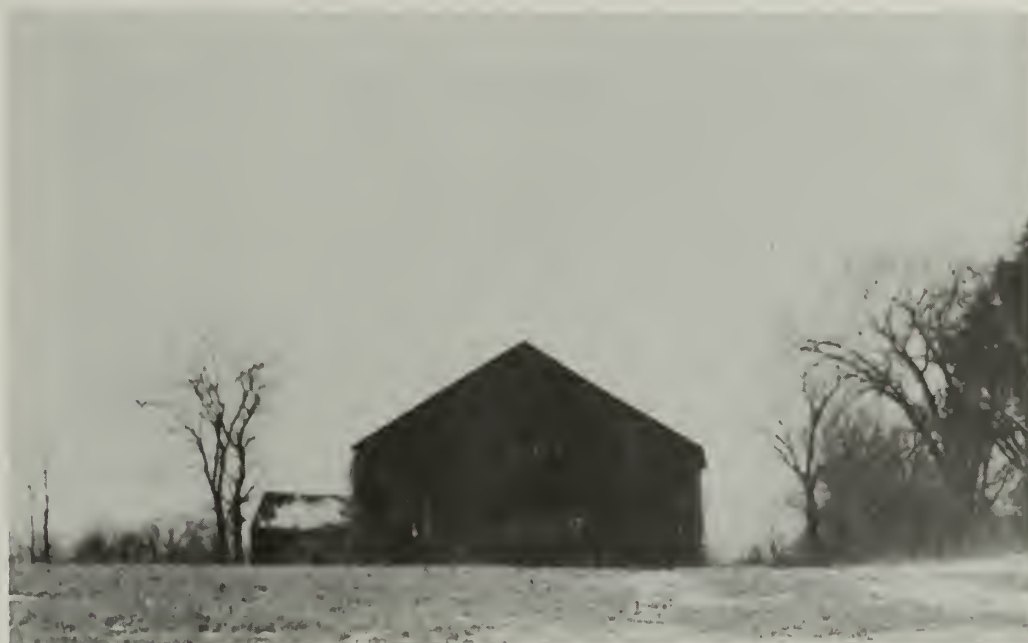
**Figure 2.7:** Black hay barn, c.1940 (Photo # CLR-471. On file, MVB NHS).

Within the house lot on the first terrace, a smaller space was created surrounding the grave of Peter Van Ness, after his death in 1804. The grave stood amidst ". . . a clump of trees within a small enclosure. . . ." behind the main house. The clump of trees referred to may have been the pines seen on the right side of figure 2.7.<sup>46</sup>

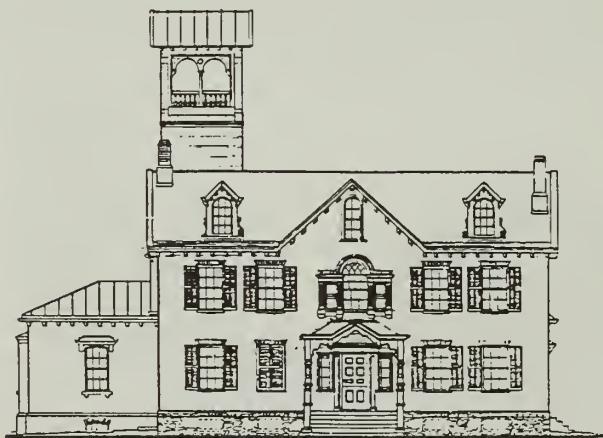
Figure 2.9: Lindenwald main house, post-1850 (DSC, National Park Service, n.d.).

In 1849, the final two years of major improvements began on the property. These last improvements were to accommodate Smith Thompson and his family as they moved onto Lindenwald. The alterations, designed and supervised by well-known architect Richard Upjohn, began that year and were completed in 1850. The purpose of the alterations was to enlarge the main house, but much more was done. The simple rectangular Van Ness house was increased greatly in size by a large addition along the rear, a south and a west wing, and a four story tower. To accommodate these changes, the stable wings were removed. Along with this tremendous increase in size, the exterior of the main house was transformed from the original Late Georgian/Early Federal style to Italianate. Ornamentation was added to the exterior including a small, finely detailed porch at the front entrance, a large gable and dormers on the front facade, and ornamentation on the overhangs of the roof. The simple Van Ness farm house was transformed into a large and elaborate mansion (fig. 2.8 and 2.9).

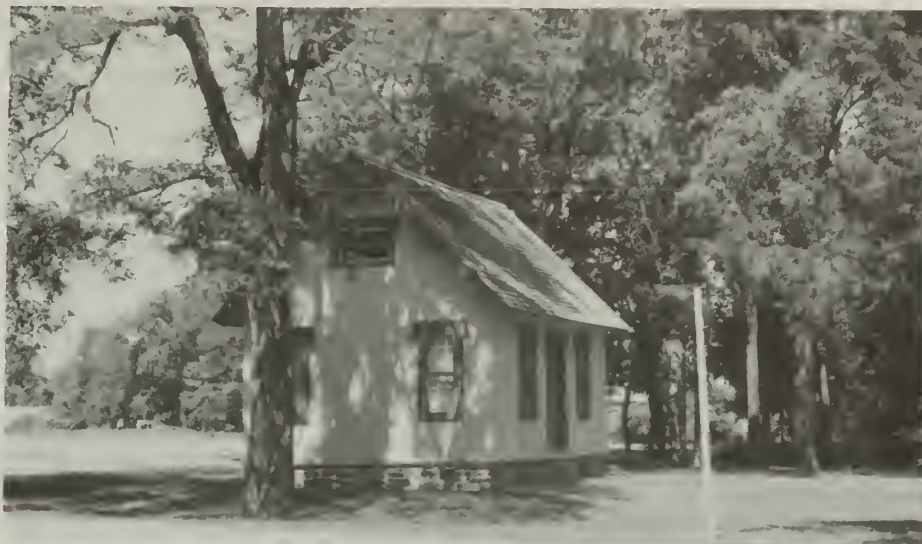
**Figure 2.10:** South gate house, 1993 (Photo # CLR- 1510. Uschold, SUNY CESF).

In addition to the alterations on the main house, two gate houses were constructed as part of the Upjohn plan, one at each entrance to the drive. The two buildings were sixteen feet by twenty-three feet and were mirror images of one another, except for the dormer in the south side of the north gate house. They were small, one and one-half story board and batten buildings with a wood-shingle, gable roof, field stone foundation, and full basement (fig. 2.10 and 2.11).<sup>66</sup>

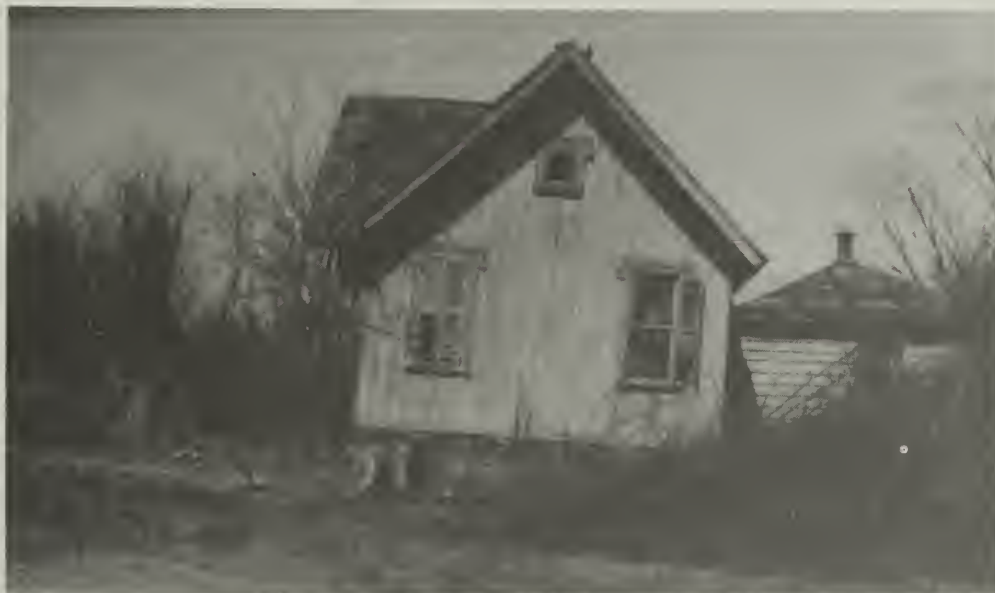
**Figure 2.11:** North gate house, c.1945 (Photo # CLR-426. On file, MVB NHS).

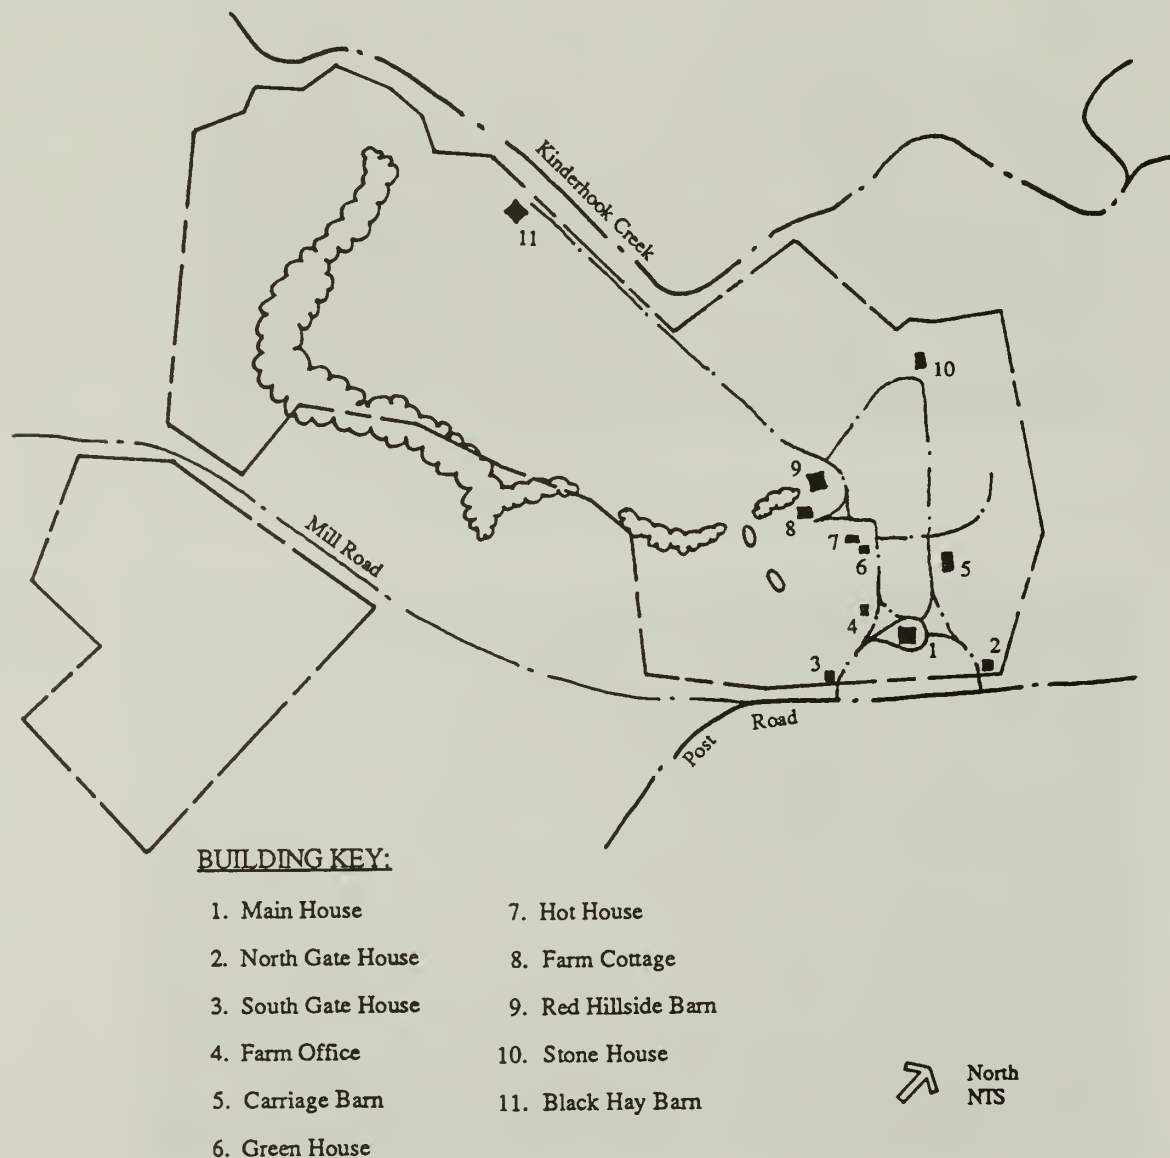
**Figure 2.12:** Buildings and Structures: Van Buren Period (Uschold, 1993. SUNY CESF).

The buildings and structures of Lindenwald during the Van Buren Period were in a constant state of change. From the modest beginnings of the Van Ness farm, Lindenwald experienced an eleven-year time span characterized by construction and renovation, ending in 1850. At the completion of these improvements, the property had been transformed from a simple country home into a substantial and successful working farm. The buildings and structures on the property at this time remained throughout the period. They included the main house, north gate house, south gate house, farm cottage, carriage barn, farm office, hothouse, greenhouse, red hillside barn, black hay barn, and stone house. Figure 2.12 illustrates the buildings and structures for the Van Buren Period.

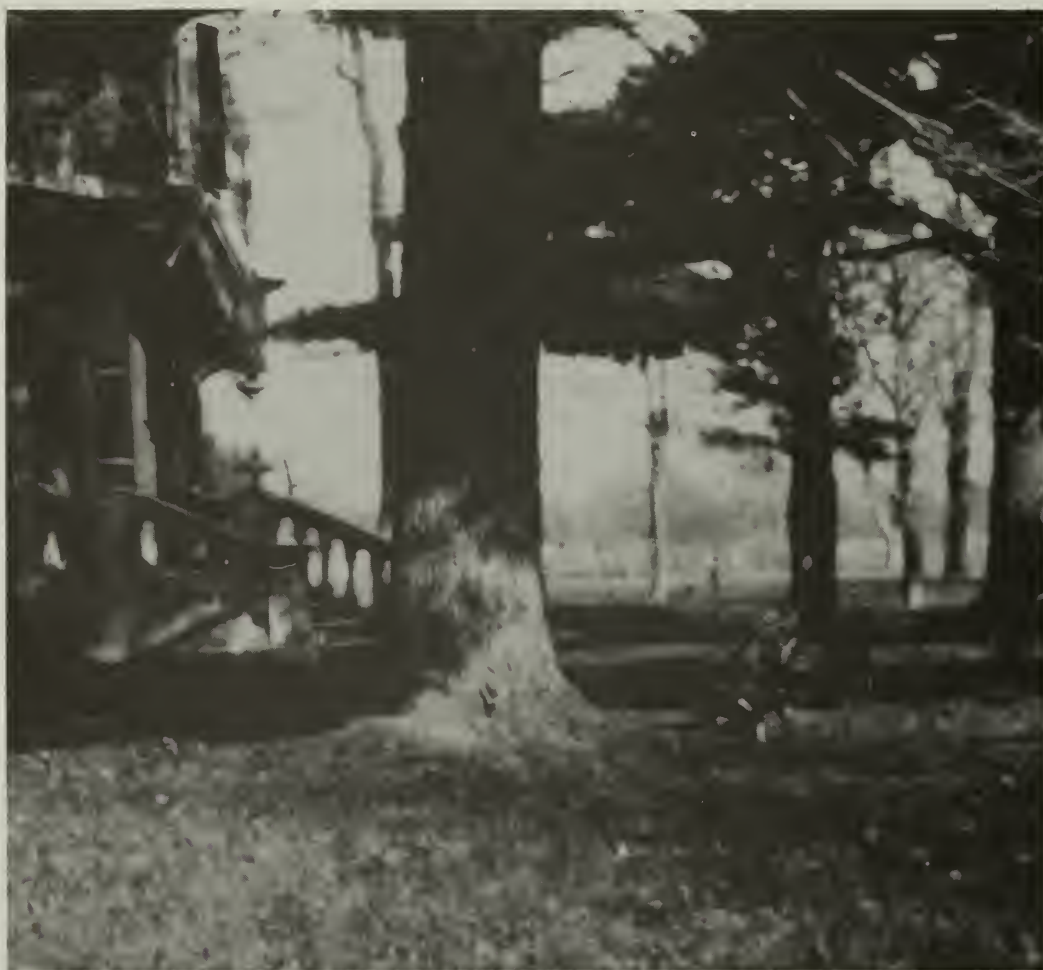
**Figure 2.13:** Pear orchard north of main house, front portion of north orchard, c.1900 (Photo # CLR-311.5. On file, MVB NHS).

Orchards were an important element of Van Buren's farm. In addition to fruit trees in the garden, the farm had a south orchard, a north orchard, and a nursery. Orchard trees consisted of apples, pears, peaches, plums, and cherries.<sup>81</sup> The north orchard was actually two separate orchards, having apple trees in the rear and pear trees in the front (fig. 2.13). The south orchard was apples (fig. 2.6).<sup>82</sup> Although specific information regarding the nursery was not found, it may have been within the garden or south orchard. In 1848 Van Buren states ". . . I say nothing of my garden & nursery & orchards, but what would you say to 15500 young apple trees & 2000 young pear trees for sale!"<sup>83</sup> The reference to such a large number of trees, and the fact they were for sale, may be a description of the nursery.

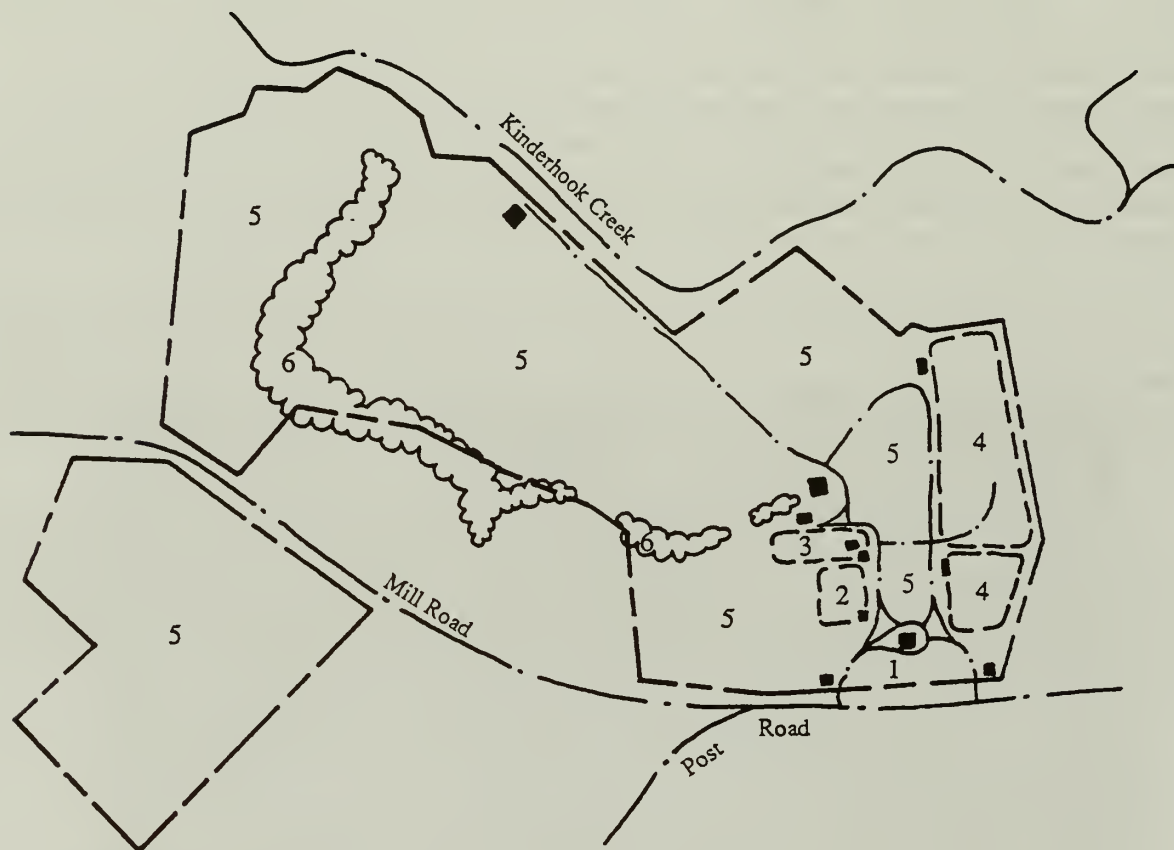
VEGETATION KEY:

1. Front Lawn
2. Garden
3. South Orchard
4. North Orchard
5. Agricultural Field
6. Woodland

The appearance that only a few crops were being grown in 1841, or even 1843, could be due to Van Buren not yet having acquired all of the property to complete his farm. The 1841 and 1848 lists in no way illustrate a complete inventory of what was being grown at that time; it was clearly just a mention of some of the crops. On the other hand, the inventory of crops recorded in 1850 seems reasonable evidence of Van Buren's intention to create a prosperous and self-sufficient farm. Figure 2.14 illustrates the general pattern of the vegetation for the Van Buren Period.

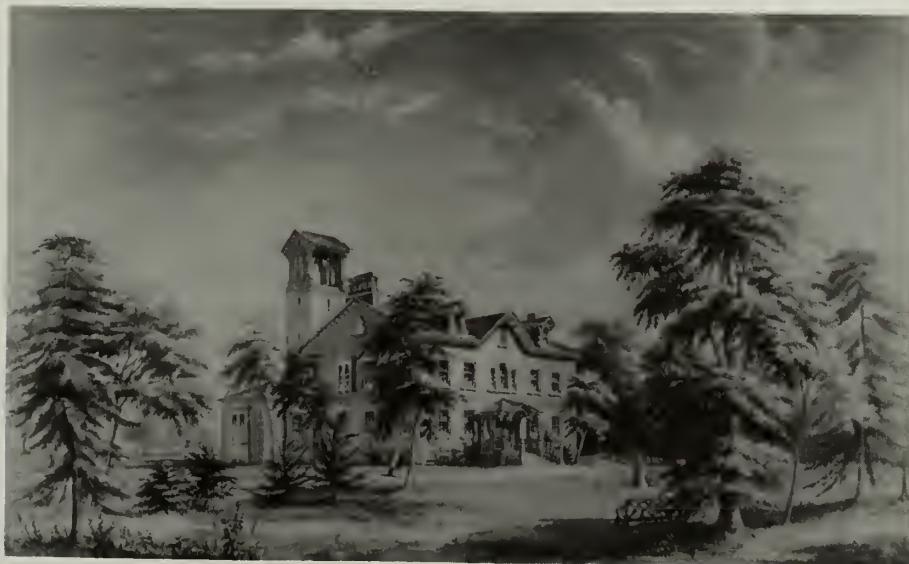
**Figure 2.16:** c.1849 Upjohn Rendering of Main house (Photo # CLR-202, photographic copy of original painting. On file, MVB NHS).

The circa 1843 sketch of the main house (fig. 2.15), prior to renovation, and the circa 1849 Upjohn rendering (fig. 2.16), post renovation, are not entirely reliable references regarding the landscape. In the past these illustrations have been thought to be valuable sources documenting the vegetation of the property for the Van Buren tenure. Due to the questionable reliability of these two sources, their use in this report has been limited.<sup>87</sup>

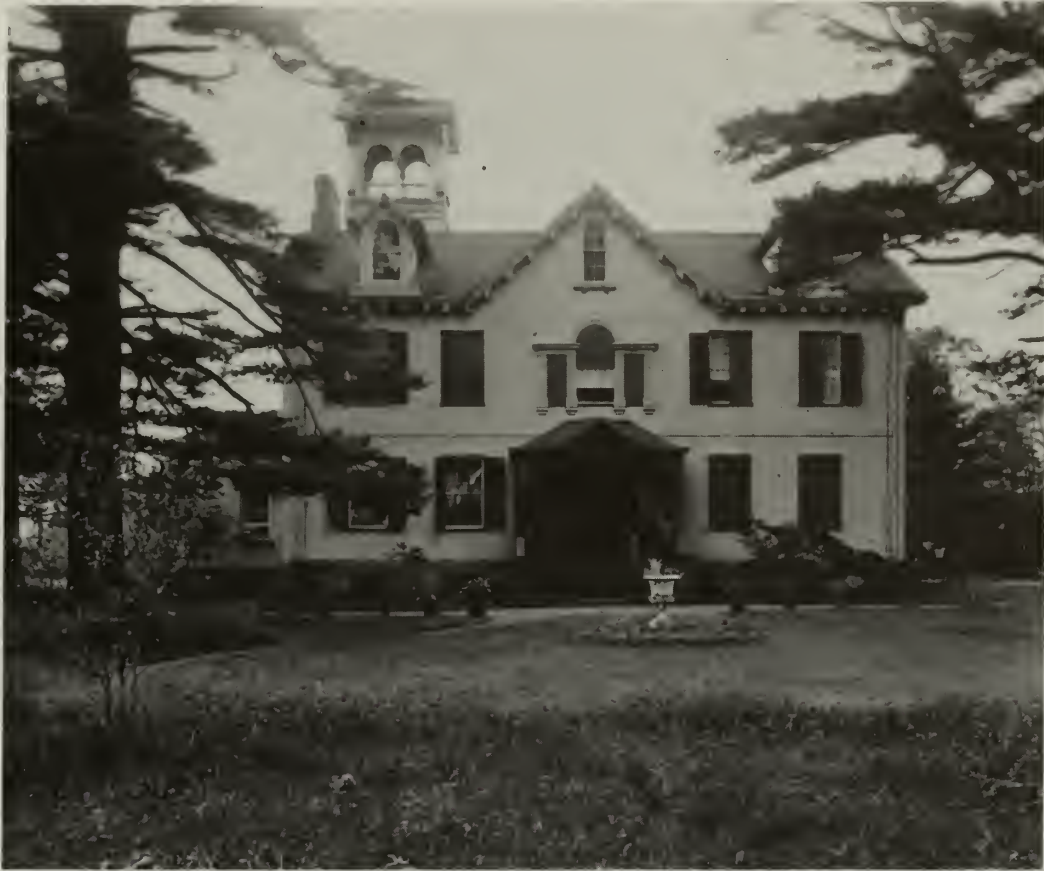
**Figure 2.17:** Front garden at entrance to main house, c.1913 (Photo # CLR-302. On file, MVB NHS).

Along the outside edge of the small space at the entrance to the main house, a circular pedestrian path existed. This path was approximately two foot wide and extended around the outside edge of the lawn within the space (fig. 2.17).

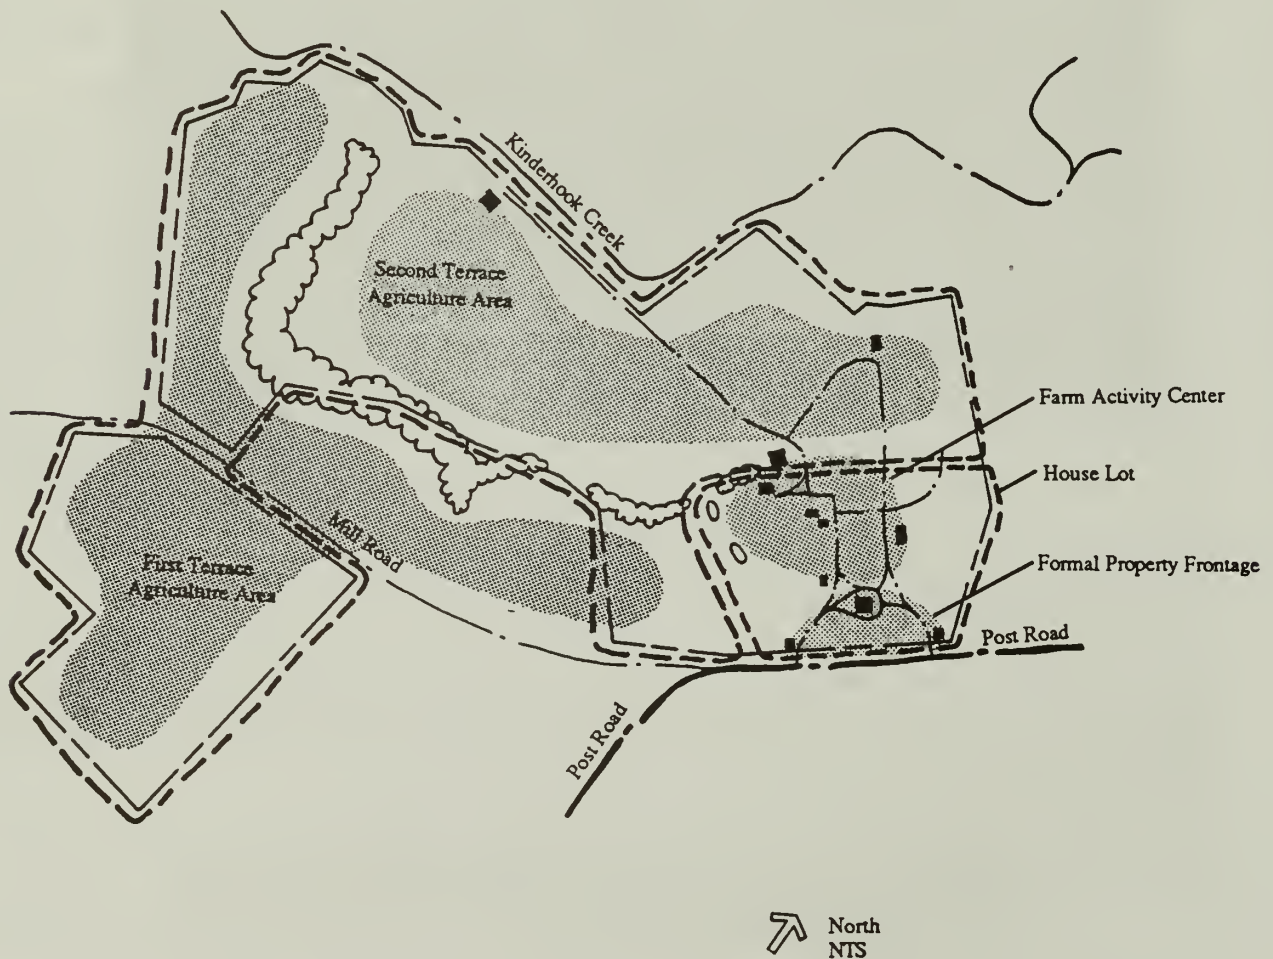
Figure 2.18: Spatial Organization: Van Buren Period (Uschold, 1993. SUNY CESF).

From Post Road, the view of the main house was partially screened by the grove of pines. The grove was located along the road, directly in front of the main house. The view from the main house to the road is undocumented. Figure 2.18 illustrates the spatial organization of the Van Buren Period.

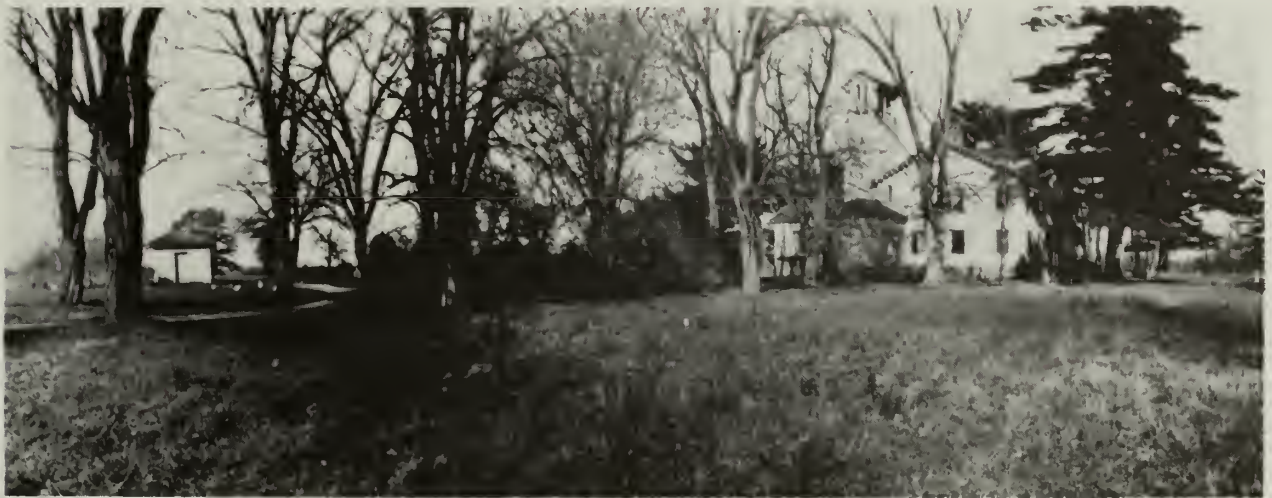
**Figure 2.19:** South entrance drive and road to farm cottage, c.1913 (Photo # CLR-301. On file, MVB NHS).

No documentation was found regarding the construction materials of the roads and paths. Photographs from later years suggest they were compacted soil.<sup>91</sup> In addition to these roads, there may have been other access paths to reach the fields, but they are undocumented at this time. Figure 2.20 illustrates the circulation for the Van Buren Period.

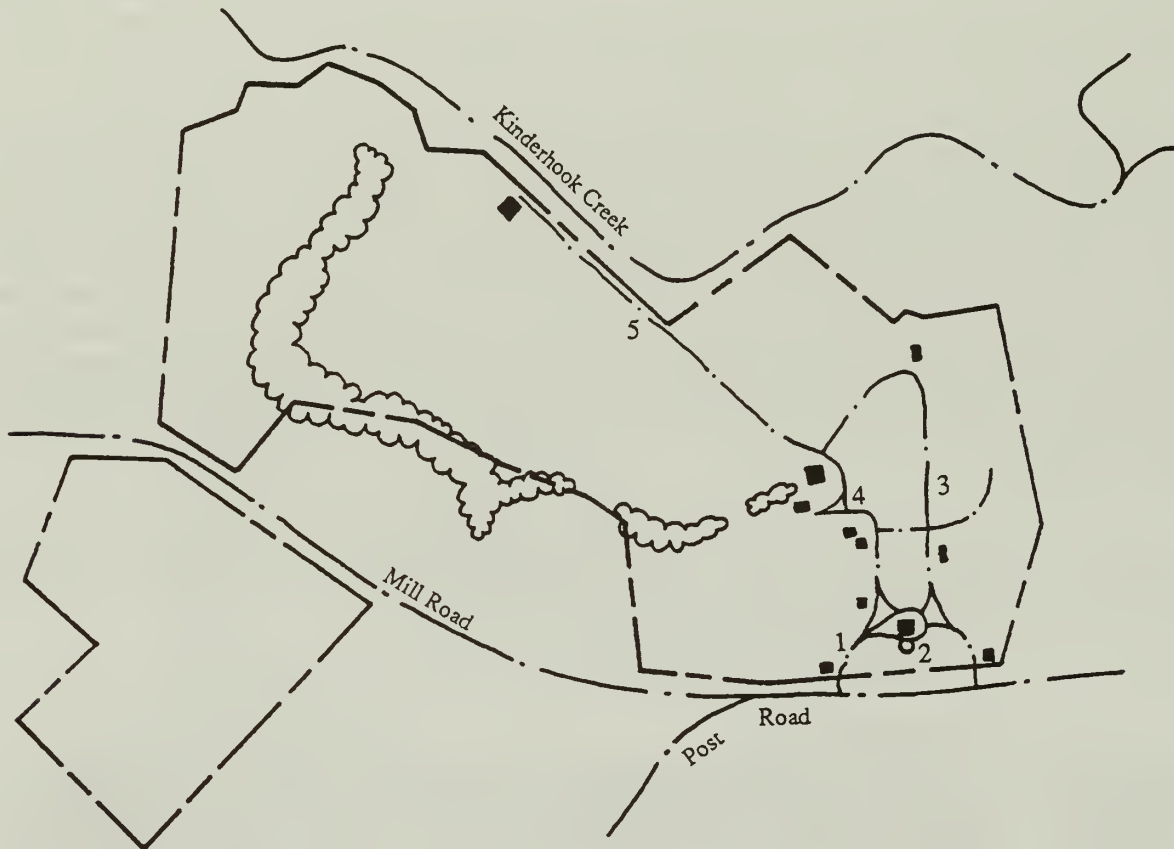
CIRCULATION KEY:

1. Entry Drive
2. Front Garden Path
3. Road to Carriage Barn and Stone House
4. Road to Farm Cottage and Red Hillside Barn
5. Road to Black Hay Barn

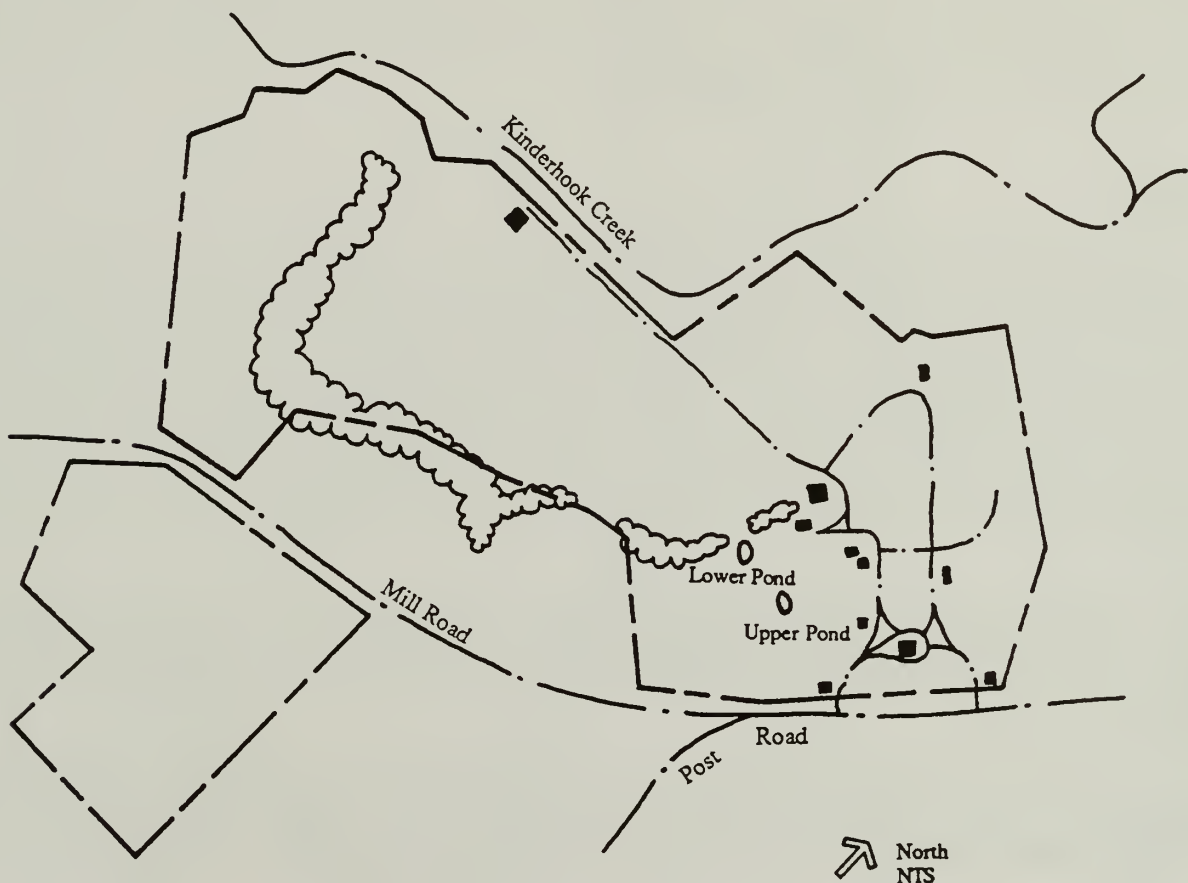
Figure 2.21: Water Features: Van Buren Period (Uschold, 1993. SUNY CESF).

The Van Buren Period is the only time in the history of the property during which any designed water features were constructed within the core. In 1840, Van Buren hired a contractor to, among other things, create fish ponds from the spring by the garden.<sup>92</sup> Two fish ponds were created by damming the ravine leading from the natural spring located on the south end of the house lot. The upper pond was held by a stone dam at its west end. Van Buren later stocked these ponds with several kinds of fish including trout, pickerel, and perch. The first, or upper, pond was along the southwest border of the garden (fig. 2.4). An 1845 news article in the *Albany Cultivator* states: "... two artificial ponds located in the garden. ..."<sup>93</sup> While the exact location of the upper pond is documented, the exact location of the lower pond is less clear; it was located somewhere southeast of the farm cottage on the edge of the first terrace slope.<sup>94</sup> The exact origin of the spring that fed the ponds also is unclear. Figure 2.21 illustrates the water features for the Van Buren Period.

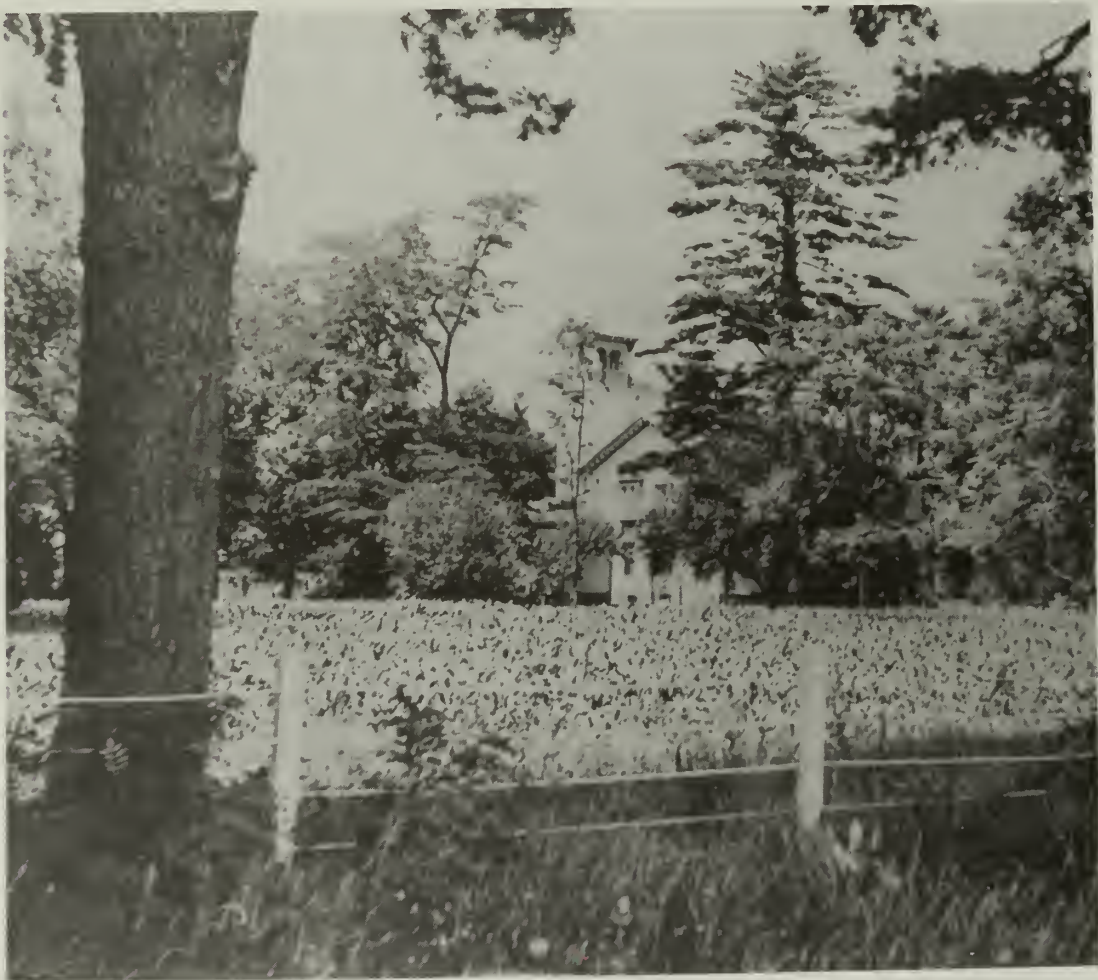
**Figure 3.1:** Agriculture use (corn field) of front lawn, c.1905 (Photo # CLR-303. On file, MVB NHS).

The Wagoners were known as thrifty and successful farmers in the Kinderhook area.<sup>100</sup> Together, the two brothers operated the property as working farm. In addition to their reputation as prosperous farmers, a circa 1905 photograph (fig. 3.1) illustrates crops growing on the south portion of the front lawn, suggesting very intense farming for the property. Period photographs indicate the farm was well-maintained during the Wagoner occupancy. The main house appears to have been in excellent condition and the lawn area directly in front of the main house finely manicured (fig. 3.2).
