# CULTURAL LANDSCAPE REPORT

### MARTIN VAN BUREN

### NATIONAL HISTORIC SITE

Site History, Existing Conditions, and Analysis

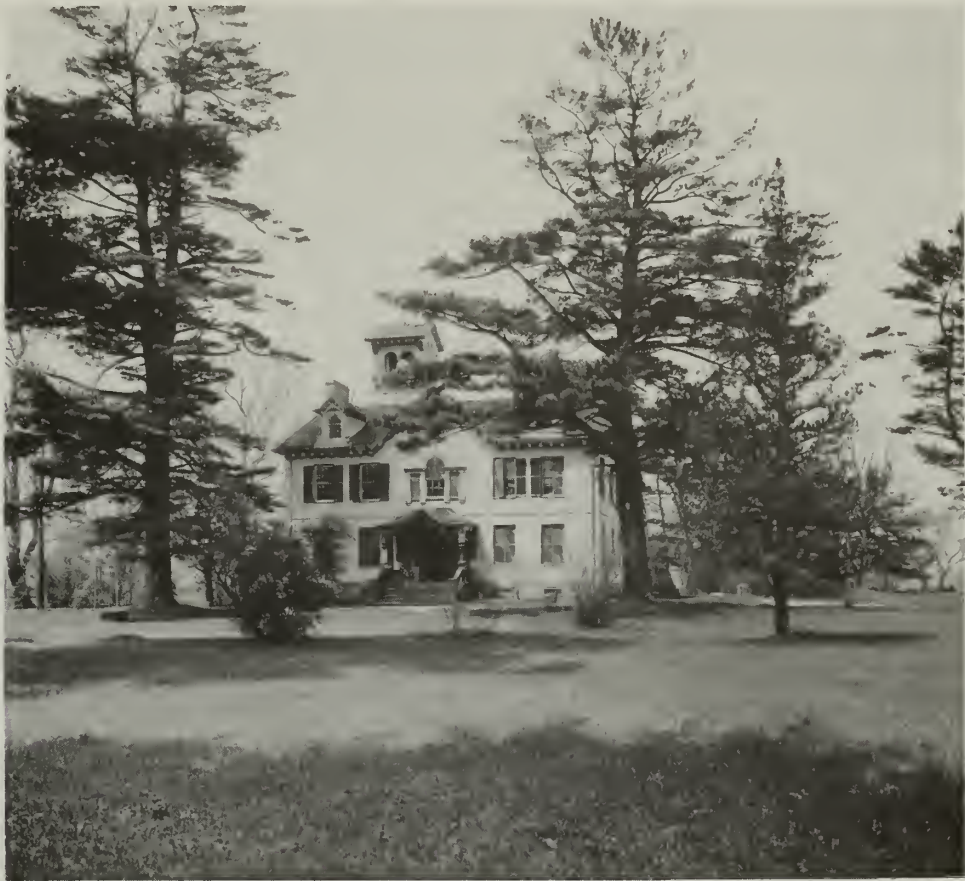
Figure 3.2: Front lawn and main house, c.1913 (Photo # CLR-304. On file, MVB NHS).

The Wagoners were known as thrifty and successful farmers in the Kinderhook area.<sup>100</sup> Together, the two brothers operated the property as working farm. In addition to their reputation as prosperous farmers, a circa 1905 photograph (fig. 3.1) illustrates crops growing on the south portion of the front lawn, suggesting very intense farming for the property. Period photographs indicate the farm was well-maintained during the Wagoner occupancy. The main house appears to have been in excellent condition and the lawn area directly in front of the main house finely manicured (fig. 3.2).

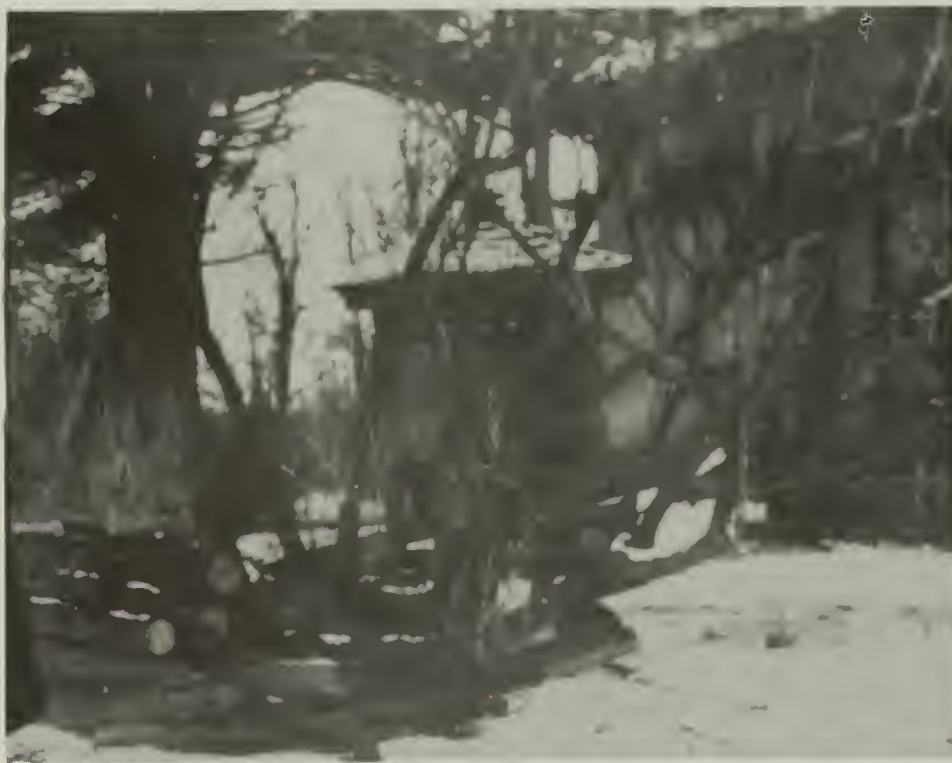
**Figure 3.3:** Well house, c.1920 (Photo # CLR-423. On file, MVB NHS).

Located behind the main house, the well house, wood shed, and Wagoner garage are first documented during this period. The well house was located behind the main house, over top of the well that served it. It was a small wood frame construction approximately five feet square. It had a shingled hip roof that allowed for a ceiling approximately six feet high. The sides were somewhat enclosed, possibly with a type of lattice. A circa 1920 photograph (fig. 3.3) shows the well house in its Wagoner Period location over the well. It remains undocumented whether this structure existed before the Wagoner Period or if it was constructed during this time.

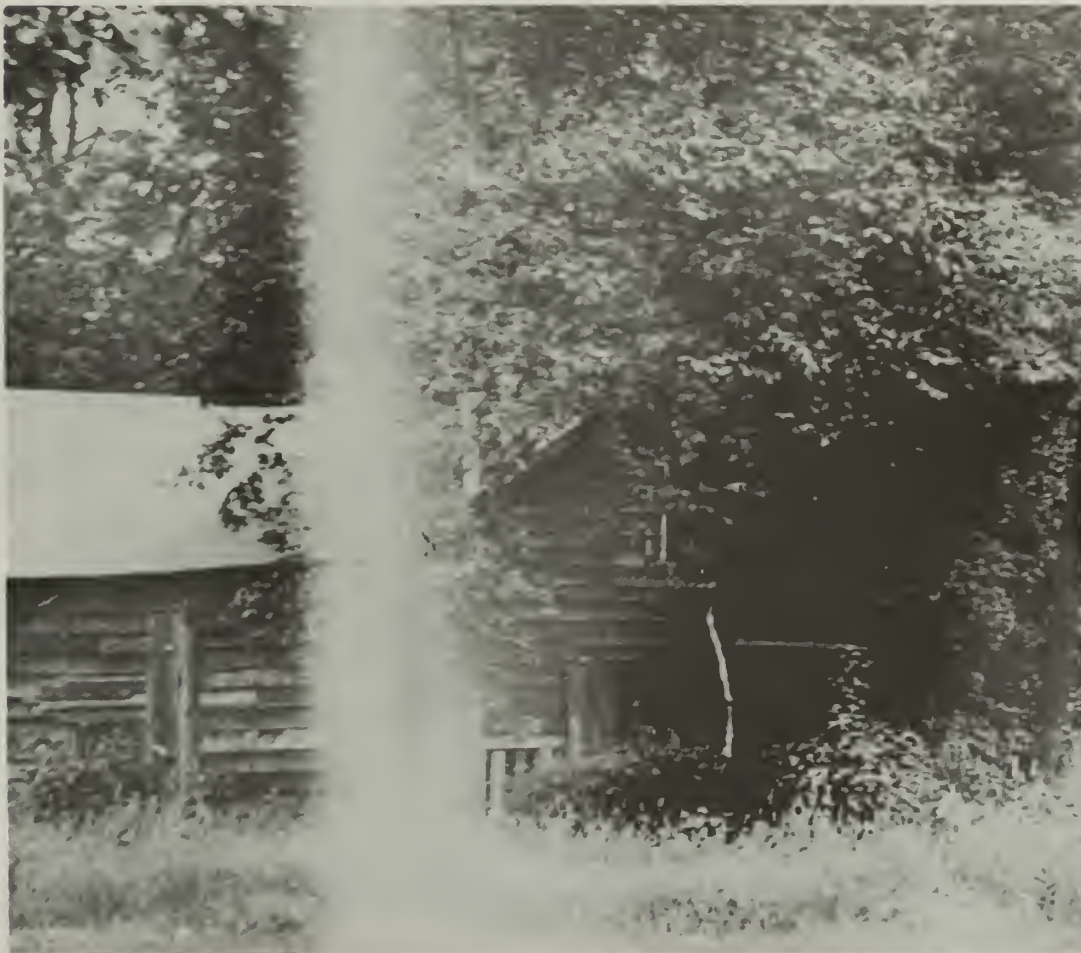
Figure 3.4: Wood shed, c.1900 (Photo # CLR-004. On file, MVB NHS).

Two buildings were also located behind the main house across the drive: a wood shed and garage. Like the well house, these buildings are first documented by their appearance in several photographs from the Wagoner Period. The wood shed, as it was known later, was a one and one-half story wood frame building approximately thirty-five feet by twenty-five feet (fig. 3.4 and 3.5). The origin of the wood shed is unclear. It may have existed from the Van Buren Period, or even the Van Ness. Its description as a wood shed originates from the following period, therefore, its use during the Wagoner Period is unknown. Its appearance and poor condition in the photographs suggest it was standing for a long time before the photos were taken. Its sturdy construction and lack of foundation suggest that it may have been moved. Archeological survey of the area suggests that it may have been rotated ninety degrees. The only documented use and detailed description does not appear until the deProsse Period.<sup>101</sup>

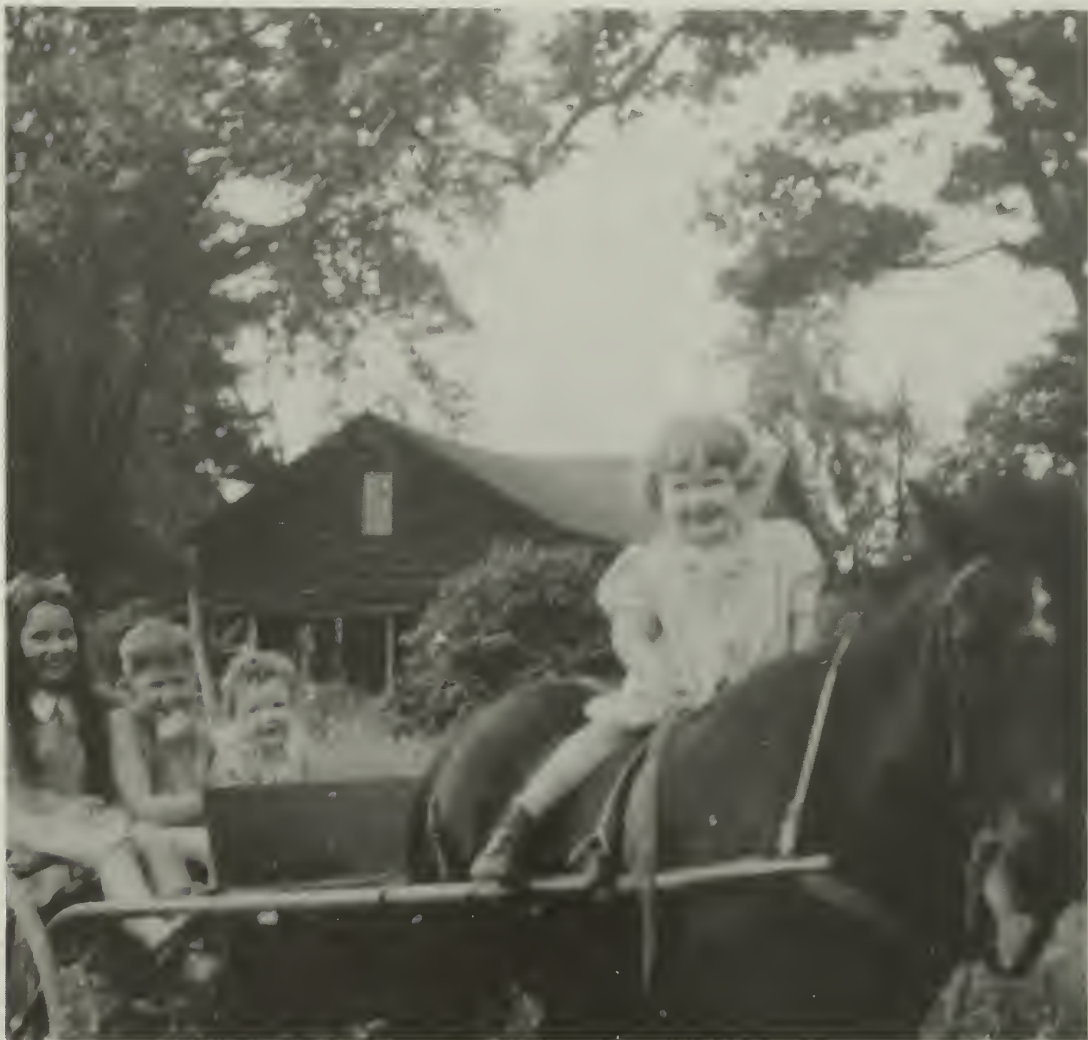
**Figure 3.5:** Wood shed, c.1940 (Photo # CLR-416. On file, MVB NHS).

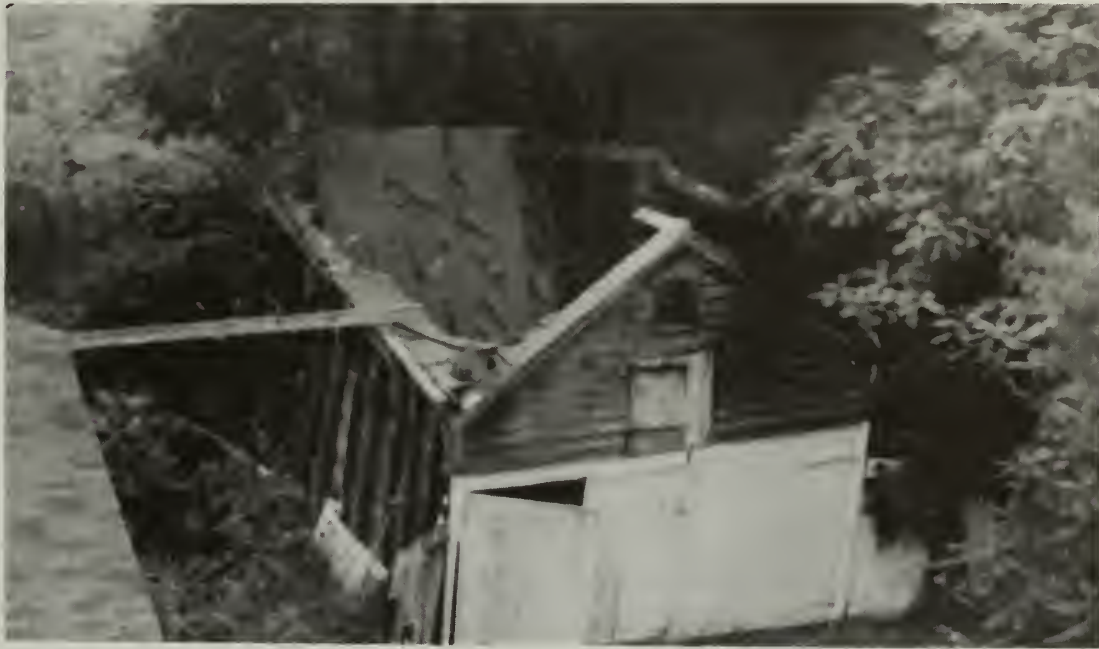
Adjacent to this building, to the northeast, was the garage. This garage, referred to as the Wagoner garage, was also a wood-frame, one and one half story building approximately forty feet by forty feet and is believed to have been constructed by the Wagoners (fig. 3.6).<sup>102</sup>

**Figure 3.6:** Wagoner garage, 1969 (Photo # CLR-429. On file, MVB NHS).

The small complex of buildings directly behind the main house consisted of the wood shed, Wagoner garage, two privies, and a few small structures (fig. 4.10). The wood shed (fig. 4.11) and Wagoner garage (fig. 3.6) were connected to each other by a tool shed and pig pen. On the opposite end of the garage, another shed, similar to the tool shed, was used to store left over slate for the roof of the main house. It was called the slate shed and had been previously used as an ice house during the early part of the period. Behind the wood shed was a three hole privy. Another two hole privy was located in front of the wood shed (see Appendix F). During the beginning of the Campbell ownership, the wood shed, two privies, and pig pen were removed. The Wagoner garage, tool shed and slate shed attached to it were the only part of this complex left standing. These removals were made by Campbell to construct a new garage behind the main house (fig. 4.12). The Campbell garage was a one-story, cinder block building with an asphalt shingled, gable roof. It had four bays for cars and was twenty-five feet by fifty feet.<sup>123</sup>

The Campbell garage was renovated for use as the maintenance shop for the Park in 1978. Three bays are used for work and storage space and the fourth is office space. This garage also has been painted yellow (fig. 5.10). The Wagoner garage collapsed in 1974 and the debris was removed from the property (fig. 5.11). Campbell's antique shop was removed from the property in 1981 due to its visually intrusive character and location (fig. 4.15).<sup>138</sup>

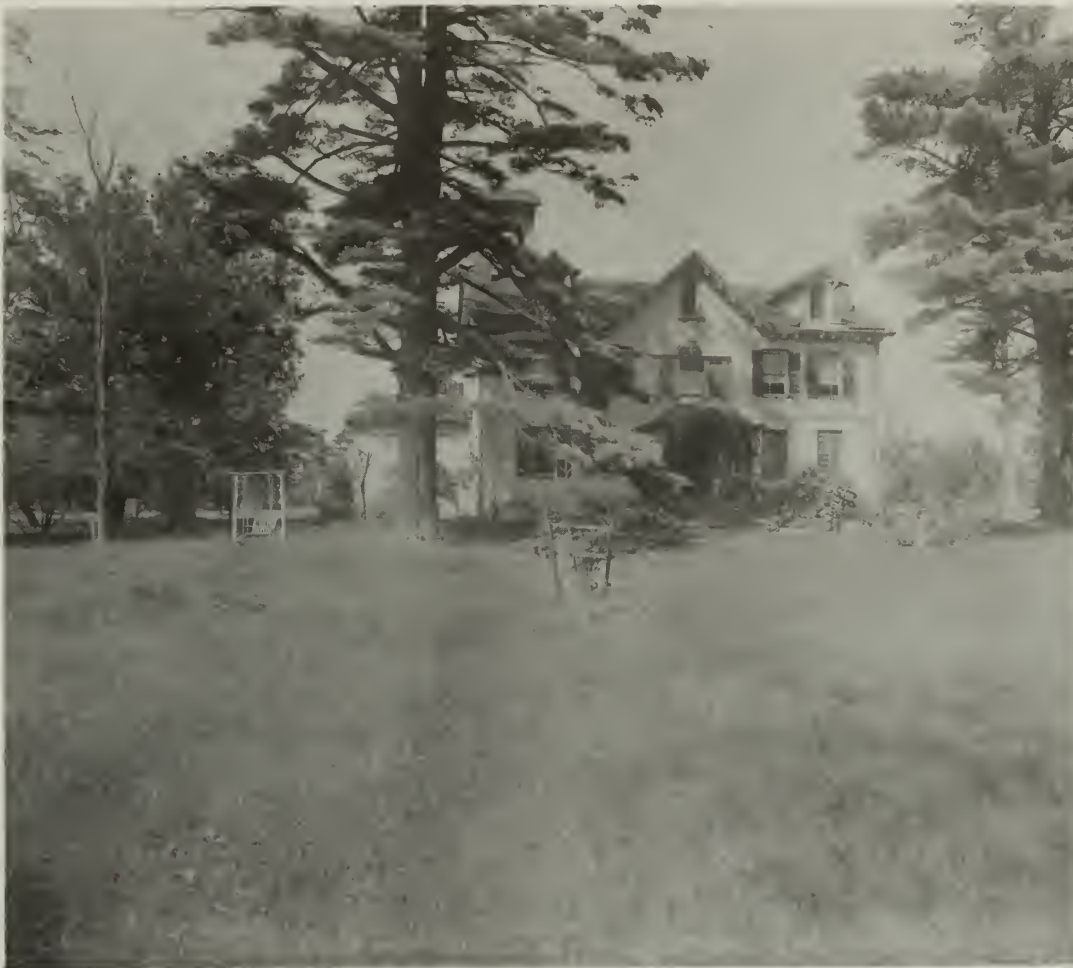
This period provides detailed documentation of the circular garden space located at the front entrance to the main house. This small space was defined by a hierarchy of circular plantings of trees and shrubs and the circular walk around its edge. The entrance to the garden was adjacent to the drive, across from the front entry to the main house. The circular path within the space separated the outside planting bed from the inside manicured lawn. Three Eastern White Pines formed the outer most edge of the planting bed, enclosing the space: one on either side of the entrance to the space and one at the far end directly opposite its entry. Within the space created by the pines was a circular arrangement of shrubs. There were five or six shrubs of different species spaced along the edge of the path. The number of shrubs varied with time. The planting bed containing the pines and shrubs had a higher growth of grass or wild flowers in it, eight to ten inches in height. The area within the circular path had very finely manicured grass, one to two inches in height. At the center of the space was an urn and a small circular planting bed approximately eight feet in diameter. Roses were planted in the urn and within the planting bed. Approximately eight plants surrounded the urn and one was planted in it. Outside of this garden space, the lawn continued to be maintained at a higher level, six to eight inches (fig. 3.7).<sup>103</sup>

**Figure 3.7:** Front garden and front lawn, c.1913 (Photo # CLR-006. On file, MVB NHS).

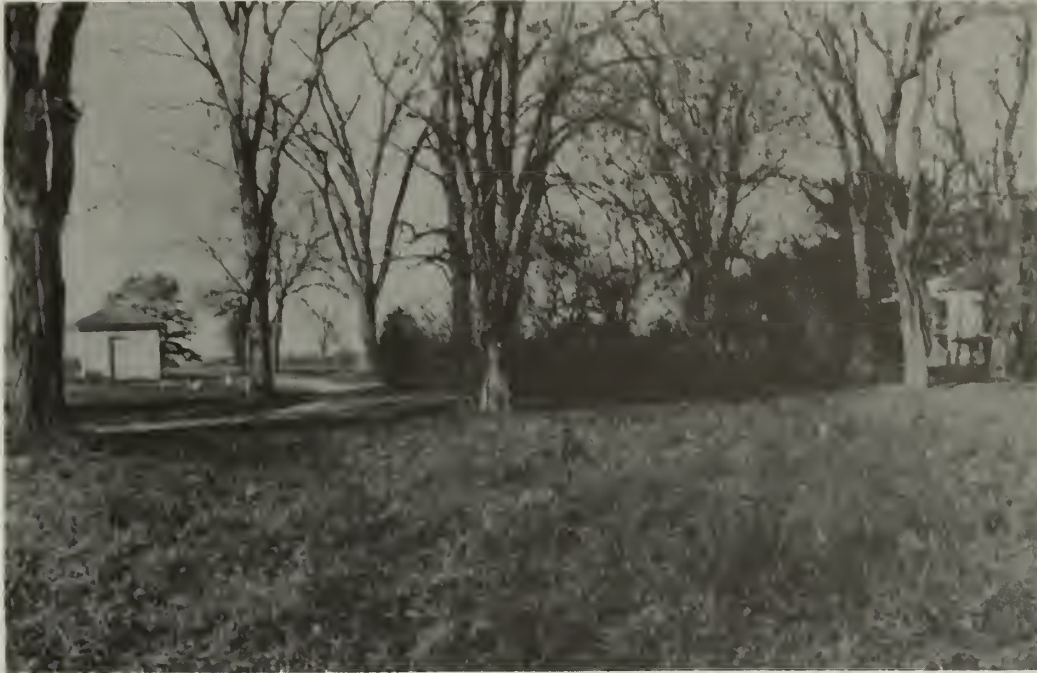
**Figure 3.8:** Entry drive, road to farm cottage, and garden fence, c.1913 (Photo # CLR-301.5. On file, MVB NHS).

Two wood posts, three to four feet tall, and used for tethering horses, stood along the entry drive. Approximately thirty feet from the front corners of the main house, one was located at each side of the approach to the main house (fig 3.11). Two fences are documented for this period. A post and wire fence stood along the Post Road boundary of the property. This fence was approximately four feet tall and appears to have been painted white. It was located between the front pine row and Post Road along the front boundary of the house lot (fig 3.1). At the two entries this fence had wood gates across the drive. They were composed of two hinged gates swinging inward and met in the center. The gates were apparently made of wood and had a more ornamental character than the fence they joined (fig 3.12). Another fence stood along the northeast and northwest boundaries of the garden. This wood picket fence was approximately four feet tall and seems to have been painted a light color (fig 3.2 and 3.8).

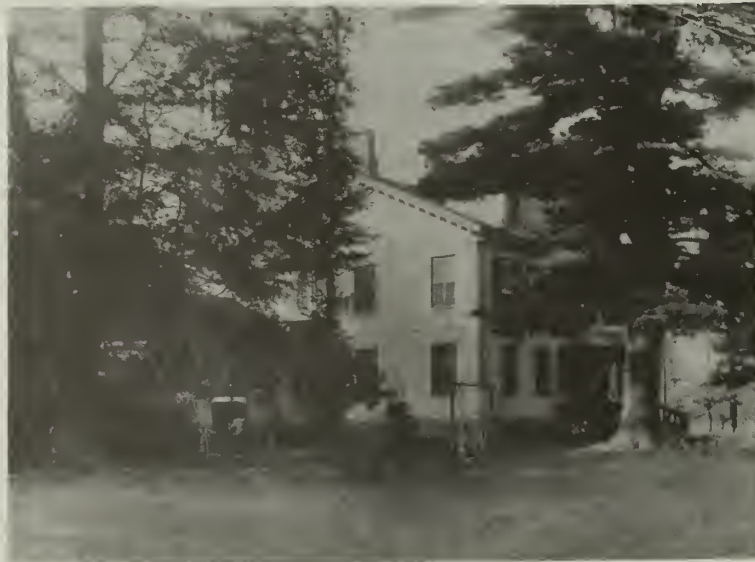
**Figure 3.10:** View of main house, showing rectangular trellis and lawn swing, c.1913 (Photo # CLR-308. On file, MVB NHS).

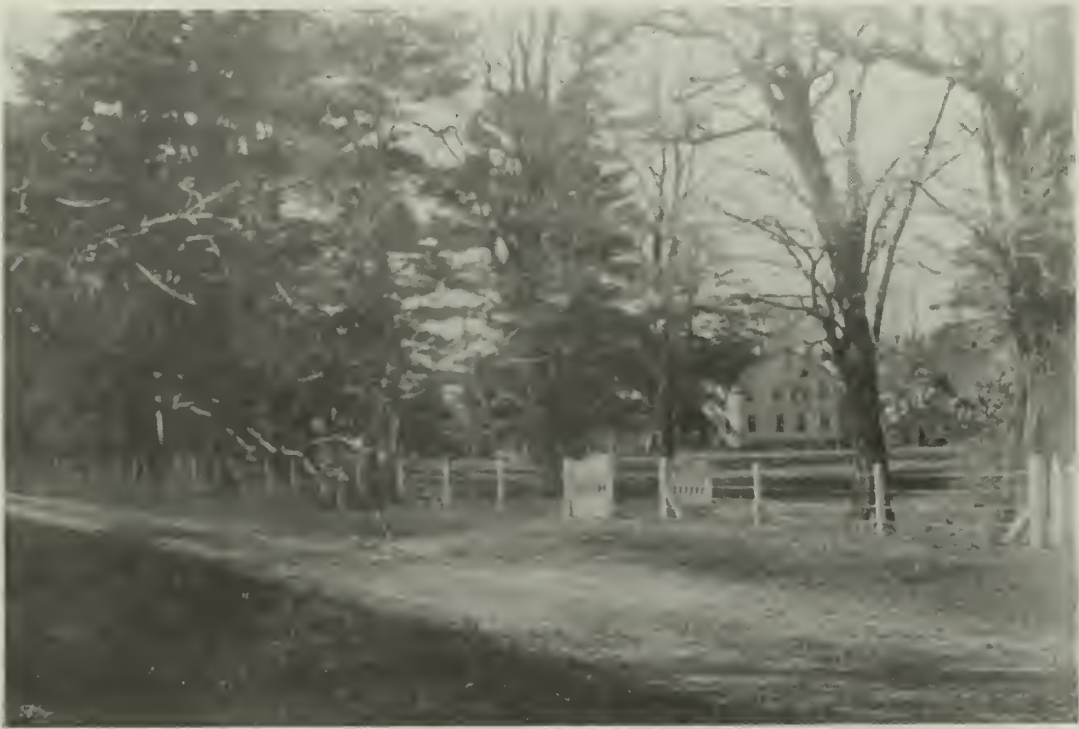
**Figure 3.12:** View along Post Road, showing front fence and gates to entry drive, c.1895 (Photo # CLR-315. On file, MVB NHS).

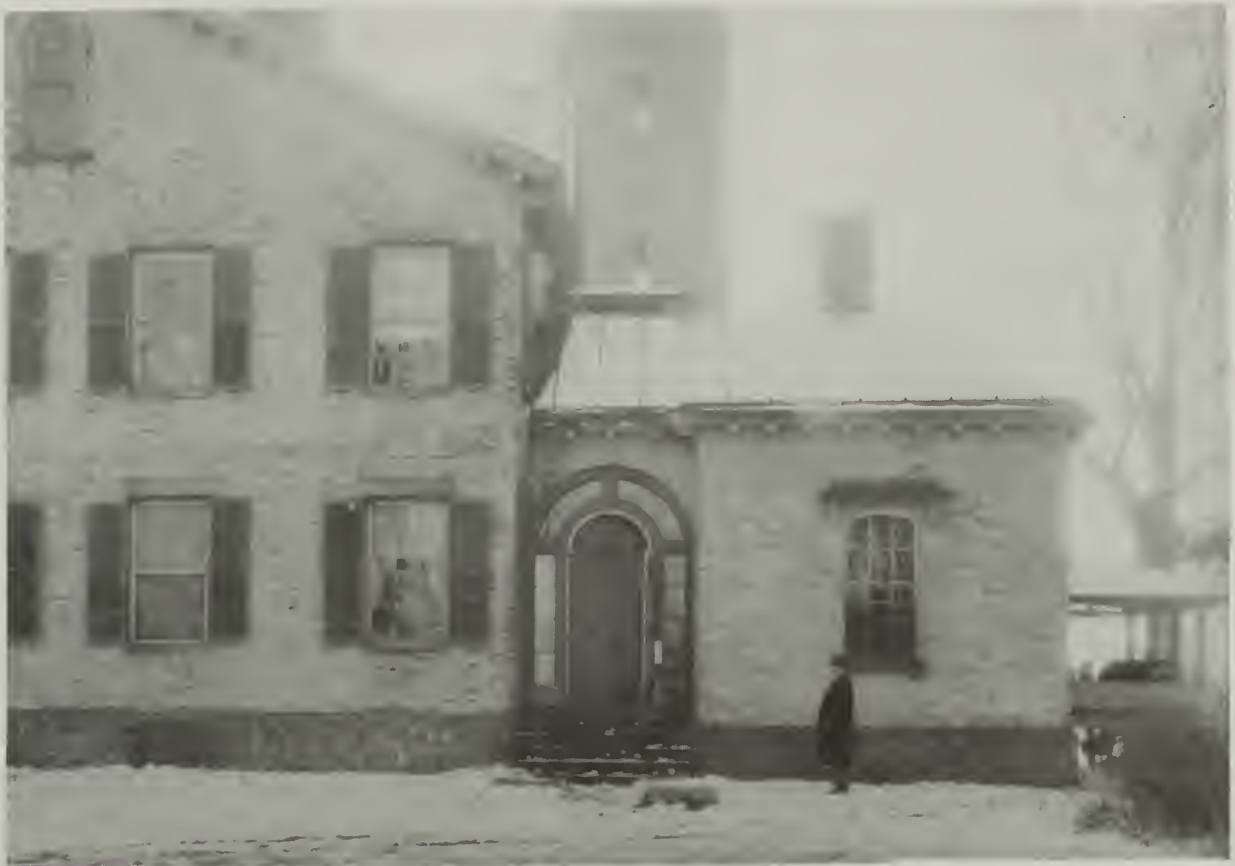
The main house underwent many changes during the deProsse Period, both on the interior and exterior. On the exterior, a large ornamental front porch, small rear porch, and much ornamentation were added. The porch added to the rear wrapped around the corner of the west wing (fig. 4.3). The exact date of this addition is unknown, but it occurred between 1917 and 1936 and was later enlarged during the deProsse Period (fig. 4.4).

**Figure 4.3:** Rear porch on main house, 1937 (Photo # CLR-450. On file, MVB NHS).

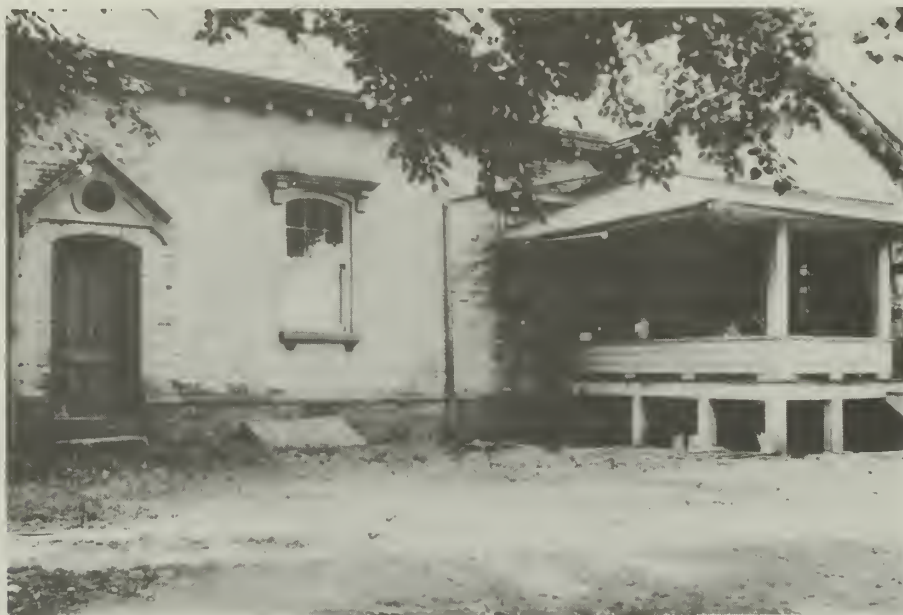
**Figure 4.4:** Enlarged rear porch on main house, 1936 (Photo # CLR-463. On file, MVB NHS).

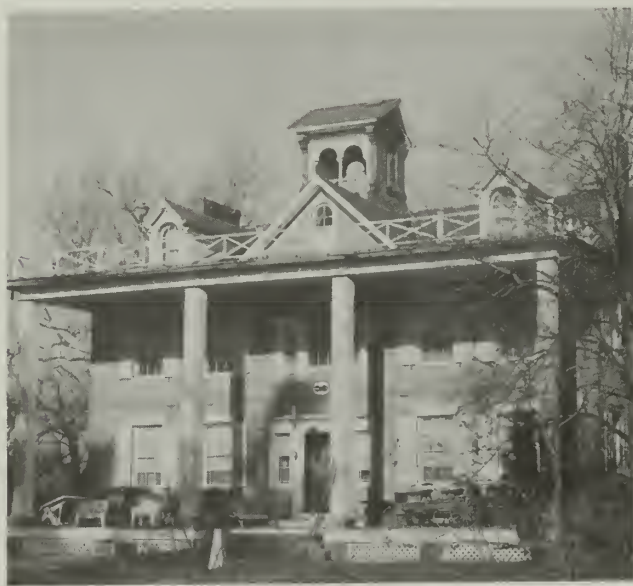
**Figure 4.5:** Campbell front porch on main house, 1974 (Photo # CLR-530. On file, MVB NHS).

At the end of the deProsse ownership, the front porch was severely deteriorated and had to be removed. When Campbell purchased the property, he added a large porch covering the entire front facade of the main house. Campbell also added ornamentation to the exterior of the main house, around many of the windows and on the roof overhang, disguising the previously Italianate characteristics (fig. 4.5).

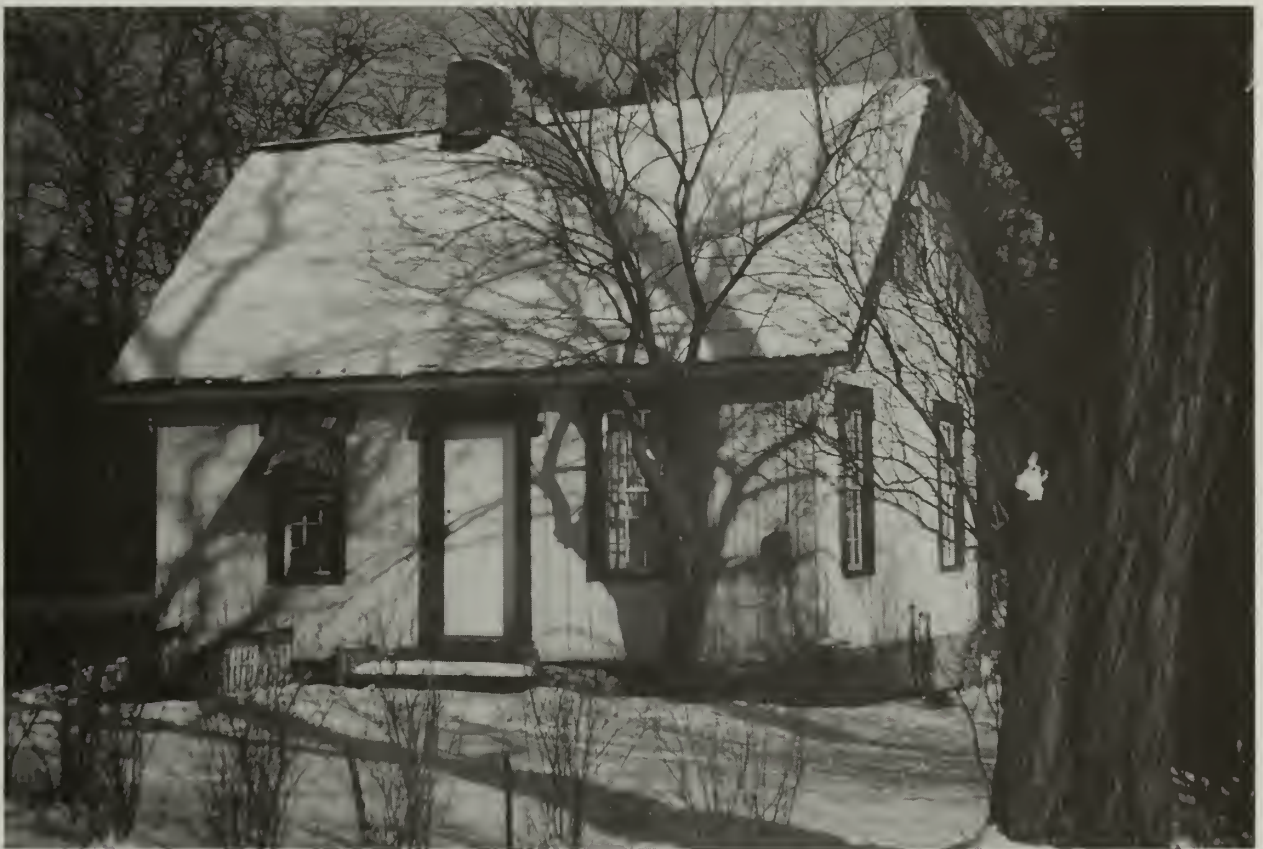
The south gate house was periodically used a residence during this period. Farm help lived in it until circa 1935. It had a one-hole privy next to it, but no well. The south gate house was vacant from 1935 until 1947, when the interior was renovated and it was labeled the "honeymoon cottage" for use by Jeanne deProsse after her marriage to Ned Akers (fig. 4.6).<sup>115</sup> They lived in the south gate house for three years. It was vacant again from 1950 until 1957. William deProsse, Jr. and his wife lived in the south gate house for three months after their wedding in 1957.<sup>116</sup> Beginning in 1957, Ken Campbell used it for his antique business. He lived in the south gate house for the last few years of his occupancy, staying even after the National Park Service took over the property.

Figure 4.6: South gate house, 1950 (Photo # CLR-434. On file, MVB NHS).

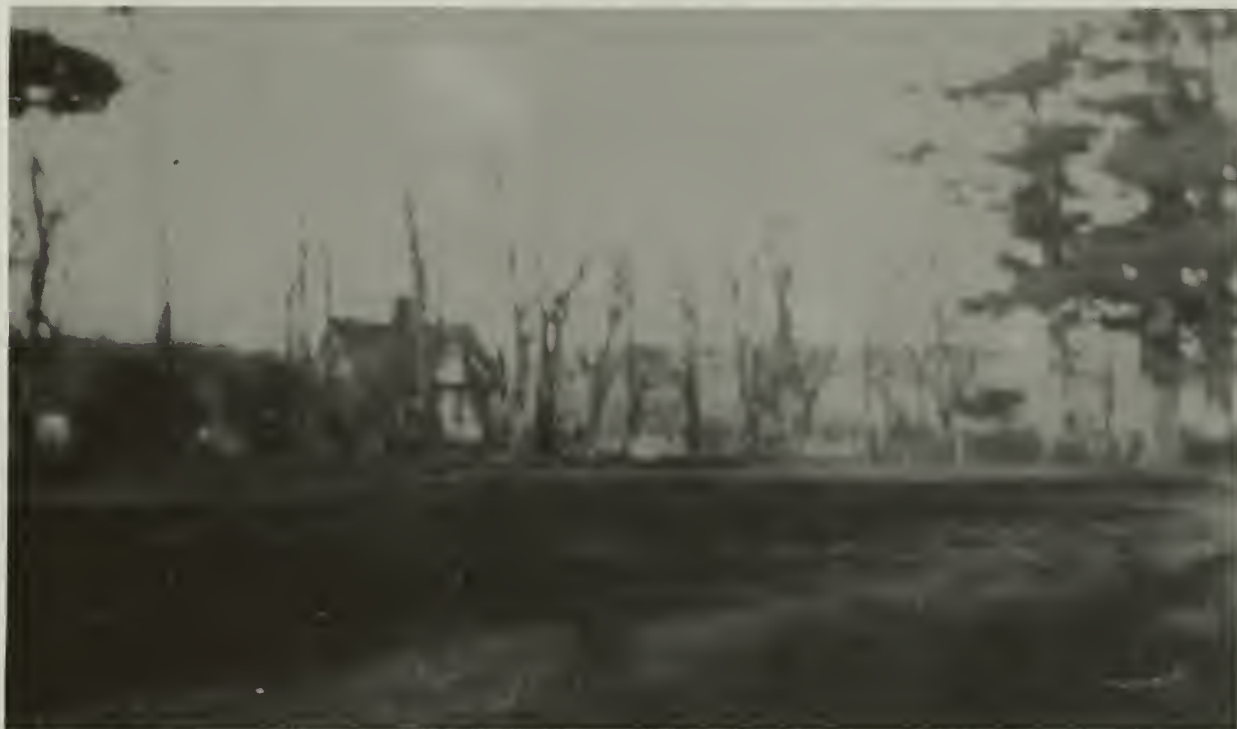
The north gate house (fig. 4.7) was occupied by farm help until the 1930s. At some time during this occupancy, the garden building seen in figure 2.11 was moved from the garden and attached to the rear of the north gate house.<sup>117</sup> This gate house had a well and a two-hole privy at its northwest corner. It was then vacant in the 1940s and was severely deteriorated in the 1950s. At this time it was sold to a family on Post Road and moved to their property where they used the lumber in the construction of their house.

**Figure 4.7:** North gate house, n.d. (1890–1930) (Photo # CLR-003. On file, MVB NHS).

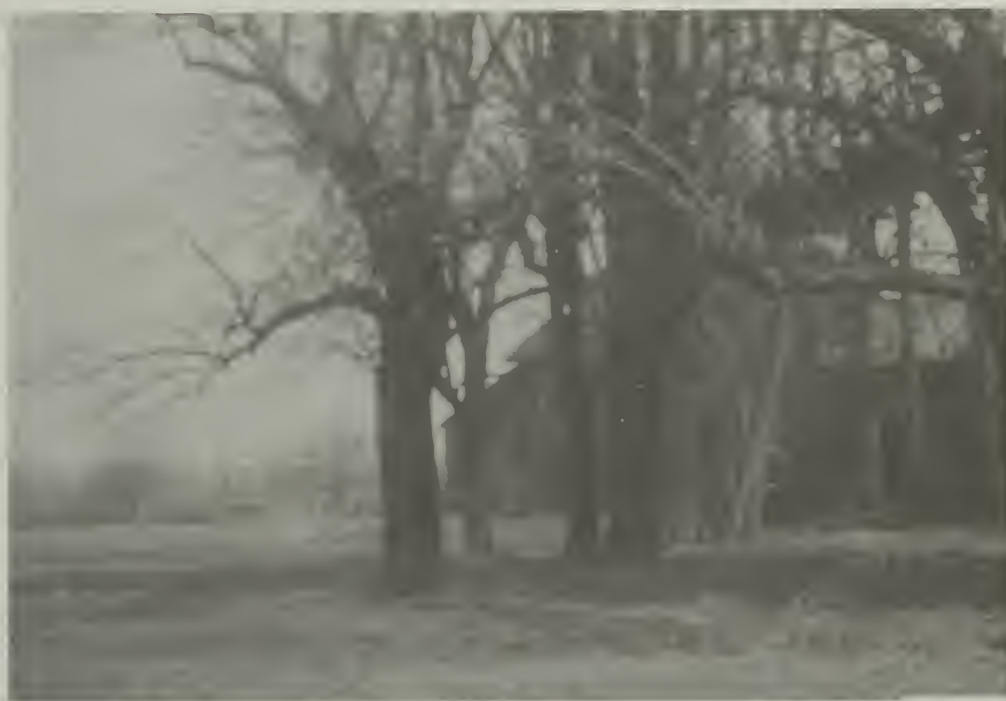
The carriage barn (fig. 1.7 and 4.8) was northwest of the house and approximately thirty feet wide and sixty-five feet long. It was positioned perpendicular to the house, its long axis running northwest/southeast. The building had a main section approximately thirty feet square. Appendages at both ends made the entire length approximately sixty-five feet. The main section or bay of the barn was divided into two areas. The west portion was for carriage storage and the east portion contained animal stalls. The west portion had a sliding door on both the south and north walls for carriage access, and the carriages were stored in the area along the west wall. The east portion was comprised of stalls along both the north and south walls. The south wall had wood tie stalls for securing horses while the north wall had box stalls for storing horses and other animals. It is unknown whether the barn was one large continuous space or whether it was divided into an east and west section as it appears in figure 1.7. The building contained a loft that extended its entire length. Figure 1.7 illustrates the different roof height of the two sections and it would seem the height of the loft in each section was also different. The east section had a lower roof and may have had a lower loft to accommodate this height. The exterior of the barn was covered with six inch wood lap siding and the roof was covered with wood shingles. The carriage barn was over one hundred years old at the start of this period and was deteriorating. As a result, it was dismantled in approximately 1937. All of the debris from the building was removed from the site at that time (see Appendix F for floor plan).<sup>119</sup>

**Figure 4.8:** Carriage barn, n.d. (1890–1936) (Photo # CLR-001. On file, MVB NHS).

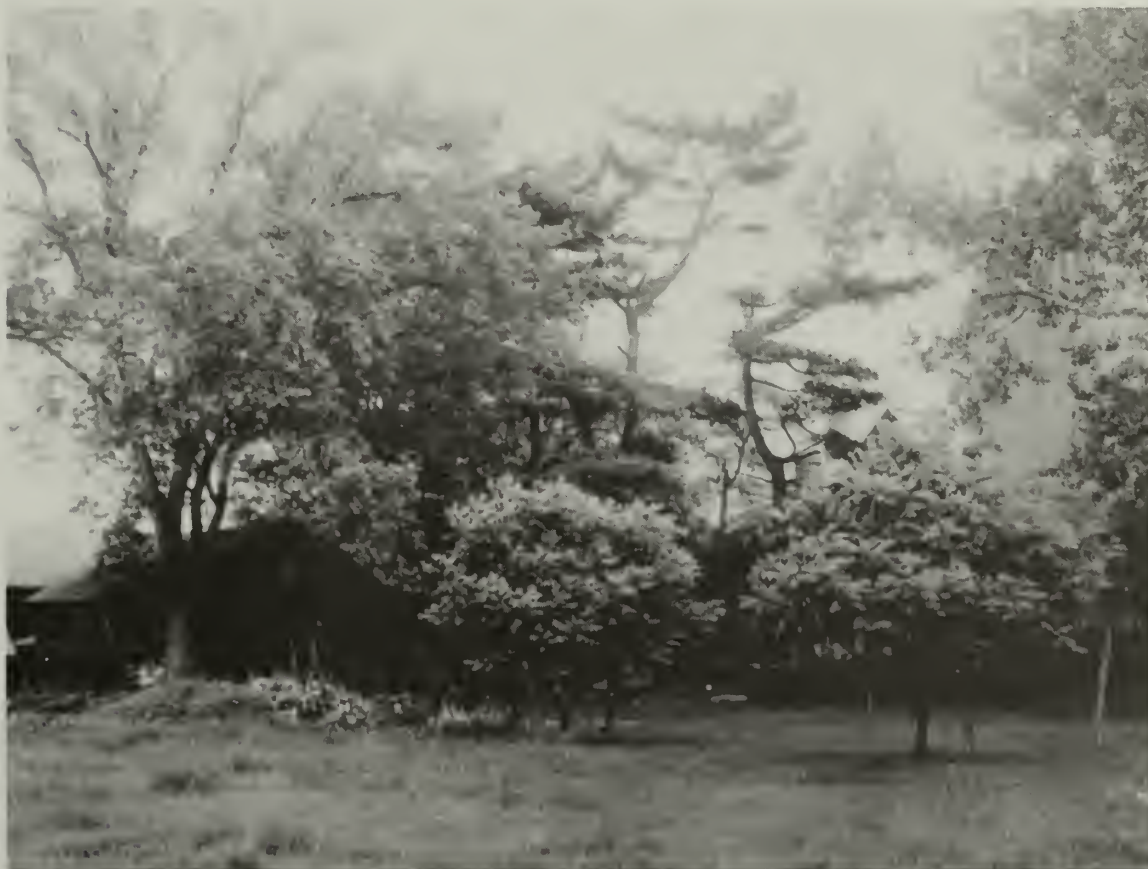
**Figure 4.10:** Shed complex behind main house, c.1945 (Photo # CLR-419. On file, MVB NHS).

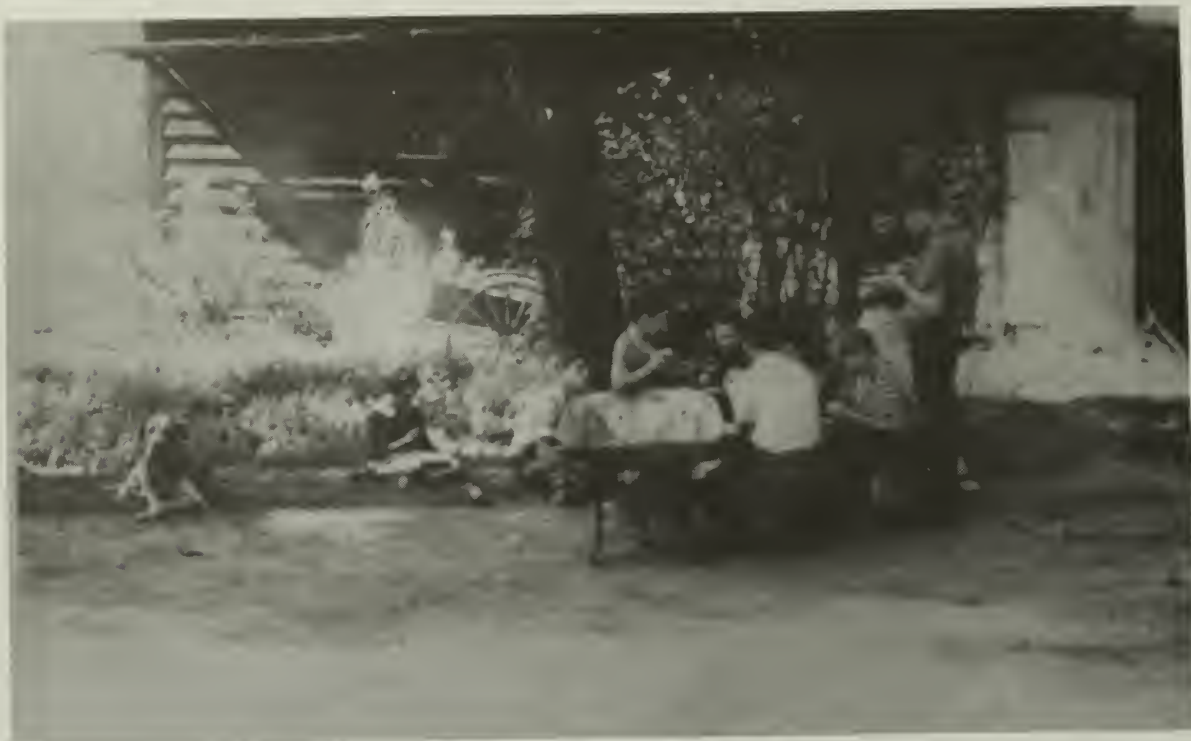
**Figure 4.11:** Wood shed behind main house, c.1940 (Photo # CLR-411. On file, MVB NHS).

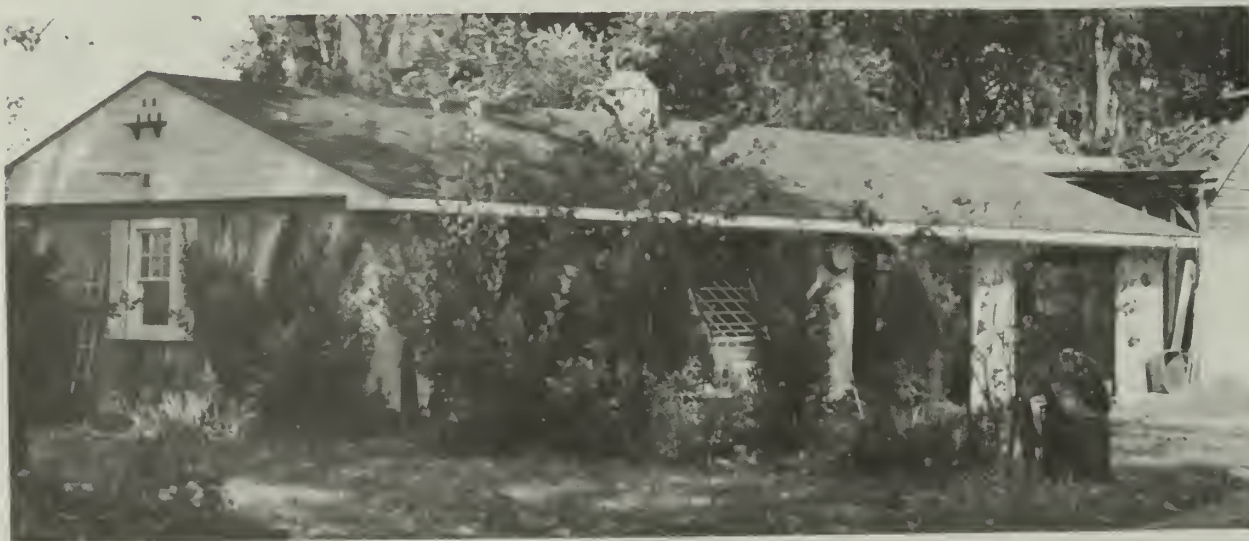
**Figure 4.12:** Campbell garage, behind main house, c.1969 (Photo # CLR-418. On file, MVB NHS).

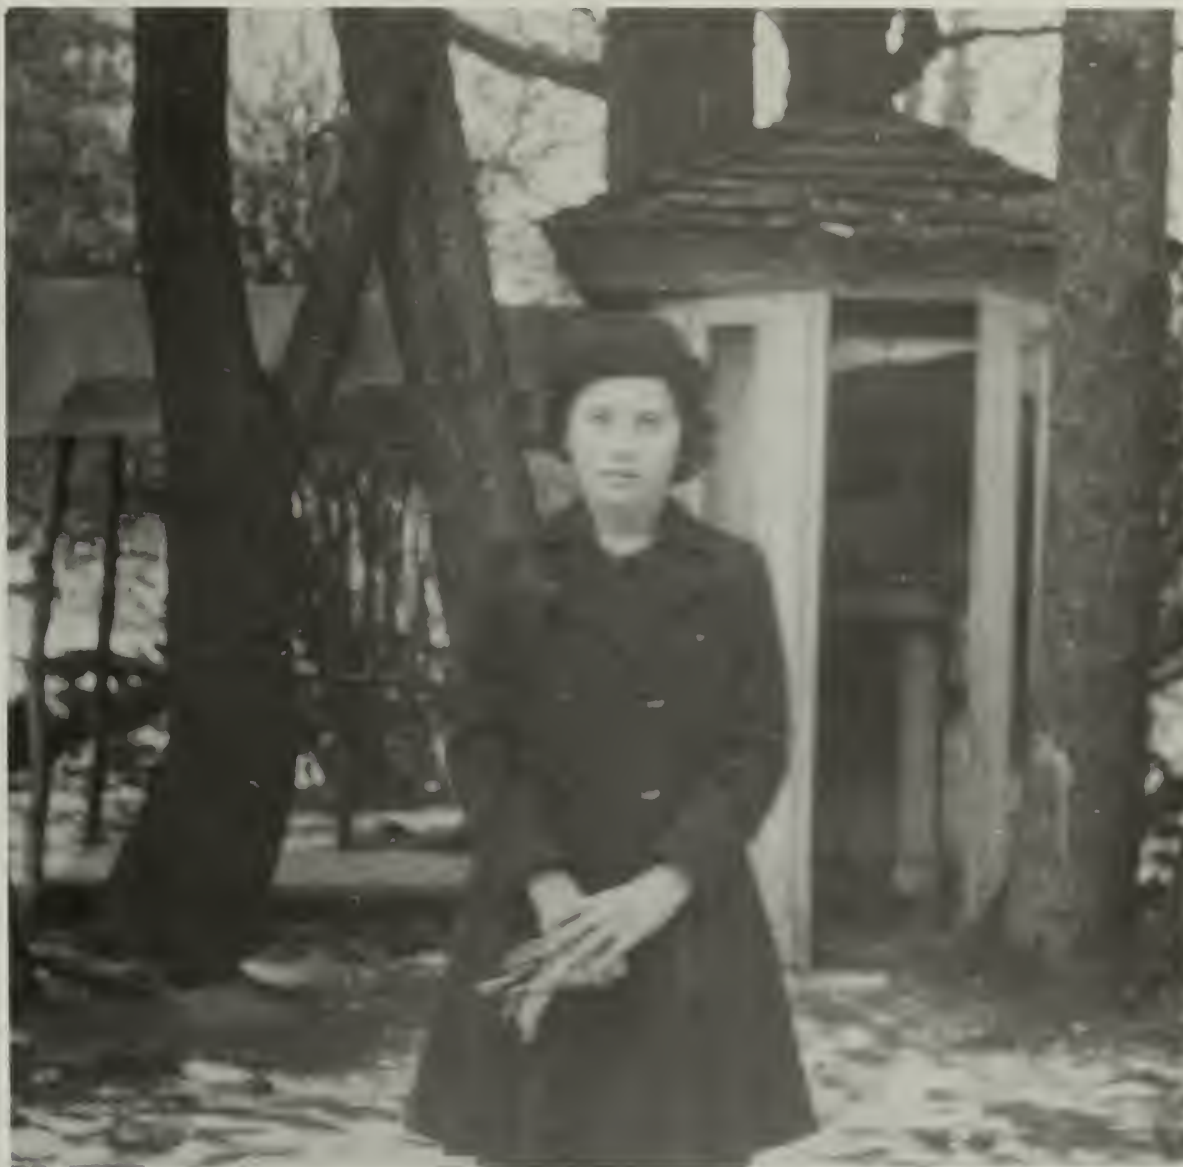
The well house, located on top of the well behind the main house during the Wagoner Period, was moved to the northeast corner of the Wagoner garage during the 1930s (fig. 4.13 and 4.14). Located in a grove of trees, it was converted to a play house for the deProsse children. It had either fallen down or been removed by the end of the deProsse Period, probably during the Campbell ownership.<sup>124</sup>

**Figure 4.13:** Well house converted into play house, c.1935 (Photo # CLR-427. On file, MVB NHS).

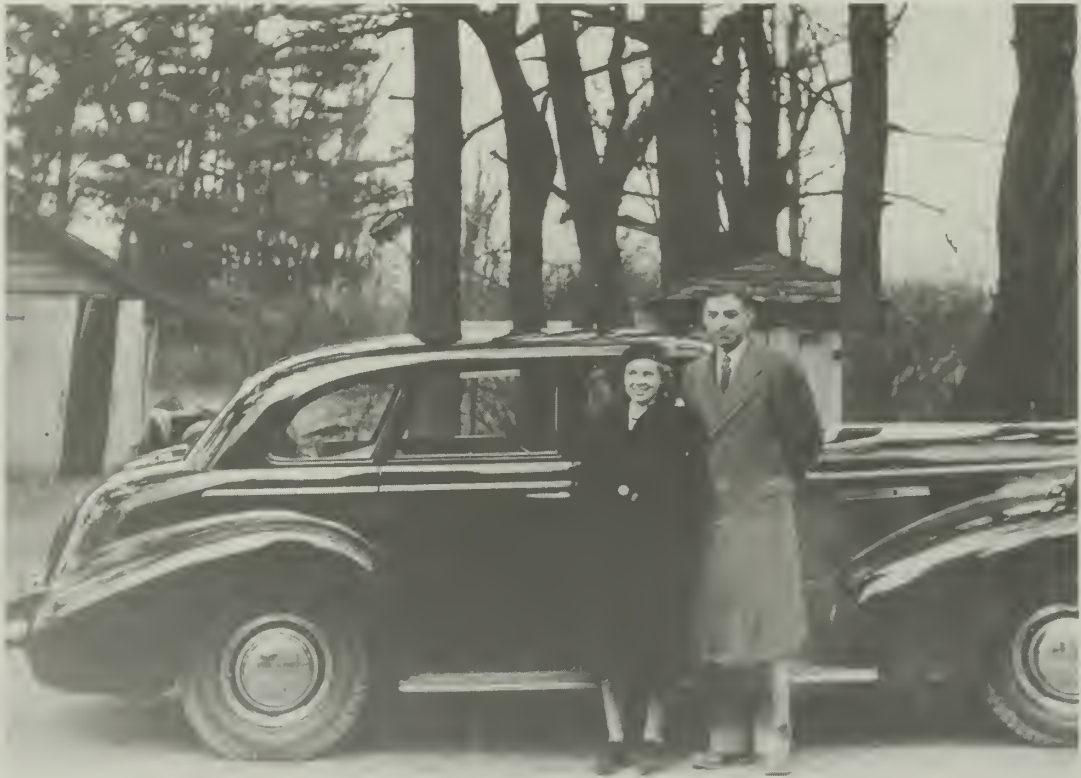
**Figure 4.14:** Slate shed in Wagoner garage and well house/play house, behind main house, c.1940 (Photo # CLR-407. On file, MVB NHS).

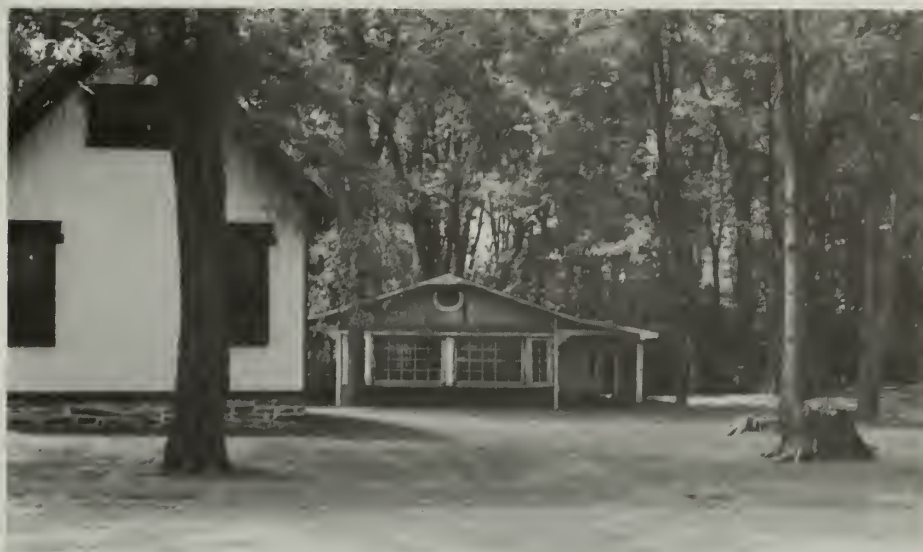
During the 1960s, Campbell constructed a small shop on the property from which he sold antiques. The shop was located adjacent to the south gate house and was approximately twenty feet square with covered porches on the north and south sides (fig. 4.15).

**Figure 4.15:** Campbell antique shop, 1981 (Photo # CLR-537. On file, MVB NHS).

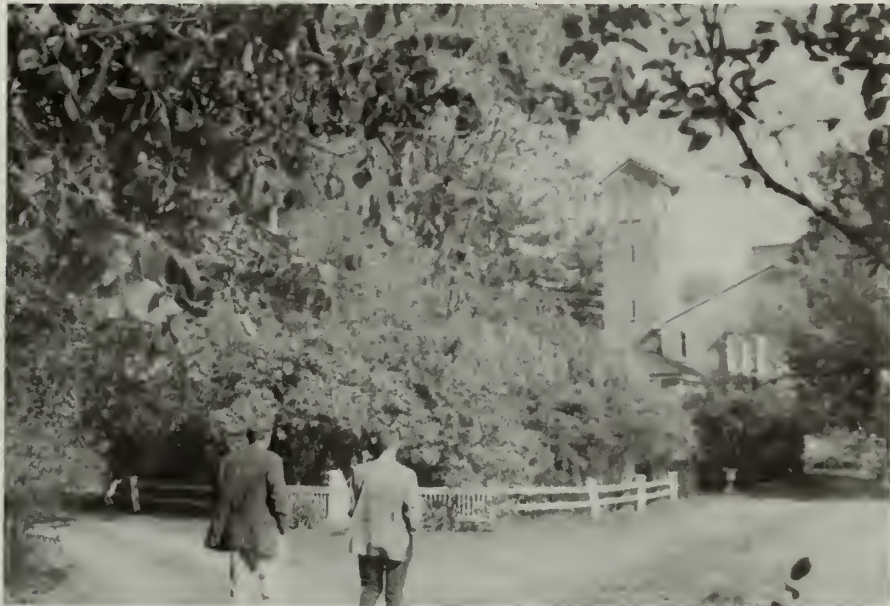
**Figure 4.28:** Furnishings and objects, south of main house, 1969 (Photo # CLR-453. On file, MVB NHS).

Several sections of fence were also added to the property during the Campbell ownership (fig. 4.28). The south and east sides of the Lilac grove south of the main house were fenced and both ends of the entry drive had gates. These fences were approximately four feet high, constructed of wood timbers, and painted white. The gates across the entry drives were white, wood gates of a simpler design than the gates recorded there previously. A fence also existed around the Peter Van Ness grave, behind the main house. This fence was constructed of large wood timbers and stood approximately one or two feet high. It surrounded a square area about twenty feet by twenty feet around the grave (fig. 4.29).

During the Campbell ownership, several decorative items were added. Several decorative objects were scattered around the front lawn and south side of the main house including: an artificial well house, bird bath, flag pole, arbor, wagon wheels, planters, and statues. Due to Campbell's antique business, there were many items for sale displayed on the property.<sup>134</sup>

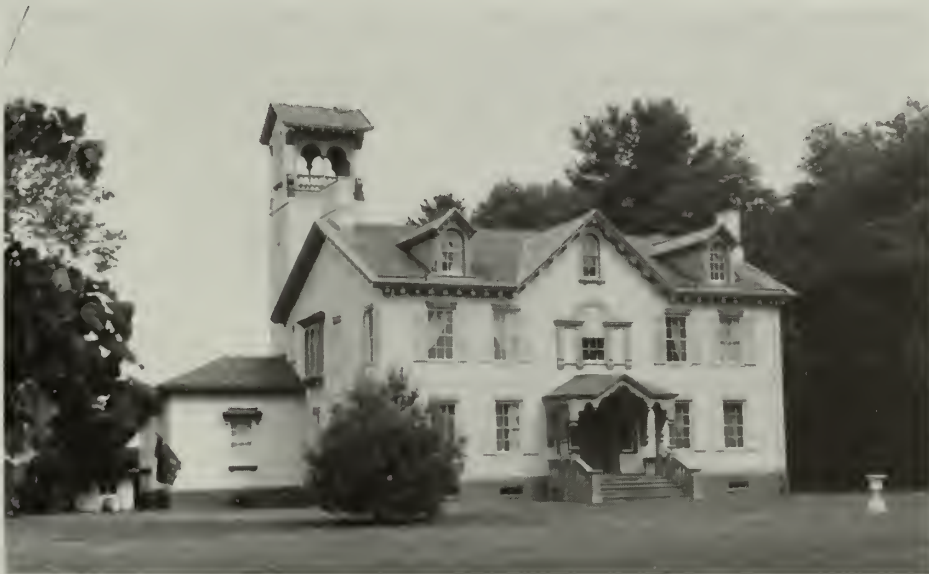
The main house, in a dilapidated state at acquisition, underwent extensive restoration efforts. The non-historic front and rear porches were removed and the historic front porch was replaced. The interior was completed in 1987 and the exterior in 1991, returning the house to its 1850s appearance. The house is now painted yellow with brown trim (fig. 5.6).

**Figure 5.6:** Lindenwald, main house, 1993 (Photo # CLR-1411. Uschold, SUNY CESF).
