# CULTURAL LANDSCAPE REPORT

### MARTIN VAN BUREN

### NATIONAL HISTORIC SITE

Site History, Existing Conditions, and Analysis

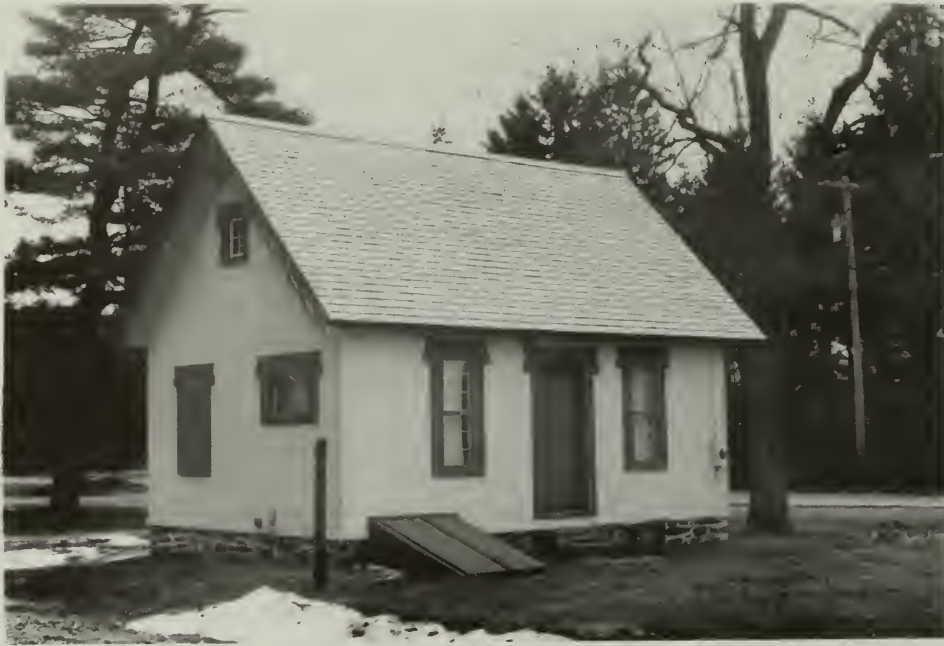
The exterior of the south gate house was also restored, with the exception of the original chimney, which was left off because it was believed to be non-historic. The interior of the south gate house was repaired and is now used as storage space. The exterior of the south gate house has been painted to match the house (fig. 5.7). The interior has three rooms on the first level: a large room with a fireplace, once the living room, and two small rooms that served as the kitchen and bath. Stairs from the bathroom lead to the upper level. The basement is accessed by steps on the exterior of the building. The north gate house foundation was filled with debris in 1973. This fill was removed and the foundation was back-filled with soil to ground level to stabilize it from deterioration.<sup>137</sup> A one-foot high portion of the stone foundation remains above grade. The foundation is now threatened by several Black Cherry (*Prunus serotina*) trees that have grown up around it. (fig. 5.8). The farm office foundation, constructed of flat stones at grade level, is also extant. Since it is at grade level and located in an area maintained as lawn, it is becoming overgrown and covered with grass (fig. 5.9).

Figure 5.7: South gate house, 1993 (Photo # CLR-1316. Uschold, SUNY CESF).

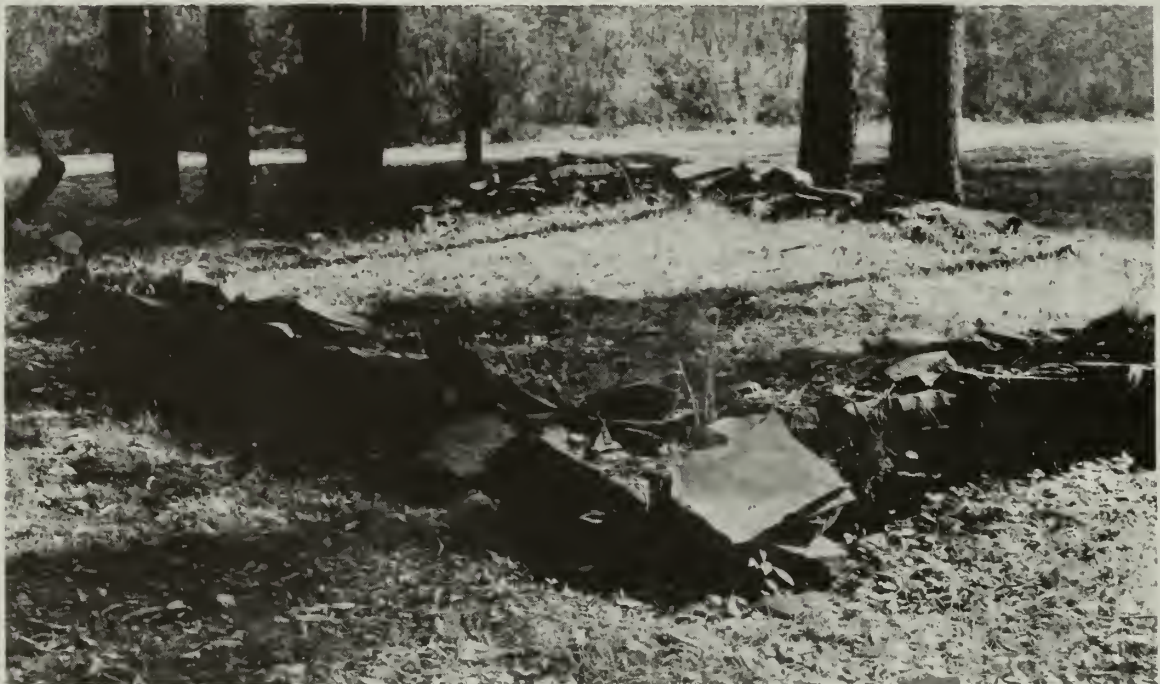
Figure 5.8: North gate house foundation, 1993 (Photo # CLR-1654. J. Harris, NPS).

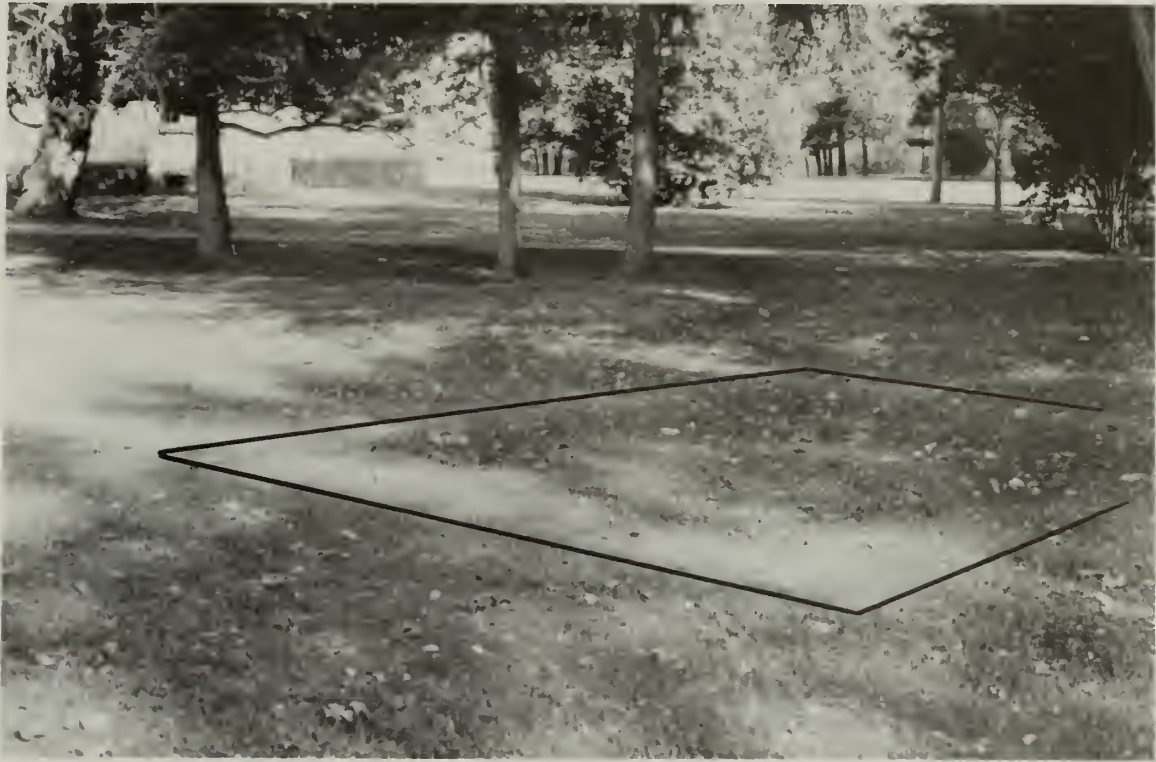
**Figure 5.9:** Farm office foundation, 1993 (Photo # CLR-1666. J. Harris, NPS).

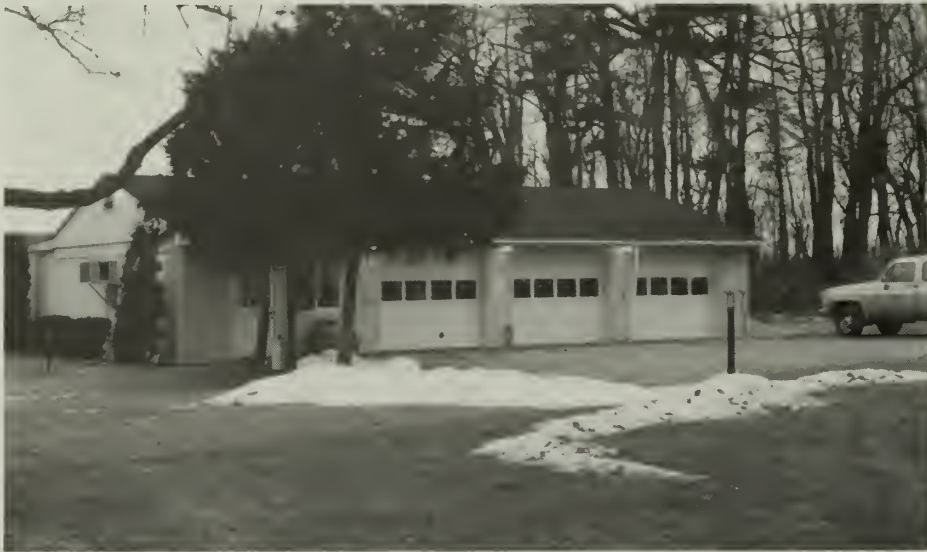
The Campbell garage was renovated for use as the maintenance shop for the Park in 1978. Three bays are used for work and storage space and the fourth is office space. This garage also has been painted yellow (fig. 5.10). The Wagoner garage collapsed in 1974 and the debris was removed from the property (fig. 5.11). Campbell's antique shop was removed from the property in 1981 due to its visually intrusive character and location (fig. 4.15).<sup>138</sup>

**Figure 5.10:** Campbell garage: maintenance garage, 1993 (Photo # CLR-1116. Uschold, SUNY CESF).

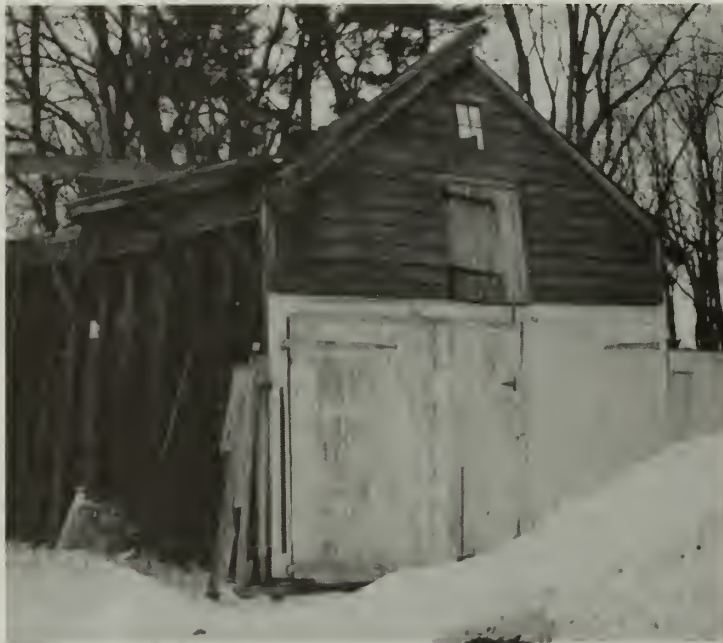
**Figure 5.11:** Wagoner garage, 1974 (Photo # CLR-501. On file, MVB NHS).

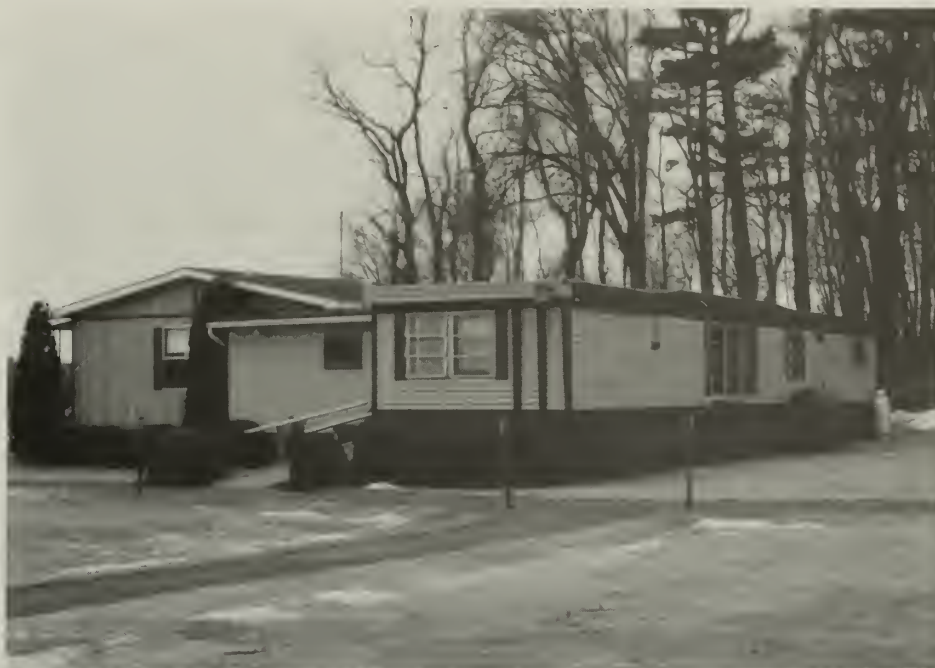
In 1977, a mobile home was added for use as Park offices. It was replaced in 1980 by a twelve by fifty-six foot mobile home. This mobile home was supplemented in 1983 by a twenty-four by forty foot, double wide mobile home and a vestibule was constructed between the new and old mobile homes (fig. 5.12). Located behind the main house, the twelve foot wide mobile home now houses the curatorial offices and the newer one houses the administrative offices. Another building, known as the pole barn, located next to the offices, is used for curatorial storage and the maintenance office. The pole barn was constructed in 1983–84 as a temporary structure to house curatorial items (fig. 5.13).<sup>139</sup>

**Figure 5.12:** Mobile homes: administrative and curatorial offices, 1993 (Photo # CLR-1118. Uschold, SUNY CESF).

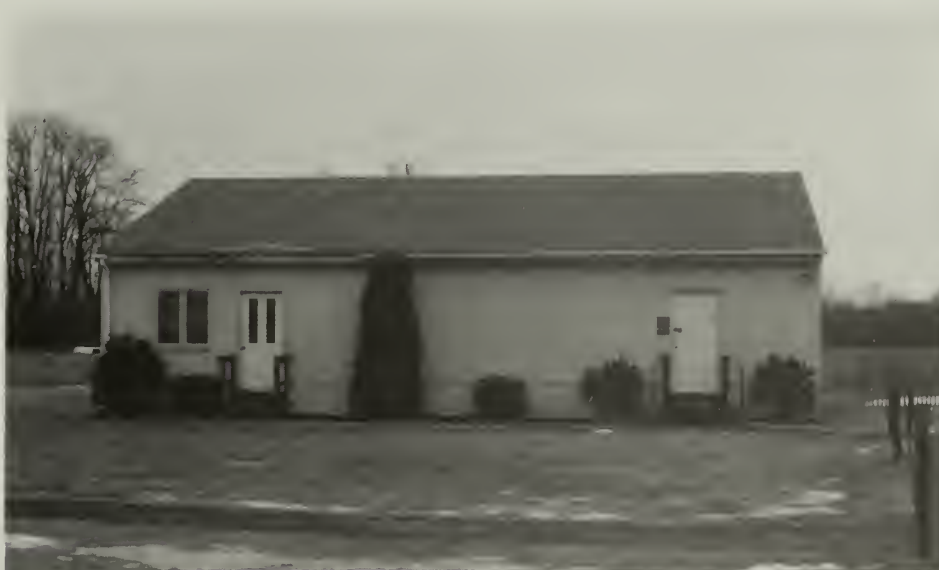
**Figure 5.13.:** Pole barn: curatorial storage and maintenance office, 1993 (Photo # CLR-1117. Uschold, SUNY CESF).

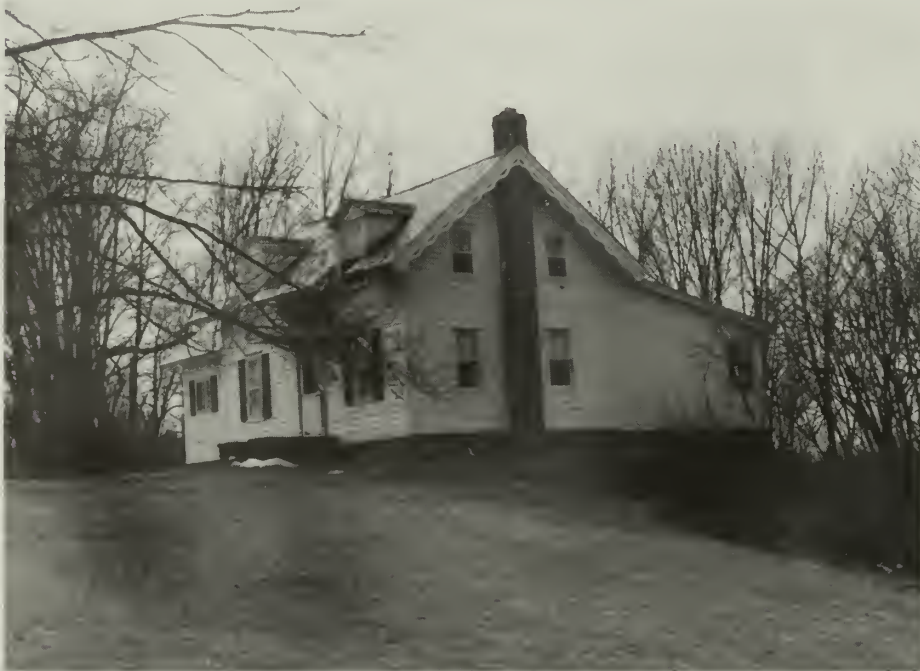
The farmland, now owned by Meyer, had an extensive complex of buildings at the beginning of the period and more buildings have been added to it during this period. The farm cottage is extant, although it has been greatly altered. It has undergone a number of renovation and modernization efforts. Additions have been built on the west and north sides of the building. It is now being used as a residence (fig. 5.14). The farm complex also contains a ranch house built in 1985. In addition, there are three silos, one large barn, seven garages and sheds, one hothouse, and one greenhouse (fig. 5.15 & 5.16).

**Figure 5.14:** Farm cottage, 1993 (Photo # CLR-1112. Uschold, SUNY CESF).

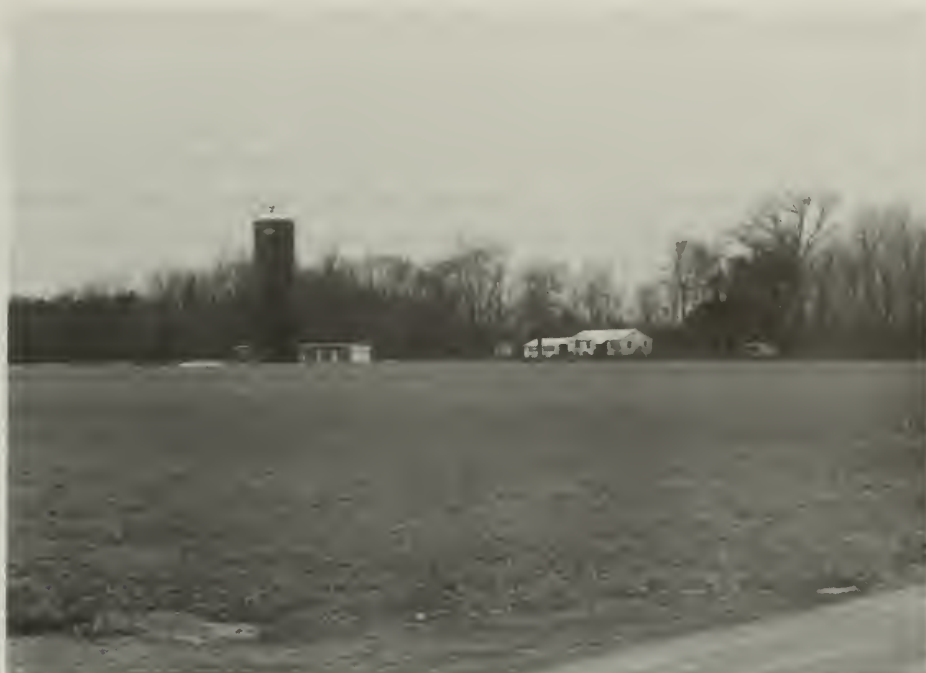
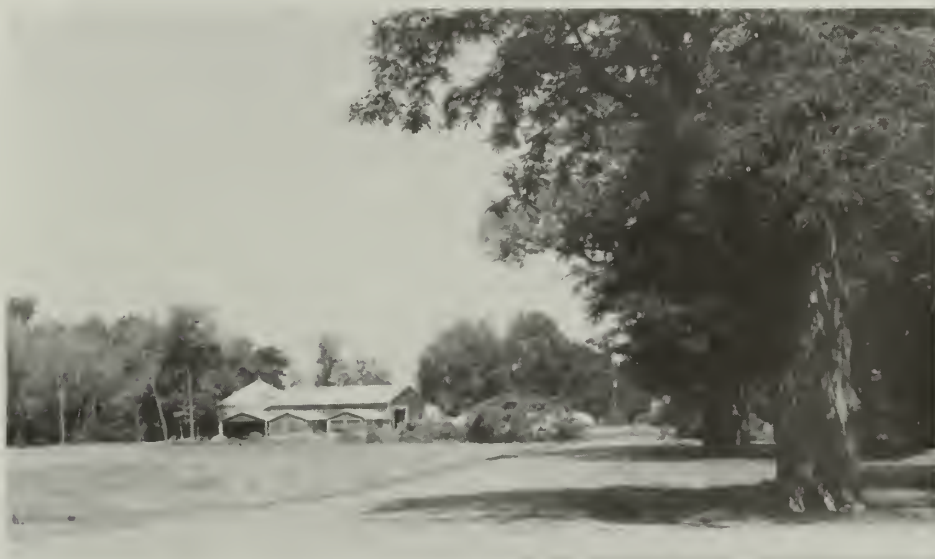
**Figure 5.15:** Meyer farm complex and 1985 ranch house, 1993 (Photo # CLR-1313. Uschold, SUNY CESF).

**Figure 5.16:** Meyer farm complex, 1993 (Photo # CLR-1509. Uschold, SUNY CESF).

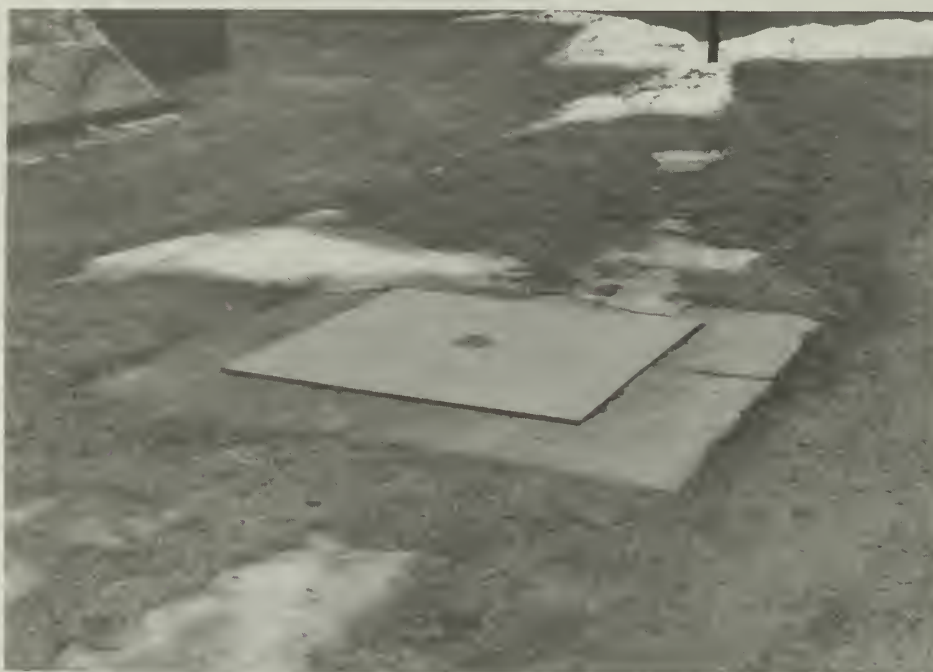
Water is provided to the Park by an underground well located behind the main house. This well was installed by the Park in 1978. The well provides the amount of water needed at the Park, however it is not dependable for drinking water. The historic well that served the main house still exists at the rear of the house (fig. 5.17). A steel cover has been placed over the well for protection. The sewage from the Park buildings is handled by a 1000-gallon septic tank which was placed underground in front of the pole barn. The septic system which served the main house and was implemented during the deProsse Period, was removed as non-historic in 1984. Four leach tanks were added, located around the main house, and are used for disposal of the storm water run-off from the gutters of the house. These leach tanks are dry wells constructed of concrete. On the north side of the front lawn, a 10,000-gallon water tank was placed underground. It has no connections to the Park's other water supply and was added for the sole purpose of fire protection.

**Figure 5.17:** Historic well for main house, 1993 (Photo # CLR-1115. Uschold, SUNY CESF).

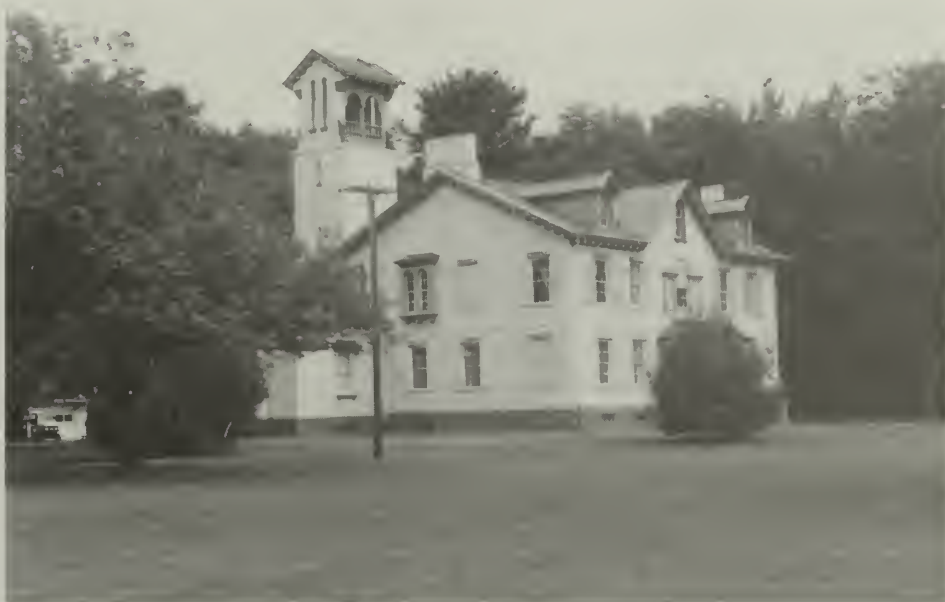
The electric service to the property was re-routed and improved in 1984. Electric service now enters the property via an underground line on the north end of the front lawn. The line runs directly from Post Road and goes straight to a transformer, located in the north wood lot near the main house. From there it goes underground to the main house, continuing to the garage, mobile homes, and pole barn. The south gate house receives its electric service directly from the line running along Post Road. An overhead line runs from the Post Road line to the gate house. From the gate house, this overhead line continues to a pole at the edge of the south wood lot. This extension is no longer in service and stops at the electric pole at the edge of the south wood lot.<sup>140</sup> The overhead electric line that previously served the main house still exists, passing directly across the front lawn. It continues to serve the farm complex behind the Park (fig. 5.18).

**Figure 5.18:** Electric service pole for Meyer farm complex, 1993 (Photo # CLR-1415. Uschold, SUNY CESF).

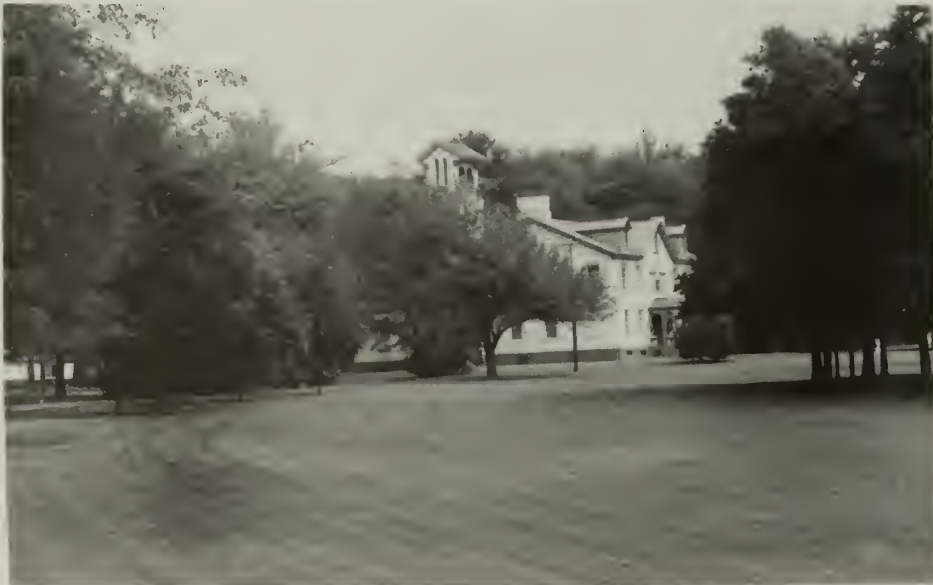
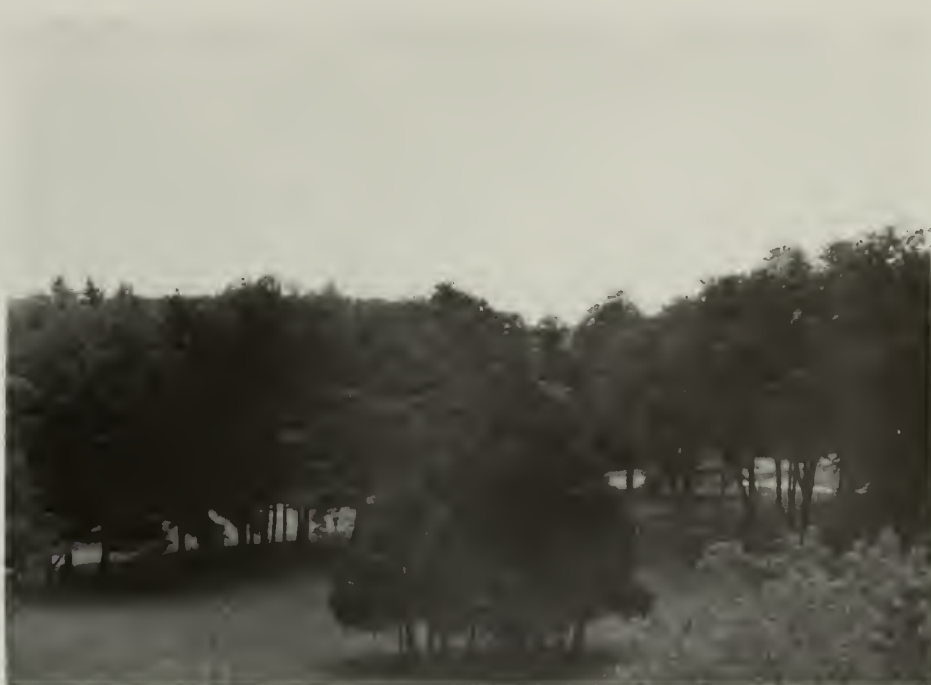
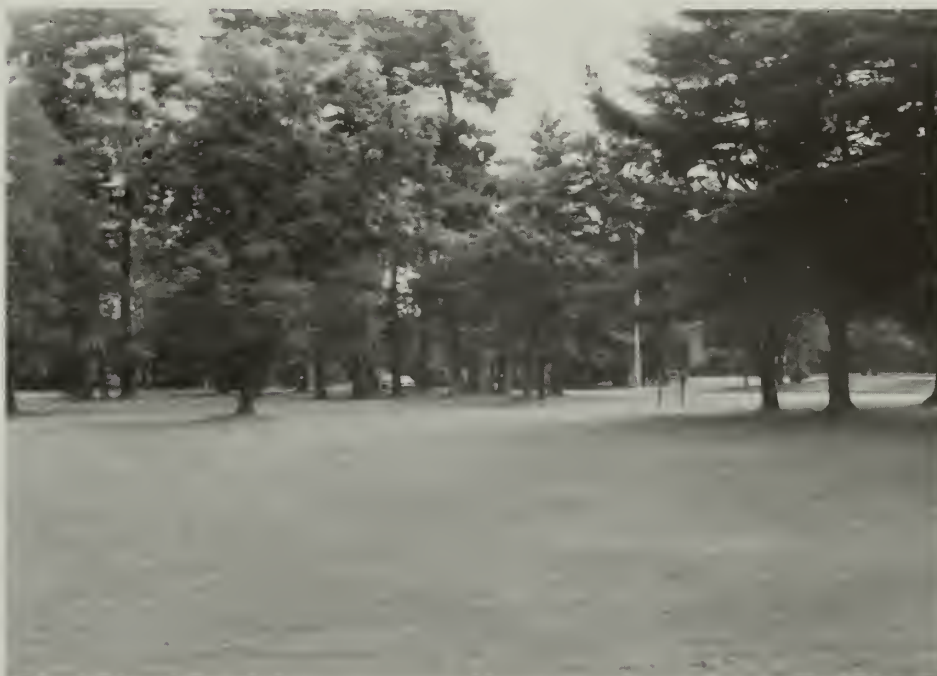
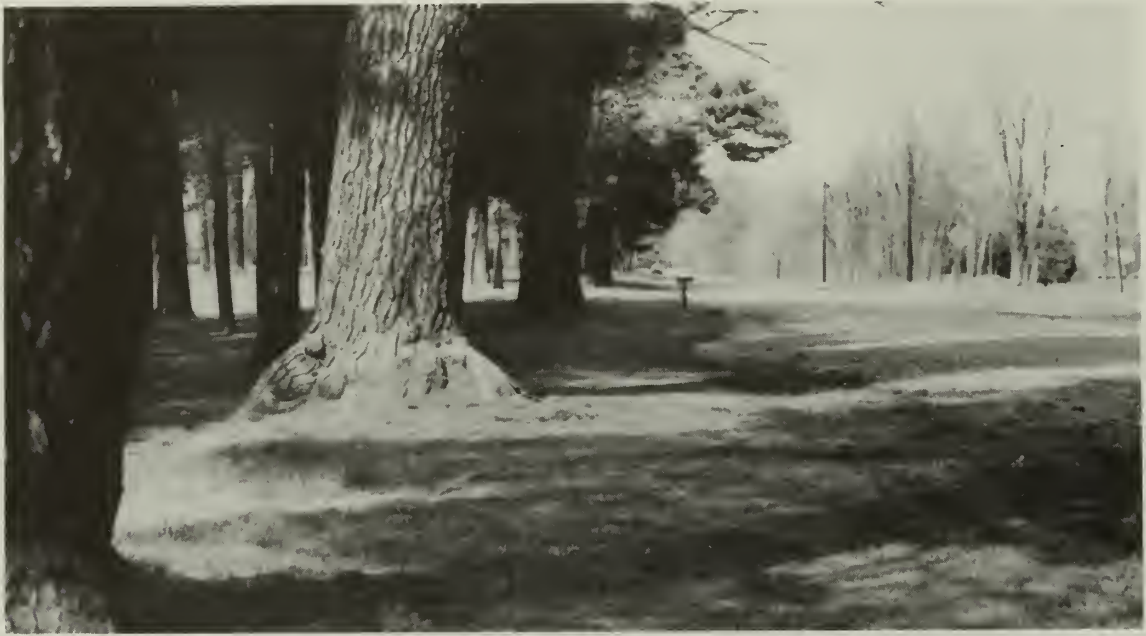
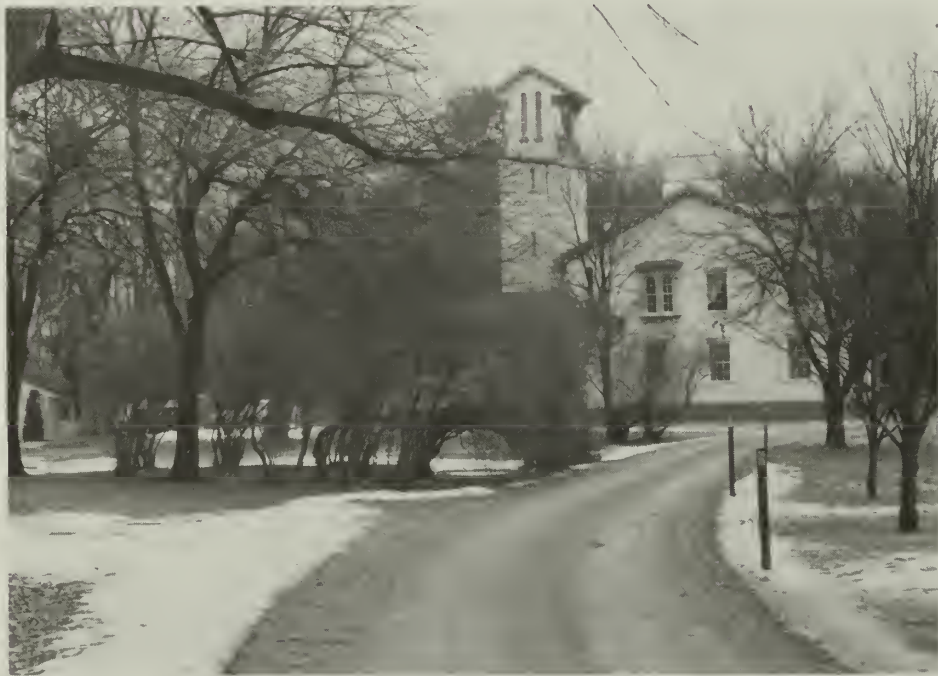
Over a period of years, beginning in 1976, vegetation was cut back and cleared from the property. The lawn was cleared of all plants except the larger trees and shrubs. The pine row along the road was cleared, leaving only the larger trees, of various species, to maintain the row. The north and south wood lots were cut back a few feet from the entry drive and several feet from the south gate house, antique shop, and north gate house foundation, leaving the larger trees. The vegetation surrounding the garages was cleared completely and the north wood lot cut back on its south boundary. Upon completion of the clearing, lawn was established and maintained around all of these features (fig. 5.19–5.23).

**Figure 5.19:** Front south lawn, 1993 (Photo # CLR-1421. Uschold, SUNY CESF).

**Figure 5.20:** Front lawn, pine row, & south drive, 1993 (Photo # CLR-1520. Uschold, SUNY CESF).

**Figure 5.21:** Pine row & front pine grove, 1993 (Photo # CLR-1423. Uschold, SUNY CESF).

**Figure 5.22:** Pine row, 1993 (Photo # CLR-2061. Uschold, SUNY CESF).

**Figure 5.23:** Vegetation south of main house, 1993 (Photo # CLR-1308. Uschold, SUNY CESF).

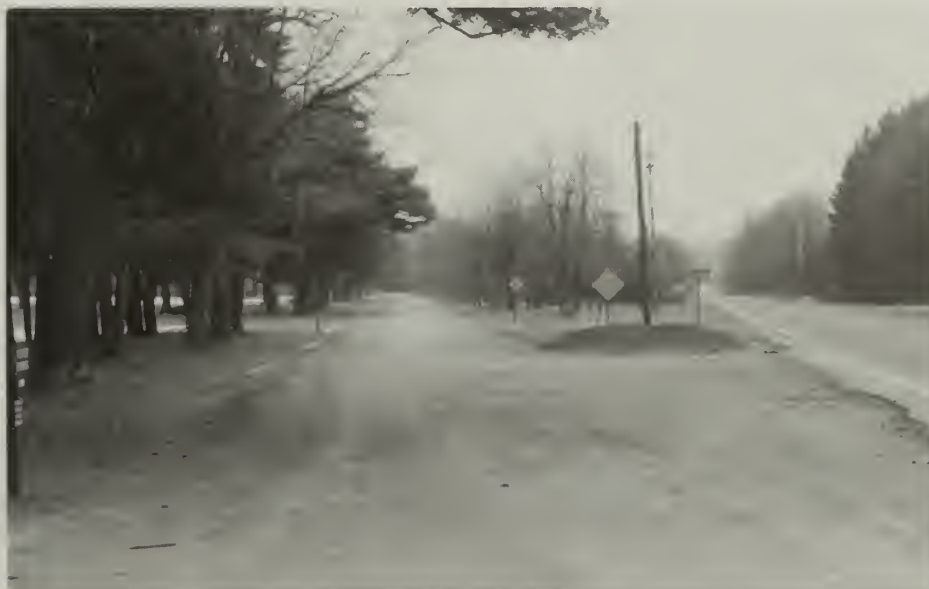
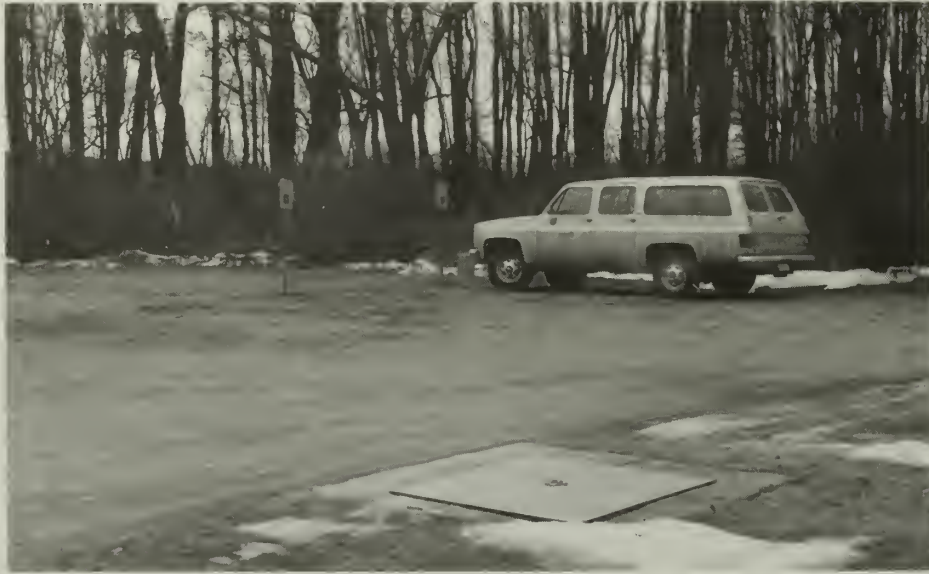
Visitor parking for the Park is along Post Road, in front of the site. Visitors park along the road and walk across the front lawn or up either side of the entry drive. Handicap parking for two vehicles is available next to the maintenance garage behind the main house. It is accessed by the south entry drive. The north drive is blocked (fig. 5.33 & 5.34).

**Figure 5.33:** Visitor parking, along Post Road, 1993 (Photo # CLR-1311. Uschold, SUNY CESF).

**Figure 5.34:** Handicap parking, rear of main house, 1993 (Photo # CLR-1121. Uschold, SUNY CESF).

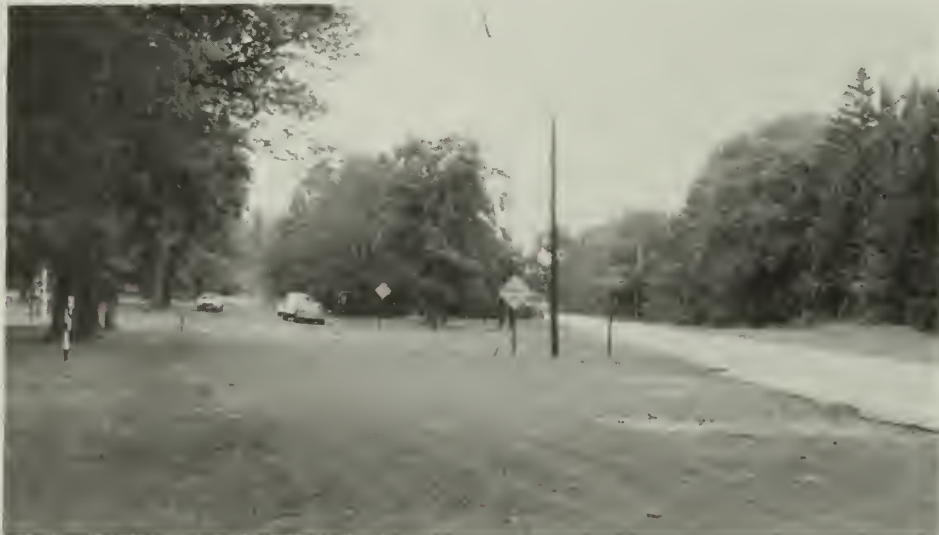
New York State Route 9h, which intersects Post Road in front of the Park, is a very busy, 55 mph highway. The intersection of this route and Post Road is directly in front of the south gate house. This is also the point where visitors access Post Road and enter the Park and Route 9h curves sharply to the south, intersecting Mill Road a few hundred yards to the south. This intersection creates a traffic hazard for any vehicle trying to access any of these roadways (fig. 5.35 & 5.36).

**Figure 5.35:** New York State Route 9h & Post Road, 1993 (Photo # CLR-1606. Uschold, SUNY CESF).

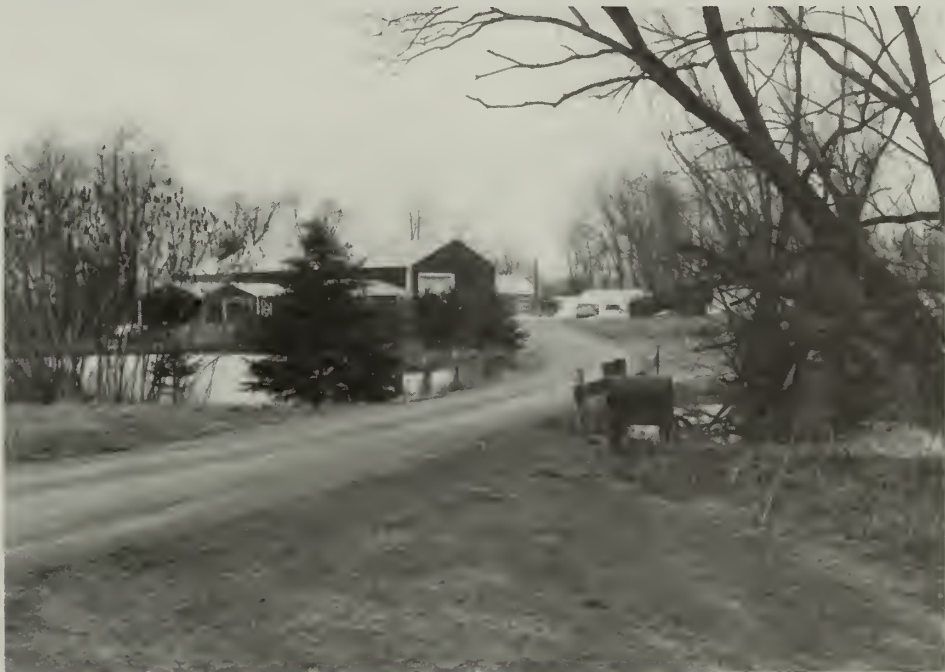
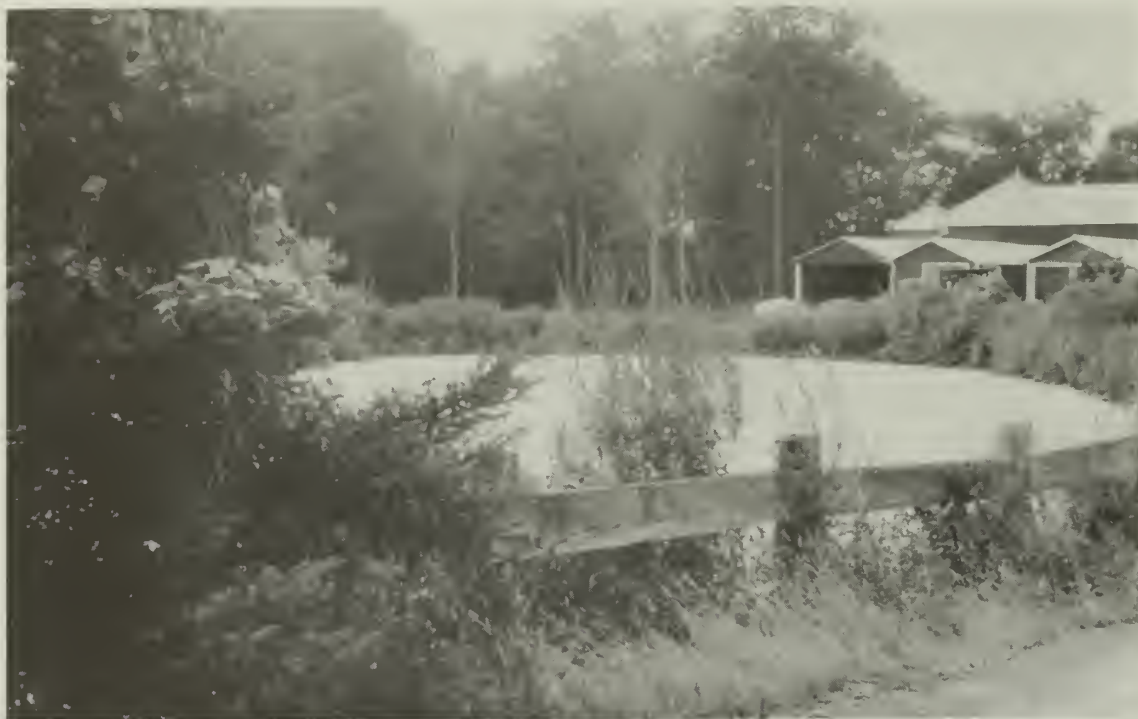
The only designed water feature within Park control is the upper fish pond. It abuts the farm road and is located on a conservation easement controlled by the Park. The pond, enlarged by Meyer during the deProsse Period, currently is used for irrigation purposes on his farm. On the opposite side of the farm road is a small pond created as a result of the farm road's construction. This small shallow pond has formed by the fill for this road. A culvert runs underneath the farm road, connecting this small pond with the upper fish pond. This pond fluctuates greatly depending on the season. It is almost non-existent during the dry summer months (fig. 5.36–5.38).

**Figure 5.36:** Upper fish pond and smaller pond flanking farm road, 1993 (Photo # CLR-1318. Uschold, SUNY CESF).

**Figure 5.37:** Upper fish pond, 1993 (Photo # CLR-3004. Uschold, SUNY CESF).

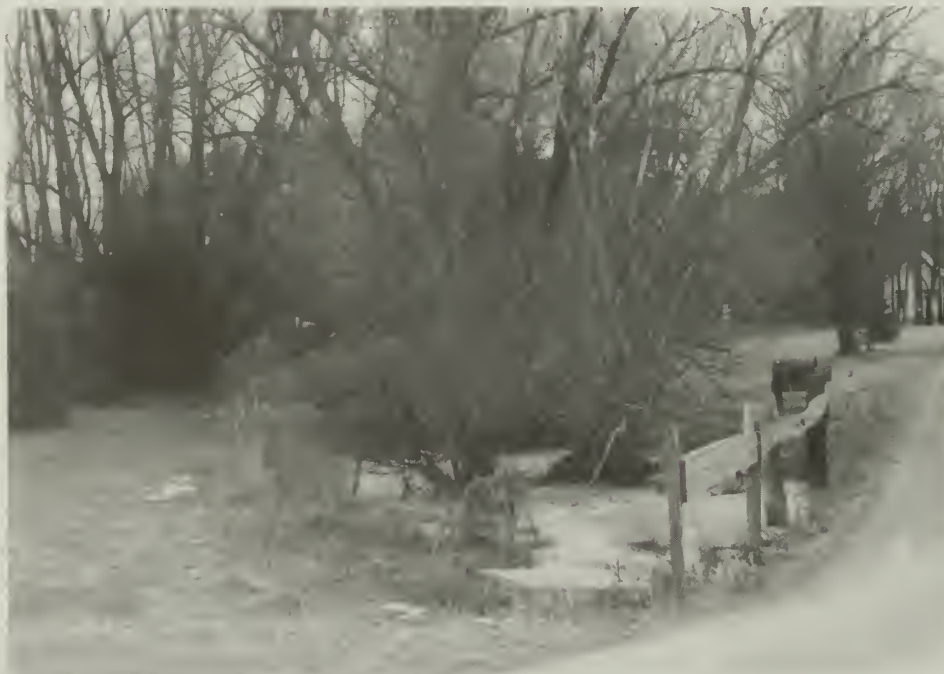
**Figure 5.39:** Existing pond at base of slope, 1993 (Photo # CLR-1107. Uschold, SUNY CESF).

Meyer also altered the existing pond on the second terrace at the bottom of the transition slope and constructed four additional ponds on the farm. The pond at the bottom of the slope was redefined and is now also used for irrigation on the farm. Meyer constructed two additional ponds at the southwest end of this existing pond. These three ponds directly abut the bottom of the slope (fig. 5.39–5.41). Two smaller ponds were constructed within the slope between the first and second terraces. A southern one located behind the farm complex and northern adjacent to the farm road leading to the second terrace (fig. 5.42 and 5.43).<sup>143</sup>

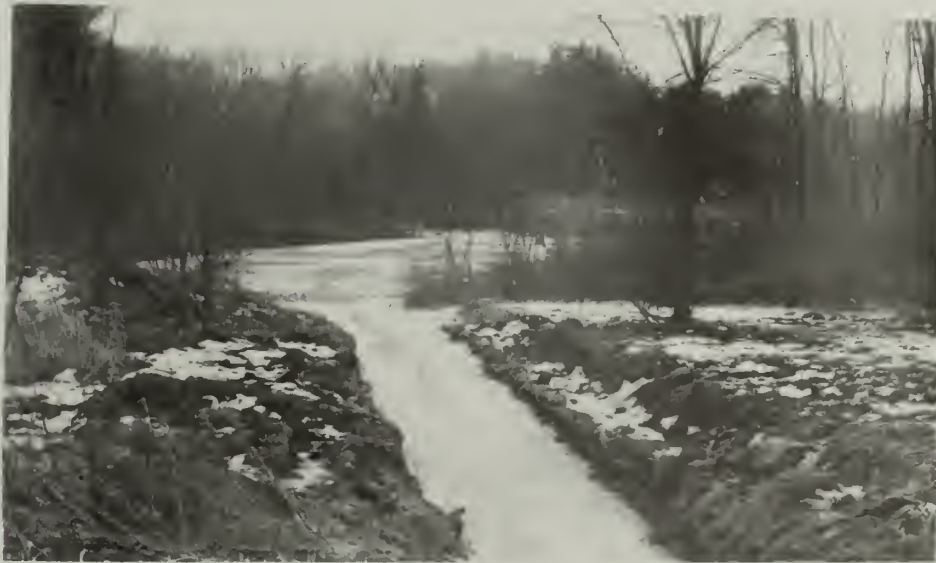
Figure 5.40: Northern Meyer pond at base of slope, 1993 (Photo # CLR-1672. J. Harris, NPS).

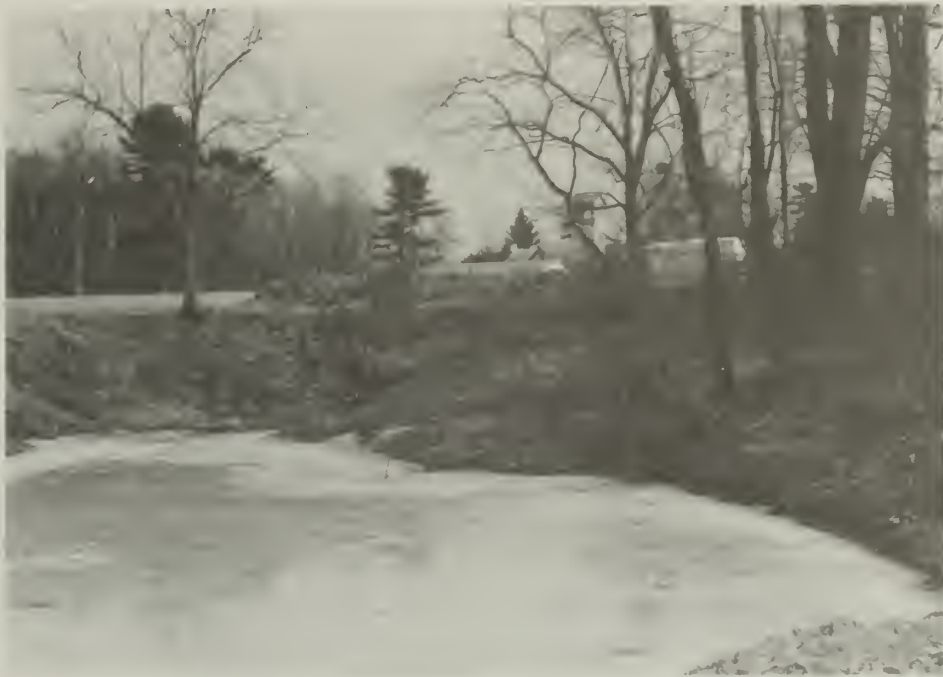
**Figure 5.43:** Southern Meyer pond within slope, 1993 (Photo # CLR-1669. J. Harris, NPS).

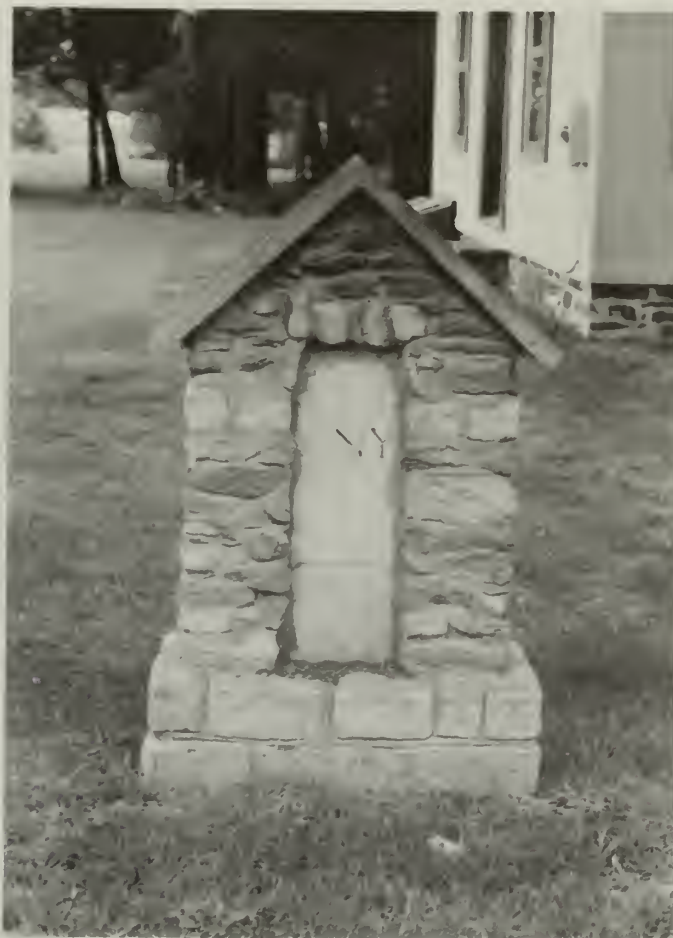
**Figure 5.45:** Stone marker in front of south gate house, 1993 (Photo # CLR-1601. Uschold, SUNY CESF).

While the staff was clearing the site of debris, all of the decorative items added by Campbell were removed, including all fences he constructed on the property. The only furnishing saved was the urn previously in front of the main house (fig 5.44). After the lawn was established, a replica of the urn was placed in the original location in front of the main house. A one-foot square concrete pad was constructed to support the urn. The original urn is kept in storage in the pole barn. A stone marker stands in front of the south gate house, placed there by Campbell as a result of his antique business. The origin of the marker was unknown at the time of the National Park Service grounds clean-up and it was, therefore, left in place (fig. 5.45).

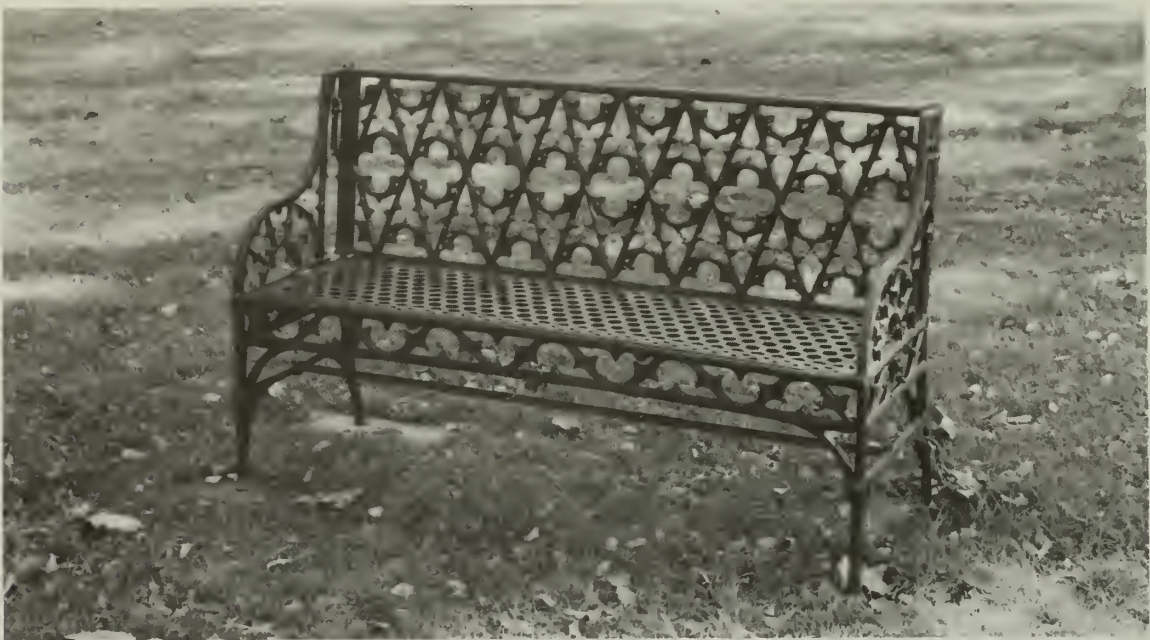
**Figure 5.46:** Benches on front lawn, 1993 (Photo # CLR-1659. J. Harris, NPS).

Many contemporary items have been added to the Park. Two reproductions of the original front lawn benches have been placed near the entrance to the main house (fig. 5.46). A flagpole and park sign also are on the front lawn, along the Post Road boundary. The flagpole is aluminum and approximately thirty feet tall. The sign is wood, approximately eight feet tall, and states the name of the Park (fig. 5.47). Three aluminum sheds have been placed behind the maintenance garage and mobile homes (fig. 5.48). Four portable toilets for visitor use are located in the north wood lot. They are positioned approximately twenty-five feet into the woods near the north entrance to the main house (fig. 5.49).

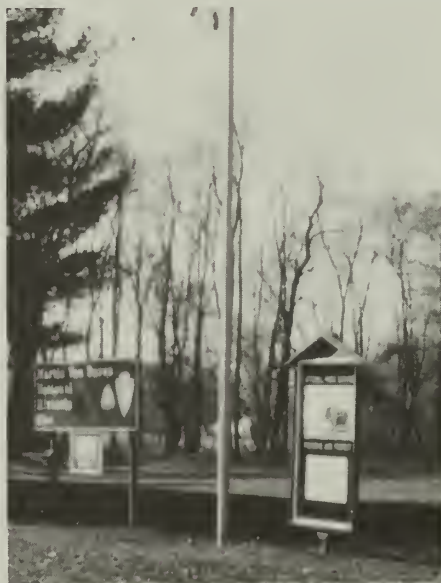
**Figure 5.47:** Park sign & flagpole in front of park, 1993 (Photo # CLR-3005. Uschold, SUNY CESF).

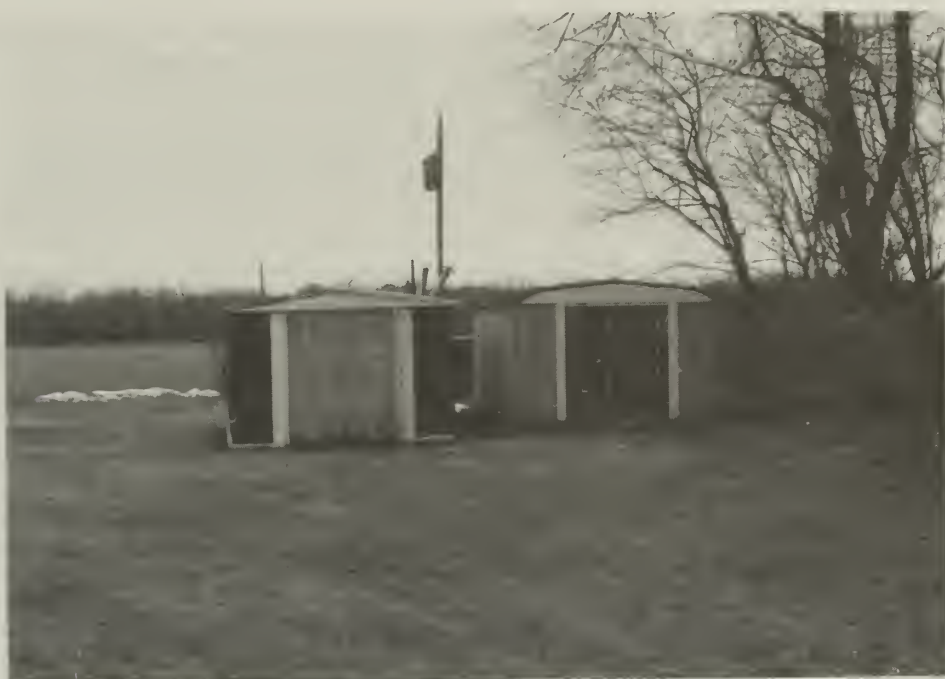
**Figure 5.48:** Aluminum sheds at rear of park, 1993 (Photo # CLR-1122. Uschold, SUNY CESF).

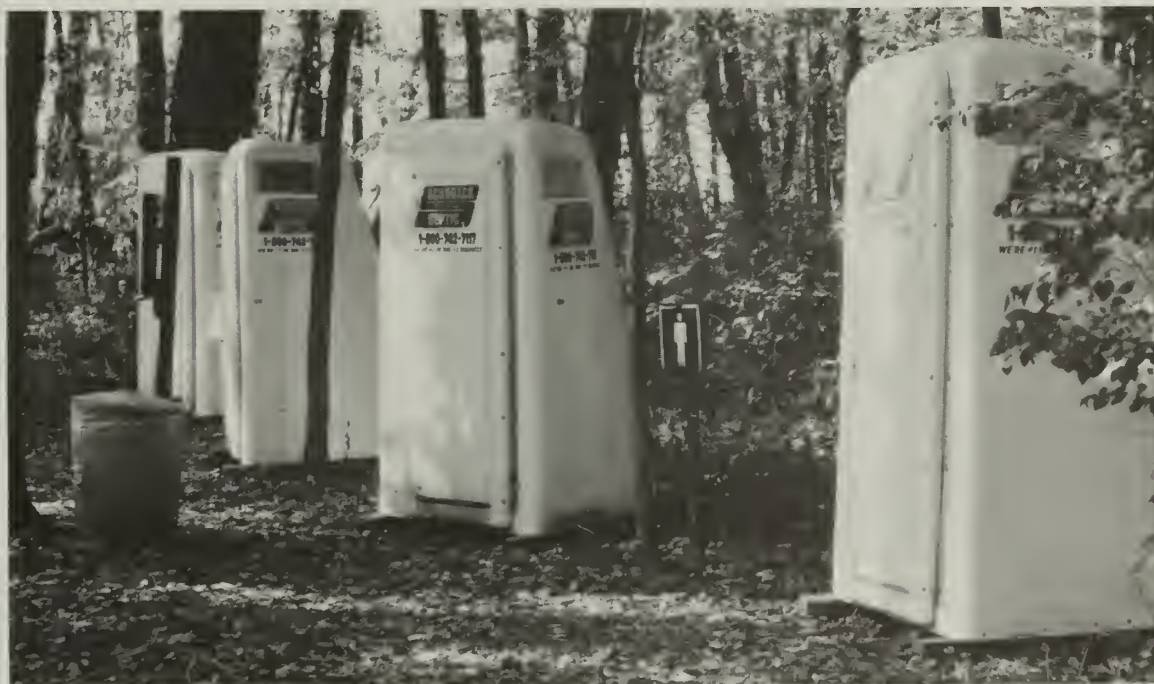
**Figure 5.49:** Portable toilets for visitor rest rooms, 1993 (Photo # CLR-3006. J. Harris, NPS).

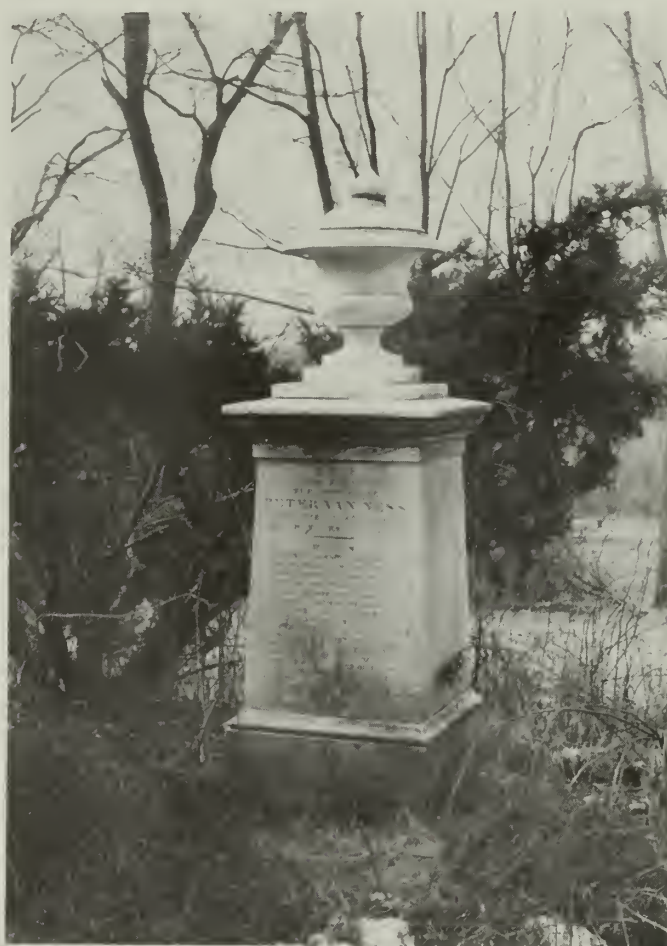
Located on the Meyer property is the headstone and grave of Peter Van Ness and his wife. The grave is no longer surrounded by a fence and the surrounding agriculture fields are now encroaching within five feet of it (fig. 5.50).

**Figure 5.50:** Headstone for Peter Van Ness grave behind main house, on Meyer property, 1993 (Photo # CLR-1102. Uschold, SUNY CESF).
