Abraham Lincoln Birthplace Unit Cultural Landscape Report

Abraham Lincoln Birthplace Unit,
Abraham Lincoln Birthplace
National Historic Site

Cultural Landscape Report

National Park Service
Southeast Regional Office
Cultural Resources Division

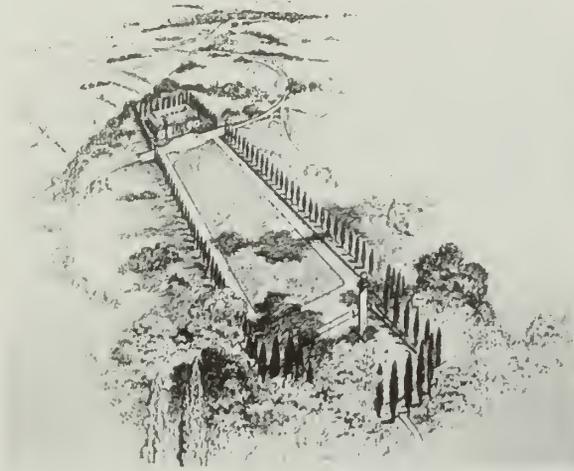
FIGURE 3. Pope's plan for a Lincoln Birthplace Memorial, 1908.

used the same classical design vocabulary evident in the Lowell and Guerin plans, but the structure is more temple-like than the previous design (Fig. 3). Unlike the Lowell and Guerin plans, which were based on a site visit and captured the reality of the hilly terrain and the shape of the site, Pope placed his building in a “broad green plaza” that showed little reference to the existing conditions. Pope’s final plans for the site would change dramatically, but the Lombardy poplar allée, setting off a raised temple-like structure with forecourt, were elements that remained in the final design. This article is the first mention that the “museum will house, as its central object of interest, the weather-worn little log cabin in which Abraham Lincoln was born.” The project, “which will tell the early yeomanry life out of which Lincoln came,” was expected to cost “two hundred and fifty thousand dollars.” The text

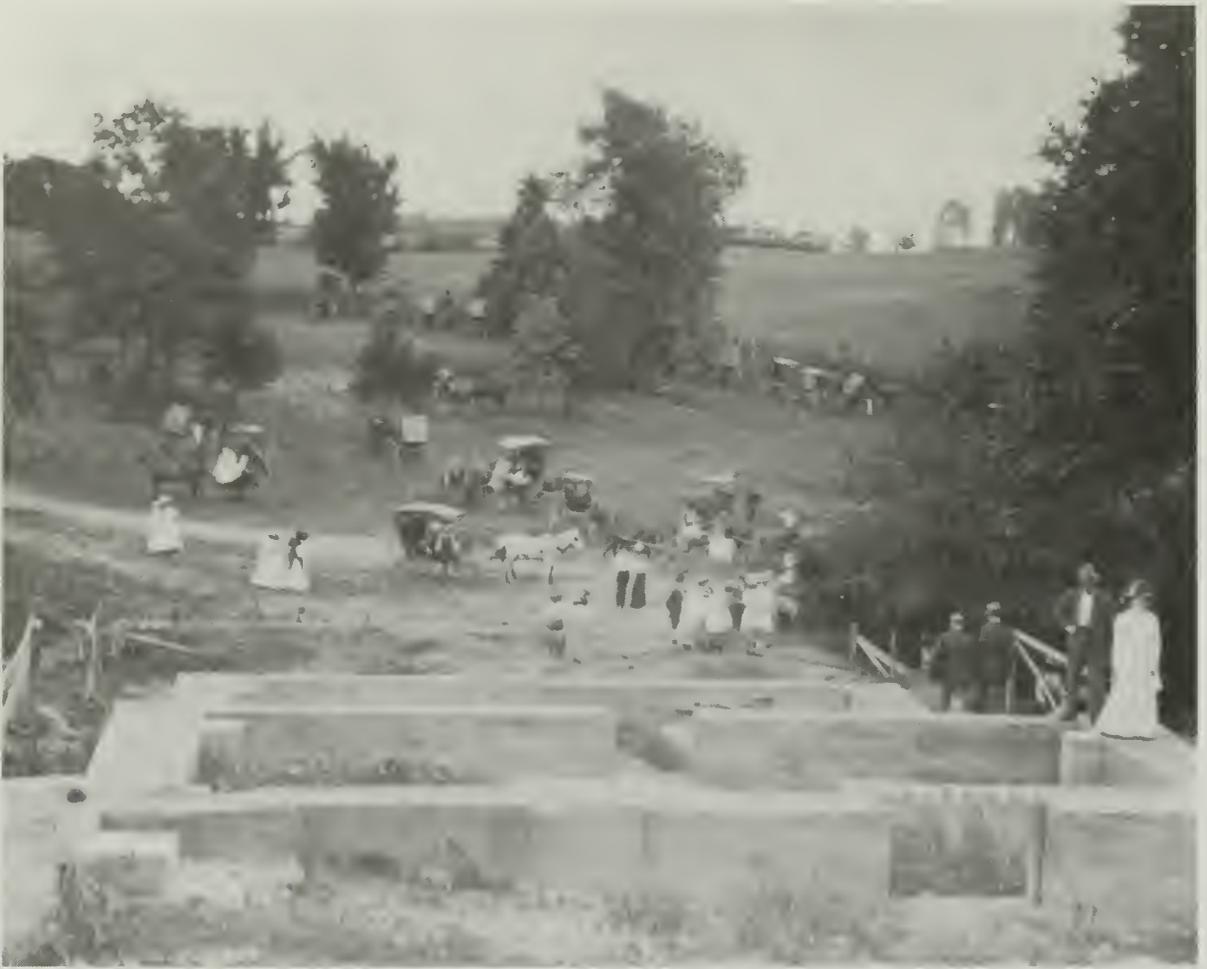
FIGURE 6. Construction of the Memorial Building Stairway, c. 1910.

plantings, were in place at the time of the dedication (Fig. 6).

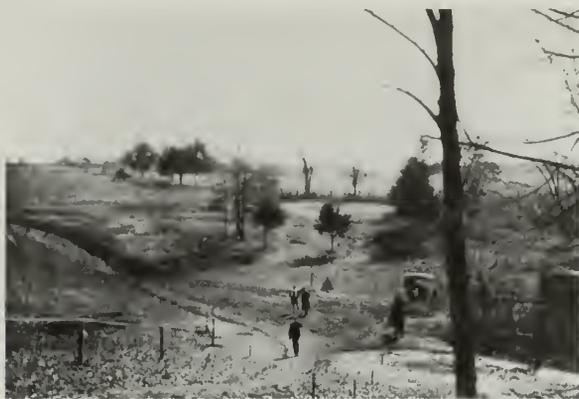
FIGURE 7. Construction shot showing agricultural setting of the site, c. 1910.

Site Design and Layout. The centerpiece of the design is the neoclassical Memorial Building, which enclosed the Birth Cabin. It was sited atop the knoll at the spot where the Lincoln cabin allegedly stood (identified as early as the 1860 Rowbotham sketch), and with the orientation that *McClure's Magazine* captured in its 1895 photograph. The formal axial relationship of the Memorial Building and the Plaza set up a controlled frontal view of the Memorial Building facade, which was reinforced by a symmetrical planting of Lombardy poplars (*Populus nigra* 'Italica') outside the formal stairway. From the highpoint at the Memorial Building, the visitor had a distant, southeasterly view of an agricultural patchwork, dotted with small farms and woods relatively unchanged from Lincoln's childhood (Fig. 7).

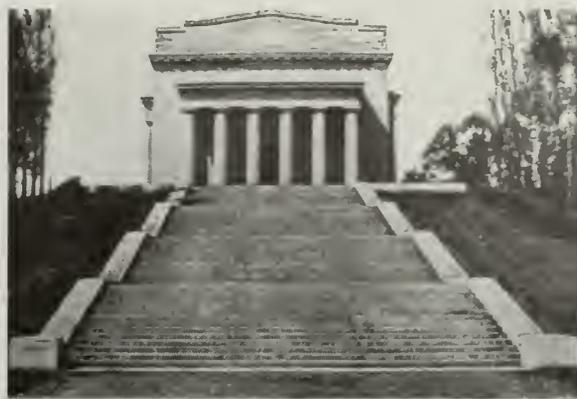
FIGURE 8. Memorial Building and Stairway, 1924.

ascended fifty-six steps, one for each year of Lincoln's life. The Memorial Stairway was broken into groups of fourteen risers with four landings (Fig. 8).

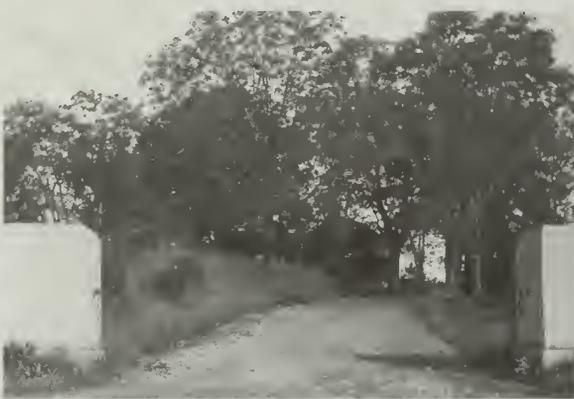
FIGURE 10. Granite entry markers, undated.

Circulation. The formal entry to the site continued to be from the Jackson Highway. The approach, although improved to a gravel surface, seems to have remained a curvilinear route, along which vehicles and visitors made their way into the Plaza, and from there, made the final ascent to the Memorial Building. No other formal paths or walks were developed at this time outside the Plaza area. Pink granite entry markers incised with the park's name were placed somewhere near the entry, although their exact location is not known (Fig. 10).

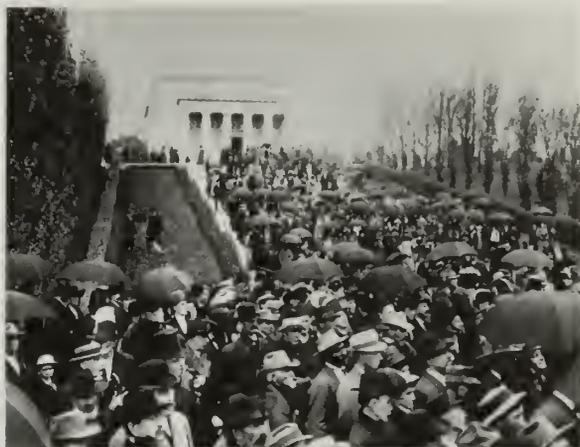
FIGURE 12. Dedication photo showing mature plant material along Memorial Stairway, 1911.

Rome.³⁹ The multi-tiered evergreen hedge planting echoed the Memorial Building facade's fine details of massing and line. The period photographs document sizeable trees (at least fourteen feet tall) and fully formed shrub plantings in place for the dedication. It is evident by the refinement of height and massing of the hedges that a considerable sum was spent to obtain mature plant material. Gaps, which are typical between new plantings, are not evident in the period photographs, and it is clear by the evenly pruned lines of the hedges that some level of management was already occurring at the site. Without additional information, it is assumed that the material of the landings was gravel, and that the lawn panels were planted in Kentucky bluegrass.⁴⁰ (Fig. 12)

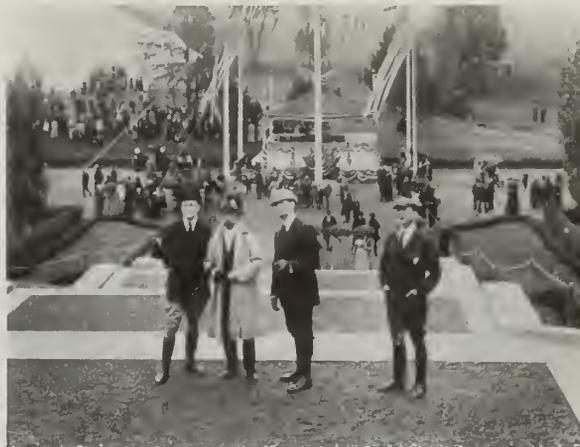
FIGURE 13. Dedication photo showing Memorial Plaza, 1911.

Plaza and Flagstaff. The Plaza was completed as Pope planned at least as far as the drawings illustrate and period photographs document. It is clear that the taller hedge planting, which extends beyond the camera's field of view, enclosed the entire Plaza as Pope's rendering suggests it should, even to the detail of the reverse-radius corners at the base of the Memorial Stairway. The back edge, however, appears to be rectilinear. The material of the Plaza appears to be gravel, from which an elegantly detailed, white, cast-metal flagstaff emerges. The height of the flagstaff is not known,

but it is tall enough for the flag to be out of view. The flagstaff is central to the Plaza and on axis with the center of the Memorial Building. Unlike Pope's rendering, however, which depicted a modest square base, the flagstaff base as installed was a pink granite ring, the material matching the Memorial Building and Stairway. It was approximately twelve inches tall and five feet in diameter (Fig. 13).

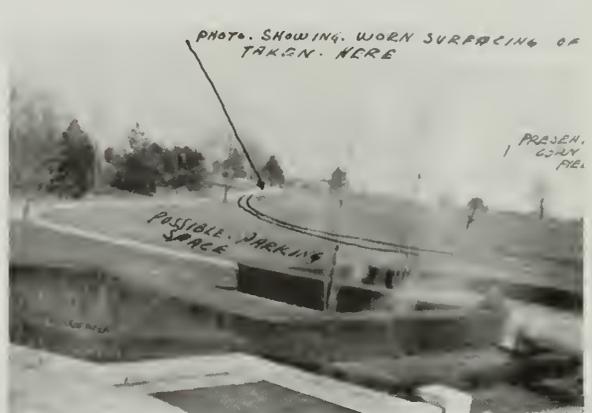
FIGURE 17. The entrance road and park landscape beyond, 1928.

Beyond the hedge to the south, Figure 17 shows a rising, uneven terrain with longer grass and scattered evergreen and deciduous trees that

would have predated the Memorial Building landscape improvements. The photograph suggests that the site improvements described in the 1910 report were limited to shaping the knoll and achieving a smooth even grade on the Plaza. A fence line can be distinguished along the southern property boundary, and haystacks dot the field beyond.

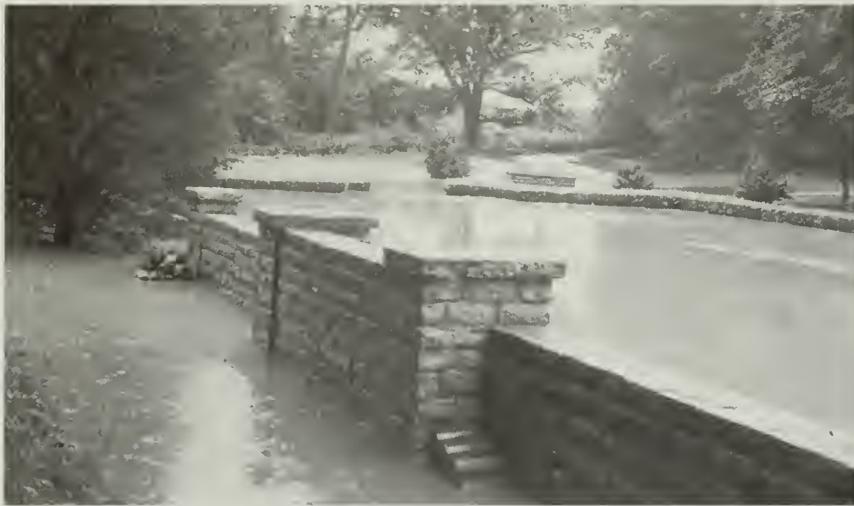
FIGURE 19. Memorial Plaza under water, 1935.

The most serious problem Jones reported was seasonal flooding that submerged the Plaza in several feet of water, for which the only outlet was the Sinking Spring.⁴⁵ Heavy rains carried silt from the surrounding agricultural fields into the Plaza, which was the low spot for approximately 105 acres. As the waters slowly receded through their only outlet—the Sinking Spring—_inches of mud were deposited on the Plaza, making the surface impossible to maintain, and conditions for visitors, on foot or in vehicles, untenable (Fig. 19). In addition to the problems caused by these floodwaters, the approach road leading to the Plaza had never been paved, and during wet seasons, visitors would drive their vehicles across the fields to avoid the muddy lane.

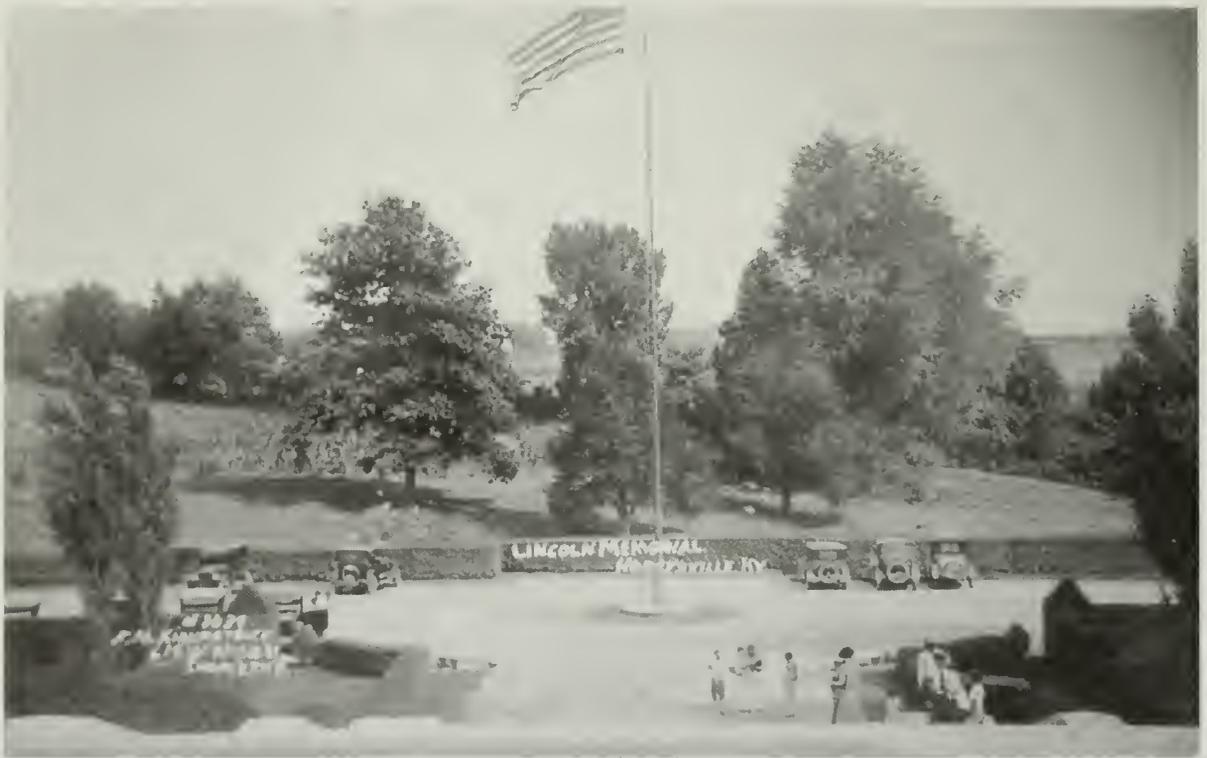
FIGURE 20. View of Memorial Plaza with cultivated fields in the background, 1928.

[T]he land is rolling, bordering on ruggedness, and geologically belongs to the cavernous limestone of the middle Mississippi system. . . . about 30 acres [of the farm] are cleared for farming by the assistant caretaker, the greater part of the farm is almost impenetrable except with the assistance of a brush-hook, due to a dense undergrowth of wild grape, greenbrier, blackberry, sumack [*sic*] and other shrubs. The farm is well wooded on both sides of the highway with cedar in preponderance. Other trees in order of frequency of occurrence are – several varieties of oak, wild cherry, wild plum, sycamore, maple, ash poplar and black locust. . . . The tracts that are worked by the assistant caretaker are in corn, though at other times some hay has been grown. Nearly all the adjacent land is cleared and most of it is under cultivation. About four acres of the land under cultivation by the assistant caretaker are on the slope off onto the Memorial Building between the Plaza and the log house, presenting an unsightly appearance and at the same time contributing to the deposit of silt on the plaza by erosion. Instructions have been given to discontinue cultivation of this area and in September a mixture of three parts Kentucky blue grass and one part red top and one part white clover will be sown at the rate of 175 pounds per acre.⁵⁰ (Fig. 20)

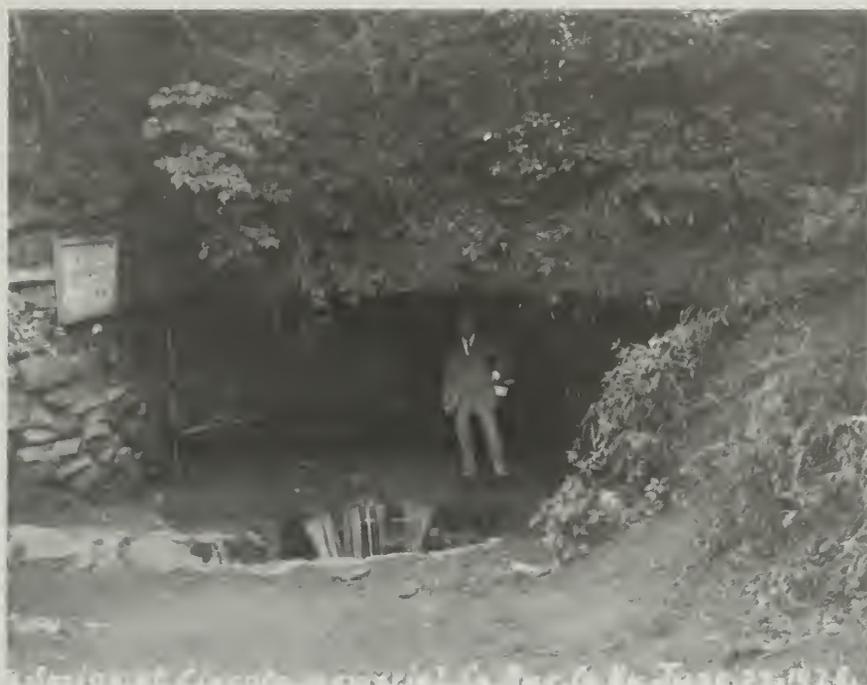
FIGURE 21. Picturesque nature of the Sinking Spring, 1928.

The report included a detailed description of the Sinking Spring as “the only natural distinguishing feature of the farm” and “picturesque as an object of interest” (Fig. 21). Access to the spring was through a “narrow opening in the hedge, . . . over a series of stone flags half way down the steep slope. The balance of the distance, of about 30 feet is by foot path.” The concern was that in heavy rains, the path became covered in “six inches of silt” resulting in a “slippery, dangerous condition, as a loss of footing might mean a ten foot fall.”⁵⁴ Various recommendations were proposed, and some rejected, for improving this situation. The report confirmed that the Plaza had a crushed rock base, which by 1928 was covered in ten inches of deposited silt from years of flooding. It recommended that the crushed rock in the Plaza, as well as in the stairway landings, be replaced with “sidewalk brick on a concrete foundation”⁵⁵ (Fig. 22).

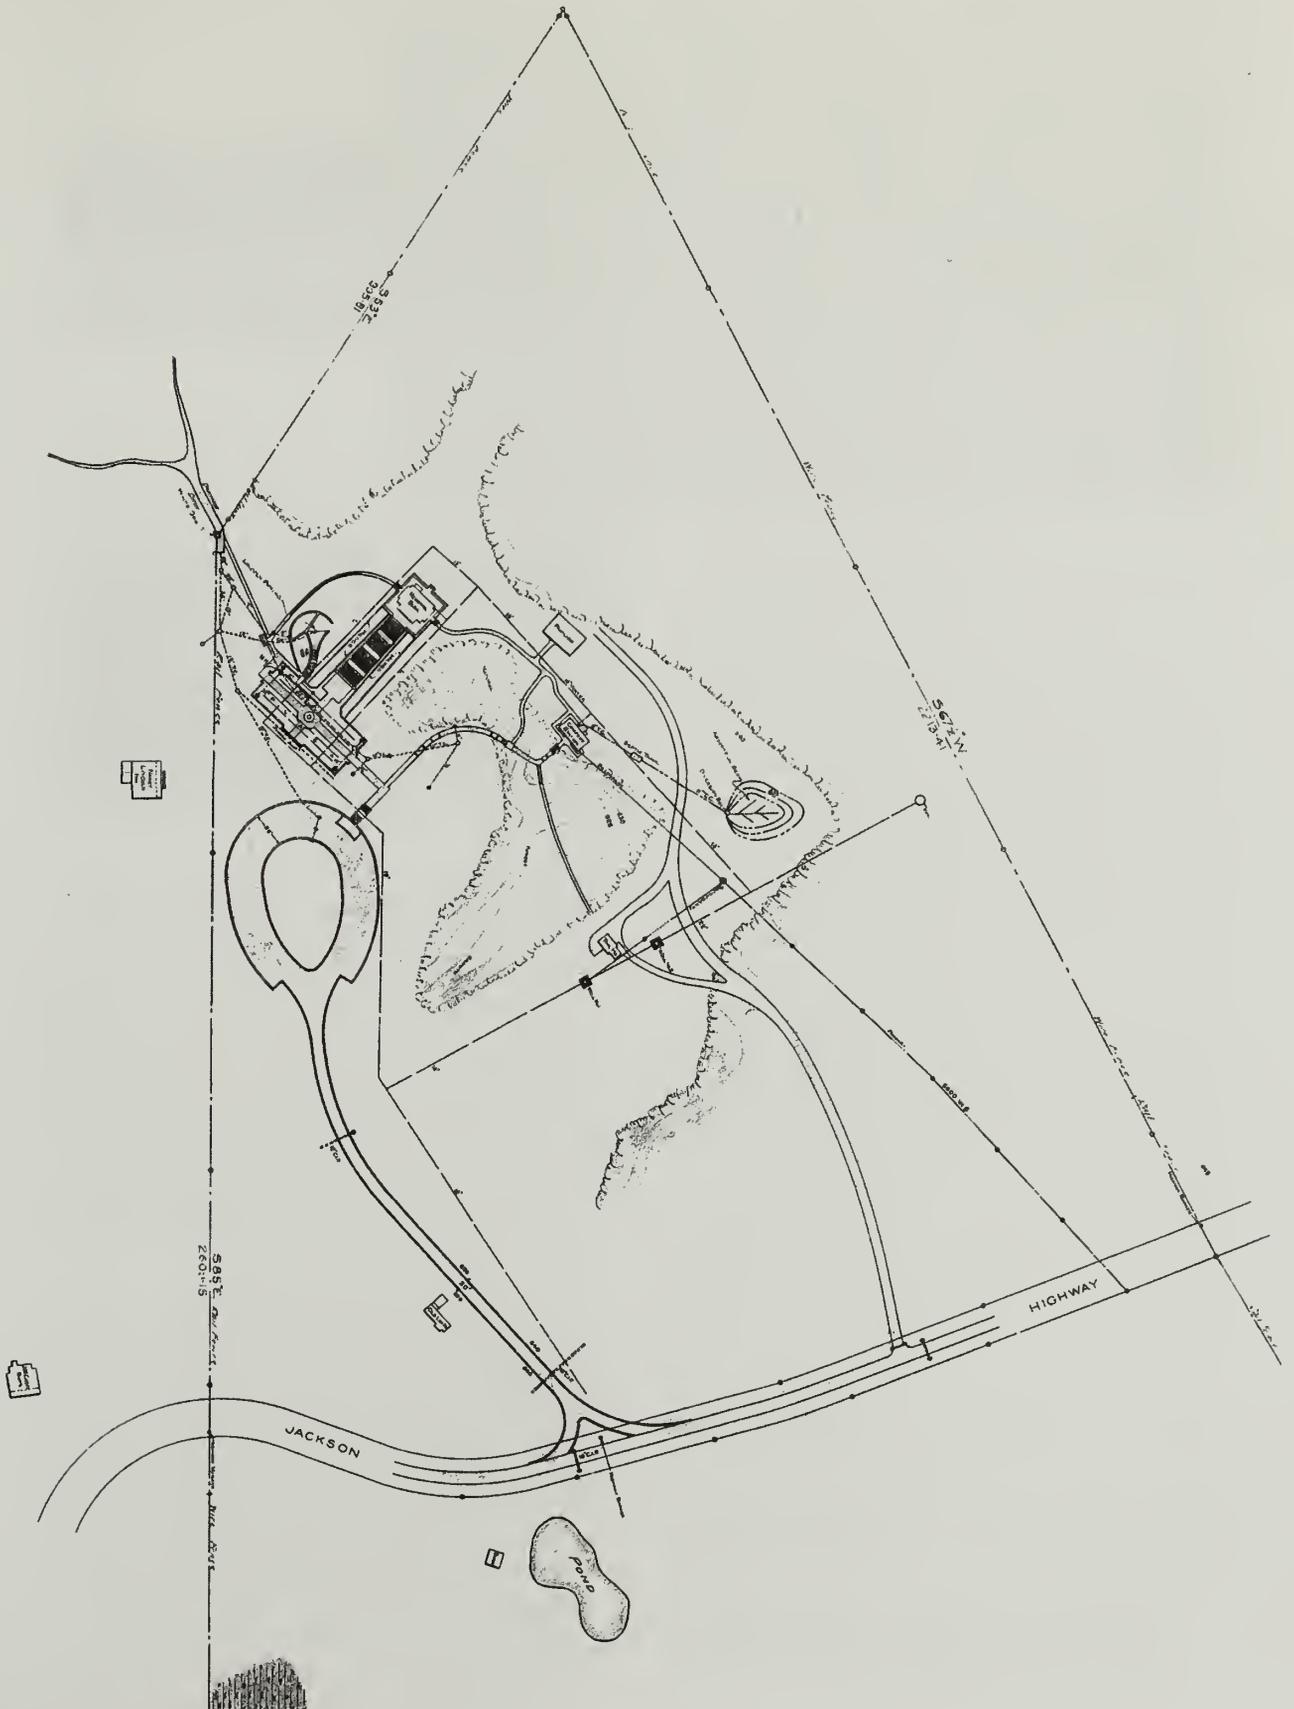
FIGURE 23. Lincoln Farm National Monument - Reservation Map, 1932.

information for this period are the “Lincoln Farm National Monument-Reservation Map” (338/9009 dated 1932, Fig. 23) drawn by the Quartermaster General, War Department documents, period photographs, and Peterson’s administrative history. Peterson’s work is particularly good for its detailed descriptions of the sequencing of War Department improvement projects, which is not repeated in the CLR. A fourth source is an undated set of existing conditions (338/6003) that seems to record the work accomplished by the War Department on or about the time of transfer to the NPS. They cover the western half of the site only. What is not established is whether these were the first existing drawings accomplished by the NPS or the last as-built plans documenting the War Department’s efforts. In addition to showing two-foot contour elevations and individual tree sizes and species, these plans were drawn in much greater detail than any map that has been found to date and will be used to supplement information not illustrated on the plans but supported by other sources.

the monumental character of the Pope-designed landscape. They illustrate how Pope's entire effort was crowded into the southwest corner of the property, with its principal views offsite (see a more detailed description under Views and Vistas).

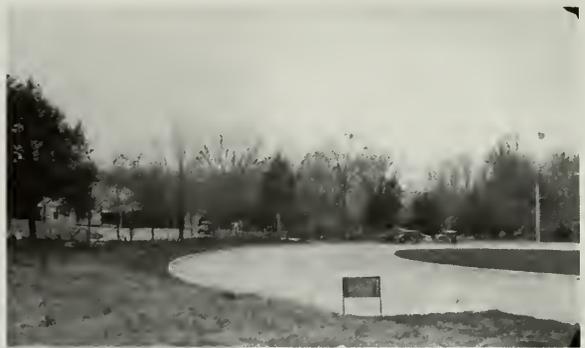
FIGURE 24. View of parking ellipse, 1930s.

Highway following, for the most part, the LFA alignment. It terminated in a parking ellipse sited approximately 5 feet above and just east of the Plaza. A generously sized grass island (approximately 220 feet by 120 feet) formed the center of the ellipse. Using the more detailed, undated plans, the parking ellipse was to have had a 20-foot-wide center travel lane, with 18-foot parking lanes on either side. Although the parking was not striped, the allocated space would allow in excess of fifty parked cars (Fig. 24).

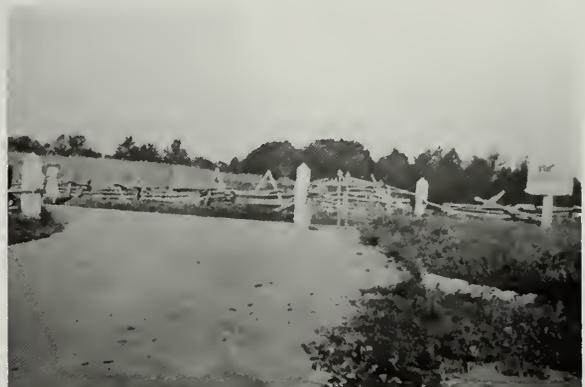
FIGURE 25. View of entrance, 1934.

Entry treatments are only documented in period photographs. Although no record details their removal, it is safe to assume that the War Department removed the LFA pink granite entry markers because of the improvements at the entrance (widening, paving, and planted islands). The LFA markers were replaced with four stone pillars with a pointed top. Wire gates were added to close the entrance when the park was closed to visitors (Fig. 25).

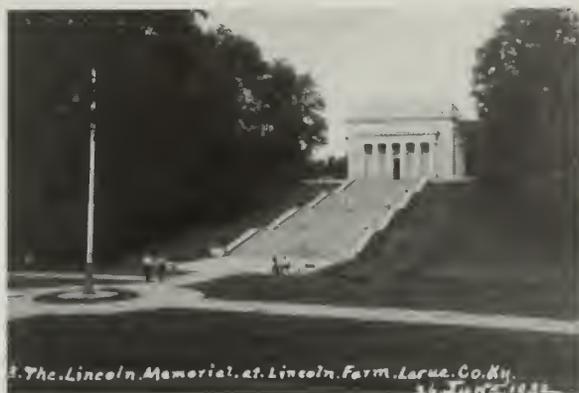
FIGURE 27. Lincoln Memorial Building Landscape after War Department improvements, 1932.

made in the park's administrative history of 1968 or in War Department records available at the park. However, it is clear from period photographs that the Lombardy poplars, which flanked the Memorial Building Stairway, were replaced with younger specimens at about this time. It is worth noting that Lombardy poplars are susceptible to canker diseases and are often short-lived. This could account for the need to replace the original trees so soon after their initial planting. Neither the 1932 plan nor the undated plans document a line of trees in association with the hedges outside the Memorial Building Stairway. Also at this time, period photographs document that the multi-tiered hedges on either side of the Memorial Building Stairway were simplified into a single rectangle at one height. Simplification of the hedge may have resulted from either lack of staff to keep the hedges trimmed as designed or lack of training on how to care for this sophisticated planting (Fig. 27).

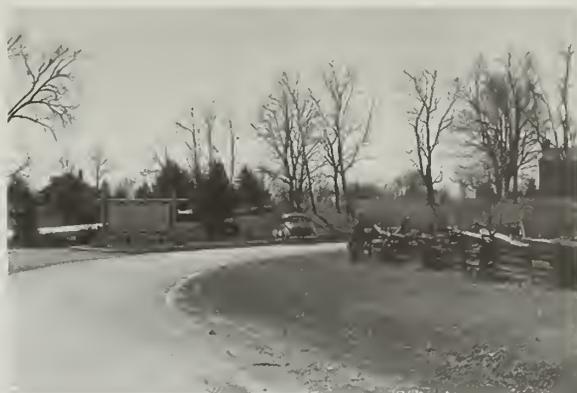
FIGURE 29. New entrance features, 1930s.

Small-scale Features. The undated plans document the addition of twelve, six-foot benches in the Memorial Landscape. Four—one at each corner—placed at the Memorial Building Terrace level, two—facing each other—on each of the stair landings, and two—at the base of the Stairway in the front corners of the Plaza. Also at this time, Peterson records that the park obtained “2,500 old rails” from Fort Knox, which were “set up around those sections of the park visible from the highway, the approach road, and the plaza.”⁶¹ Period photographs illustrate an eight-rail snake fence with a two-rail vertical cross support. A small wood entrance sign elevated on a wooden post was placed in the center of the planted island (Fig. 29).

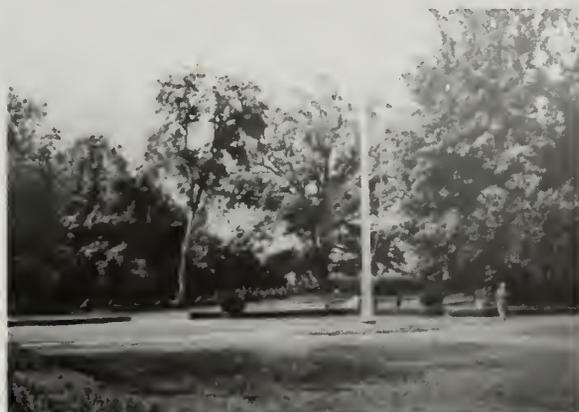
FIGURE 28. Closeup of Memorial Plaza, 1928.

Plaza and Flagstaff. The Plaza, in addition to being trenched for an underground drainage system, was modified for pedestrian use. With the improvement of the approach road and construction of the parking ellipse, automobiles were no longer able to enter the Plaza. Therefore, what had been a broad gravel surface to accommodate this use was put into grass, with formal stone walks established on cross axis with the flagstaff. The stone walkways met at a stone paved circle that ringed the flagstaff. A two-foot-wide grass ring was maintained between the flagstaff base and the walkway (Fig. 28).

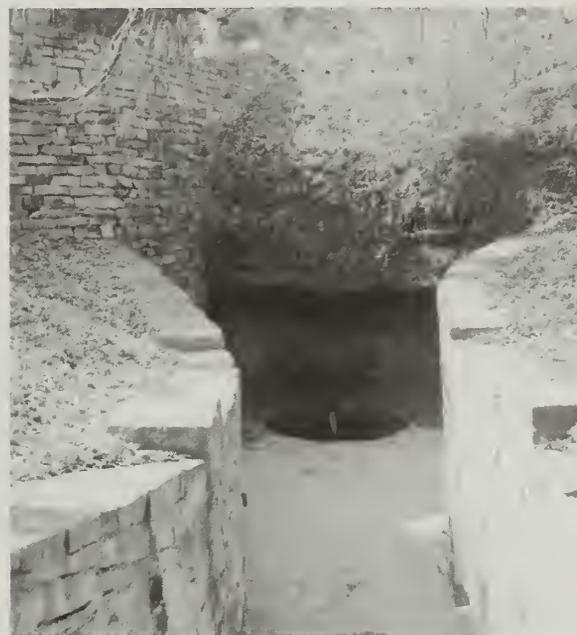
FIGURE 30. The Sinking Spring, 1938.

Sinking Spring. In order to address the visitor access hazards pointed out in the 1928 report, stone retaining walls and stone steps were constructed at the spring to formalize a safe way down to the water level. Through an enlarged opening in the Plaza hedge, a straight flagstone walk was constructed connecting the Plaza to a landing at the top of the steps. The steps descended approximately fifteen feet to another stone landing just above the spring itself. Although no photographs survive to document the completed construction, a 1934 inspection report

by the NPS upon transfer of the property to their jurisdiction gives some indication of the resulting effect. The Sinking Spring, once a beautiful natural setting, had been turned into a “walled-in artificial place approached by steps walled in on each side with a high retaining wall and too much masonry”⁶³ (Fig. 30)

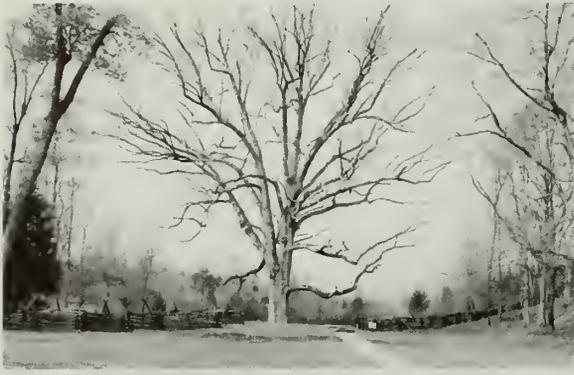
FIGURE 31. The Boundary Oak, 1938.

concrete and banded with iron and guy wires. The tree was in danger of being strangled by the iron band and old decay had been detected behind the concrete.”⁶⁴ According to a memo from Maslin to the Quartermaster General in July of 1929, a tree surgeon was called in to assess the tree’s condition, and the tree was given only a 50 percent chance of survival. In addition to this already precarious condition, the engineering solution to the Plaza’s flooding problems included the construction of a retention area at the base of the oak where floodwaters could be held and allowed to dissipate slowly so as not submerge the Plaza. Period photographs show that the work did not visually impair the oak, but it surely was a factor in hastening the oak’s death, which occurred in 1976 (Fig. 31).

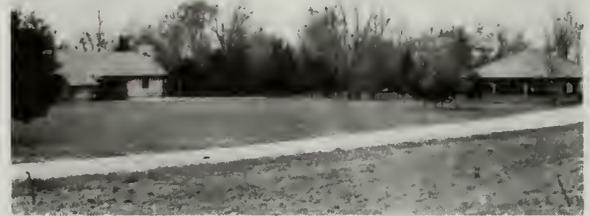
FIGURE 33. Rustic picnic pavilion and restroom facility, 1938.

Other Structures. Two rustic log structures were constructed to the northeast of the Memorial Building: a picnic pavilion and a restroom facility (Fig. 33). Both structures were a considerable distance from the parking ellipse and could not be accessed by automobile (see “Circulation” for a description of the walkways constructed to provide visitor access). A stone maintenance garage and two stone pump houses were placed off the service road.

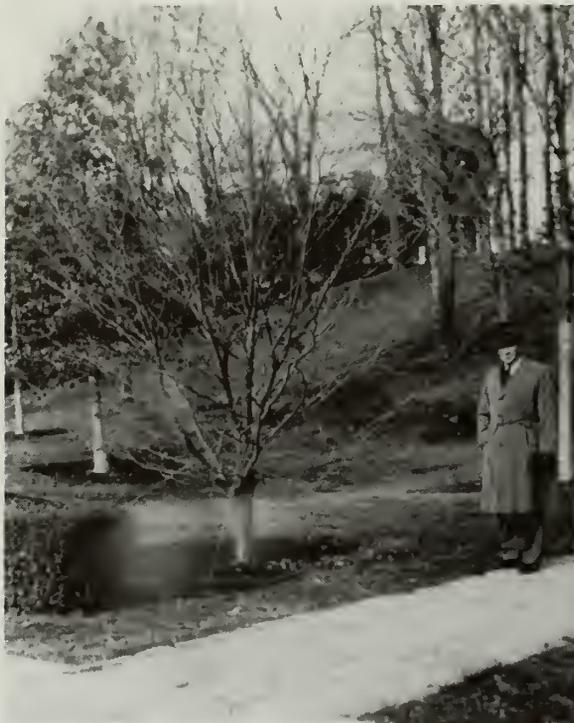
FIGURE 38. Deciduous trees planted outside the formal landscape, 1935.

In addition to the evergreen planting immediately around the Memorial Building, some large deciduous trees were planted to improve the wooded areas just outside the formal landscape and along the walk from the parking ellipse to the Plaza (Fig. 38).

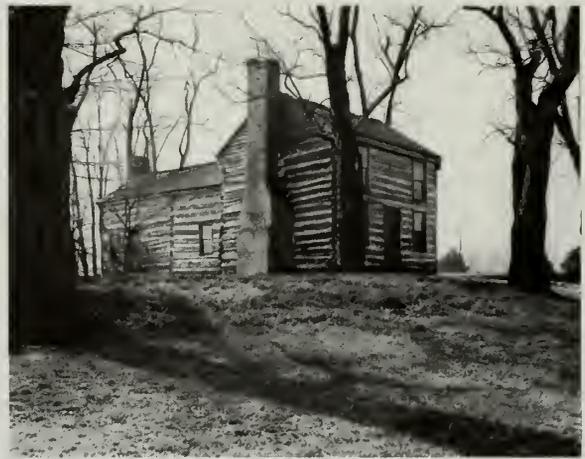
FIGURE 39. The Creal house, 1938.

The other major effort of the Park Development Era was a final decision on the disposition of the Creal house. In January 1941, a "Report on the Inspection of the 'Creal House,' Abraham Lincoln National Historical Park" was submitted by Thor Borresen, Assistant Historical Technician. Borresen described the house as having been "constructed of hand hewn oak logs" and represented "several periods of construction of varying ages." In a detailed assessment of each section, Borresen determined that the structure was about 65 to 125 years old, with the oldest

sections being of the highest quality log and construction technique (Fig. 39). He wrote that during its use by the "W.P.A. . . . all the clay chinking between the logs was removed and lime mortar chinking was replaced."⁶⁹ Although unsure of its historical significance in connection to the Lincoln story, Borreson recorded that Superintendent Cissell's family was kin to the Creals, and that the Creals were the only owners since the Lincolns. He also indicated that the house, as an agglomeration of log structures, was probably moved to its present site from another location, possibly after the construction of the Louisville Nashville Road in order to be closer to it. Borreson remarked that the house was an interesting artifact in that it represented the efforts of early pioneers to improve their living condition. "Beginning with a small one room cabin they gradually expanded as their incomes became larger. Thus the provider, through his determination and physical effort, provided a nominal comfort for his increasing family." He concluded the report with "[W]e would then have the two extremes. The Creal cabin group would show the humble conditions under which Abraham Lincoln was born. The formal memorial building would illustrate how a great nation perpetuates the memory of a great man."⁷⁰ Despite the interest in the structure and the fact that its like was quickly disappearing from the

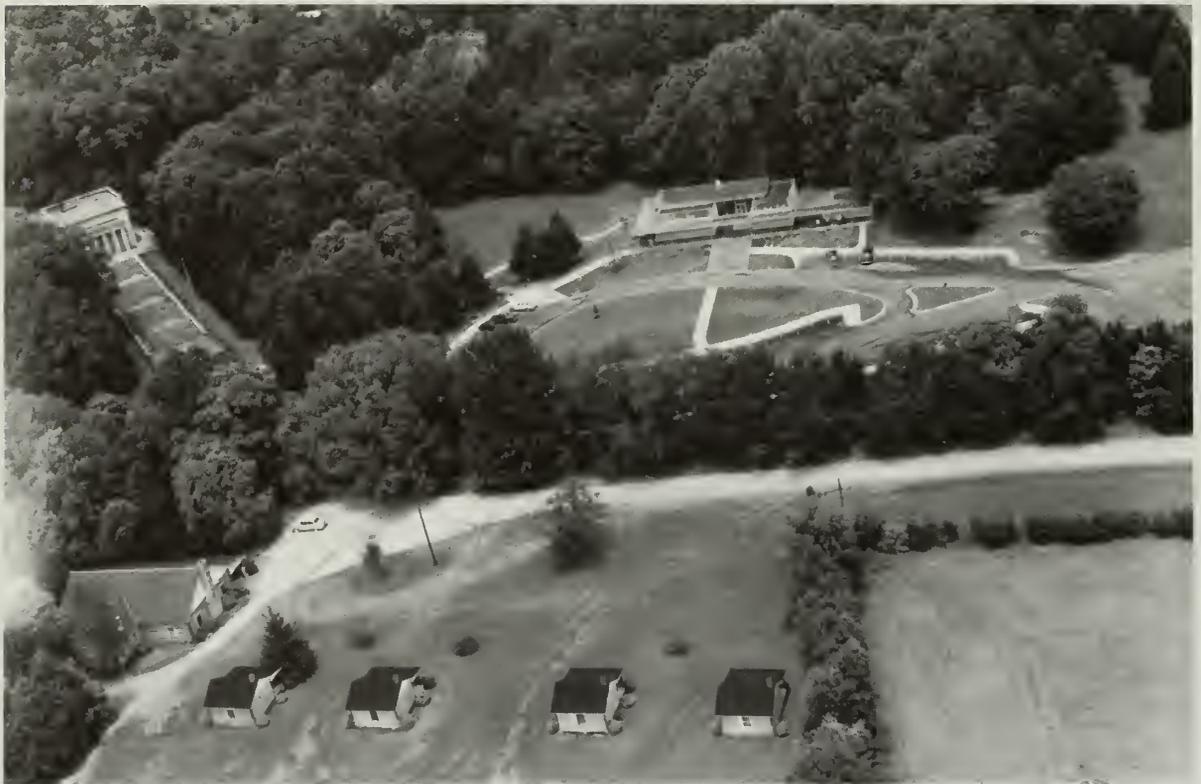
FIGURE 42. Aerial photograph, 1959 (note change in vegetation from Figure 26).

Views and Vistas. The addition of a Visitor Center in such a prominent location changed the views to and from the Memorial Building Landscape. In addition to the building, trees added to the planting island to screen newly created parking spaces also changed views along the entrance road (Fig. 42)

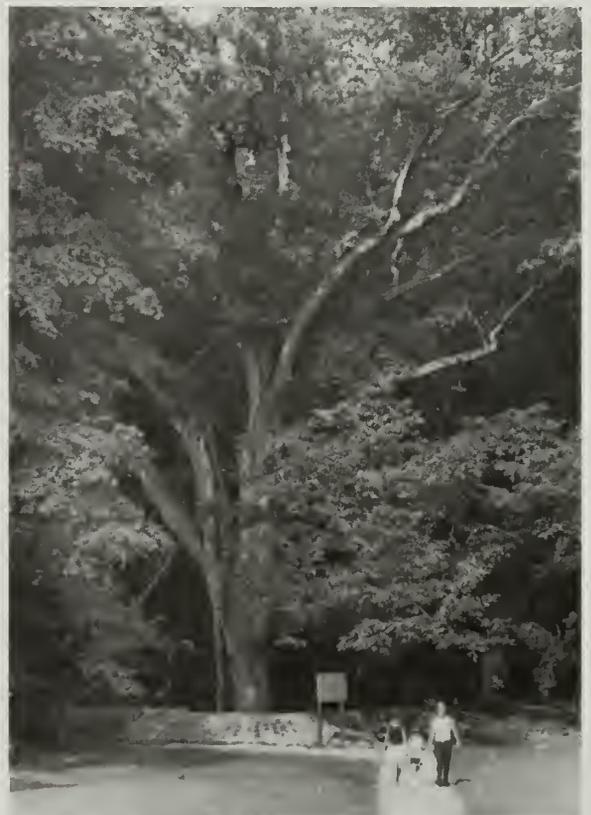
FIGURE 43. The Boundary Oak, 1959.

Boundary Oak. Although not documented, it would appear from period photographs that the park continued to change the conditions immediately surrounding the Boundary Oak. An additional six-and-one-half acres was purchased in the late 1940s to protect the oak, but period photographs document continued manipulation of the area for flood control (Fig. 43).

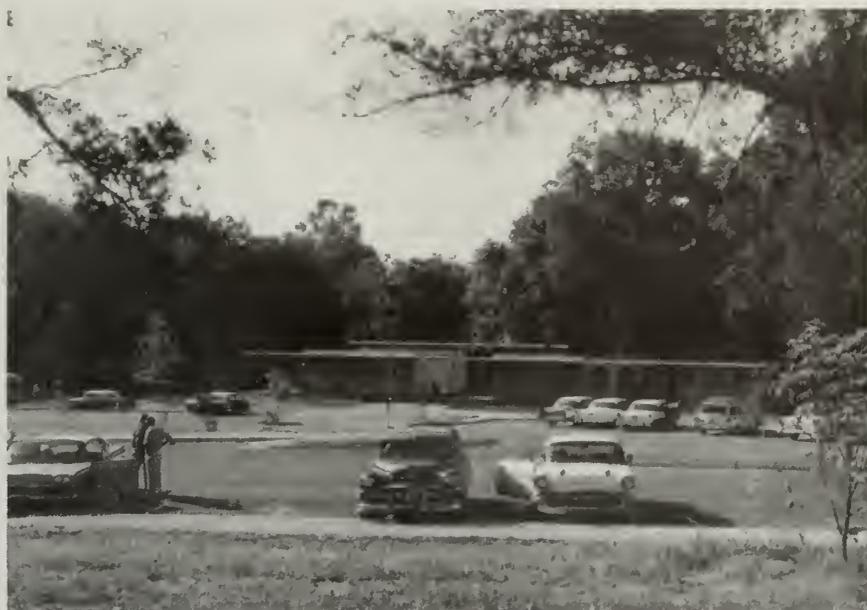
FIGURE 44. The Visitor Center, 1959.

The Visitor Center with its freestanding rest room was the most significant building constructed at the park during Mission 66 (Fig. 44). Designed in the Modern Style, the Visitor Center employed structural steel and masonry (white brick). The main entrance into the lobby was set back from the front facade, forming an entry courtyard. A covered walkway ran the length of the south and west facades of the building. The flat-roofed cover of the walkway abutted the building on the inside edge and was supported by six-inch-square metal columns spaced approximately ten feet on center along the outer edge of the walkway. A broad entry walk connected the Visitor Center to the parking ellipse with two steps occurring at the intersection of the covered walkway and the entry walk. Secondary walks half that width connected the Visitor Center to the War Department steps leading down to the Plaza and to parking.

Visitor Center. Plans approved in 1991 (completed in 1992) called for a permanent roof to be constructed enclosing the entry courtyard. Unlike any of the other horizontal lines of the Visitor Center, this addition was a steep tinted-

glass front-facing gable. A major addition to the Visitor Center occurred between 1993-94, including the relocation of rest rooms and administrative offices and the addition of a handicapped ramp and water fountain. The installation of a new roof occurred in 2003, which changed the roof lines back to a flat profile and removed the glass atrium.

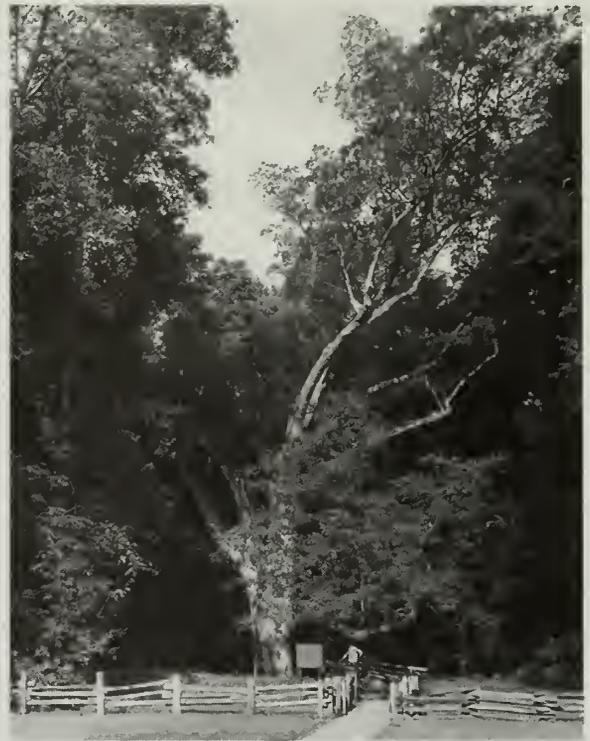
FIGURE 45. The Boundary Oak, undated.

Boundary Oak. In 1976, following a year in which the area surrounding the Boundary Oak flooded, the new growth put out by the white oak failed to mature. The tree was finally taken down in 1986, and testing revealed the age to be 195 years. Before its death, the oak reached 6 feet in diameter, 90 feet in height, and had a crown spread of 115 feet (Fig. 45).

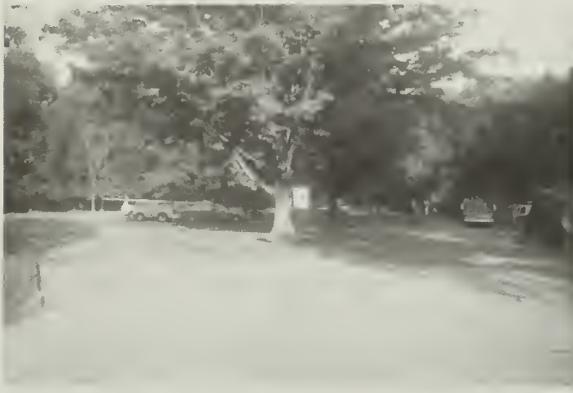
FIGURE 49. Parking ellipse, 2003.

Vehicles enter the Birthplace Unit from U.S. 31E onto an asphalt two-way entrance road. Traffic circulates one-way around an ellipse with angled parking on both sides (Fig. 49). A graveled overflow parking area is located east of the ellipse.

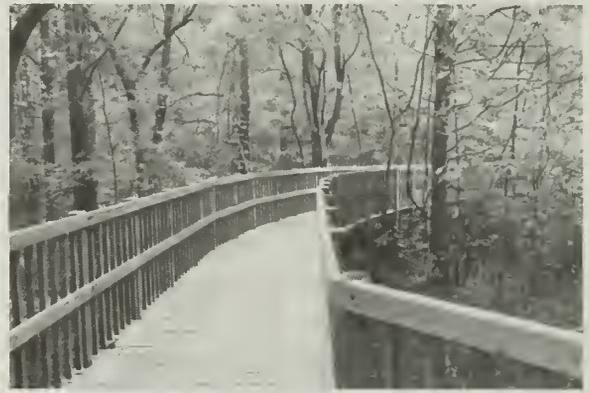
FIGURE 50. Boardwalk through wooded area, 1996.

A .3-mile trail constructed circa 1970 provides visitors with a short walk through the woods west of the Memorial Building. Several trails exploring the wooded areas of the eastern half of the Birthplace Unit were developed in the early 1970s. Another major addition in 1991 was a raised 800-foot-long boardwalk from the east end of the Visitor Center to the back of the Memorial Building called the Pathway of a President (Fig. 50). Its chief purpose was to provide a

completely accessible route to the Memorial Building, which was previously unavailable to visitors. Almost the entire length of the route is wooded, with an overlook down onto the walkway east of the Memorial Building.²

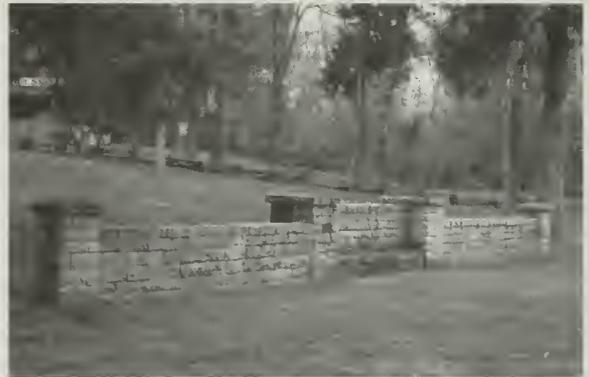
FIGURE 51. Lack of screening for the Nancy Lincoln Inn, 2001.

The maturing vegetation, particularly the evergreen trees, is starting to block most of the important views associated with the Pope and War Department landscape. The only remaining unimpeded view is from the Memorial Plaza up to the Memorial Building. The woodland adjacent to the cedars, and the overly mature cedars themselves, have increasingly compromised this vista as well. At the same time, the cedars planted between the Memorial Plaza and the Nancy Lincoln Inn no longer function as a screen, due to the loss of the lower limbs (Fig. 51).

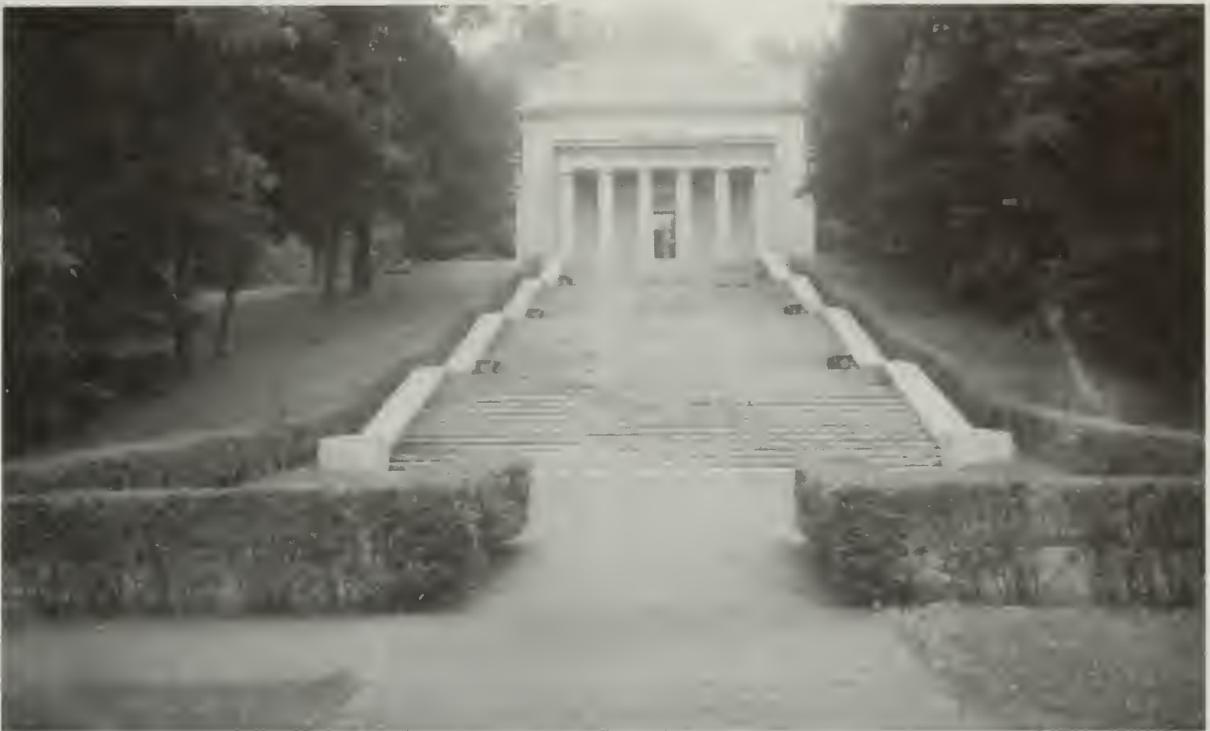
FIGURE 52. Red cedar allée, 2003.

While the mature cedars continue to provide a vegetated edge, they lack the intended formality of the Lombardy poplars or the cedars when first planted. Today, twenty-three cedars are extant within the allée along the Memorial Stairway. These trees represent approximately one-half of the original red cedar allée (Fig. 52).

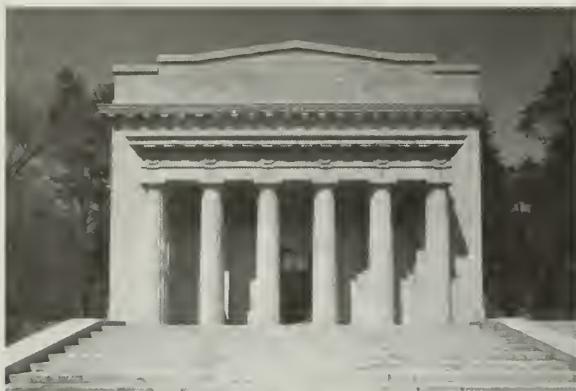
FIGURE 53. The Memorial Building, 1984.

The Memorial Building measures about 50 feet by 35 feet and encloses a single chamber. Constructed of pink Stony Creek granite and reinforced concrete, the building is elevated about 1 inch above the surrounding platform sidewalk. The platform sidewalk is about 75 feet by 80 feet and features several concrete benches around its perimeter. There are also steps at the center of the east, north, and west sides (Fig. 53).

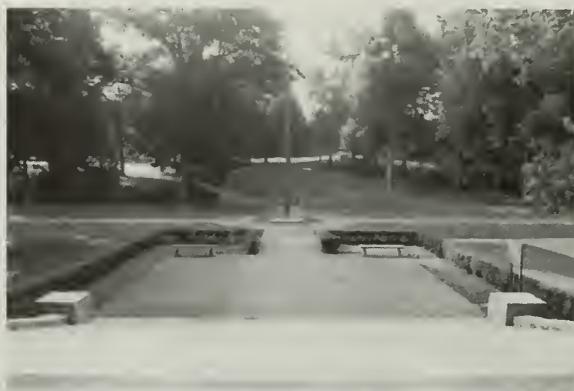
FIGURE 54. Memorial Plaza, 1994.

The 200-foot-by-80-foot grassed rectangular Plaza is oriented on a northeast by southwest axis and is transected by exposed aggregate concrete paths and a centrally located flagpole with a pink granite circular base. An 8-foot-by-4-foot coursed limestone bench is set in a 44-foot wall and serves as the southwest Plaza boundary (Fig. 54). A limestone and concrete stair descends from the parking ellipse to the northeast Plaza entrance. This 13-foot-long stair consists of two

runs of twelve and thirteen steps and two coursed limestone walls.

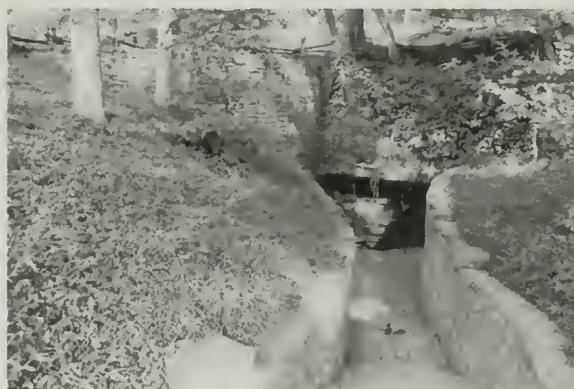
FIGURE 55. The Sinking Spring, 1994.

The Sinking Spring lies directly south of the Memorial Building Stairway and has coursed limestone walls, progressively taller from the top of the stair to the spring, creating a stair wall that also serves as a retaining wall behind the spring. Three runs of eight flagstone steps descend to a flagstone platform, which encircles the spring pool, approximately six to eight feet below (Fig. 55). Two drain pipes are located in this sinkhole and are connected to storm drain pipes under the plaza. Two stone benches are affixed to the south wall at the platform level.

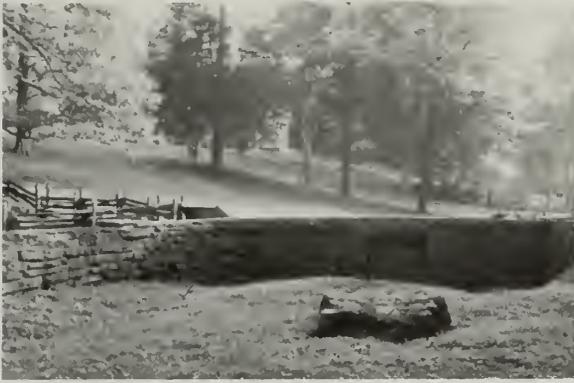
FIGURE 56. Historic location of the Boundary Oak, 1994.

The completion of a rehabilitation project occurred in 1991, including the capping of the stone wall, replacement of the rail fence, and the placement of sod in the area.⁴ The historic setting of the Boundary Oak has been lost due to the limestone wall and drain that were built adjacent to it. The historic location of the Boundary Oak continues to function as a retention area that holds floodwaters and allows them to dissipate without flooding the Plaza (Fig. 56).

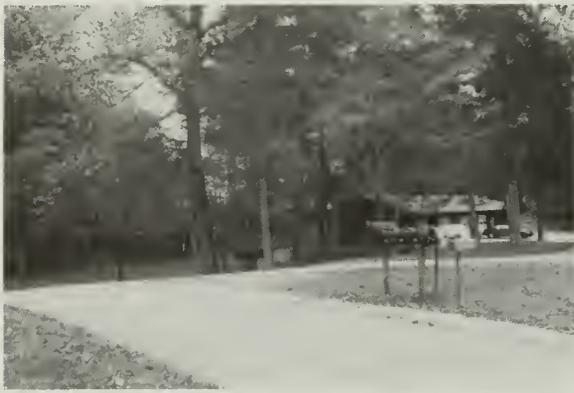
FIGURE 58. Maintenance complex, 1996.

A single-story, four-bay maintenance shed, constructed after the demolition of the stone garage in 1973, is located northeast of the Memorial Building (Fig. 58). Two stone War Department-era structures (a storage building and a pump house) are located on either side of the maintenance shed.

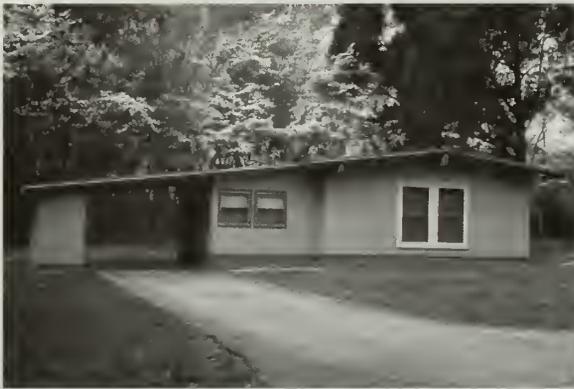
Two single-story, ranch-style houses, used to provide housing for seasonal employees and visitors, are located north of the maintenance drive (Fig. 59).

FIGURE 59. Park housing, 2001.
