Abraham Lincoln Birthplace Unit Cultural Landscape Report

Abraham Lincoln Birthplace Unit,
Abraham Lincoln Birthplace
National Historic Site

Cultural Landscape Report

National Park Service
Southeast Regional Office
Cultural Resources Division

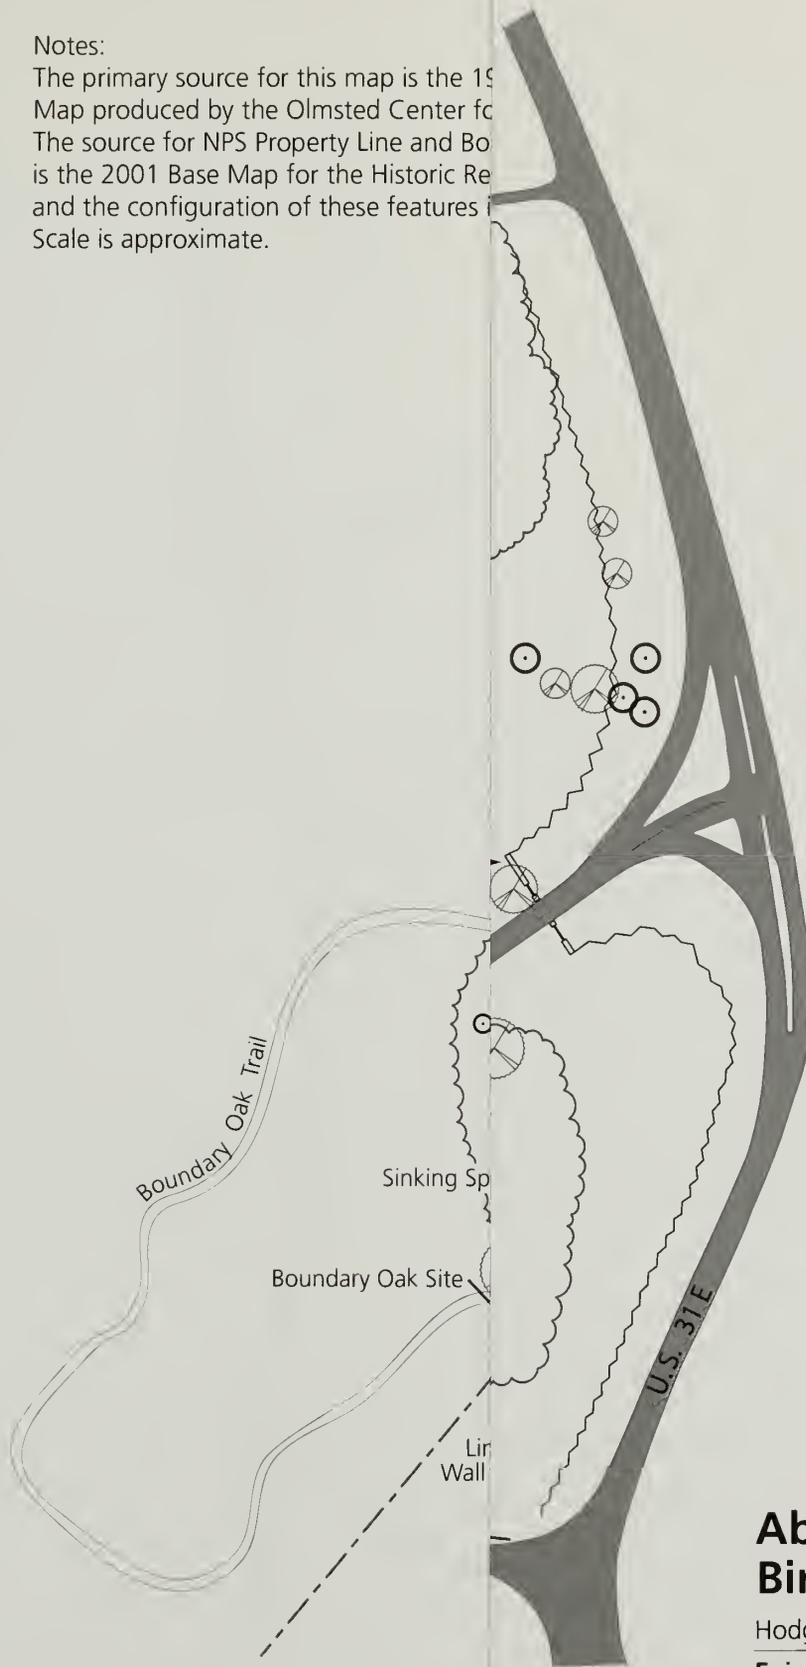
Existing Conditions Map - West
November 2003
Figure 60

The primary source for this map is the 1997 Existing Conditions Map produced by the Olmsted Center for Landscape Preservation. The source for NPS Property Line and Boundary Oak Trail is the 2001 Base Map for the Historic Resource Study, and the configuration of these features is approximate. Scale is approximate.

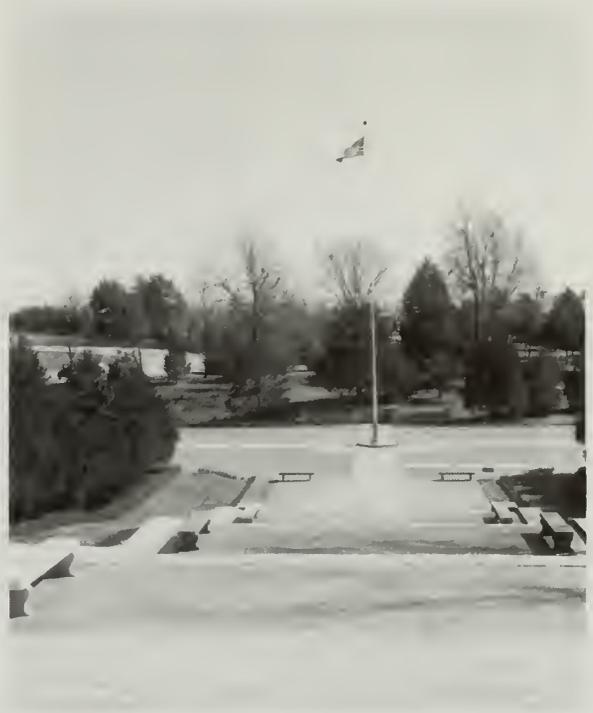
FIGURE 62. Memorial Building Landscape, 1938.

Site suggests that the period of significance begins with the construction of the Pope Memorial Building in 1911 and lasts through completion of the work accomplished by the 1935 Planting Plan implemented by the NPS soon after it gained management of the park (Fig. 62).

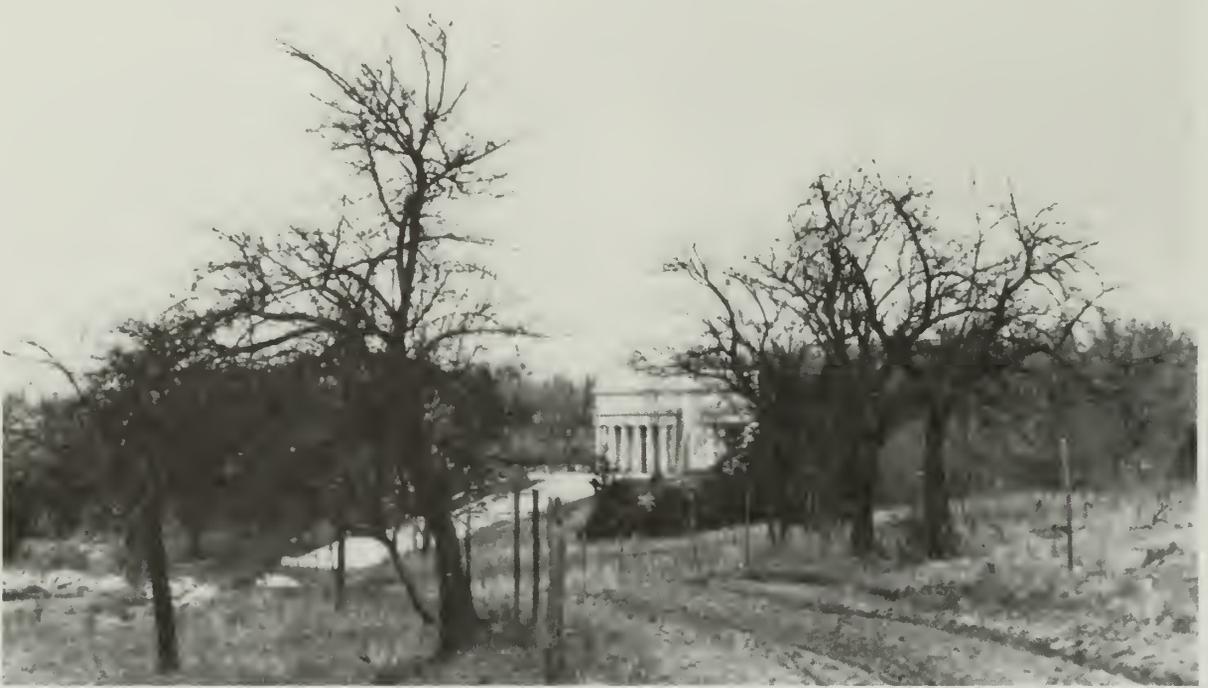
FIGURE 63. Memorial Building Landscape under construction, c. 1910.

The designed Memorial Landscape exhibits a high degree of integrity in relation to its location within the Thomas Lincoln property, also known as Sinking Spring Farm. The Memorial Building purposefully occupied the accepted site of the Lincoln cabin and was oriented in the same direction (southeast) as the log cabin reconstructed by Dennett and Bigham circa 1895. The Sinking Spring and Boundary Oak, adjacent to the Lincoln Farm Association development, were drawn into the memorial plan with the improvements completed by the War Department. Therefore, the Memorial Landscape occupies the heart of the Thomas Lincoln Farm as it existed at the time of Lincoln's birth (Fig. 63).

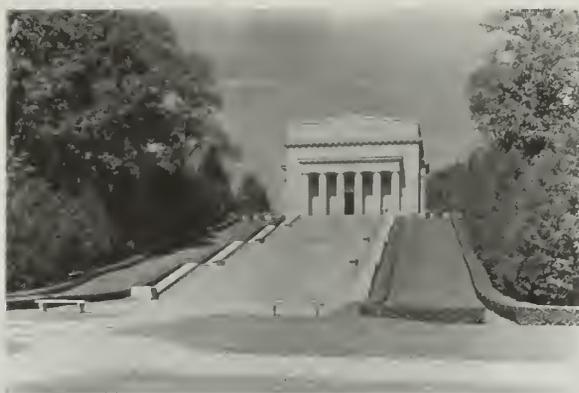
FIGURE 64. Memorial Building Landscape after planting of red cedars, 1935.

Because of development outside the park that neither the War Department nor the NPS could control, the NPS 1935 Planting Plan changed the way visitors perceived the site, from one with external views and vistas, to one that is very internally focused. Although the planting of cedars in 1935 was intended to frame the approach walk and view toward the Memorial Building in much the same way the poplars had, the long-term effect has compromised the original design. Approximately one-half of the original red cedar allée survives. Red cedars, as they age, lose the

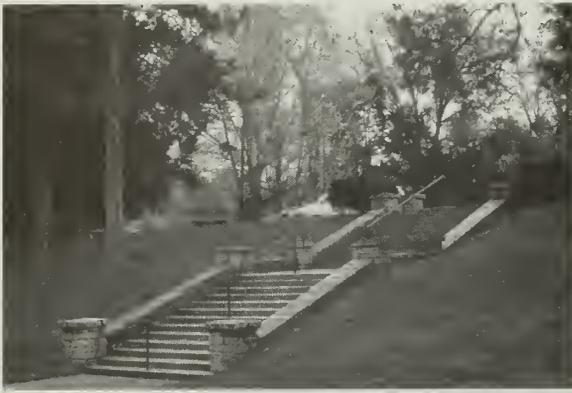
The materials of the extant War Department development suffered greater change. In 1984, the NPS replaced the axial stone paths in the Plaza with exposed aggregate concrete. Stone stairs

FIGURE 66. Steps leading down from parking ellipse, 2001.

leading down from the parking ellipse to paths in the Plaza were also replaced with aggregate concrete at this time (Fig. 66).

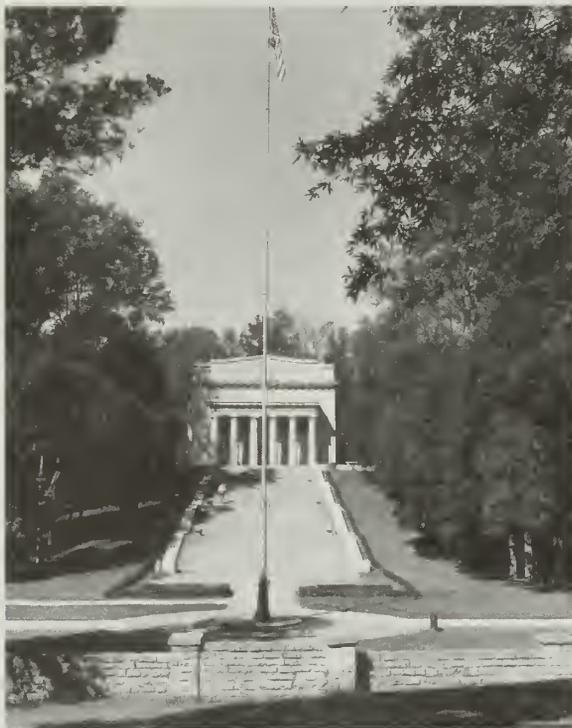
FIGURE 67. Hedges along Memorial Building Stairway, undated.

The integrity of the significant Pope-era plant material has also been altered by the NPS. The decision to replace the Lombardy poplars with cedars caused a dramatic change in the relationship of the vegetation and the architecture. Also, the simplification of the hedges along the Memorial Building Stairway diminished the integrity of the Pope design (Fig. 67).

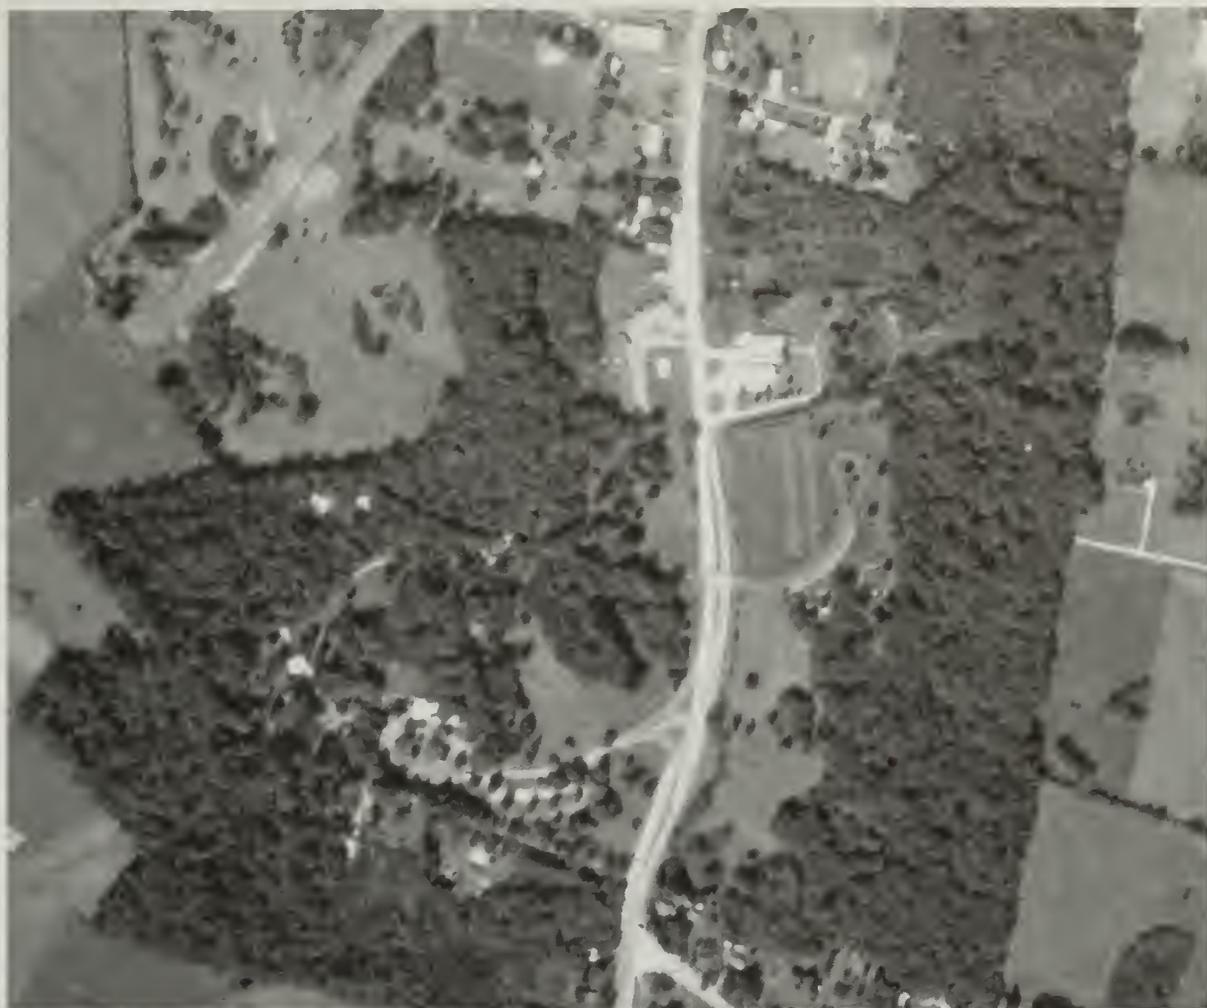
The feeling of the Memorial Landscape—a temple set on a hill that could be seen from a distance and more importantly, seeing a pastoral landscape from the temple—has been altered over time. First, incompatible development (both within the Birthplace Unit and outside the Birthplace Unit boundary) that could be seen from the core of the Memorial Landscape diminished the integrity of feeling. Secondly, the increasing amount of vegetation, both planted and seeded naturally, that was encouraged to grow up between the incompatible development and the Memorial Landscape also contributed to a loss of integrity (Fig. 68).

FIGURE 68. Aerial photograph showing increased vegetation, 1990s.

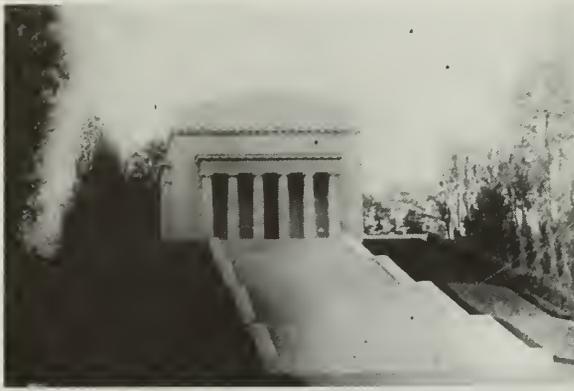
The original planting in 1911 consisted primarily of a formal allée and hedge leading from the main Plaza along the Memorial Stairway to the Memorial Building. The original allée was a columnar deciduous tree, which provided a vegetative 'container' leading visitors, visually and physically, up the steps to the Memorial. The hedge along the allée was a formally sheared shrub, which added to the monumentality of the design (Fig. 69).

FIGURE 69. Memorial Building Landscape, c. 1920.

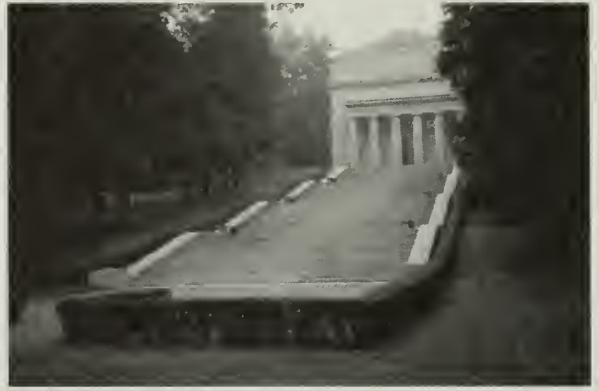
cedar provided a design effect similar to the original deciduous trees. Today, due to the age of the red cedars in the allée and the loss of several of the trees, the original intent of leading visitors to the Memorial has been lost. The few cedars that

FIGURE 70. Memorial Building Landscape, 2001.

do remain from the allée have lost their columnar shape because of their age. The existing privet hedge remains in good condition, although its arrangement is slightly altered (Fig. 70).

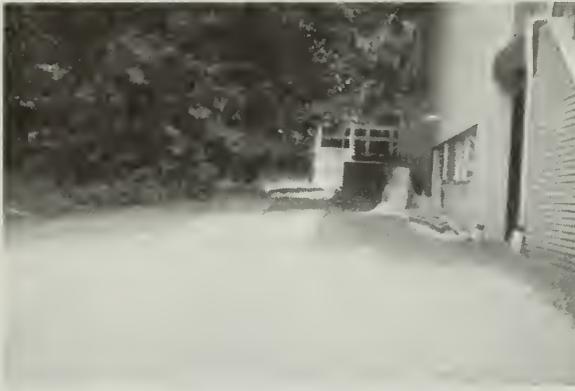
FIGURE 71. Asphalt walk at the rear of the Visitor Center, 2003.

- Screen with native vegetation the asphalt walk at the back of the Visitor Center so that it cannot be seen from the Memorial Plaza or from the walkway that winds through the woods to the back of the Memorial Building (Fig. 71).
- Establish a fully accessible walk from the west end of the parking lot to the Memorial Plaza. Along its route develop a small plaza that aligns with the Memorial Building for a “best” view of the Memorial Building.
- Explore options for rerouting the walkway to the Nancy Lincoln Inn. The existing walkway causes confusion for the visitor as to the location of Park property, because of the Inn’s proximity to the Birthplace Unit (Fig. 72).
- Maintain the stone edgings near the Sinking Spring (Fig. 73).

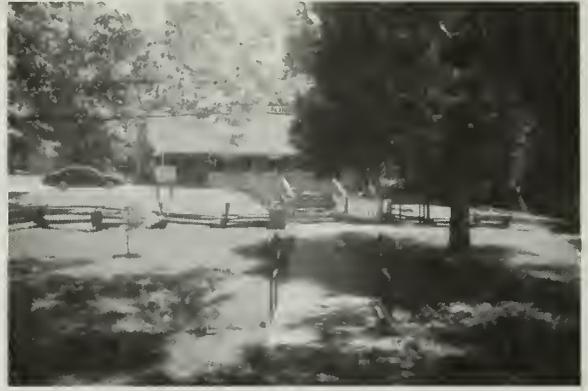
FIGURE 72. Walkway to the Nancy Lincoln Inn, 2003.

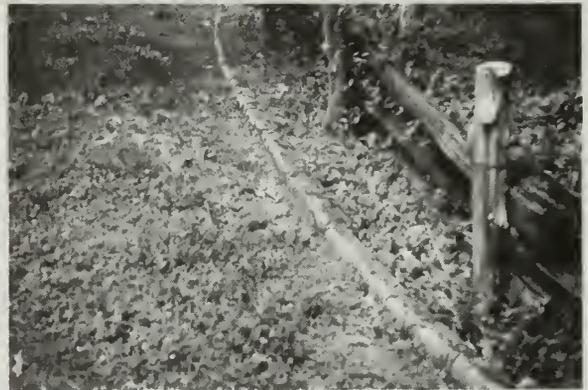
FIGURE 73. Stone edgings near the Sinking Spring, 2003.

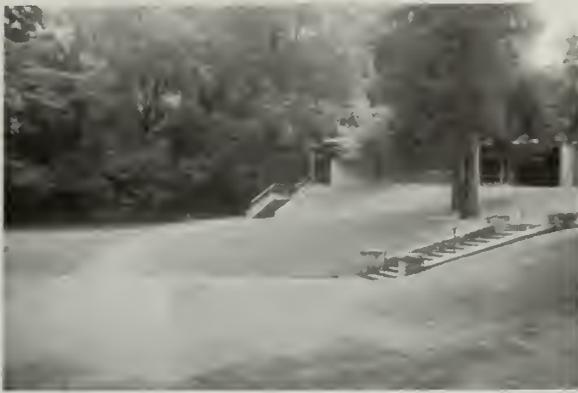
FIGURE 74. Steps on the west side of the Visitor Center, 2003

- Preserve and maintain Memorial Building Stairway and walls.
- Remove modern features such as the old speaker grills.
- Remove the steps on the northwest side of the Visitor Center and the connecting concrete aggregate walkway (Fig. 74).

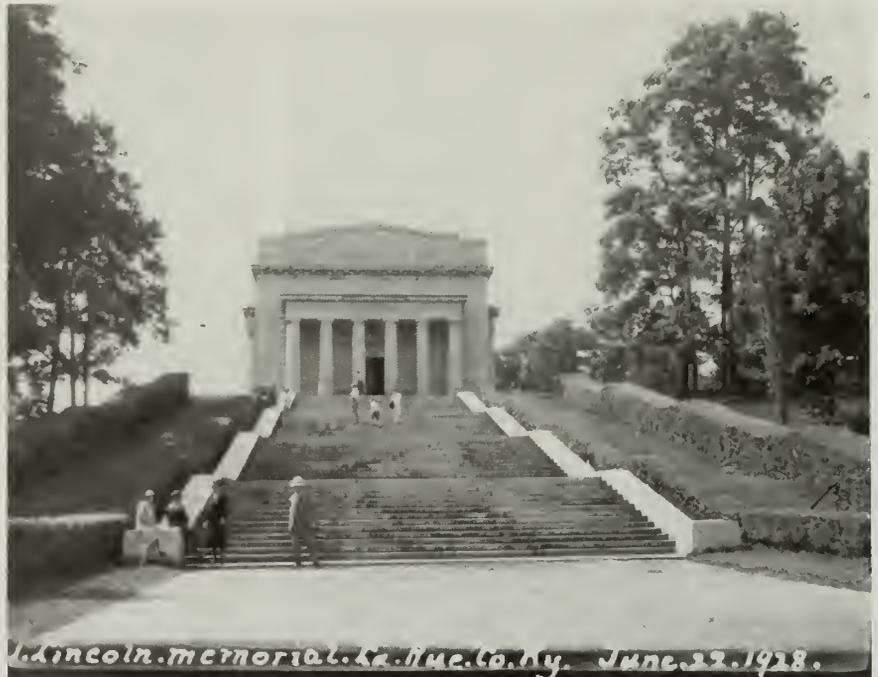
FIGURE 76. Memorial Building Landscape showing original hedge configuration, 1928.

Hedges. The formal hedges that were established by the LFA—two different heights defining the grass panels and an enclosing hedge that defined the Memorial Plaza—are important character-defining features of the original Memorial Landscape that need to be rehabilitated/restored. Because portions of the hedge need to be replanted and because the privet currently planted is invasive, a substitution may be made for the entire hedge (Fig. 76).

- Replace privet hedge with *Ilex crenata* ‘Steeds’ (Japanese holly). This cultivar would be an appropriate choice as it shears well and is cold hardy. Use 3 gal. containers planted 2 ft. on center.
- Replant missing hedge. The existing hedge along the Memorial Stairway represents a small portion of the 1930s hedge planting. In order to re-establish the hedge to match the alignment and heights in 1933, at least the missing outer row defining the terraced sod panels should be reestablished.
- Rehabilitate the hedge defining the edge of the Memorial Plaza to match the alignment on the 1935 Planting Plan.
- Develop maintenance guidelines for the hedges to be included in the Preservation Maintenance Plan.

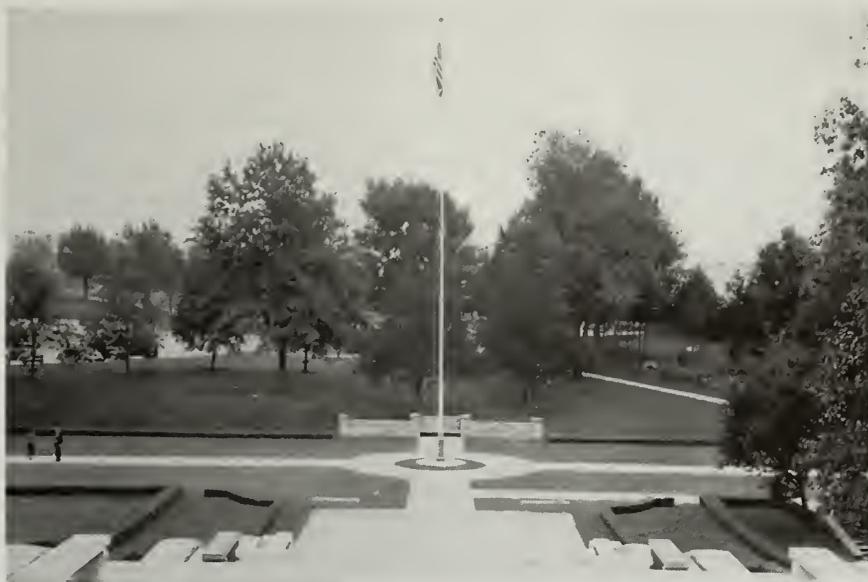
FIGURE 77. Plantings used to restrict views, 1938.

- Reestablish screen plantings to restrict views from the Memorial Building to the zone around the Memorial Plaza with the flagstaff as the central element. Use the NPS 1935 Planting Plan as a guide (Fig. 77).

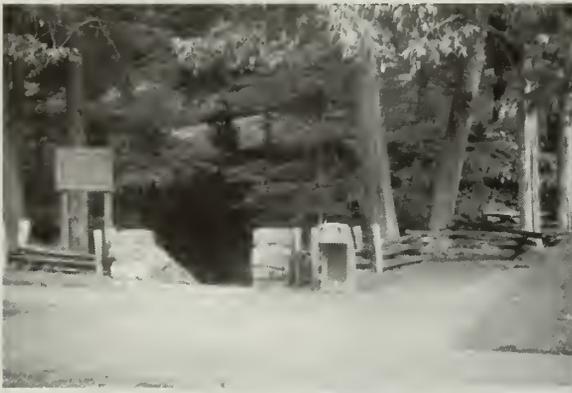
FIGURE 78. Cast concrete drinking fountain, 2003.

- Preserve and maintain the War Department rock work associated with the Sinking Spring.
- Relocate the cast-concrete drinking fountain away from the Memorial Plaza (Fig. 78).
- Reestablish the hedges and paths to their 1935 configuration in the area around the Sinking Spring.

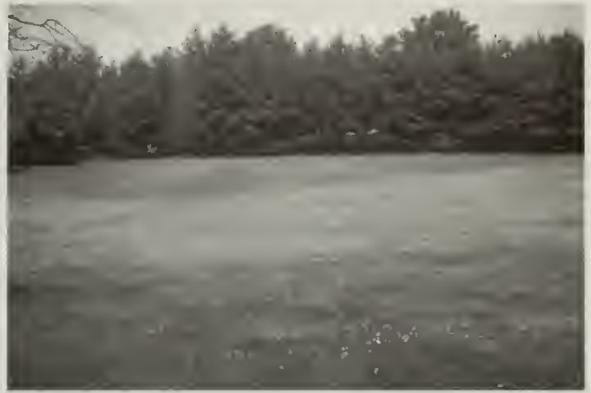
FIGURE 79. Portion of sixteen acres currently being mowed weekly, 2003.

- Screen the picnic shelter/restroom structures with native vegetation, planted parallel to U.S. 31E. White pines (currently planted along Keith Road) are appropriate plantings for screening in this location.
- Reduce mowing in this area to the extent possible. Sixteen acres are currently being mowed every week during the growing season (Fig. 79).
- Maintain a buffer of tall grass between mown recreation areas and the highway to create a pastoral feeling that carries across the highway.
- Control all invasive exotics affecting the eastern half of the park.

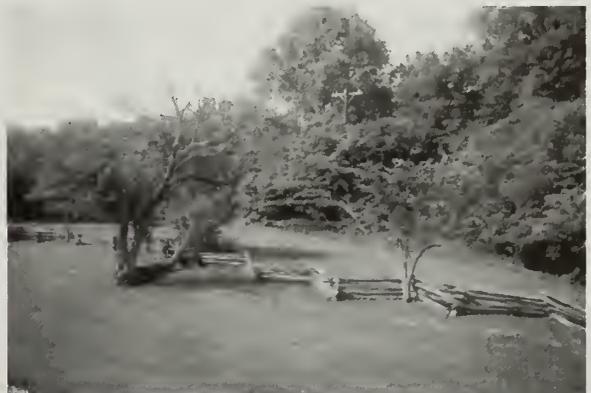
The dogwoods and redbuds currently planted along U.S. 31E are understory trees that have not done well and need replacing (Fig. 80). The town of Hodgenville has planted hawthorns along U.S. 31-E. Planting the same species at the park entrance would create a sense of unity along the roadway.

FIGURE 80. Redbuds planted along U.S. 31E, 2003.

- Add plantings of *Crataegus viridis* 'Winter King,' a cultivar with yearlong interest, at the park entrance along U.S. 31E.

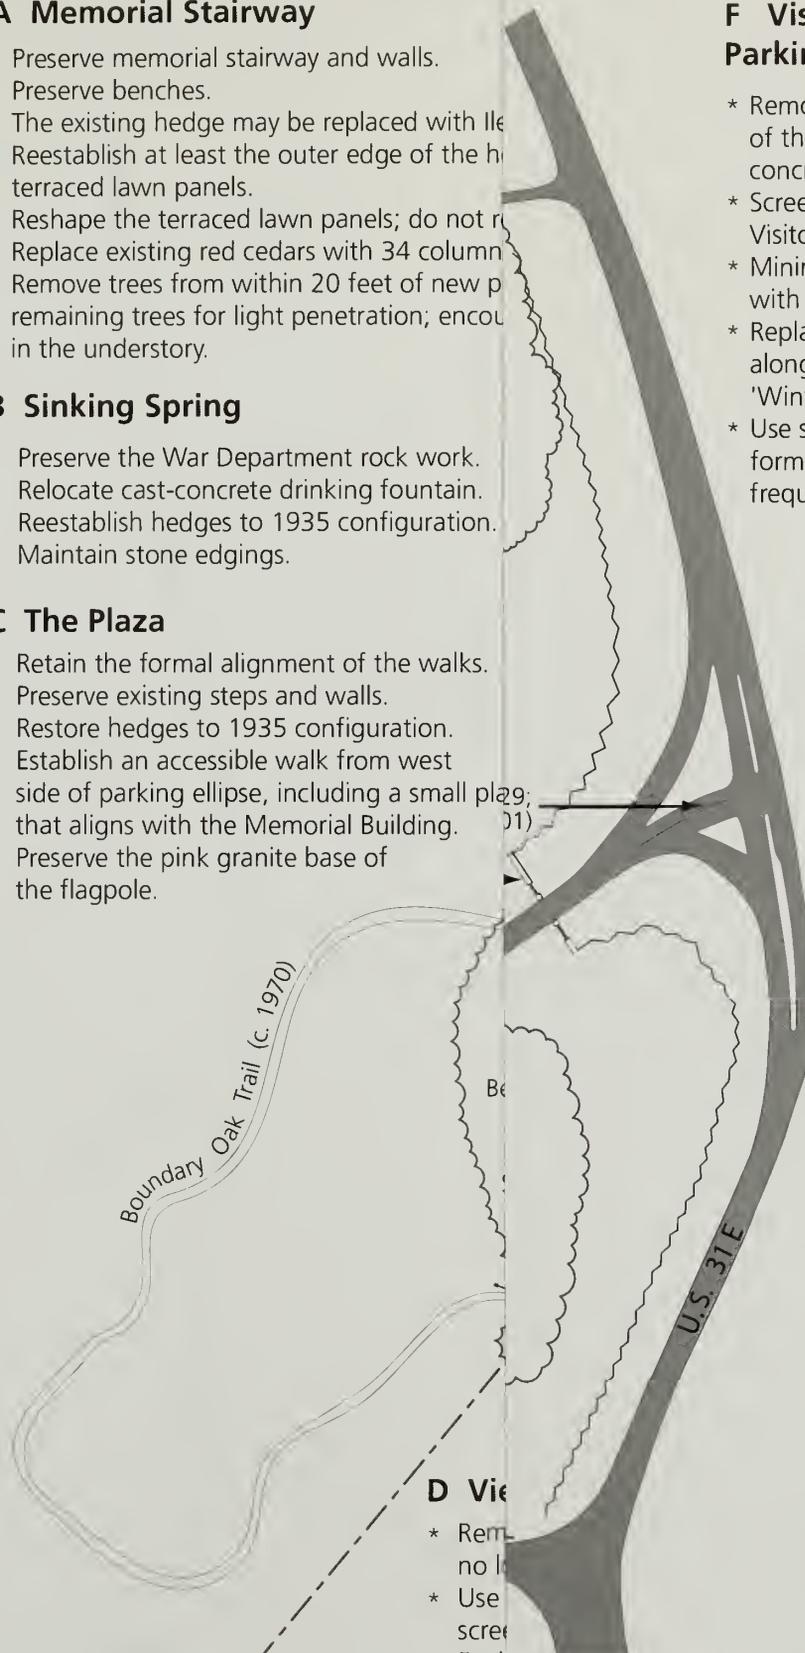
Figure 81

- * Remove...
- * no l...
- * Use...
- * screen...
- * Expl...
- * Ced...
- * shou...

Specific recommendations concerning treatment of the allée and other landscape features are presented below and on the accompanying treatment plans (Fig. 81 & 82). These recommendations have been developed and refined through consultation between NPS regional landscape architects, park management, and other interested parties during the preparation of this cultural landscape report.

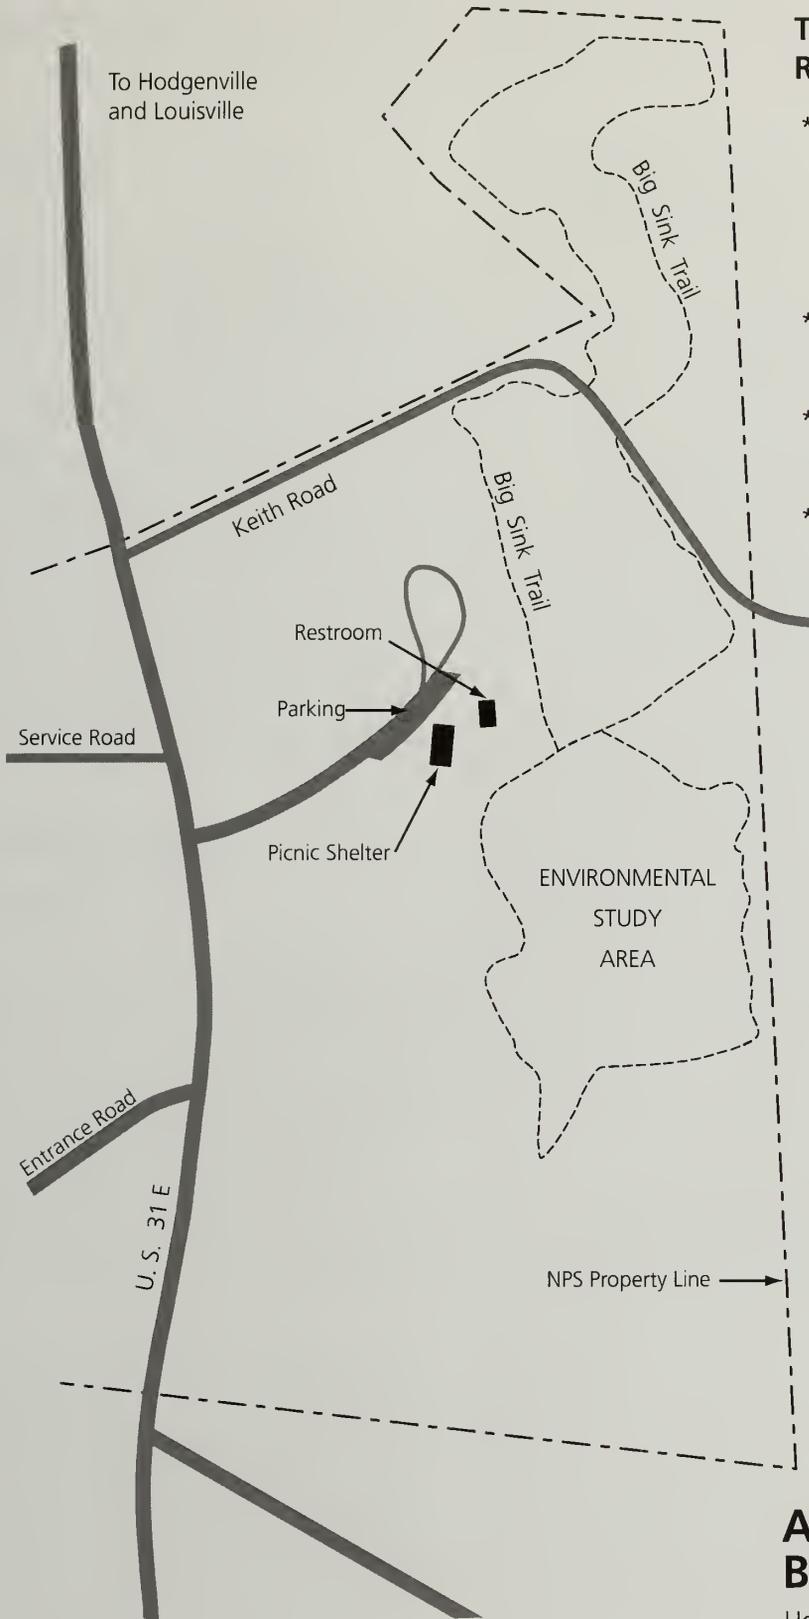
Treatment Recommendations

- * Parallel to U.S. 31E, screen the picnic pavilion and restroom structure with native vegetation, such as the white pines planted along Keith Road.
- * Reduce mowing of the sixteen acres to the extent possible.
- * Maintain a buffer of tall grass between the mown area and the highway.
- * Control all invasive exotics.
