# GENERAL PHILIP SCHUYLER HOUSE

## Saratoga National Historical Park Schuylerville, New York

Historic Structure Report Volume 2

#### HISTORIC STRUCTURE REPORT

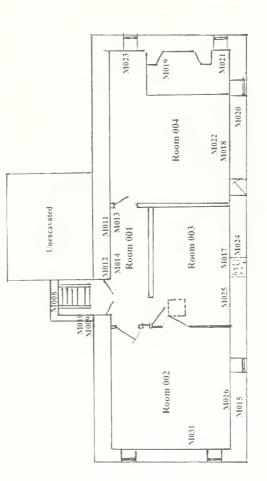
GENERAL PHILIP SCHUYLER HOUSE CELLAR PLAN

Type A - 1777 Lime Mortar Type B - Circa-1815 Lime Mortar Type C - Circa-1815 Lime Mortar Type D - Post-1890 Portland Cement Mortar

Nineteen samples of mortar were removed from the interior stone foundation walls of the Schuyler House cellar. Most of the samples were soft lime mortars that probably date to circa 1815. Three samples were soft lime mortars that appear to date to circa 1777. A few samples were portland-cement mortars (Type D) used for repointing during the ca.-1960 restoration.

Sixteen of the foundation mortar samples were soft lime mortars with mixes that had no hair binder or seashell fragments, but which had sands identical to those found in the ca.-1815 plasters in the servants' rooms (Type B). All contained fine beige-brown sand with the slightly coarser texture, lighter color, and black aggregate found in the plaster used in the servants' rooms. Two of the samples were removed from the infill blocking a former cellar-window opening in the center of the west wall, indicating that this opening was blocked circa 1815 when the front portico was built.

Three samples removed from the foundation appear to date to 1777 (Type A). They are all soft lime mortars with very fine beige sands. All of these samples were bedding mortars, and one was from the north-wall chimney arch that is thought to date to 1777.

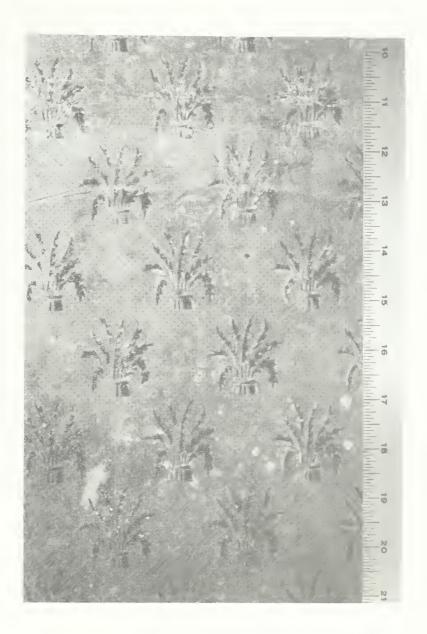
Wallpaper sample W001 consists of four fragments that were found on the fireplace wall and under a window (location unknown) in the parlor of the Schuyler House. The wallpaper is highquality hand-made paper composed of rag pulp that consists mostly of white fibers with occasional blue strands. The design is a sprig pattern of wheat sheaves with tiny black dots covering the field, and is block-printed in tempura colors of dark green-blue and black on a light gray ground. The grid of black dots was known as a "pin ground" or a "flyspeck ground," which was thought to camouflage fly specks and other dirt.<sup>11</sup> Two of the fragments have horizontal seams joining portions of two sheets of paper (fig. 1); none of the fragments represents a full sheet and thus the size of an individual sheet of the wallpaper is unknown. The imprint (color transfer) of the same paper can be seen on the back of one fragment, evidence that areas of the fireplace wall had two layers of the same pattern, the second layer apparently hung to cover damage caused by a chimney fire.<sup>12</sup> On the reverse of the largest fragment is an English Georgian excise tax stamp ("GR" crowned, with "PAPER J 6" underneath - fig. 2). This mark indicates that the tax had been paid on each sheet of paper in the piece, and identifies the wallpaper as having been manufactured in England.

Figure 1. Detail of Schuyler House Circa-1791 Wheat-Sheaves Wallpaper with Horizontal Seam Visible Near Top (1998).

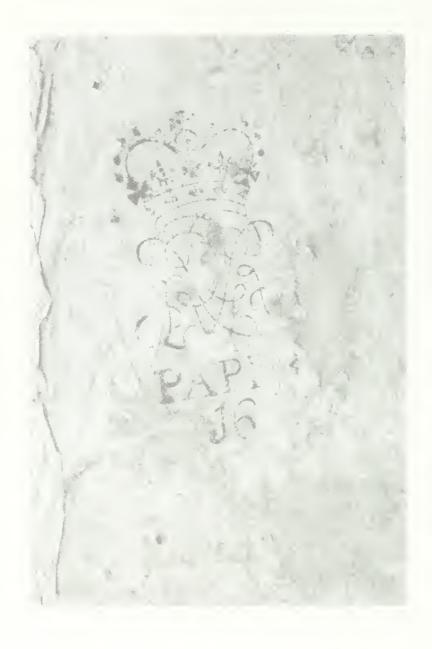
Figure 2. Georgian Tax Excise Stamp on Reverse of Circa-1791 Wheat-Sheaves Wallpaper (1998).

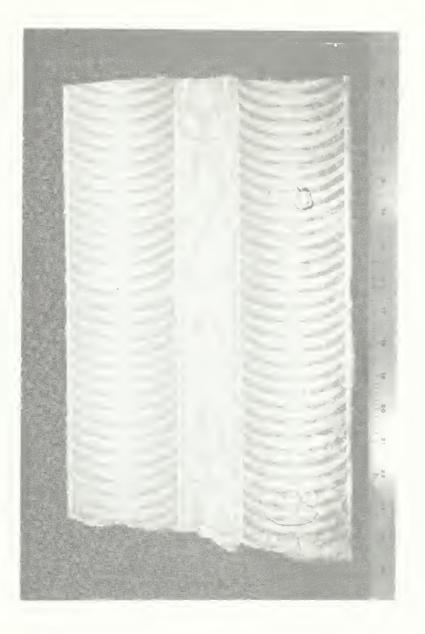
Room:	Parlor (102)	Date:	Circa 1814
<b>Printing Method:</b>	Block-printed	Repeat:	2 3/4 inches
Paper Type:	Hand-made	Width:	28 inches
	Rag pulp	Pattern:	Vertical stripes of wheat
Colors:	Orange and white on		sheaves and crescents
	mustard-yellow ground;	Sample Sizes:	8 7/8" x 15"
	distemper colors		8 3/8" x 8 1/2"
Manufacturer:	Anthony Chardon,		8 3/4" x 5 3/4"
	Philadelphia

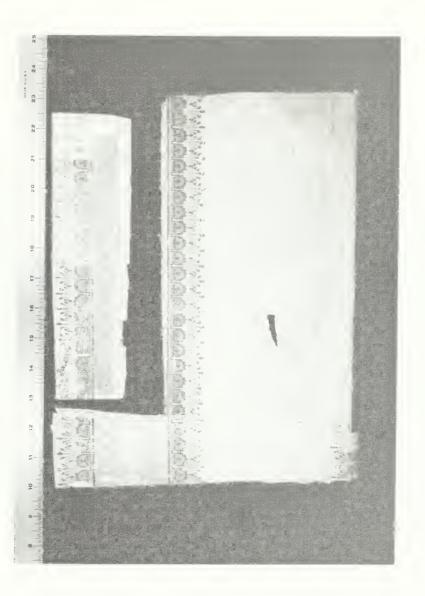
Room:	Parlor (102)	Date:	Circa 1825
<b>Printing Method:</b>	Block-printed	Repeat:	1/2 inch
Paper Type:	Hand-made	Width:	Incomplete width
	Rag pulp	Pattern:	Vertical bands of floral
Colors:	Bright green & bright		abstract and dashes;
	pink on white ground;	Sample Sizes:	6 5/8" x 13 3/8"
	distemper colors		6 3/8" x 9 3/8"
Manufacturer:	French		2 5/8" x 9 3/4"
			10 3/8" x 2 1/2"
			2 3/8" x 1 5/8"
			5/8" x 8 1/4"

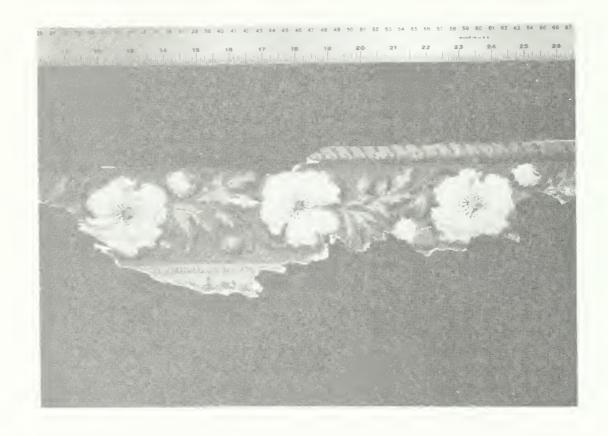
# SARA-15-W005A [Top (and Bottom) Border to W005]

Room:	Parlor (102)	Date:	Circa 1825
Printing Method:	Block-printed	Repeat:	10 5/8" (width)
Paper Type:	Hand-made	Width:	5 inches high
	Rag pulp	Pattern:	Floral and foliate vine
Colors:	White, grays, orange, rusts,		with borders
	yellow-gold, yellow, & black with dark & med. yellow-green flocking; distemper colors	Sample Size:	18" x 3 1/2"
Manufacturer:	French

Sample W005A consists of one fragment that was used as the top border to the bright-green and pink field paper. According to the pencilled notations on the reverse of the fragment, this same style of border, turned upside down, was also used as a bottom border. The border is 5-inches high and has an elaborate, realistic design block-printed in tempura colors and decorated with flocking. The pattern is a floral and foliate vine; the flowers are printed in white, light gray, and medium gray with an orange and yellow-gold eye and dark rust dots; and the leaves are printed in yellow-gold, rust, yellow, and black. Dark yellow-green flocking outlines much of the pattern and medium yellow-green flocking fills in the background. Along one edge of the border is a 5/8-inch-high abstract design in rust, yellow-gold, and black trimmed along the bottom (when used at the ceiling) with dark-green flocking; along the other edge of the border is a different, 1-inch-wide, abstract design in the same colors but without the dark-green flocking. A blue ground is barely visible behind the entire pattern where there has been color loss. On the reverse of the fragment, the imprint of the border to the circa-1820 drapery figure wallpaper (W004A) can be seen, and an arrow and "this edge top at ceiling but bottom at baseboard" has been marked in pencil.

Although not as elaborate as the earlier drapery-figure wallpaper, the border to this wallpaper also displays the intricate detail, multitude of colors, and realistic design of the best French wallpapers of the early nineteenth century, and it is probable that this wallpaper and border were also manufactured in France. One can only wonder at the bizarre combination of colors of the bright green and pink on the field paper and the earthy golds, rusts, and yellow greens on the border (fig. 7). It is also apparent, when following the directions of the pencilled notations on the reverse of the border, that the top and bottom borders had been hung upside down. It is probable that this wallpaper and border did not go uncovered for long.

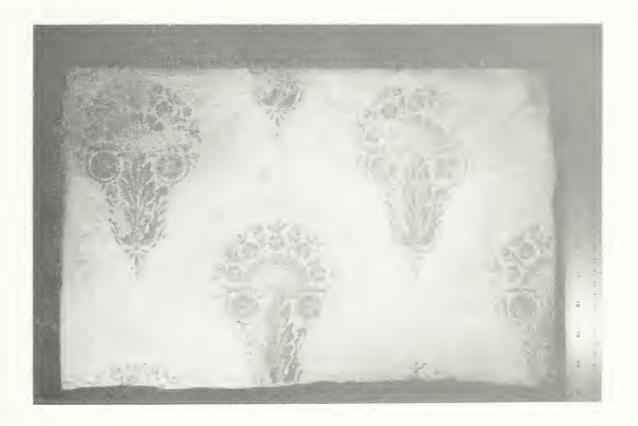
#### Wallpaper Samples SARA-15-W006, W006A, and W006B

Samples W006A and W006B consist of one fragment each of the top and bottom borders to the blue medallion wallpaper. From the fragments (and from the pencilled notations on the reverse of each) it can be seen that the top and bottom borders were identical and were hung in the same orientation to the field paper. Although neither fragment represents a full design, it appears that the border was approximately 9 inches high. Each border has an elaborate, realistic design block-printed in tempura colors. The pattern consists of a wide ribbon printed in gray, medium gray, and white, gathered every 9 inches by a ribbon medallion of the same colors with a gold, rust, and dark-rust center. The ribbon is edged in bands of deep blue and medium blue. The background around the ribbon is printed in medium blue with dark blue stars. A light pink-salmon ground is visible where there has been color loss. The top of the border is edged with a 1-inch-wide band of roping printed in gold, rust, and dark rust. The bottom is edged with a 3-inch-wide band in the same colors but with a design combining a foliate, feathers, and small medallions similar to the ribbon medallions. On the reverse of the fragments, the imprint of the flocked border (W005A) to the green and pink wallpaper can be seen, and either "top border" or "bottom border" has been marked in pencil.

The borders to this blue-medallion wallpaper again display the delicate shading, multitude of colors, and intricate realistic design that was the hallmark of the best French wallpapers in the early nineteenth century, and it is probable that the wallpaper and borders were manufactured in France. With its ribbon and bows, the design of these borders is a variation of the French drapery figure style, although not as wide nor as elaborate as the circa-1820 drapery-figure border (W004A) hung on the parlor walls. The samples also include neoclassical elements in the feathers along the bottom band of the ribbon border, and in the medallion-like forms of the bows and the stylized floral/foliate of the field paper. Medallions and neoclassical themes were popular in the 1820s and the 1830s, and in **figure 9** can be seen a reproduction of a circa 1820-1835 border with a design similar to that of the ribbon border. Therefore, the date of the document Schuyler House blue medallion wallpaper with the ribbon borders is thought to be circa 1830.

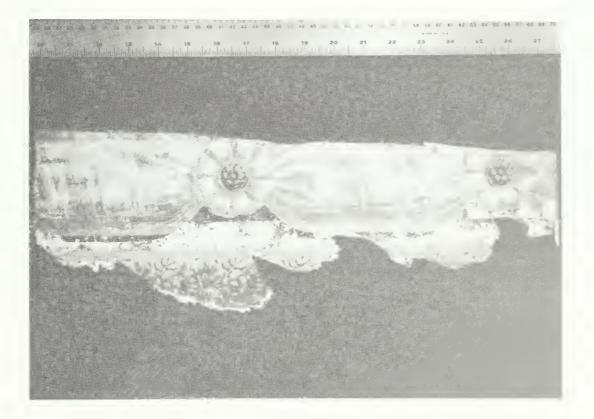
# SARA-15-W006B [Bottom Border to W006]

Room:	Parlor (102)	Date:	Circa 1830
Printing Method:	Block-printed	<b>Repeat:</b>	9 1/4 inches (width)
Paper Type:	Hand-made	Width:	9 inches
	Rag pulp	Pattern:	Ribbon & medallion bows;
Colors:	Grays & white ribbon; rusts & gold in medallion & bottom band; blues in back-	Sample Size:	bands of roping & foliate/ feathers/medallions 18" x 6"
Manufacturer:	ground; distemper colors French

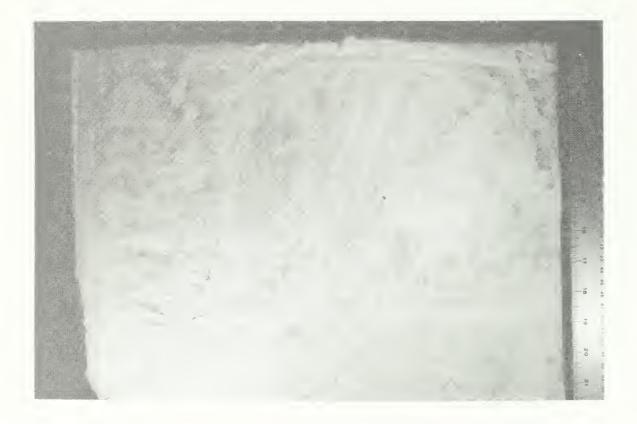
This gray foliate and foliate border (fig. 10) was the last wallpaper removed from the parlor and, again, appears from its realistic and intricate design and use of colors to be of French manufacture. Because of its horizontal seam it is known to date to before circa 1840, and stylistically the neoclassical design of the field paper and the border are typical of the styles popular in the late 1820s through the 1830s.<sup>29</sup> For this reason the wallpaper is thought to be the one hung for the marriage of the daughter of Philip Schuyler, 2d, in 1836 and is dated to that year.

Figure 10. Schuyler House Circa-1836 "Feathers" Wallpaper with Flocked Bottom Border (1998).

9.	Reproduction of 1820-1835 French floral/medallion border. From Richard C. Nylander, <i>Wallpapers for Historic Buildings</i> , page 86	40
10.	Schuyler House circa-1836 "feathers" wallpaper with flocked bottom border. NPS photograph by Maureen K. Phillips, 1998.	44

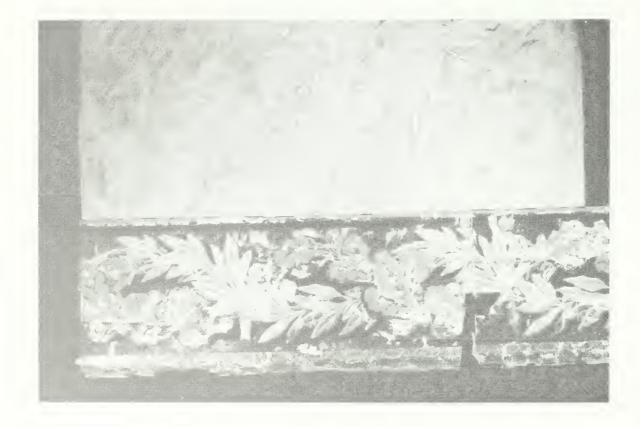
Room:	$D_{a-lar}$ (102)	Data	Circo 1926
Koom:	Parlor (102)	Date:	Circa 1836
Printing Method:	Block-printed	Repeat:	8 3/8 inches (width)
Paper Type:	Hand-made	Width:	5 inches high
	Rag pulp	Pattern:	Intertwined foliate
Colors:	Grays, white, rusts,		vines
	gold, & yellow with	Sample Sizes:	5 1/2" x 5"
	green & dark-green		12 5/8" x 5"
	flocking; distemper colors		
Manufacturer:	French

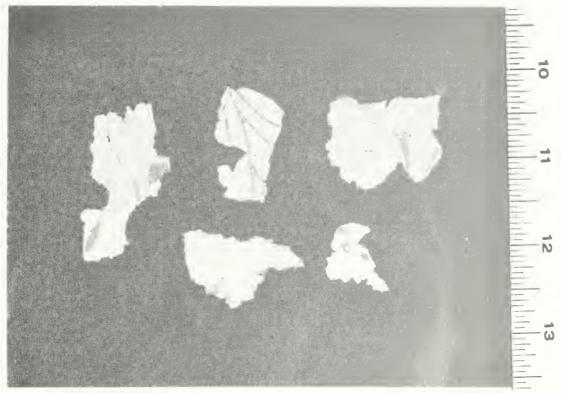
#### SARA-15-W012

Wallpaper sample W012 consists of five small fragments that were located over the blue and gray fragments of wallpaper sample W011. The wallpaper is composed of rag pulp. No complete design appears on the fragments; all that can be seen is what appear to be gold-metallic or gilded stems and leaves of a foliate design on an olive-green ground. The colors appear to have been machine-printed and it is therefore probable that the paper was machine-made. The fact that the design was machine-printed would date the wallpaper to after circa-1845. The combination of a machine-made, machine-printed paper with gilded elements would probably date this wallpaper to the 1850s or 1860s.<sup>33</sup>

Room:	Reception Hall (101)	Date:	Unknown
Printing Method:	Machine-printed (?)	Repeat:	Unknown
Paper Type:	Machine-made (?)	Width:	Incomplete
	Rag pulp	Pattern:	Unknown
Colors:	Gilding/gold metallic	Sample Sizes:	7/8" x 1/2"
	on olive-green ground		1 3/8" x 3/4"
Manufacturer:	Unknown		1 1/4" x 7/8"
			1 3/4" x 7/8"

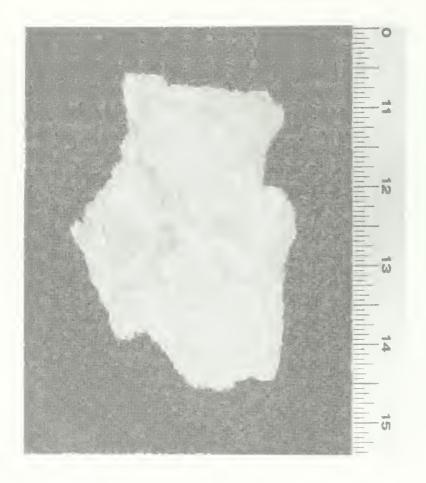
#### SARA-15-W013

Wallpaper sample W013 consists of one small fragment that was located over the olive-green and gold-metallic fragments of wallpaper sample W012. The wallpaper is composed of mechanical wood pulp and is textured with horizontal ridges. What can be seen of the design is a light-yellow and yellow floral machine-printed over a gold ground. The colors and the pattern suggest that this wallpaper probably dates to the last quarter of the nineteenth century.
