CRM BULLETIN

A National Park Service
Technical Bulletin

Vol.4, No.1
March 1981

Twenty-Eight Coats of White House History

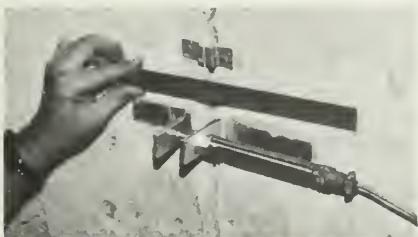
An electronic gauge in place. This gauge is a linear variable differential transformer (LVDT). Its operation is similar to the dial gauge with a spring-loaded spindle resting on a bracket except that it produces a voltage output that can be read at a remote location.

For the ceiling cracks, however, the mechanical gauges may not be appropriate. It is necessary to get to the gauge to read it, and erecting scaffolding every month may be far more expensive than the cost of electronic gauges with a remote readout. The wires from several gauges can go to a central point where the power supply and readout meter are located. All gauges can be read from one meter by plugging in the cables from each gauge, one at a time. In some applications, strip chart recorders are useful in detecting the effects of wind, seismic activity, sonic booms, and other temporary loads. In most cases, however, continuous recording only produces more data than is needed, and the great volume of paper produced is often stored without being analyzed. Periodic readings, recorded manually, and plotted as a function of time, will show long-term trends in structural movement.
