33 PRESERVATION BRIEFS

The Preservation and Repair of Historic Stained and Leaded Glass

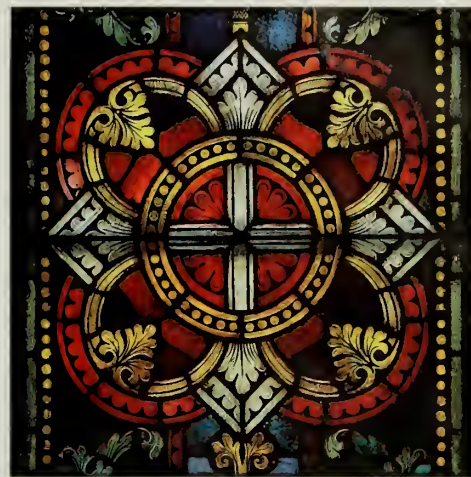
"Stained glass" can mean colored, painted or enameled glass, or glass tinted with true glass "stains." In this Brief the term refers to both colored and painted glass. "Leaded glass" refers generically to all glass assemblies held in place by lead, copper, or zinc comes. Because the construction, protection, and repair techniques of leaded glass units are similar, whether the glass itself is colored or clear, "stained glass" and "leaded glass" are used interchangeably throughout the text.

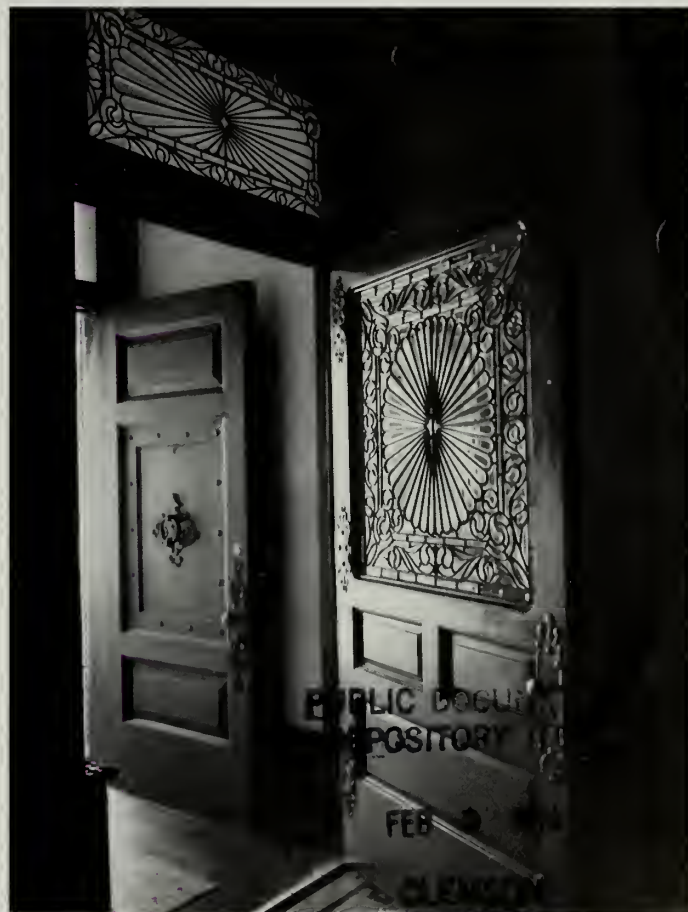
Figure 1. The door and transom of the Edwin Fisher House, Wheeling, West Virginia (1891-1892), suggest the richness of 19th century leaded glass. Photo: Jack E. Boucher, HABS.

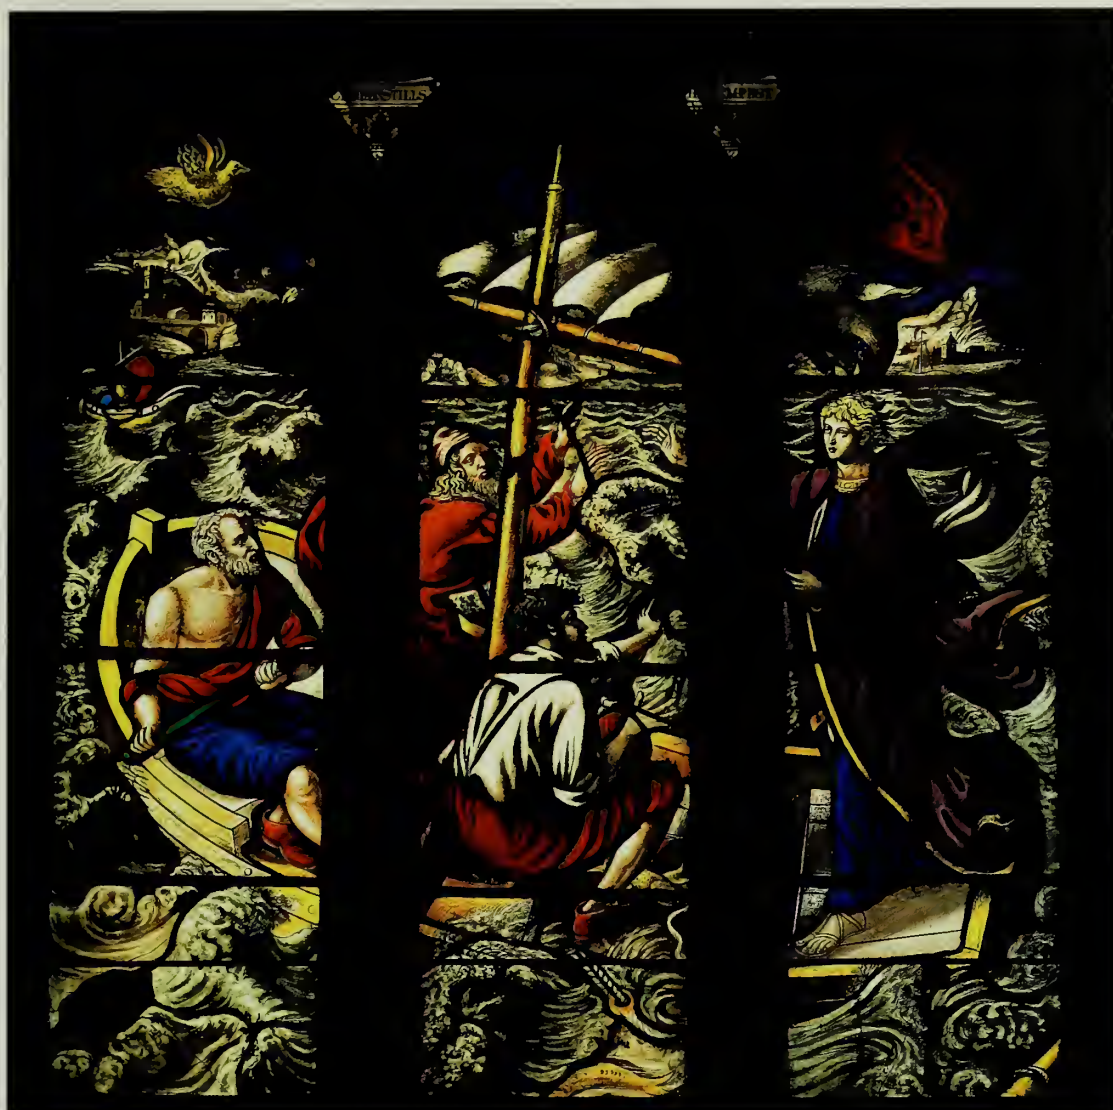
Figure 4. The windows at St. Ann and the Holy Trinity Episcopal Church, Brooklyn, New York, were made between 1843-1849 by John and William Jay Bolton. Photo: Leland A. Cook.

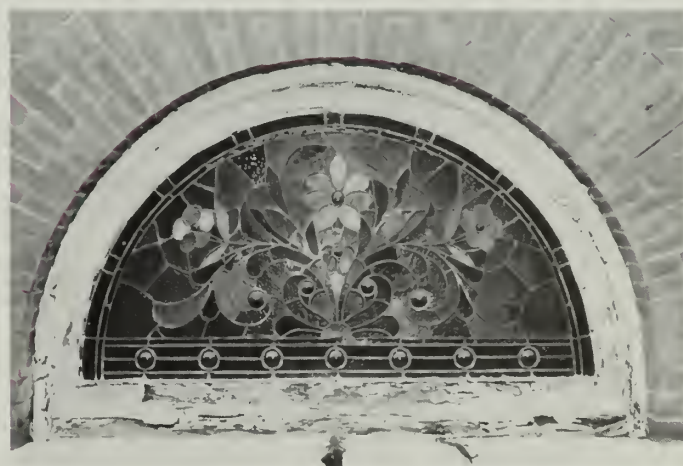
Figure 5. Stained glass is an exterior feature as well as an interior one. As part of any preservation project, stained glass should be photographed from the outside as well as the inside. The frame of this Aesthetic Movement window (circa 1880) needs repair. Photo: Neal A. Vogel.

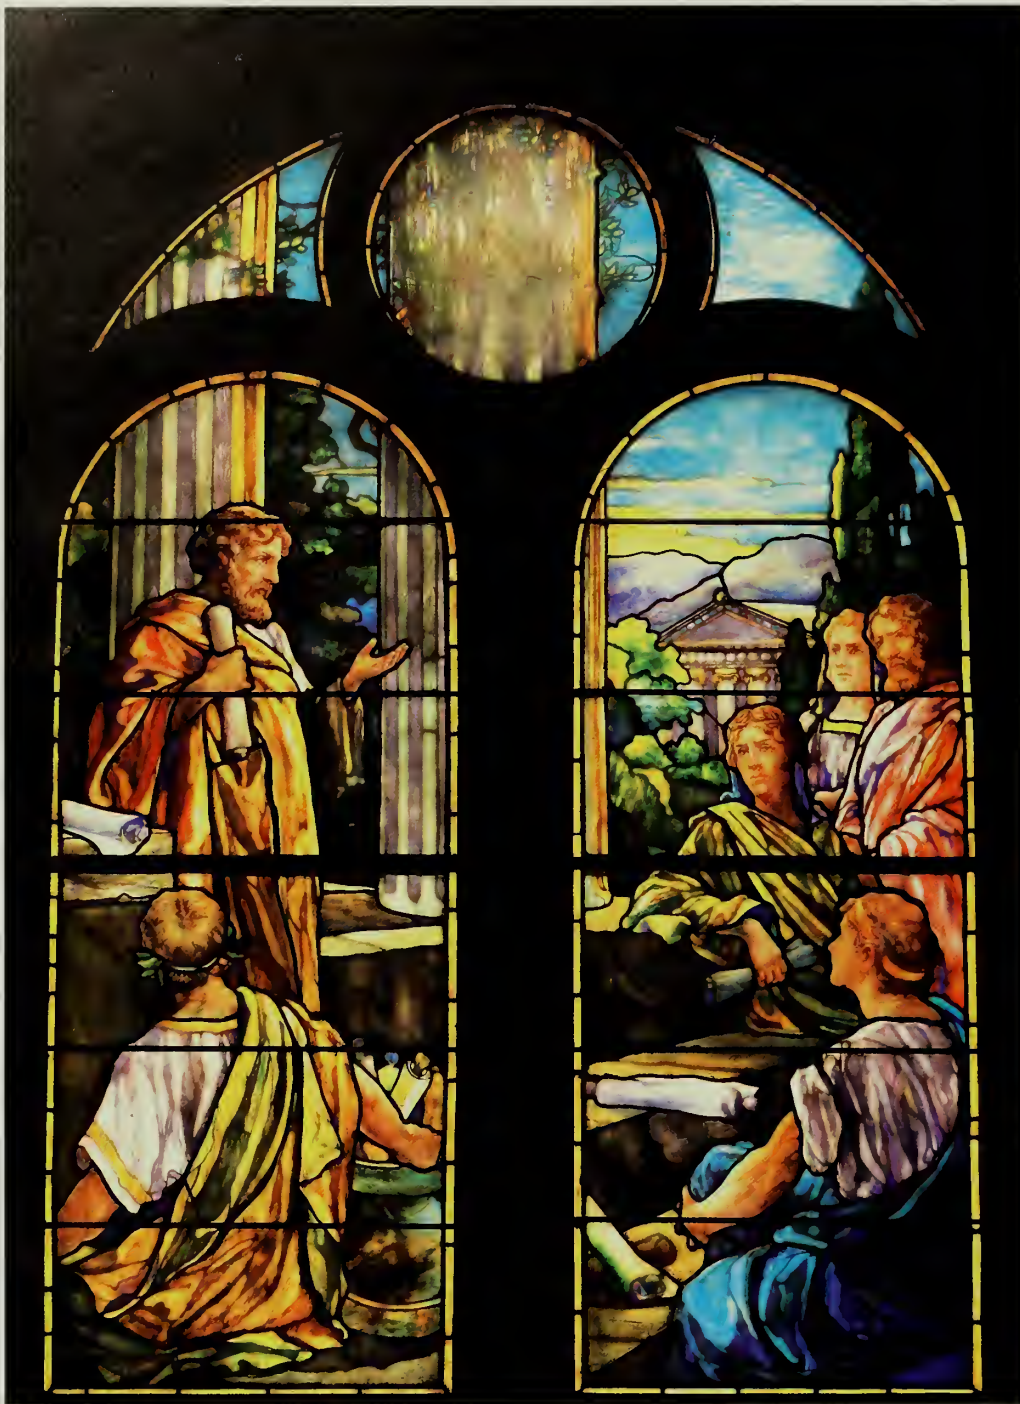
Figure 6. A 1907 window typical of those produced by Tiffany Studios. Characteristics include the use of opalescent glass, intricate leading, copper foil, extensive etching, plating (i.e., several layers of glass), and a scene with perspective that simulates a painting. Hyde Park Union Church, Chicago. Photo: Diana Kincaid.

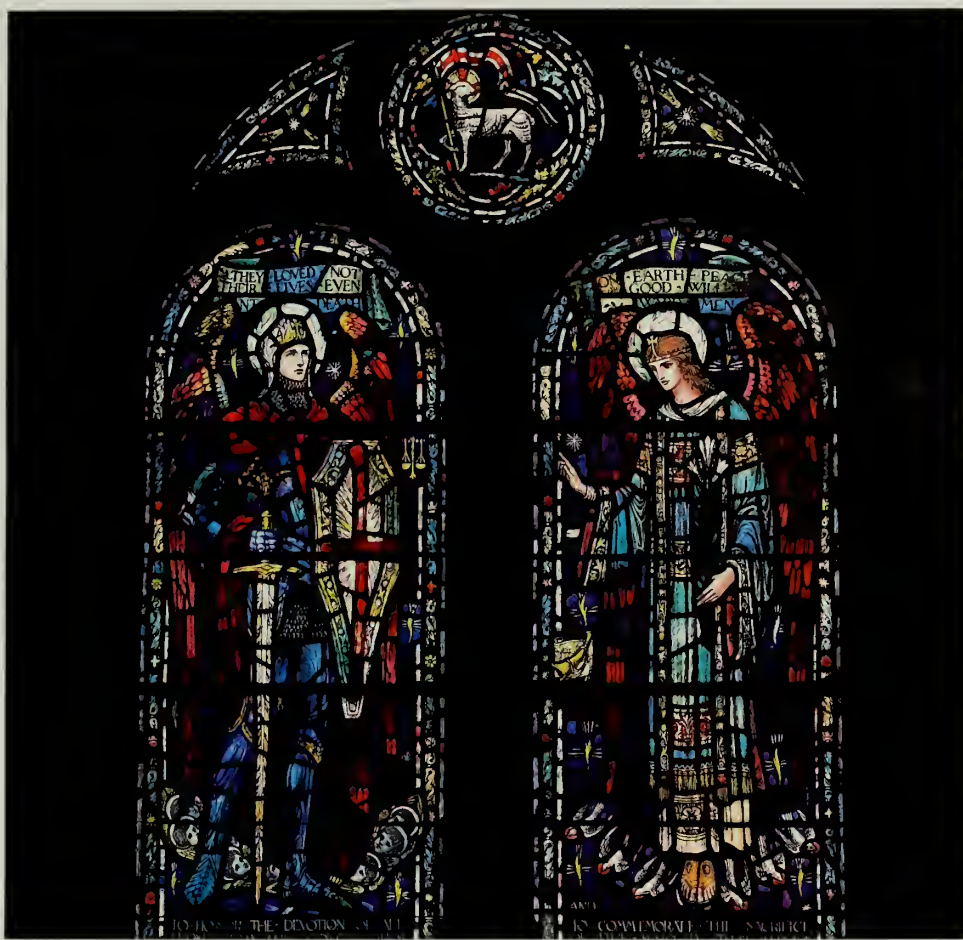
Figure 7. Charles J. Connick was another American master of stained glass. He worked in a modernized Neo-Gothic style. This window is from 1921. Photo: Diana Kincaid.

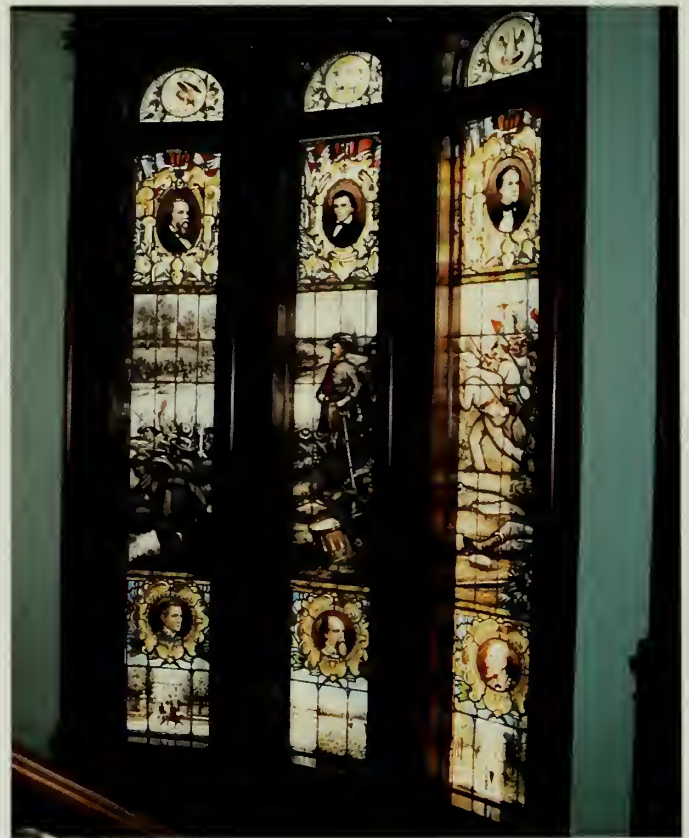
Figure 10. This image illustrates Thomas J. "Stonewall" Jackson and J.E.B. Stuart at the Second Battle of Manassas. The window comprises three of nine panels entitled "The Rise and Fall of the Confederacy" at Rhodes Hall in Atlanta. These windows were executed by Von Gerichten Art Glass Company of Columbus, Ohio, 1905 (installed). A.G. Rhodes reportedly returned one scene to the studio to be redone because the Yankees weren't running fast enough. Photo: Tommy Jones; Courtesy, Georgia Trust for Historic Preservation.

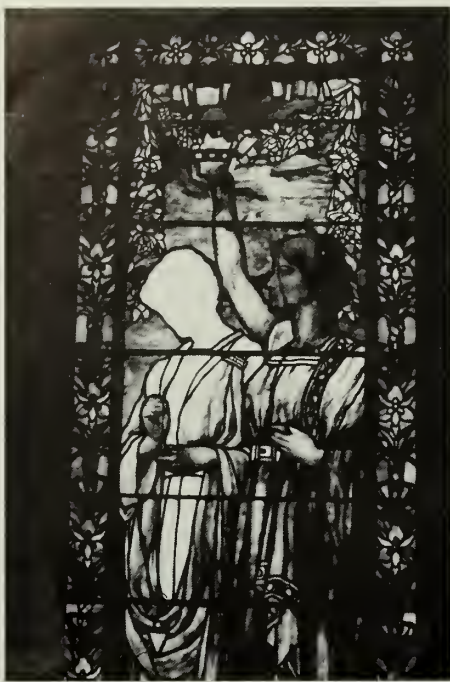
Figure 11. The face paint has failed substantially in the figure at the left. Ghost images of the feature are barely visible. Window (1903) by Edwin P. Sperry, glass by Tiffany Studios; "Old Main," (1891-1893) Illinois Institute of Technology, Chicago. Photo: Rolf Achilles.

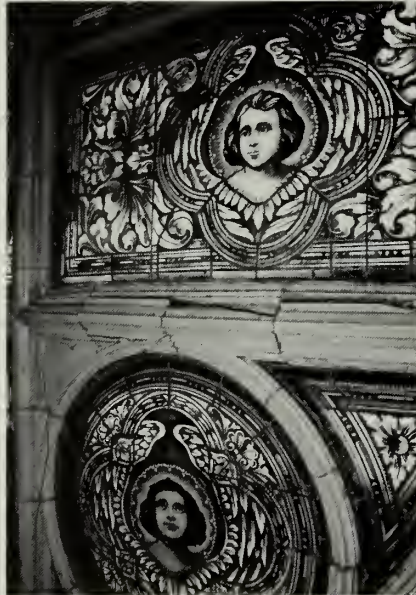
Figure 12. These stained glass angels appear concerned over the cracked terra cotta frames of the rose window they grace. Photo: Neal A. Vogel.

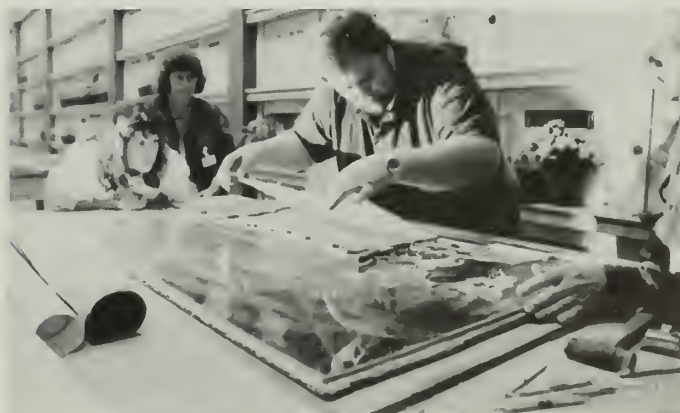
Figure 14. The instructor removes one of six etched plates from a ca. 1905 Tiffany window in order to clean the interspaces and provide a rare educational opportunity at a restoration workshop. Cypress Lawn Memorial Park, Colma, California. Photo: Neal A. Vogel.

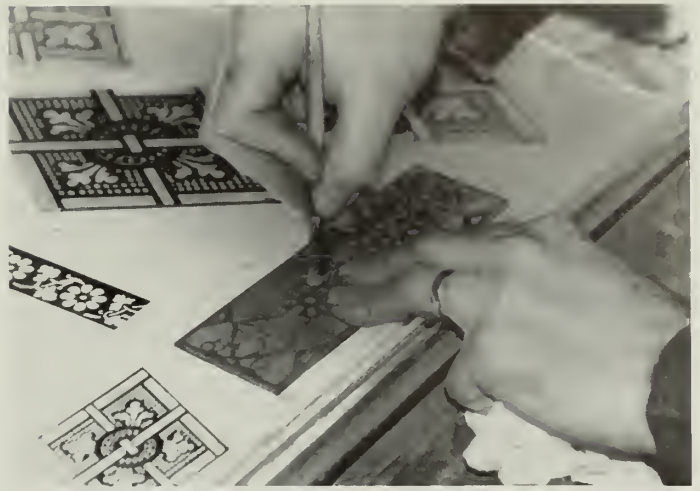
Figure 15. New stencils are used to produce matching replacement glass for repetitive stenciled patterns in a ca. 1870 window. Photo: Neal A. Vogel.

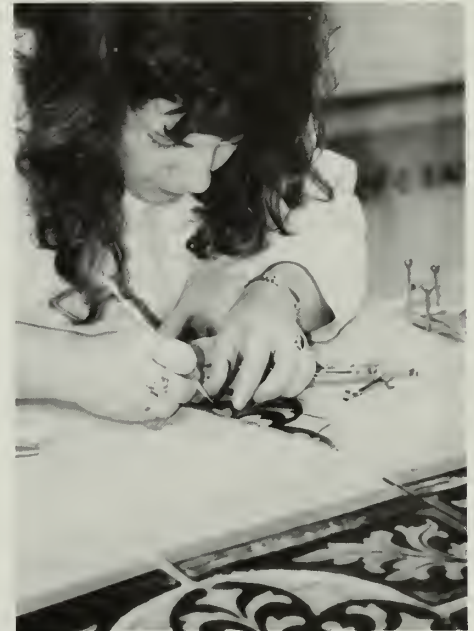
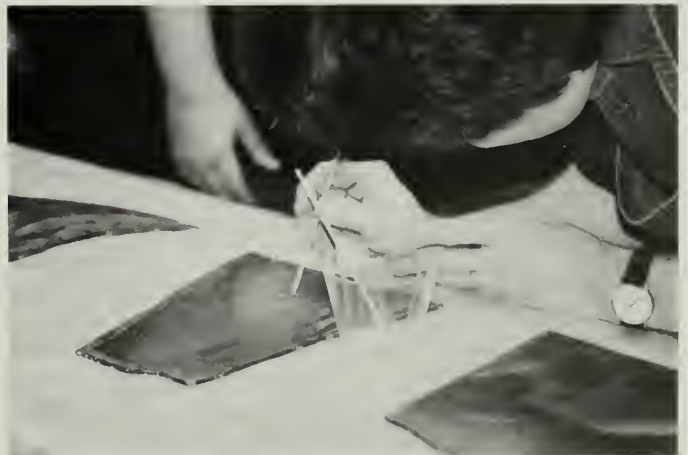
Figure 17. A valuable piece of flashed glass is carefully edge-glued with epoxy and a steady hand. Photo: Neal A. Vogel.

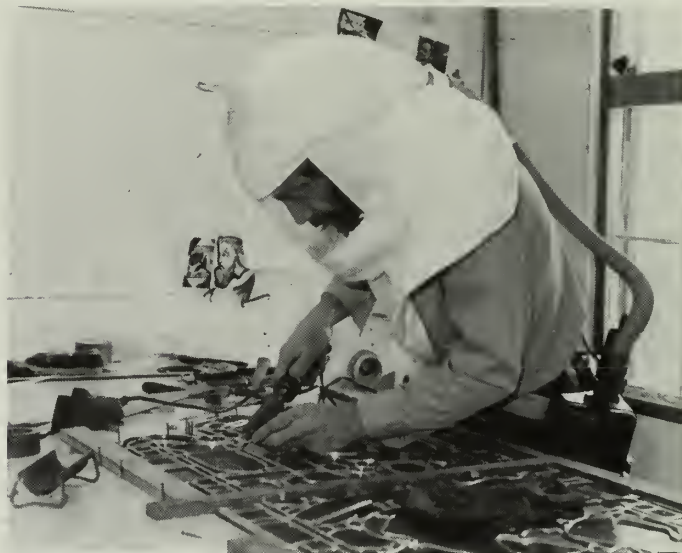
Figure 18. A craftsman releads a window. The full hood offers protection from lead fumes. Photo: Neal A. Vogel.

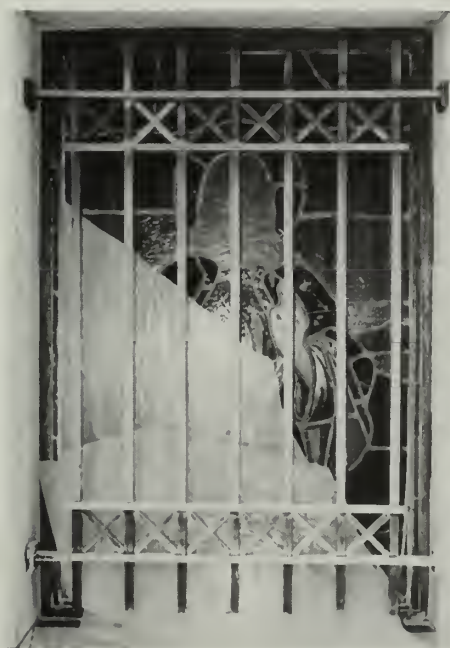
Figure 19. Stained glass in mausoleums requires protective glazing since vandalism is frequent in cemeteries. This plate glass intentionally softened the light transmitted through the window. This feature should be reproduced in the replacement glazing. It may be possible to repair the plate glass and install another, stronger (clear) layer on the outside. Photo: Neal A. Vogel.

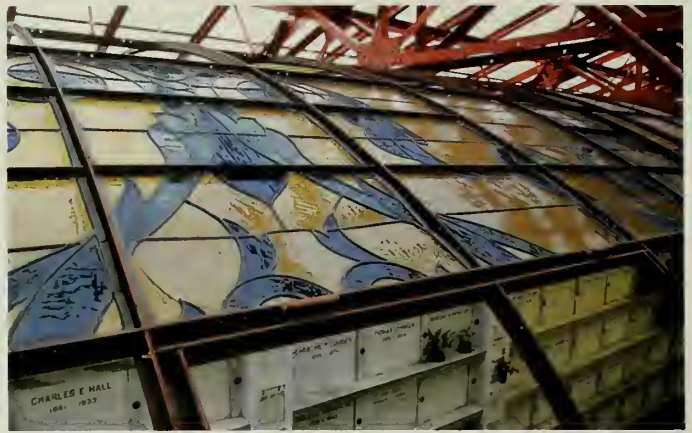
(b). Before repairs began on the vaulted glass ceiling below, a new diffusing skylight was installed to correct recurring leaks. *Catacombs* (ca. 1920), Cypress Lawn Memorial Park, Colma, California. Photo: Neal A. Vogel.

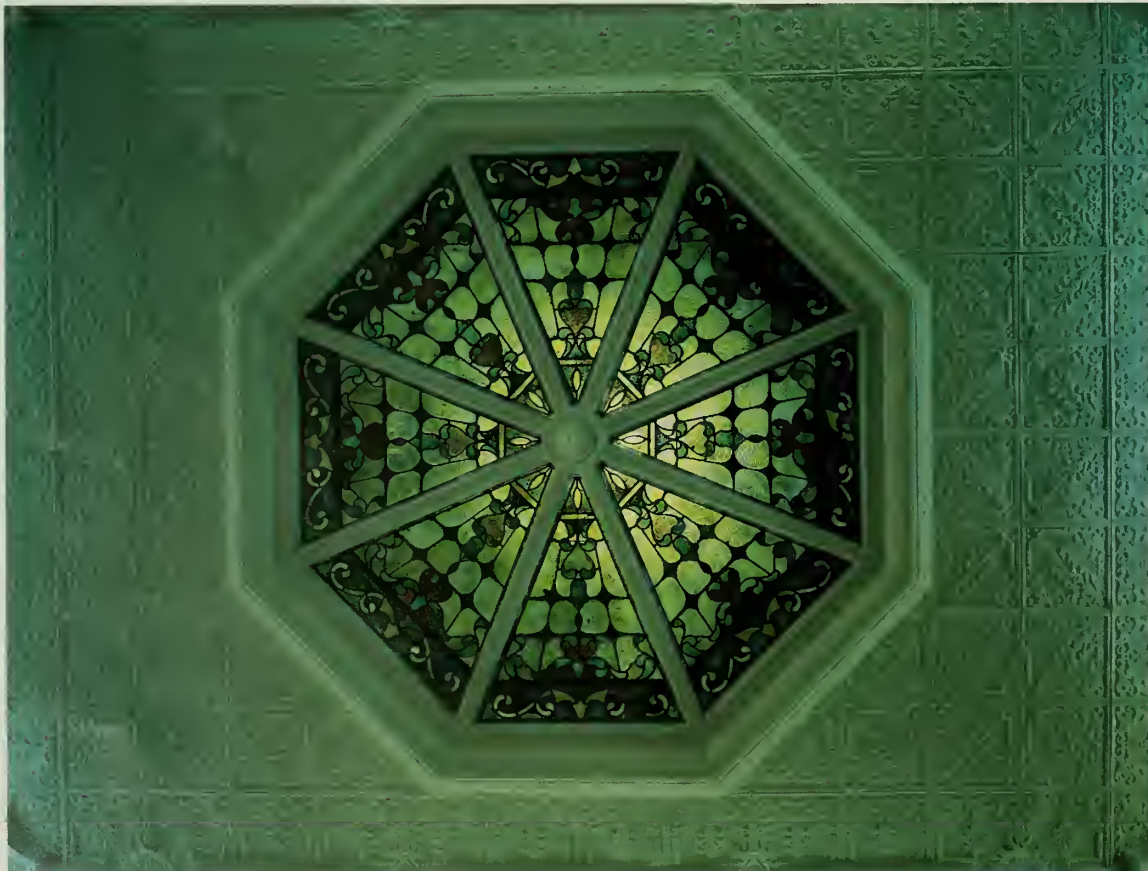
(a). Stained glass ceilings and domes are often principal interior features of churches, hotels, restaurants, railway stations, and civic buildings. This one illuminates the Carnegie Free Library in Union, South Carolina. Photo: Jack E. Boucher, HABS.

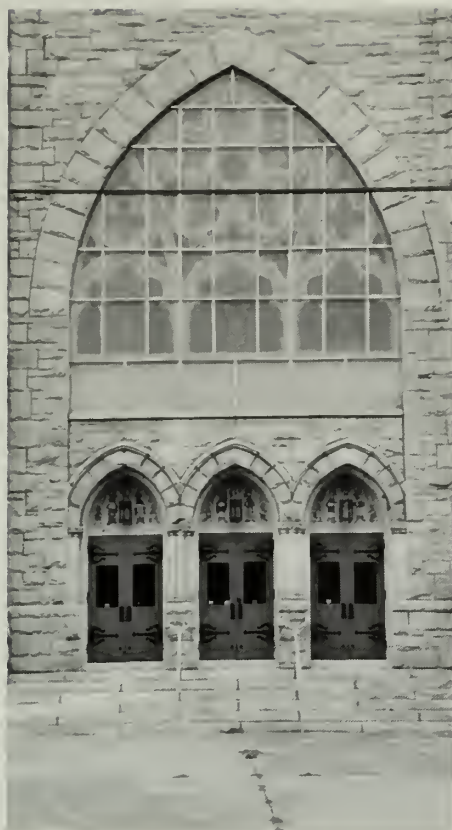
Figure 20. (a) The aluminum frame grid used for protective glazing totally disregards the original tracery of this Neo-Gothic church. The grid mars the appearance of the window inside and out. It also impairs the overall historic character of the building. (b) Protective glazing in this instance preserves both the appearance of the window and its contribution to the building. The latter building is the Cathedral Basilica of the Assumption (St. Mary's Cathedral), Covington, Kentucky (1895-1910). The window, 67' x 24' (20.4m x 7.3m), is among the largest stained glass windows in the United States. Photos: Neal A. Vogel.

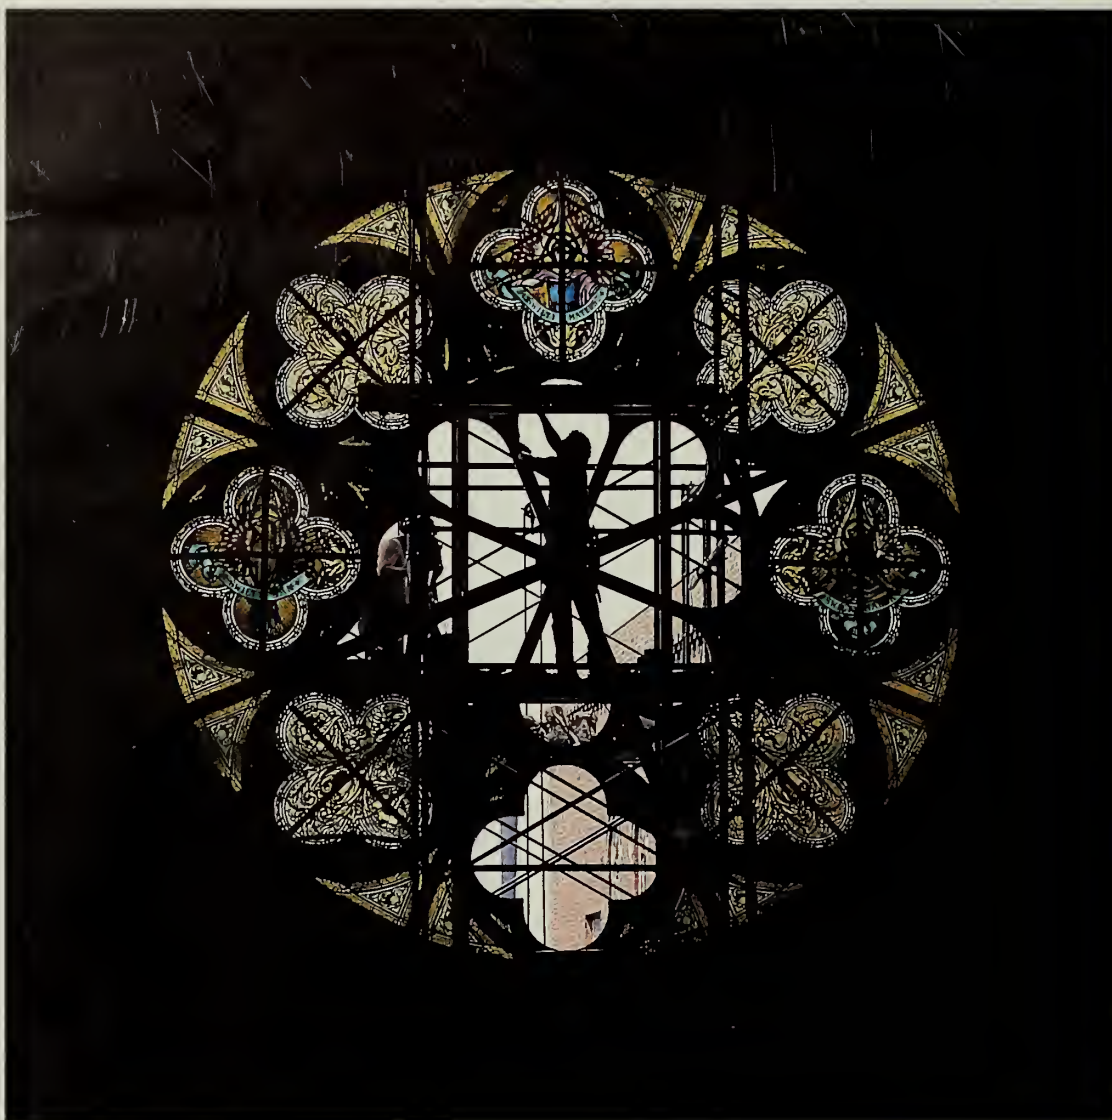
The rose window at St. John Cantius, Chicago (1906-1908), undergoing restoration (interior view). Photo: Neal A. Vogel.
