Oakland Plantation Big House Historic Structure Report

CANE RIVER CREOLE NATIONAL HISTORICAL PARK
OAKLAND PLANTATION

HISTORIC
STRUCTURE
REPORT

2004
Historic Structure Report
Big House at Oakland Plantation
Cane River Creole National Historical Park
Natchez, Louisiana
LCS#: 91620

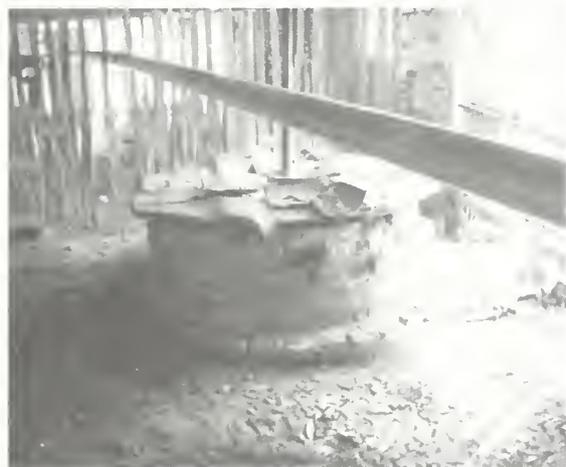
The most prominent site features that were historically associated with the Big House were the cisterns. Two of these are still intact although no longer in use. Both are underground cisterns, one beneath the west end of the gallery on the south side of the kitchen wing and another beneath the pump on the rear gallery of the house itself. A third underground cistern was located under what is now the southwest corner of Room 214B, but it collapsed and was filled in by NPS personnel in 1996. Two above-ground water tanks were features of the site through most of the twentieth century. Both consisted of cylindrical,

Figure 29 View of cistern beneath rear gallery. (NPS-SERO-CRS, 2001)

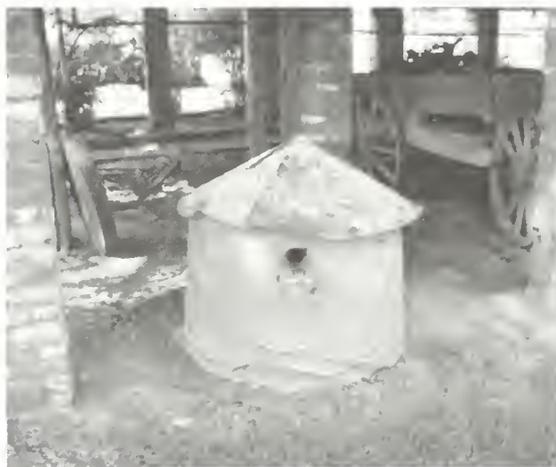
Figure 30 View of cistern beneath kitchen gallery. (NPS-SERO-CRS, 2001)

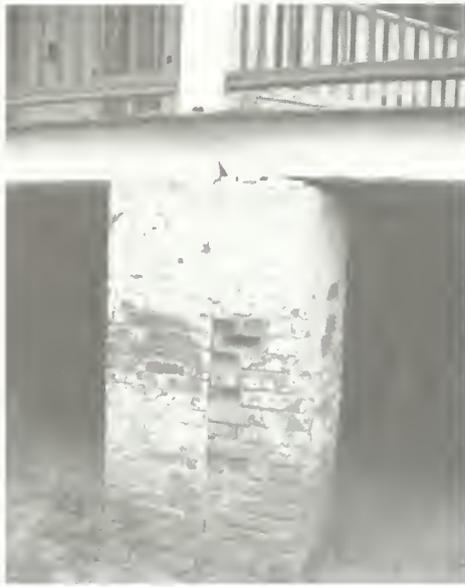
Figure 31 Brick piers on north end of east gallery. Pier at left is from the original house, c. 1821; pier at right is from the first expansion of the house, c. 1825. (NPS-SERO-CRS, 2001)

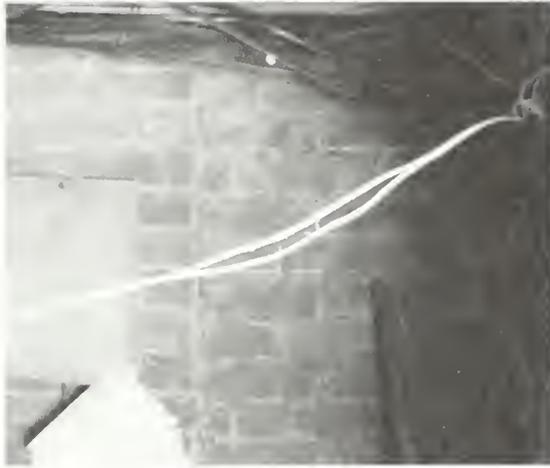
Figure 33 Detail of north wall of gas room (106), showing two earliest generations of brick work, both with mortar joints pencilled in white over red. (NPS-SERO-CRS, 2001)

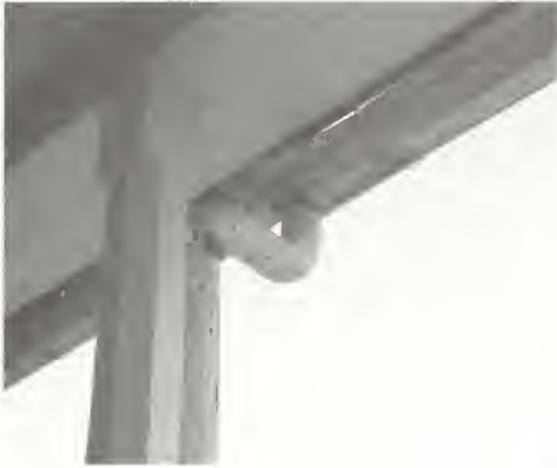
Roofing: On the main house, historic wood-shingled roofing was replaced by slate roofing salvaged when the Lecomte House in Natchitoches was torn down in 1906. That slate roof was replaced by the existing cement-asbestos roof in 1953. Most of the shingles are in good condition. Flashing around chimneys and dormers is galvanized steel, some of which may date to the early twentieth century. The triangular, sheet-metal vents at each end of the roof ridge were apparently installed along with the slate roof around 1906. With the exception of the dormers which retain their original decking, roof decking consists of closely-spaced 1” by 6” boards. This decking is in very good

Figure 36 Typical semi-octagonal gutter and round downspouts, which date to early twentieth century. (NPS-SERO-CRS, 2001)

- Monitor effectiveness of current roof repairs and how frequently the coating requires renewal.
- If suitable replacements can be found, replace missing ridge shingles.
- Repair metal roofing and flashing; properly prepare both and repaint with appropriate silver-colored paint.
- Reinstate horizontal downspout at west end of kitchen wing.
- Repair existing gutters and downspouts, replacing only those portions that have rusted beyond repair.
- Keep gutters and downspouts painted, including the interior of the gutter trough. Exterior should be painted white; interior of gutter trough should be painted with appropriate rust-inhibitive coating.
- Insure rapid drainage of downspout runoff away from the house.

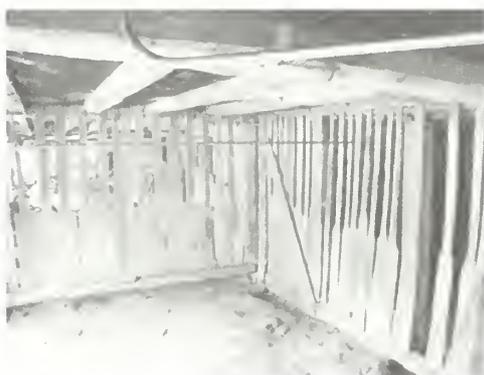
Grade-level courses of brick at the west end of the kitchen wing and a wooden door frame on the south side below Room 217 are all that

Figure 40 View of a somewhat of foundation enclosure. (NPS-SERO-CRS, 2001)

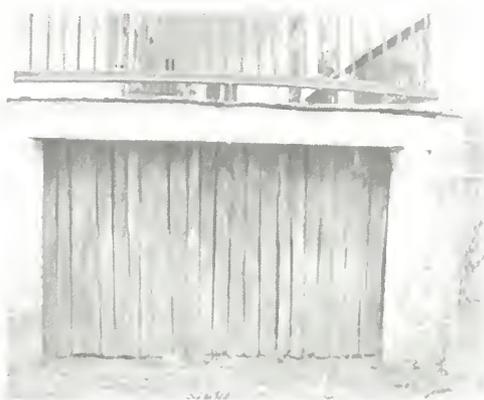
Figure 41 View of the third type of foundation enclosure. (NPS-SERO-CRS, 2001)

remain from the enclosure of that area. Horizontal boards (now covered with corrugated metal) above a grade-level course of brick are present beneath the west side of Room 214B. Wood-framed walls with horizontal planking were once present between the piers of the kitchen wing, but only fragments of the framing remain in place beneath the east end of the south side of the wing. These walls were reportedly removed in the 1940s.

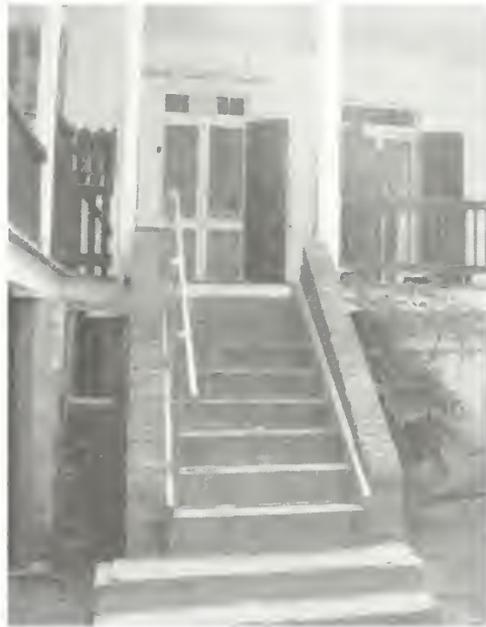
Figure 44 Brick stairs to rear gallery, shown here, and similar stairs to the south gallery replaced wooden stairs after World War II. Brick stairs to front gallery date to the nineteenth century. (NPS-SERO-CRS, 2001)

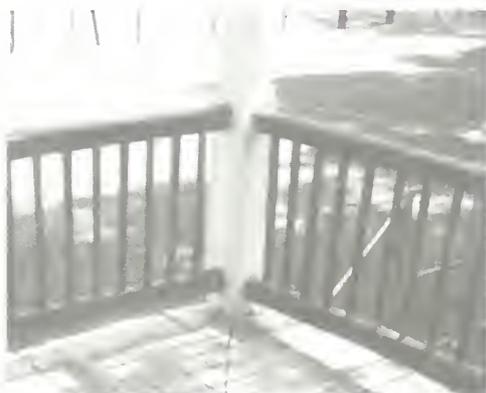
Figure 45 Typical gallery post, balustrades, and flooring. (NPS-SERO-CRS, 2001)

The main gallery balustrades are approximately 28" high with the bottom rail set about 4" from the floor. The top rail is 3½" by 3" and the bottom rail is 2" by 3"; the edges of both rails are reeded. Balusters are plain, 1" square, and set on 4½" centers. On the south gallery of the old kitchen addition, top rails are 2½" by 3½", bottom rails are 2" by 2½", and 1"- square balusters are set on 4" centers. Wooden gates are located at the tops of the three sets of existing stairs and of the now-missing stairs to the north gallery. Historic photographs show that the gate at the top of the front stairs was not in place around 1910 and the other gates may not have been either. Although the design of these gates does not match the balustrades and appear to have been salvaged from another location, their materials and manner of construction indicate that all four gates date to the nineteenth century. The column on the south side of the front

- Repair floor framing as necessary.
- Replace floor boards as necessary, replacing entire boards as has been done on previous occasions.
- Maintain protective coatings on balustrades and posts.

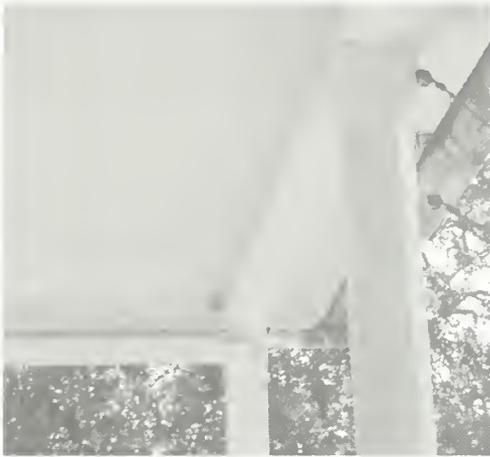
On the main part of the house, the headers that support the perimeter of the roof above the galleries have beaded edges and are supported by a series of twenty-five wooden columns or posts, one of which is engaged by the wall on the west side of Room 201 and another by the northeast corner of Room 211. A portion of one of the original gallery headers, painted gray, was reused as a floor joist beneath the south-east corner of Room 209.

Figure 46 View of typical porch header and column top. (NPS-SERO-CRS, 2001)

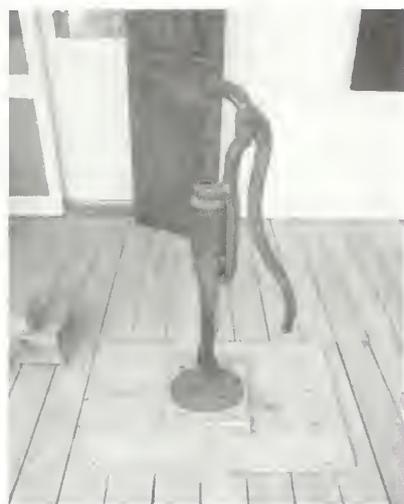
Figure 48 Myers pump on rear gallery, still connected to cistern located below. (NPS-SERO-CRS, 2001)

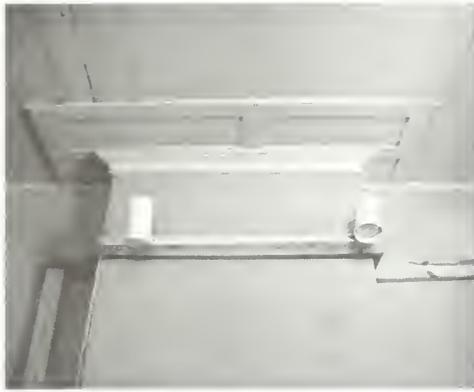
Figure 49 Board ceiling, typical of those found in most rooms on the main floor of the house. Paneling detail around chimney breast is typical of that found in 202, 205, 206, and 210, although molding details are different in each room. (NPS-SERO-CRS, 2001)

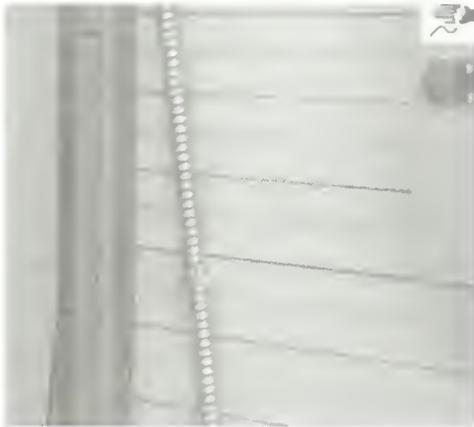
Figure 50 Typical beaded, tongue-and-groove boards used to panel parts or all of walls and ceilings in 202, 204, 207, 209, 215, and 216. (NPS-SERO-CRS, 2001)

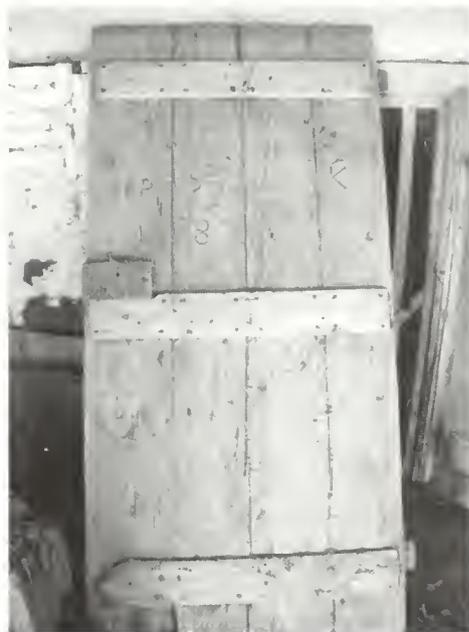
Figure 51 View of board door at basement level, typical of the oldest doors in the house. (NPS-SERO-CRS, 2001)

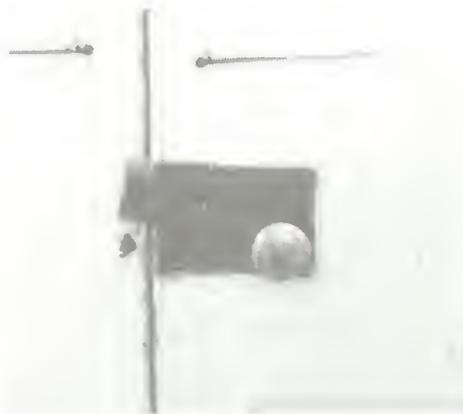
Figure 53 Early spring lock on French doors in dining room. (NPS-SERO-CRS, 2001)

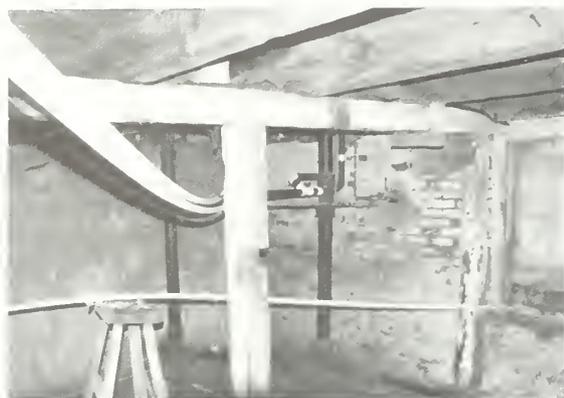
Figure 54 View southeast in Room 101, showing plumbing lines from bathroom 203. (NPS-SERO-CRS, 2001)

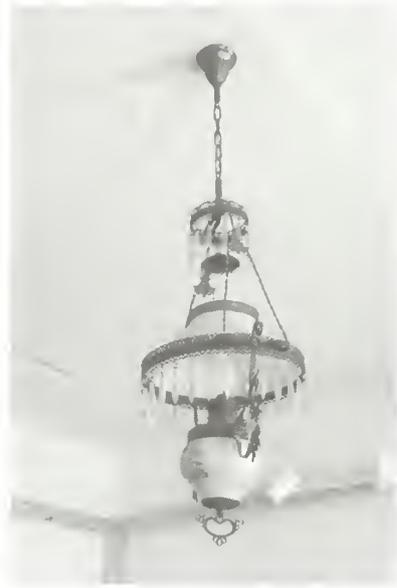
Figure 78 View of electrified kerosene chandelier in parlor. (NPS- SERO-CRS, 2001)

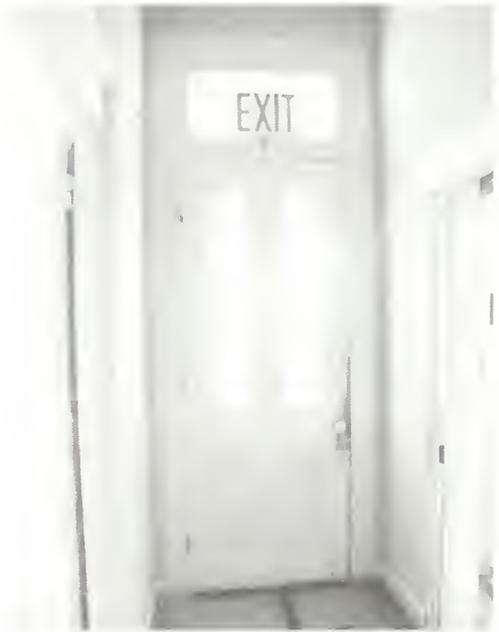
Figure 85 View of front door, installed as part of 1880s renovation. (NPS-SERO-CRS, 2001)

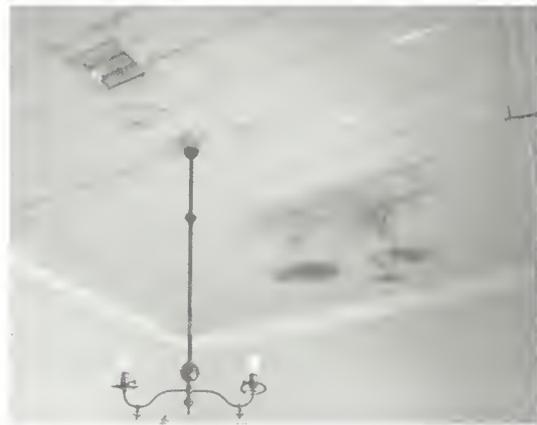
Figure 95 View of water-damaged ceiling in stranger's room. (NPS-SERO-CRS, 2001)

- Clean cypress and pine floors; refinish as necessary.
- Replace vinyl floor covering in kitchen, matching pattern and material of existing covering.
- Repair plaster and woodwork as necessary.
- Clean all painted finishes, using the gentlest means possible.
- Repaint ceiling in stranger's room (211) and elsewhere only as necessary.
- As an aid to interpretation, make exposures of historic paints inside and outside the house.

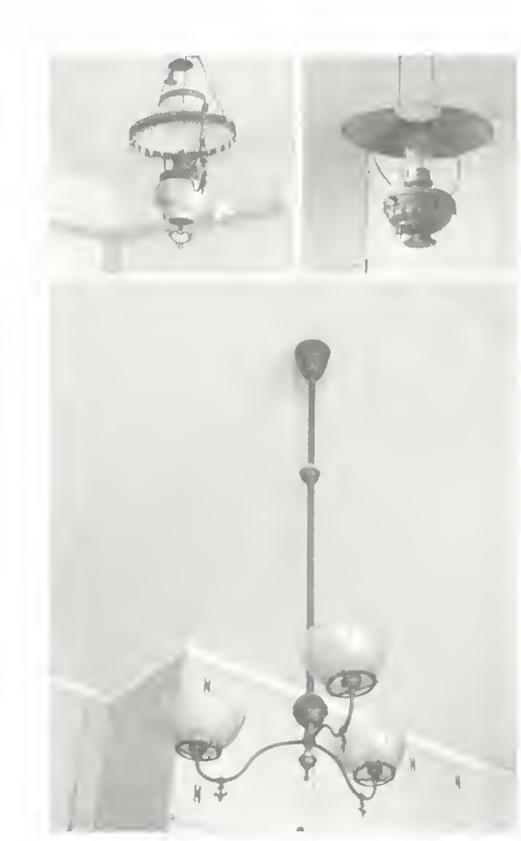
Figure 112 Top, view of nineteenth-century kerosene light fixtures and, below early twentieth-century gas light fixtures, all of which were converted to electricity in the late 1930s.

- Install new branch circuit wiring to re-feed historic outlets and to feed any new outlets that are deemed necessary.
- Restore and rewire historic lighting fixtures to working order, replacing missing elements as necessary.
- Recreate the historic meter, fuse boxes and associated wiring on south gallery.
- Install complete fire detection and security system.

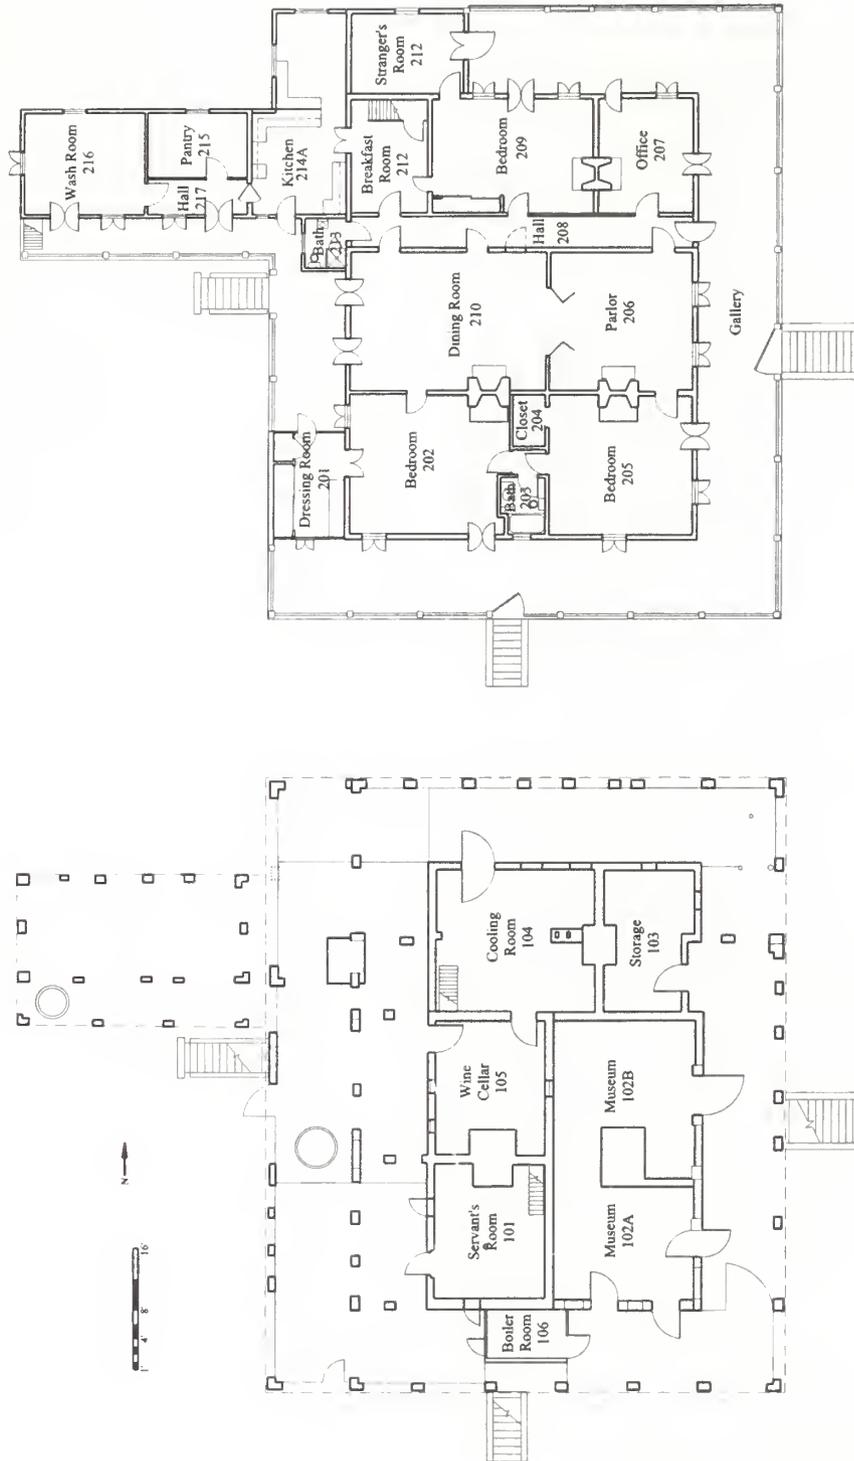
Figure 113 Plans of existing basement and main story of house. (NPS-SERO-CRS, 2001)
