PRESERVATION BRIEFS

The Preservation and Repair of Historic Log Buildings

Bruce D. Bomberger

U.S. Department of the Interior
National Park Service
Cultural Resources
Preservation Assistance

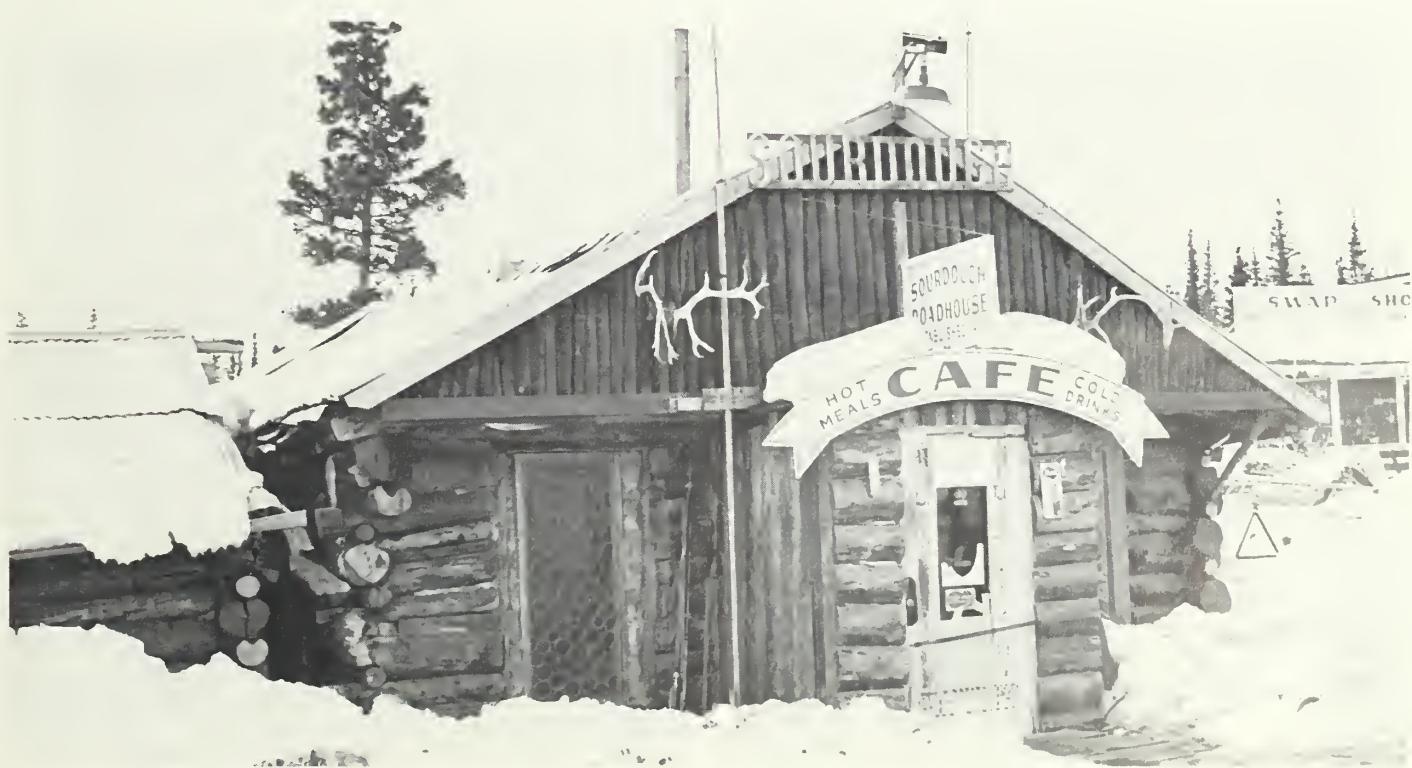
Fig. 1. Log construction was practical in the rough frontier and climate of Alaska, where it was used for a variety of structures such as the Sonndough Lodge (c. 1903) near Gakona. Built to serve the trail leading to the Klondike gold discoveries, this 1-story, L-shaped roadhouse is primarily of horizontal log construction with vertical logs in the front gable. Photo: National Park Service Files.

ting. "Log cabin" or "log house" often conjures up associations with colonial American history and rough frontier life (Fig. 1). While unaltered colonial era buildings in general are rare, historic log buildings as a group are neither as old nor as rare as generally believed. One and two-story log houses were built in towns and settlements across the country until about the middle of the 19th century, and in many areas, particularly in the West, as well as the Midwest and southern mountain regions, log continued to be a basic building material despite the introduction of wooden balloon frame construction (Fig. 2). By the early 20th century, the popularity of "rustic" architecture had revived log construction throughout the country, and in many areas where it had not been used for decades.

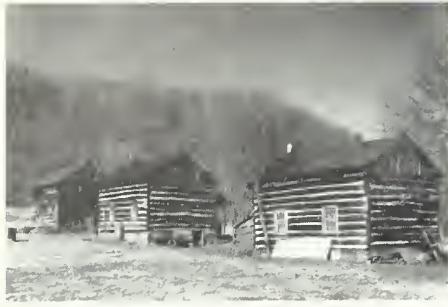
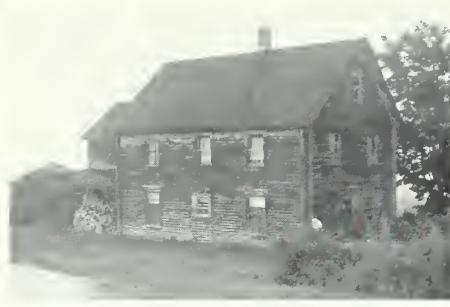
Fig. 2. Logs, both round and hewn, continued to be a basic construction material throughout much of the 19th century, here illustrated by (a) these c. 1831 industrial workers' houses for forgemen at the Mt. Etna Iron Furnace in Pennsylvania, and (b) the Larsson-Ostlund House built by Swedish immigrants in New Sweden, Maine, during the 1870s. (c) Corner detail of the Larsson-Ostlund House with the original clapboarding removed during restoration shows close-fitting log joints in the Scandinavian style that did not require chinking. Photos: (a) Jet Lowe, HAER Collection, (b-c) Maine Historic Preservation Commission.

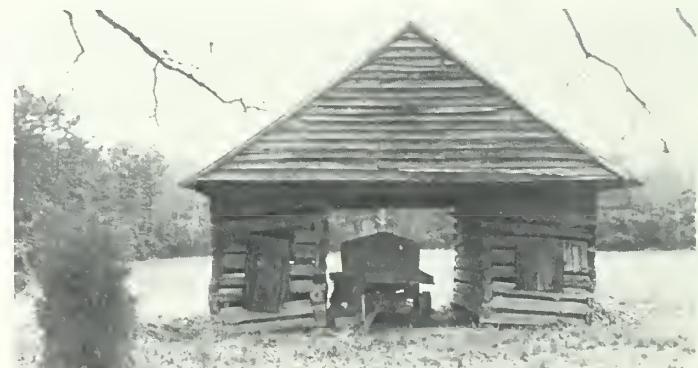
Fig. 3. This mid-19th century double-pen corncrib on the Jamison Farm in Rowan County, North Carolina, is an example of a type of log building that did not require chinking. Photo: Denise Whitley.

structed as temporary shelters by soldiers during the Revolutionary War, and across the country, Americans used logs not only to build houses, but also commercial structures, schools, churches, gristmills, barns, corncribs and a variety of outbuildings (Fig. 3).

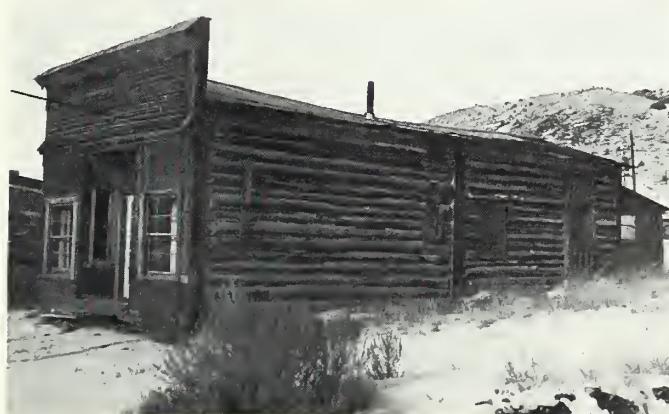
Fig. 4. Beginning around the mid-19th century, entire western boomtowns were hastily constructed of frame and log, such as the buildings in Bannack, Montana, the site of the State's first gold discovery. Photo: National Park Service Files.

Around the mid-19th century, successive generations of fur traders, metal prospectors, and settlers that included farmers and ranchers began to construct log buildings in the Rocky Mountains, the Northwest, California, and Alaska (Fig. 4). In California and Alaska, Americans encountered log buildings that had been erected by Russian traders and colonists in the late 18th and early 19th centuries. Scandinavian and Finnish immigrants who settled in the Upper Midwest later in the 19th century also brought their own log building techniques with them. And, many log structures in the Southwest, particularly in New Mexico, show Hispanic influences of its early settlers.

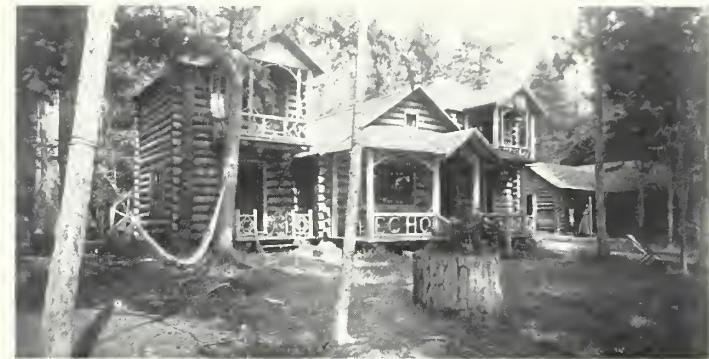
Fig. 5. The main lodge of Echo Camp on Raquette Lake in New York State was built in 1883 by the governor of Connecticut. It typifies the Adirondack style in the use of exposed round logs with crowns, and porches and balconies constructed with bowed logs and round log columns. Photo: Courtesy The Adirondack Museum.

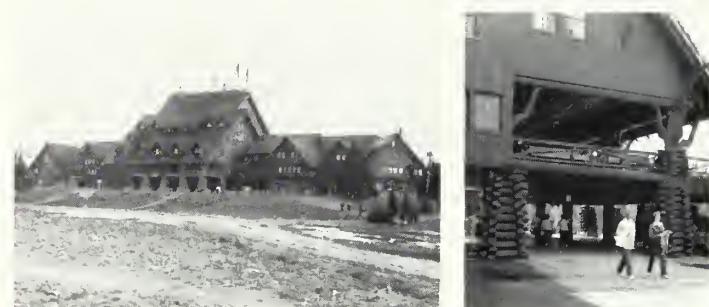
Fig. 6. (a) Old Faithful Inn, Yellowstone National Park, Wyoming, shown here in 1912, brought the Rustic style to the West in 1903 in an original design, and a scale befitting its setting. (b) Although only the first story is of horizontal log construction, the use of logs is striking in the trestle work and cribbed piers around the entrance. Photo: (a) Courtesy National Park Service, (b) Laura Soulliere Harrison.

The Adirondack or Rustic style was balanced in the West with construction of the Old Faithful Inn at Yellowstone National Park in Wyoming, designed by Robert C. Reamer, and begun in 1903 (Fig. 6). This popular resort was tremendously influential in its use of locally-available natural materials, especially log, and gave impetus to Rustic as a true national style. From the turn of the century through the 1920s, Gustav

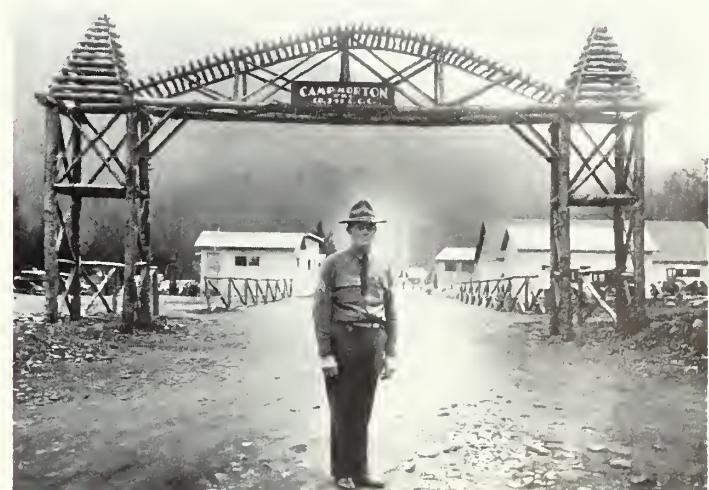
Fig. 7. The Civilian Conservation Corps built many recreational log structures across the country in the 1930s and 40s, including this rustic log gateway to Camp Morton, Lycoming County, Pennsylvania. Photo: Courtesy Lycoming County Historical Society and Museum.

Stickley and other leaders of the Craftsman Movement promoted exposed log construction. During the 1930s and 40s, the Civilian Conservation Corps (CCC) used log construction extensively in many of the country's Federal and State parks to build cabins, lean-tos, visitor centers, and maintenance and support buildings that are still in service (Fig. 7).

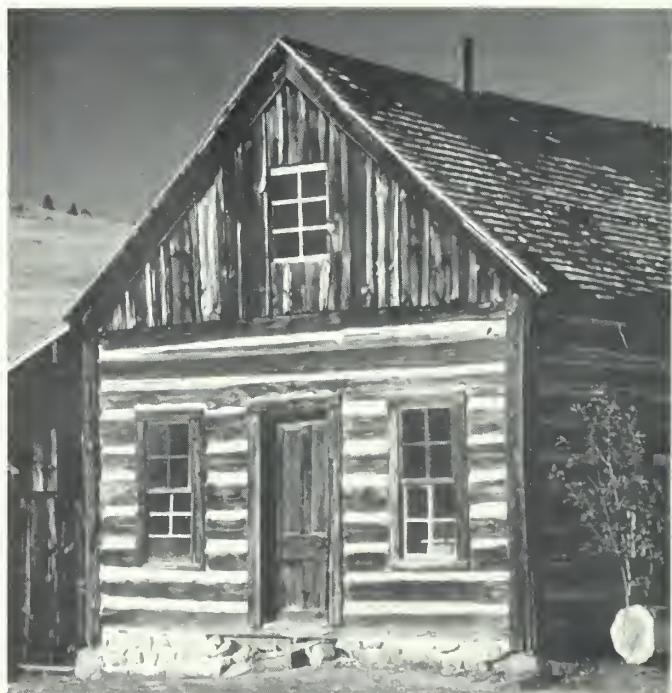
Fig. 9. This historic log building on the Walker Ranch in Boulder, Colorado is an example of the Rocky Mountain cabin form which is typified by the entrance door being located in the gable end. Photo: Bernard Weisgerber.

A somewhat different form evolved in the West around the middle of the 19th century which became especially distinctive of the Rocky Mountain cabin. While the entrance doorway to most earlier log houses was generally placed beneath the eaves, as a means of adapting to the greater snowfall in the Rockies, here the entrance was placed in the gable end, and sometimes protected from roof slides by a porch supported by two corner posts created by an extension of the roof beyond the gable wall (Fig. 9).

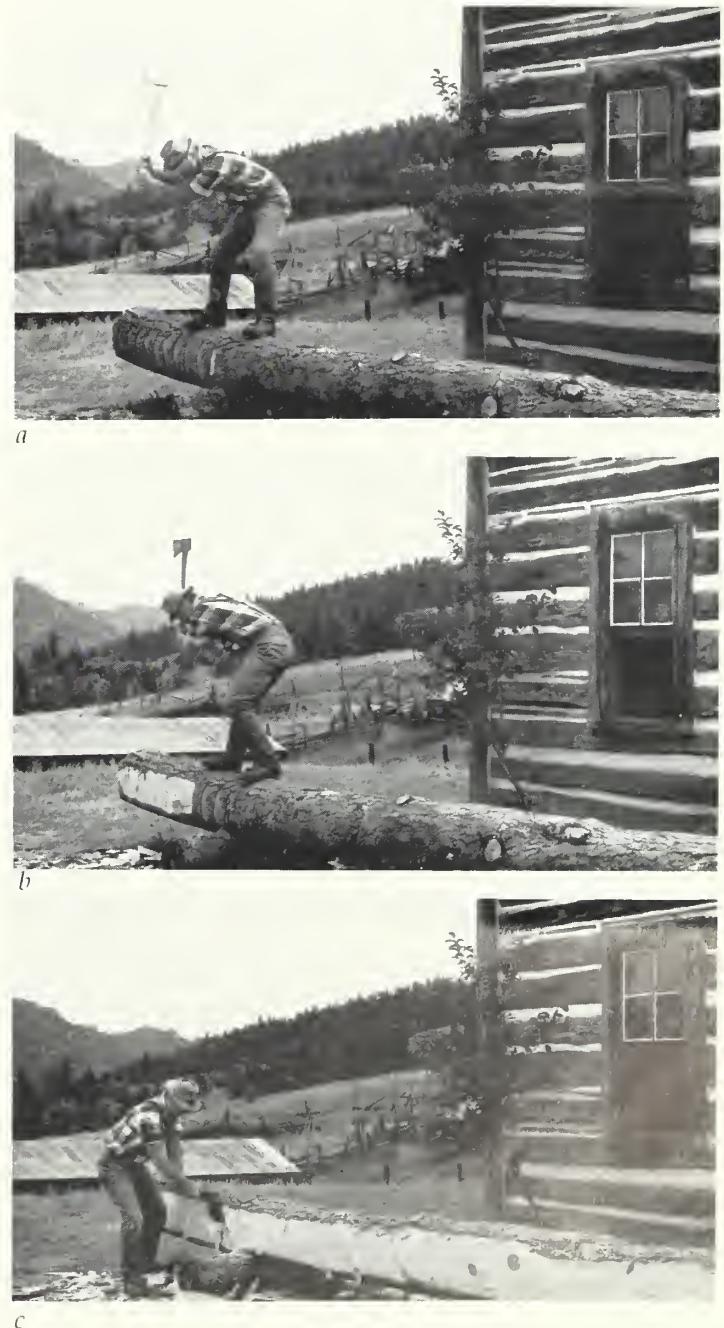
Fig. 11. Log-hewing tools and techniques: (a) scoring the log with a single-bladed felling axe, or "pole axe" in preparation for removing a uniform thickness of wood; (b) removal to depth of scoring; (c) finish hewing with a broad axe. Photos: Courtesy Bernard Weisgerber.

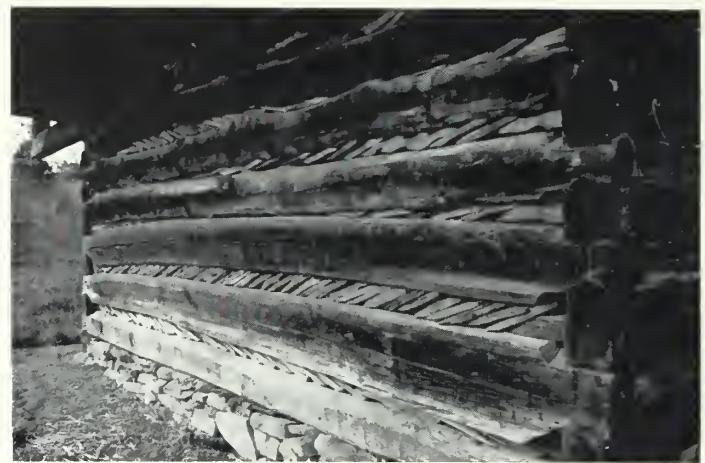
Fig. 12. The log joints have been cleaned out in preparation for new daubing exposing carefully laid stone chinking in this building in Virginia. Photo: Bernard Weisgerber.

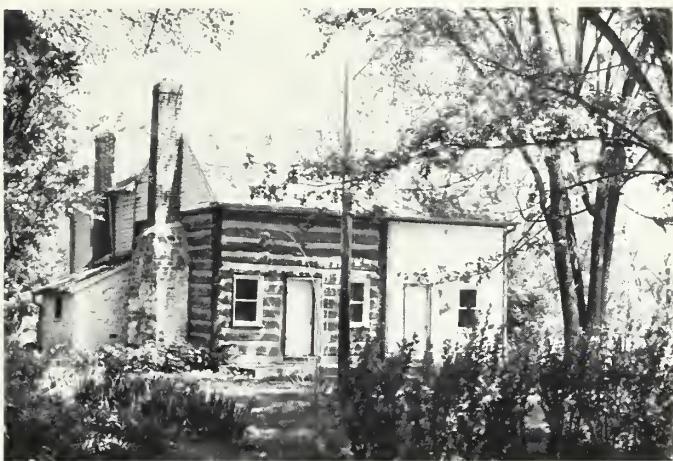
Fig. 13. Historic wood clapboard siding originally applied to conceal the fact that this house was built in two sections of different materials has been inappropriately removed from the 1793 log portion. Photo: National Park Service Files.

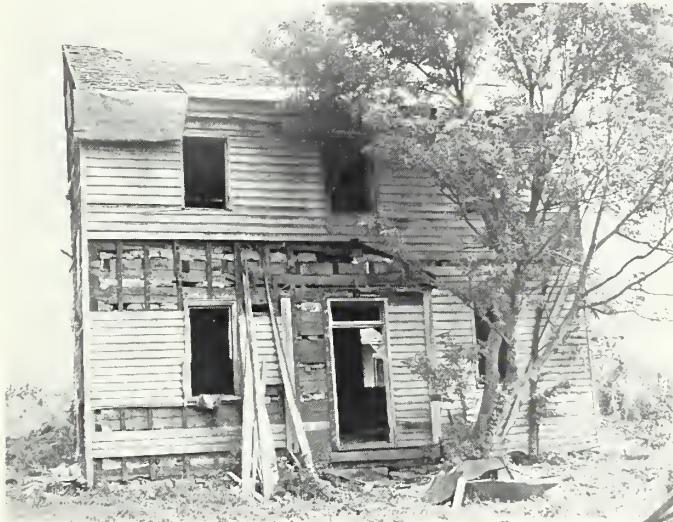
Fig. 14. Removal of the historic wood siding from the 1804 Zachariah Price DeWitt House in Butler County, Ohio, reveals that the clapboards were attached to vertical wood furring strips nailed to the logs. Photo: National Park Service Files.

Vertical wood furring strips were generally nailed to the logs prior to applying weatherboarding or stucco (Fig. 14). This ensured that the walls would be plumb, and provided a base on which to attach the clapboards, or on which to nail the wood lath for stucco.

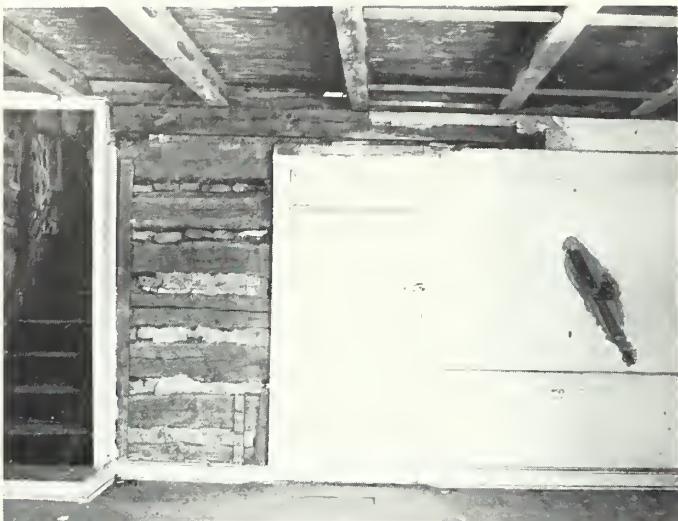
Fig. 16. This photograph of the interior of a 1793 log house in Maryland reveals much about historic log building construction and interior finish treatments. To the left of the plank door plaster has been removed exposing the stone chinking and danbing; remnants of vertical furring strips attached to the logs show evidence of traditional horizontal lath, while the hole broken through the plaster wall on the right shows the use of diagonal lath. The open door reveals a very steep, enclosed stairway typical of many early log houses. Although plaster has been removed from the ceiling, the wall to the right of the door shows the original plaster finish and fine woodwork including beaded chair rail, floor and door molding. Photo: National Park Service Files.

Logs on the interiors of many of the simpler cabins and Rustic style structures were often given a flattened surface or left exposed. But, in the more finished log houses of the 18th and 19th century, they were more commonly covered for most of the same reasons that the exterior of the logs was covered—improved insulation, ease of maintenance, aesthetics, and keeping out vermin. Covering the interior log walls with planks, lath and plaster, boards pasted with newspaper, fabric such as muslin, or wallpaper increased their resistance to air infiltration and their insulation value. Finished walls could be cleaned and painted more easily, and plastered walls and ceilings obscured the rough log construction and prepared interior surfaces for decorative wood trim in the current styles (Fig. 16).

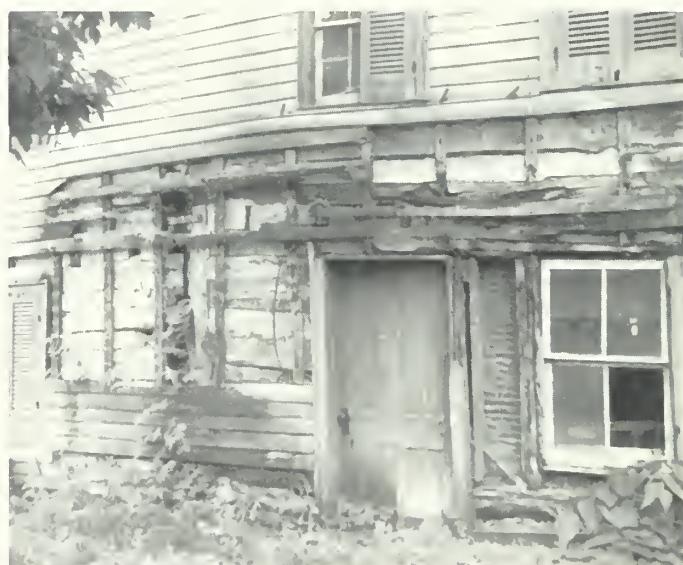
Fig. 17. Contact of this building's sill log with the ground has led to its decay, infestation by wood-destroying insects, and resulting building settlement. Photo: Anne Grimmer.

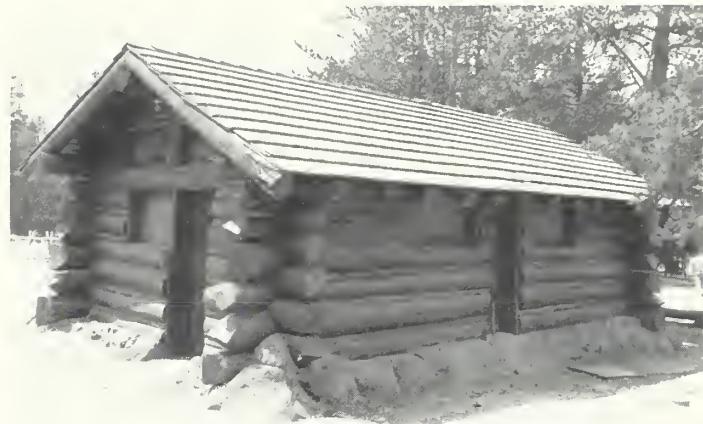
Fig. 18. Exposed roofing members of Rustic style buildings such as this structure at Yellowstone National Park are highly susceptible to deterioration. Photo: Laura Soulliere Harrison.

story was added, or repaired as the result of storm or fire damage. Often, roof framing may be composed of reused material recycled from earlier buildings. Inspection of the roof framing should note its configuration and condition. Typical problems to look for are framing members that have been dislodged from their sockets in the roof plate, or that are cracked, ridge damage, sagging rafters, broken ties and braces, and decay of exterior exposed rafter or purlin ends, especially common on Rustic style buildings (Fig. 18).

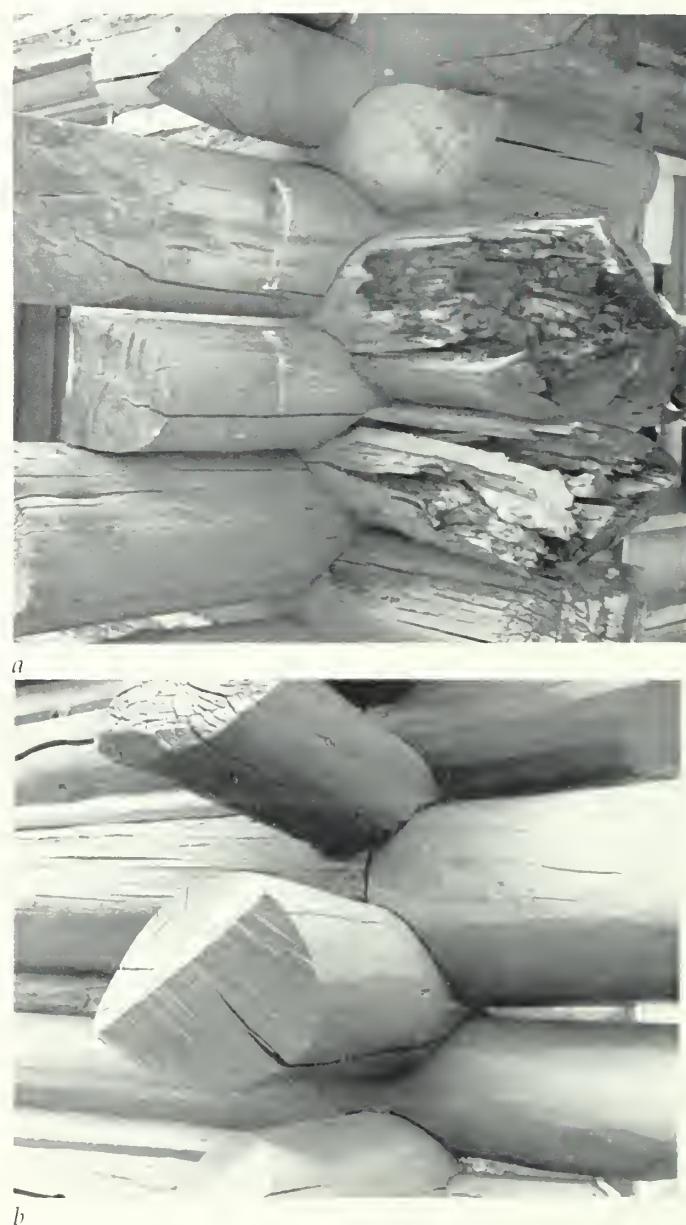
Fig. 20. (a) These deteriorated log crowns were (b) repaired with new crowns which were attached to the historic logs with reinforcing bars and epoxy. Epoxy repair of log crowns is most successful when the repaired crowns are protected from excess moisture by a roof overhang. Photos: Harrison Goodall.

The technique of treating, for an example, a decayed log crown with epoxies is begun by removing loose decayed wood, and drying the area if necessary (Fig. 20). The rot-affected cavity and surface of the log end is then saturated with liquid epoxy by repeated brushing, or by soaking it in a plastic bag filled with epoxy that is attached to the log. The porous condition of the rot-damaged wood will draw up the epoxy like a lamp wick. Once the liquid epoxy has saturated the log end and cured, the log end has been consolidated, and is ready for the application of an epoxy putty filler. The filler resin and hardener must also be mixed; pigments must be mixed with the filler epoxy to color the patch, and more importantly to protect it from ultraviolet sunlight. The filler can be applied with a putty knife, pressing it into the irregularities of the cavity. The cured patch can be worked like wood and painted with an opaque stain or a dull finish paint to help it blend with surrounding wood, although epoxy repairs can be difficult to disguise on natural, unpainted wood.

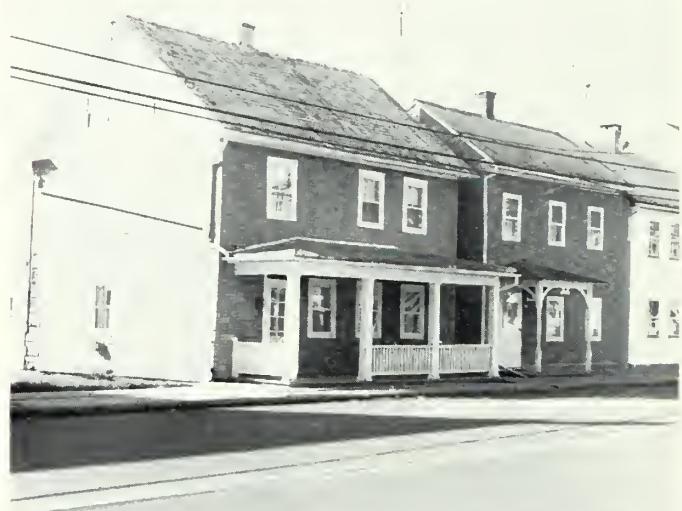
b

Fig. 24. Some towns still retain a high number of early log houses. (a) Middleway, West Virginia, is a small village dominated by 18th and 19th century log houses, and, with the exception of outbuildings, all are clad in original wood siding or stucco. Removal of one of the houses from this streetscape would not only result in a loss of integrity to the building, but also to the historic district. (b) The original wood clapboard of two of these c. 1830 log houses in Stouchsburg, Pennsylvania, has been covered with asphalt siding, and later porches added. Rehabilitation plans might appropriately include retention of the porches as having acquired significance over time, and removal of the asphalt siding. Uneven spacing between the two upper left windows of the house on the left, and the center chimney are indications that the house was built in two stages. Photos: (a) Anne Grimmer, (b) Pennsylvania Historical and Museum Commission.

Log buildings are too often viewed as portable resources. Like other historic buildings, moved or relocated log structures can suffer a loss of integrity of materials and of setting (Fig. 24). Historic buildings listed in the National Register of Historic Places may be subject to loss of that status if moved. Despite the popularity of dismantling and relocating log buildings, they should be moved only as a last resort, if that is the only way to save them from demolition. If they must be moved, it is preferable that they be moved intact—that is, in one piece rather than disassembled. Disassembling and moving a log building can result in considerable loss of the historic building materials. While the logs and roof framing members can be numbered for reassembly, dismantling a log building can result in loss of such features as foundation and chimney, chinking and daubing, exterior cladding, and interior finishes. Furthermore, log buildings can rarely be put back together as easily as they were taken apart.

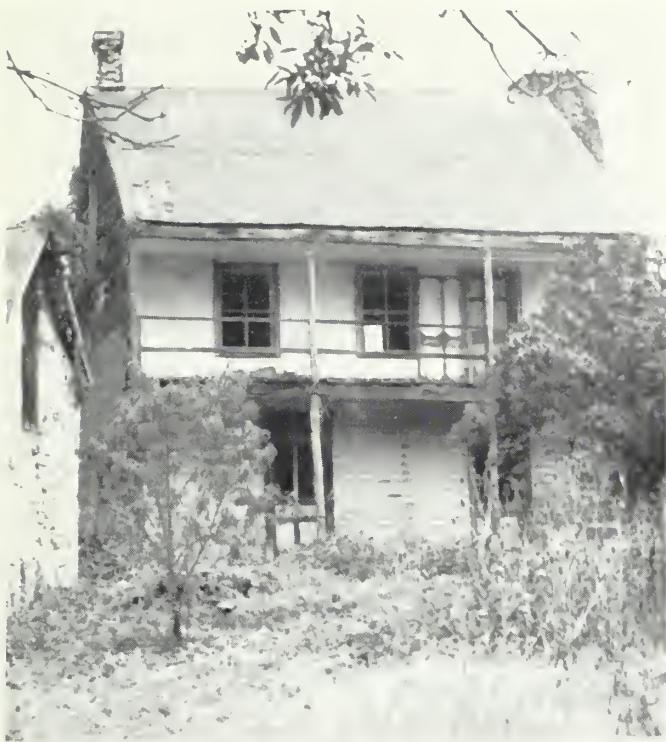
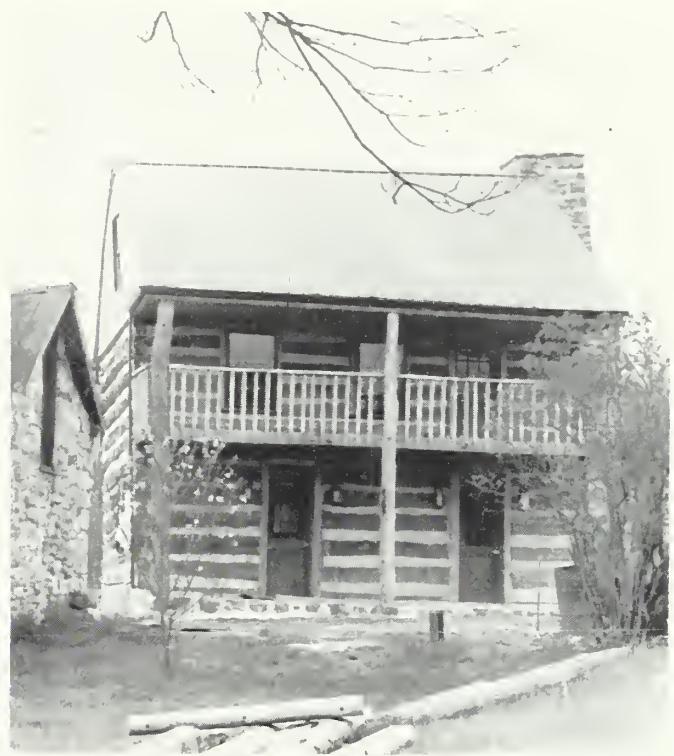
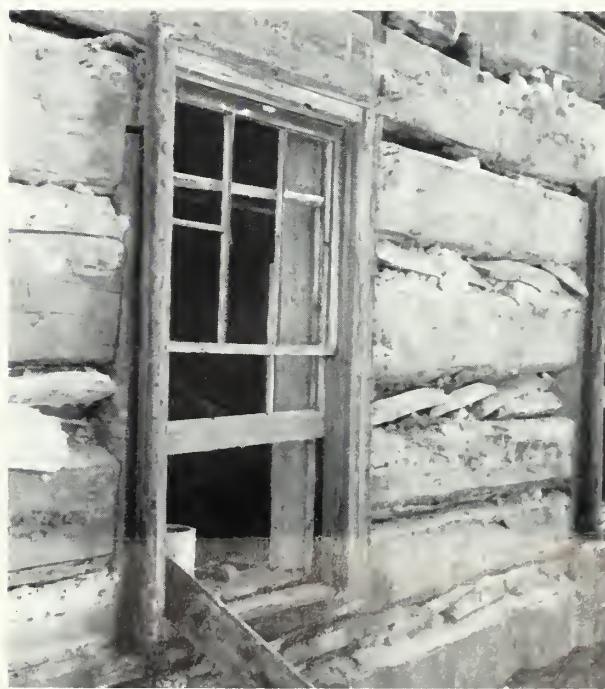
Fig. 25. (a) Prior to rehabilitation, the exterior of this late 18th century log house was sided with wood clapboard, which had been covered over by a later artificial siding, while the upper gallery of the second floor porch was stuccoed. (b) During the rehabilitation both the historic wood siding and stucco were removed to expose the logs, the gables were sided with wood shingles, and what would have originally been milled wood columns supporting the porch were replaced with rough, unmilled log posts. Collectively, these treatments diminished the building's architectural integrity, and gave it an appearance it never had. (c) The depth that the window frames extend out beyond the log surface allowing space for siding is an indication that cladding was part of the building's original construction.
