Oakland Plantation Prud'homme's Store

Historic Structure Report

CANE RIVER CREOLE NATIONAL HISTORICAL PARK
OAKLAND PLANTATION

~ PRUD'HOMME'S STORE ~
HISTORIC STRUCTURE REPORT

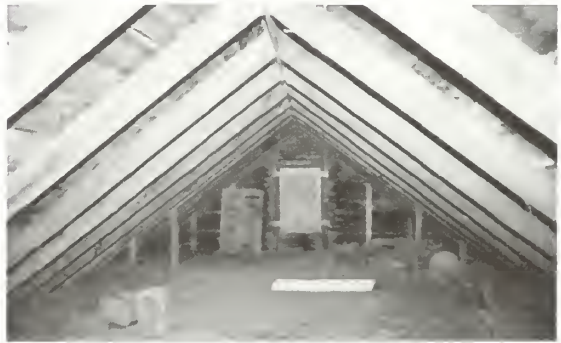
Figure 19 View west in attic of store. (NPS-SERO-CRS, 2001)

shingles, presumably cypress, laid in typical fashion over rough- sawn, widely- spaced roof lath (i.e., sheathing). The original wood- shingled roofs have now been replaced with standing- seam, galvanized roofing, except over 003 and 004, which are both covered with corrugated sheet metal roofing. The original wood- shingled roofing remains intact over 003.

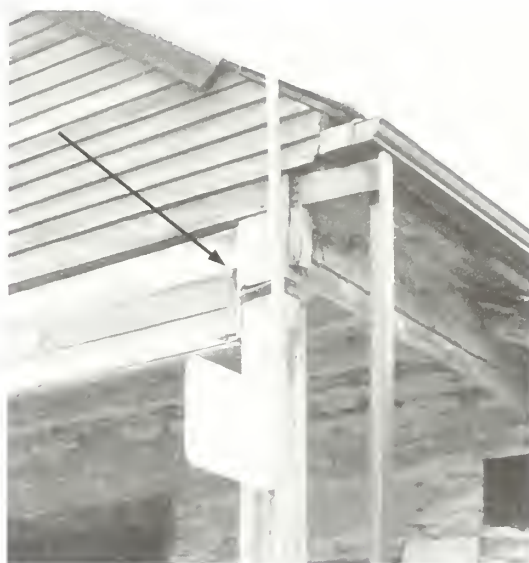
Figure 27 View of northeast corner of building, showing mixture of exterior finishes. Arrow notes original detail of post top. (NPS-SERO-CRS, 2001)

The 7" by 7" posts that support each corner of the gabled portion of the porch appear to be original. Some of the original drip cap and trim at the top of each post is missing. A plain 4" by

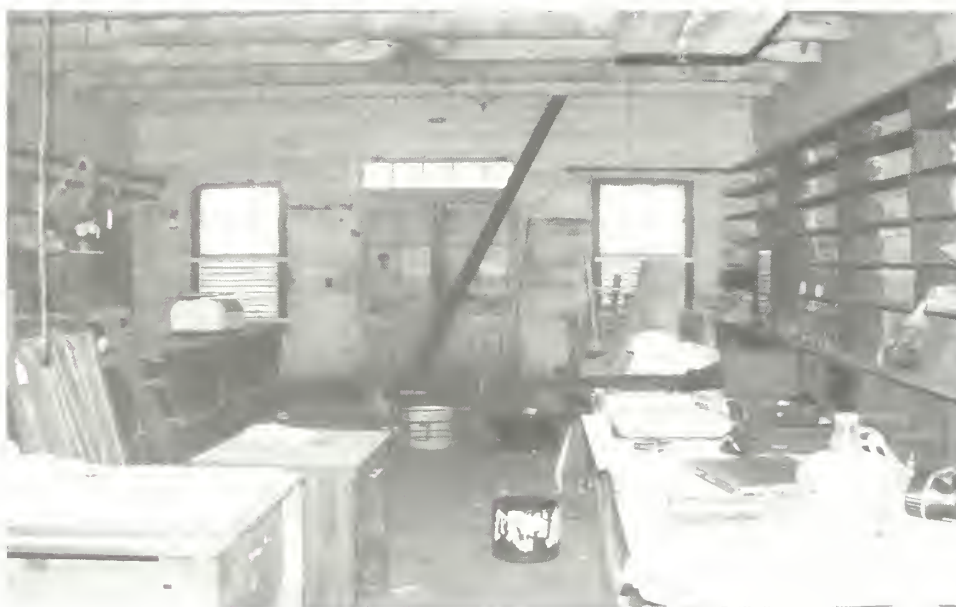
Figure 31 View east in 002. (NPS-SERO-CRS, 2001)

Walls: Wall framing typically uses 4" by 6" corner posts and 2½" by 3¾", circular- sawn studs, set on 28 to 32 inch centers. Walls are finished with plain boards (not tongue- and- groove), nine to thirteen inches wide, all of which have been whitewashed. Two early openings in these walls have been closed. On the north wall, near the north end of 003, is the outline of an original (c. 1870) window opening. On the west wall, above and to the left of the door on that wall, is a small opening, now closed, that apparently pre- dated the addition of the office (006). Its purpose has not been identified, although it may have simply been for ventilation, a necessity if kerosene and other such oils were being sold in the store prior to the addition of the north shed (003).
