A  
Glossary of  
Historic  
Masonry  
Deterioration  
Problems  
and  
Preservation  
Treatments

Compiled by Anne E. Grimmer

Department of the Interior  
National Park Service  
Preservation Assistance Division

1984

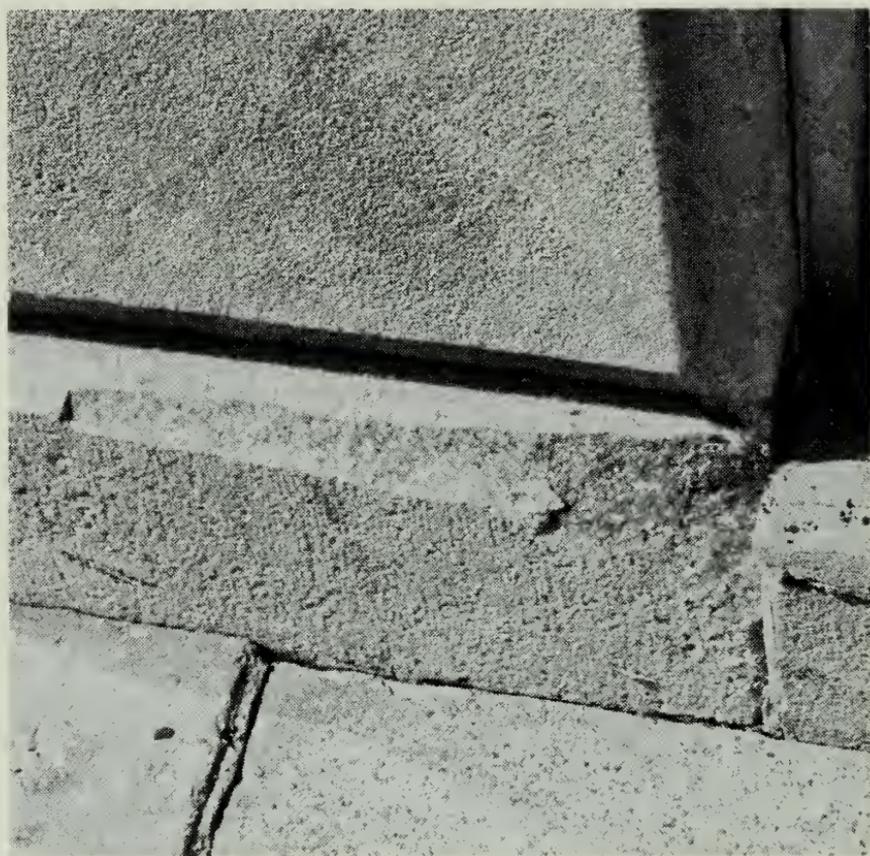
Small pieces or larger fragments of masonry separating from the masonry unit, often at corners or mortar joints. This may be the result of damage caused by later alterations or repairs, such as use of too hard a mortar, or by accident or through vandalism.

*Chipping of granite sill. Photograph: Anne E. Grimmer.*

*Preservation Treatment:* See Dutchman Repair, p.56; Replacement/Patching with Like or Compatible Substitute Materials, p.59.

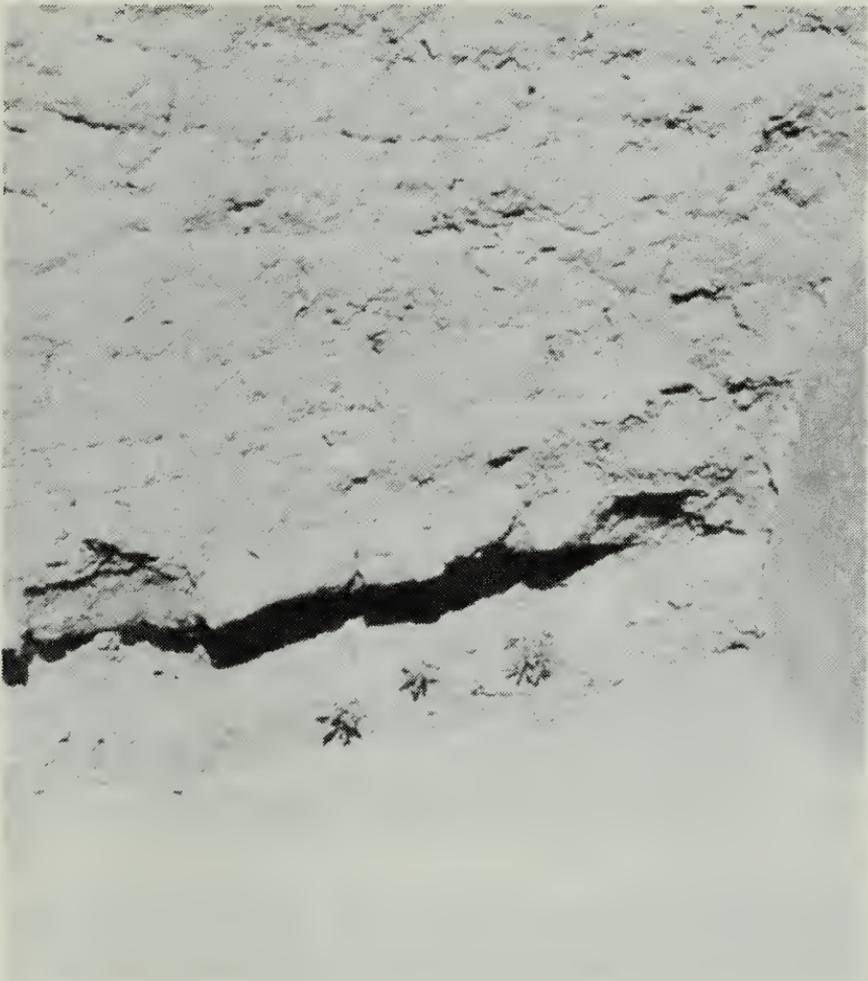
The hollowing out of an adobe wall just above grade level. Coving may be caused by standing rainwater or rainwater splash off the ground. It can also be caused by salts deposited in the adobe by the evaporation of water.

*Coving of adobe wall. Photograph: National Park Service.*

*Preservation Treatment:* See Replacement/Patching with Like or Compatible Substitute Materials, p.59.

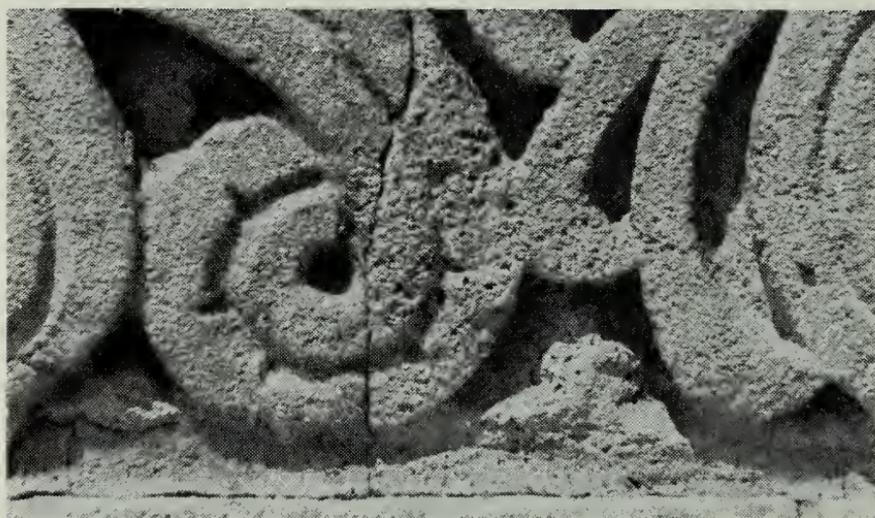
A term describing narrow fissures from 1/16 to 1/2 inch wide in a block of masonry. Cracking may result from a variety of conditions, such as structural settlement of a building, too hard a repointing mortar, or it may be an inherent characteristic of the masonry itself, such as unfired brick or adobe. Small cracks within a single block of masonry may not be serious, but longer and wider cracks extending over a larger area may be indicative of structural problems, and should be monitored.

*Cracking of limestone. Photograph: John H. Myers.*

*Preservation Treatment:* See Mechanical Repair, p.58; Replacement/Patching with Like or Compatible Substitute Materials, p.59.

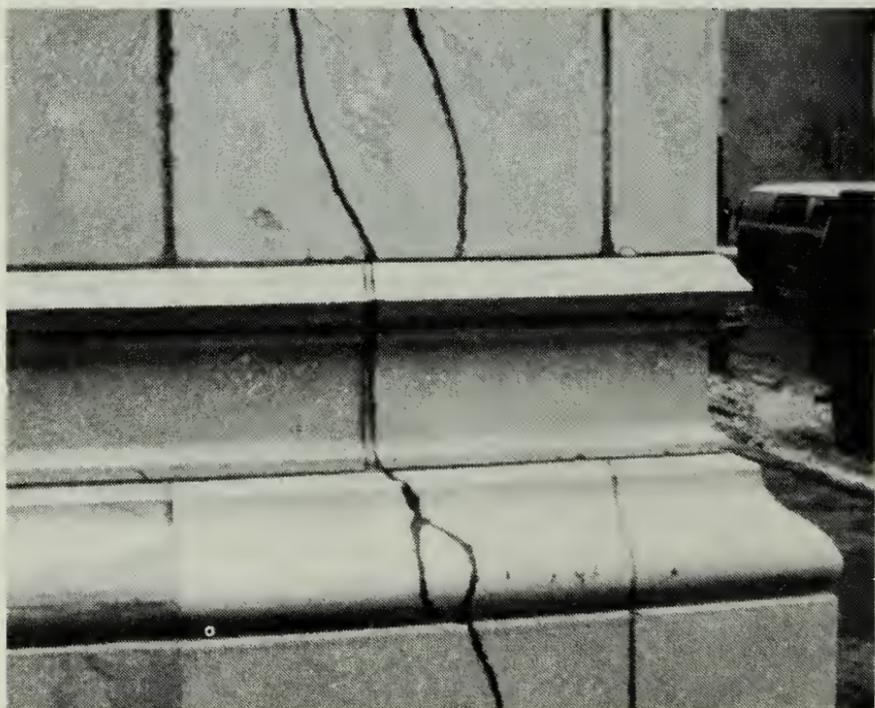
*Cracking of glazed terra cotta. Photograph: National Park Service.*

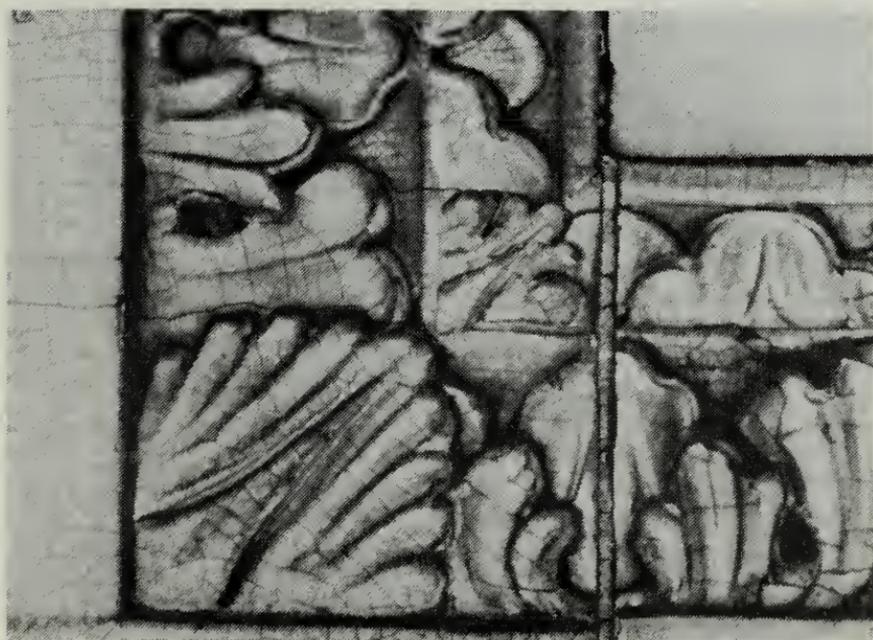
The formation of a pattern of tiny cracks or crackles in the glaze of glazed terra cotta. Crazing (dunting as it is called when it occurs immediately after the firing process and is caused by too rapid cooling) may develop over time as the terra cotta is exposed to the weather. When a terra cotta unit first comes from the kiln after firing, it has dried to its smallest possible size. With the passage of time it expands as it absorbs moisture from the air. The glaze then goes into tension because it has a lesser capacity for expansion than the porous tile body; it no longer "fits" the expanding unit onto which it was originally fired. If the strength of the glaze is exceeded by this expansion, the glaze will crack or craze (sometimes called moisture crazing). Unless the cracks visibly extend into the porous tile body beneath the glaze, crazing should not be regarded as highly serious material failure. It does, however, tend to increase the water absorption capability of the glazed terra cotta unit.

*Crazing of glazed terra cotta. Photograph: National Park Service.*

*Preservation Treatment:* To date, no completely effective treatment has been developed for this condition.

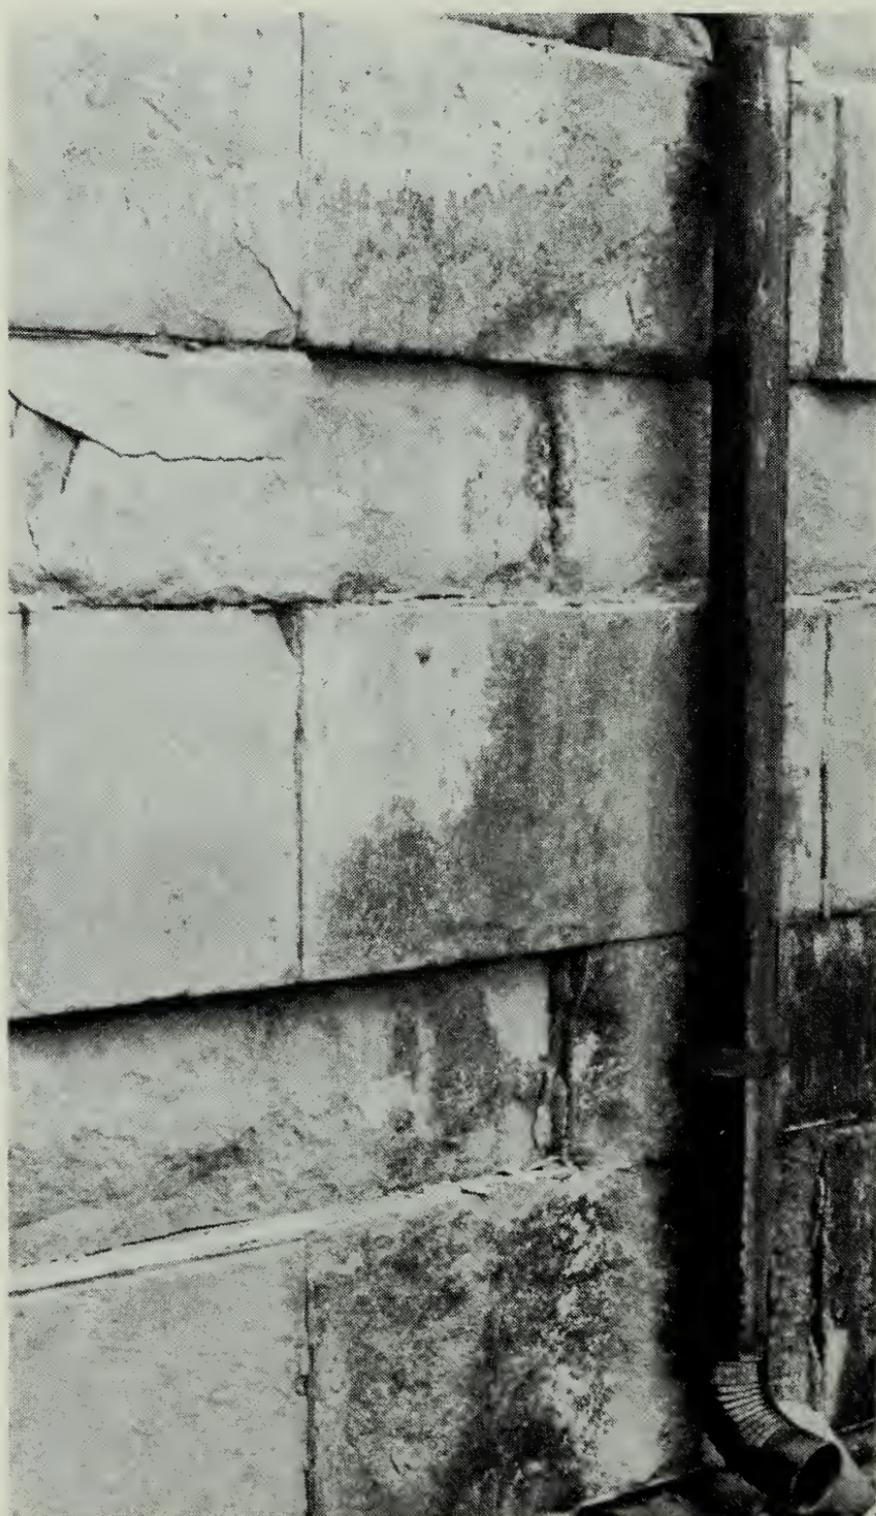
This condition is indicative of a certain brittleness or tendency of the masonry to break up or dissolve. It may be caused by an inherent weakness of the masonry and gradual dissolution of the binder, or it may be the result of external factors affecting the strength or durability of the masonry, such as salts or moisture entering the masonry.

*Crumbling limestone resulting primarily from excess moisture penetration. Photograph: National Park Service.*

*Preservation Treatment:* See Consolidation, p.52.

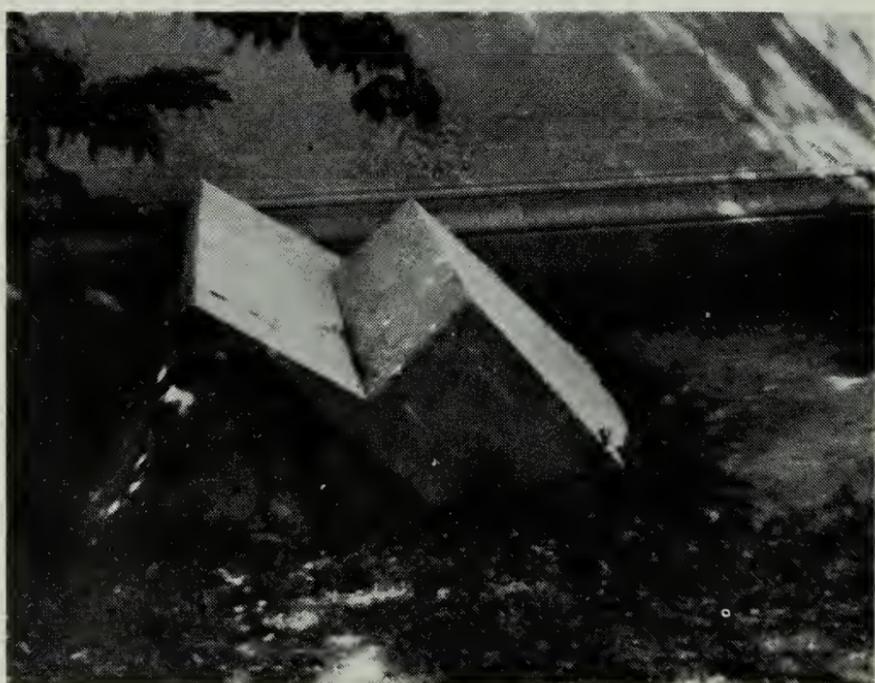
The result of a complete break (or failure of an original construction joint) in which the detached portion of masonry survives intact.

*Detachment of section of marble pediment. Photograph: Walter Smalling.*

*Section of marble lying on the ground at base of building after it had separated from pediment above. Photograph: Walter Smalling.*

*Preservation Treatment:* See Mechanical Repair, p.58.

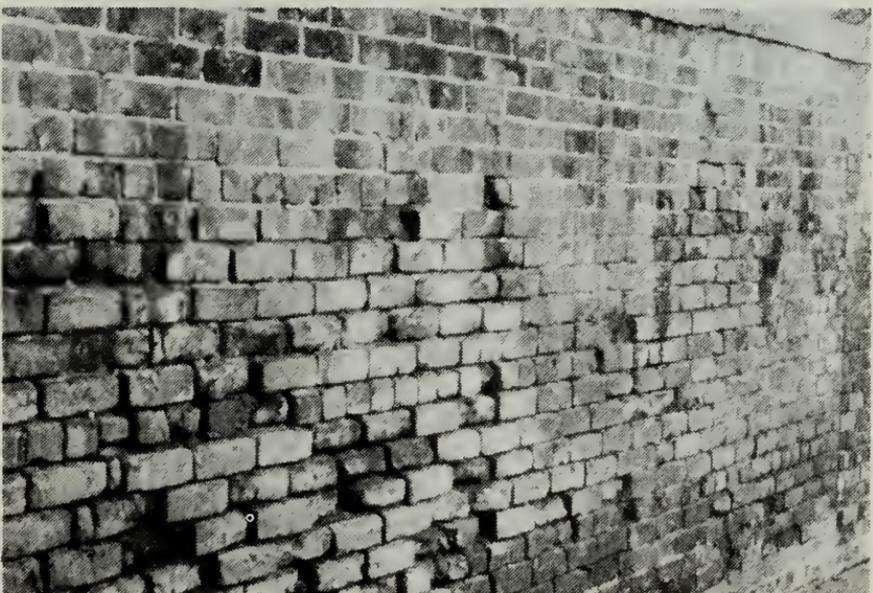
A whitish haze of soluble salts on masonry generally caused by excessive "pulling" of soluble salts into the masonry and out through the surface. Capillary action may pull soluble salts which result in efflorescence from the ground into the masonry, such as chlorides from salting of streets and sidewalks in winter and nitrates from fertilizers. In addition, carbonates from lime mortar and air-borne or water-deposited pollutants in the atmosphere may cause sulfates to be deposited on the surface of the masonry. Sulfates resulting from the curing and firing process are a common source of efflorescence in brick. Finally, efflorescence may be a combined salt residue left on the masonry surface by chemical cleaning, too strong a chemical solution, or improper rinsing.

*Efflorescence and spalling on brick wall. Photograph: Anne E. Grimmer.*

*Preservation Treatment:* See Poulticing, p.44; Water Washing, p.46.

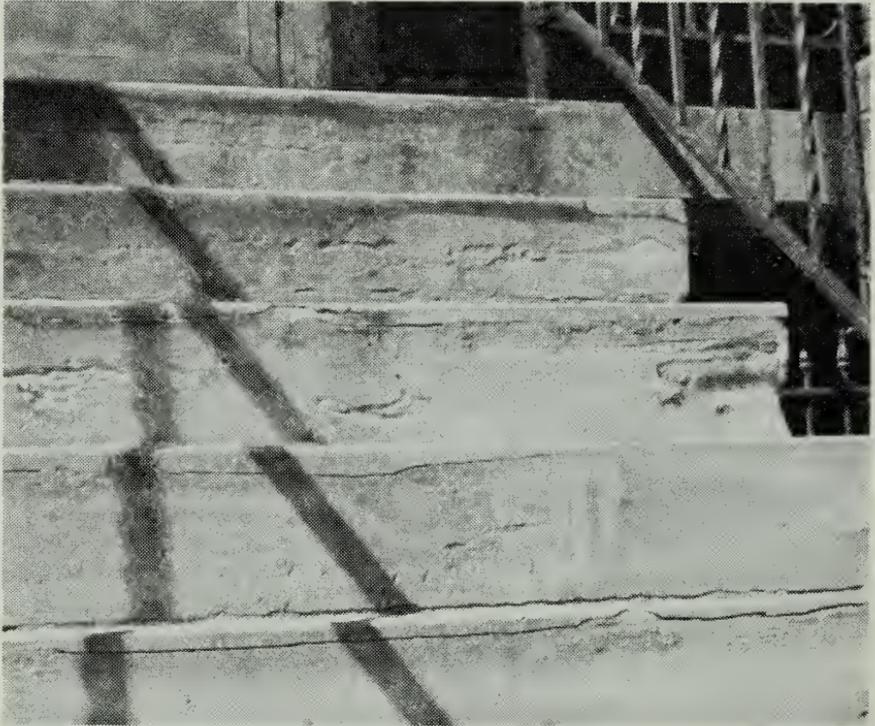
Wearing away of the surface, edges, corners or carved details of masonry slowly and usually by the natural action of wind or windblown particles and water. Erosion is one of the most serious kinds of adobe deterioration.

*Differential erosion of sandstone steps follows bedding planes of greater and lesser resistance. Photograph: Anne E. Grimmer.*

*Preservation Treatment:* See Replacement/Patching with Like or Compatible Substitute Materials, p.59.

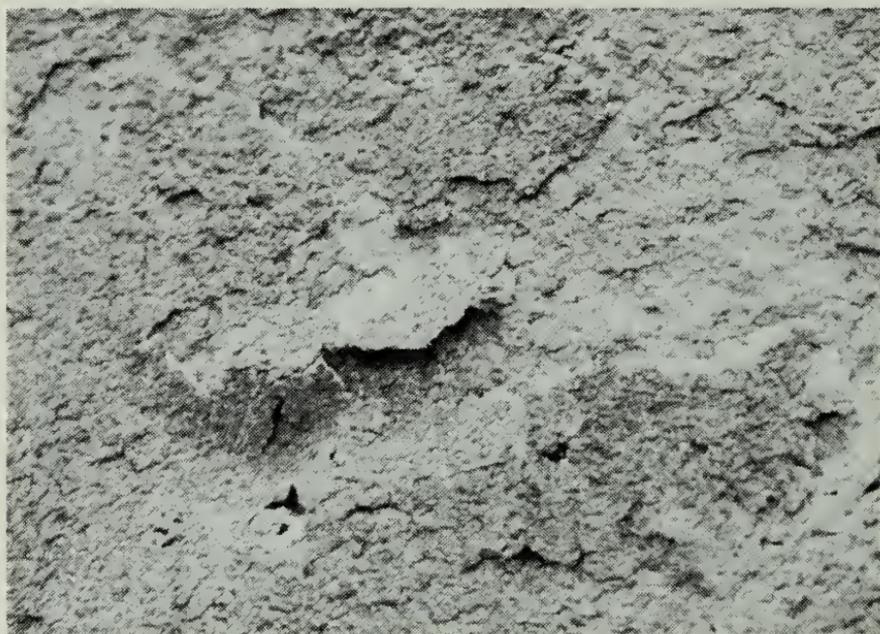
Flaking is an early stage of peeling, exfoliation, delamination or spalling, and is best explained as the detachment of small, flat, thin pieces of the outer layers of stone from a larger piece of building stone. Flaking is usually caused by capillary moisture or freeze-thaw cycles that occur within the masonry. The application of a water-repellent coating may result in flaking of the masonry when trapped moisture is forced to the surface.

*Flaking of granite. Photograph: Baird M. Smith, AIA.*

*Preservation Treatment:* To date, no completely effective treatment has been developed for this condition.

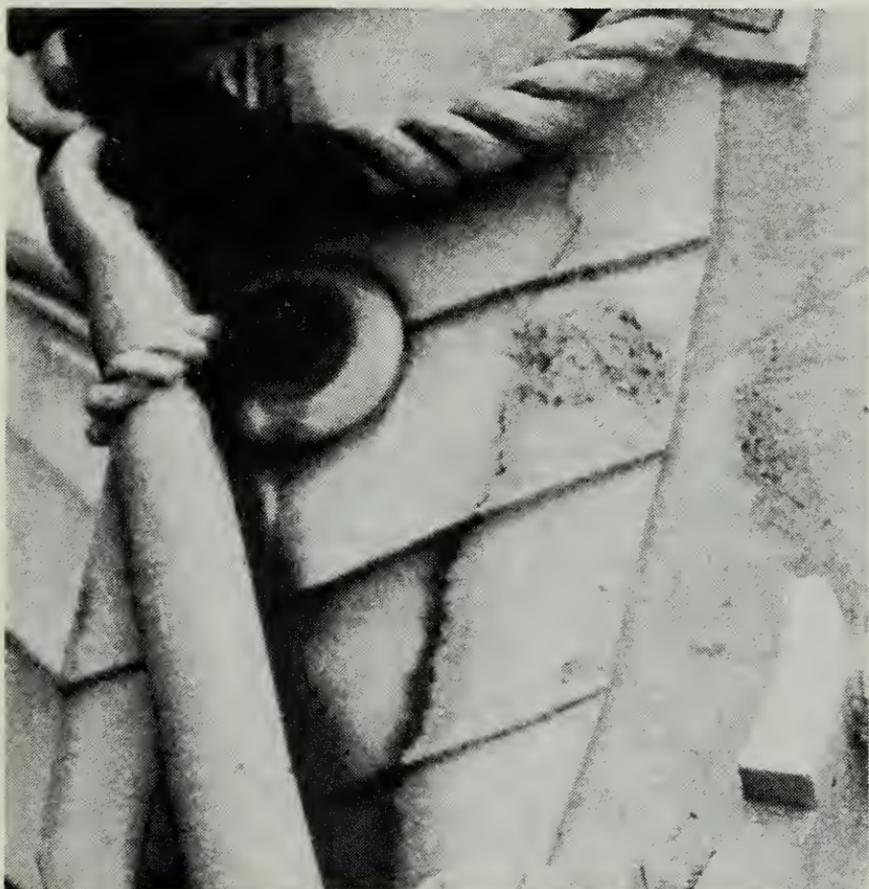
*Friability in limestone. Photograph: Anne E. Grimmer.*

*Preservation Treatment:* See Consolidation, p.52.

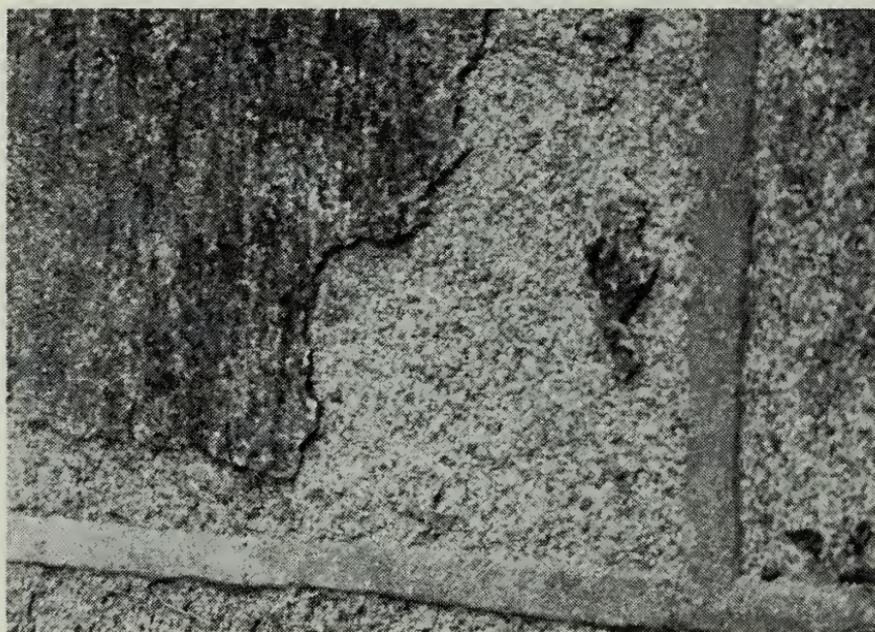
Peeling of stone may be caused by an inherent defect in the surface of the masonry or the result of weathering. Improper application of a masonry coating may result in a lack of adhesion to the substrate, and cause the surface of the masonry or coating to flake or peel away from the substrate in strips or layers.

*Peeling of granite. Photograph: Baird M. Smith, AIA.*

*Preservation Treatment:* To date, no completely effective treatment has been developed for this condition.

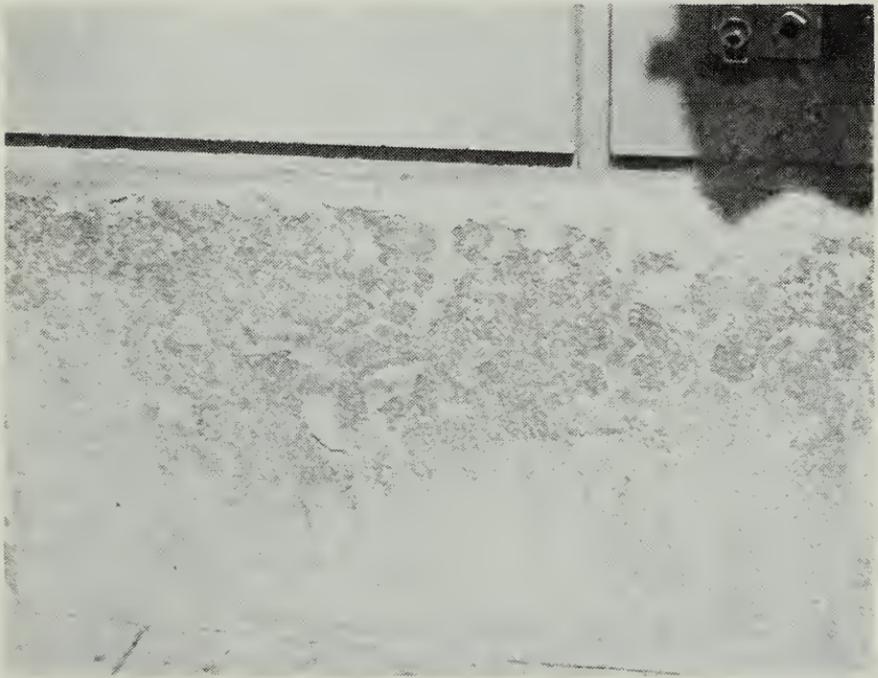
Sometimes called salt erosion, this condition results in an obvious pattern of erosion or etching of the stones caused by salt, usually from the salting of icy sidewalks. Unless the use of de-icing salts is discontinued, this condition can eventually result in spalling and exfoliation of the stone surface.

*Salt fretting on granite base probably resulting from use of de-icing salts on sidewalk. Photograph: Anne E. Grimmer.*

*Preservation Treatment:* To date, no completely effective treatment has been developed for this condition.

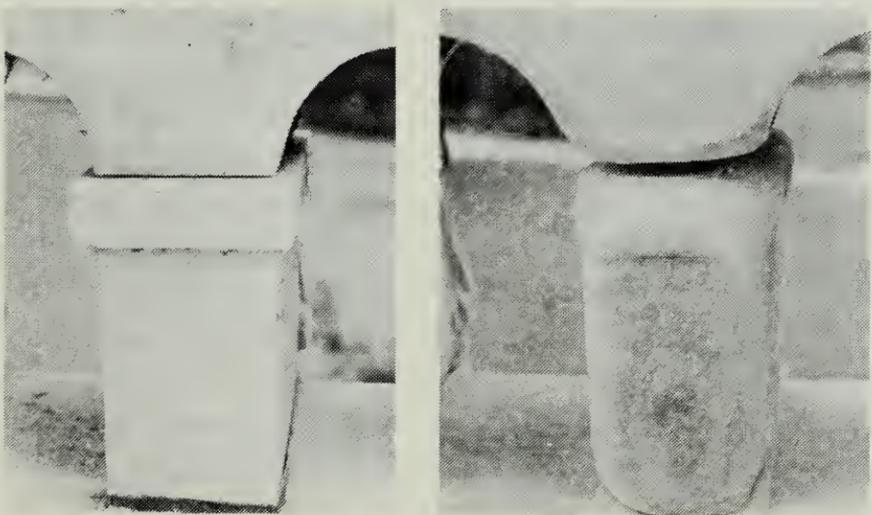
*Weathering has reduced the formerly sharp edges and rounded the corners of this marble baluster. Photograph: John H. Myers.*

*Preservation Treatment:* Replacement/Patching with Like or Compatible Substitute Materials, p.59.

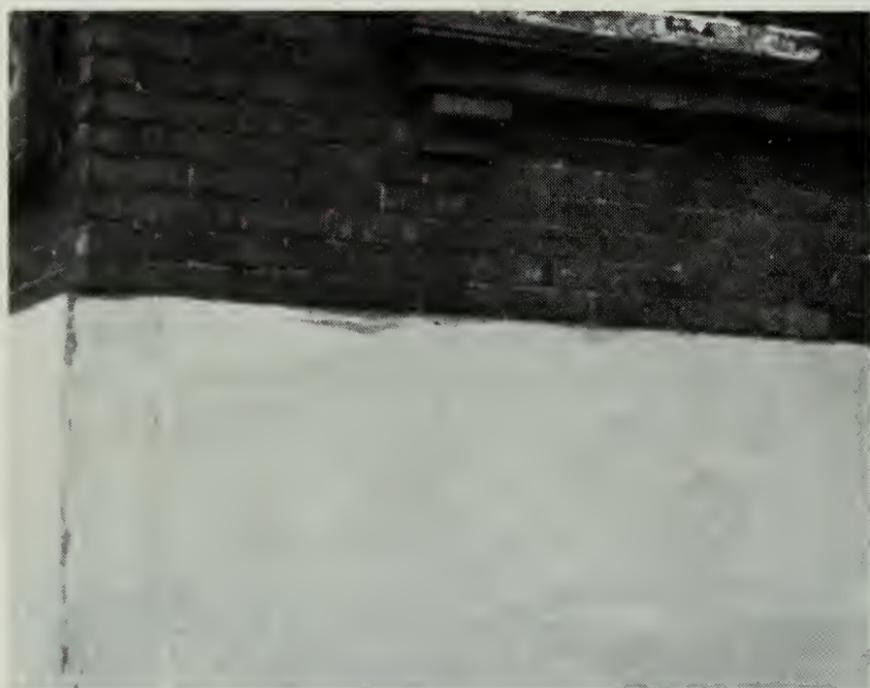
In masonry construction, a thin coat of cement mortar (often containing dampproofing ingredients) applied to provide a smooth surface for rough masonry, or as a dampproofing measure for rough masonry, foundation and basement walls. In Great Britain, parging or pargeting describes the traditional decorative plastering of the exterior, including timbers, with a tough lime plaster reinforced with ox-hair and decorated with impressions or patterns made with a mold or comb.

*Parging over brick. Photograph: National Park Service.*

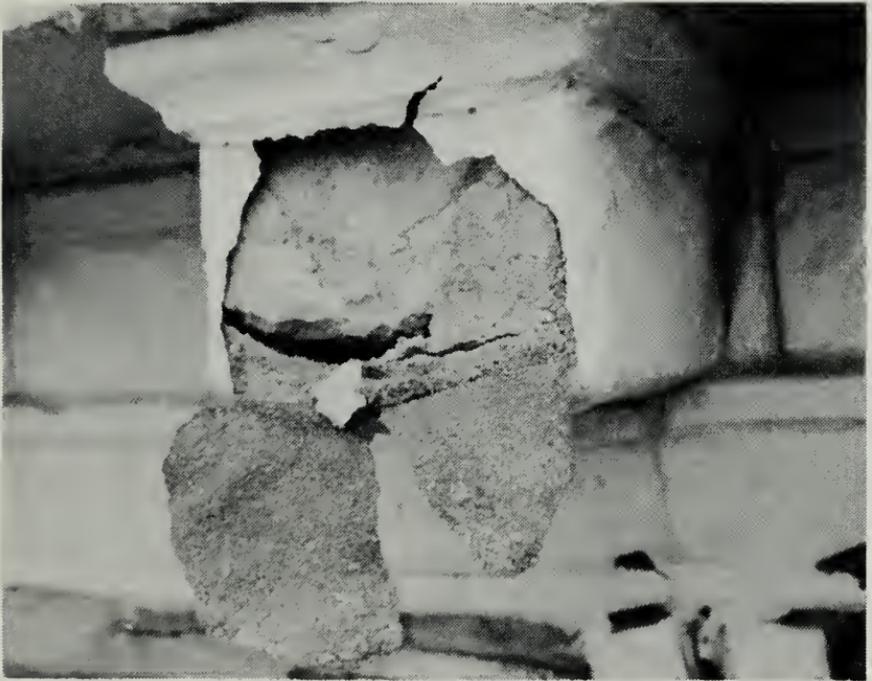
*A neoprene coating over a limestone cornice has trapped water (which entered through leaks in the parapet) inside these stone dentils. The built-up water pressure has finally forced the coating to pop off, taking with it pieces of the stone. Photograph: National Park Service.*

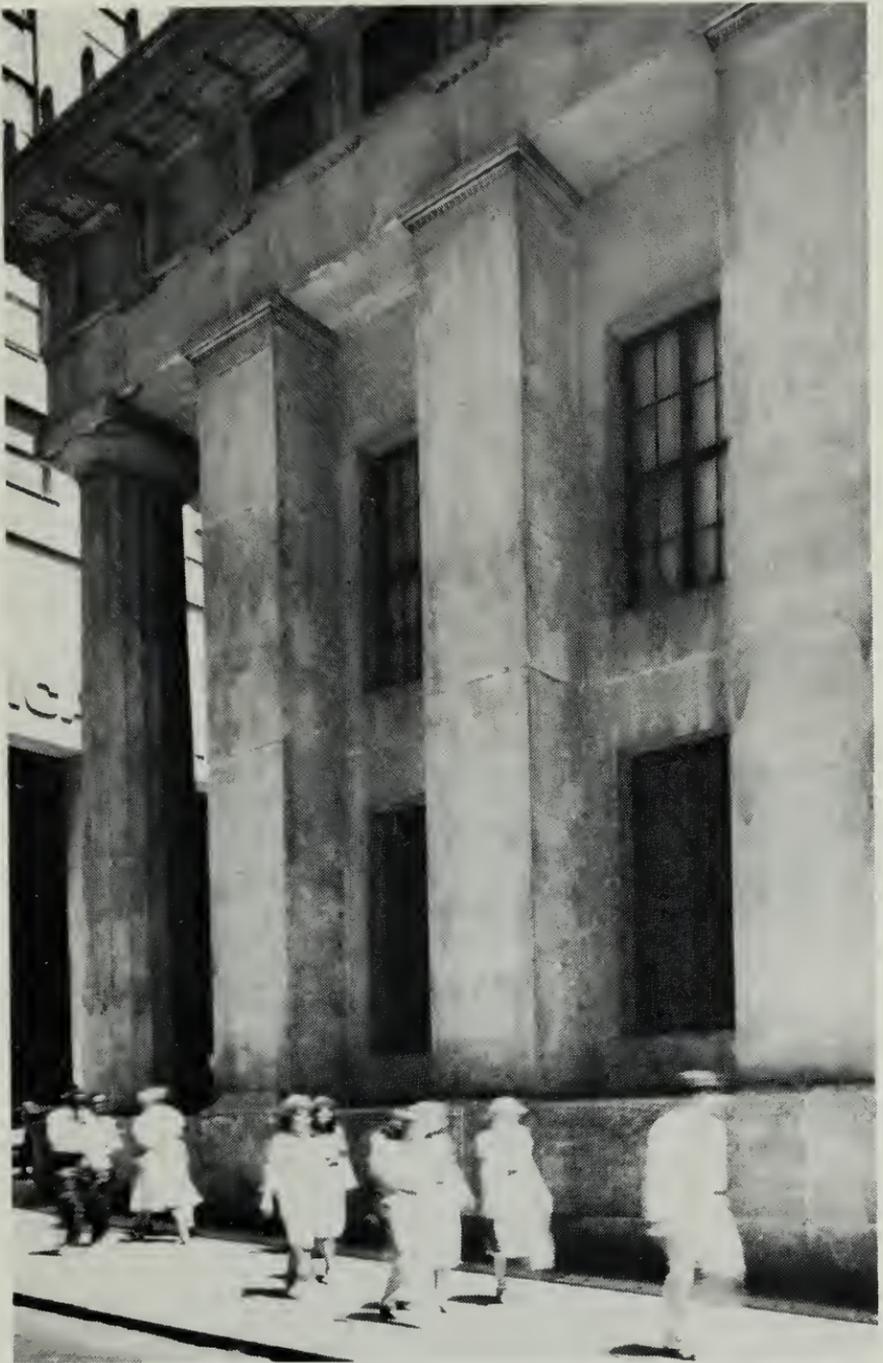
*Water-repellent coating improperly applied gives a blotchy appearance to the stonework. Photograph: Walter Smalling.*

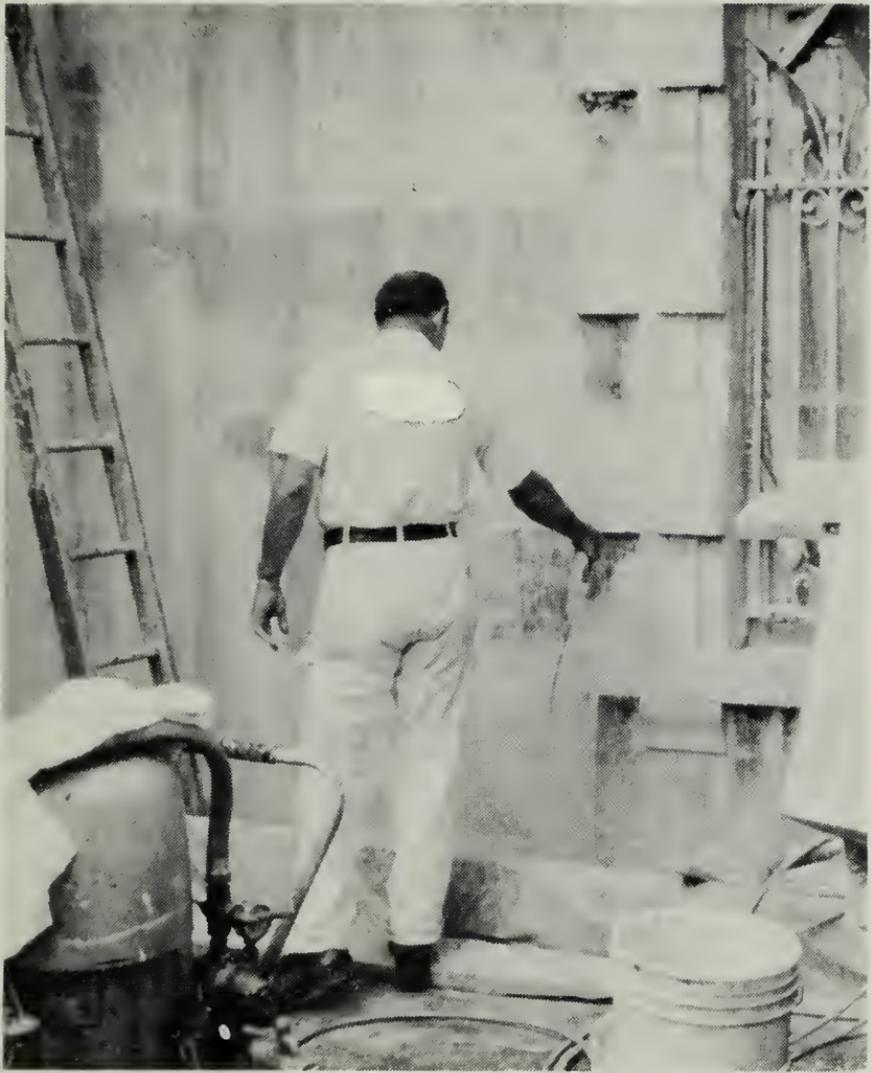
*Paint removal from sandstone. Photograph: Baird M. Smith, AIA.*

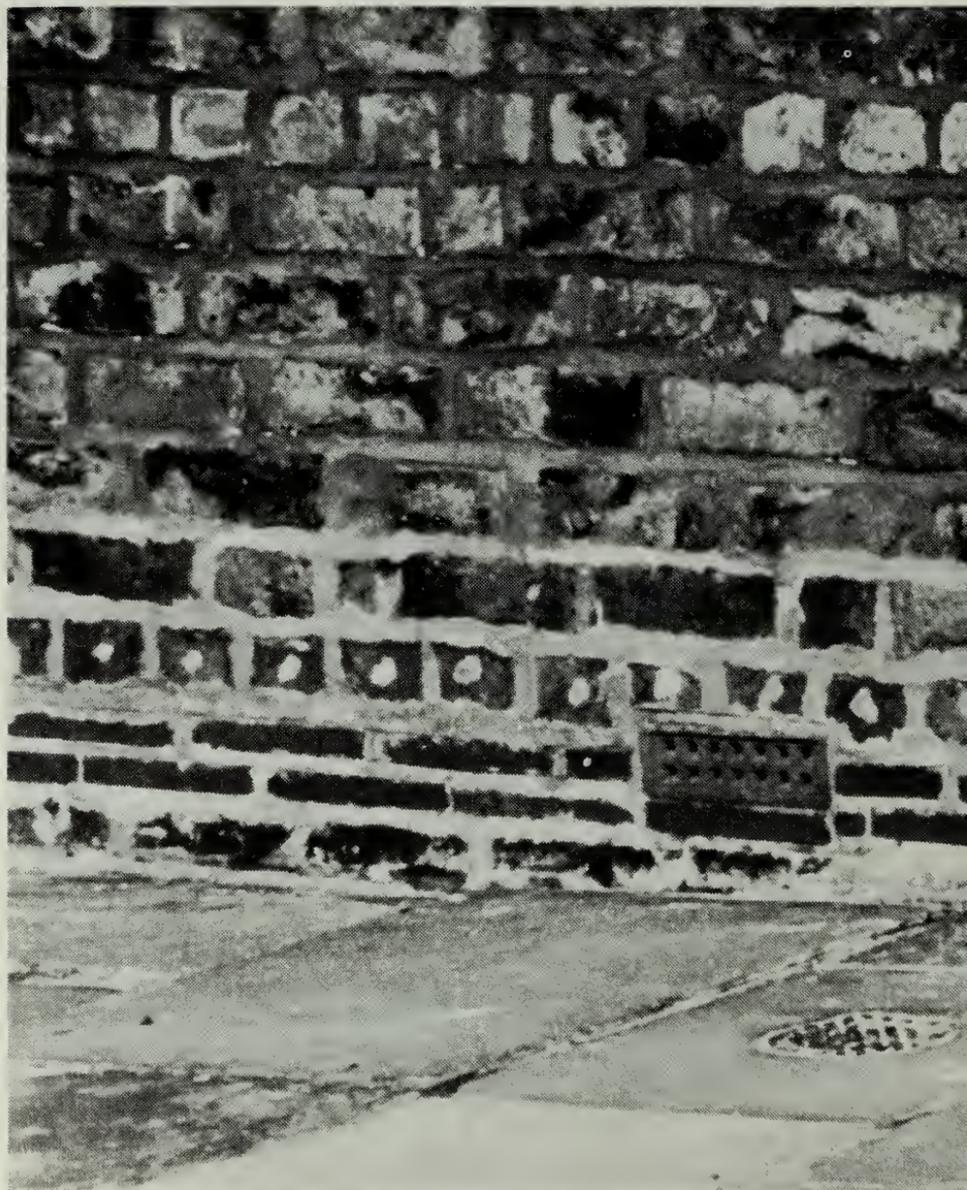
*The horizontal row of white dots in the brick headers indicates that a chemical dampproof course has been injected. Photograph: Baird M. Smith, AIA.*
