## A HISTORIC STRUCTURE REPORT OF FIRST FORT, SECOND FORT, AND THE ARSENAL AND HISTORICAL BASE MAP

### FORT UNION NATIONAL MONUMENT FORT UNION, NEW MEXICO

by  
Laura Soullieré Harrison  
and  
James E. Ivey

**Professional Papers No. 43**

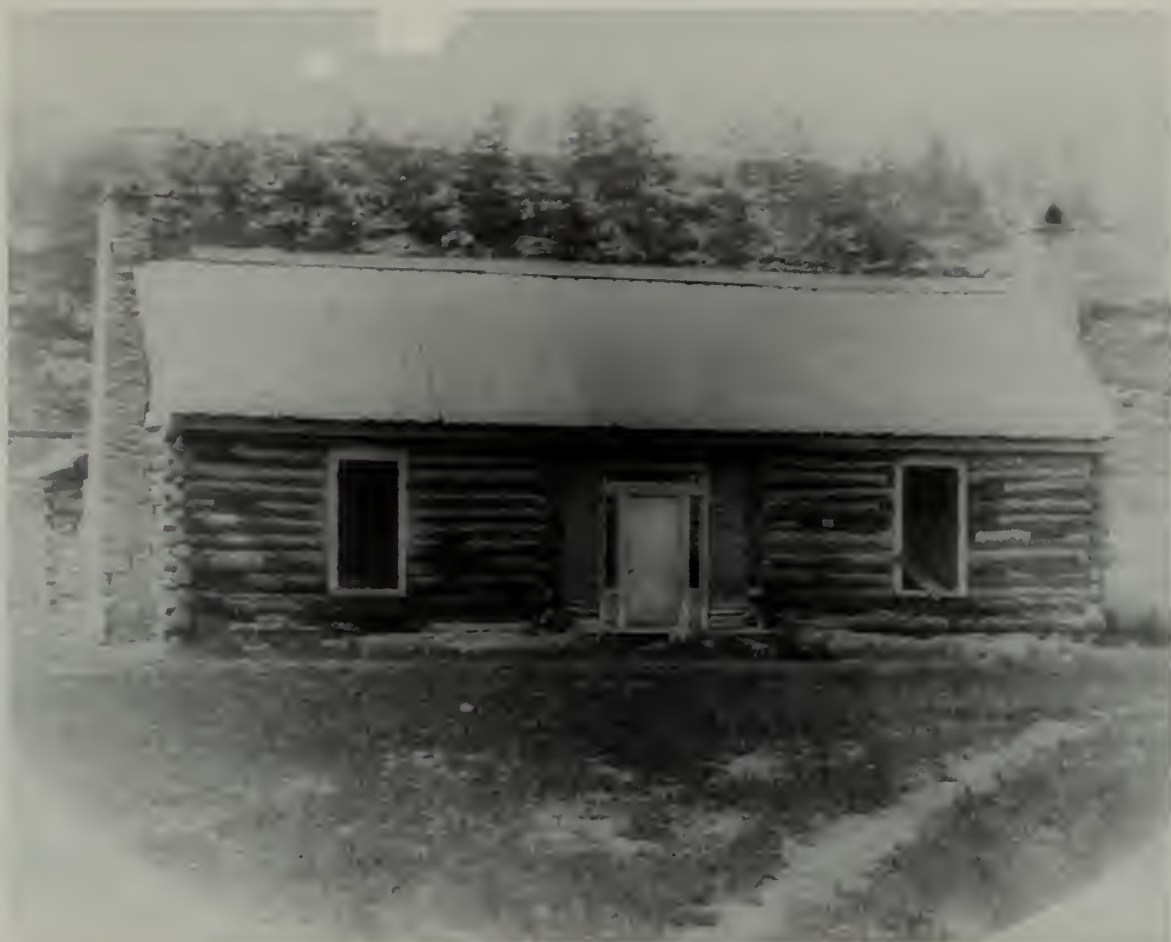
Figure 2. This building, identified in the files at Fort Union as the first fort, was taken from the east-southeast about 1865. It is either HS-129, 130, 131, or 132. The building has no foundation, and the sill logs lie on the ground. The building has a board roof, gable-end chimneys, a log addition (kitchen) to the rear behind which is the stockaded fence for the yard. Katie Bowen described her house (which would have been similar) as containing a central hall, one bedroom, and a parlor for the principal rooms, with a kitchen, store room, and servant's room at the rear of the building, and servant's sleeping room attached. Museum of New Mexico.

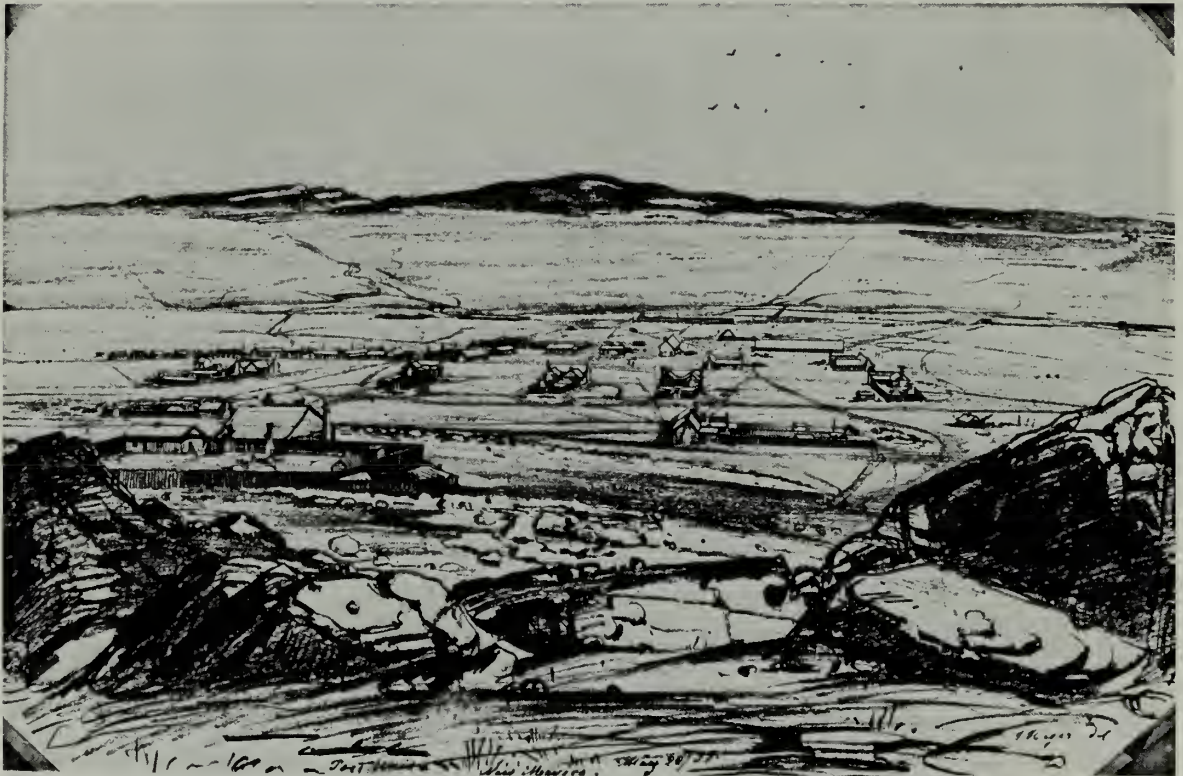
Figure 3. This 1859 drawing of the first Fort Union depicts the general layout of the installation. The Commanding Officer's Quarters sat on a rise above the fort proper. Note the layout of the officer's quarters with their fenced yards, the paths and roadways connecting different areas of the fort. Of particular note is the Commanding Officer's Quarters on the left of the sketch. The ridge line and placement of the chimneys is different than that of the other structures, possibly indicating expansion between the time of construction in 1851 and this drawing (1859). Drawing by Joseph Heger. Arizona Historical Society.

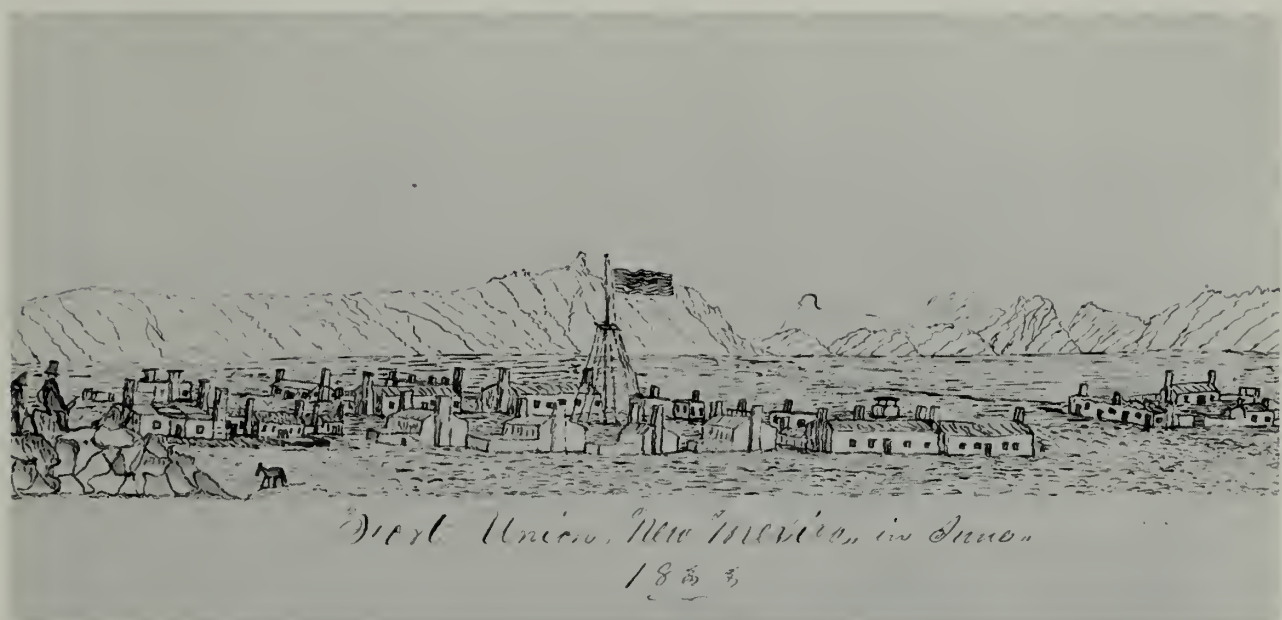
Figure 4. This primitive sketch of Fort Union in 1853 appeared in *A Cannoneer in Navajo Country: Journal of Private Josiah M. Rice, 1851*. Although the sketch lacked the detail given by more accomplished artists, the drawing showed certain architectural features. On the right, some of the buildings retained flat, earthen roofs. Kansas Historical Society.

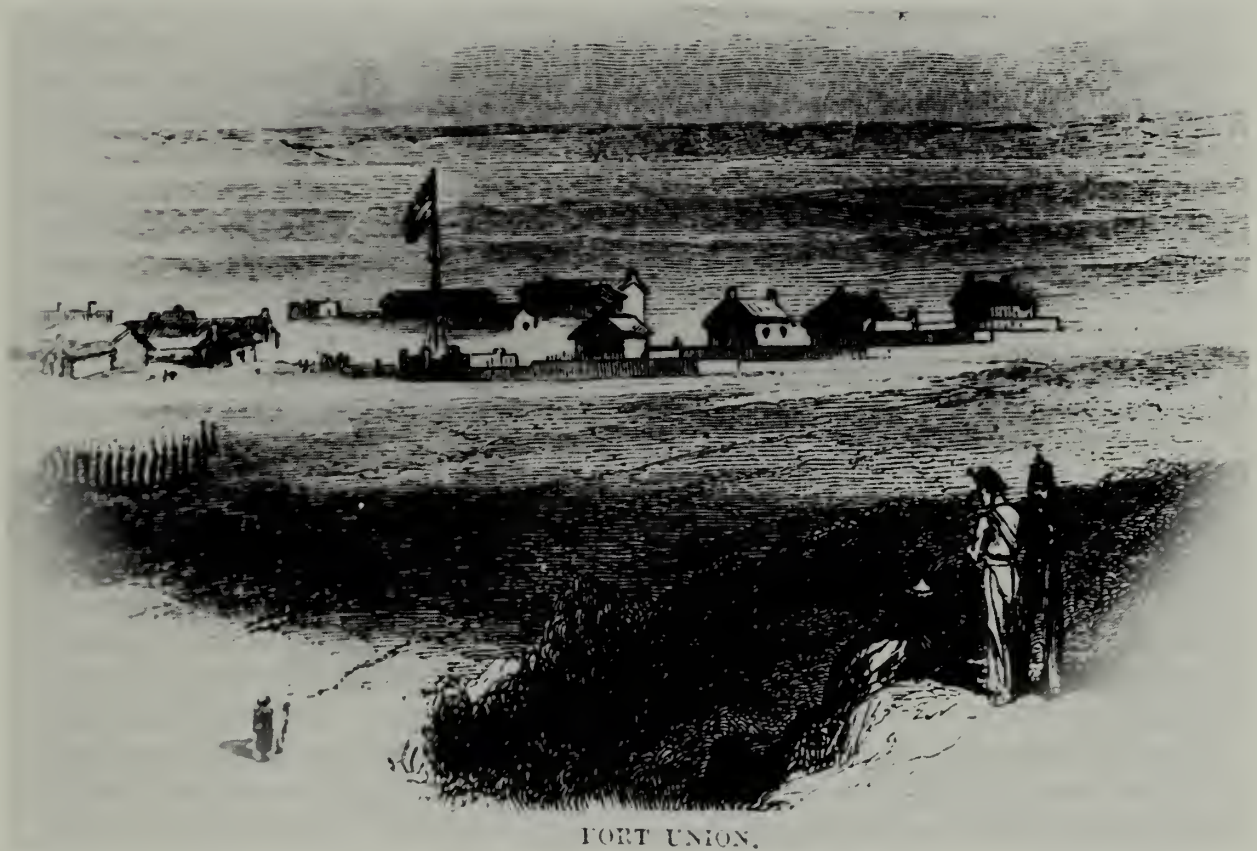
FORT UNION.

Figure 5. This depiction of Fort Union showed the simplicity of construction of the buildings of the fort, along with the apparent regularity of the development around the flagstaff. This appeared in the W.W.H. Davis book *El Gringo; or New Mexico and Her People*, published in 1857. Davis visited Fort Union in 1853.

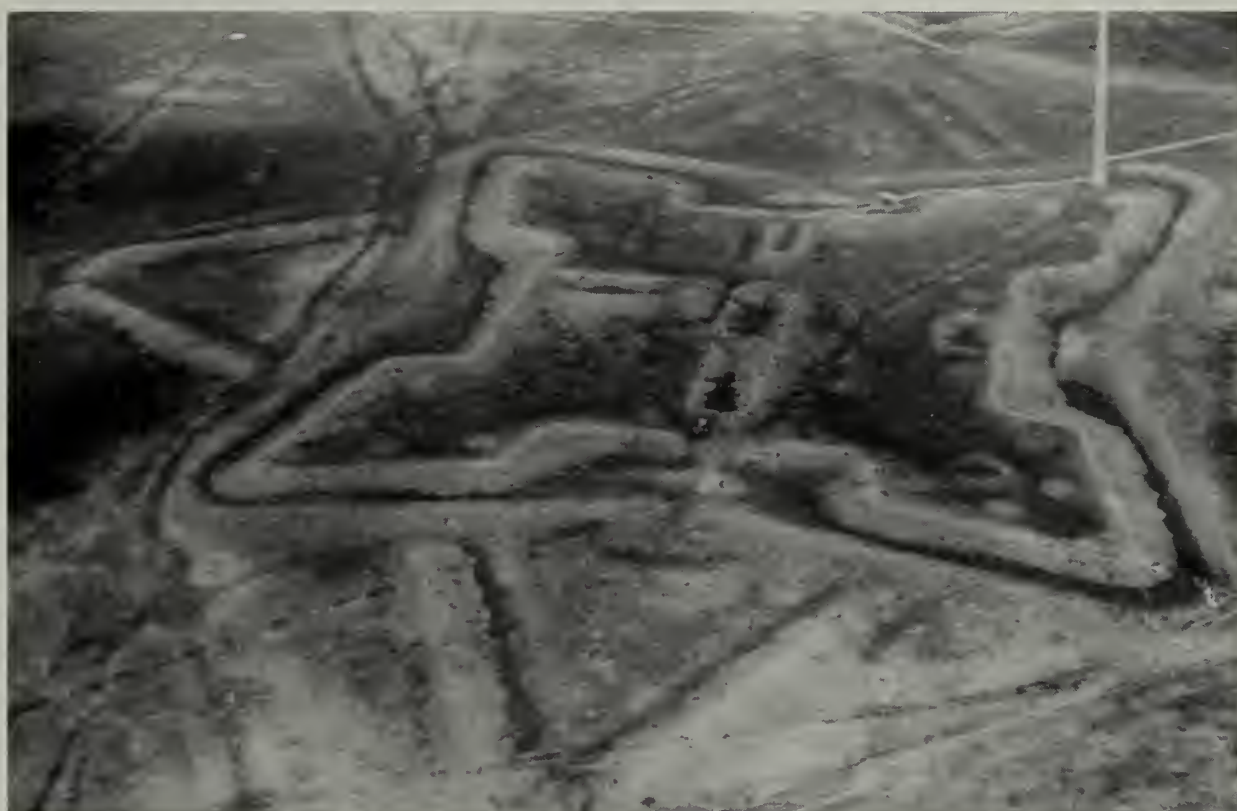
Figure 6. The second Fort Union was an earthen fortification laid out in the shape of an eight-pointed star. This photograph was taken from the southwest in 1930. Fort Union National Monument.

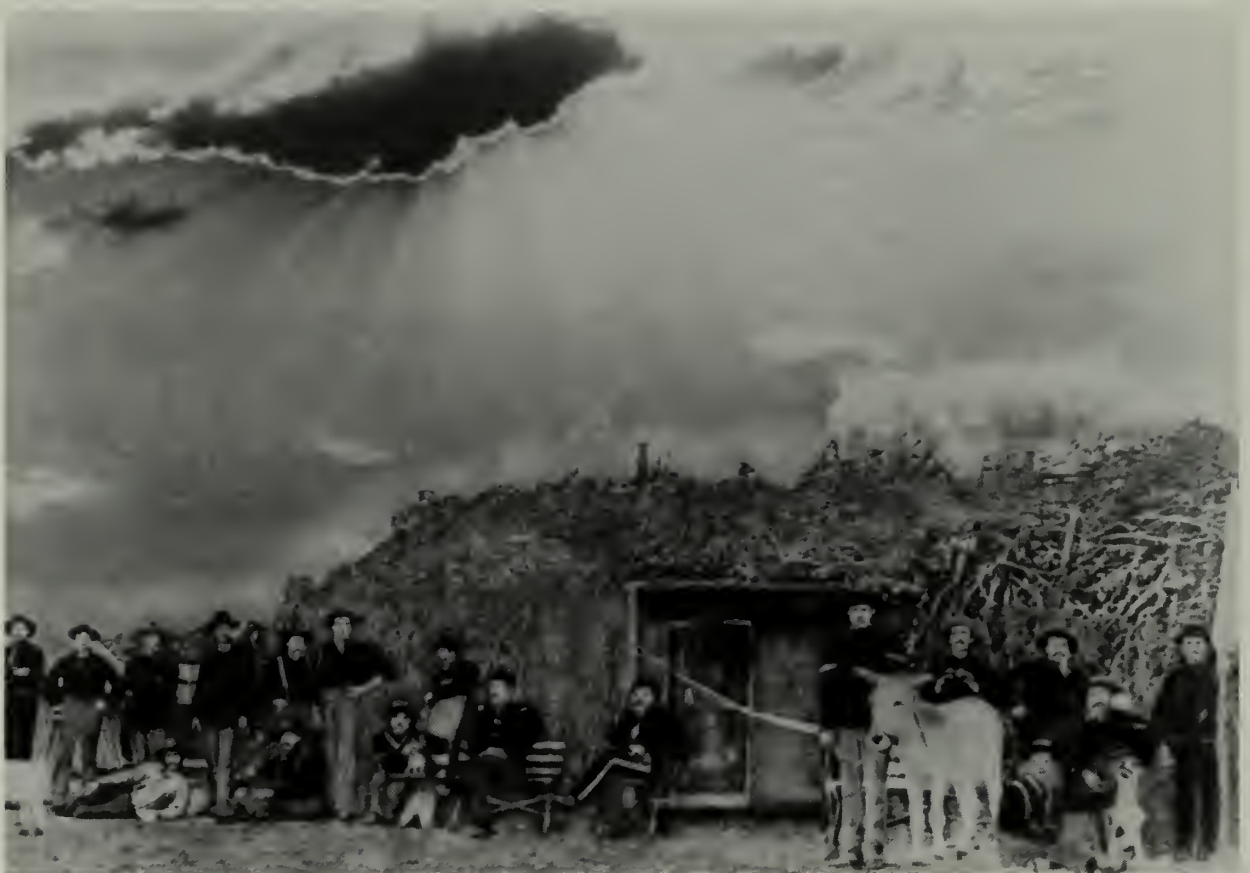
Figure 7. This photograph shows the approximate scale of the earthen fortification as well as some aspects of its construction. This is the south angle of either HS-206 or 207, the enlisted barracks in the redans. The branches overlying the parapet retarded erosion. Log framing outlined the entrance. Fort Union National Monument.

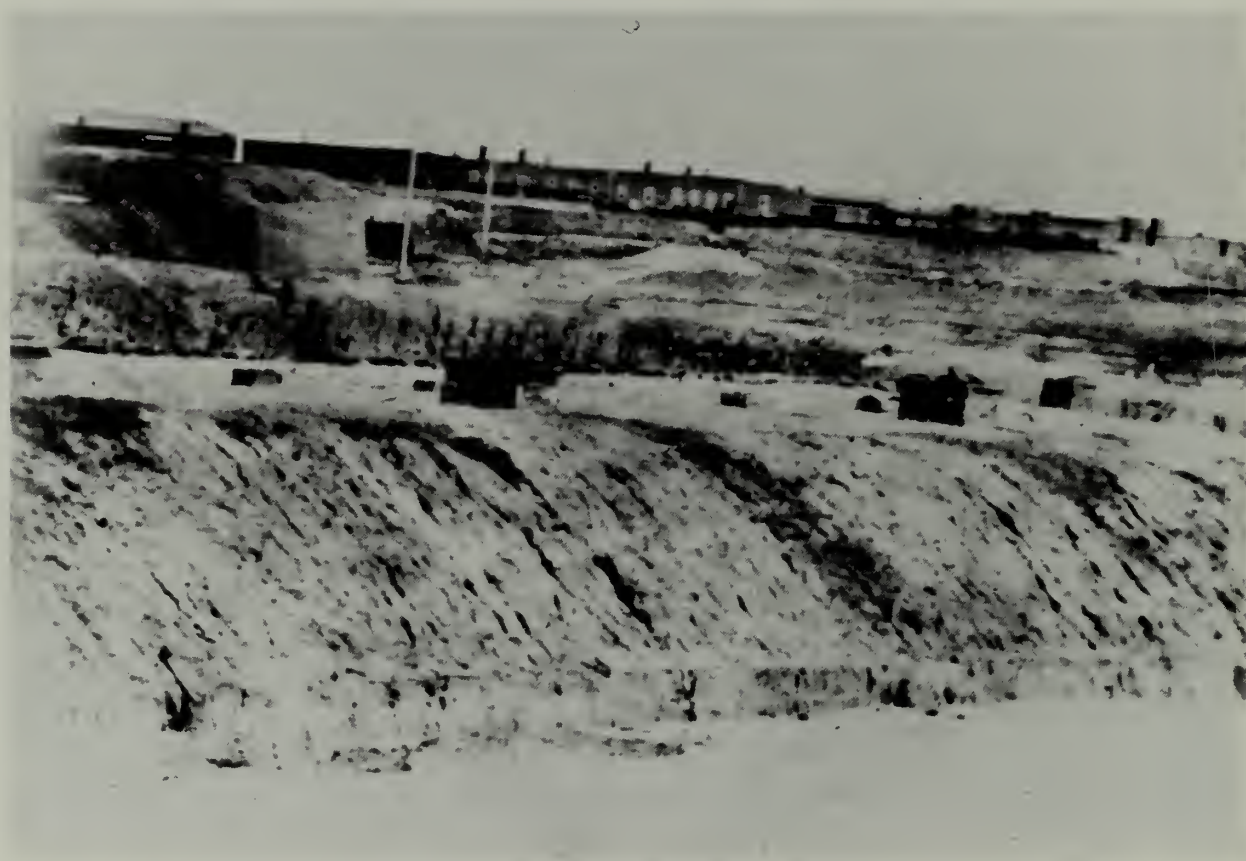
Figure 8. This photograph of the star fort shows the deterioration of the earthwork due to erosion. The brick chimneys pierce the roof of the redan, HS-205, at fairly regular intervals. The Third Fort Union is in the background. National Archives, Still Pictures Branch.

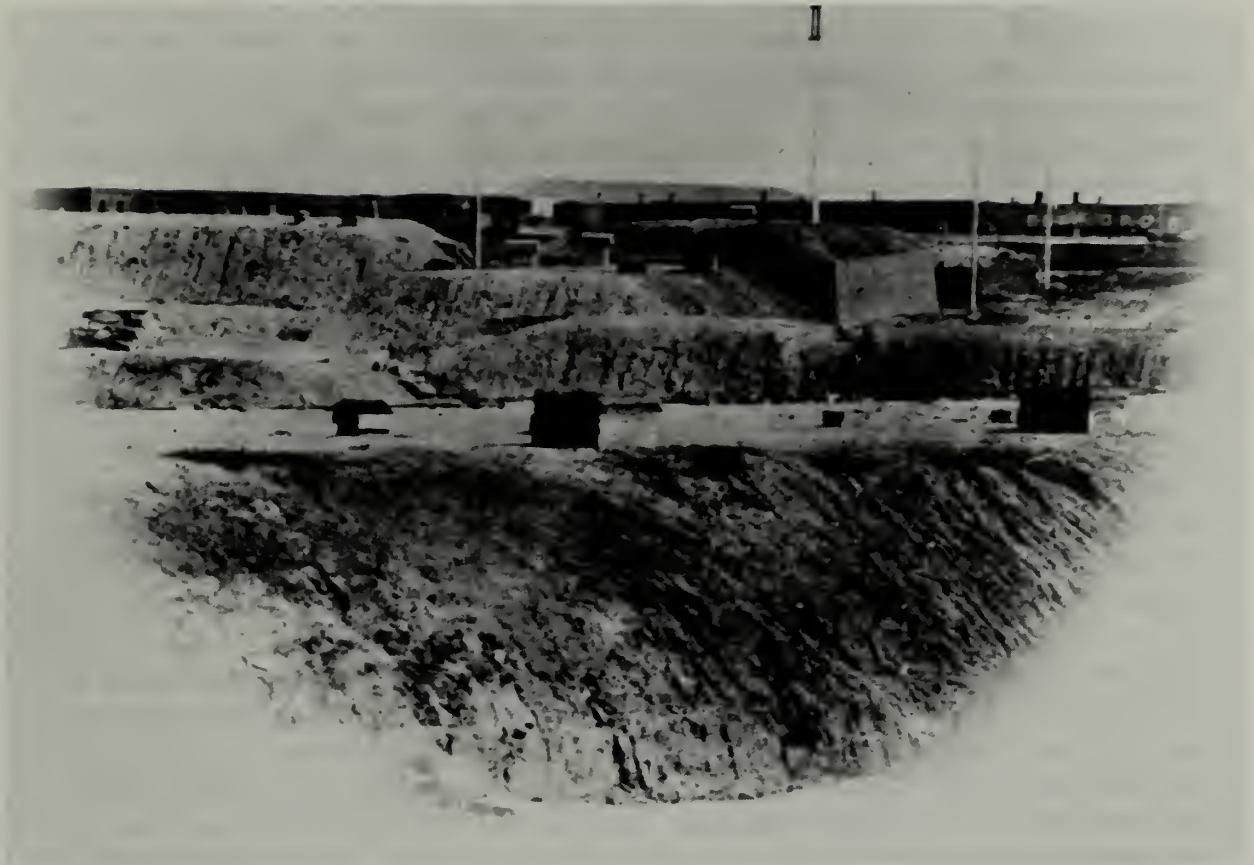
Figure 9. The rivulets of erosion are again obvious in this photograph of the earthworks taken in 1865. The lack of sod on the structures accelerated deterioration. National Archives, Still Pictures Branch.

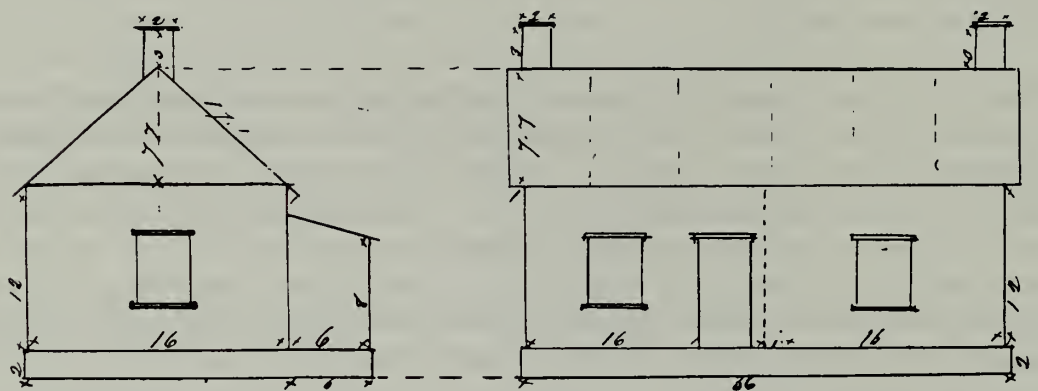
*Plan of a Set of Quarters for Hired employees at  
Union Arsenal, or other man with a family.*

*The house to be built of adobes & consisting  
of three rooms of 16x16 feet each. The third one,  
or kitchen, to be in rear of the main building  
a porch to extend the front of the building and  
a cellar under one room.*

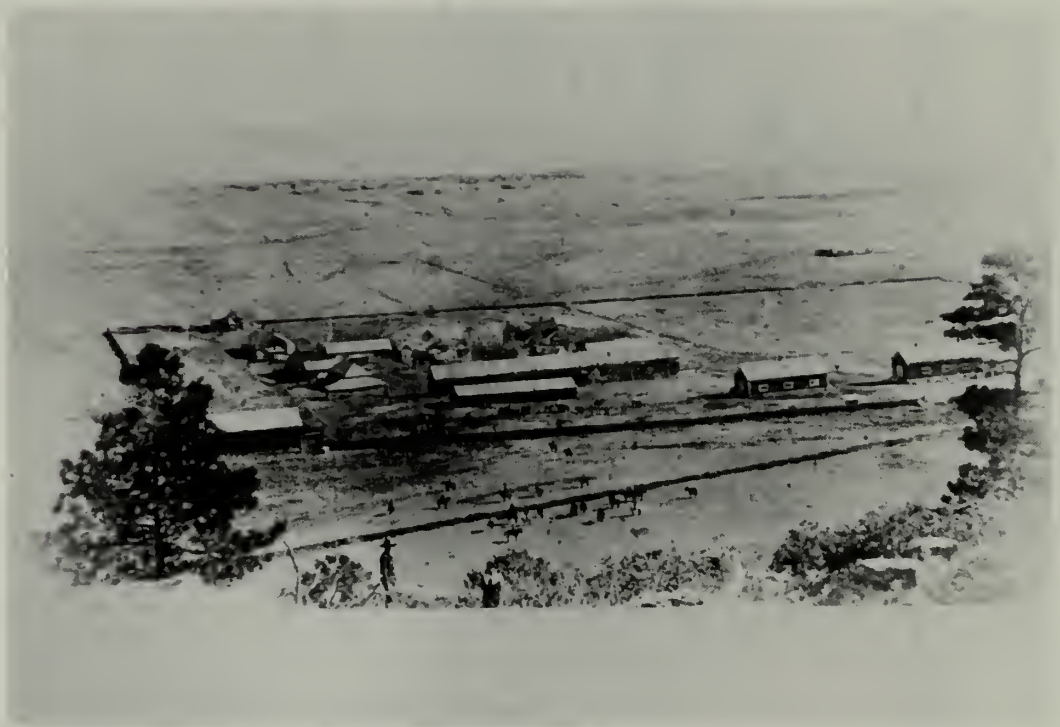
Figure 14. This photograph (ca. 1882) shows the arsenal installation at about the time of Shoemaker's retirement. He had completed all construction by this stage. Arizona Historical Society.

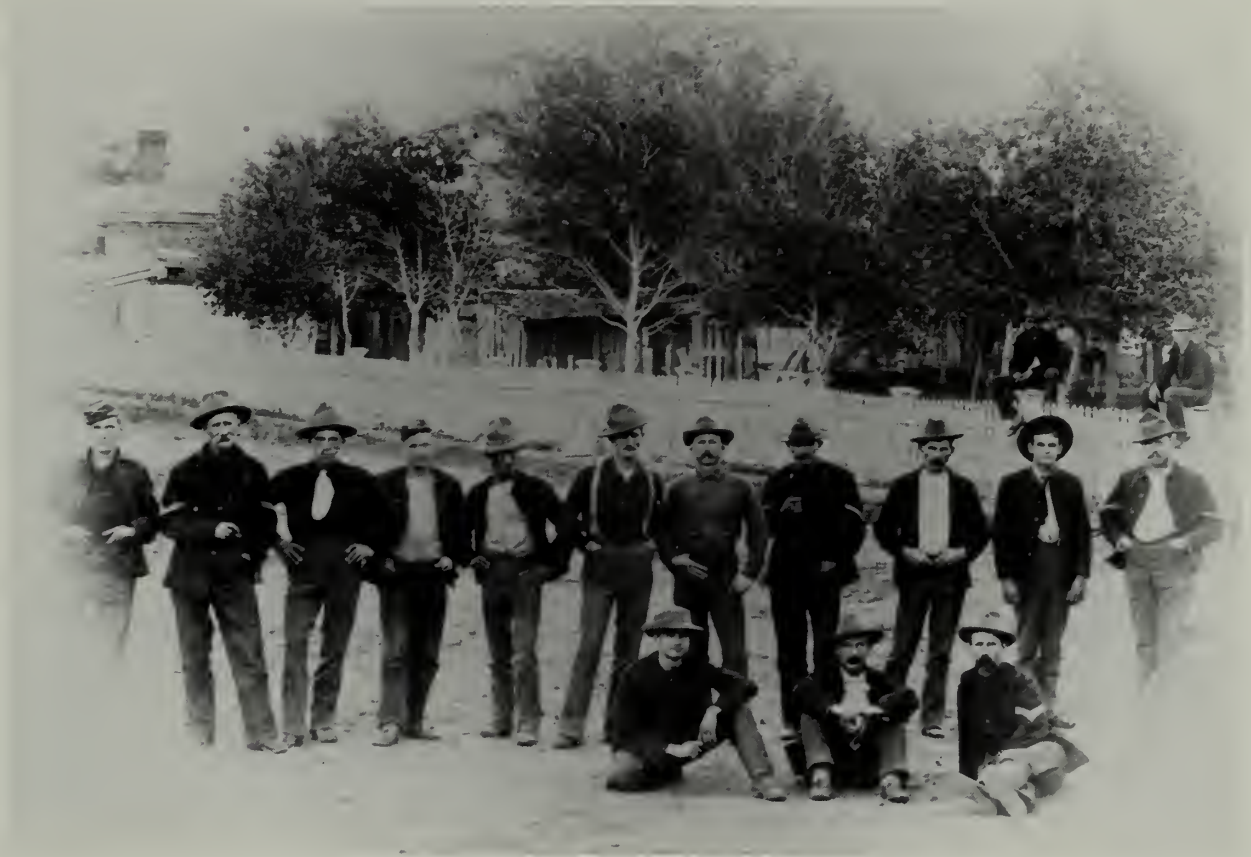
Figure 15. Although this photograph was taken after Shoemaker's death his impact on the land was still overwhelming. The wooden fence, shade trees, architectural details and gutters on the buildings were signs of permanent settlement. This was a dramatic change from the impermanent construction of Fort Union of the 1850s. Fort Union National Monument.

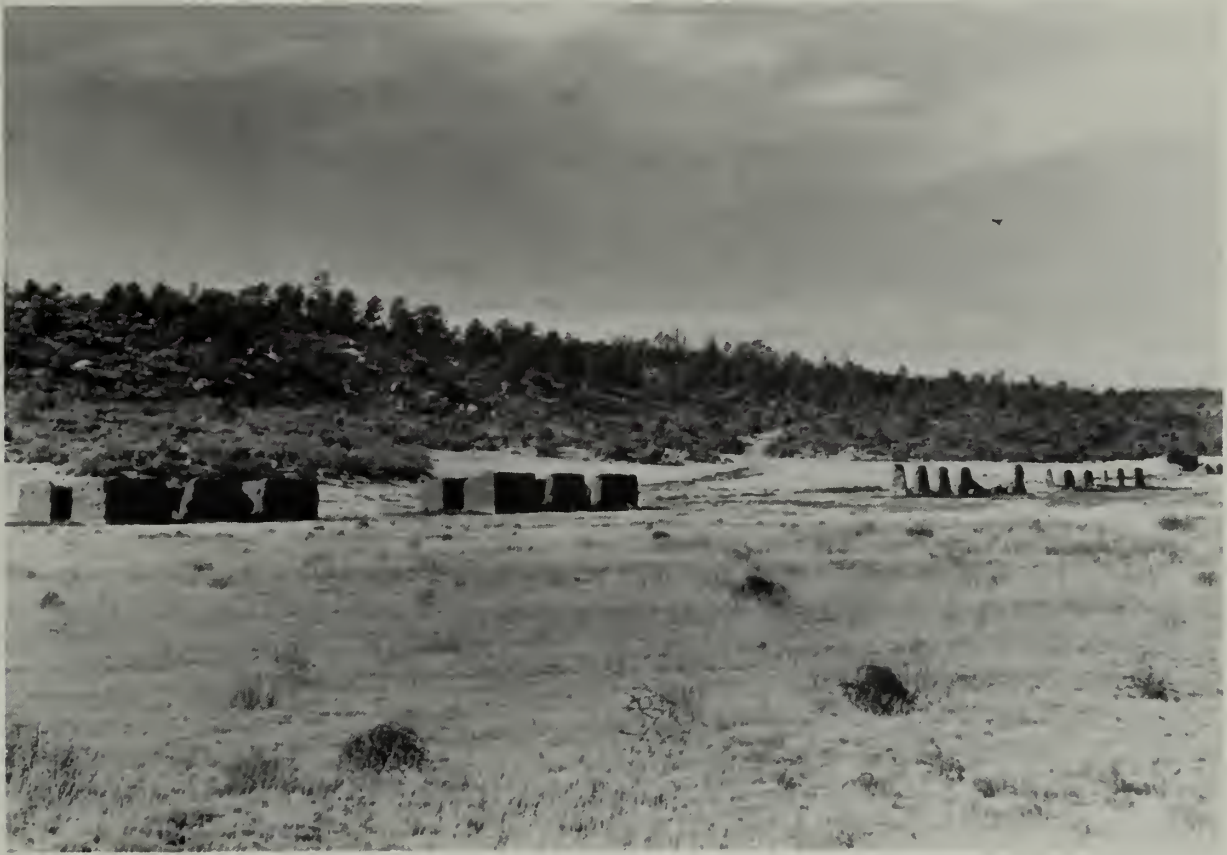
Figure 16. After the roofing materials and lumber were salvaged from the arsenal buildings, deterioration came rapidly.

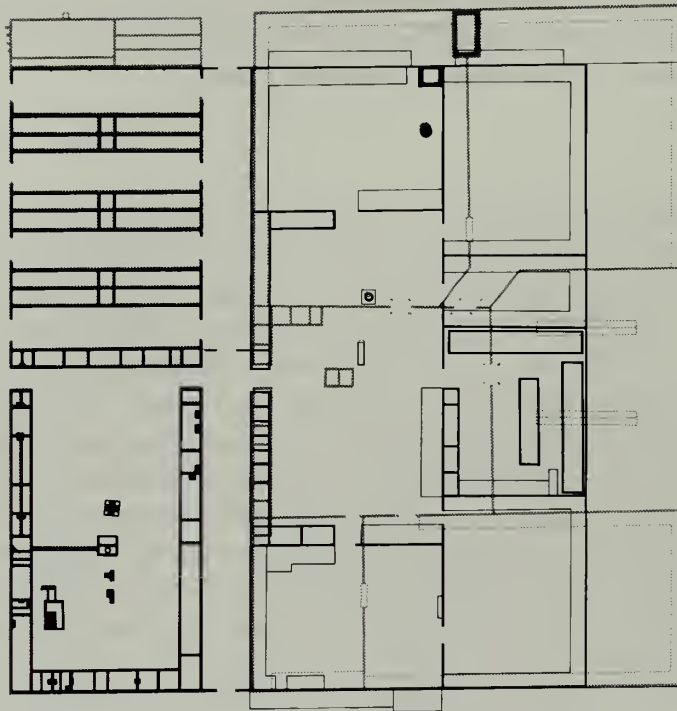
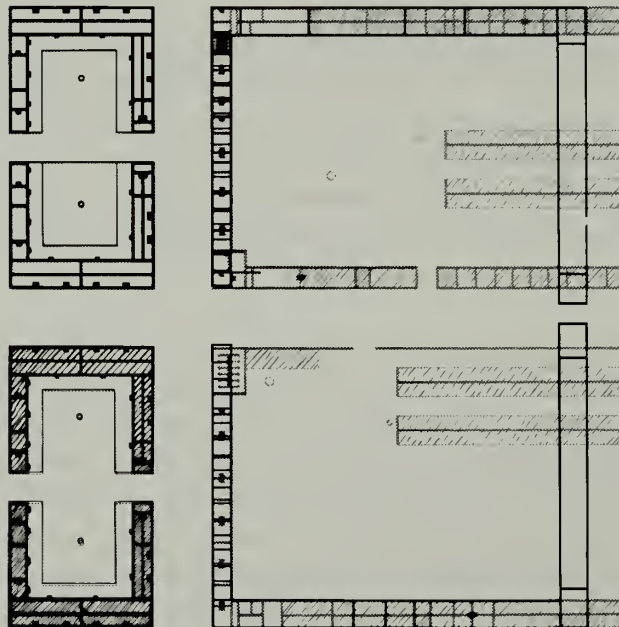
Figure 17. Early and later versions of the Post Corral and Depot Corral.
